Publication No. WI-2008-02

The Watershed Institute

Imminent Geologic & Hydrologic Hazards on Fort Ord BLM Lands, CA

Douglas Smith Ph.D., P.G.

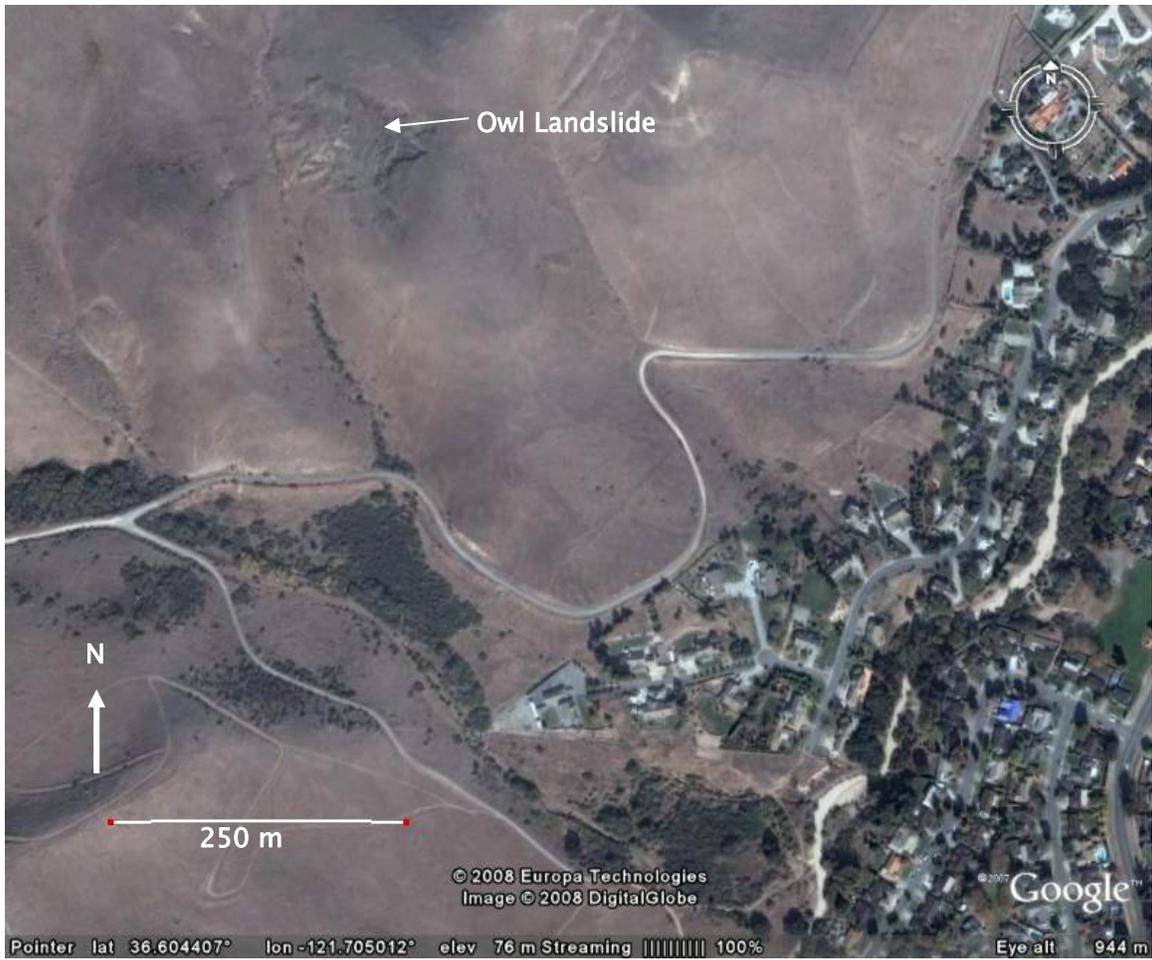
Debris flows form when water-saturated soil and moves down slope, commonly during intense rainfall events. The flows can move slowly or quickly, but typically have high strength. They are able to buoy large rock and wood pieces as they move along. Debris flows cause millions of dollars of damage to California properties each year. The Owl landslide is a large region with soil slip within colluvium of the Paso Robles Fm. It could form a debris flow given the right hydrologic conditions, and it is located up-gradient from residences (Figs. 1 and 2). Aerial photographic analysis indicates that the slope first failed during the 1998–1999 El Nino event (Smith et al., 2004). Monitoring of the landslide shows that it has not had significant movement since that time (Smith et al., 2004).

Figure 1: The Owl landslide and down-slope urban development

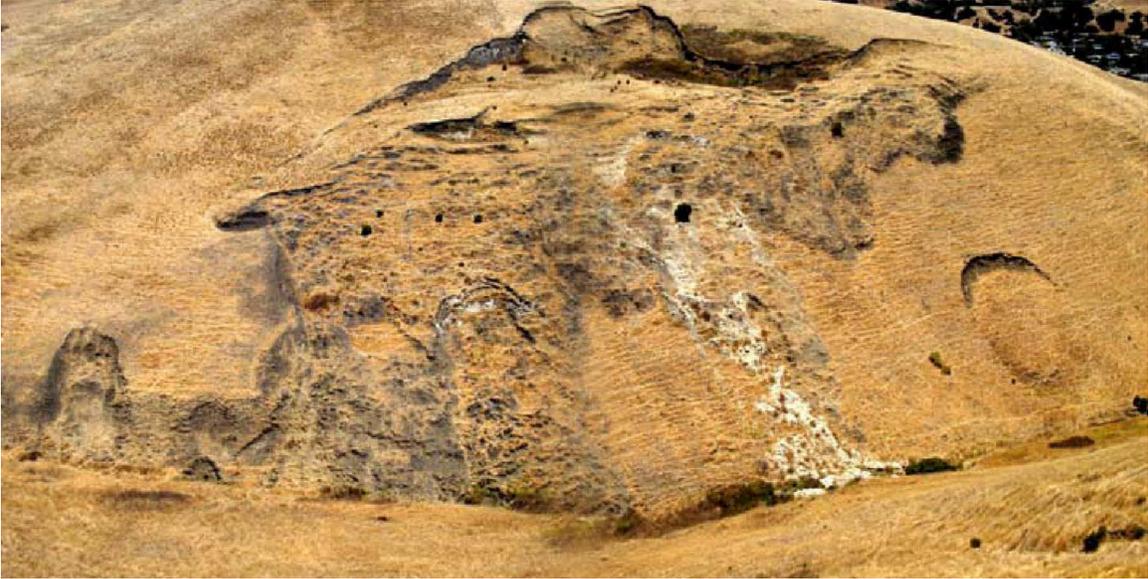
Figure 2: Close-up of Owl landslide. Photo montage of kite-born aerial photos (Smith, et al., 2004)

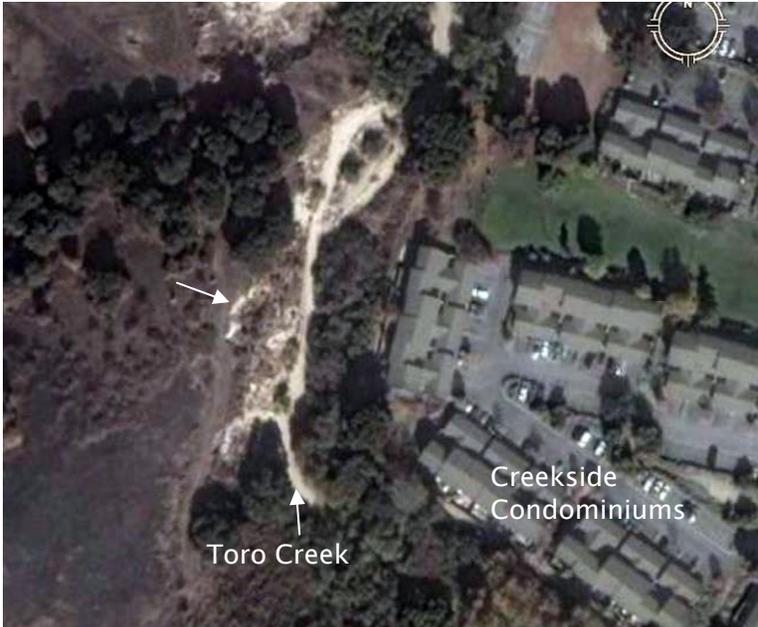
The Creekside Condominiums are located along the banks of Toro Creek (Fig. 3). The properties were flooded during the high water events of the 1998–1999 El Nino rains. Any aggradation or occlusion in the Toro Creek channel will add risk to flooding hazard in the condominiums.

Figure 2: Creekside landslide. Arrow shows headwall scarp.

The condominiums are on a low terrace on the right side of Toro Creek. The left bank, adjacent to the condominiums is a tall eroding slope with the potential for sudden failure leading to channel blockage. The bank is locally undercut and shows evidence of both historic and recent sliding. Although the volume of potential slide material is not large, it is certainly large enough volume to locally block the creek channel. High flow events could lead to catastrophic slope failure and instantaneous flooding of the adjacent condominiums. Recent site inspection verified that the toe of slide is being steepened by erosion during recent flow events.
