Publication No. WI-2020-02
03 June 2020

The Watershed Institute

Carmel River Reroute and Dam Removal Fish Passage Assessment (Spring 2020)

**Doug Smith (Ph.D.)
Mikaela Bogdan**

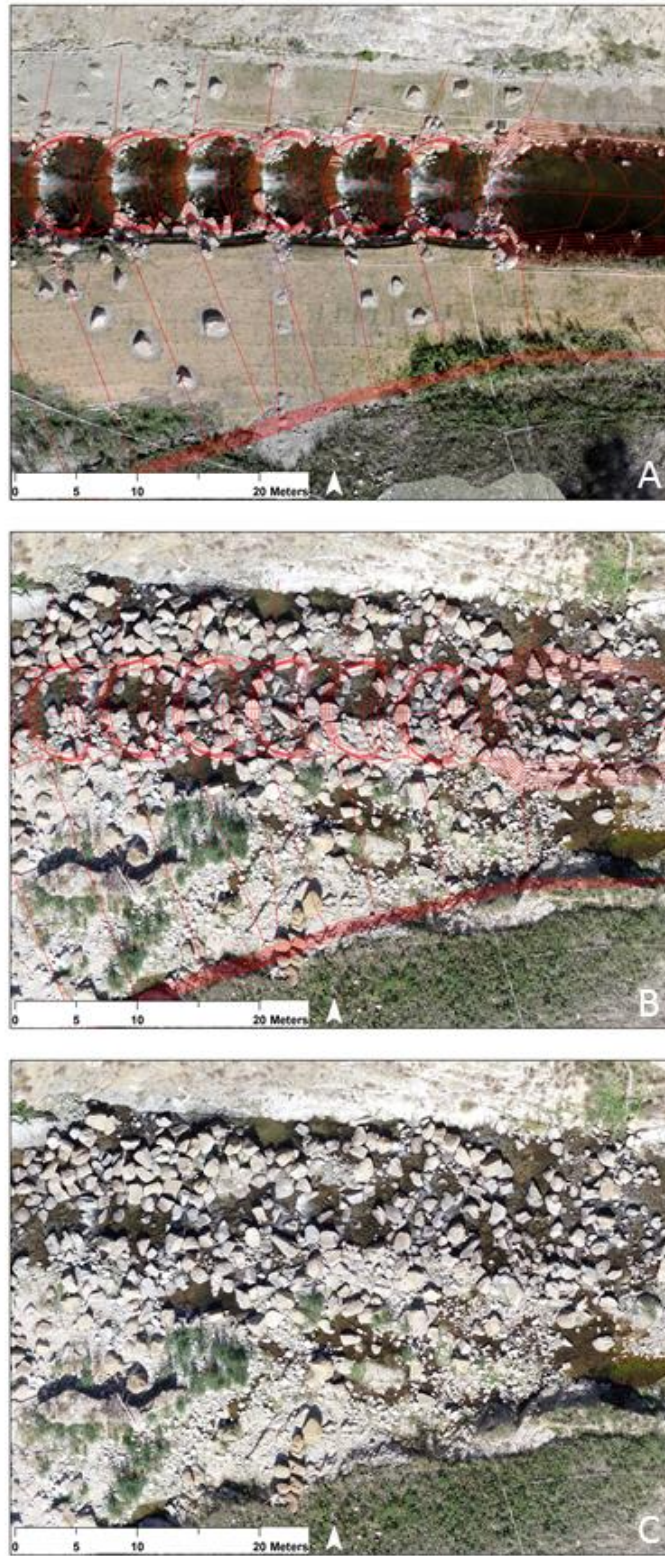
Figure 2. Example of step-pool sequences “auto-naturalized” by high flows of 2017. A) Design blueprint on step pool sequence in 2016. B) Same view as A in 2017. C) Same image as B with design removed.

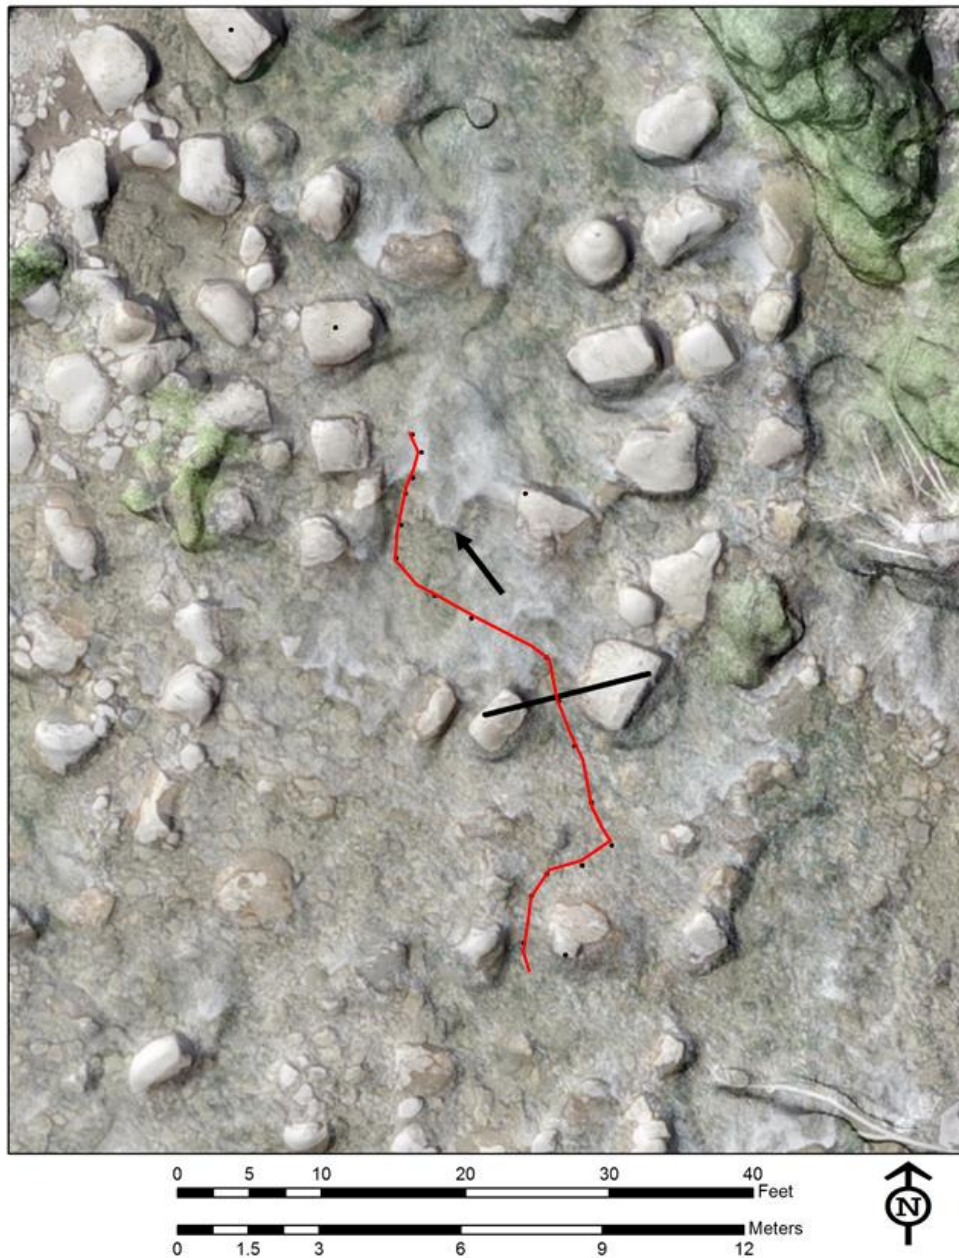
Site 1 (black bar in Fig. 5) is most favorable passage up a short step that had a maximum depth of approximately 0.9 ft (Figs. 6, 7, 8). The site is located approximately 10 ft upstream of an impediment (black arrow) surveyed as site 23 in summer 2018 and site 2 in 2019.

Figure 5. Site 1 showing locations of longitudinal profile (red) and cross section (black). Black bar indicates the cross section where shallow water is the most conducive path. Flow is to the north. Red dots are total station shots. Black arrow shows impediment surveyed in both 2018 and 2019 (Smith et al. 2018; 2019). Background image is blended orthophoto and hillshade obtained 5/2/2019 at a flow of 85 cfs.

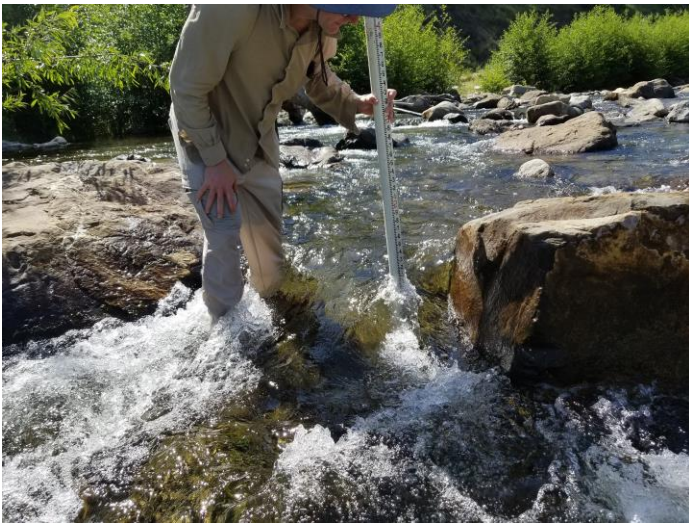
Figure 6. Site 1 field photo. Shallow conditions existed in the gap between boulders.

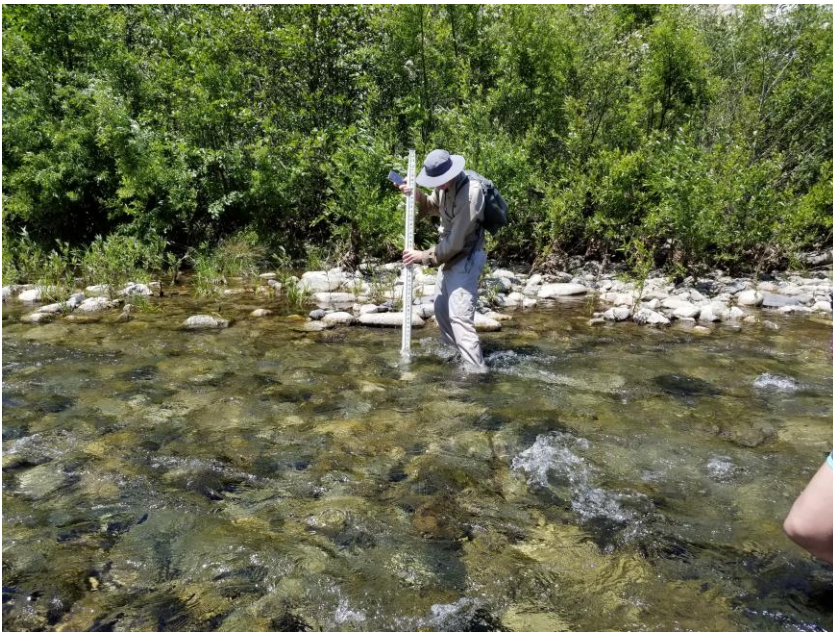
Site 2 (Fig. 9) is the head of a low-gradient riffle located 200 ft upstream of San Clemente Creek, within the reroute bedrock cut. The riffle was deeper than one foot except near the riffle crest (Fig. 10), which had a maximum depth of approximately 0.9 feet along the most favorable pathway (Figs. 10, 11, 12). This site was reported as site 43 in summer 2018 and site 4 in 2019.

Figure 10. Site 2 field photo. Shallow conditions observed at riffle crest.

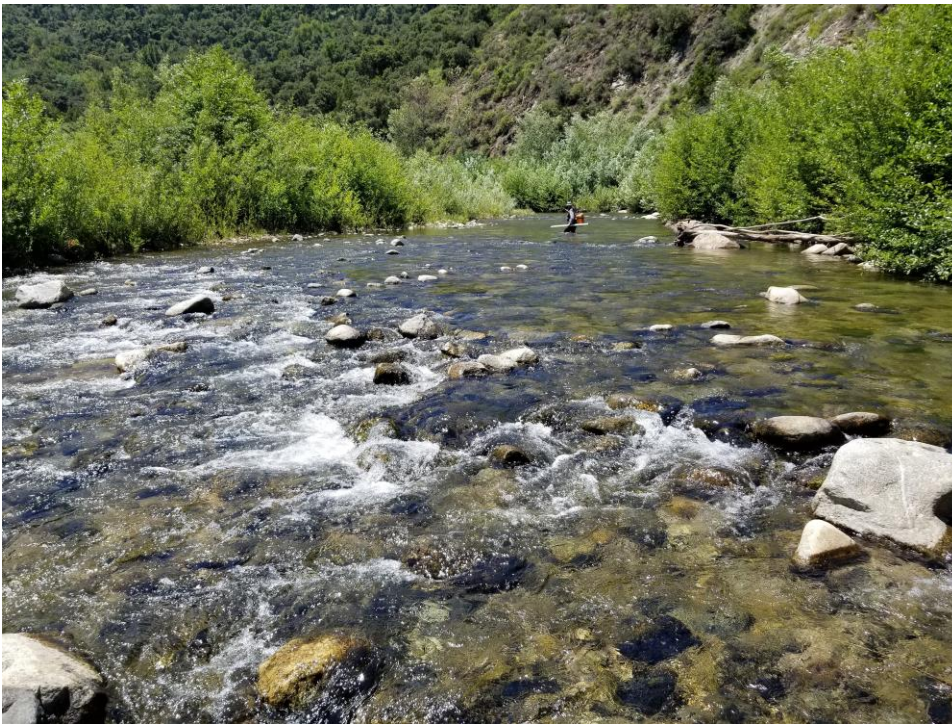
Site 3 is the head of a low-gradient riffle within the reroute reach (Fig. 13). It has a complex crest that crossed the channel at a low angle to the banks. The riffle was deeper than one foot except near the riffle crest where the maximum depth of the most conductive passage was approximately 0.9 feet (Figs. 14, 15, 16). This location is site 45 surveyed in summer 2018 and site 5 surveyed in 2019.

Figure 14. Site 3 field photo. Shallow conditions at riffle crest.

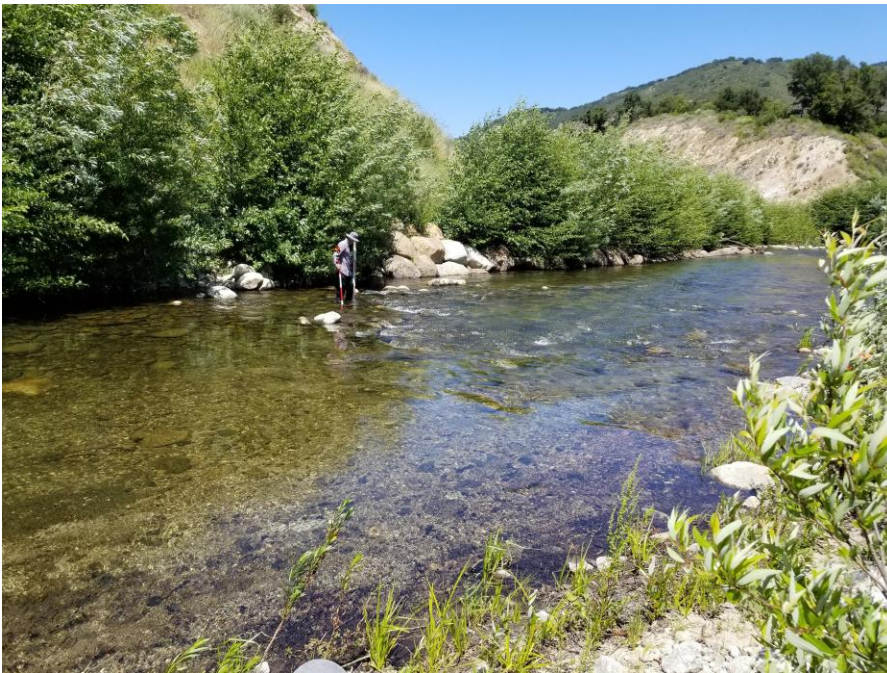
Site 4 is a low-gradient riffle located 180 ft (55 m) upstream of site 3 (Fig. 17). It is the first riffle upstream of the reroute reach bedrock cut. The riffle was deeper than one foot, including the riffle crest (Figs. 18, 19, 20). This site was surveyed as site 48 in summer 2018 and site 6 in 2019.

Figure 18. Site 4 field photo. Shallow conditions at riffle crest.

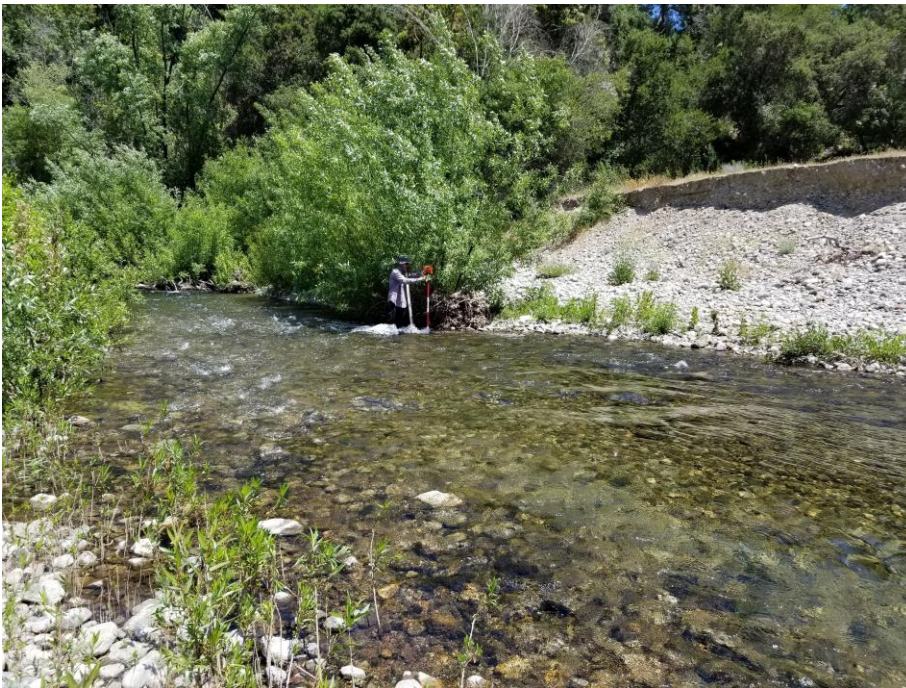
Site 5 is a low-gradient riffle located within the reservoir reach 150 ft (65 m) downstream from the upstream limit of the CRRDR (Fig. 21). The riffle was deeper than one foot except for a five-foot long reach that was at, or slightly below, the 1-foot minimum depth along the most favorable pathway (Figs. 22, 23, 24). This site was reported as impediment 51 in summer 2018 and impediment 8 in 2019.

Figure 22. Site 5 field photo. Shallow conditions within riffle.
