Publication No. WI-2023-01
04 June 2023

The Watershed Institute

Carmel River Reroute and Dam Removal Fish Passage Assessment (Spring 2023)

**Doug Smith (Ph.D.)
Gerhard Gross**

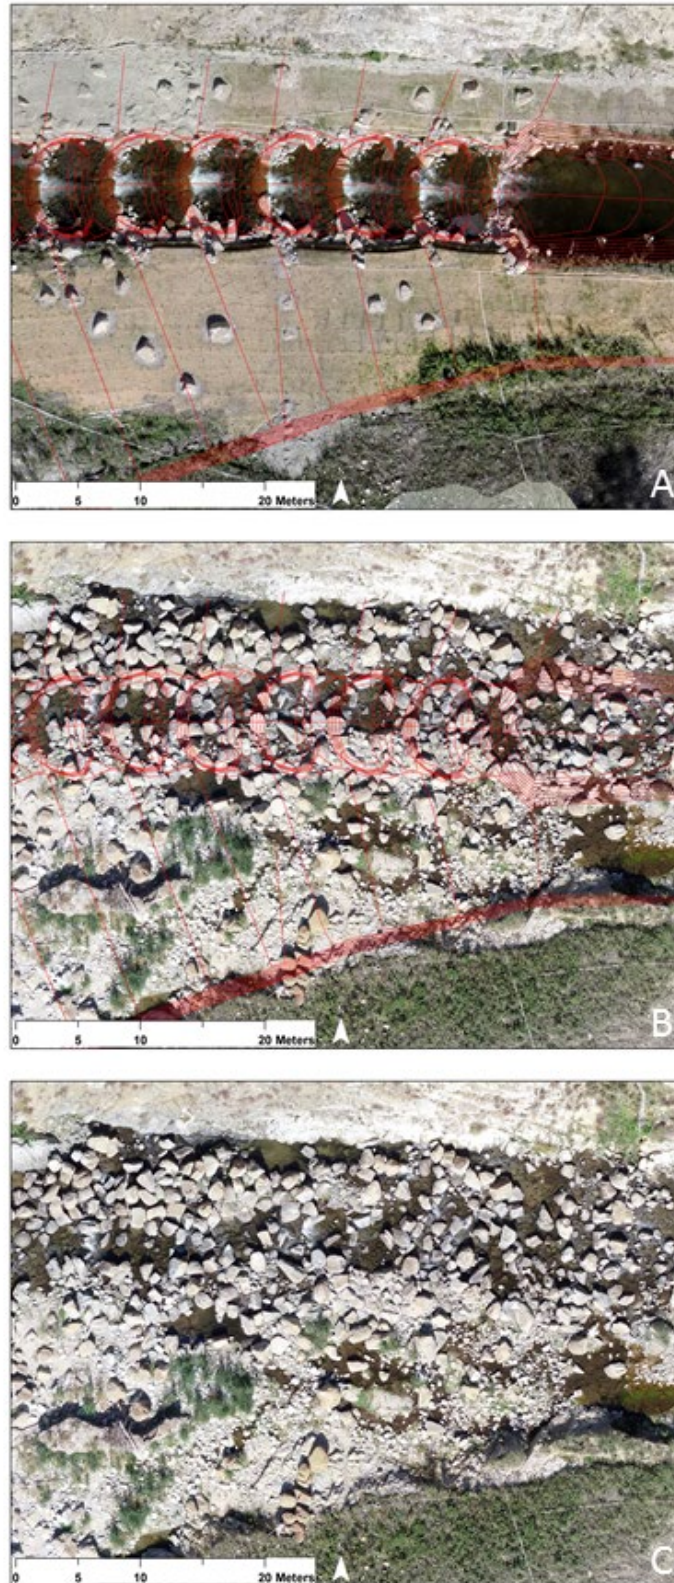
Figure 2. Example of step-pool sequences “auto-naturalized” by high flows of 2017. A) Design blueprint on step pool sequence in 2016. B) Same view as A in 2017. C) Same image as B with design removed.

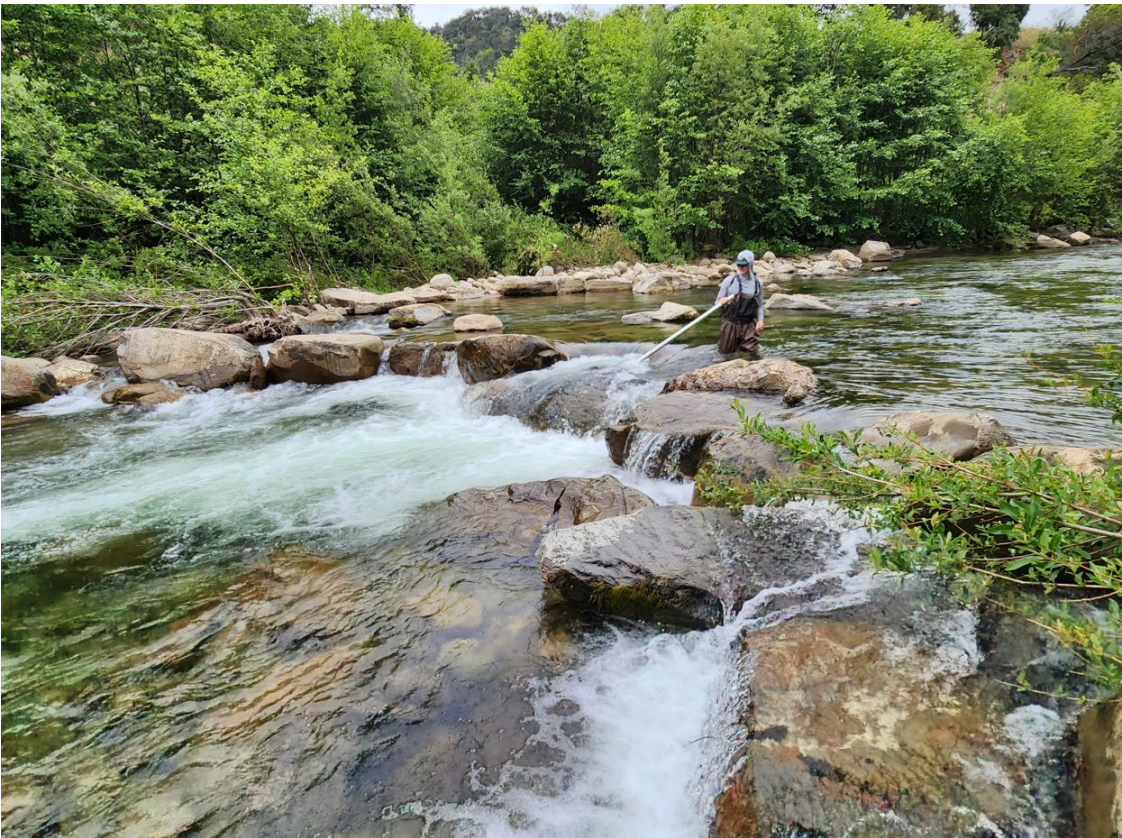
Figure 4. An original constructed arched rock weir (step-pool unit) with 70 cfs of flow. Fish can pass this feature with a modest jump from a 2.5 foot deep launching pool or by burst swimming up the center chute, which has >1 ft depth in a gap between rocks.

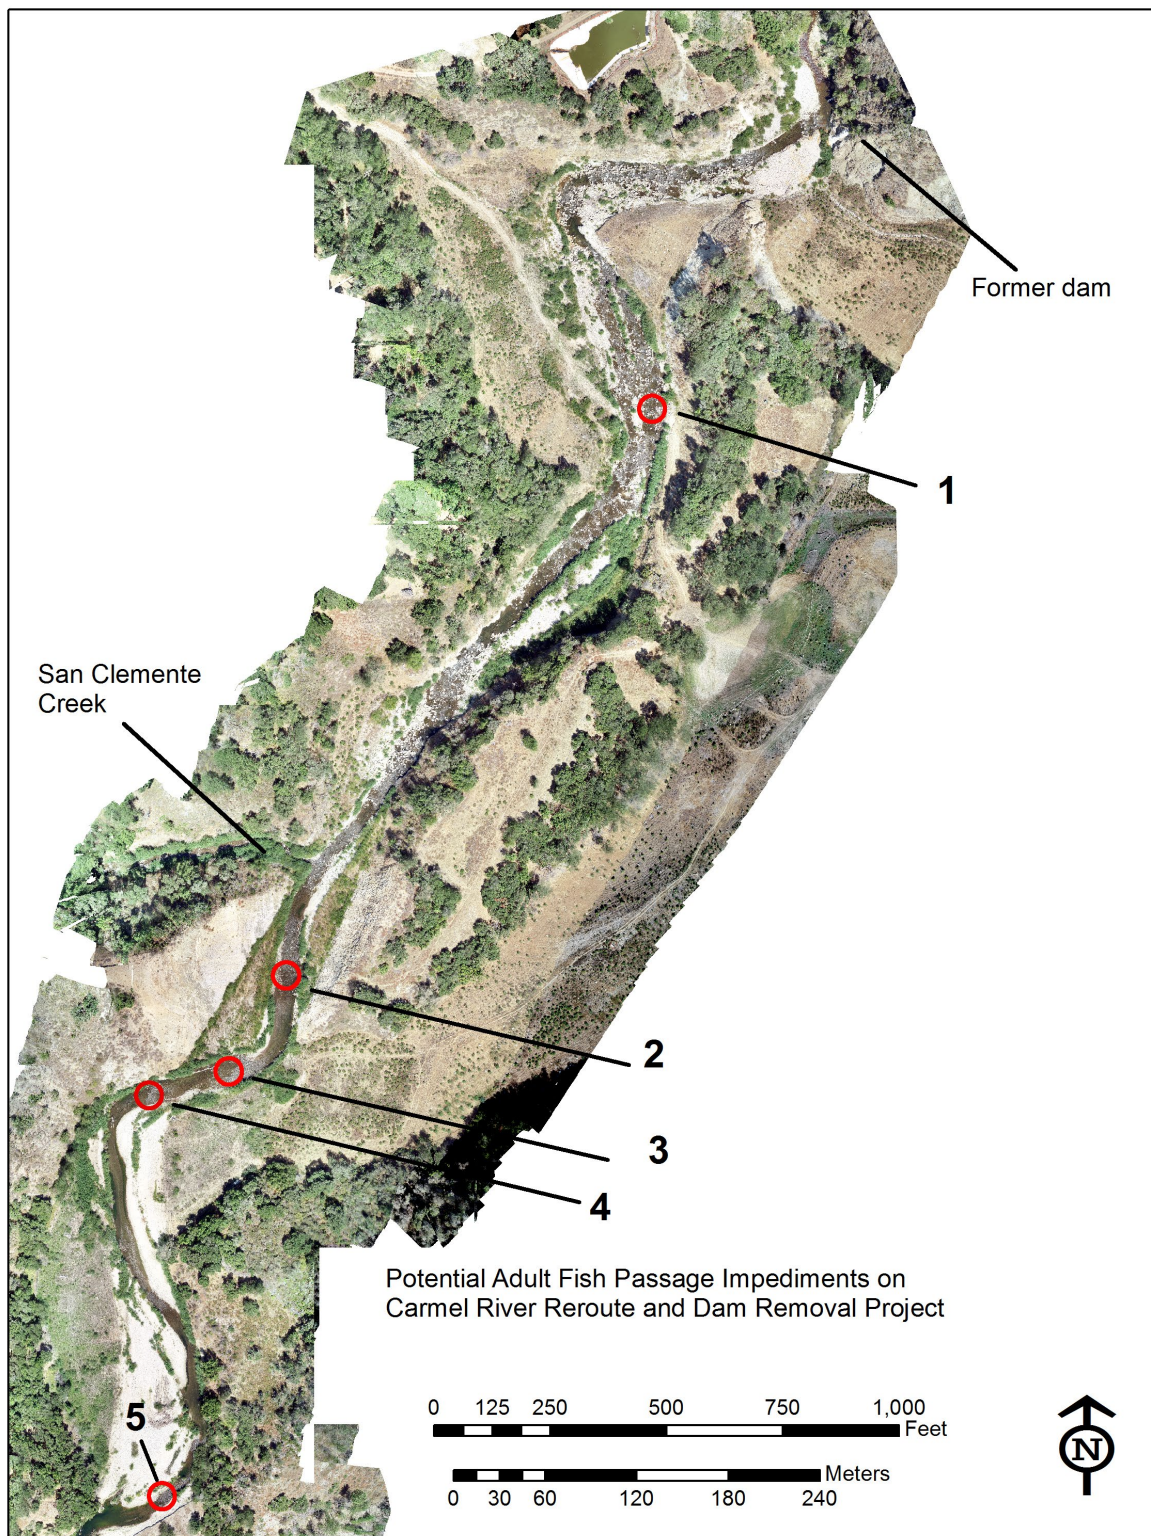
Figure 5. Five sites identified as potential impediments to fish passage in 2020. Only sites 3 and 5 were potential impediments in 2023. Orthophoto obtained on 8/31/19.

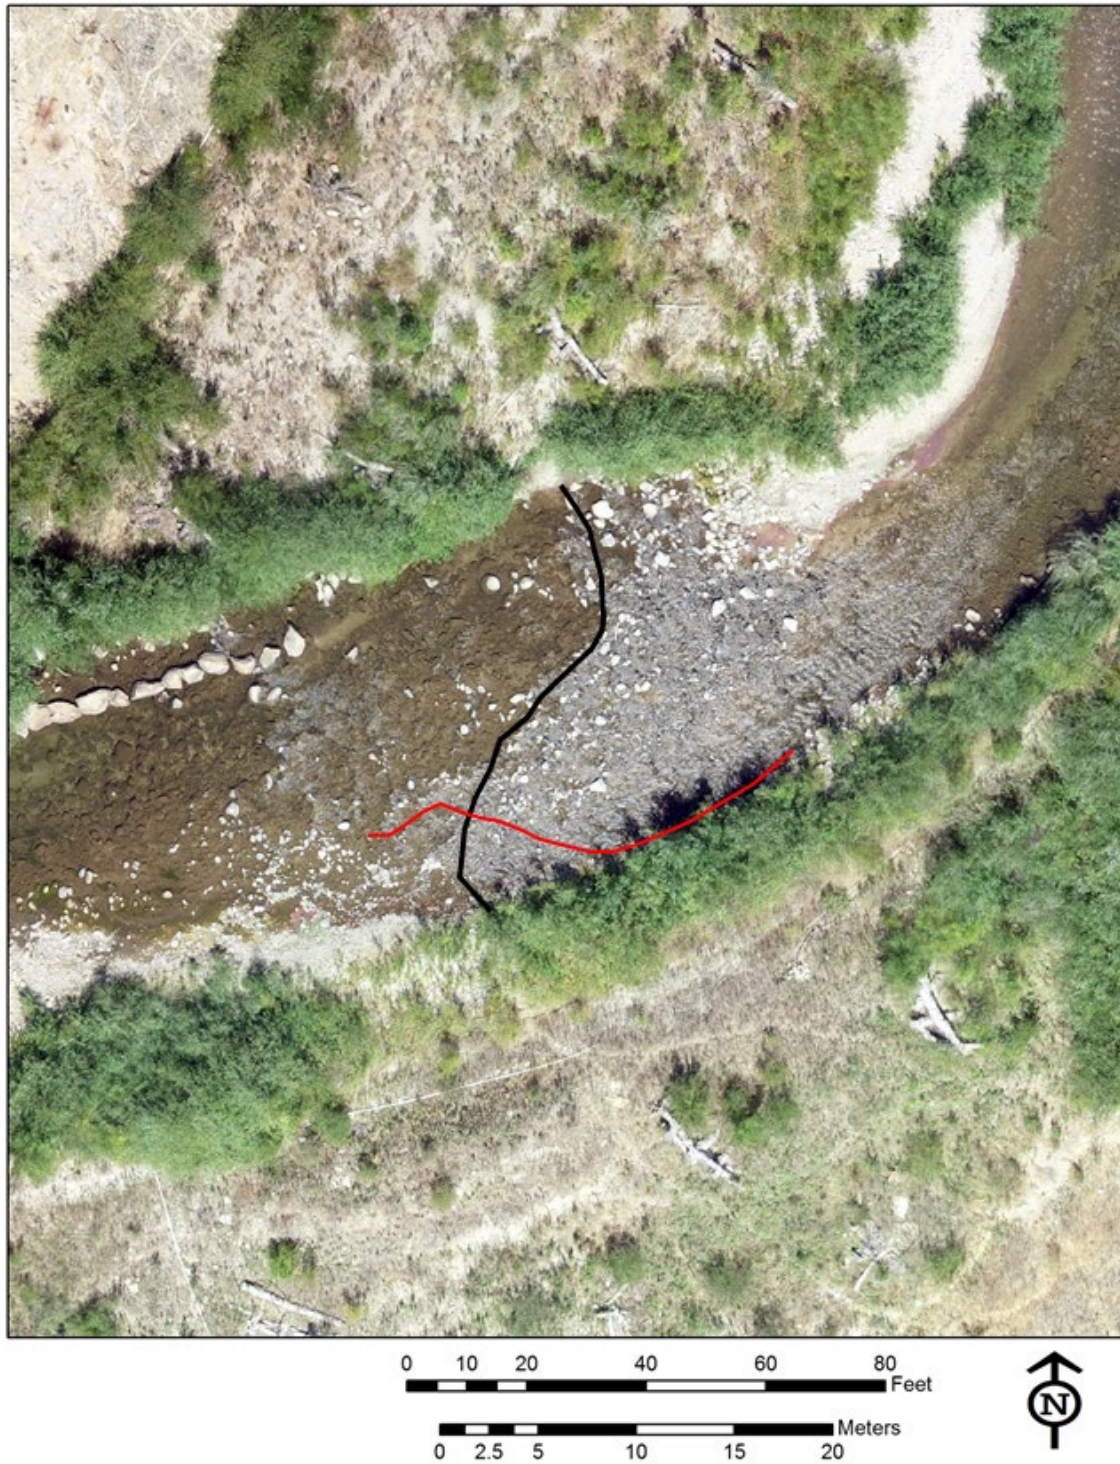
Site 3 is the head of a low-gradient riffle within the reroute reach (Fig. 5). It has a complex crest that crossed the channel at a low angle to the banks. The riffle was deeper than one foot except near the riffle crest where the maximum depth of the most conductive passage was approximately 0.9 feet (Figs. 14, 15, 16). This location is site 45 surveyed in summer 2018 and site 5 surveyed in 2019.

Figure 6: Site 3 with approximate locations of longitudinal profile (red) and cross section (black). Flow is toward the northwest. Background image is orthophoto obtained 8/31/2019 at a flow of 17 cfs.

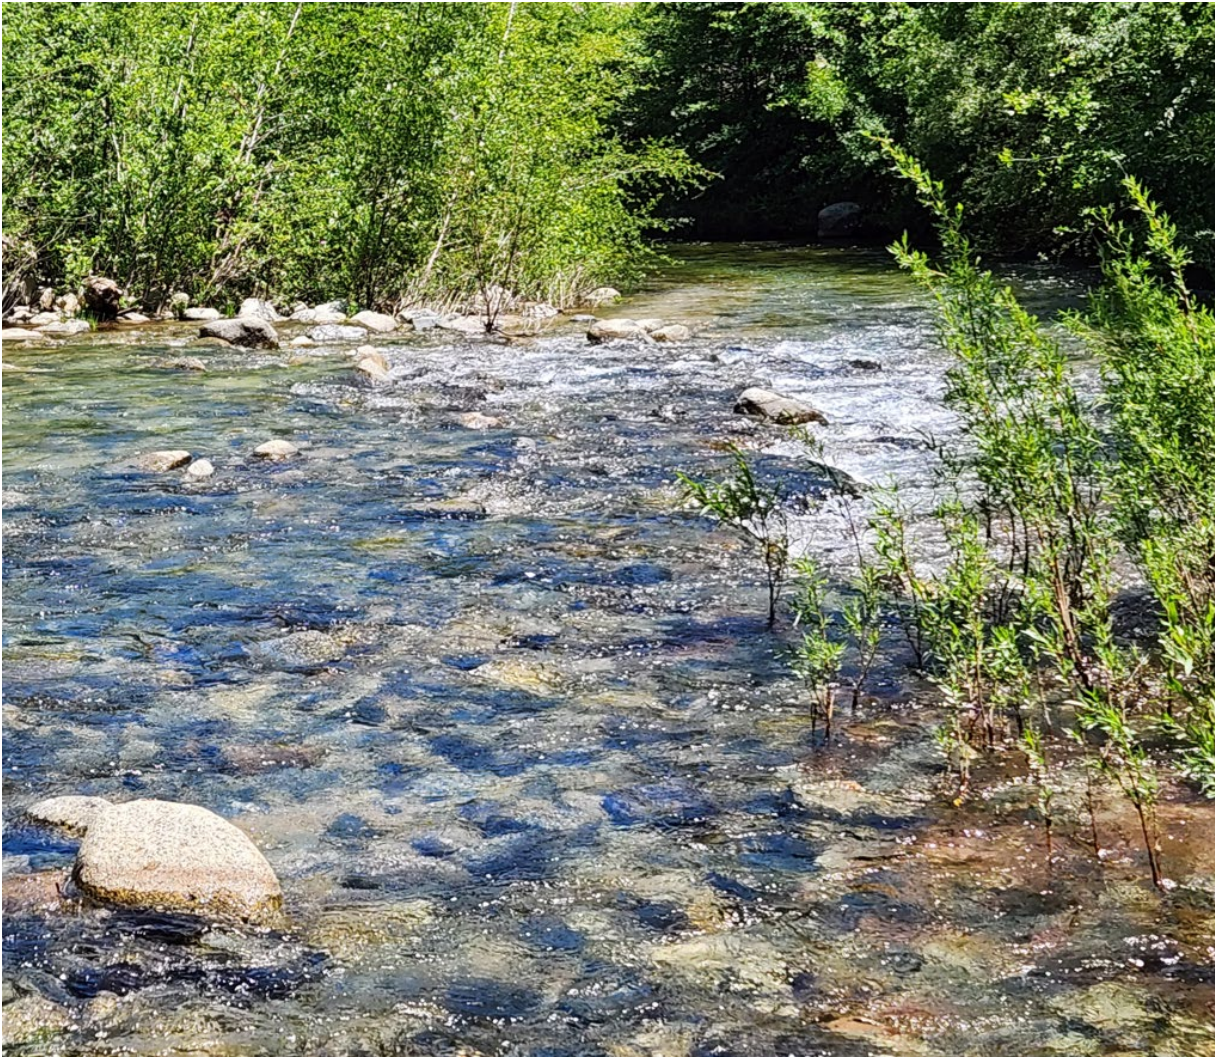
Figure 7 . Site 3 field photo. Shallow conditions at riffle crest. View downstream.

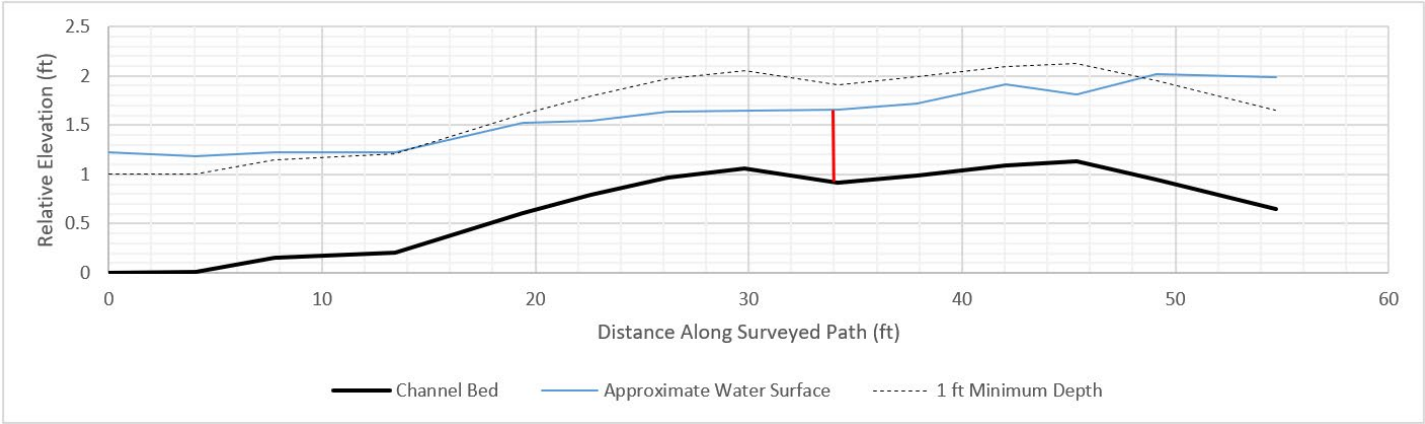
Figure 8. Site 3 longitudinal profile. Red line shows the intersection with cross section.

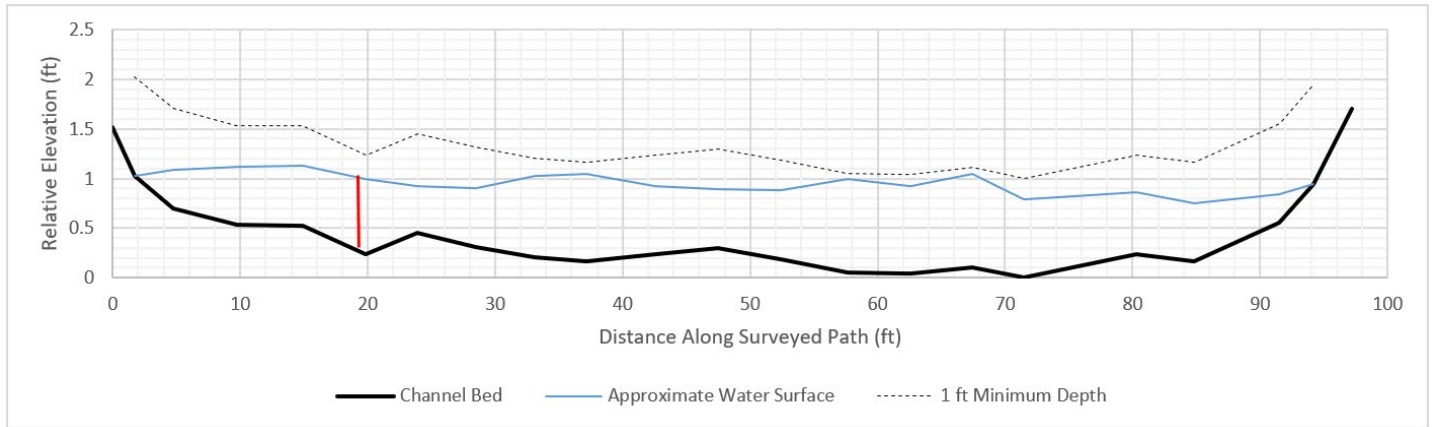
Figure 9. Site 3 cross section survey. Red line shows the intersection with cross section.

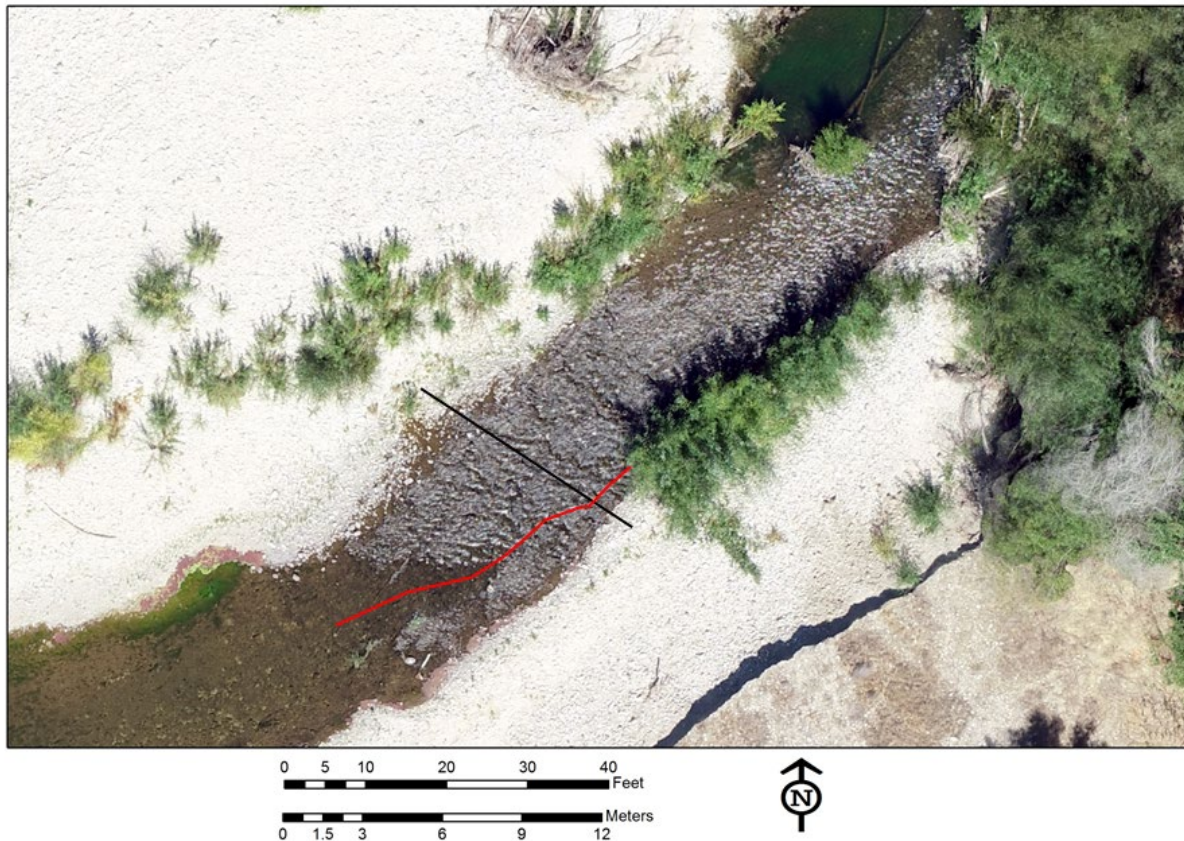
Site 5 is a low-gradient riffle located within the reservoir reach 150 ft (65 m) downstream from the upstream limit of the constructed river (Fig. 21). The riffle was deeper than one foot except for a five-foot long reach that was at, or slightly below, the 1-foot minimum depth along the most favorable pathway (Figs. 22, 23, 24). This site was reported as impediment 51 in summer 2018 and impediment 8 in 2019.

Figure 10. Site 5 with approximate locations of longitudinal profile (red) and cross section (black). Flow is toward the northwest. Background image is orthophoto obtained 8/31/2019 at a flow of 17 cfs.

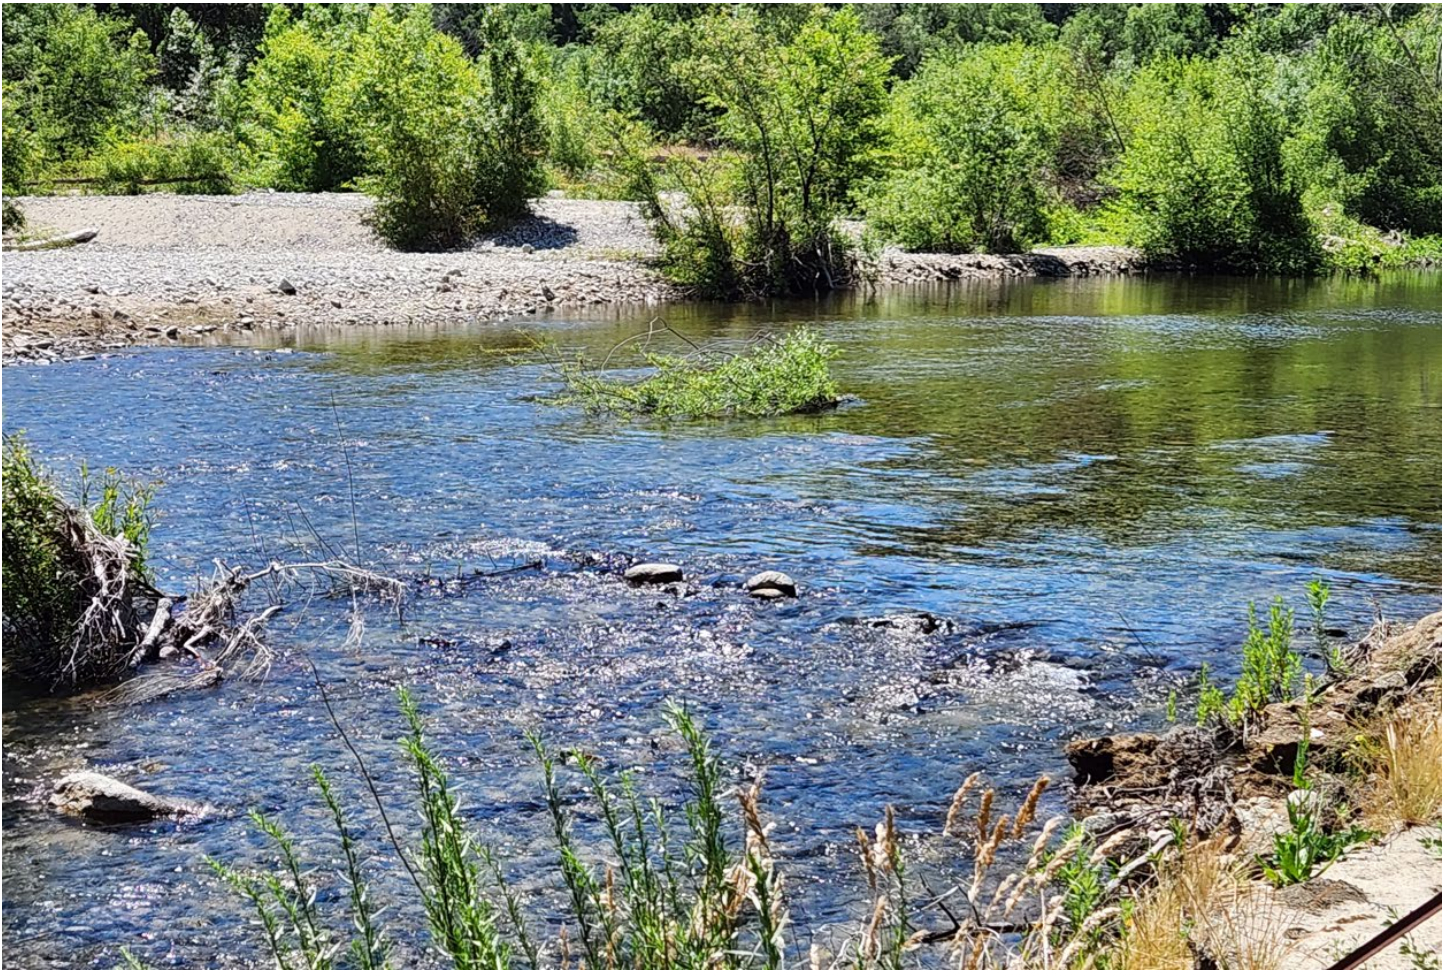
Figure 11. Site 5 field photo. Shallow conditions along riffle crest. View upstream.

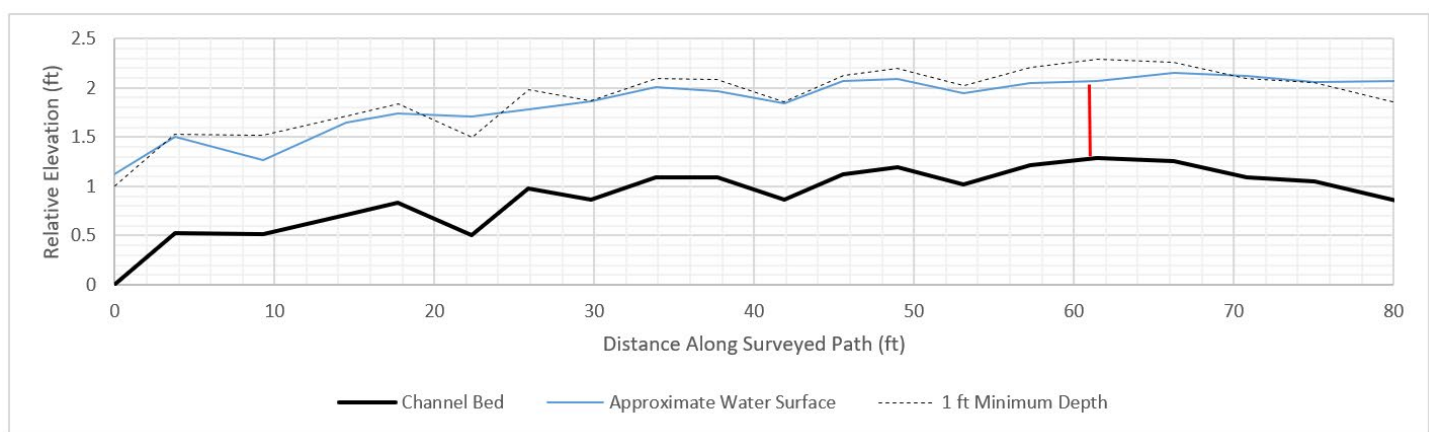
Figure 12. Site 5 longitudinal profile. Red line shows the intersection with cross section.

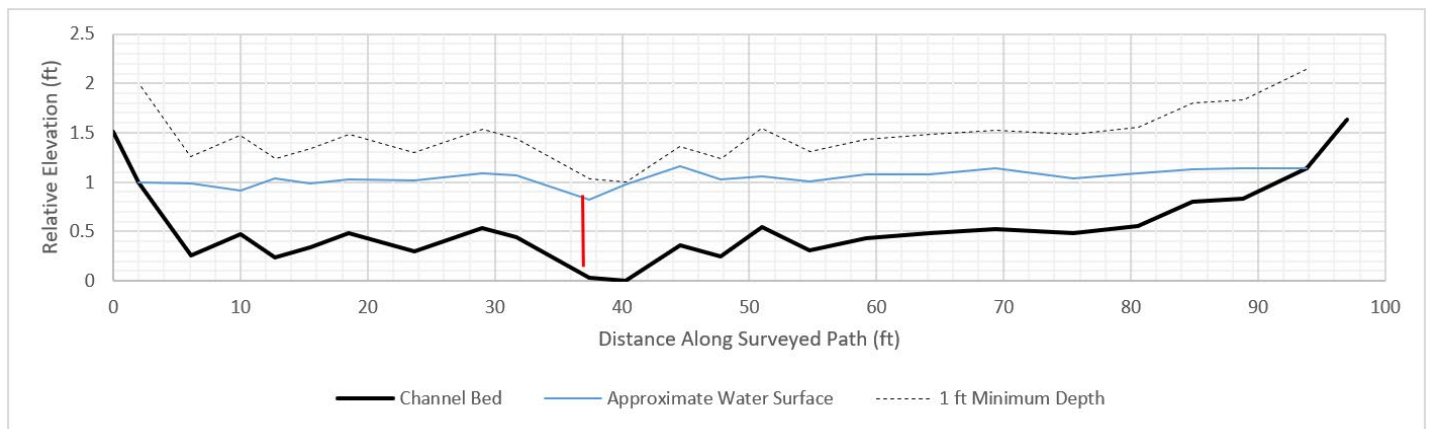
Figure 13. Site 5 cross section survey. Red line shows the intersection with cross section.
