Publication No. WI-2018-07  
30 August 2018  
Revised  
02 April 2019

**The Watershed Institute**

**Carmel River Reroute and  
Dam Removal Fish Passage  
Assessment (Summer2018)**

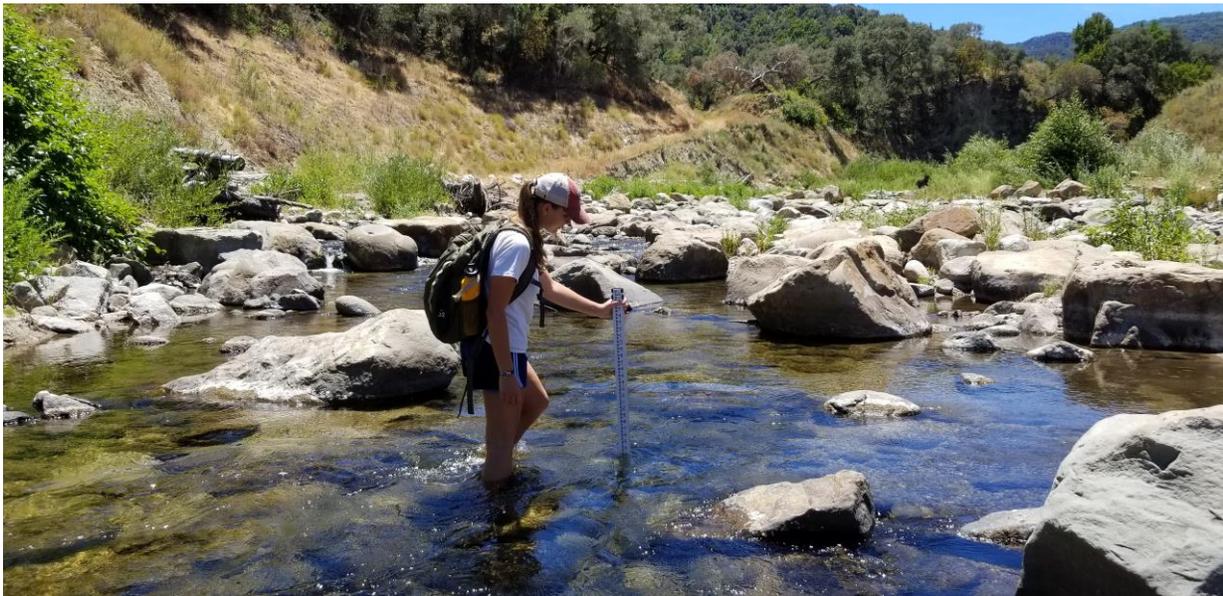
**Figure 2. Using leveling rod to measure water depth at impediment site #22.**

Reach C (Fig. 13) is dominated by a wide shallow channel. Sites 21, 22, and 23 respectively extend 25 m, 10 m and 10 m upstream because of continuous shallow and narrow channel conditions. Figure 2 shows a typical section with average depth less than 1 ft in site 22. Site 23 includes blocked passages through the original random boulder placements and channel margin inherited from the CRRDR constructed channel (Figs. 14 and 15). Appendix B-6 is a digital cross section showing typical conditions in Reach C.

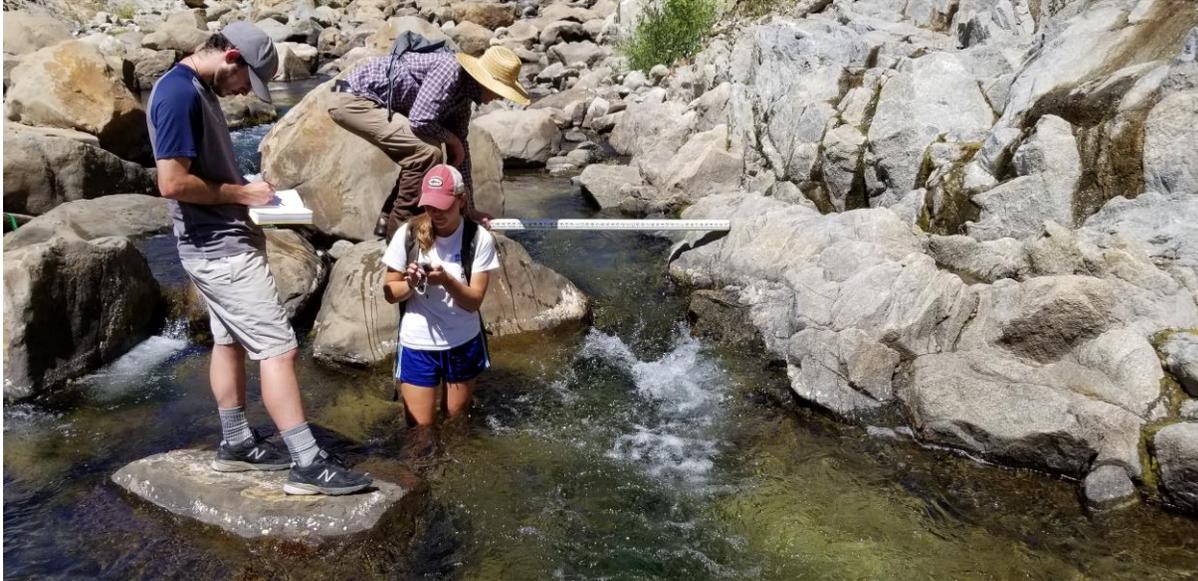
**Figure 3. Using leveling rod to approximate channel width at the water surface at impediment site #4.**

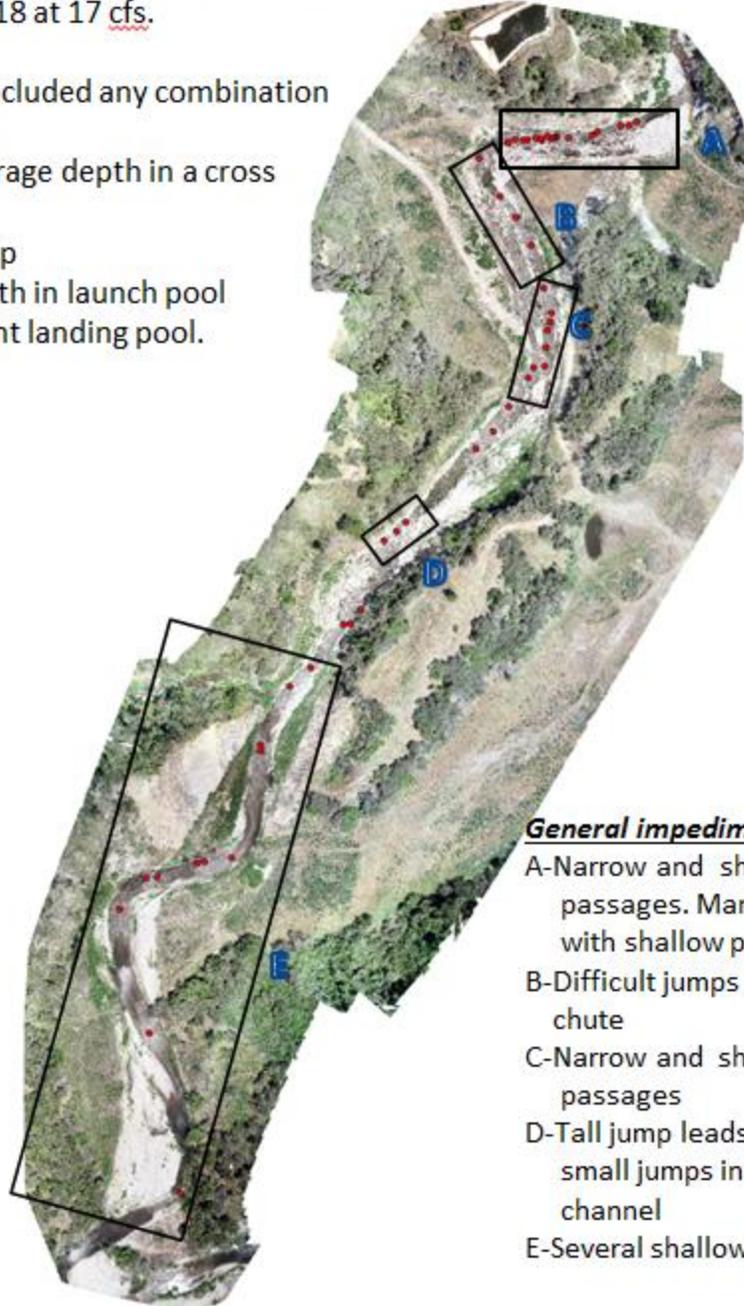
Fifty-one areas failed to meet the passage design criteria at 17 cfs (Fig. 4). While most sites failed only one of the design criteria elements, eleven sites were complex impediments involving up to 28 m of either continuous or very closely spaced problem spots. Shallow depth (whether or not associated with a jump) was the most common problem observed on July 10 at 17 cfs (Fig. 5).

- A-Narrow and shallow passages. Many small jumps with shallow pools.
- B-Difficult jumps and steep chute
- C-Narrow and shallow passages
- D-Tall jump leads to series of small jumps in narrow channel
- E-Several shallow riffles

Figure 4. Overview of impediment sites identified by foot traverse at 17 cfs. Some individual site markers represent a reach of relatively close-spaced impediments.

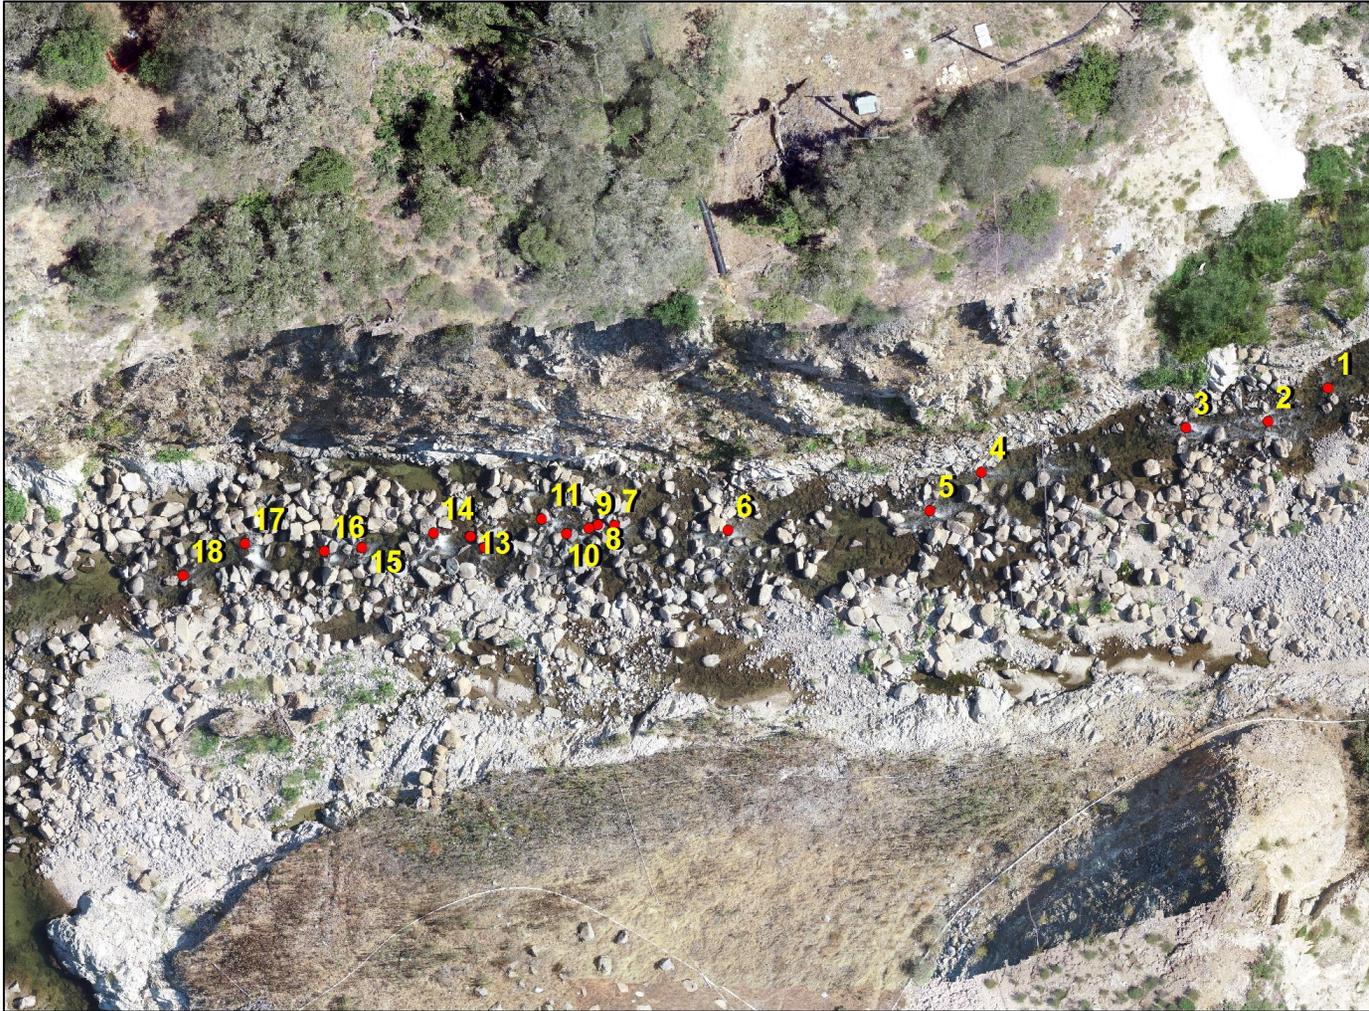
The following descriptions and figures reference the lettered reaches (A–E) of Figure 4. Reach A is characterized by many narrow passages and small jumps (Figs. 3, 6 and 7). The passages are typically less than 3 ft wide, and the jumps typically have shallow launching pools or shallow landing pools (Fig. 8). Appendix B–1 through B–4 show digital models and digital surveys in Reach A.

Figure 6. Orthophoto of Reach A. Flow is left to right.  $Q=17$  cfs

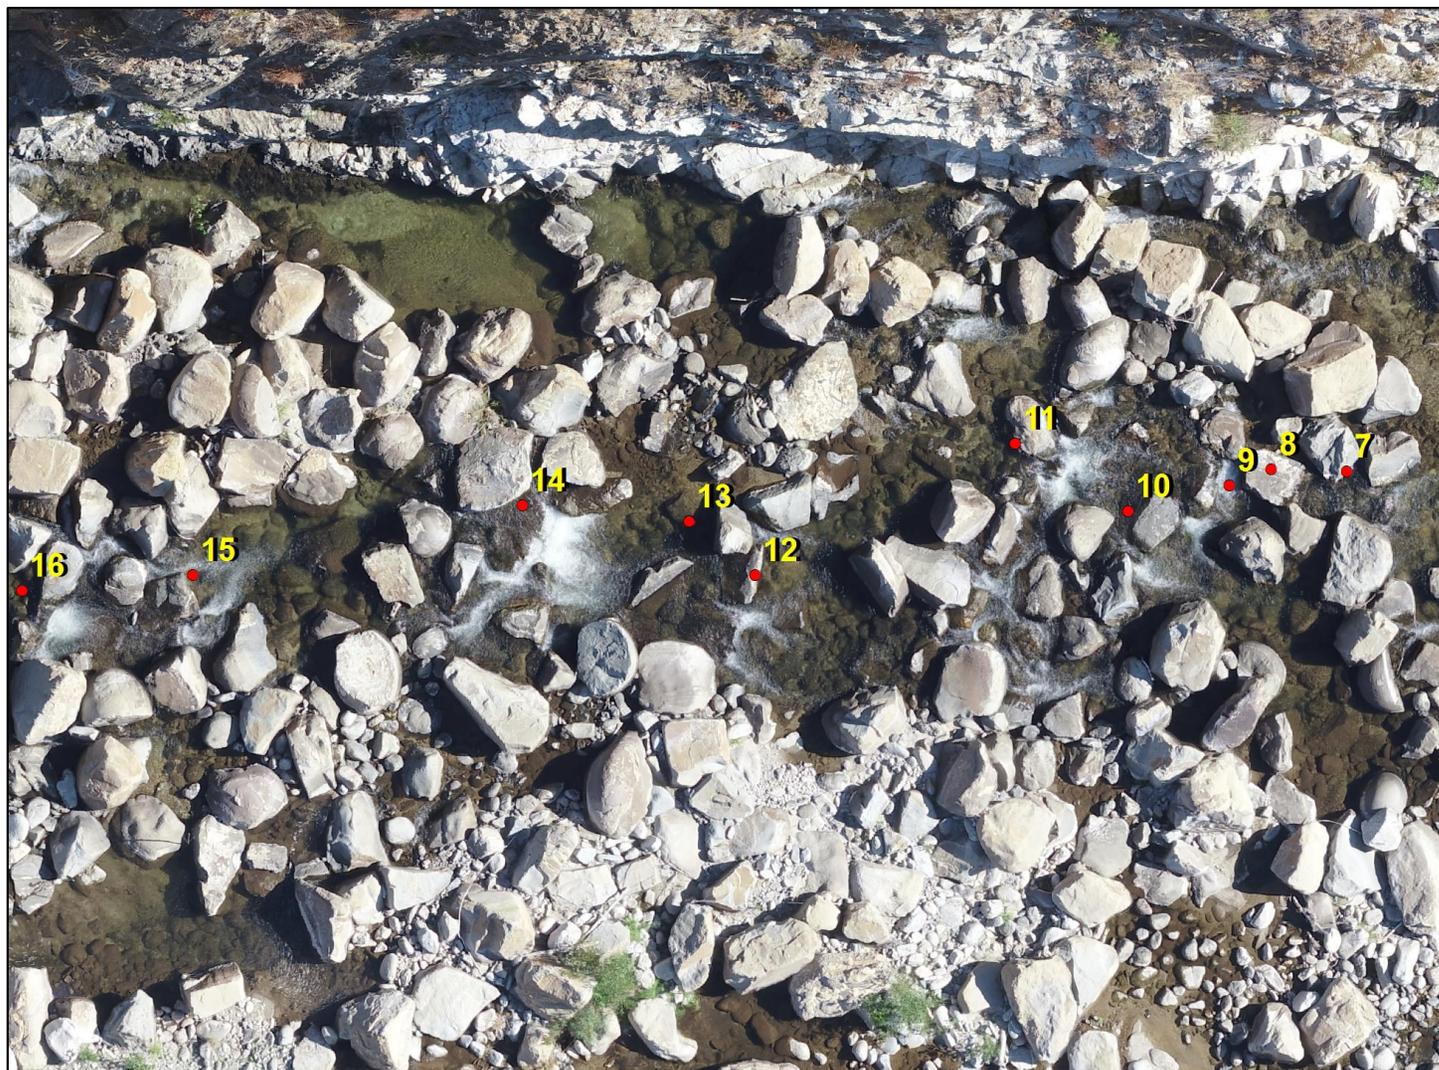
Figure 7. Close view of orthophoto of Reach A at 17 cfs. Flow is left to right.

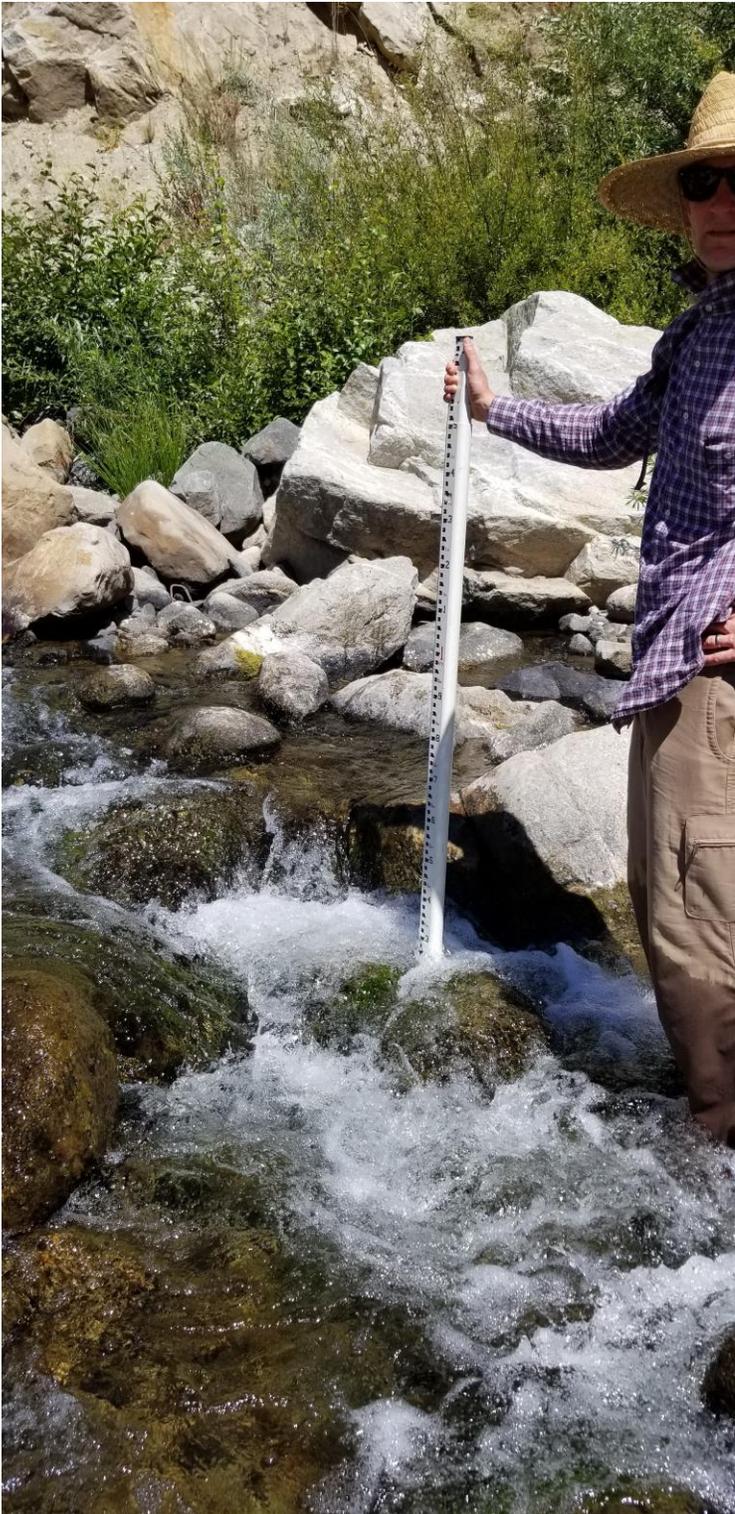
Figure 8. Shallow launch pool for short jump at site #2 in Reach A.

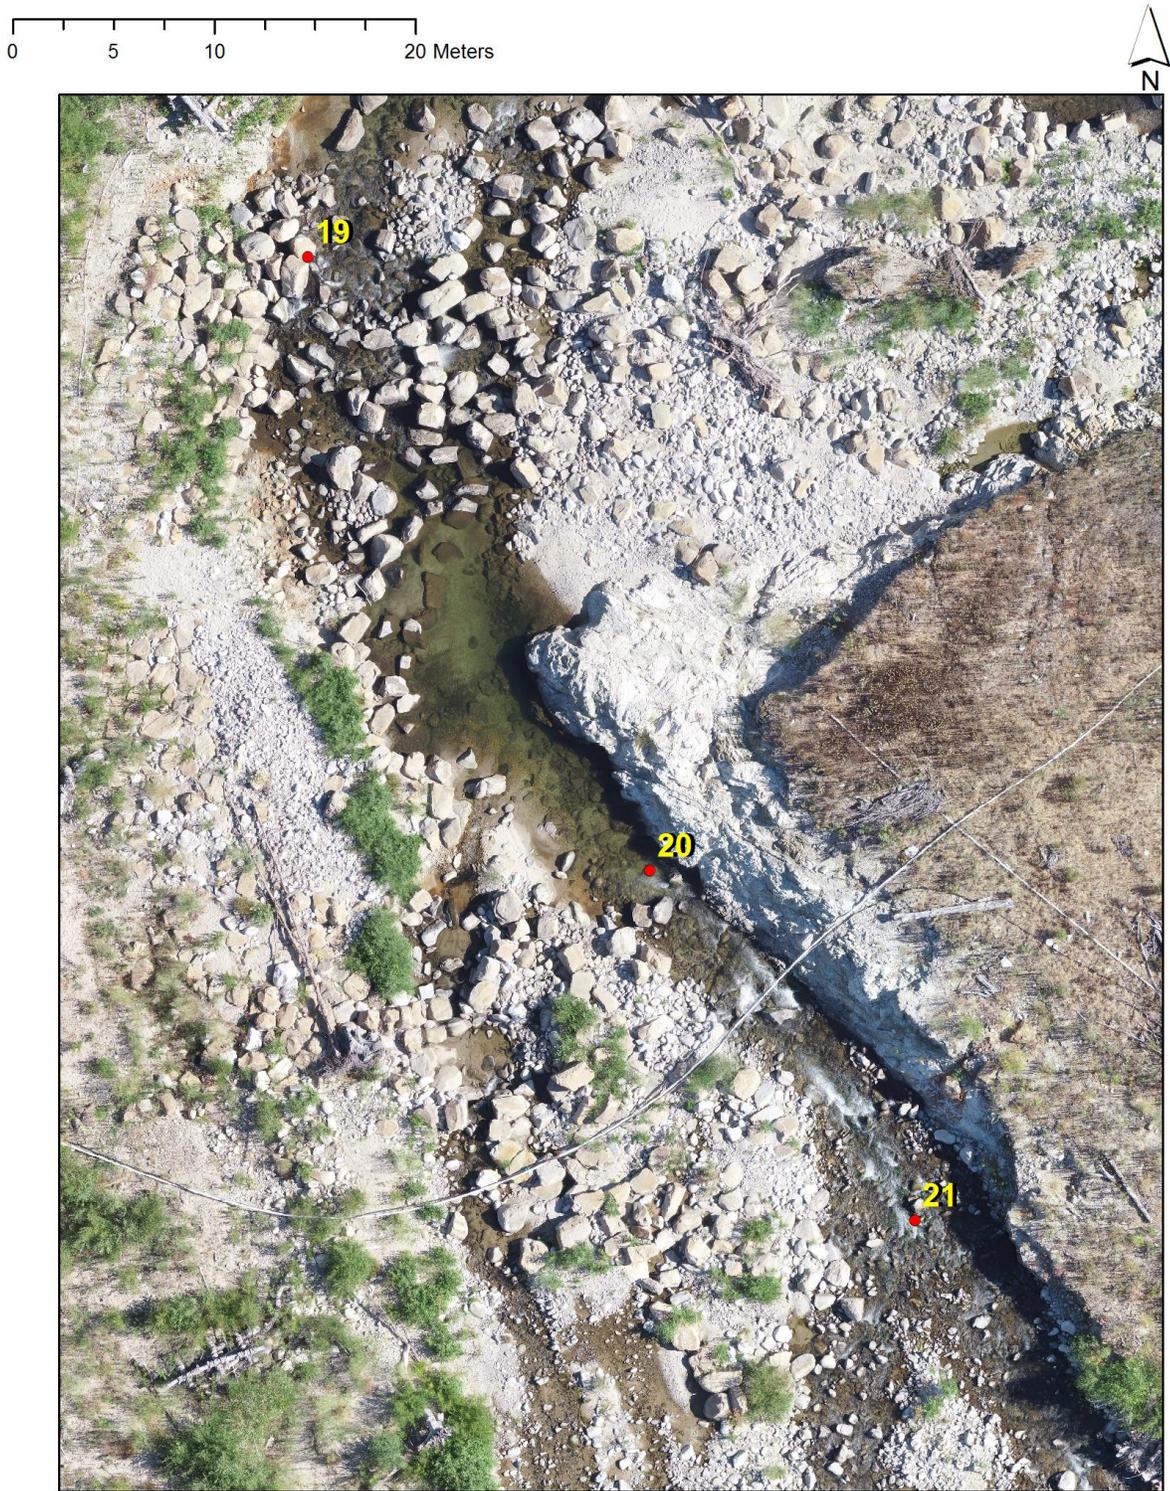
Reach B (Fig. 9) starts with a jump that exceeds design criteria at site 19 (Fig. 10). The reach includes a 7% grade cascade comprising three jumps (Fig. 11). Only the first jump (site #20) was considered to be an impediment in the cascade (Fig. 12). Appendix B-5 is a digital longitudinal profile through the steep chute in Reach B.

Figure 9. Orthophoto of Reach B. Flow is to the north.  $Q=17$  cfs.

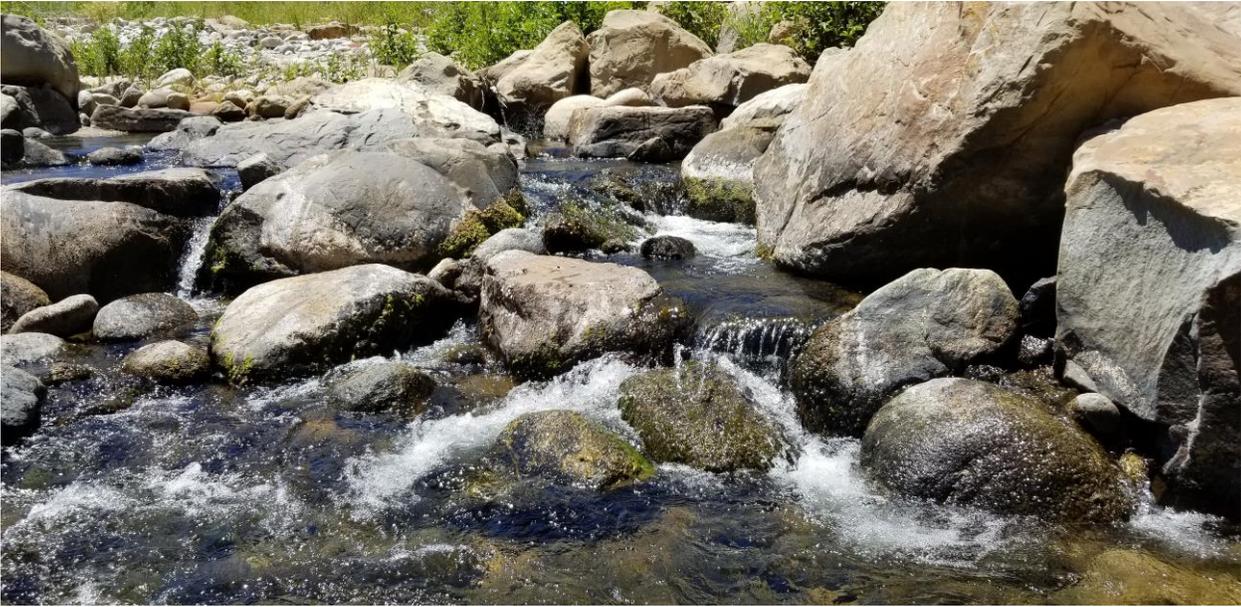
Figure 10. Jump at site #19.

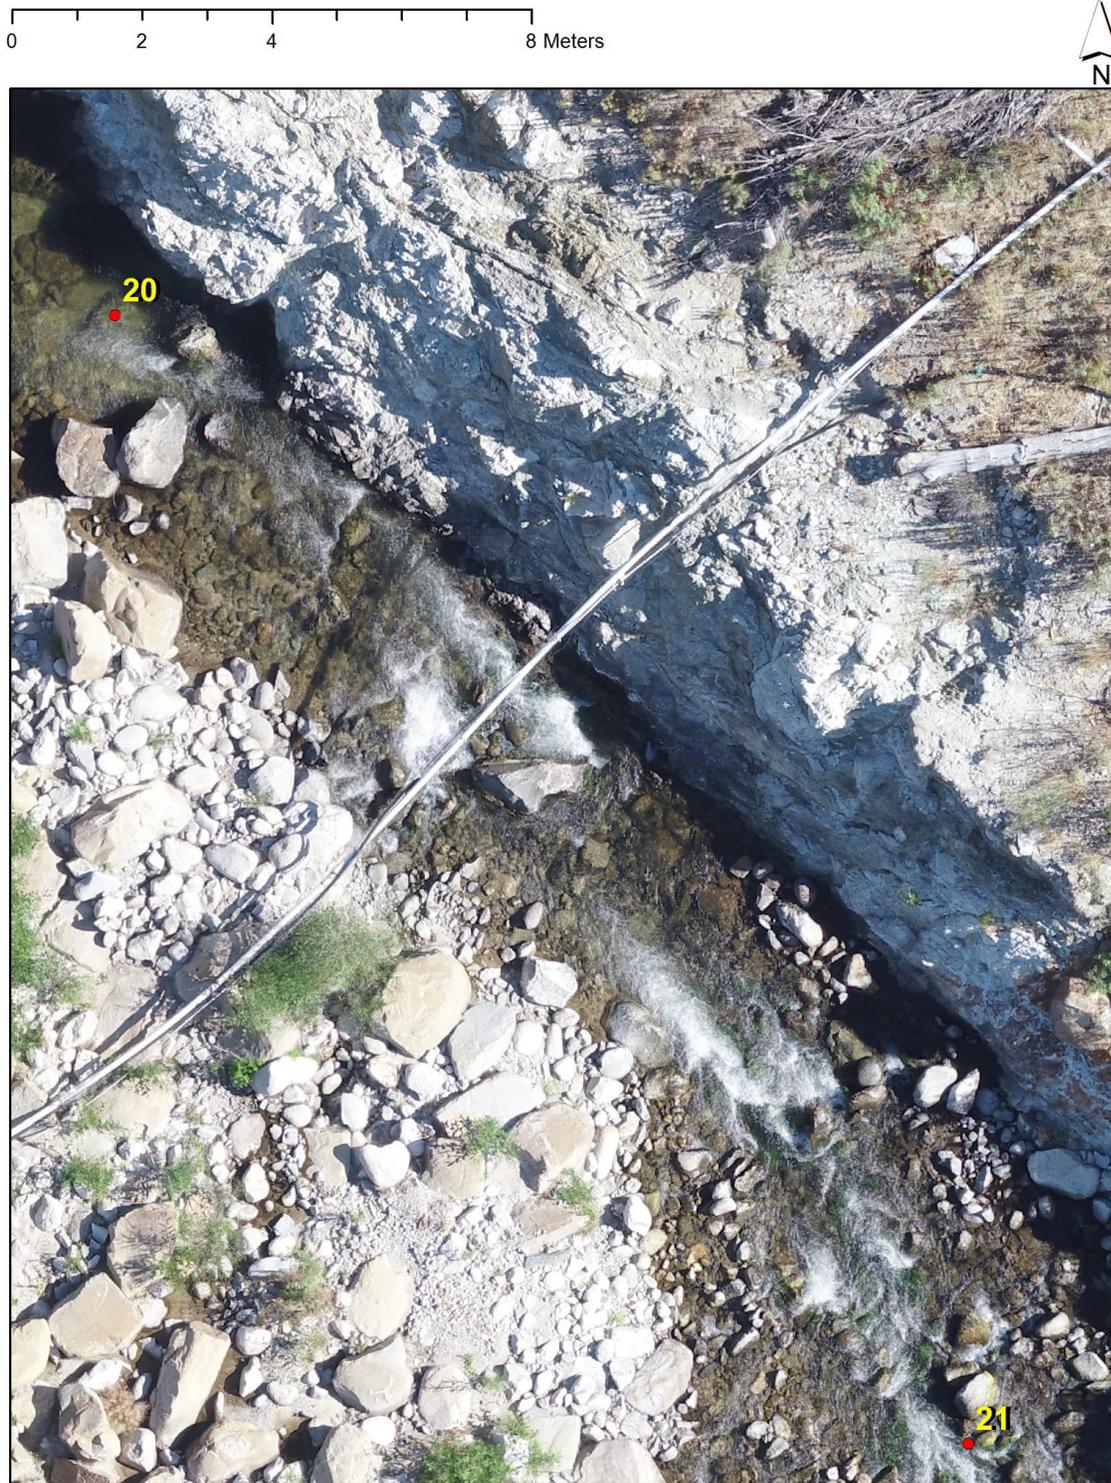
Figure 11. Orthophoto of cascades in Reach B comprised three small jumps, starting with site #20. Flow is to the north.  $Q=17$  cfs.

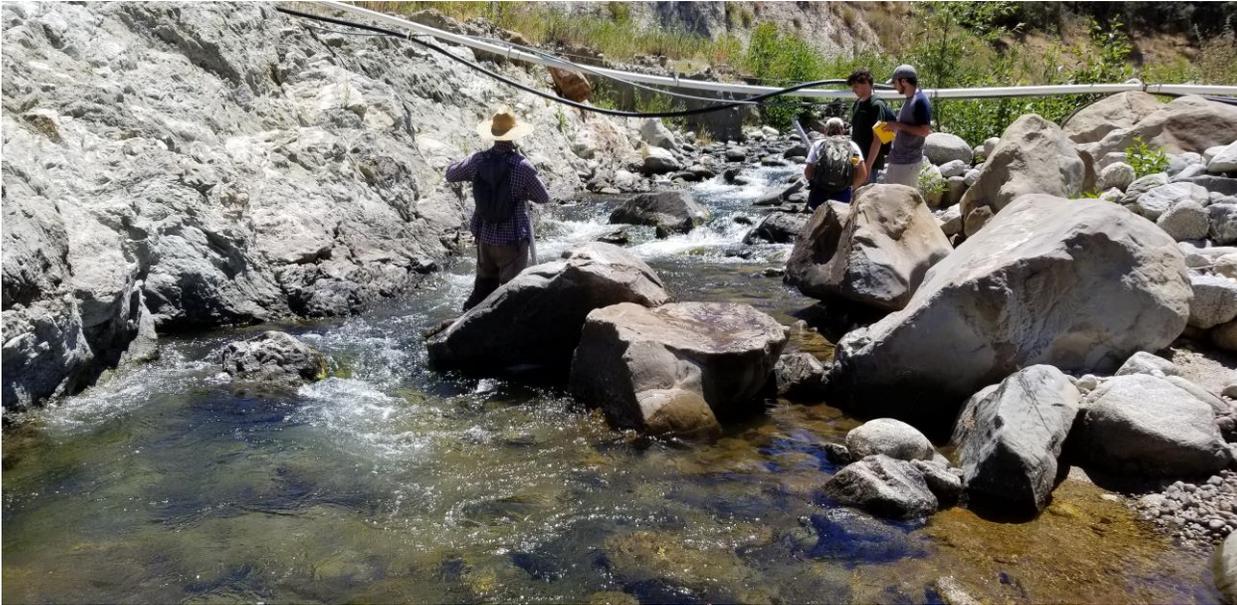
**Figure 12. Narrow passage at site #20 leads to a steep chute that was passable at 17 cfs.**

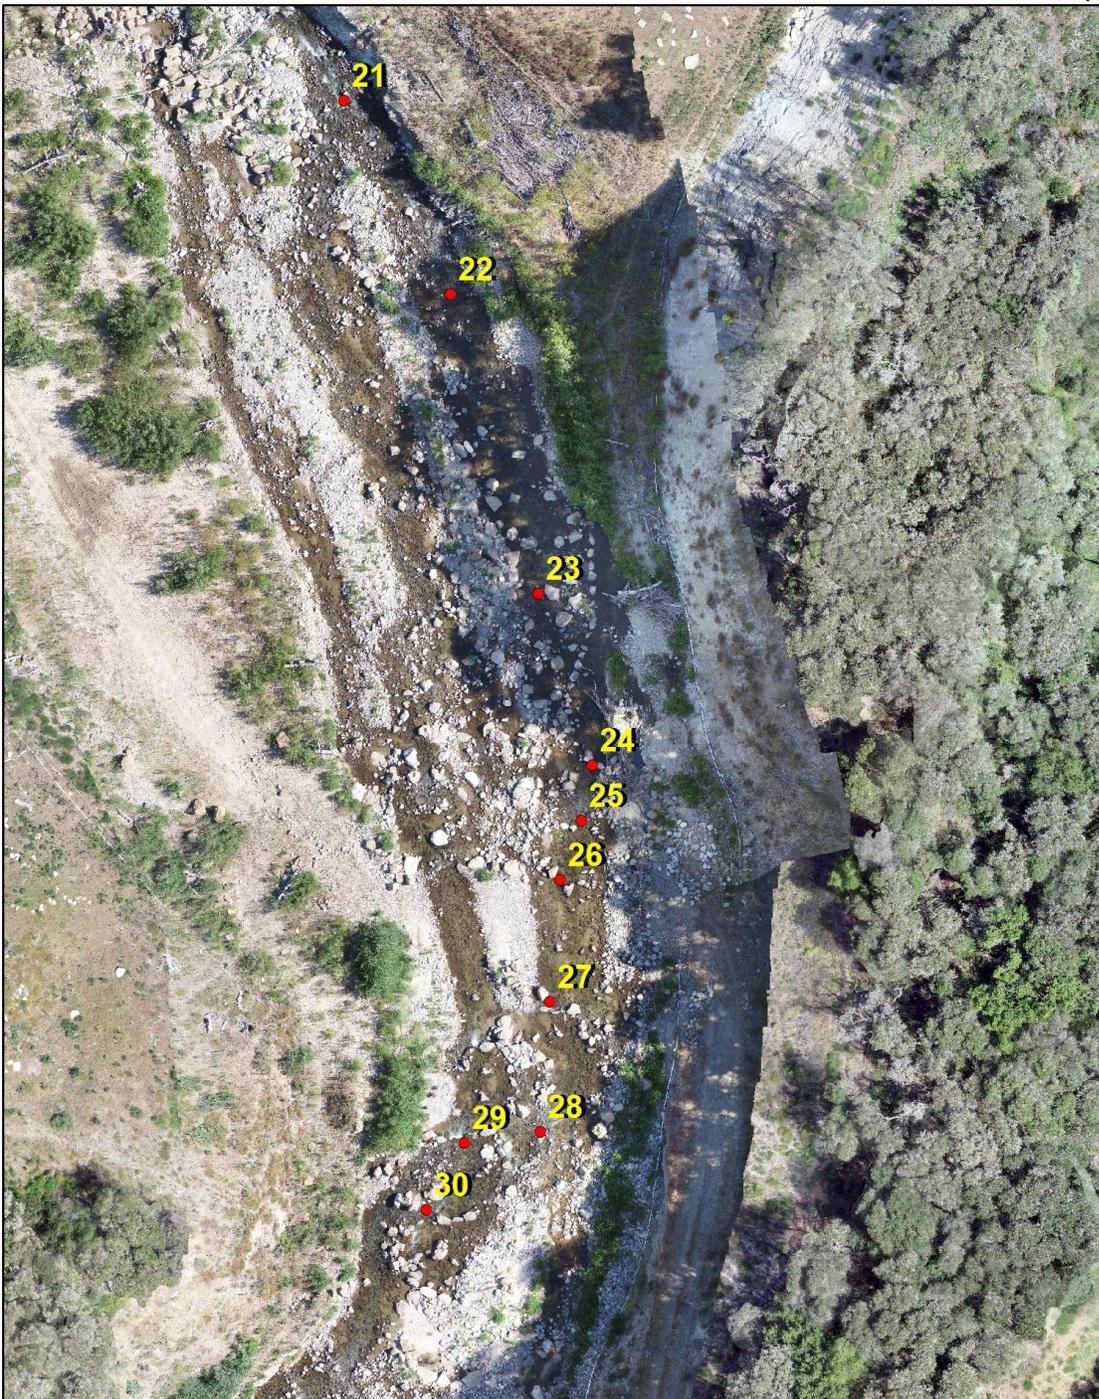
Figure 13. Orthophoto of Reach C. Flow is north.  $Q=17$  cfs

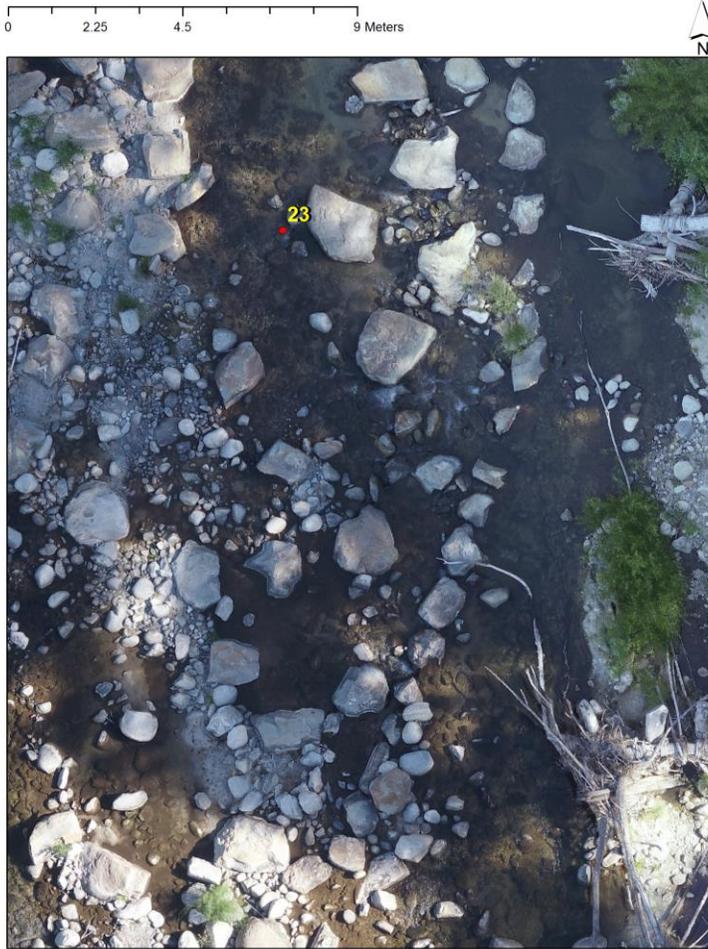
Figure 14. Orthophoto of site #23 in Reach C. Q= 17 cfs

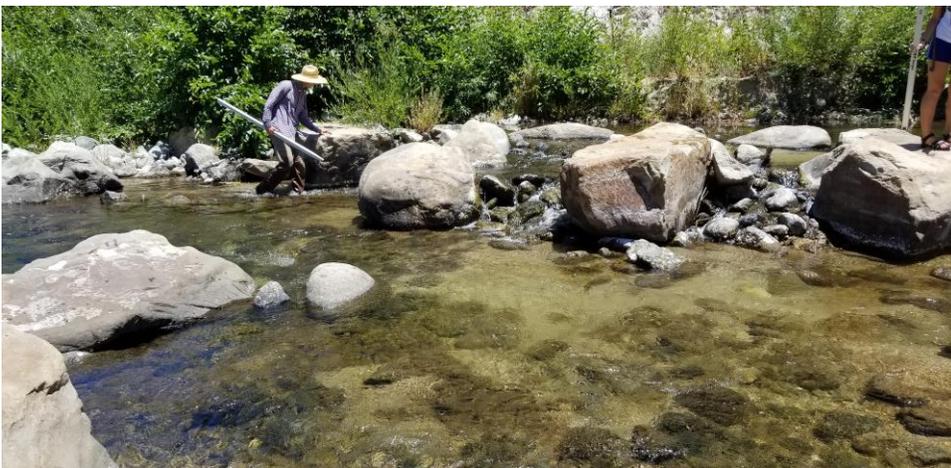
Figure 15. Close up of site #23. Barrier is formed by the large boulders and intervening cobbles located between the two people. Best passage was located outside view to right.

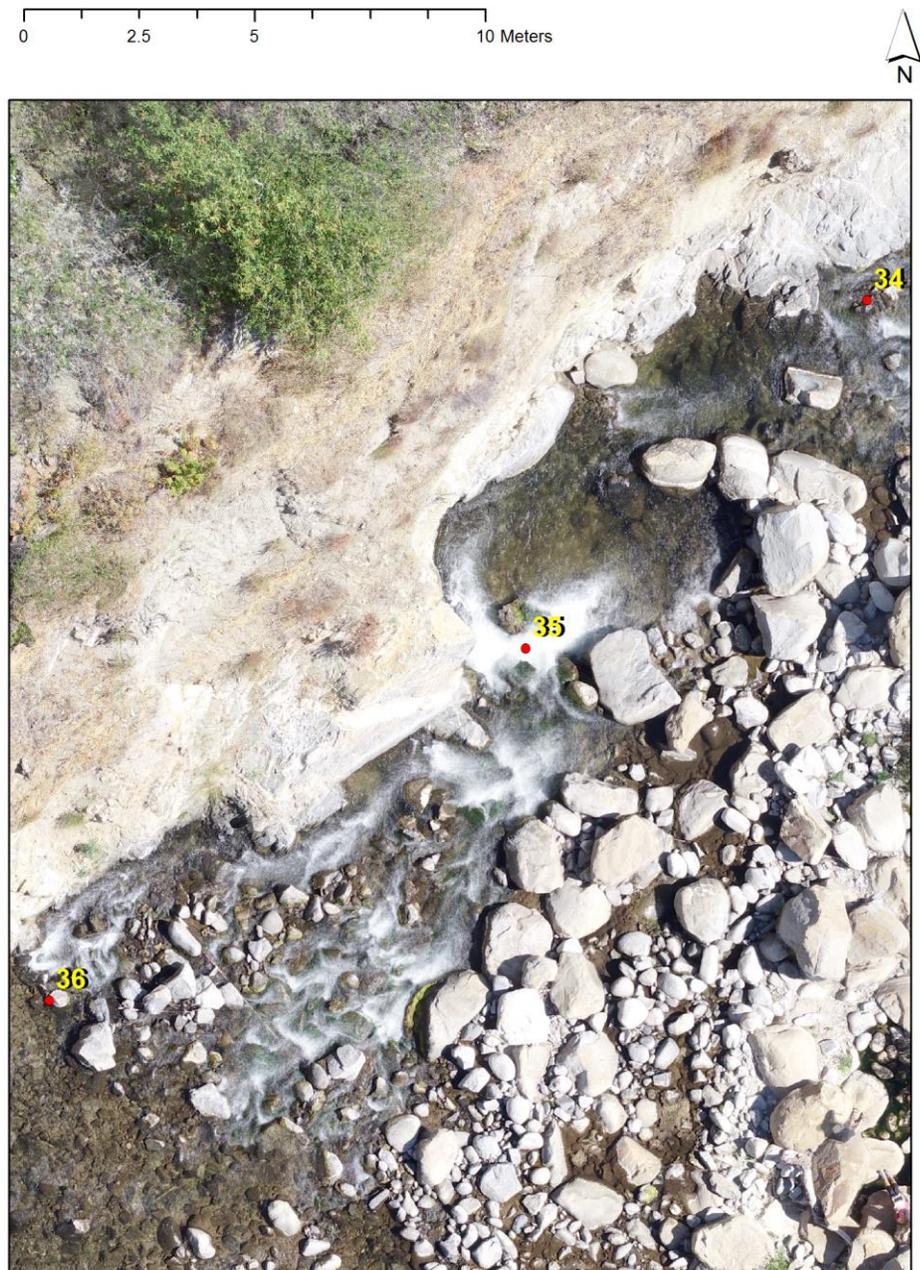
Reach D comprises a series of jumps (Fig. 16). Site 34 is a short jump with shallow water. Site 35 starts with a jump that exceeds 2 ft followed by a steep 19 m long reach with several smaller jumps (Figs 17 and 18). Appendix B-7 is a digital longitudinal profile through the steep chute in Reach D.

Figure 16. Orthophoto of Reach D. Flow is northwest. Q=17 cfs.

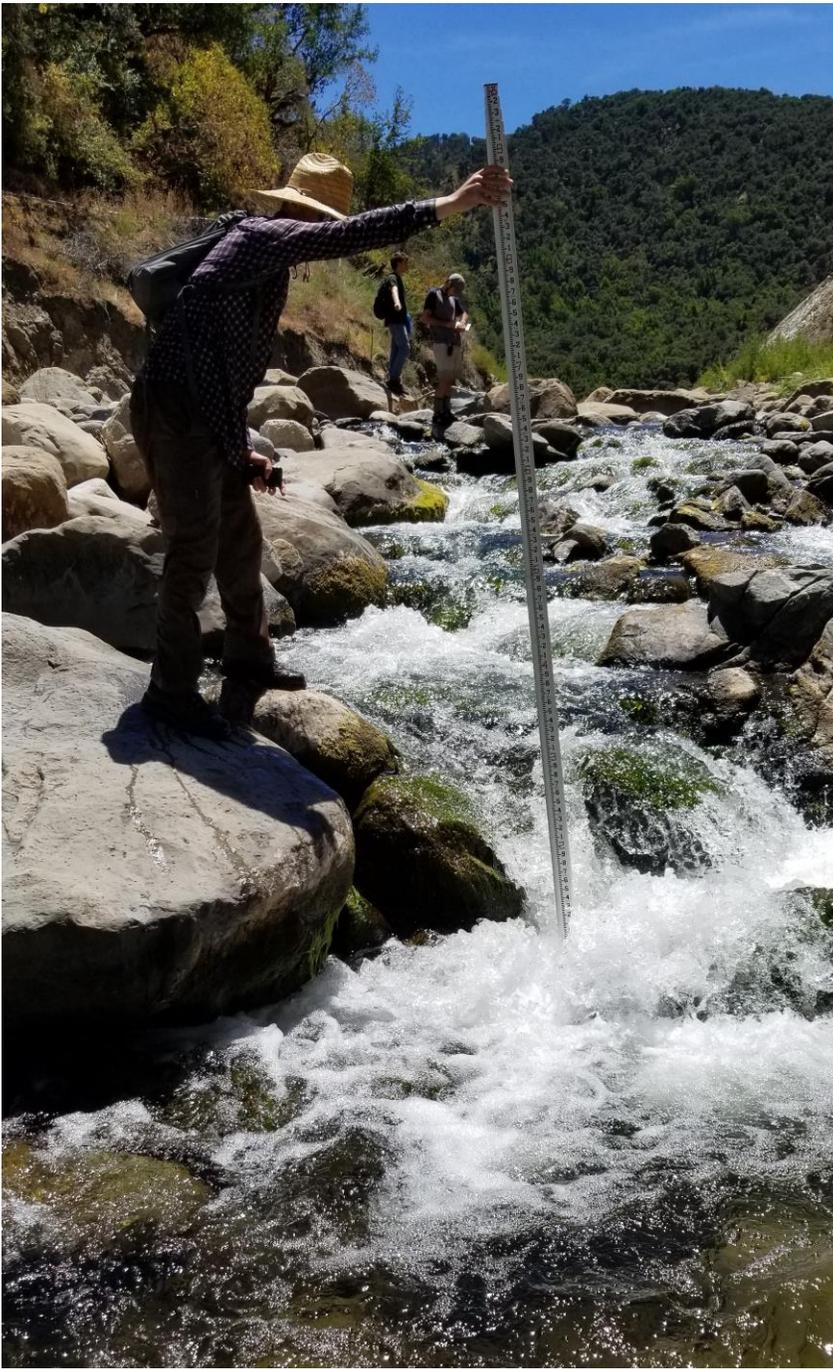
Figure 17. Level rod indicates a 1 ft deep launching pool for a greater than 2 foot tall jump at site #35.

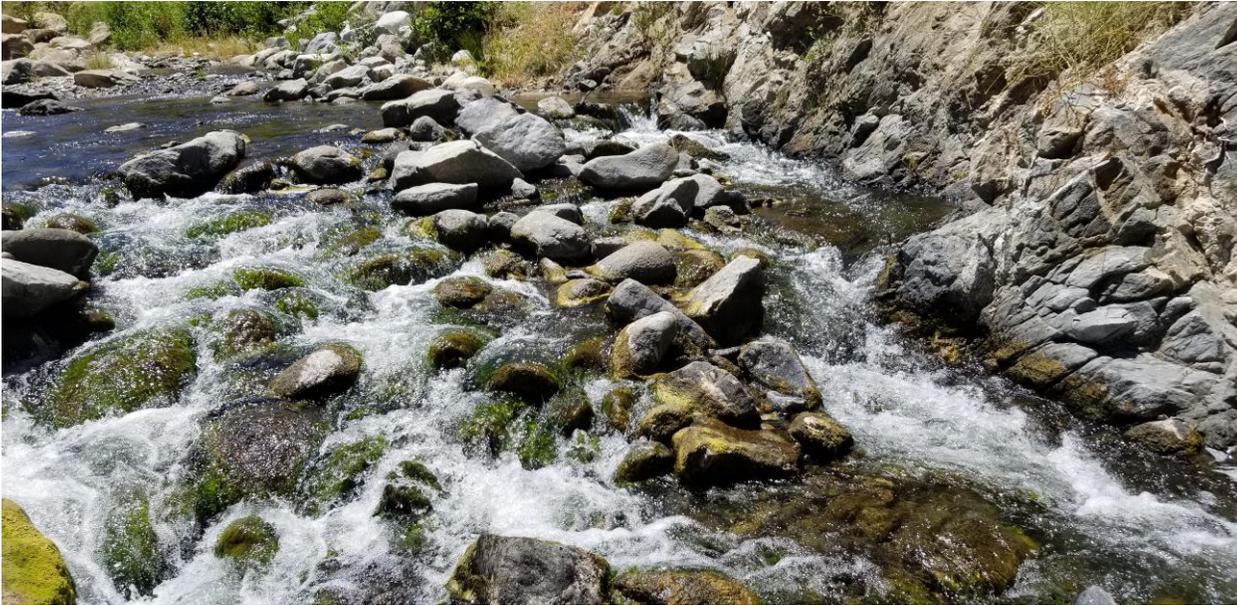
**Figure 18. View upstream at site #35 chute above the tall jump. Best passage opportunity is along left channel (right side of photo).**

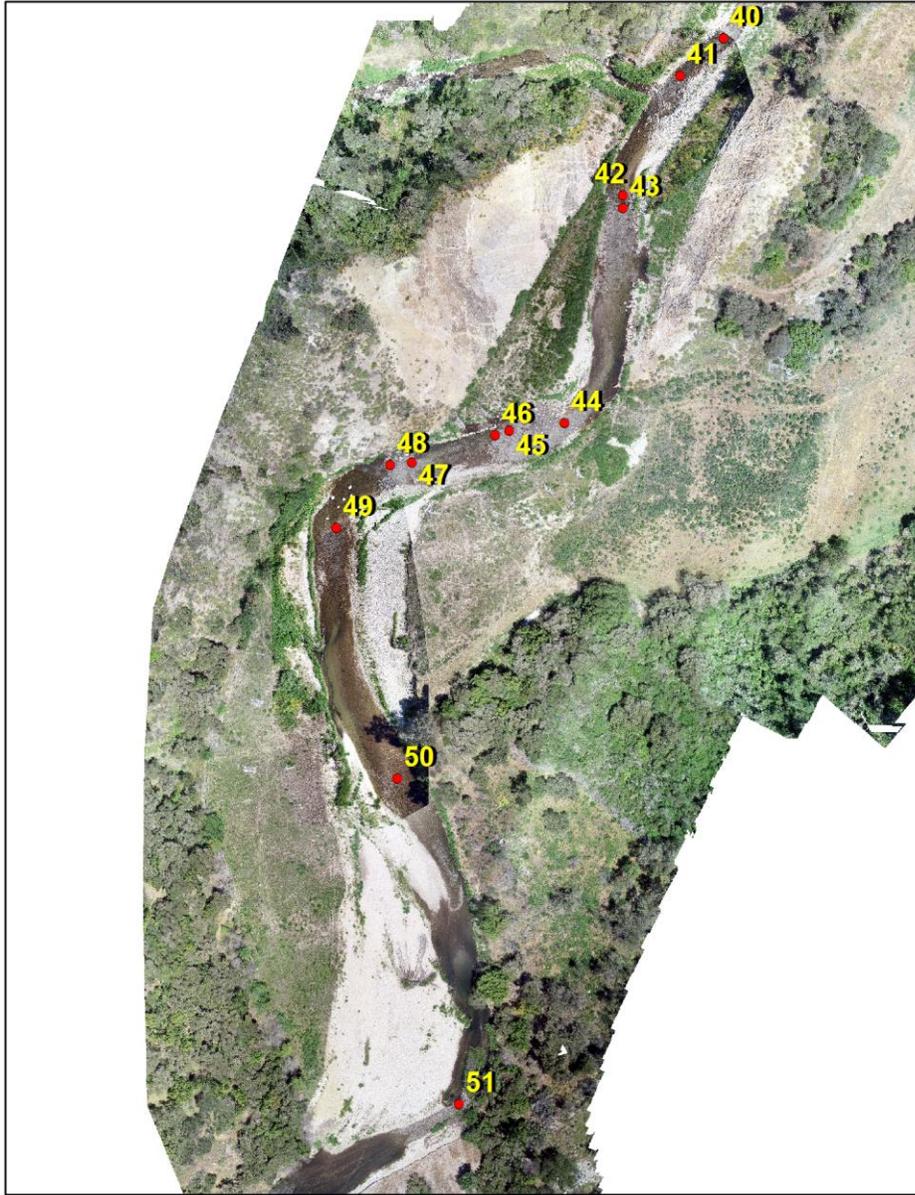
Reach E is the relatively low-gradient river segment extending from below the San Clemente Creek mouth to the upstream end of the CRRDR project (Fig. 19). The chief impediment in this reach is the presence of shallow water on wide gravel riffles and bars in the riffle-pool sequences (Figs. 20 to 24). A tributary mouth bar at the terminus of San Clemente Creek formed a significant barrier to San Clemente at 17 cfs (Fig. 22). The launching pool is 0.5 ft deep, the jump height is 1.5 ft from the water surface, and there is no landing pool. Approximately 1 cfs was flowing from San Clemente Creek. Appendix B-8 and B-9 provide a digital cross section and longitudinal profile through site 41 at the San Clemente mouth in Reach E.

Figure 19. Orthophotos of Reach E . Flow is north. Q= 17 cfs at sites 41, 42, 43, 49 and 50 (July 15 imagery). Q= 30 cfs at other sites in the view (May 29 imagery).

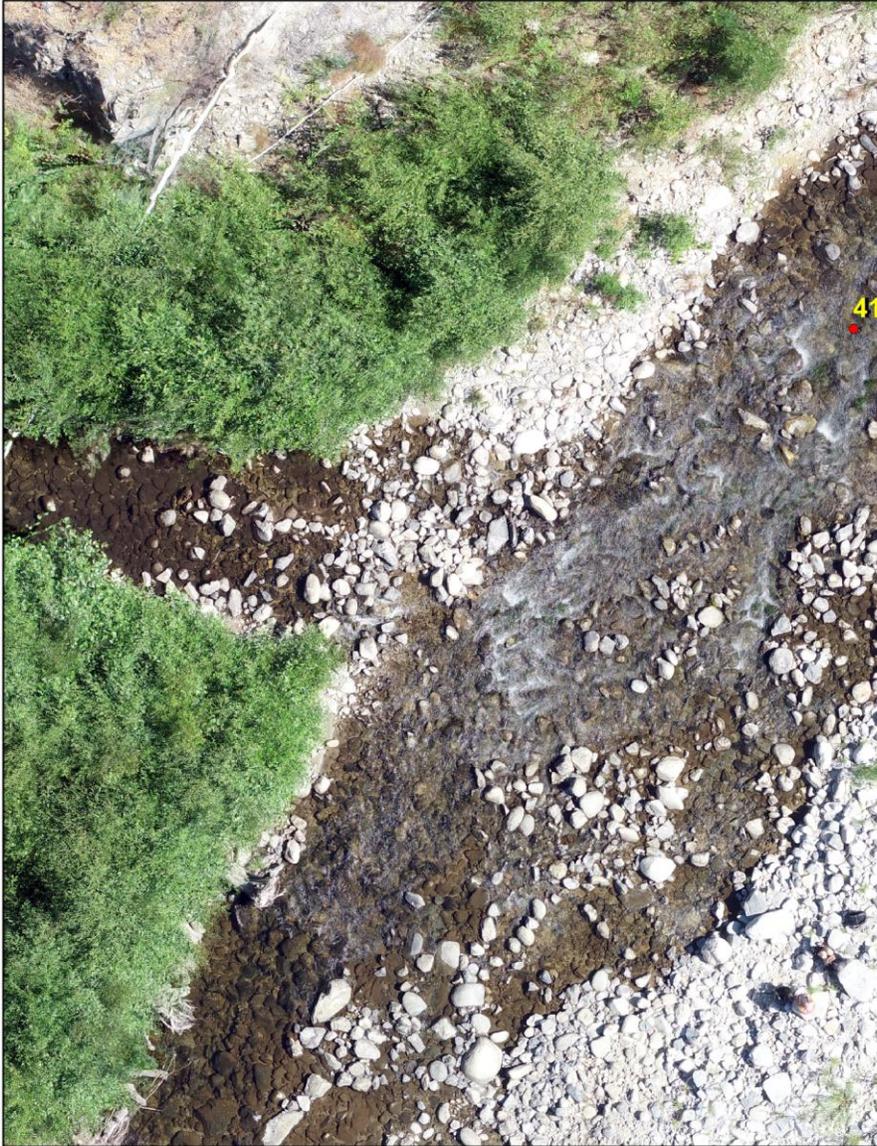
Figure 20. Orthophoto of Site # 41. Flow is north.  $Q= 17$  cfs. The impediment is a steep shallow riffle crossing the mouth of San Clemente Creek. Note dry boulder and gravel ridge forming a barrier to the entrance to San Clemente Creek.

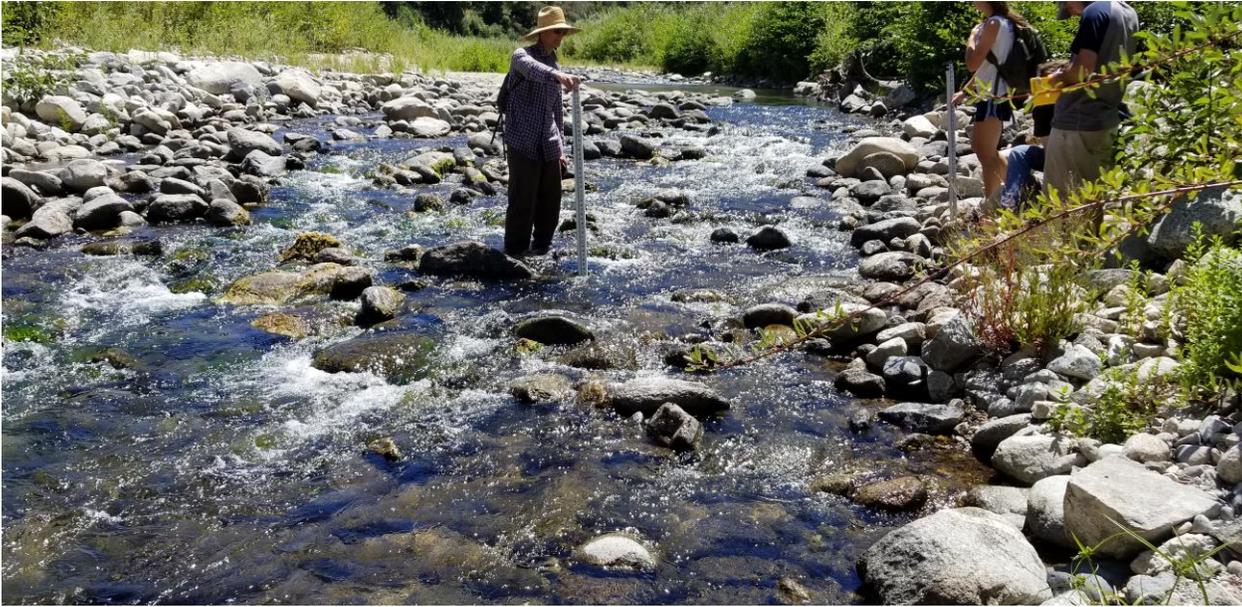
Figure 21. Site #41 is a shallow riffle passing the mouth of San Clemente Creek.

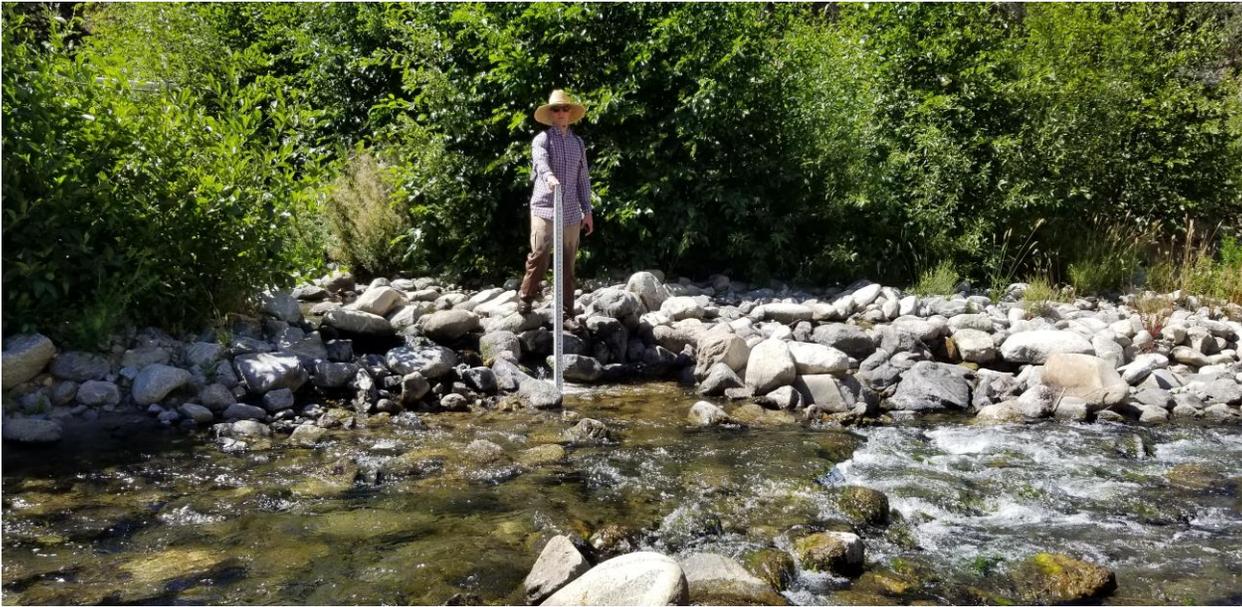
Figure 22. Difficult passage into San Clemente Creek mouth. San Clemente Creek flows toward the camera through a narrow passage located to left of person.
