Publication No. WI-2018-07  
30 August 2018  
Revised  
02 April 2019

**The Watershed Institute**

**Carmel River Reroute and  
Dam Removal Fish Passage  
Assessment (Summer2018)**

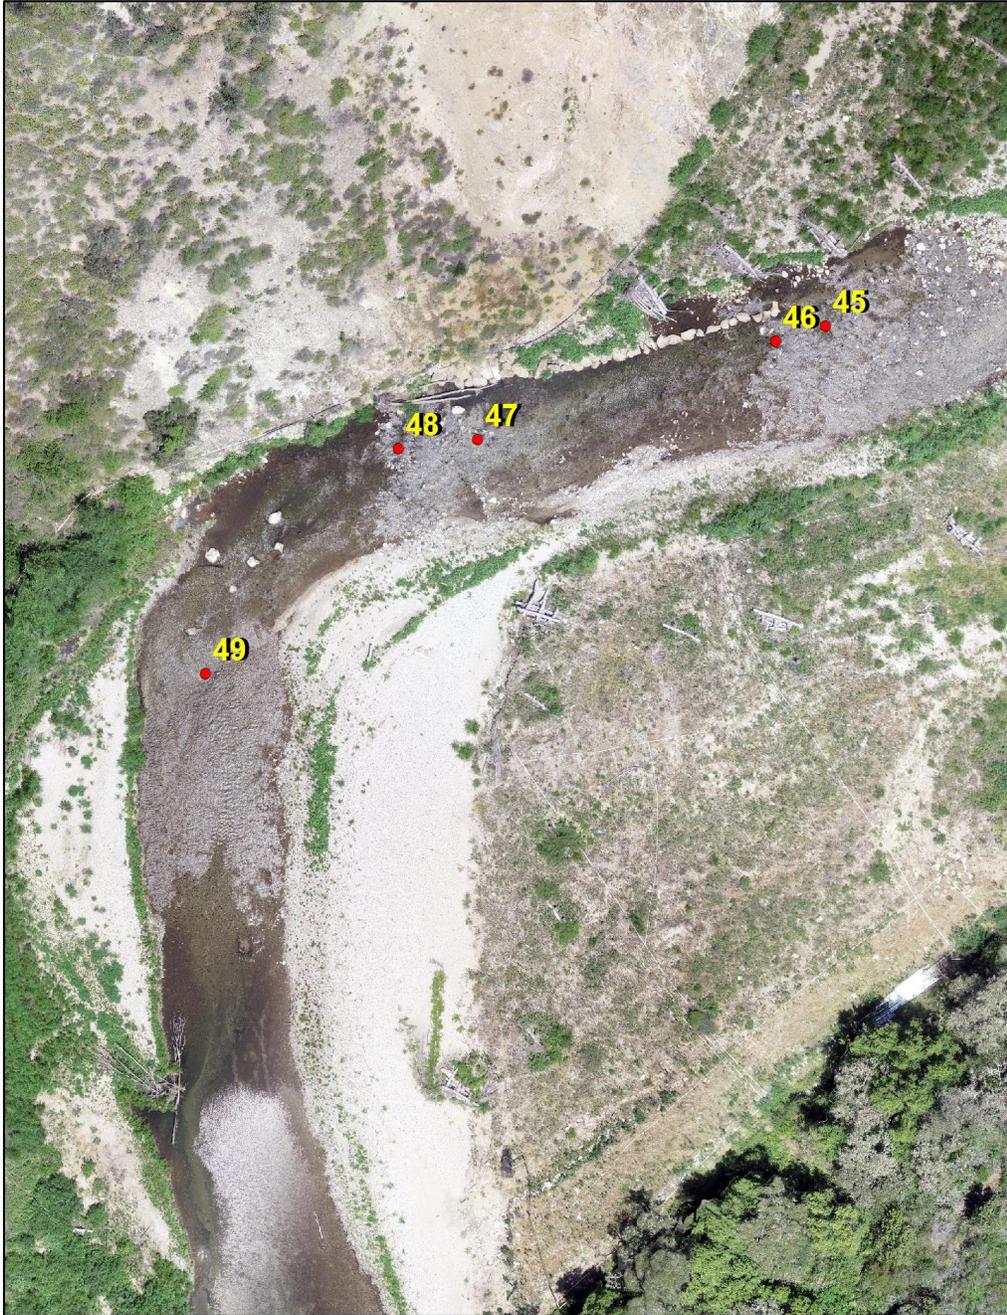
Figure 23. Shallow riffles formed barriers to migration in Reach E at 16 cfs. Orthophoto shows site at 30 cfs on 5/29/18.

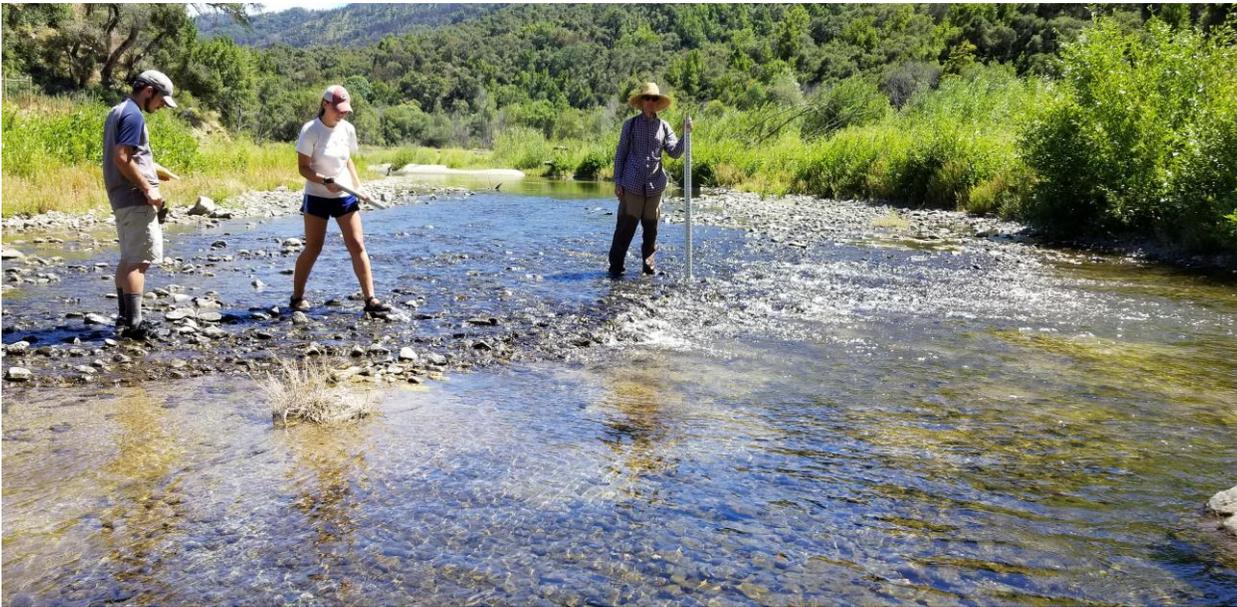
Figure 24. Shallow riffle at site #49.  $Q= 17$  cfs

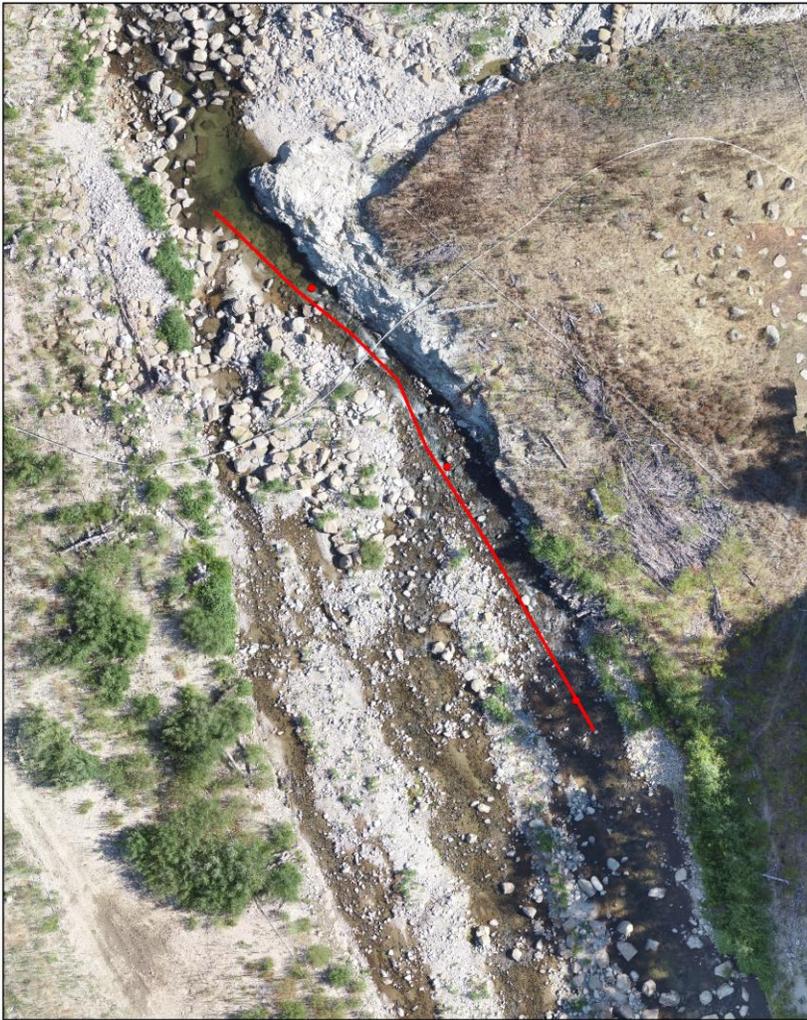
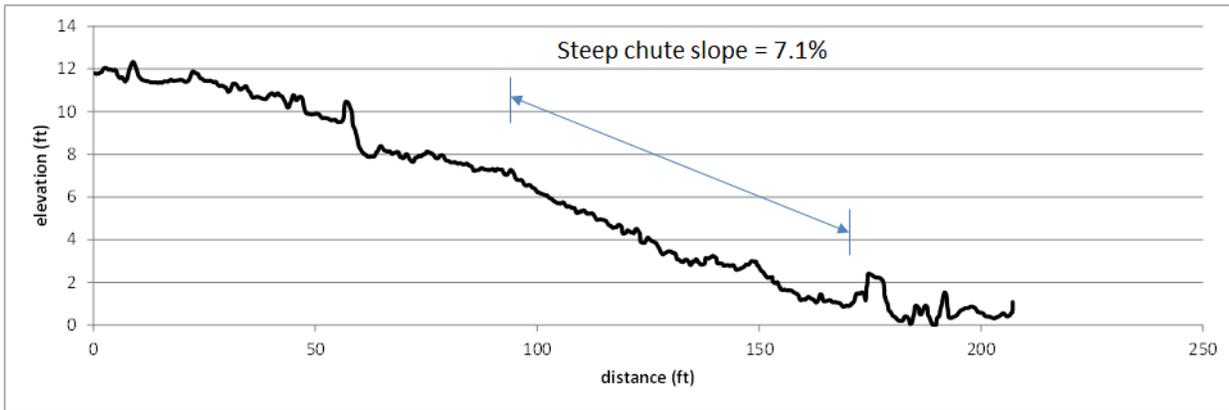
B-5. Longitudinal profile through Reach B. This is the original location of the “Section C” step-pool sequence. Flow is from south to north. Northern red dot is entrance to steep reach, potential barrier #20. Profile extends through sites #20, #21, and #22.  $Q = 15$  cfs.

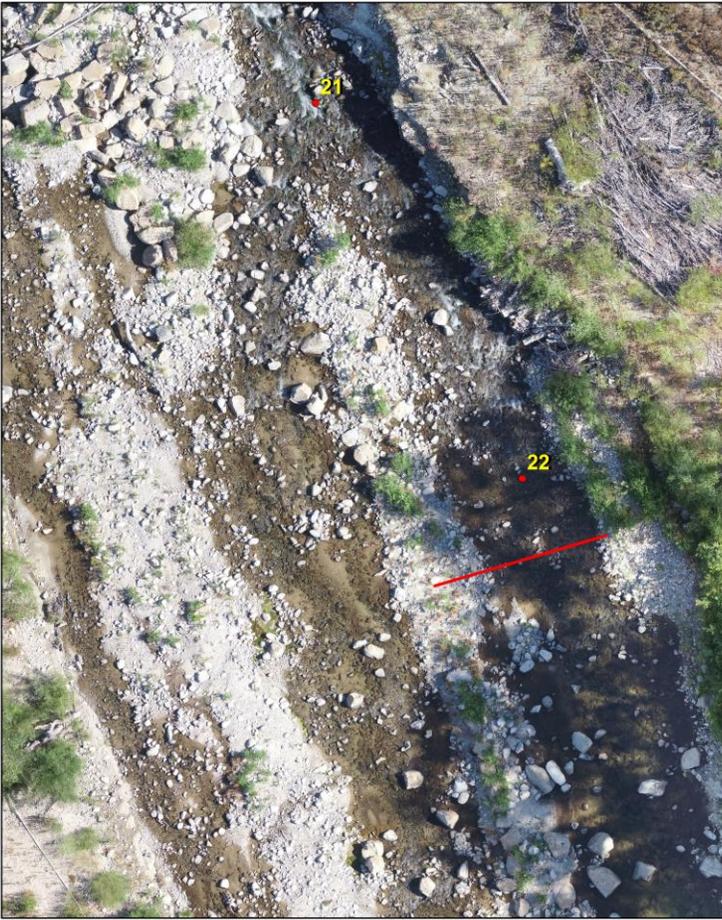
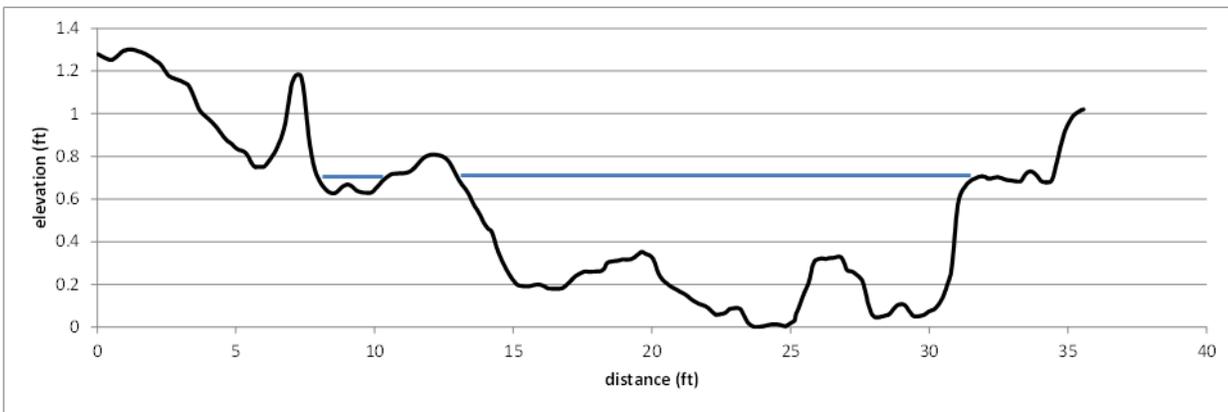
B-6. Typical shallow cross section in Reach C. Flow is from south to north. Water surface approximated from orthophoto at  $Q=15$  cfs

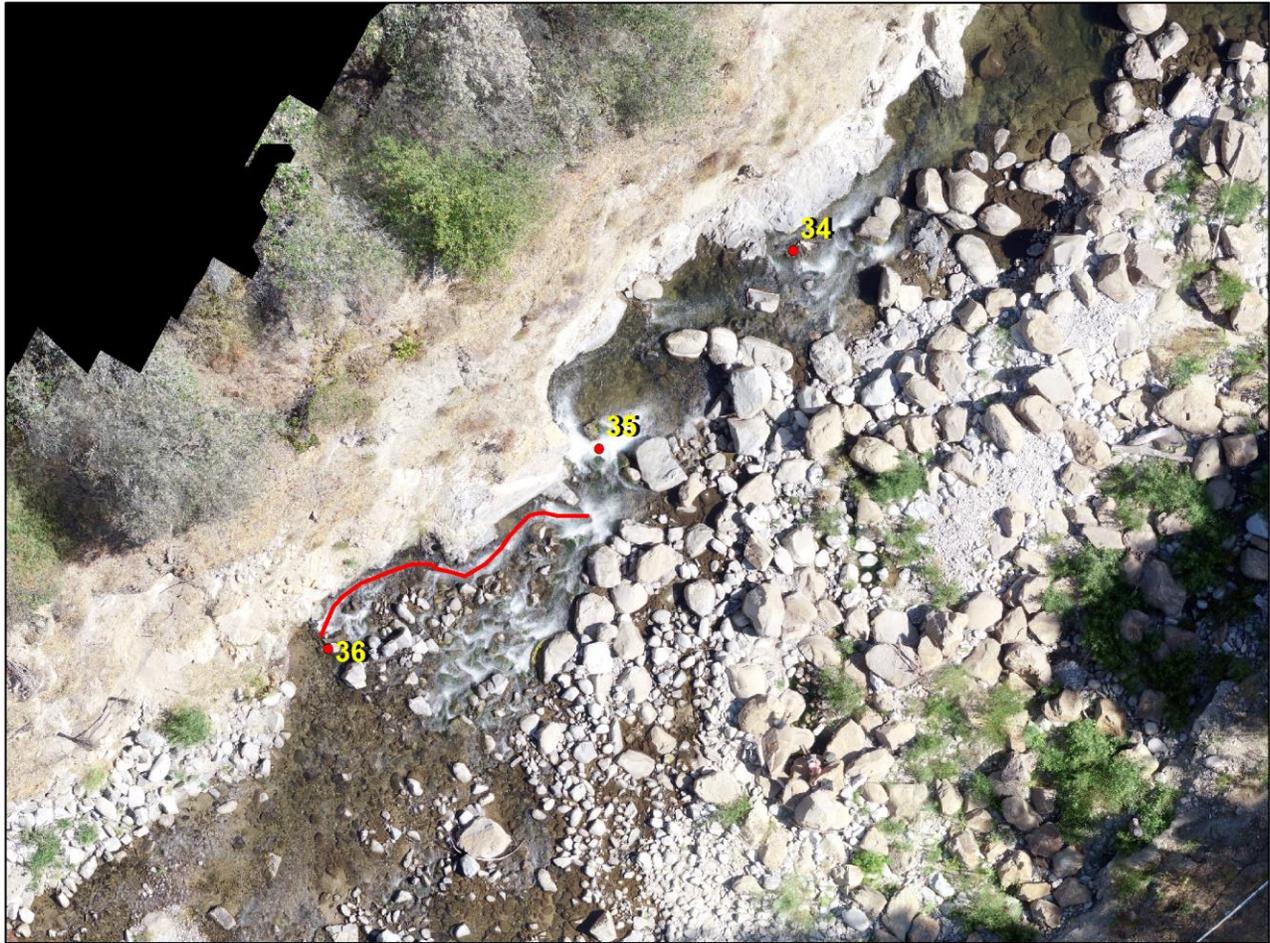
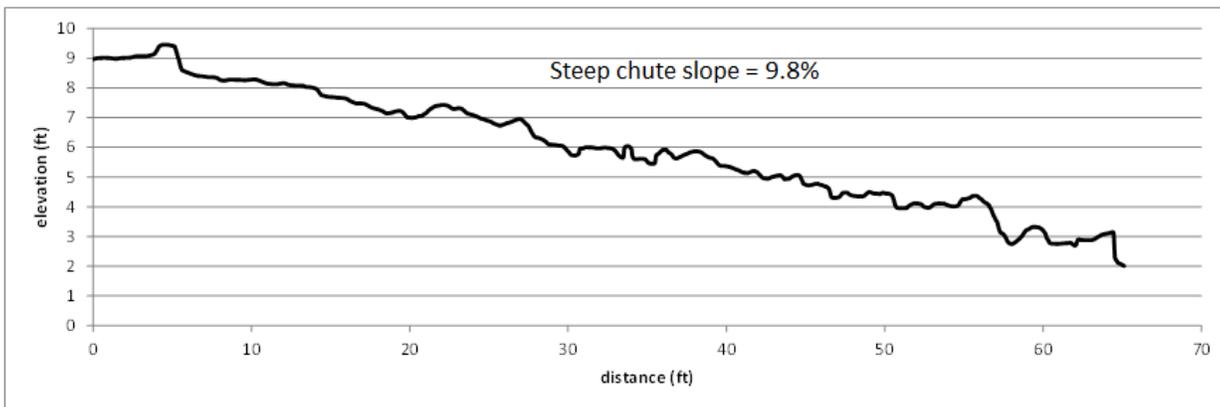
B-7. Top: Longitudinal profile of site# 35. Flow is northwest.  $Q = 15$  cfs

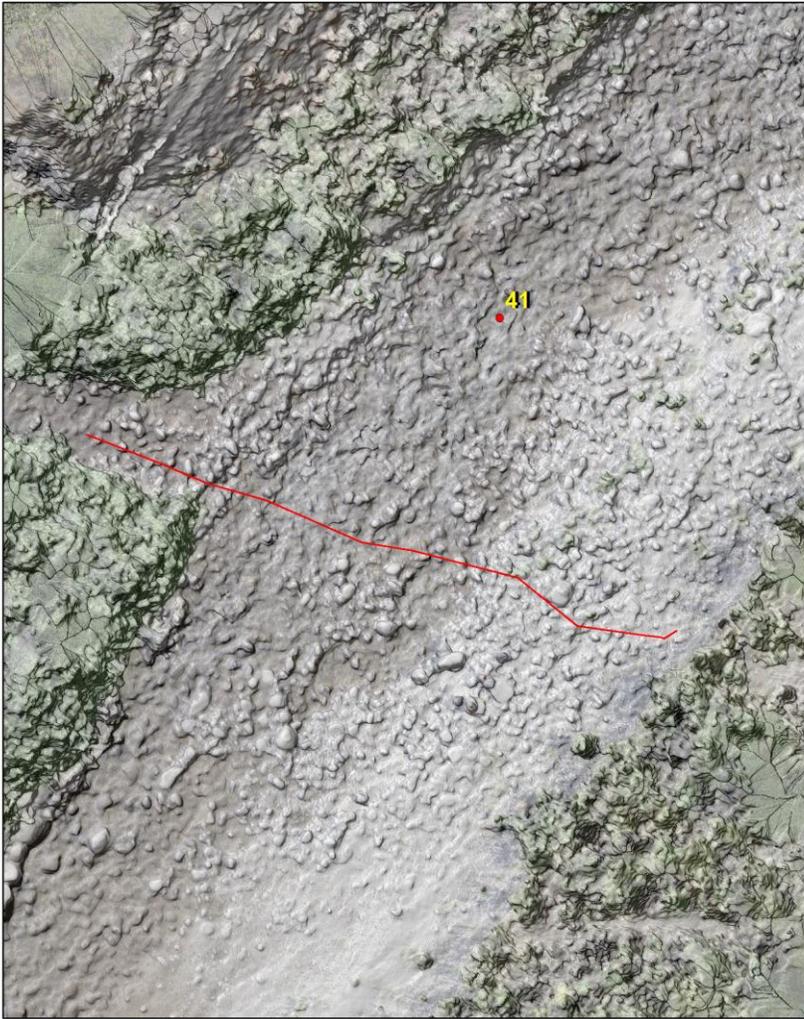
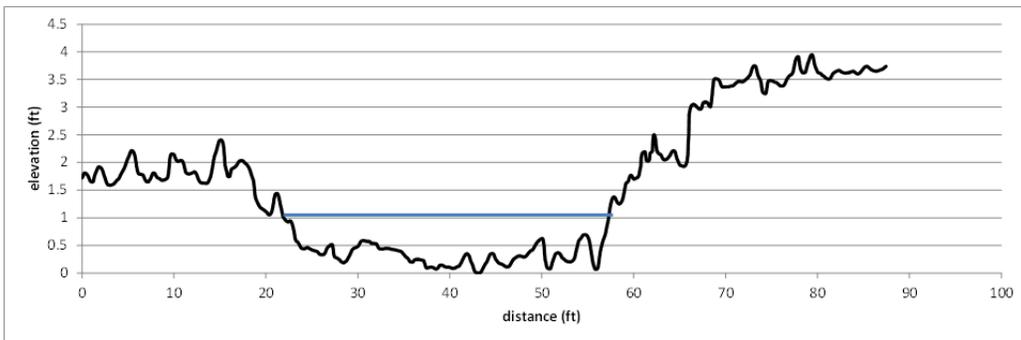
B-8. Top: combined hillshade and orthophoto reveals bed complexity at site #41 riffle. Cross section begins 15 m up San Clemente Creek mouth. Water surface is estimated from orthophoto at  $Q = 15$  cfs.

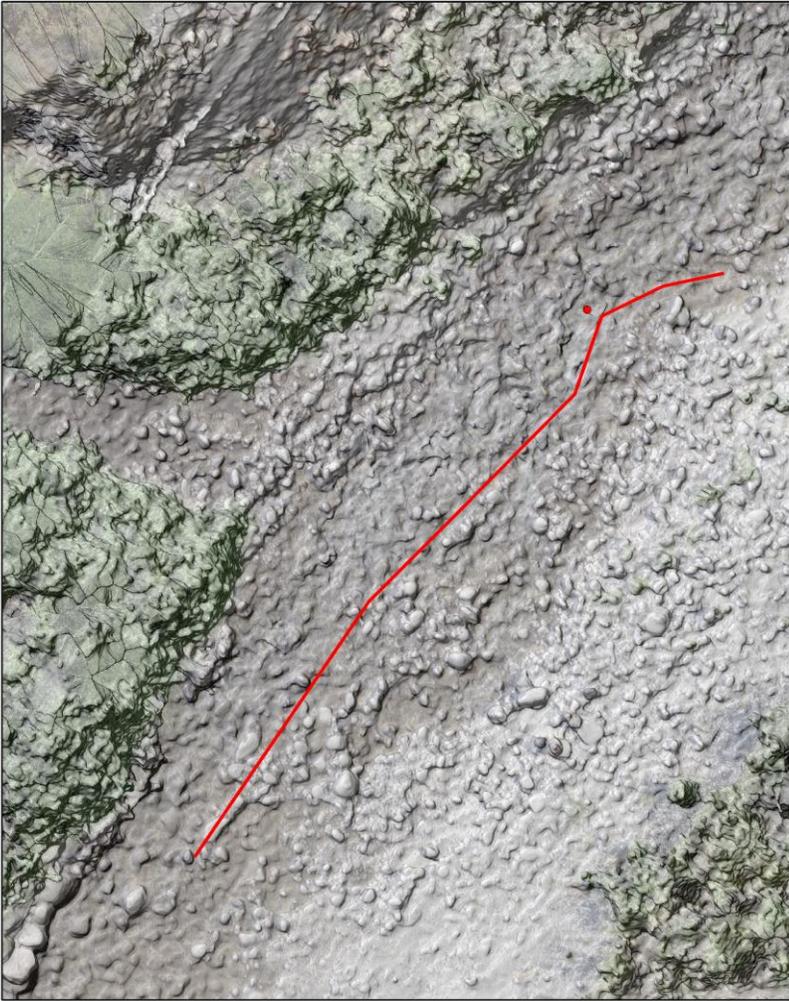
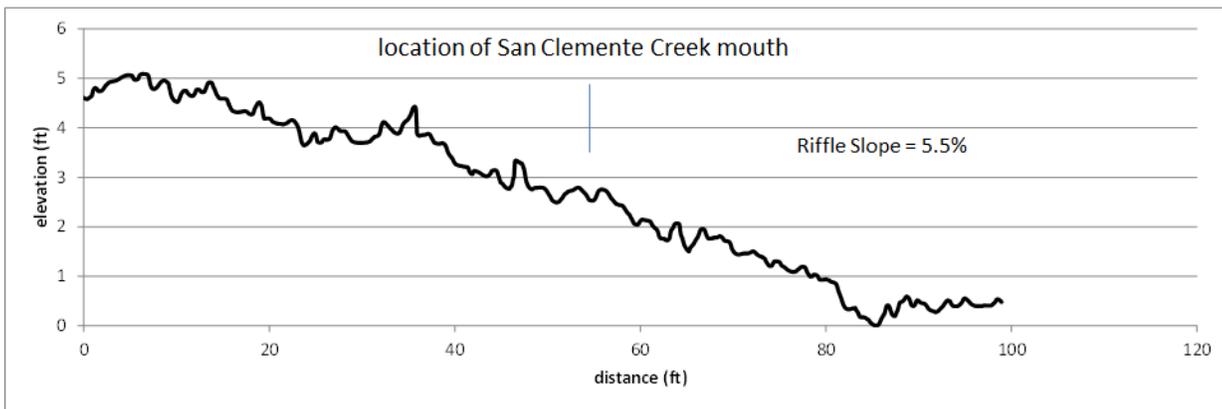
B-9. Longitudinal profile of site #41 riffle at San Clemente Creek mouth.
