# First Year Assessment of the Carmel River Reroute and Dam Removal Project

CSUMB Class: GEOL 460 Spring 2016

28 May 2016

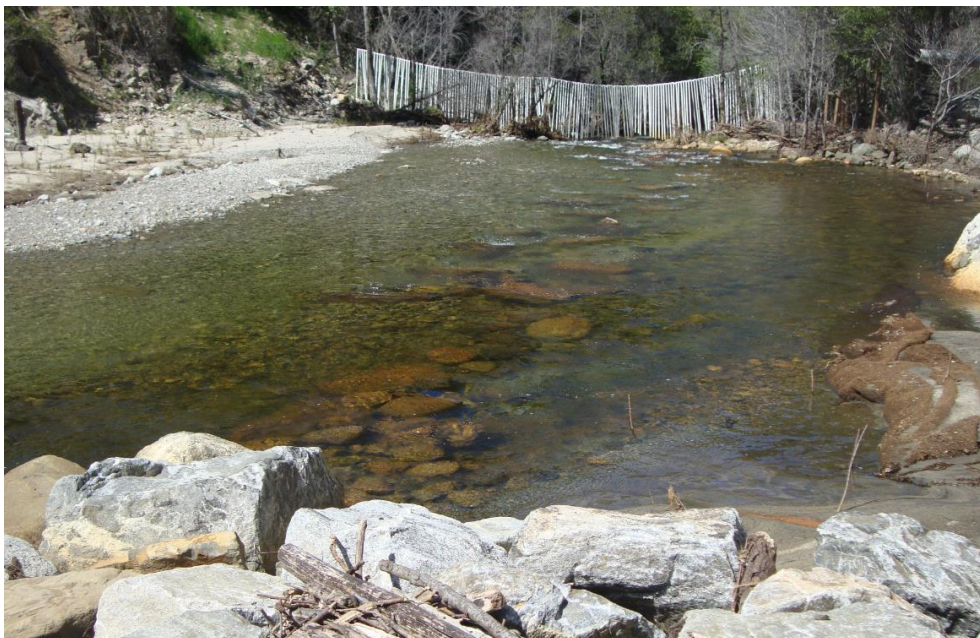
Figure 26. Downstream view of downstream terminus of the constructed channel. Submerged boulders are the right edge of pilot channel that was buried by gravel bar deposition. Flow eroded left bank and displaced fiber matting to reach bedrock wall near the previous location of right dam abutment.

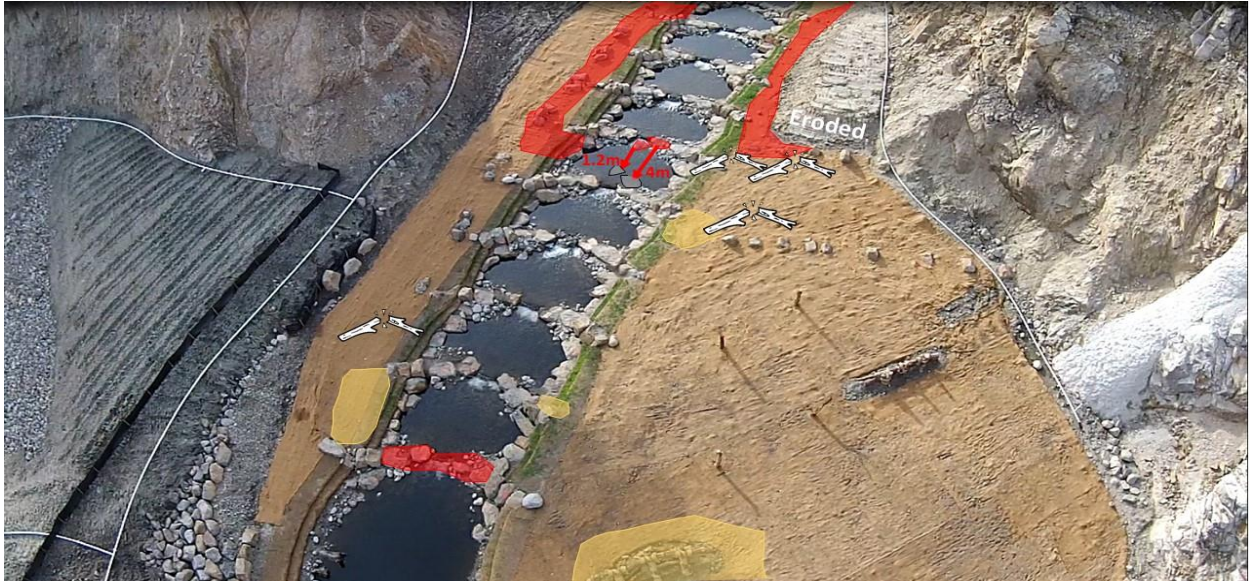
Upstream from Pool 1, we also saw changes in step pool Section A. Berm A1 was missing, and the CNB boulders were not seen in pool 1 (Figs. 27 and 28). The boulders may have been too deep to be seen. In berm A6 the crest boulder was dislodged and moved approximately 1.2 meters downstream, and the left notch boulder moved about 4 meters downstream. There was a large lateral failure on the right bank from berm A10 to berm A6 (Fig. 29). On the left bank, there was incipient lateral failure and a large amount of FES damage from berms A6 to A10. There were sediment deposits on the left floodplain by A2 and A5 (Figs. 27 and 28). Large woody debris was found on the right floodplain by A3 and on the left floodplain by berms A5 and A7. The upper bank sediment pile on the left bank was eroded (Figs. 27 and 29).

Figure 27. Oblique upstream aerial view of Pool (lower left) and section A. Berms A1–A10 can be seen.

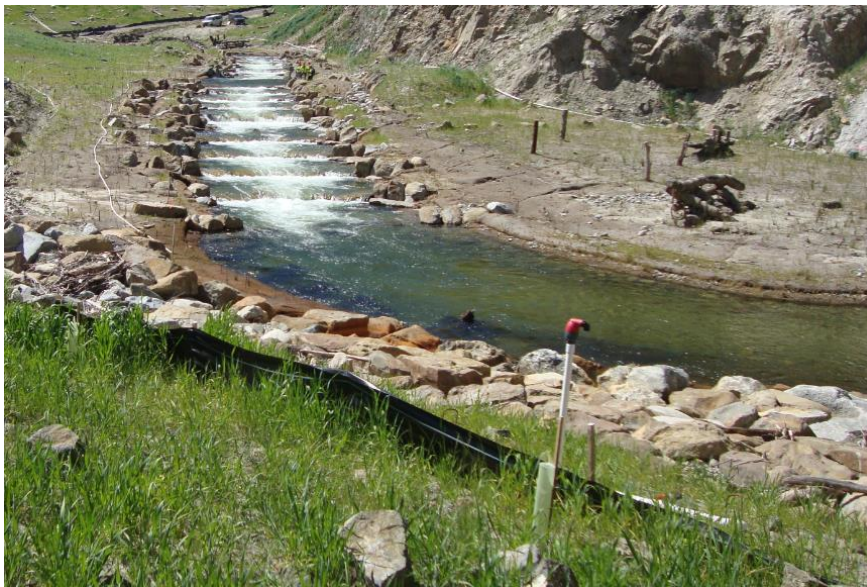
Figure 28. Upstream view of Pool 1 and section A. Banks and FES along downstream end of Section A are in excellent condition. Minor sediment deposition is present on both floodplains. Berm A1 is missing, but step on berm A2 does not appear excessive.

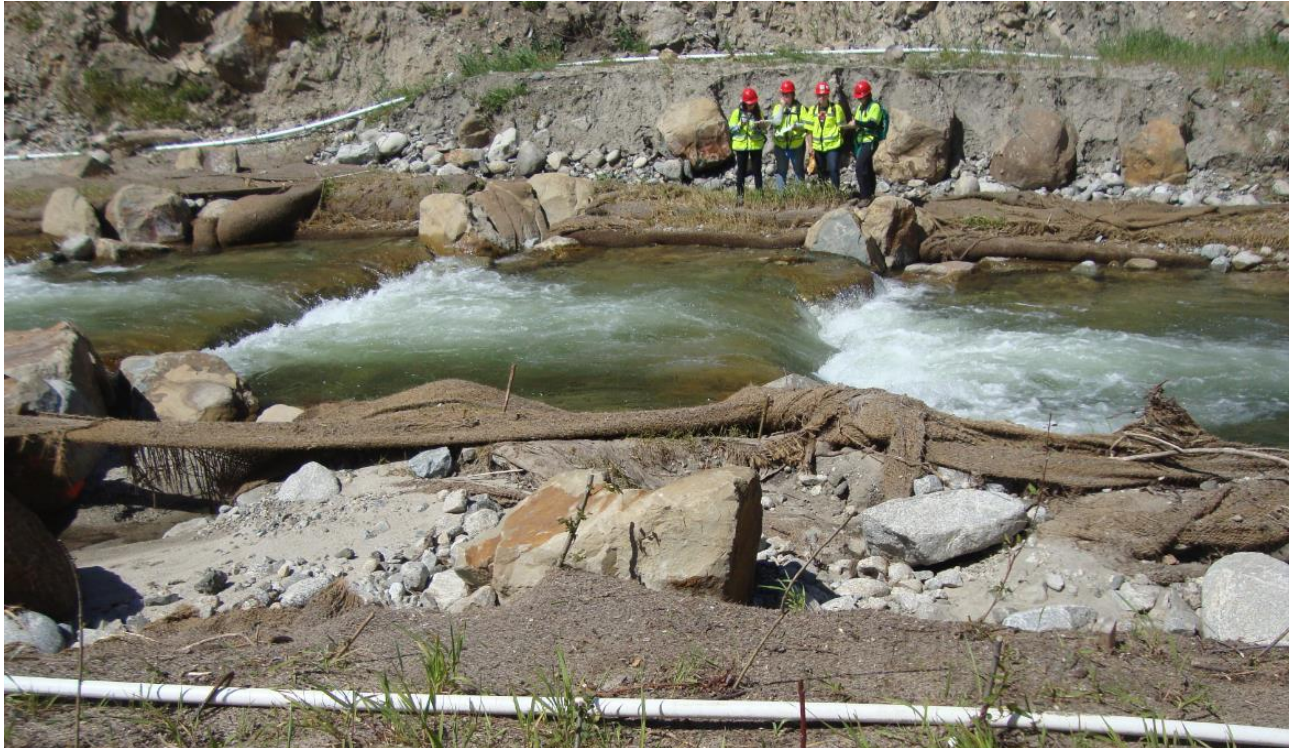
**Figure 29. View from right bank near berm A-9. Disturbed FES in foreground is right bank along central section A. Large boulders in background are seed boulders that were partially eroded from constructed upper bank.**

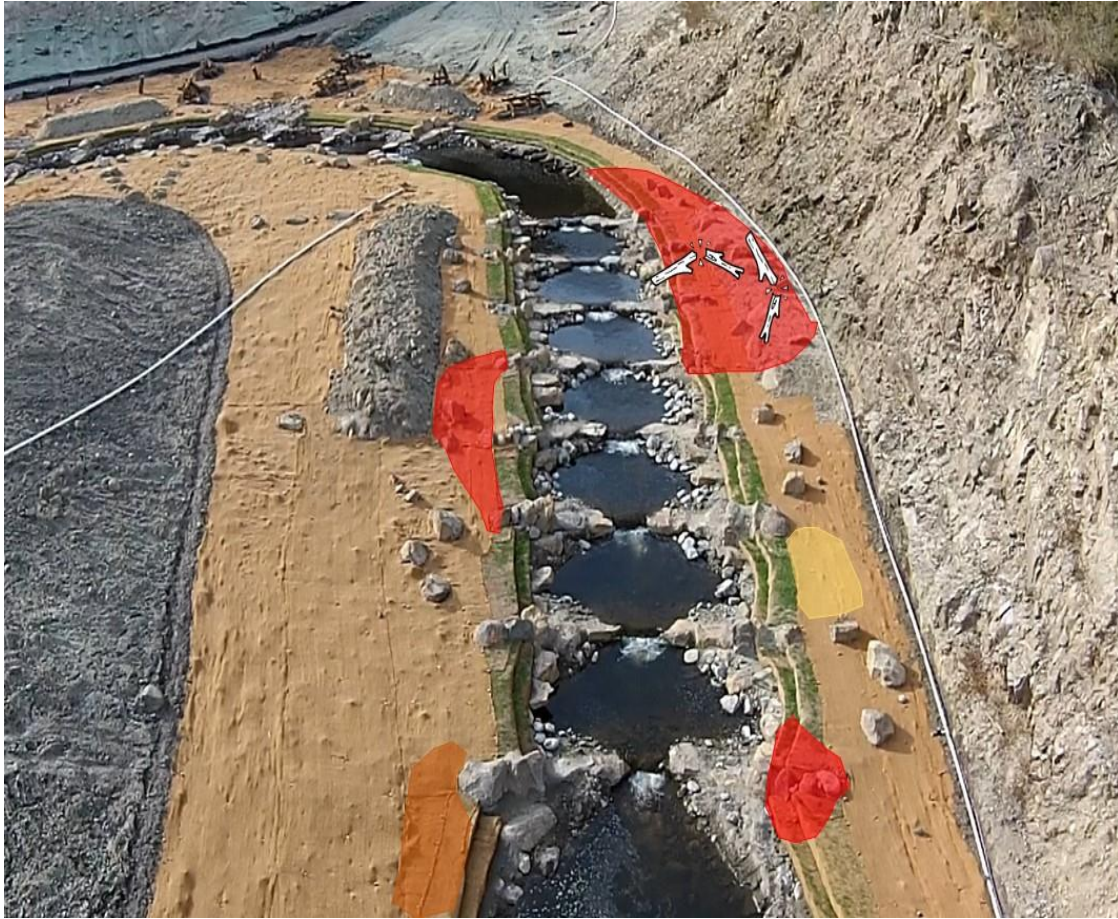
At step pool section B, there was incipient lateral failure present on both the left and right banks of berm B1, with the FES removed on the left bank (Fig. 30). There was a significant amount of sediment deposited on the floodplain between berms B2 and B3 on the left side of the channel. A large lateral failure was present on the right bank from berm B5 to berm B3. A larger lateral failure occurred on the left bank from Pool 3 to berm B5 (Figs. 30 and 31). There were two pieces of large woody debris present in the new channel route. The FES was removed and the seed boulders that were previously on the floodplain were found in the channel because the water eroded the riverbank down to the bedrock.

Figure 30. Oblique upstream aerial view of Section B showing berms B1–B8, and Pool 3 at the top of the image.

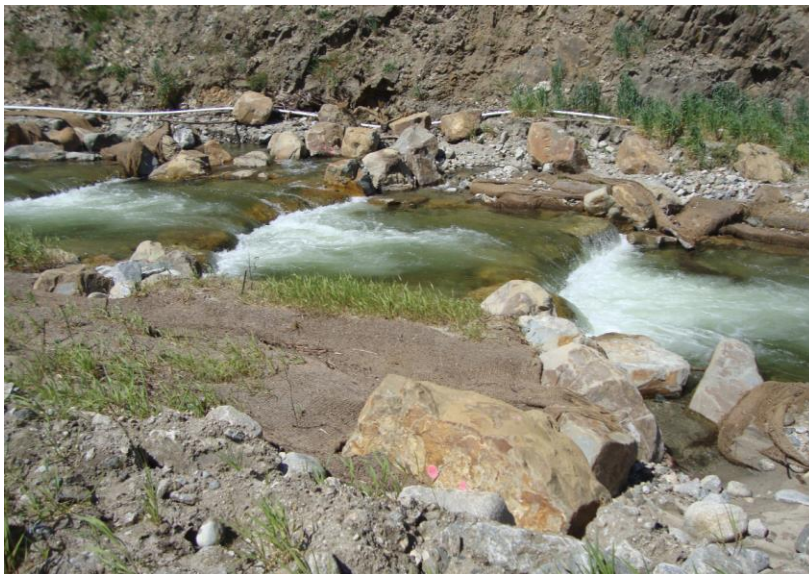
Figure 31. View of left bank along the upstream end of section B. FES has been removed, and bank was eroded back to the bedrock wall, widening the active channel.

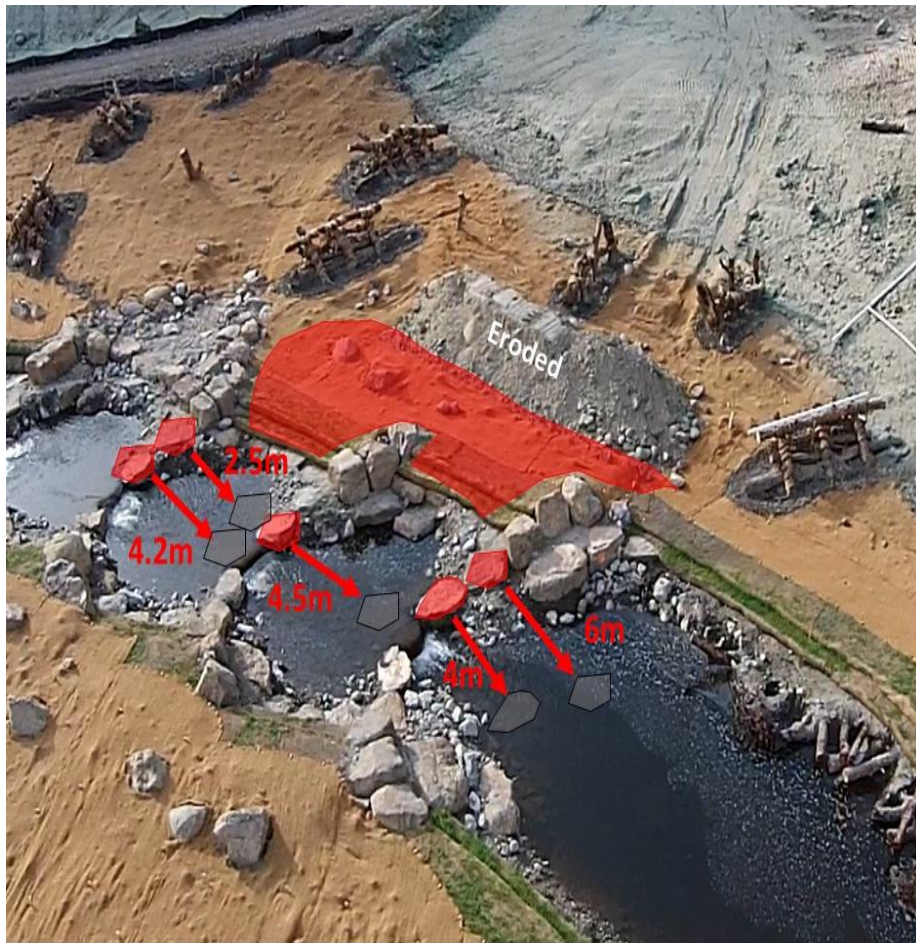
We saw the most structural adjustment in step pool Section C. The left notch boulder in berm C1 was dislodged and moved downstream 4 meters and the left key boulder was moved downstream 6 meters (Fig. 32). The left notch boulder in berm C2 was transported downstream approximately 4.5 meters. In berm C3, the left notch and left key boulders were dislodged and moved downstream approximately 4.2 and 2.5 meters, respectively. There was bank failure from berm C1 to berm C3 and the upper bank sediment pile had been eroded (Fig. 32). The right notch boulder was dislodged from berm C5, but we were unable to relocate the boulder (Fig. 33). In berm C6, the right and left notch boulders moved 2 and 4 meters, respectively. The right key boulder in berm C7 moved downstream about 4.6 meters. In berm C10, the right key and notch boulders both moved downstream approximately 4 meters. There was a lateral failure present between berms C11 and C10 where the right bank and FES were deeply eroded and removed (Fig. 34). There was a deep scour hole along the right edge of the upstream side of C11, potentially indicating piping beneath or alongside the structure (red hatch area in Fig 35; Fig. 36). We also found a significant amount of erosion present on the floodplain of section C where the designed wetlands were supposed to drain back into the river (Figs. 35 and 37), causing a large amount of bank failure from C5 to C7 (Fig. 34). The large upper bank sediment pile along this reach has been eroded (Fig. 33). Large woody debris was present on the right floodplain from berms C9 to C7.

Figure 32. Oblique upstream aerial view showing end of section C emptying into pool 3. Berms C1–C4 are visible.

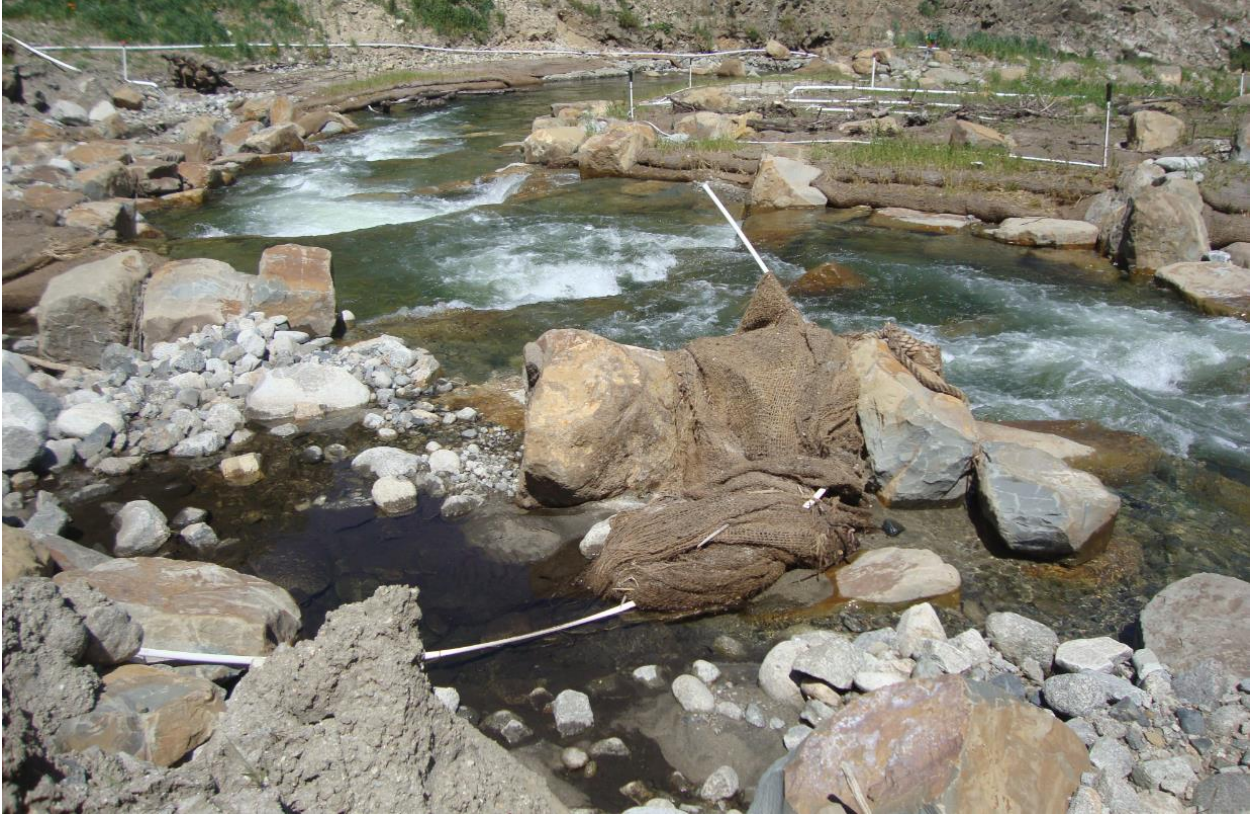
Figure 34. Downstream view of FES and bank disturbance on left bank of section C.

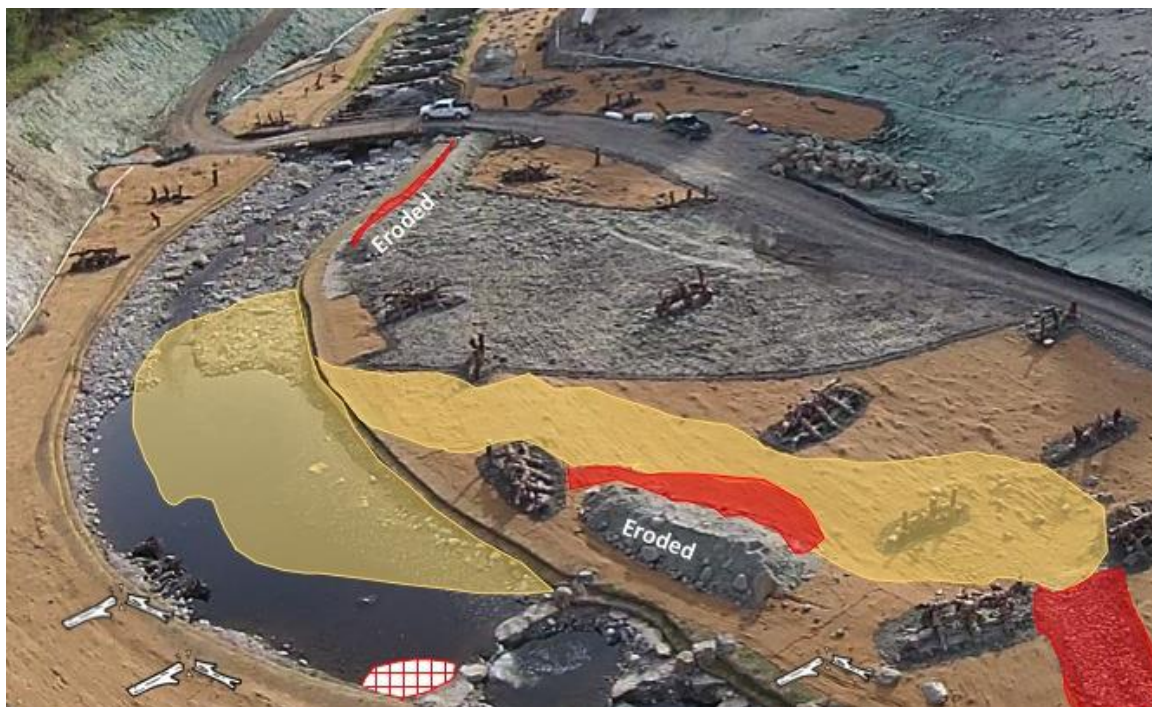
Figure 35. An upstream view of Pool 4 and Riffle D. Red cross-hatched area is a deep scour that likely indicates piping below or around the right end of berm C-11

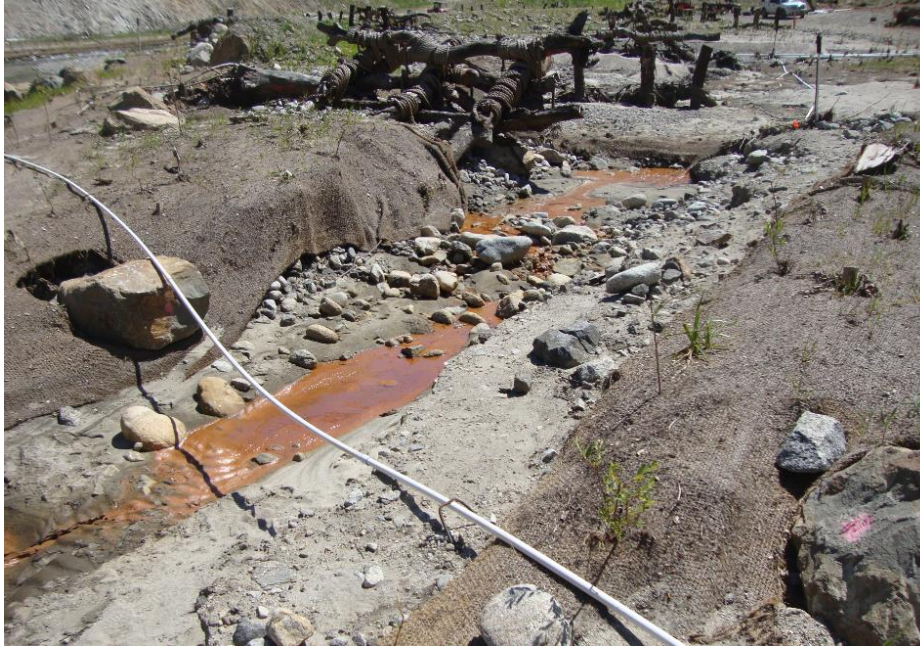
Figure 37. Up-valley view of eroded rocky spillway shown in Figure 18. Knickpoint is visible in upper part of the photo.

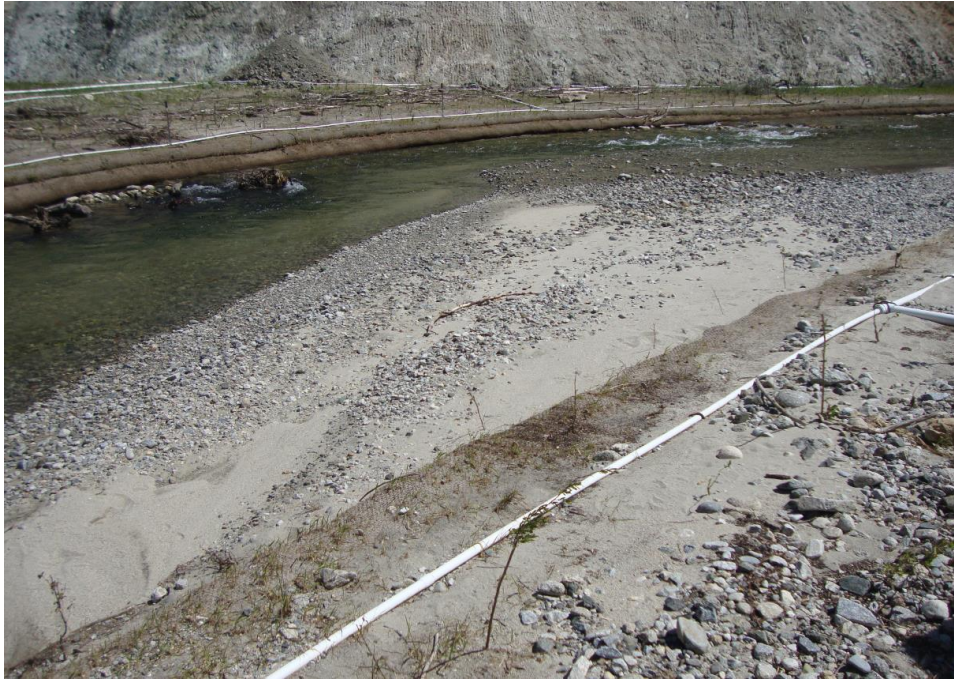
A large gravel point bar has formed downstream from Riffle D in Pool 4 (Figs. 35 and 38). We found significant sand deposits starting from that point bar and on the left floodplain, leading to the major erosional feature seen in Figures 35 and 37. A section of the left floodplain near berms C10 and C11 was damaged, with removed FES and significant erosion on the sediment pile. There was also erosion at the top of Riffle D along the left bank and upper bank sediment pile (Figs. 35 and 39). Except for the minor FES adjustment, Riffle D remained stable (Fig. 40).

**Figure 38. Upstream view of new sand and gravel point bar on left bank of Pool 4 and downstream end of Riffle D. Note excellent condition of FES and constructed rootwad structures on outside of bend.**

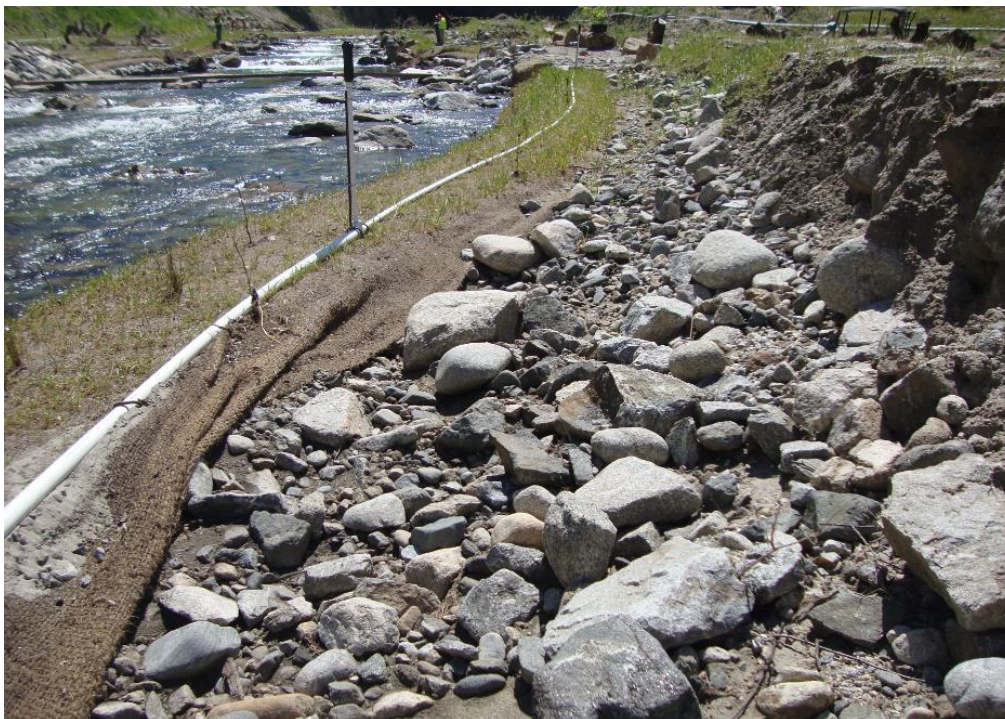
**Figure 39. Upstream view along left bank of riffle D. Example of modified FES and minor erosion of upper bank immediately upstream of the gravel bar (Fig. 38). Upper bank erosion is expected, and is a source of new gravel for the channel. Erosion location is marked in Figure 35.**

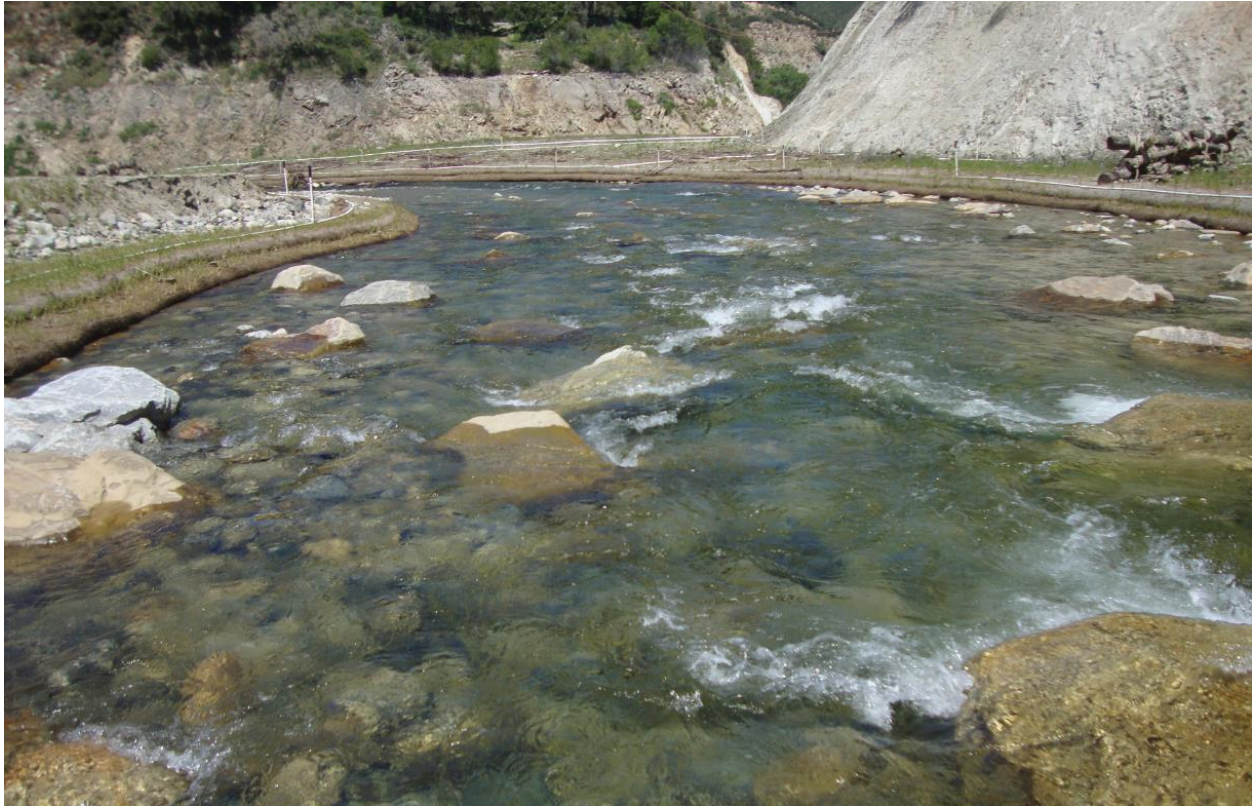
**Figure 40. Downstream view of stable plane-bed of riffle D. FES is intact on right bank, and moderately disturbed on upper left bank.**

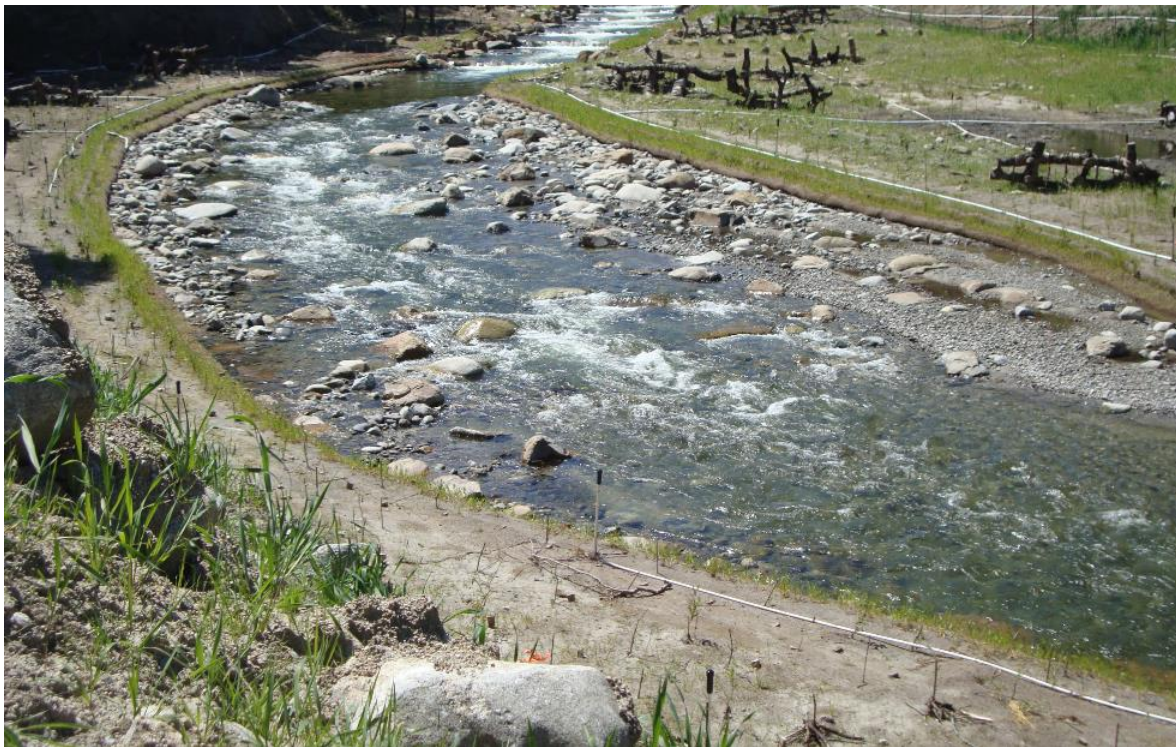
**Figure 45. Upstream view of Riffle F after winter runoff. No impacts were noted. There are sand deposits on both floodplains. There is a small side-attached bar growing on left bank. LWD structures, FES, and riparian plantings were in excellent condition.**

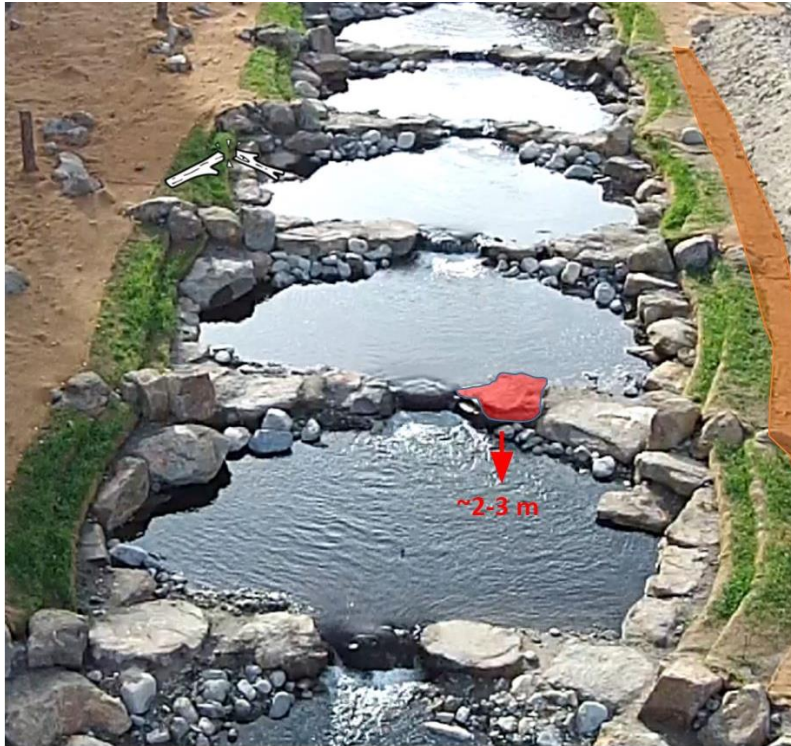
Figure 46. Oblique aerial upstream view of berms G1–G5. The left notch CNB of berm G2 was displaced.

The FES on the left bank between steps G2 and G5 and between G6 and G7 was damaged (Figs 46 and 47). There are sediment deposits against the upstream edges of the key CNB blocks, most notably on the corner of G4. In general, most of the pool deposition occurred along the right pool banks, while most of the erosion and disturbance was concentrated along the left banks. We found large woody debris on the left bank by G7 and G8 and on the right bank by G6 and G7.

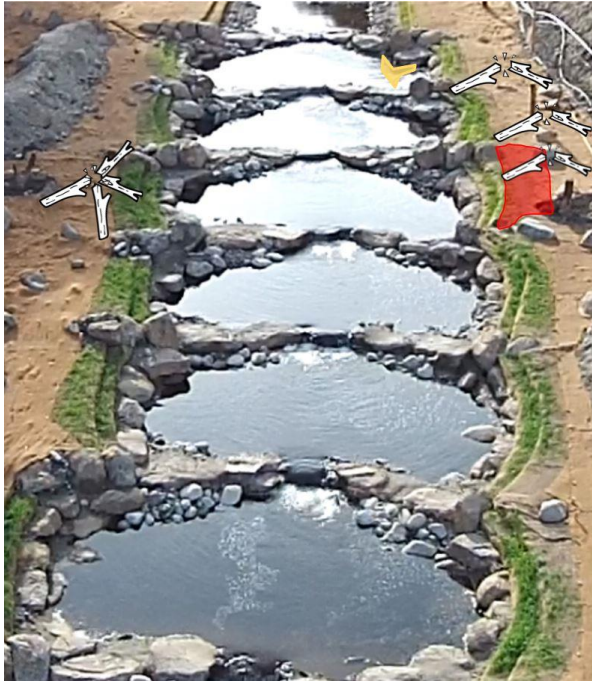
Figure 3. . Oblique aerial upstream view of berms G4-G9.

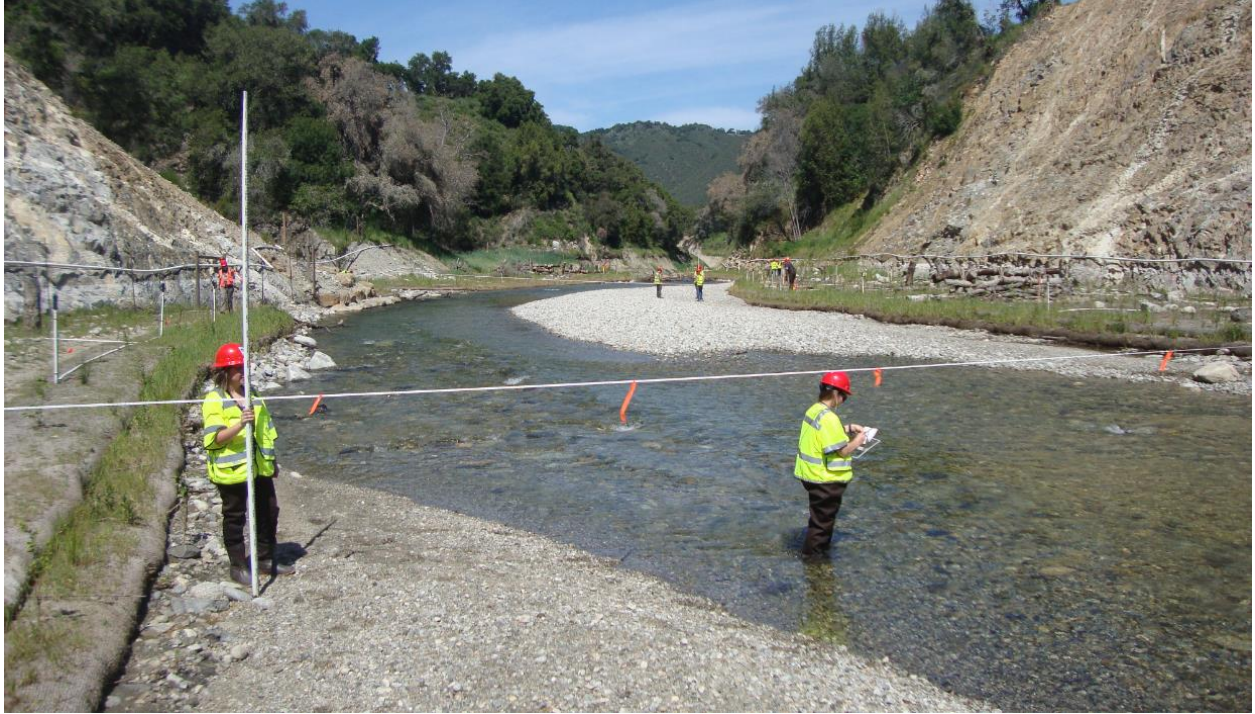
**Fig. 53. Cross section RR-4 located in a glide just upstream from the riffle head of riffle J (Fig 4). Surveyors in background mark the location of cross section RR-5 on a point bar and pool 10. FES was in excellent condition.**

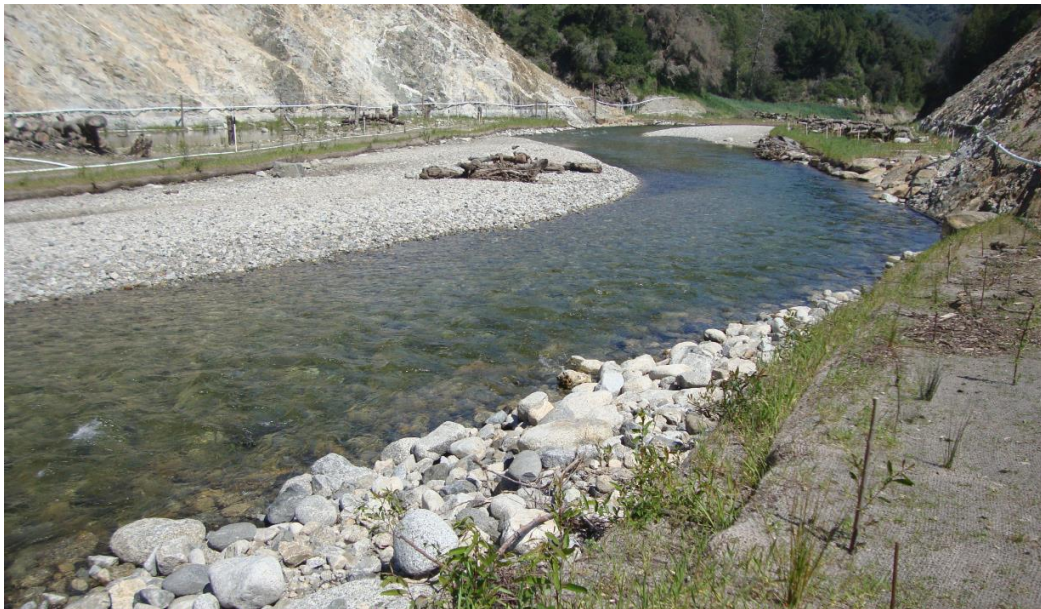
**Figure 54. Downstream view of riffle K, pool 11, and transported LWD structure on point bar. Cross section RR-3 is located along the upstream end of the LWD structure. FES and riparian plantings are in excellent condition.**

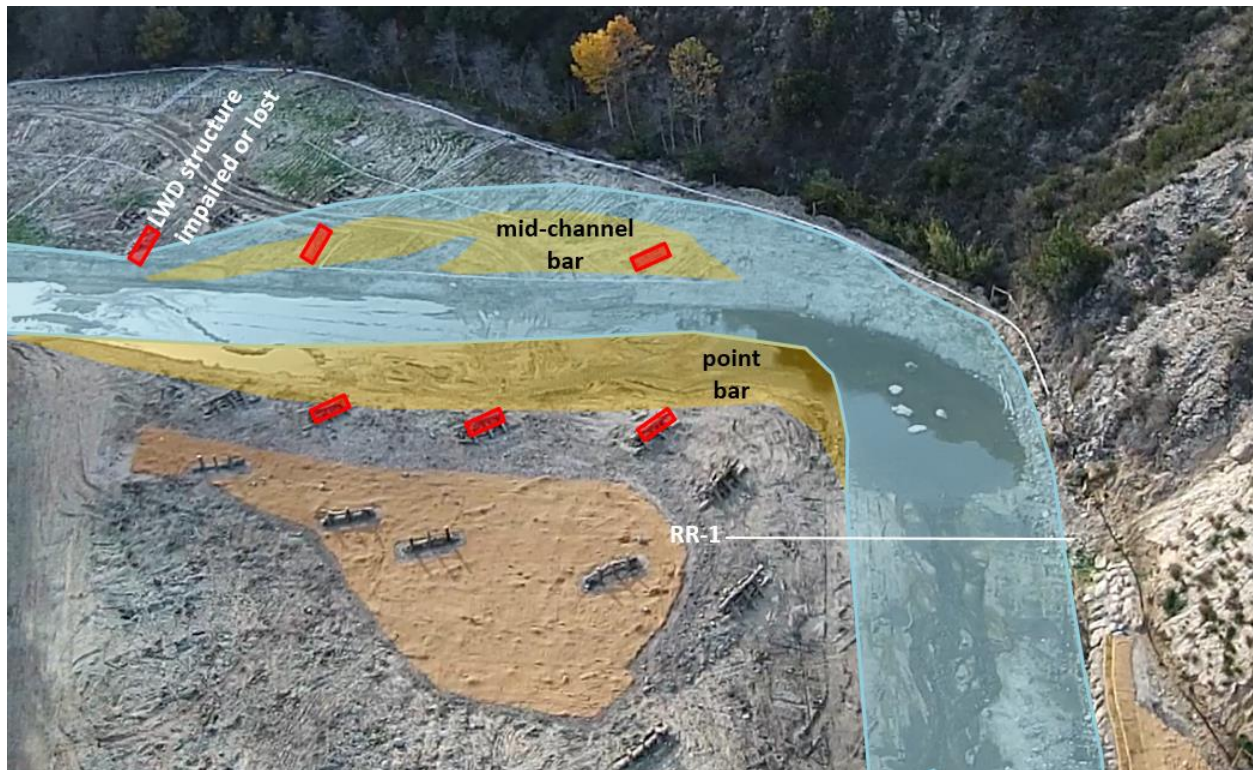
Figure 56. Upstream view of riffle K, pool 12, and the “Upper Carmel” reach. Note lateral erosion of left bank, and growth of in channel gravel bars.

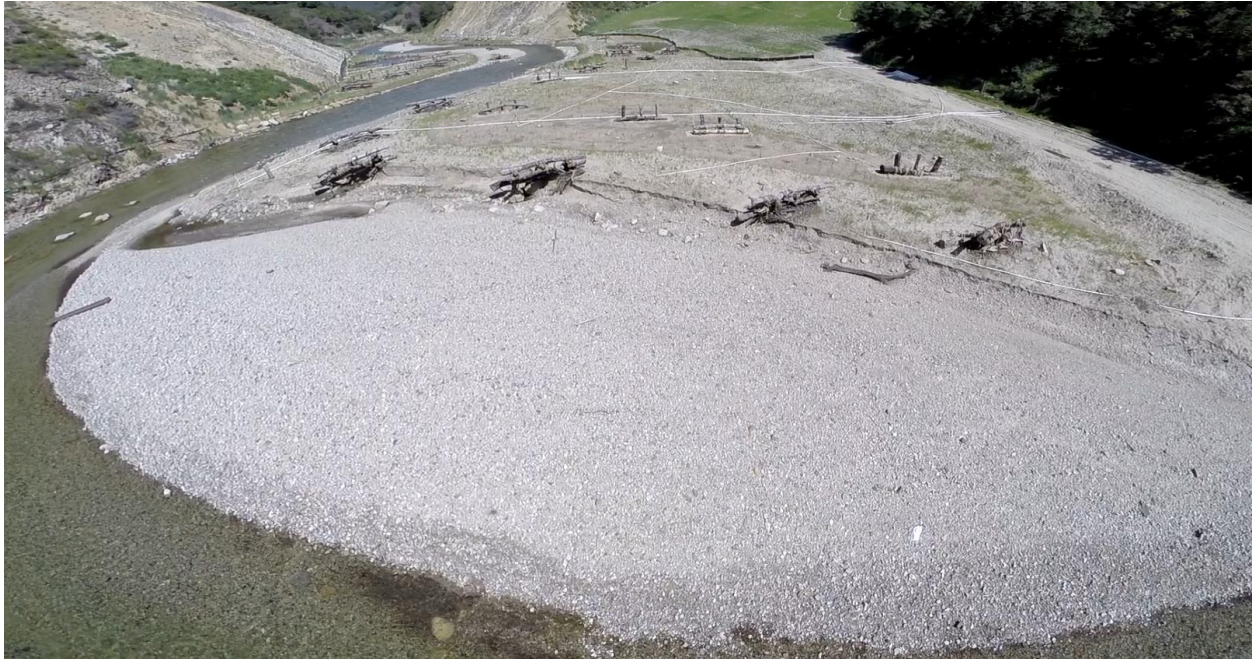
Figure 57. Fish-eye perspective down valley showing point bar growth on right bank adjacent to pool 12, and compromised LWD structures along the same bank. Figure 58 is a close up of one of the compromised LWD structures

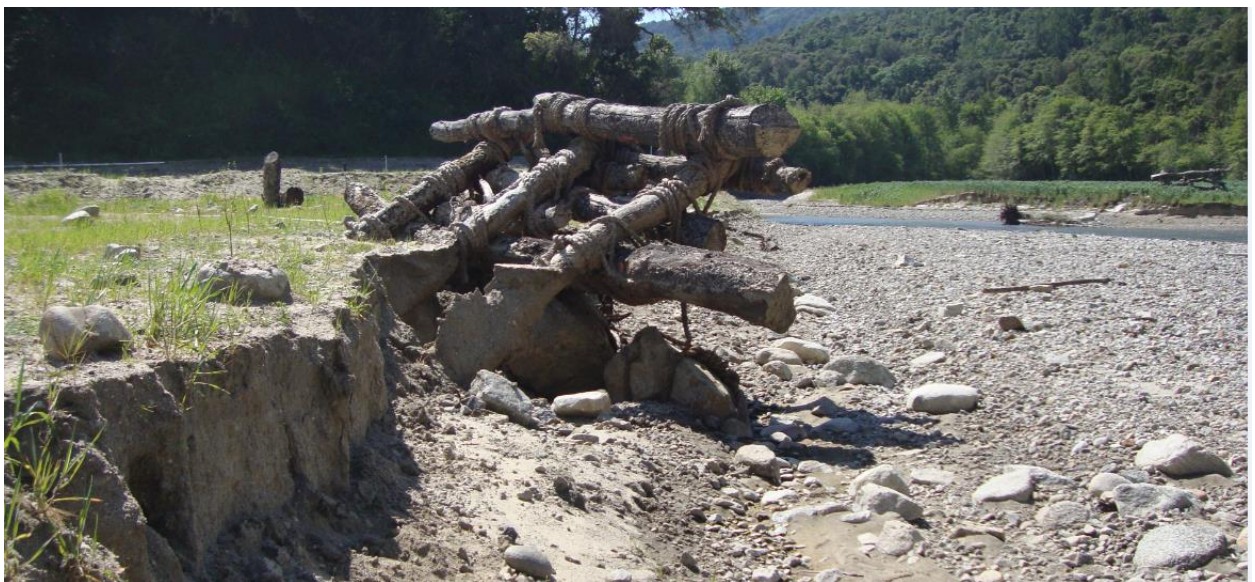
Figure 58. Upstream view of compromised LWD structure on right bank upstream from pool 12.

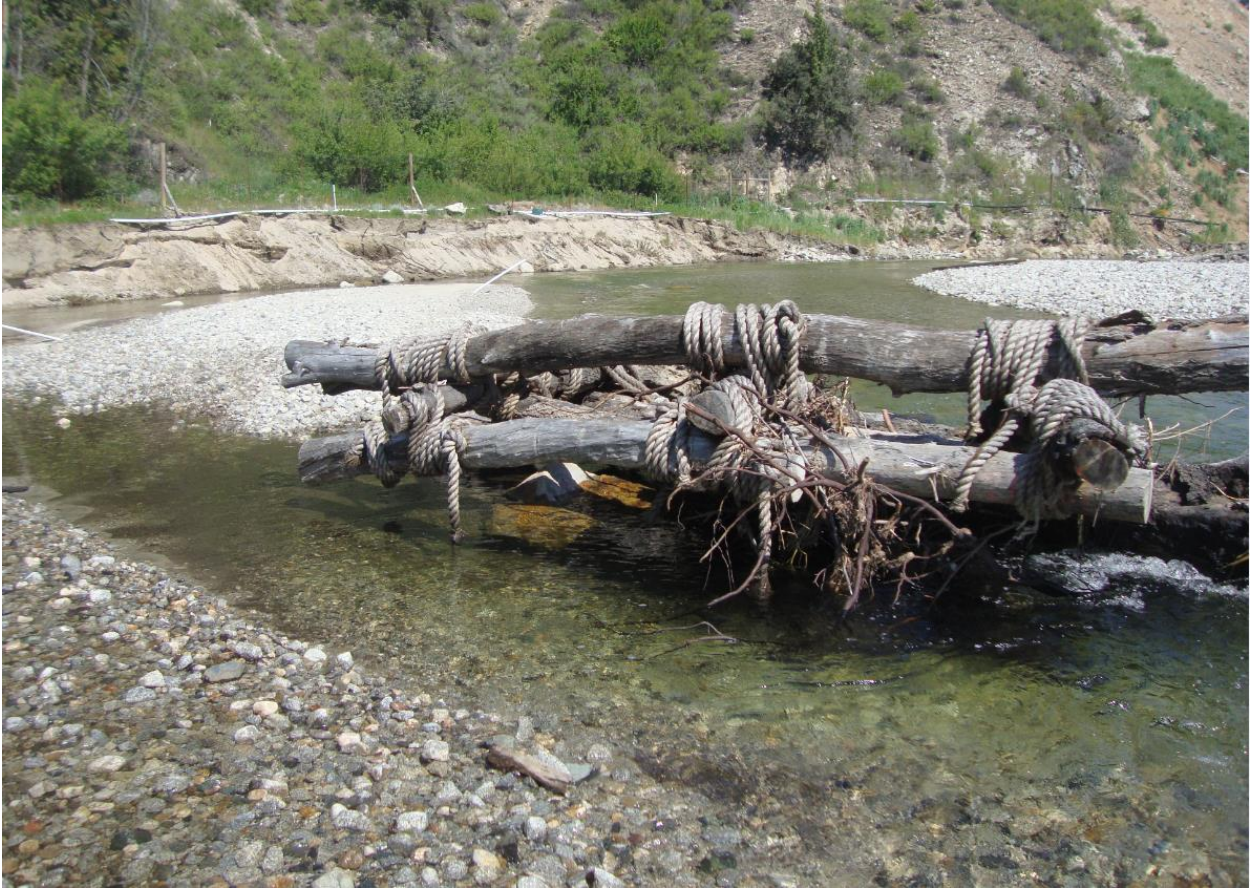
**Figure 59. Downstream view of compromised LWD structure now located on mid-channel bar upstream from pool 12.**

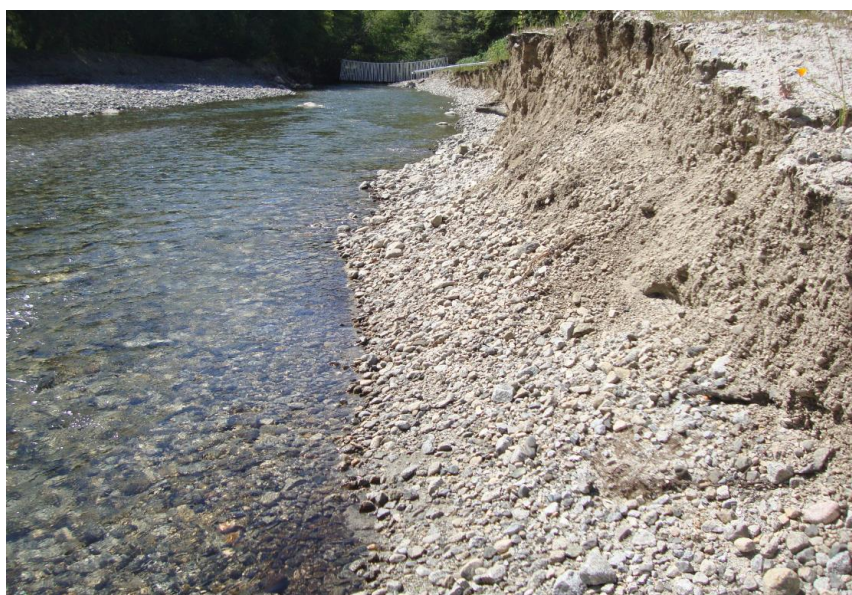
Approximate scaling of the Figure 60 oblique aerial photo, and observation that the eroded floodplain bank was approximately 1.5 to 2 m thick (Fig. 61) indicates that roughly 0.4 acre-ft of gravel was added to the bedload of the river through channel adjustment at the upstream end of the project. That sediment volume is approximately 3% of the estimated 15.2 acre-ft/yr average load (Tetra Tech 2015). Several large wood structures were either missing or structurally compromised (Figs 56–59).

Figure 61. Upstream view of eroded left bank in upper Carmel reach. Bank is between 1.5 and 2 m tall. Erosion of this bank released large volume of sand and gravel to channel.

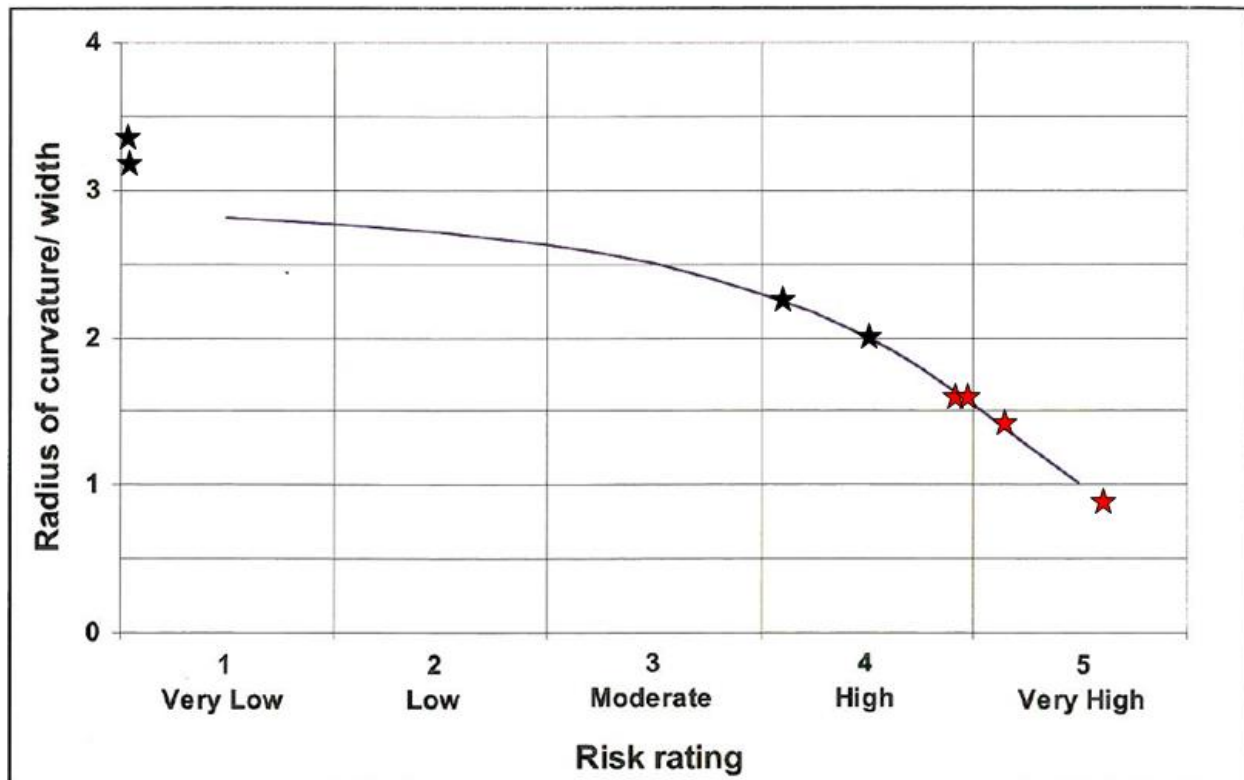
- 5) The radius of curvature is locally smaller than stable reference streams. We found that the curves in the river that had tight bends experienced more erosion than those with larger values, as expected from the literature.

**Figure 81. The risk of stream bank erosion based on the  $R_c/W_{bkf}$  ratio. (figure modified from Rosgen (2006)). Red stars indicate bends in the CRRDR project where outer bank erosion was present. Black stars indicate bends in the project where bank erosion was not evident. See Figure 80 and Table 13.**
