# First Year Assessment of the Carmel River Reroute and Dam Removal Project

CSUMB Class: GEOL 460 Spring 2016

28 May 2016

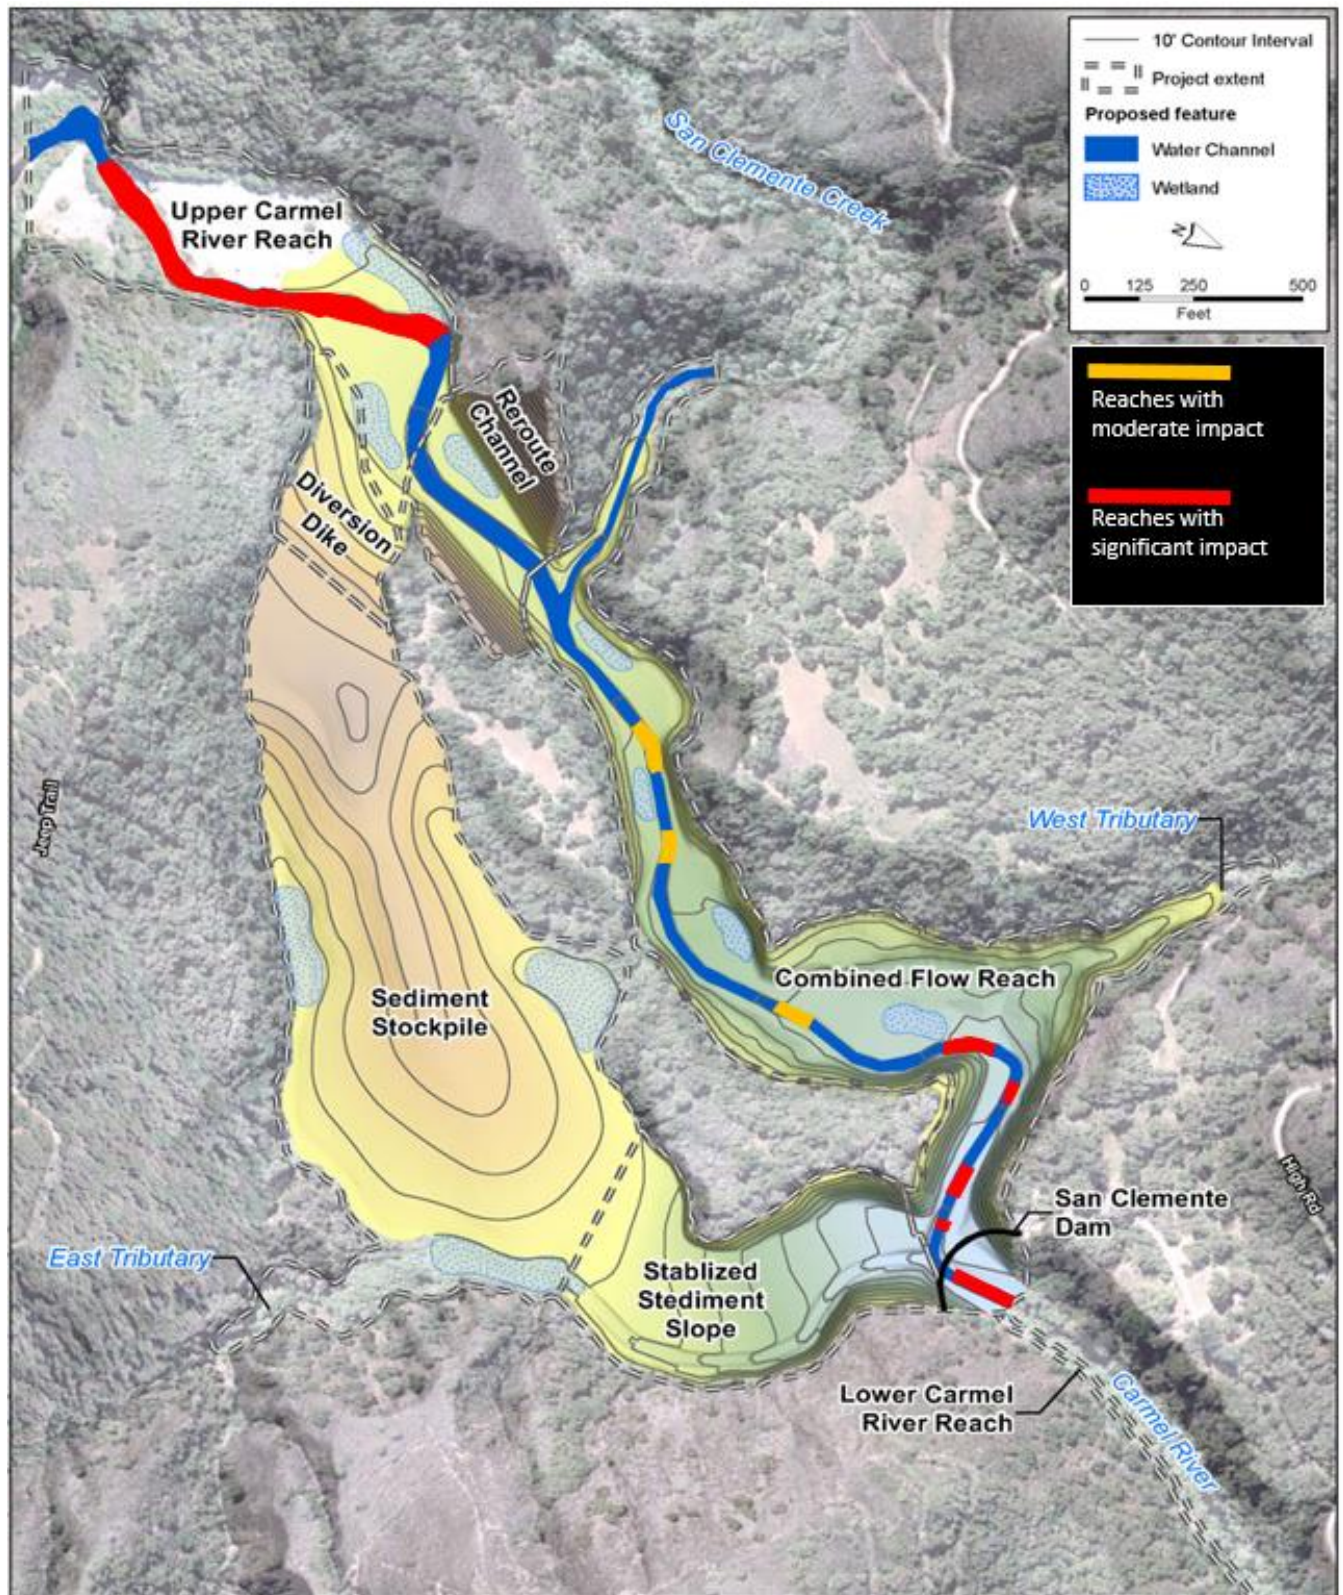
Figure 82. Summary of geomorphic change magnitude along the constructed channel. Basemap modified from URS (2012).
