Publication No. WI-2019-03

18 March 2019

The Watershed Institute

**Landslide, Channel, and Road Culvert  
Sediment sources at Hollister Hills  
State Recreational Vehicle Area  
2018 Report**

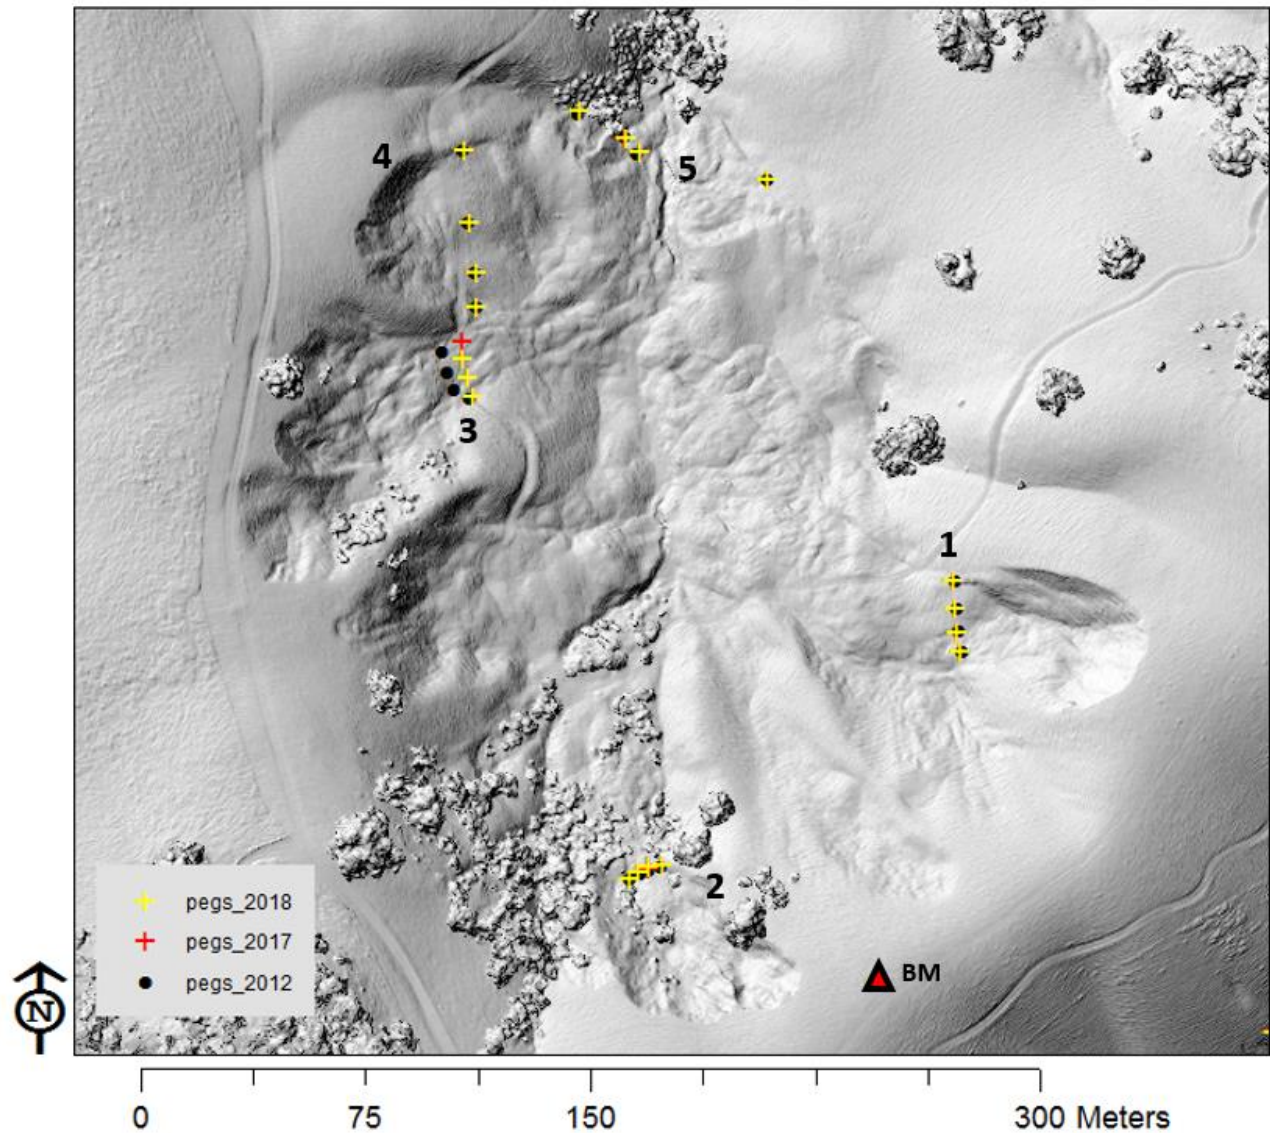
Figure 10. Twenty iron rods installed in the Colluvial Creek Slide in 2012 (black dots) were resurveyed six times. The initial positions, 2017 (red cross) and 2018 (Yellow cross) positions are plotted. Pegs are in clusters of four in each slide area. Background is hillshade from 5/2/2018 low altitude photogrammetry.

The individual slides of Colluvial Creek coalesce into a single slide body that fills the axis of the Colluvial Creek valley (Fig. 10). Active gullies erode the slide body and move sediment toward Bird Creek. Two gullies are visible in Figure 10. One is located directly west of the number 5 in Figure 10; the other is a similar feature located 100 m up-valley (south). Recently eroded banks and fresh knickpoints in the gully bottoms indicate the gullies have been recently active. However, visual inspection and repeat benchmarked cross sections of the valley downstream of the gullies (Fig. 14) have not produced evidence of active transport or storage of new material in the valley segment between the

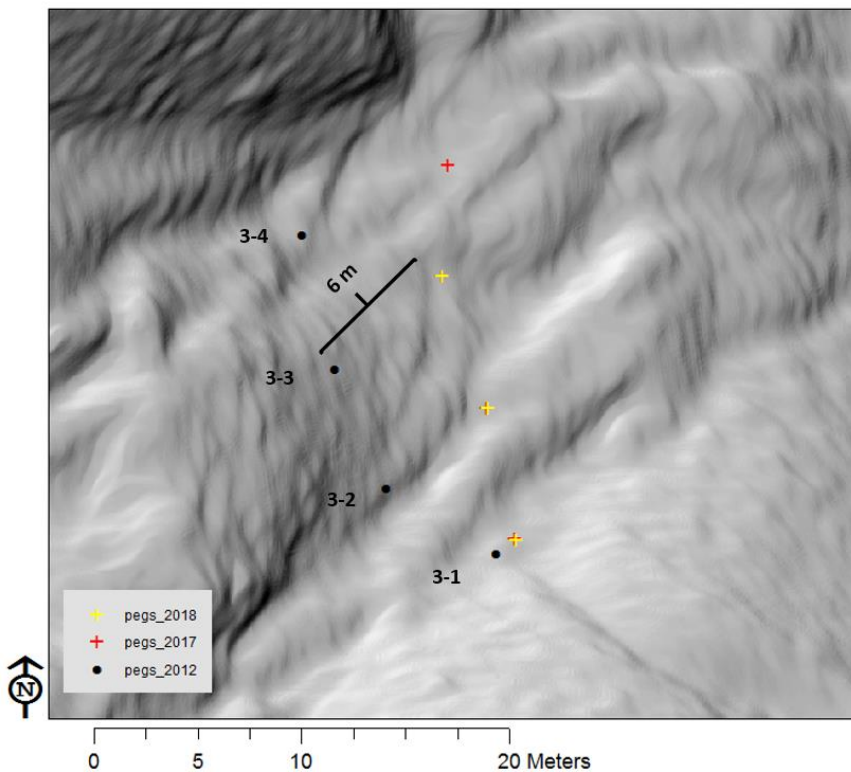
Figure 12. Close view of pegs in head of Colluvial Creek Slide number 3 (Fig. 10 for context). Background is hillshade from 5/2/2018 low altitude photogrammetry.

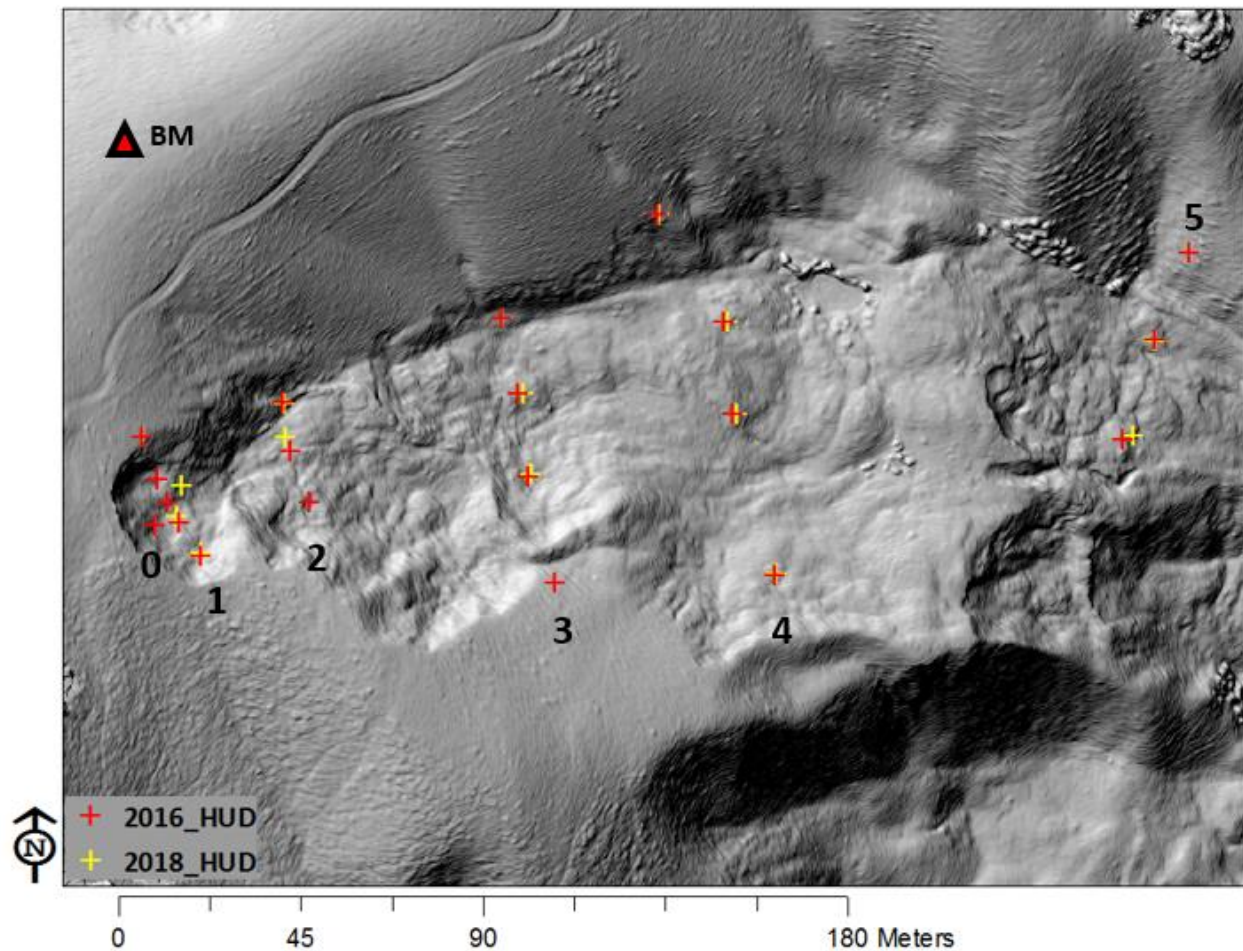
The Hudner Creek Valley contains numerous large landslides that terminate in the valley axis. One example is the “Hudner Slide” we have monitored since 2016. It is a large complex slide with a variety of processes including coherent slumping and earth flow. Like the Colluvial Slide system, small gullies erode the slide body, locally transporting sediment in flowing water. The slide toe blocked the valley axis, and a large gully has since cut up-valley through the slide toe, trapping sediment (Figs. 5 and 6). Twenty pegs placed in rows in the slide captured slide motion between 2016 and 2018 (Table 3; Fig. 16).

Figure 16. Twenty iron rods installed in the Hudner Slide in 2016 (red crosses) were resurveyed in 2018 (yellow crosses). Pegs are arranged in rows 0 through 5. Pegs are numbered sequentially from south to north in each row. Background is hillshade from 5/2/2018 low-altitude photogrammetry.

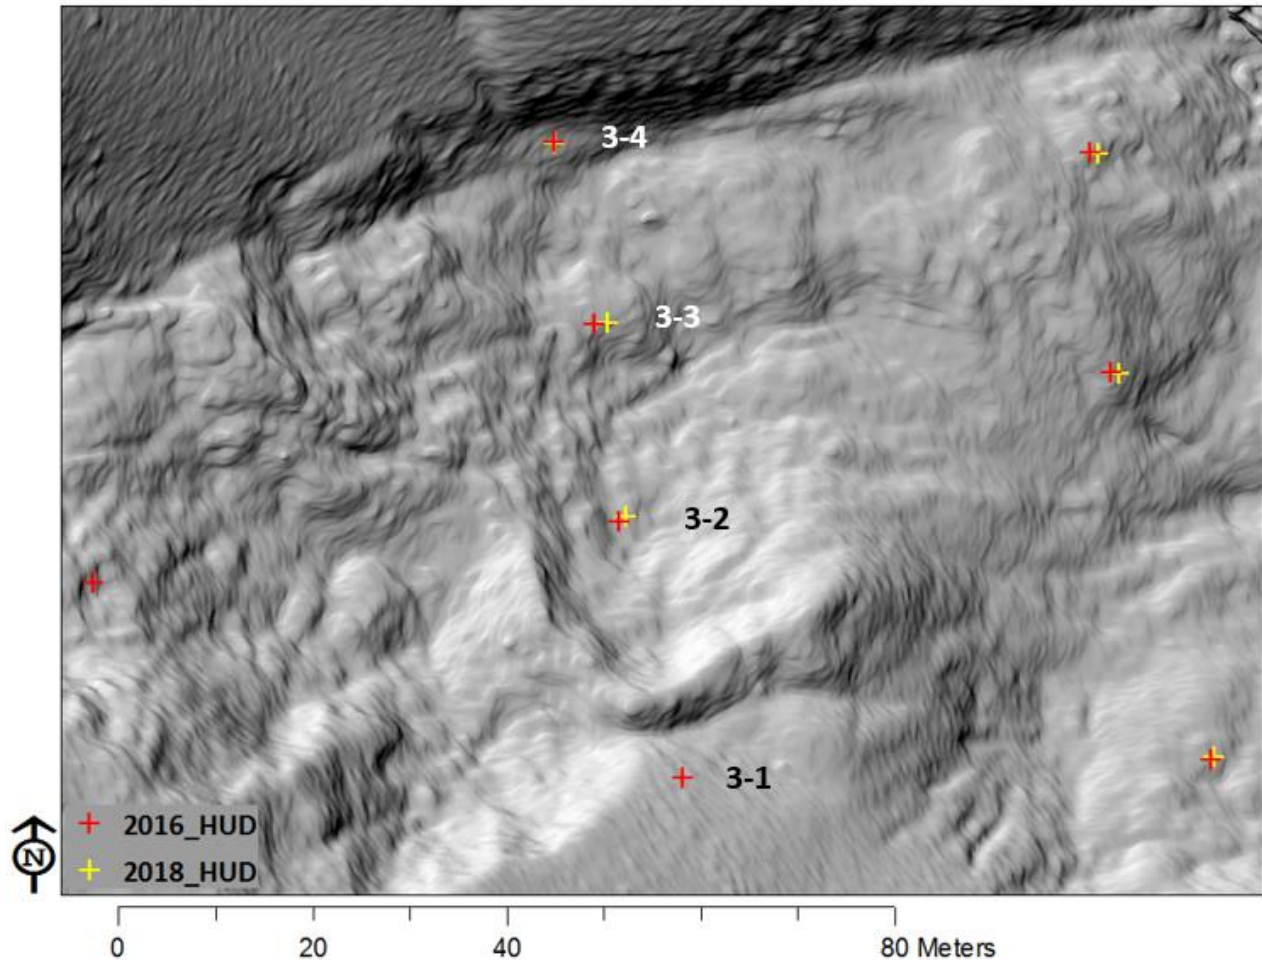
Figure 17 shows the expected behavior of a line of pegs when a coherent slide body has moved downslope; more movement occurs in the main slide body (pegs 3-2 and 3-3) than on adjacent hillslopes (pegs 3-1, 3-4). Movement on the adjacent hillslopes can be attributed to typical background colluvial processes. Movement beyond that rate in the slide body is attributable to motion of the slide.

Figure 17. Third row of pegs in Hudner Slide installed in 2016 (red crosses) were resurveyed in 2018 (yellow crosses). Peg 3-1 was missing in 2018. Locations in Figure 16. Background is hillshade from 5/2/2018 low altitude photogrammetry.

The slide pegs placed in the hillslope adjacent to the slide (e.g., 3-1 and 3-4) are considered “experimental controls” in that they approximate expected motion of the ground if a landslide event were not triggered. Slide pegs moved an average of 1.77 m, in excess of the control pegs which moved just 0.08 m on average (Table 3). Peg motion in rows 3 and 4 are compatible with downslope motion of a single coherent slide body (Figs. 16 and 17). However, other peg movement indicates that slide motion was highly variable through space (Table 3; Fig. 16), leaving the average slide motion value less indicative of true overall sediment transport rates in landslide processes. The highly variable peg movement, including significant lateral (rather than directly downslope motion) indicates that the slide locally moved as an incoherent earthflow rather than as a coherent slide.

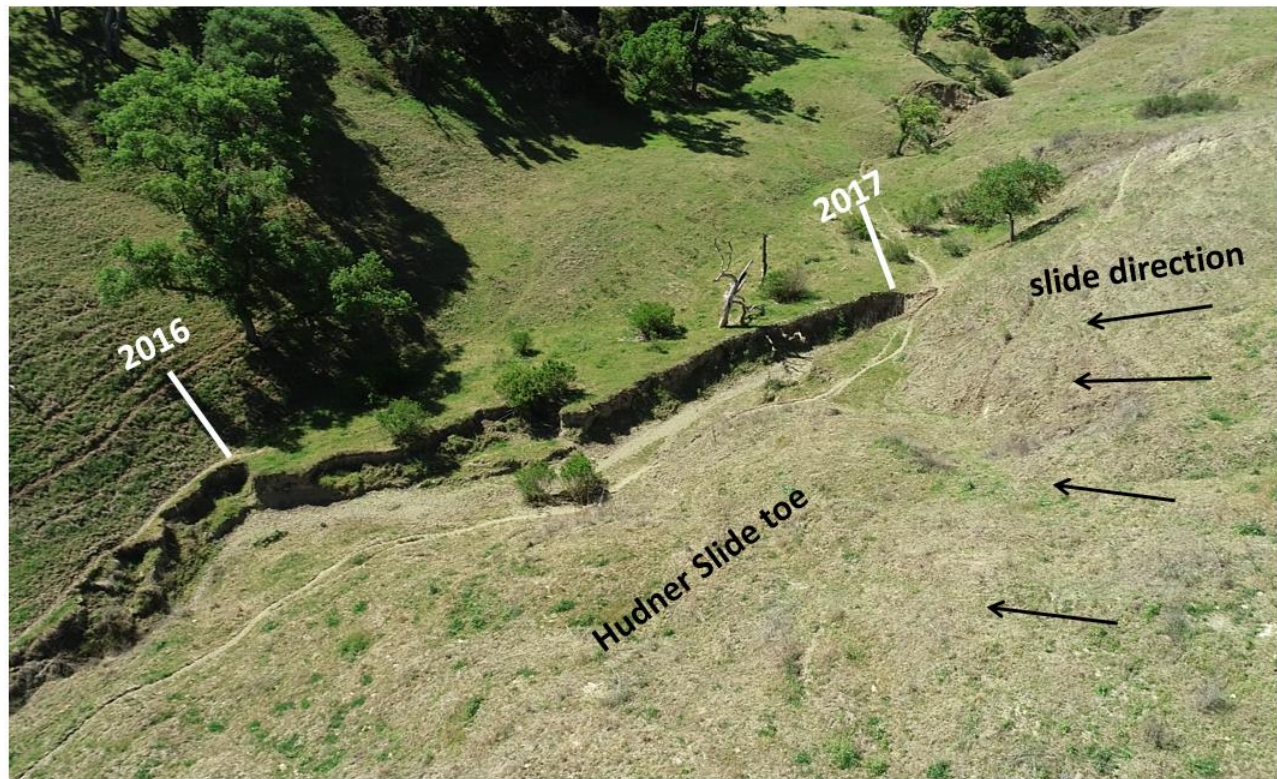
The multiphase sediment transport process active in Hudner Slide includes gullying that liberates slide-related sediment from the slide toe and sediment trapped upstream of the slide toe (Smith et al. 2016; Figs. 6 and 18). Sediment released to Bird Creek through this gully system alone during the winter of 2017 is estimated at approximately 1100 m<sup>3</sup> (1460 yd<sup>3</sup>), based upon 55 m of headward gully growth and a typical cross-sectional area of 20 m<sup>2</sup> (Fig. 19). That volume represents approximately 2950 tonne (2900 ton) assuming an alluvium density of 2590 kg/m<sup>3</sup>, which is the value calculated for sediment deposited in an “alluvial meadow” (Dumikh 2014). The volume and mass reported here are minimum contributions of sediment to Bird Creek from Hudner Creek because there are similar active gully systems located farther up the Hudner Creek valley.

Figure 18. Low-altitude oblique aerial photograph (5/2/18) of Hudner Creek gully incising toe and trapped alluvium at base of Hudner Slide. Dates are locations of gully head in 2016 and 2017.

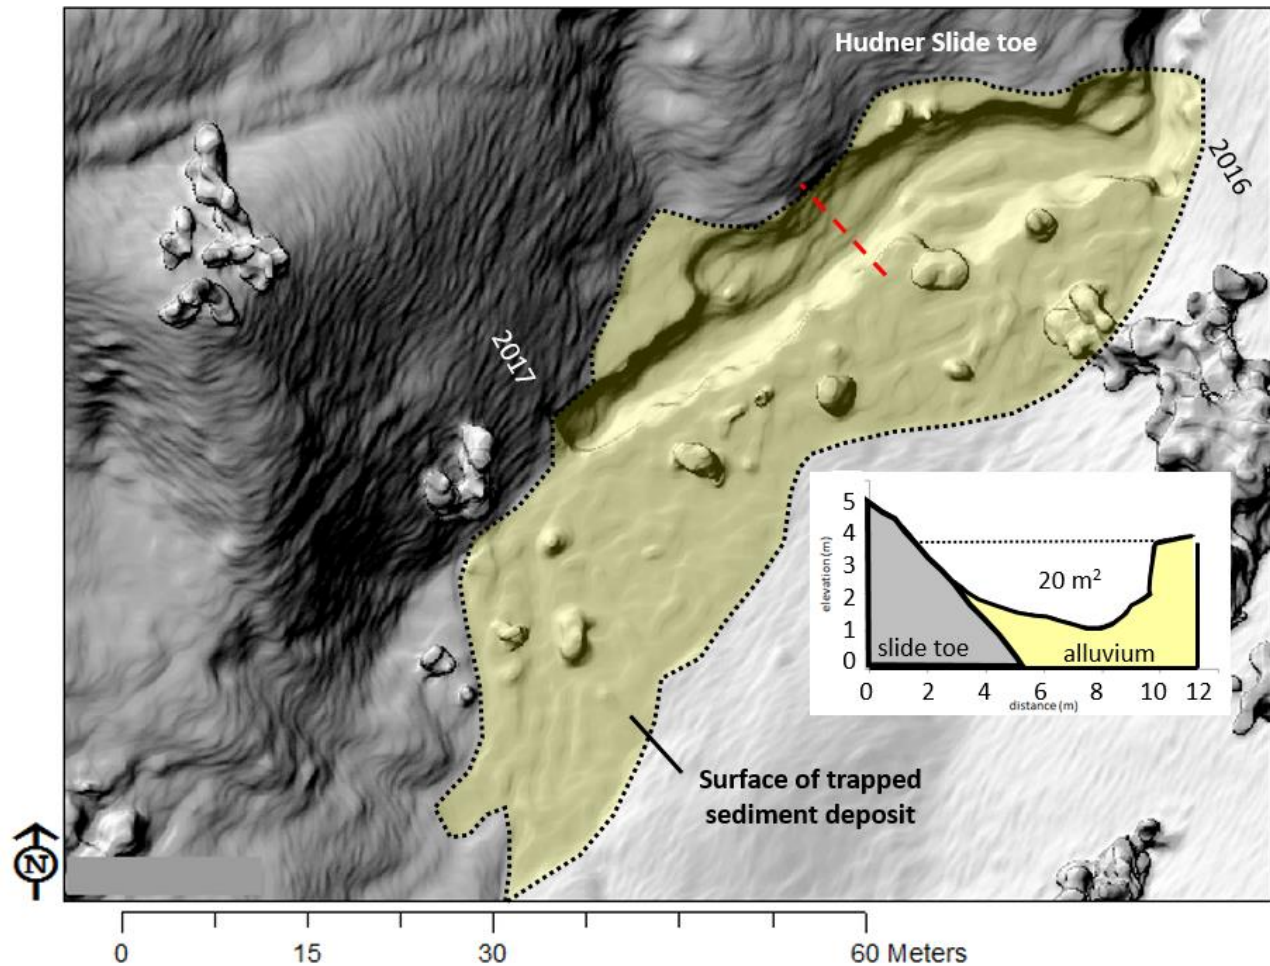
Figure 19. Hillshade shows gully at toe of Hudner Slide (5/2/18). Red dashed line is position of cross section inset. Cross section dimensions in meters. Dates are locations of gully head in 2016 and 2017.

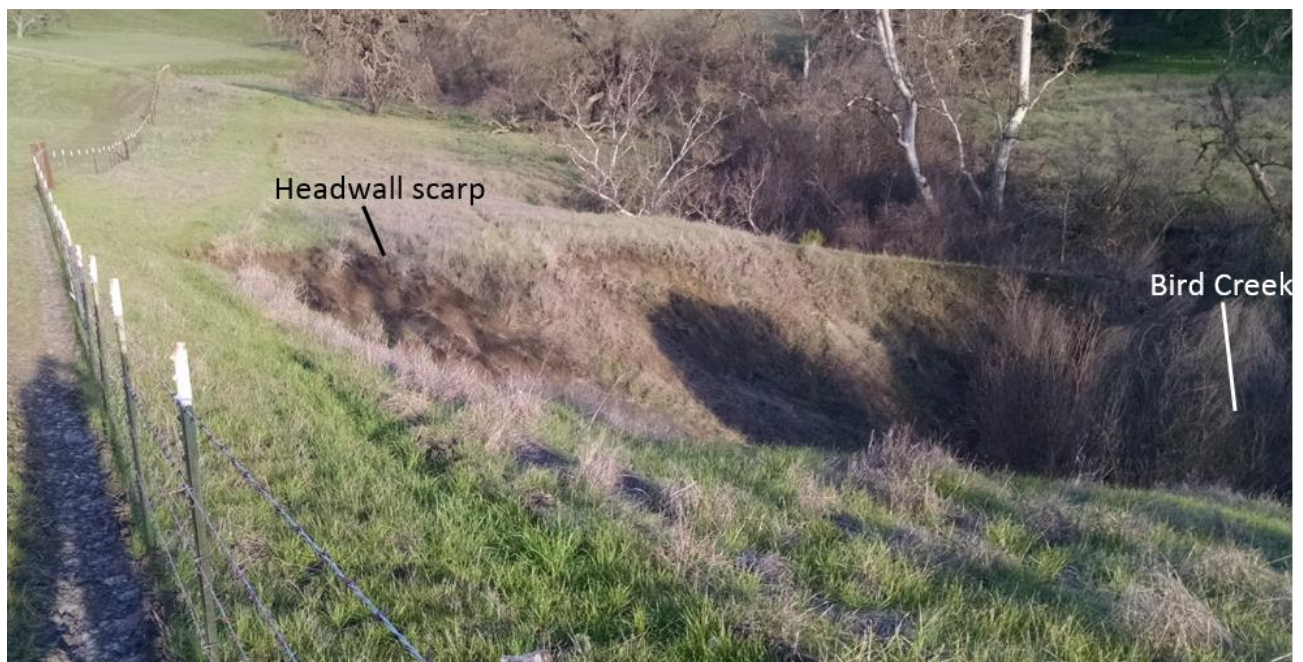
In concert with the Colluvial and Hudner slides, intense rains of 2017 triggered colluvial processes throughout the region. We noted a moderate slump generated by bank erosion in Bird Creek with an estimated volume of 300 m<sup>3</sup> (614 yd<sup>3</sup>; Fig. 20). Using a common density for colluvium (1500 kg/m<sup>3</sup>) the slide liberated 450 tonne (408 ton) of mud and sand. Unlike the larger monitored slides described above, this slide delivered all material directly to the Bird Creek channel.

**Figure 20: Slide feature that delivered material to Bird Creek in winter 2017. Photo 1/25/17.**

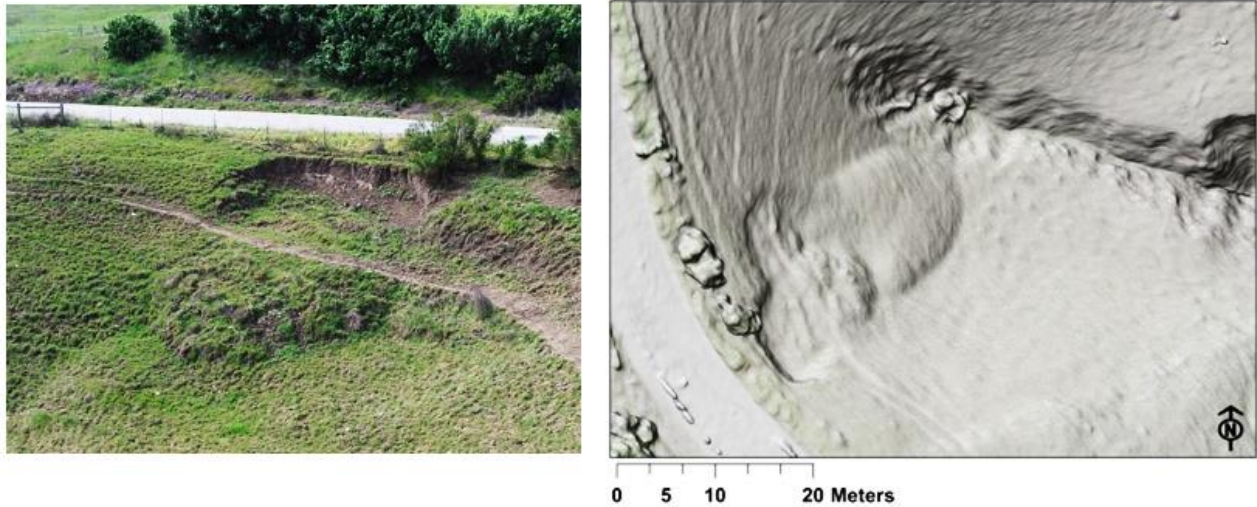
**Figure 23. Oblique aerial photograph and hillshade from spring 2018 show soil slip that was reactivated in winter 2017. Location shown in Figure 22, feature number 3. Culvert labeled number “2” in Figure 22 is visible in hillshade, 5 m north of soil slip toe.**

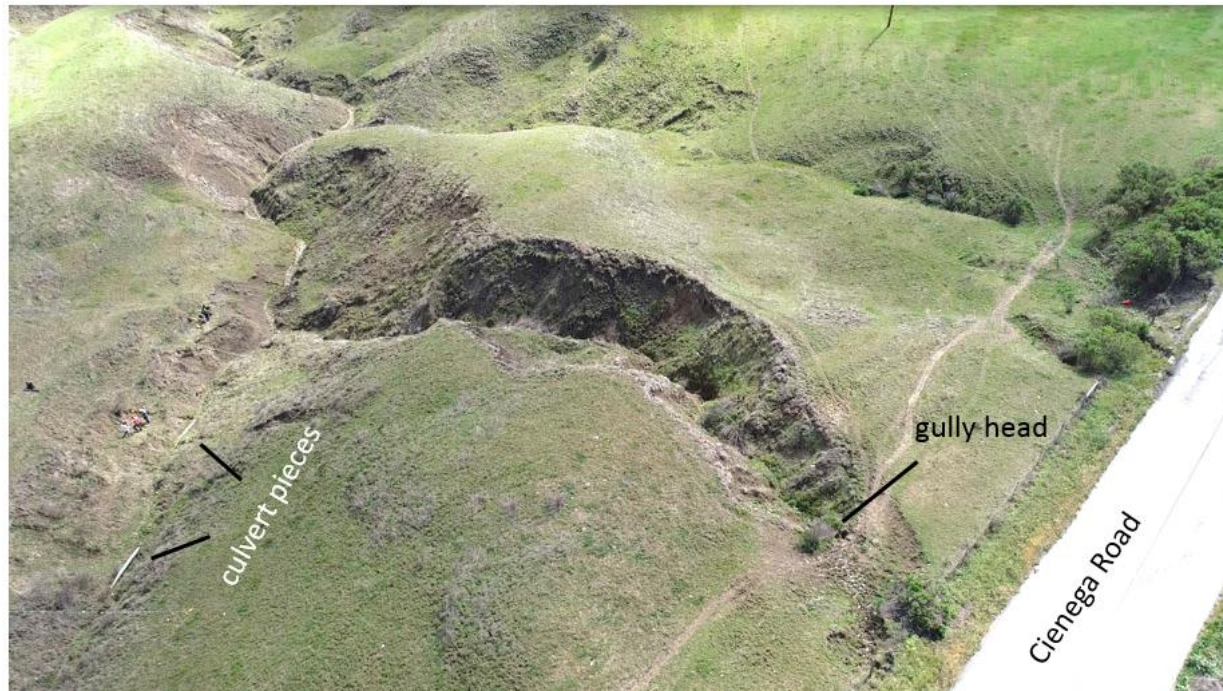
The culvert labeled “2” in Figure 22 is the source of water that has produced a large gully and ravine system that includes the features labeled “4”, “5”, and “6” in Figure 22. Feature four is a tributary gully that has cut several meters downward in response to base-level drop in the main valley fed by this culvert. The head of that tributary gully is deep, and is growing close to the Cienega Road (Figs. 24–27). Cross section transects through the high-resolution DSM shows that gully depth increases rapidly down gradient (Fig. 25). Steep walls with bare soil indicate the tributary is a chronic and significant source of sediment (Figs. 26 and 27).

Figure 24. Oblique aerial photograph from sUAS showing active gully near Cienega Road. Feature is labeled “4” in Figure 22. Hillshade of feature is Figure 25. Ground-based photo is Figure 26.

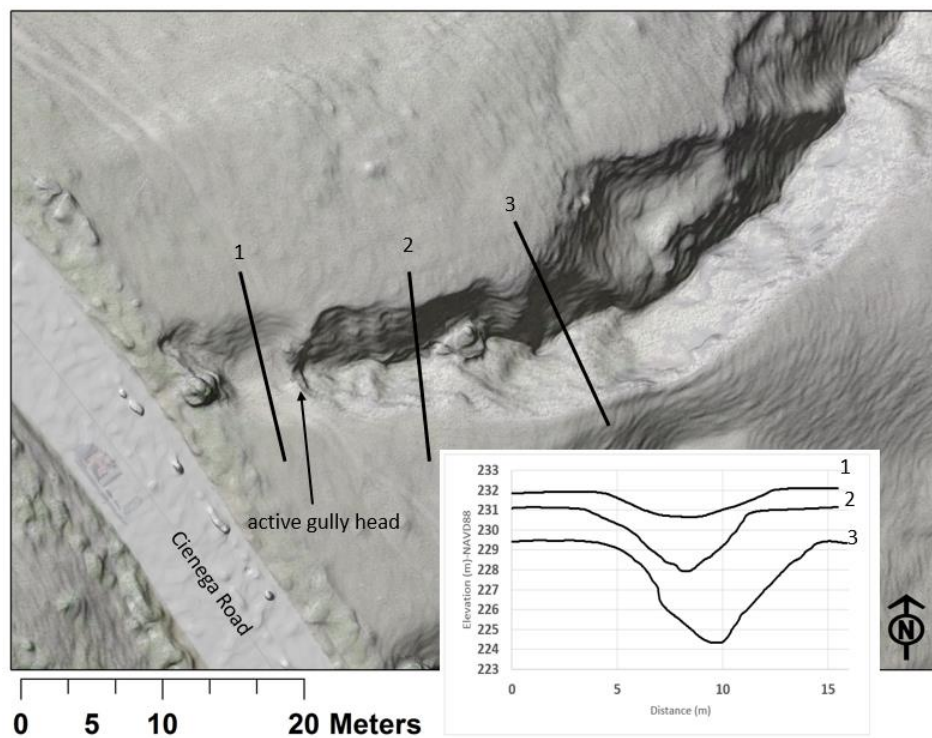
Figure 25. Hillshade showing active gully feature near Cienega Road. Location shown in Figure 22, feature number four.

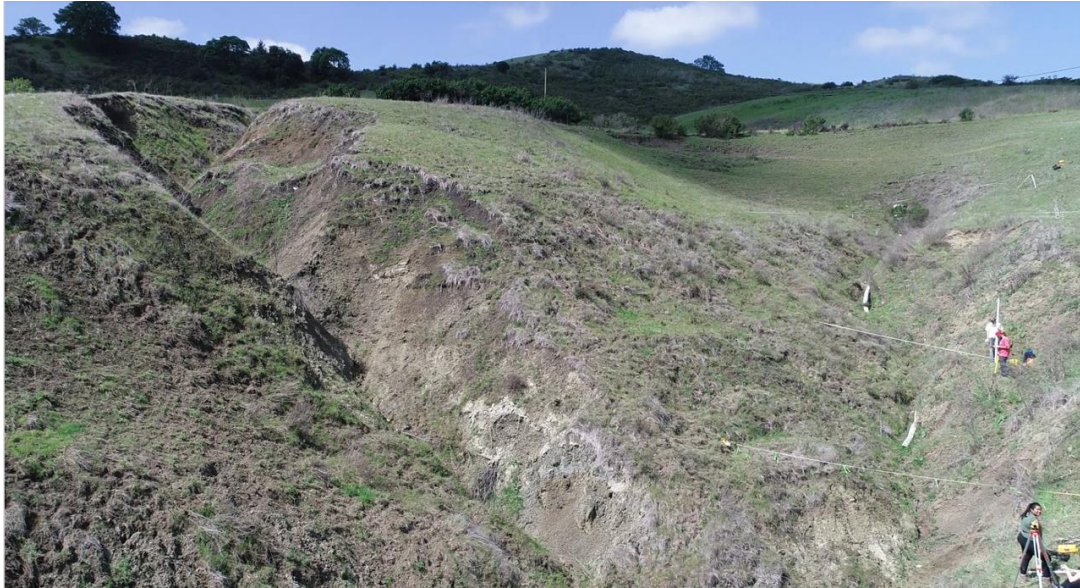
**Figure 26.** Gullies related to culvert drainage erosion. Right gully with surveyors terminates at the culvert labeled “2” in Figure 22. Broken white culvert pipe visible in thalweg is also visible in Figure 24. Left gully is feature number four in Figure 22, also shown in Figures 24 and 25. Image from Smith et al. (2016).

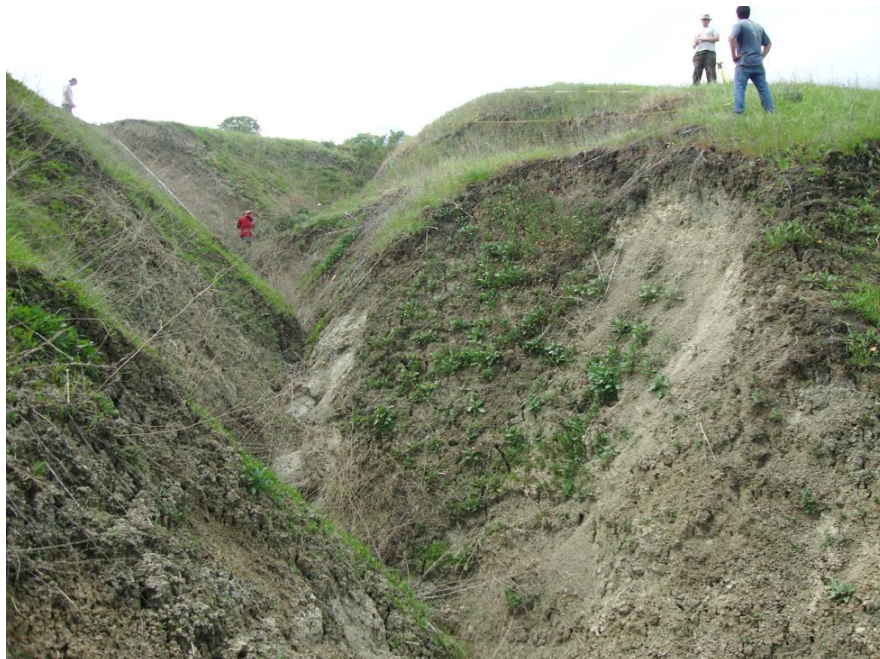
**Figure 27.** Close-up of gully walls seen in Figure 26. Image from Smith et al. (2016).

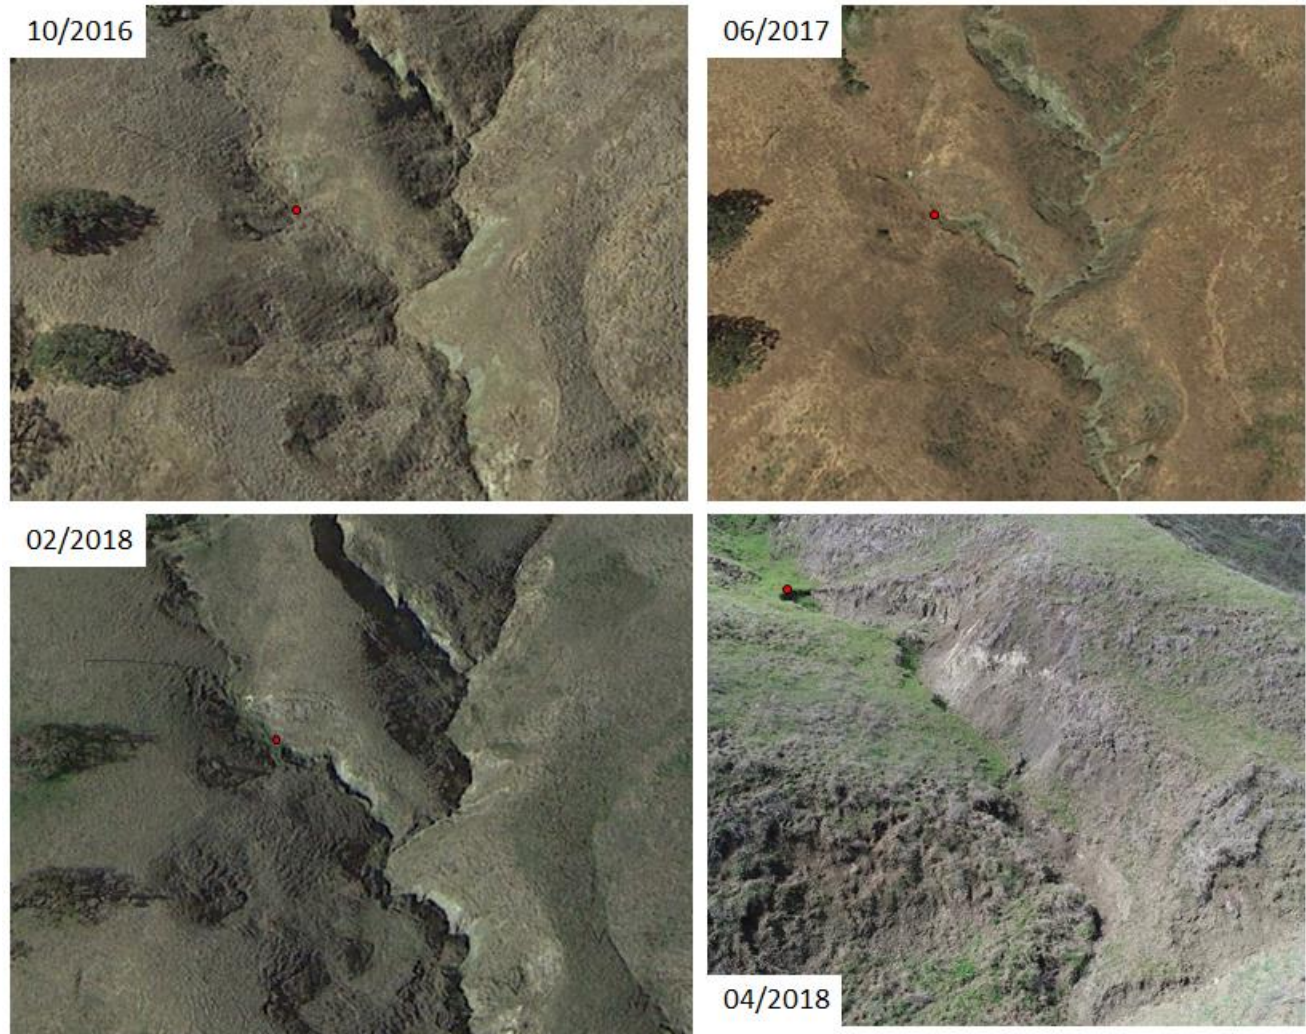
**Figure 28. Time series images from Google Earth showing gully formed in 2017. Lower right image is oblique aerial view from sUAS. View is up-gradient. Red dot in all images is the location of the gully head in 2018. Gully is feature six in Figure 22.**

The feature labeled “6” in Figure 22 is the second tributary to the main drainage below Culvert two. Serial images indicate this tributary experienced significant new erosion in winter 2017. A new gully grew headward 31 m up the drainage (Fig. 28). It is not visible in fall 2016 aerial imagery but appears for the first time in spring 2017 (Figure 28). The gully is generally between 0.5 m and 2 m deep, and is 2 m to 3 m wide. It is not a threat to Cienega Road but will likely remain a new chronic source of sediment in high rainfall years.

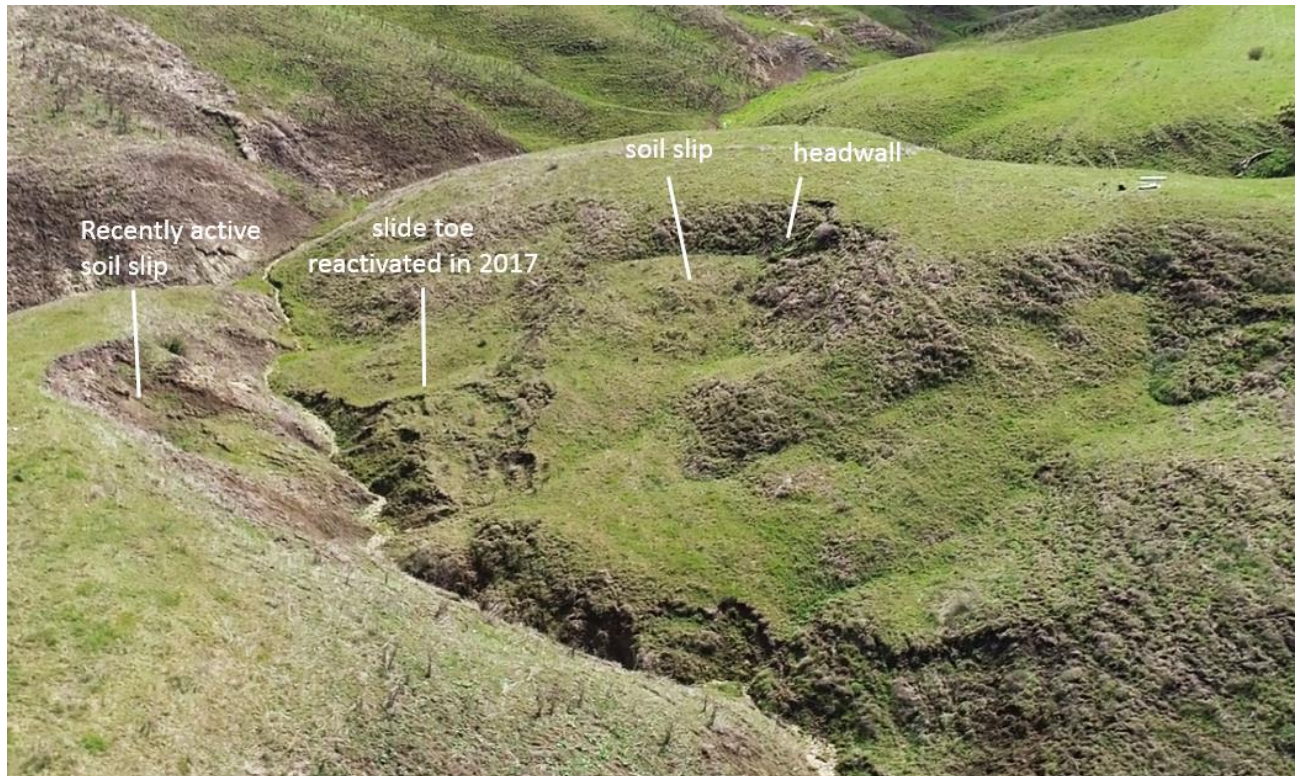
Innumerable small soil slip features are located along the walls of the main gully below culvert two (Fig. 29). Visual observations indicate the toes of many slips were reactivated in winter 2017. One of those is labeled in Figure 29. Reactivation of gullies in the tributaries and reactivation of slide toes is evidence that the main gully downcut in Winter 2017, lowering local base level for adjacent hill slopes. The system generated significant sediment that was transported to Bird Creek in winter 2017 (Fig. 30).

**Figure 29. Down gradient view showing unstable slopes in gully system below culvert labeled “2” in Figure 22. Image is oblique aerial view from sUAS. Scene depicts feature five in Figure 22.**

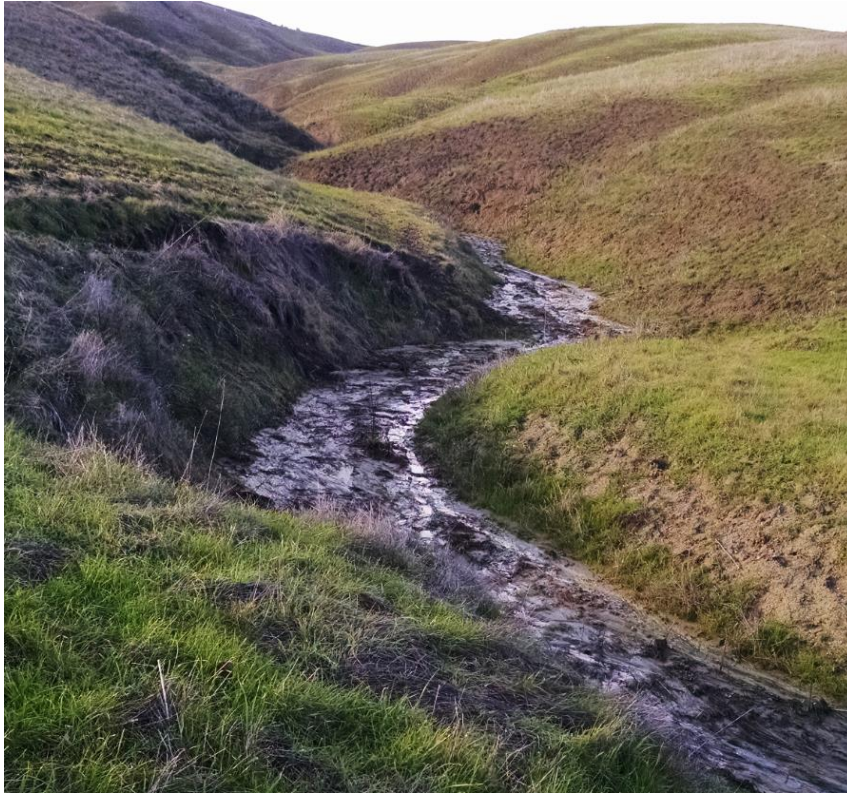
**Figure 30. Upgradient view of sediment in ravine bottom downstream of Cienega Road gullies. Photograph from 1/25/2017.**

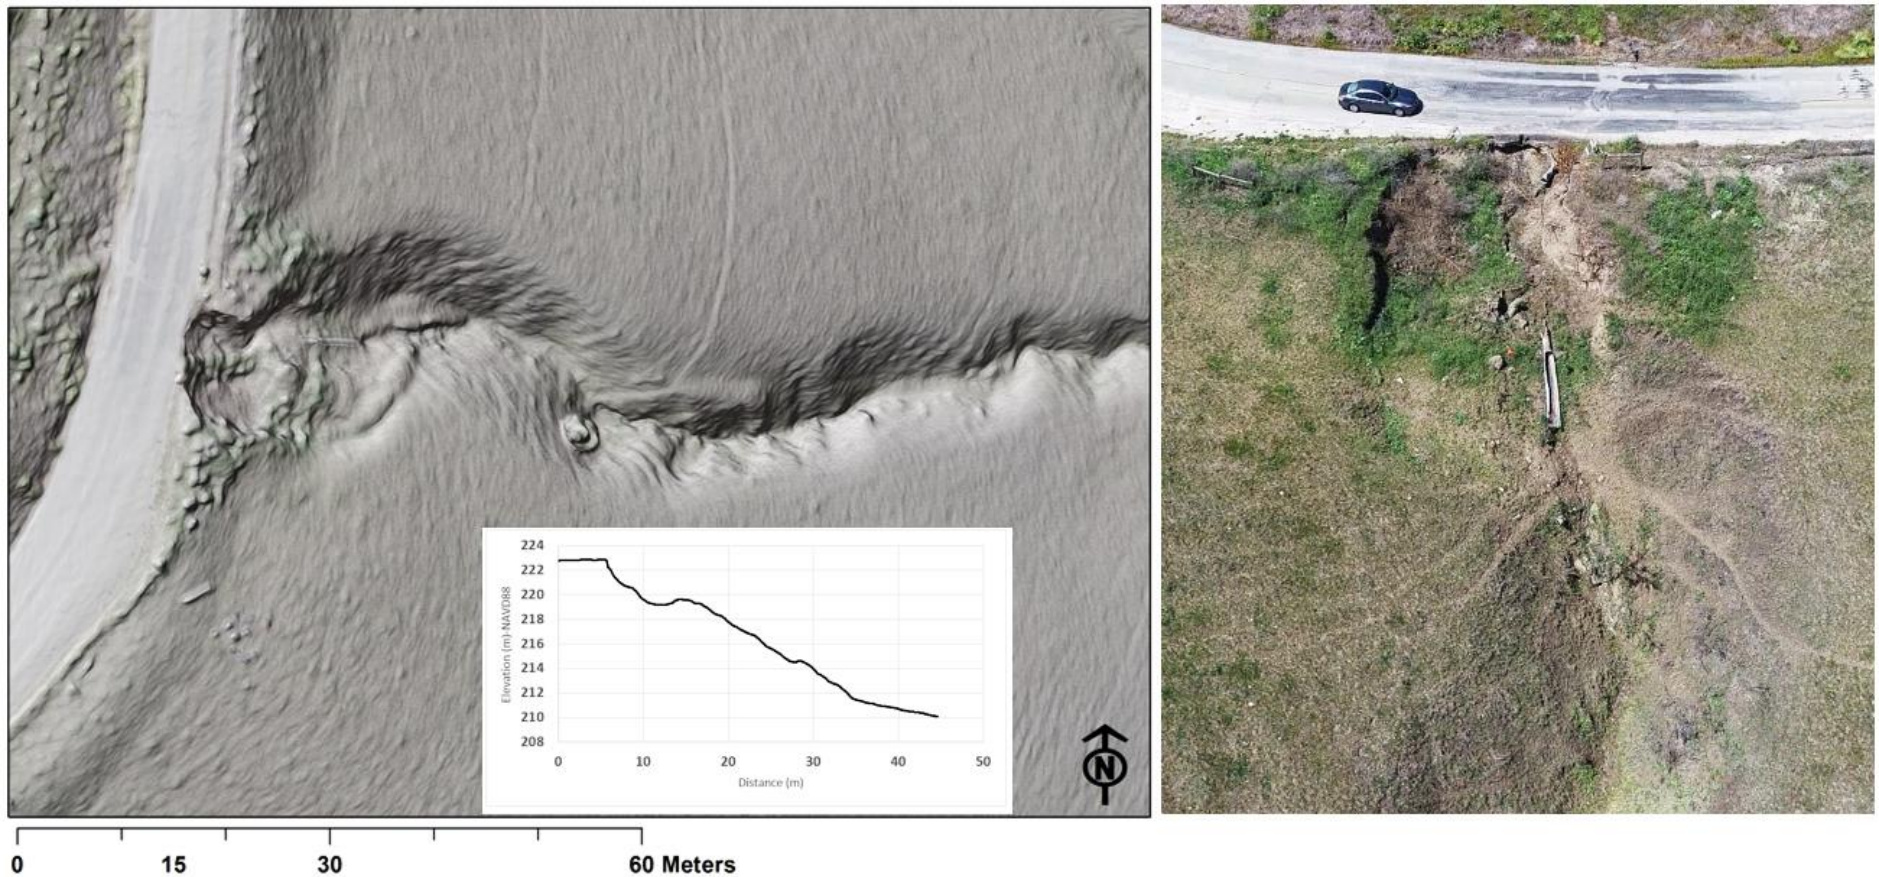
The feature labeled “7” in Figure 22 is a road culvert that has accelerated erosion downslope from Cienega road (Fig. 31). The head of the resulting gully is eroding the edge of Cienega Road, and will pose a continued threat to the road in high-intensity rains. Sediment eroded from the gully bottom and walls can reach Bird Creek along a well-established channel (Fig. 22). While this gully appears to have been active in recent years, it is not a new feature. The feature is visible in aerial images from 1976, but it does not appear to impose a threat to the road at that time. Images from 1996 show the head eroding into the roadway.

Figure 31. Hillshade and oblique sUAS aerial photograph of culvert-generated gully labeled “7” in Figure 22. Inset image is longitudinal profile of the upper reach of the gully, starting from the road surface.
