Report No. WI-2003-07 8<sup>th</sup> April 2003

Steelhead Habitat
Assessment and
Restoration in Upper
Williams Canyon Creek:
Mitteldorf Redwood
Preserve, Monterey
County, California

Dr. Douglas Smith (Ph.D.)
Bob Curry (Ph.D.)
Dennis Jackson (M.S.)
Amy Thistle
Chris Marin

8 April 2003

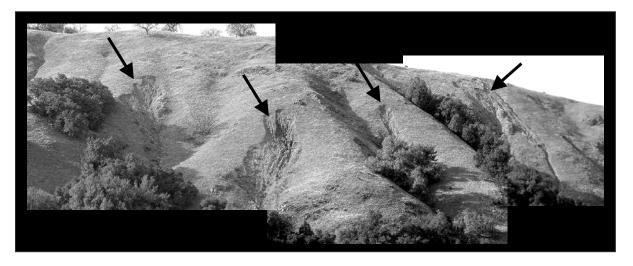
The Santa Lucia Granodiorite underlying the watershed weathers to a reddish brown grus and sandy soil with good drainage. According to our observations, it is prone to shallow slope failure by colluvial creep and by both debris flow and landslides comprising colluvium and weathered rock. There is evidence for historic and active slope failure in both the grassy slopes and forested regions of the upper watershed. Large landslides present in the Williams Canyon watershed have been typical of the region for 2 million years, and clearly represent one of the natural pathways of sediment into Williams Canyon Creek (Fig. 2). The landslides shown in Figure 2 are not visible on a 1-m resolution aerial photograph from 1994, indicating that these are new features, likely generated during the 1995 or 1998 El Nino events. Considering that landslide processes can periodically deliver very high volumes of sediment to a valley bottom, it is likely that Williams Canyon Creek has witnessed countless episodes of catastrophic sediment input in the geologic, and more recent prehistoric, past. We note that the creek bottom is locally now resting on granitic bedrock, indicating that the combined hydrology and geomorphology of the canyon has been able to process and transport all of that sediment out of the upper watershed. On the other hand, most of the pools are currently filled with sand and fine sediment, indicating the presence of chronic fine sediment sources. In addition to sporadic high flow events, a strong perennial base flow of water can be effective in moving fine sediment through the system, keeping the pools flushed of silt and clay.

Figure 2: Soil-slip landslides in grassland vegetation on west canyon slope

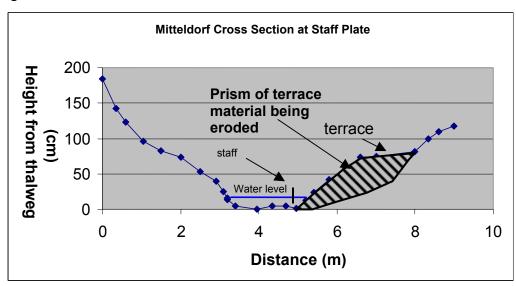
A typical cross section of Williams Canyon Creek shows a considerable volume of sediment stored in channel-side terraces (Fig. 3). At some time in the past several decades, sediment was delivered to the Creek far in excess of the Creek's ability to transport it. Sediment that could not be transported filled the canyon bottom with a long, "v"-shaped prism of sediment that is incrementally being transported out of the canyon today. The Creek has cut down through the prism(Fig. 3), locally reaching bedrock, and each year it moves a little more of the stored sediment by eroding laterally through the terrace. The terrace was likely the result of poor land-use and heavy winter rains that destabilized the landscape. Thus, there is presently a background of fine sediment mobilization and transport associated with that terrace system. There is also background fine sediment delivered to the stream from numerous landslides, gullies, and failed culverts and road crossings.

Figure 3: Sediment Stored in small terrace.

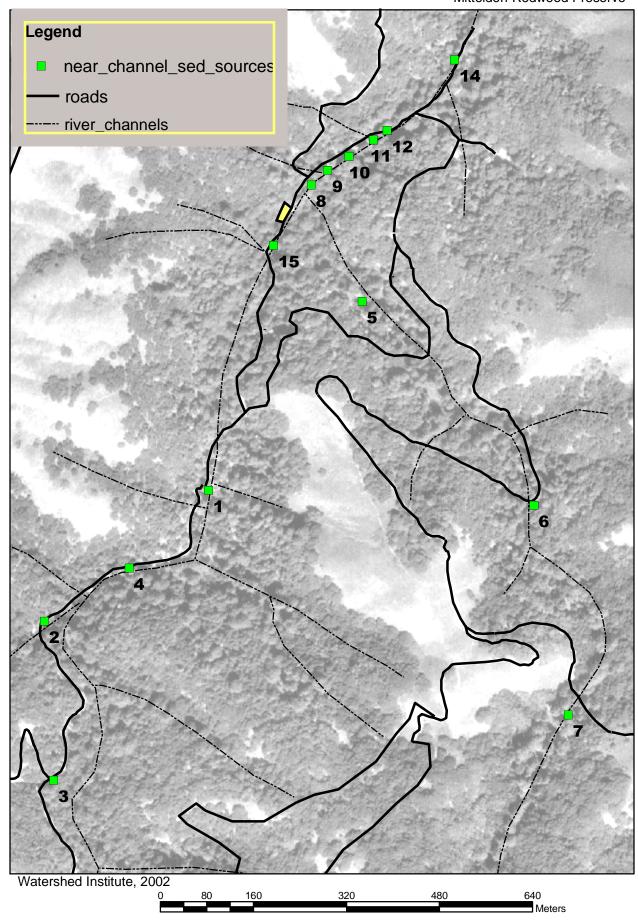
Fifteen significant near-channel sediment sources were located and described while walking along the channels in Williams and Dewing Canyons (Fig. 8; Table 6).

Site#	Priority	Location	Comments
1	2	Williams Creek	Failed culvert
2	2 3	Williams Trail	Large gully with 2m relief
3	11	Williams Trail	Road slumping, side cast failure-30m long
4	14	Williams Trail	Road slumping, side cast failure-10m long
5	8	Dewing Road	Road slumping, side cast failure-60m long
6	12	Dewing Creek	Road culvert with back pool deposits-20m long
7	1	Dewing Creek	Landing restoration- loose sediment
8	7	Williams Creek	Bank failure
9	9	Williams Creek	Gully deposits, loose sediment
10	4	Williams Creek	Large gully up to road
11	6	Williams Creek	Debris accumulation, small migration barrier
12	13	Williams Creek	Deflected flow undercuts bank/bridge foundation
13	NA	NA	NA
14	. 5	Williams Creek	Large gully
15	10	Williams Creek	Gully left bank

Figure 8: Near-channel Sediment Sources

We do not list restorative measures for these sites individually, but most will require excavation to create a more stable slope followed by native plantings. The gullies will benefit from headcut slope reduction where feasible, and energy dissipaters within the gully bottom and at the mouth. In rare cases, heavy equipment will be able to reduce the gully side slopes. On the more technical sites, we recommend consulting with an erosion control specialist who has experience with habitat restoration.

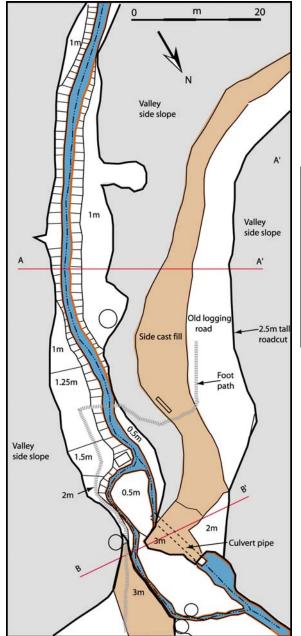
Figure 10: Map of Site 13 (Table 9; Fig.9).

<sup>1</sup> Site #	Priority	Restoration Activity
13	1	Remove remaining fill
15	2	Remove buried culvert so flow can rejoin natural channel
26	3	Remove failing Humbolt Crossing
22	4	Divert flow away from crack in landing fill; remove failing slope
16	5	Unplug culvert
18	6	Unplug culvert
28	7	Remove failing sidecast road fill
10	8	Redirect flow and install energy dissipators
5	9	Replace culvert with lager diameter to reduce plugging risk
19	10	Remove culvert and restore Dewing stream channel

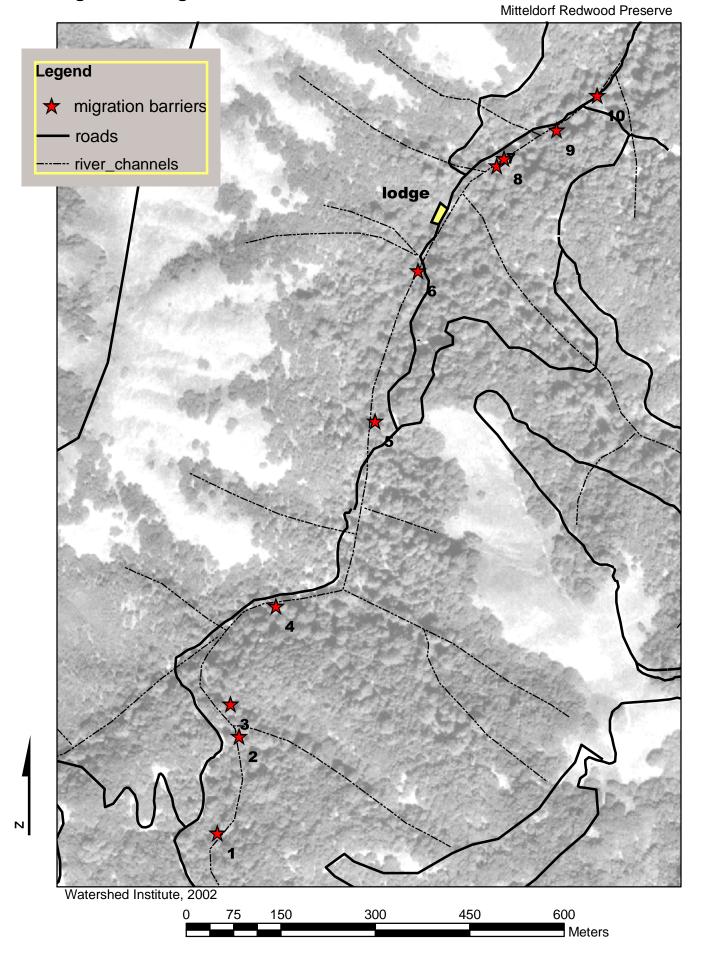
Based upon the first criteria, no migration barriers were considered high priority in Dewing Canyon. Of the 10 potential migration barriers described on BSLT property in Williams Canyon, only 4 exist below the lodge. Although the four below the lodge are not necessarily the worst debris jams, they were assigned priorities one through four because they are the most important for ensuring access to spawning gravel located near the lodge. No significant spawning gravels were noted upstream from the lodge.

Figure 12: Migration Barriers

To ensure fish access to high quality spawning sites, we recommend that any significant, human–induced migration barriers be removed from the reach of river between the BSLT property and the confluence with San Jose Creek. There are currently no insurmountable barriers between the confluence and the coastal lagoon (personal communication, Marty Gingras, California Department of Fish and Game, 2002).
