Publication No. WI-2012-07

21 December 2012

The Watershed Institute

Potrero Creek Restoration Santa Lucia Preserve Monterey County (CA): Year Three Monitoring

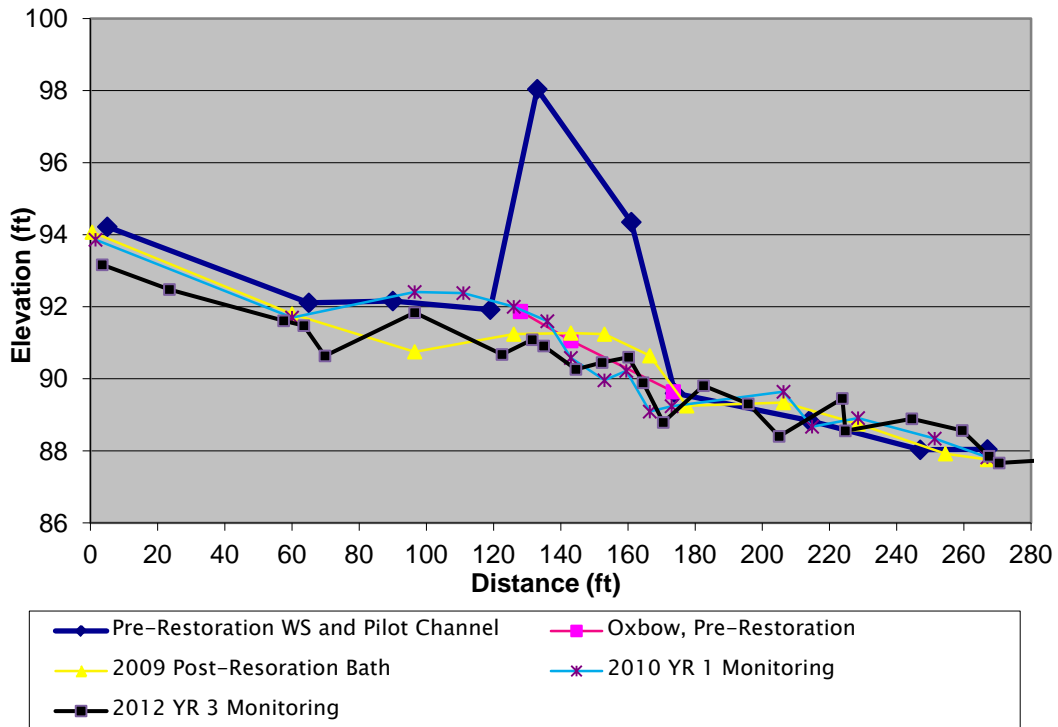
A total of 278 feet of Potrero Creek thalweg was surveyed for the longitudinal profile; which was consistent with previous surveys. Figure 4 shows the longitudinal profile results for Year 3 monitoring overlaid with the pre-restoration, 2009 post-restoration, and 2010 Year 1 monitoring surveys. Table 1 shows the overall gradient for each of the long profile surveys. The following changes are apparent in the profile.

- Overall gradient decrease is driven by net erosion at upstream end and net deposition at the downstream end of the survey reach. The gradient within the restoration reach has remained relatively stable at about 2.2%.

- An upward deflection in the profile located at 150 ft in 2009 and 110 ft in 2010 is less apparent in 2012.
- Overall variation in the profile cannot be differentiated from steady-state equilibrium.
- A qualitative review of the site in August 2011 noted that a log had made a short step and pool sequence near the exit of the restoration reach (WRA 2012). That log and step-pool geometry are still present in September 2012. The feature is located at approximately 223 ft in the profile (Fig. 4).

Figure 4: Longitudinal profile of Potrero creek restoration site.

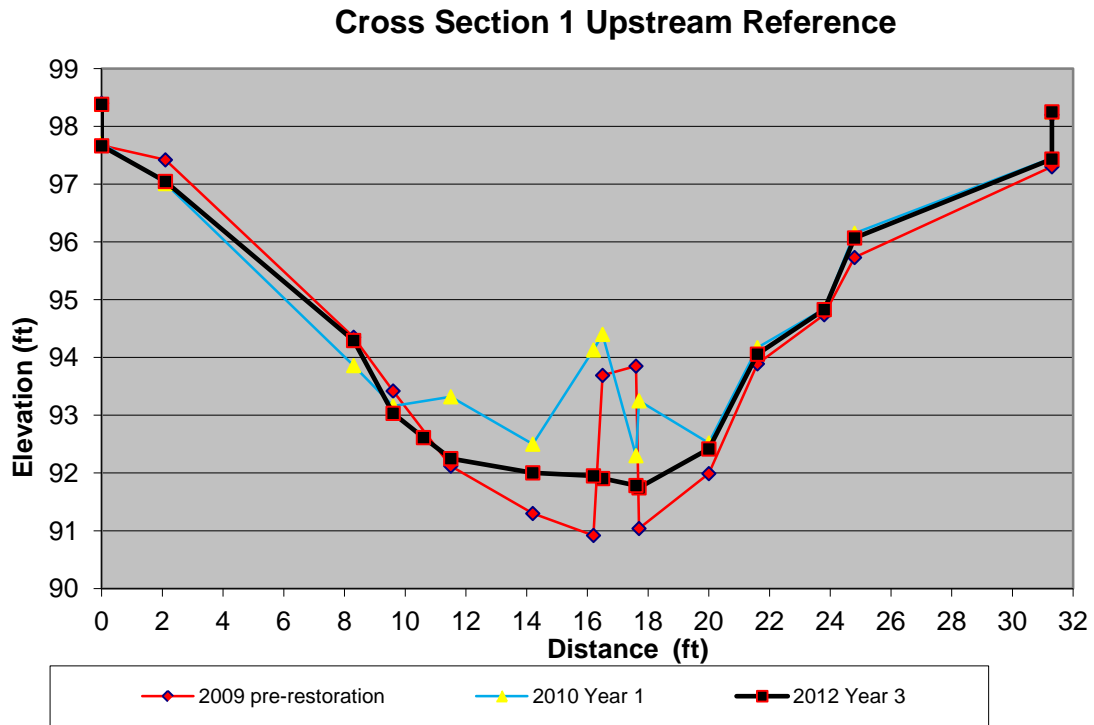
The upstream reference profile (Fig. 5) and the upstream end of the restored reach (Fig. 6) show that the stream has been alternately aggrading and degrading, in keeping with previous interpretations (WRA 2010, 2012). Alternating periods of aggradation and degradation show that the stream reach is passing an episodically-high upstream sediment load on a multiannual time frame without net change. While this behavior is in keeping with steady-state equilibrium, the time under evaluation is too short to make that evaluation. Of note is that the amount of vertical change (2 ft to 3 ft) is very high for a small creek, indicating that there is likely stream-bank instability or other chronic sediment sources located higher in the watershed. Figure 2 indicates that this watershed is underlain by highly erodible substrate that will generate excess sediment when disturbed.

Figure 5: Cross section 1, located upstream from restored reach. Downstream view.

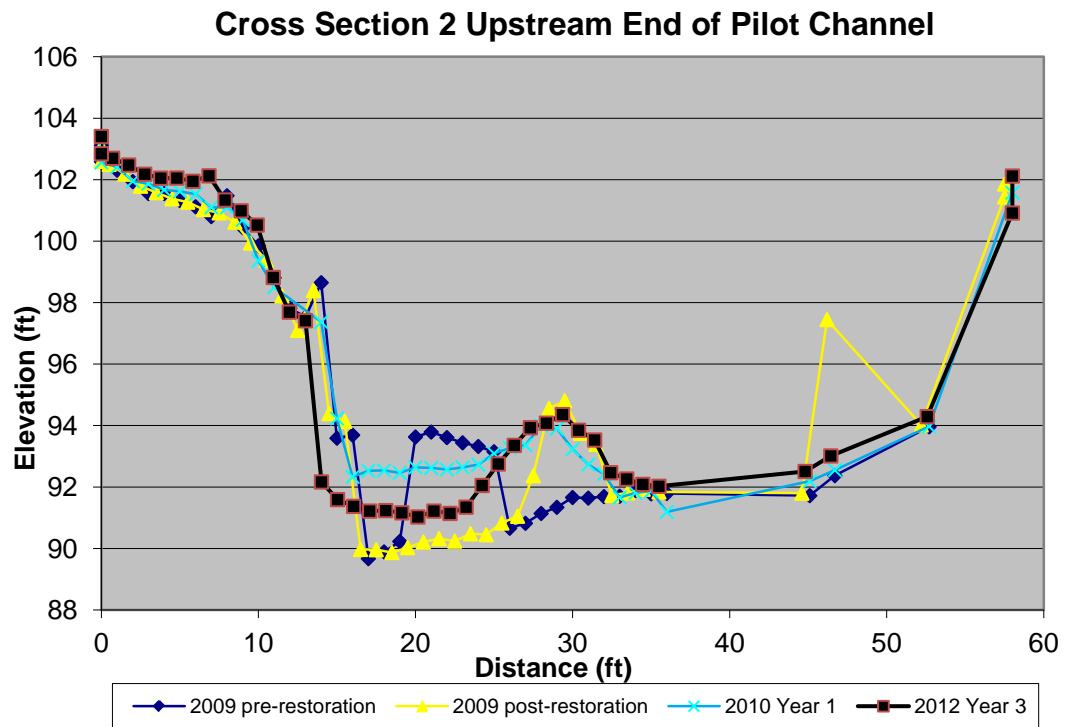
Figure 6: Cross section 2, located at the upper end of the pilot reach. Downstream view.

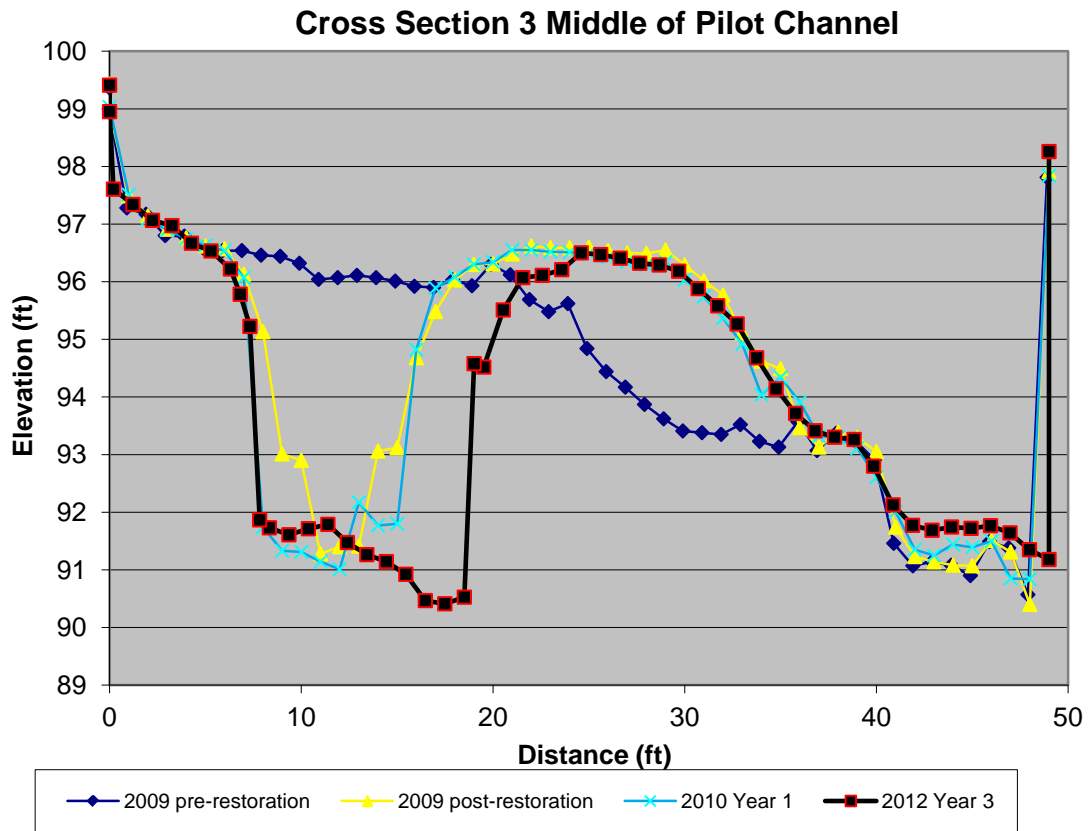
Cross section 3 (Fig. 7) is located in the middle of the pilot channel reach. Both visual inspection and the cross sectional survey indicate rapid erosion at this site. WRA (2012) reported excess erosion here in the August 2011 visual inspection as well. Bank sloughing and sediment recruitment have constructed a side-attached bar that has grown from left to right across the original pilot channel thalweg (Fig. 7, Fig 10, Appendix A p. 32). The bar has forced scouring flows against the right bank. The right bank is undercut from 1 to 3 feet, and has retreated approximately 5 feet since the 2010 survey. At this cross section, the channel has generally enlarged in size since inception (Fig. 7; Table 2, Appendix A, p. 32)

The surveys of cross sections 3, and 4 show that the original channel (Oxbow) is aggrading (Figs. 7 & 8), especially where it is influenced by backwater from the creek at the downstream end (Fig. 8). Figure 10 shows the cross section locations and the general location of pilot channel bank erosion in the vicinity of cross section 3.

Figure 7: Cross section 3, located in the middle of the pilot channel. Downstream view.

The right bank erosion problem noted near cross section 2 accelerates downstream from cross section 2 to cross section 3 (Fig. 7), where the problem has become severe. The erosion at cross section 3 is representative of many feet of stream upstream and downstream from the cross section. The erosion is the direct result of lateral channel migration, forced by the growth of a side-attached bar on the left side. An indirect cause is the lack of an adequate floodplain width in this river reach.

Project success hinges upon controlling the excess bank erosion in the middle of the pilot channel. Riparian plantings alone will be insufficient action. The two geomorphic variables to consider are:

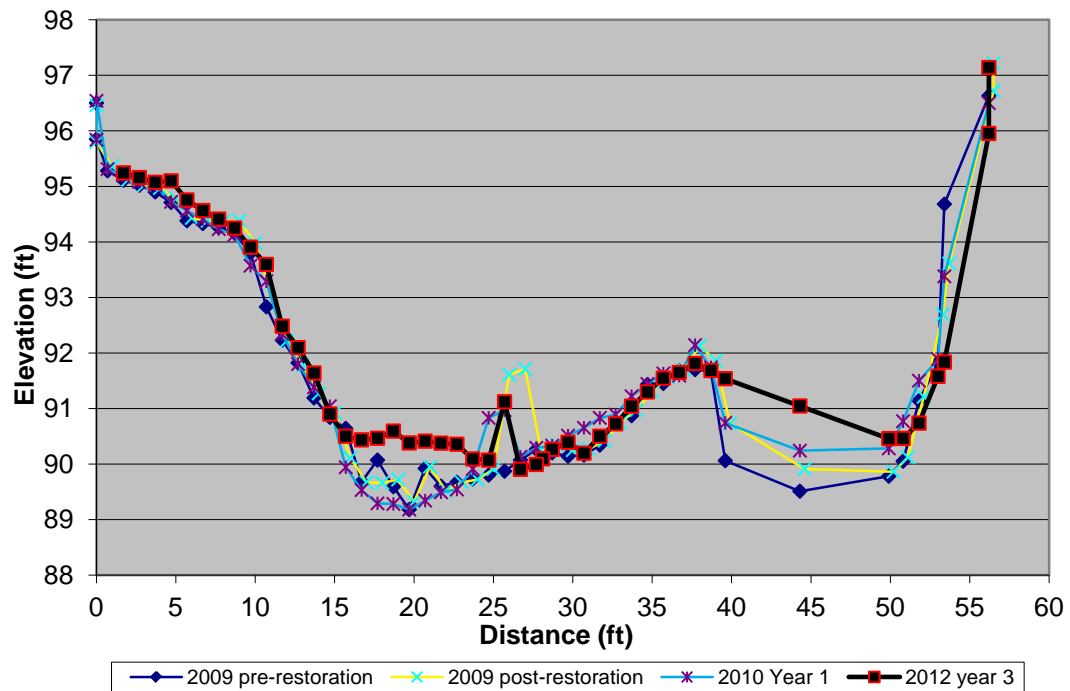
Cross Section 4 Downstream End of Pilot Channel

Cross section 4, at the downstream end of the pilot channel, shows bank stability and net aggradation (Fig. 8). The downstream reference cross section (Fig. 9) has gradually built a side-attached bar on the right bank. In response, the thalweg has moved from right to left. Both Cross sections 4 and 5 have experienced net aggradation through time (Table 2).

Figure 8: Cross section 4, located at the downstream end of the pilot channel.
Downstream view.

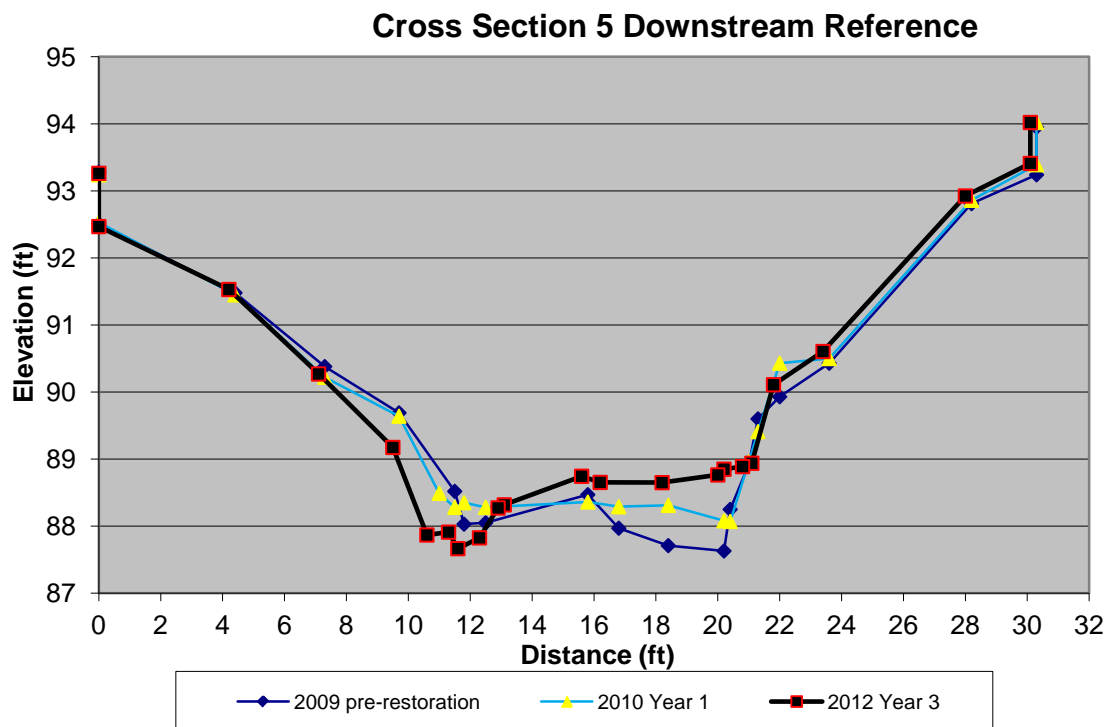
Figure 9: Cross section 5, located downstream of restored reach. Downstream view.

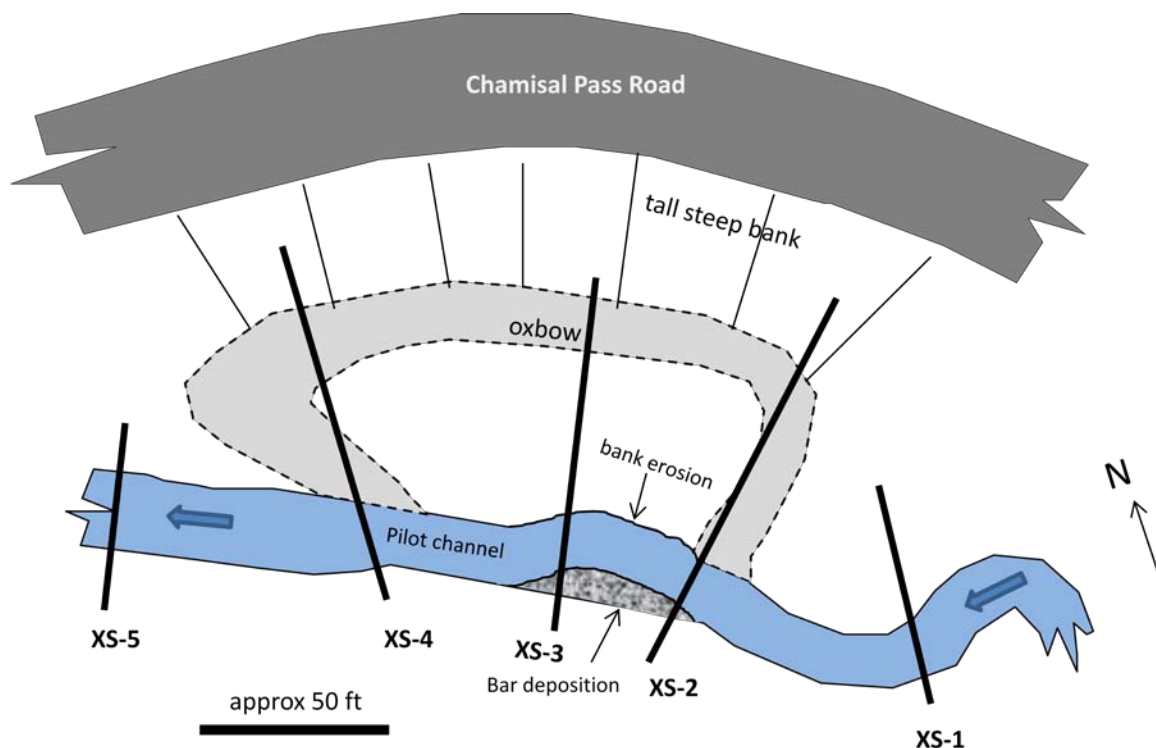
Figure 10: Site sketch map showing cross section locations and general area of bank erosion. Map redrawn from WRA (2010). Pilot channel alignment was originally straight between cross sections 2 and 3.

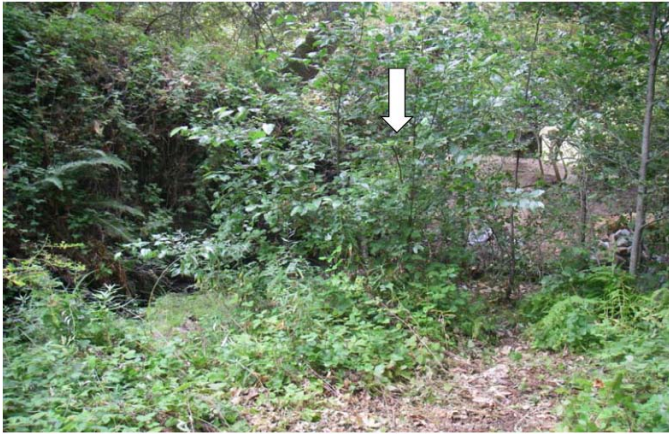
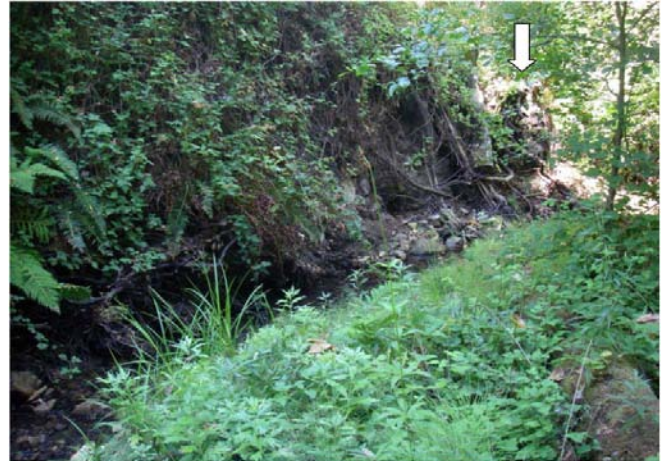
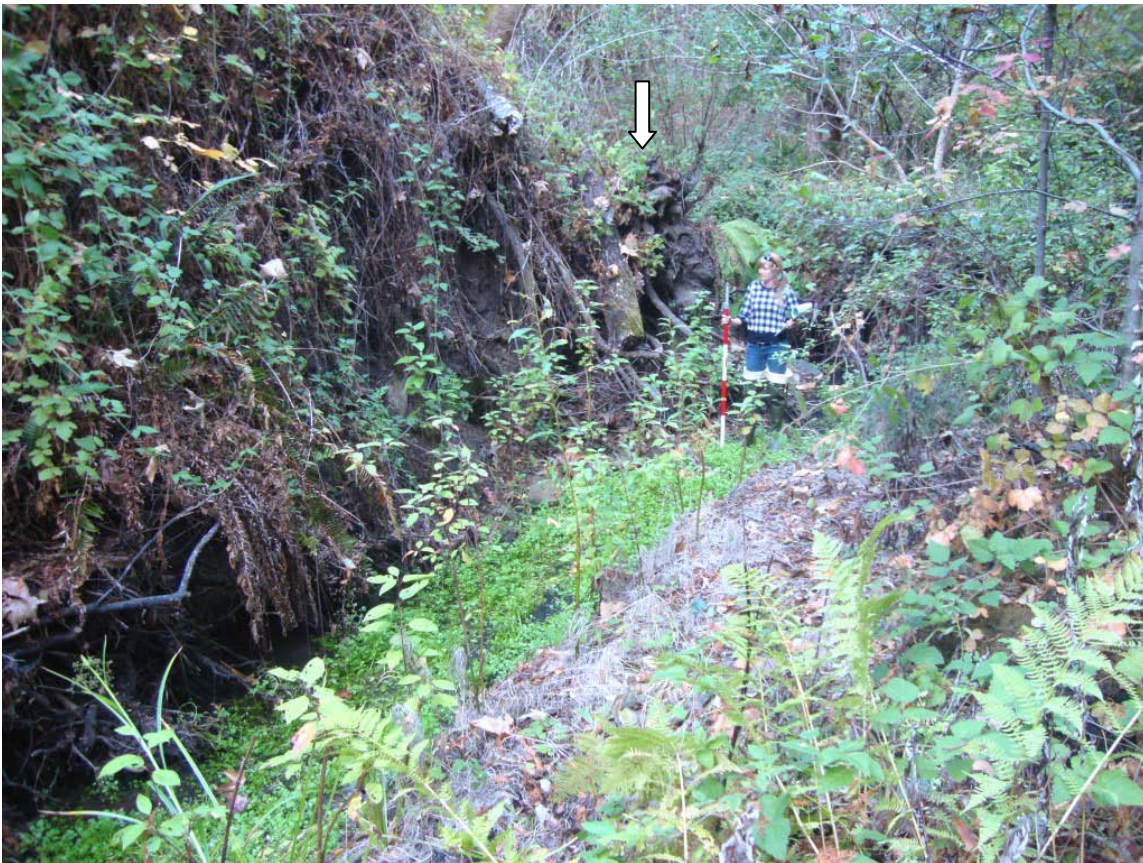
Photo point P1: Right bank of XSEC 1, downstream view. Arrow points to rootwad. Top left is 2009 post-construction. Top right is 2011 year2 monitoring. Bottom is 2012 Year 3 monitoring.

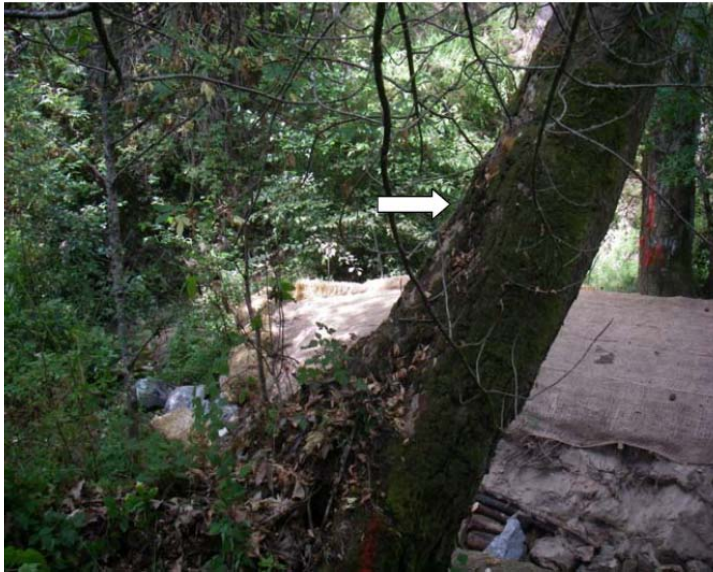
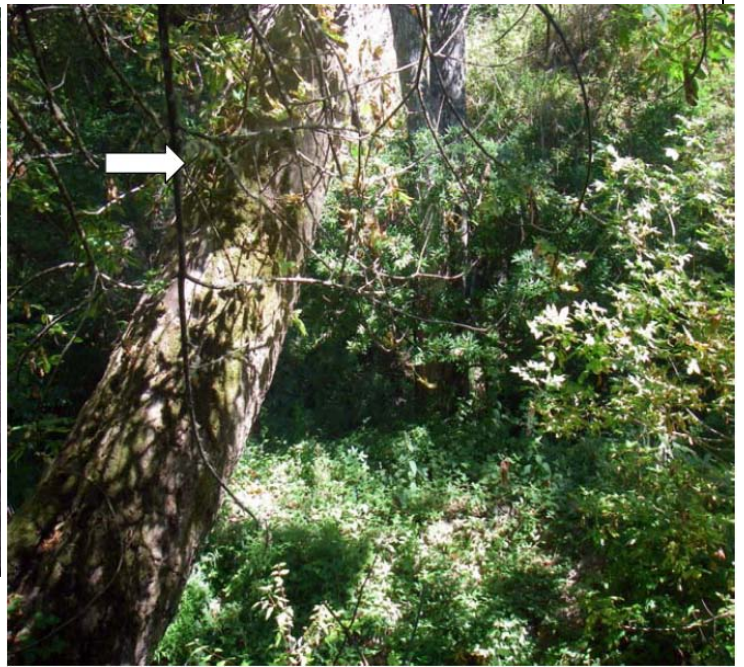
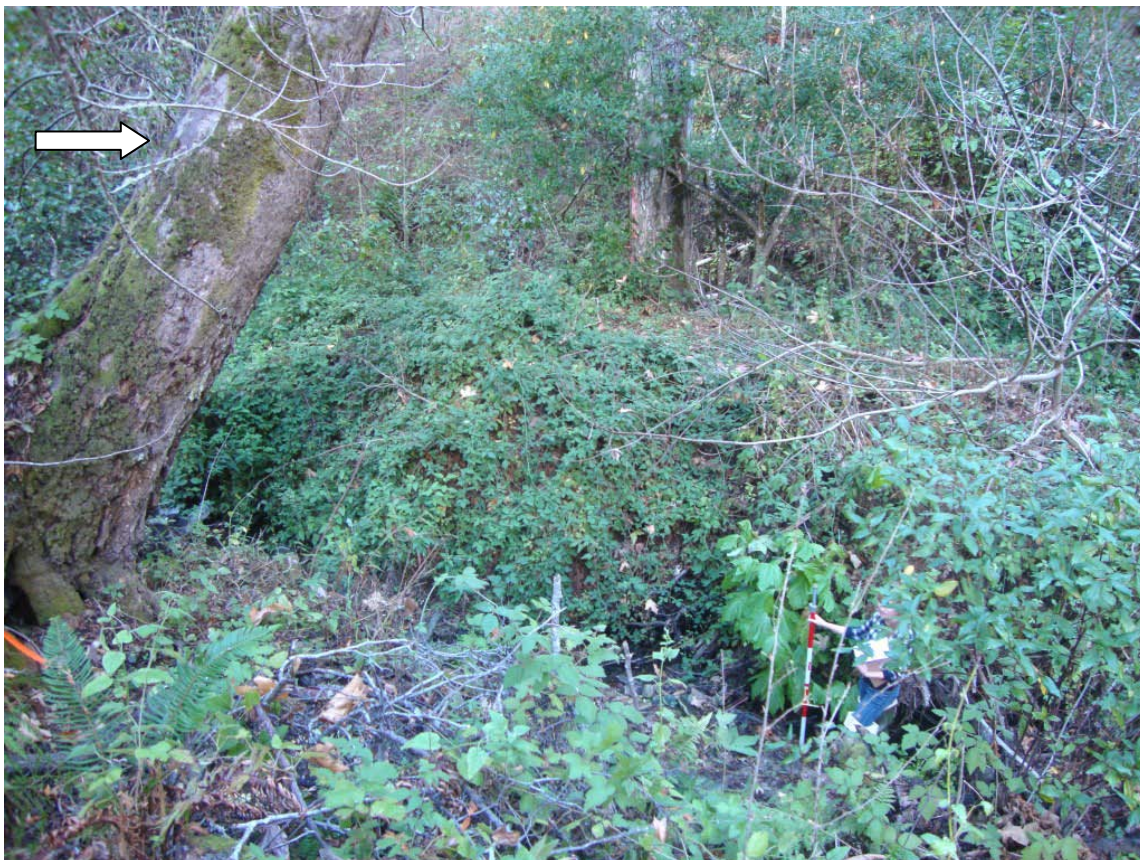
Photo point P2: Left bank of XSEC 2, downstream view. Arrow points to bent tree. Top left is 2009 post-construction. Top right is 2011 year2 monitoring. Bottom is 2012 Year 3 monitoring.

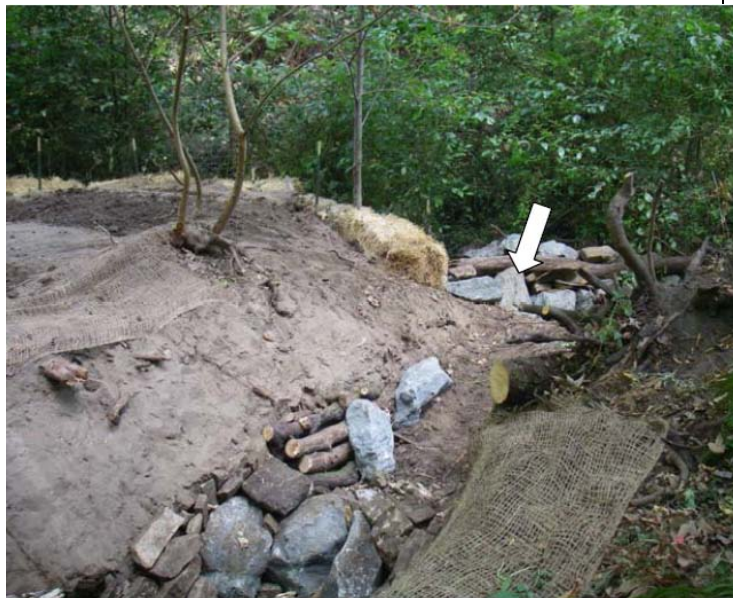
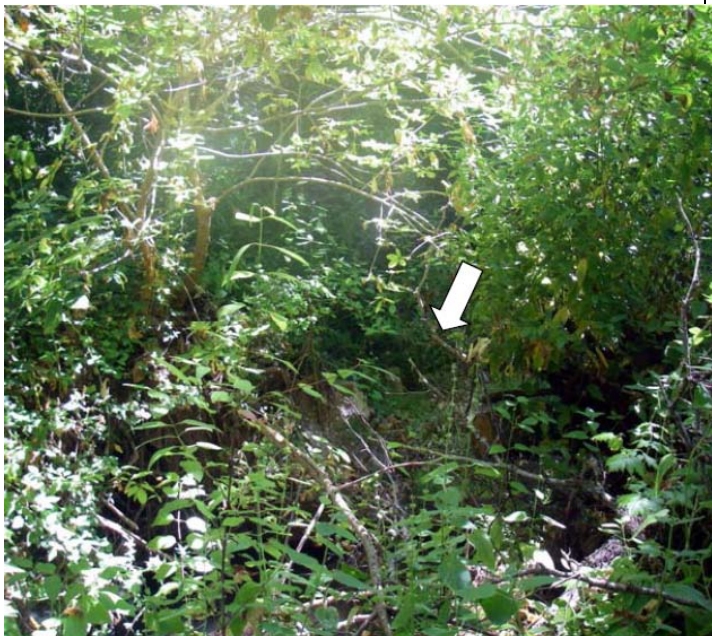
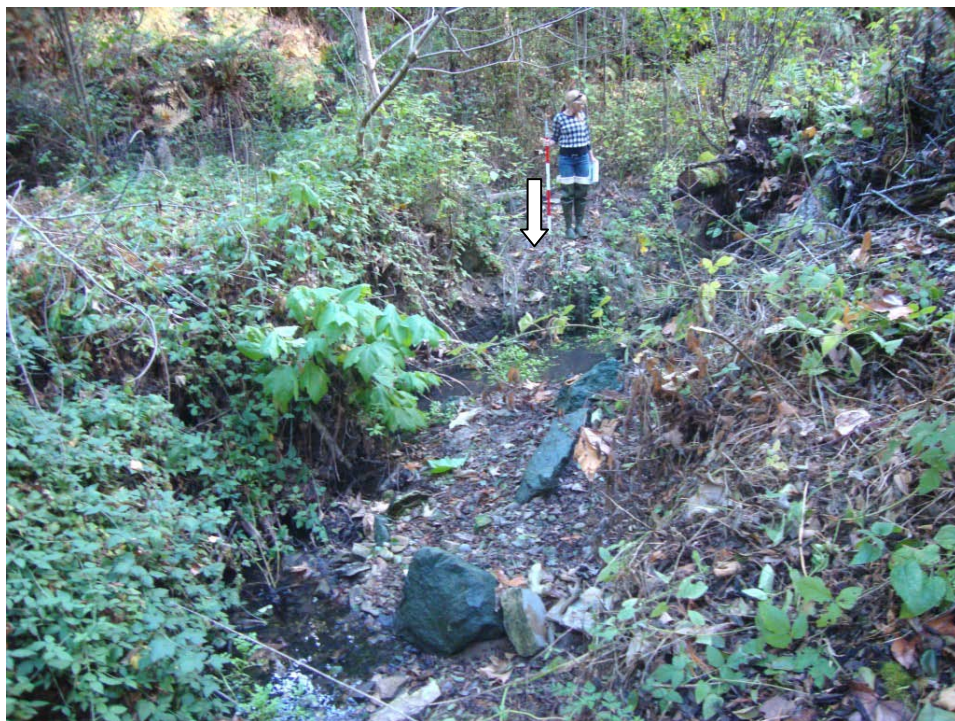
Photo point P3: Left bank of XSEC 3, upstream view. Arrow points to mouth of pilot channel. Top left is 2009 post-construction. Top right is 2011 year2 monitoring. Bottom is 2012 Year 3 monitoring.

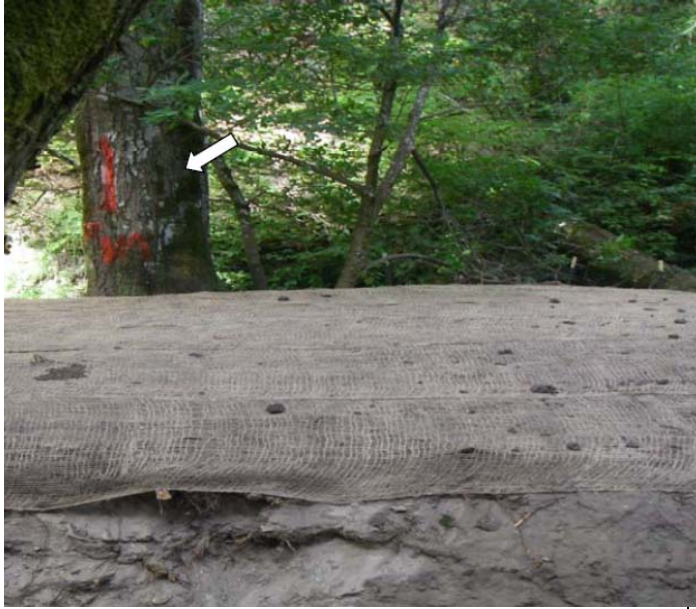
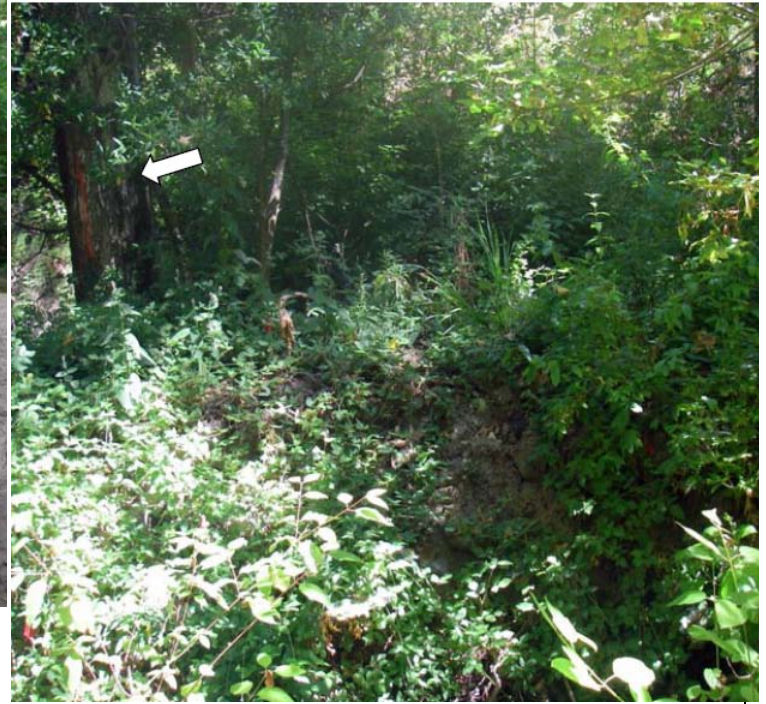
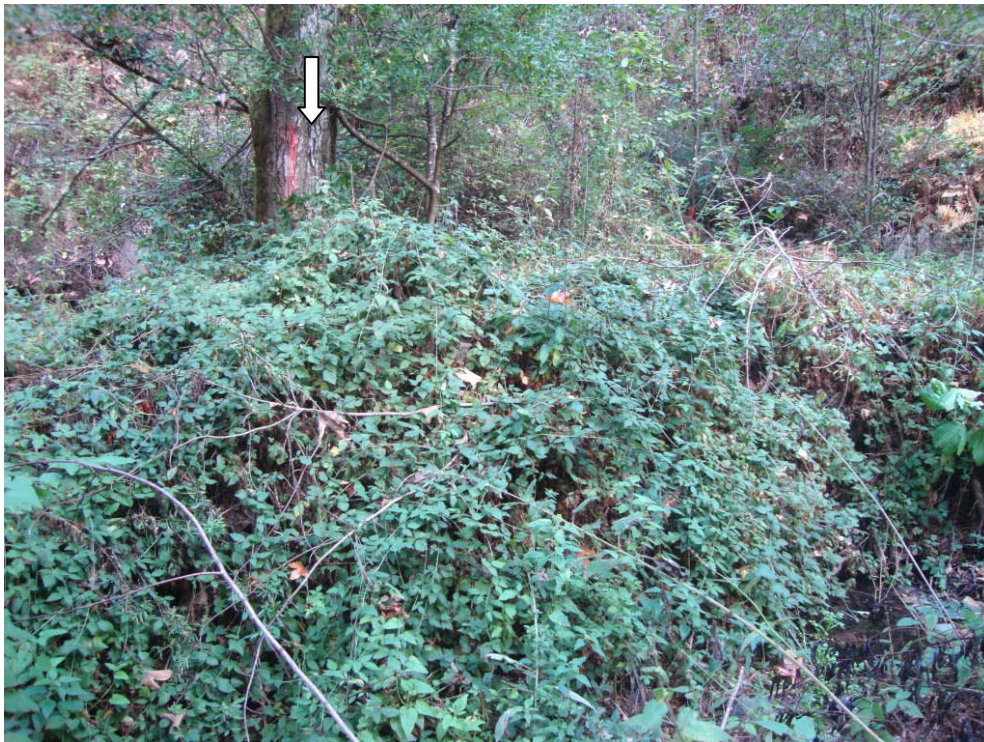
Photo point P4: Left bank of XSEC 4, upstream view. Arrow points to temporary benchmark. Top left is 2009 post-construction. Top right is 2011 year2 monitoring. Bottom is 2012 Year 3 monitoring.

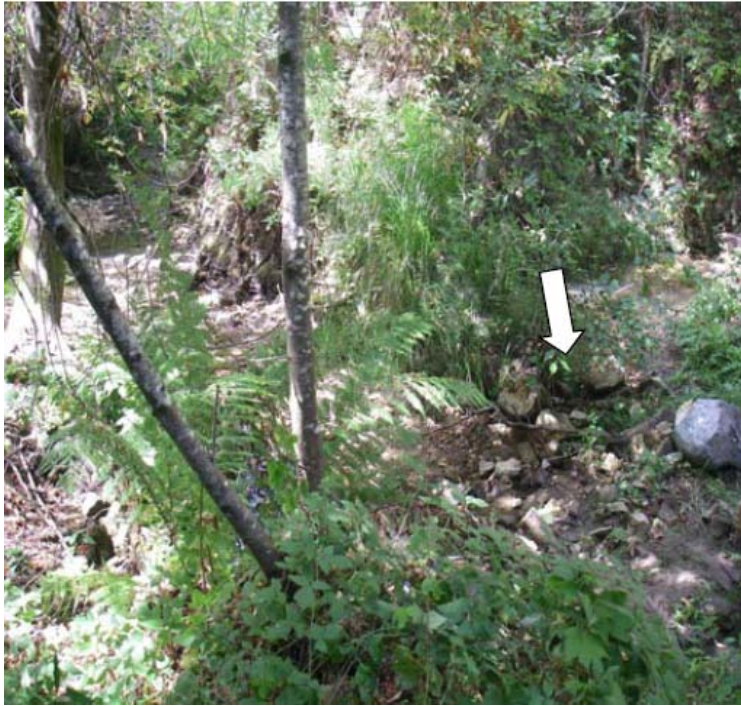
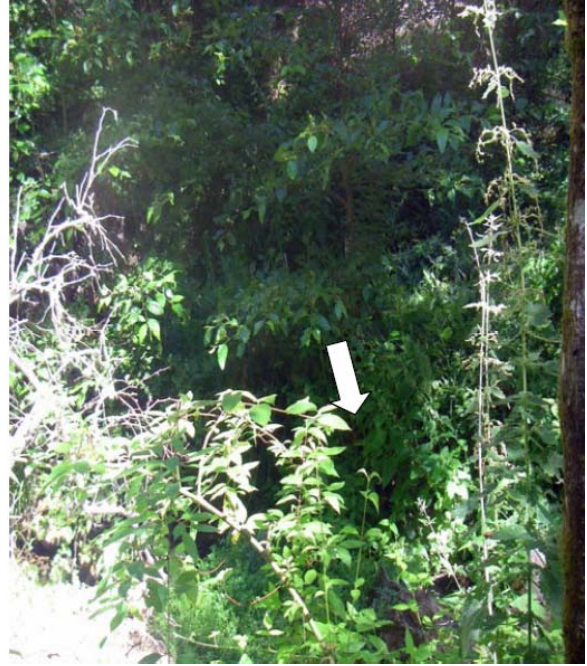
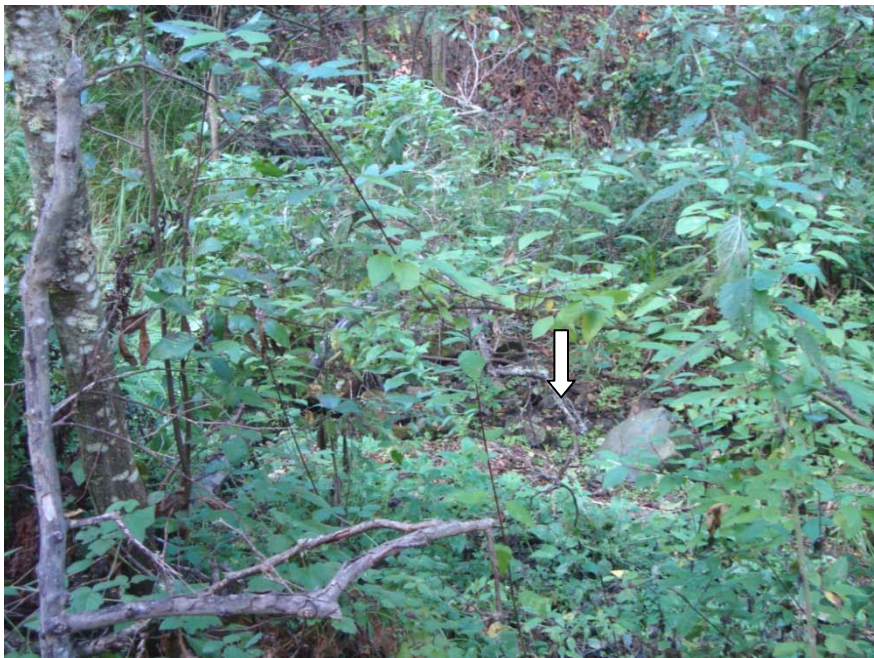
Photo point P4: Left bank of XSEC 4, downstream view. Arrow points to oxbow confluence. Top left is 2009 post-construction. Top right is 2011 year2 monitoring. Bottom is 2012 Year 3 monitoring.

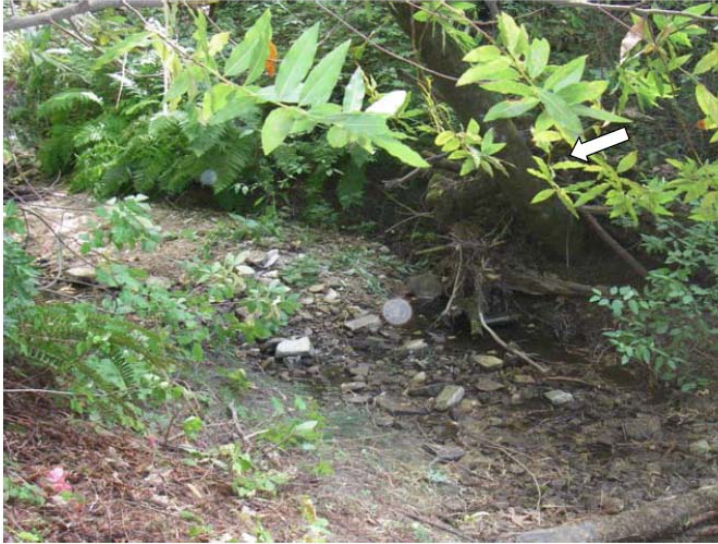
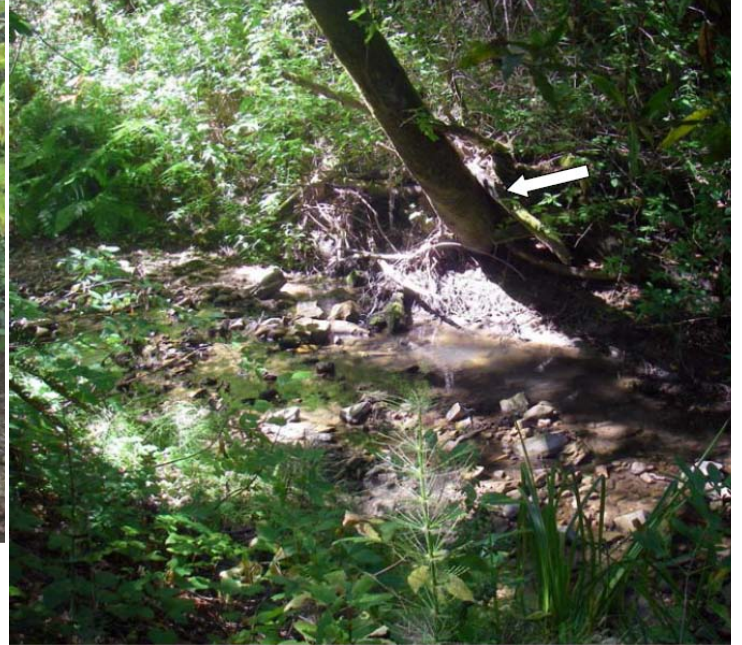
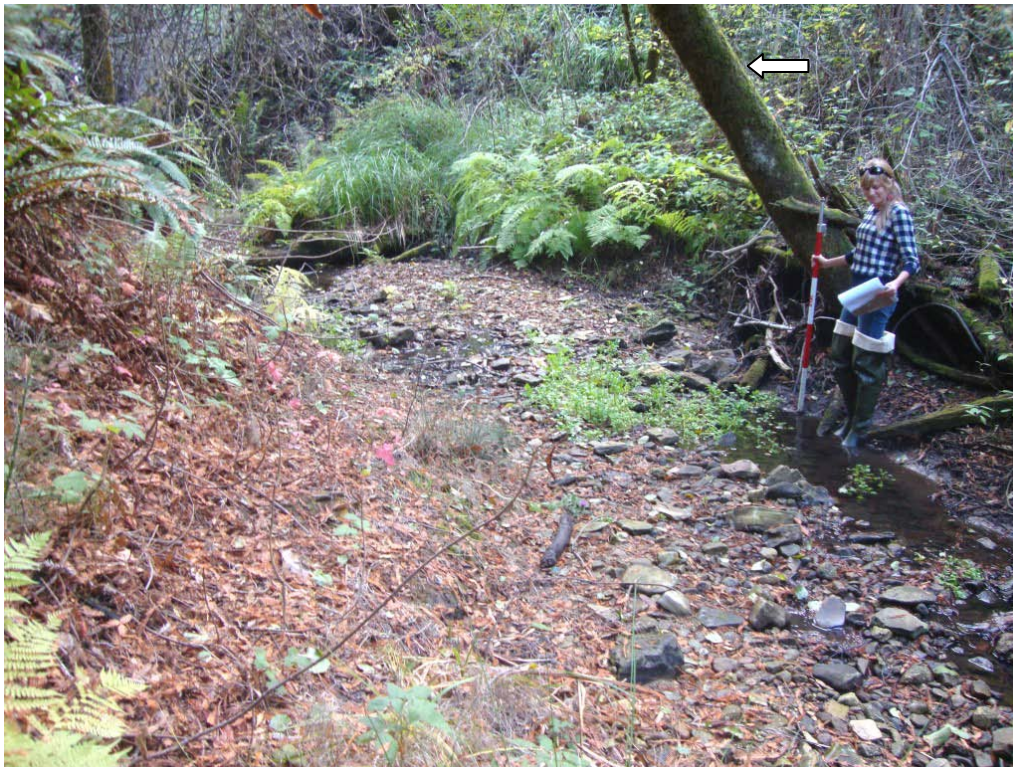
Photo point P5: Right bank of XSEC 5, upstream view. Arrow points to overhanging tree. Top left is 2009 post-construction. Top right is 2011 year2 monitoring. Bottom is 2012 Year 3 monitoring.

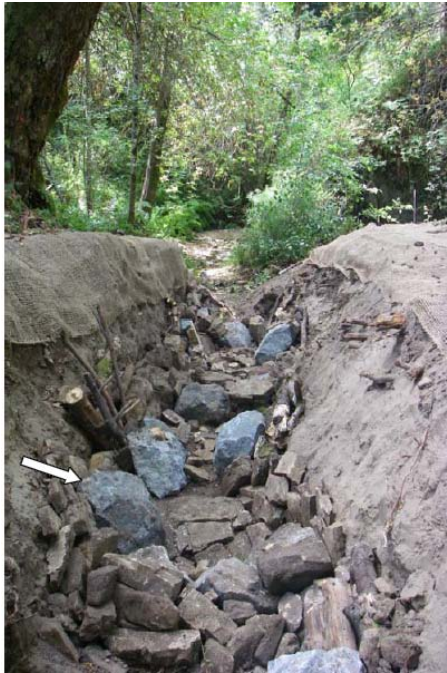
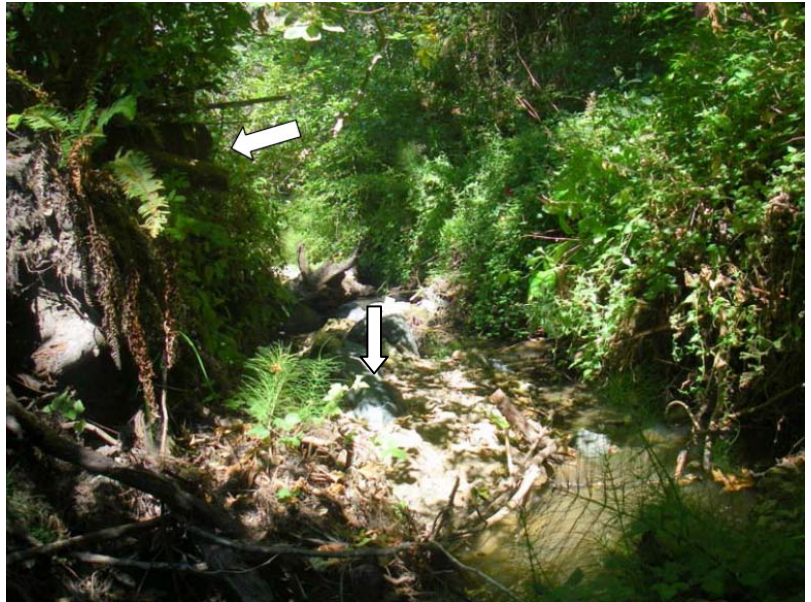
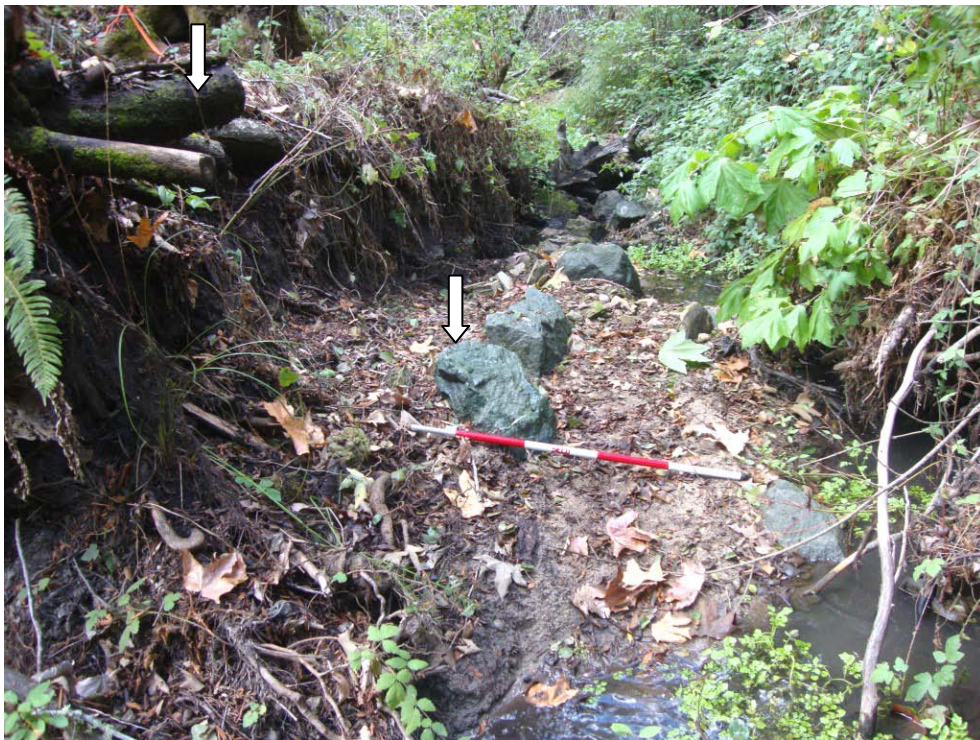
Mouth of pilot channel: downstream view. Arrow points to rock and rootwad. Top left is 2009 post-construction. Top right is 2011 year2 monitoring. Bottom is 2012 Year 3 monitoring
