Publication No. WI-2014-13

8 December 2014

## **The Watershed Institute**

## **Potrero Creek Restoration Santa Lucia Preserve Monterey County (CA): Year Five Monitoring**

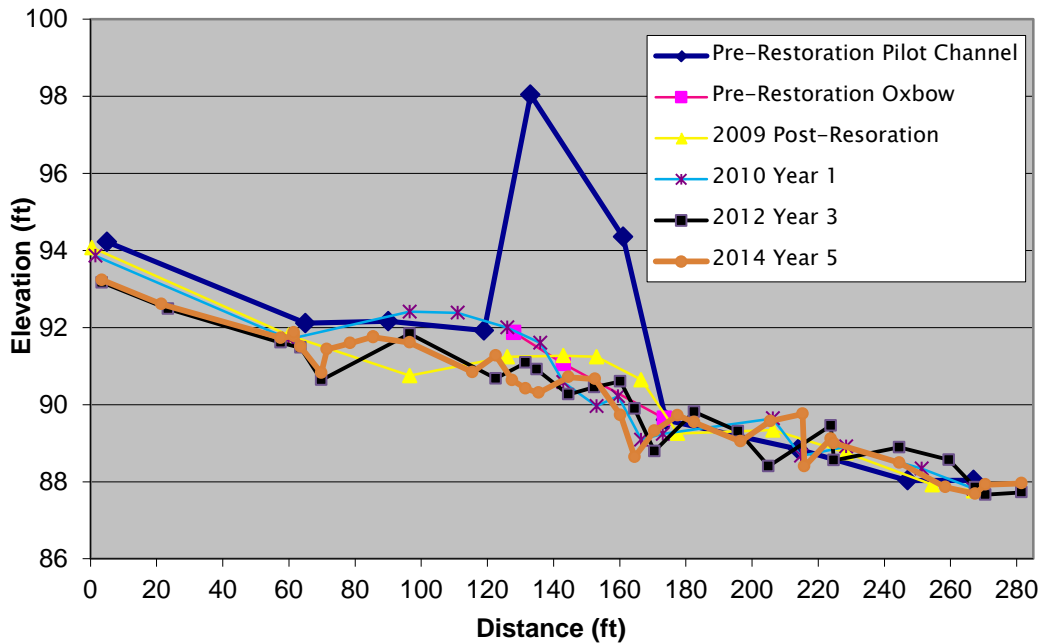
Figure 4: Longitudinal profile of Potrero creek restoration site.

A total of 278 feet of Potrero Creek thalweg were surveyed for the longitudinal profile; which is consistent with previous surveys. Figure 4 shows the longitudinal profile results for Year 5 monitoring overlaid with all previous surveys. Table 2 shows the overall gradient for each of the long profile surveys. The following changes are apparent in the profile.

- Overall gradient decrease is driven by net erosion at upstream end of the survey reach. The gradient within the restoration reach has remained relatively stable at about 2.2%.
- An upward deflection in the profile located at 150 ft in 2009 and 110 ft in 2010 is less apparent in 2012 and 2014.
- Overall variation in the profile cannot be differentiated from steady-state equilibrium over the short 5 year monitoring period.
- A qualitative review of the site in August 2011 noted that a log had made a short step and pool sequence near the exit of the restoration reach (WRA 2012). That log and step-pool geometry are still present in September 2012. The feature is located at approximately 223 ft in the profile (Fig. 4). The scour at the

downstream side of the log provides perennial pool habitat, still present in August 2014, following several relatively dry years.

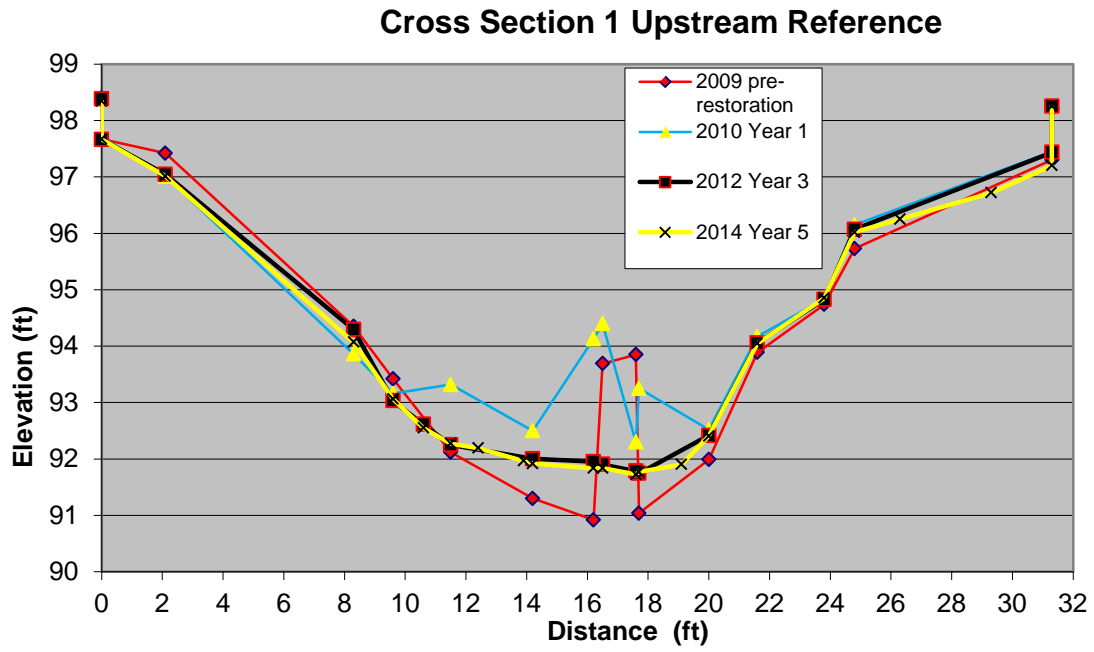
Figure 5: Cross section 1, located upstream from restored reach. Downstream view.

The upstream reference profile (Fig. 5) and the upstream end of the restored reach (Fig. 6) show that the stream has been alternately aggrading and degrading, in keeping with

previous interpretations (WRA 2010, 2012; Smith et al., 2012). Alternating periods of aggradation and degradation show that the stream reach is passing an episodically-high upstream sediment load on a multiannual time frame without net change. While this behavior is in keeping with steady-state equilibrium, the time under evaluation is too short to draw that conclusion. Of note is that the amount of vertical change (2 ft to 3 ft) is very high for a small creek, indicating that there is likely stream-bank instability or other chronic sediment sources located higher in the watershed. Figure 2 indicates that this watershed is underlain by highly erodible substrate that will generate excess sediment when disturbed. There has been virtually no change in channel geometry since 2012 because there have been no geomorphically-significant flows during that period.

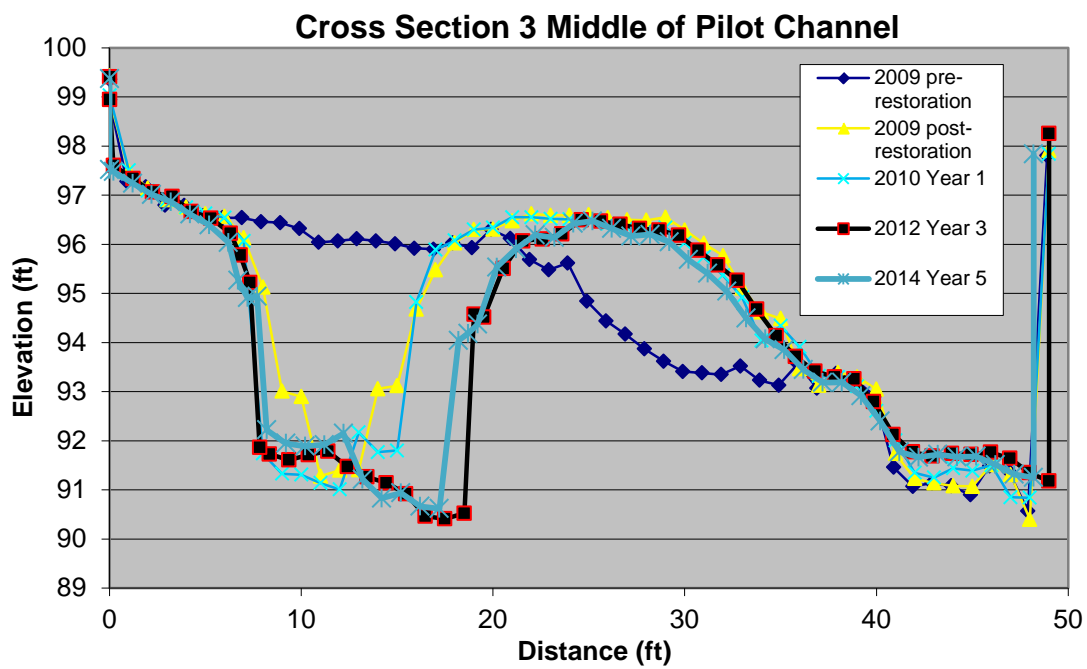
Figure 7: Cross section 3, located in the middle of the pilot channel. Downstream view.

Cross section 3 (Fig. 7) is located in the middle of the pilot channel reach. Both visual inspection and the cross sectional survey indicated rapid erosion at this site between 2009 and 2012. WRA (2012) reported excess erosion here in the August 2011 visual inspection as well. Bank sloughing and sediment recruitment have constructed a side-attached bar that has grown from left to right across the original pilot channel thalweg (Fig. 7, Fig 10, Appendix A p. 32). The bar has forced scouring flows against the right bank. The right bank is undercut from 1 to 3 feet, and has retreated approximately 5 feet since the 2010 survey. At this cross section, the channel has generally enlarged in size since inception (Fig. 7; Table 3, Appendix A, p. 32). There has been virtually no change in channel geometry since 2012 because there have been no geomorphically-significant flows during that period.

The surveys of cross sections 3, and 4 show that the original channel (Oxbow) is aggrading (Figs. 7 & 8), especially where it is influenced by backwater from the creek at the downstream end (Fig. 8). Figure 10 shows the cross section locations and the general location of pilot channel bank erosion in the vicinity of cross section 3.

The right bank erosion problem noted near cross section 2 accelerates downstream from cross section 2 to cross section 3 (Fig. 7), where the problem was considered severe in 2012. The erosion is the direct result of lateral channel migration, forced by the growth of a side-attached bar on the left side. An indirect cause is the lack of an adequate floodplain width in this river reach. The observed channel widening was anticipated since the constructed channel was an undersized “pilot channel” that was left to enlarge and mature through time. The channel will probably continue to widen during high flow events. It is unclear how large the channel will become.

Annual visual inspection following high runoff years, and appropriate response to high erosion rates will guard against project failure.

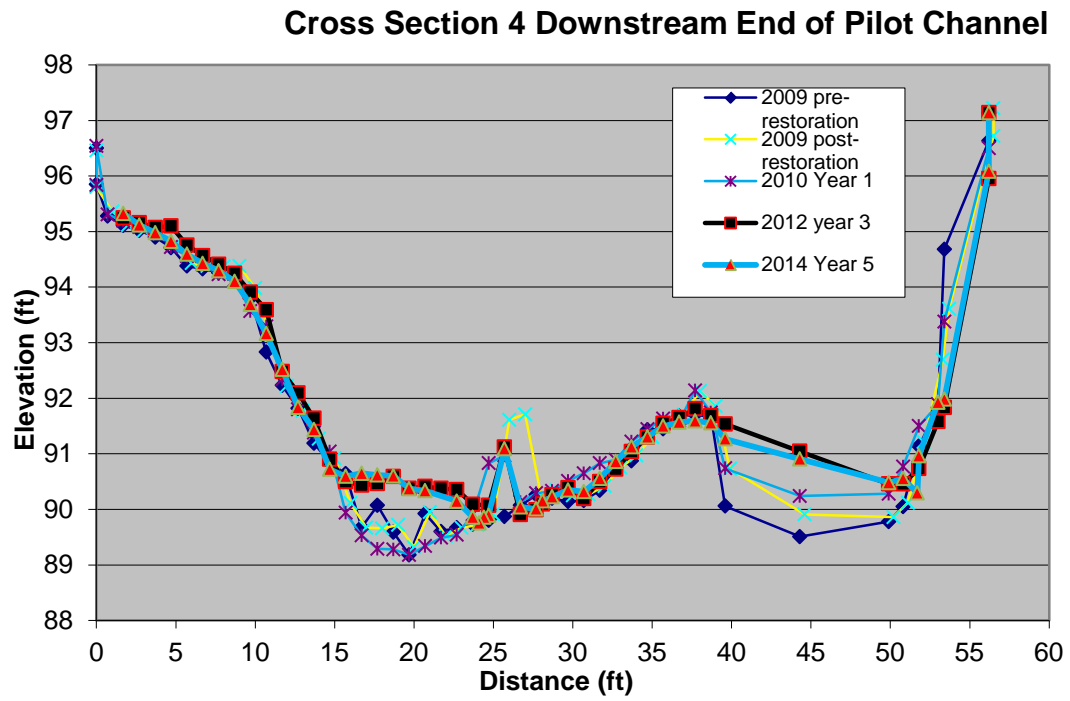
Figure 8: Cross section 4, located at the downstream end of the pilot channel.  
Downstream view.

Cross section 4, at the downstream end of the pilot channel, shows bank stability and net aggradation of 1.5 feet in the channel and 2 feet in the oxbow (Fig. 8). The downstream reference cross section (Fig. 9) has gradually built a side-attached bar on the right bank. In response, the thalweg has moved from right to left. Both cross sections have not changed significantly since 2012 because of prevailing dry conditions (Table 3).

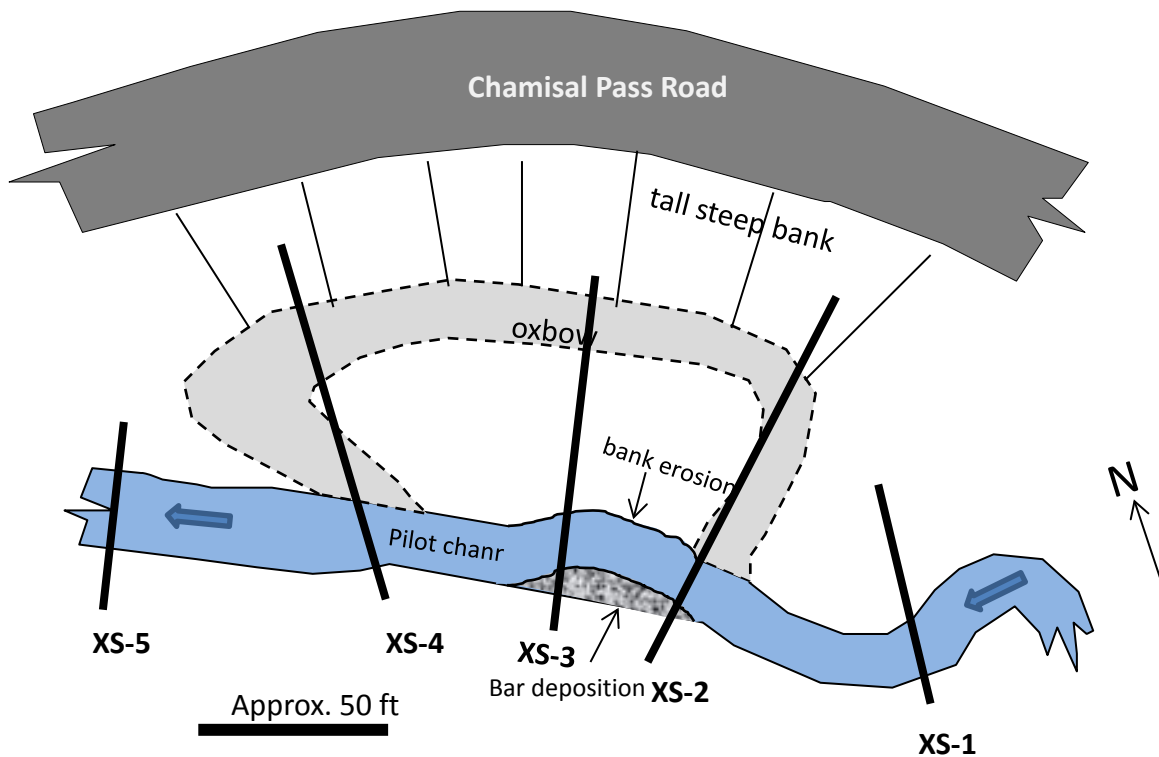
Figure 10: Site sketch map showing cross section locations and general area of bank erosion. Map redrawn from WRA (2010). Pilot channel alignment was originally straight between cross sections 2 and 3.

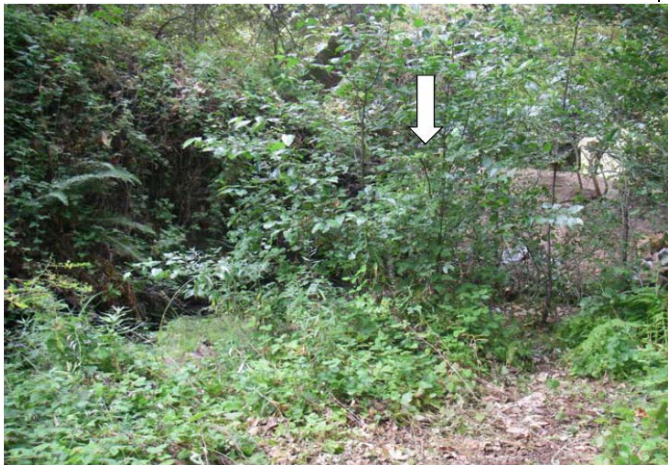
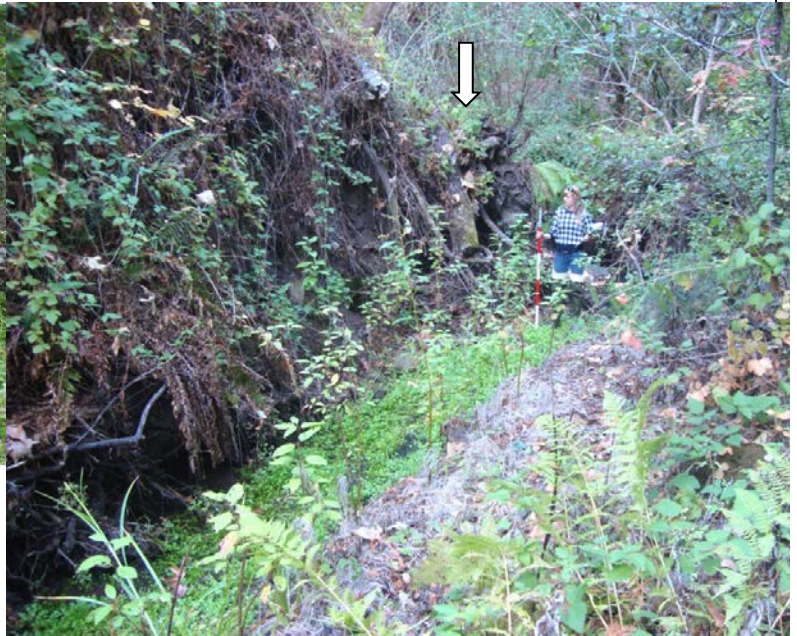
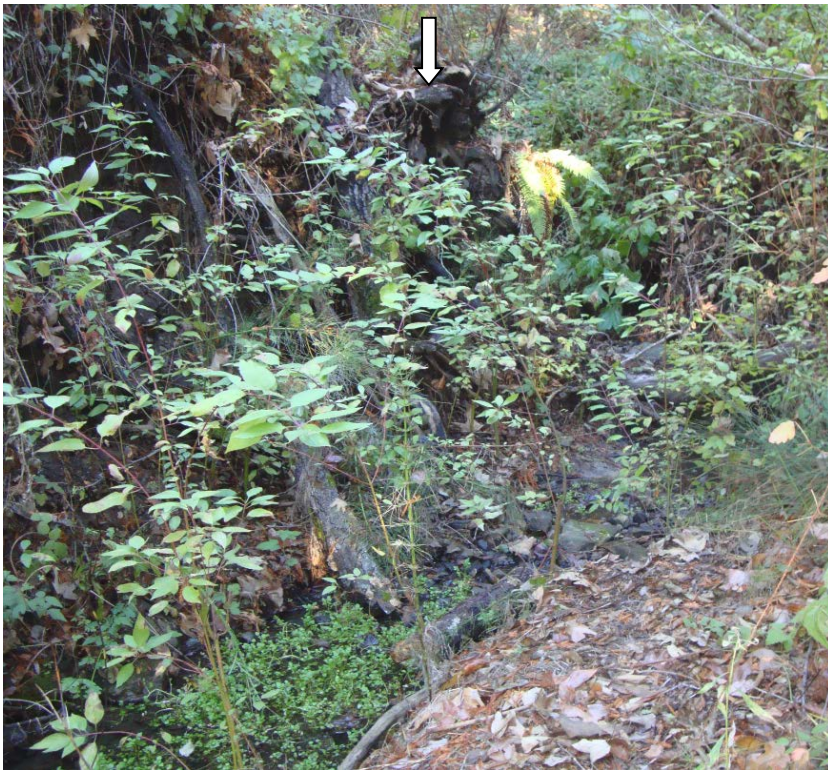
Photo point P1: Right bank of XSEC 1, downstream view. Arrow points to root wad. Top left is 2009 post-construction. Top right is 2012 year3 monitoring. Bottom is 2014 Year 5 monitoring.

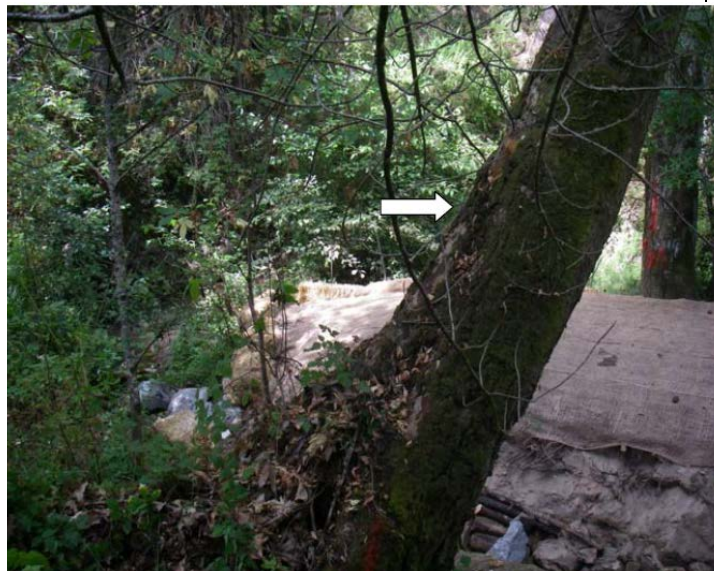
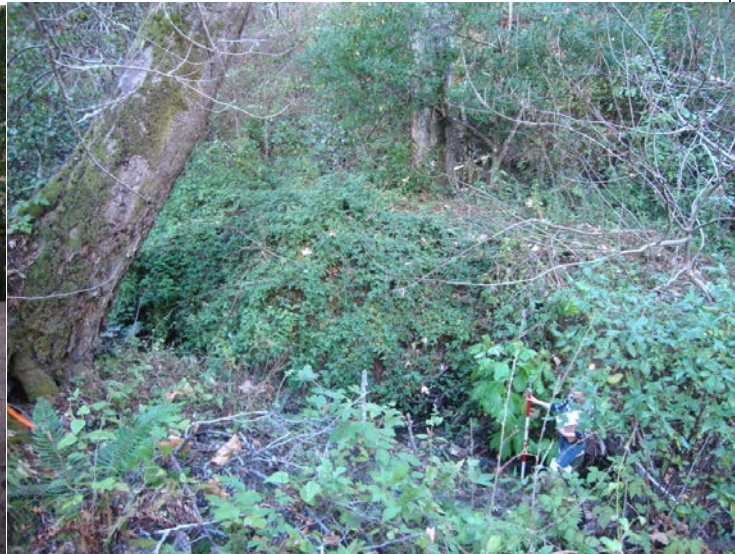
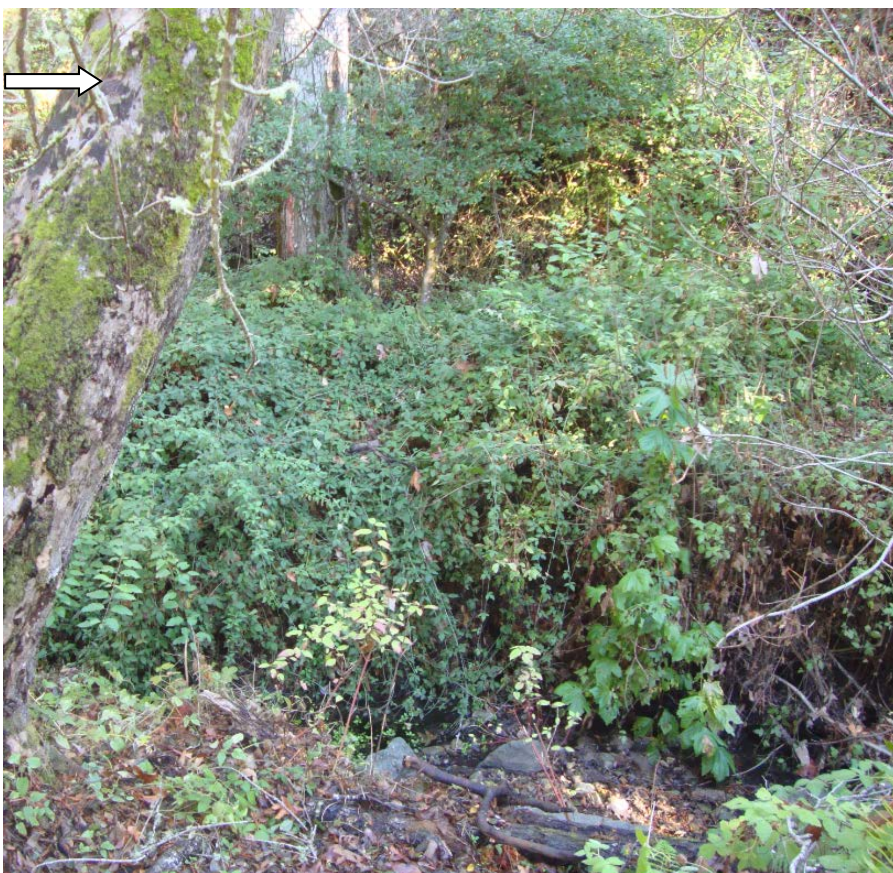
Photo point P2: Left bank of XSEC 2, downstream view. Arrow points to bent tree. Top left is 2009 post-construction. Top right is 2012 year3 monitoring. Bottom is 2014 Year 5 monitoring.

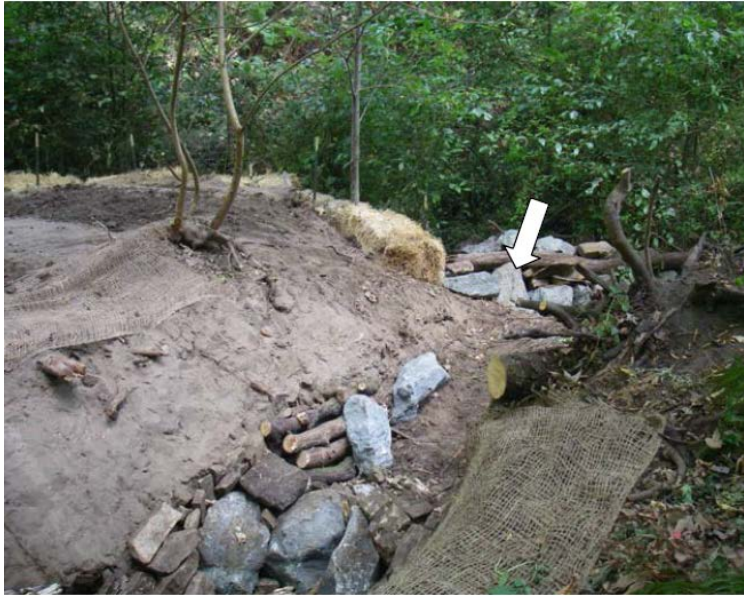
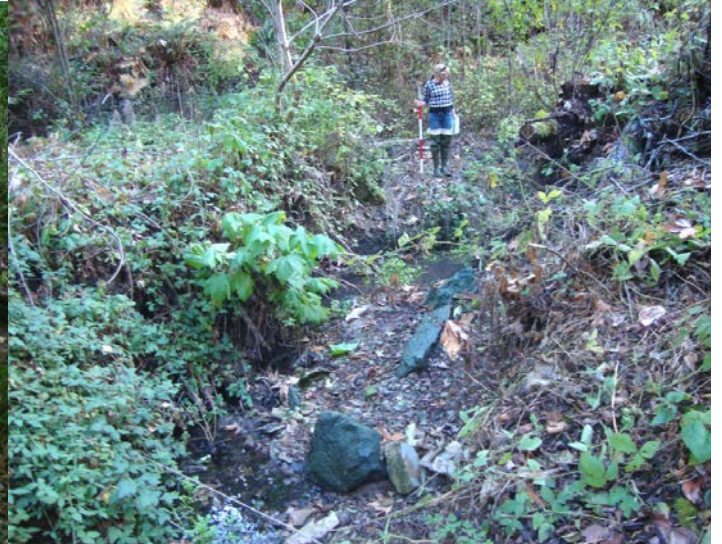
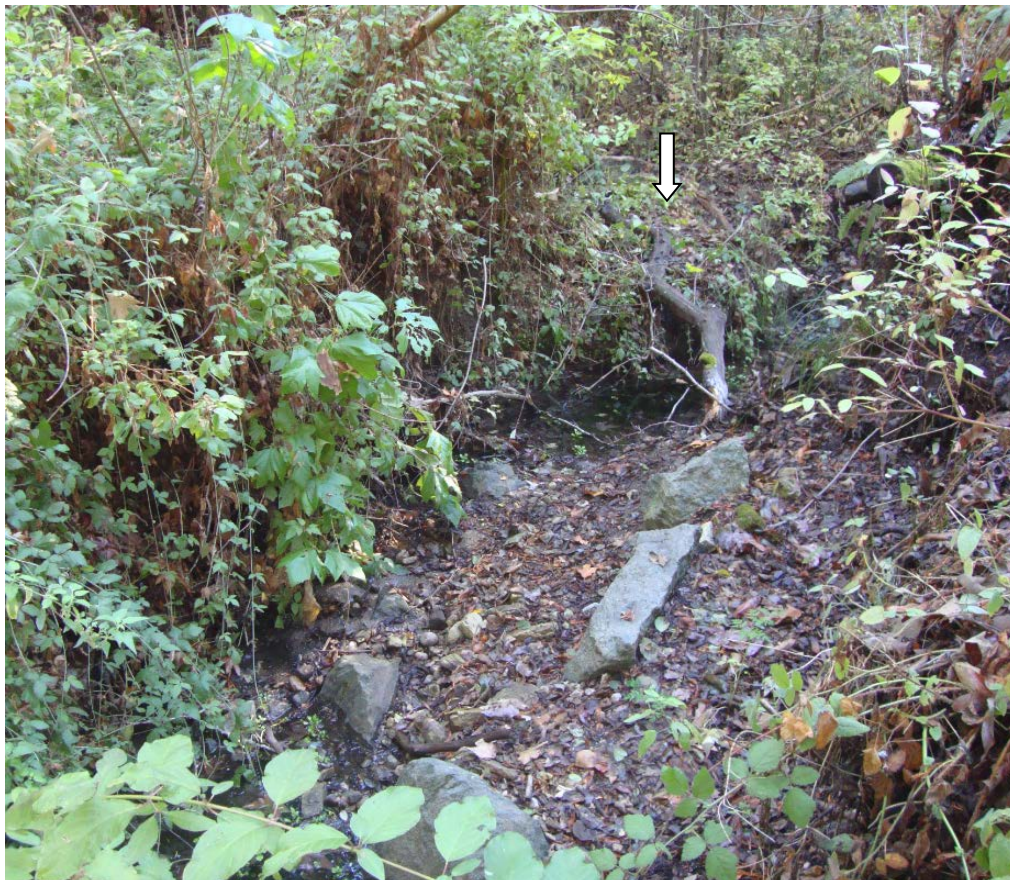
Photo point P3: Left bank of XSEC 3, upstream view. Arrow points to mouth of pilot channel. Top left is 2009 post-construction. Top right is 2012 year 3 monitoring. Bottom is 2014 Year 5 monitoring.

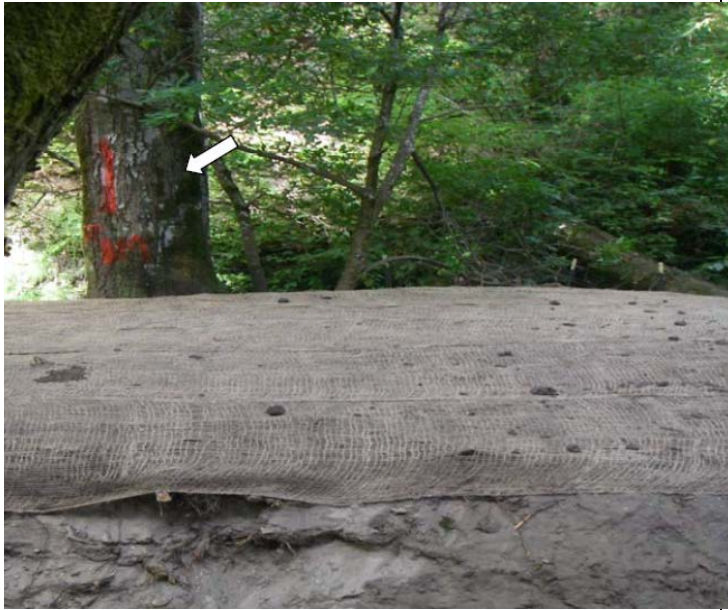
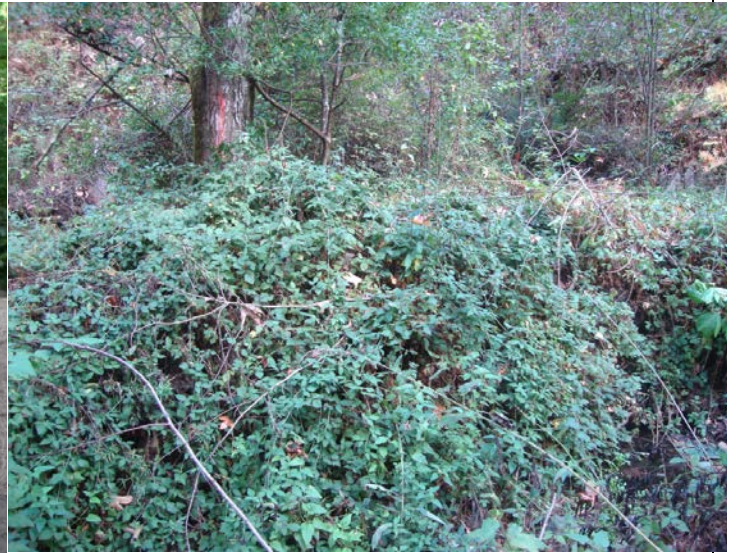
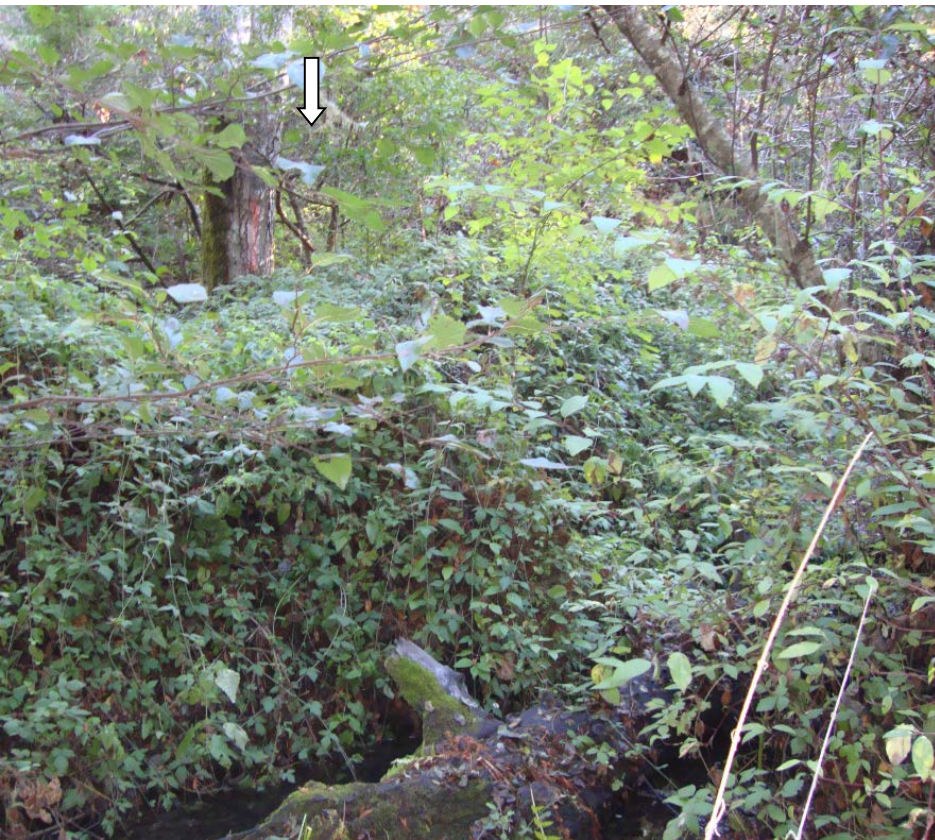
Photo point P4: Left bank of XSEC 4, upstream view. Arrow points to temporary benchmark. Top left is 2009 post-construction. Top right is 2012 year 3 monitoring. Bottom is 2014 Year 5 monitoring.

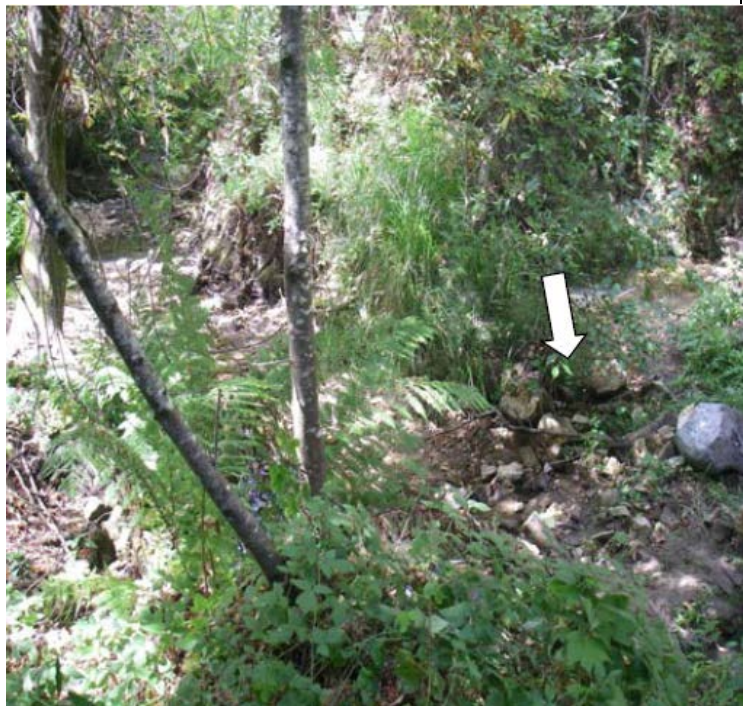
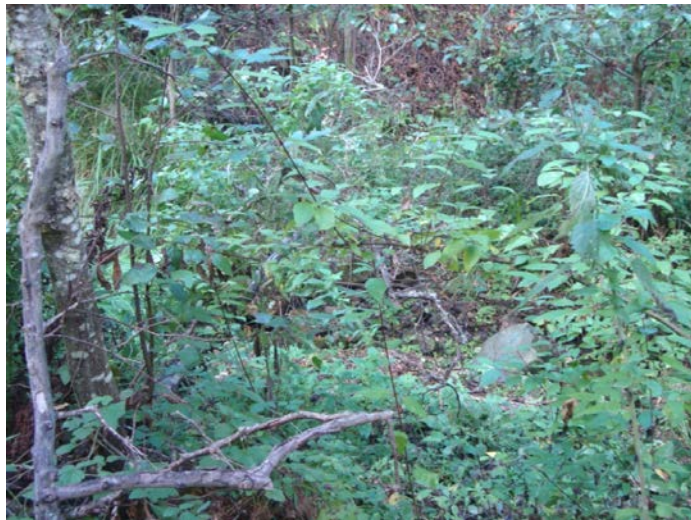
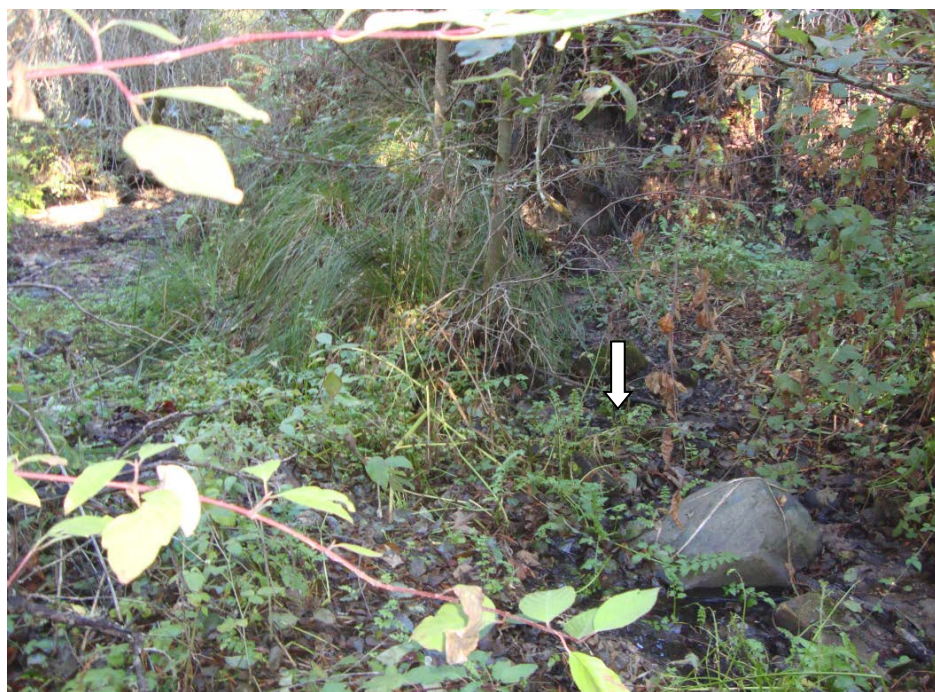
Photo point P4: Left bank of XSEC 4, downstream view. Arrow points to oxbow confluence. Top left is 2009 post-construction. Top right is 2012 year 3 monitoring. Bottom is 2014 Year 5 monitoring.

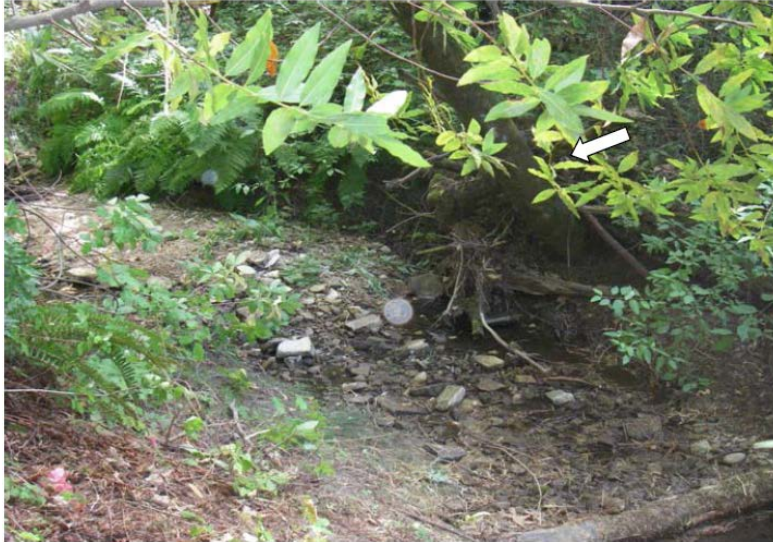
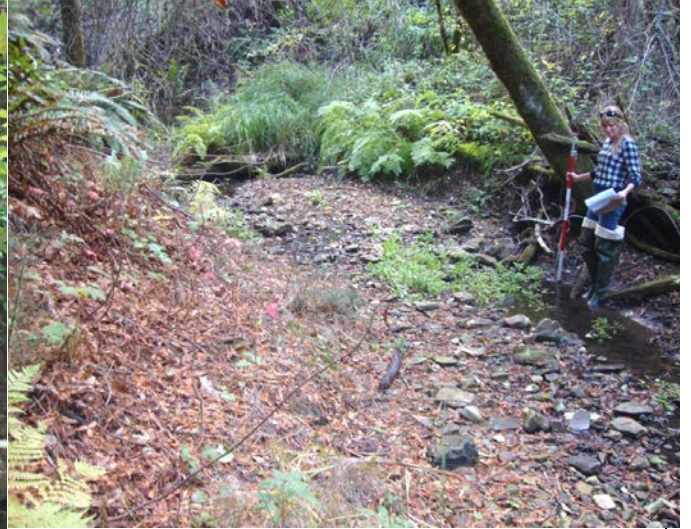
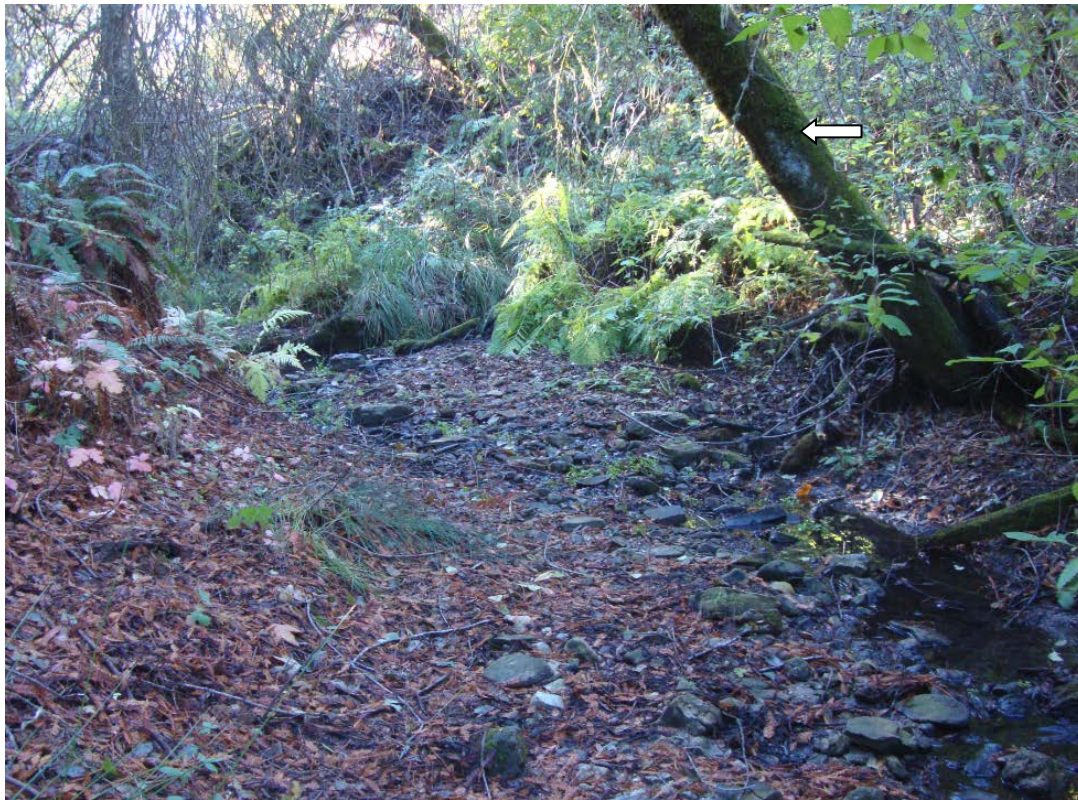
Photo point P5: Right bank of XSEC 5, upstream view. Arrow points to overhanging tree. Top left is 2009 post-construction. Top right is 2012 year 3 monitoring. Bottom is 2014 Year 5 monitoring.

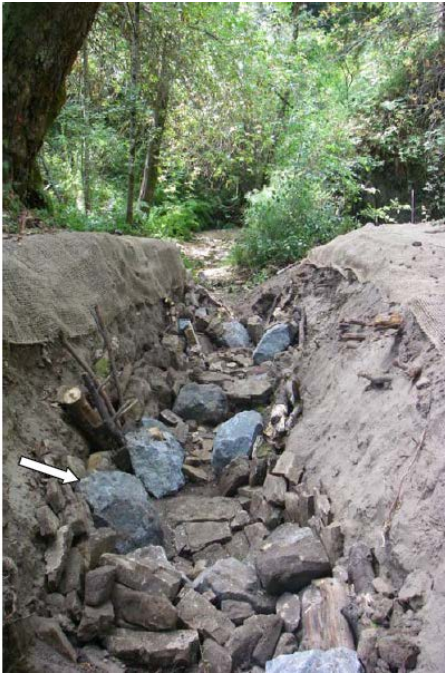
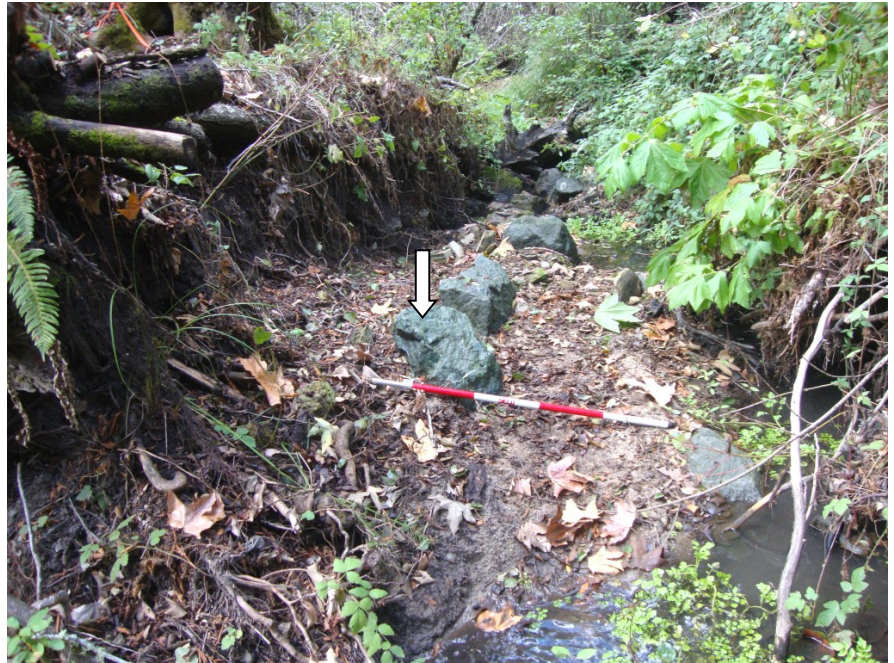
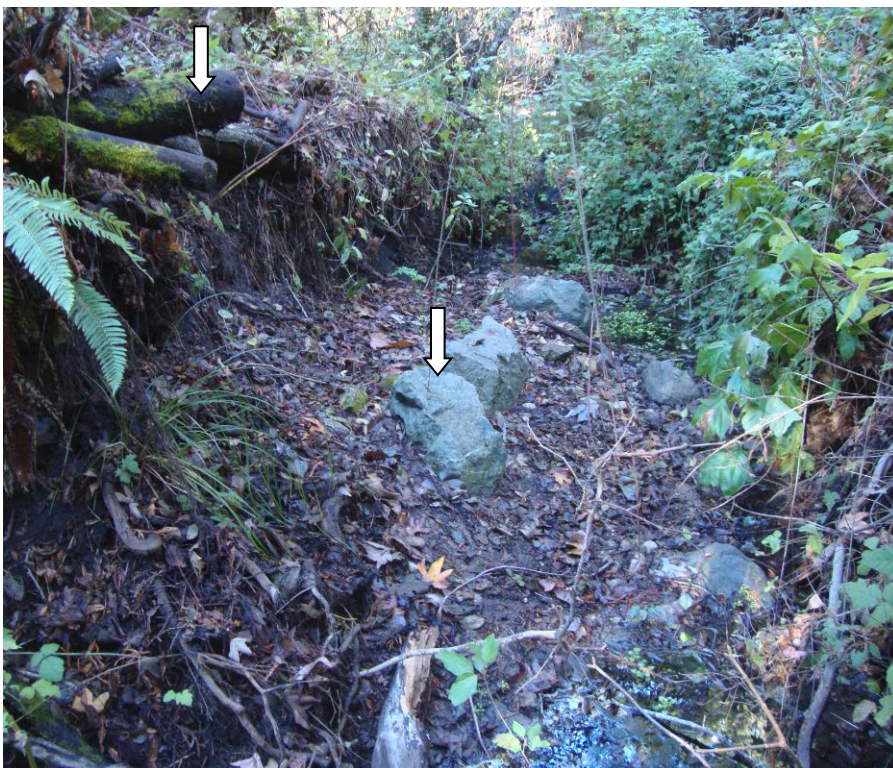
Mouth of pilot channel: downstream view. Arrow points to rock and root wad. Top left is 2009 post-construction. Top right is 2012 year 3 monitoring. Bottom is 2014 Year 5 monitoring
