Report No. WI-2005-02 21st January 2005

The Watershed Institute

Garrapata Creek Watershed **Steelhead Barrier Assessment**

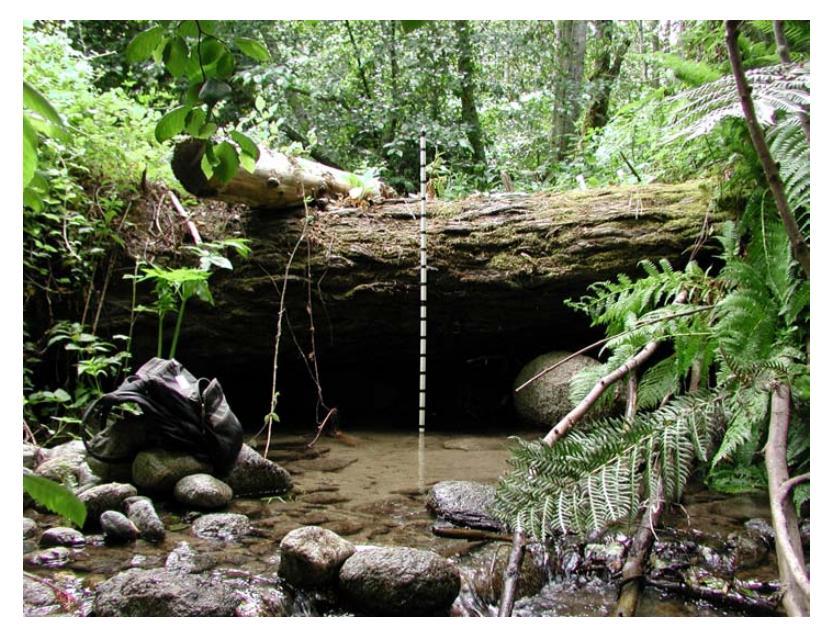
Figure 5.1 Structure gb01 looking upstream. Photo: Joel Casagrande, 8 June 2004.

This structure should be improved immediately. Using a hand or chain saw, cut/notch the main

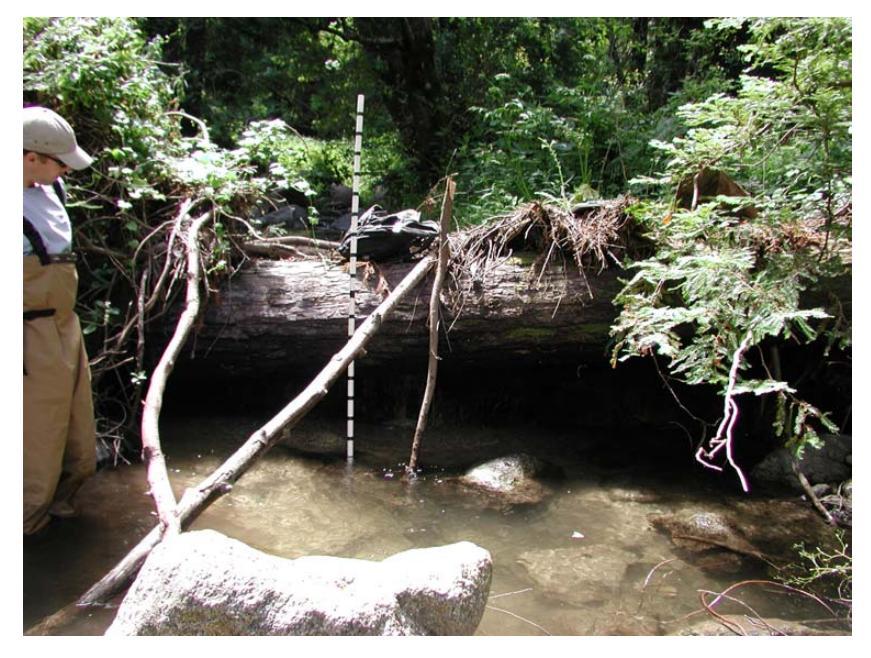
Figure 5.3 Structure gb02 looking upstream. Photo: Joel Casagrande 8 Jun 2004

Using a hand or chain saw, cut the main log creating a 1-1.25 m (3-4 ft) wide opening along the right bank. Leave remainder of the structure in place as important habitat. Small debris and three medium sized logs were removed from backside of the structure and placed higher on the bank. This created a small path underneath, however this will likely clog in the near future unless the large key log is notched.

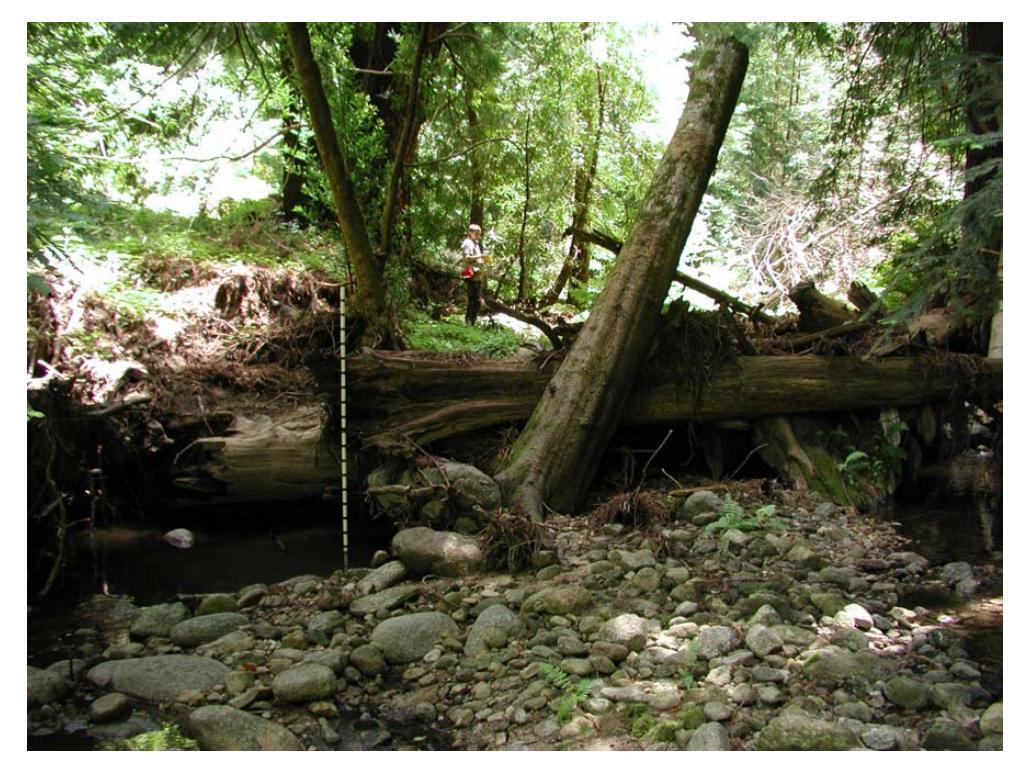
Figure 5.4 Structure gb03 looking upstream. Photo: Joel Casagrande 8 June 2004.

Clear and remove small and medium sized woody debris from left bank (right side of Figure 5.4) to create a second passage way along left bank. Cut a piece of the main log approximately 2.5 m (~8 ft) in length from the left bank. Leave remainder of woody material in place as habitat.

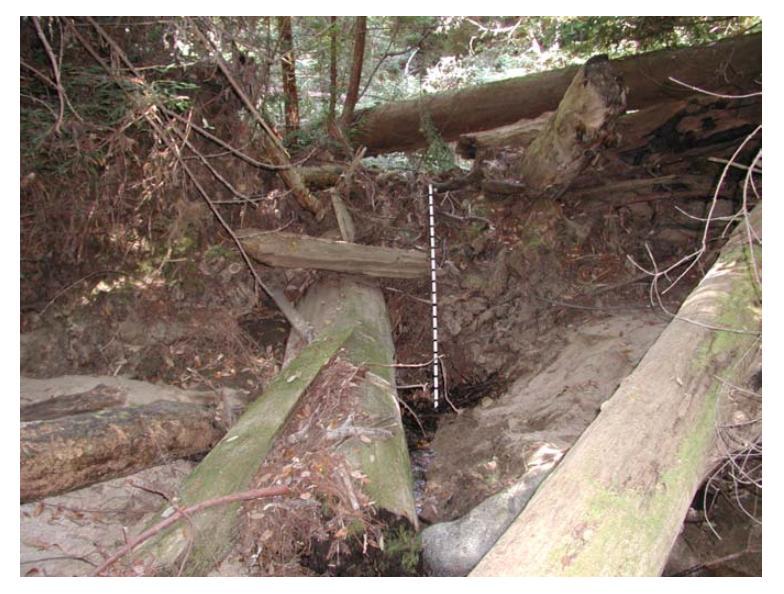
Figure 5.5 Structure gb04 looking downstream from back side of barrier. Note the sediment accumulations on the left. Photo: Joel Casagrande 11 August 2004.

Starting upstream, remove excess small and medium woody material. Larger logs impacting passage should be cut/notched at their lowest point. All attempts should be made to use the larger woody material for habitat features in the local vicinity. Larger logs not directly affecting fish passage should be left in place as important habitat features. If possible, remove sediments using shovels and buckets to higher, level ground.

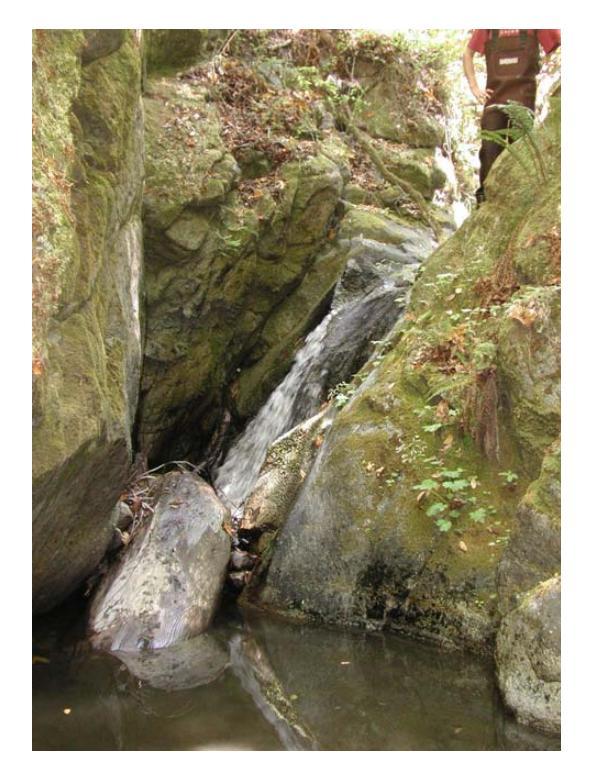
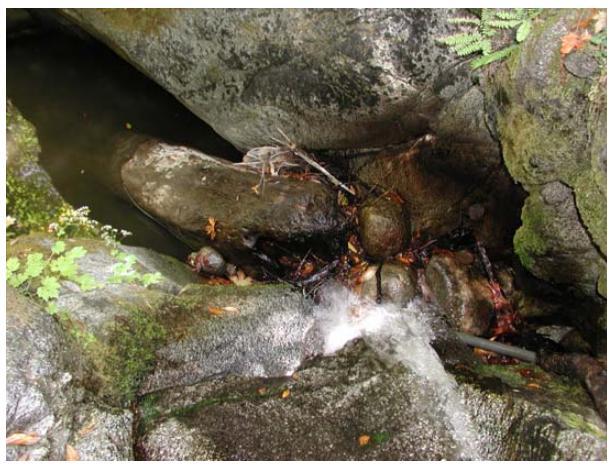
Figure 5.6a Structure gb05. Photo: Joel Casagrande 11 August 2004.

Figure 5.5b Accumulated debris and log in the downstream pool. Note the erosion and scour of moss and lichen from the bedrock across from the spilling waterfall. This illustrates the 90° angle of the spill. Photo: Joel Casagrande 11 August 2004.
Description

Cut and remove the log piece and coarse sediments from the spilling zone to better attract fish.

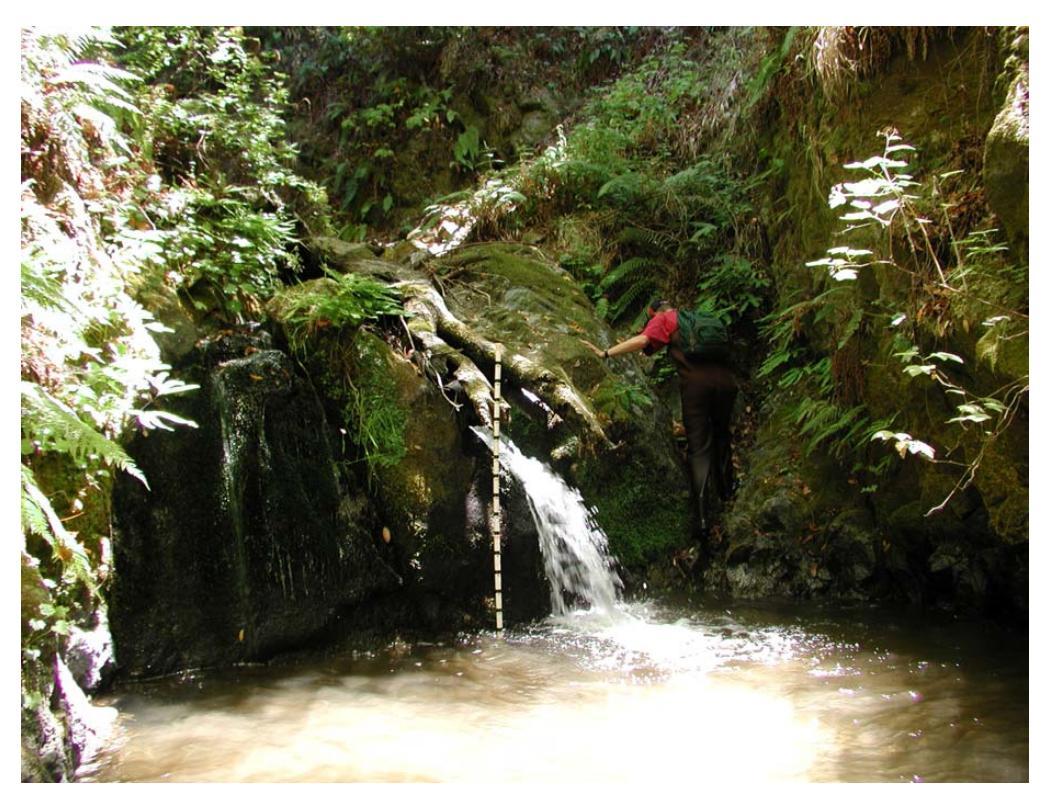
Figure 5.7 Structure gb06 looking upstream. Photo: Joel Casagrande 11 August 2004.

Cut the log at the forked junction, leaving the upstream half as woody structure in the stream. In time the pool will likely re-scour but only after upstream sediment sources are located and contained.

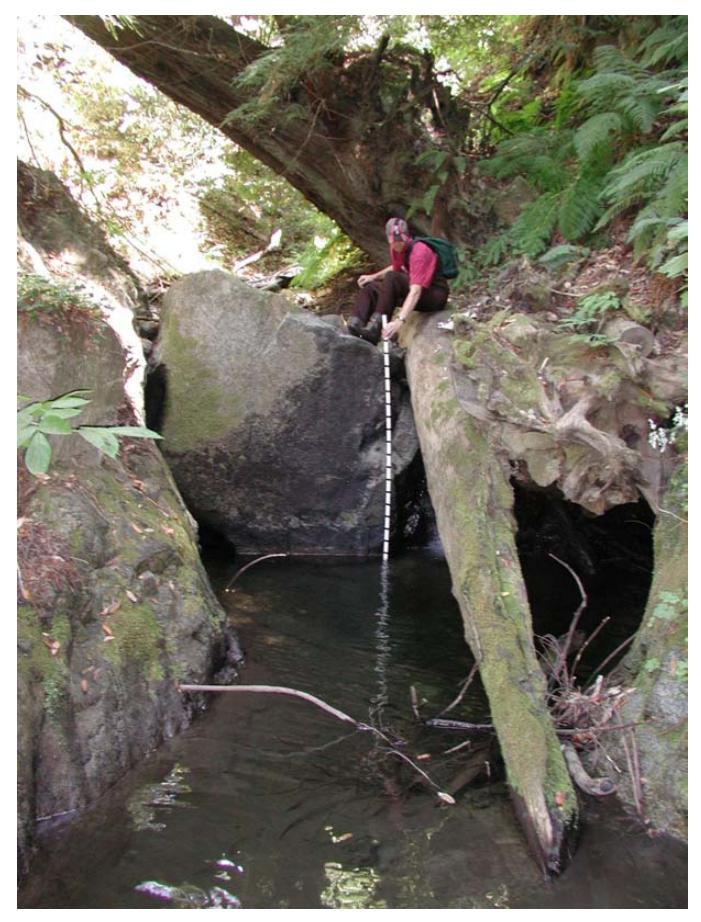
Figure 5.8 Structure gb07 looking upstream. Photo: Joel Casagrande 11 August 2004.

Because this is a natural occurrence, no recommendations for improvement are warranted. In time the pool will likely re-scour but only after upstream sediment sources are located and contained.

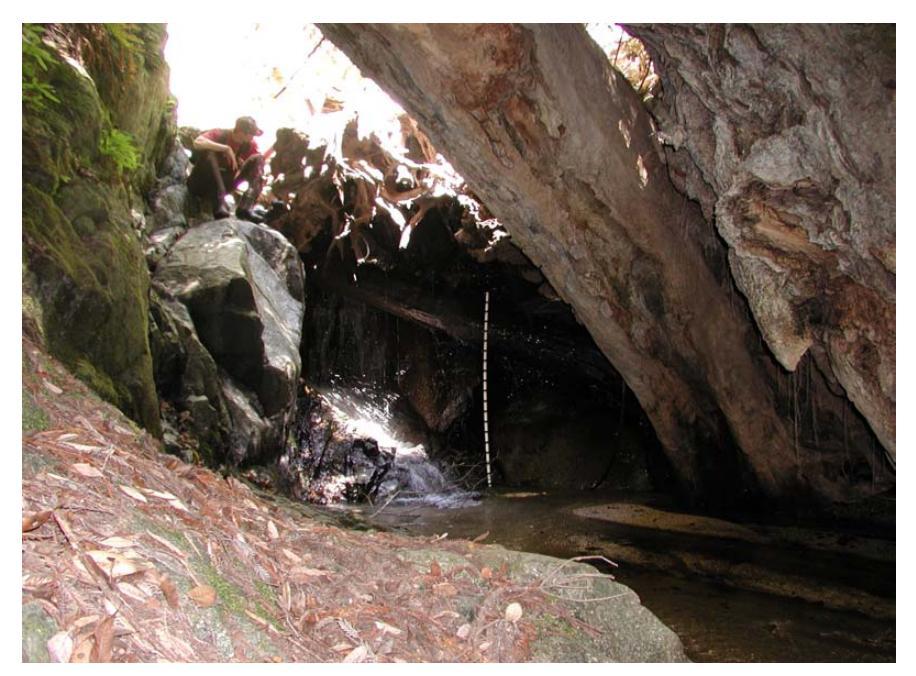
Figure 5.9 Structure gb08 looking upstream. Note accumulated sediment at downstream side. Photo: Joel Casagrande 12 September 2004.

At present, no modifications should be made to this structure due to high efforts, cost, and threat to downstream habitat – See Section 8: Structure Prioritization.

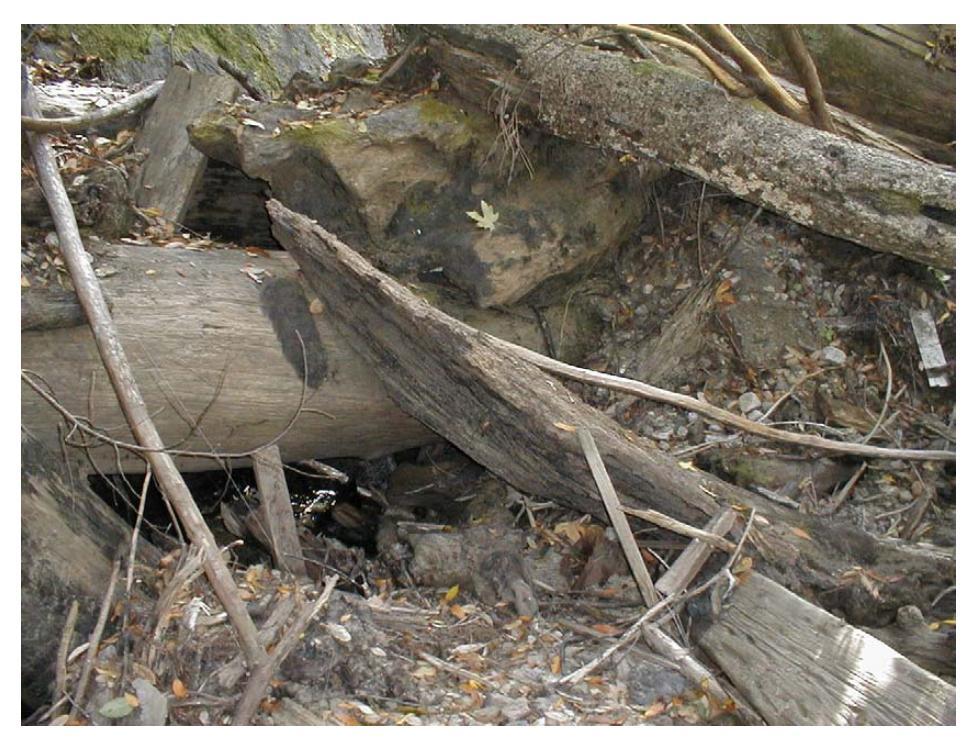
Figure 5.10 Structure gb09 looking downstream from the backside of the barrier. Photo: Joel Casagrande 12 September 2004.

Currently poor habitat upstream therefore improvement may not be warranted. Starting at the upstream extent of the debris pile, remove small and medium sized woody debris by hand out of the channel. Cut larger logs that are attracting and accumulating material. A small amount of woody debris was removed in the field; more must be removed in order to increase access.

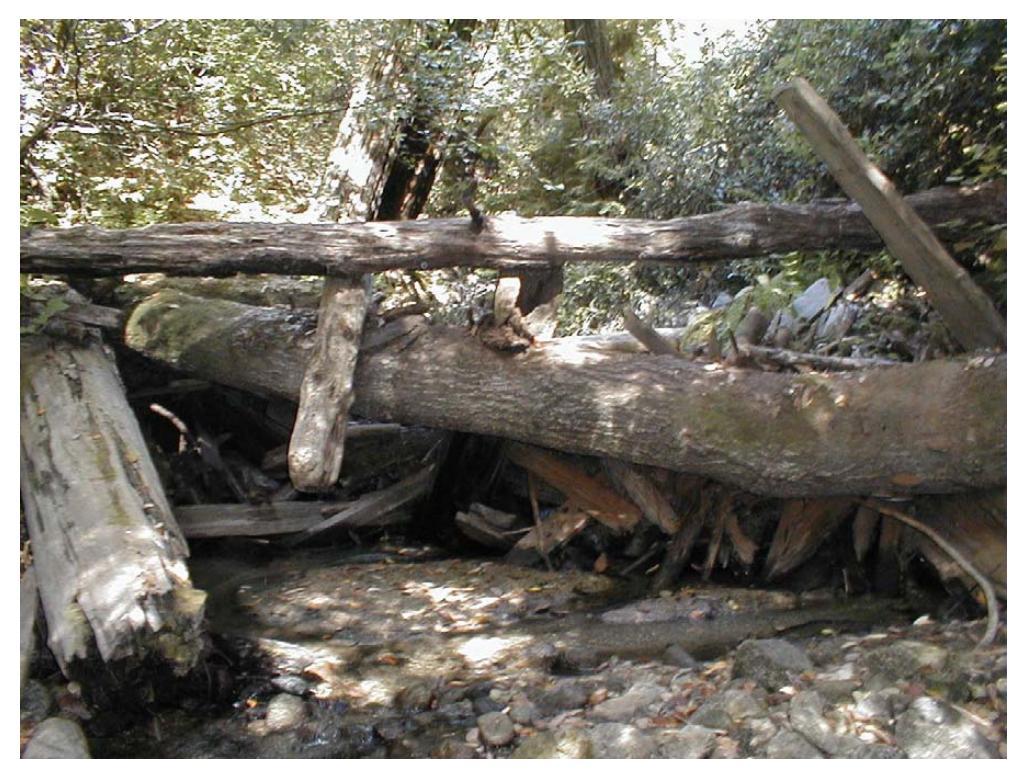
Figure 5.11 Structure gb10 looking upstream. Photo: Joel Casagrande 12 September 2004

Clear small woody debris from the base of the larger tanoak log crossing the channel. This would improve conditions enough for suitable access, however material will likely clog again in the future. To avoid this, use a hand or chain saw to cut the large tanoak log into smaller pieces. Leave log shown along left side of Fig. 5.11 in place as habitat.

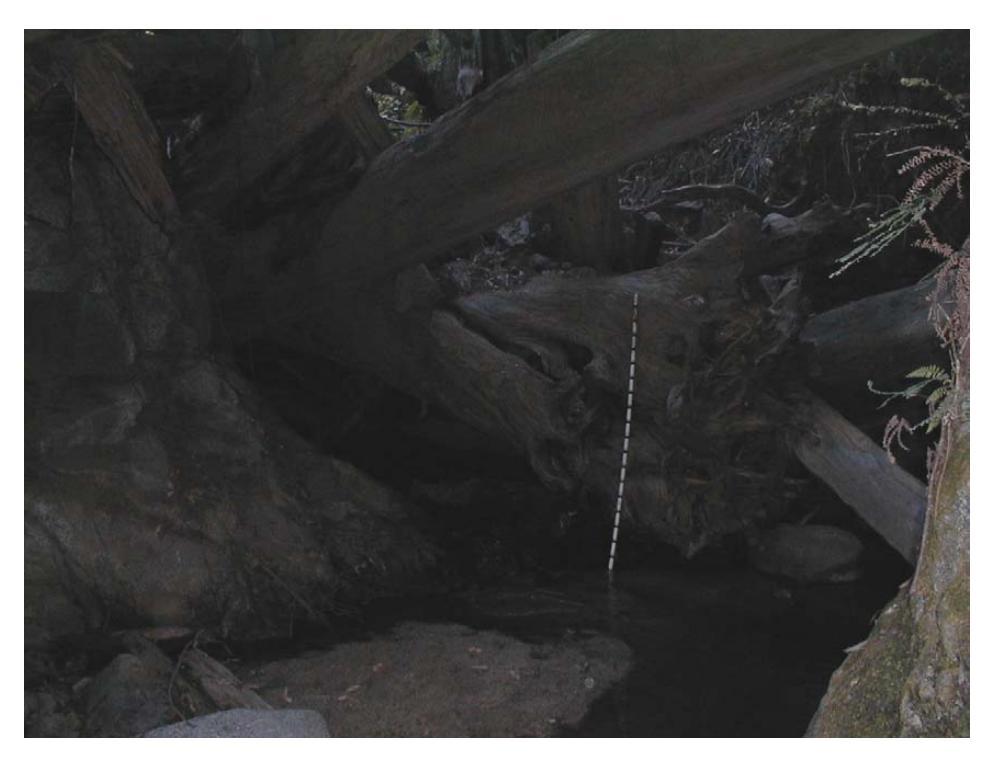
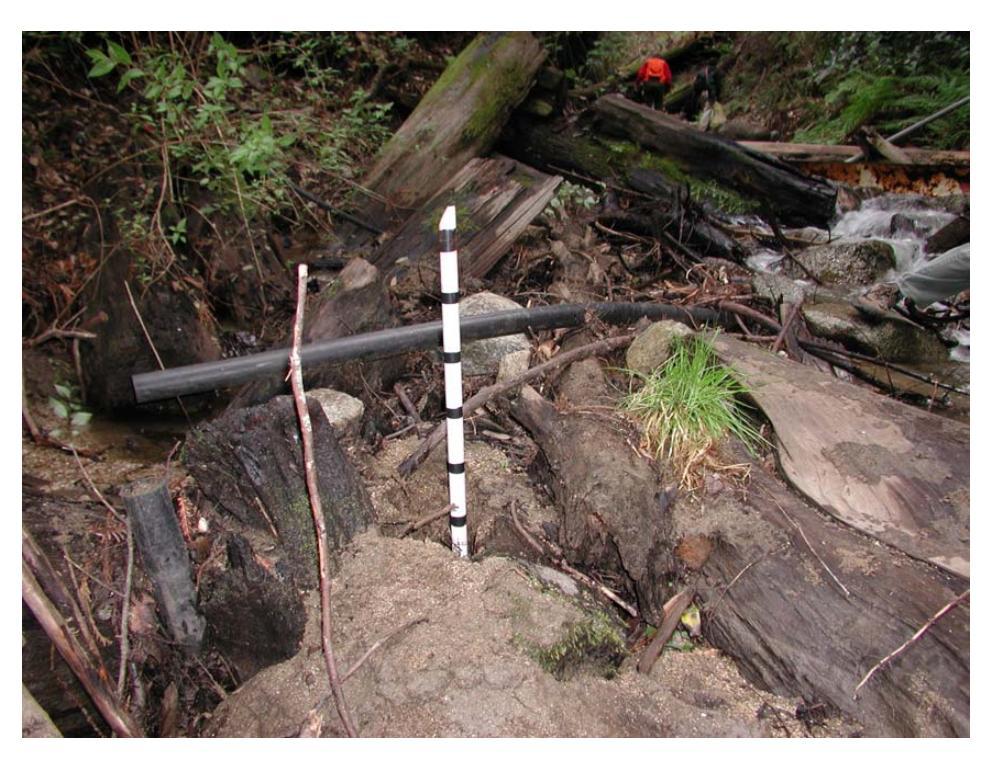
Figure 5.12 Structure gb11 looking upstream along left bank. Photo: Joel Casagrande 12 September 2004.

Figure 5.13 Sediment accumulation at structure gb11. This 2 m staff was driven 1.5 m into the bed approximately 5 m upstream of the logjam. Photo: Joel Casagrande 30 March 2004.

Several suggestions have been made on how to best improve this strucutre. One was to install two smaller structures downstream of the present barrier. This would create three smaller, more passable jumps as opposed to one large jump at the present barrier. Logs and other materials to create these structures would be taken from the present barrier and anchored into the channel with cables. Members of the project's Technical Advisory Committee (TAC), and the representative from CDFG, did not fully accept the idea of adding more structures to the stream. This site is likely prone to having debris jams on a natural cycle due to the confined nature of the channel reach. If this barrier were removed or enhanced, it is likely that a new strucutre would form in the future. Also, the upper banks are steep and inaccessible to heavy machinery that would be needed to construct these structures effectively. In addition, there is a substantial volume of sediment stored behind this structure. Any significant modification of the present logjam would likely release an adverse amount of fine sediment downstream, thus jeapordizing current spawning habitat downstream in the watershed. The TAC and CDFG would like to focus efforts on evaluting logjams and debris obstacles downstream of this barrier and finding the source of this decomposed granite farther up in the watershed.

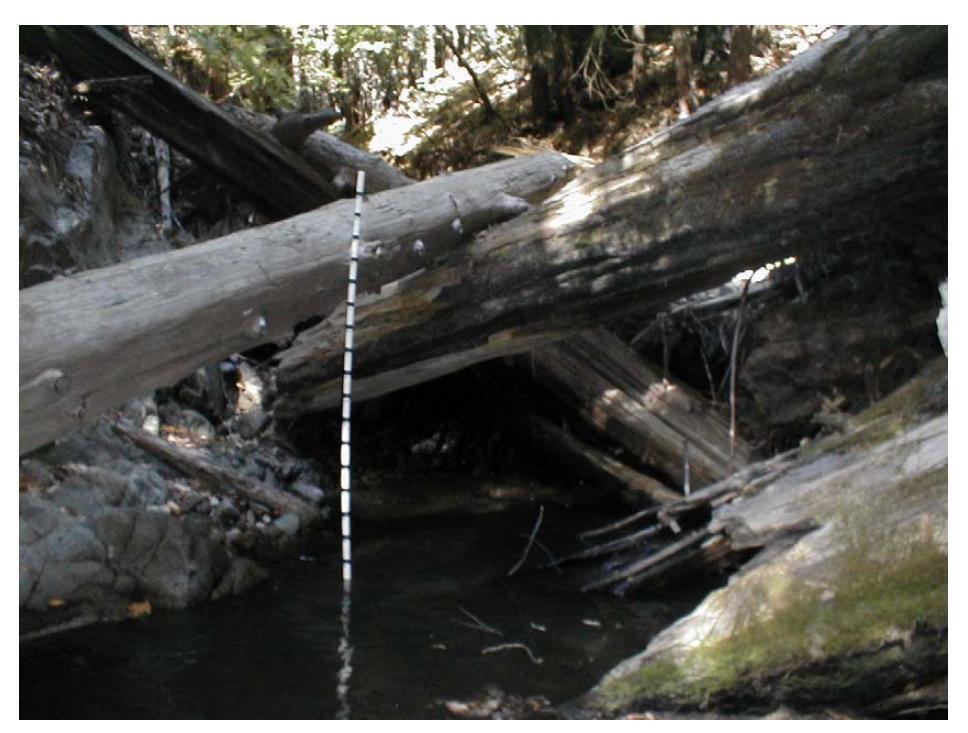
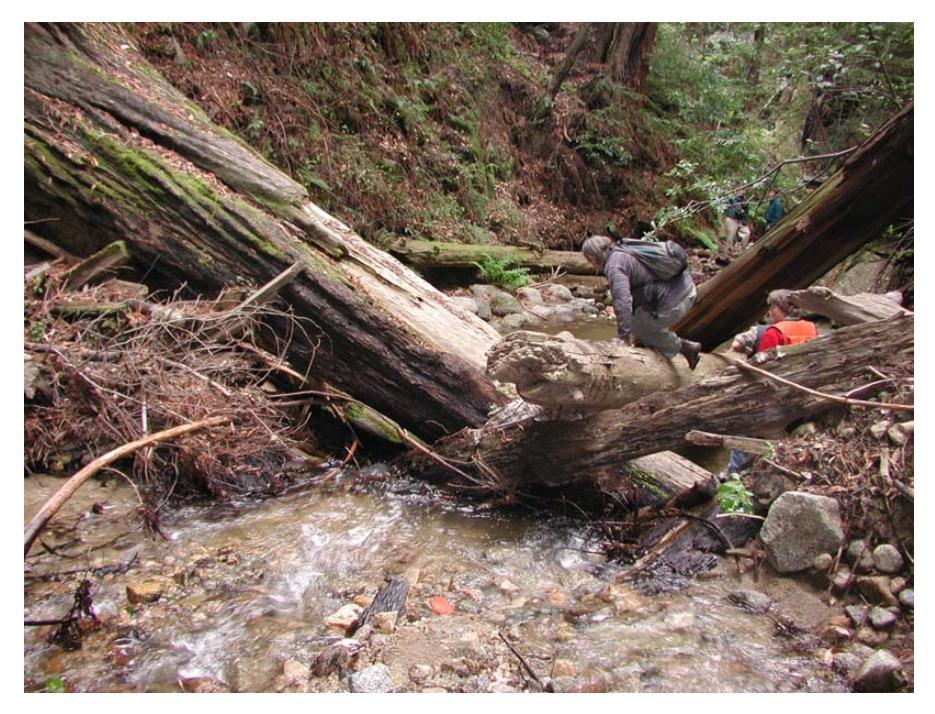
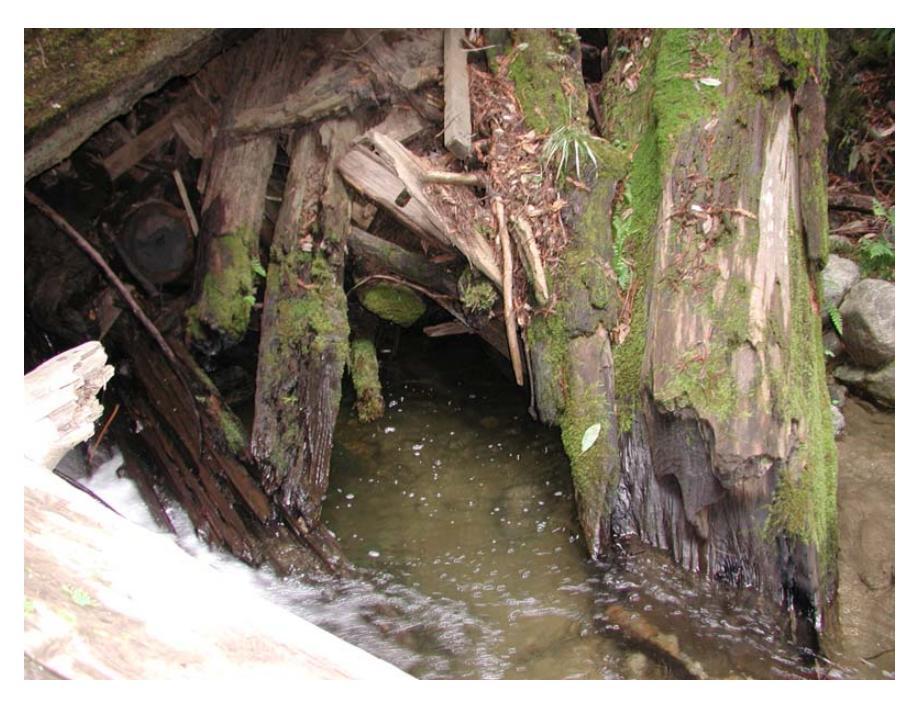
Figure 5.14 Structure gb012 looking upstream. Photo: Joel Casagrande 12 September 2004.

Figure 5.15 Structure gb12 looking downstream from upstream of the barrier. Photo: Joel Casagrande 30 March 2004.

Figure 5.16 Structure gb12 looking towards the left bank showing complex pool conditions downstream of the logjam. Photo: Joel Casagrande 30 March 2004.

Remove small and medium sized woody debris from the backside of the logjam. This would increase the opening along the left bank and possibly allow for transport of accumulated coarse substrate, therefore equilibrating the difference in bed elevations.

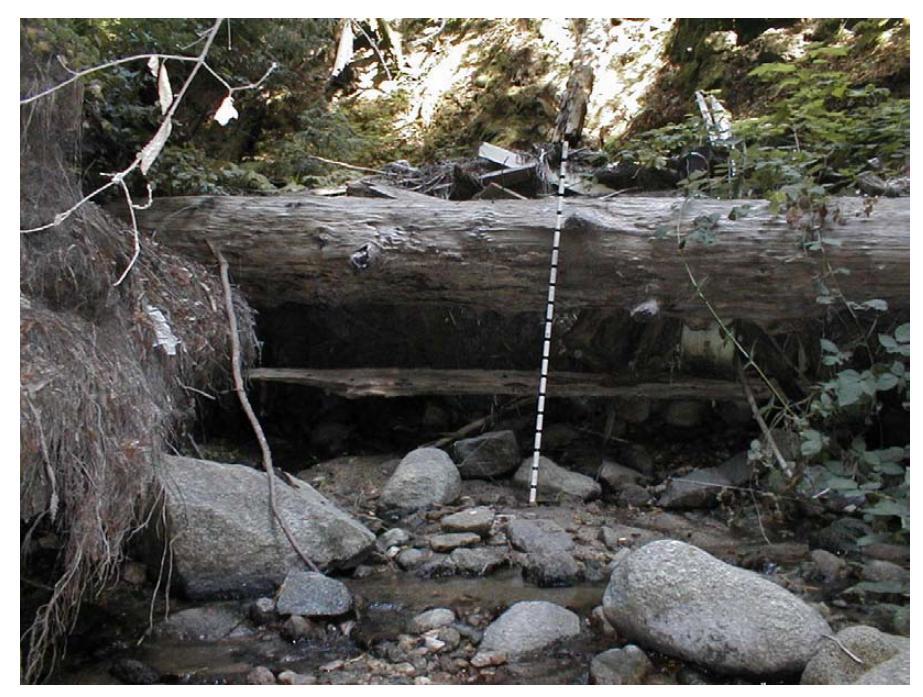
Figure 5.17 Structure gb13 looking upstream. Photo: Joel Casagrande 12 September 2004.

Starting upstream, remove all small and medium sized woody debris out of the channel. Cut a section from the middle of the main log and remove from the channel, leaving the ends along the bank as habitat features. There is a road adjacent to the left bank that could be used to transport woody material.

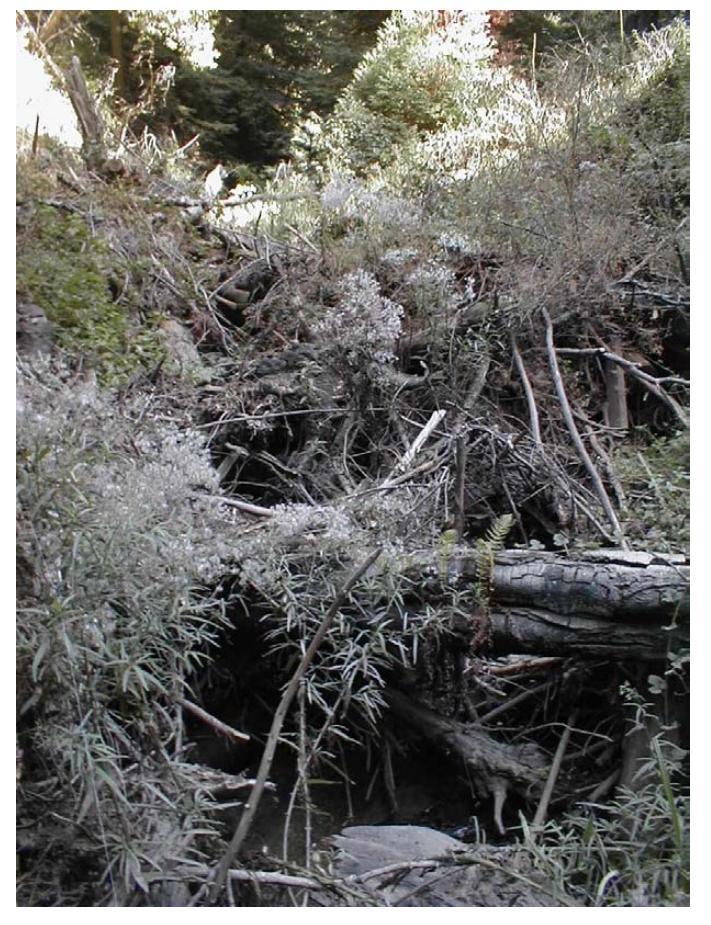
Figure 5.18 Structure gb14. This picture, taken from standing on top and looking upstream, shows approximately half of the logjam present at this site. Photo: Joel Casagrande 12 September 2004.

To increase habitat for resident trout, clear small and medium sized woody debris by hand from the channel. The road adjacent on the left bank could be used to transport the material to an appropriate disposal site. Larger pieces can be left in the channel as habitat complexity as long as they are not likely to cause a future logjam.

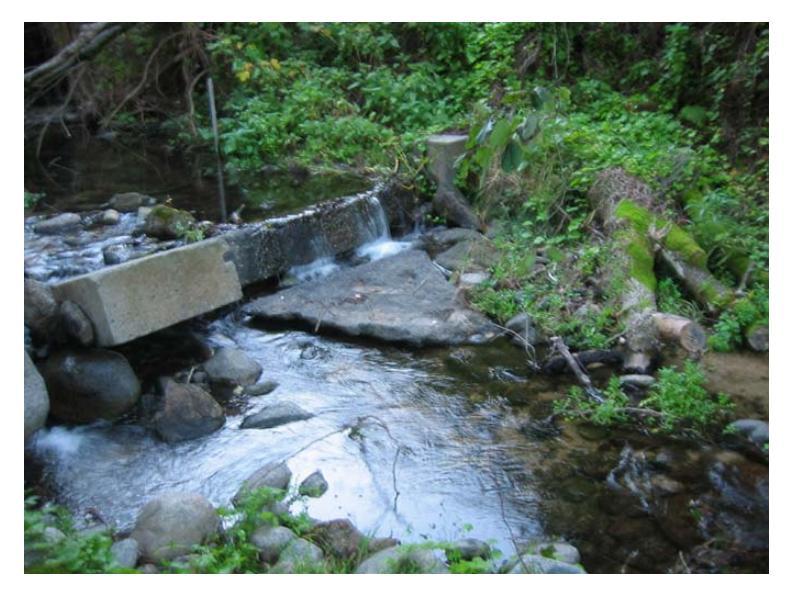
Figure 5.19 Concrete slab/apron on lower Garrapata Creek. Photo: Ken Ekelund, December 1, 2004.

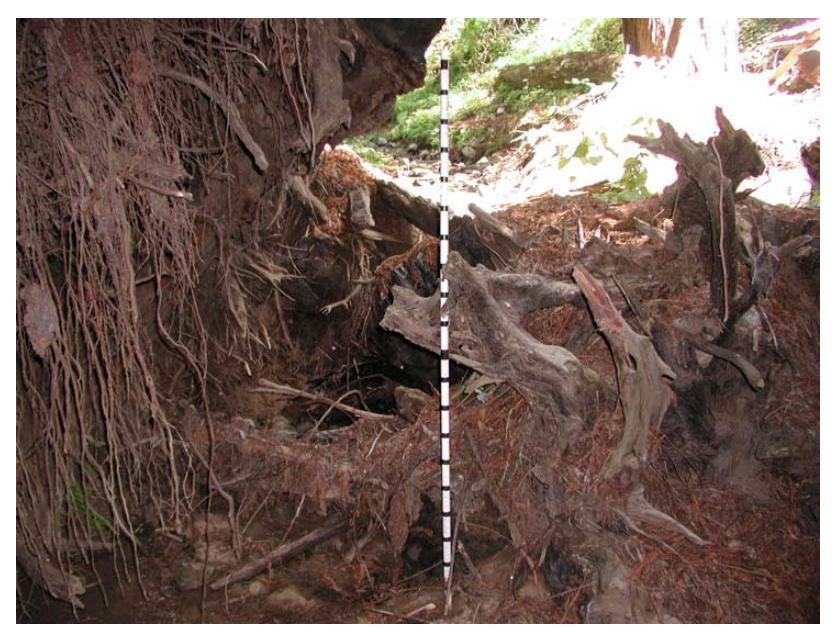
Figure 6.1 Structure jb01 looking upstream along left bank. Photo: Joel Casagrande 2 June 2004.

Remove small and medium sized woody debris that has accumulated upstream. Improve a path along both the right and left banks by cutting larger logs. Leave largest log and rootwad in place as habitat.

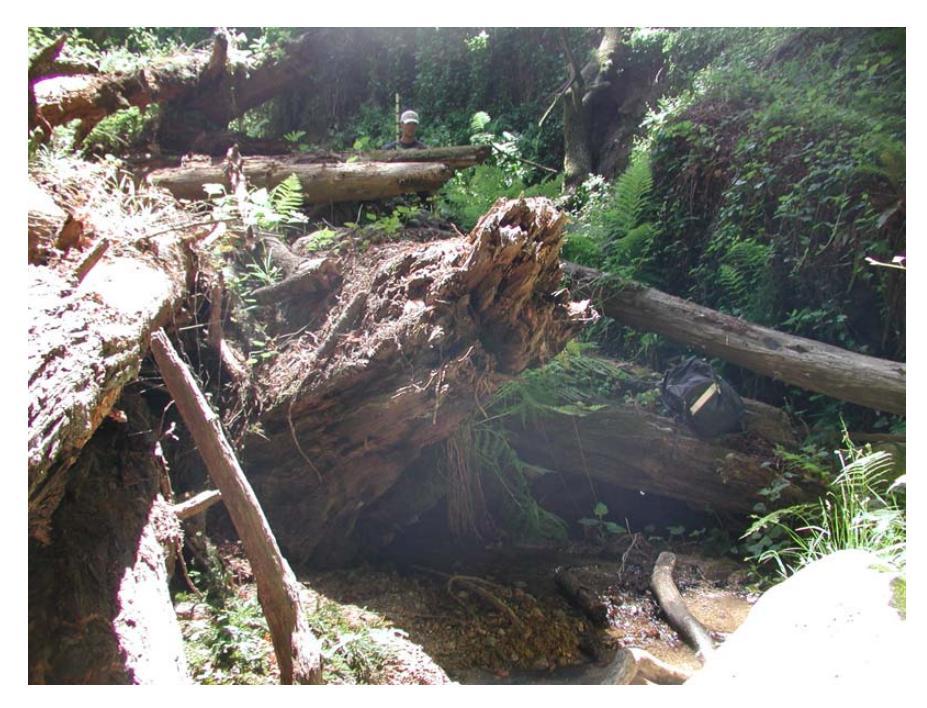
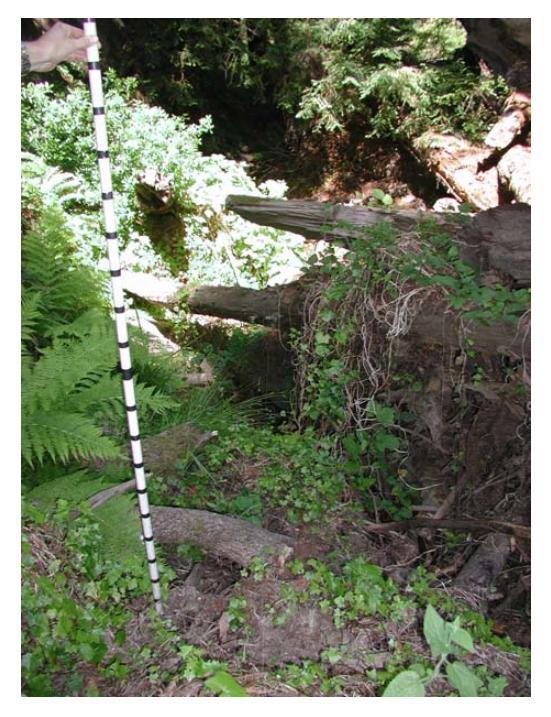
Figure 6.7 Structure jb05 looking upstream. Backpack is directly in front of the left bank path. Photo: Joel Casagrande 3 June 2004

Figure 6.8 Structure jb05 looking downstream from upstream along the left bank. Photo: Joel Casagrande, 3 June 2004.

A clear path free of jumps and debris should be created along the left bank. Several medium to large sized logs should be notched along the left bank of the channel.

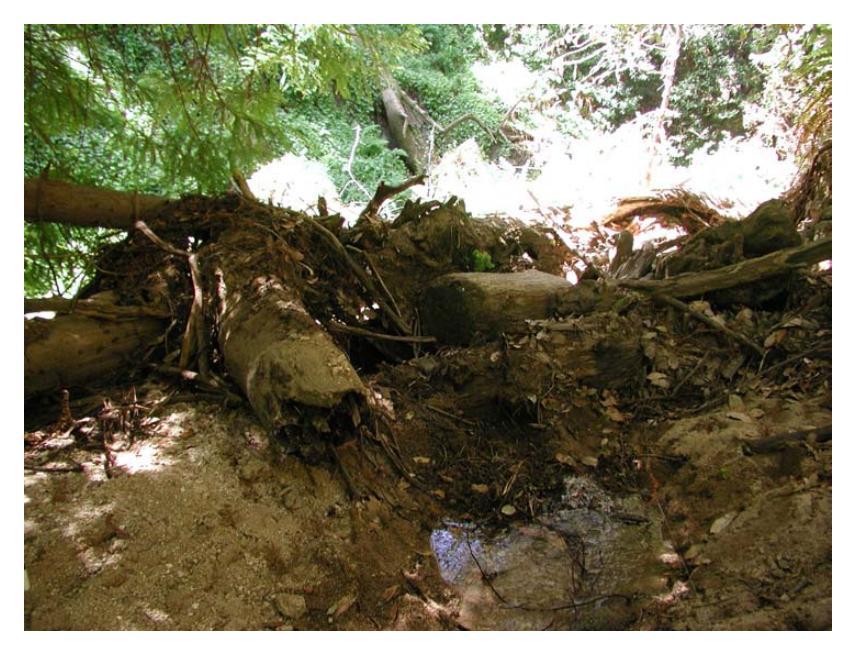
Figure 6.9 Structure jb06 looking downstream from upstream side. Note accumulated sediments. Photo: Joel Casagrande 3 June 2004.

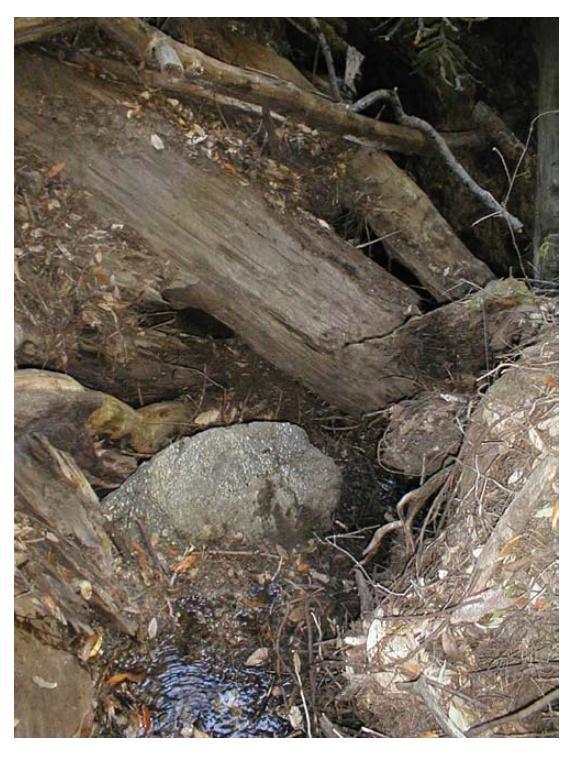
Figure 7.2 Structure b01 looking downstream after small woody debris was removed. Larger logs at center should be cut to prevent future clogging. Photo: Joel Casagrande 12 September 2004.

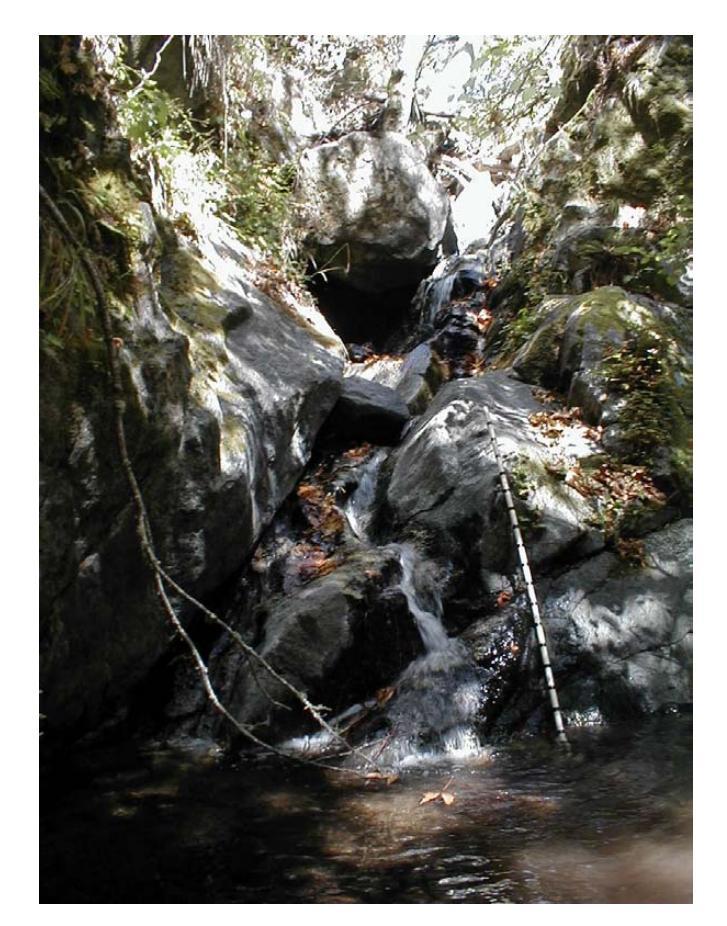
Figure 7.5 This waterfall cascade complex (~ 8 m high) is a steep natural barrier to adult steelhead migration. Note the 2-meter staff at right for scale. Photo: Joel Casagrande, 12 September 2004.
[Page intentionally left blank]

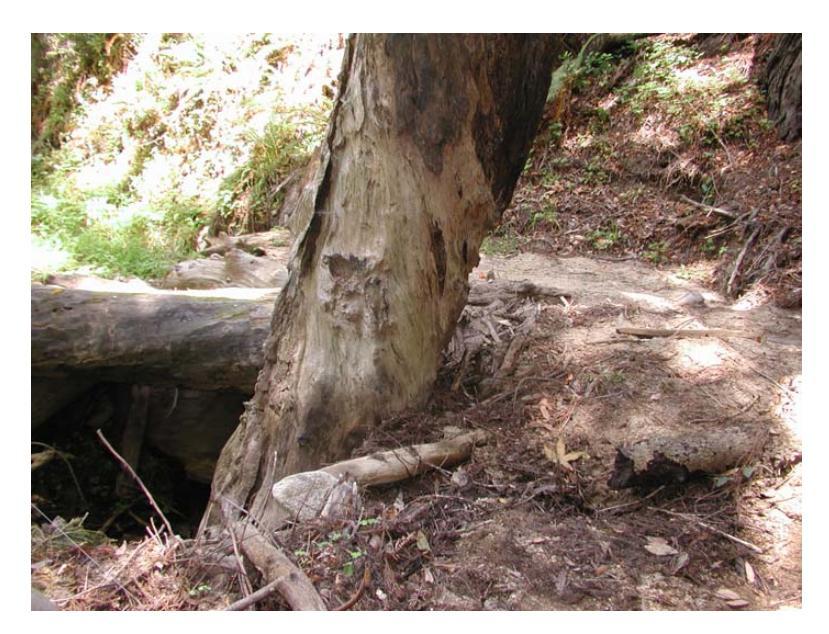
Figure 8.1 Significant sediment accumulation at Structure jb09. The upstream side is shown on the right and the downstream side is shown at left. The height of the structure approximately 2.0 m above the downstream channel and sediment is backed up for several meters. Photo: Joel Casagrande 3 June 2004.

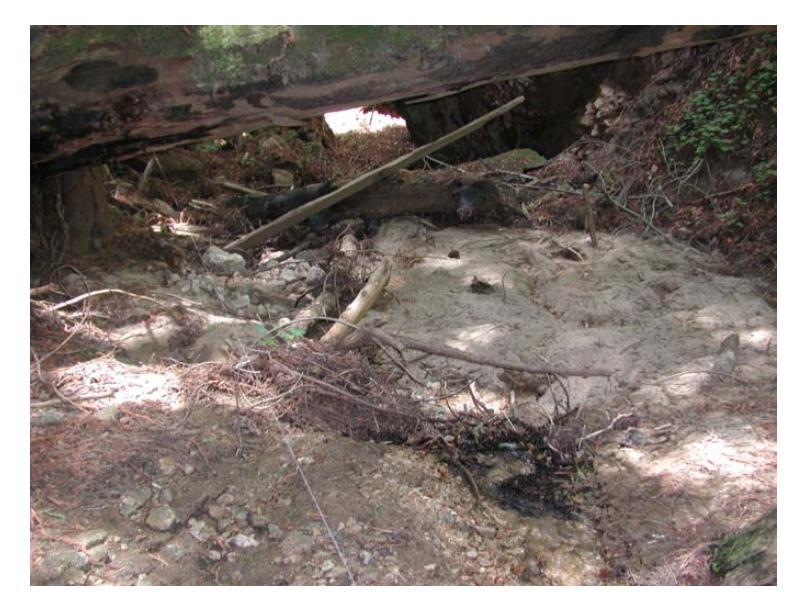
Figure 8.2 Fine Sediment accumulation behind Structure jb07 (looking downstream from upstream of the logjam). Here summer flow percolates into the accumulated sands 2–3 m upstream of the logjam (bottom/center of picture) and seeps out at the downstream base of the logjam. Photo: Joel Casagrande 3 June 2004.

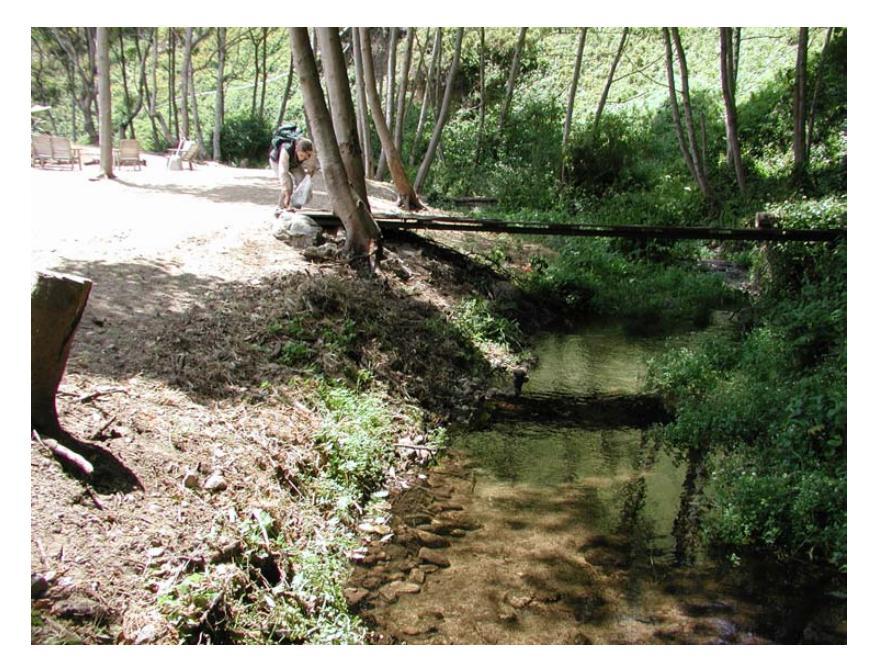
Figure 9.1 Unprotected banks in lower Garrapata Creek. This photo was taken looking upstream at about the midpoint of the entire bare reach. Photo: Joel Casagrande 1 July 2004.

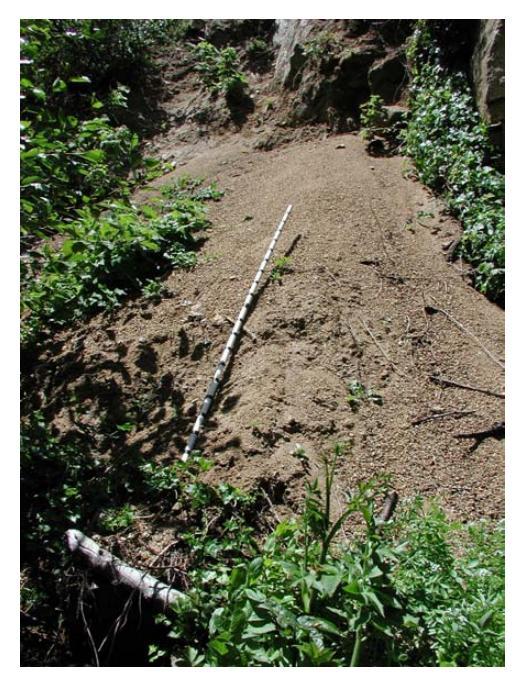
Figure 9.2 Small landslide in lower Garrapata Creek. The staff shown is 2 meters in length. Photo: Joel Casagrande 2 June 2004.

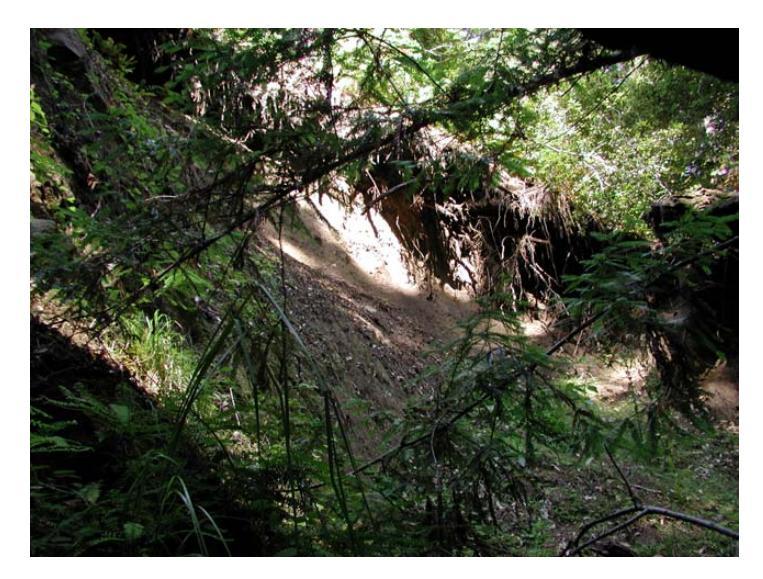
Figure 9.4 Significant bank scour above structure gb04. The current streamflow is obscured by foliage in the lower right corner of the photo. Photo: Joel Casagrande 11 August 2004.

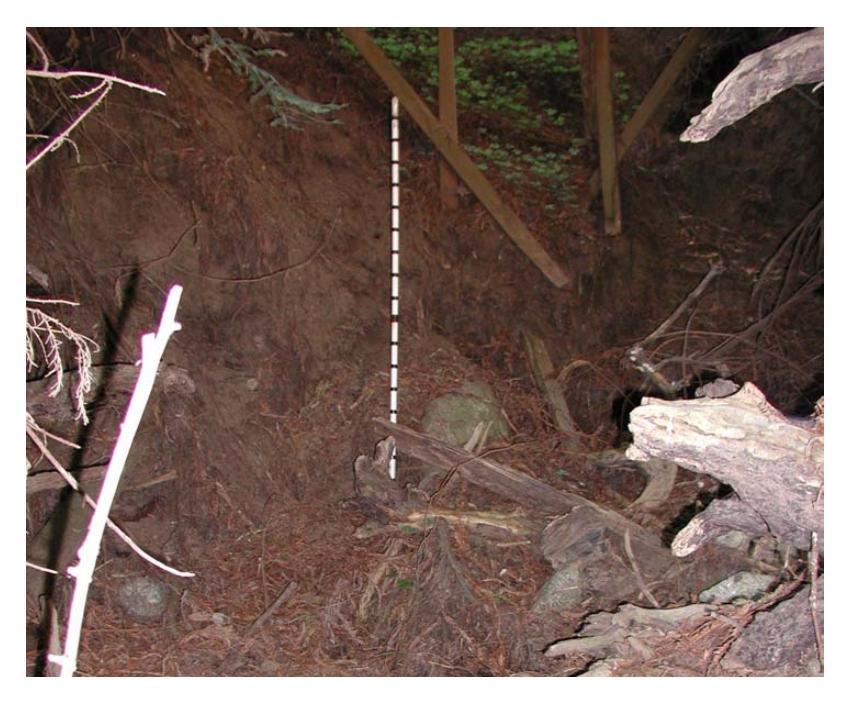
Figure 9.5 Exposed rootwad along the right bank at Structure jb01. Wood buttresses in background appeared to be becoming exposed due to bank scour. Photo: Joel Casagrande 02 June 2004.

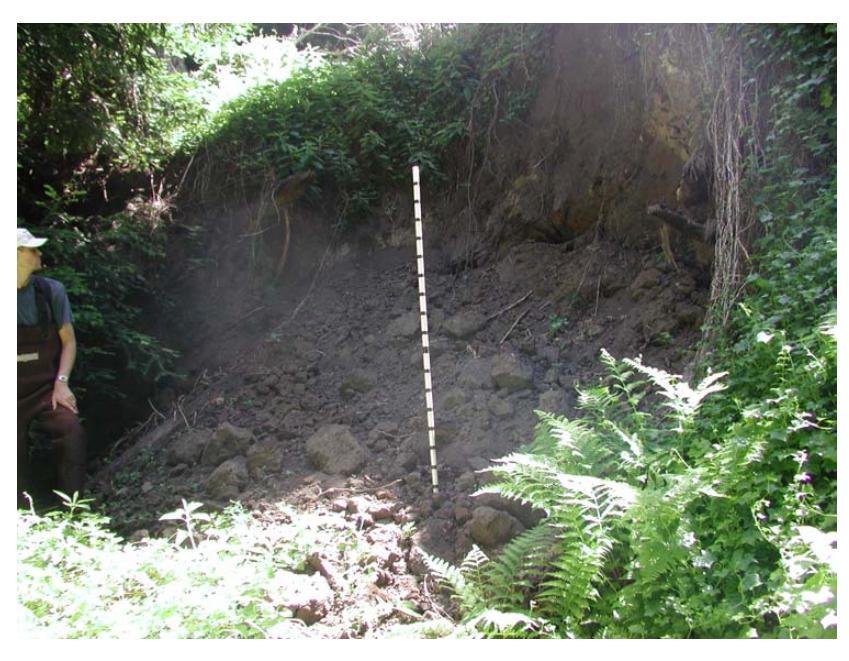
Figure 9.6 This bank failure in Joshua Creek is currently contributing sand-sized material to Joshua Creek. Photo: Joel Casagrande 3 June 2004.

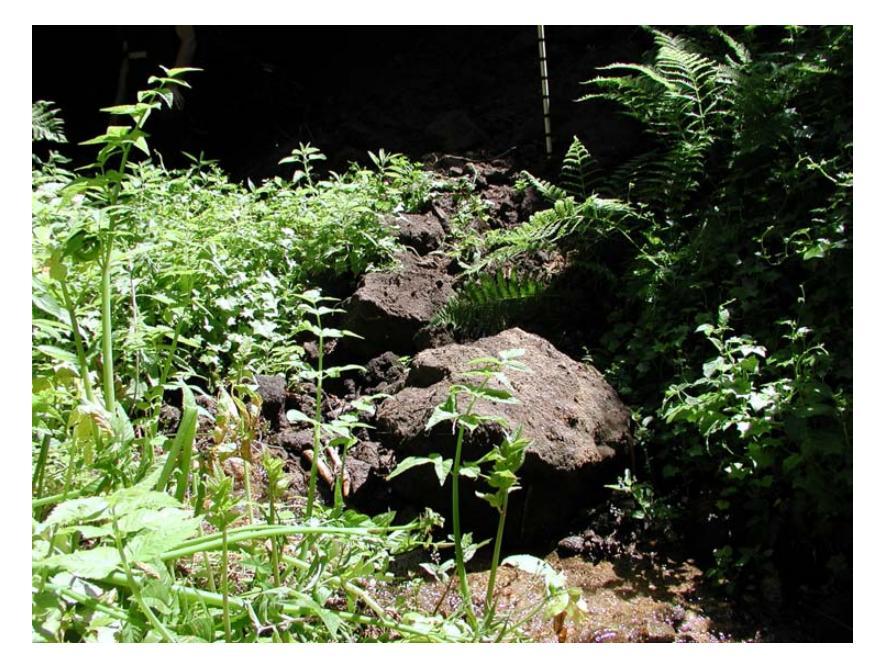
Figure 9.7 The toe of the failed bank with large clusters of sand that have recently fell into the wetted stream channel. Note young vegetation growing suggesting this is an active and recent slide. Photo: Joel Casagrande 3 June 2004.
