Report No. WI-2015-01 15 January 2015

January 2014 Aquatic Habitat Assessment on San Jose and Potrero Creeks, Santa Lucia Preserve, Monterey

County, California

Chelsea Neill Sheldon Leiker Douglas Smith (Ph.D.)

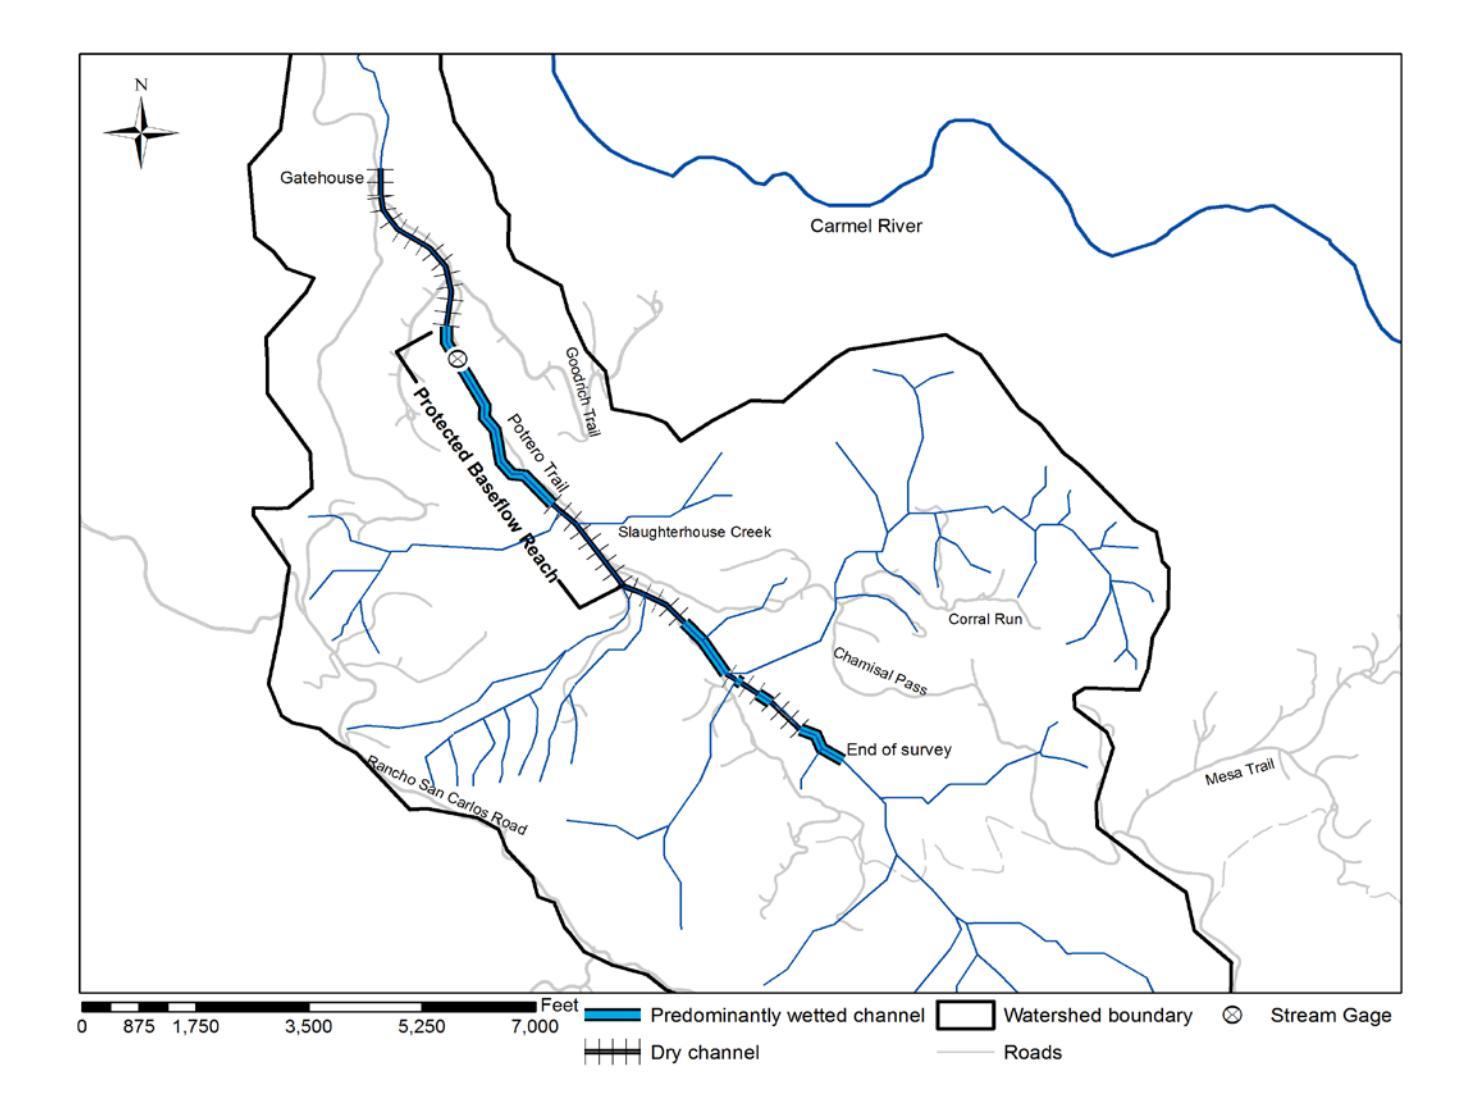
Figure 2: Map of generalized flow conditions on Potrero Creek on September 13, 2013. There was continuous surface flow throughout the mid to lower portion of the "Protected Baseflow Reach." Downstream of the "Protected Baseflow Reach" the channel was dry. The upper reach was mainly dry with intermittent surface flow.

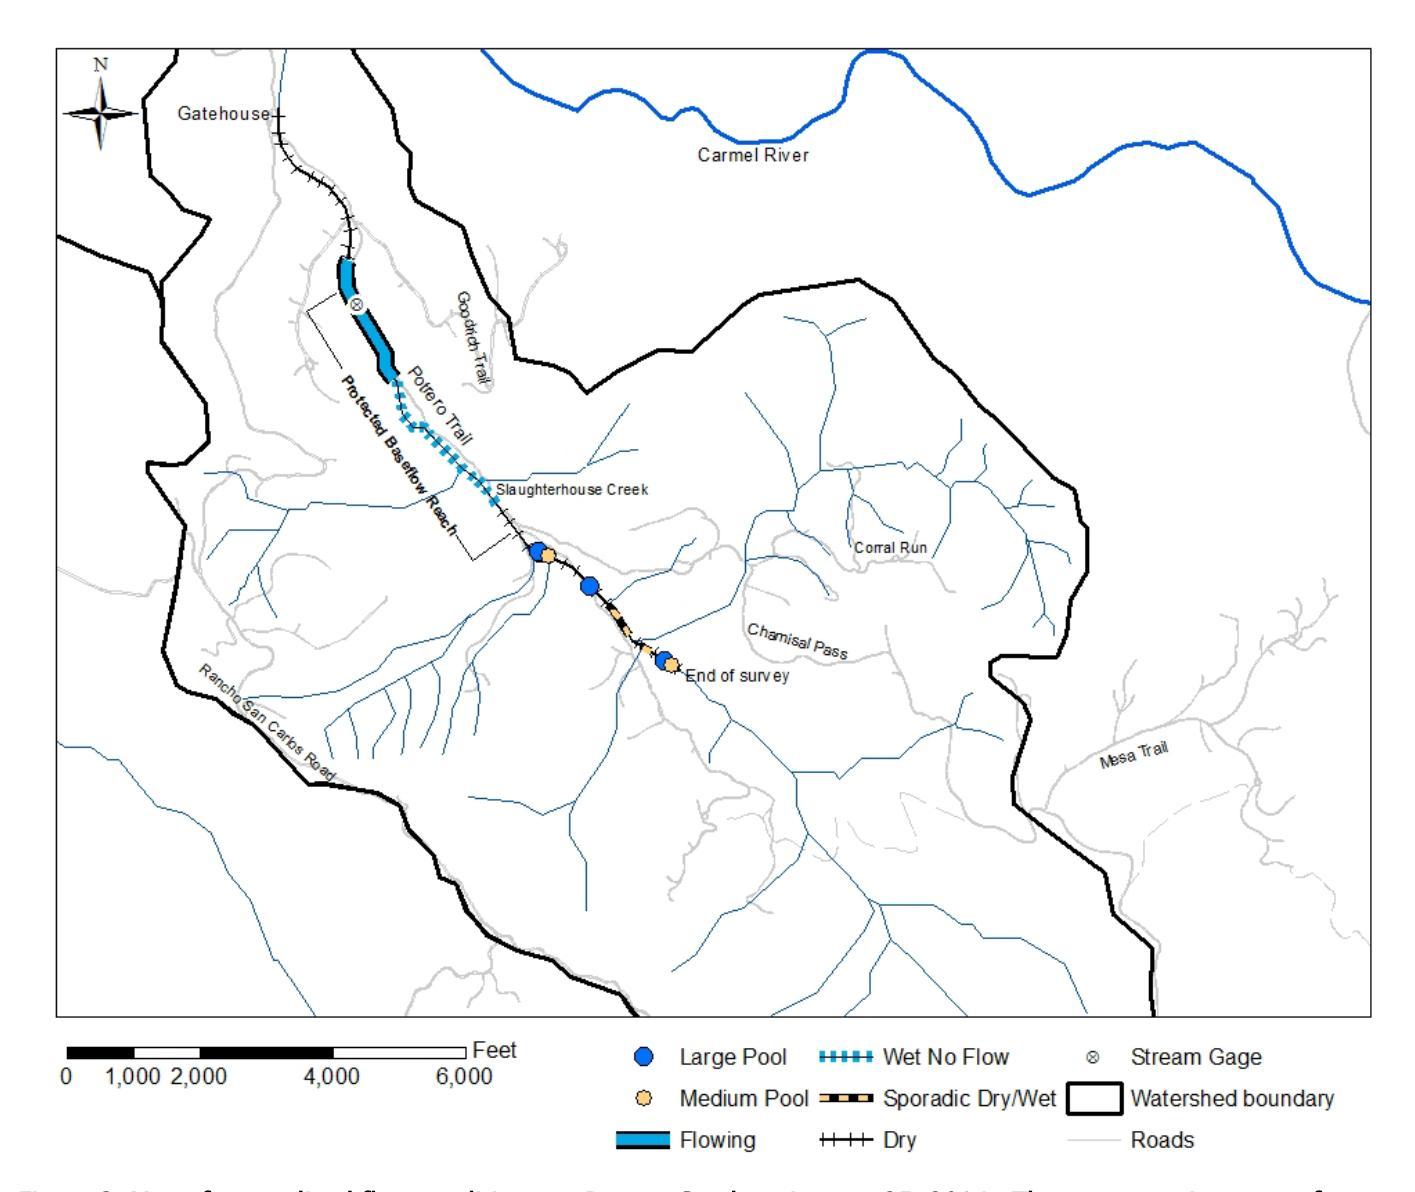
The Potrero Creek baseflow survey was conducted on September 13, 2013 and the drought conditions survey was conducted on January 25, 2014. The survey extended from the SLP gatehouse to Potrero Trail Bridge crossing (Figure 2 and 3). In both September and January the creek was dry downstream of the "Protected Baseflow Reach". In both surveys there was water present in the mid to lower section of the "Protected Baseflow Reach" while the upper portion was dry. Areas that had a predominantly wetted channel upstream of the "Protected Baseflow Reach" in September were characterized by pools and areas of sporadic wet and dry in January. In January many of the pools in the upper reach were murky and had poor visual water quality. In general there was less surface flow and water present in January 2014 than in September 2013.

Figure 3: Map of generalized flow conditions on Potrero Creek on January 25, 2014. There was continuous surface flow throughout the lower portion of the "Protected Baseflow Reach" and the channel was wet with no visible flow in the mid to upper portion of the "Protected Baseflow Reach". Downstream of the "Protected Baseflow Reach" the channel was dry. The upper reach was mainly dry with sporadic wet areas and pools.

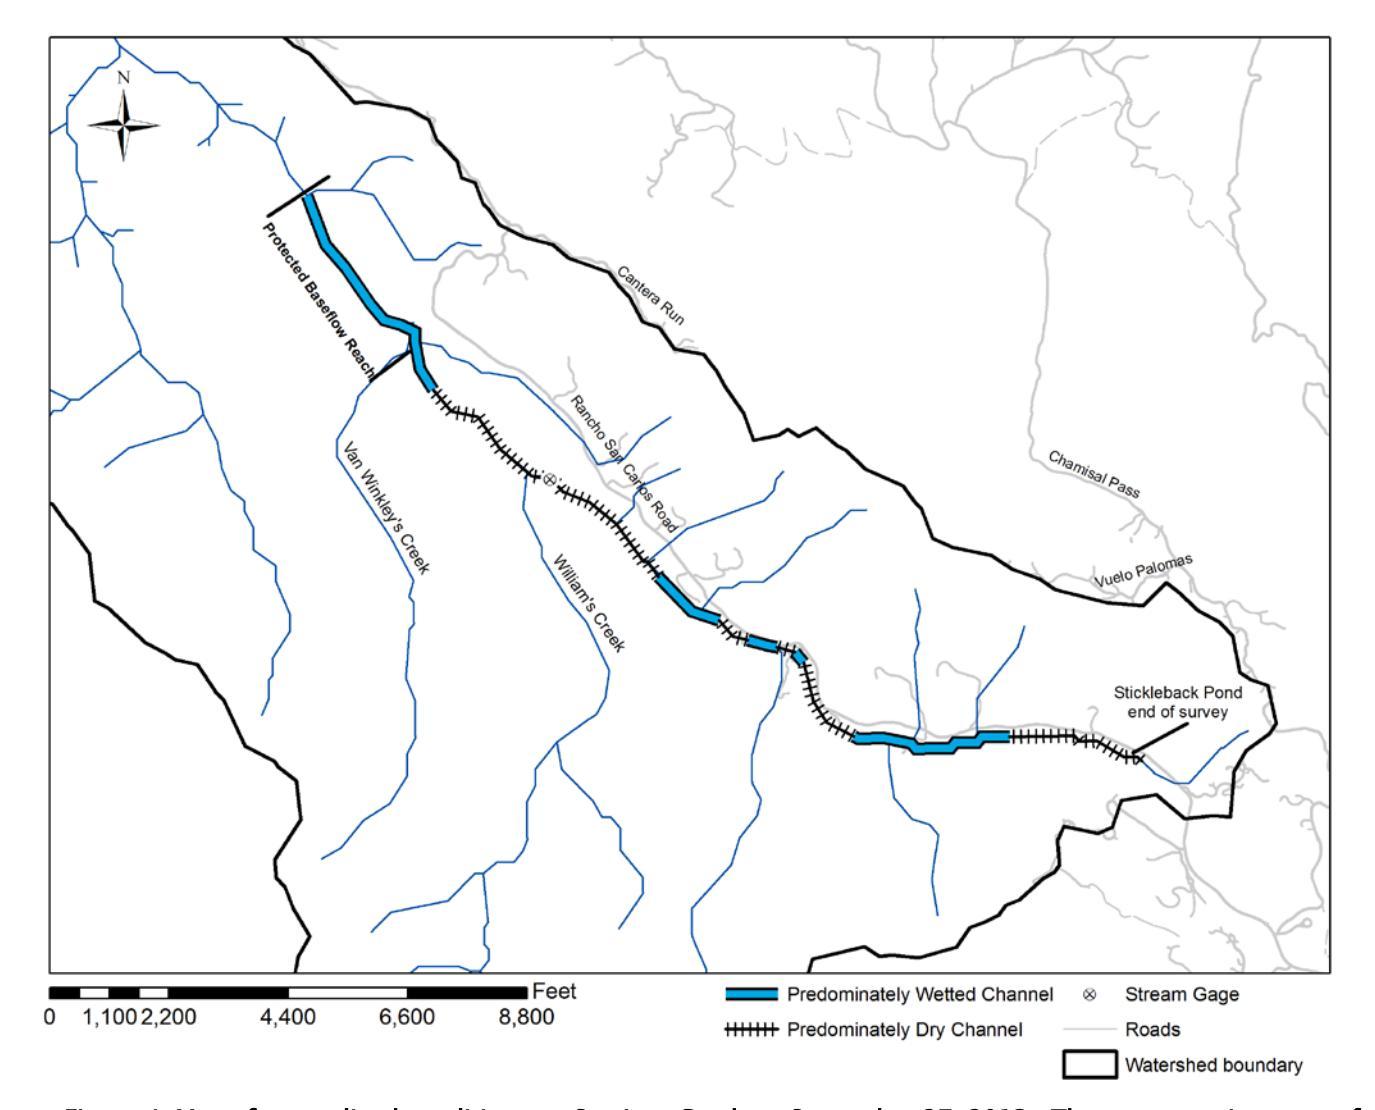
Figure 4: Map of generalized conditions on San Jose Creek on September 27, 2013. There was continuous surface flow in the "Protected Baseflow Reach" and dry conditions for the remainder of the surveyed reach with intermittent surface flow.

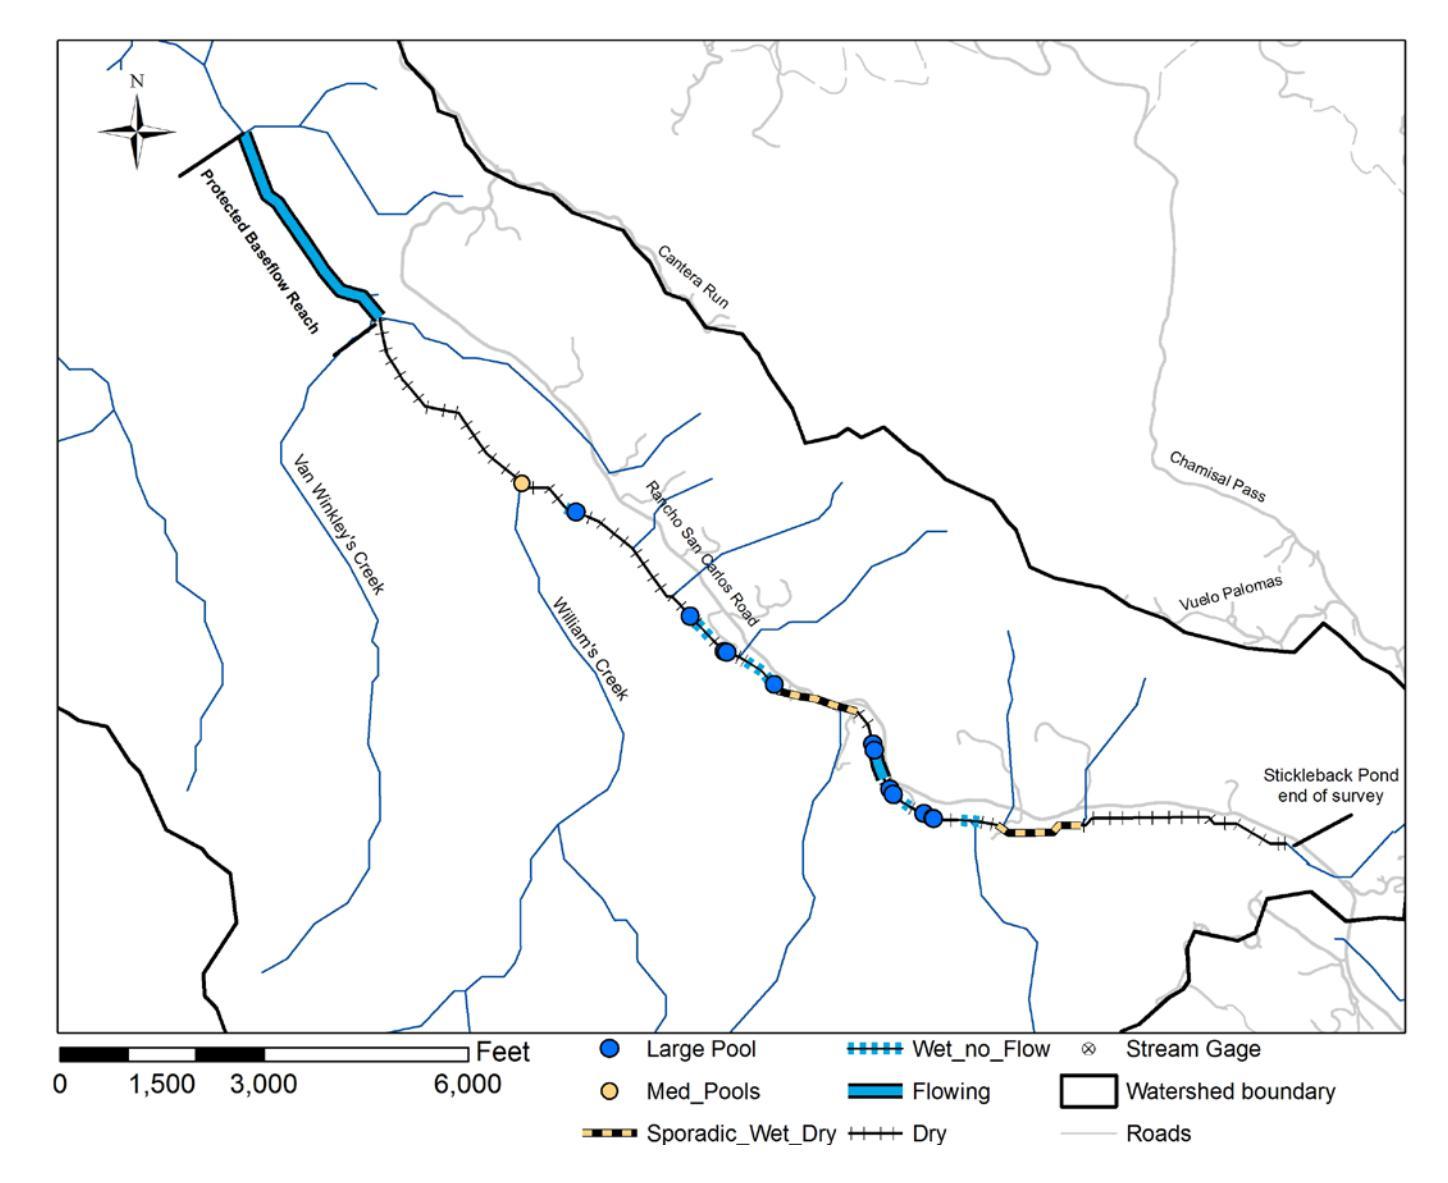
The San Jose Creek baseflow survey was conducted on September 27, 2013 and the drought conditions survey was conducted on January 24, 2014. The survey began at the SLP property line and extended upstream to Stickleback Pond (Figure 4 and 5). In both September and January there was continuous surface flow in the "Protected Baseflow Reach". Areas that had a predominantly wetted channel upstream of the "Protected Baseflow Reach" in September were characterized by pools and areas of sporadic wet and dry in January. In general there was less surface flow and water present in January 2014 than in September 2013.

Figure 5: Map of generalized flow conditions on San Jose Creek on January 24, 2014. There was continuous surface flow throughout the lower portion of the "Protected Baseflow Reach". The channel was dry through the middle of the reach, and sporadically wet and dry with some pools in the upper portion of the reach.
