Report No. WI-2016-16
23 December 2016

2016 Photo Monitoring

Santa Lucia Preserve,
Monterey County, California

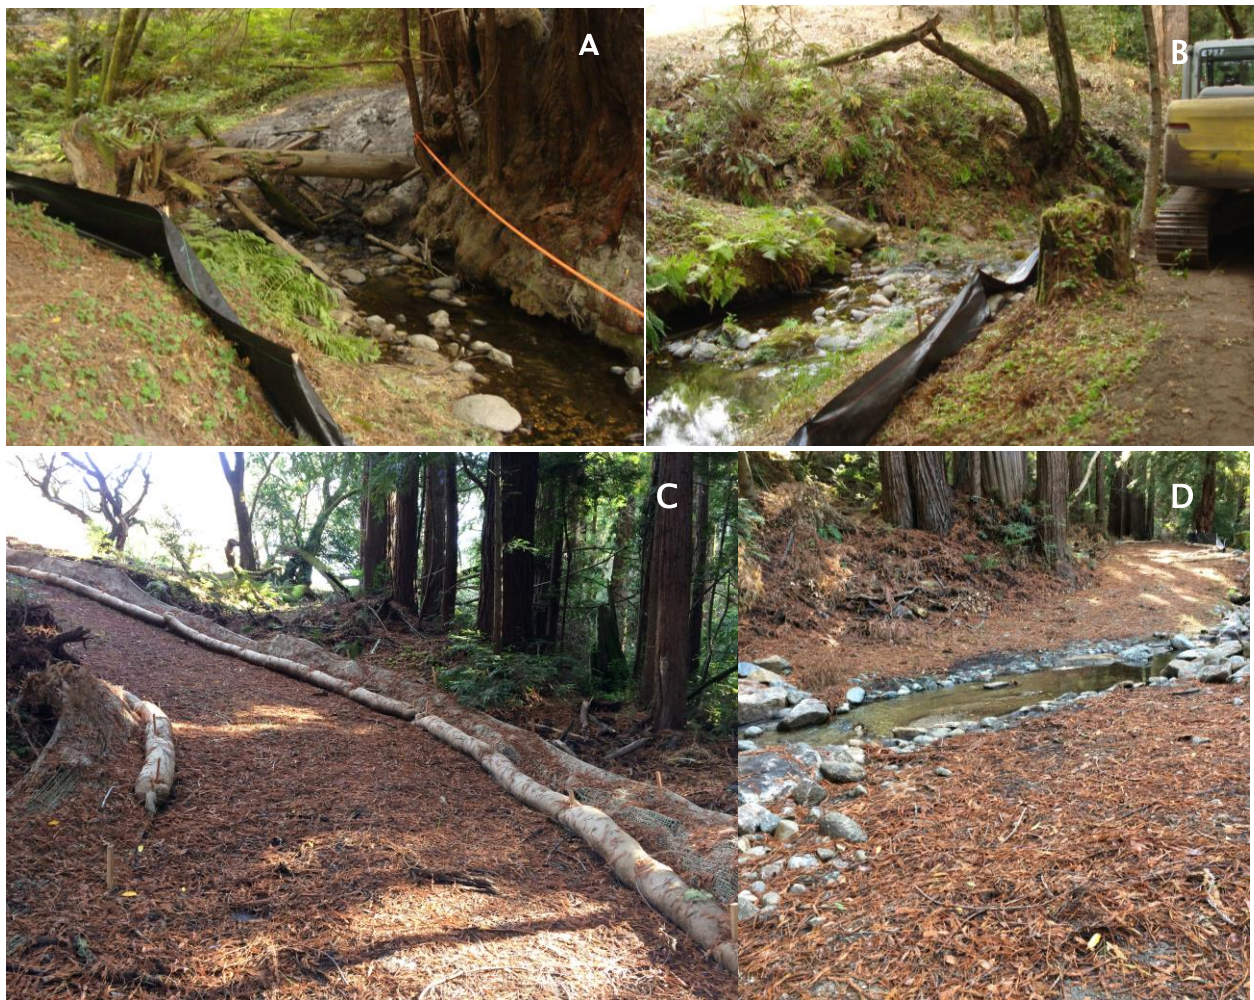
The Soberanes Fire started in late July 2016 by an unattended campfire on Soberanes Canyon Trail in Garrapata State Park. The fire burned a total of 206 square miles and crossed into the Carmel Watershed in early August. The SLP was widely burned by both wildfire and backfires, and was also a major center for fire-fighting and containment activities. Containment work involved cutting many miles of firebreaks along the watershed slopes and across rivers. San Jose Creek was subject to a controlled burn and was a staging area for firefighters (Figure 2, A & B). These

Figure 2. Bulldozer fire break impacts on the banks of San Jose Creek. A & B are before the bulldozer impacts were mitigated. Photos C & D show the fire break after the site was regraded and repaired. Photos taken from a single location on a trail looking away from the stream (C) and across the stream (D).

fire-related disturbances have the potential to impact stream water quality and channel morphology (Merrill and Casaday 2003). Best management practices, including placing locally-sourced boulders to reestablish the low-flow channel, have been employed after the evacuation of heavy equipment and firefighting efforts in the SLP (Figure 2, C & D). The goal of this report is to continue a baseline data set for photo monitoring to capture future impacts of the fire such as erosion, deposition and debris flows. The most recent photo monitoring images (taken in November 2016) are compared to both the oldest available corresponding images and the most recent previous photos taken in August 2014. All additional historical photographs of the SLP beginning in 1998 are available in the SLC office and in Paddock et al. (2011).

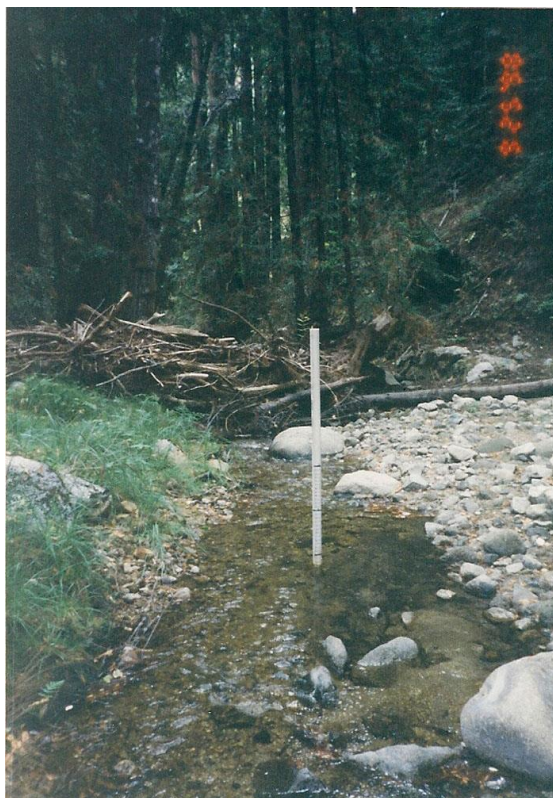
San Clemente has more cobbles and boulders visible in the channel and floodplain in 2016 than in 1998 in both upstream and downstream views. The physical rearrangement of boulders in the photos indicates that large particles have been transported into place as well as being exhumed by the removal of finer sediment deposits. In 1998 there was a woody debris accumulation across the channel. In 2016 the debris has accumulated a bit further upstream. In the upstream view, the bar on the left bank, at the base of the downed Redwood tree, has stabilized and grown over with grassy vegetation (Figures 3–6).

Figure 3: Downstream view of San Clemente Creek in March 1998

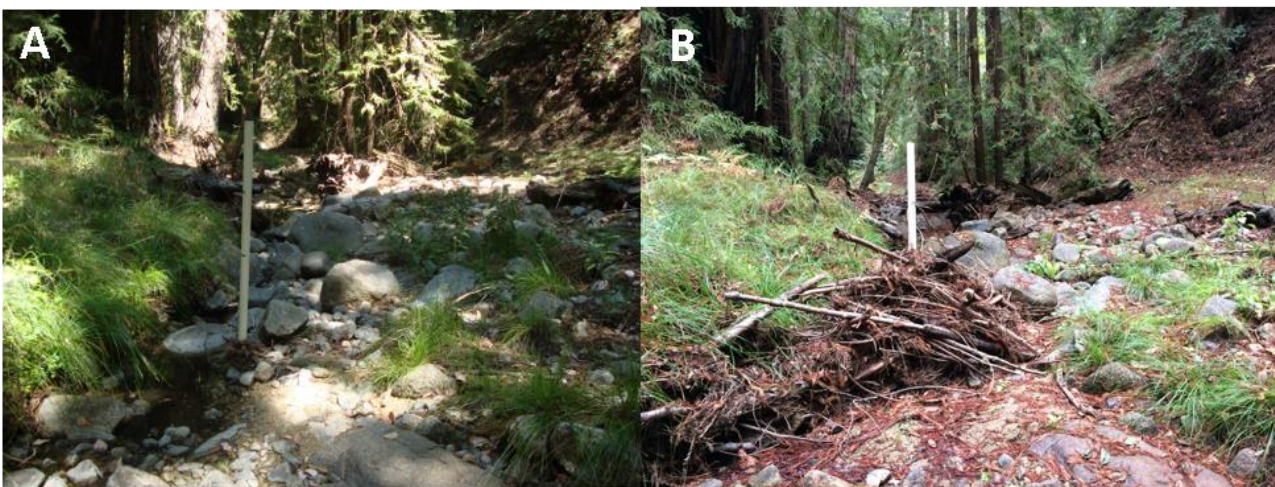
Figure 4: Downstream view of San Clemente Creek on (A) August 18, 2014 and (B) November 4, 2016

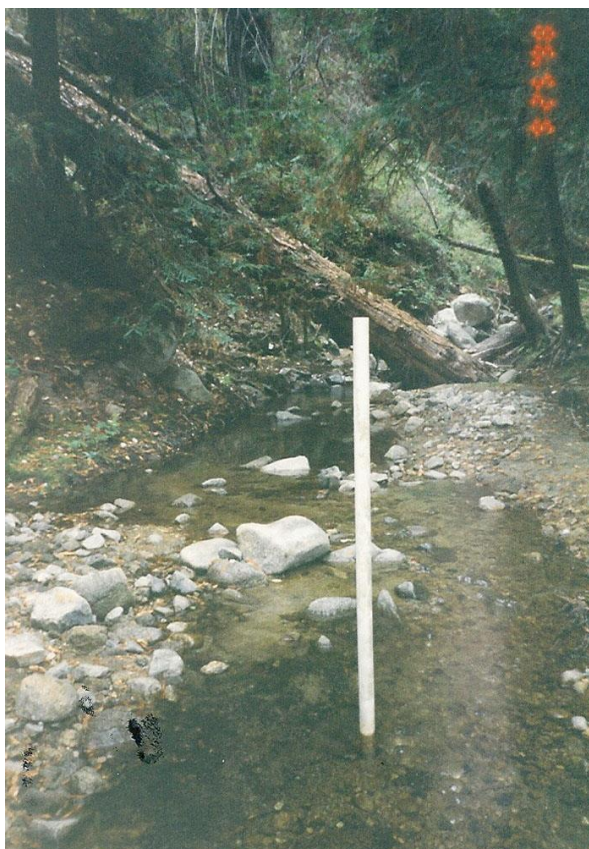
Figure 5: Upstream view of San Clemente Creek in March 1998

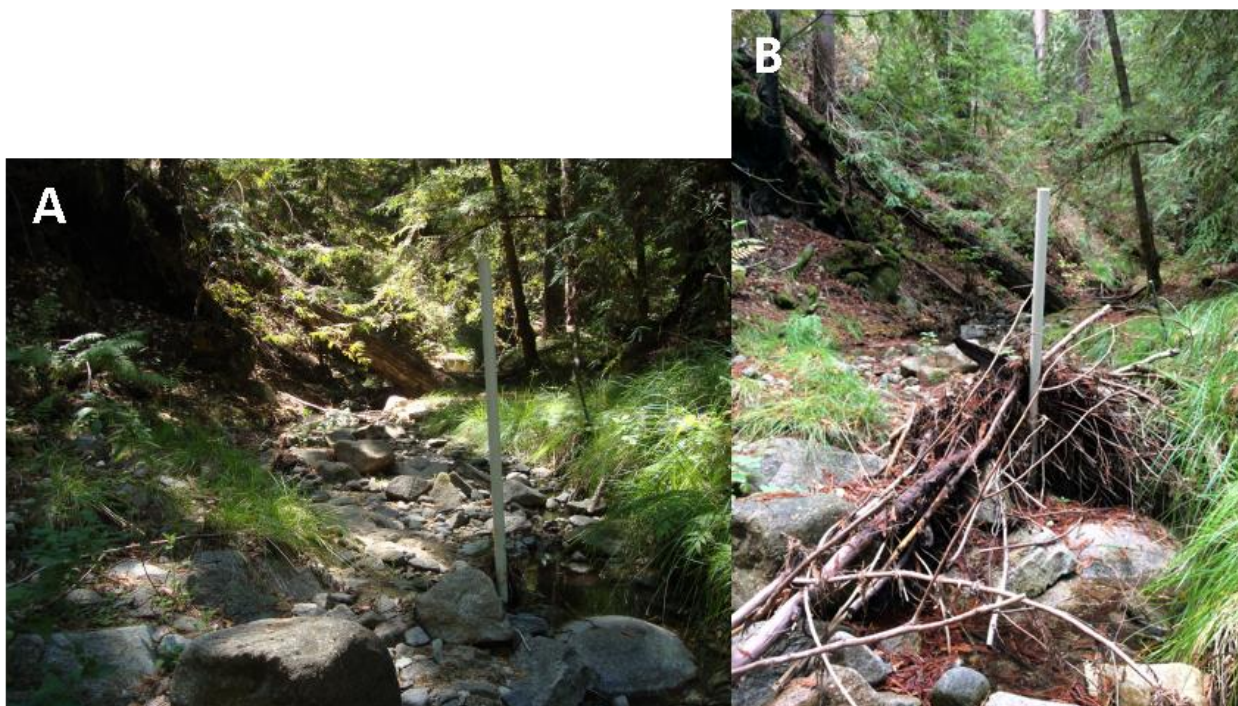
Figure 6: Upstream view of San Clemente Creek on (A) August 18, 2014 and (B) November 4, 2016

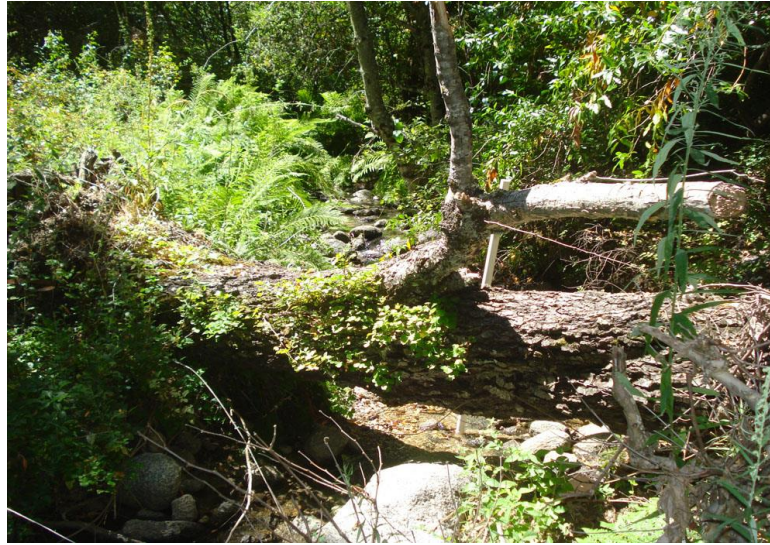
The site was established in 2011. There have been minor changes in the channel from 2011 to 2016. There is more sand present within the channel in 2016 as compared to 2011. There is dense vegetation and coarse woody debris (Figure 7–10).

Figure 7: Upstream view of Upper San Clemente August 2011

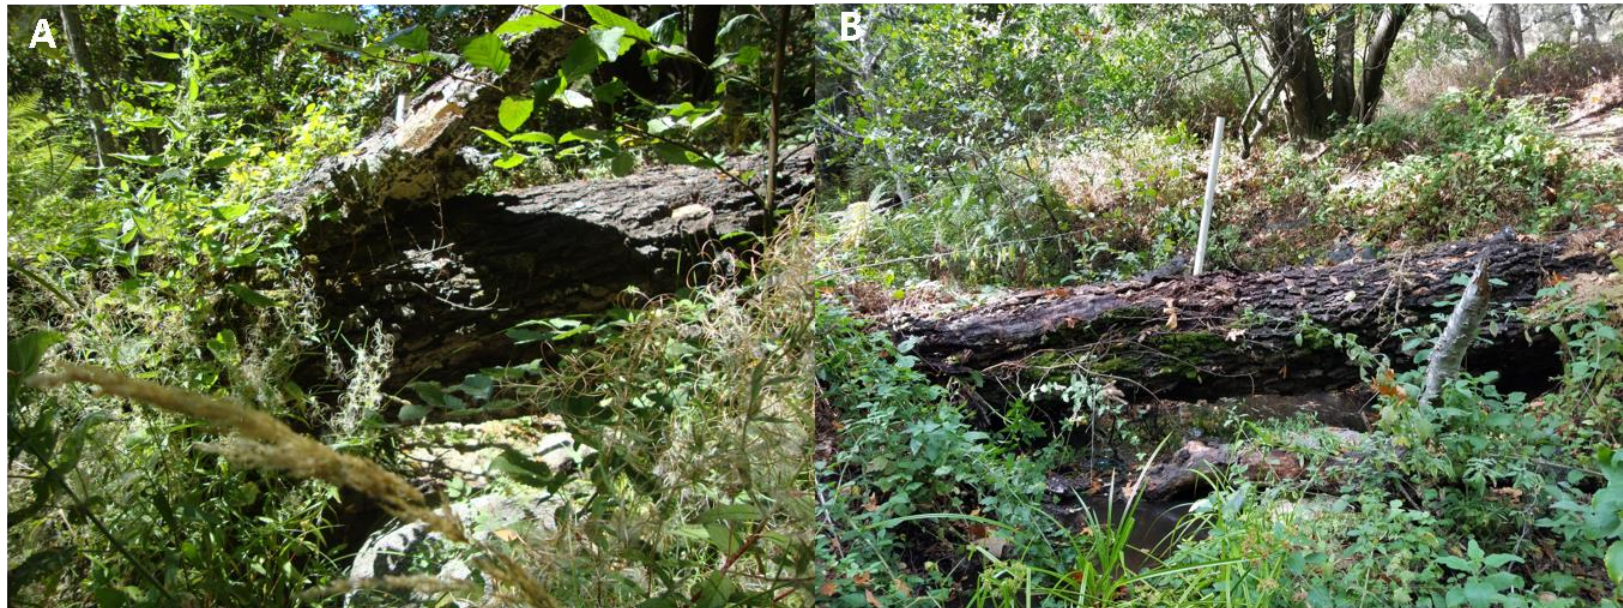
Figure 8: Upstream view of Upper San Clemente on (A) August 18, 2014 and (B) November 4, 2016

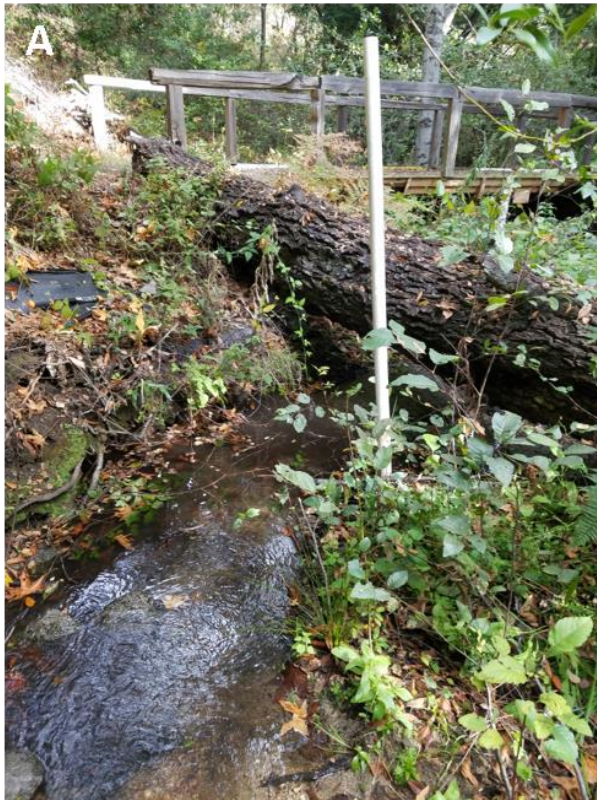
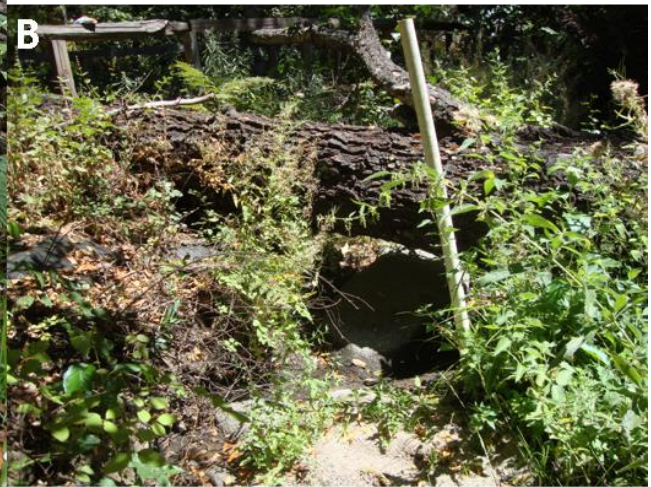
Figure 10: Downstream view of Upper San Clemente on (A) August 18, 2014 and (B) November 4, 2016

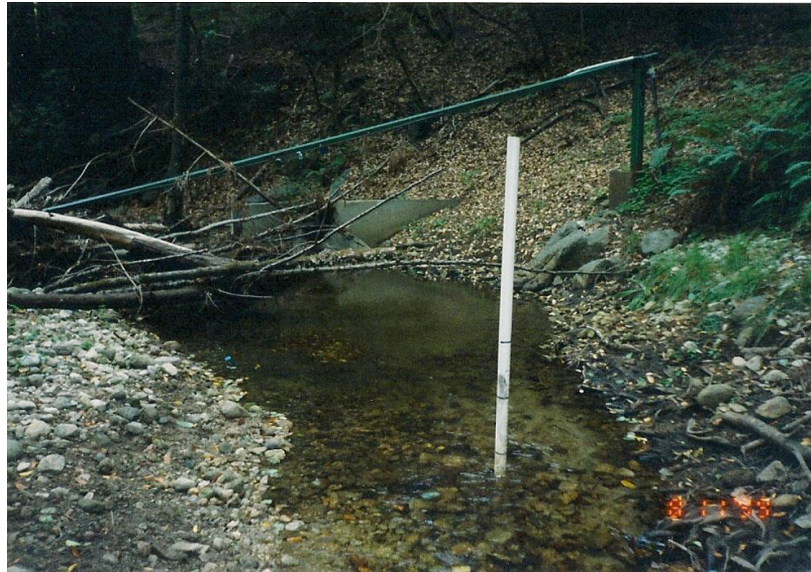
San Jose has had an increase in vegetation in 2016 compared to 1999 in both upstream and downstream views. The increased vegetation has stabilized the channel banks and visible bar. There is large woody debris moving through the system, as old debris visible in 1998 is no longer visible in 2016 and new woody debris has accumulated in the channel and on the channel banks. Local changes include fine particle deposition where there was woody debris in 1999, visible on the right bank in the downstream photo and fewer cobbles (Figures 11–14).

Figure 11: Downstream view of San Jose Creek in August 1999

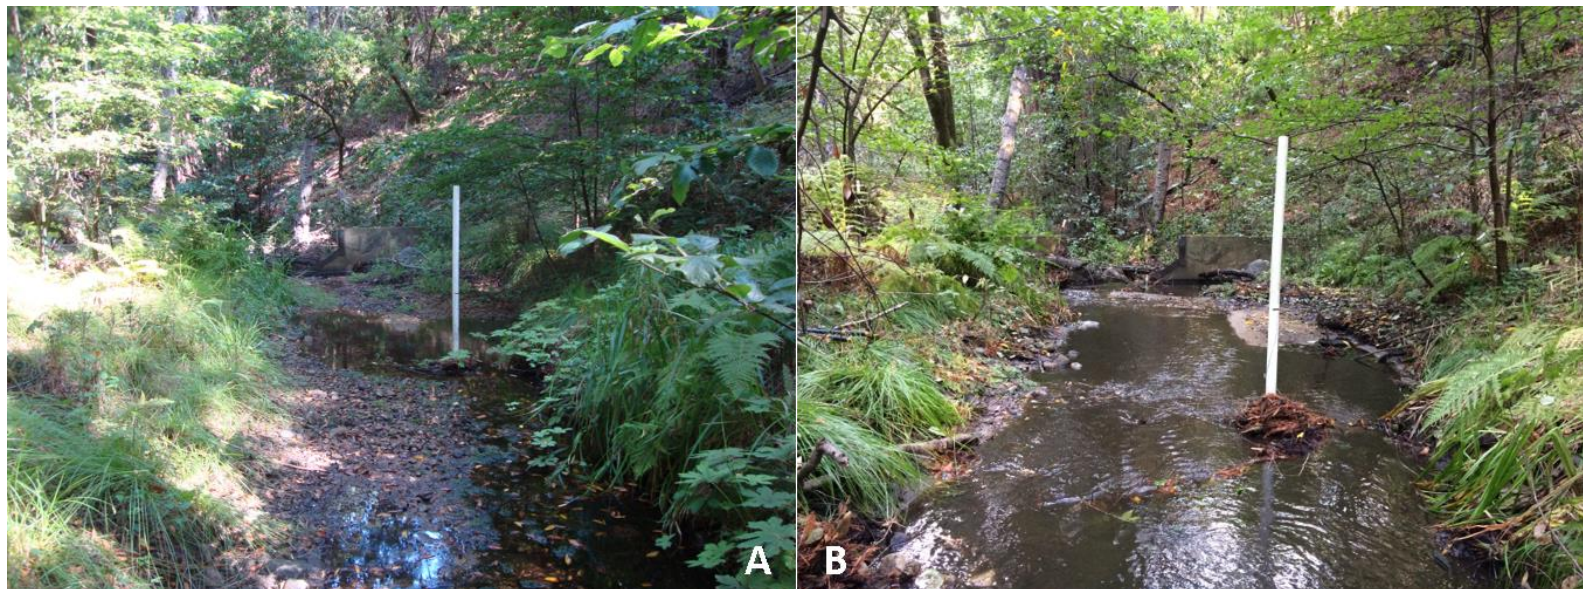
Figure 12: Downstream view of San Jose Creek on (A) August 18, 2014 and (B) November 4, 2016.

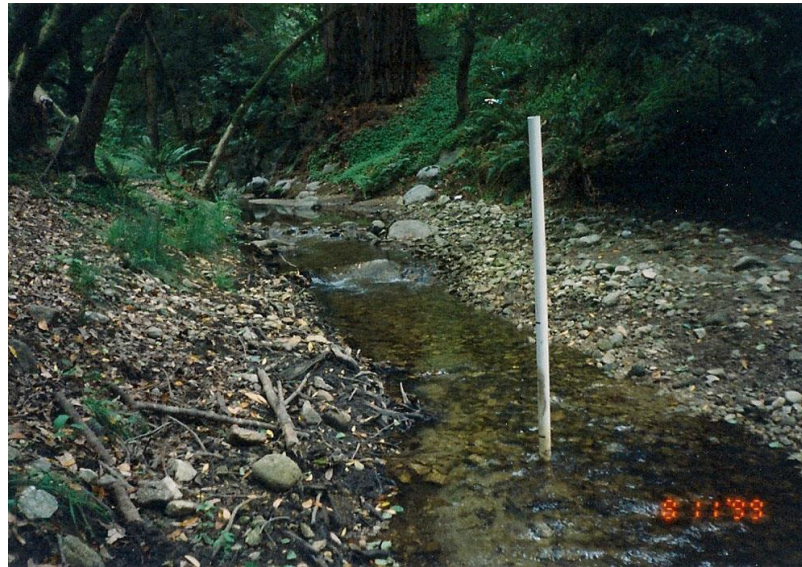
Figure 13: Upstream view of San Jose Creek in August 1999

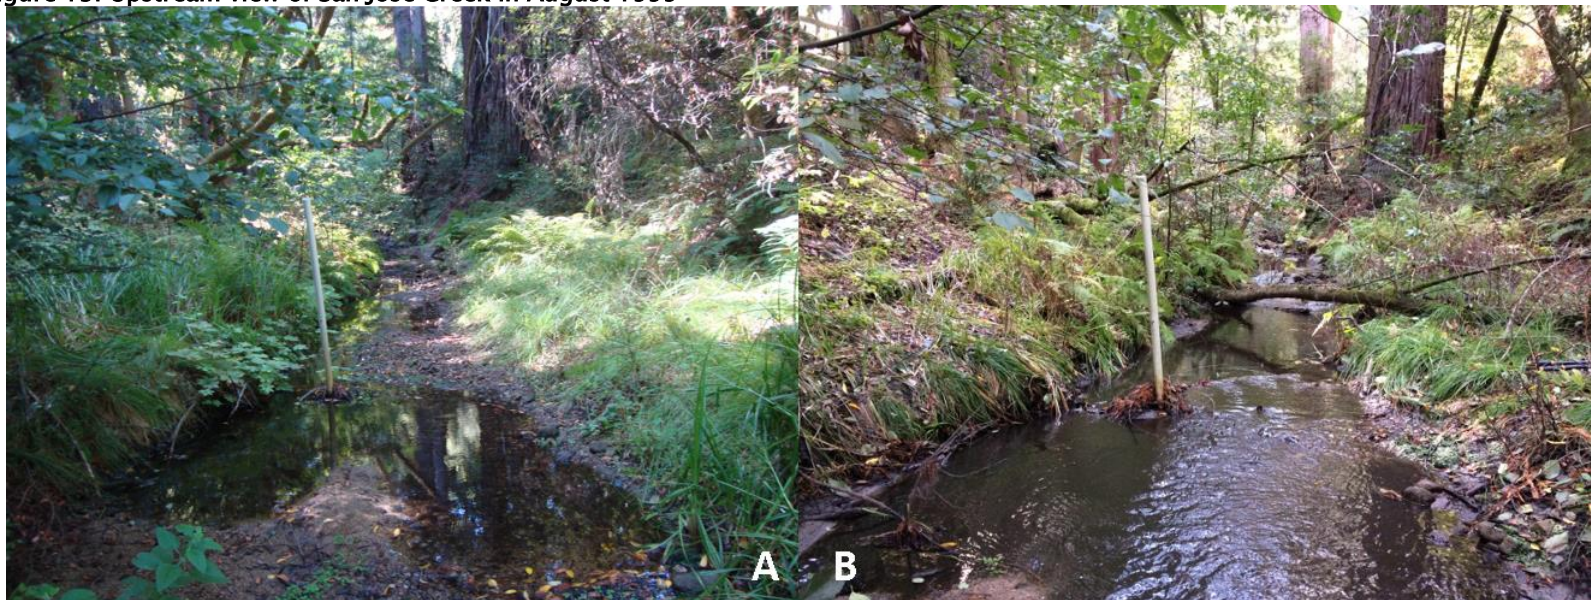
Figure 14: Upstream view of San Jose Creek on (A) August 18, 2014 and (B) November 4, 2016

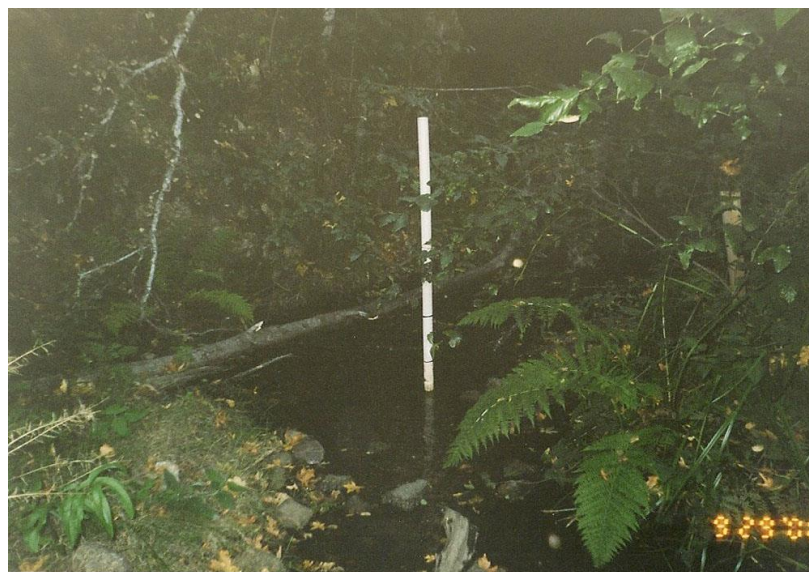
It is difficult to analyze potential change at Upper San Jose because of the sparse lighting of the photographs from 2000. There has been a large increase in vegetation and woody debris from 2000 to 2016 (Figures 15–18). Between the photomonitoring site and where Figure 2 was taken, field technicians noted a large deposit of fine sediment was not present in the past years.

Figure 15: Downstream view of Upper San Jose Creek in September 2000

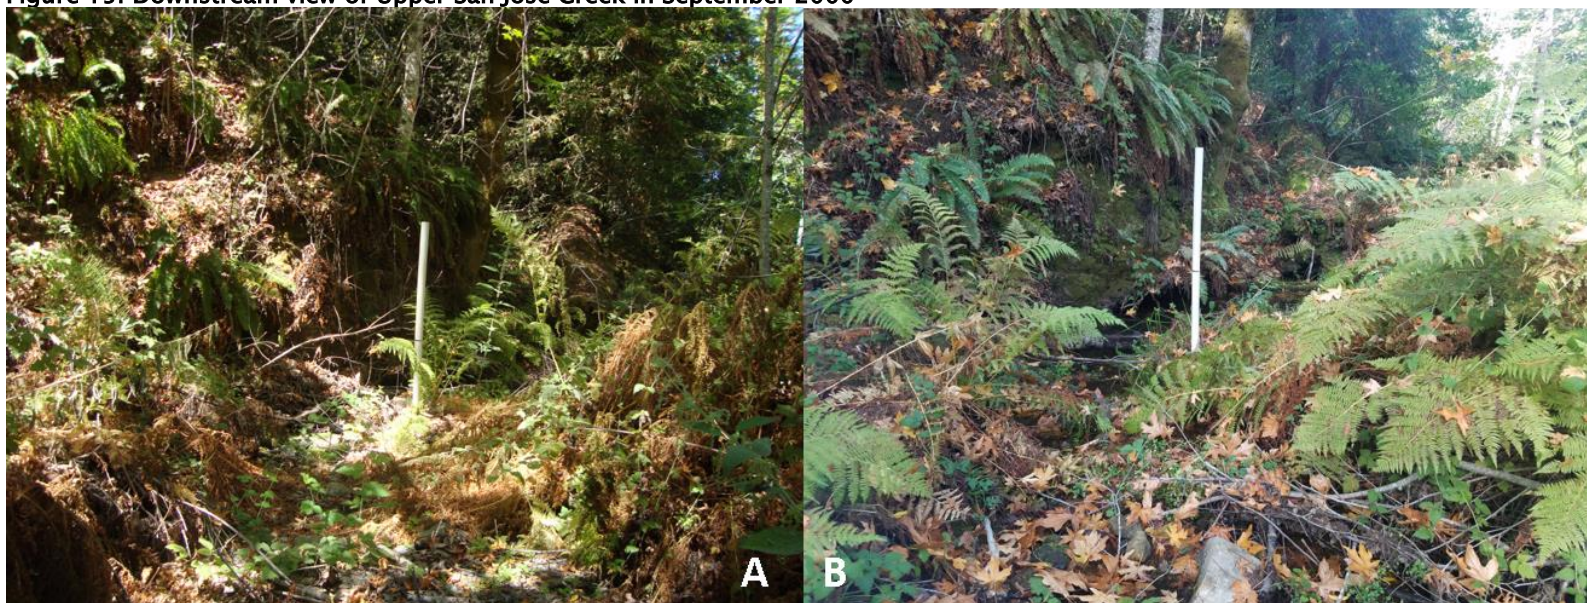
Figure 16: Downstream view of Upper San Jose Creek on (A) August 18, 2014 and (B) November 4, 2016

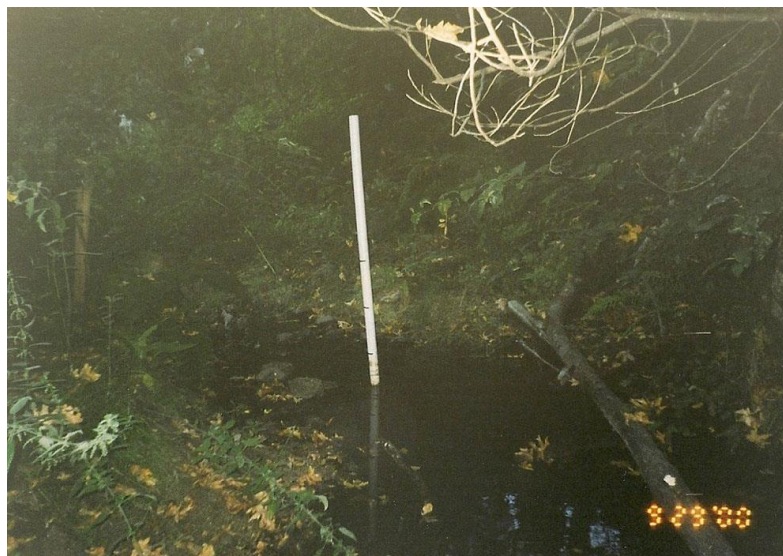
Figure 17: Upstream view of upper San Jose Creek in September 2000

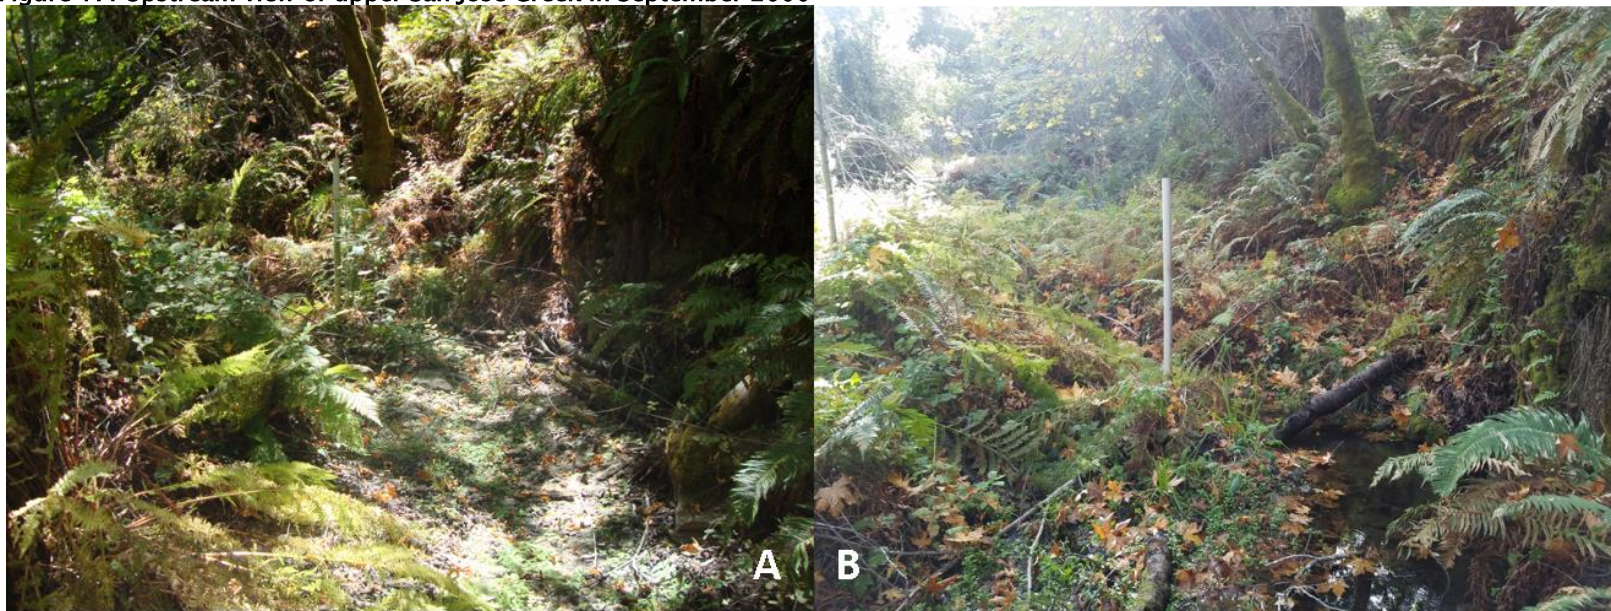
Figure 18: Upstream view of upper San Jose Creek on (A) August 18, 2014 and (B) November 4, 2016

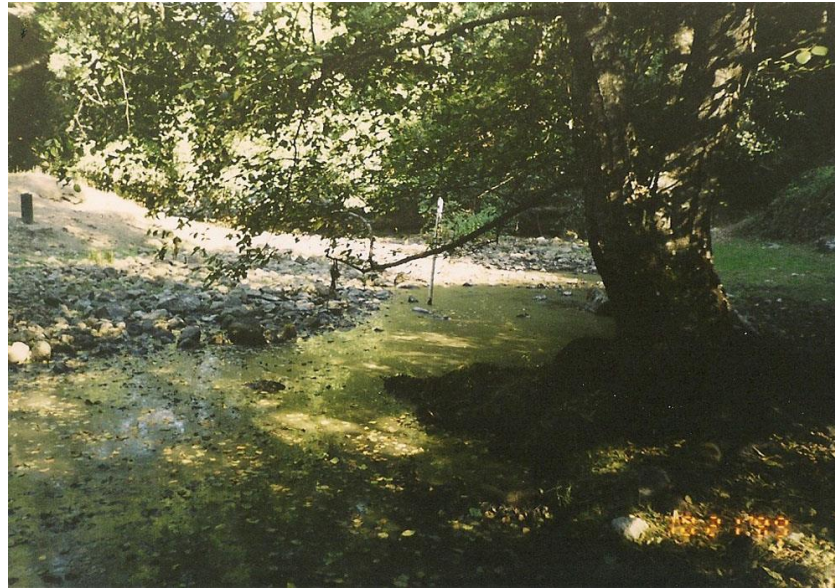
Lower Garzas has an increase in riparian forest growth and channel bank vegetation in 2016 compared to 1999. There appear to be fewer cobbles in 2016 as well. There is an accumulation of woody debris, not shown in the photographs, that has created a pool where there was a riffle in 1999 (Figures 19–22).

Figure 19: Downstream view of Lower Las Garzas Creek in October 1999

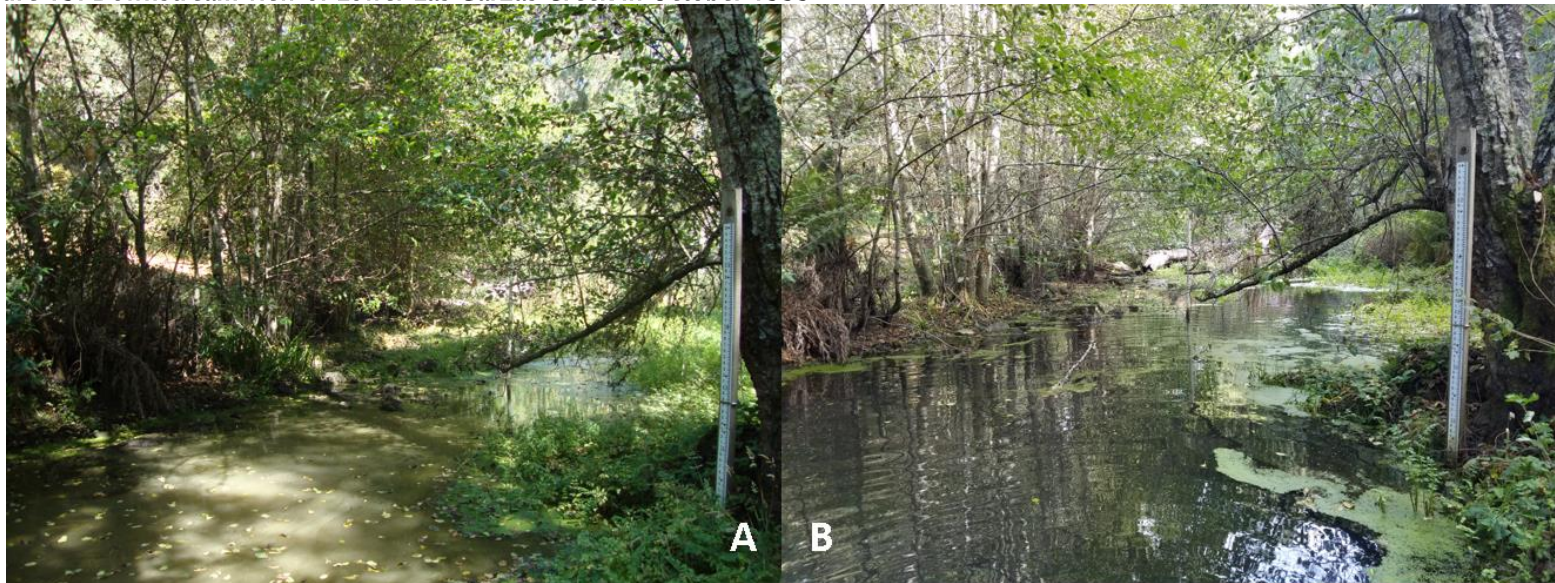
Figure 20: Downstream view of Lower Las Garzas Creek on (A) August 18, 2014 and (B) November 4, 2016

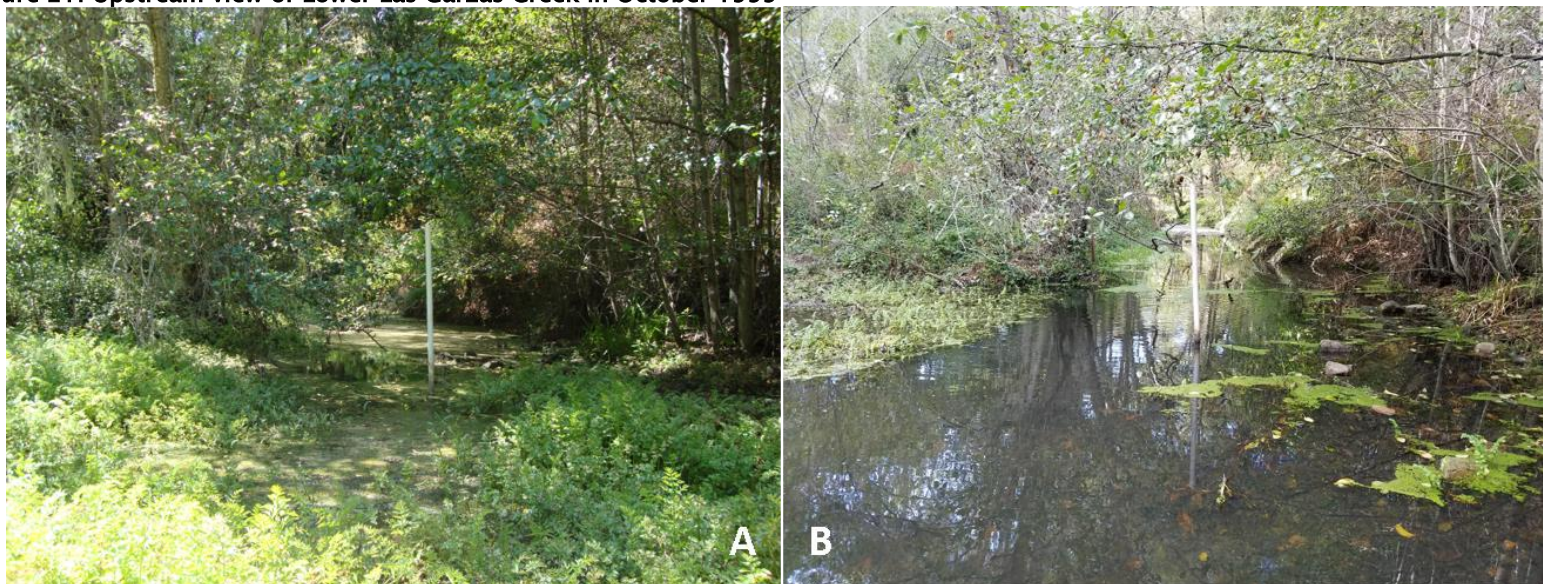
Figure 22: Upstream view of Lower Las Garzas Creek in (A) August 18, 2014 and (B) November 4, 2016

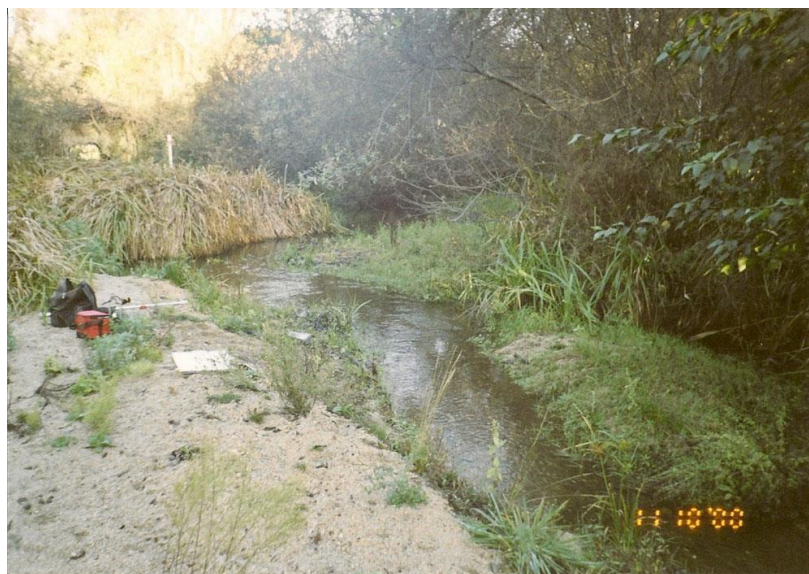
The comparison of the photographs of Middle Garzas is difficult because of the dense vegetation that has accumulated along the channel banks. Vegetation type also seems to have shifted from ferns and reeds to larger woody trees and shrubs. The dense vegetation has stabilized the banks in 2016 (Figures 23–26).

Figure 23: Downstream view of Middle Las Garzas Creek in November 2000

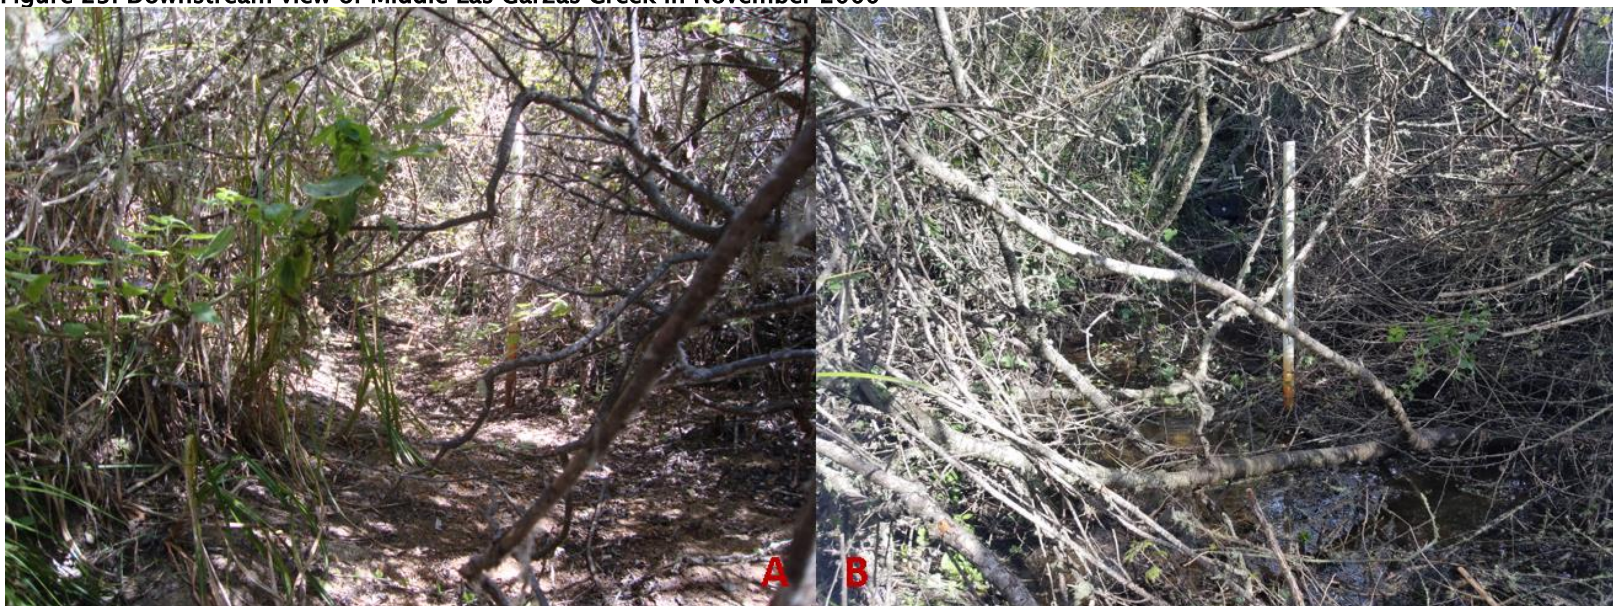
Figure 24: Downstream view of Middle Las Garzas Creek on (A) August 18, 2014 and (B) November 4, 2016

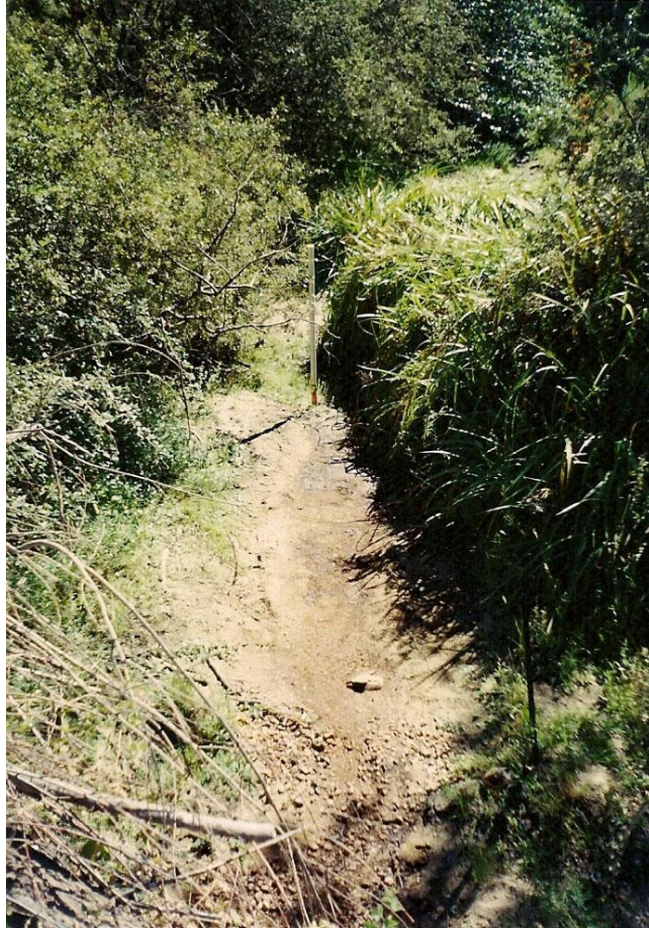
Figure 25: Upstream view of Middle Las Garzas Creek in August 2000 (estimate of date)

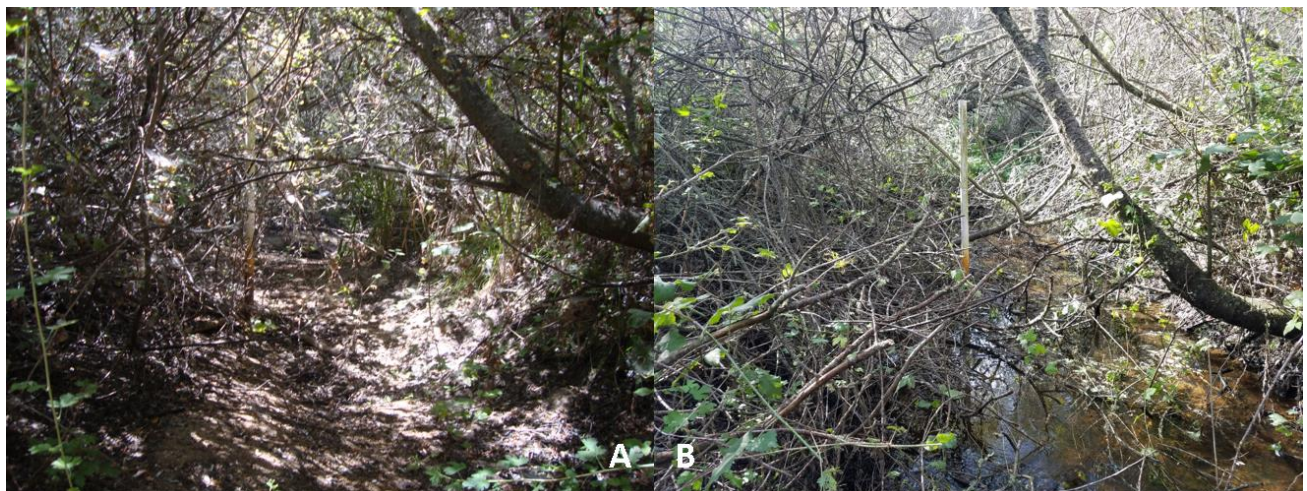
Figure 26: Upstream view of Middle Las Garzas Creek on (A) August 18, 2014 and (B) November 4, 2016

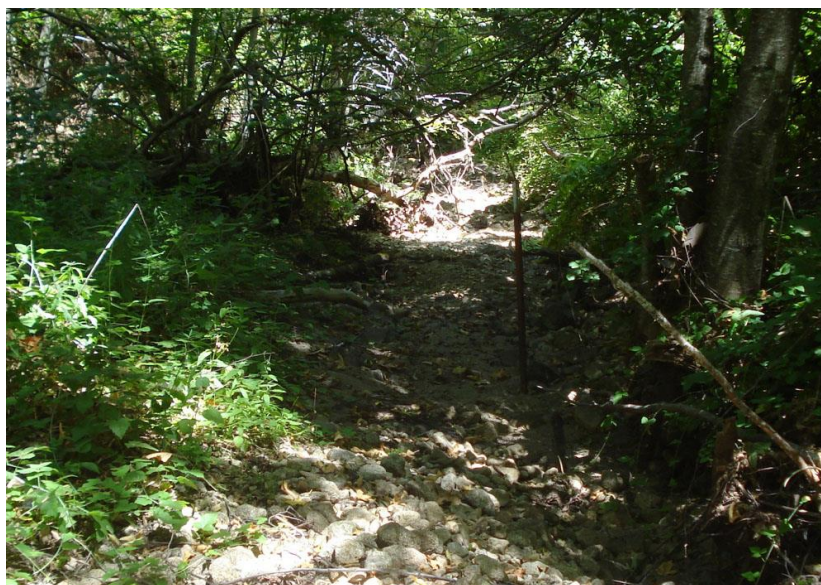
The oldest photograph available for Upper Garzas is from 2009. The rebar at this site has been knocked over and now sits at a 45-degree angle. There have been no visible changes apparent from photo monitoring in 2009 and 2013 (Figures 27–30).

Figure 27: Downstream view of Upper Las Garzas Creek in August 2009

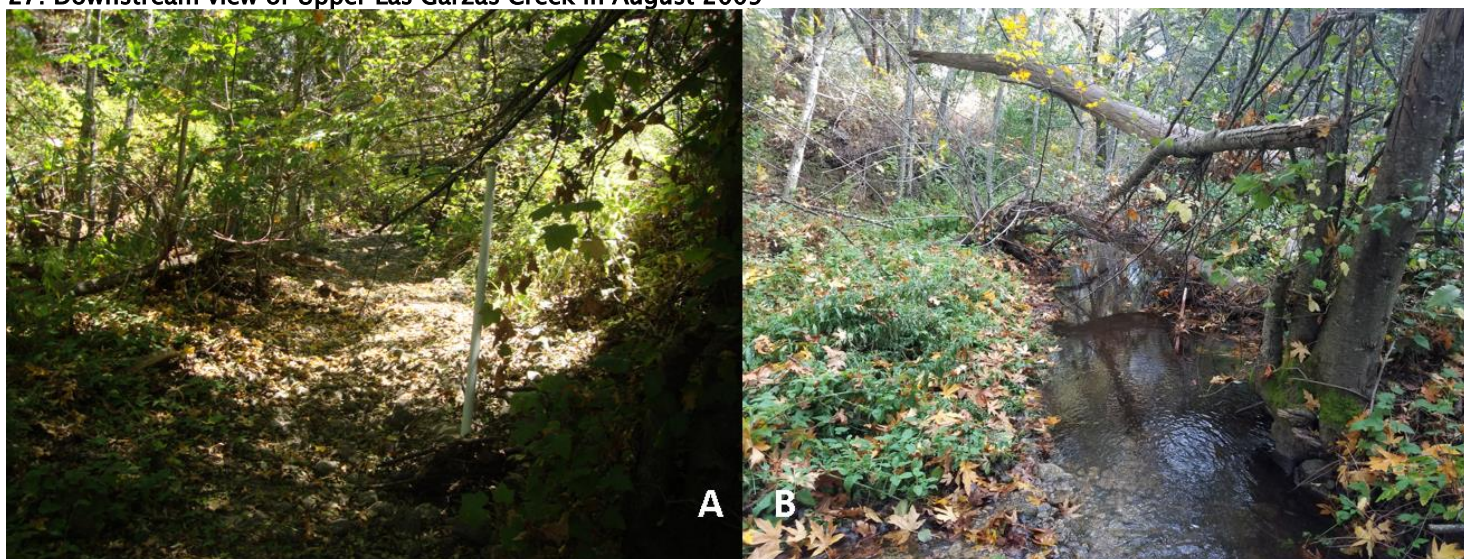
Figure 28: Downstream view of Upper Las Garzas Creek on (A) August 18, 2014 and (B) November 4, 2016, Rebar was bent over approximately 45 degrees

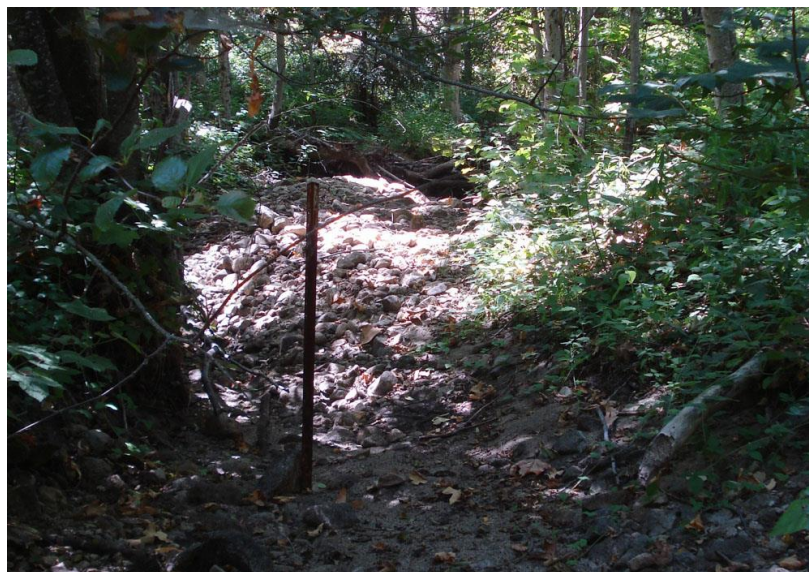
Figure 29: Upstream view of Upper Las Garzas Creek in August 2009

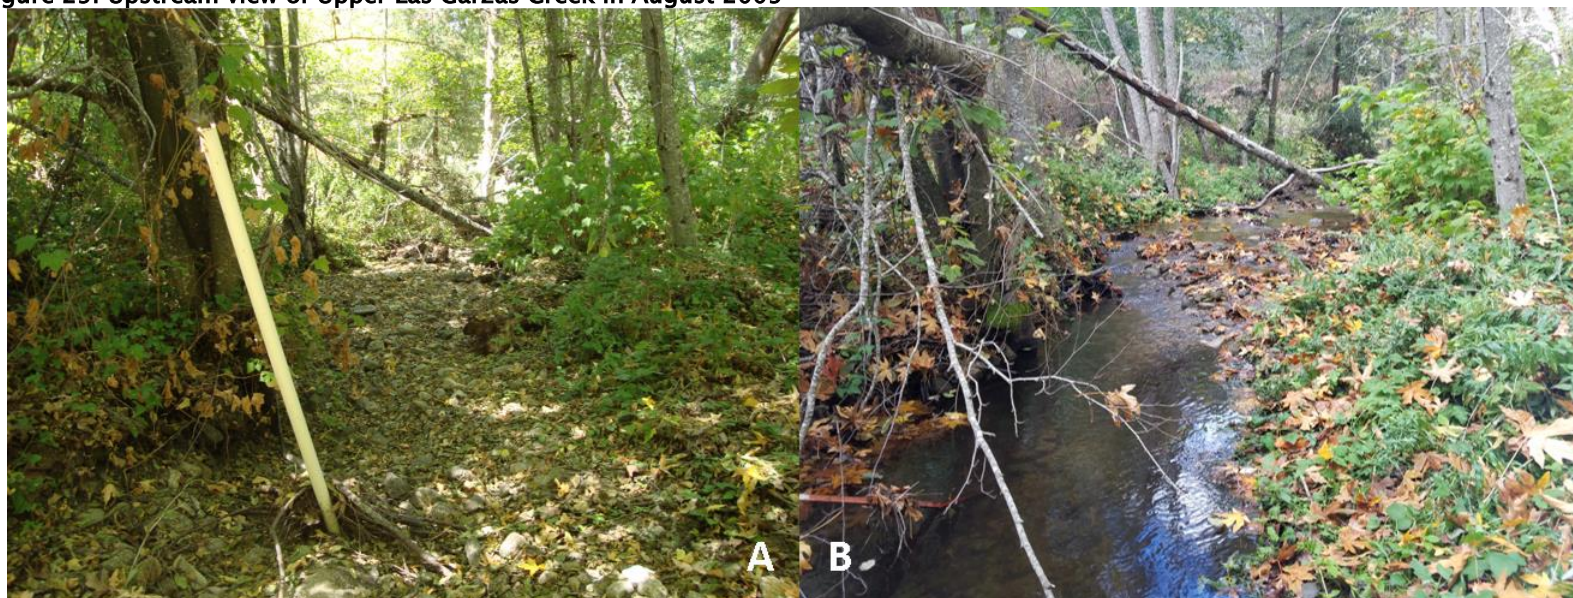
Figure 30: Upstream view of Upper Las Garzas Creek on (A) August 18, 2014 and (B) November 4, 2016. Damaged rebar in lower left corner

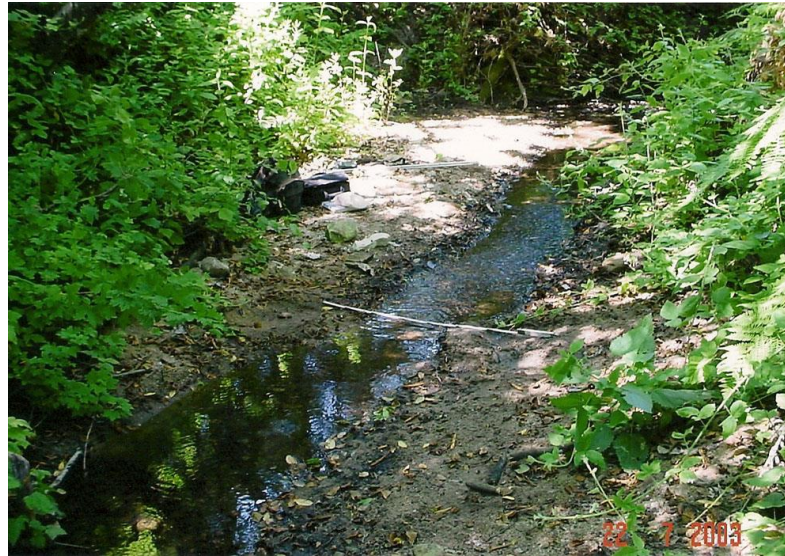
The Potrero channel has shifted from the right bank to the left bank between 2003 and 2016. The channel change is visible in the downstream photo and the exposed sand bar. There has been an increase in large woody vegetation from 2003 to 2016. Particle size appears to remain constant (Figures 31–34).

Figure 31: Downstream view of Potrero Creek in July 2003

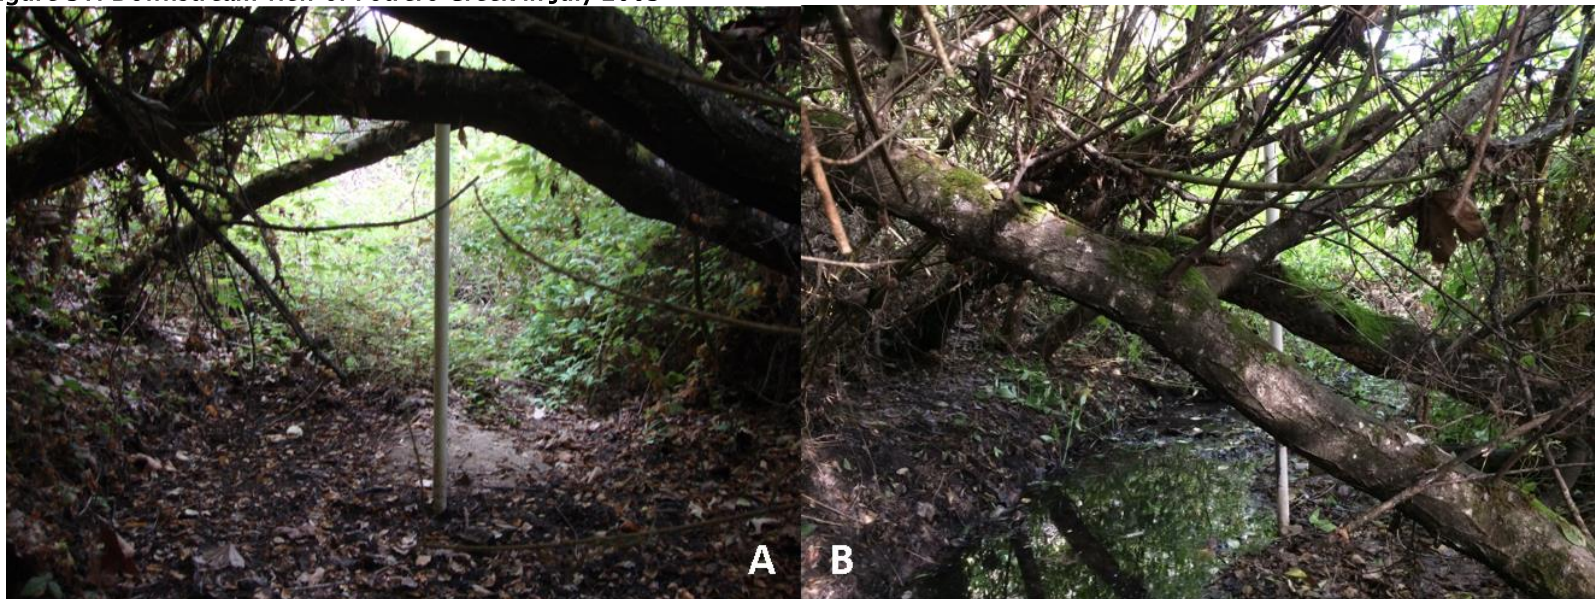
Figure 32: Downstream view of Potrero Creek on (A) August 18, 2014 and (B) November 4, 2016
