Report No. WI-2016-16
23 December 2016

2016 Photo Monitoring

Santa Lucia Preserve,
Monterey County, California

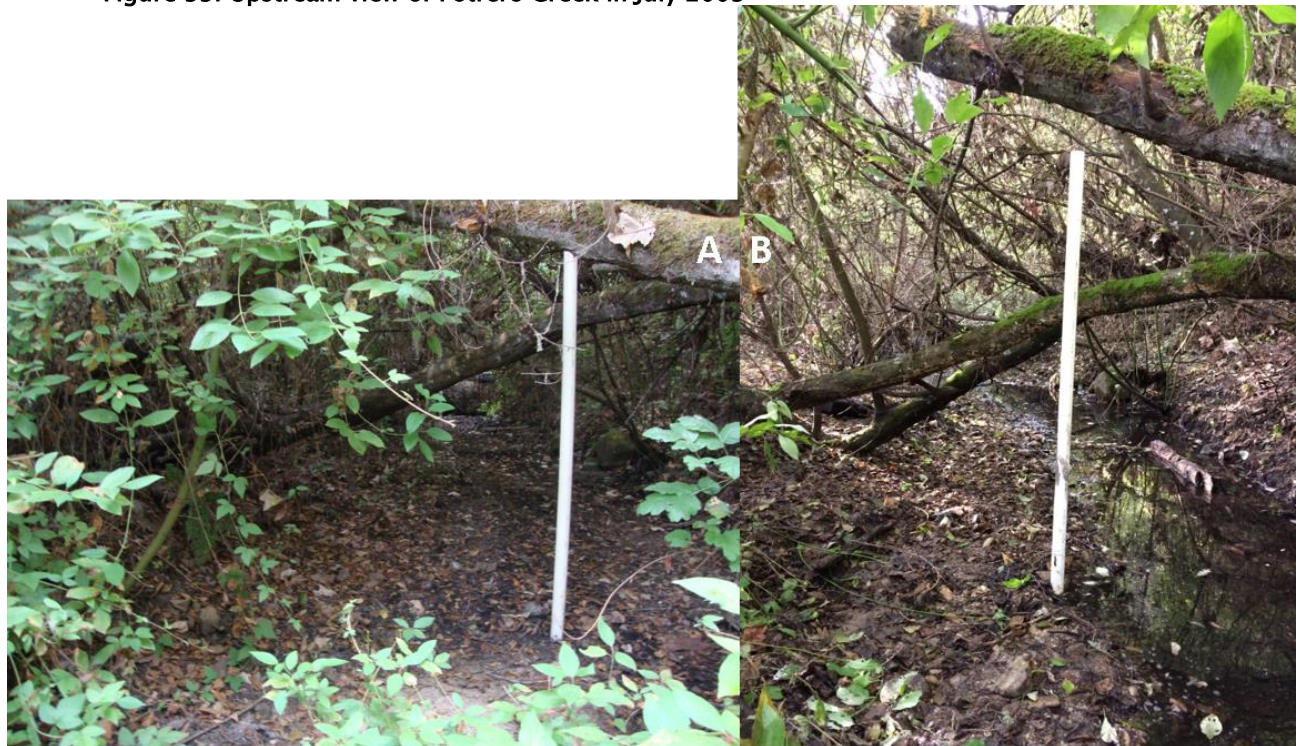
The Potrero channel has shifted from the right bank to the left bank between 2003 and 2016. The channel change is visible in the downstream photo and the exposed sand bar. There has been an increase in large woody vegetation from 2003 to 2016. Particle size appears to remain constant (Figures 31–34).

Figure 34: Upstream view of Potrero Creek on (A) August 18, 2014 and (B) November 4, 2016
