Report No. WI-2017-08
4 December 2017

2017 Photo Monitoring

Santa Lucia Preserve,
Monterey County, California

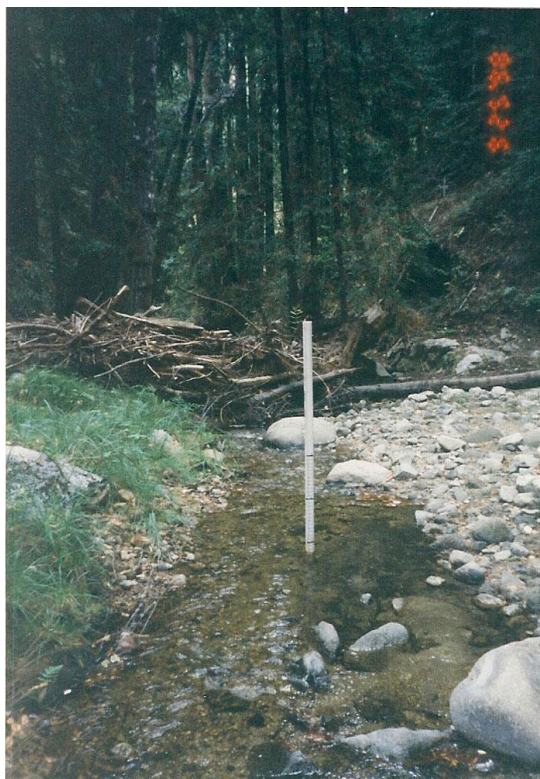
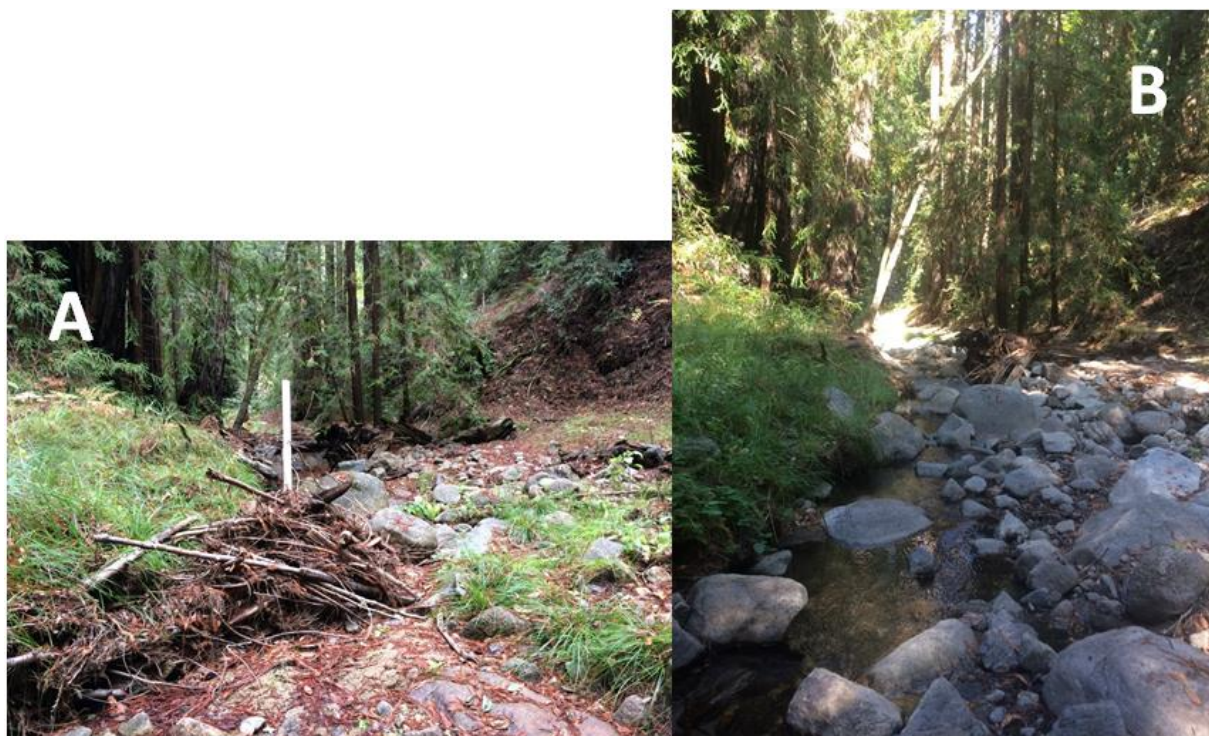
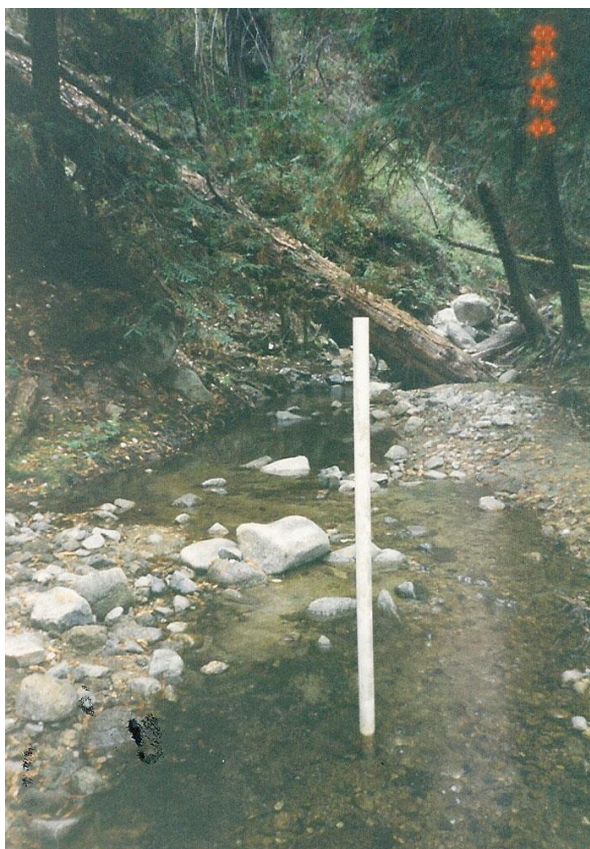
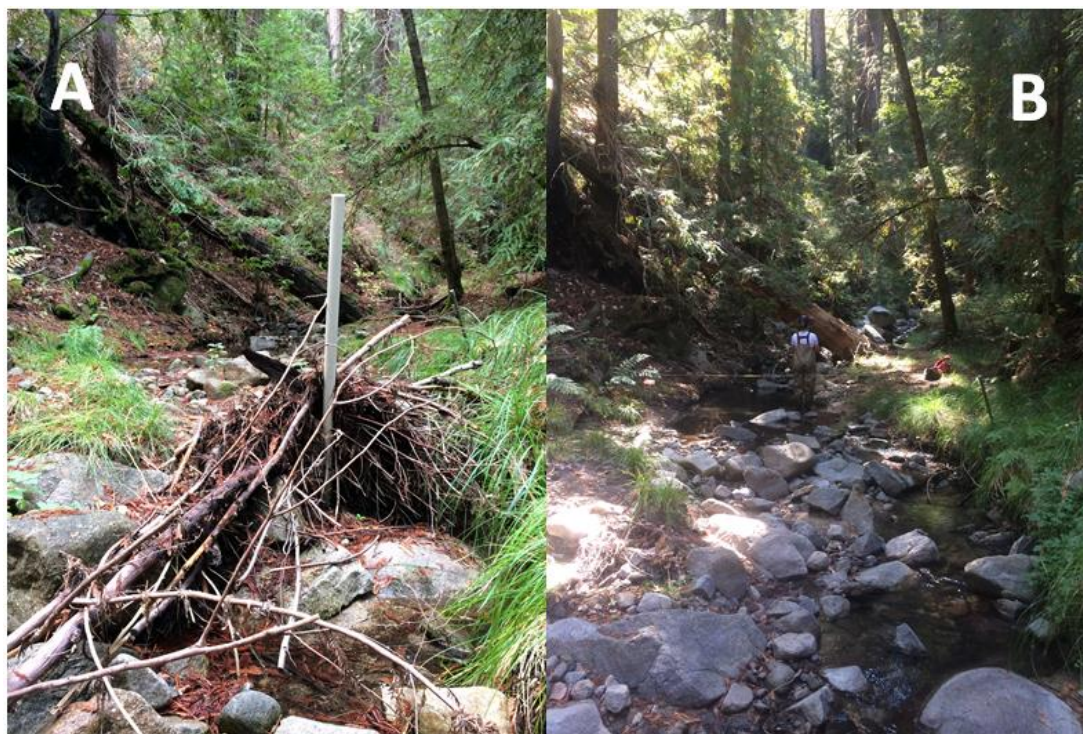
Much of the finer gravel has been washed away since 1998, leaving a coarse boulder lag deposit. The physical rearrangement of boulders in the photos indicates that large particles have been transported into place as well as being exhumed by the removal of finer sediment deposits. The left bank has built and vegetated since 1998. (Figures 2–5).

Figure 2: Downstream view of San Clemente Creek in March 1998

Figure 3: Downstream view of San Clemente Creek on (A) November 4, 2016 and (B) September 17, 2017

Figure 4: Upstream view of San Clemente Creek in March 1998

Figure 5: Upstream view of San Clemente Creek on (A) November 4, 2016 and (B) September 17, 2017

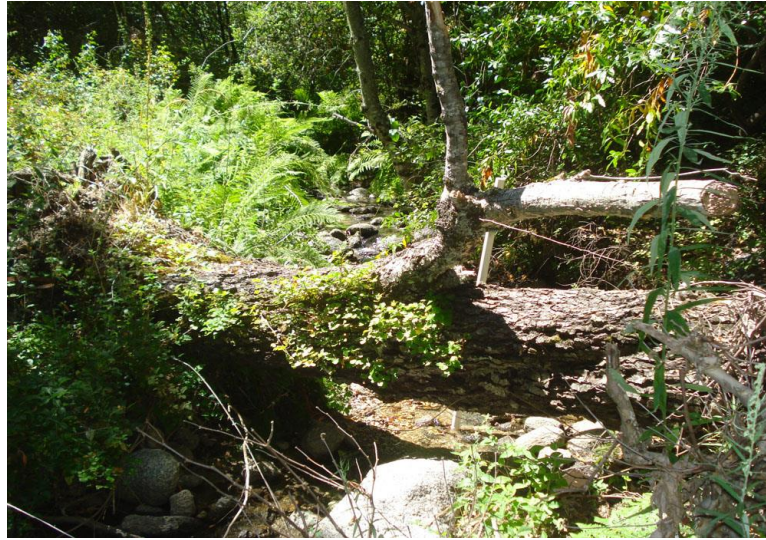
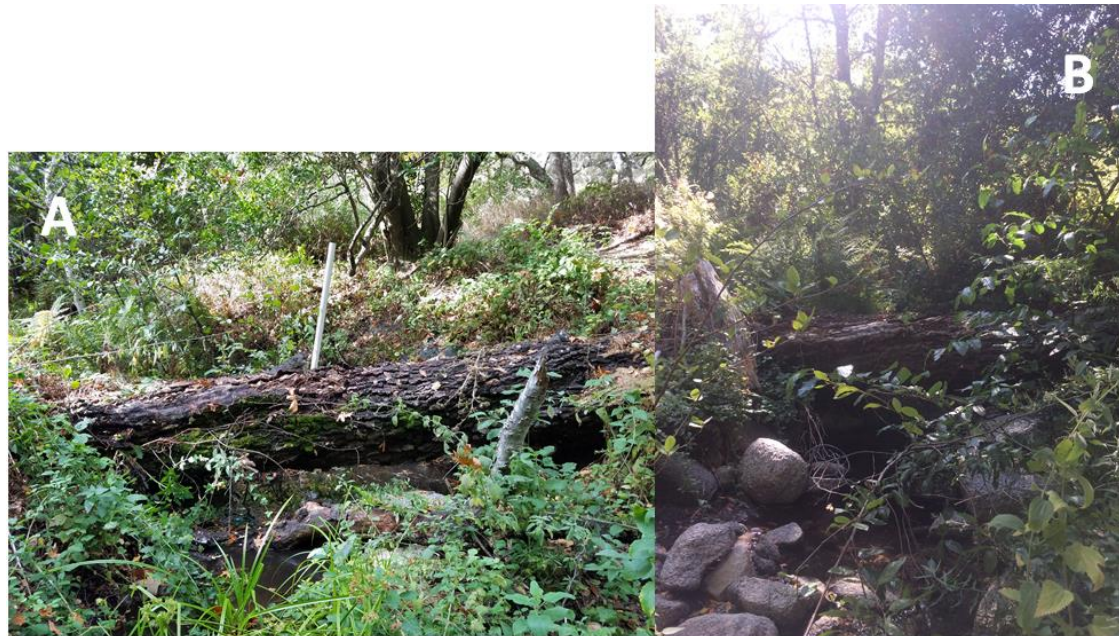
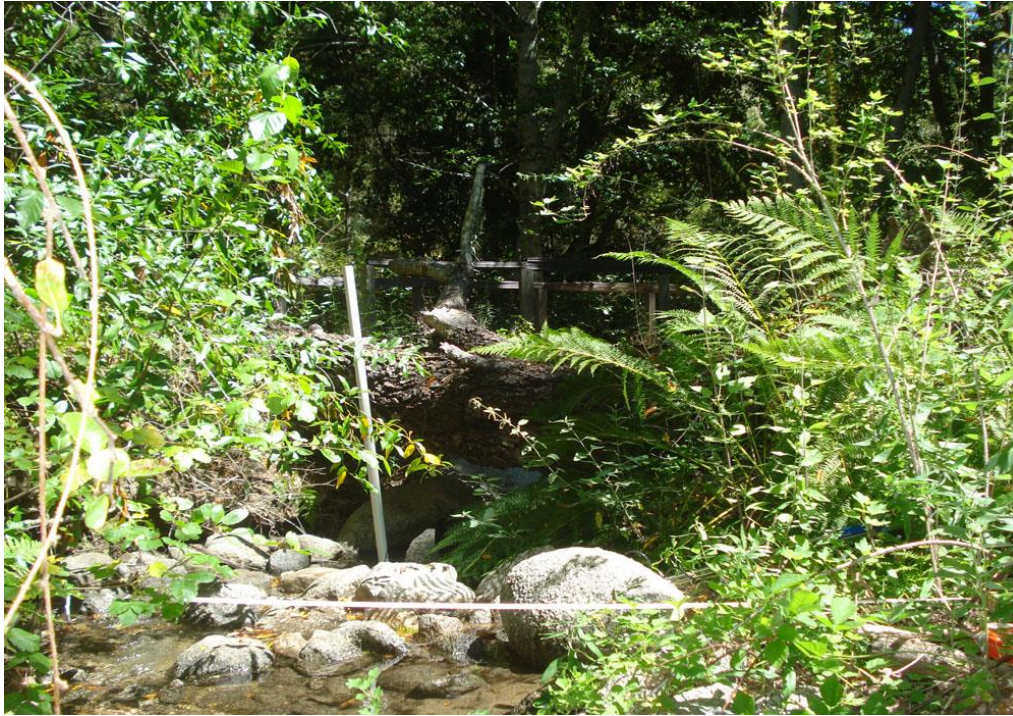
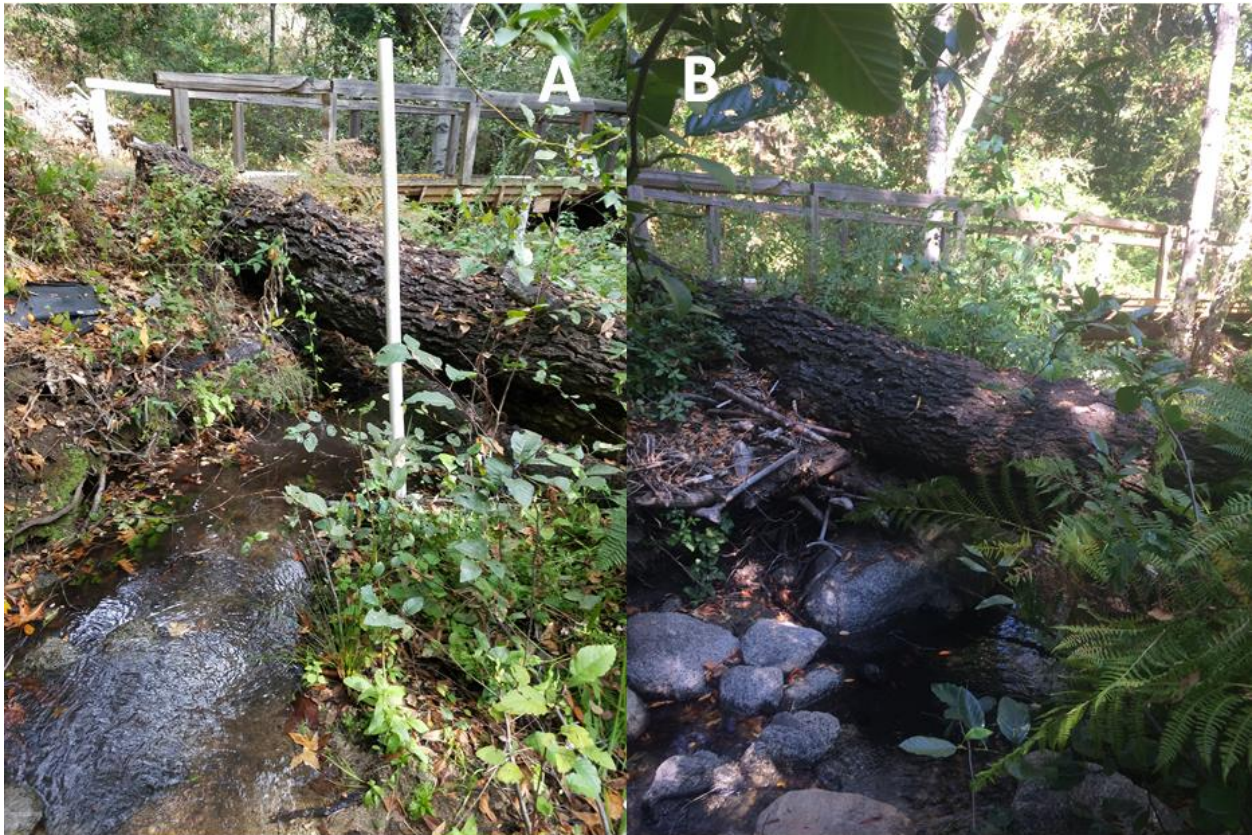
The site was established in 2011. There have been minor changes in the channel from 2011 to 2016. The channel has widened and exposed the boulder bed, and there has been some erosion on the right bank. The photo monitoring marker was washed away, and there is dense vegetation and coarse woody debris (Figure 6–9).

Figure 6: Upstream view of Upper San Clemente August 2011

Figure 7: Upstream view of Upper San Clemente on (A) November 4, 2016 and (B) September 17, 2017

Figure 8: Downstream view of Upper San Clemente August 2011

Figure 9: Downstream view of Upper San Clemente on (A) November 4, 2016 and (B) September 17, 2017

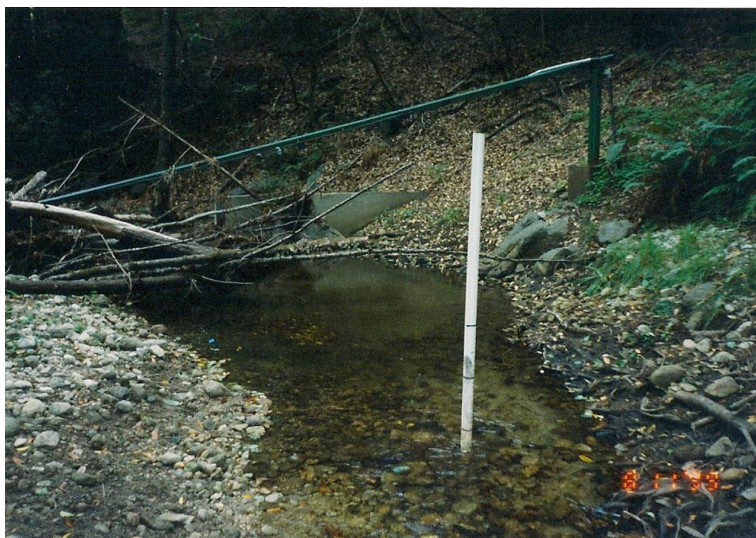
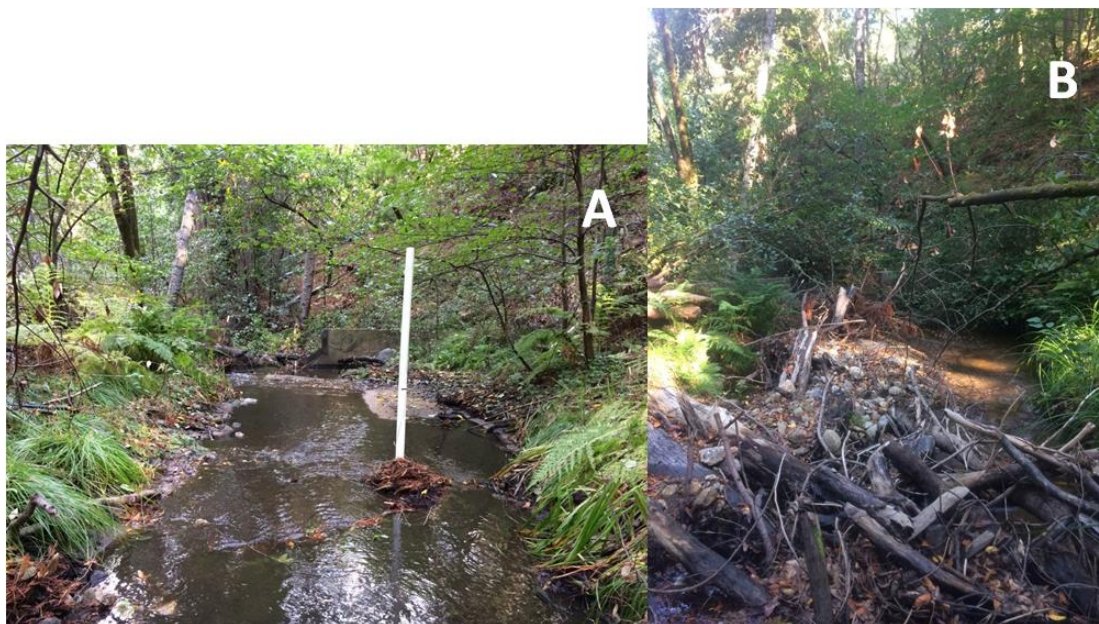
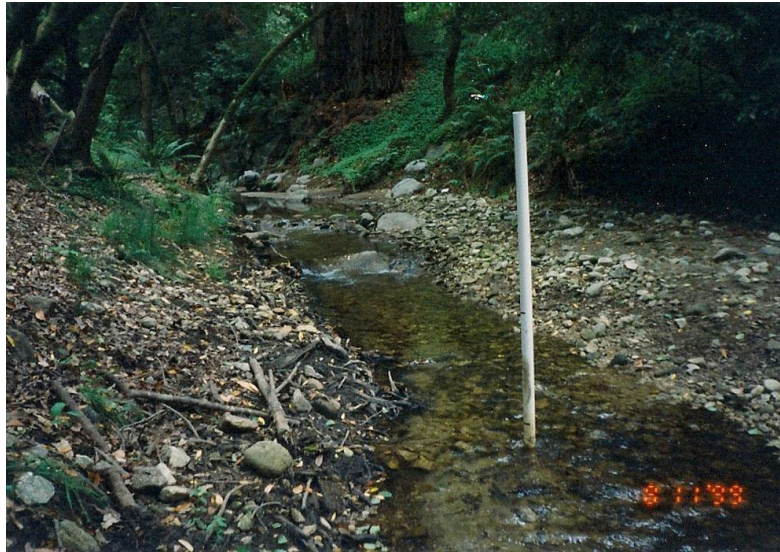
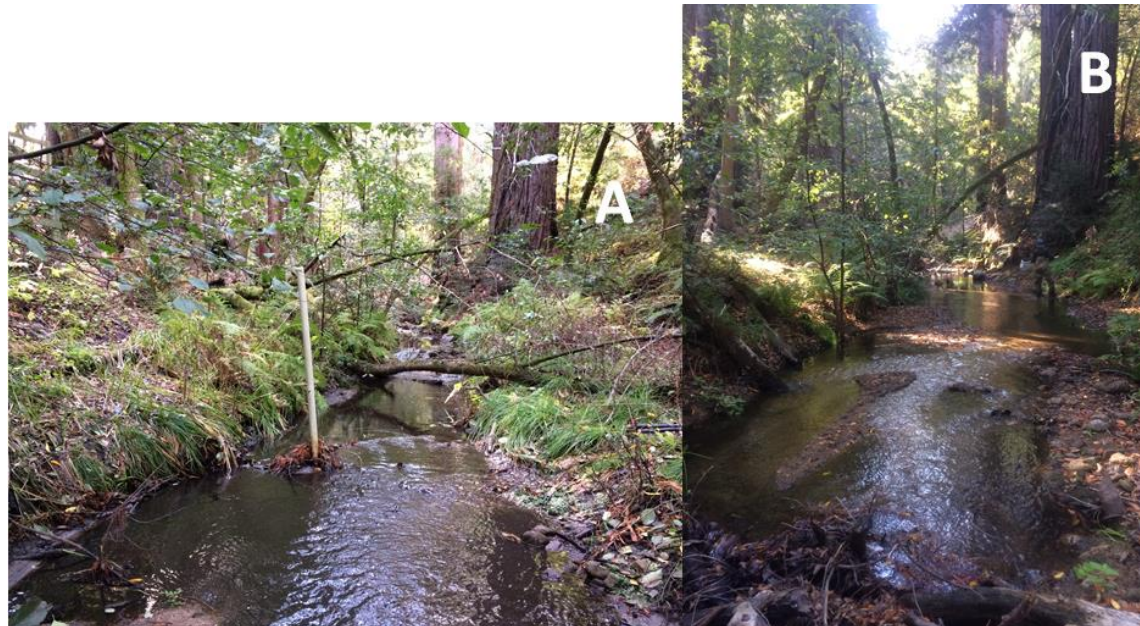
San Jose has widened significantly between 2016 and 2017, and has developed a minor side attached bar and central bar from gravel deposits in the channel. Since 1998, there has been a lot of riparian growth. Between 2016 and 2017 there has been a lot of large wood accumulation, and the tree fall on the right bank will eventually add more large wood to the stream. (Figures 10–13).

Figure 10: Downstream view of San Jose Creek in August 1999

Figure 11: Downstream view of San Jose Creek on (A) November 4, 2016 and (B) September 17, 2017

Figure 12: Upstream view of San Jose Creek in August 1999

Figure 13: Upstream view of San Jose Creek on (A) November 4, 2016 and (B) September 17, 2017

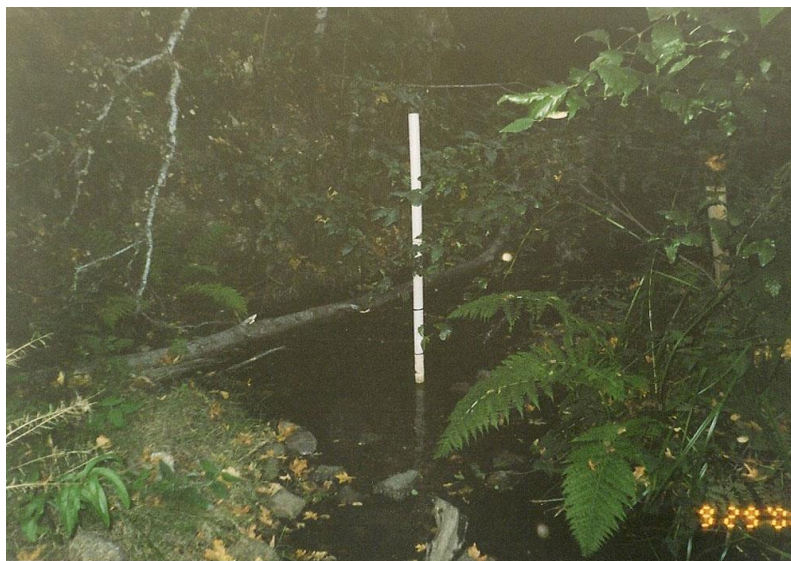
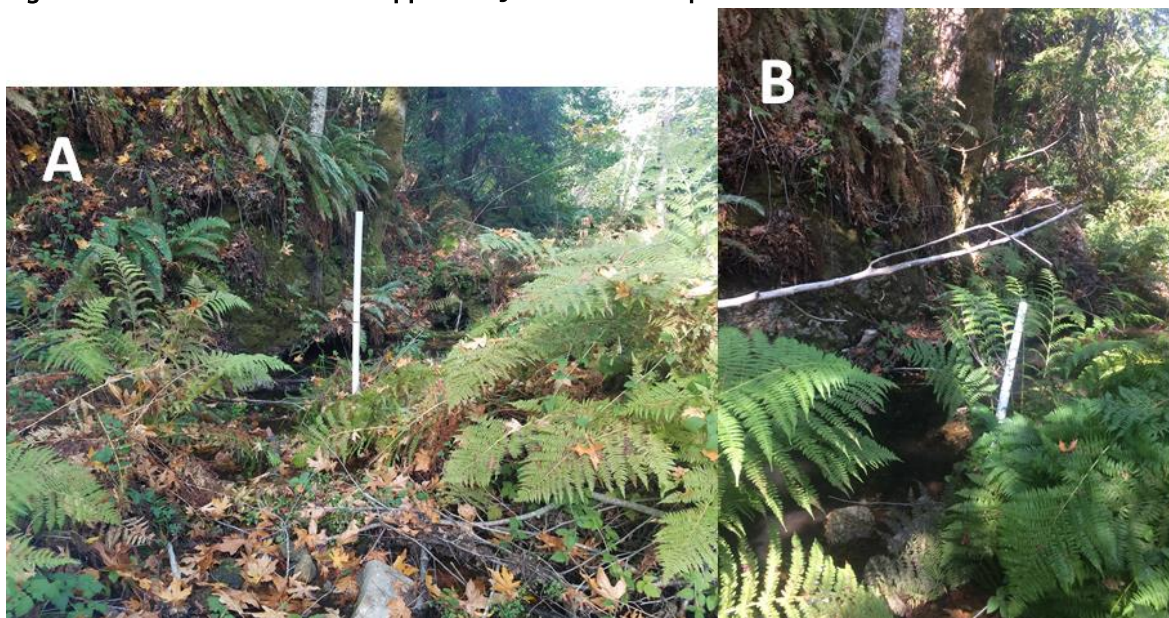
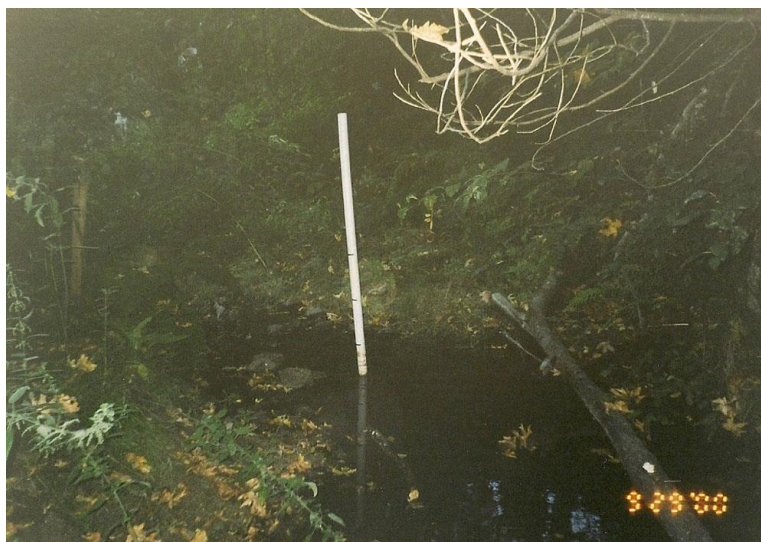
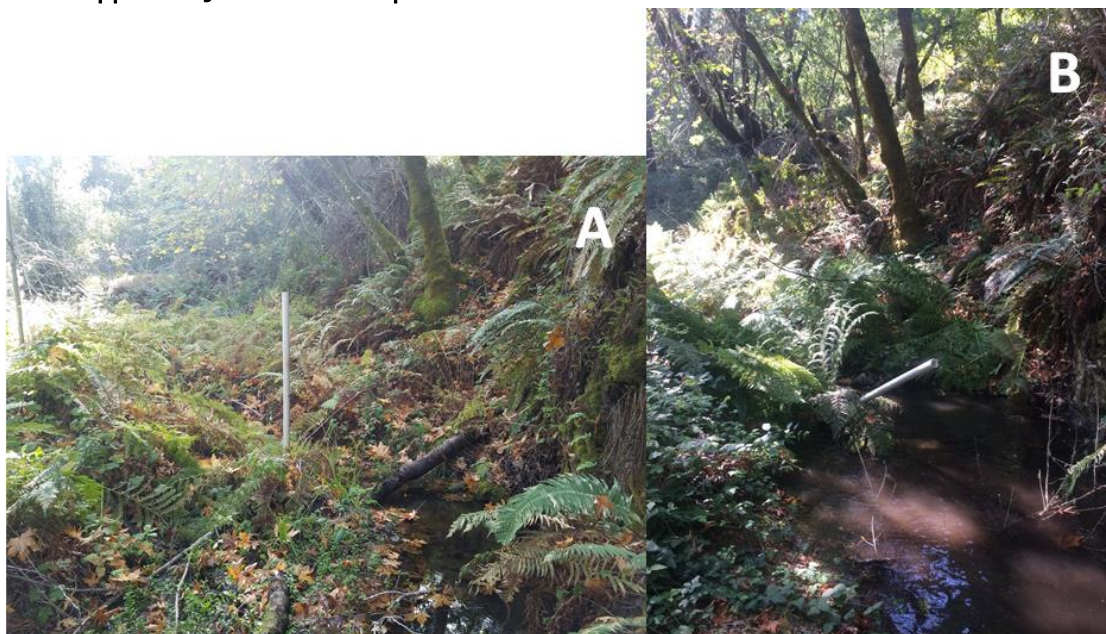
It is difficult to analyze potential change at Upper San Jose because of the sparse lighting of the photographs from 2000. There has been a large increase in vegetation and woody debris from 2000 to 2017. The woody debris accumulation in 2016 has washed away in 2017, but there remains too much vegetation to assess channel changes; no change. (Figures 14–17).

Figure 14: Downstream view of Upper San Jose Creek in September 2000

Figure 15: Downstream view of Upper San Jose Creek on (A) November 4, 2016 and (B) September 17, 2017

Figure 16: Upstream view of upper San Jose Creek in September 2000

Figure 17: Upstream view of upper San Jose Creek on (A) November 4, 2016 and (B) September 17, 2017

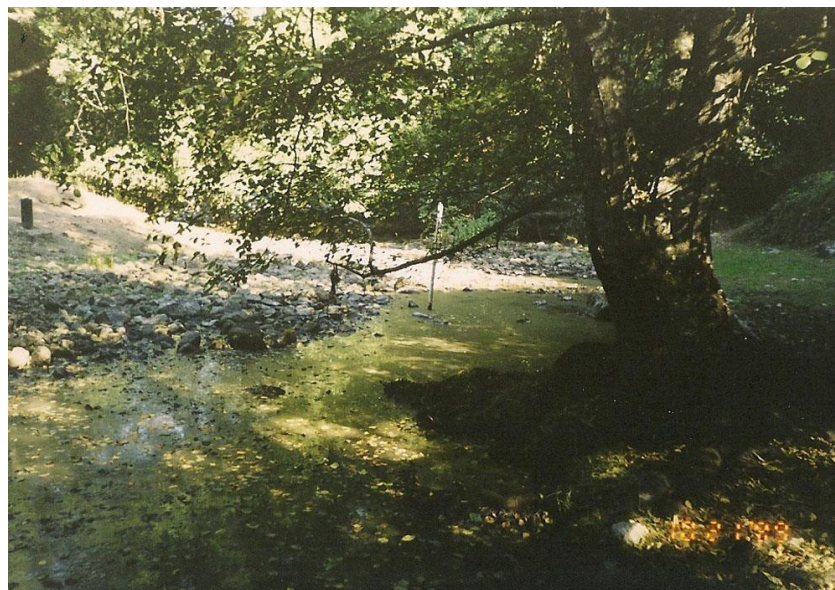
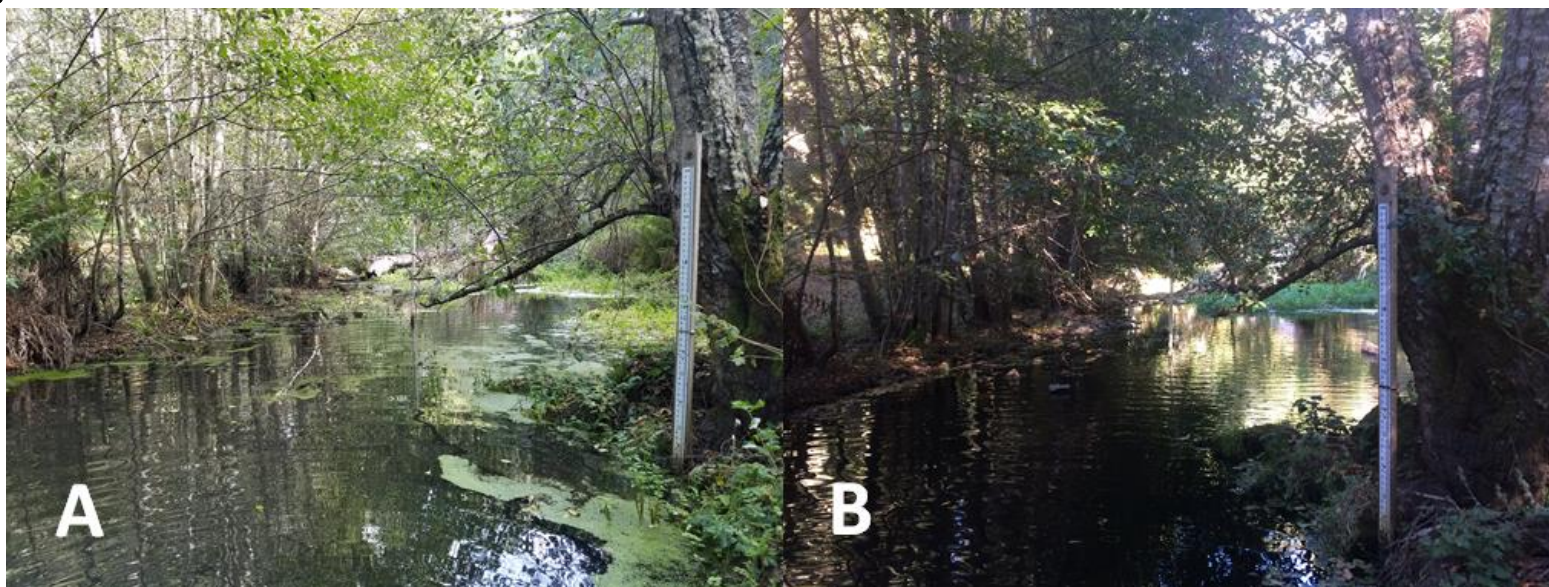
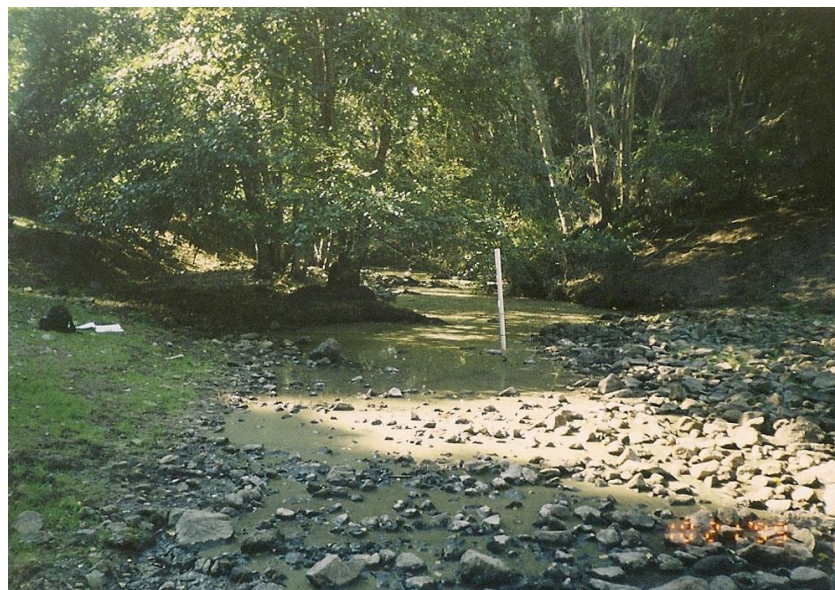
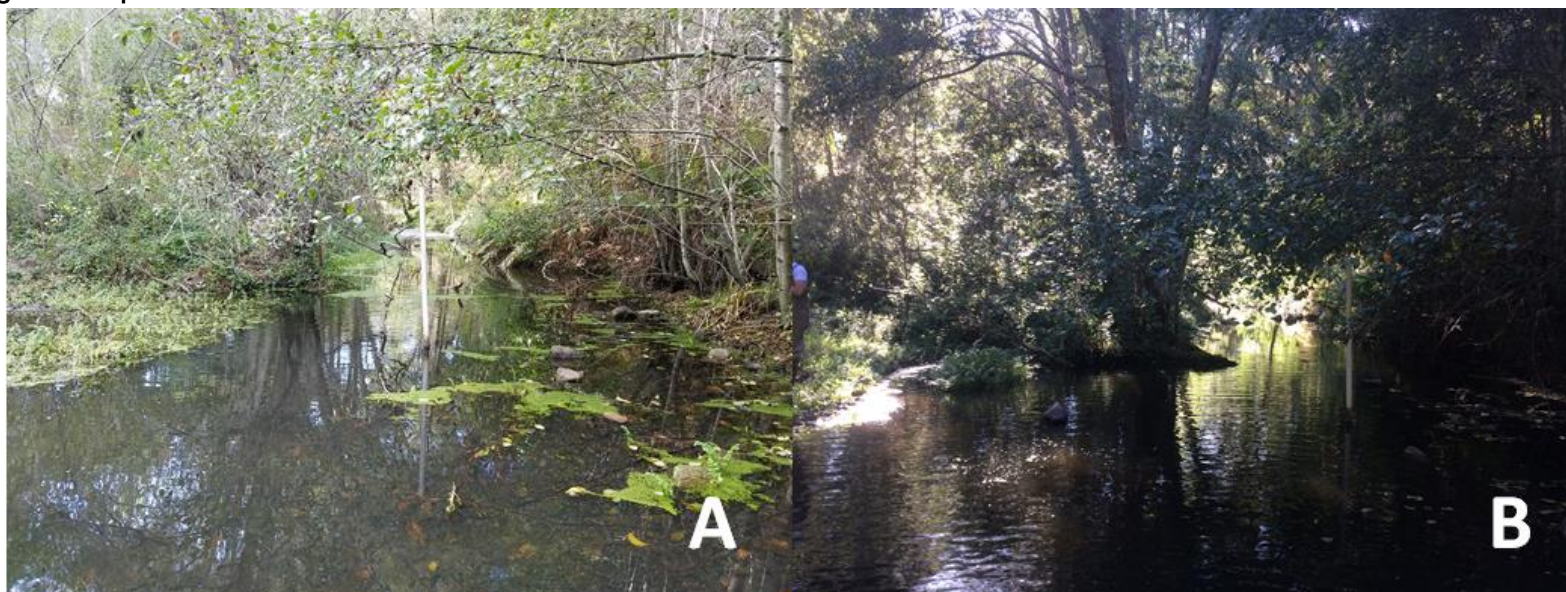
Lower Garzas has an increase in riparian forest growth and channel bank vegetation in 2017 compared to 1999. The channel has widened since 1999, but there is not much change between 2016 and 2017. (Figures 18–21).

Figure 18: Downstream view of Lower Las Garzas Creek in October 1999

Figure 19: Downstream view of Lower Las Garzas Creek on (A) November 4, 2016 and (B) September 17, 2017

Figure 20: Upstream view of Lower Las Garzas Creek in October 1999

Figure 21: Upstream view of Lower Las Garzas Creek in (A) November 4, 2016 and (B) September 17, 2017

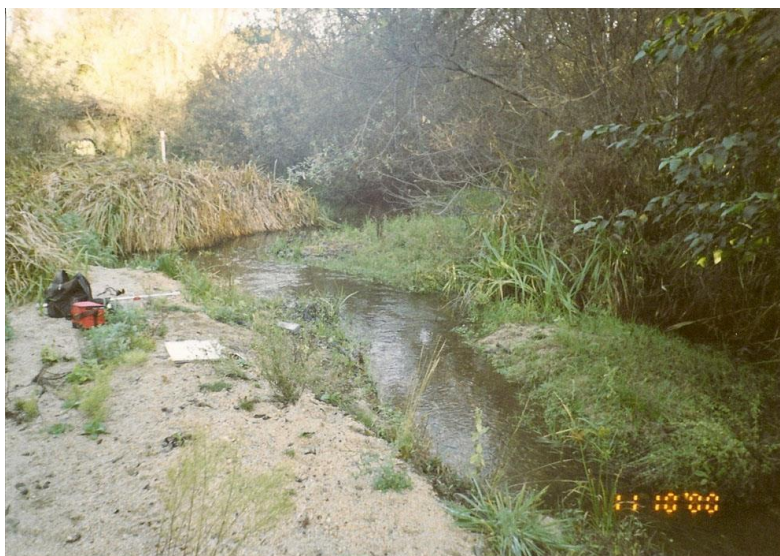
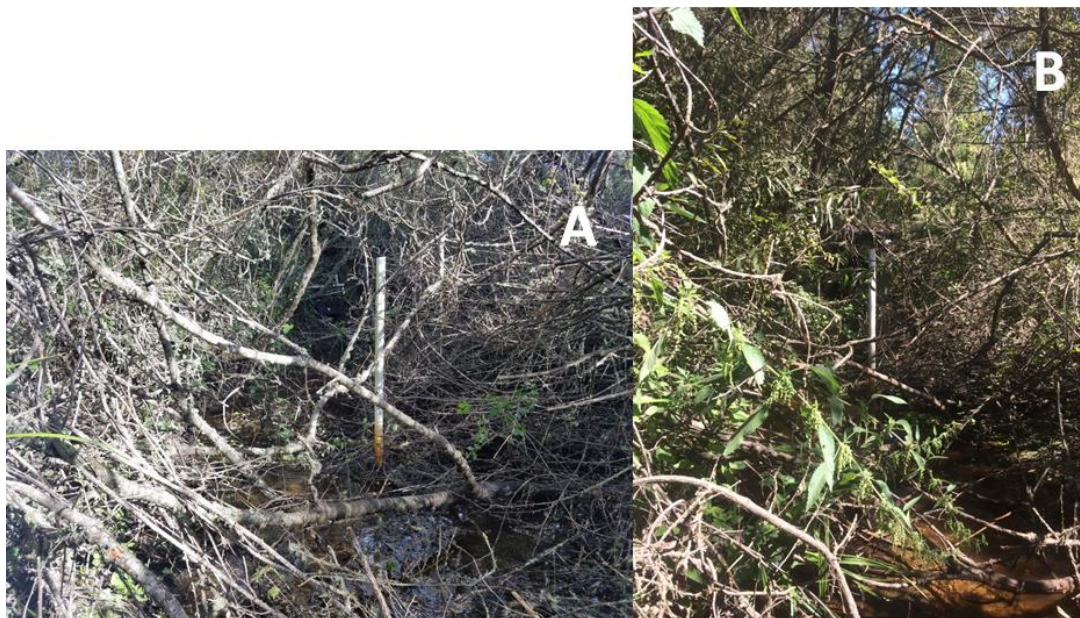
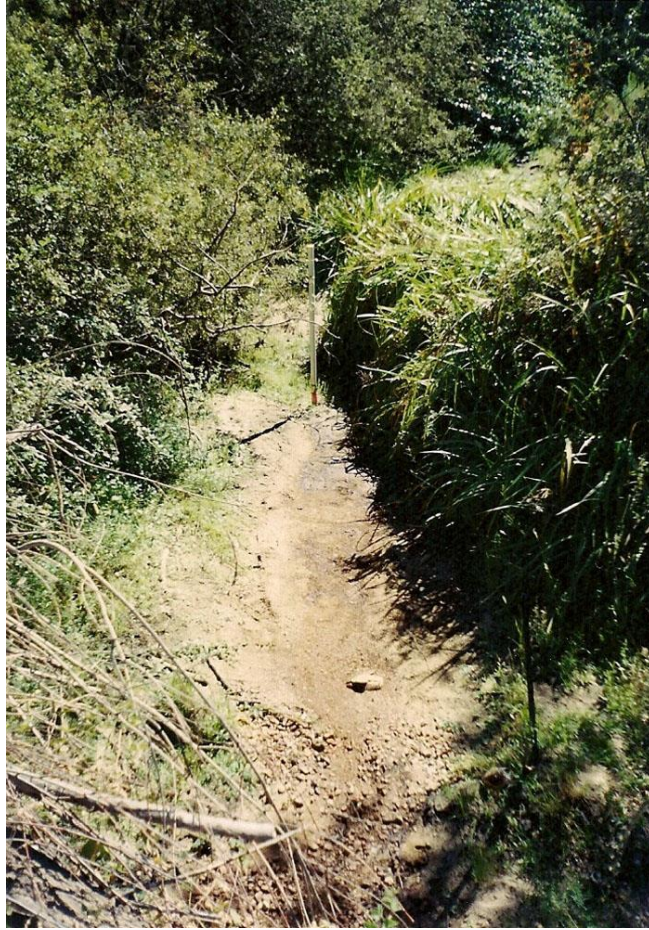
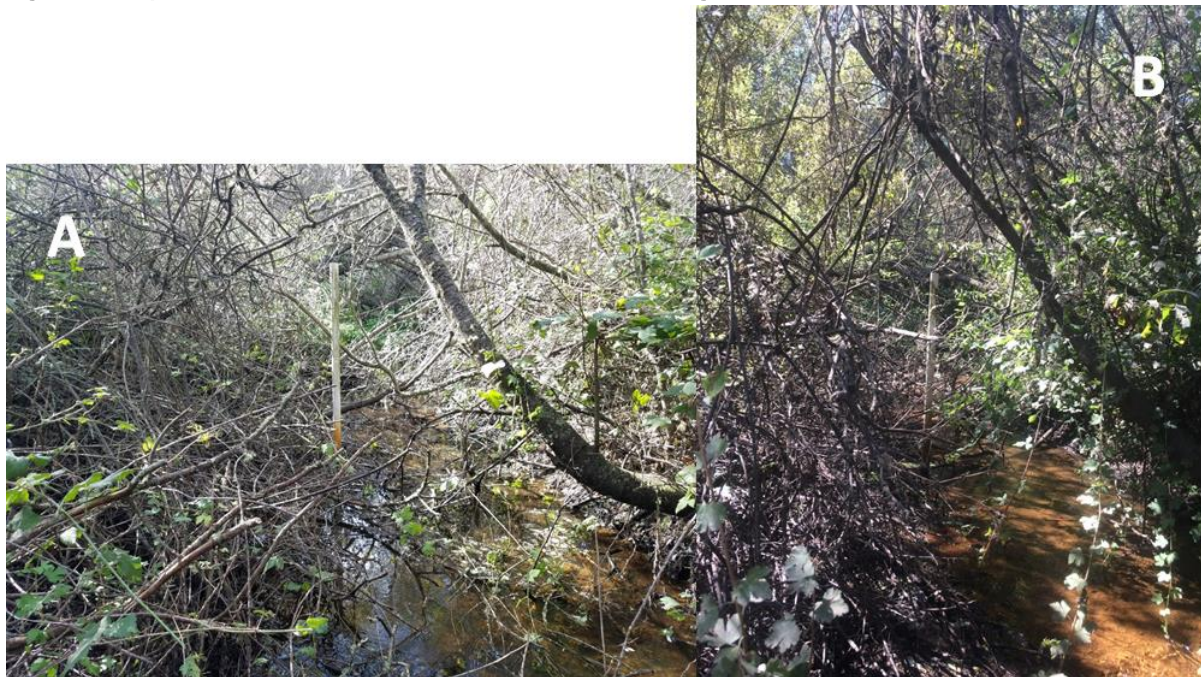
The comparison of the photographs of Middle Garzas is difficult because of the dense vegetation that has accumulated along the channel banks since 2000, but there has been no change. Vegetation type also seems to have shifted from ferns and reeds to larger woody trees and shrubs. (Figures 22–25).

Figure 22: Downstream view of Middle Las Garzas Creek in November 2000

Figure 23: Downstream view of Middle Las Garzas Creek on (A) November 4, 2016 and (B) September 17, 2017

Figure 24: Upstream view of Middle Las Garzas Creek in August 2000 (estimate of date)

Figure 25: Upstream view of Middle Las Garzas Creek on (A) November 4, 2016 and (B) September 17, 2017

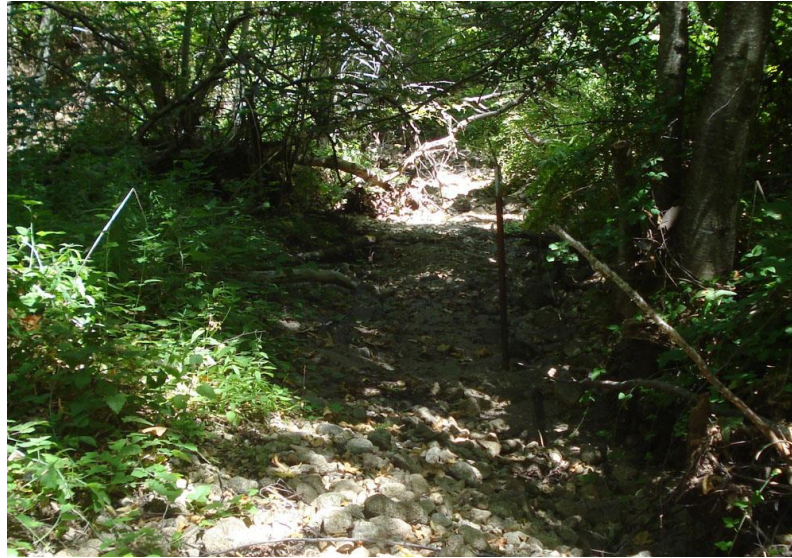
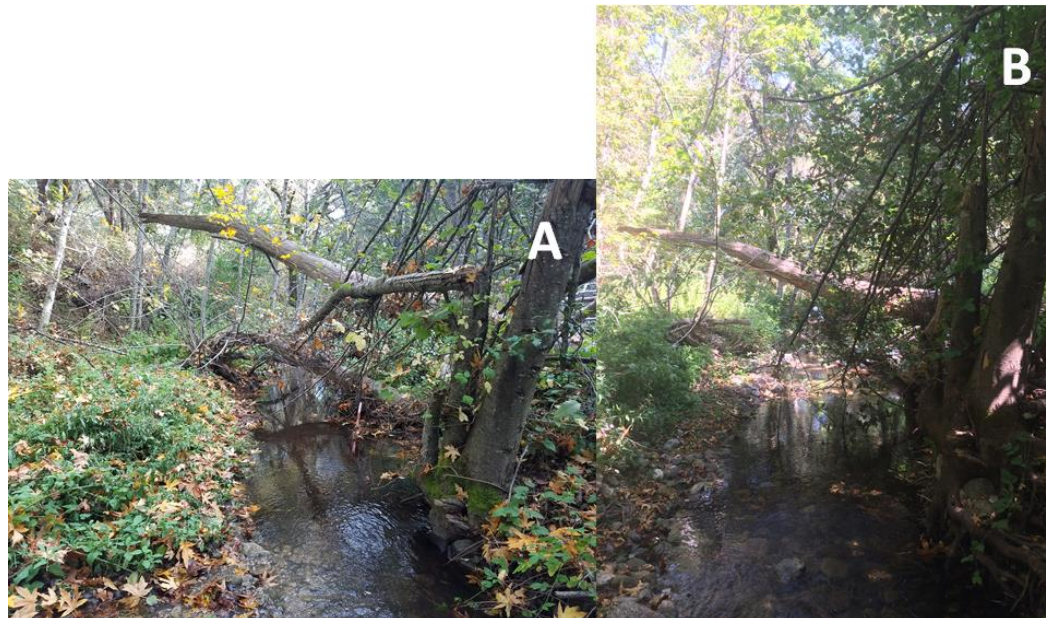
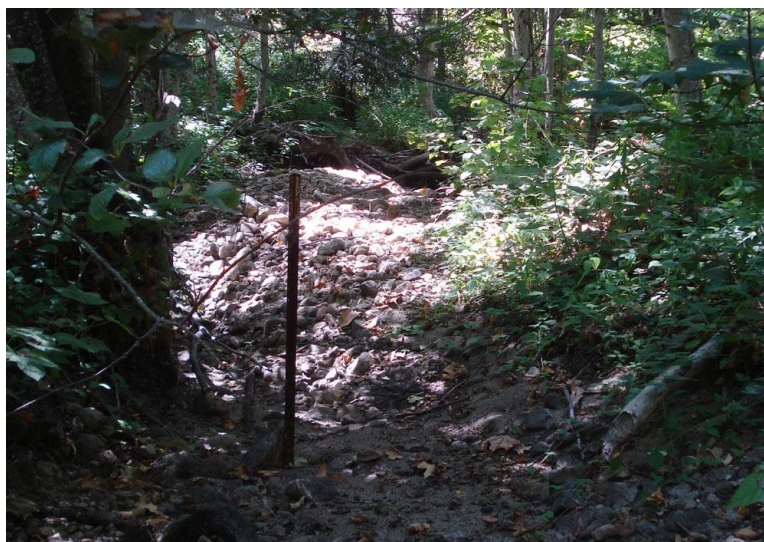
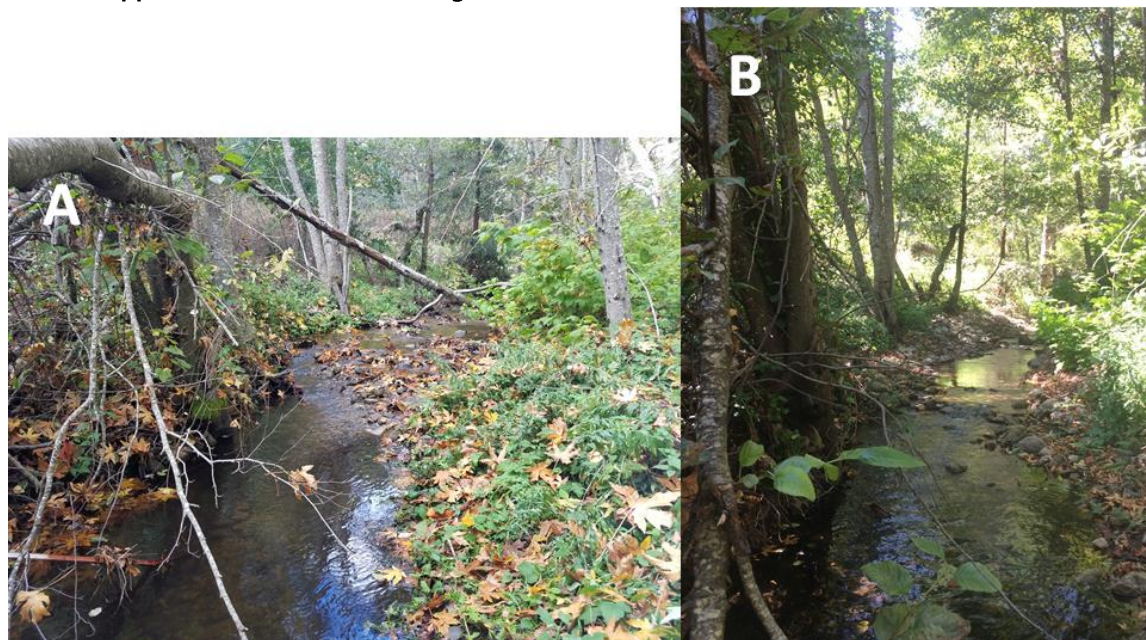
The oldest photograph available for Upper Garzas is from 2009. The rebar at this site has been washed away. There are minor attached side bars in 2017, and the stream has widened slightly between 2016 and 2017. (Figures 26–29).

Figure 26: Downstream view of Upper Las Garzas Creek in August 2009

Figure 27: Downstream view of Upper Las Garzas Creek on (A) November 4, 2016 and (B) September 17, 2017

Figure 28: Upstream view of Upper Las Garzas Creek in August 2009

Figure 29: Upstream view of Upper Las Garzas Creek on (A) November 4, 2016 and (B) September 17, 2017

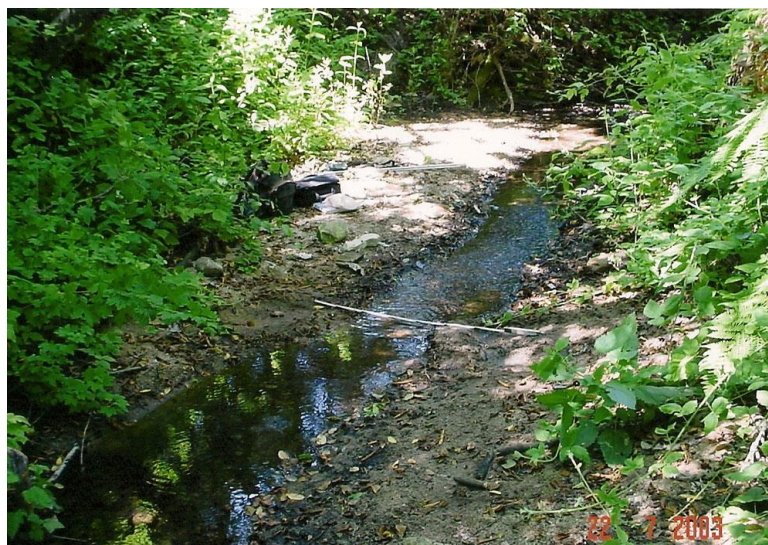
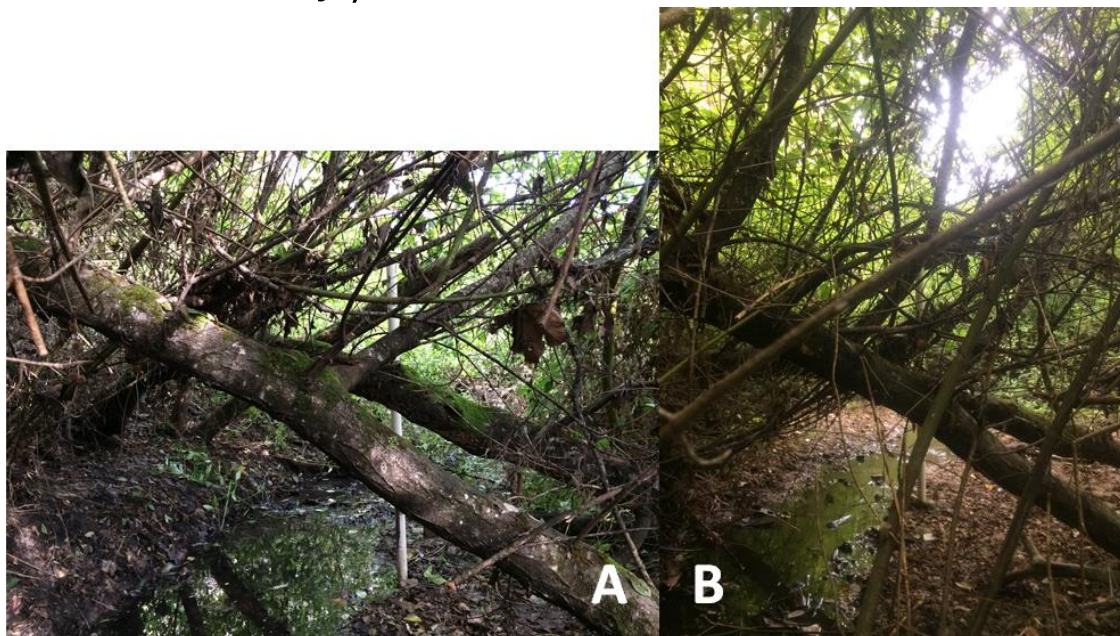
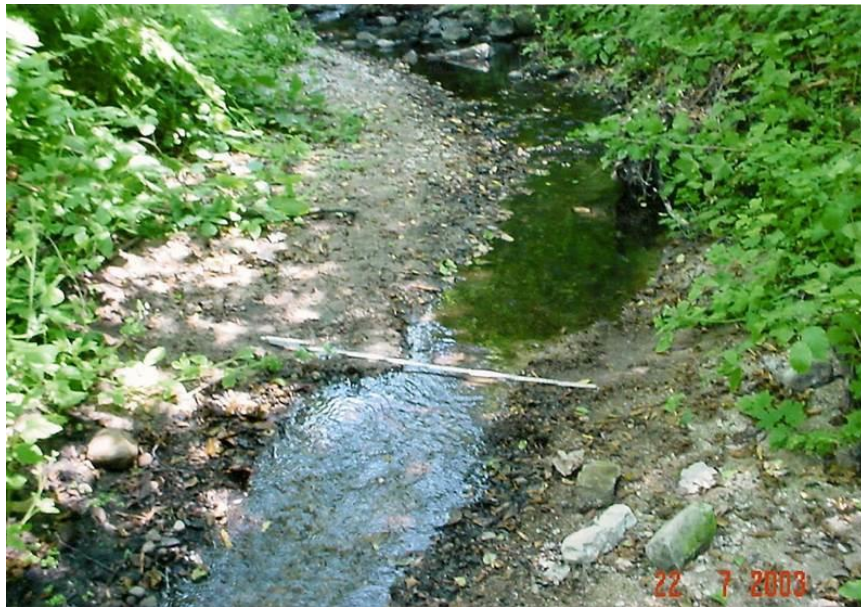
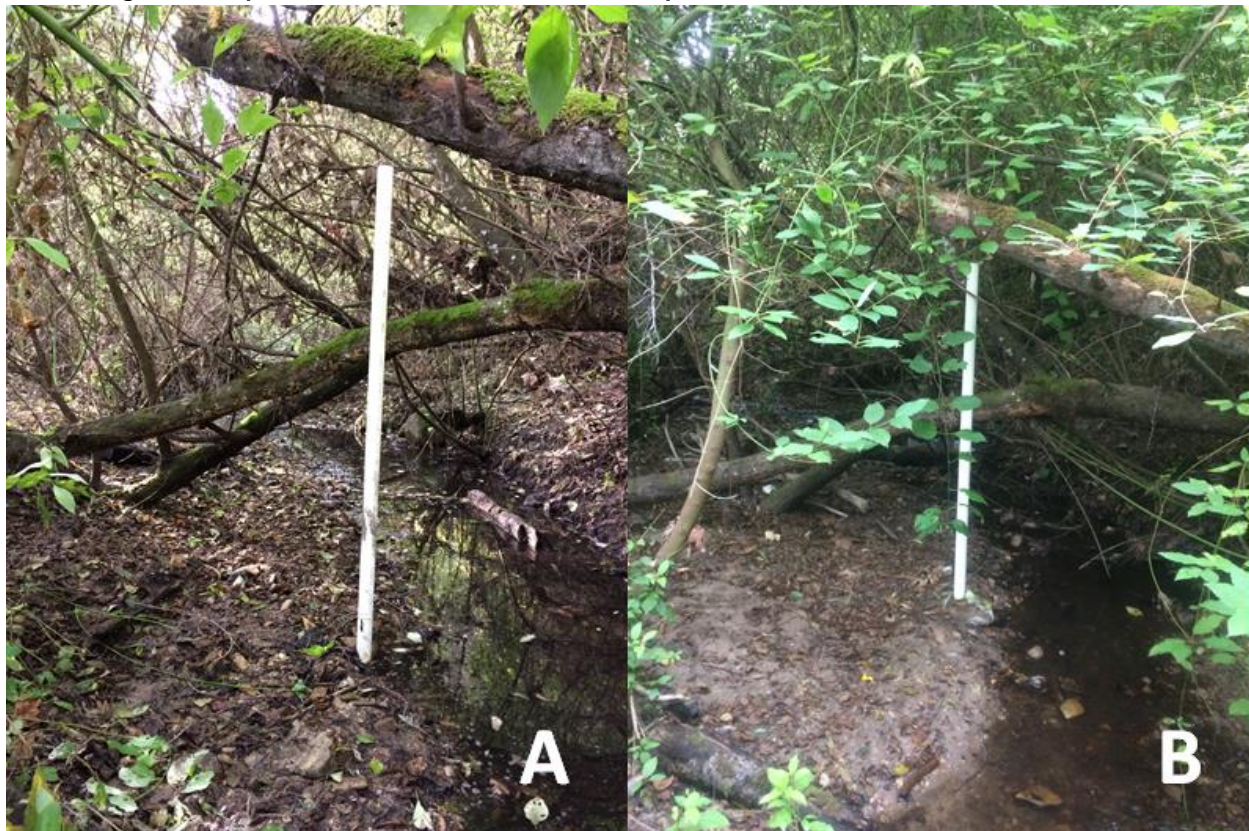
There has been an increase in dense riparian vegetation from 2003 and 2017. There have been no significant changes in the channel since 2003, and particle size appears to remain constant (Figures 30–33).

Figure 30: Downstream view of Potrero Creek in July 2003

Figure 31: Downstream view of Potrero Creek on (A) November 4, 2016 and (B) September 17, 2017

Figure 32: Upstream view of Potrero Creek in July 2003

Figure 33: Upstream view of Potrero Creek on (A) November 4, 2016 and (B) September 17, 2017
