Report No. WI-2013-03
17 April 2013

2012 Water Quality and Photo Monitoring

Santa Lucia Preserve,
Monterey County, California

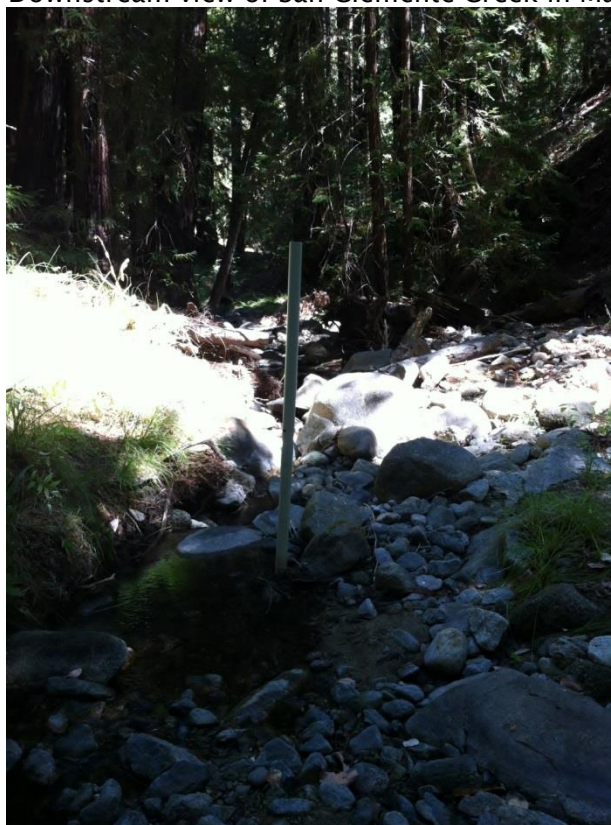
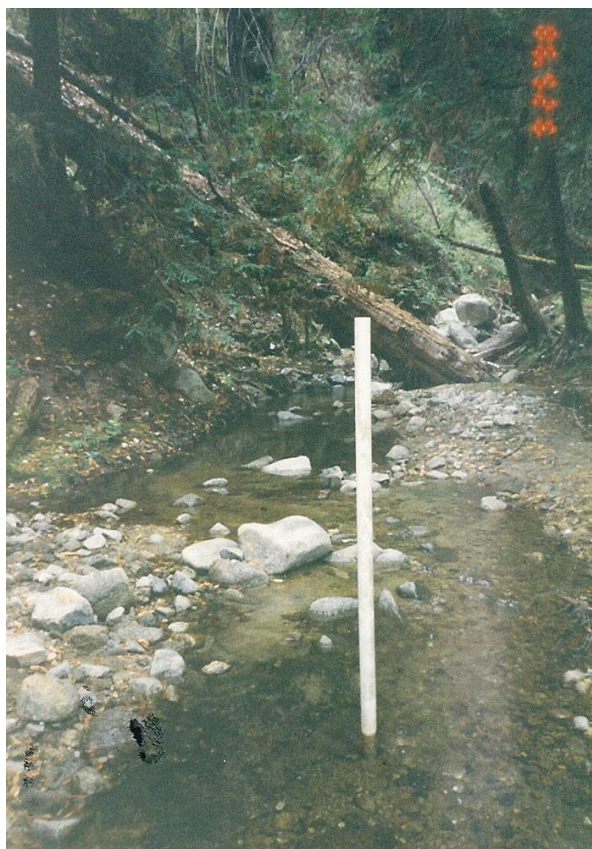
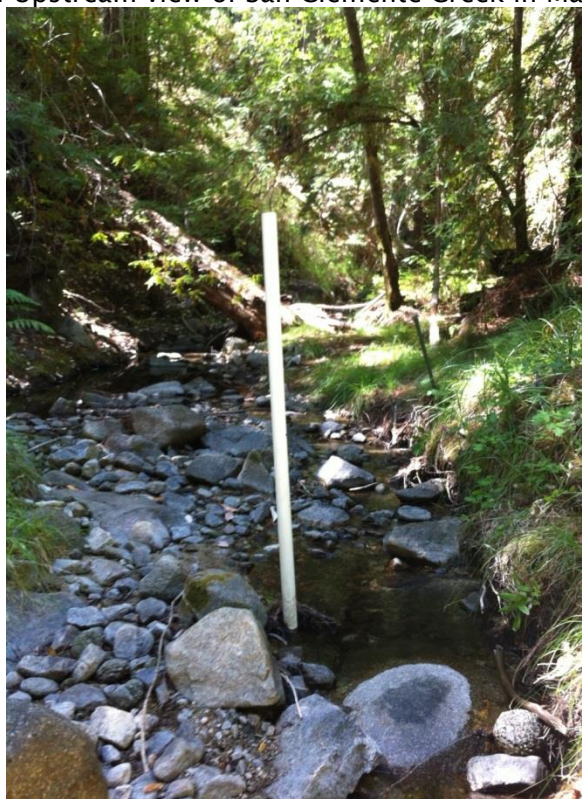
San Clemente has more cobbles and boulders visible in the channel and floodplain in 2012 than in 1998 in both upstream and downstream views. There are also fewer patches of smaller gravel and fines. The physical rearrangement of boulders in the photos indicates that large particles have been transported into place as well as being exhumed by the removal of finer sediment deposits. In 1998 there was a woody debris accumulation across the channel that is much smaller in 2012. In the upstream view, the bar on the left bank, at the base of the downed Redwood tree, has stabilized and grown over with grassy vegetation (Figures 2–5).

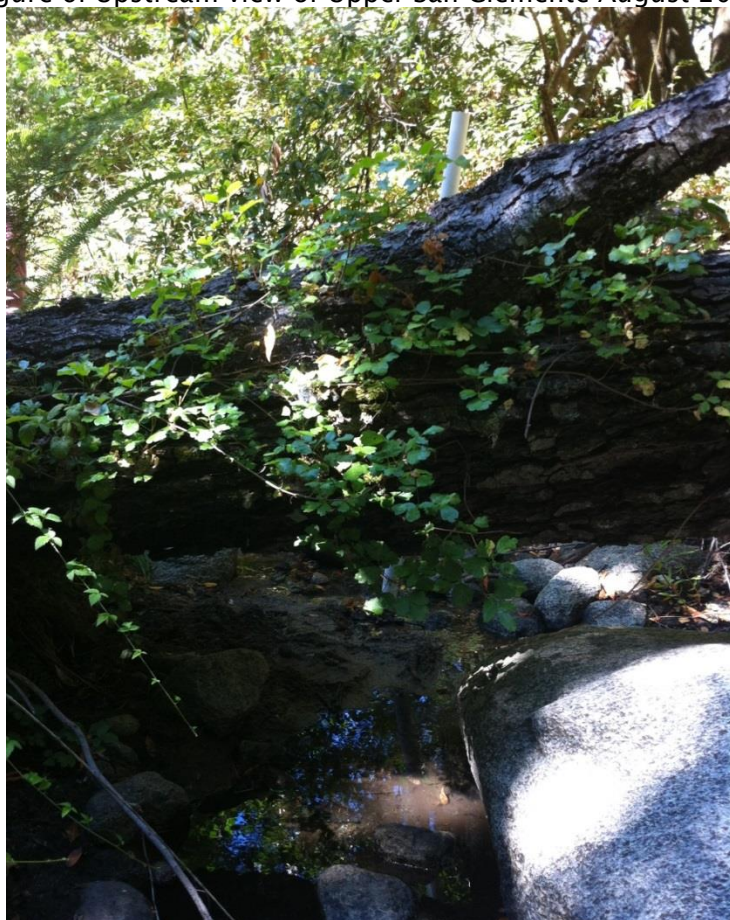
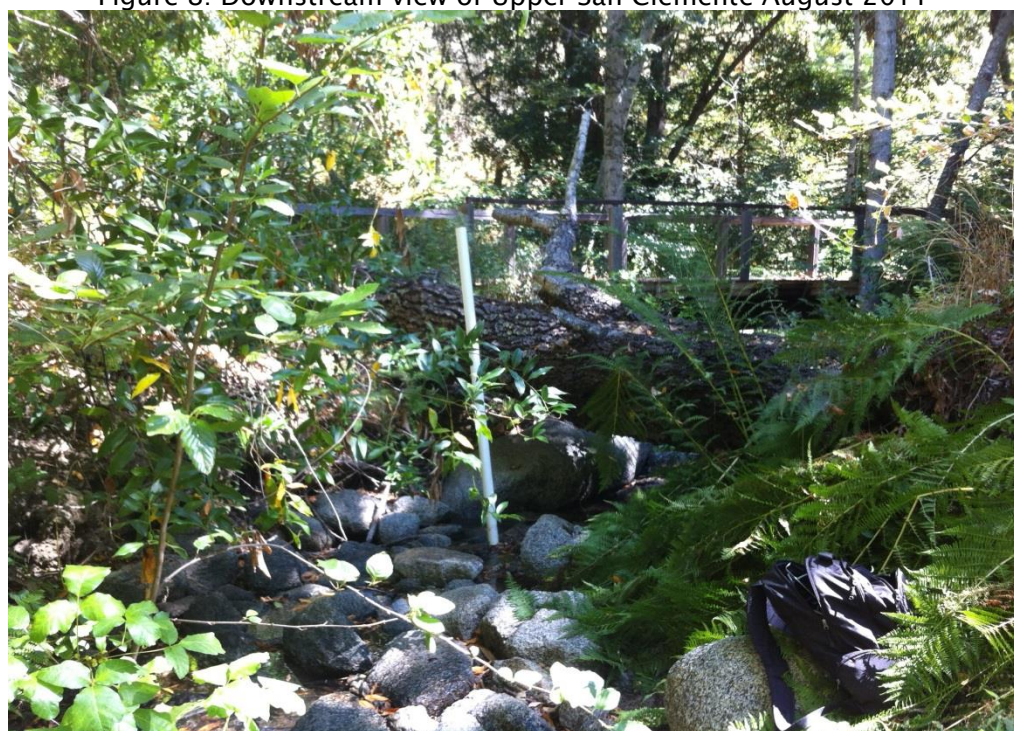
The site was established in 2011. There have been no major changes in the channel from 2011 to 2012. There are large boulders in the stream bed, dense vegetation and coarse woody debris (Figure 6–9).

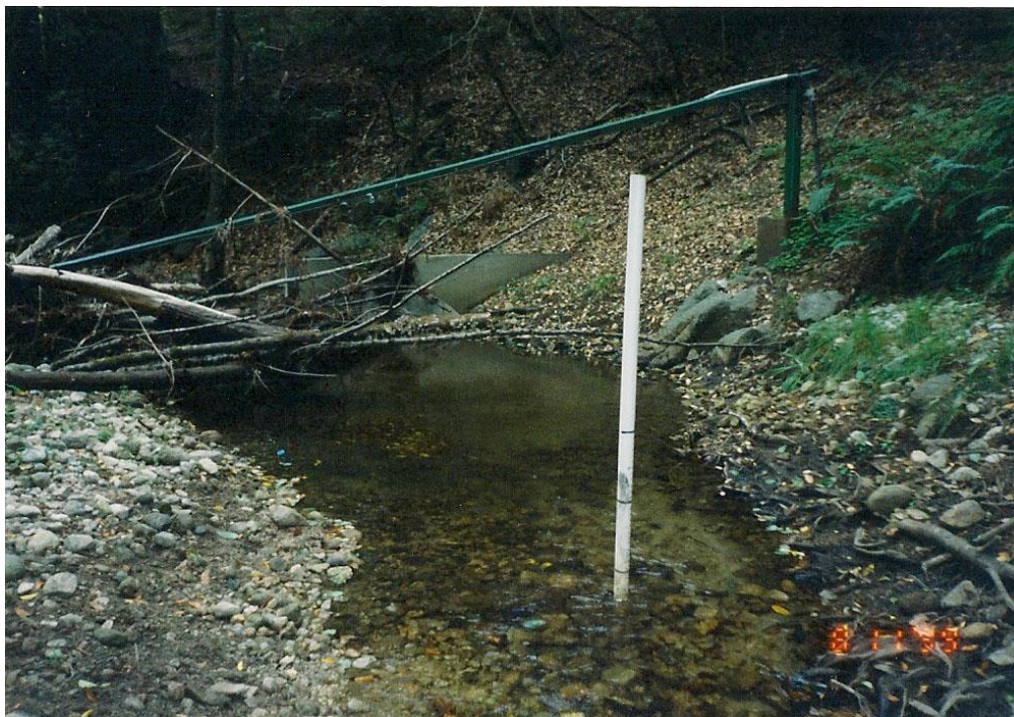
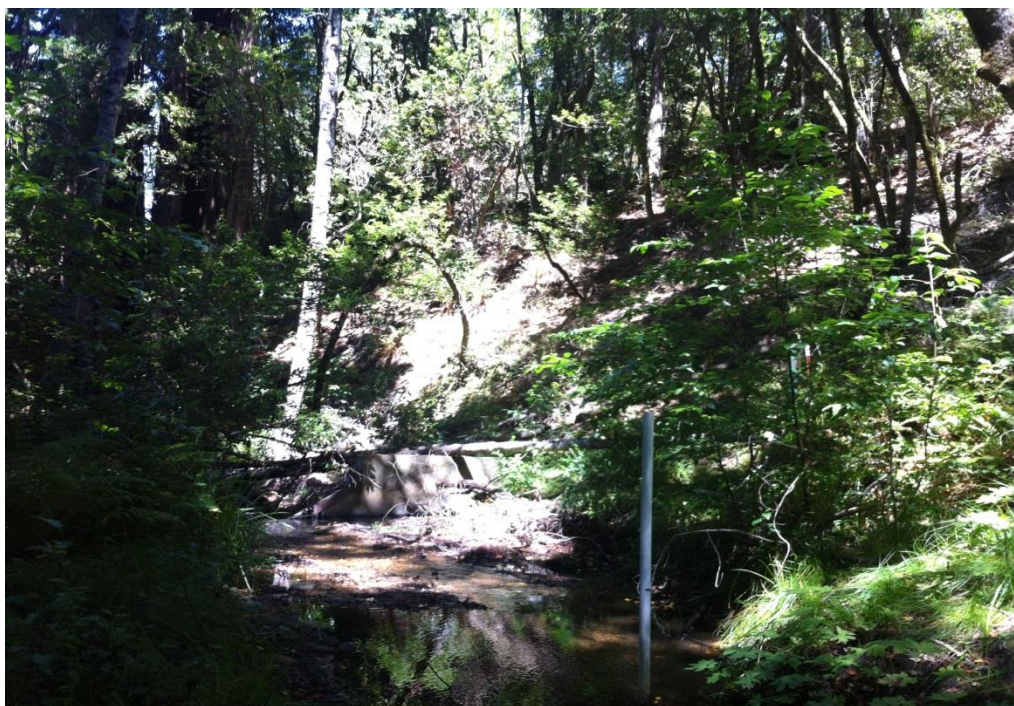
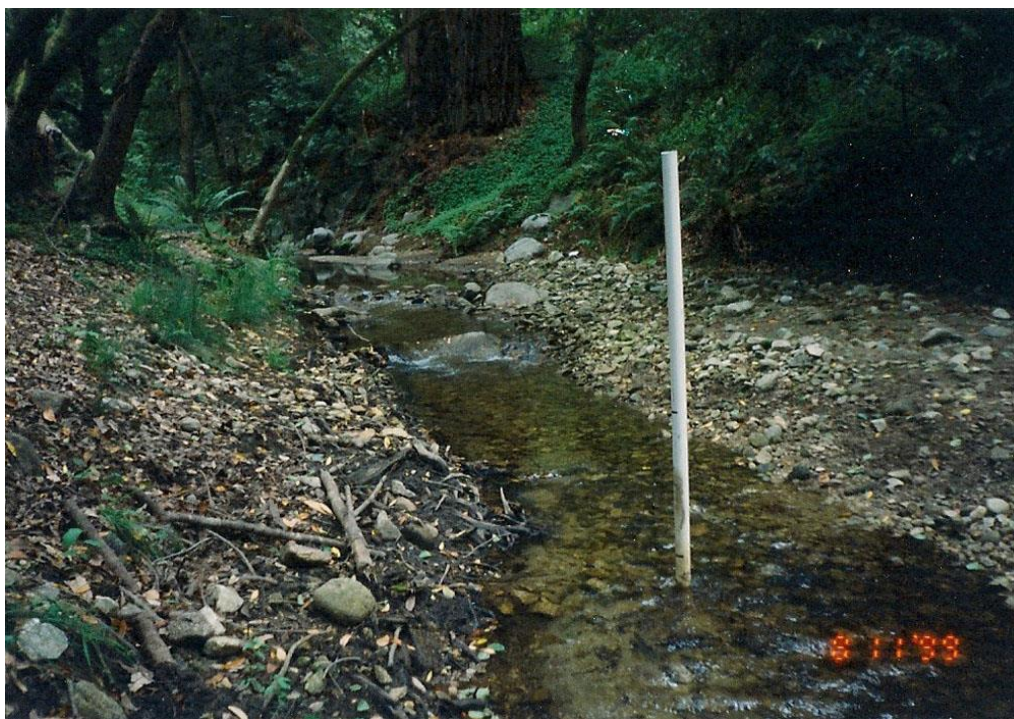
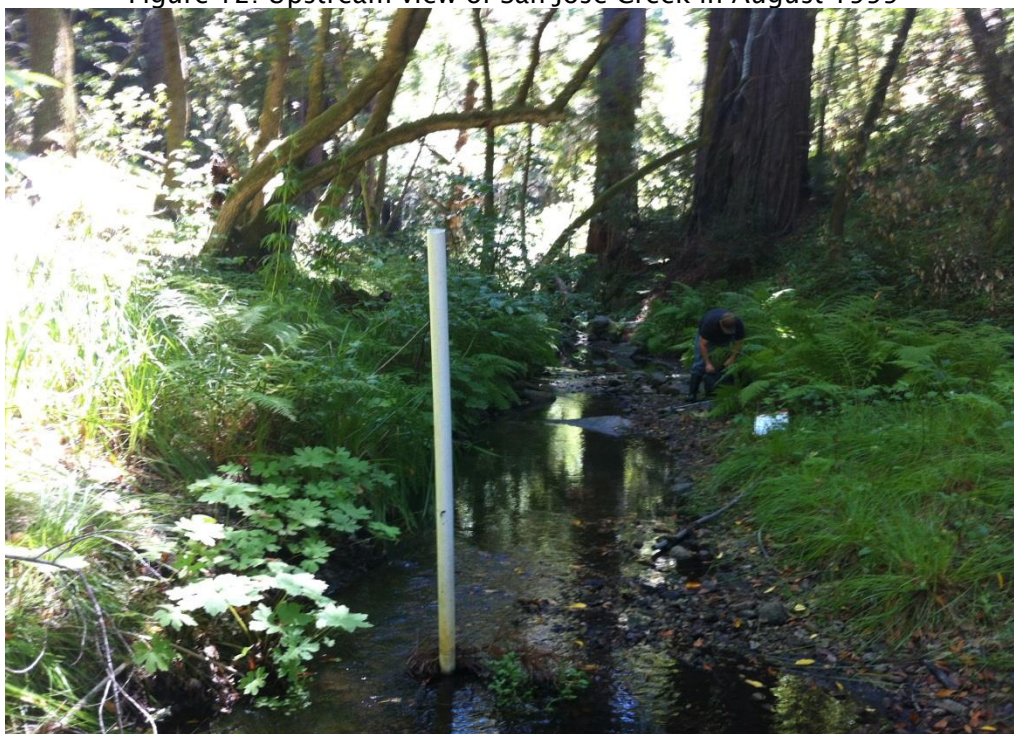
San Jose has had an increase in vegetation in 2012 compared to 1999 in both upstream and downstream views. The increased vegetation has stabilized the channel banks and visible bar. There is large woody debris moving through the system, as old debris visible in 1998 is replaced with new debris in 2012. Local changes include fine particle deposition where there was woody debris in 1999, visible on the left bank in the downstream and upstream photos and fewer cobbles (Figures 10–13).

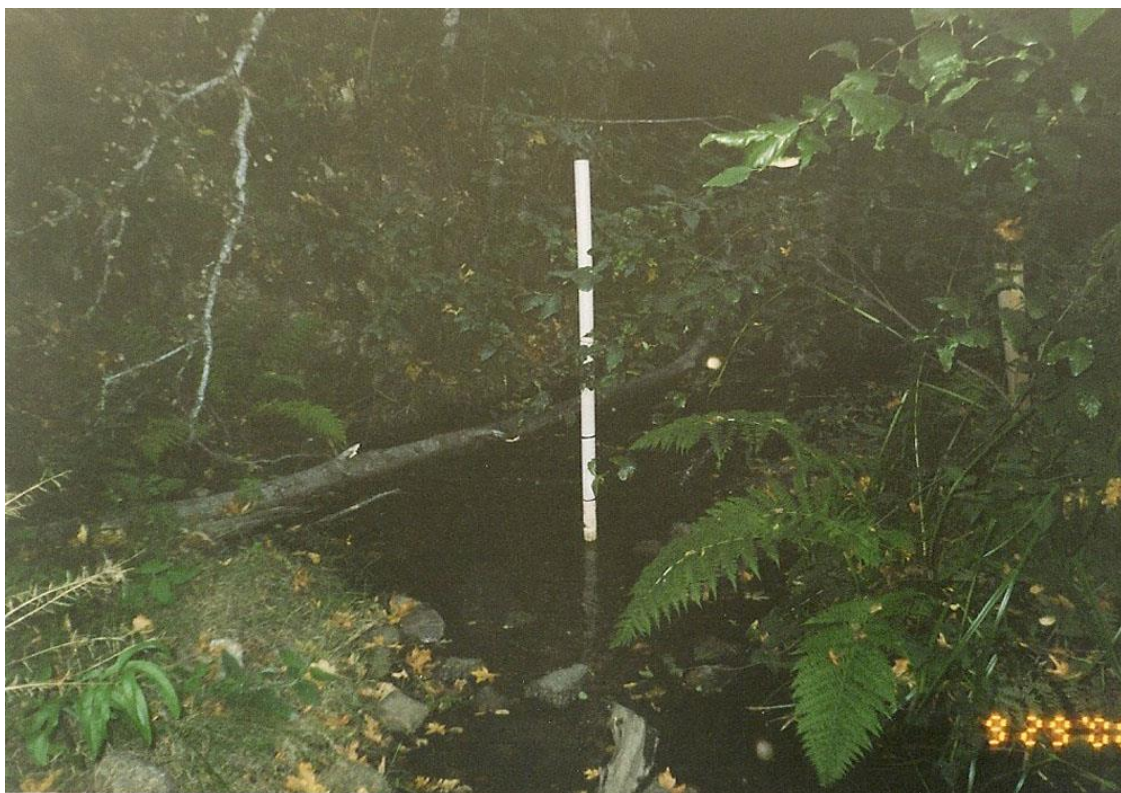
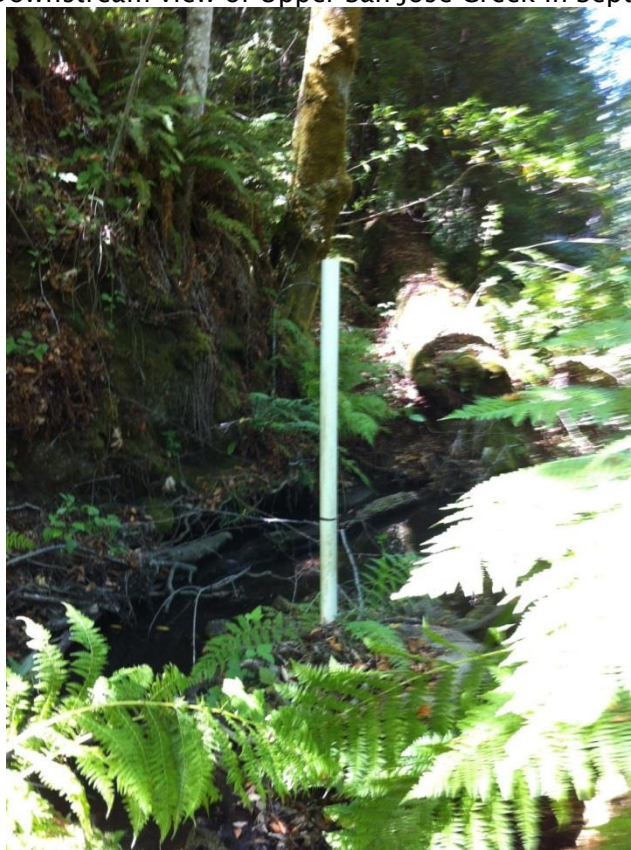
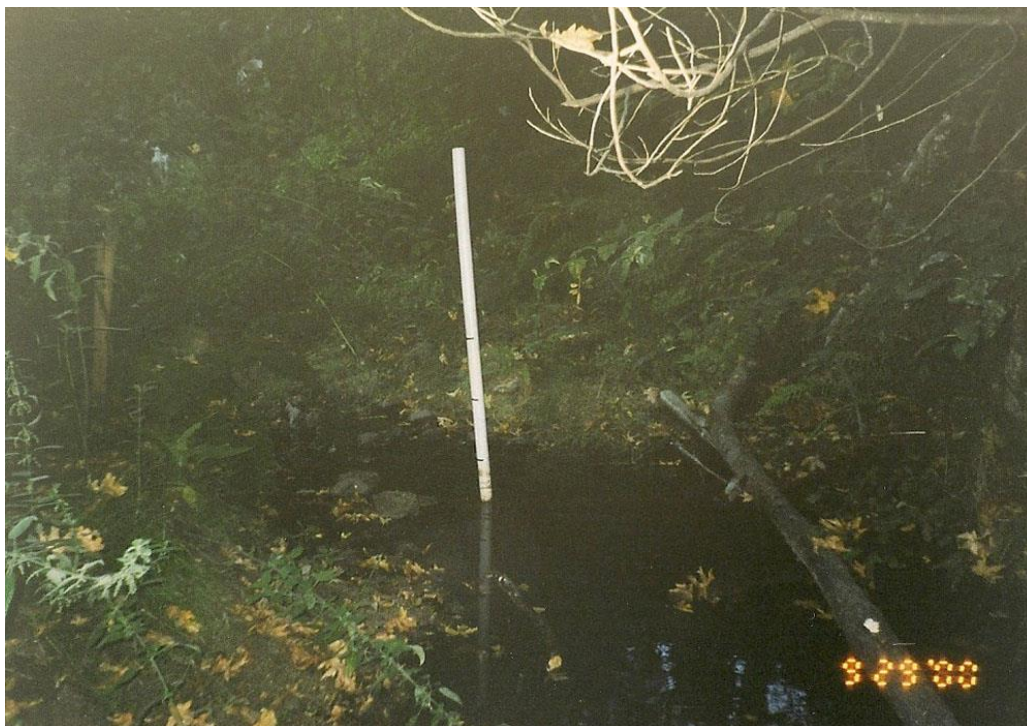
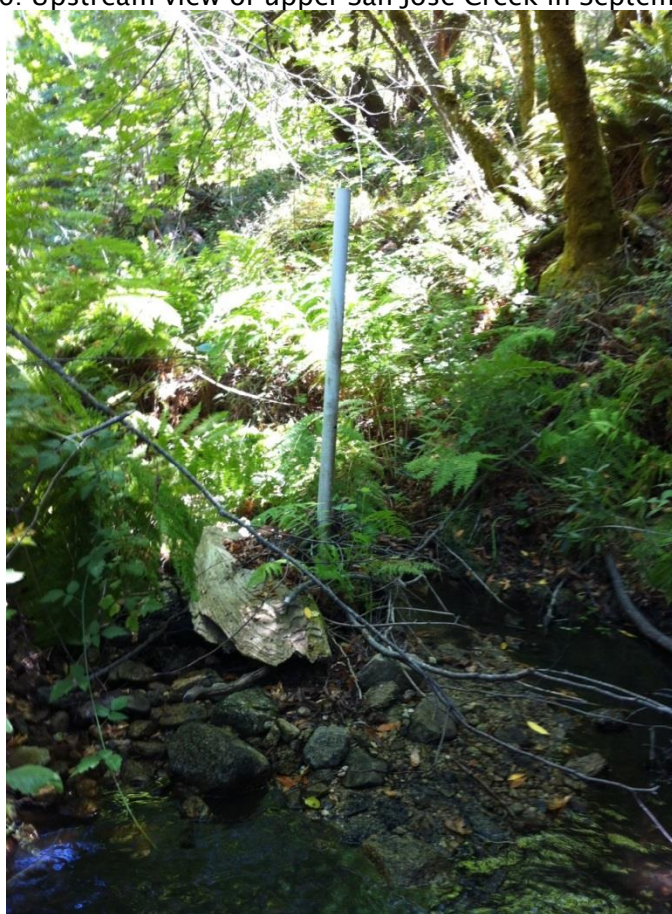
It is difficult to analyze potential change at Upper San Jose because of the dark nature of the photographs from 2000. There is a new cobble bar near the photo monitoring post visible in 2012. There has been an increase in vegetation from 2000 to 2012. There has also been an accumulation of woody debris on the upstream side of the new cobble bar (Figures 14–17).

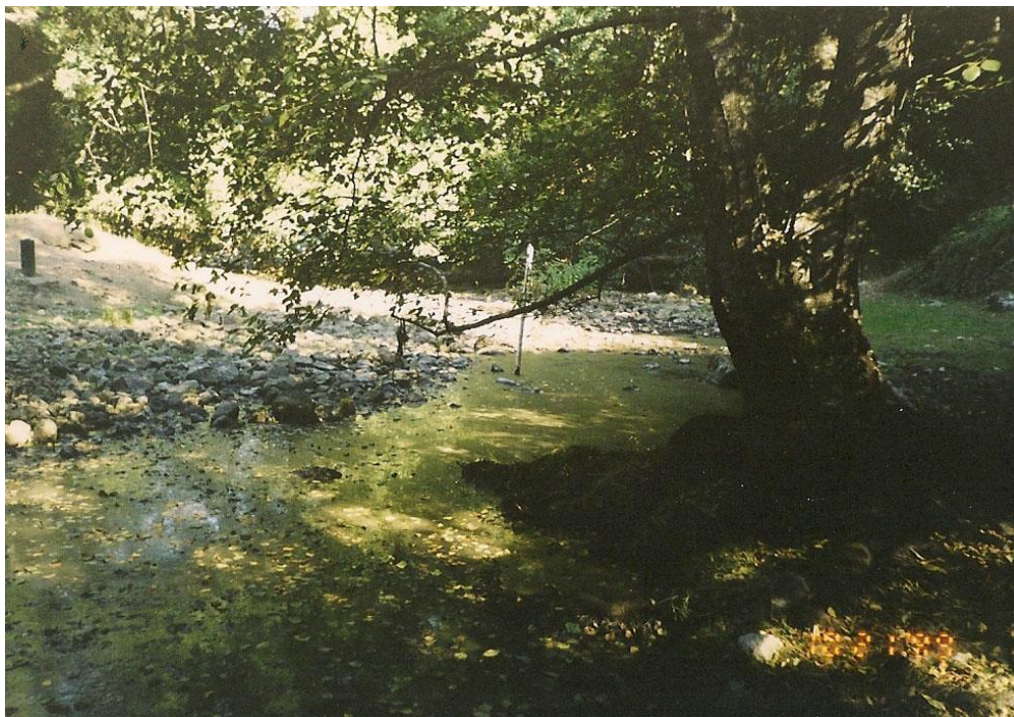
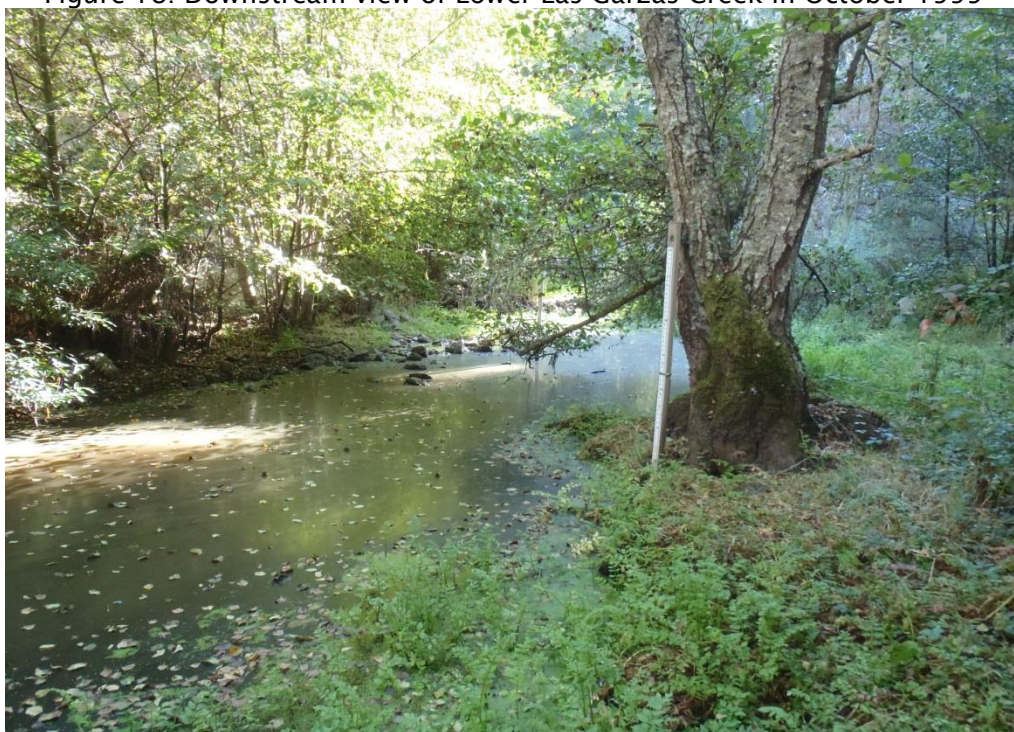
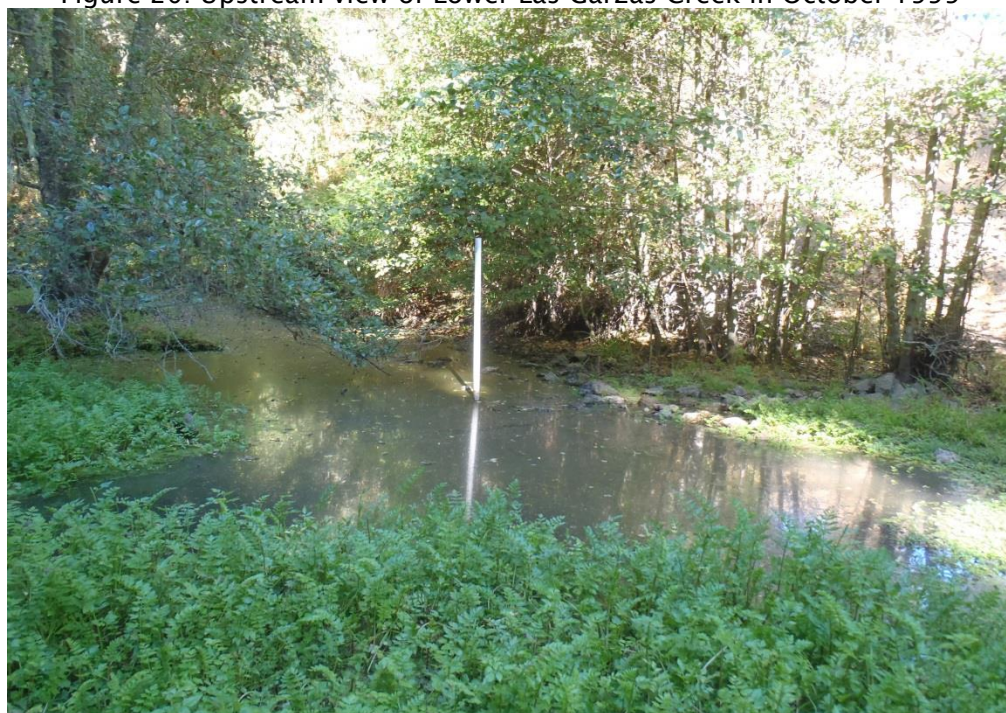
Lower Garzas has an increase in riparian forest growth and channel bank vegetation in 2012 compared to 1999. There is an accumulation of woody debris, not shown in the photographs, that has created a pool where there was a riffle in 1999 (Figures 18–21).

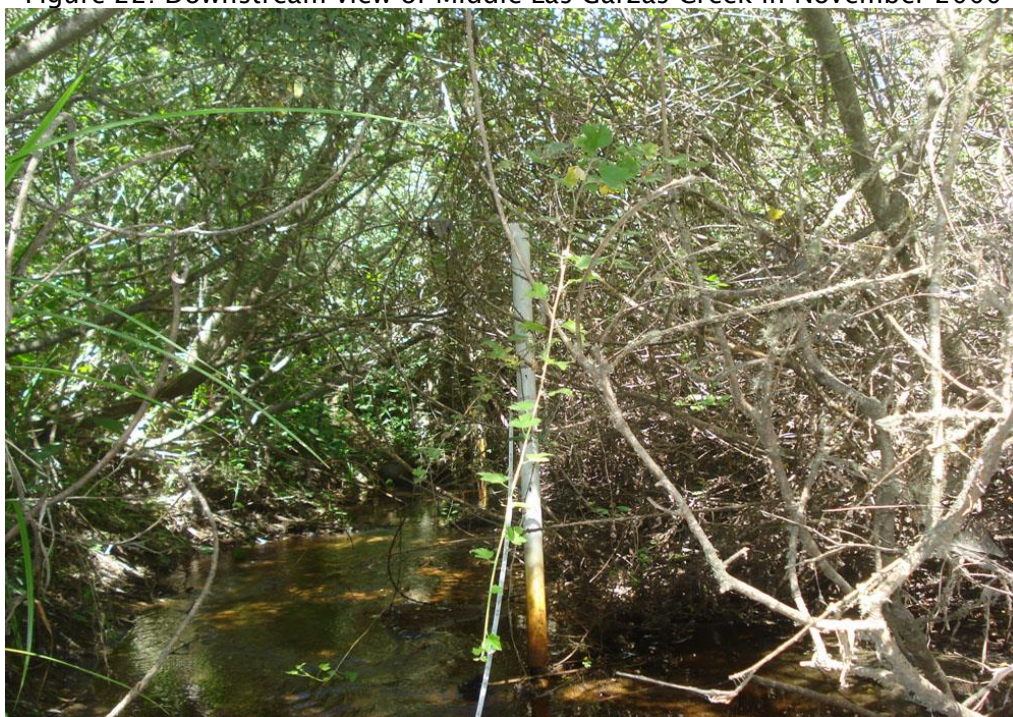
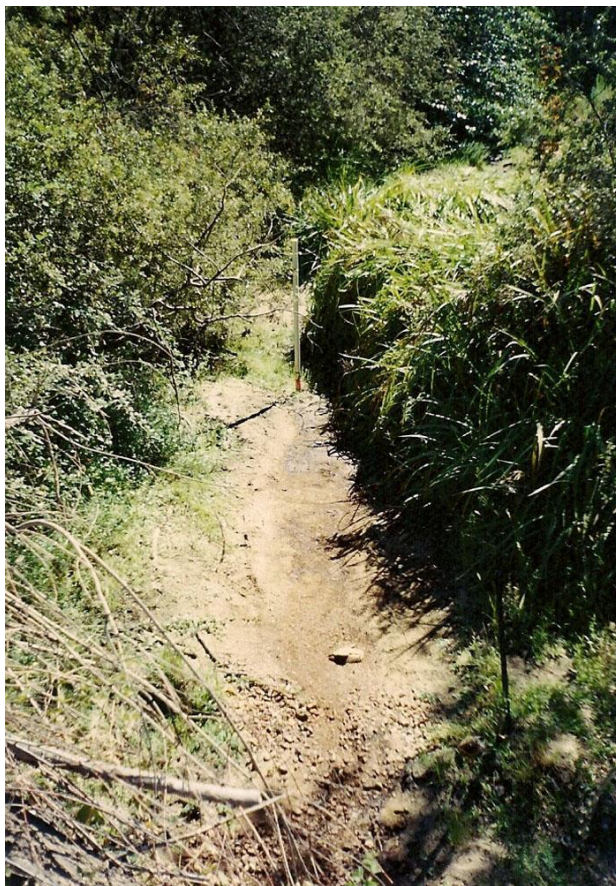
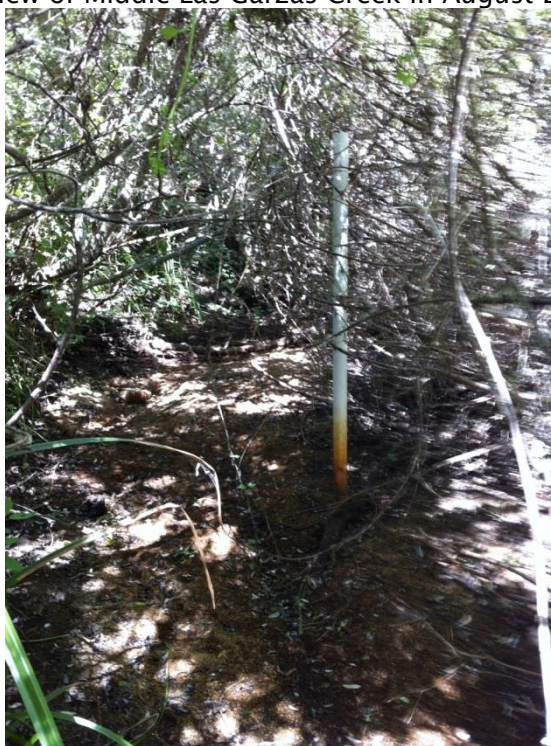
The comparison of the photographs of Middle Garzas is difficult because of the dense vegetation that has accumulated along the channel banks. A steep channel bank is visible on the left bank in the upstream photo from 2012, which suggests potential degradation of the stream channel (Figures 22–25).

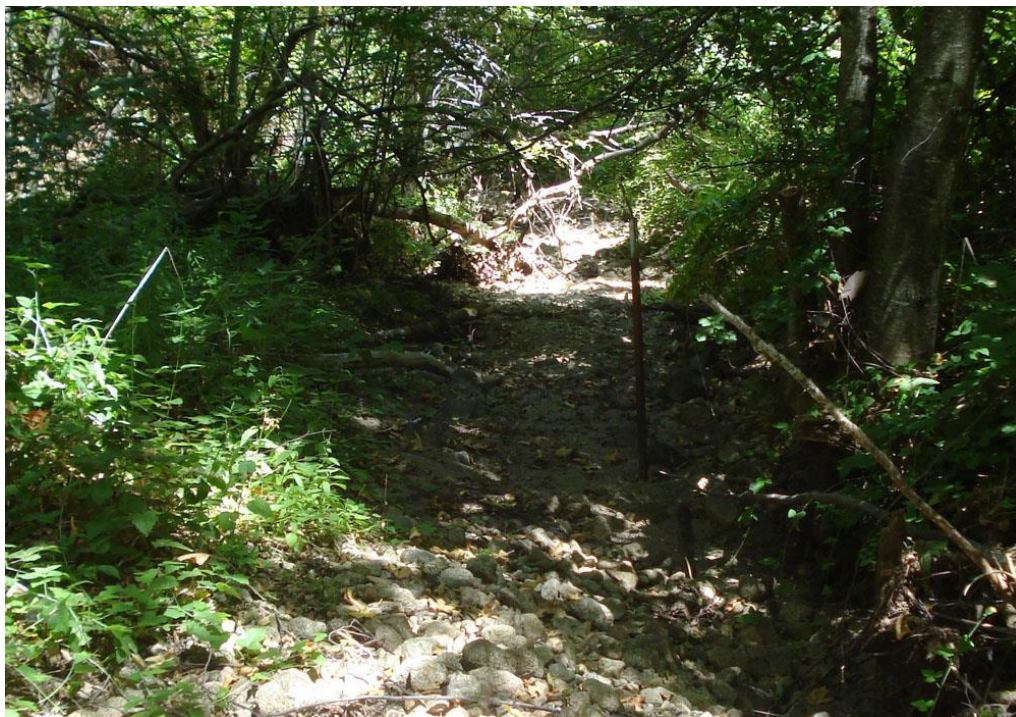
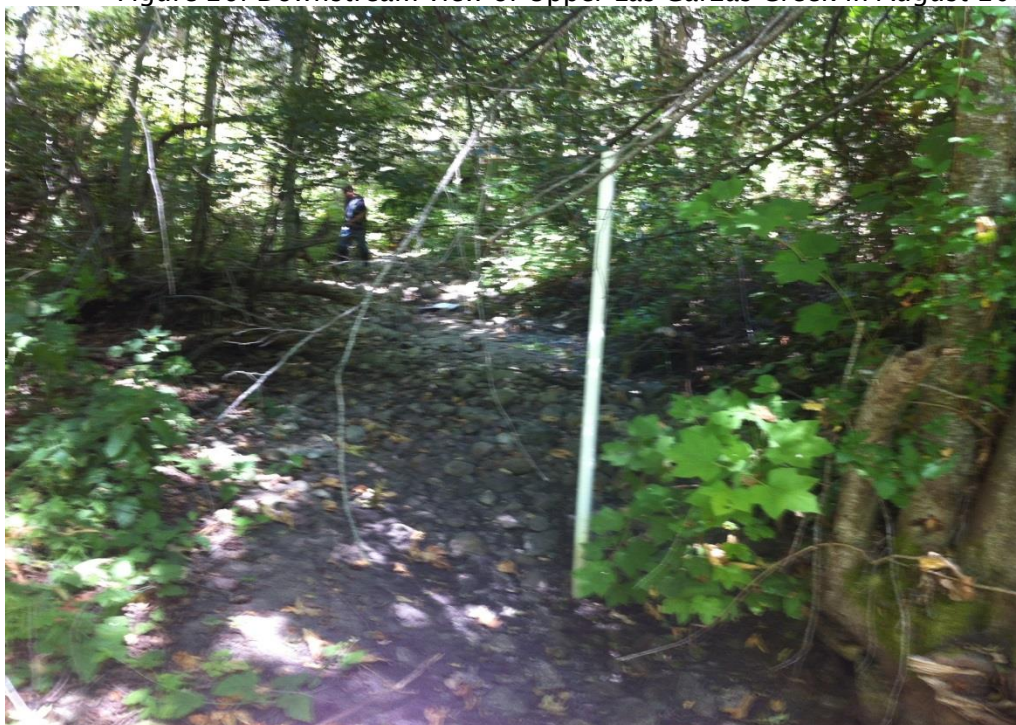
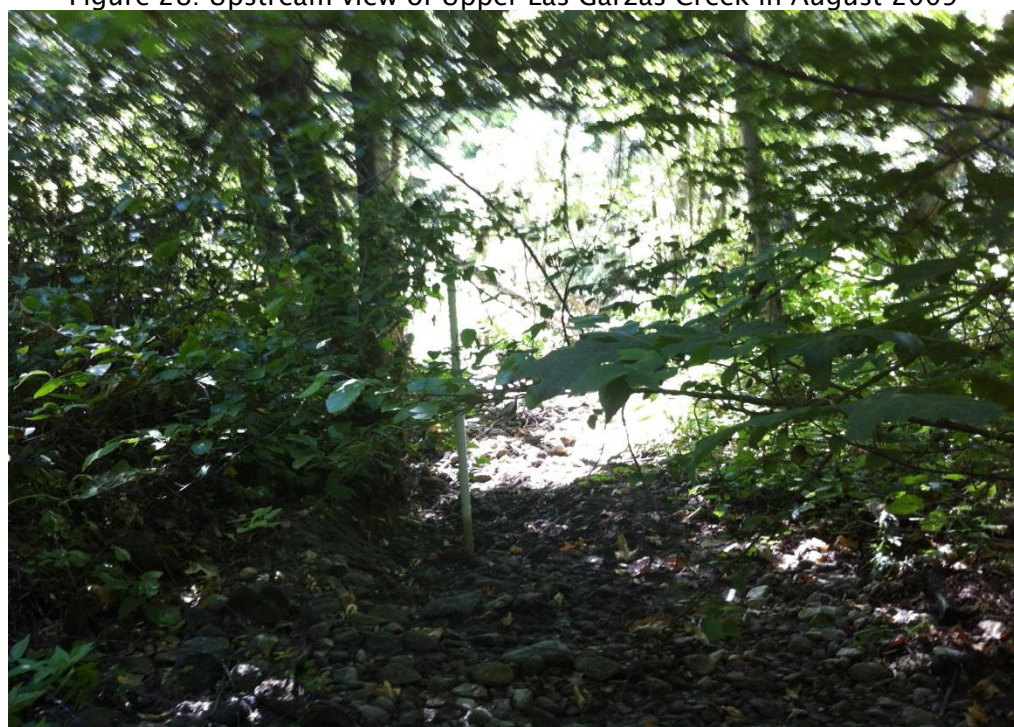
The oldest photograph available for Upper Garzas is from 2009. There have been no visible changes apparent from photo monitoring in 2009 and 2012 (Figures 26–29).

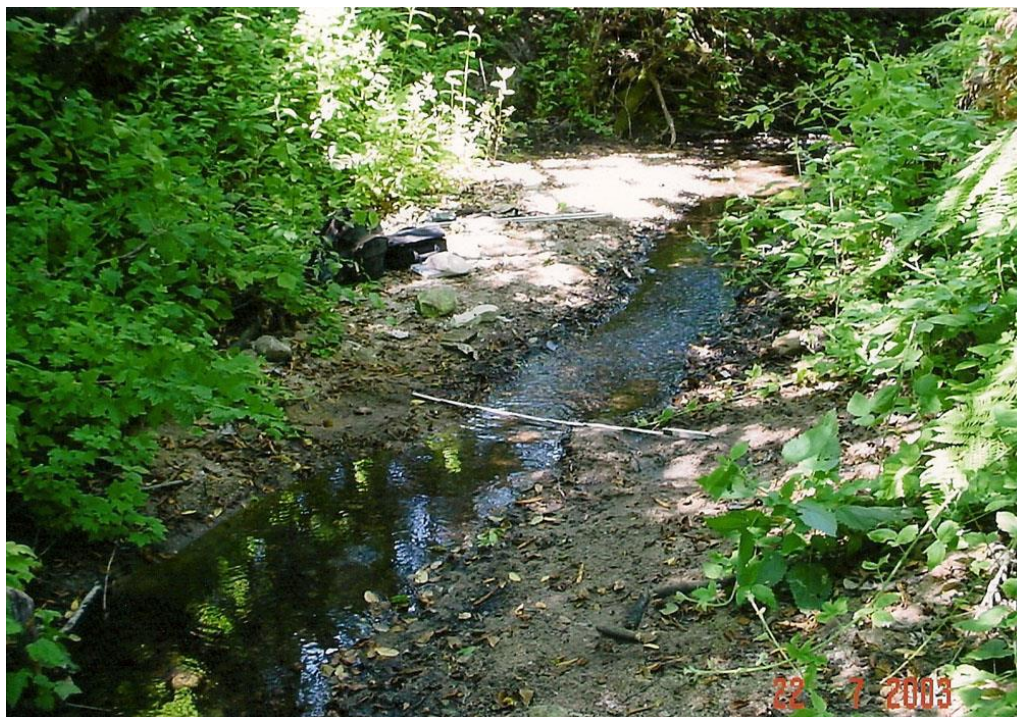
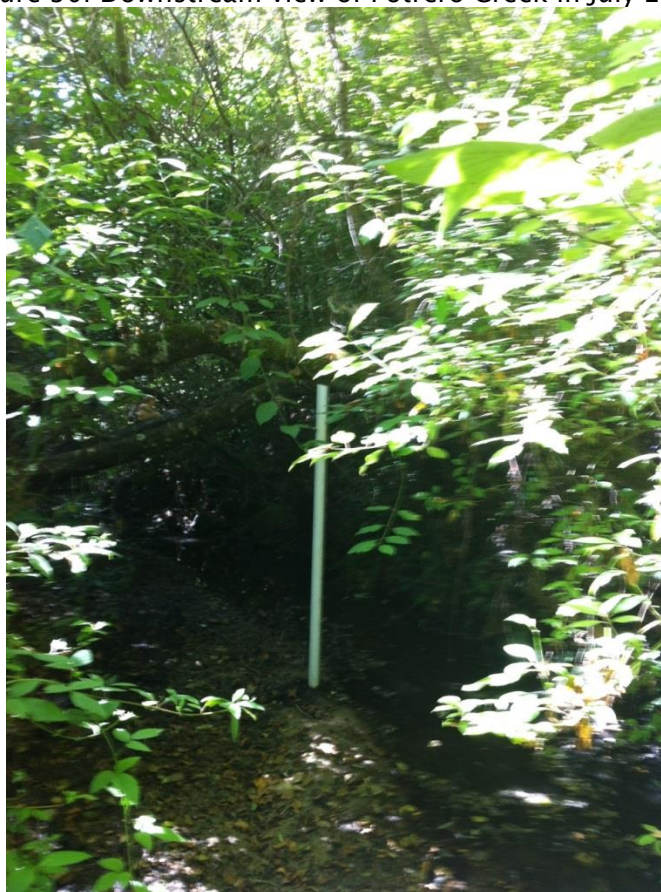
The Potrero channel has shifted from the right bank to the left bank between 2003 and 2012. The channel change is visible in the downstream photo and the exposed sand bar. There are no other notable visible changes. Vegetation and particle size appear to remain constant (Figures 30–33).
