Report No. WI-2014-10  
31 October 2014

## 2014 Water Quality and Photo Monitoring

Santa Lucia Preserve,  
Monterey County, California

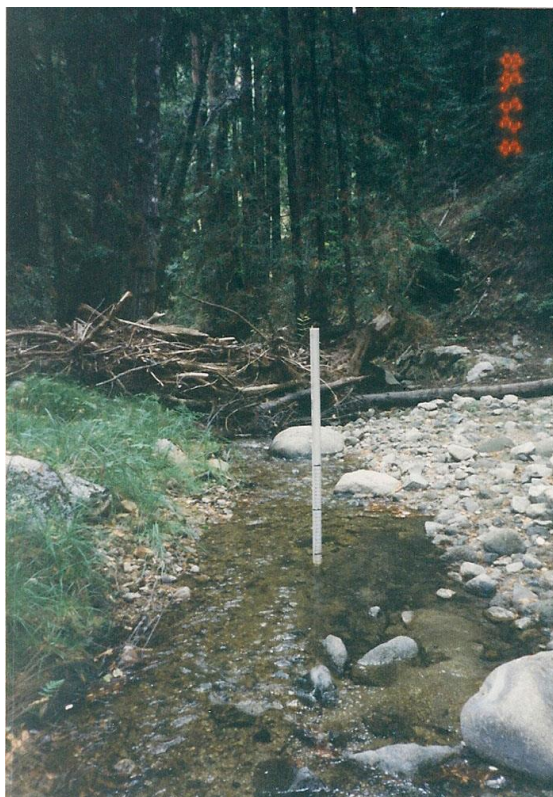
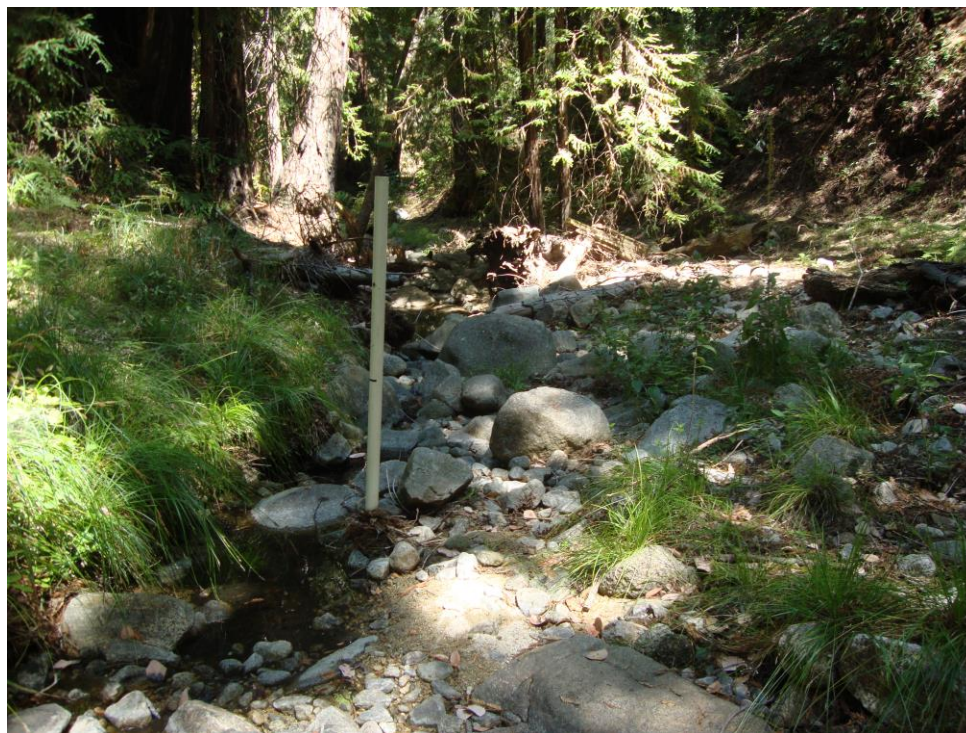
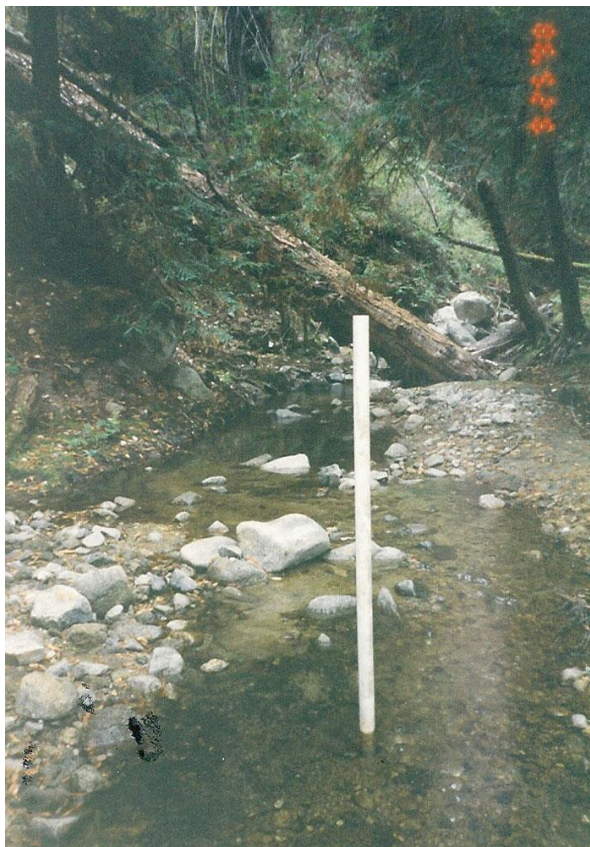
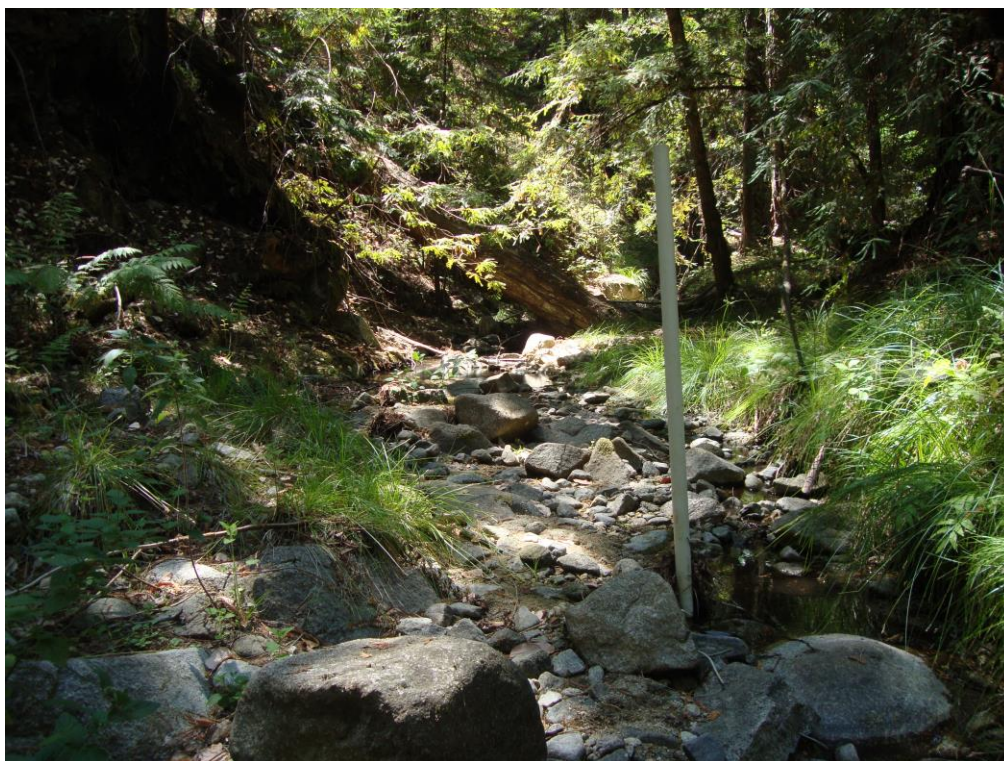
San Clemente has more cobbles and boulders visible in the channel and floodplain in 2014 than in 1998 in both upstream and downstream views. There are also fewer patches of smaller gravel and fines. The physical rearrangement of boulders in the photos indicates that large particles have been transported into place as well as being exhumed by the removal of finer sediment deposits. In 1998 there was a woody debris accumulation across the channel that is much smaller in 2014. In the upstream view, the bar on the left bank, at the base of the downed Redwood tree, has stabilized and grown over with grassy vegetation (Figures 2–5).

Figure 2: Downstream view of San Clemente Creek in March 1998

Figure 3: Downstream view of San Clemente Creek on August 18, 2014

Figure 4: Upstream view of San Clemente Creek in March 1998

Figure 5: Upstream view of San Clemente Creek on August 18, 2014

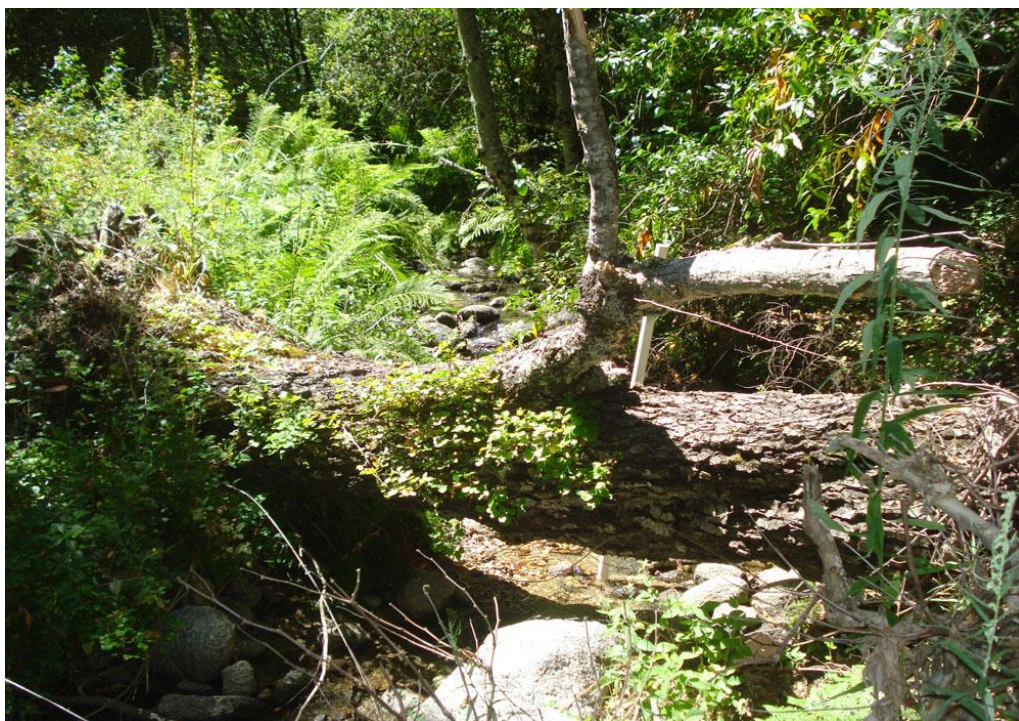
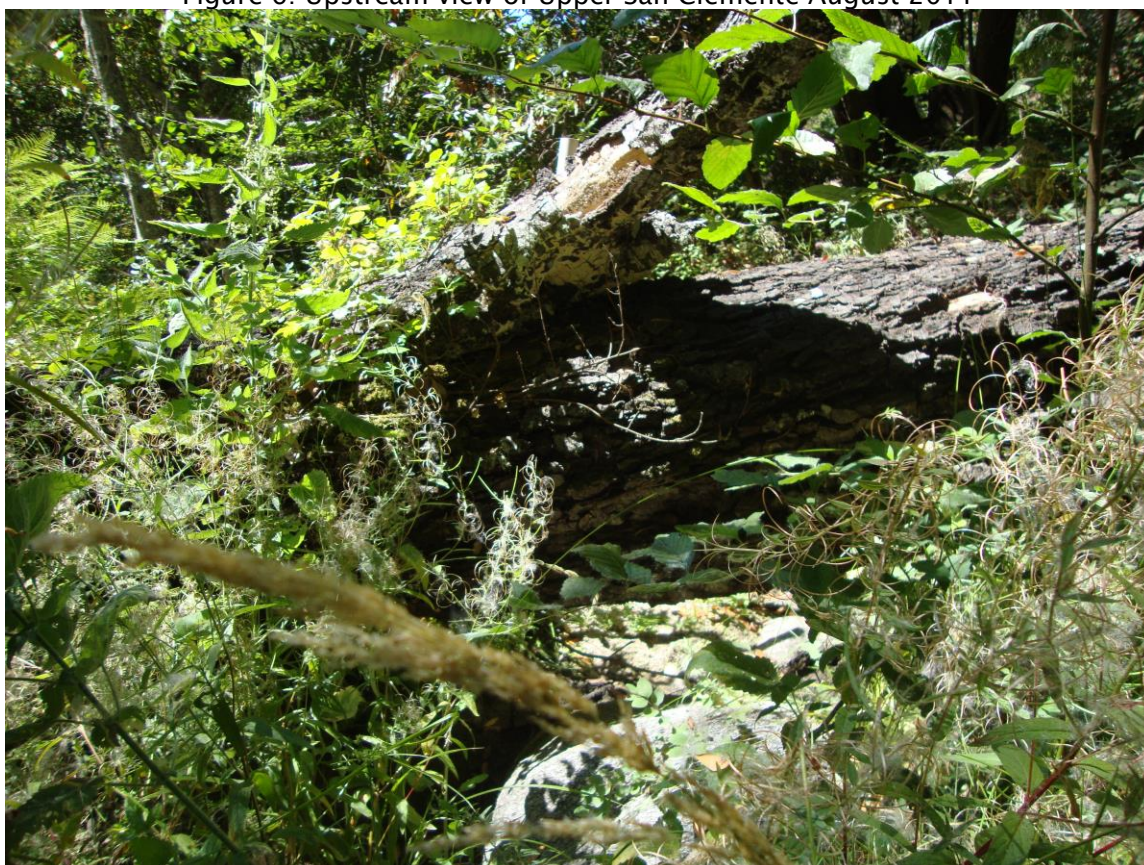
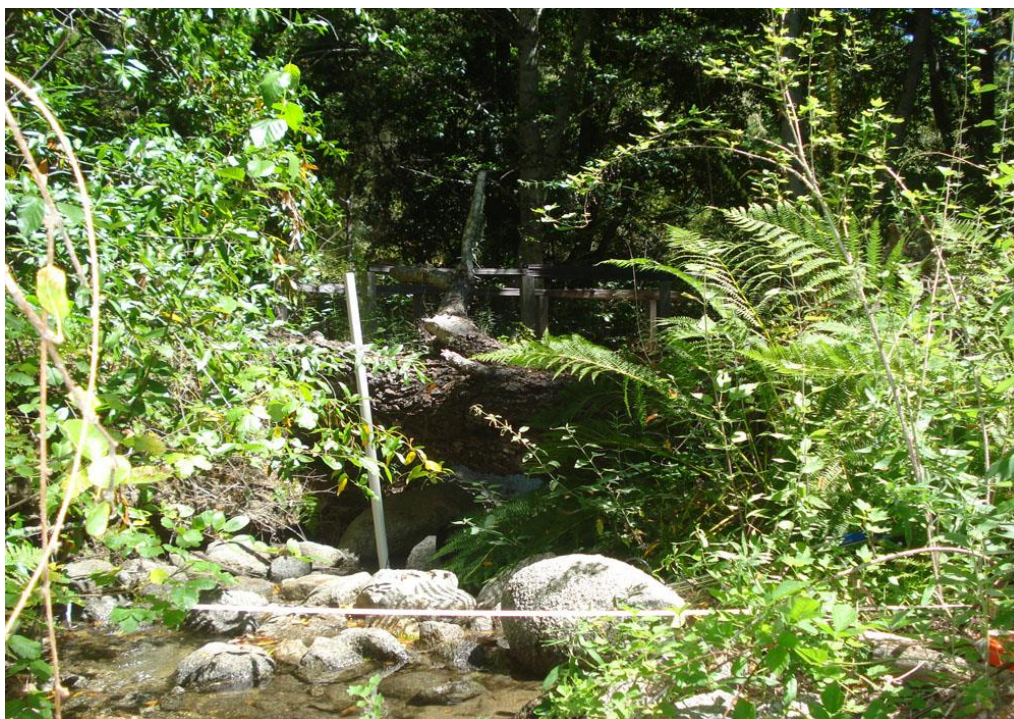
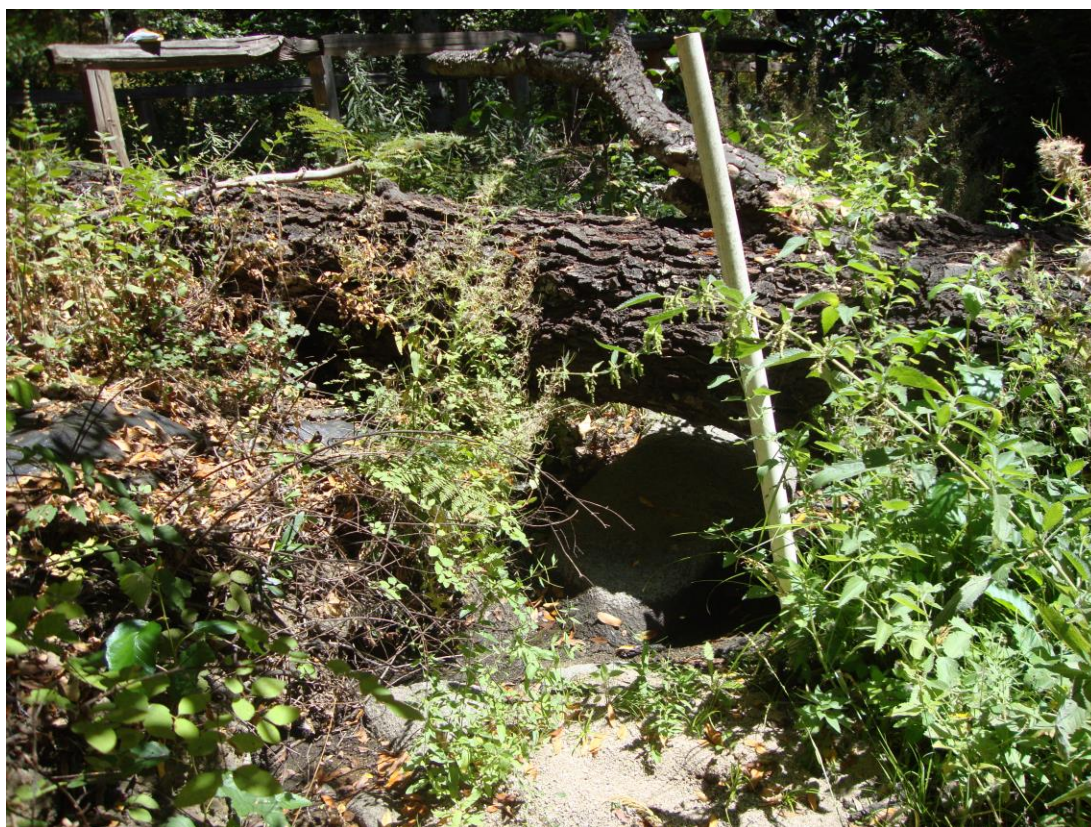
The site was established in 2011. There have been minor changes in the channel from 2011 to 2014. There is more sand present within the channel in 2014 as compared to 2011. There are large boulders in the stream bed, dense vegetation and coarse woody debris (Figure 6–9).

Figure 6: Upstream view of Upper San Clemente August 2011

Figure 7: Upstream view of Upper San Clemente on August 18, 2014

Figure 8: Downstream view of Upper San Clemente August 2011

Figure 9: Downstream view of Upper San Clemente on August 18, 2014

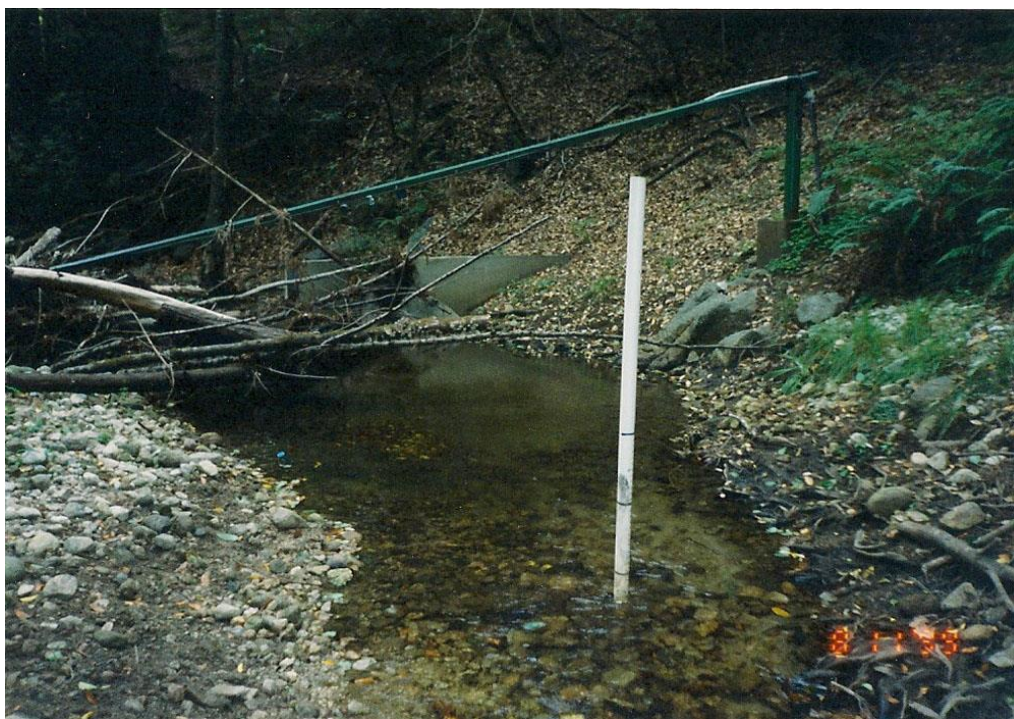
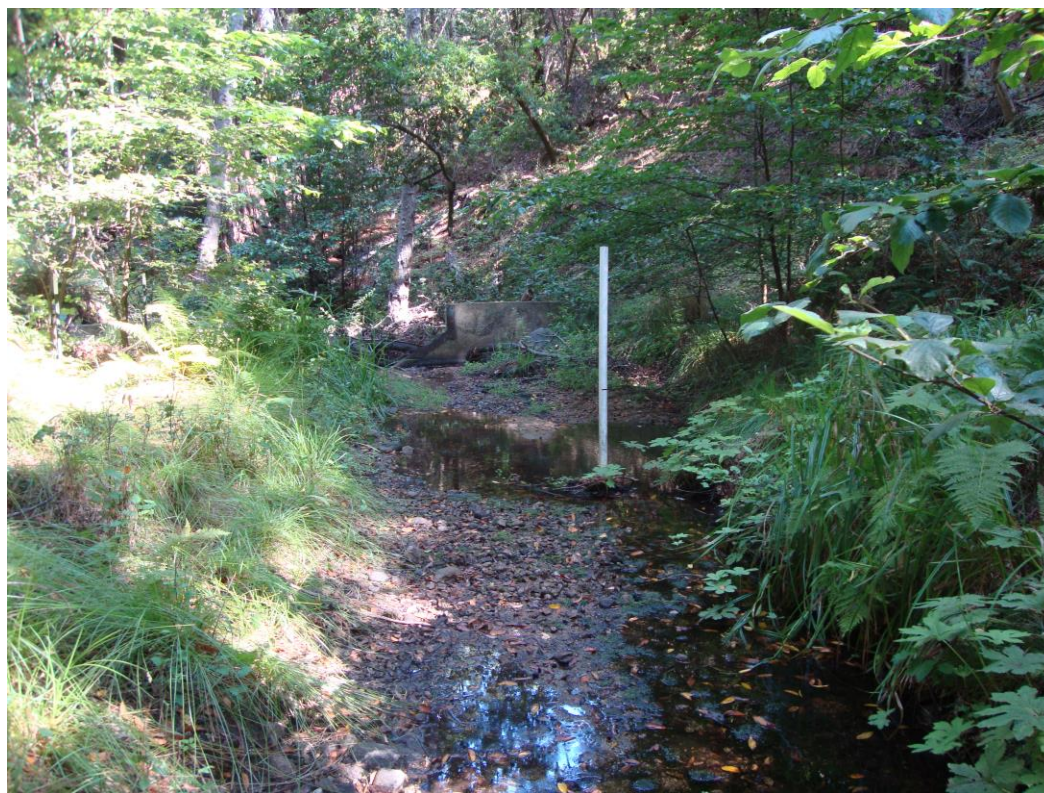
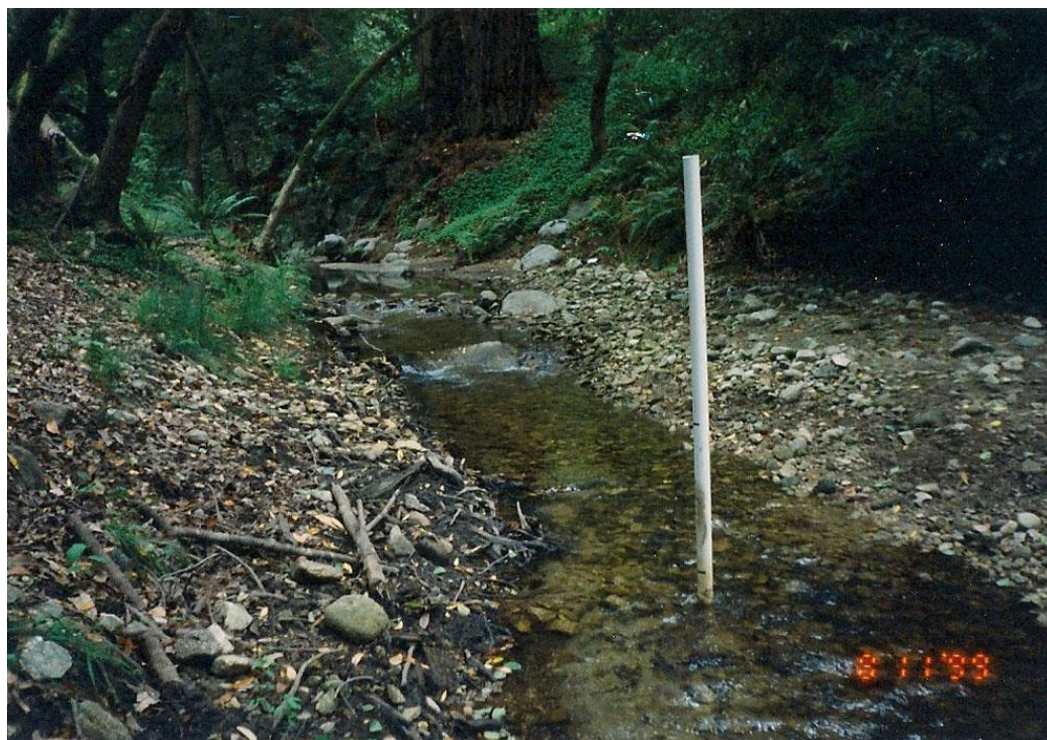
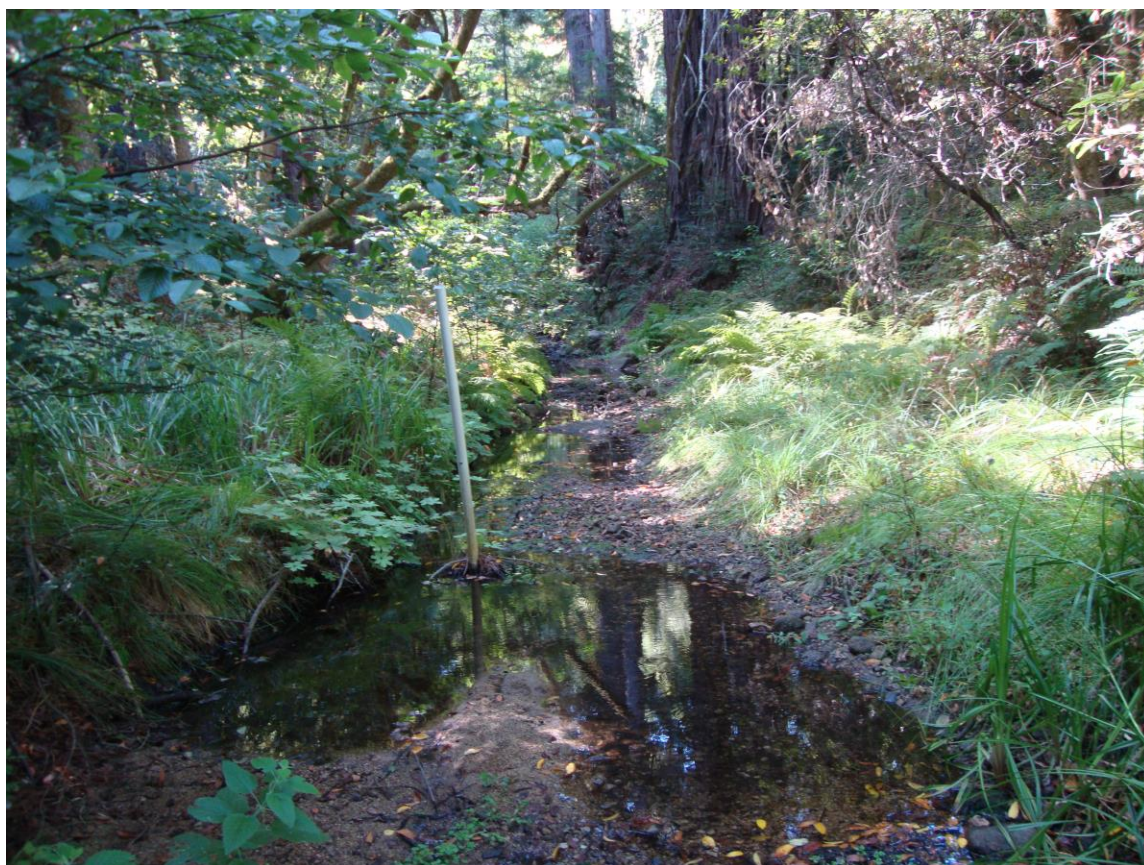
San Jose has had an increase in vegetation in 2014 compared to 1999 in both upstream and downstream views. The increased vegetation has stabilized the channel banks and visible bar. There is large woody debris moving through the system, as old debris visible in 1998 is no longer visible in 2014. Local changes include fine particle deposition where there was woody debris in 1999, visible on the left bank in the downstream and upstream photos and fewer cobbles (Figures 10–13).

Figure 10: Downstream view of San Jose Creek in August 1999

Figure 11: Downstream view of San Jose Creek on August 18, 2014

Figure 12: Upstream view of San Jose Creek in August 1999

Figure 13: Upstream view of San Jose Creek on August 18, 2014

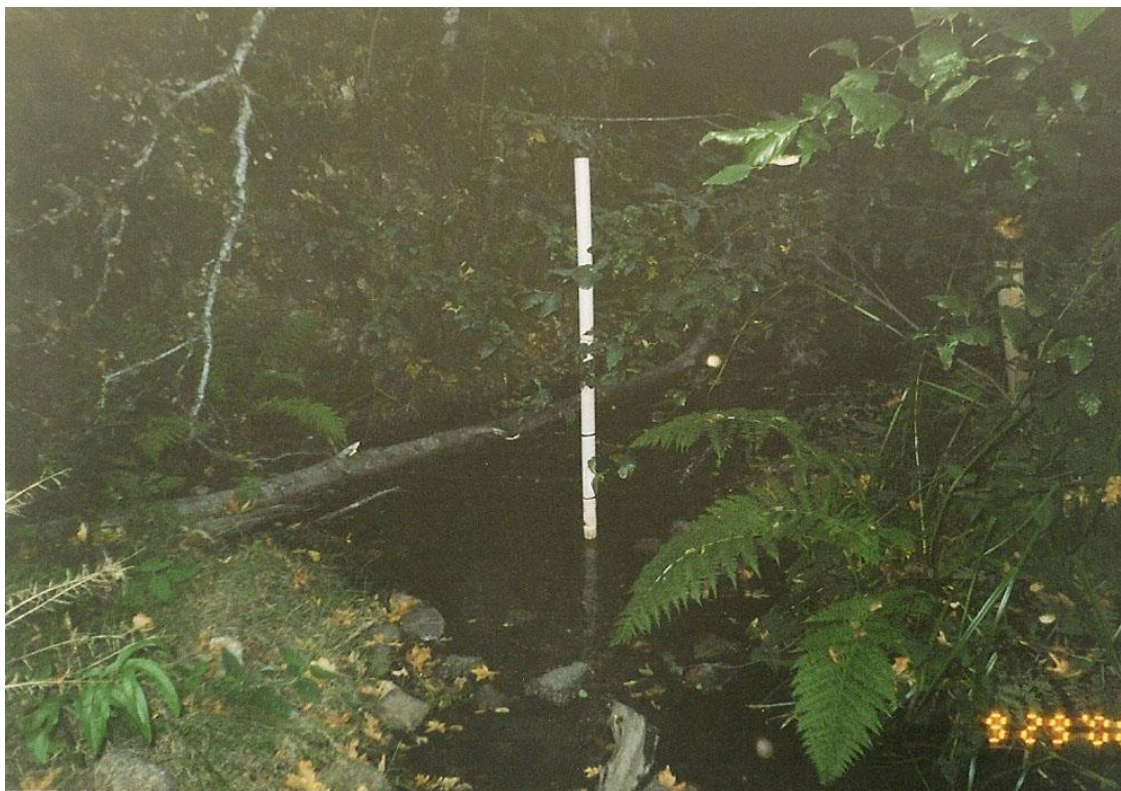
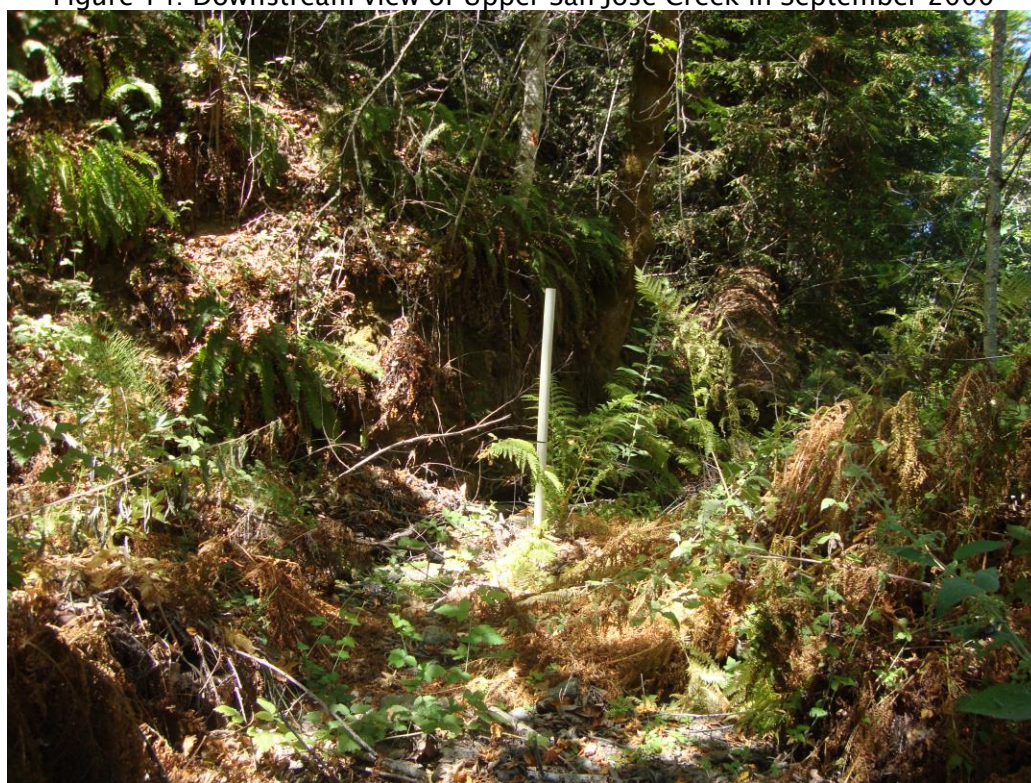
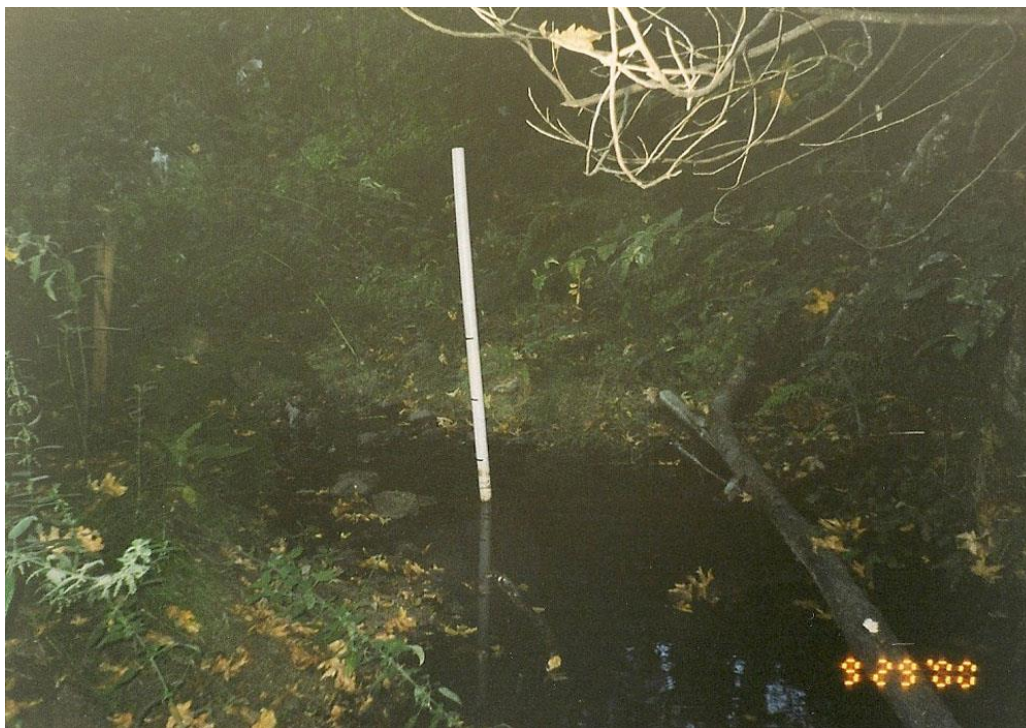
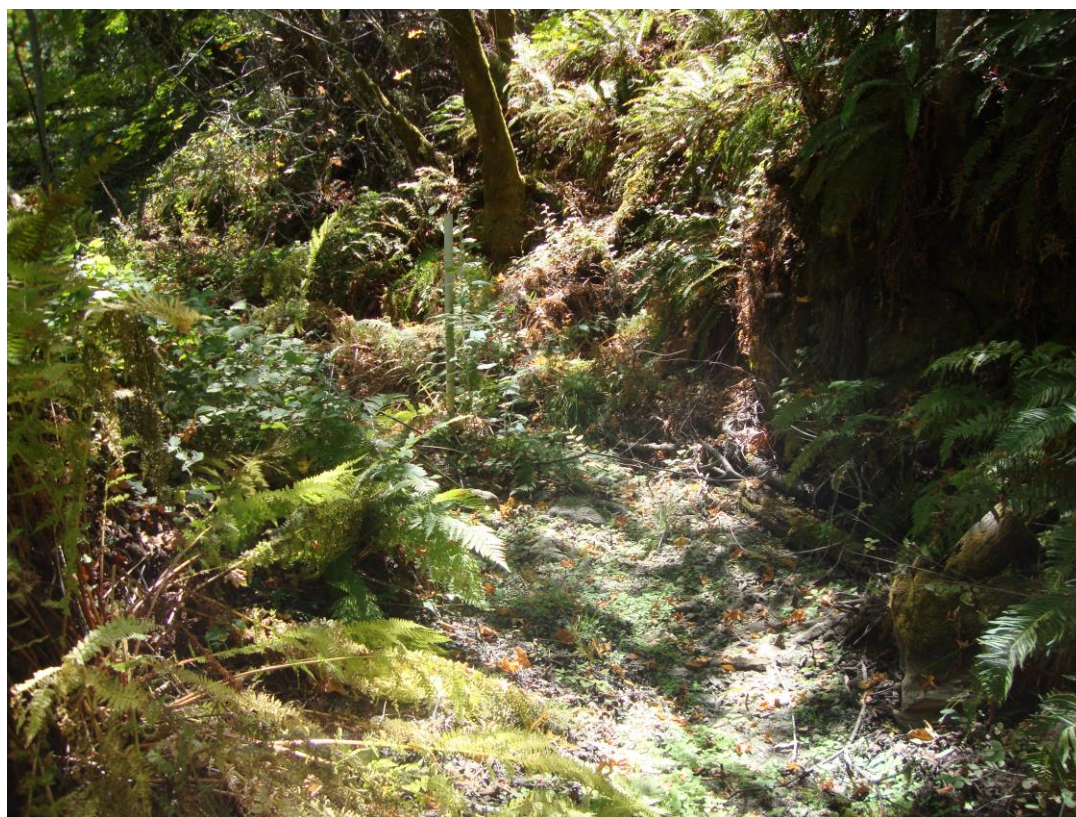
It is difficult to analyze potential change at Upper San Jose because of the dark nature of the photographs from 2000. There appear to be more cobbles present near the photo monitoring post visible in 2014. There has been an increase in vegetation from 2000 to 2014 (Figures 14–17).

Figure 14: Downstream view of Upper San Jose Creek in September 2000

Figure 15: Downstream view of Upper San Jose Creek on August 18, 2014

Figure 16: Upstream view of upper San Jose Creek in September 2000

Figure 17: Upstream view of upper San Jose Creek on August 18 2014

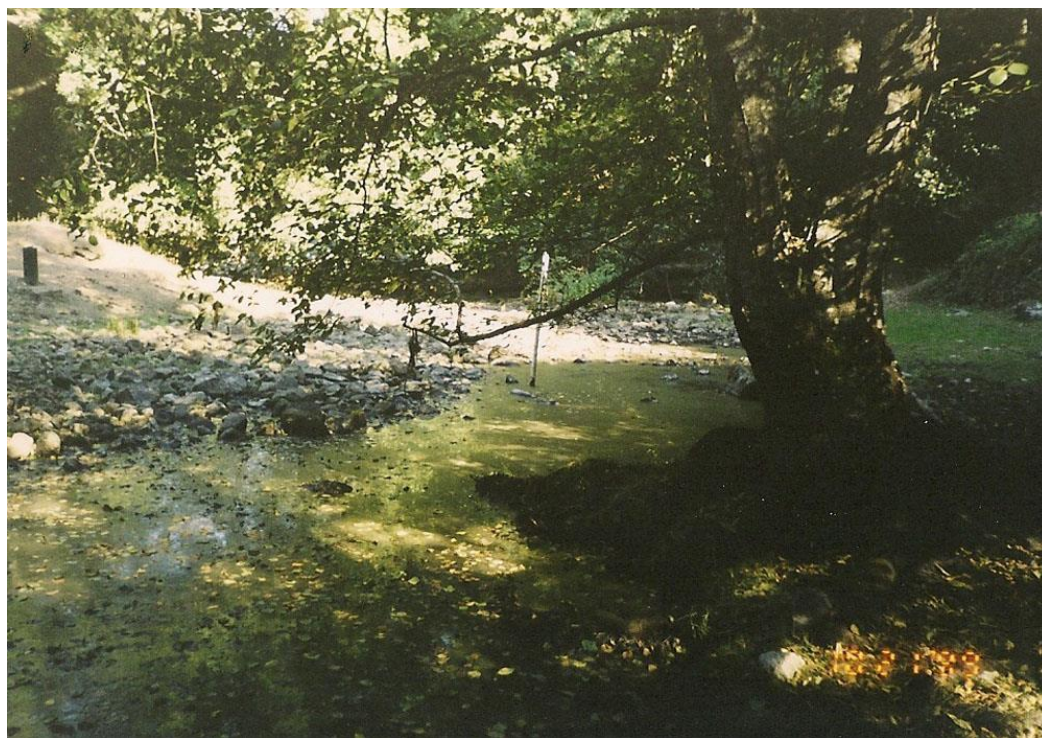
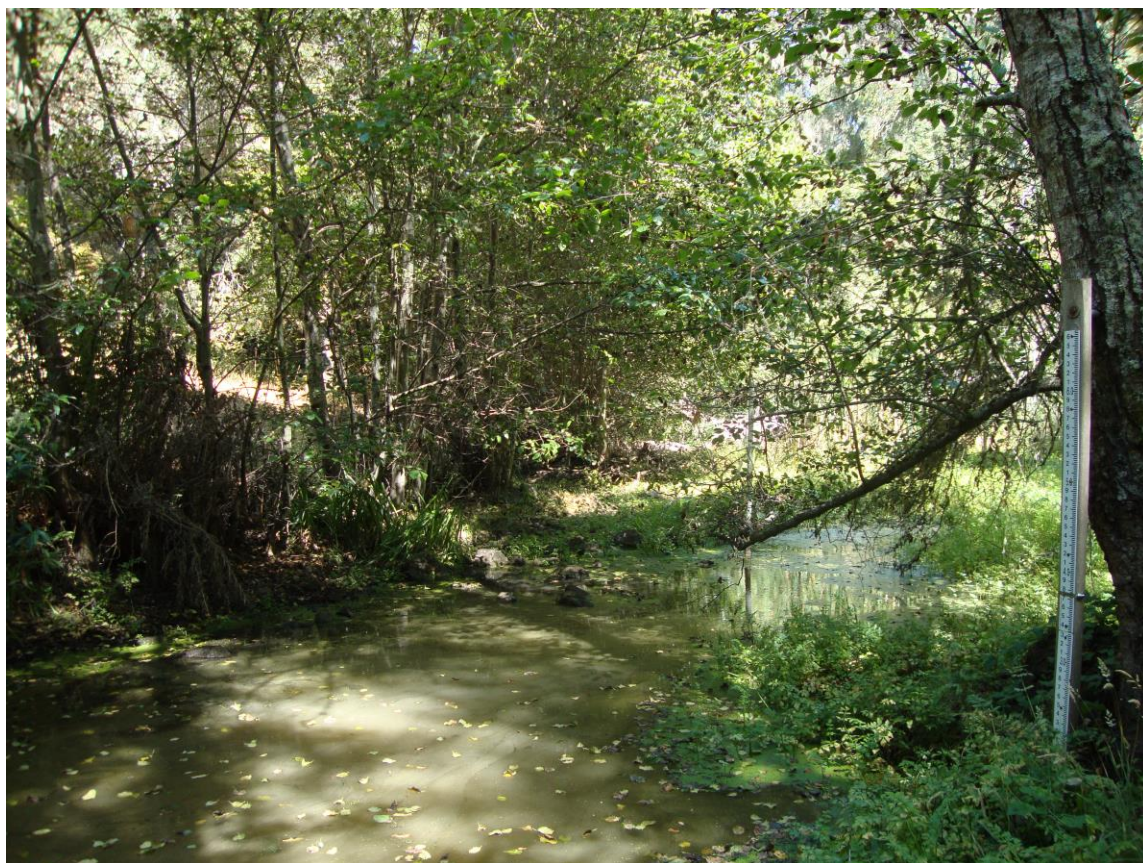
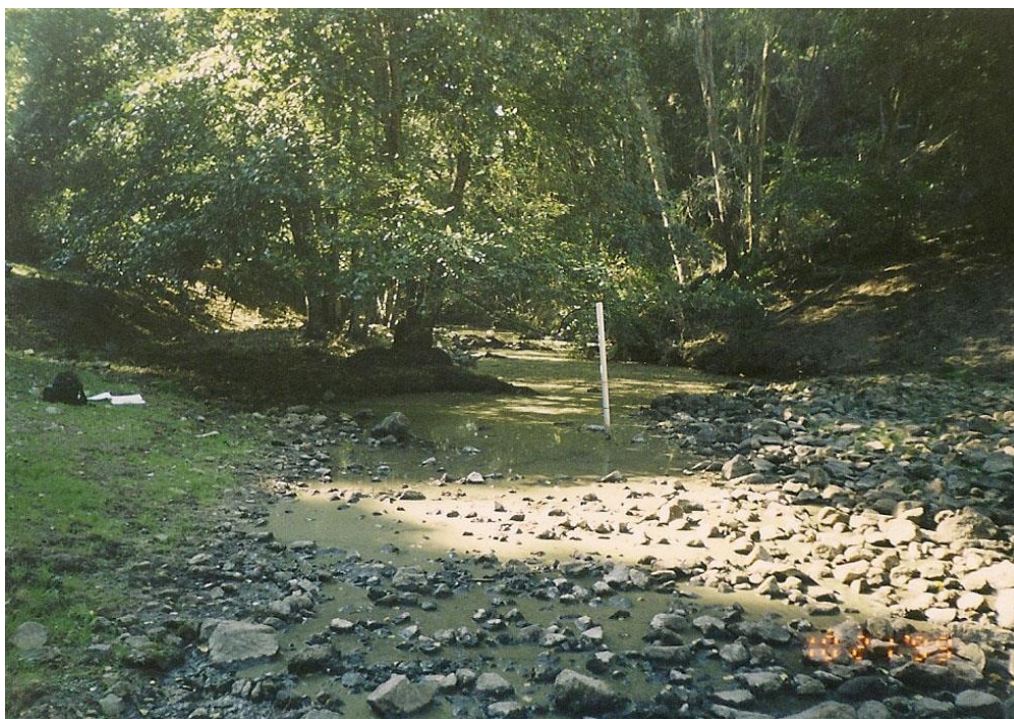
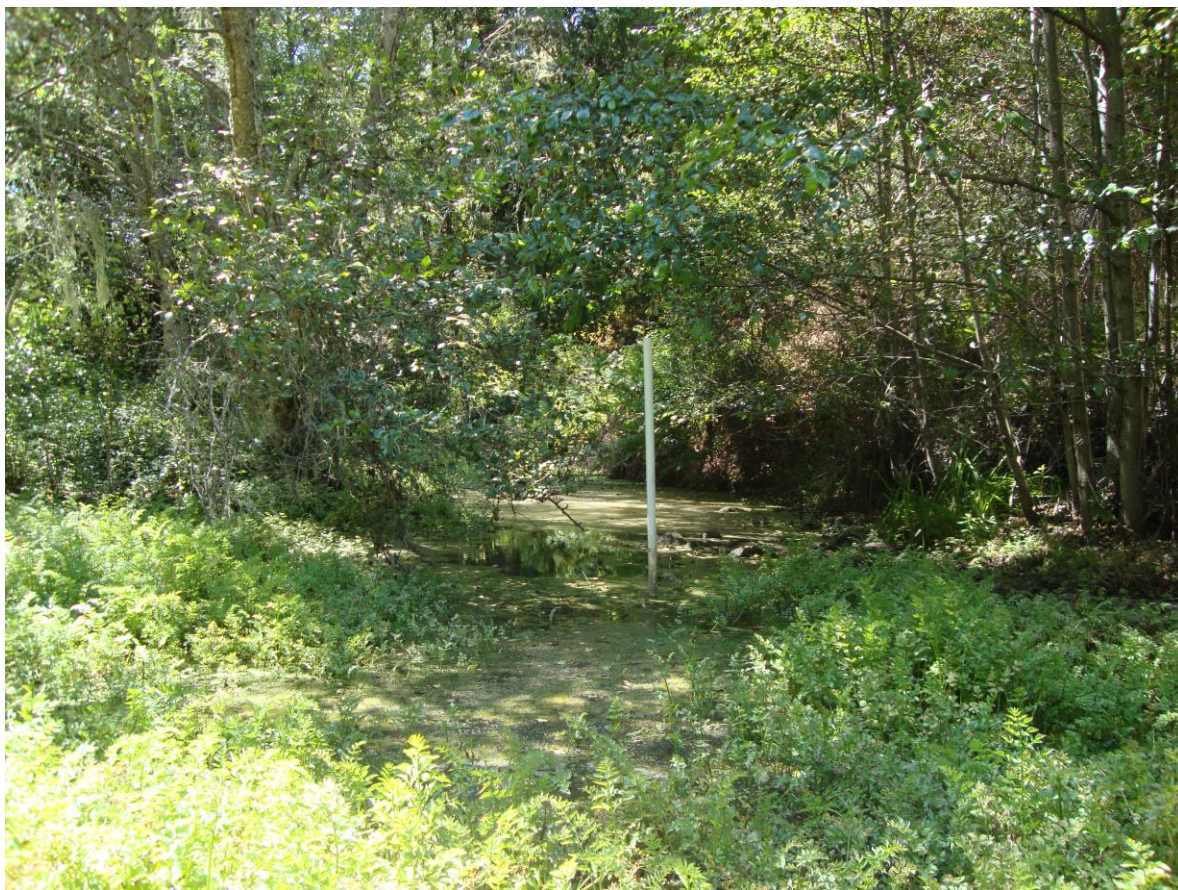
Lower Garzas has an increase in riparian forest growth and channel bank vegetation in 2014 compared to 1999. There is an accumulation of woody debris, not shown in the photographs, that has created a pool where there was a riffle in 1999 (Figures 18–21).

Figure 18: Downstream view of Lower Las Garzas Creek in October 1999

Figure 19: Downstream view of Lower Las Garzas Creek on August 18, 2014

Figure 20: Upstream view of Lower Las Garzas Creek in October 1999

Figure 21: Upstream view of Lower Las Garzas Creek in August 18, 2014

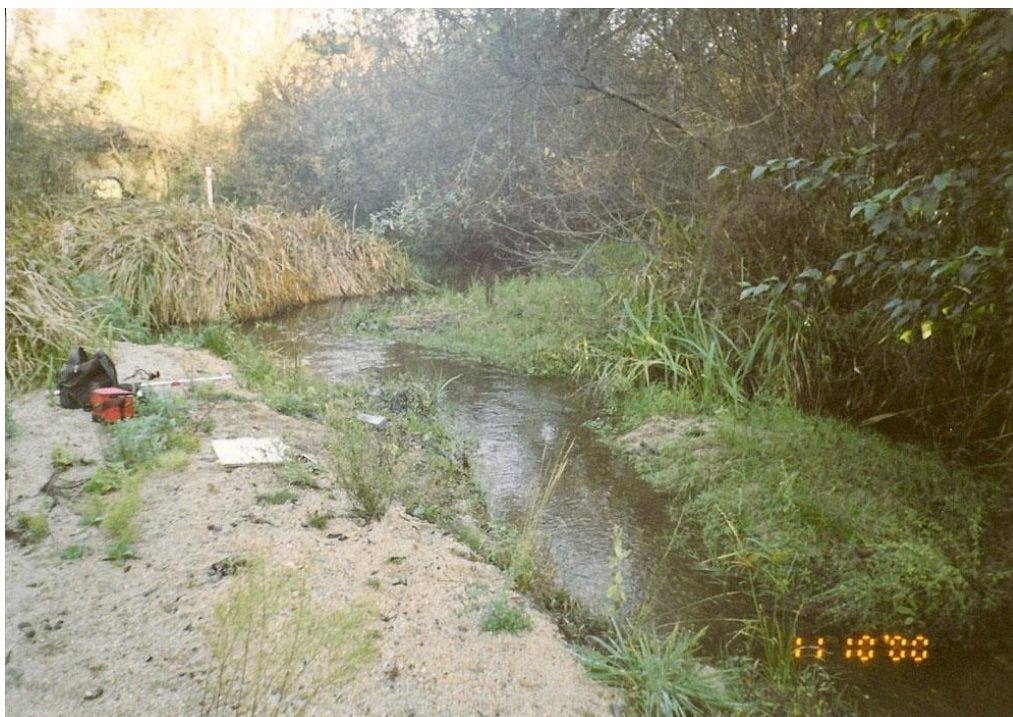
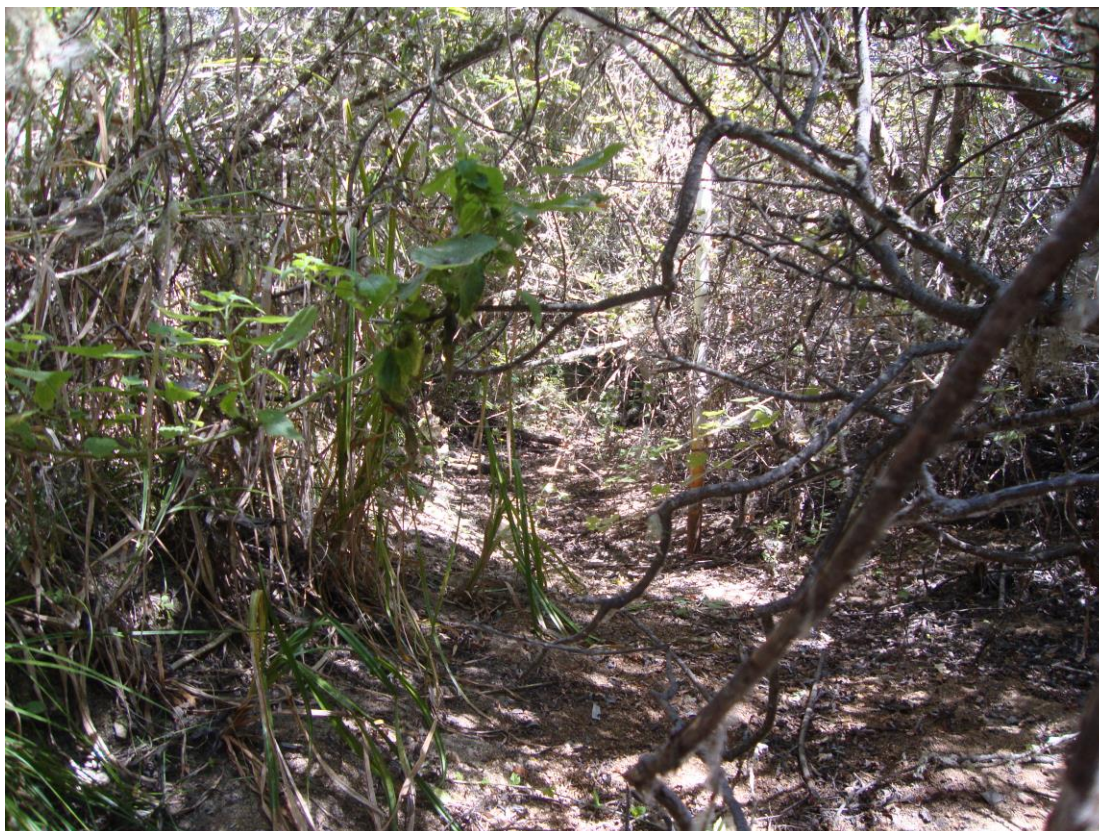
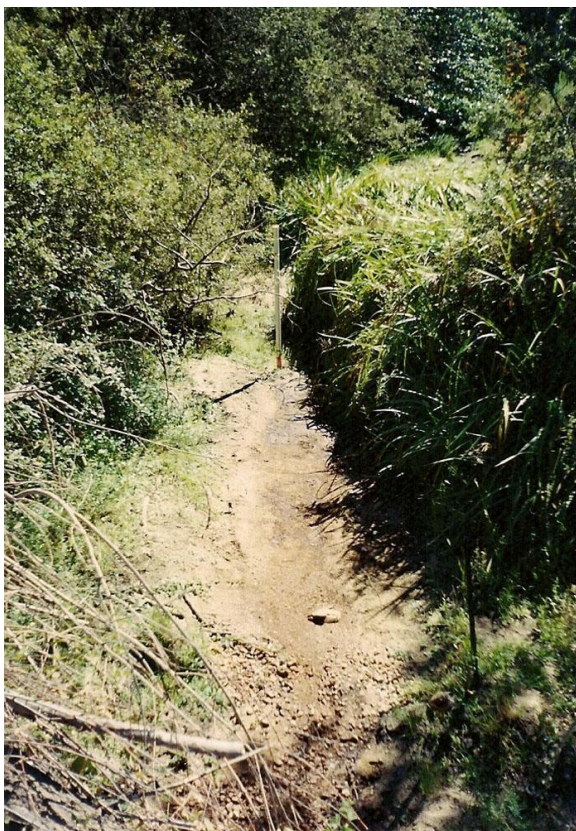
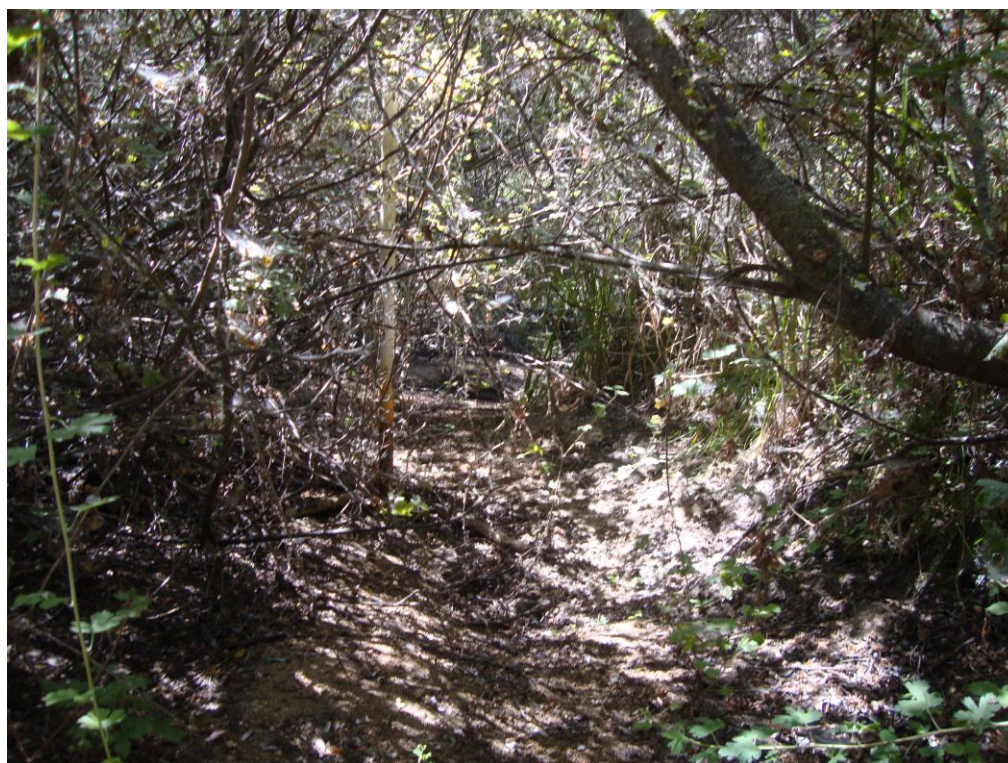
The comparison of the photographs of Middle Garzas is difficult because of the dense vegetation that has accumulated along the channel banks. The dense vegetation has stabilized the banks in 2014 (Figures 22–25).

Figure 22: Downstream view of Middle Las Garzas Creek in November 2000

Figure 23: Downstream view of Middle Las Garzas Creek on August 18, 2014

Figure 24: Upstream view of Middle Las Garzas Creek in August 2000 (estimate of date)

Figure 25: Upstream view of Middle Las Garzas Creek on August 18, 2014

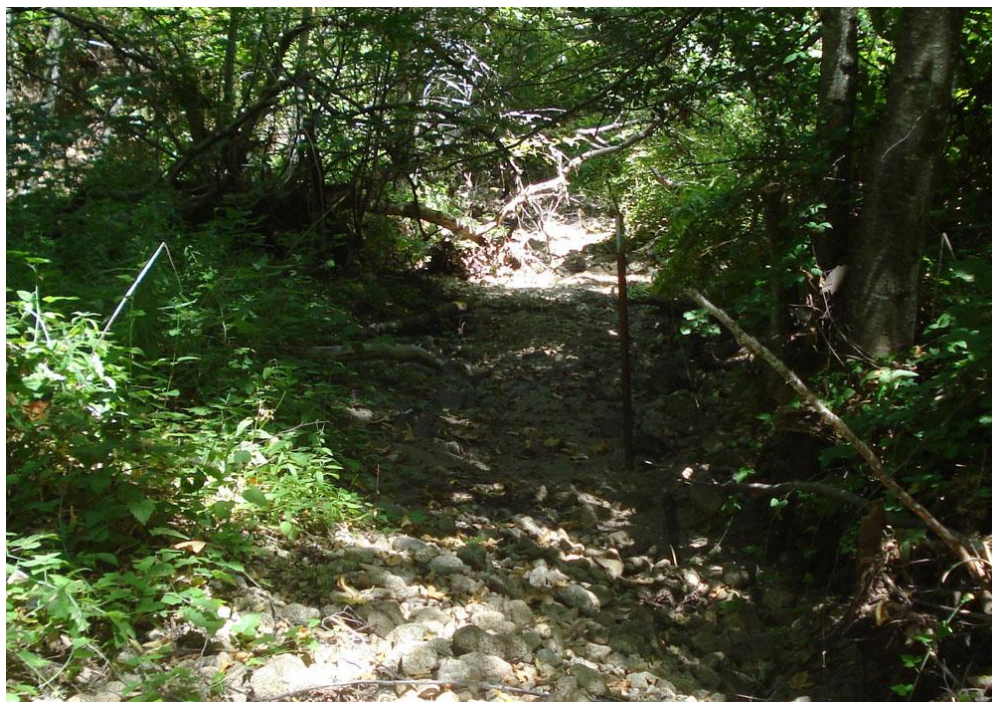
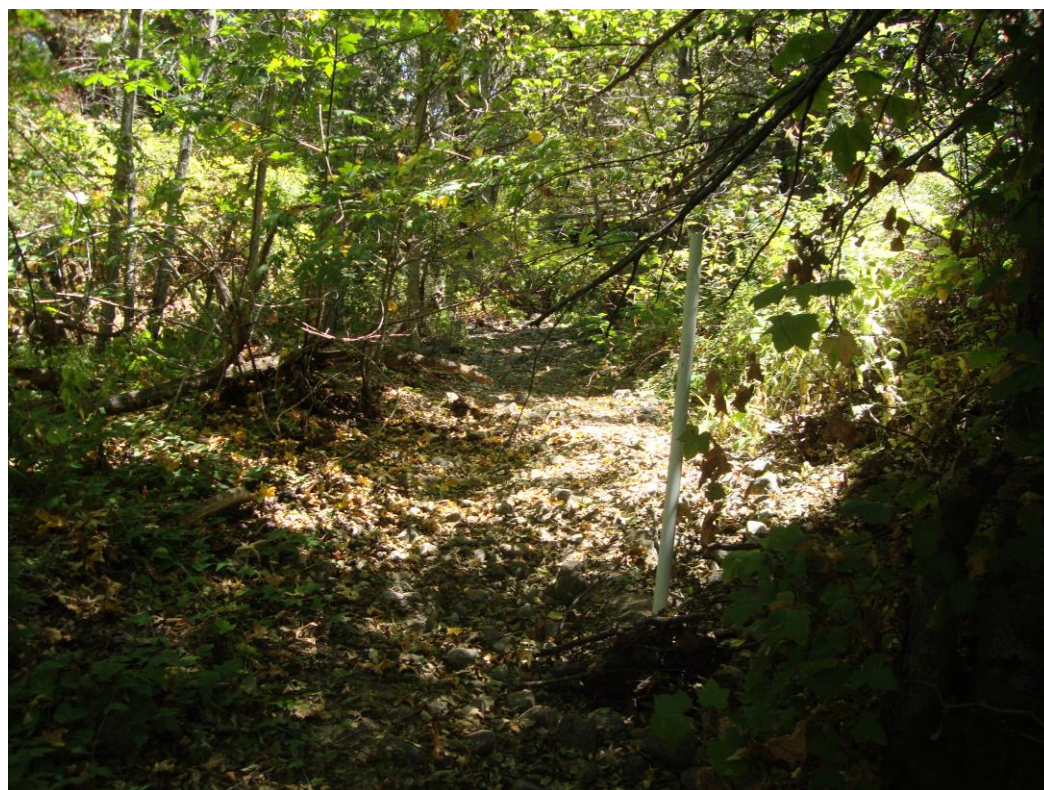
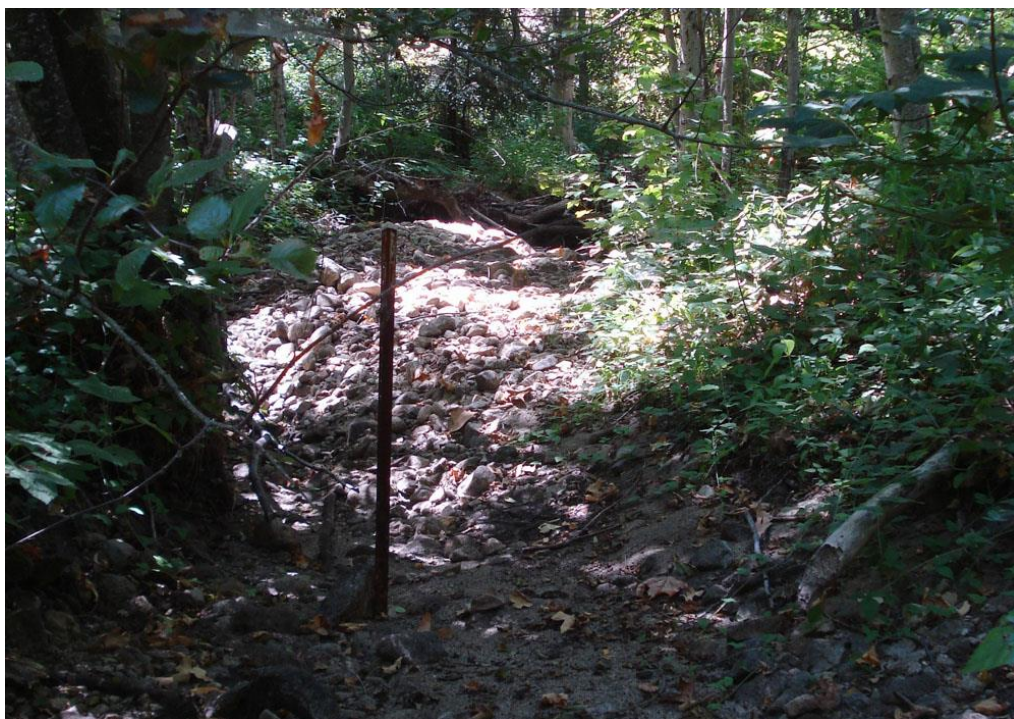
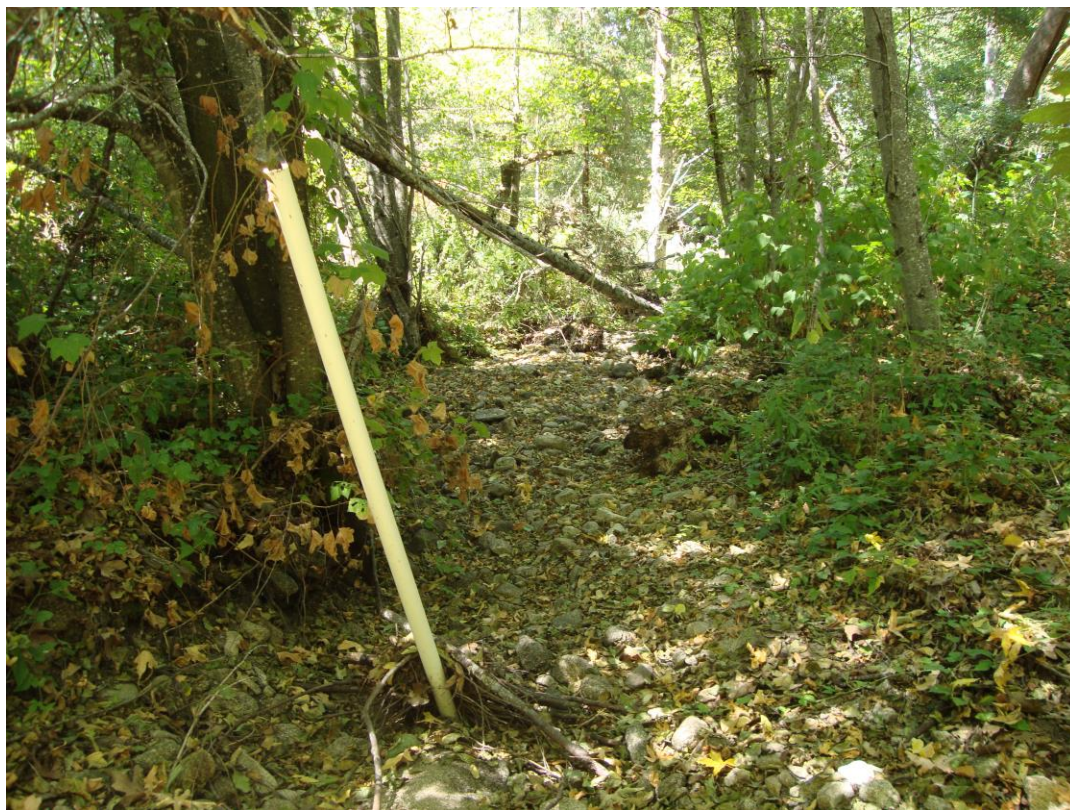
The oldest photograph available for Upper Garzas is from 2009. There have been no visible changes apparent from photo monitoring in 2009 and 2013 (Figures 26–29).

Figure 26: Downstream view of Upper Las Garzas Creek in August 2009

Figure 27: Downstream view of Upper Las Garzas Creek on August 18, 2014

Figure 28: Upstream view of Upper Las Garzas Creek in August 2009

Figure 29: Upstream view of Upper Las Garzas Creek on August 18, 2014
