Report No. WI-2014-10  
31 October 2014

## 2014 Water Quality and Photo Monitoring

Santa Lucia Preserve,  
Monterey County, California

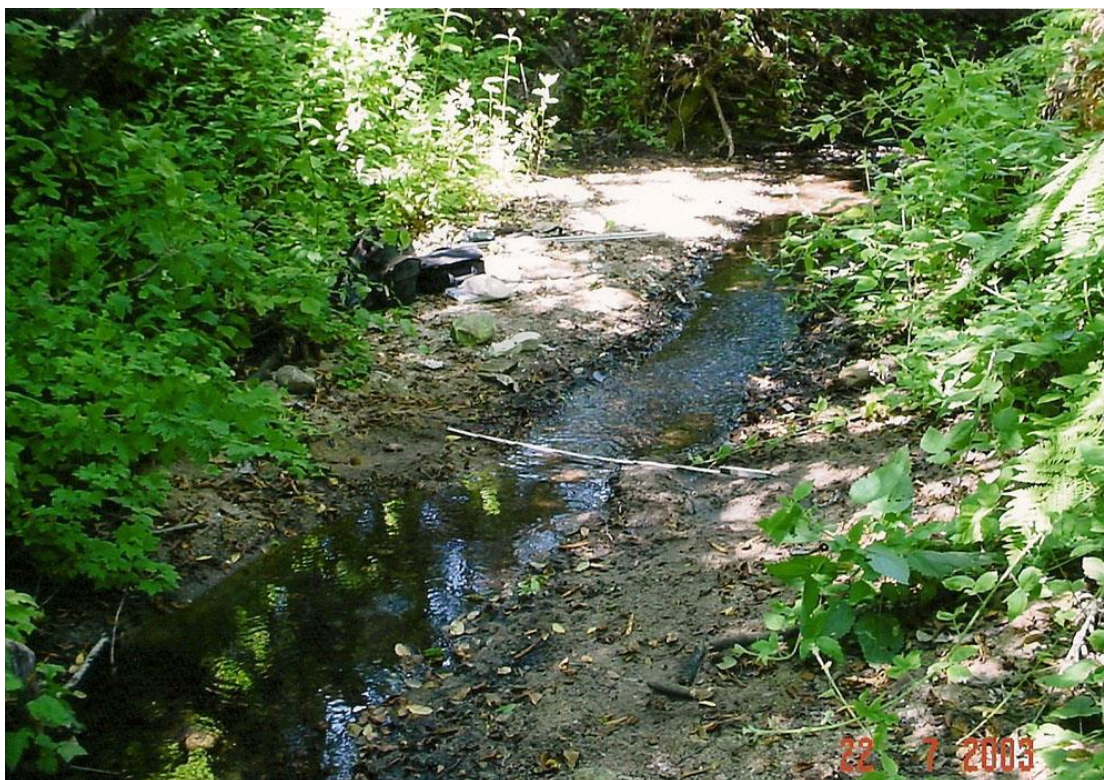
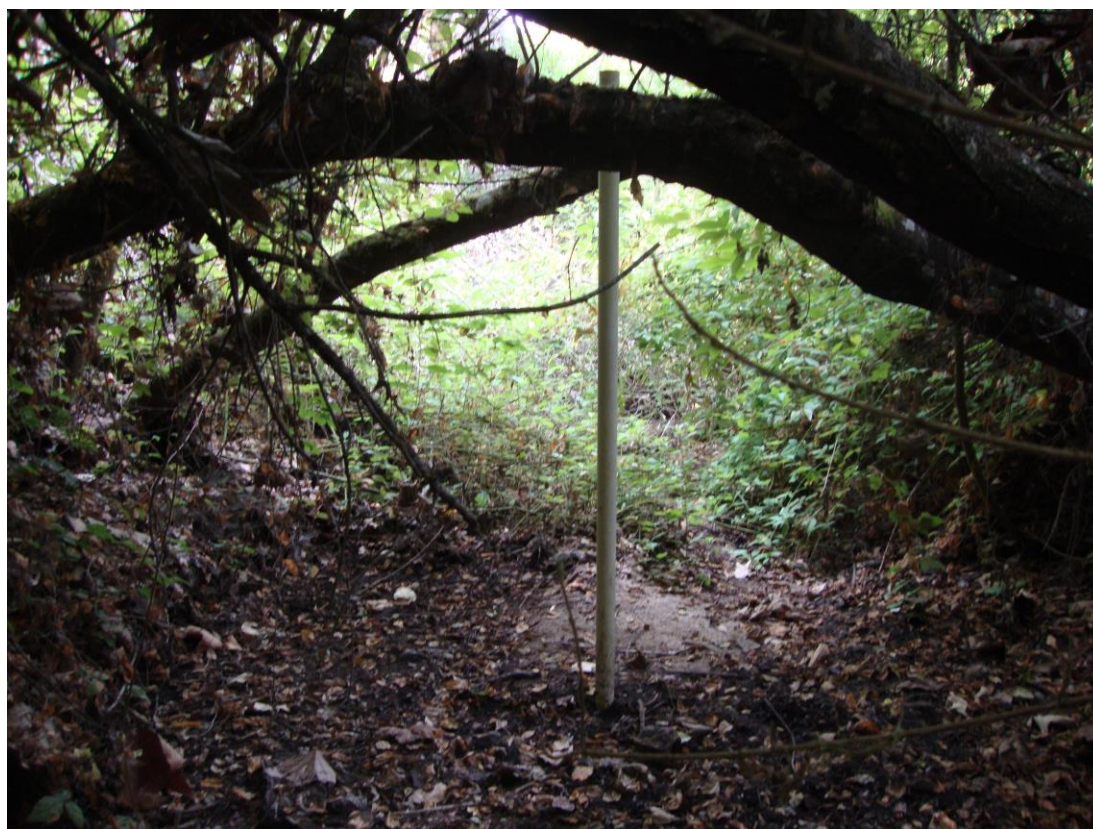
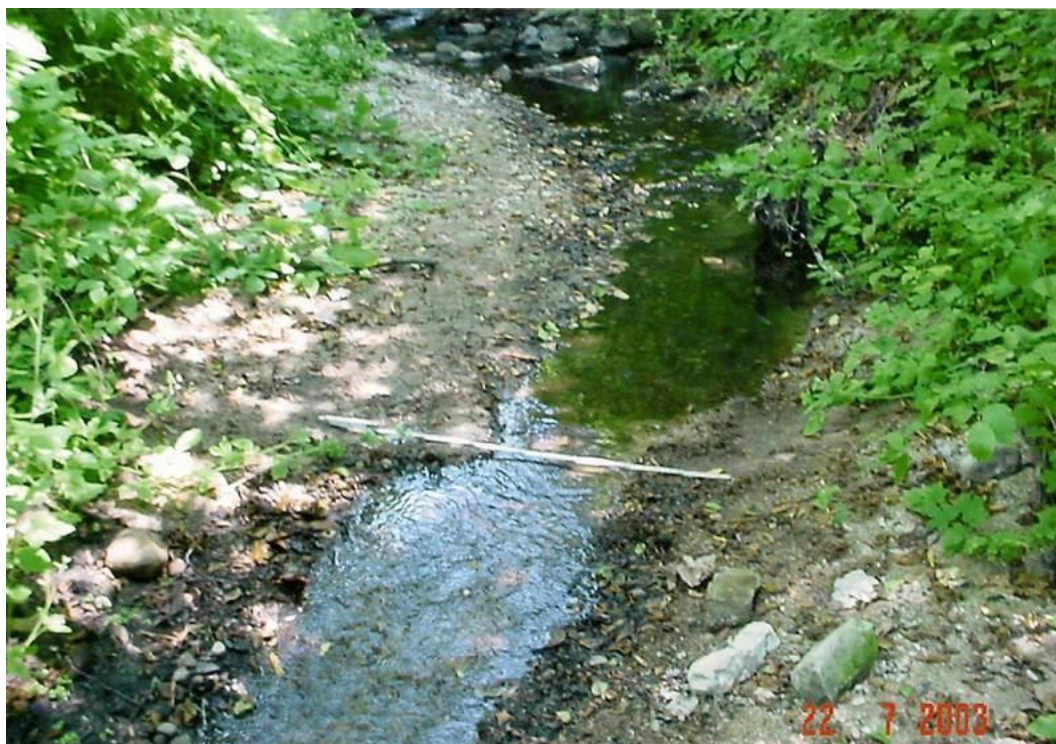
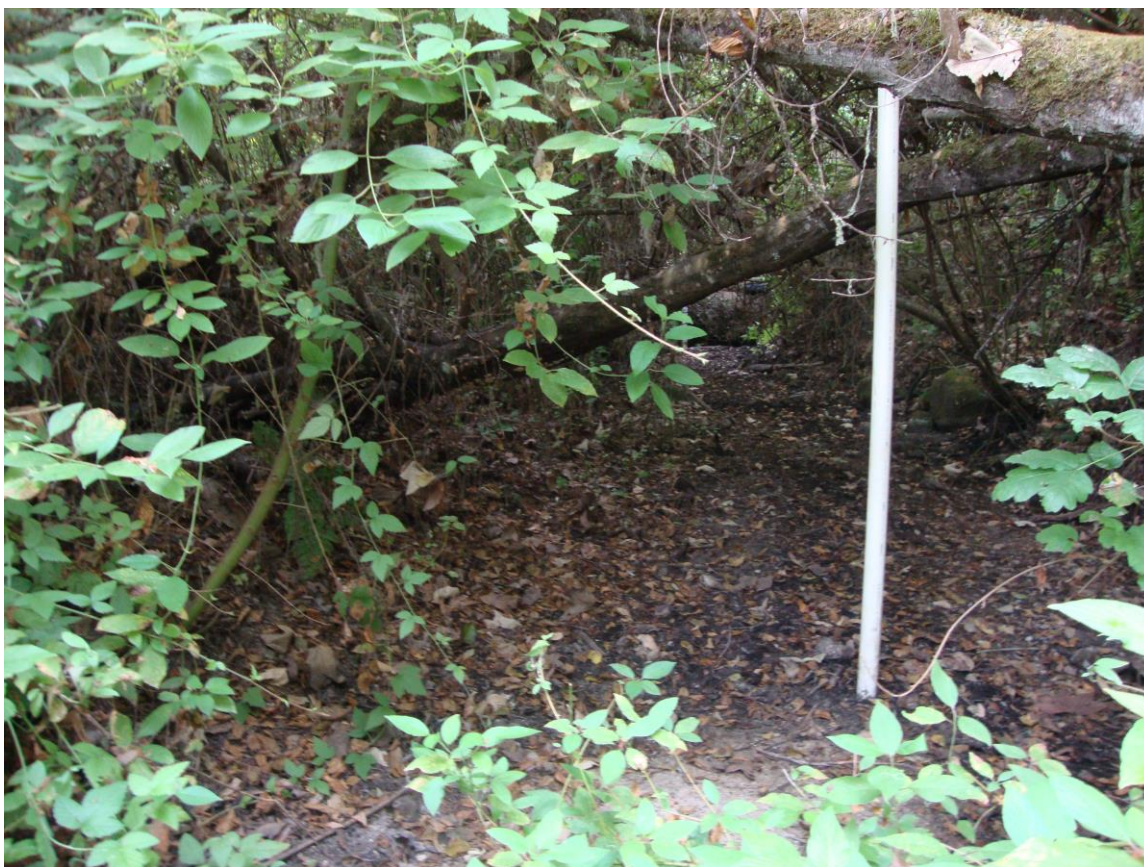
The Potrero channel has shifted from the right bank to the left bank between 2003 and 2014. The channel change is visible in the downstream photo and the exposed sand bar. There has been an increase in vegetation from 2003 to 2014. Particle size appears to remain constant (Figures 30–33).

Figure 30: Downstream view of Potrero Creek in July 2003

Figure 31: Downstream view of Potrero Creek on August 18, 2014

Figure 30: Upstream view of Potrero Creek in July 2003

Figure 31: Upstream view of Potrero Creek on August 18, 2014
