Publication No. WI-2018-08

The Watershed Institute

School of Natural Sciences
California State University
Monterey Bay

**Current Conditions and
Restoration Scenarios for
the Carmel River and
Riparian Corridor at the
Rancho Cañada Parcel of
Palo Corona Park: Carmel
Valley, CA**

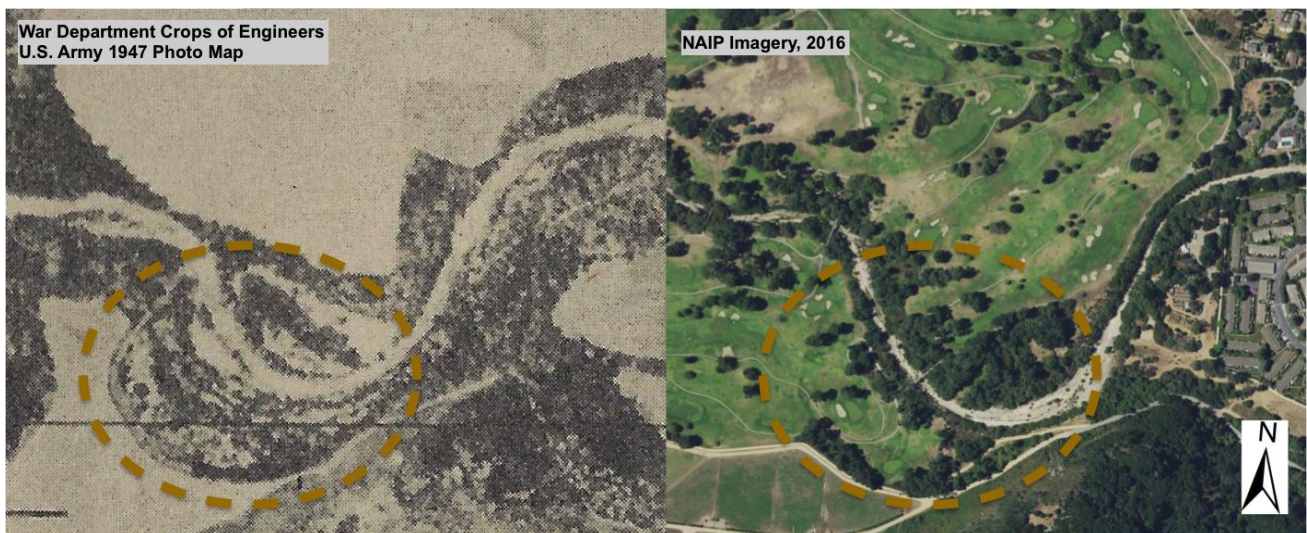
Figure 3. Comparison of aerial imagery from 1947 and 2016 showing area in southeast area of the Rancho Cañada Unit that was the site of gravel mining operation into the 1960's. The low-lying, denuded area (circled) would flood after high rainfall events (Larry Hampson pers. comm.).

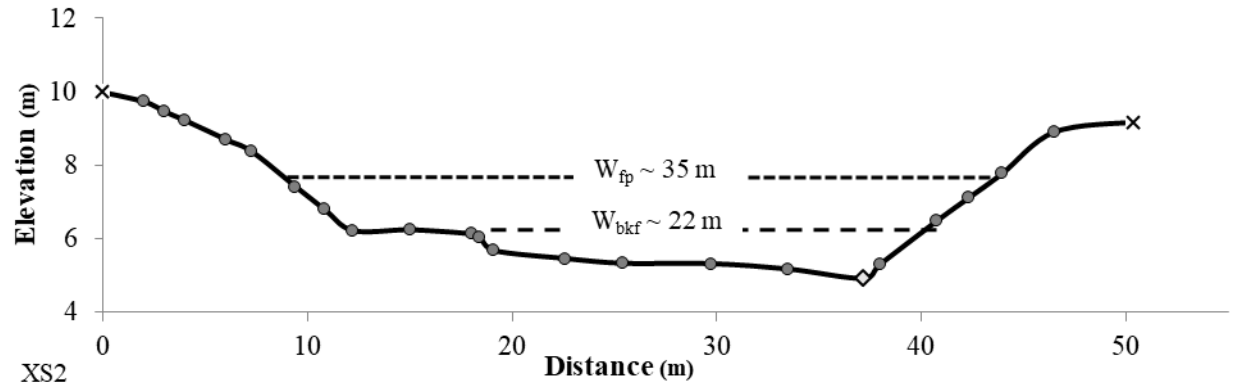
Figure 7. Cross Section 2 current channel dimensions surveyed on September 14th, 2018 measured at established benchmarks (X) from the left to right river back looking downstream with indicated distances for flood-prone width (W_{fp}) and bank full widths (W_{bkf}) calculated from maximum channel depth (D_{max}) determined at the thalweg (\diamond).

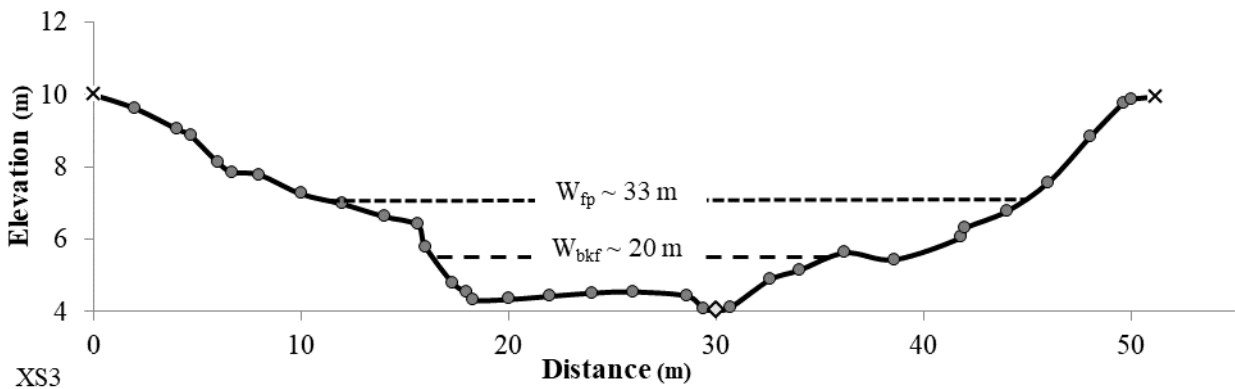
Figure 8. Cross Section 3 current channel dimensions surveyed on September 14th, 2018 measured at established benchmarks (X) from the left to right river back looking downstream with indicated distances for flood-prone width (W_{fp}) and bank full widths (W_{bkf}) calculated from maximum channel depth (D_{max}) determined at the thalweg (\diamond).

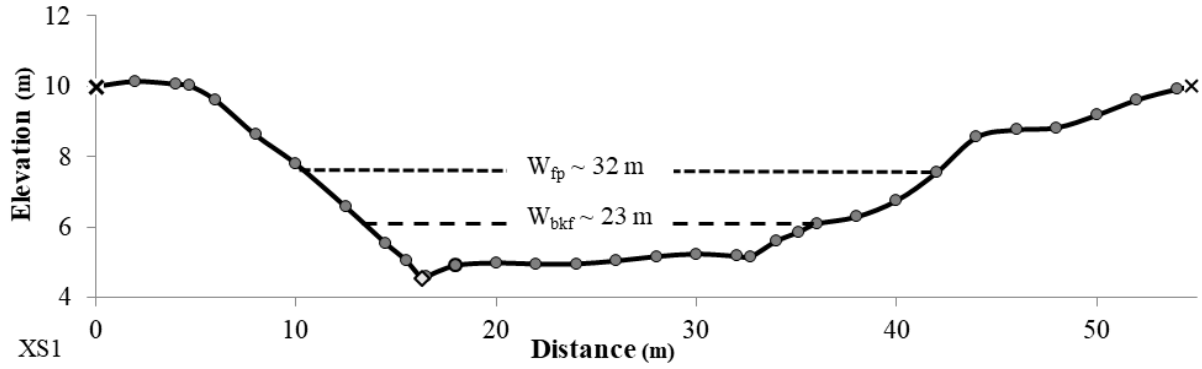
Figure 6. Cross Section 1 current channel dimensions surveyed on September 14th, 2018 measured at established benchmarks (X) from the left to right river back looking downstream with indicated distances for flood-prone width (W_{fp}) and bank full widths (W_{bkf}) calculated from maximum channel depth (D_{max}) determined at the thalweg (\diamond).

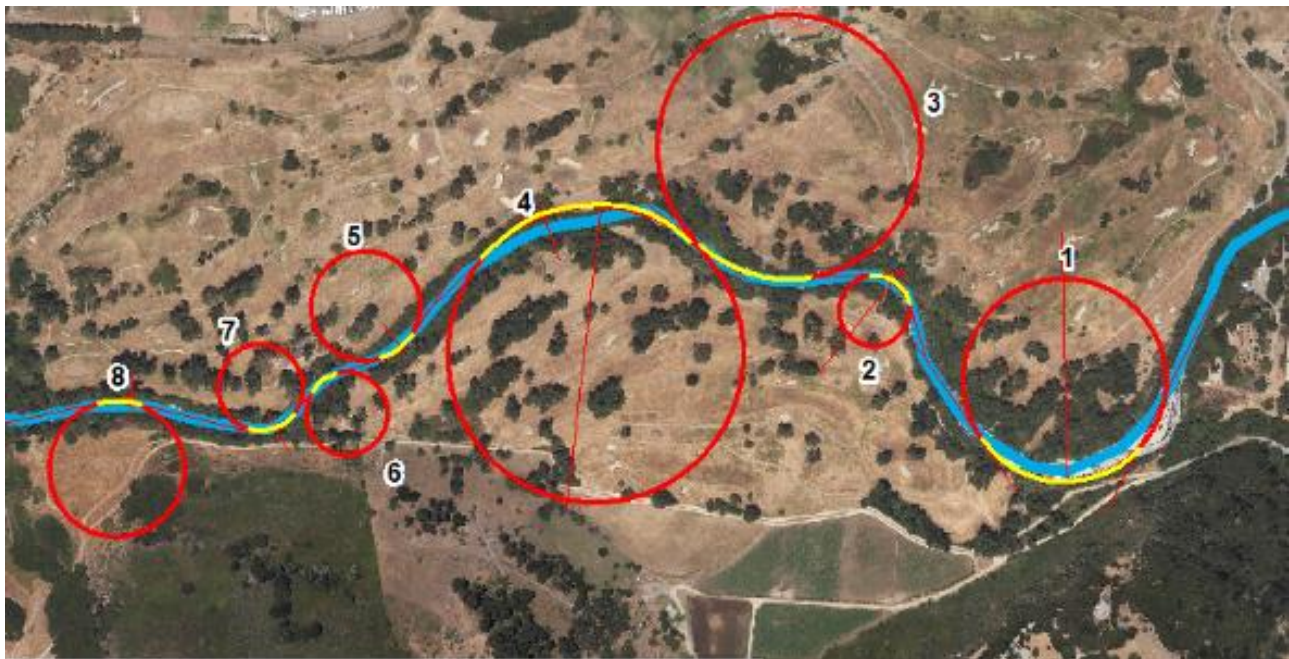
Using ArcGIS Mapping we calculated the current average radius of curvature to be about 101 m and a beltwidth of approximately 324 m (Fig. 11, Table 3).

The current sinuosity is 1.11, which is low for natural low gradient rivers (Rosgen 1994).

Figure 11. Current pattern of the study reach.

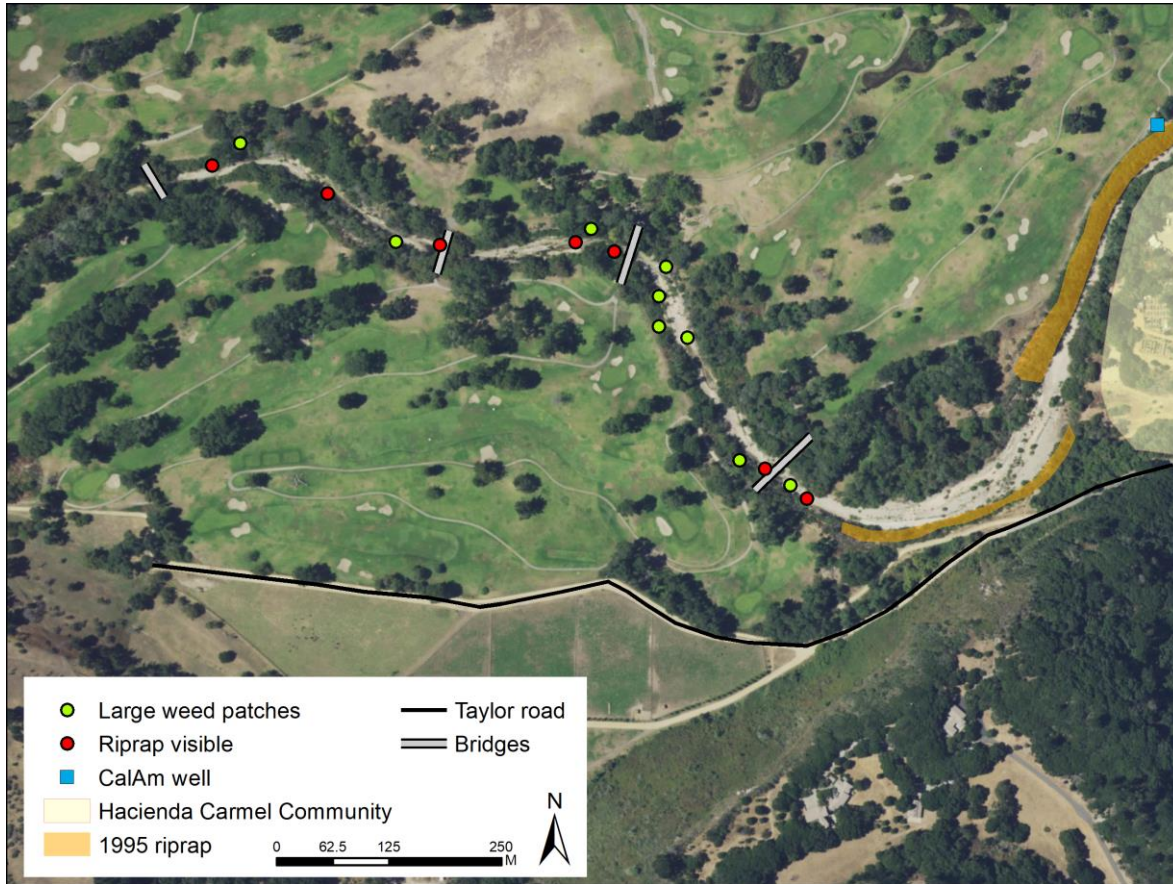
Problem sites include areas with large cover of invasive species and riprap. Figure 13 highlights some of the major areas that should be targeted for initial management.

Figure 13. Large weed patches are composed of cape ivy, poison hemlock, and pampas grass. Visible riprap and the 1995 riprap were installed to prevent erosion but may need to be removed to restore natural channel flow in the future.

Invasive plants, especially cape ivy, need to be managed. We recommend hand-pulling cape ivy twice a year and/or scorching. Hand-pulling invasive species is a common control method for non-native plants due to a relatively low cost, lack of required equipment, and does not involve chemicals (Flory and Clay 2009). Scorching, or burning, may remove invasive species quicker than hand-pulling, but may have negative long-term effects. Keeley et al. 2003 showed that both diversity and non-native species increased over the years after a prescribed burn, and frequent burning can alter vegetation balance in favor of non-natives. We therefore recommend hand-pulling as the best vegetation management strategy.
