Publication No. WI-2012-01

The Watershed Institute

*Central
Coast
Watershed
Studies*

Installation and Initial Analysis of Two Stream Gages on San Jose Creek, Monterey County, CA

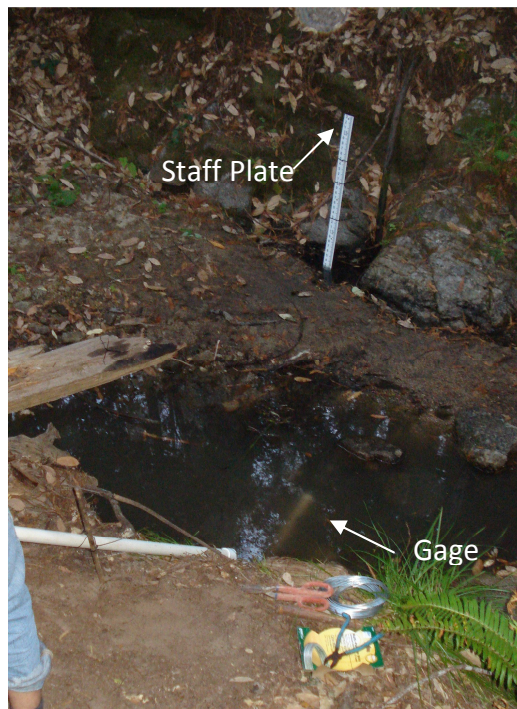
Figure 5. Upper San Jose Creek Gage and staff plate on October 10, 2009. The pipe housing the gage was staked to the creek bottom. A staff plate was installed on the left bank.

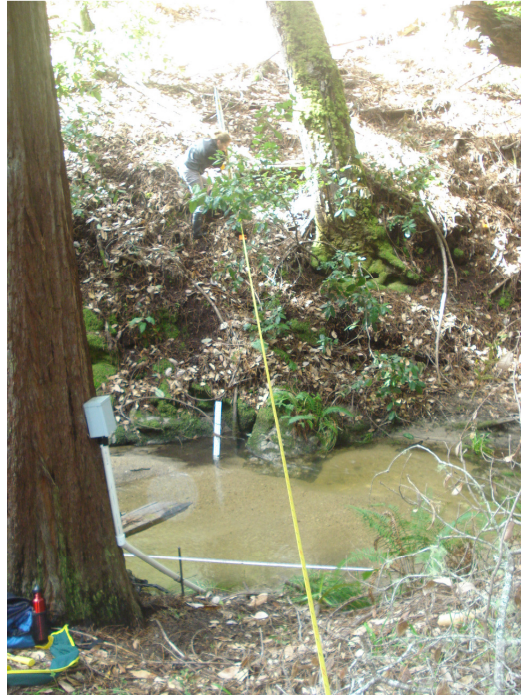
Figure 6. Upper San Jose Creek Gage and staff plate on March 14, 2011. A survey cross section was completed over the gage pool and staff plate.

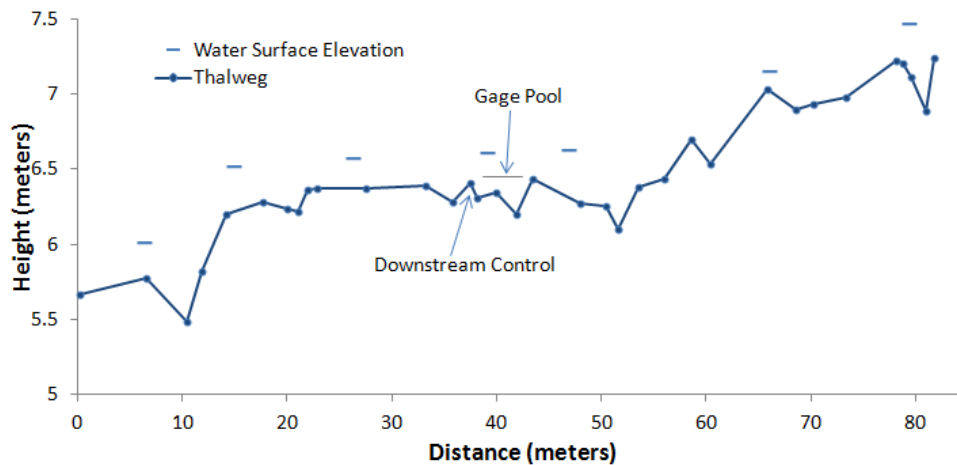
Figure 8. Longitudinal profile survey of Upper San Jose Creek gage and 40 meters upstream and downstream of gage. The vertical scale is exaggerated for illustrative purposes. The slope of the surveyed water surface is 2%.

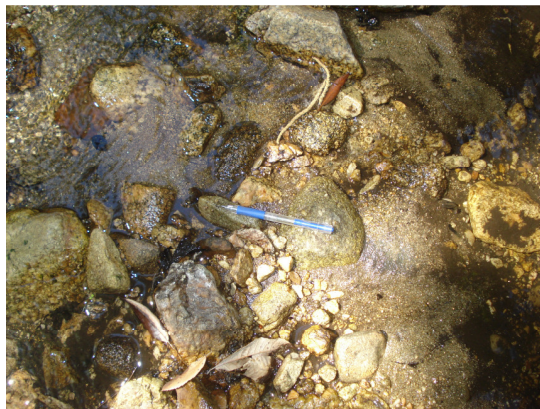
Figure 9. Upper San Jose Creek gage pool control. The substrate consists of small embedded cobbles and sand.

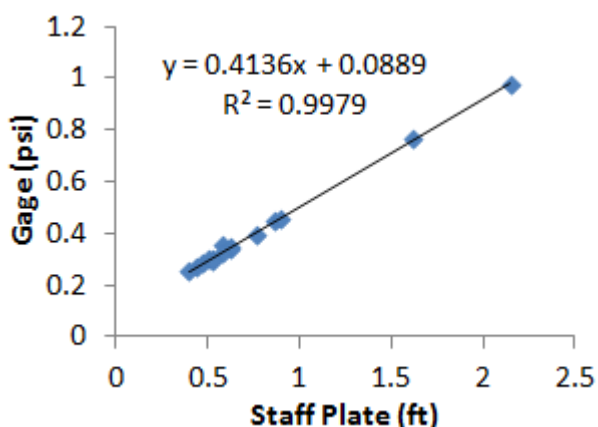
Figure 10. Staff Plate water surface elevation (ft) and gage reading (ft) from the Upper San Jose gage. The high R^2 value of 0.9979 indicated a stable relationship between staff plate readings and gage readings.

The gage was installed on October 10, 2009. The results presented in this report are modeled from a rating curve developed by water year 2011 discharge measurements and pressure readings (October 2010-September 2011). The relationship between the gage and the staff plate has remained stable since October of 2009 (Figure 10). The high R^2 value and the one-to-one relationship between staff plate (ft) and gage (psi) both indicated the gage readings were stable and indicative of changes in the water surface elevation. The gage reach and surrounding cross sections were surveyed on March 14, 2011. There was aggradation in the channel since the installation of the gage. The sediment level on the staff plate on October 10, 2009 was 0.2 feet. The sediment level on the staff plate on March 14, 2011 was 0.97 ft. There was 0.77 ft of aggradation recorded by the sediment level on the staff plate.

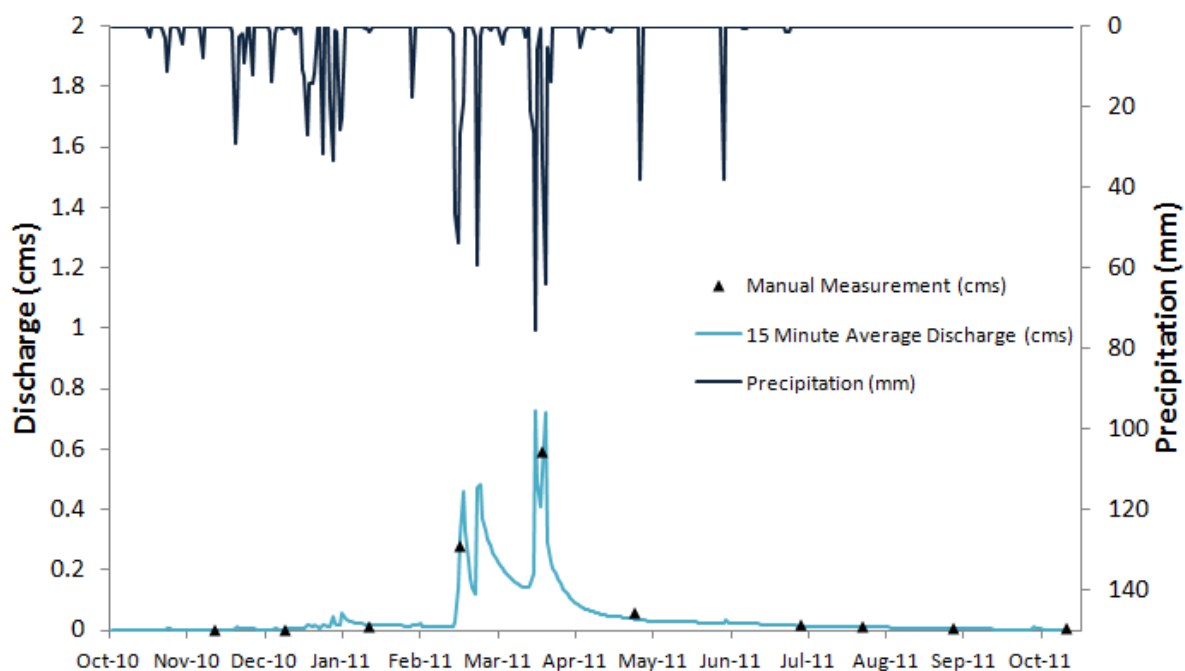
Figure 12. Hydrograph of San Jose Creek in water year 2011. At the SLP golf course precipitation gage there was a total of 936 mm (36.83 inches) of precipitation in water year 2011. The rating curve is valid up to 0.59 cms.

The rating curve was used to convert the 15 minute pressure readings to streamflow estimates for water year 2011 (Figure 12). Monthly and annual surface flow discharges were calculated from streamflow estimates (Table 1). The rating curve is valid up to 0.59 cms. In water year 2011 Upper San Jose Creek had a total discharge of $1,466 \times 10^3 \text{ m}^3$. The peak monthly discharge was in February ($572 \times 10^3 \text{ m}^3$). Average monthly summer baseflow (July-September) was $17 \times 10^3 \text{ m}^3$.

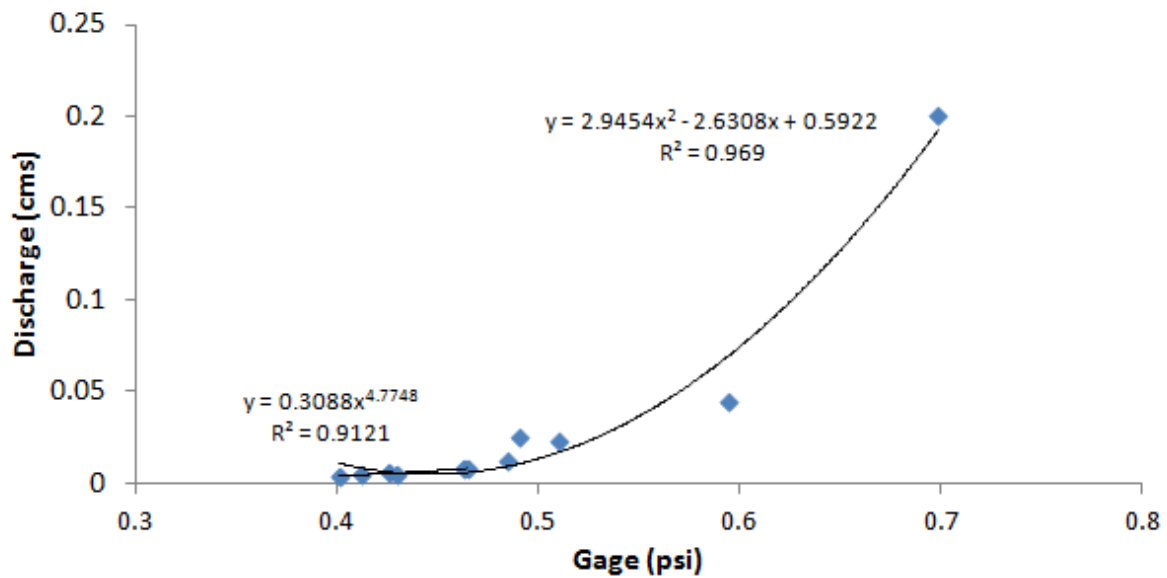
Figure 14. Pressure-Discharge relationship at the Williams Canyon Creek gage. Twelve discharge measurements were plotted against the corresponding gage readings to develop a rating-curve. A second order polynomial was used to describe the relationship between gage (psi) and stream discharge (cms). A power function was used to describe the relationship of discharge (cms) to gage (psi) values below 0.430 psi.

On Williams Canyon Creek a rating curve was initially created in March 2011 from six stream measurements taken between September 2010 and March 2011 (Paddock 2011). The relationship between the staff plate (ft) and gage (PSI) remained stable since the gage was installed in August of 2010. The rating curve was further developed by the inclusion of an additional six stream measurements from March 2011 to October 2011, including a high flow measurement of 0.2 cms. A pressure-discharge relationship was described by a second order polynomial equation developed by regression. A power function was used to describe the relationship of discharge (cms) to stage (psi) values below 0.430 psi (Figure 14).
