Publication No. WI-2019-05
8 July 2019

Assessing steelhead passage and channel stability following dam removal on the Carmel River

Spring 2019

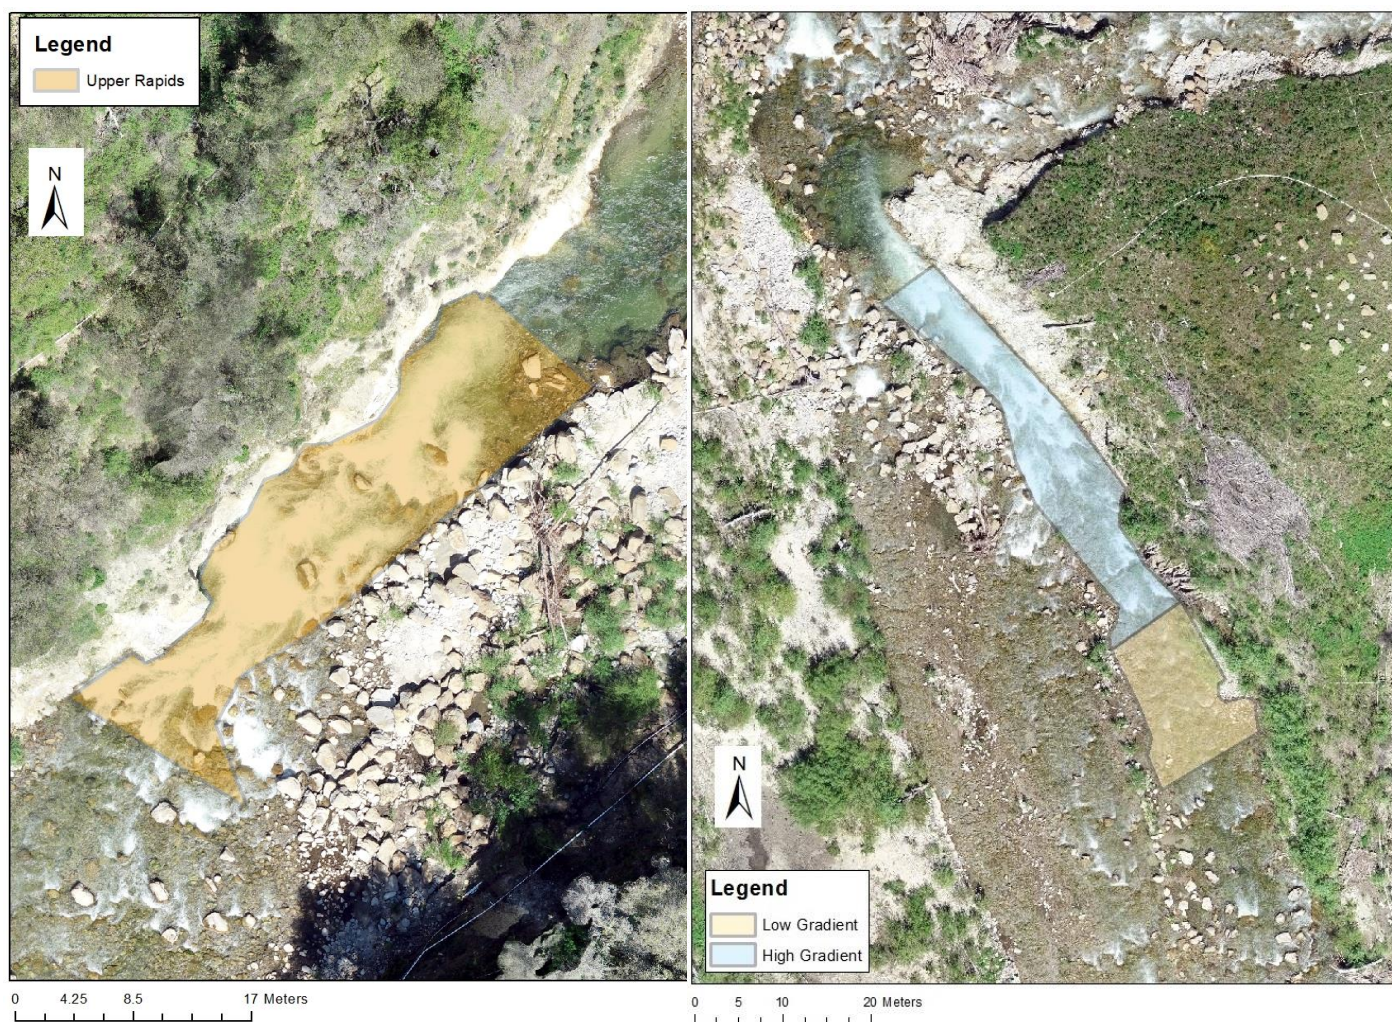
Figure 6. Upper rapids (left), above lower rapids and lower rapids (right) where floats were deployed and sUAS video was taken to estimate surface velocity.

We estimated velocity at three hydraulically and morphologically distinct reaches. The “upper rapids” reach represents a steep cascade (5% gradient) reach with larger steps. The “above lower rapids” reach represents a riffle reach with less gradient (2% gradient). The “lower rapids” reach is a narrow, steep reach (5% gradient) with small steps. These three sites were selected to represent the range of potential velocity barriers observed at 240 cfs (Figure 6). We used the float method (using oranges) for measuring velocity in these reaches because safety concerns prohibited use of current meters. Easily identifiable features in the sUAS videos were selected as starting and stopping points for the floats in each distinct reach. Timestamps on the sUAS videos were used to calculate the time it took each float to move from the designated starting point to the stopping point and the distances between starting and stopping points were measured from sUAS photogrammetry in ArcMap (v. 10.5). Video also illustrated natural resting points where eddying occurred. We calculated surface velocity for each hydraulically distinct reach by dividing the distance between starting and stopping points by the time taken for the float to move from start to finish. Surface velocity determined using floats overestimates the average velocity of the river by approximately 15%, so the surface velocities were multiplied by 0.85 to correct the error. A table of thresholds for steelhead passage at varying velocities over given distances was created in Microsoft Excel.

Average velocity in the upper rapids is 1.93 m/s and average velocity for the lower rapids is 2.06 m/s. The lower rapids high-gradient section has an average velocity of 2.18 m/s while the low-gradient part of the lower section has an average velocity of 1.98 m/s (Table 5). Table 6 shows velocity thresholds for steelhead passage. Number of trials using floats to estimate velocity in high gradient and low gradient rapids are indicated within colored cells. Ten trials fell within acceptable velocity and distance ranges and five trials were above the maximum velocity threshold for passage steelhead passage (Table 6).

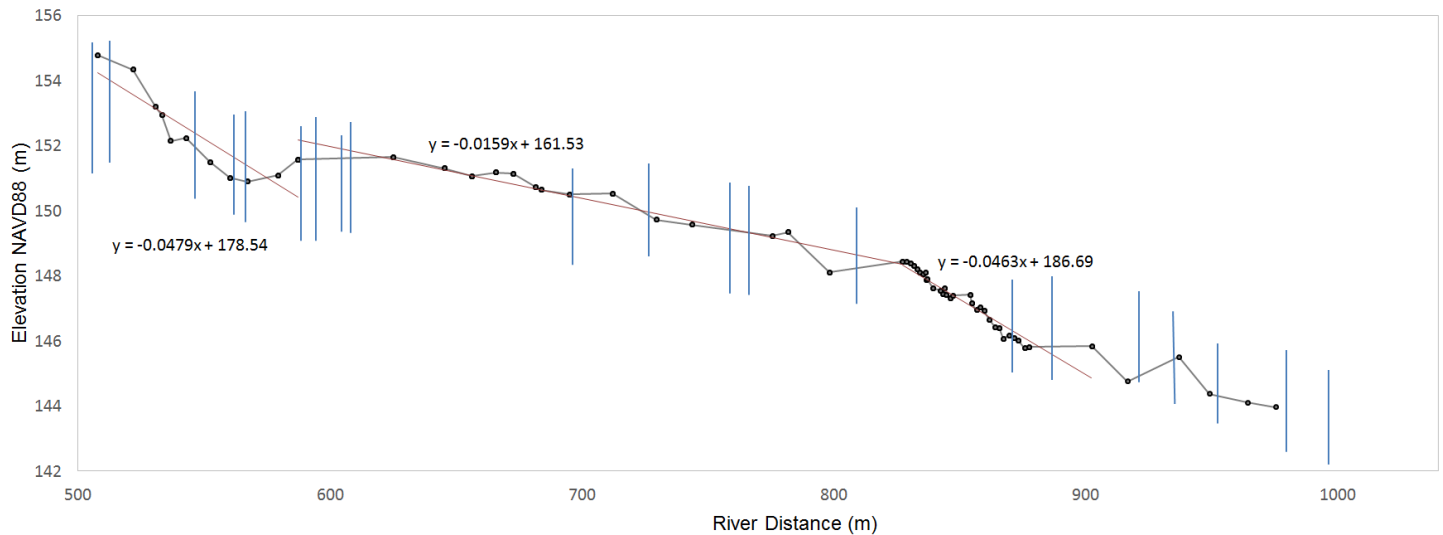
Figure 8. Longitudinal profile of study reach. Blue lines indicate locations of transects used for analyzing boulder movement. Trendlines are shown in red. Linear equations for each section of similar slopes are shown. Slopes for transects 1–5 (starting from downstream) were found using orthoimagery instead of regression and are therefore not shown on the long profile.

Local slope for each transect was regressed from the 2018 long profile. The channel was broken up into sections based on similarity in slope for any given reach and transect locations were indicated on the profile (Figure 8). Slopes for transects 1–5 were calculated using distance and elevation values from a profile drawn in ArcMap (v. 10.6) because these transects either extended past the 2018 long profile or they were located along a reach where slope was oversimplified by collection of too few data points in the long profile. All slope values were used to conduct further statistical analysis.

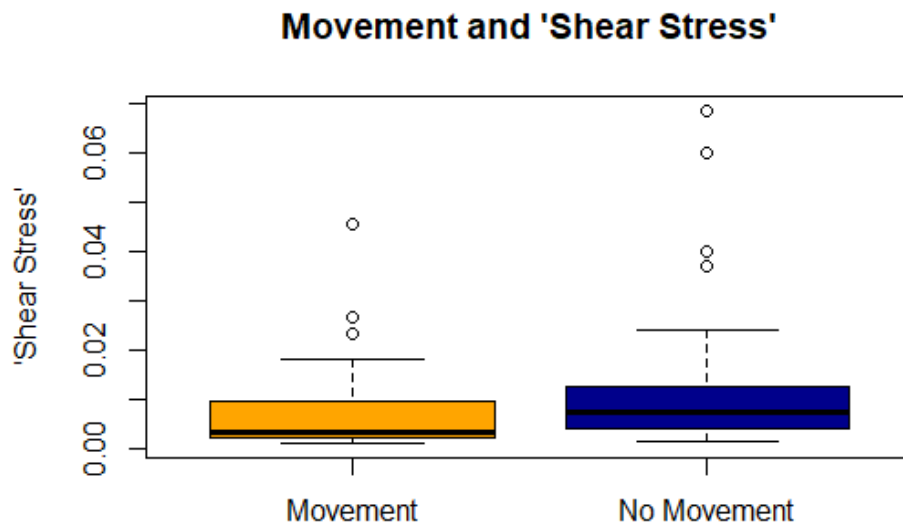
We assessed the mobility of 185 boulders and found that 85% did not move between WY18 and WY19. Translational movement measured ranged from 0.5 m to 7 m with a mean distance of 2 m. Boxplots showing probability of movement as a function of a shear stress index indicate there is no significant impact of shear stress on probability of movement (Figure 12). Our index of shear stress used the cross-channel distance from the thalweg as a substitute for hydraulic radius. This substitution assumed that depth shallowed gradually between a maximum depth at the thalweg, and the water's edge. In the CRRDR, the channel does not generally shallow with distance from the thalweg, so the index is a weak approximation of shear stress.

Figure 12. Boxplot showing relationship between shear stress and probability of boulder movement. Slope/distance from thalweg was used as a proxy for shear stress.

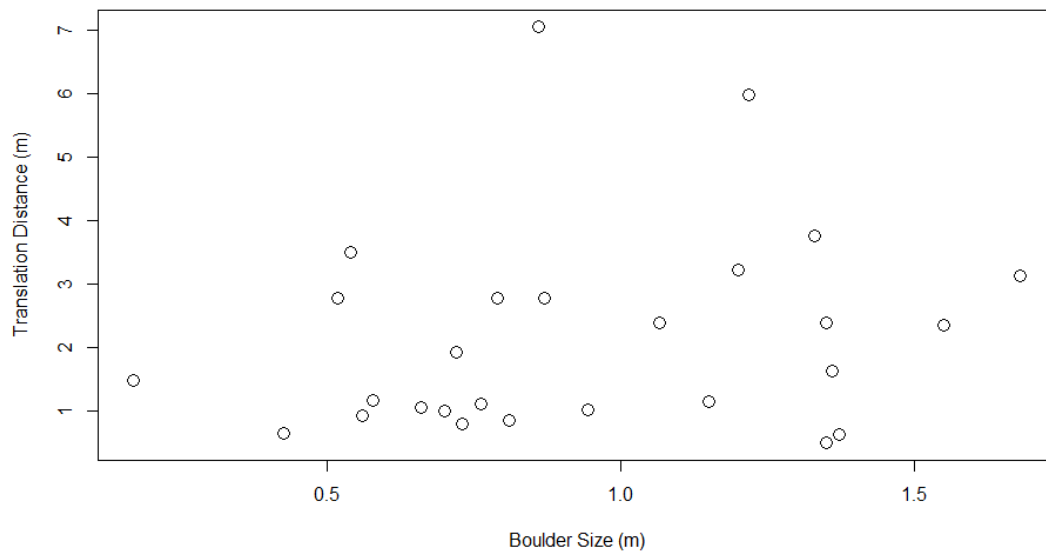
A linear regression assessing translational distance of boulder movement as a function of boulder size resulted in a p-value of 0.30 ($df = 25$, t-value = 1.043). The associated scatter plot shows the insignificant relationship between boulder size and distance of movement (Figure 14). A logistic regression of probability of movement as a function of boulder size resulted in a significant p-value

Figure 14. Scatter plot translational distance as a function of boulder size.
