Report No. WI-2004-05/2
1 November 2004

The Watershed Institute

Physical and Hydrologic Assessment of the Carmel River Watershed California

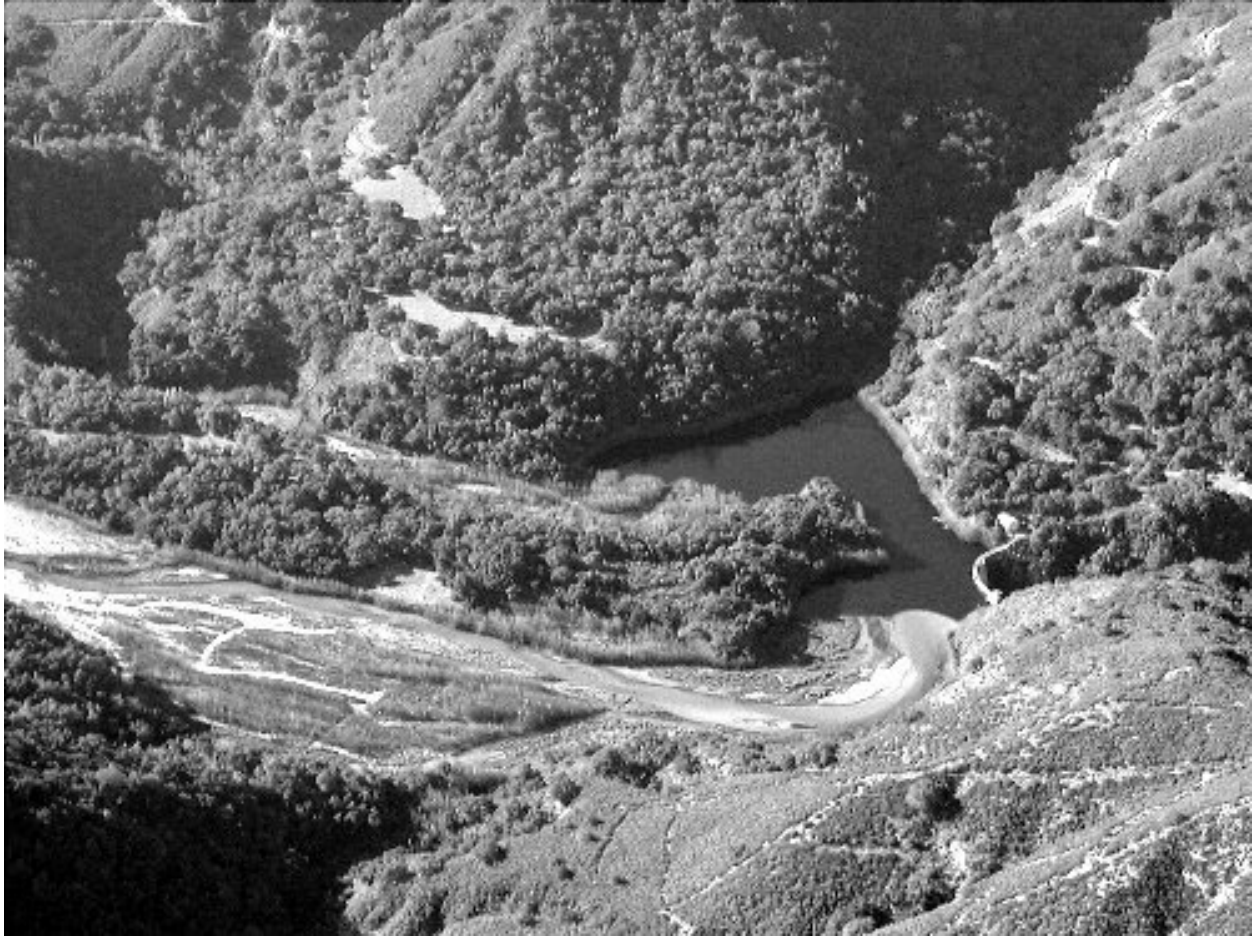
Figure 5: San Clemente Dam in early 2003 showing the reservoir nearly filled with sediment. The “floodplain” and river channel upstream (left) from the dam was open water when the reservoir first filled in the 1920’s. In early 2004, the sediment was nearly touching the face of the dam. The Cachagua and Tularcitos Fault zones are located close to the dam.

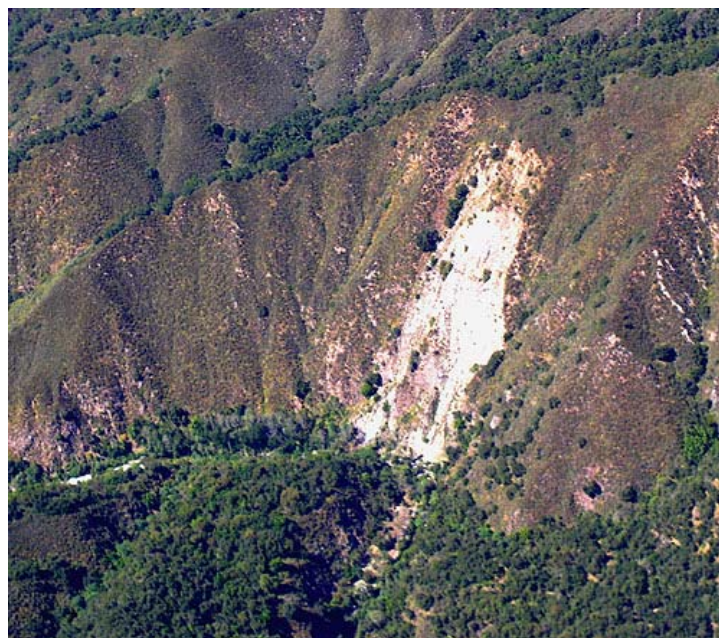
Figure 6: Active landslide located above San Clemente Reservoir. This landslide is long-lived, and perennially reactivated because it is located along outside bend of Carmel River, where erosion undercuts the steep slope (Robert Johnson and Associates, 1986).

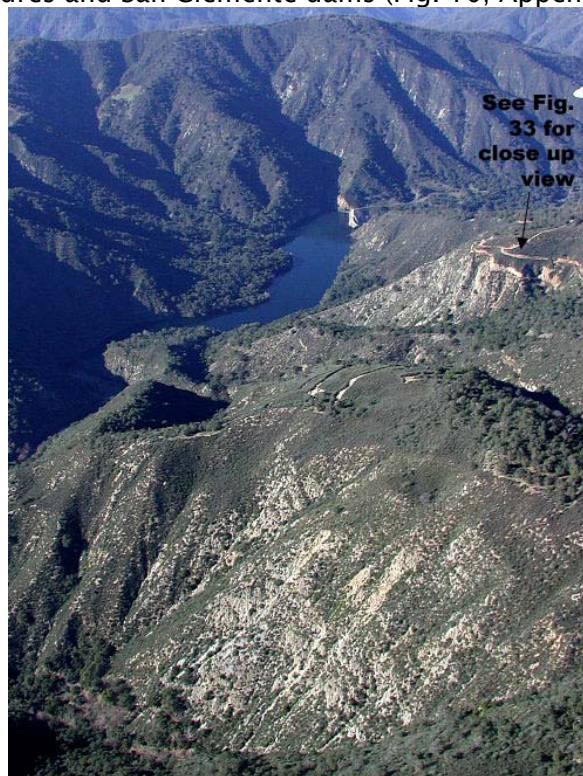
Figure 10: Steep eroding slopes of granitic rock up-valley from Los Padres Reservoir.

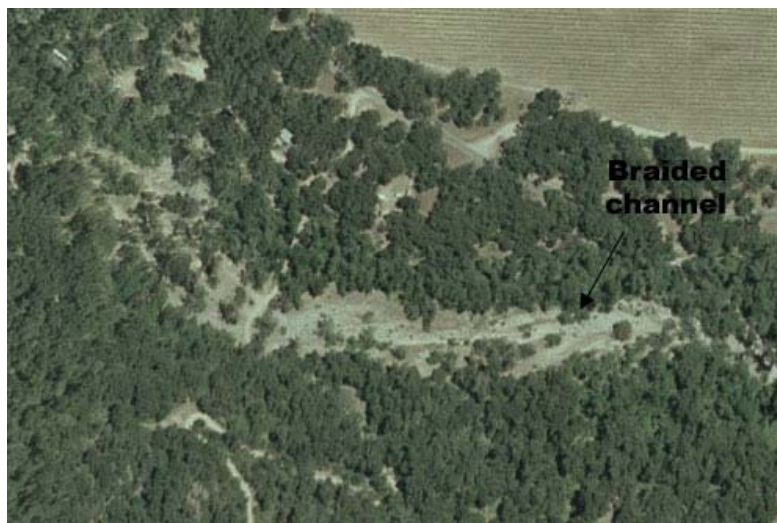
Figure 11: Braided channels in Carmel channel below confluence with Cachagua. 5775800E; 2042600N.

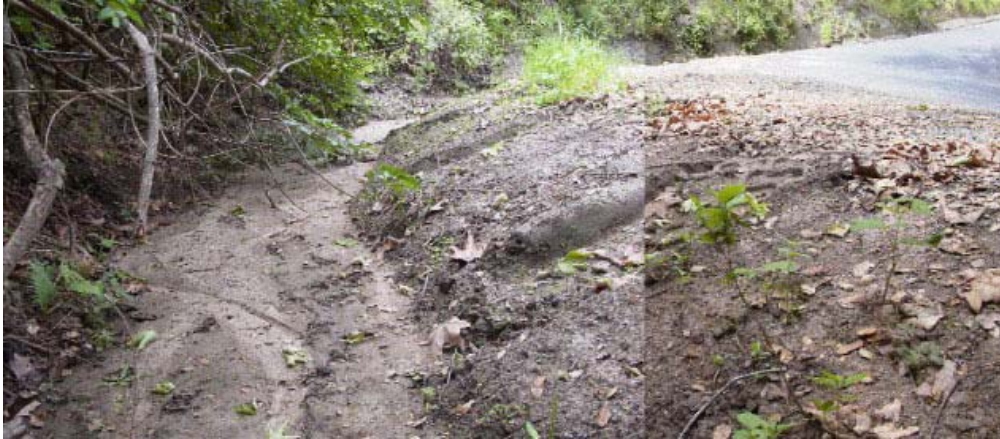
Figure 12: Road ditch along Robinson Canyon Road carries sediment derived from eroding road cuts directly to a culvert leading to a tributary creek bed.

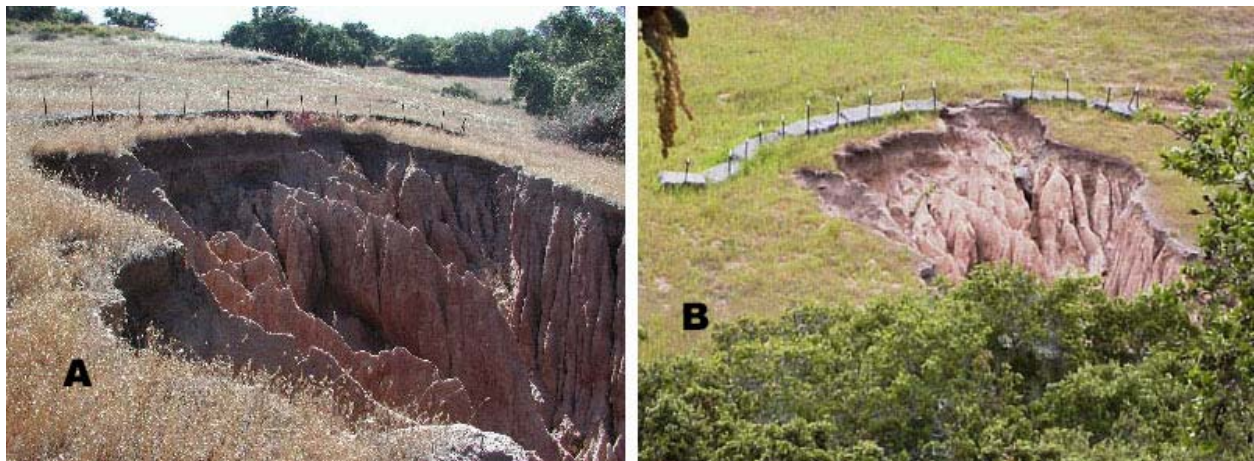
Figure 13A: Head of large gully eroded into weak Chamisal Formation. Gully likely formed from road cut on Robinson Road. There is no indication of destabilizing factors higher on the slope. Photo from June 2003. Figure 13B: Same location as Figure 13A. Photo from April 2004. Note that the gully head has breached the hay bales indicating growth, even in year without high precipitation.

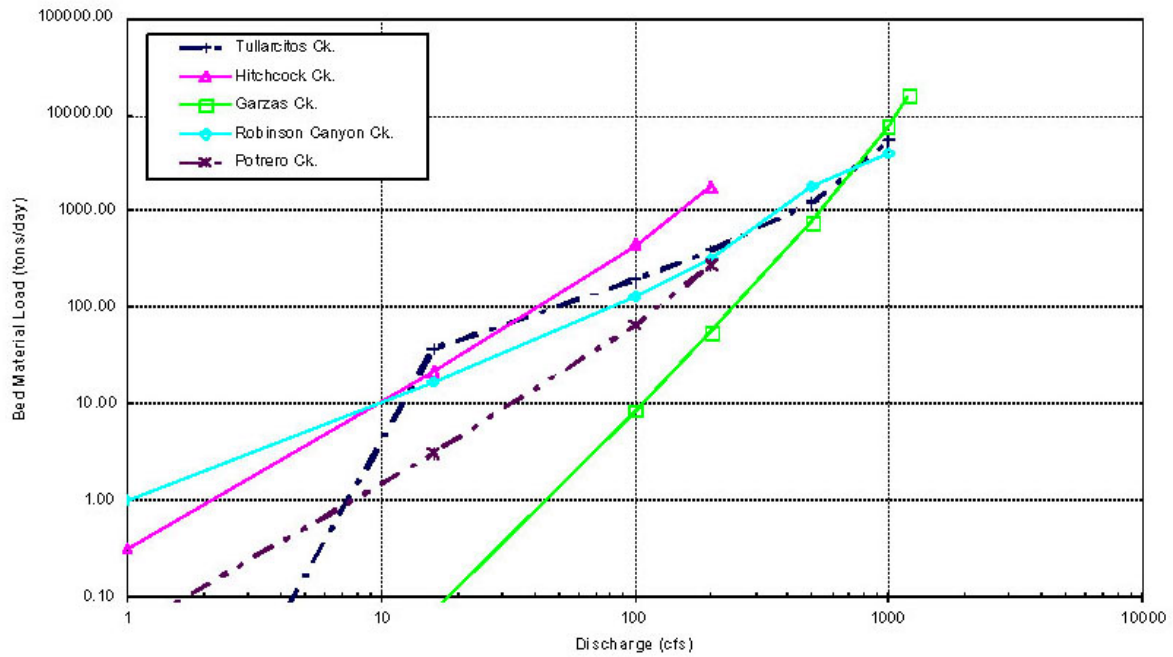
Of note is that estimated sediment-rating graphs show that Tularcitos Creek moves a disproportionately high sediment load with relatively little flow, and then, as water flow increases, the sediment rate is comparable to other tributaries (Fig. 16).

Figure 16: Estimated sediment rating relations for select tributaries to the Carmel River (MEI, 2002). Bottom axis is water discharge (ft^3/s); Vertical axis is bed material load (tons/day).

Although Figure 16 suggests that significant sediment measurement data exist, including measurements at over 1000 cfs, it is clearly based upon synthesis of data from very few studies, and at much lower flows (MEI, 2002). As sediment yield is one obvious barometer of watershed condition and departure from optimum conditions, we highly recommend that frequent bedload and suspended load monitoring become a regular part of future watershed management.

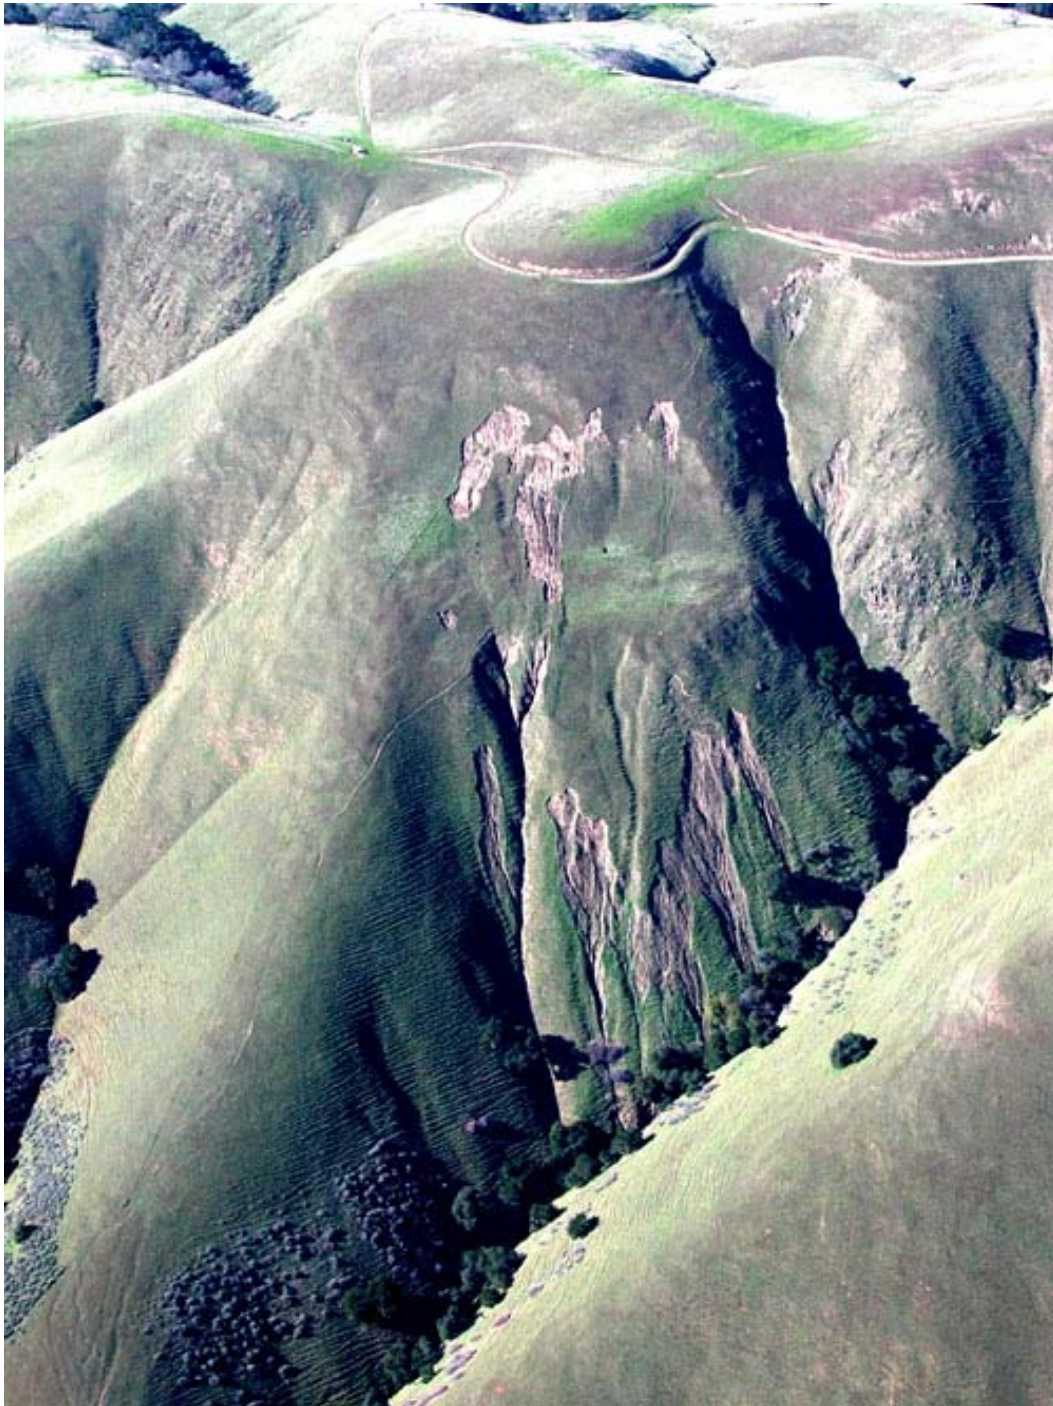
Figure 17: Soil slips in steep slopes that form the divide between Chupines Subwatershed and Toro Creek Watershed. Also note the bare road cuts that can also be a source of excess sediment in wet weather. See Figure 53 for close up terraced hillslope. 5784700E; 2077600N.

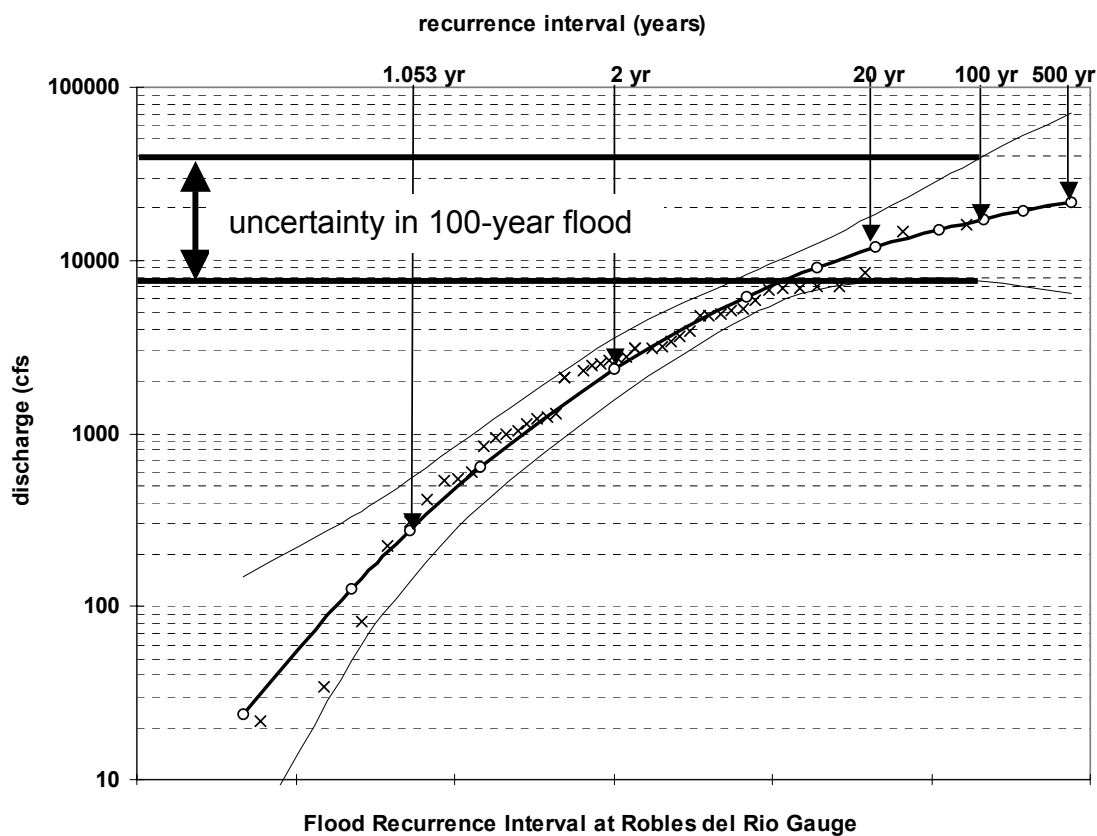
Figure 26: Plot of Carmel annual floods. Bold line is the calculated relationship between discharge (cfs) and recurrence interval (years). The fine lines are the upper and lower 95% confidence limits on the relationship. Log Pearson Type-III analysis using regionalized skew for Robles del Rio U.S.G.S. gauge data from 1955 to 2001.

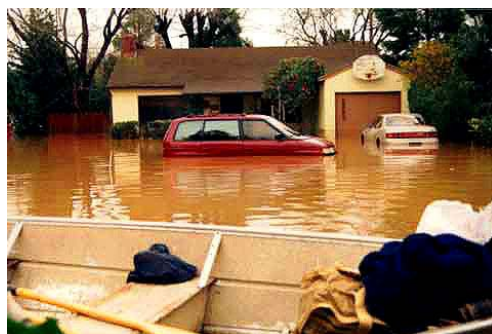
The greatest flood during the 48 years of gauge operation was the 1995 flood with approximately 16,000 cfs. That event roughly corresponds to the 65-year flood. The next highest flood caused significant damage in 1998 with a 14,700 cfs flow (Fig. 27).

Figure 27: Flood damage near "Mission Fields" neighborhood following the 1998 Carmel River flood. Photo courtesy of Edward Murphy.

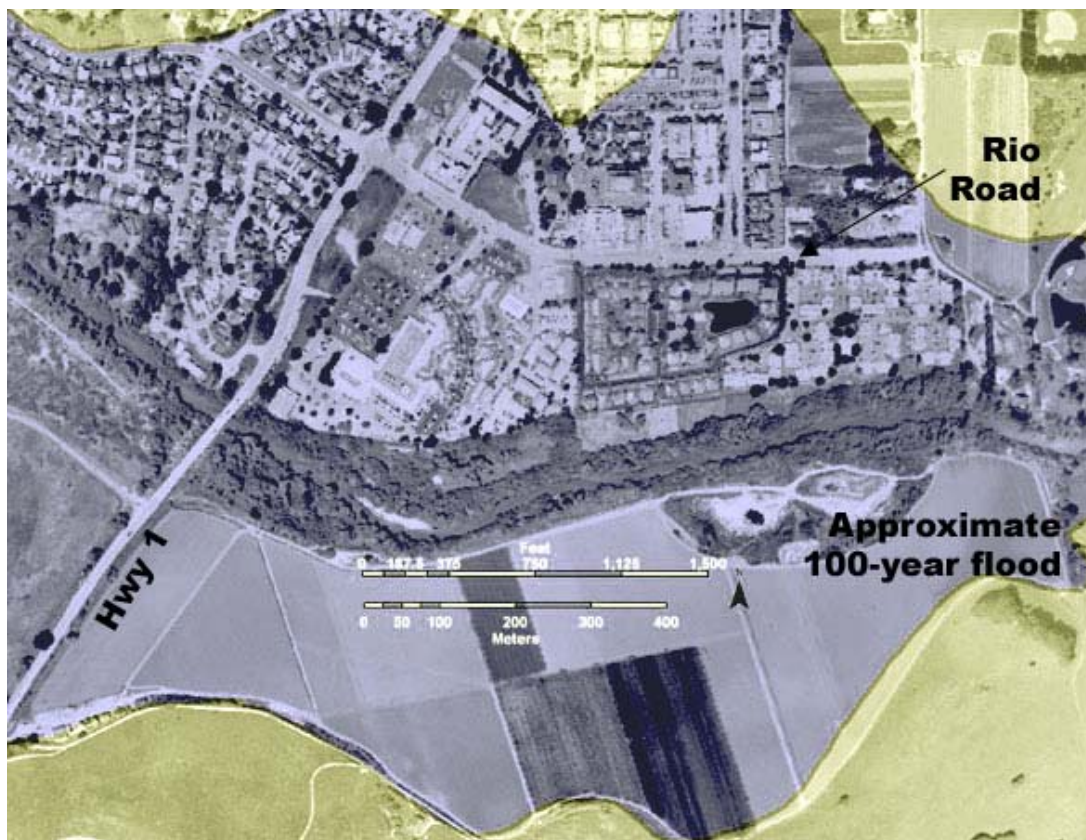
Figure 28: Example of urban development that would be affected by the estimated 100-year flood. Approximate affected area shown in blue (FEMA, 1996). Levees exist along both sides of the Carmel River upstream (right) of Highway One. Background photo from MEI (2002).

The result of the levees is to protect developed land from moderate flows, but also to encourage urban development by fostering a false sense of security about flood hazard on the Carmel River floodplain. The latter result will ultimately lead to very significant economic losses when high magnitude floods occur. Further, the moderate floods that are confined in the levees will be directed downstream instead of laterally onto the floodplain, so flood hazards are increased downstream where residential areas exist on the floodplain. Although we do not assign cause and effect for recent floods, the developments downstream from the Carmel levees have suffered significant flood damage in recent years (Fig. 27). More recently, a levee located opposite the Mission Fields development has been notched to provide flood relief and flood storage on the southern floodplain of the river.

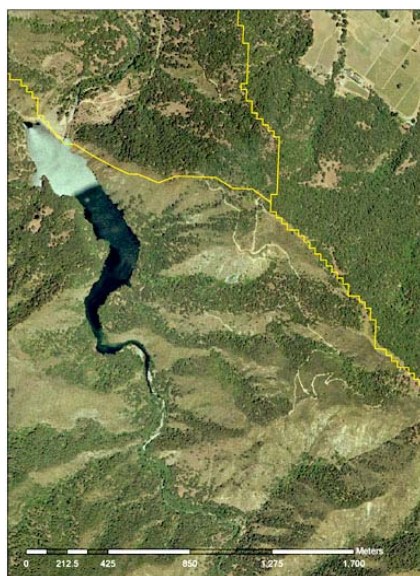
Figure 32: Los Padres Dam and Reservoir.

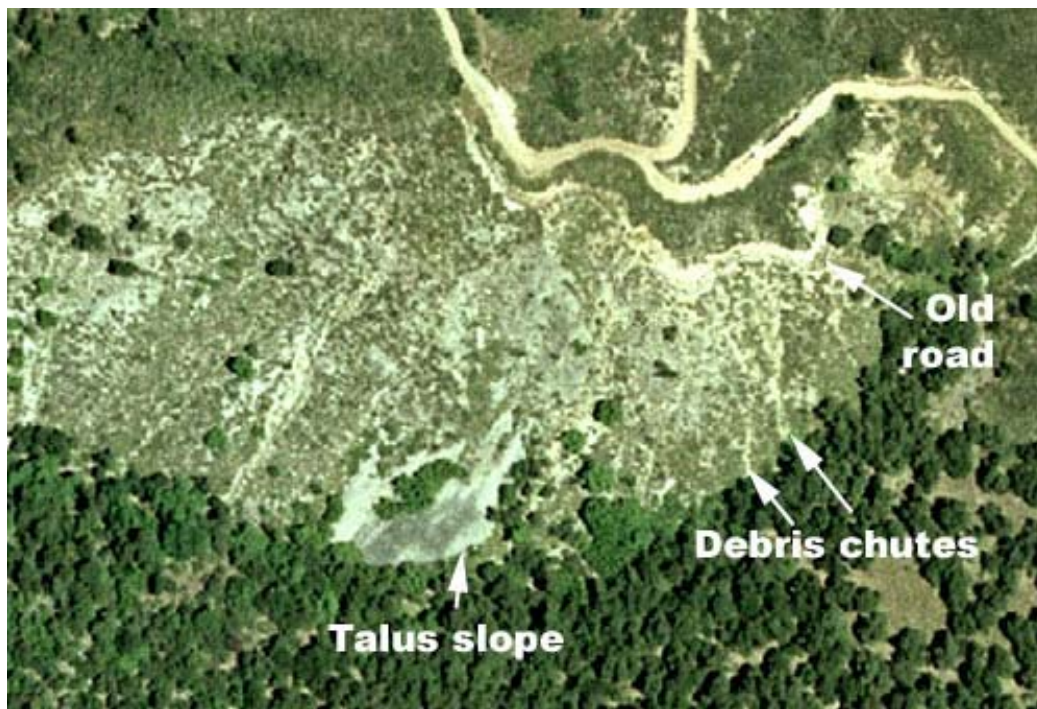
Figure 33: Abandoned dirt road located along steep granite slopes in Los Padres Dam Subwatershed is still contributing to slope instability. Note the talus cone at base of slope indicating high rates of sediment generation. See Figure 10 for location. Vertical view of 5779400E; 2032600N.

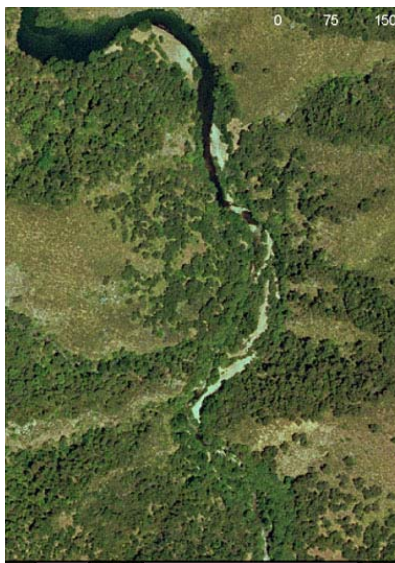
Figure 34: upper reaches of Los Padres Reservoir are filling with bedload sediment. Vertical view.

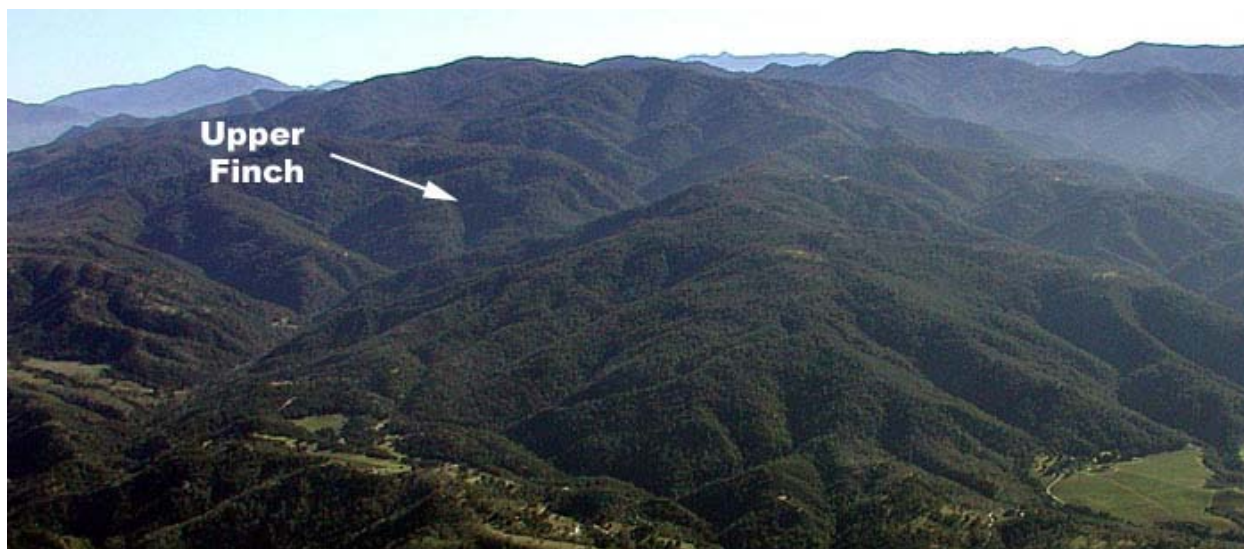
Miller Fork and Upper Finch Creek are well-vegetated watersheds with sparse roads (Fig, 35). Los Padres National Forest Service “Stream Habitat and TES Occupancy Reports” for Miller Creek dating between 1957 and 1999 describe abundant steelhead trout in Miller Fork. The Carmel Road climbs up to the Arroyo Seco Watershed divide along the upper reaches of Finch Creek. The creek channel is generally incised, with eroding banks. Excess sediment is presently filling geomorphic pools.

Figure 35: Overview of well-forested Upper Finch Subwatershed. View toward the South.

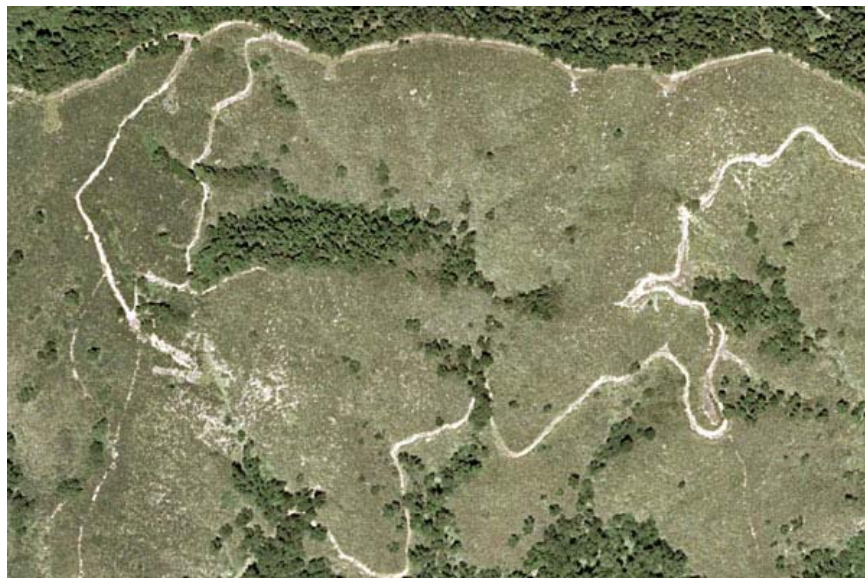
Figure 37: Examples of poorly-maintained dirt roads on steep slopes down valley from the small lake on San Clemente Creek. 5750400E; 2047600N.

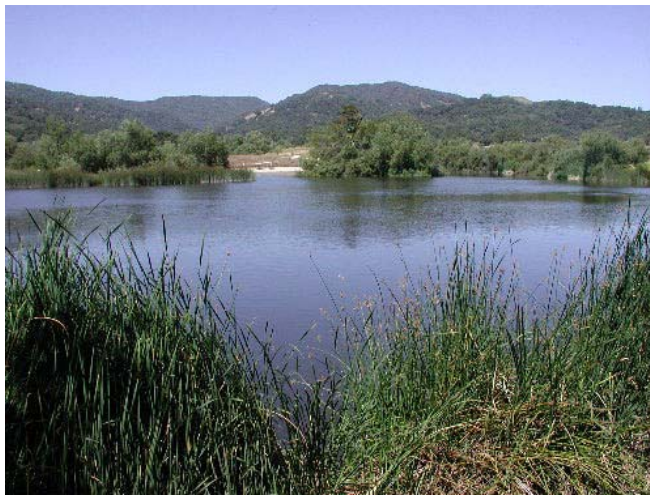
Garzas Creek is split into an upper and lower subwatershed, divided at the outlet of Moore's Lake (Fig. 38), which occupies low ground in San Franciscito Flats. Garzas Creek has headwaters high on in the Santa Lucia Range where there is high annual precipitation, and the entire watershed is densely forested with lesser patches of grassland. The combination of high precipitation and good hydrologic condition makes the watershed among the finest in terms of yield and annual contribution to the Carmel Valley (Table 3). Land use in the Upper Garzas

Figure. 38: View of well-vegetated Upper Las Garzas Subwatershed across Moore's Lake.

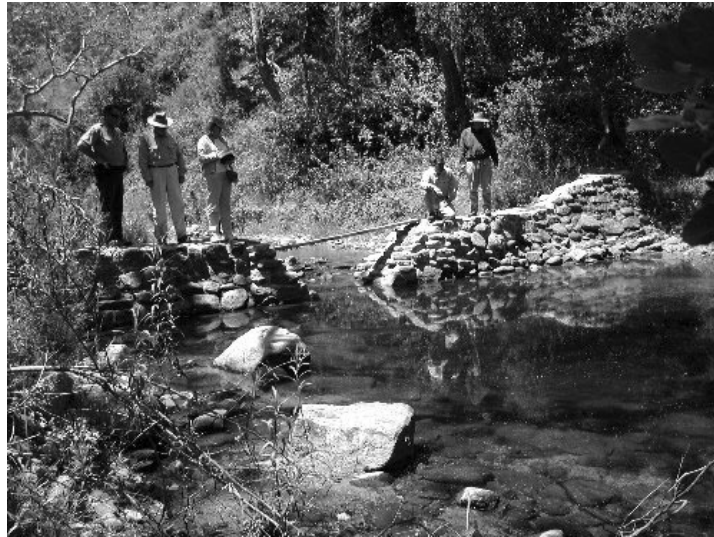
Figure 39: Private low dam on Lower Las Garzas Creek is now notched for fish passage.

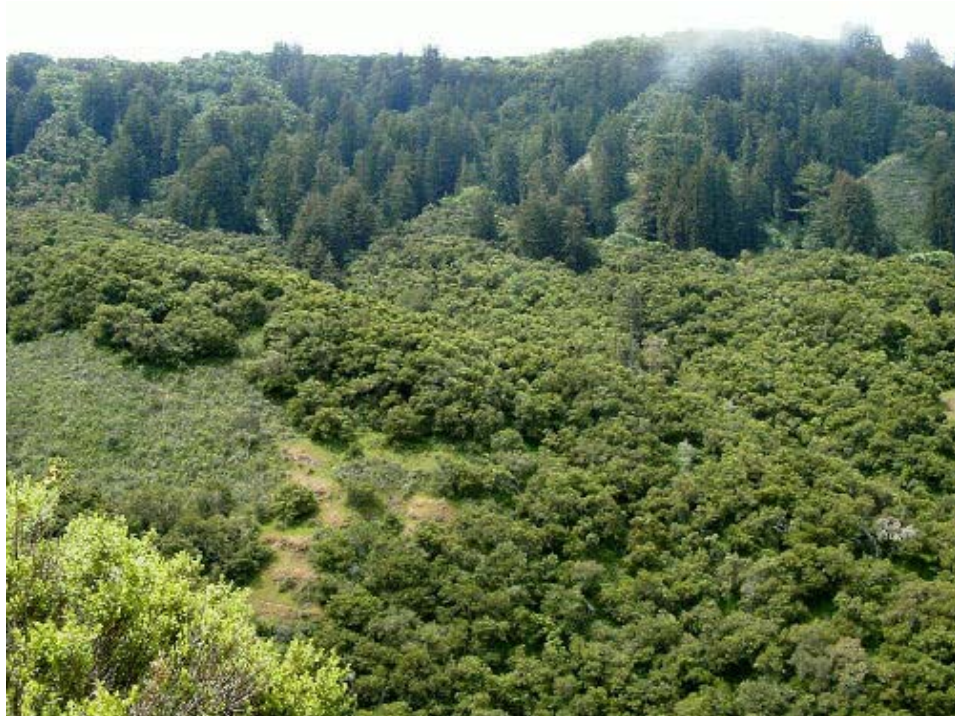
These watersheds are relatively more urbanized than the previously described Santa Lucia subwatersheds. Robinson Canyon has a considerable wealth of intact forest (Fig 40) and picturesque sandstone outcrops. The canyon also has too much sand eroding from road cuts, stream banks, gullies, and soil slips (Figs. 12, 13a, 13b, and 14). Near those erosion sites, road workers had graded excess sediment from the road surface or ditches onto the shoulder of the road where the next rains would wash the spoils directly into the creek bed (Fig 41). There is also an un-maintained road cut erosion repair that is producing fine sediment (Fig. 42). Jute net technology is an effective erosion control if the substrate is well-prepared, the net is well-staked, and the site is properly maintained while vegetation has a chance to grow through the netting. Nascent gullies are locally exposed where the jute net has become unstaked (Fig. 42). The net is “hanging” above the ground in much of the installation, leaving young plants unable to reach the net, and allowing erosive water flows beneath the net (Fig. 42).

Figure 40: Densely vegetated landscape in upper Robinson Canyon. View to the west from Robinson Canyon Road.

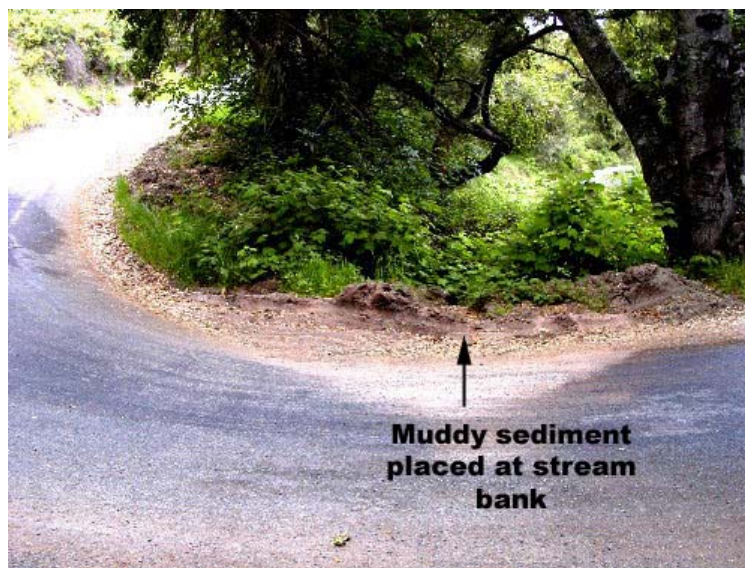
Figure 41: Sand and mud moved to roadside near edge of tributary channel.

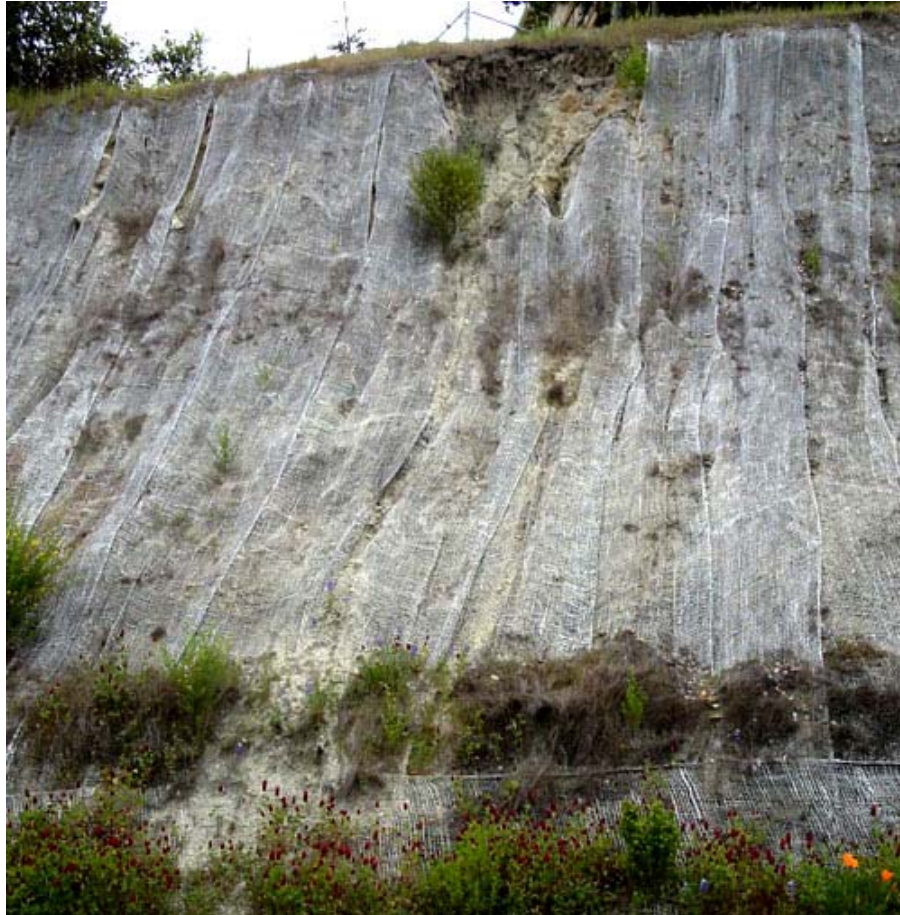
Figure 42: Planted jute net erosion control on steep road cut in Robinson Canyon.

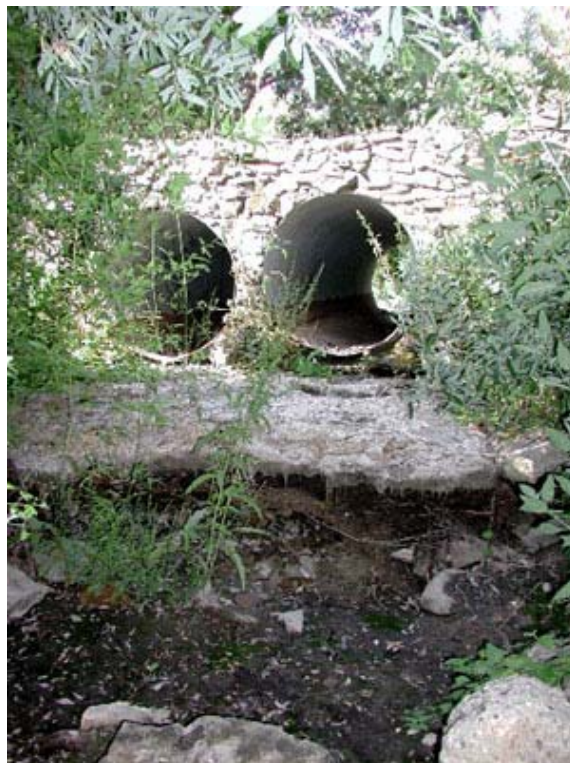
Figure 43: Undercut concrete culvert foundation is an impediment to trout migration. The jump lacks a “landing pool.” View upstream.

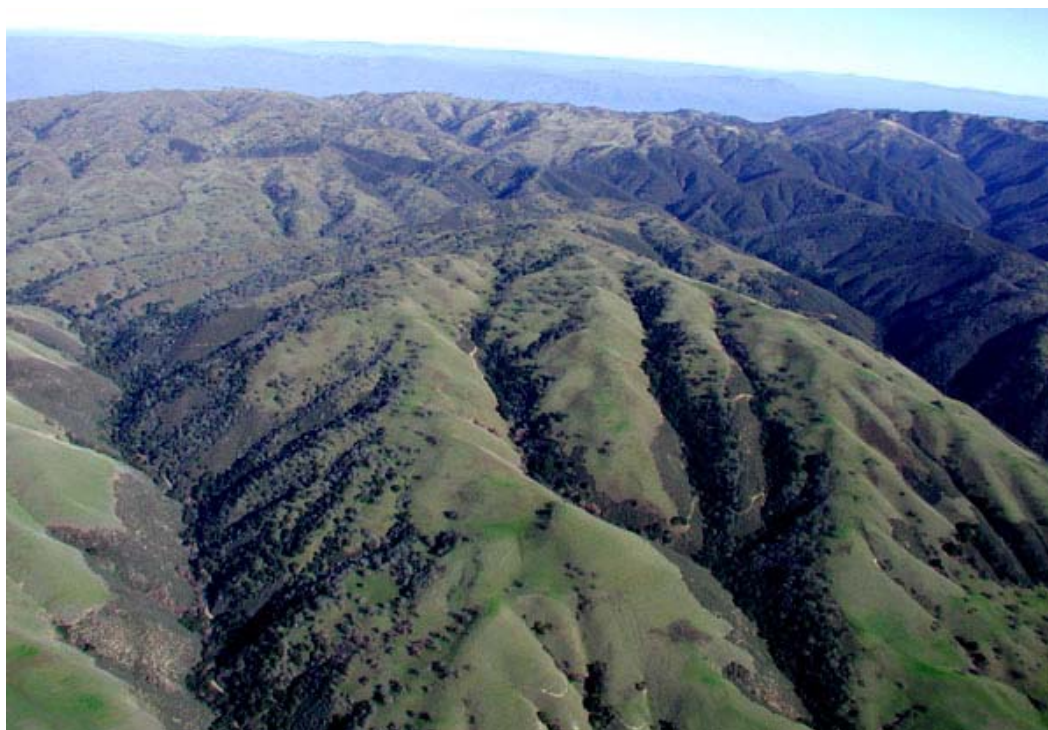
The upper reaches of the Cachagua drainage and the sub-basins of the Tularcitos drainage are cut into the Sierra de Salinas, forming the northwestern flank of Carmel Watershed. The landscape, climate, ecosystems and land-use differ markedly from the Santa Lucia range described above. The land tends to be more arid, with significantly lower annual rainfall. Hastings Natural History Preserve at the mouth of Bear Canyon subwatershed reports a rainfall average of 21.3 inches/yr (HNHP, 2004). The landscape is also more accessible than along the Santa Lucia Range. The land has traditionally been used for cattle ranching, with the impacts of overuse locally apparent. The region has sparse ranches set in a broad, annual grassland, oak forest, and chaparral ecosystem (Fig. 44 rana fork; Appendix A-4).

Figure 44: Rana Creek is drainage on the left. Oblique aerial photo toward the northeast.

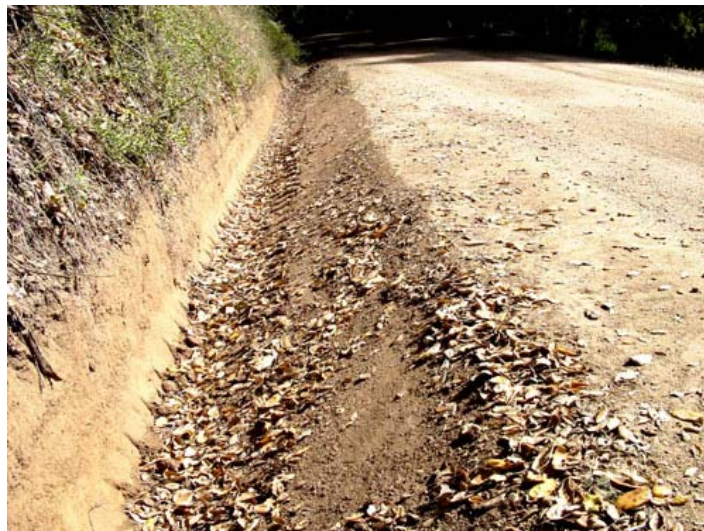
Figure 45: Road ditch on dirt road near Robertson Creek.

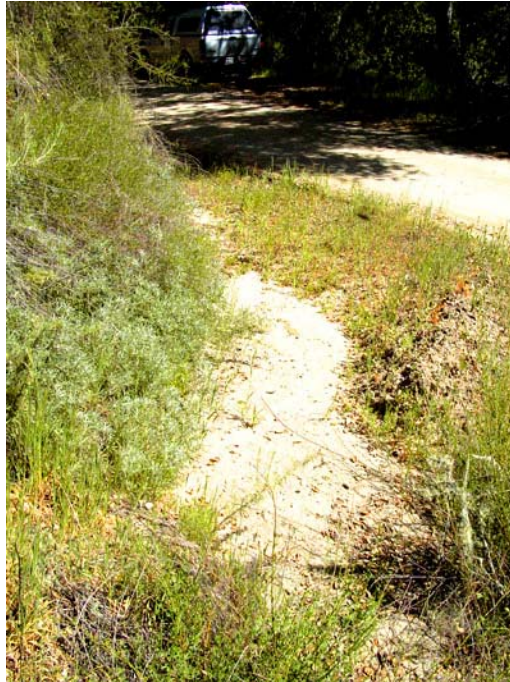
Figure 46: Sand carried from roadside ditches (e.g., fig. 45) to a culvert leading to Robertson Creek.

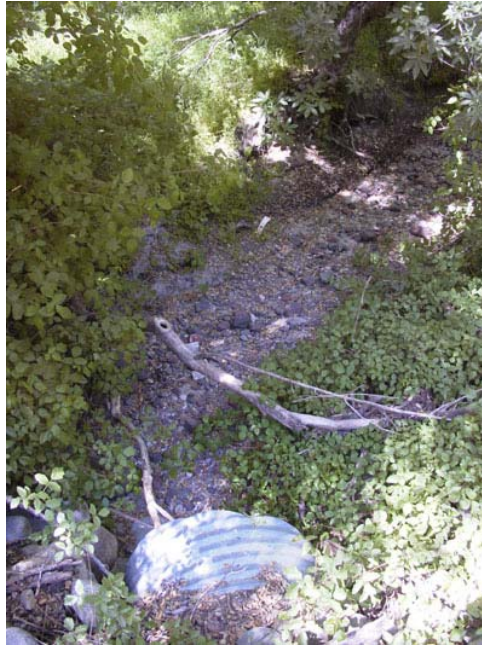
Figure 47: Creek bed is at grade with inlet to typical corrugated culvert.

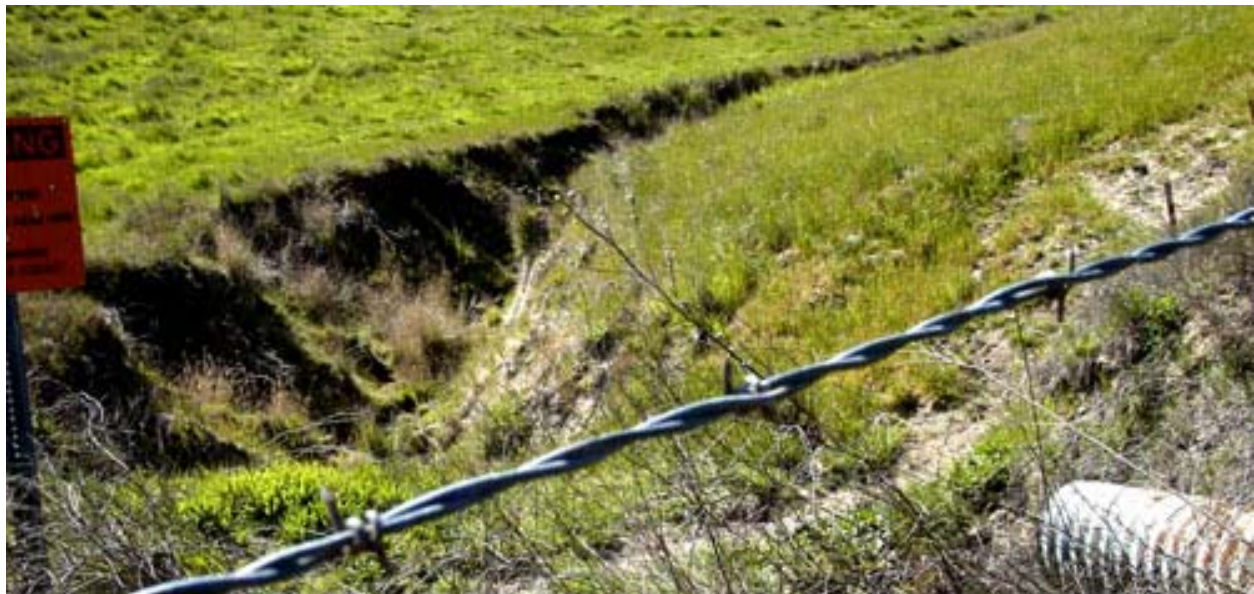
Figure 49: Gully eroded in meadow downstream from culvert under Carmel Valley Road.

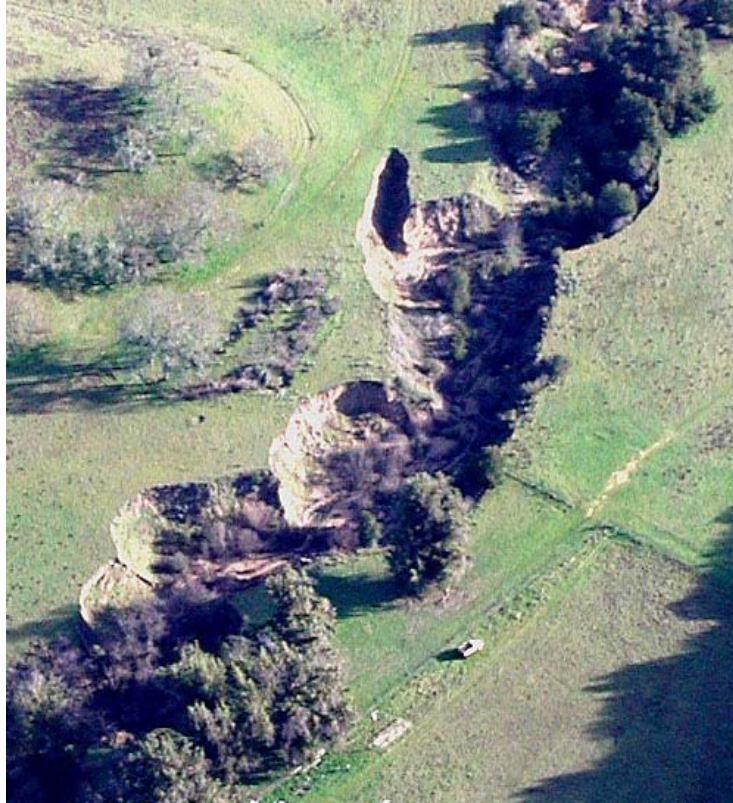
Figure 50A: Deeply incised channel near Carmel Valley Road in Conejo Creek of the Lower Finch Subwatershed. Vegetation has begun to recover along base of steep banks. Pickup truck for scale. Stream flow is top to bottom

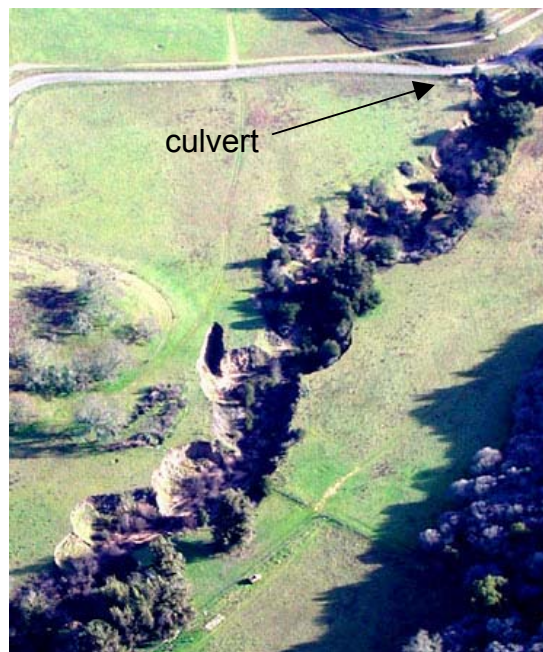
Figure 50B: Broader view of region near Figure 50A. Note culvert beneath Carmel Valley Road. Further reconnaissance indicates that the culvert made this incision worse.

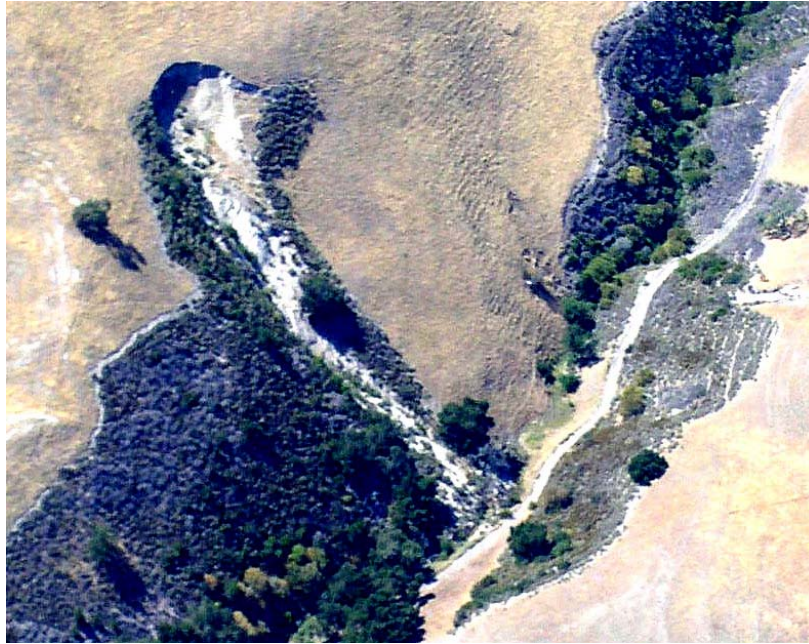
Figure 51: Landslide in Tertiary sedimentary rocks of Sycamore Gulch drainage. Landslide run out is greater than 600 feet long. 5782215E; 2063480N

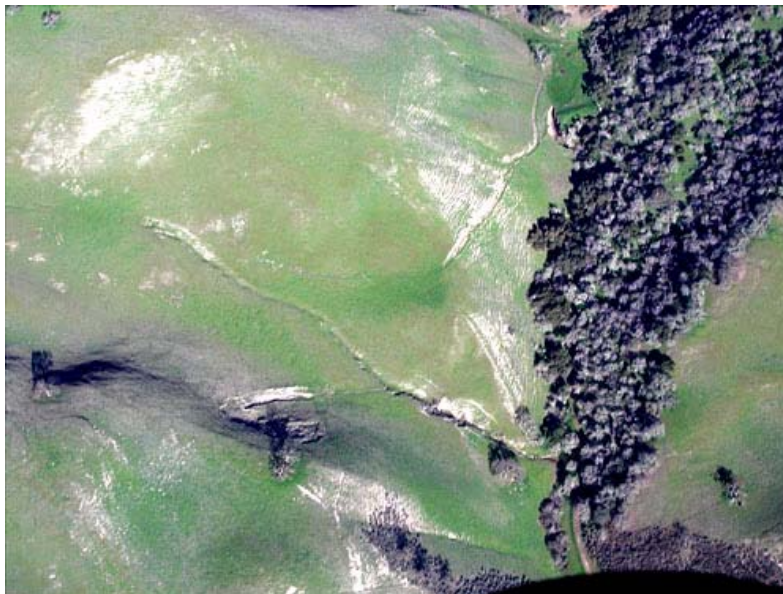
Figure 52: Terrecettes in Sycamore Gulch drainage.

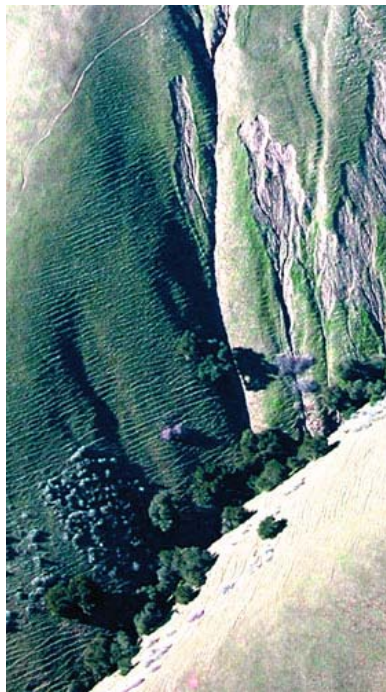
Figure 53: Terrecettes across steep slopes in Chupines Subwatershed.

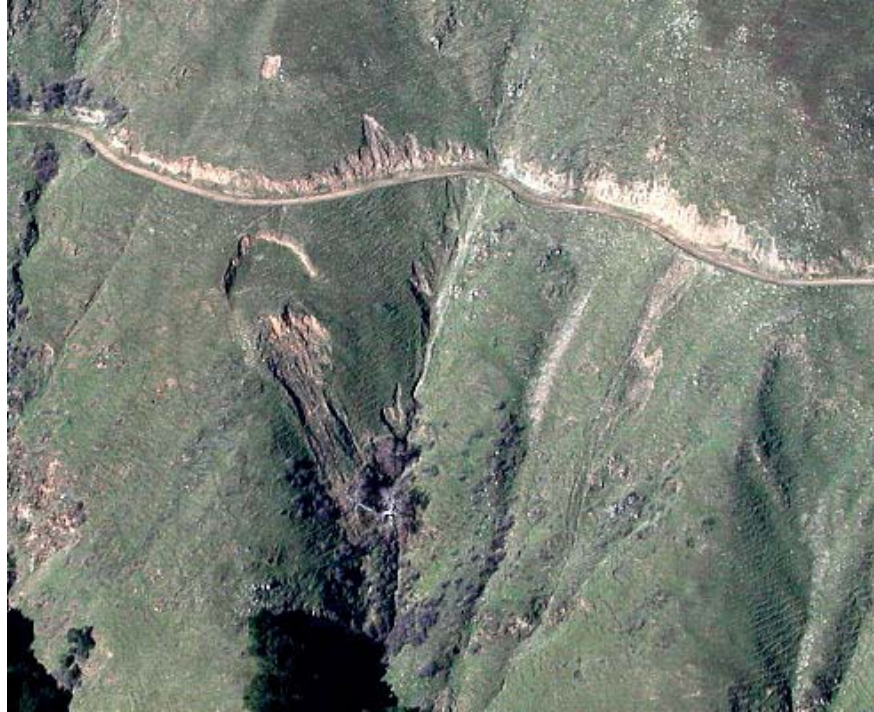
Figure 54: Landslides, gullies and unstable road cuts are abundant sediment sources in Chupines Subwatershed. Note grazing terrecettes on steep slopes.

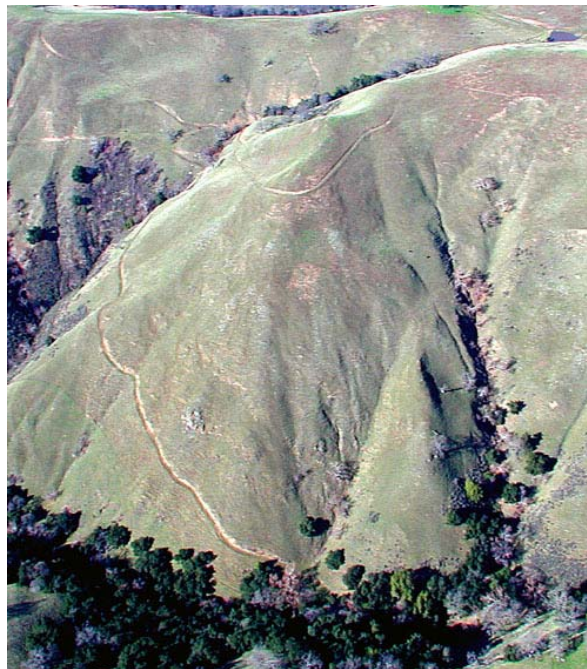
Figure 55: Steep road crosses steep slope.

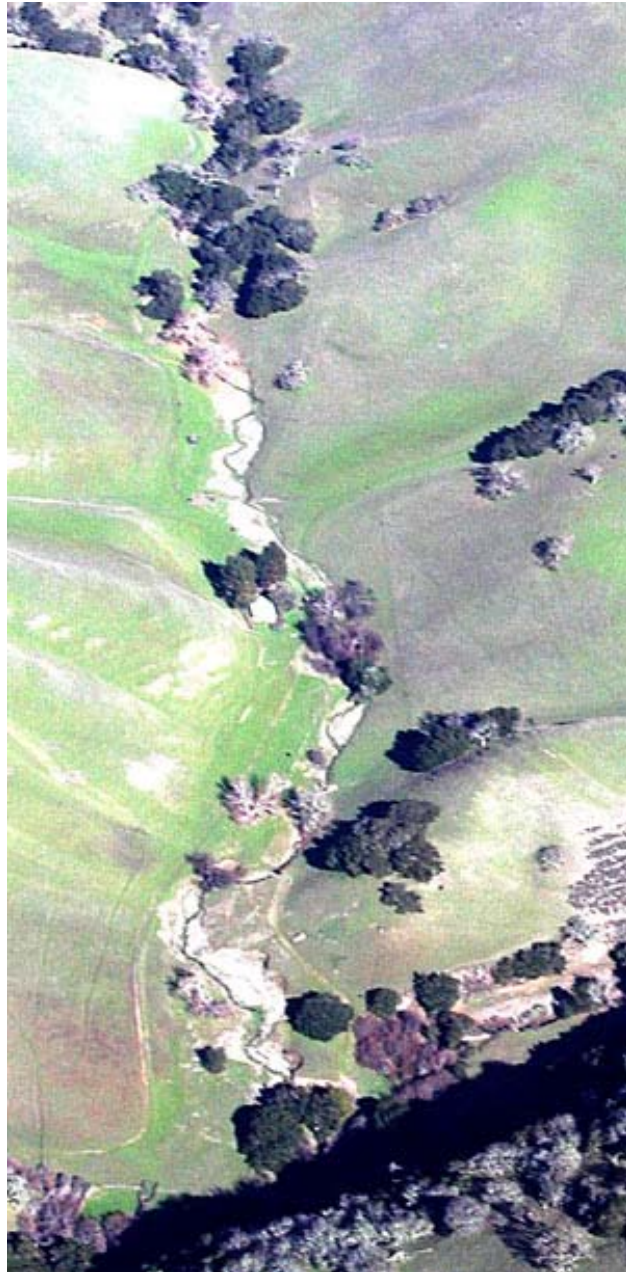
Figure 56: Chupines Creek with impaired riparian corridor. 81750E; 2072150N.
