Report No. WI-2004-05/2
1 November 2004

The Watershed Institute

Physical and Hydrologic Assessment of the Carmel River Watershed California

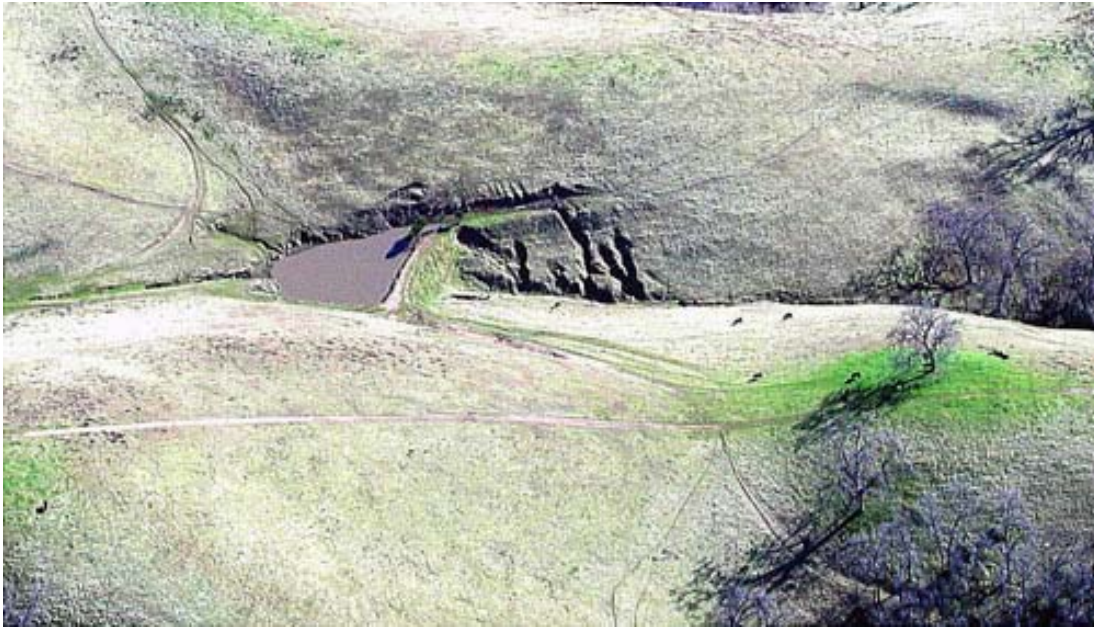
Figure 56: Cattle stock pond in Chupines Subwatershed with gullies near earthen dam. Dots in mid-ground are cattle. 5791200E; 2081300N.

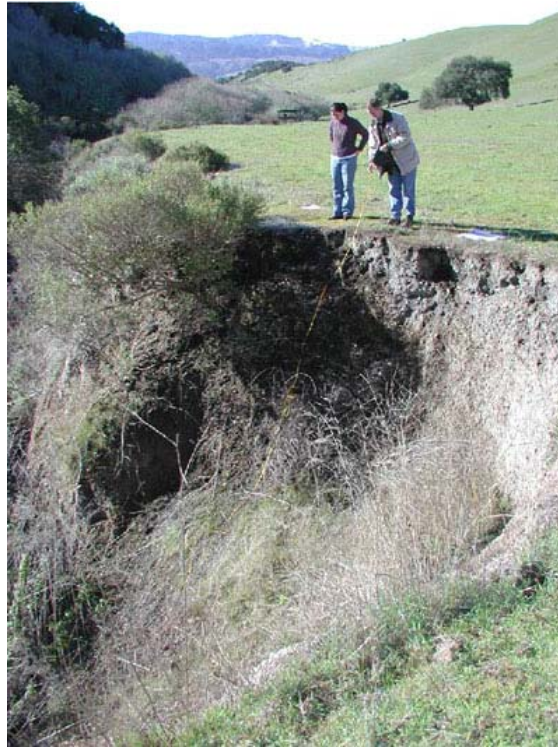
Figure 58: Side of deep gully along northeastern flank of Mid-Carmel Subwatershed.

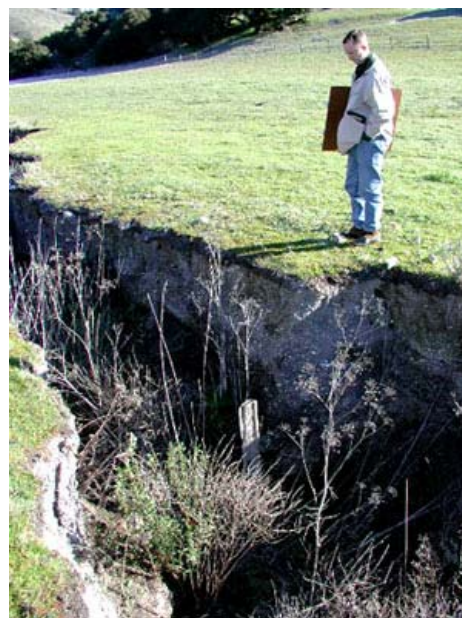
Figure 59: Erect fencepost exhumed by gullying in the valley bottom. Site located downvalley from Figure 58.

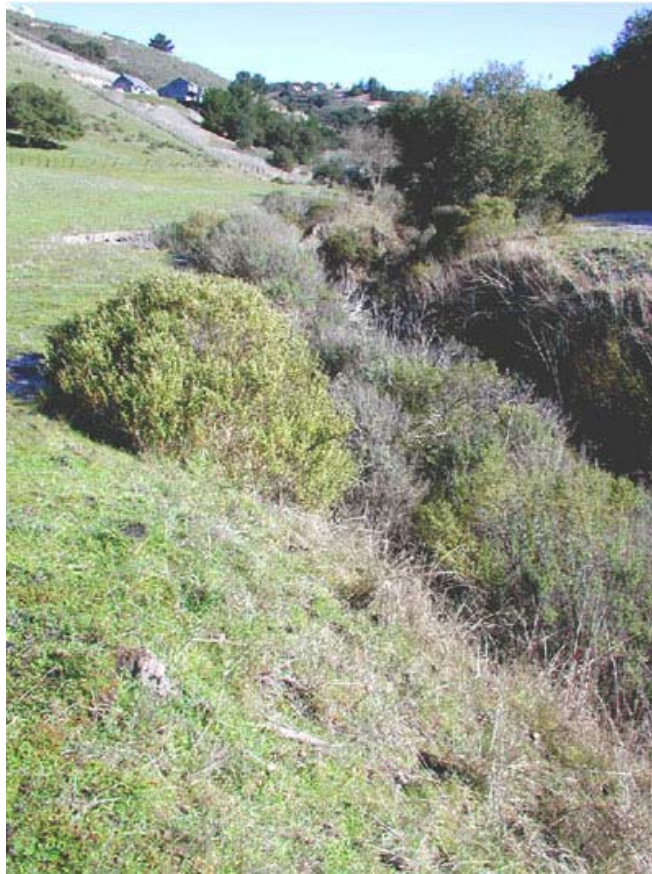
Figure 60: Gully naturally revegetated with native species including Buckeye, willows, and coyote bush provides model for proactive gully restoration in this subwatershed.

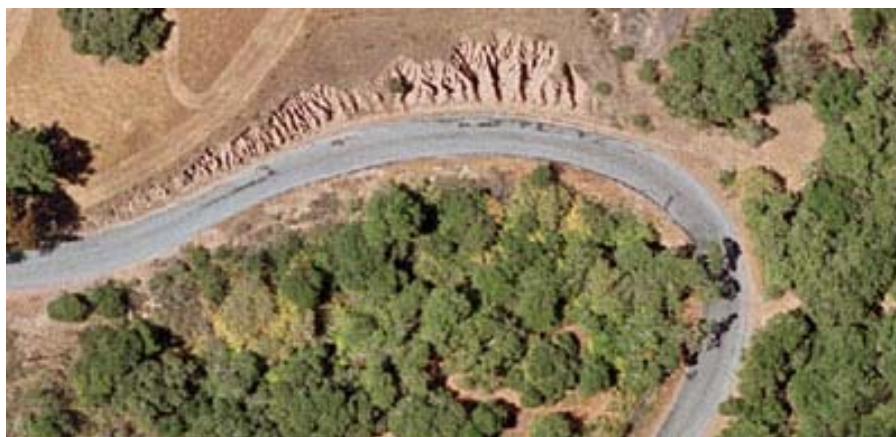
Figure 61: Badlands topography resulting from road cut in erodible substrate. 5750600E; 2080430N.

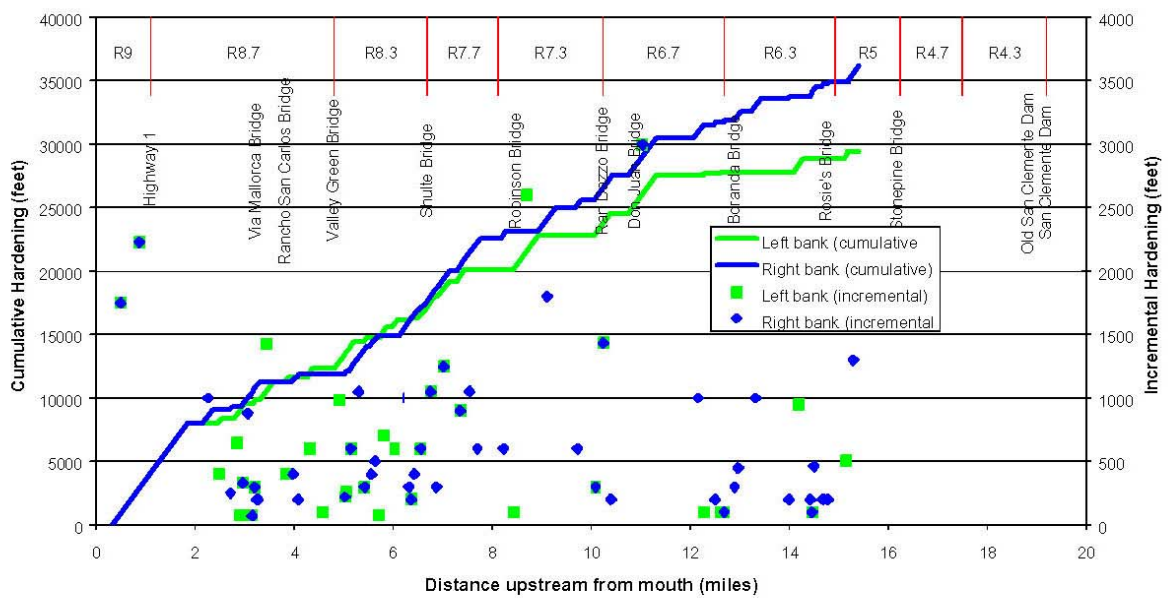
Figure 62: Graph of feet of bank hardening as a function of miles from mouth of the Carmel River (MEI, 2002).

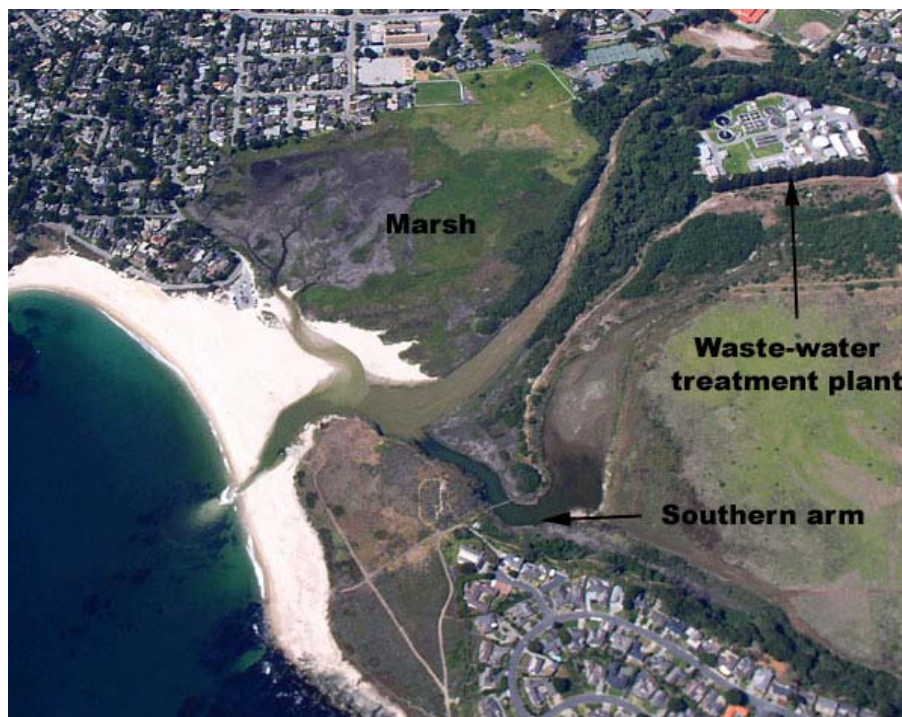
In keeping with the present high sea level and drowned river valleys of the California Coastline, the mouth of the Carmel River is a coastal lagoon (Fig. 63).

Figure 63: Carmel Lagoon with opening to the sea.

Excess sedimentation—Excess sediment is filling the lagoon with fine material derived from the Carmel Watershed (Fig. 63). The entrance to the southern arm of the lagoon is filling with sediment (Fig. 63). That area used to be a deep pool habitat for trout. Maintaining deep pools in the southern arm may provide some relief, however, it is unclear whether the water will provide much more habitat considering the typical saline–fresh water stratification that occurs there and the likely refilling as time goes on.

Artificial Breaching-- Artificial breaching of the sandbar (Fig. 63) reduces the frequency of flooding the lagoon wetlands, potentially leading to a shift from freshwater to saline water invertebrate species in some areas of the lagoon. Breaching lowers the water level artificially fast, potentially leaving steelhead stranded. Leaving the breach open too long after the rainy season ends results in salty conditions during the summer and early fall, but closing the breach might result in flooding. Solutions to this problem include monitoring and modeling to determine the optimum conditions for breach opening and closing to optimize conditions for residents and fish. Especially critical is determining the combination of river discharge and ocean tide at which to close the breach to avoid flooding and poor water quality.

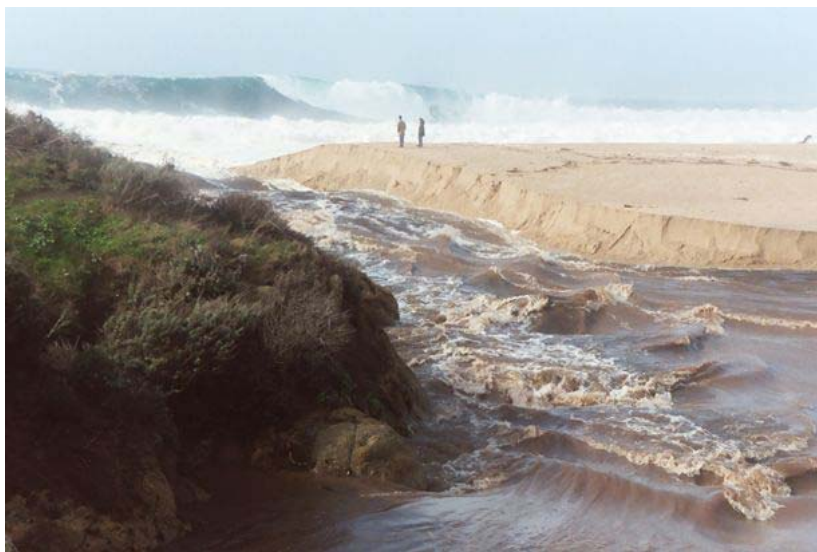
Figure 64: Connection between lagoon and sea cut by bulldozer to reduce flood risk during winter rains. Photo by Fred Watson
