Publication No. WI-2017-03

## The Watershed Institute

## Large Woody Debris on the Carmel River From the Dam Keeper's House to Carmel Lagoon Fall 2016

The following report documents the Fall 2016 locations and characteristics of large woody debris (LWD) along the lower reach of the Carmel River in California, from the former Dam Keepers House to the Carmel Lagoon. The report includes an ArcMap GIS project and electronic spreadsheets containing the data.

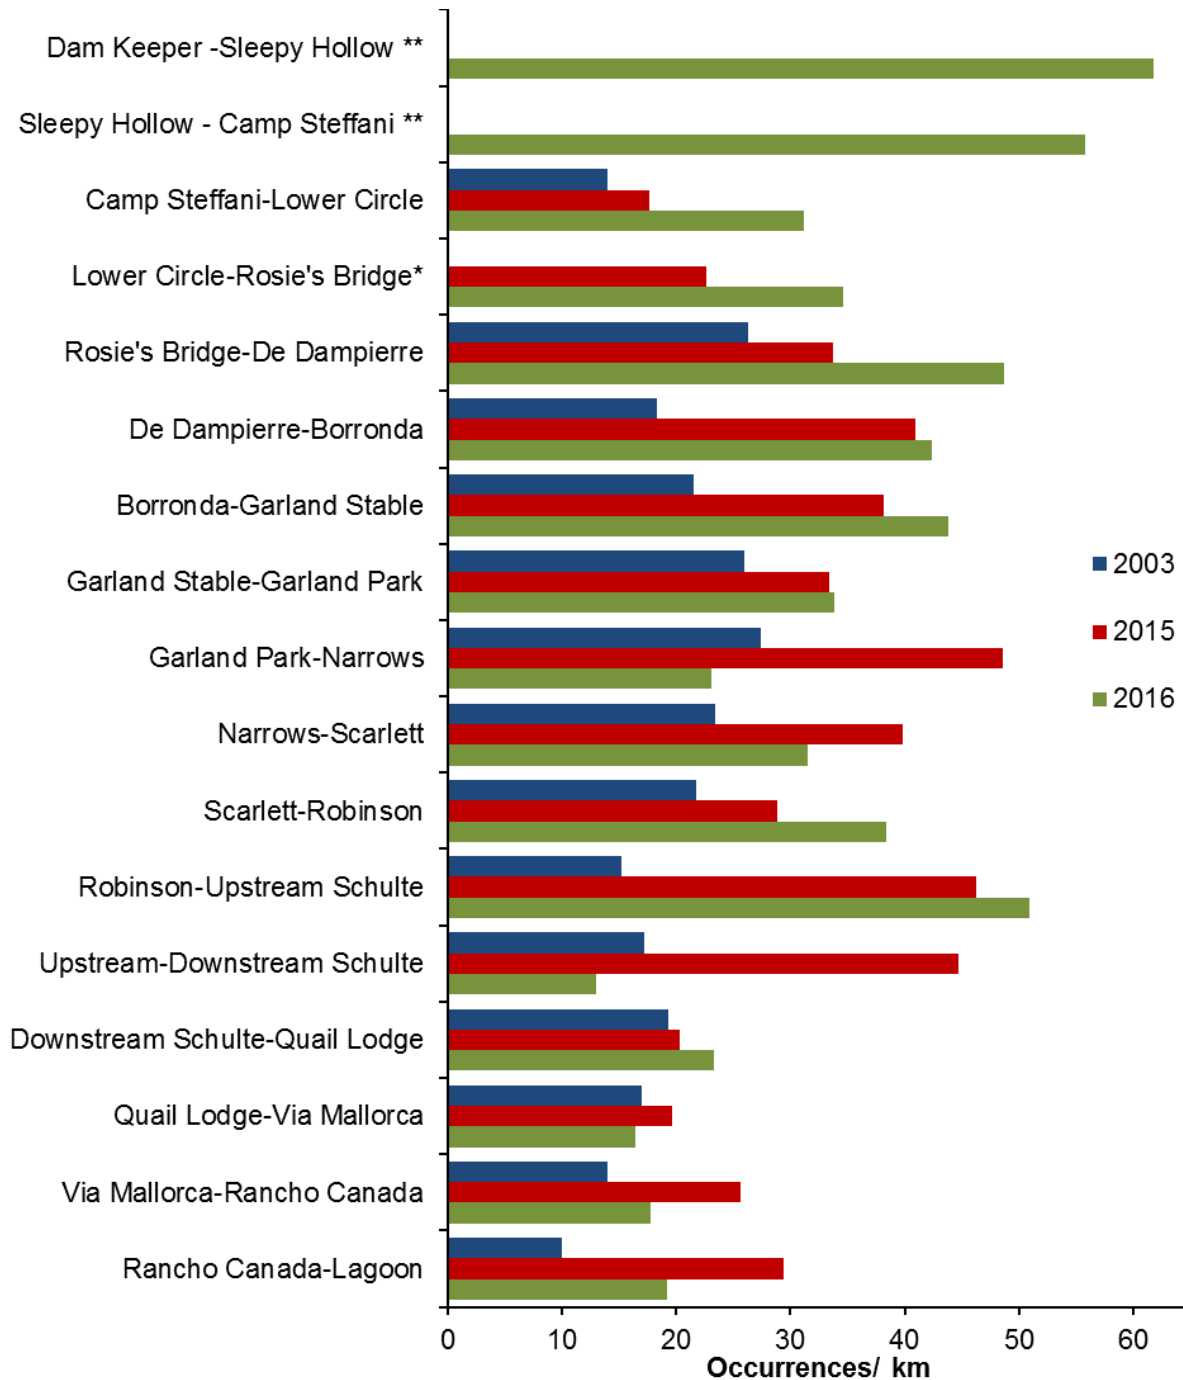
\* Lower Circle to Rosie's Bridge was not surveyed in 2003.

\*\* Dam Keeper to Camp Steffani was not surveyed in 2003 or 2015.

**Figure 7. Occurrences of large woody debris (LWD) per kilometer by reach for 2003, 2015, and 2016. Accumulations were considered a single occurrence for this figure.**

The average density of LWD for the entire 2016 study area was 31.2 occurrences per kilometer (Table 2). Density was low (13–29 LWD/km) in reaches that were close to the lagoon and highest (46–63 LWD/km) in the two additional reaches surveyed below the former SCD (Fig. 3, 7).

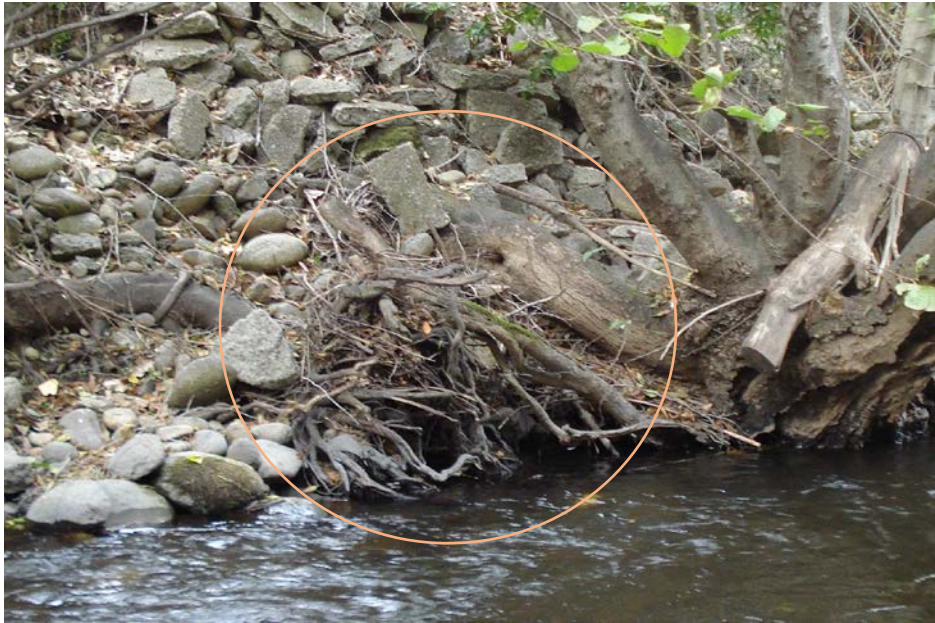
Figure 9. LWD Rootball located in the Sleepy Hollow to Camp Steffani reach.

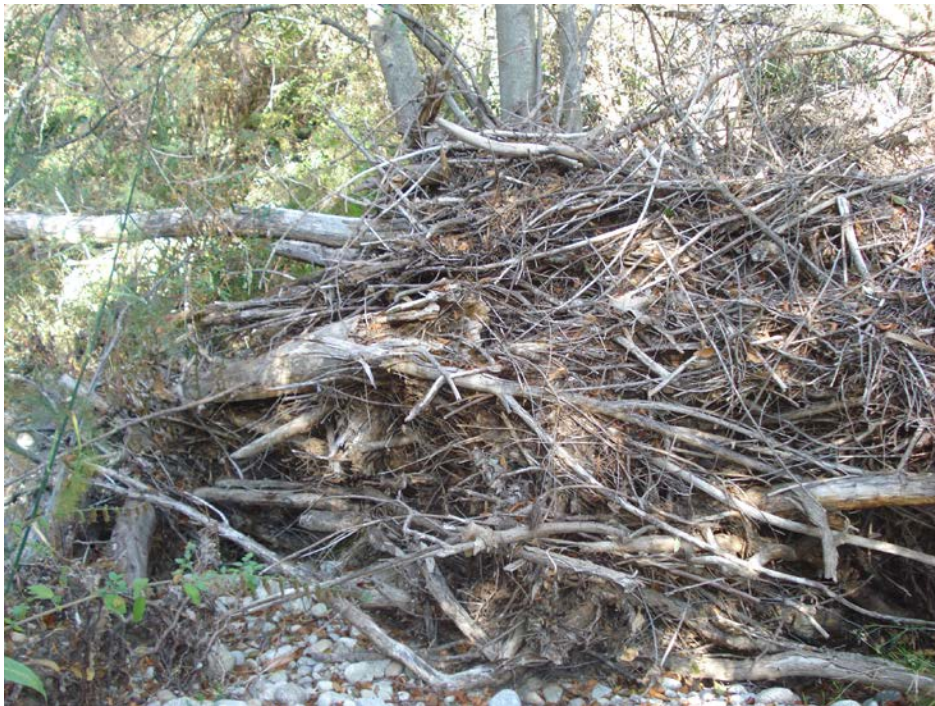
Figure 10. Multiple piece accumulation composed of nine pieces with an average length of 3.0–4.5. Dominant substrate type: cobble.

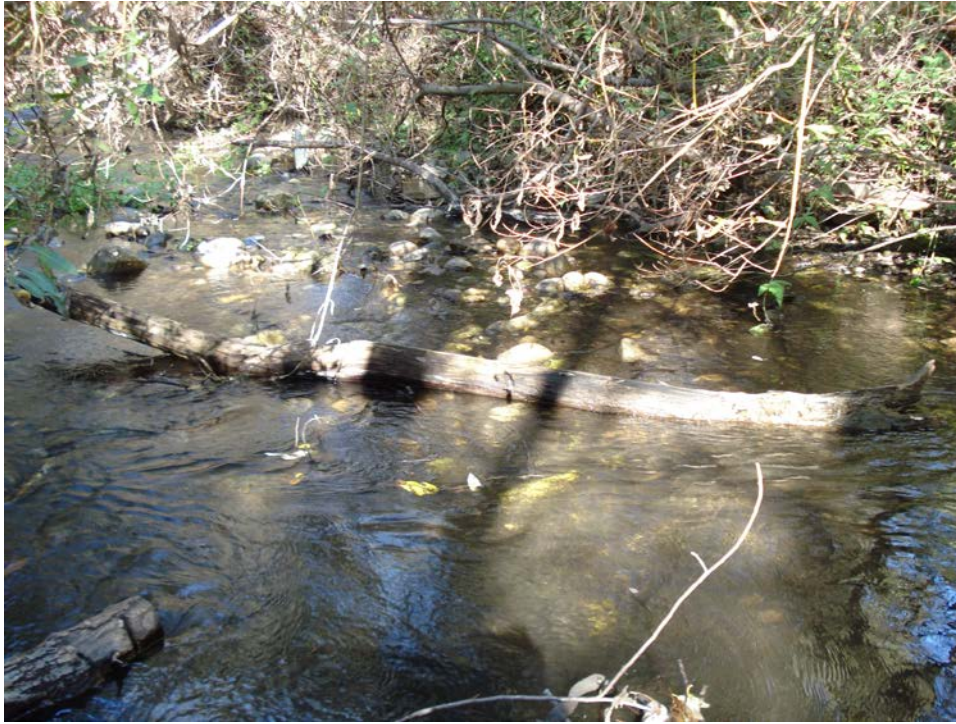
Figure 11. Single piece observance in the main channel reach between Garland Park stables and Garland Park, substrate beneath the occurrence was estimated as cobble.

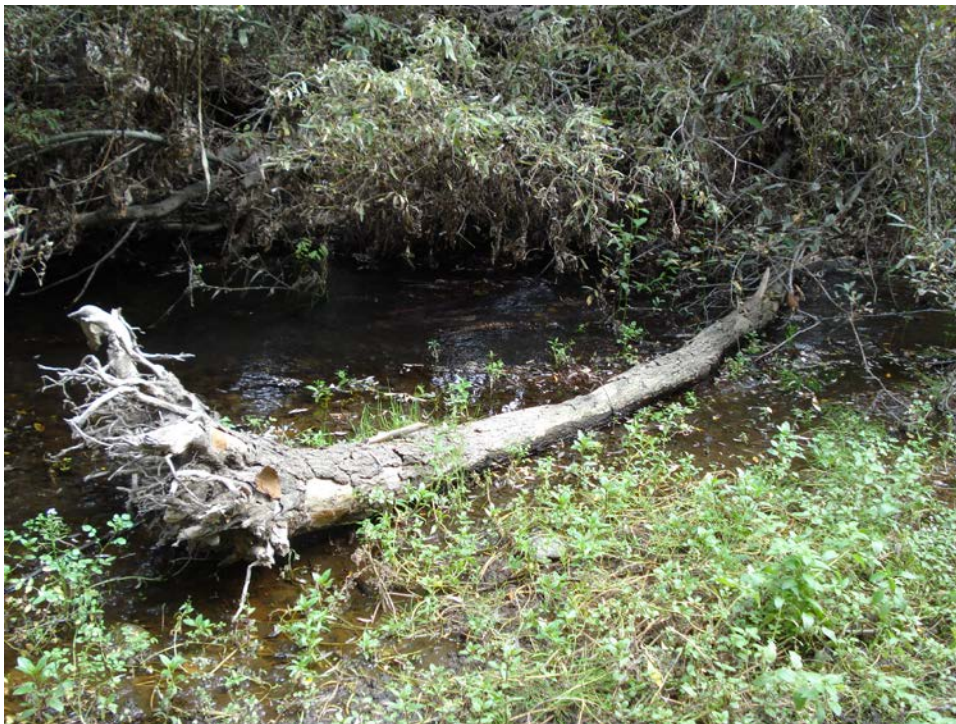
Figure 12. Single piece with rootball located in the main channel in Garland Park.

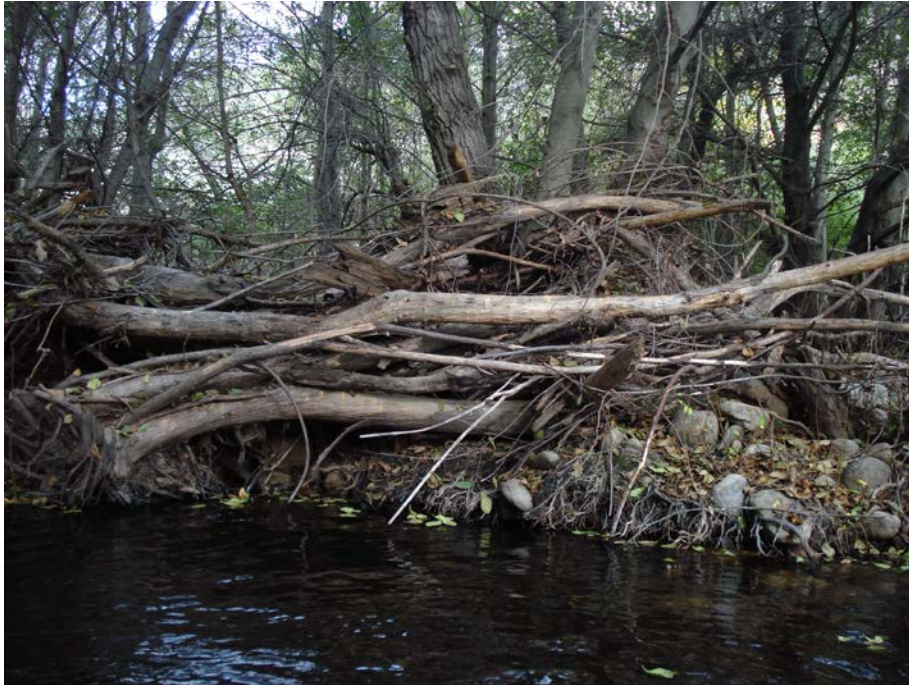
Figure 13. LWD located between the former Dam Keeper's House and Sleepy Hollow community. Wood surveyed in this reach was generally longer and wider than wood found in lower reaches.

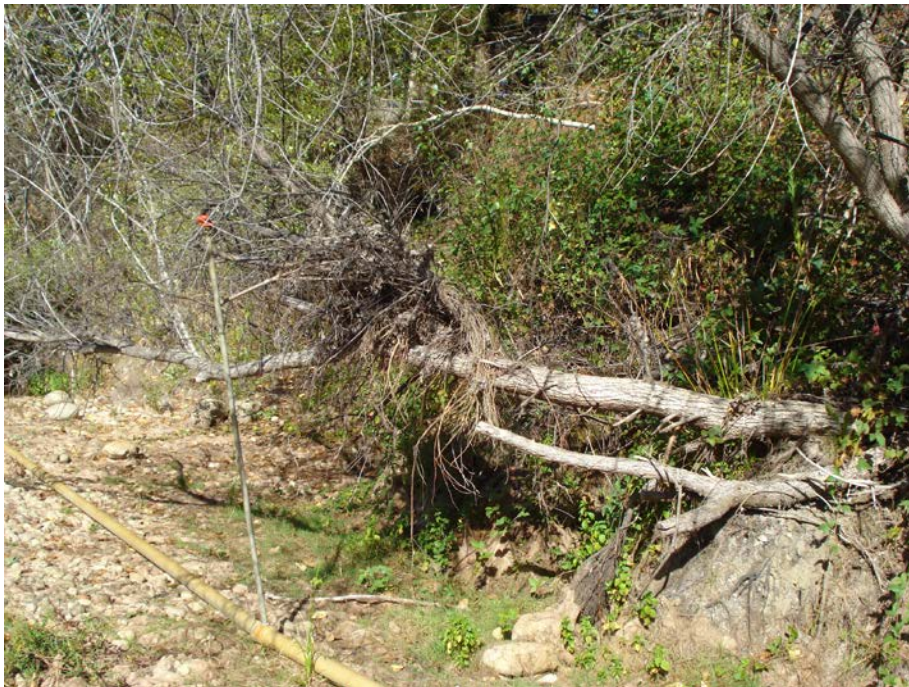
Figure 14. Irrigation pipeline installed by the MPWMD as part of the RHP in the Quail to Via Mallorca survey area. The LWD on the right was outside the active channel, but recorded due to recruitment potential during a high flow event.
