**2016 Post–San Clemente Dam  
Removal Morphological  
Monitoring of the Carmel  
River Channel in  
Monterey County, California**

Publication No. WI-2017-01  
30 March 2017

**The Watershed Institute**

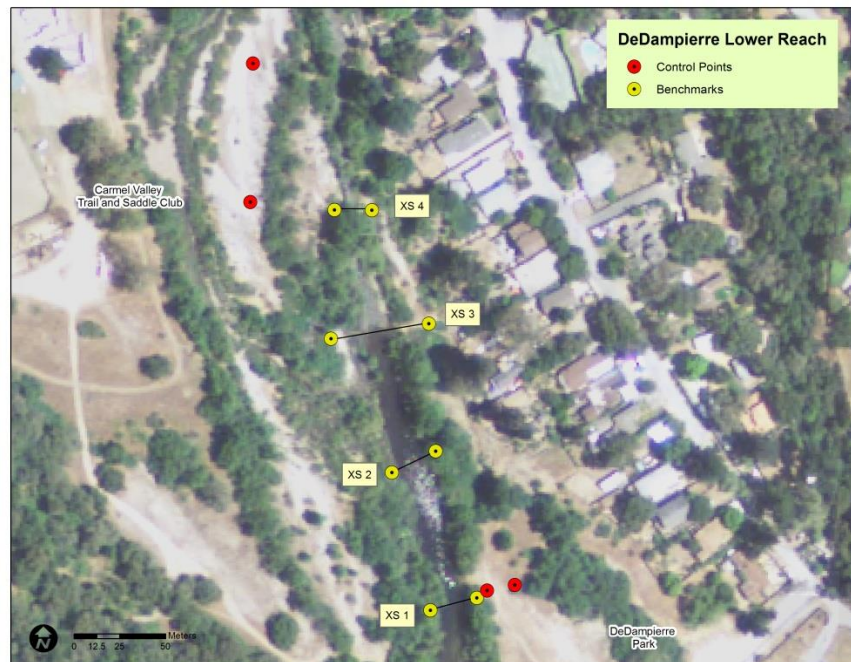
Figure 6. Location of georeferenced control points and cross sections within the DeDampierre Lower Reach.

This reach is located directly downstream of the DeDampierre Upper Reach. The upstream portion of the reach is a wide and open channel with a pool and long run. The reach narrows after cross section 3 (XS 3 of Fig. 6) and has a steeper gradient than Upper DeDampierre.

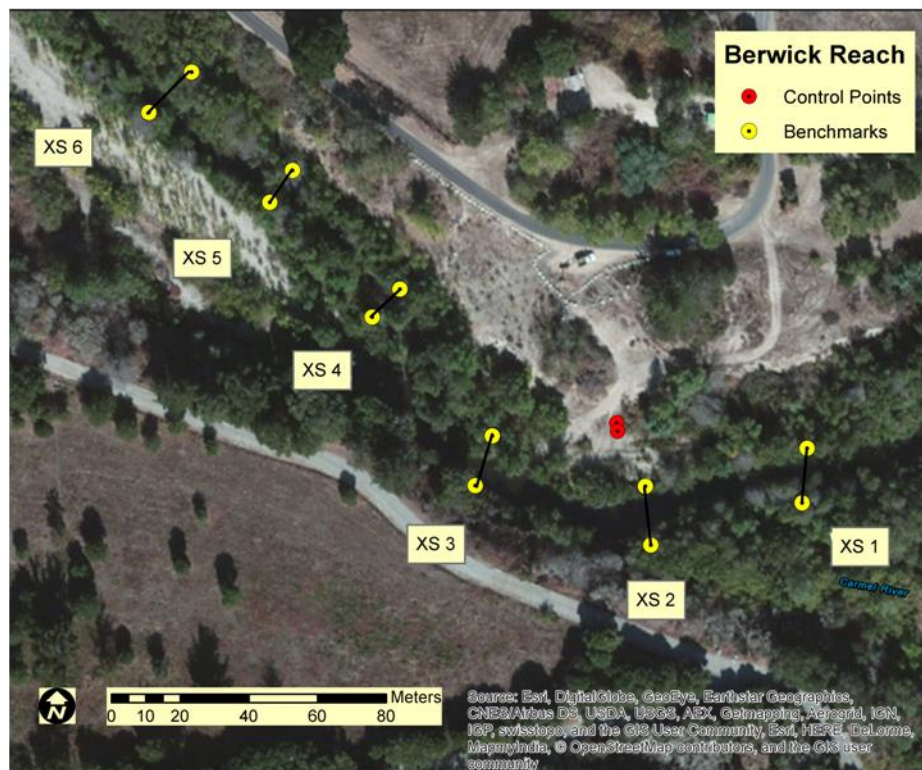
Figure 8. Location of georeferenced control points and cross sections within the Berwick Reach.

The Berwick reach was established in 2015 (Figs. 8 and 9).

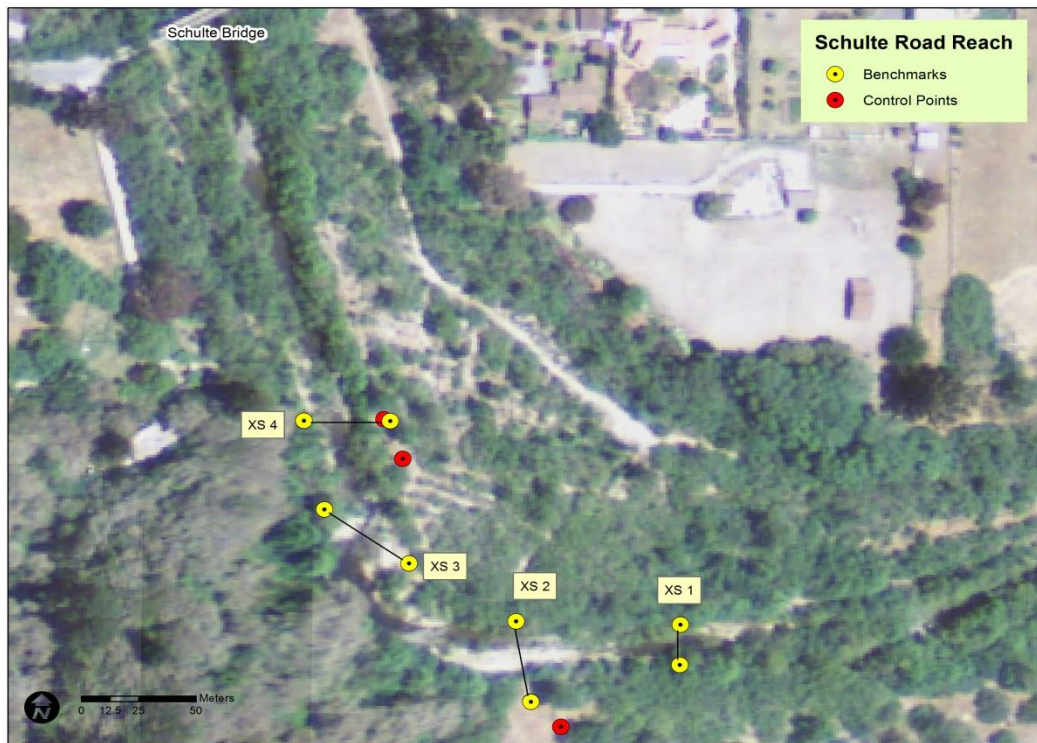
Figure 10. Locations of georeferenced control points and cross sections within the Schulte Road Reach.

The Schulte reach is located approximately 200 m upstream of the Schulte Bridge and extends above the 'Steinbeck Pool' which is located between cross sections 2 and 3 (Fig. 10).

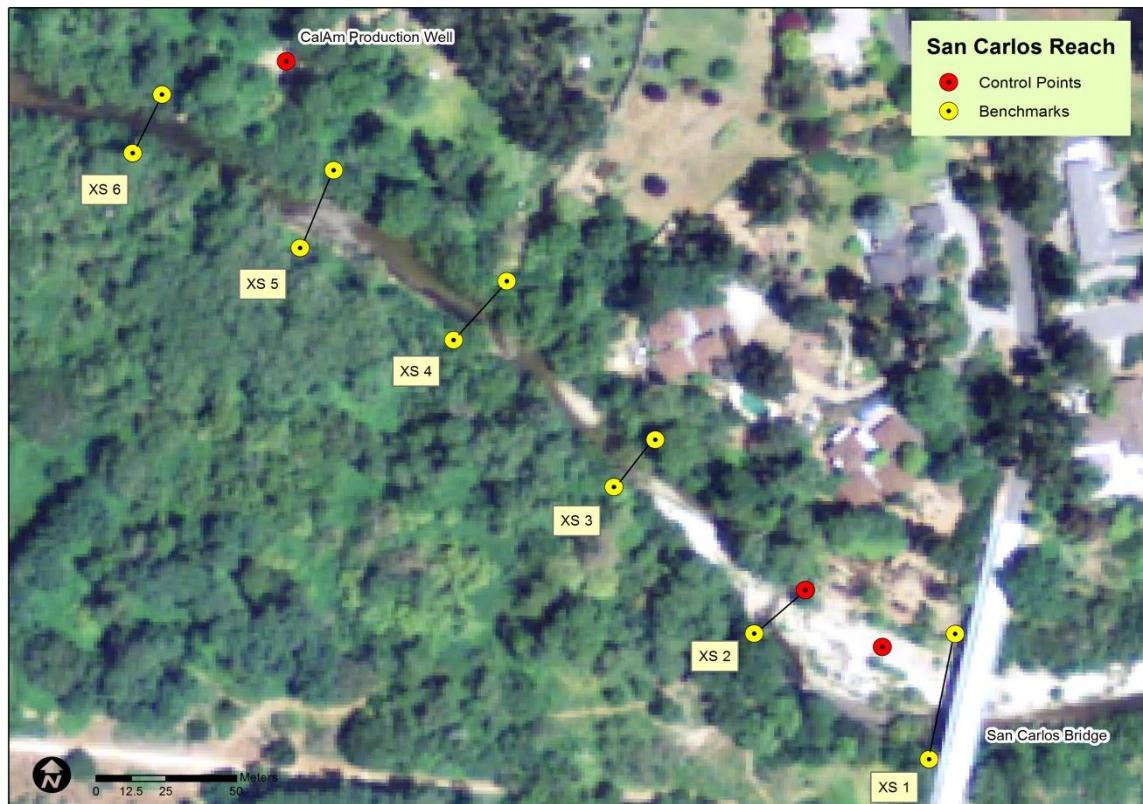
Figure 12. Locations of georeferenced control points and cross sections within the San Carlos Reach.

The San Carlos Reach is located downstream of the Rancho San Carlos Bridge (Fig. 12).

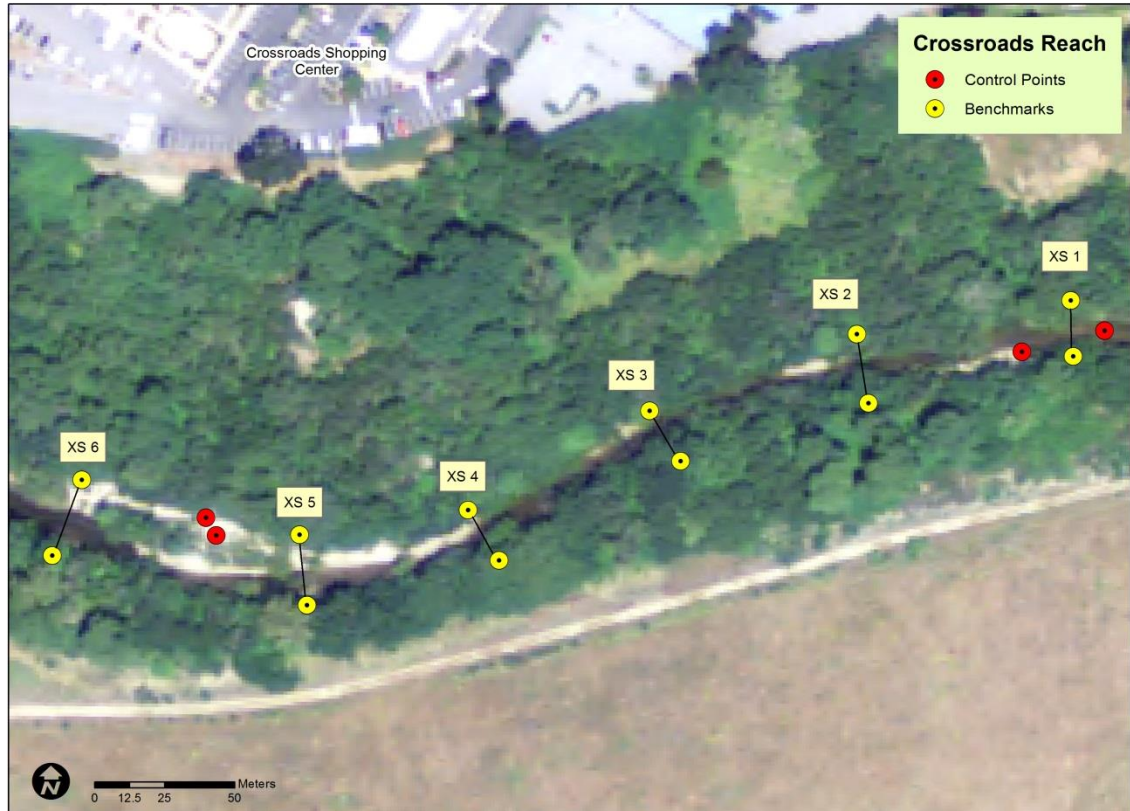
Figure 14. Locations of georeferenced control points and cross sections within the Crossroads Reach.

Crossroads is the lowermost reach monitored, and is located adjacent to the Crossroads shopping center near the mouth of Carmel Valley (Fig. 14).

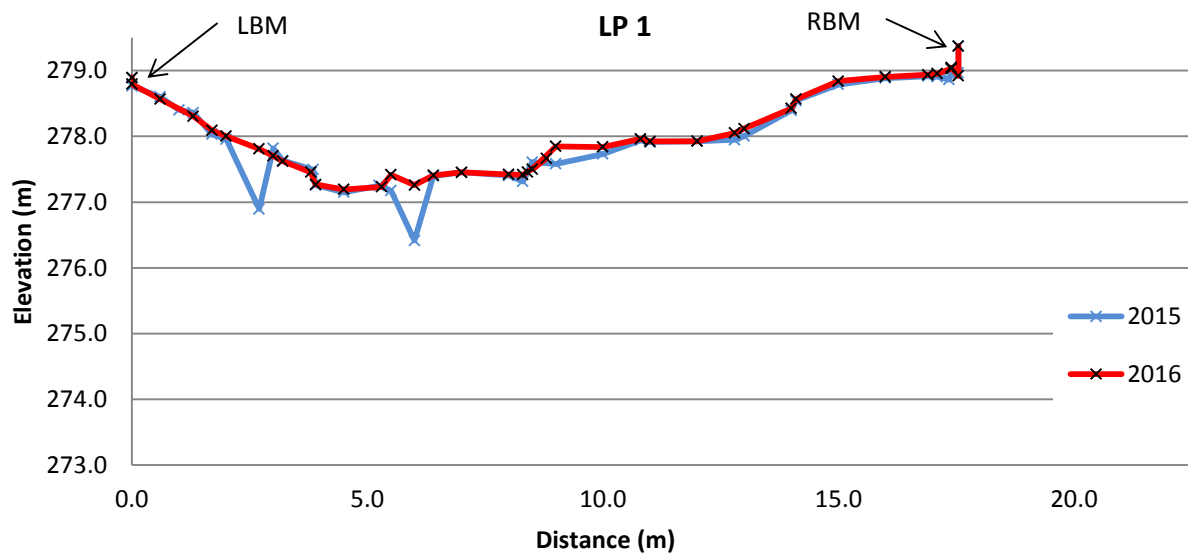
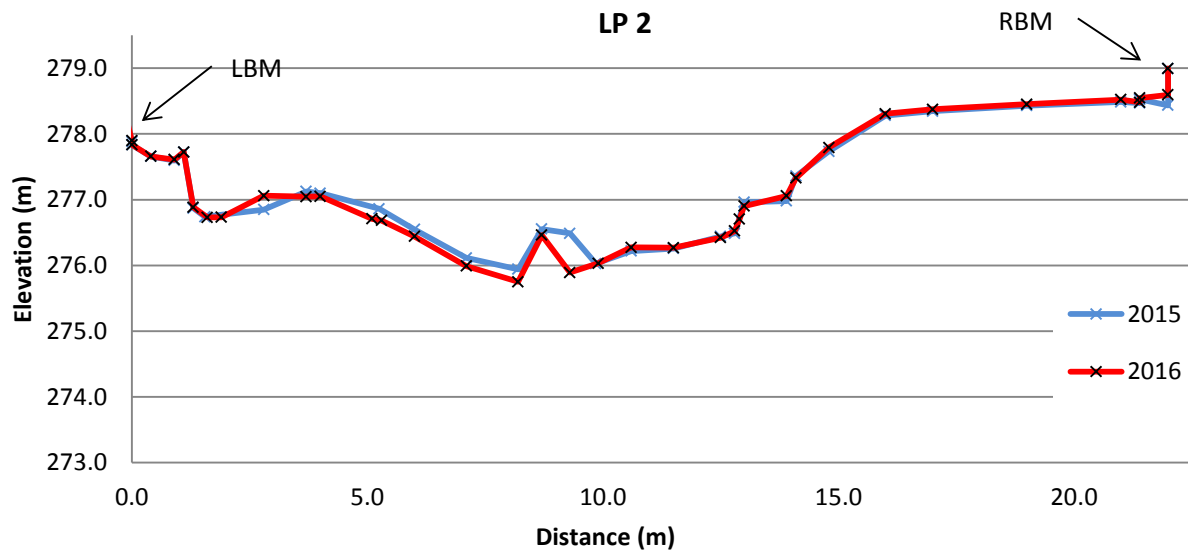
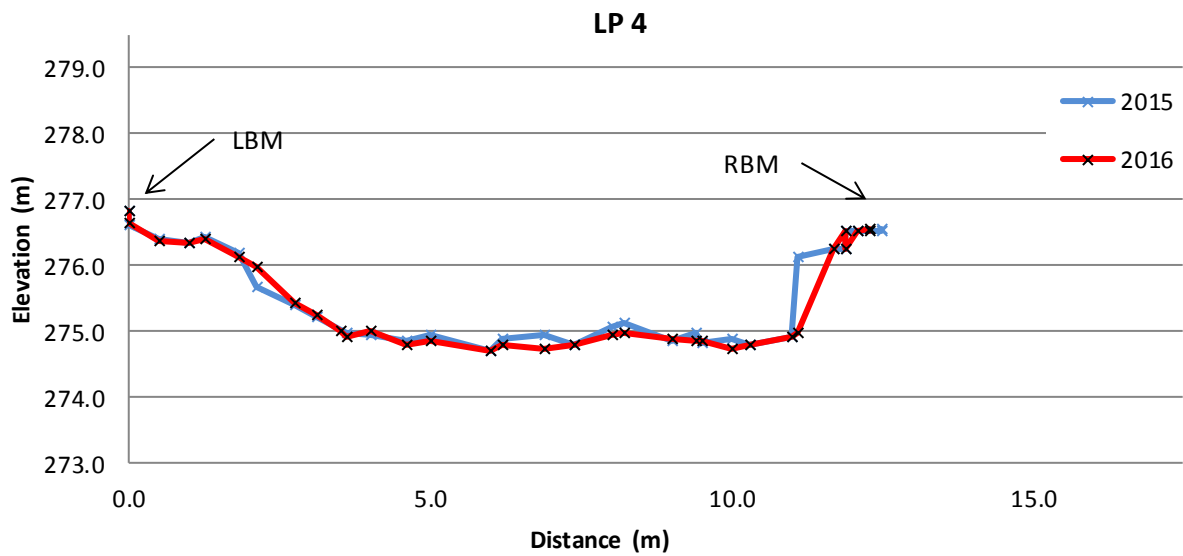
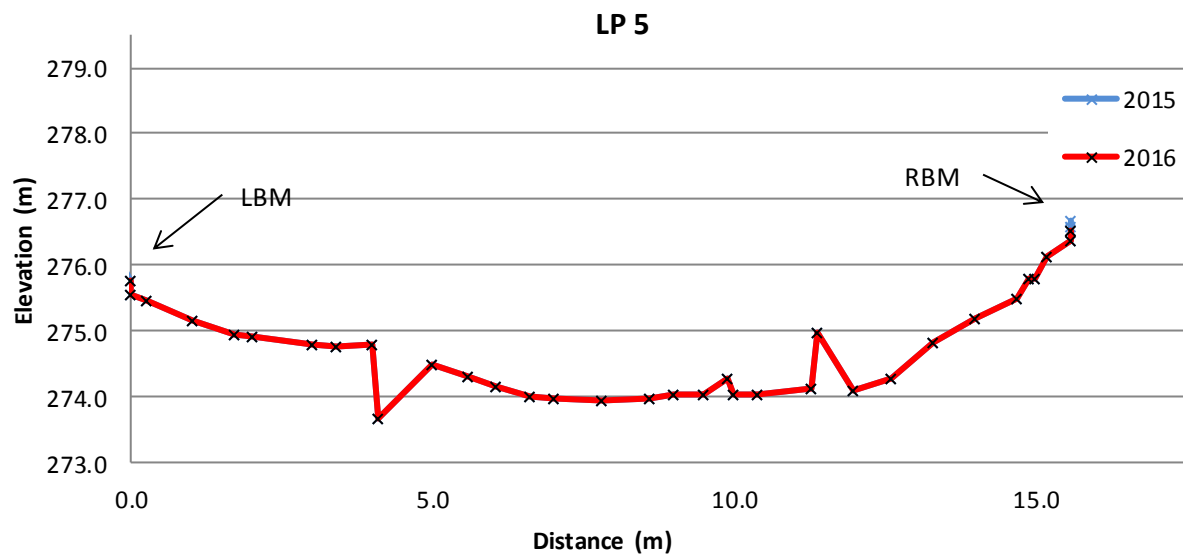
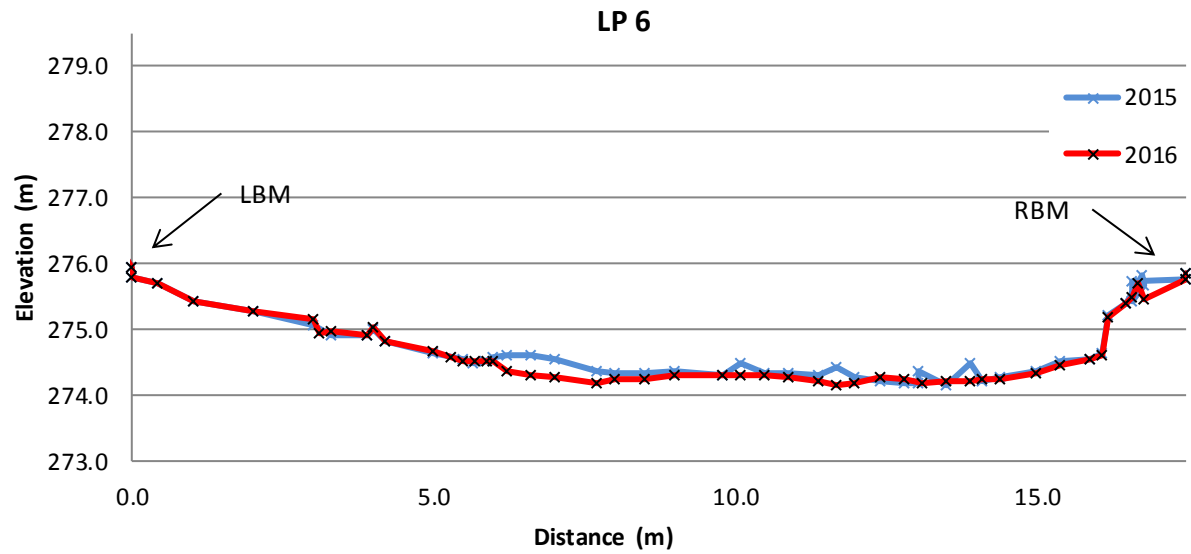
Channel geometry for each cross section surveyed within each reach. Cross sections are denoted by their reach abbreviation (LP, DDU, DDL, BW, SR, SC, and CR) and transect number descending from upstream to downstream (1 to 4 or 6). An asterisk (\*) next to the left or right benchmark (LBM or RMB) indicates a different benchmark than the original (2013 or 2015) survey.

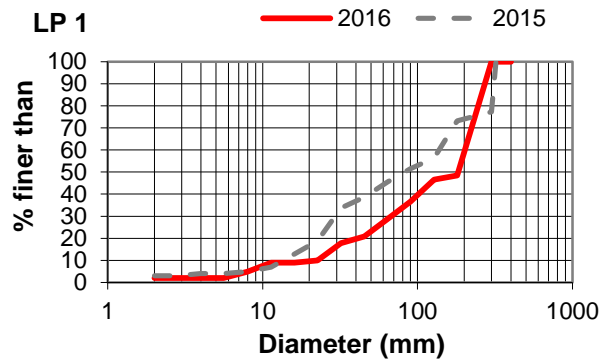
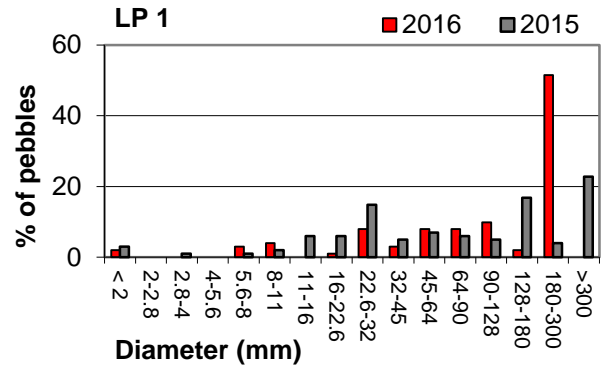
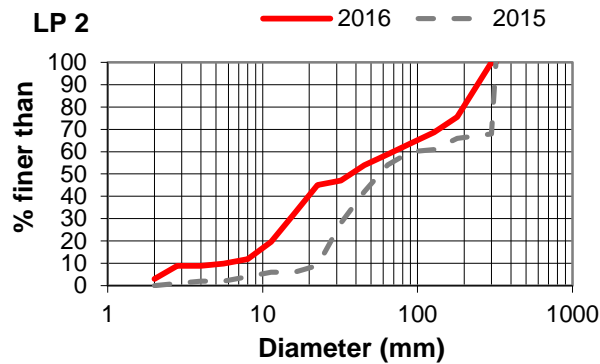
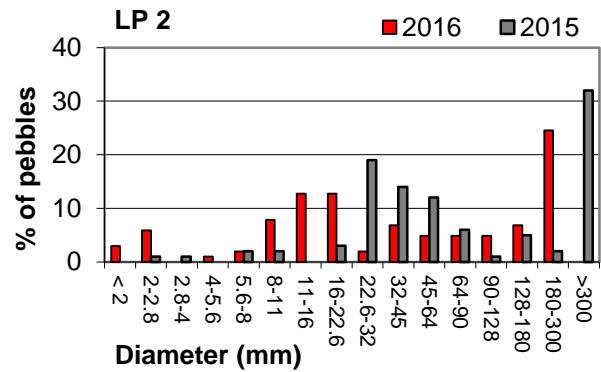
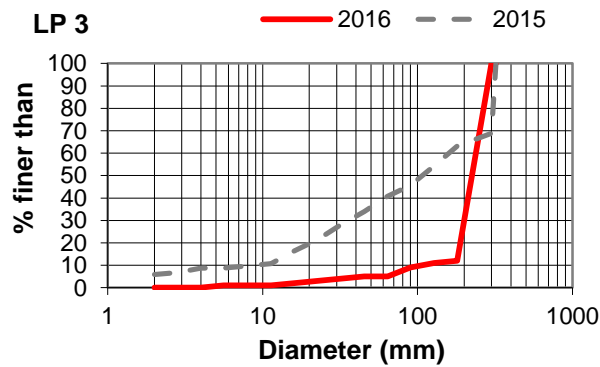
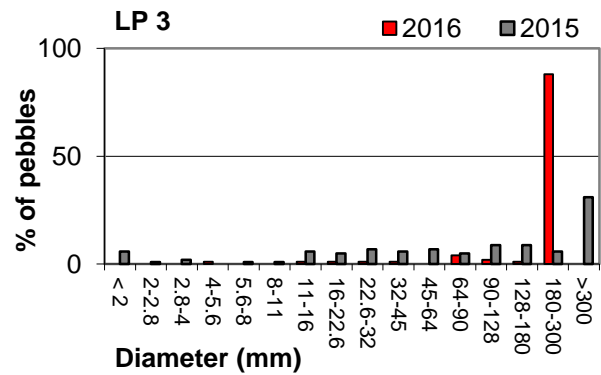
## **7 Appendix B: Pebble Count Plots**

Channel pebble counts for each cross section within each reach. Reaches are denoted by their reach abbreviation (LP, DDU, DDL, BW, SR, SC, and CR) and transect number descending from upstream to downstream (1 to 4 or 6).
