**2017 Post-San Clemente Dam  
Removal Morphological  
Monitoring of the Carmel  
River Channel in  
Monterey County, California**

Publication No. WI-2018-3  
8 February 2018

**The Watershed Institute**

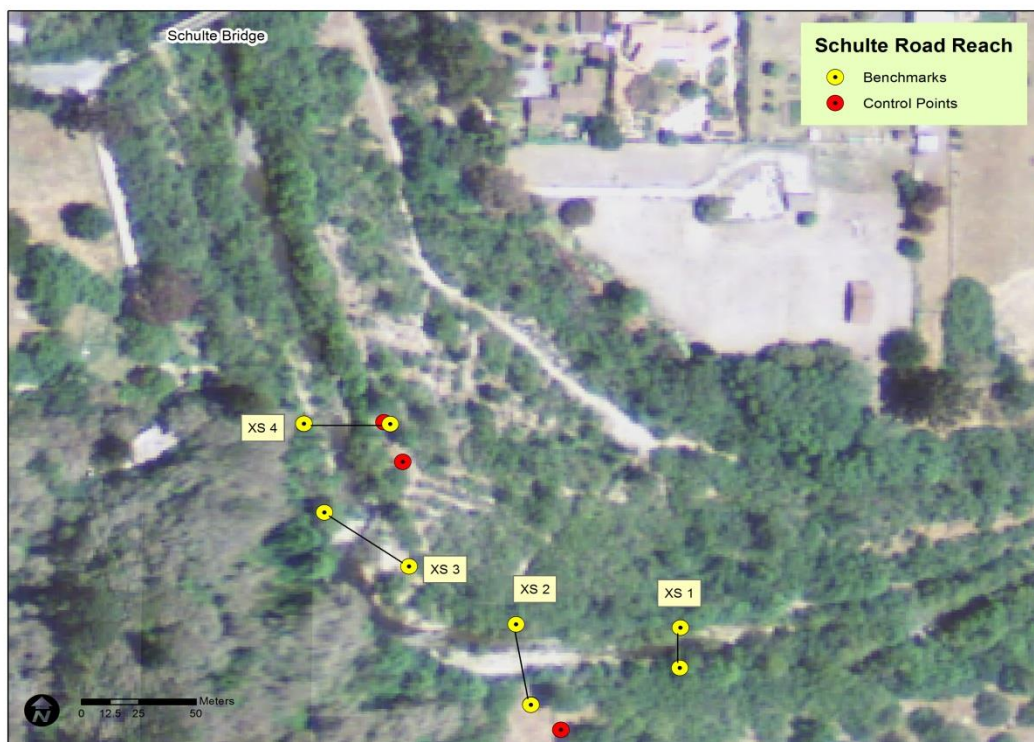
**Figure 10. Locations of georeferenced control points and cross sections within the Schulte Road Reach.**

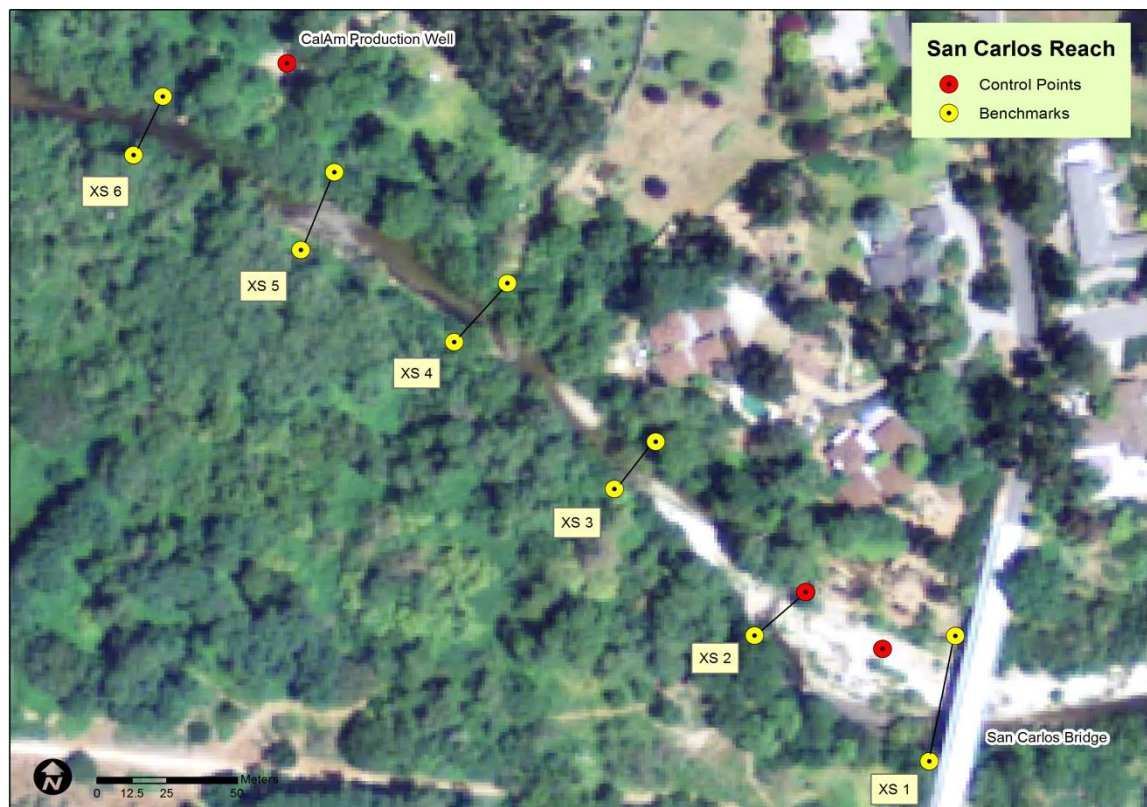
Figure 12. Locations of georeferenced control points and cross sections within the San Carlos Reach.

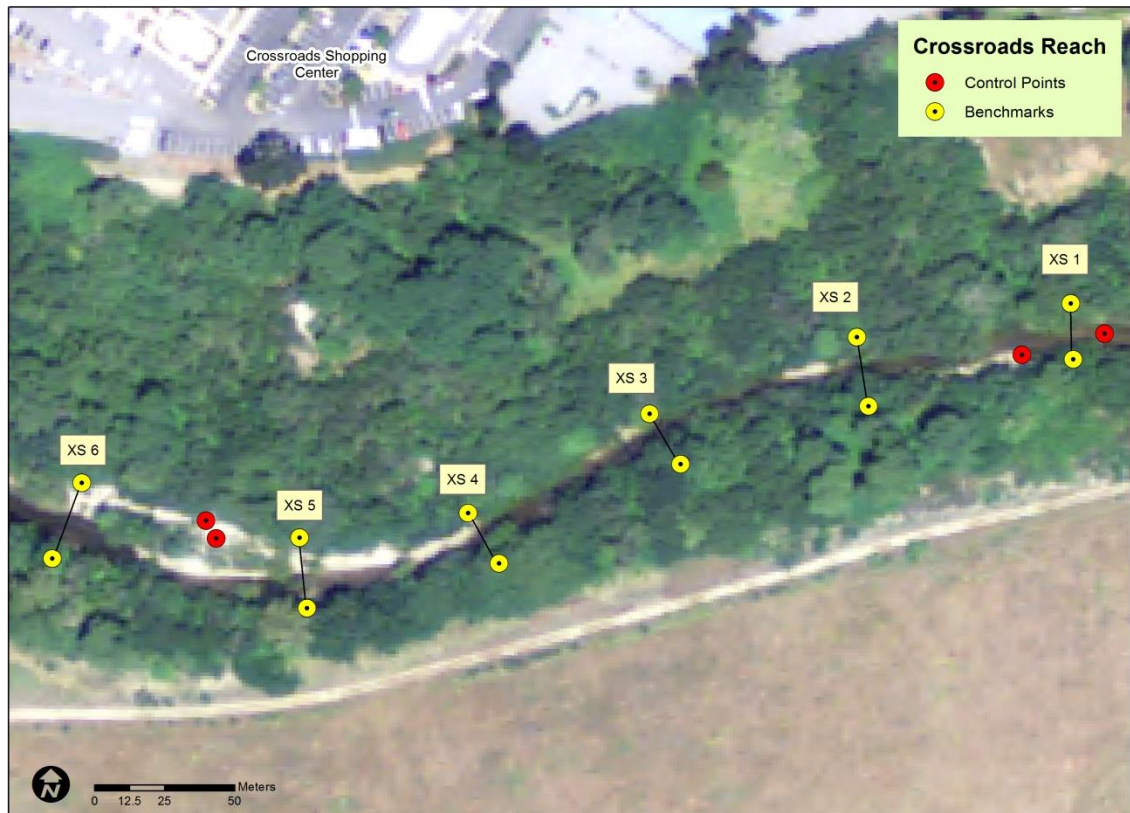
Figure 14. Locations of georeferenced control points and cross sections within the Crossroads Reach.

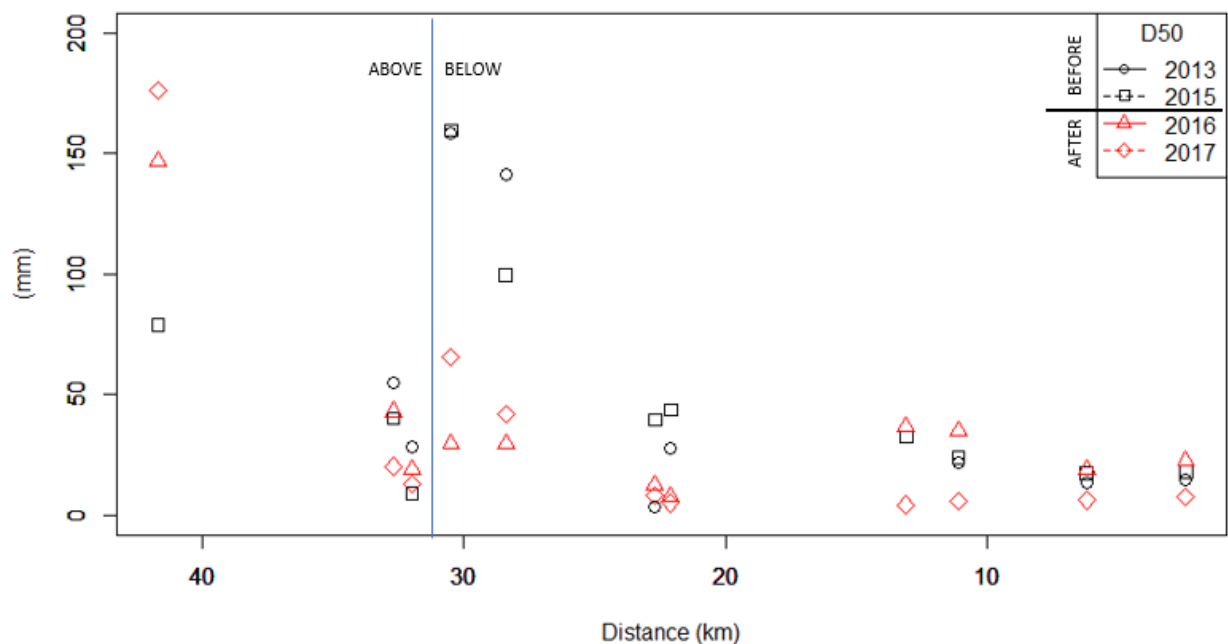
In general, sand and small gravel blanketed the Carmel channel below the dam site following the high runoff of 2017, and a rarely seen delta sand bar formed in the ocean at the Carmel River mouth. The grain size data can be interpreted in a before-after-control-impact (BACI) framework (fig. 16). The median grain size fell significantly in all sites located below the dam site especially near the dam, where 96 years of gravel starvation had had left a boulder substrate (Fig. 16). The 2017 fining is related to the dam removal, since the control sites upstream of the dam did not fine.

Figure 16. Median grain size (D50) of gran size as a function of year and distance upstream of the Carmel River mouth. Data are divided into before and after periods and above and below dam sites. Data from this study and East et al. (2017a)

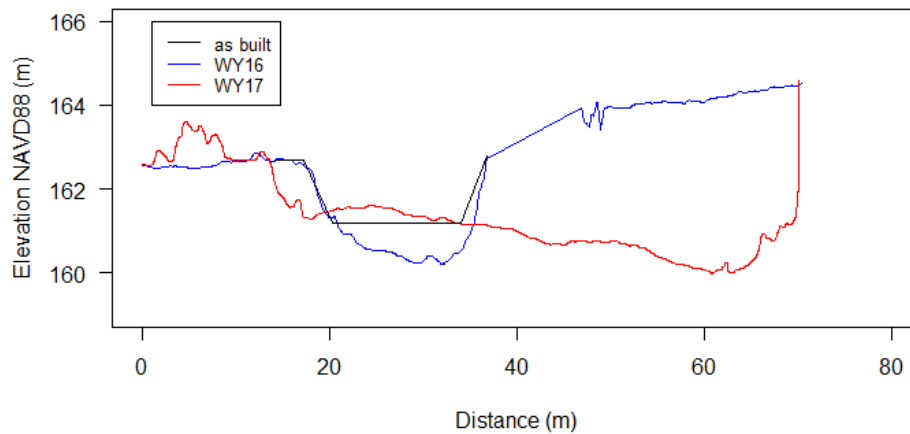
- 1) CSUMB (2016) reported that the volume of sand deposited downstream from the dam site in the first year after dam removal was the same order of magnitude as the volume calculated to have been eroded from the reservoir site.
- 2) Serial cross sections in the reservoir sediments show that extreme erosion continued into water-year 2017 (Fig. 17 and Harrison et al. 2017).

**Figure 17. Cross-sectional change in the Carmel River channel between 2015 (as built) and 2017 in reservoir sediment located upstream from the former dam site.**

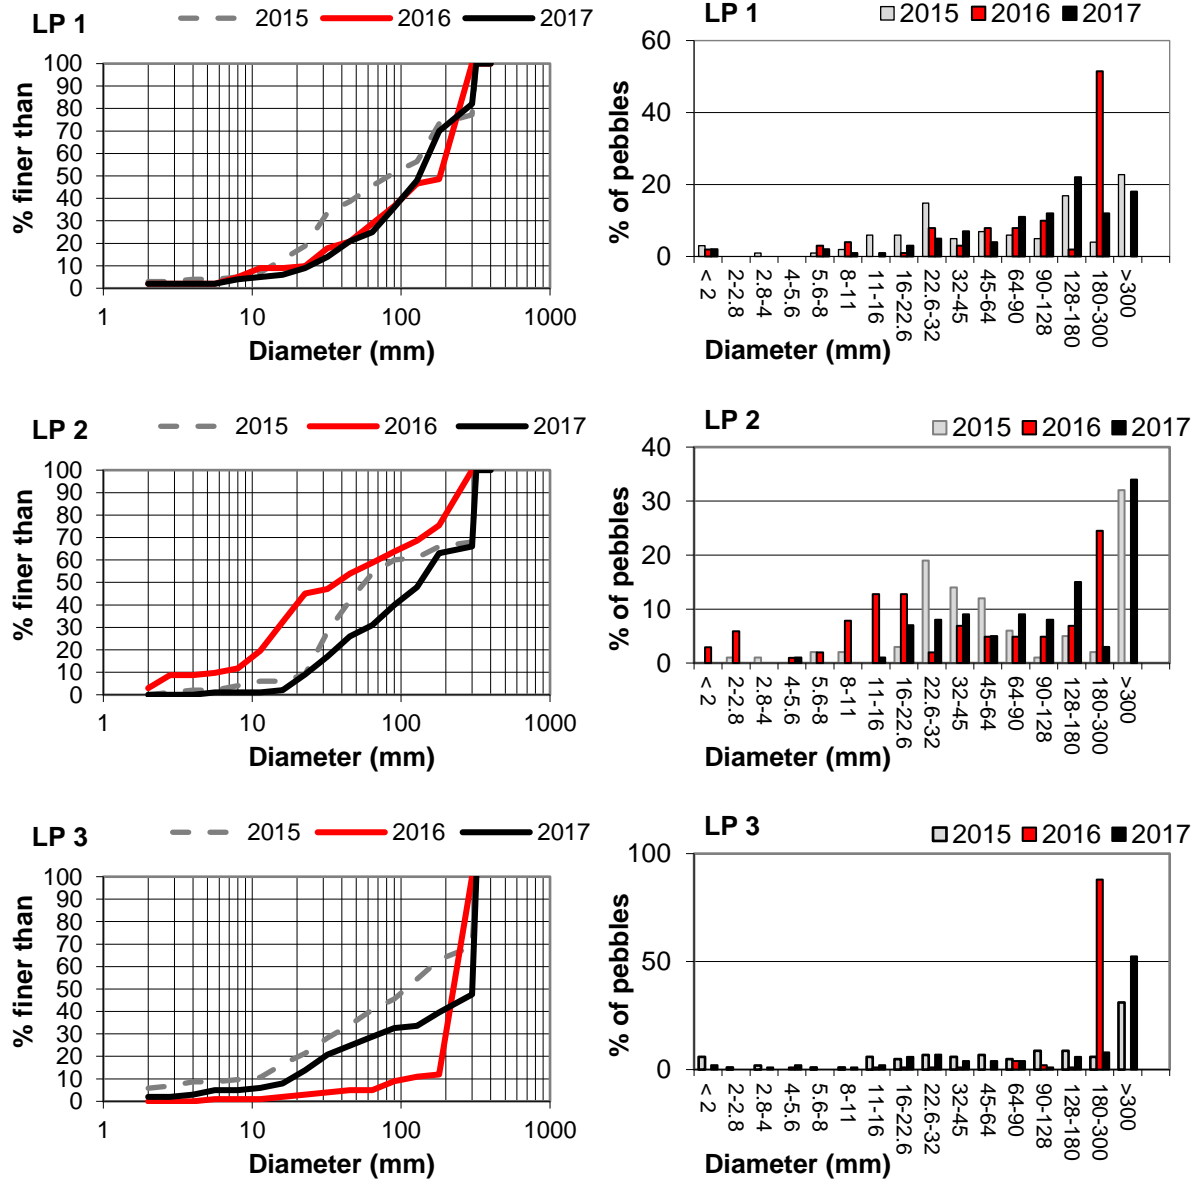
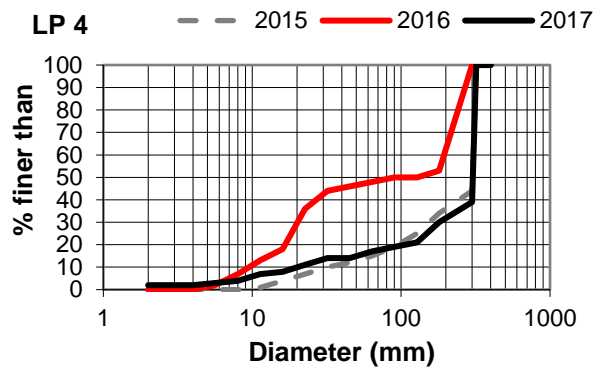
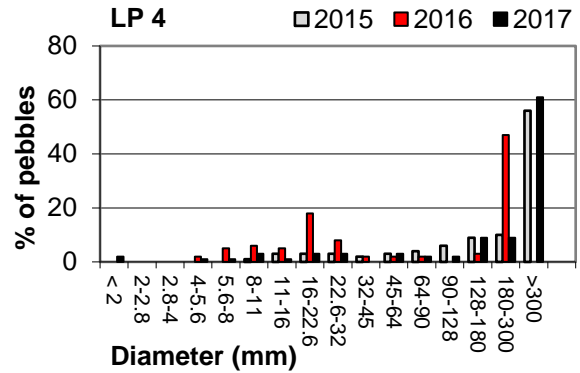
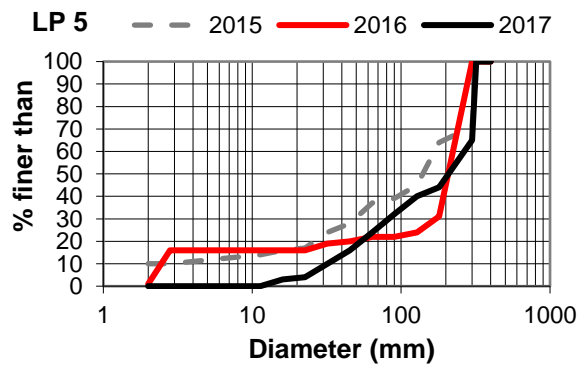
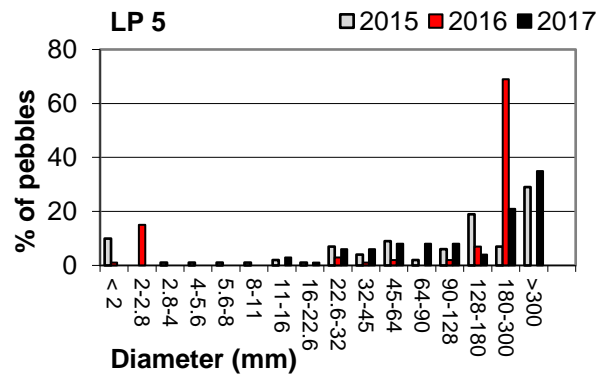
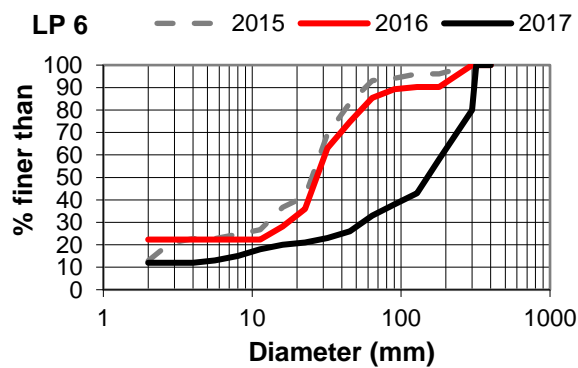
## 7 Appendix B: Pebble Count Plots

Channel pebble counts for each cross section within each reach. Reaches are denoted by their reach abbreviation (LP, DDU, DDL, BW, SR, SC, and CR) and transect number descending from upstream to downstream (1 to 4 or 6).

6.3 after 2017 flows (Table 6). The fining of substrate is due to the increase in sand and fine-coarse gravels found at most of the cross sections (Fig. 13; Appendix B).
