**2019 Post–San Clemente Dam  
Removal Morphological  
Monitoring of the Carmel  
River Channel in  
Monterey County, California**

Publication No. WI-2020-01  
02 March 2020

**The Watershed Institute**

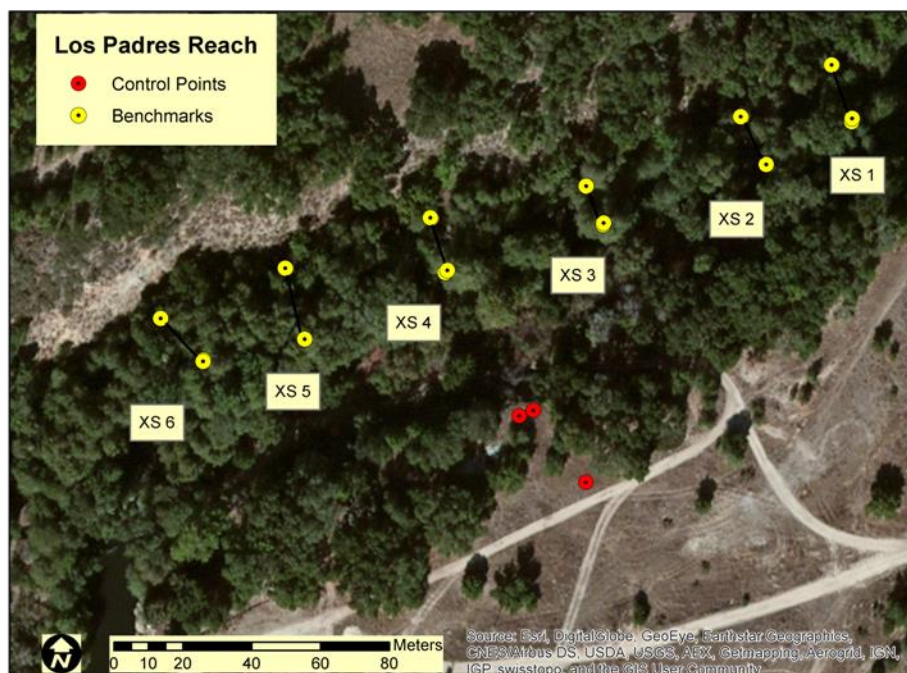
Figure 2. Location of georeferenced control points and cross sections within the Los Padres Reach.

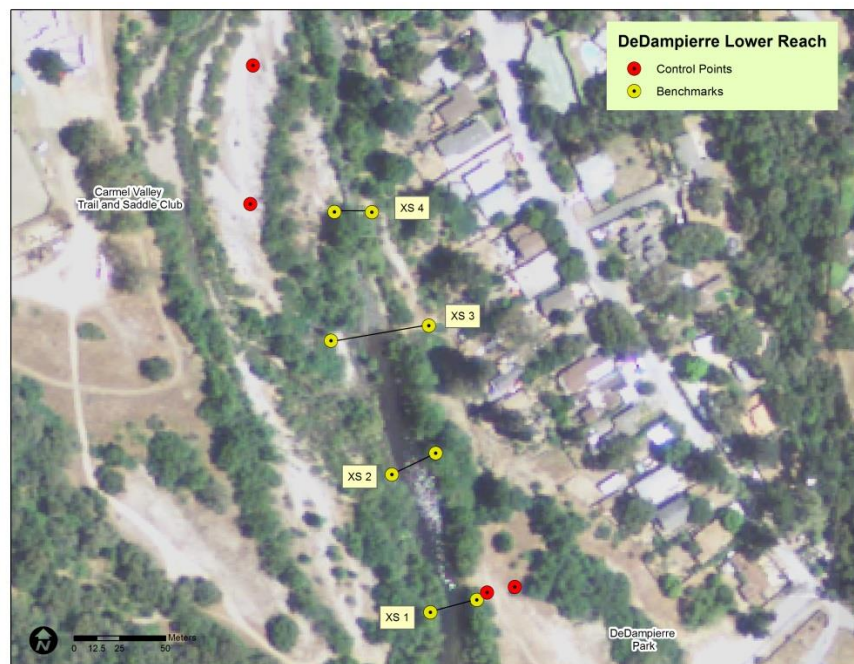
Figure 6. Location of georeferenced control points and cross sections within the DeDampierre Lower Reach.

The DeDampierre Lower reach is located directly downstream of the DeDampierre Upper Reach near the northern extent of DeDampierre Park (Fig. 6). The upstream portion of the reach is a wide and open channel with a pool and long run. The reach narrows downstream from cross section 3 and has a steeper gradient than Upper DeDampierre. We obtained cross section and pebble counts at all cross section locations.

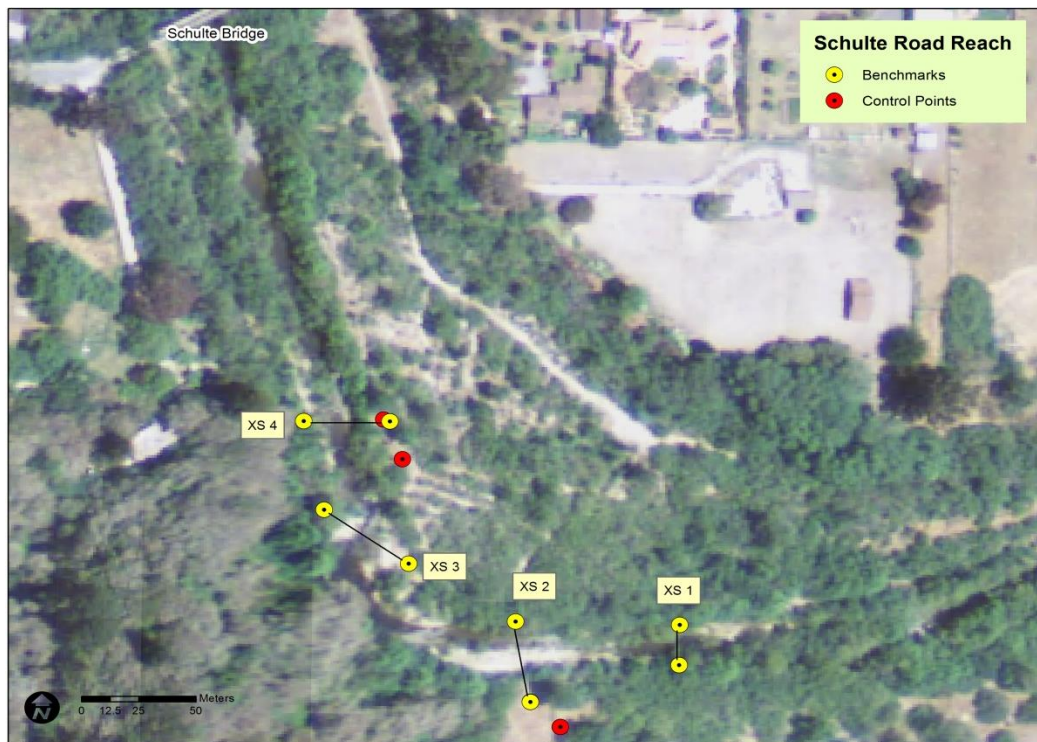
Figure 10. Locations of georeferenced control points and cross sections within the Schulte Road Reach.

The Schulte Road reach is located approximately 200 m upstream of the Schulte Bridge and extends above the 'Steinbeck Pool' which is located between cross sections 2 and 3 (Fig. 10). The reach spans a 90-degree northern bend in the river. We obtained cross sectional and pebble count data at every cross-section location.

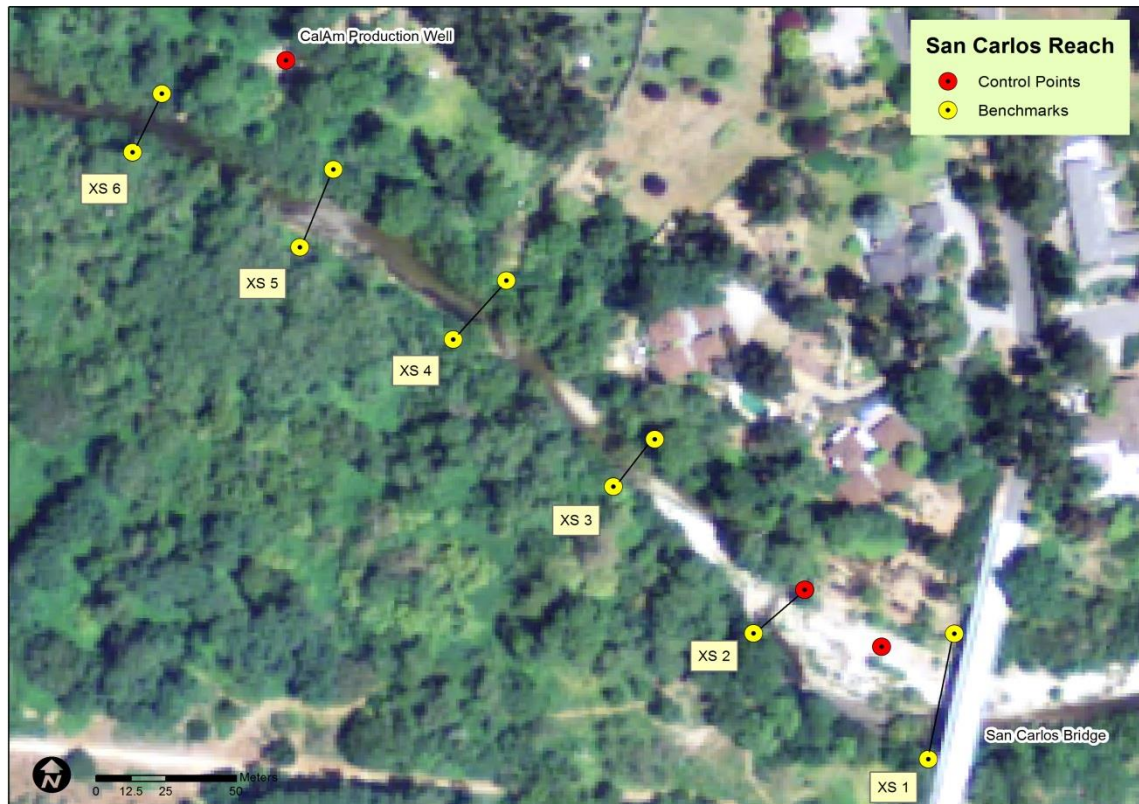
Figure 12. Locations of georeferenced control points and cross sections within the San Carlos Reach.

The San Carlos Reach is located downstream of the Rancho San Carlos Bridge (Fig. 12). We obtained cross sectional data from all transects except SC3, and we collected pebble count data at all locations.

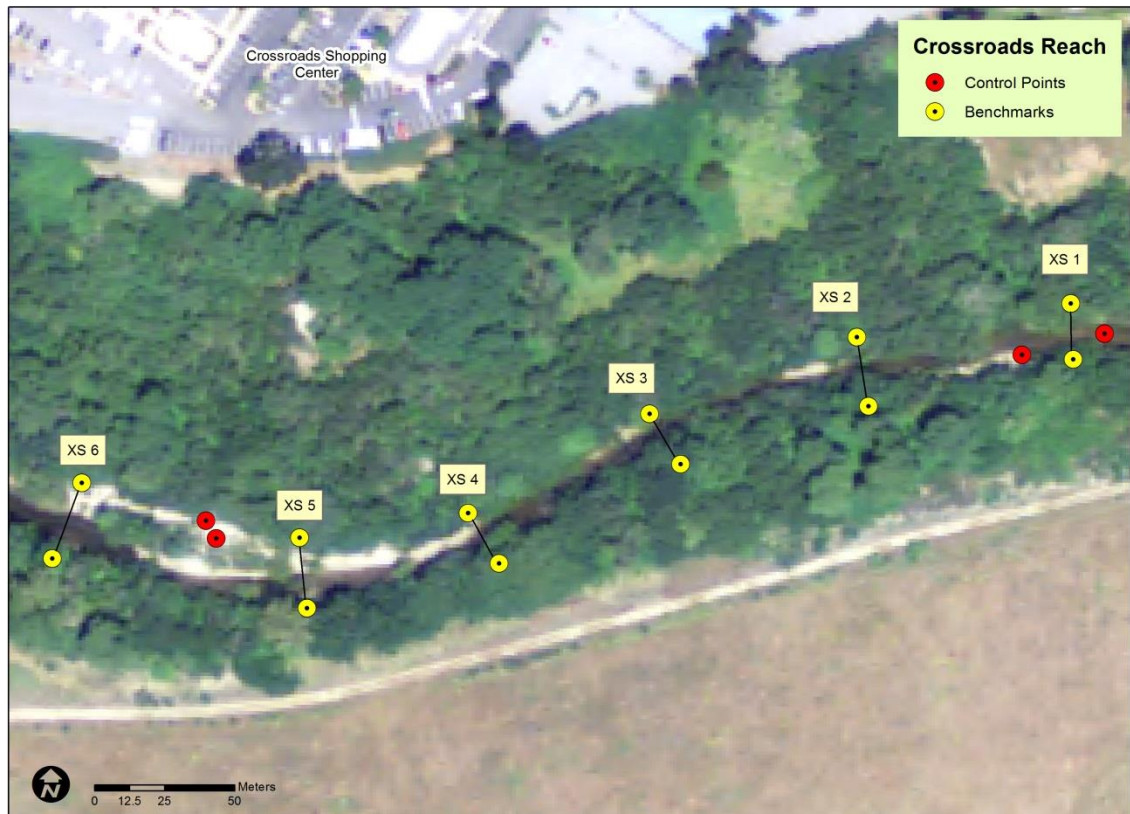
Figure 14. Locations of georeferenced control points and cross sections within the Crossroads Reach.

Crossroads was the downstream end of the study, located adjacent to the Crossroads shopping center near the mouth of Carmel Valley (Fig. 14). We obtained cross sectional and pebble count data at all cross-section locations.

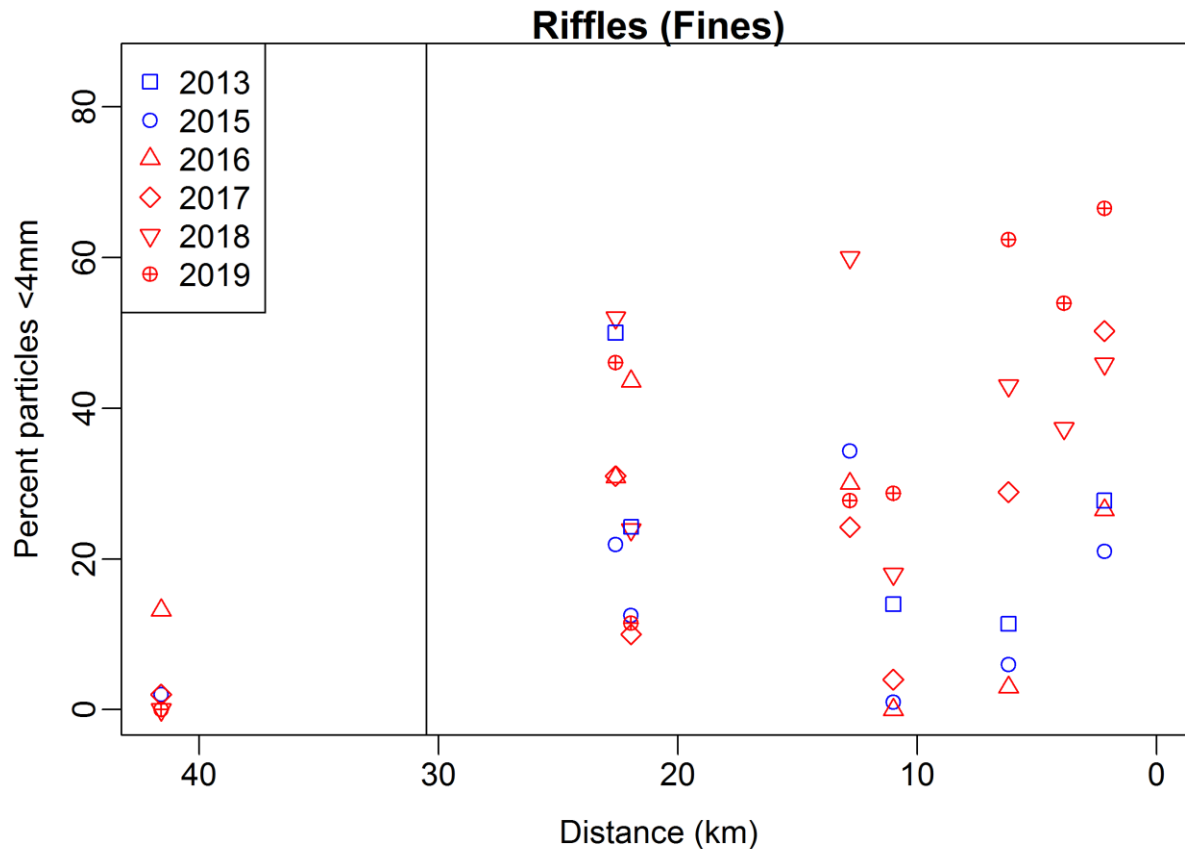
Figure 17. Percent of particles with diameter <4 mm in riffle morphological units as a function of year and distance upstream of the Carmel River mouth. Data points in blue show surveys conducted before dam removal, and those in red show surveys conducted after dam removal. A line shows the location of the former San Clemente Dam (30.5 km).

The percentage of fines was slightly lower in riffles than in pools and runs. Visually, riffles appeared to have a coarser grain size, and showed less change in relief. The pattern of downstream sites gaining fines while more upstream sites lost them continued in 2019, with DDU, DDL, and BW losing fines while the three downstream sites gained them (Fig. 17).

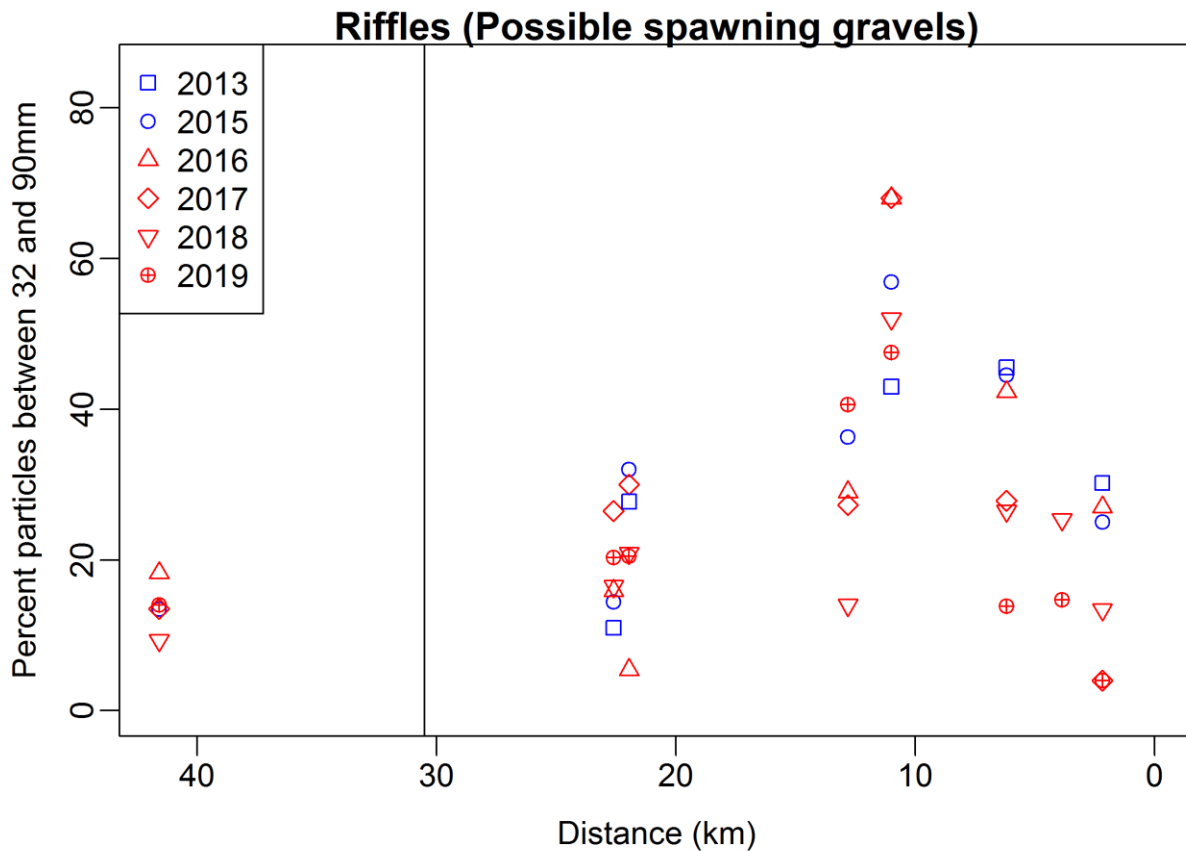
Figure 19. Percent of particles with diameter between 32 and 90 mm in riffle morphological units as a function of year and distance upstream of the Carmel River mouth. Data points in blue show surveys conducted before dam removal, and those in red show surveys conducted after dam removal. A line shows the location of the former San Clemente Dam (30.5km).

Changes were more consistent in spawning gravels in riffles. The downstream sites of CRO, SC, and SR all lost spawning gravels, while DDU and BW gained them and DDL remained virtually the same. The increase at DDU is consistent with the decrease in fines seen at riffles at that site. The gravel placement at LP can also be seen in riffles.
