Publication No. WI-2003-08
13 November 2003

The Watershed Institute

Chualar Creek Pilot Project Water Quality Monitoring March 2001 – December 2002 Final Report

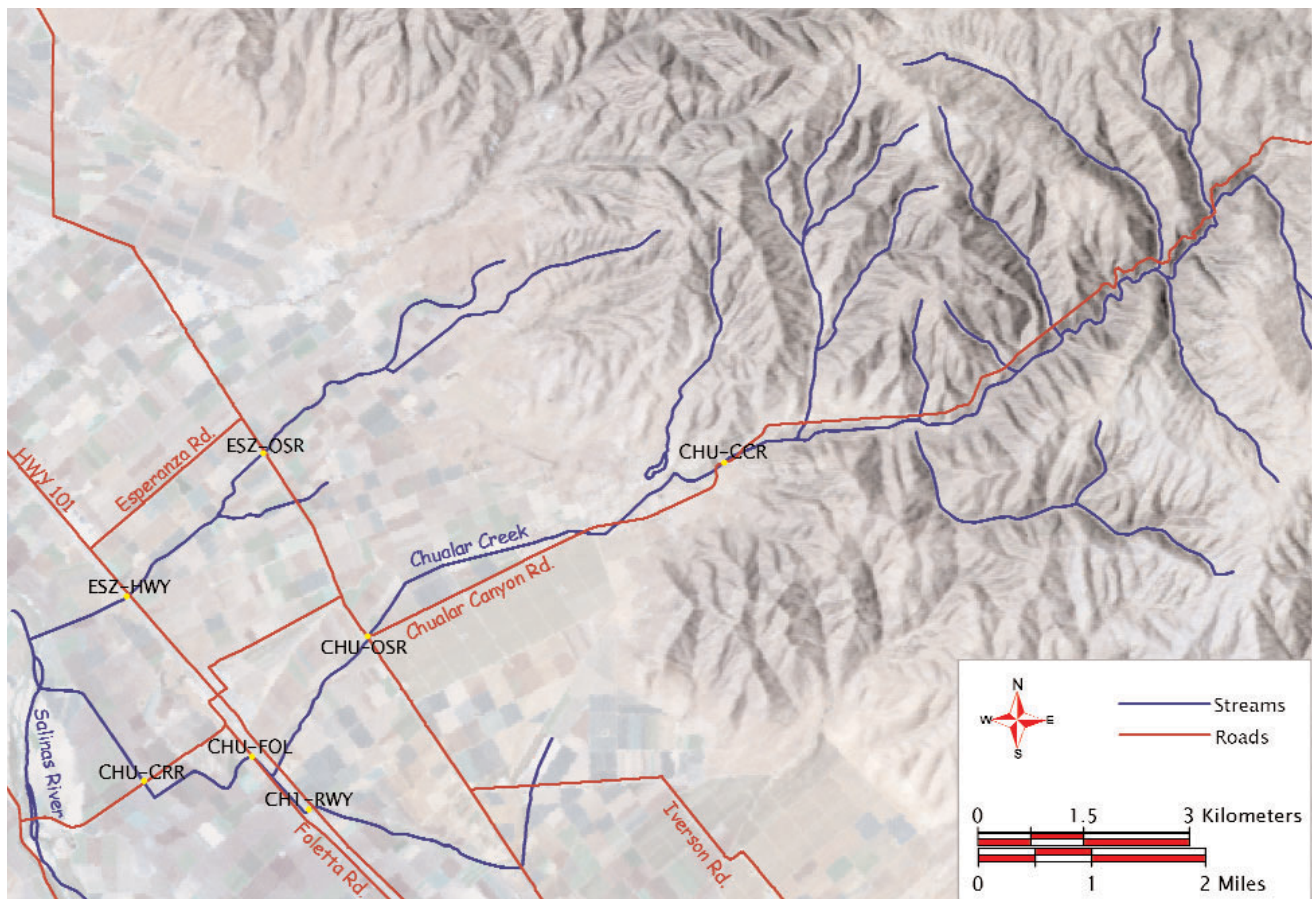
Figure 3.1 Chualar Creek Pilot Project Area and Monitoring Sites.

A total of 7 monitoring sites, all at publicly accessible locations, were selected for this study (Fig. 3.1). The monitoring plan included sampling at two main sites, therefore two locations were chosen as the primary monitoring sites: one immediately upstream of the project area and one immediately downstream of the area. These primary “above” and “below” sites for the project were CHU-CCR (above) and CHU-CRR (below). However, it should be noted that CHU-CCR is predominantly non-perennial, and that CHU-OSR was selected as an alternate site to be monitored when CHU-CCR was not flowing. Additional sites that were monitored less frequently included: CHU-FOL, CH1-RWY, ESZ-HWY, and ESZ-OSR.

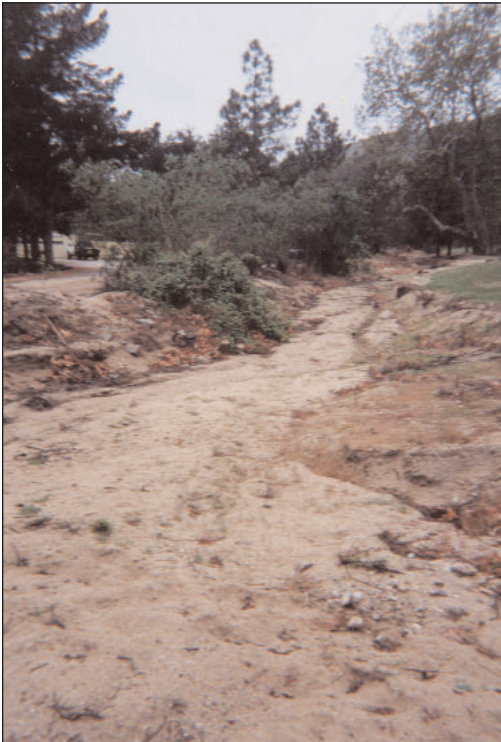
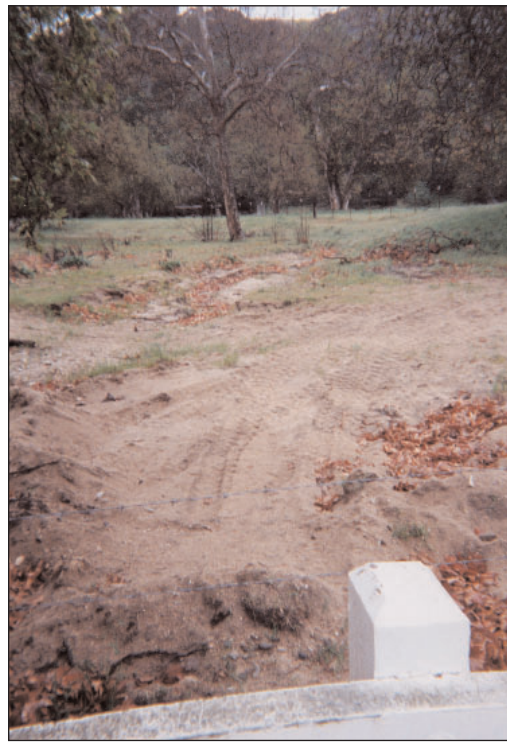
The section of Chualar Creek near site CHU-CCR (Fig. 3.2–3.3) is predominantly dry all year, except in high rainfall years. This site was chosen as the “above” site for the project area because it is located in the upper watershed above the irrigated agricultural lands. The primary land use above this site is natural lands/grazing with some scattered vineyards and residential areas. Site CHU-CCR collects runoff from all land uses above the row-crop areas. The primary substrate is sand with some gravel and cobble.

Figure 3.2 Site CHU- CCR: downstream of bridge (photo: Julie Hager Mar 02).

Figure 3.3 Site CHU-CCR: upstream of bridge (photo: Julie Hager Mar 02).

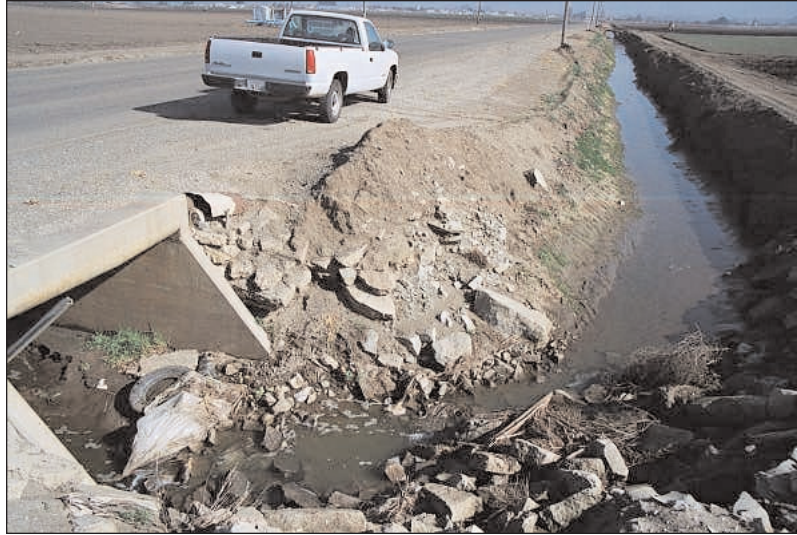
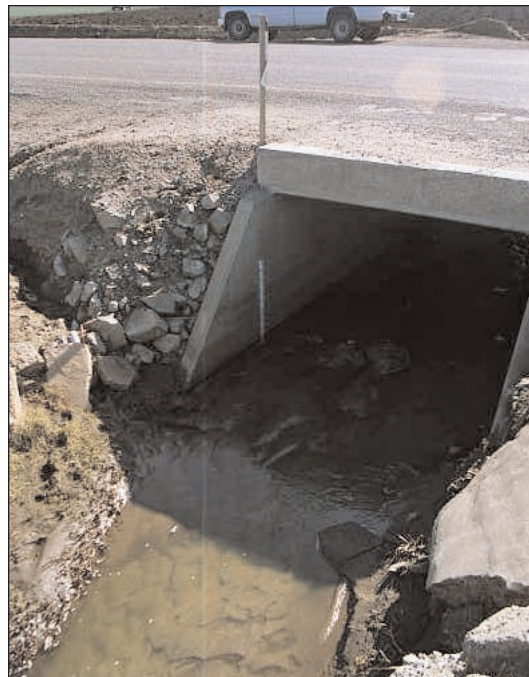
Site CHU-CRR (Fig. 3.4–3.5) is located on Chualar River Road immediately downstream of the road crossing. This was the “below” site for the project area. This site collects almost all runoff from the Chualar Creek watershed, as it is located approximately one mile from the confluence with the Salinas River.

Figure 3.4 Site CHU-CRR: Upstream of River Road crossing (photo: Fred Watson).

Figure 3.5 Site CHU-CRR: Downstream of River Road crossing; staff plate visible on right bank side of road crossing (photo: Fred Watson).

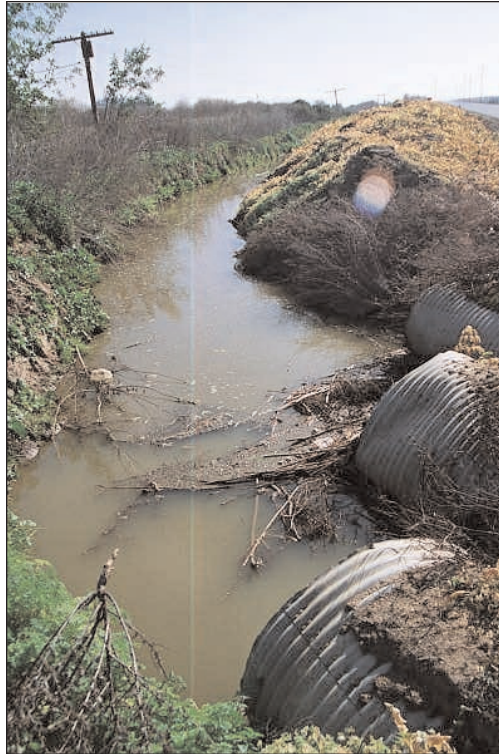
Figure 3.6 Site CHU-FOL: Upstream of Foletta Road (photo: Fred Watson).

Site CHU-FOL (Figure 3.6–3.7) is located on the west side Foletta Road (west of Highway 101) and upstream of site CHU-CRR. A tributary drainage that flows south of Chualar joins Chualar Creek immediately upstream of this site.

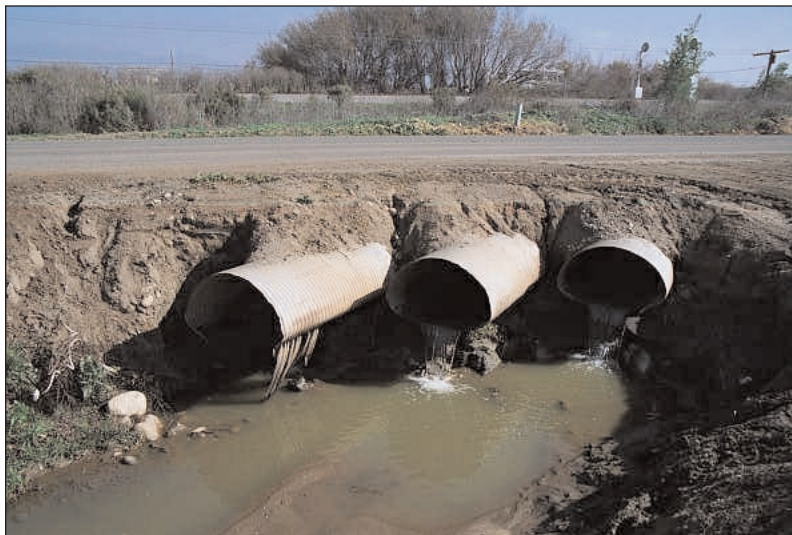
Figure 3.7 Site CHU-FOL: Downstream of Foletta Road (photo: Fred Watson).

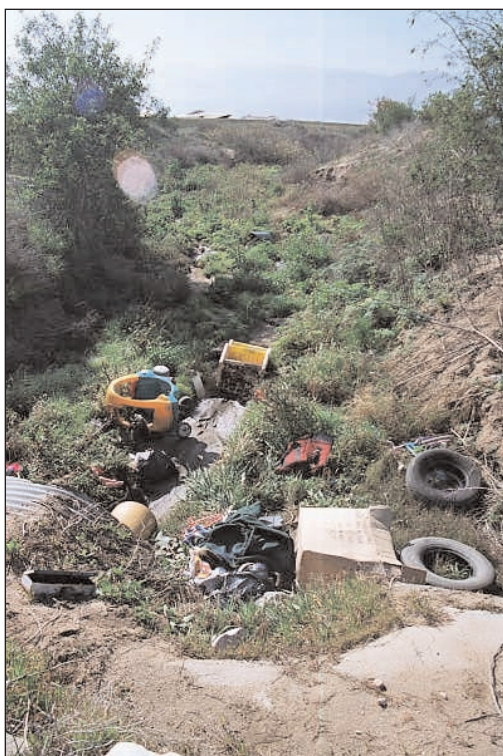
Figure 3.8. Site CHU-OSR: Downstream of Old Stage Road (photo: Fred Watson).

Site CHU-OSR (Fig. 3.8–3.9) is located at Old Stage Road near the bottom of Chualar Canyon. Towards the end of the monitoring period, this site became the secondary “above” site for the project, as a result of the lack of flow at CHU-CCR. The primary land uses above this site include natural/grazing lands, small residential, and a few scattered vineyards. However, due to the dry nature of the headwaters, flow from these land uses rarely reaches site CHU-OSR. Much of the row-crop agricultural land is downstream of this location, with the exception of a couple of farms near the bottom of the canyon.

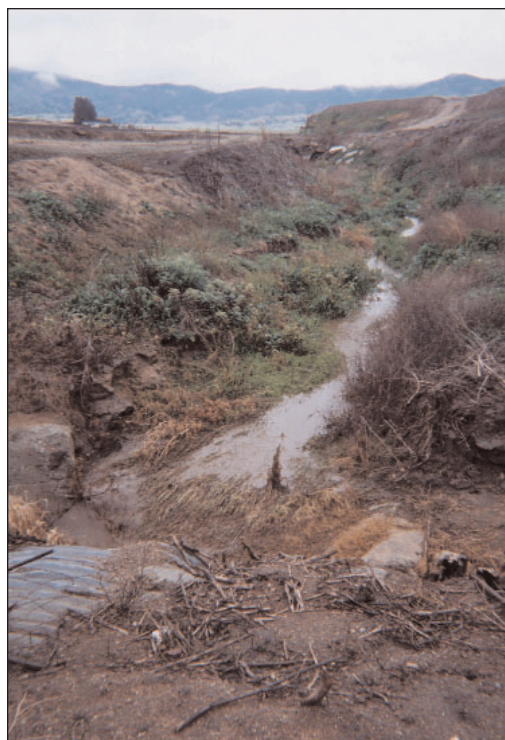
Figure 3.9 Site CHU-OSR: Upstream of Old Stage Road (photo: Julie Hager).

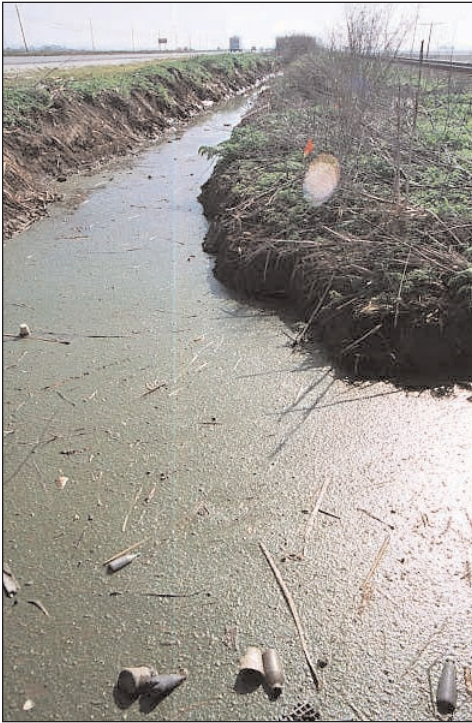
Figure 3.10 Site CH1-RWY:
Downstream of sampling site
(photo: Fred Watson).

Site CH1-RWY (Fig. 3.10–3.11) is located on the drainage that flows south of Chualar Creek. It too is a channelized ditch with the majority of its flow resulting from agricultural tail water. This monitoring site was located on Foletta Road just before the confluence with Chualar creek.

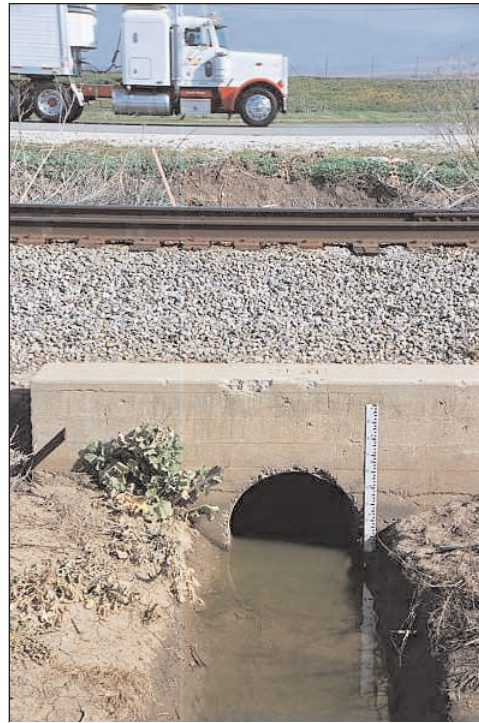
Figure 3.11 Site CH1-RWY:
Culvert and sampling location
(photo: Fred Watson).

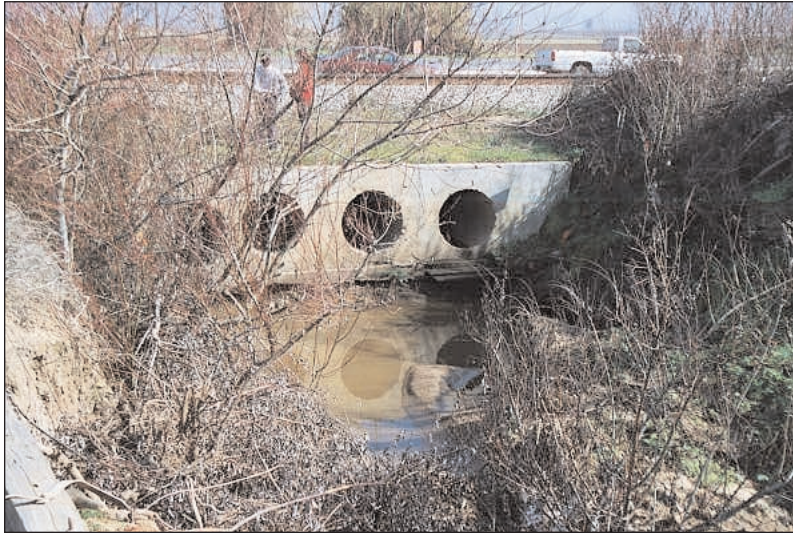
Site ESZ-HWY (Fig. 3.12–3.13) is located on a drainage ditch that flows north of Chualar Creek. This site is located at the bottom of the drainage system, less than one mile before the confluence with the Salinas river. The primary land uses of this catchment area include row crop agriculture and greenhouses.

Figure 3.12 Site ESZ-HWY: Culvert and monitoring location (photo: Fred Watson).

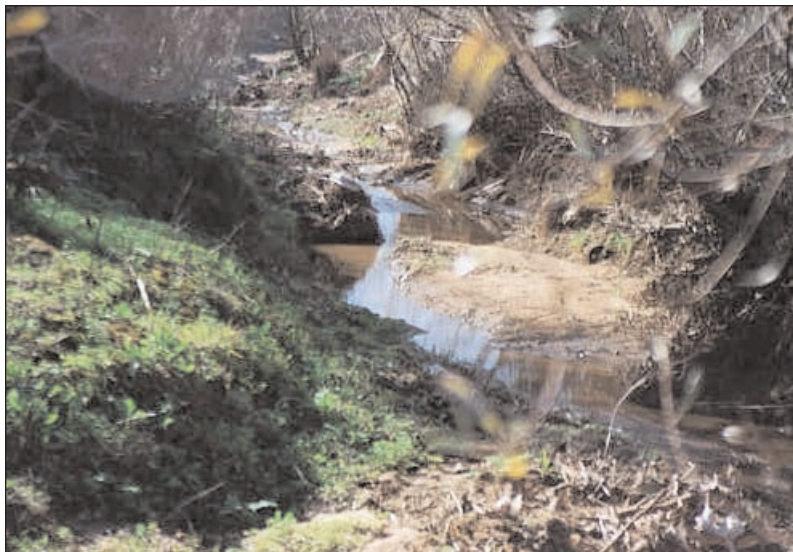
Figure 3.13 Site ESZ-HWY: Downstream of monitoring location (photo: Fred Watson).

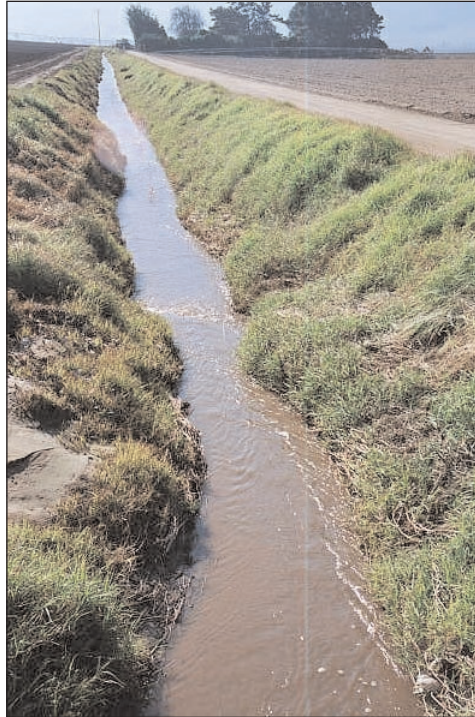
Figure 3.14 Site ESZ-OSR: Downstream of Old Stage Road (photo: Fred Watson).

Site ESZ-OSR (Fig. 3.14–3.15) is on the same drainage ditch north of Chualar Creek and upstream of site ESZ-HWY. The primary land use above this site is row-crop agriculture and greenhouses.

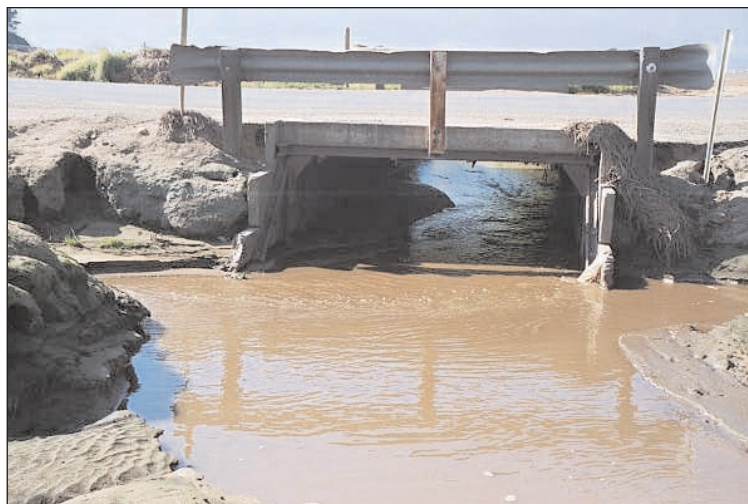
Figure 3.15 Site ESZ-OSR: Upstream of Old Stage Road (photo: Fred Watson).

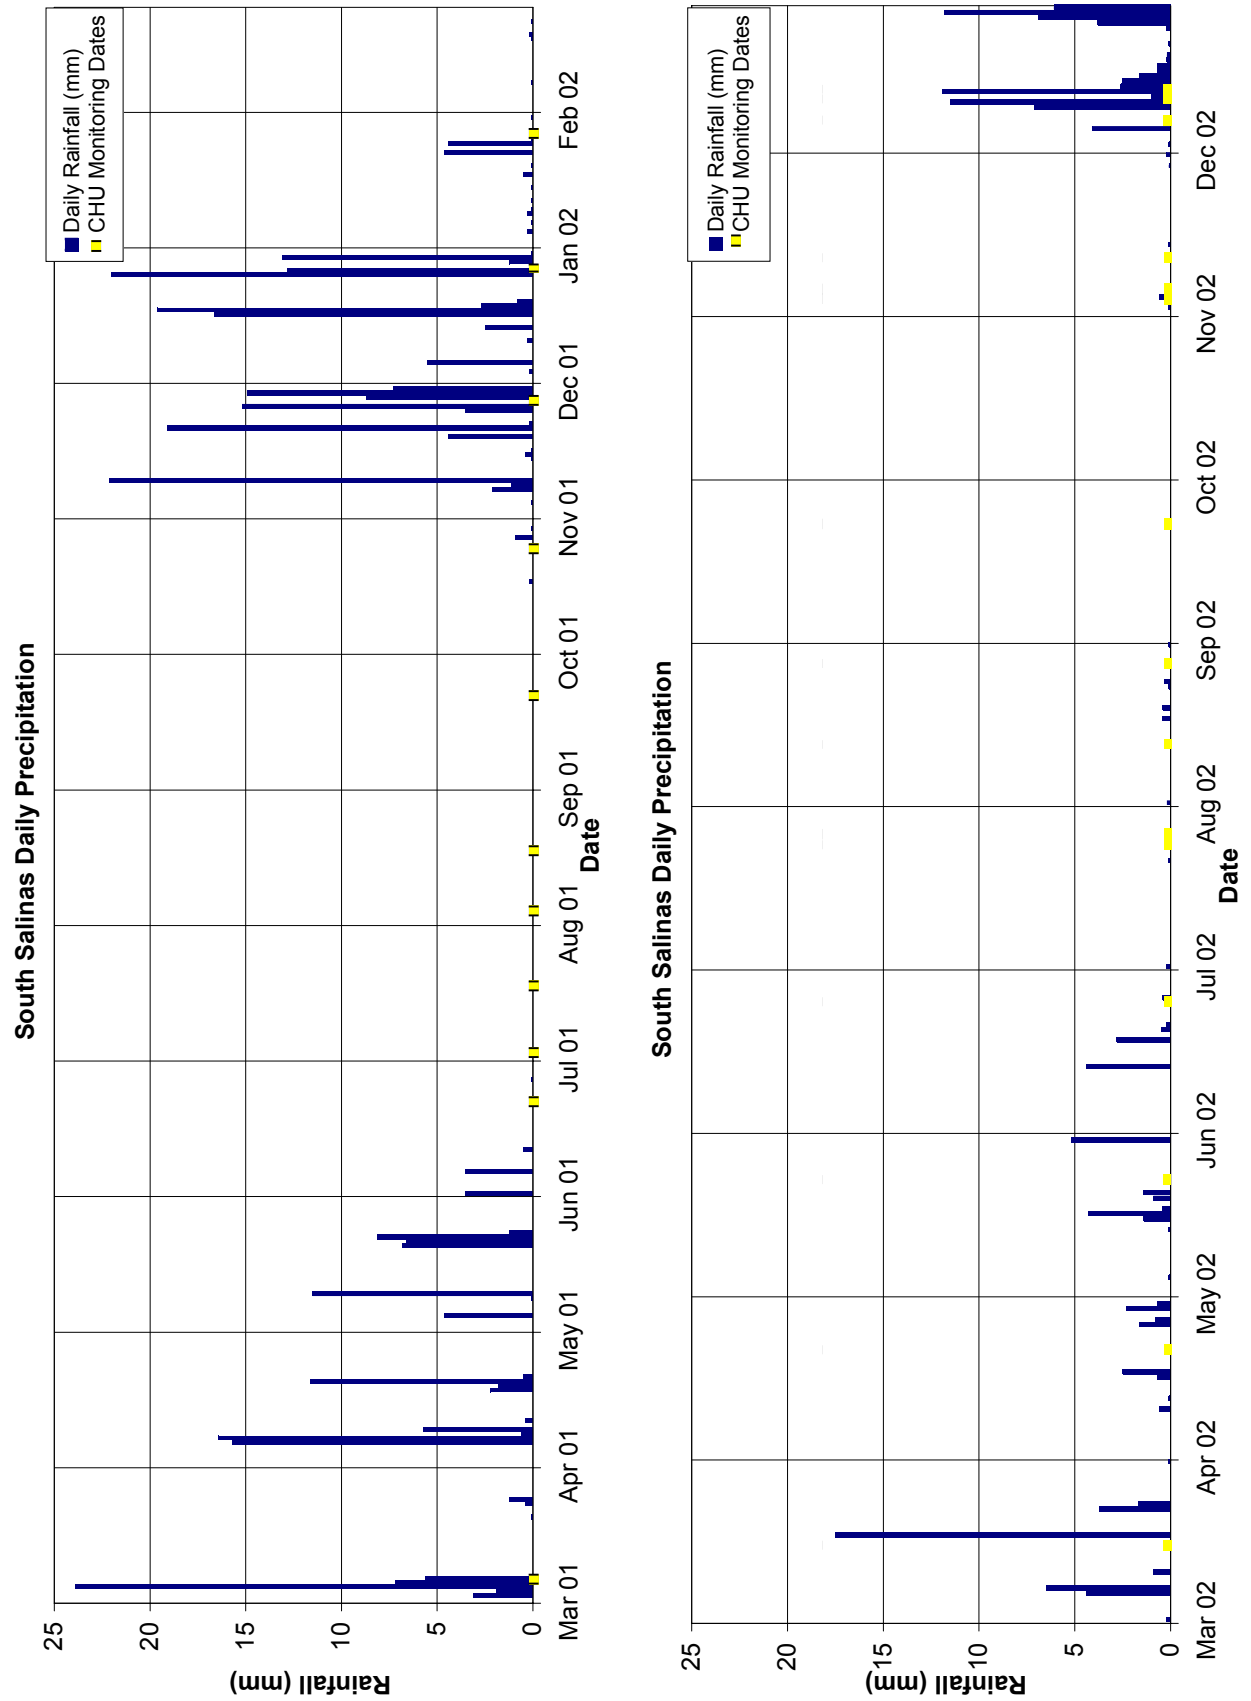
The total precipitation for the 2000 water year, during which most of the CCAMP monitoring took place, was approximately 37 cm (14.5 inches). Figure 4.1 presents a precipitation summary for the Salinas area for the time period of the Chualar monitoring. Maximum and minimum daily air temperature values for the same area are shown in Figure 4.2. These data were retrieved from the California Irrigation Management Information System South Salinas Station #89 (CIMIS 2002). It should be noted that error in precipitation measurements is not uncommon at this site due to its close proximity to an irrigated agricultural field. Intermittent rainfall occurred from March 2001 until June 2001 and was then followed by a dry period from July 2001 to October 2001. Rain commenced again in November 2001 and periodically fell through April 2002. The same rainfall patterns occurred in 2002 with intermittent rainfall from March to June, a dry period from July to October, and winter rains from November through the end of the monitoring period. Based on 62 years of rain data for the Salinas area, the average water year (October to September) precipitation is approximately 33 cm (13 inches). The total 2001 water year precipitation for south Salinas was approximately 41 cm (16 inches). Most monitoring of Chualar Creek occurred during the 2002 water year, during which the total precipitation was approximately 28 cm (11 inches). Monitoring also continued into the 2003 water year. As of December 31, 2002 the approximate total precipitation for the 2003 water year was 7 cm (2.7 inches). The warmest air temperatures occurred in May 2001, and July/August 2002, while the lowest temperatures were recorded in January 2002. This pattern of precipitation and air temperature is typical for the mediterranean climate that characterizes the Central Coast region of California.

Figure 4.1 Daily Precipitation Data for CIMIS South Salinas Station.

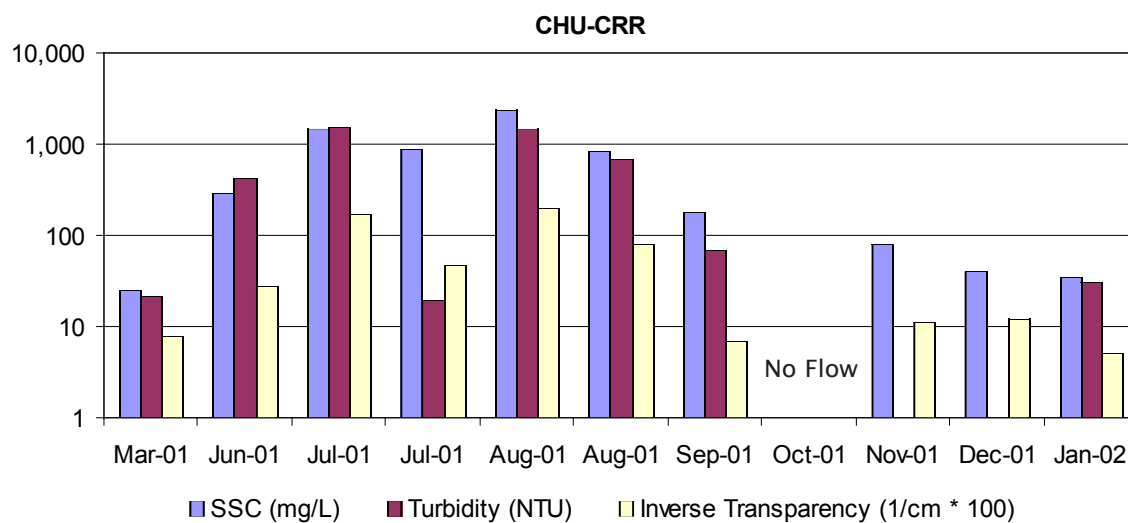
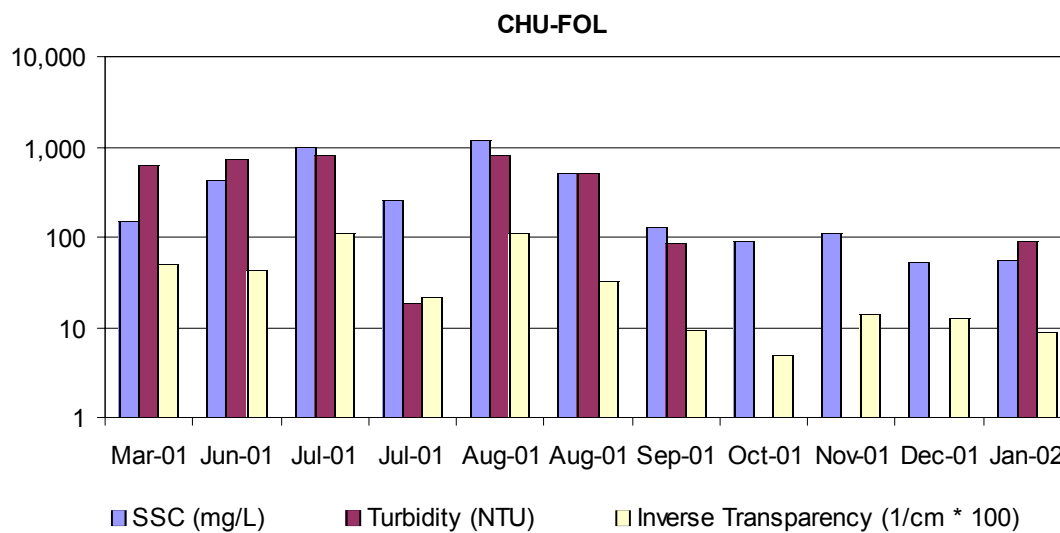
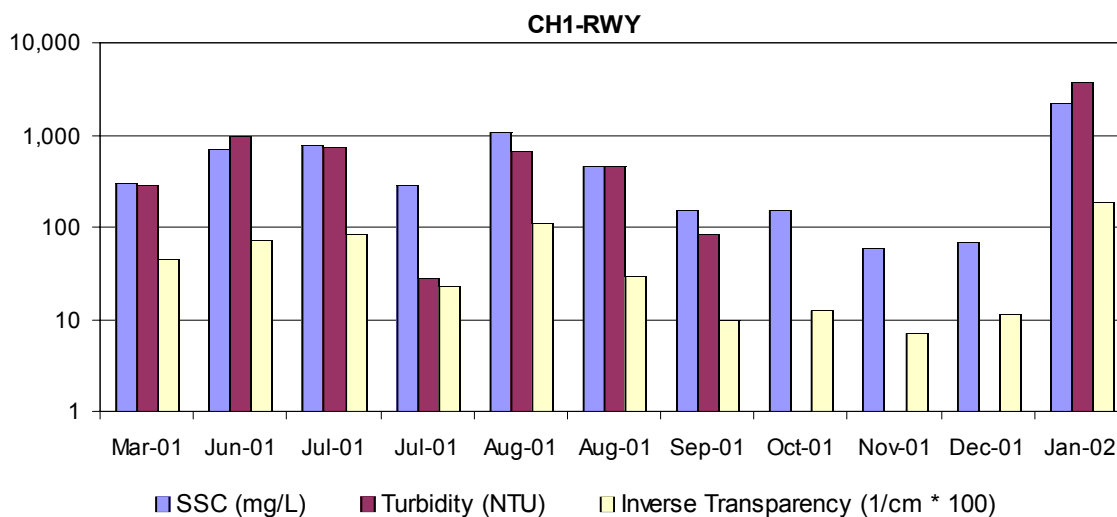
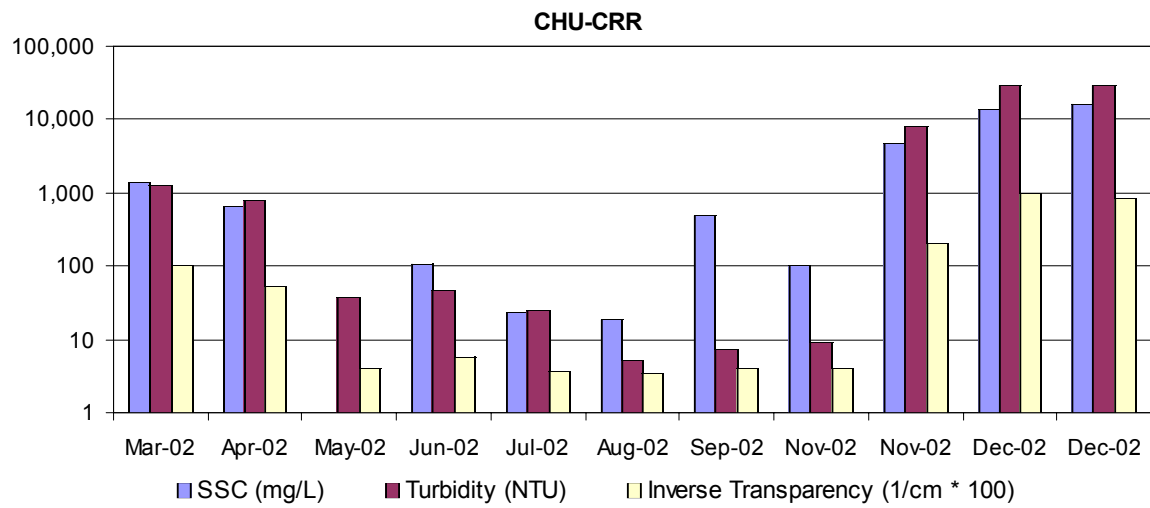
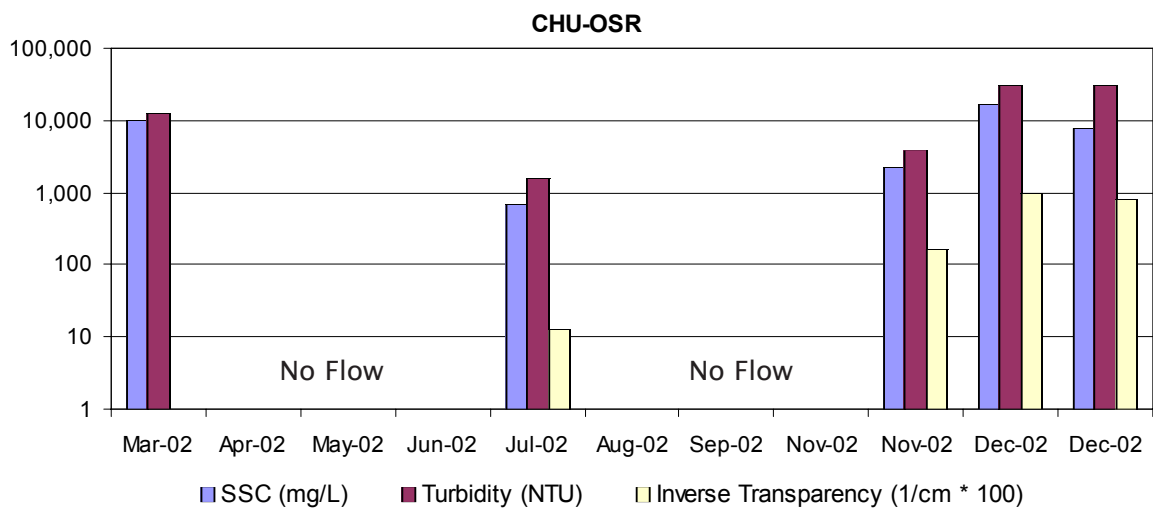
Turbidity is the scattering of light due to suspended particles, both organic and inorganic. Figures 4.3 to 4.7 illustrate a strong correspondence between the values for SSC and turbidity. For comparison to the turbidity levels observed at the Chualar sites, the USEPA (2000) recommended water quality criteria for the Central Coast region is 1.84 NTU.

Figure 4.3 Suspended sediment and turbidity time series for CHU-CRR.

Figure 4.4 Suspended sediment and turbidity time series for CHU-FOL.

Figure 4.5 Suspended sediment and turbidity time series for CH1-RWY.

Figure 4.6 Suspended sediment and turbidity time series for CHU-CRR.

Figure 4.7 Suspended sediment and turbidity time series for CHU-OSR.

ly highest in the summer, with the exception of January 2002 at site CH1-RWY (Fig. 4.5). The trend was reversed in 2002 (most likely the result of sampling during rain events), with smaller transparency readings occurring from May to early November and high values in late November through March. CCAMP transparency data were not analyzed for this report.

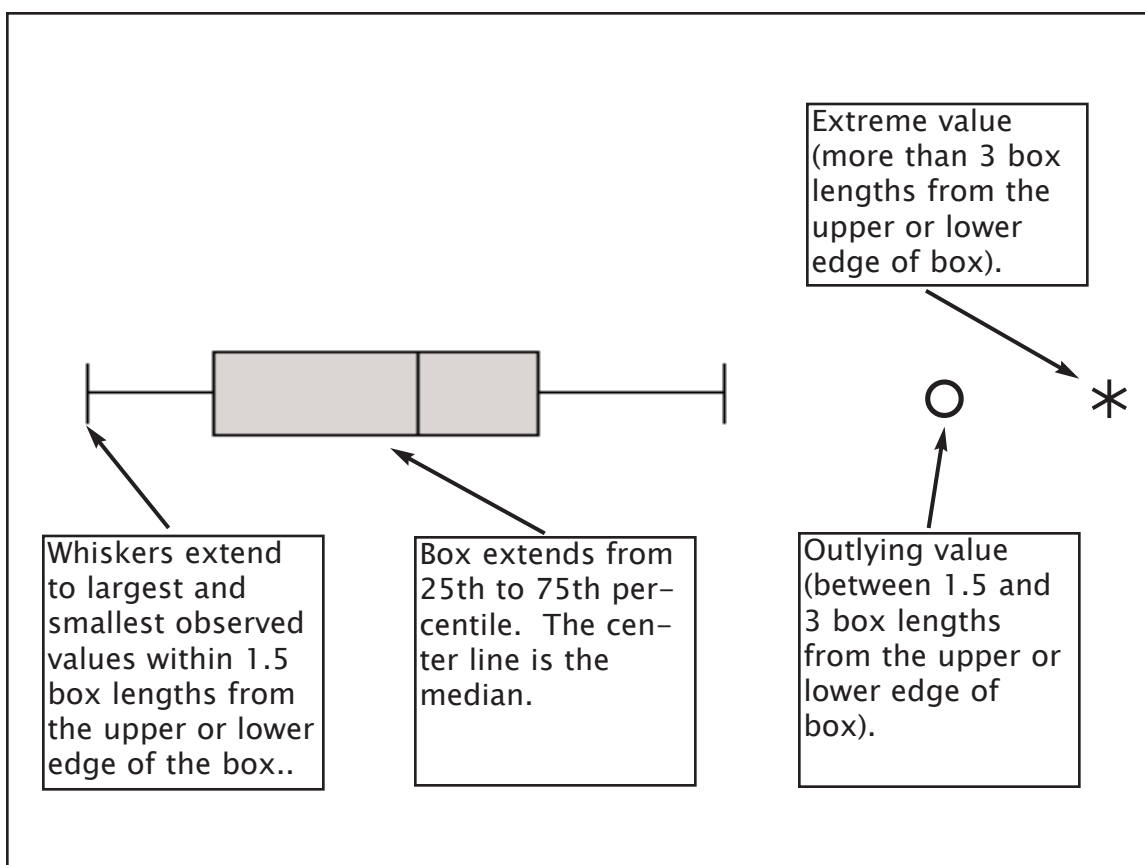
Figure 4.10 Whisker plot schematic. All whisker plots are made using SPSS 11.0.

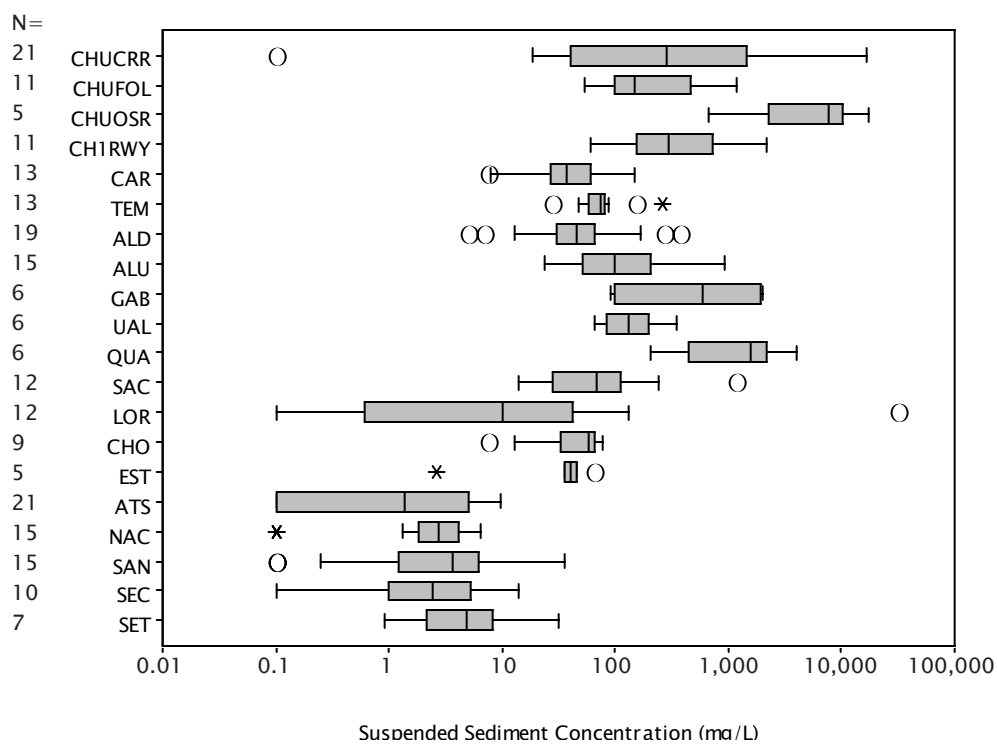
Figure 4.11 Suspended sediment data for selected CCAMP and Chualar sites. Note: Chualar samples were analyzed using SSC, and CCAMP samples were analyzed using TSS.

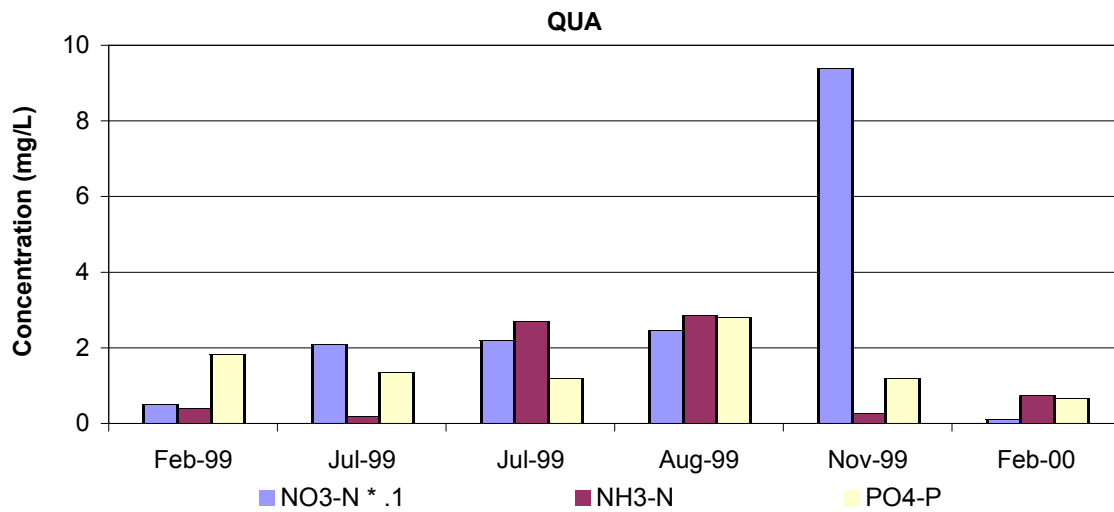
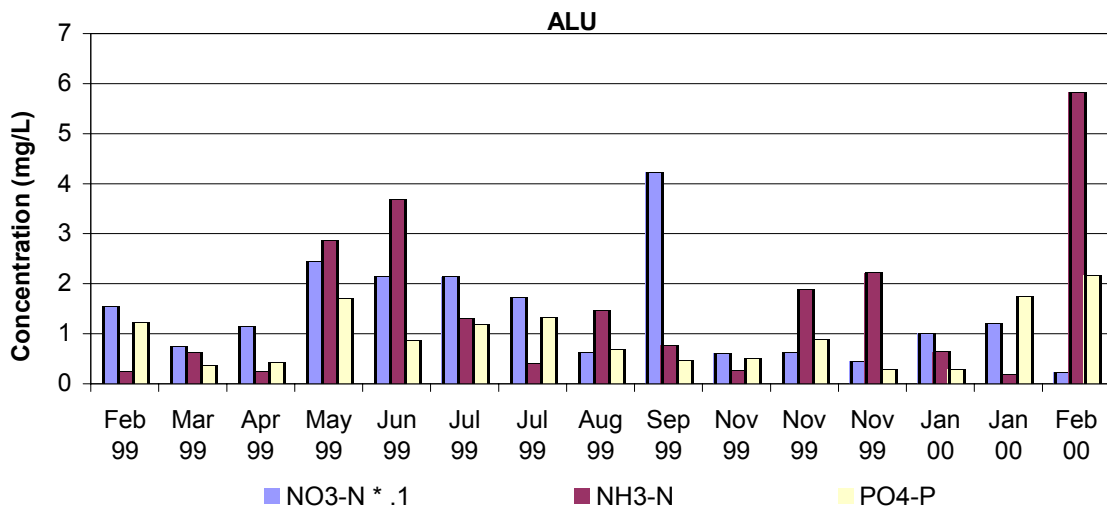
At CCAMP site QUA (Figure 4.24), nitrate-N values were highest in July and August, with an even more concentrated spike occurring in November. At ALU (Figure 4.25), nitrate-N levels were highest in June and July with an even higher concentrated spike occurring in September. When Chualar nitrate-N results are compared to preliminary nitrate-N data collected by CCAMP (Fig. 4.26), the average concentrations found at the Chualar sites were some of the highest in the Salinas Valley. However, elevated levels were also found at CCAMP sites: TEM, UAL, and QUA.

Figure 4.24 Nutrient time series for CCAMP site QUA.

Figure 4.25 Nutrient times series for CCAMP site ALU.

At CCAMP sites QUA and ALU (Fig. 4.24 to 4.25), orthophosphate-P values were also variable throughout the year. The orthophosphate-P concentrations for Chualar (with the exception of CHU-OSR) were similar in range to nearby streams

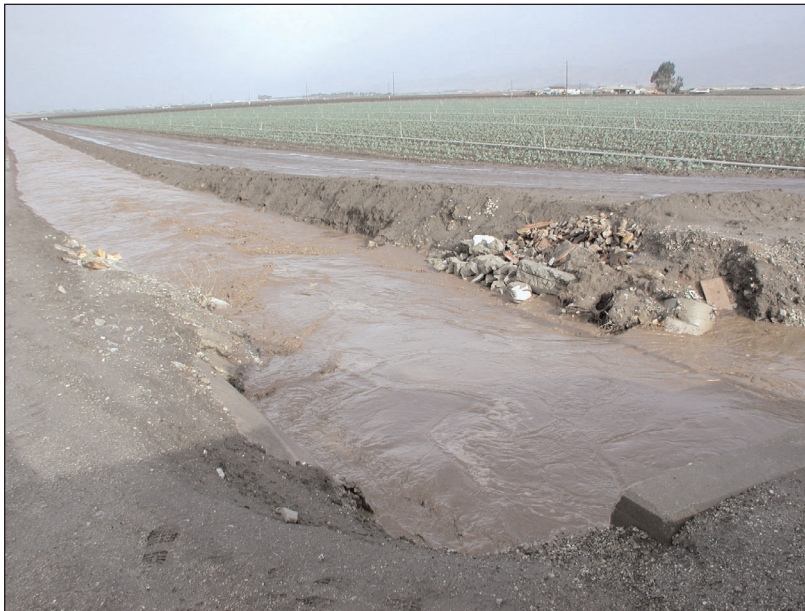
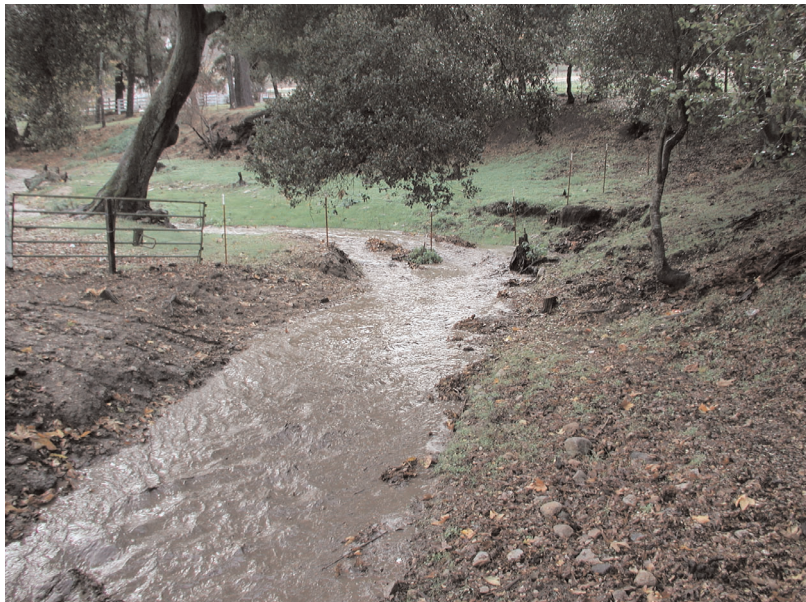
Figure 4.30 Flow during December 2002 rain event at CHU-CRR (photo: Julie Hager 17 Dec 02).

Figure 4.31 Flow during December 2002 rain event at CHU-CCR (photo: Julie Hager 17 Dec 02).

Larger discharges and instantaneous loads were measured during the December 2002 event. The rainfall total from December 13th to the 23rd was approximately 1.6 inches (40.6 mm) or greater. Data was retrieved from the CIMIS Salinas South Station and was flagged due to missing hourly data. Approximately 0.5 inches (12.7 mm) of rainfall was received on the 16th. At CHU-CRR discharge was $1.5 \text{ m}^3/\text{s}$ (55 cfs) on December 16th and $2 \text{ m}^3/\text{s}$ (73 cfs) on December 17th. Figure 4.32 shows measured and computed discharges for CHU-CRR (based on a stage vs. discharge curve constructed by CCoWS; see Figure 4.33), as well as hydrographs for the Reclamation Ditch and San Lorenzo Creek, the most similar USGS gaged creeks in the region. The instantaneous loads for suspended sediment and nutrients are presented in Table 4.3. The maximum estimated SSC load was 34,275 g/s, the nitrate-N load was 23.4 g/s, the ammonia-N load was 2.5 g/s, and orthophosphate-P load was 40 g/s. Figure 4.30 and 4.31 show sediment laden flow at CHU-CRR and CHU-CCR.

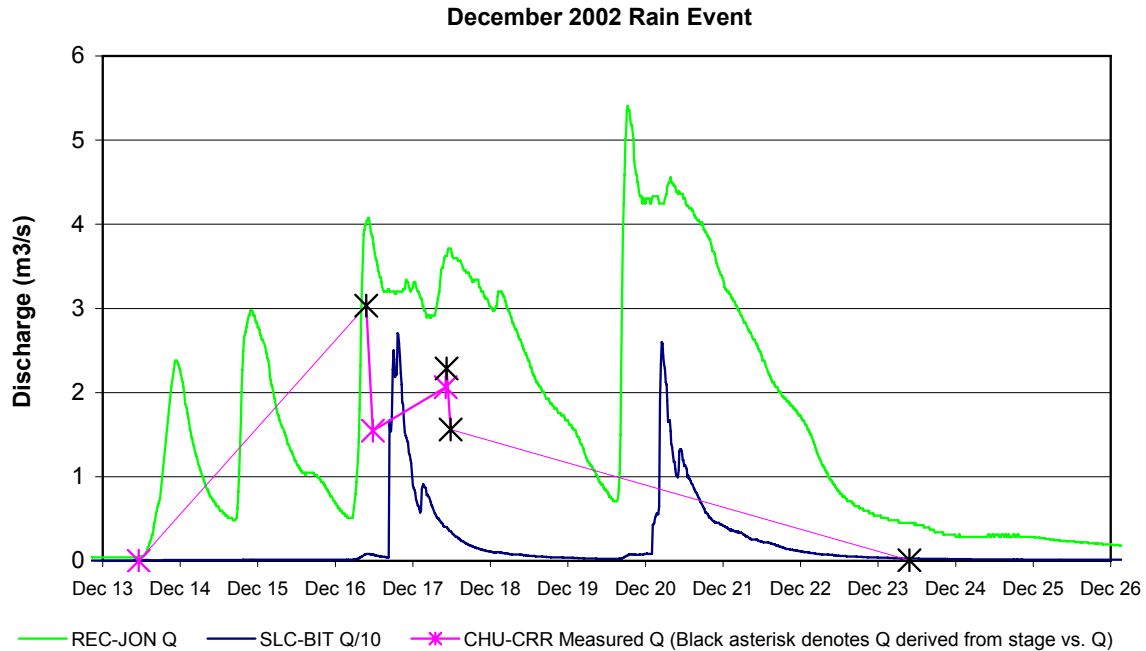
Figure 4.32 Hydrographs for December 2002 rain event. CHU-CRR (pink line) shows measured discharges as well as those estimated using a stage-discharge curve constructed by CCoWS. Hydrographs for the Reclamation Ditch at San Jon Road (REC-JON) and San Lorenzo Creek at Bitterwater Road (SLC-BIT) are based on hourly flow data from USGS (2002). Hydrographs for REC-JON and SLC-BIT, the two gaged sites in the region that are most similar to Chualar Creek, are displayed in order to give a rough estimate of the hydrograph shape at CHU-CRR.

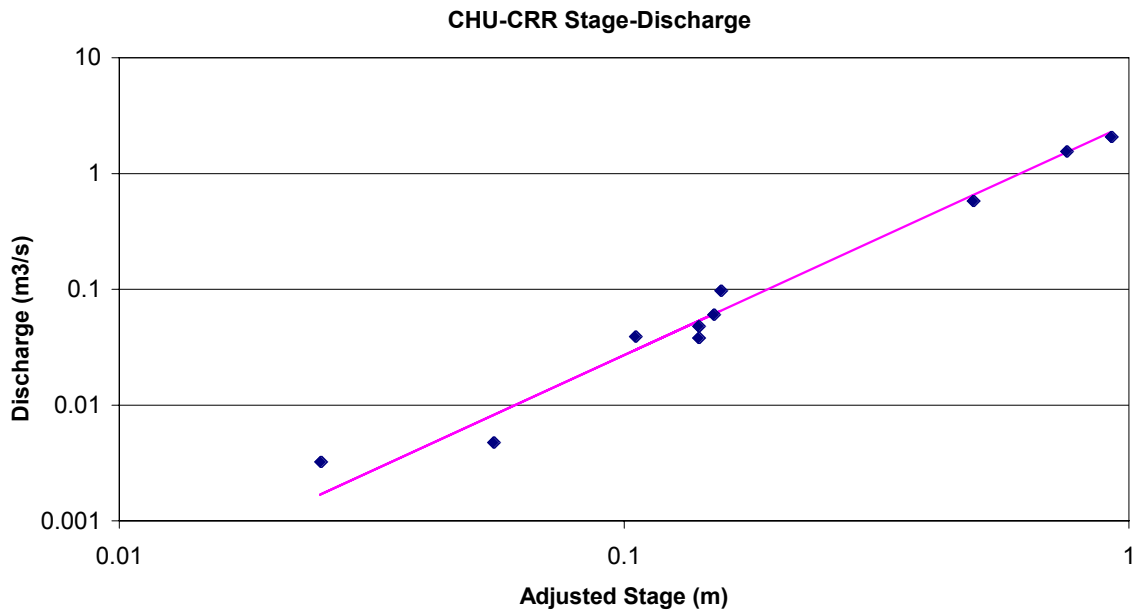
Figure 4.33 Stage-Discharge curve for CHU-CRR. Adjusted stage is measured stage minus the measured stage at which flow is zero.
