Publication No. WI-2003-08
13 November 2003

The Watershed Institute

Chualar Creek Pilot Project Water Quality Monitoring March 2001 – December 2002 Final Report

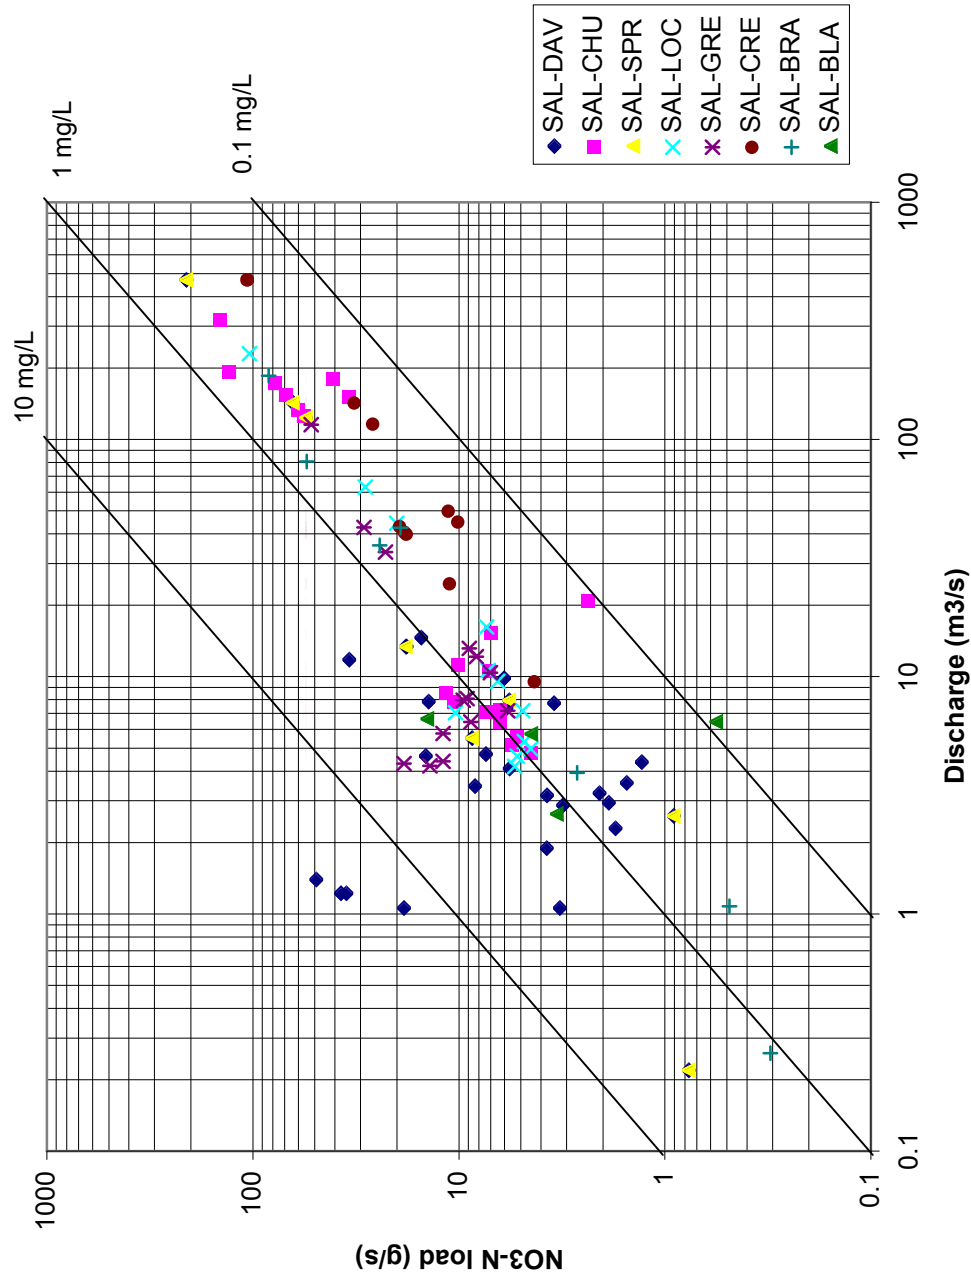
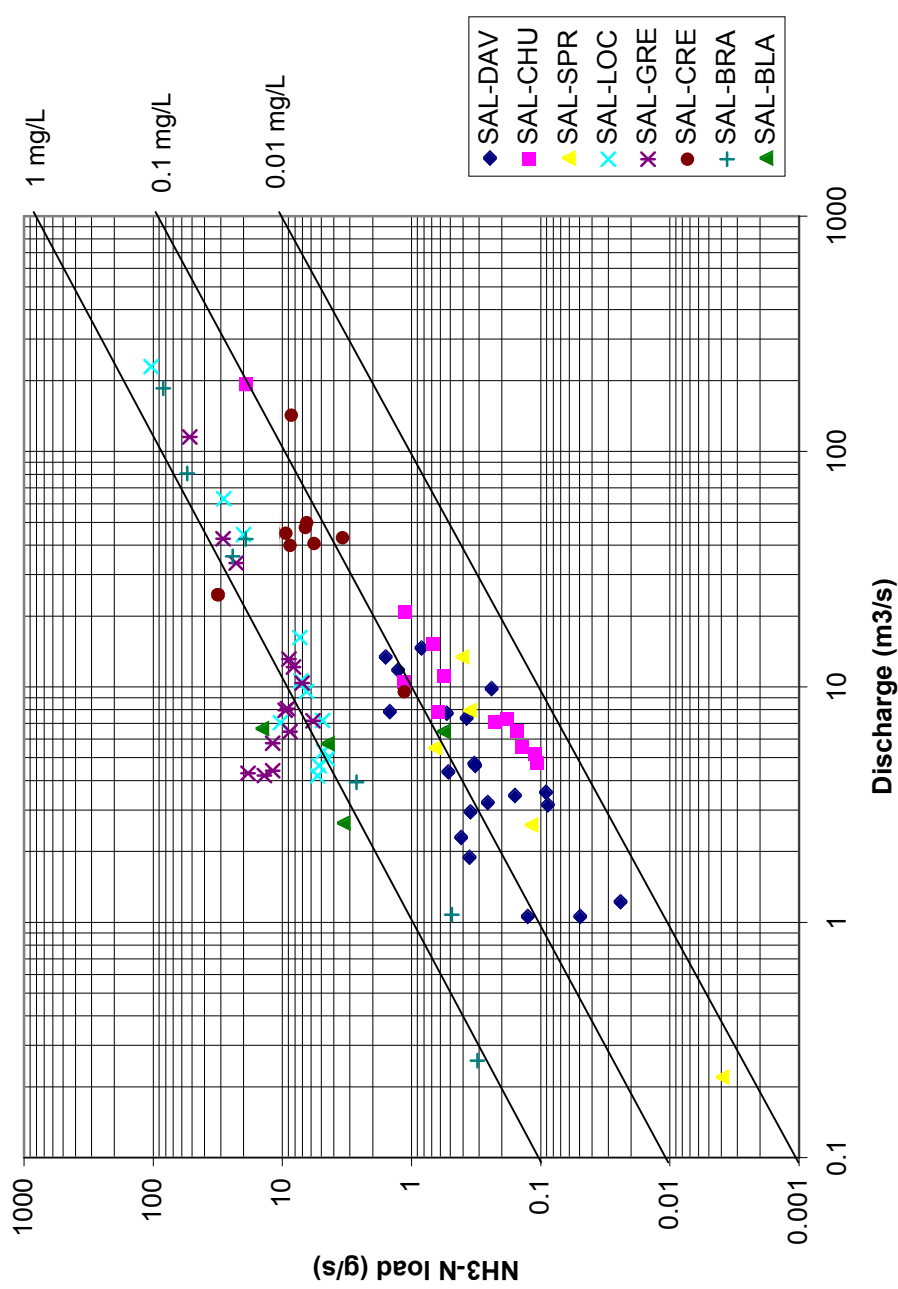
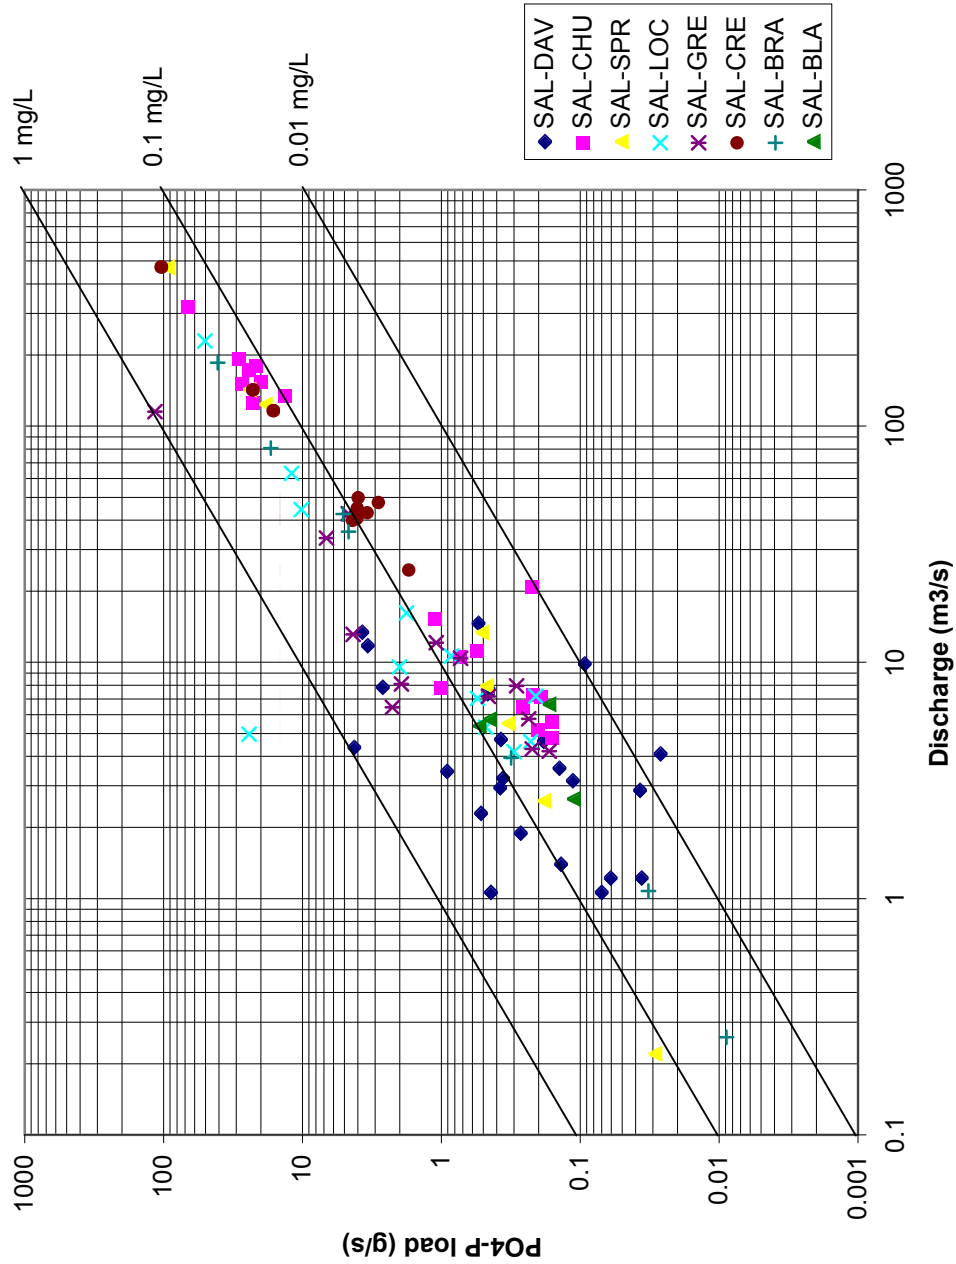
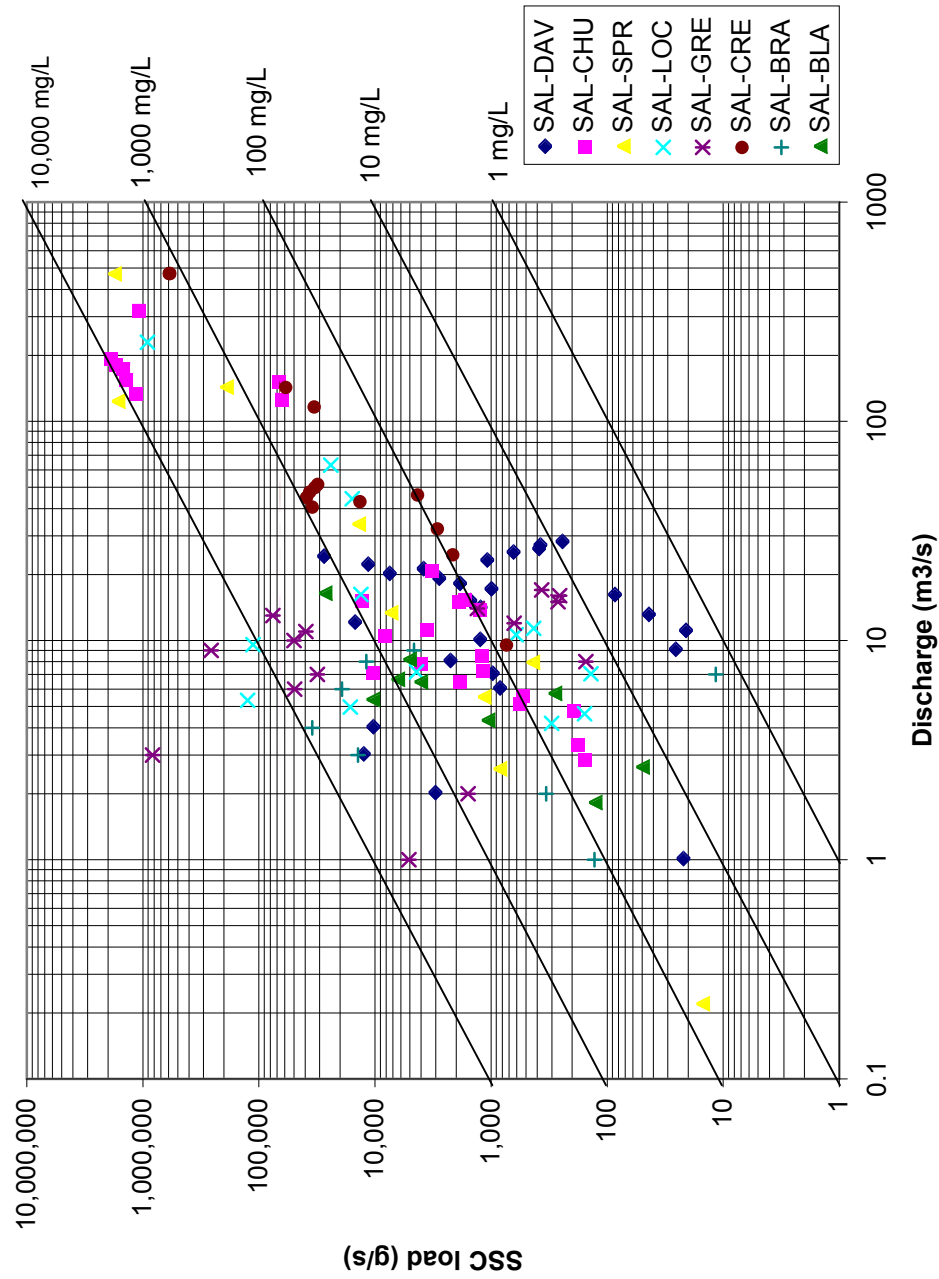
Figure 4.34 Nitrate-N instantaneous loads for selected CCoWS sampling sites along the Salinas River. Discharges were derived from stage vs. discharge curves constructed by CCoWS and based on a combination of CCoWS and USGS flow measurements. The black circles indicates the range of estimated instantaneous nitrate-N loads that occurred at Chualar site CHU-CRR during the December 2002 rain event. The pink circle indicates the estimated range of instantaneous nitrate-N loads for the Salinas River near Chualar at a flow range similar to the magnitude of flow that occurred on the Salinas River during the December 2002 event.

Figure 4.35 Ammonia-N instantaneous loads for selected CCoWS sampling sites along the Salinas River. Discharges were derived from stage vs. discharge curves constructed by CCoWS and based on a combination of CCoWS and USGS flow measurements. The black circles indicates the range of estimated instantaneous ammonia-N loads that occurred at Chualar site CHU-CRR during the December 2002 rain event. The pink circle indicates the estimated range of instantaneous ammonia-N loads for the Salinas River near Chualar at a flow range similar to the magnitude of flow that occurred on the Salinas River during the December 2002 event.

Figure 4.36 Orthophosphate-P instantaneous loads for selected CCoWS sampling sites along the Salinas River. Discharges were derived from stage vs. discharge curves constructed by CCoWS and USGS flow measurements. The black circles indicates the range of estimated instantaneous Orthophosphate-P loads that occurred at Chualar site CHU-CRR during the December 2002 rain event. The pink circle indicates the estimated range of instantaneous Orthophosphate-P loads for the Salinas River near Chualar at a flow range similar to the magnitude of flow that occurred on the Salinas River during the December 2002 event.

Figure 4.37 SSC instantaneous loads for selected CCoWS sampling sites along the Salinas River. Discharges were derived from stage vs. discharge curves constructed by CCoWS and based on a combination of CCoWS and USGS flow measurements. The black circles indicates the range of estimated instantaneous SSC loads that occurred at Chualar site CHU-CRR during the December 2002 rain event. The pink circle indicates the estimated range of instantaneous SSC loads for the Salinas River near Chualar at a flow range similar to the magnitude of flow that occurred on the Salinas River during the December 2002 event.
