Publication No. WI-2014-05

The Watershed Institute

An Existing Conditions and Drought-year Storm- Water Quality Study of Majors Creek: Monterey, CA

Spring 2014

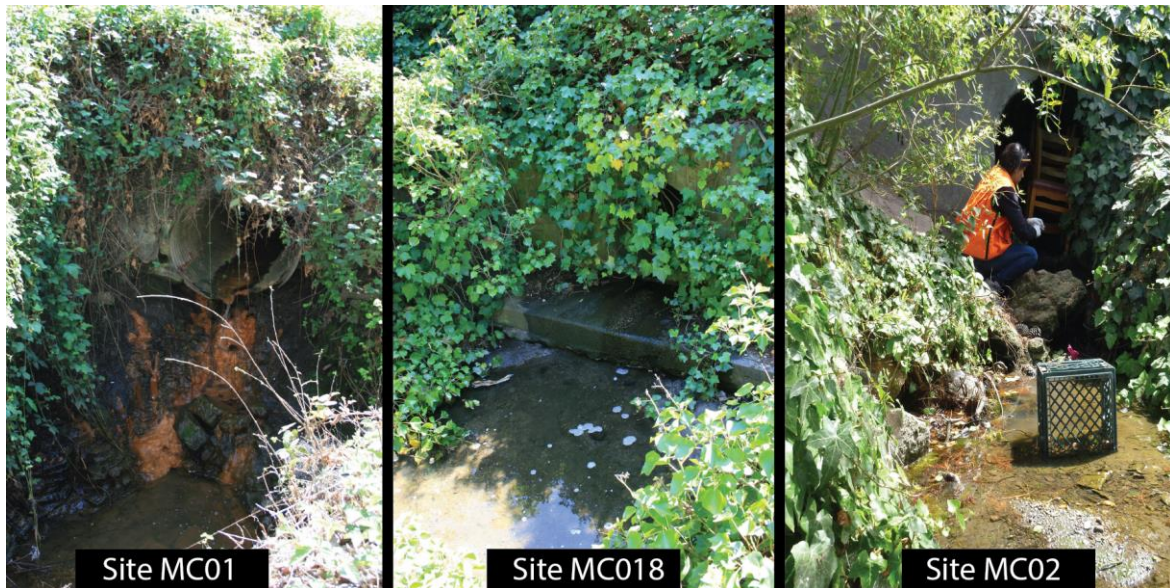
Sample sites were all located at hydraulic control points, as suggested by Harmel et al. (2006) since this diminishes the chances of discharge changes due to morphological changes in natural channels. Additionally, the discharges from storm water are measured most accurately when sampled from a man-made flow control structure (USEPA 1992). Each sample location was at a culvert outfall. Pictures of the sample locations are shown in Figure 4 below.

Figure 4: Photographs of the sample location culvert outfalls.

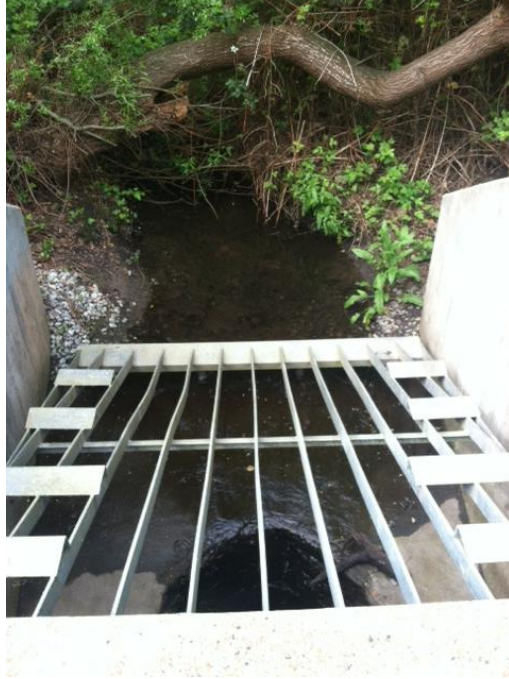
Figure 5: Inlet to the MC01 Culvert when Majors Creek was flowing on April 6, 2013.

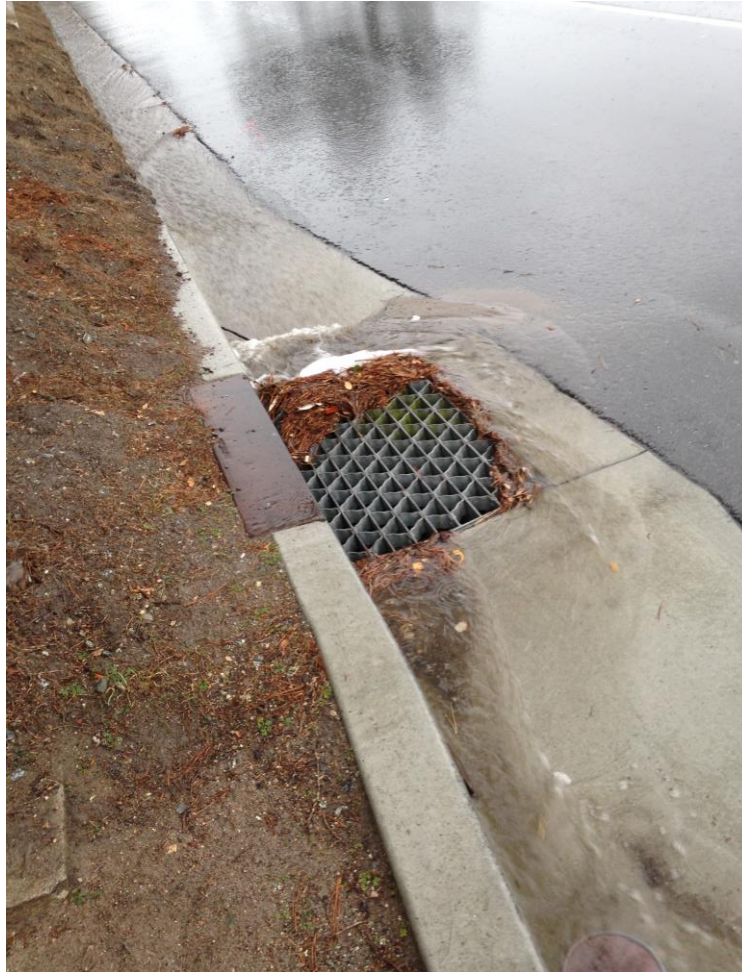
GIS analysis found the watershed for Majors Creek using both natural slope as well as storm drain diverted areas. There was one storm drain, at the southeast corner of Munras and El Dorado that was found to be blocked with debris during multiple storms that led to runoff being diverted into the Majors Creek watershed (Figure 6). This drain and its sub-watershed (approximately 1 acre) were then included in the Majors Creek watershed delineation. From the analysis, we found that Majors Creek watershed has an area of 365 acres. The open-air reach of Majors Creek was determined to be 0.97 miles long, but this could not be ground-verified due to dense vegetation in portions of the Creek. Of the total watershed area, 200 acres were within the City of Monterey boundary, leaving 165 acres in Monterey County land.

Figure 6: Storm drain at SE corner of Munras and El Dorado intersection blocked with debris during Feb 28th rain event. Runoff was rerouted past the drain, down El Dorado Street, and into the storm drain that feeds into the MC01 culvert.

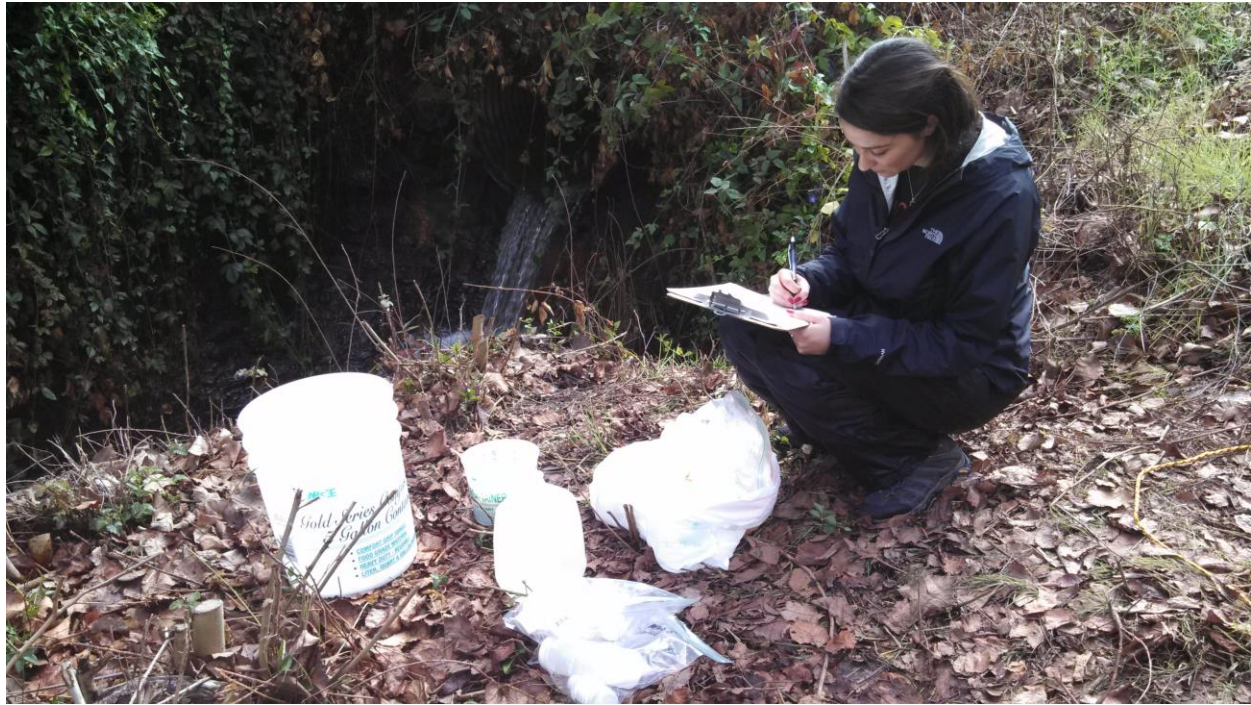
Water samples were taken on nine separate days during the course of this study. Graphs of precipitation and runoff discharge can be seen in Appendix C. Figure 8 shows Andrea Goodmansen collecting sample from sample site MC01.

Figure 8: Samples being collected by Andrea Goodmansen from MC01 on February 26, 2014.

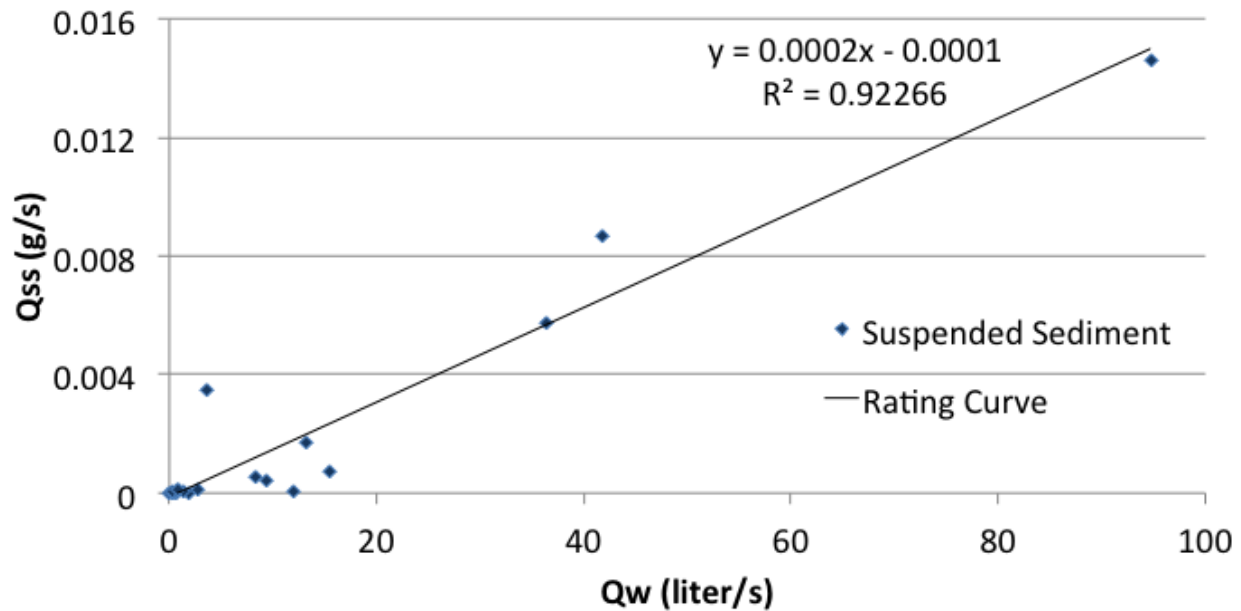
Table 11: Graph of the rating curve that best fit the Majors Creek suspended sediment runoff.

A total of 33 suspended sediment samples were collected during the course of this study. To create a suspended sediment (SS) rating curve used to interpolate SS discharge rate over a wide range of water discharge, observed SS discharge was correlated with Creek discharge for all MC01 samples (n=19). This relationship was best described by the linear equation $Q_{ss} = 0.0002 \cdot Q_w - 0.0001$, where Q_{ss} = suspended sediment discharge (g/s) and Q_w = water discharge (L/s) ($R^2=0.9227$) as can be seen in Table 11.

The total SS discharged over the course of the seven storms during this study was estimated to be 610 grams. Per storm, the discharge of SS was estimated to be: February 6, 2014 = 90g; February 7, 2014 = 5g; February 26, 2014 = 115g; February 28, 2014 = 191g; March 1, 2014 = 137g; March 26, 2014 = 10g; March 29, 2014 62g. Estimated SS load for February 7 and March 1 storms have less confidence as no water discharge samples were collected on those days and thus discharge values were completely estimated.

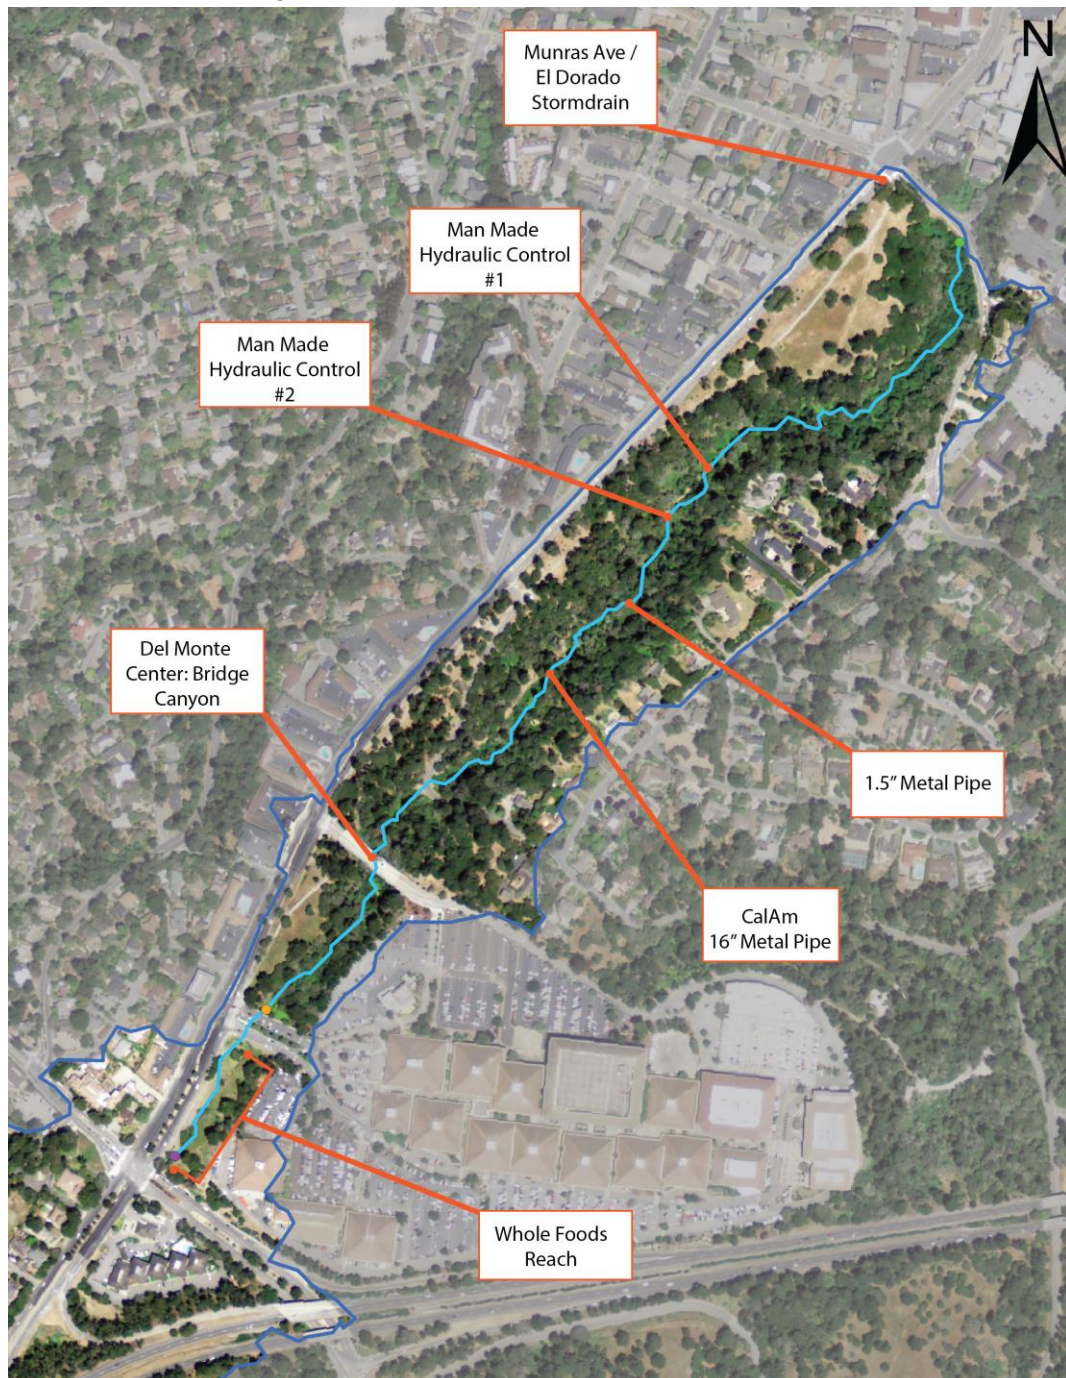
Throughout the course of this study, five stream surveys were conducted in order to evaluate the characteristics of the Majors Creek. Surveys included appraising stream channel features, manmade elements, and areas of fluvial geomorphic interest. Figure 12 displays areas of specific interest found during these surveys.

Figure 12. Location of important features along Majors Creek.

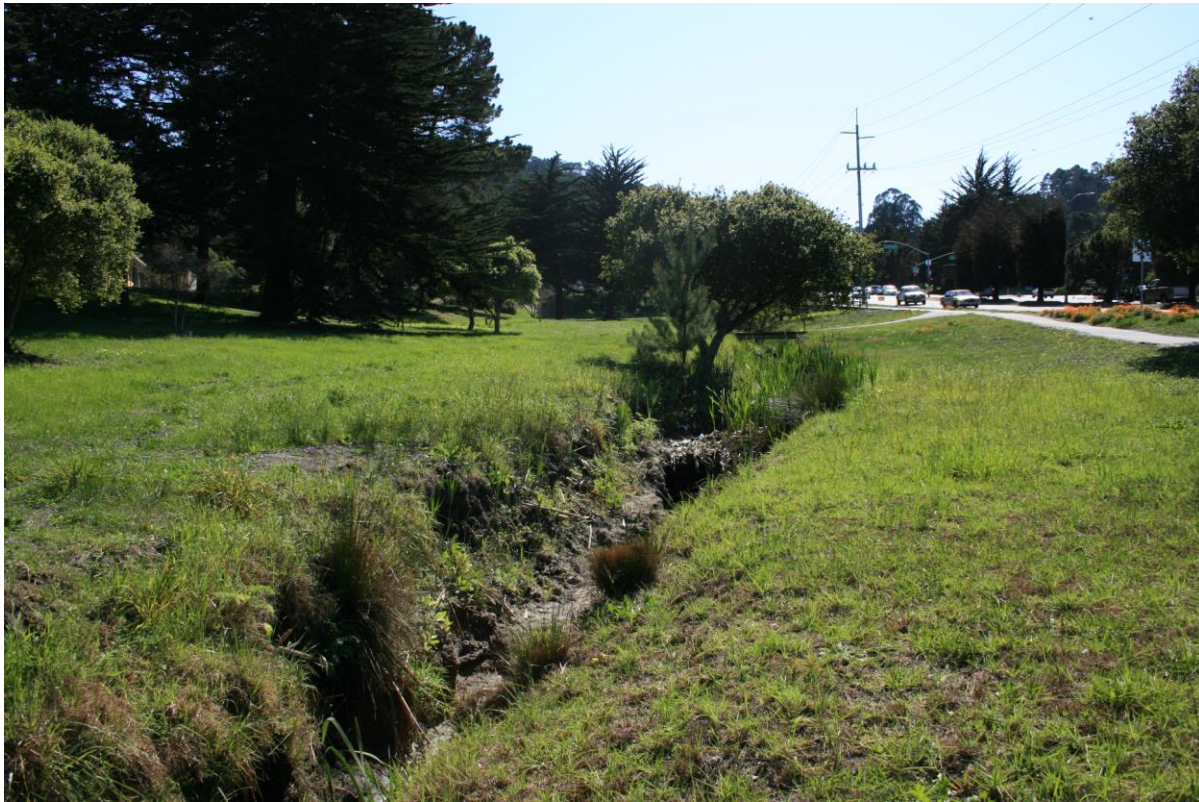
The first survey is of the Whole Foods Reach of Majors Creek, seen in Figure 13. The Whole Foods Reach is a 1.5 acre portion of land NW of the Munras Ave/ Soledad Drive intersection. This is the first open-ai red reach of Majors Creek. Geologically, this section seems to be on Old Marine Terraces, with about 5 feet of artificial fill on top of 2 feet of breccia conglomerate rock with bedrock below. The elevation of this reach ranges from 236- to 218- feet above sea level with a 4% slope. The stream in this reach has an incised channel and some undercutting of channel walls was noted.

Figure 13: Whole Foods Reach of Majors Creek.

This Whole Foods Reach was found to be impacted by a few factors. First, the pollution plume from the Gas Station Leakage would have affected this section of the stream as the gas station sits just uphill from this reach. Sampling wells from the plume monitoring can be found on this reach's flood plain. If the remediation program put in place to remove this plume is followed, no other actions should be required to amend this issue.

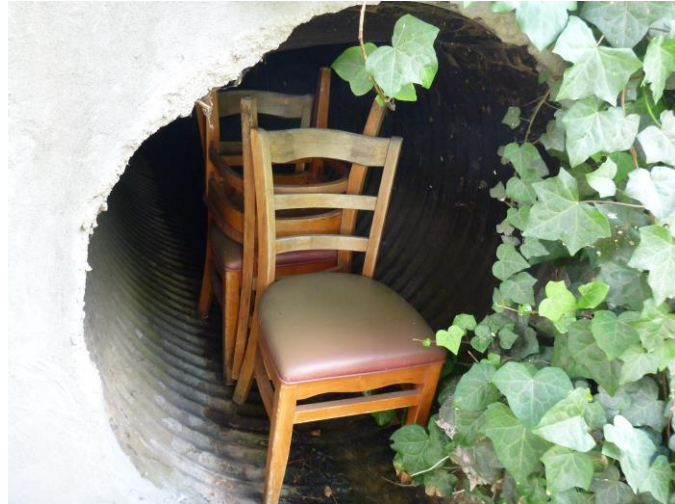
Also, this area was observed to be a popular area for transient people to congregate. The only detectable impacts from this was trash in the Creek channel. Items found in the channel include food containers, clothing, glass bottles, and chairs (Figure 14). While the majority of the trash was found in this section of the Creek, trash was found throughout the entire open-air stretch of Majors Creek.

Figure 14: Chairs found inside MC02 Culvert at the top of the Whole Foods Reach of Majors Creek.

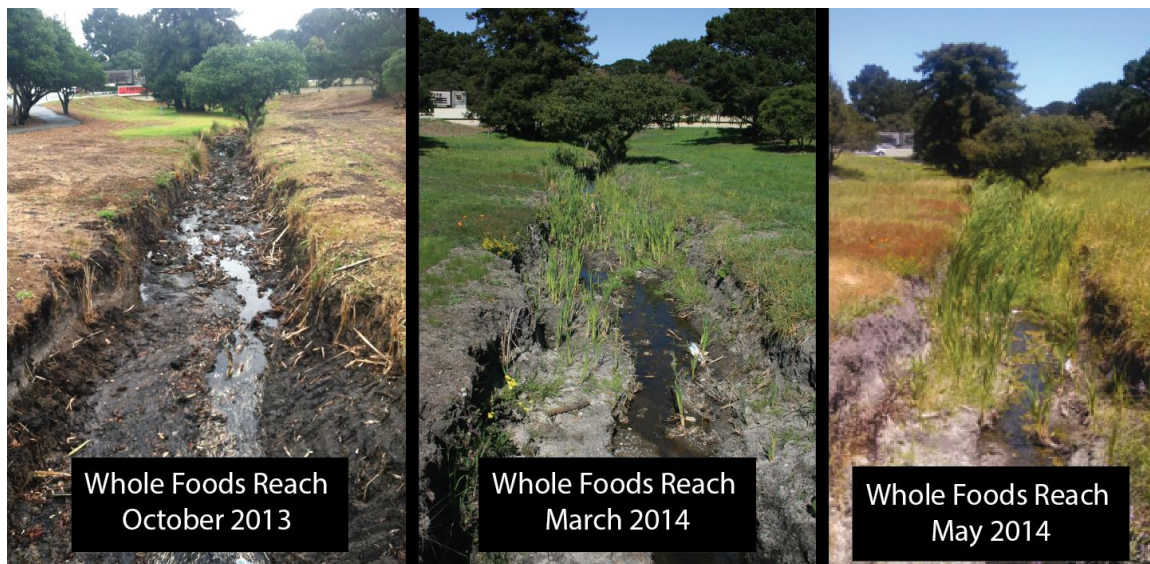
One visit to the Whole Foods Reach of Majors Creek revealed that City maintenance had mowed the vegetation in the Creek as well as on the floodplain in October 2013 (Figure 15, left). Before the mowing, reeds grew in the channel, and their root systems could be seen after. Close to five months later, reeds have been observed to begin regrow within the Creek (Figure 15, right).

Figure 15: Downstream view from footbridge of Majors Creek in the Whole Foods Reach post-mowing (left), 5 months later (middle), and 7 months later (right).

This channel and vegetation disruption has likely had an effect of storm water discharge as well as sediment and pollutant loads. A number of studies have found that in-stream vegetation, such as California bulrush, can help stabilize streambeds, decrease flow velocity, and store

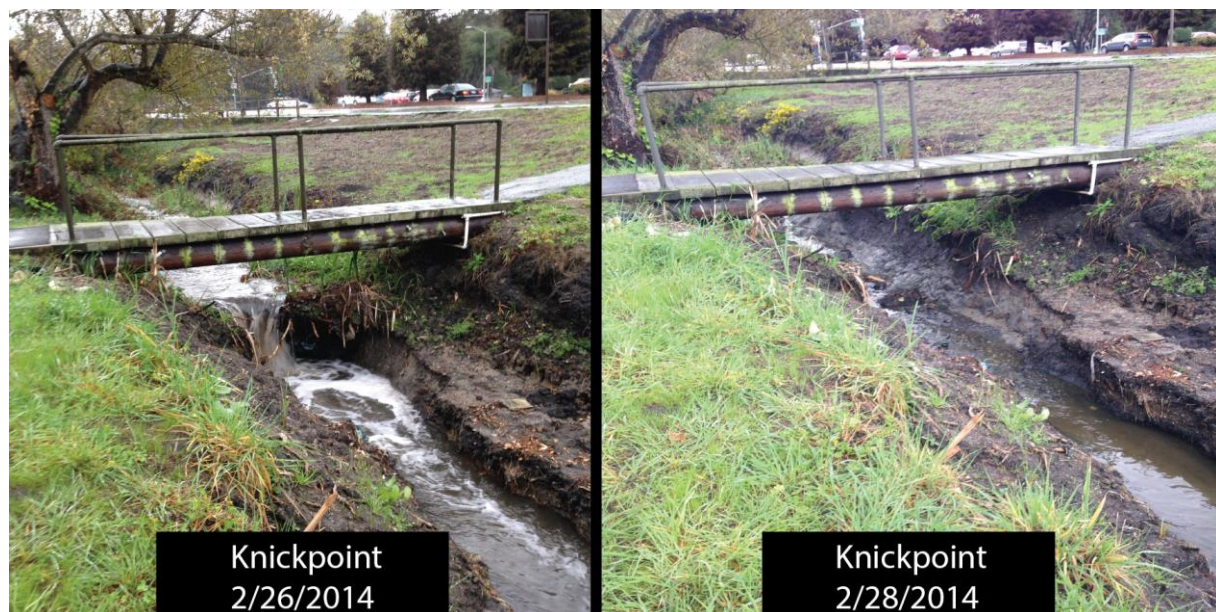
Also within the Whole Food Reach of Majors Creek, surveys revealed two knickpoints. The first knickpoint, located 10 ft downstream of the Oak Tree, did not significantly migrate during the course of this study. Channel surveys of this knickpoint however did show that a large chunk of soil (about 4 ft³) had been dislodged from the knickpoint. The second knickpoint, see in Figures 16 and 17, was located under the footbridge at the start of this study, and then migrated upstream during the February 28th, 2014 rain event.

Figure 16: Upstream knickpoint in the Whole Foods reach of Majors Creek on February 26, 2014 (left) and on February 28, 2014 (right).

The movement of this knickpoint is important to note because it is a sign that this system is out of balance. It is recommended that monitoring of both knickpoints continues both before the start of the 2014 wet season as well as throughout the wet season. Coupling knickpoint monitoring with suspended sediment samples and channel vegetation surveys is also recommended.

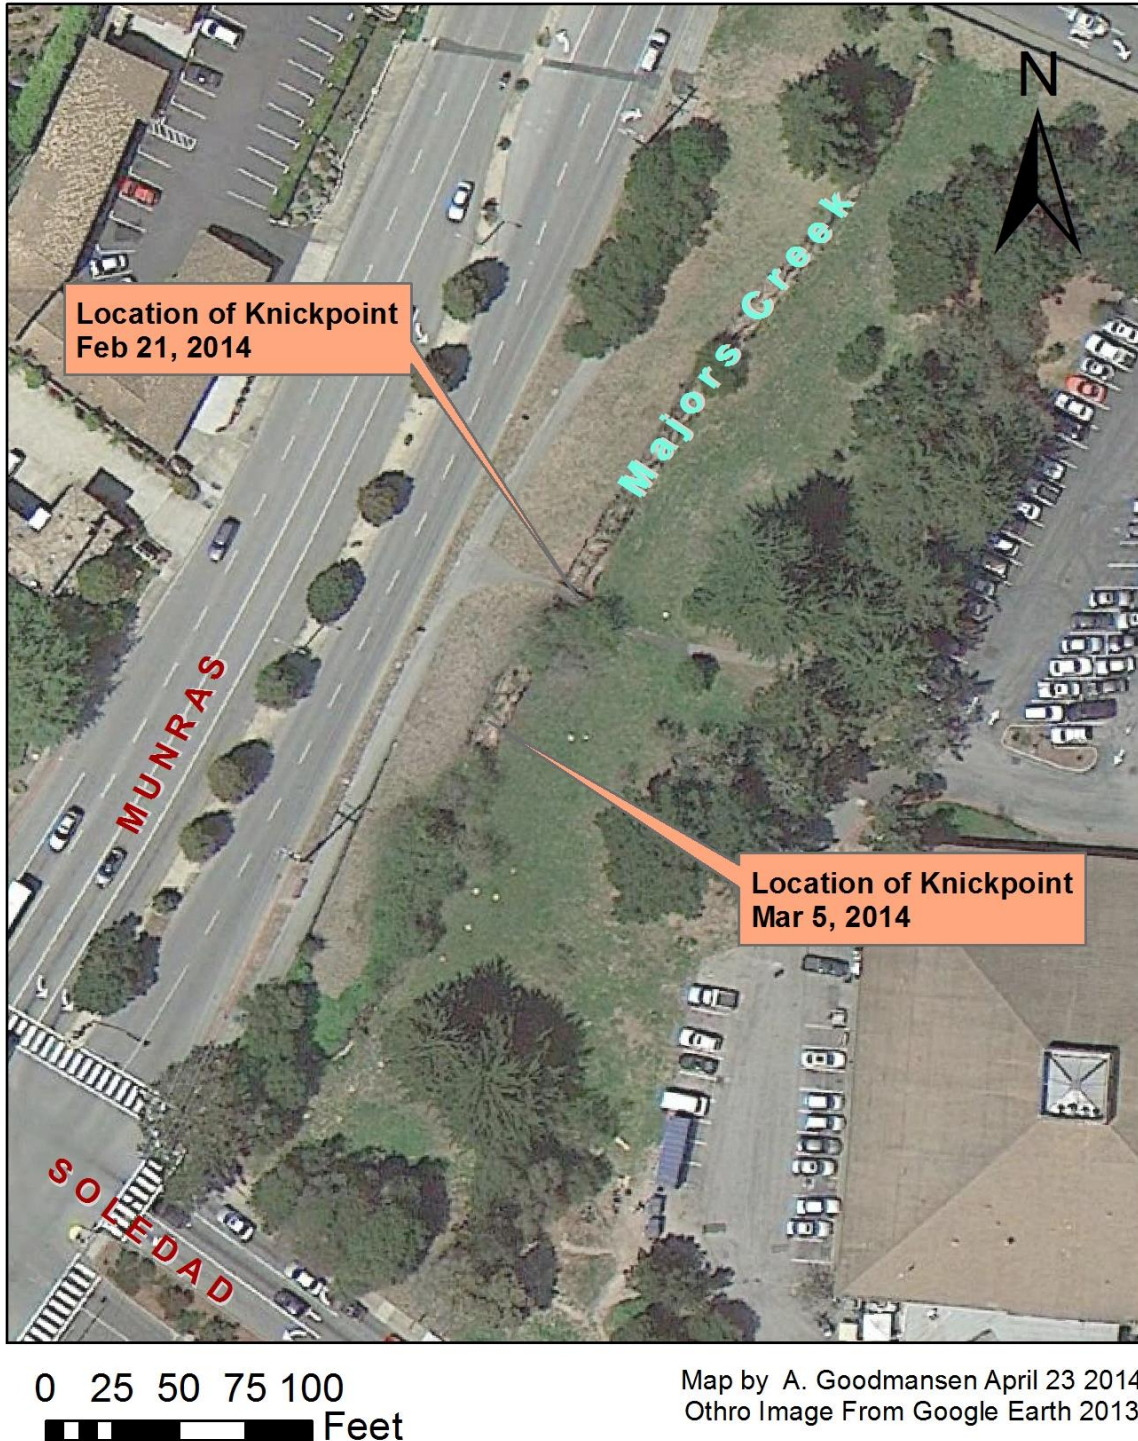
Majors Creek Knickpoint Migration

GIS knickpoint analysis revealed that there was sediment deposition (max 0.87 ft) within the channel in areas where plunge pools were noted in thalweg surveys, as well as erosion (max 3.60 ft) in areas where knickpoint migration was noted. Figure 18 shows change in the elevation of the channel bed between February 21, 2014 and March 5, 2014. The volume of sediment removed by the upstream knickpoint was calculated to be 247 ft³ using a mask that was 3.28 ft wide.

Figure 17: Knickpoint location within the Whole Foods Reach of Majors Creek.

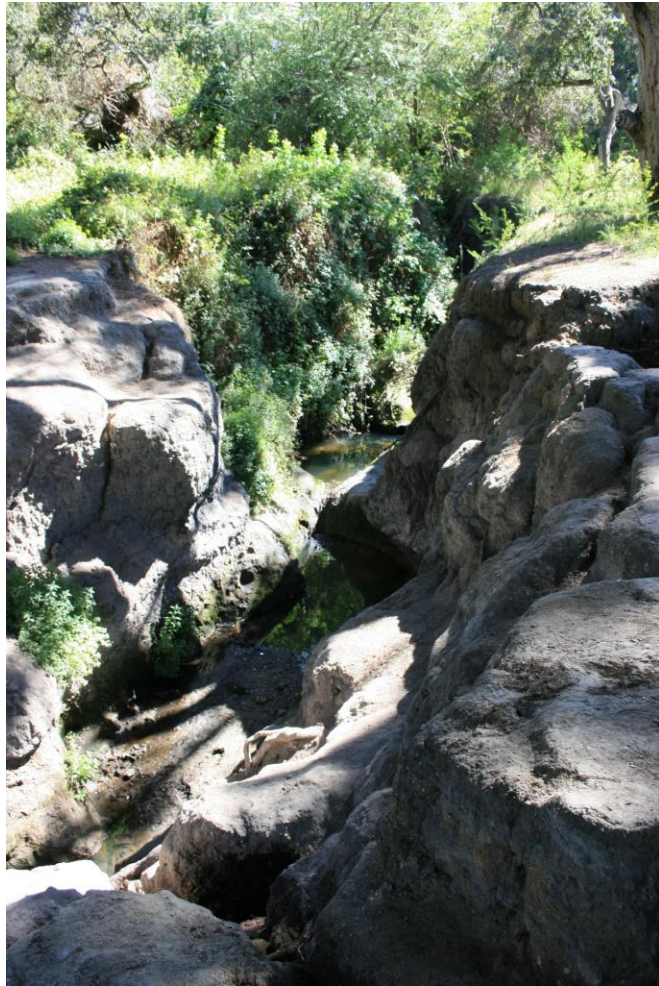
Figure 19: 'Canyon' and step-pools found on Major Creek under the Del Monte Center Bridge.

While there does not seem to be any immediate threat from either the Canyon or the overland erosion, we suggest that maintenance is performed on the Bridge drains to ensure that discharge does not continue to erode the overland terrace.

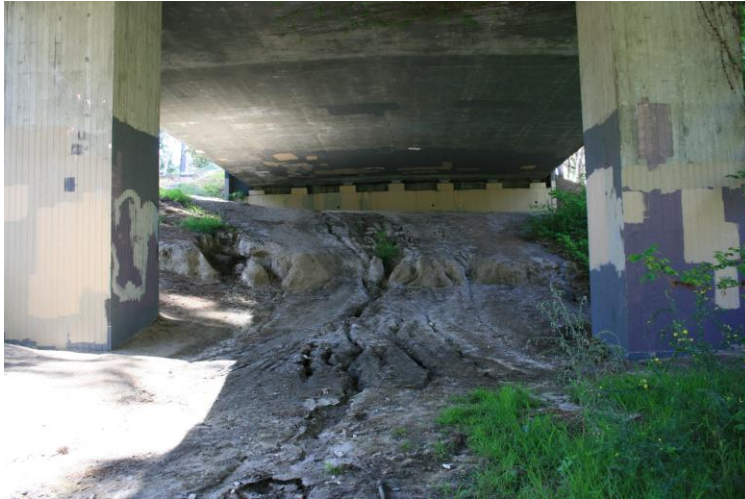
Figure 20: Overland erosion under the Del Monte Center Bridge.

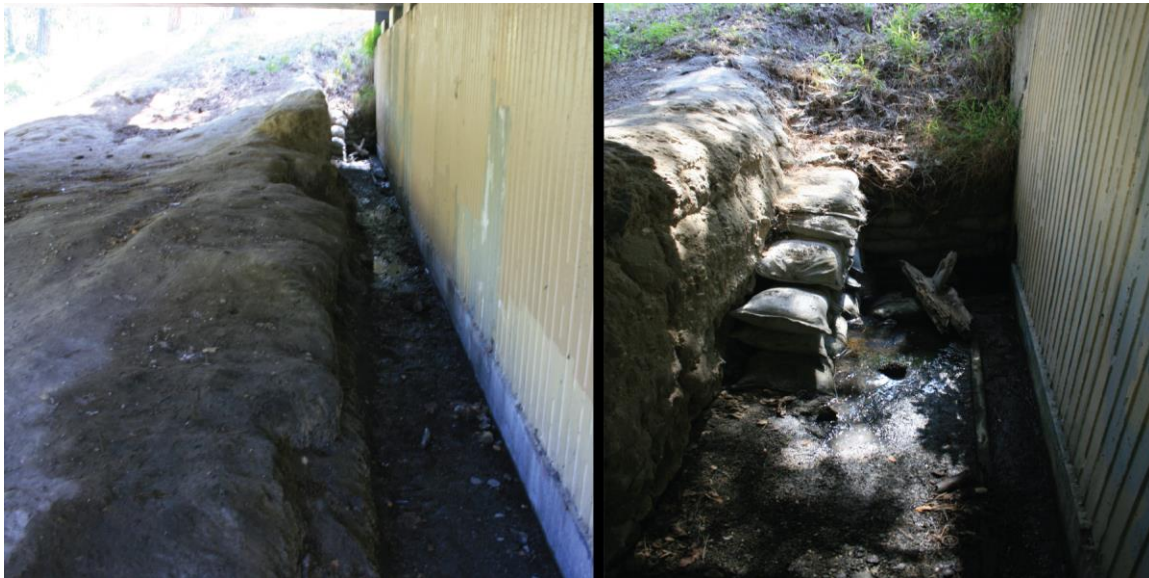
Figure 21: Drain diversion from Del Monte Center Bridge. To the left is the channelized path diverting water to the north, and the image on the right shows the sandbags used at south drain.

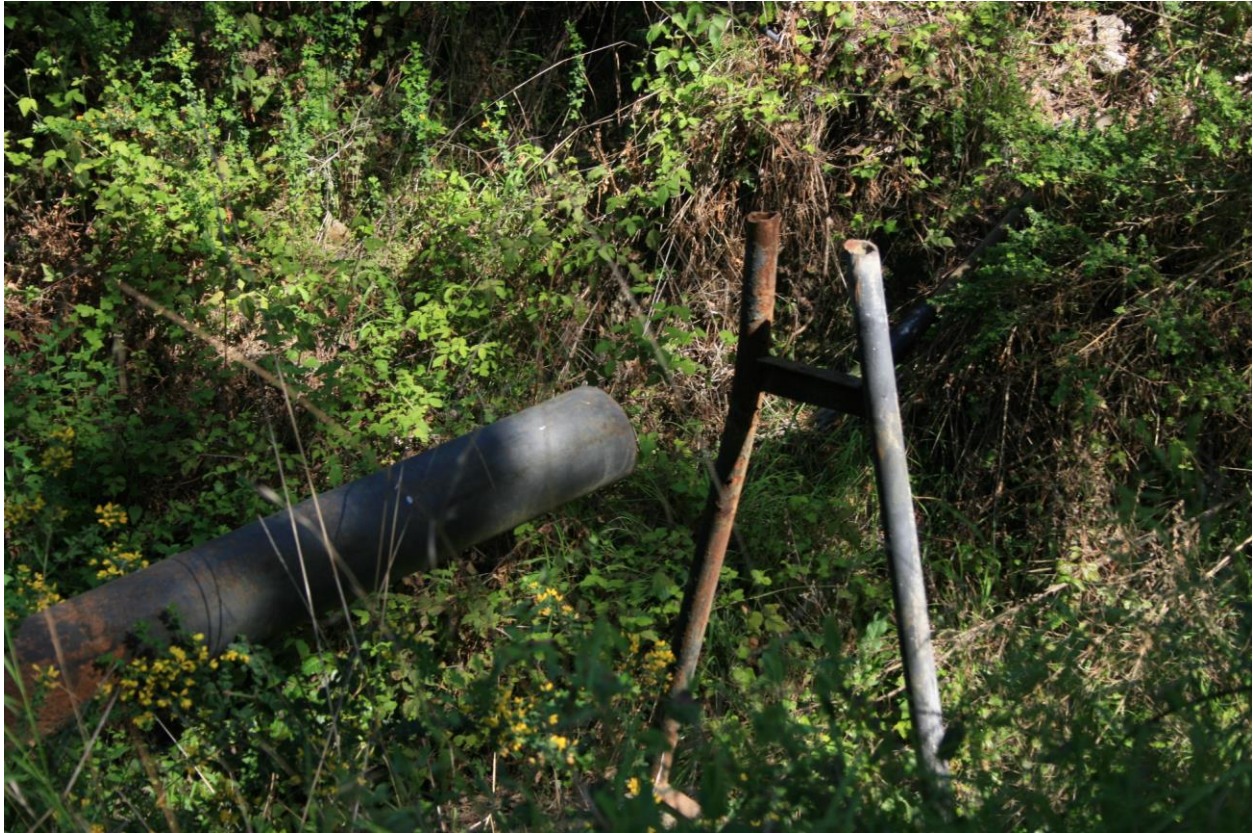
Figure 22: CalAm pipe and support structure in Majors Creek.

from the Creek. Removal of the pipe and support structure would increase the aesthetics of this reach of Majors Creek. Additionally, there is the possibility of the support structure causing debris build up in the Creek, which would change the creek's hydraulics.

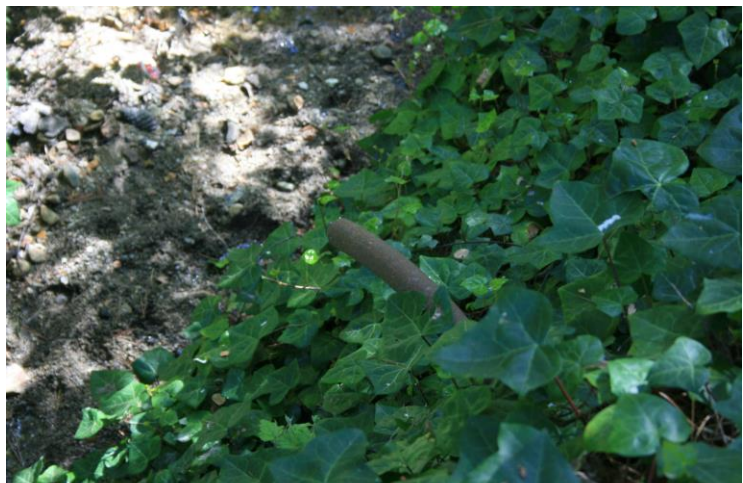
A metal pipe measuring 1.5 inch in diameter was found coming from the west bank into Majors Creek (Figure 23). This small pipe does not have a definite reasoning, but we guess that it may have been used to uptake surface water for ranch use in the past. This pipe was monitored during storm events and no discharge was observed from this pipe. There is no perceive threats from this pipe, but should continue to be investigated.

Figure 23: 1.5" metal pipe coming into Majors Creek.

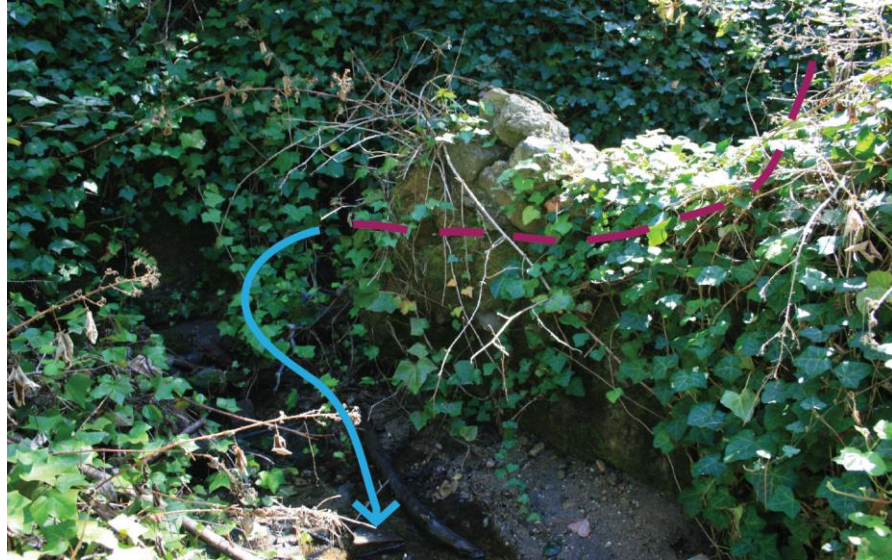
Two man made hydraulic controls were discovered on Majors Creek within the Don Dahvee Park Reach (Figure 24). The City of Monterey had no information on these structures prior to this study. Both structures seem to be from the same era and made of concrete and rock materials. The upstream structure, 'Man Made Control #2', has failed and is no longer a controlling upstream channel elevation. The remaining portion of the structure was measured to be 5x16 feet. The Creek is now forced to flow around the structure on the left bank (when facing downstream, toward the east). The east bank of composed of old terrace deposited with vegetation. While there seems to be no immediate threat, the east bank does show signs of erosion, and due to the steep slope of the bank any erosion would be increasingly incremental. Removing this failed man made control may improve conditions of the creek at this location.

Figure 24: Man made control #2 (failed control) on Majors Creek. Red and blue lines indicate path of creek.

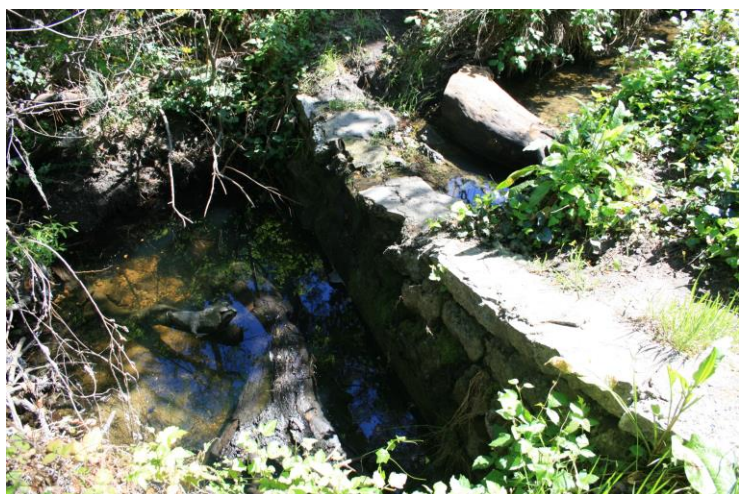
A second man made control located on Majors Creek was found to be intact and acting as a hydraulic control (Figure 25). This structure measures to be 4x13 feet and made up of concrete and rock materials. As this structure seems to be in good condition, we recommend that it remains in the Creek.

Figure 25: Man made control #1 on Majors Creek.

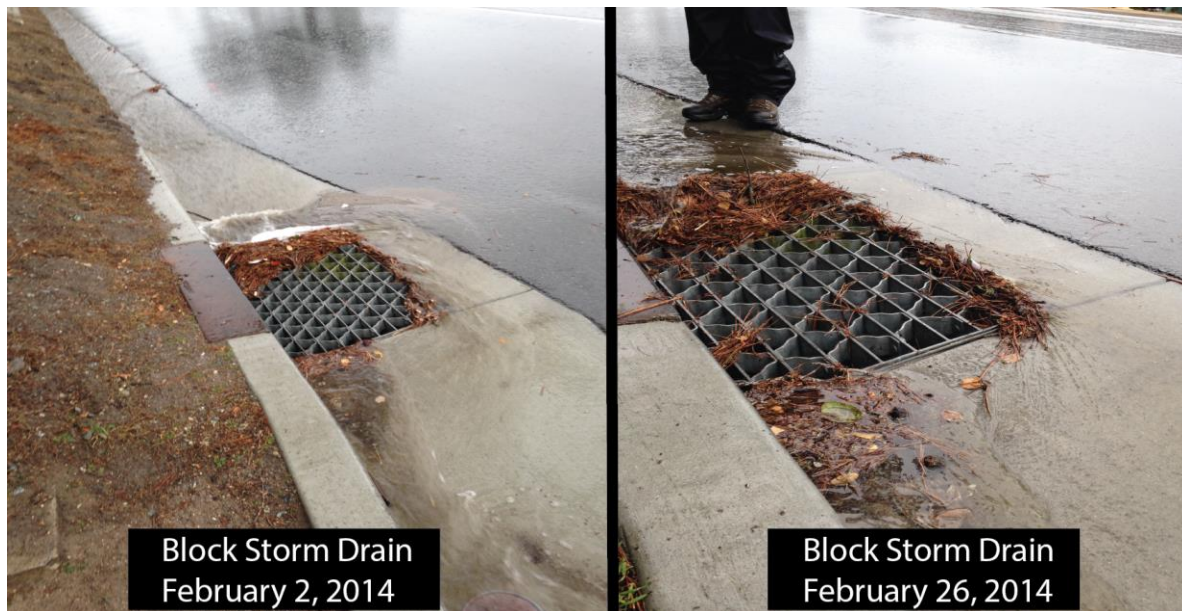
The last important finding from the stream surveys was the discovery of the functionality of the storm drain at the SW corner of the Munras Ave/ El Dorado St intersection (Figure 26). As previously mentioned, this storm drain inlet connects to a drain that delivers runoff one-quarter mile to the west near Pacific St. Instead of directing runoff to this other location (within a different watershed), the drain was noted to be blocked with debris in such a way that it rerouted water around the storm drain, down El Dorado St, into the storm drain at the intersection of El Dorado St and Major Sherman Lane, which feed directly into the MC01 culvert. This debris blockage and runoff rerouting was noted on several occasions.

Figure 26: Storm drain at the SE corner of Munras Ave and El Dorado St. Drain was observed to become blocked with debris on several occasions and the blockage rerouted water around the drain and into the Majors Creek watershed.

As discussed previously in the *Storm Water Sampling* section, this is an important factor that needs to be evaluated. When this drain is blocked, Majors Creek receives additional runoff from this sub-watershed, thus pollutants are incorporated into Majors Creek water samples, and not the water samples of the creek/stream that this storm drain is intended to flow to. Water quality samples taken on February 2, 2014 were determined to be from that drainage as well as El Dorado St east of Major Sherman Lane and contained concentrations of zinc and copper that were above pollutant limits. In contrast to this, February 6th storm event did not include any runoff from this storm drain as debris was removed by City Maintenance and runoff was observed to be entering the storm drain.

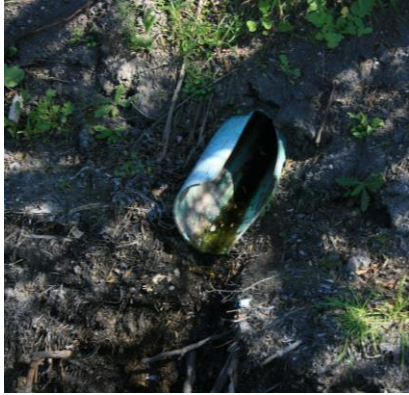
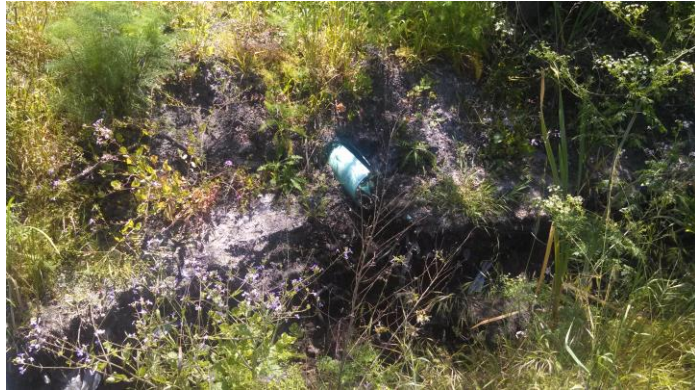
12-inch PVC pipe, near Whole Foods, located on the East Bank of upper Majors Creek

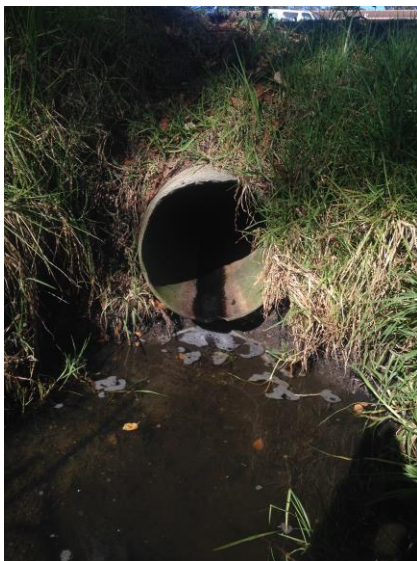
18-inch cement pipe, near Whole Foods, located on West Bank of upper Majors Creek

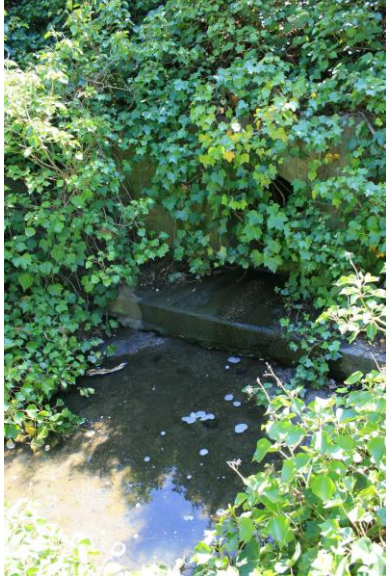
36-inch culvert under Del Monte Center entrance, located in-stream to convey flow under road.

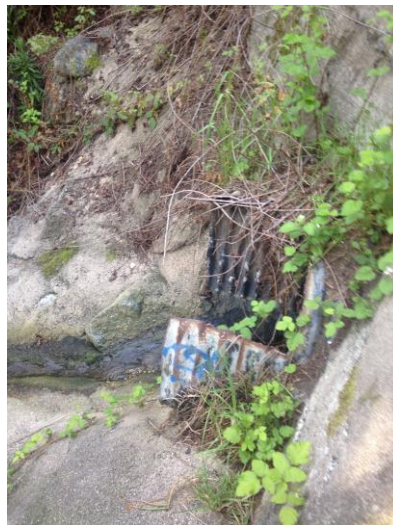
36-inch CMP culvert under Don Dahvee Lane, located in-stream to convey flow under road.
