Report No. WI-2006-01
31st January 2006
(minor revision 8th March 2006)

The Watershed Institute

Garrapata Creek Lagoon, Central Coast, California: A Preliminary Assessment

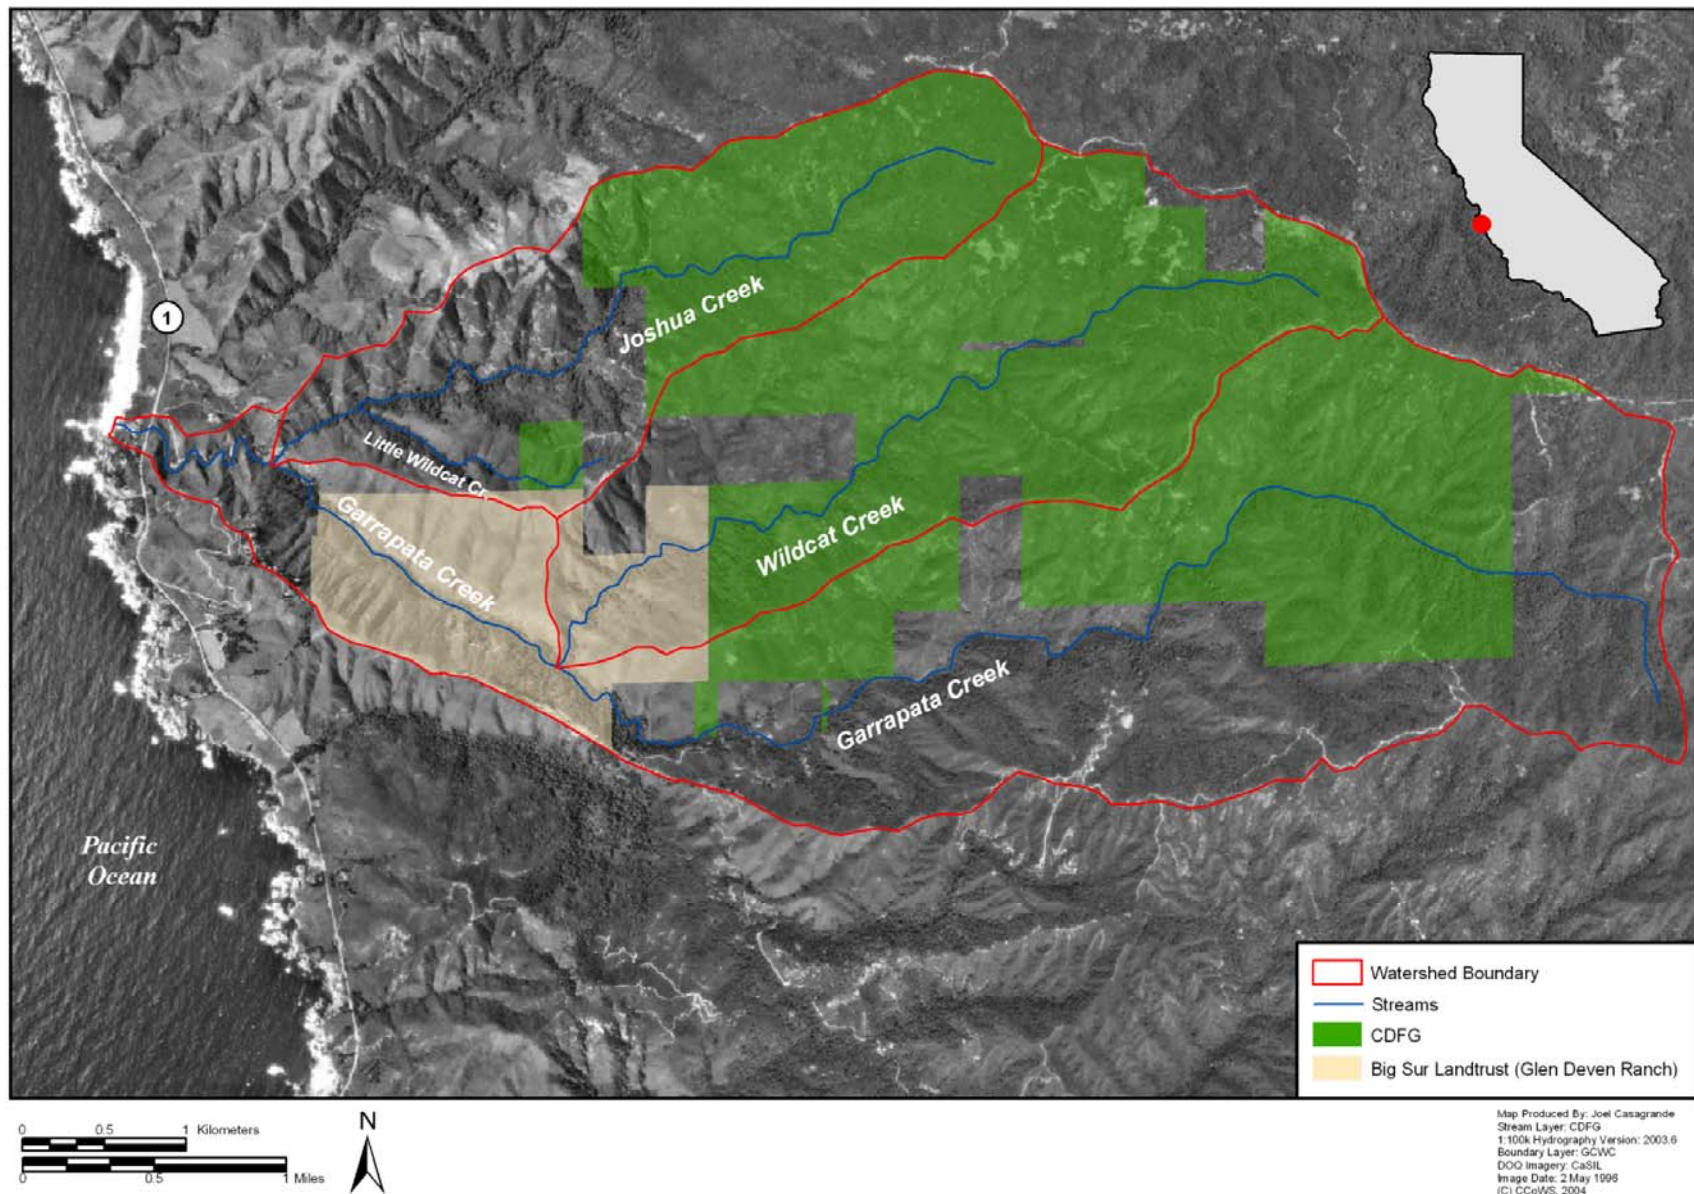
Figure 2.1. The Garrapata Creek Watershed. Public lands are shaded. (from Casagrande & Smith, 2005)

The Garrapata Creek Watershed is located in Monterey County, approximately 16 km (10 mi) south of Carmel, California (Fig. 2.1). The Watershed drains approximately 27.7 km² (10.7 mi²) of primarily chaparral/scrub lands, canyon forests, and light residential development (PWA, 2003). The riparian vegetative community is dominated by redwood and tanoak in the mid to upper reaches of the watershed, with an alder/willow dominant community in the downstream reaches that extends to just below Highway 1. Below Highway 1 the channel is dominated by emergent aquatic vegetation.

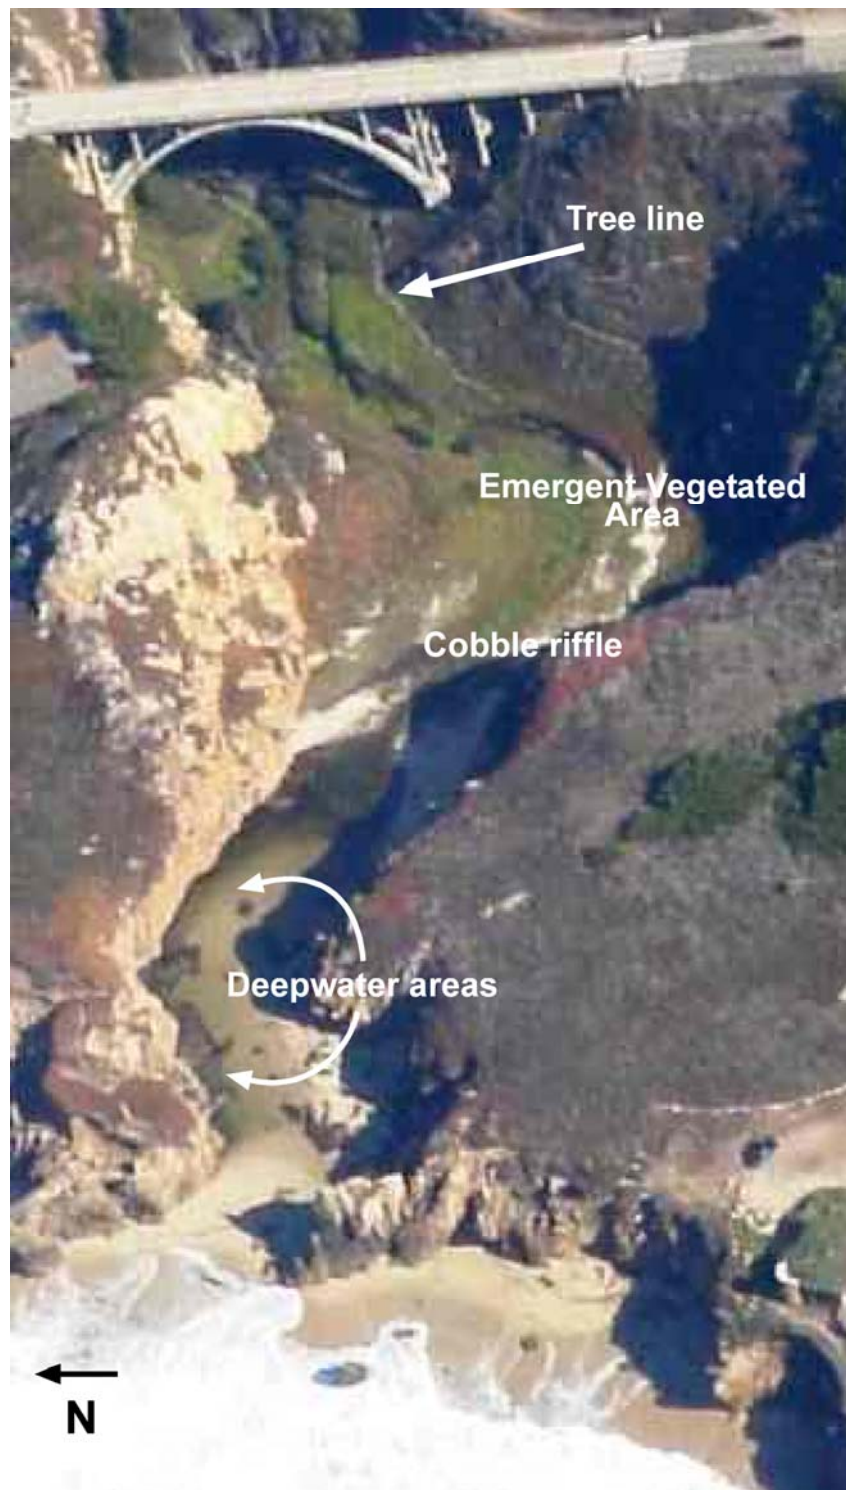
Figure 2.2 Garrapata Creek Lagoon. Photo: Doug Smith, 31 Oct 04.

The lagoon remains relatively shallow throughout the year. Depths in the lagoon are driven by the sandbar height. Typically, the deepest portions of the lagoon are found along the bedrock bluffs to the north (Figs 2.2 & 2.6). A maximum depth during the 2005 season was measured 1.6 m at the base of the northern bedrock. Overhead cover for steelhead is limited in part by the shallow nature of the lagoon, but also due to the lack of emergent vegetation (i.e. pondweed).

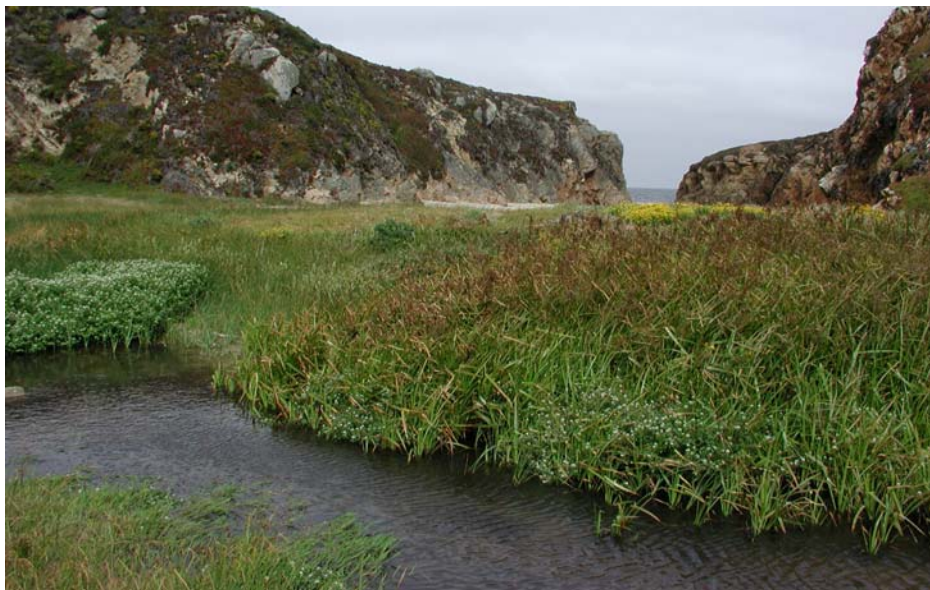
Figure 2.3 Upstream emergent vegetated reaches of Garrapata Creek near Highway 1. The main embayment of the lagoon is further downstream against the bluffs in the upper right corner of the photo. Photo: Joel Casagrande, 1 July 2004.

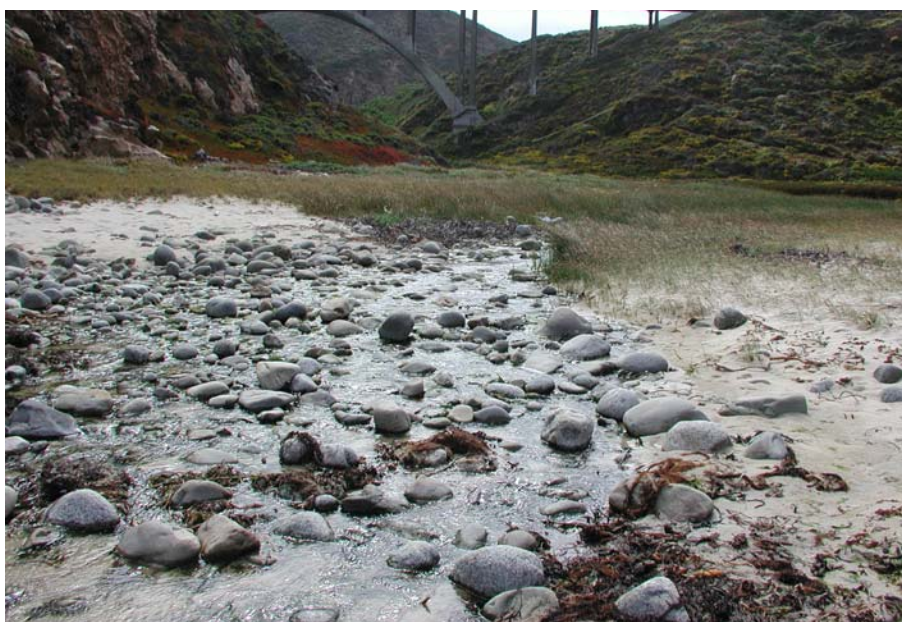
Figure 2.4 The cobble riffle separating the lower portion of Garrapata Creek from the lagoon embayment (looking upstream). Note the kelp accumulations in the foreground indicating the upstream extent of previous wave action. Photo: Joel Casagrande, 1 July 2004.

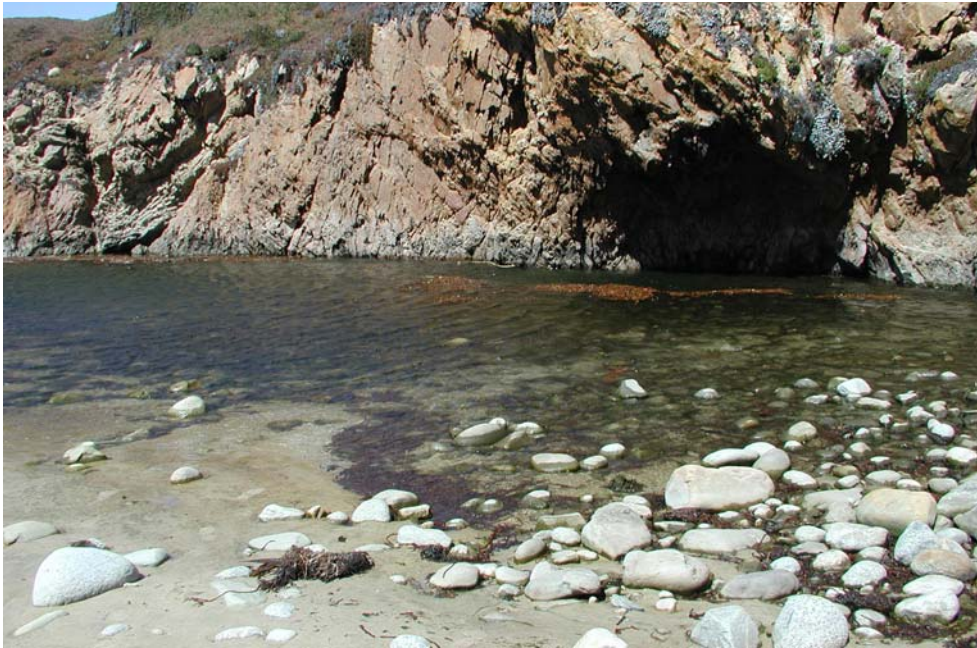
Figure 2.5 The eastern half of the main embayment with the downstream end of the cobble riffle shown in the lower right foreground. Photo: Joel Casagrande, 17 September 2005.

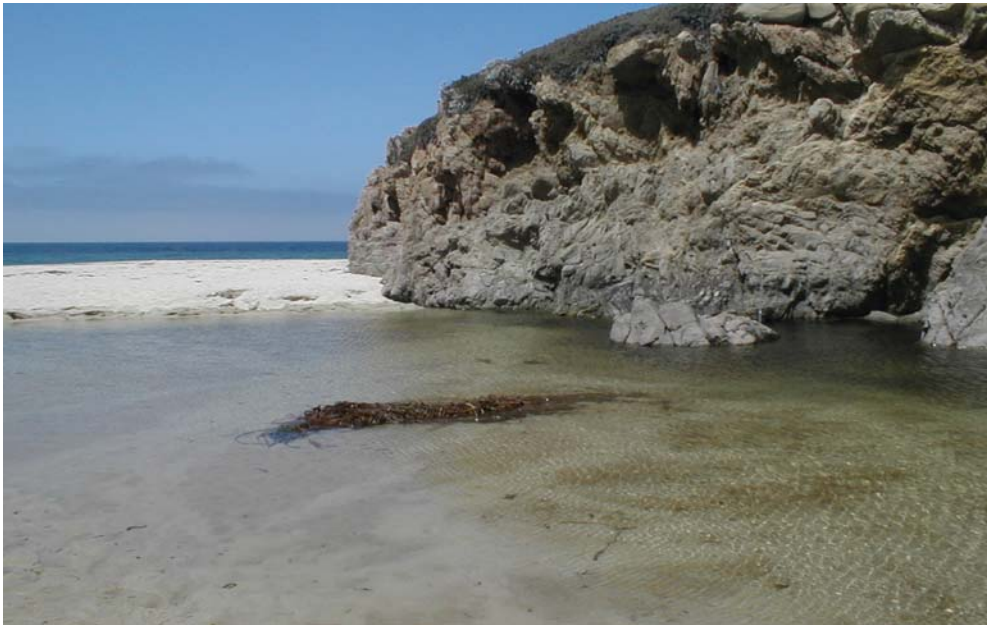
Figure 2.6 The western portion of the main embayment. Deeper water were located at the base of the bedrock bluffs in the upper right corner of the photo. Photo: Joel Casagrande, 04 August 2005.

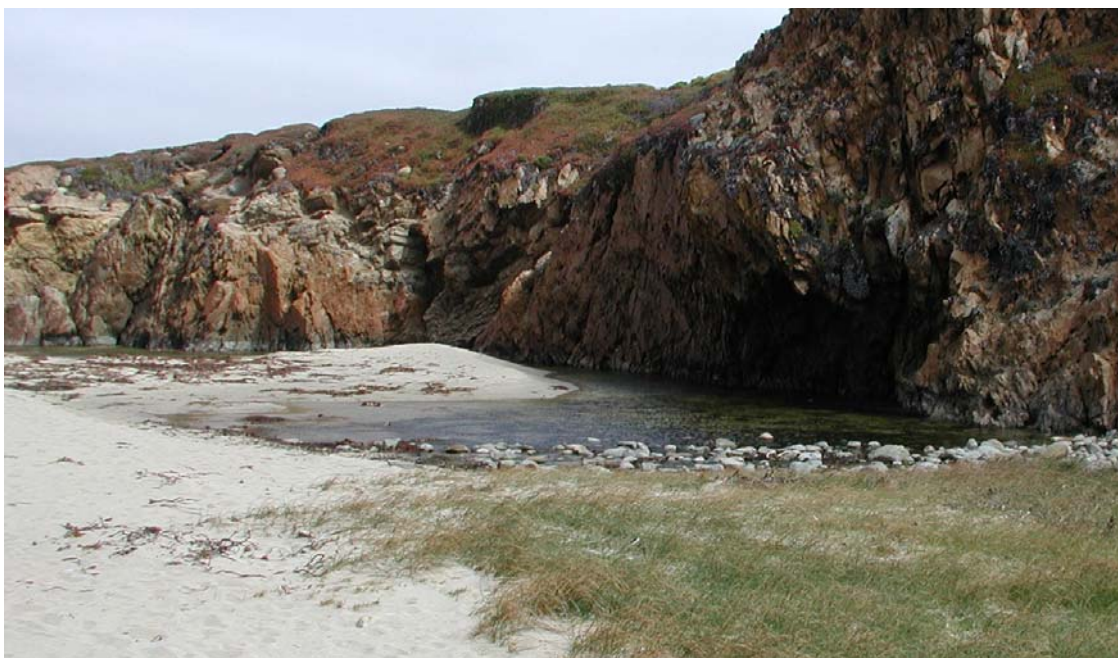
Figure 2.7 The lagoon main embayment in early July 2004. Sand accumulations at mid lagoon nearly separated the lagoon into two halves. This same shape re-occurred in late fall 2005 (See Appendix). Photo: Joel Casagrande, 01 July 2004.

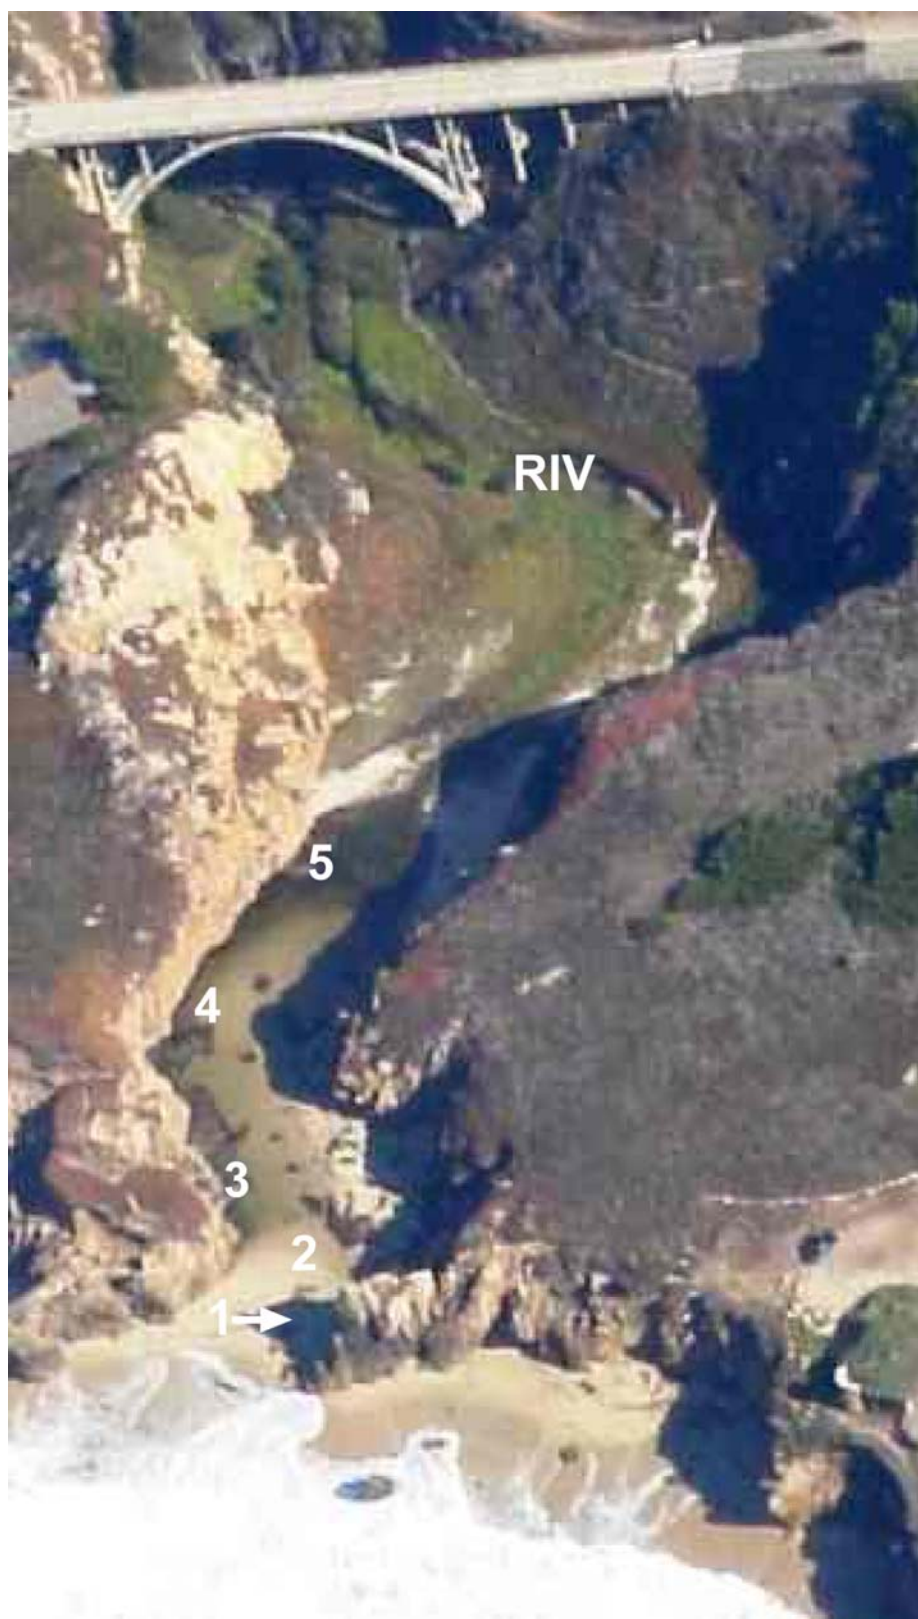
Figure 3.1 Sampling locations in Garrapata Lagoon.

Water quality conditions and macroinvertebrates were assessed at six sites (Figure 3.1) on several different days, although macroinvertebrates were not sampled at every site or on every sampling run. The sites were selected to represent all possible conditions with respect to depth, substrate conditions, and more importantly proximity to the ocean and creek inflow. Four sites were monitored in the main body of the lagoon (Sites 2–5), one in the outflow channel close to the ocean and one upstream in the inflowing creek.

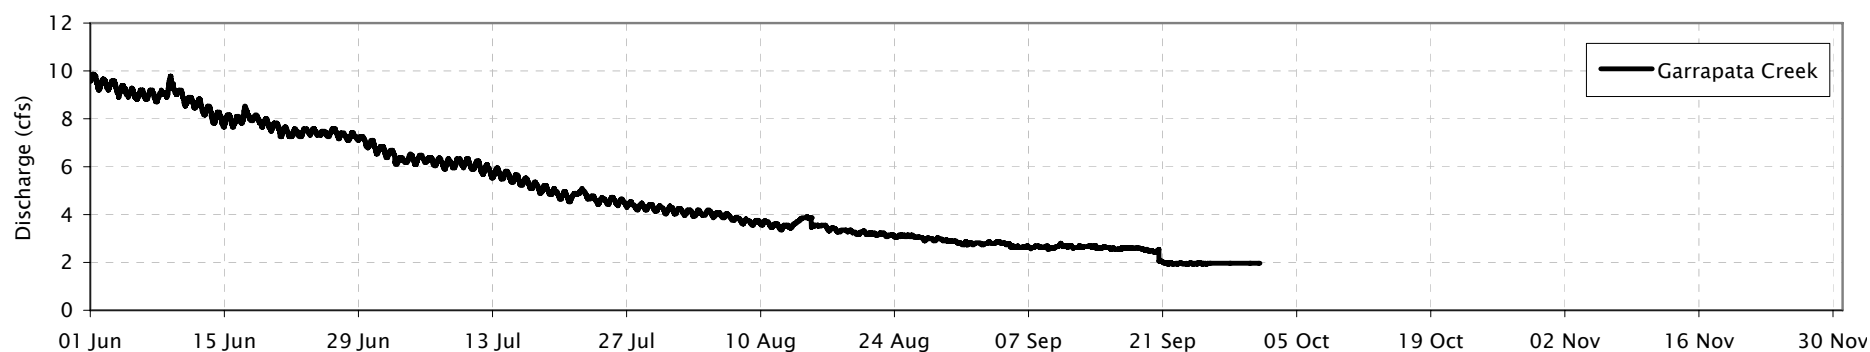
Figure 4.1 Garrapata creek hydrograph. Note gage error: record ends Sep. 30th.

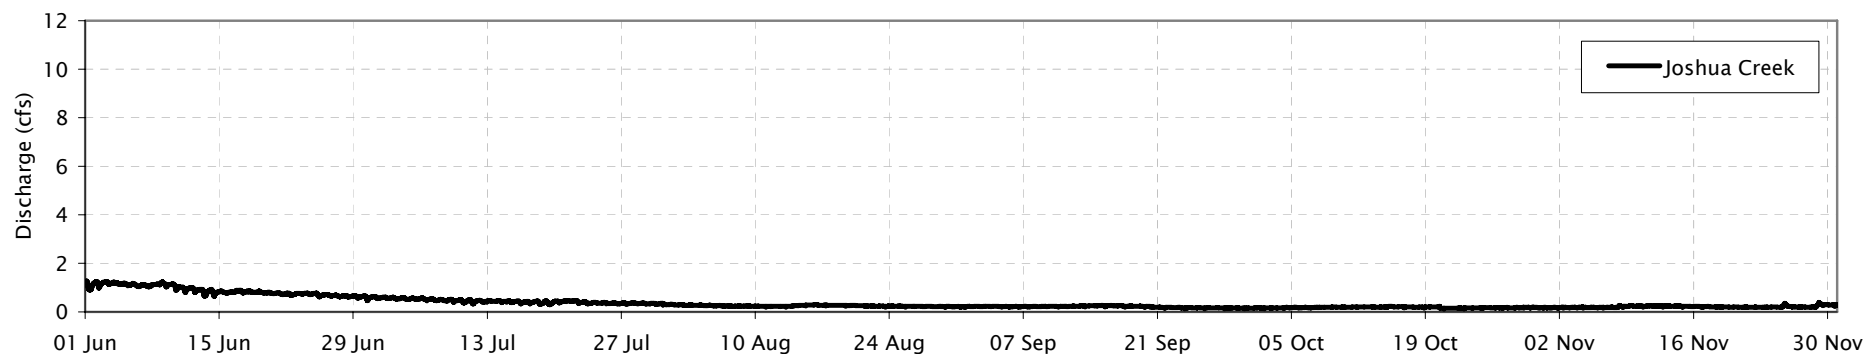
Figure 4.2 Joshua Creek hydrograph (June 1st to November 30th, 2005).

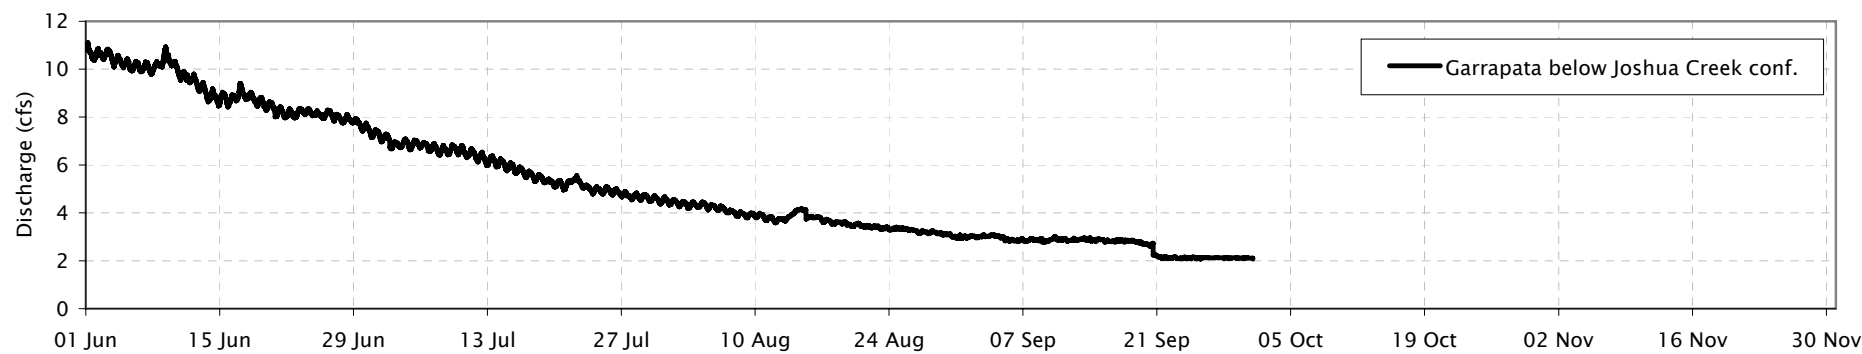
Figure 4.3 Hydrograph for Garrapata Creek below the Joshua Creek confluence. Note gage error: record ends Sep. 30th.

Streamflow had declined substantially since June 23rd (Fig. 4.3 & Table 5.1). Water quality conditions were well mixed with cool temperatures (15°C) and oxygenated waters to depth, fresh waters at the surface, and more saline waters on the bottom (Figs 6.3 & 6.4). Kelp was abundant on the bottom of the lagoon at sites 3 and 4, however anoxic conditions were not present. Streamflow entering the lagoon was enough to maintain adequate dissolved oxygen levels. Maximum depth in the lagoon was slightly greater than 1 meter along the bedrock bluffs in the northwest corner. Ocean wave heights around this time were not significant, thus allowing a modest freshwater lens to develop in the lagoon. Water quality conditions were suitable for steelhead at this time, although none were observed.

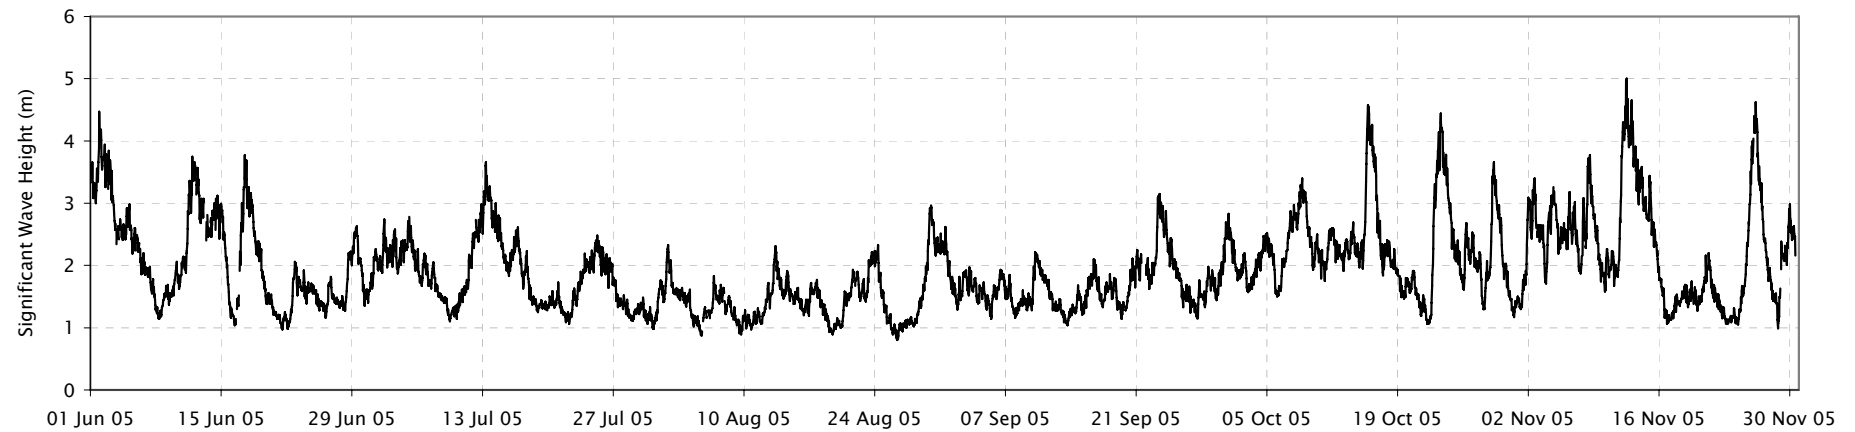
Figure 4.4 Significant wave height Monterey Bay. Data Source: National Data Buoy Center, NOAA/NWS Moor Buoy 46042

During the present study, significant wave events occurred in early June and more consistently from mid October through the end of the year (Fig. 4.4) Previous studies have shown that such wave events often result in significant wave overwash, which often leads to adverse water quality conditions in the lagoon (Smith, 1990; Casagrande & Watson, 2002, 2003; Watson & Casagrande, 2004). In addition to saltwater, waves often deliver copious amounts of kelp, which decay on the lagoon bottom often producing anoxic conditions.

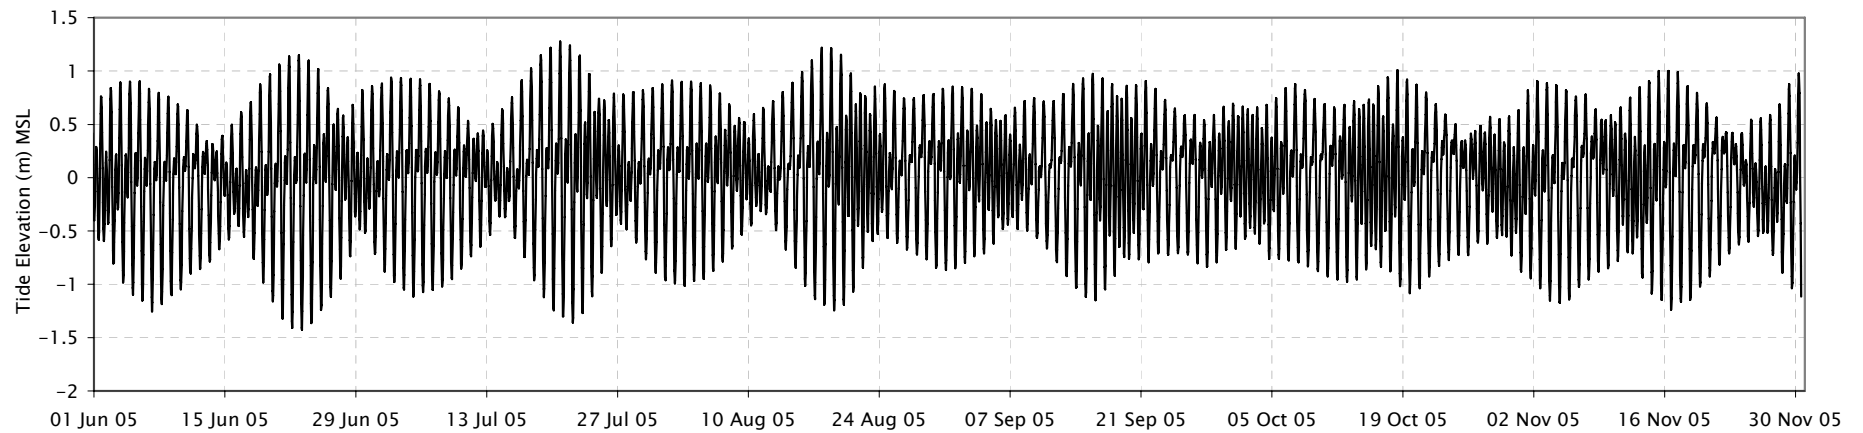
Figure 4.5 Tide elevations Monterey Harbor. Data Source: NOAA/NOS, Station 9413450.

On August 27, afternoon water quality conditions were measured throughout the lagoon. Streamflow was still entering the lagoon and a small opening in the sandbar remained in the southwest corner (Fig. 6.6). Morning weather conditions were overcast, windy and cool, and by afternoon, skies were partly cloudy, but remained windy and cool (Table 5.1). There were noticeable changes in the sandbar condition and the outflow channel between the lagoon and the ocean when compared to the previous visits to the lagoon (Fig. 6.7). Although wave heights appear to have been minimal prior to the 27th (Fig. 4.4), high tides were near peak levels between August 16th and 20th (Fig. 4.5), which may explain the significant changes in the sandbar.

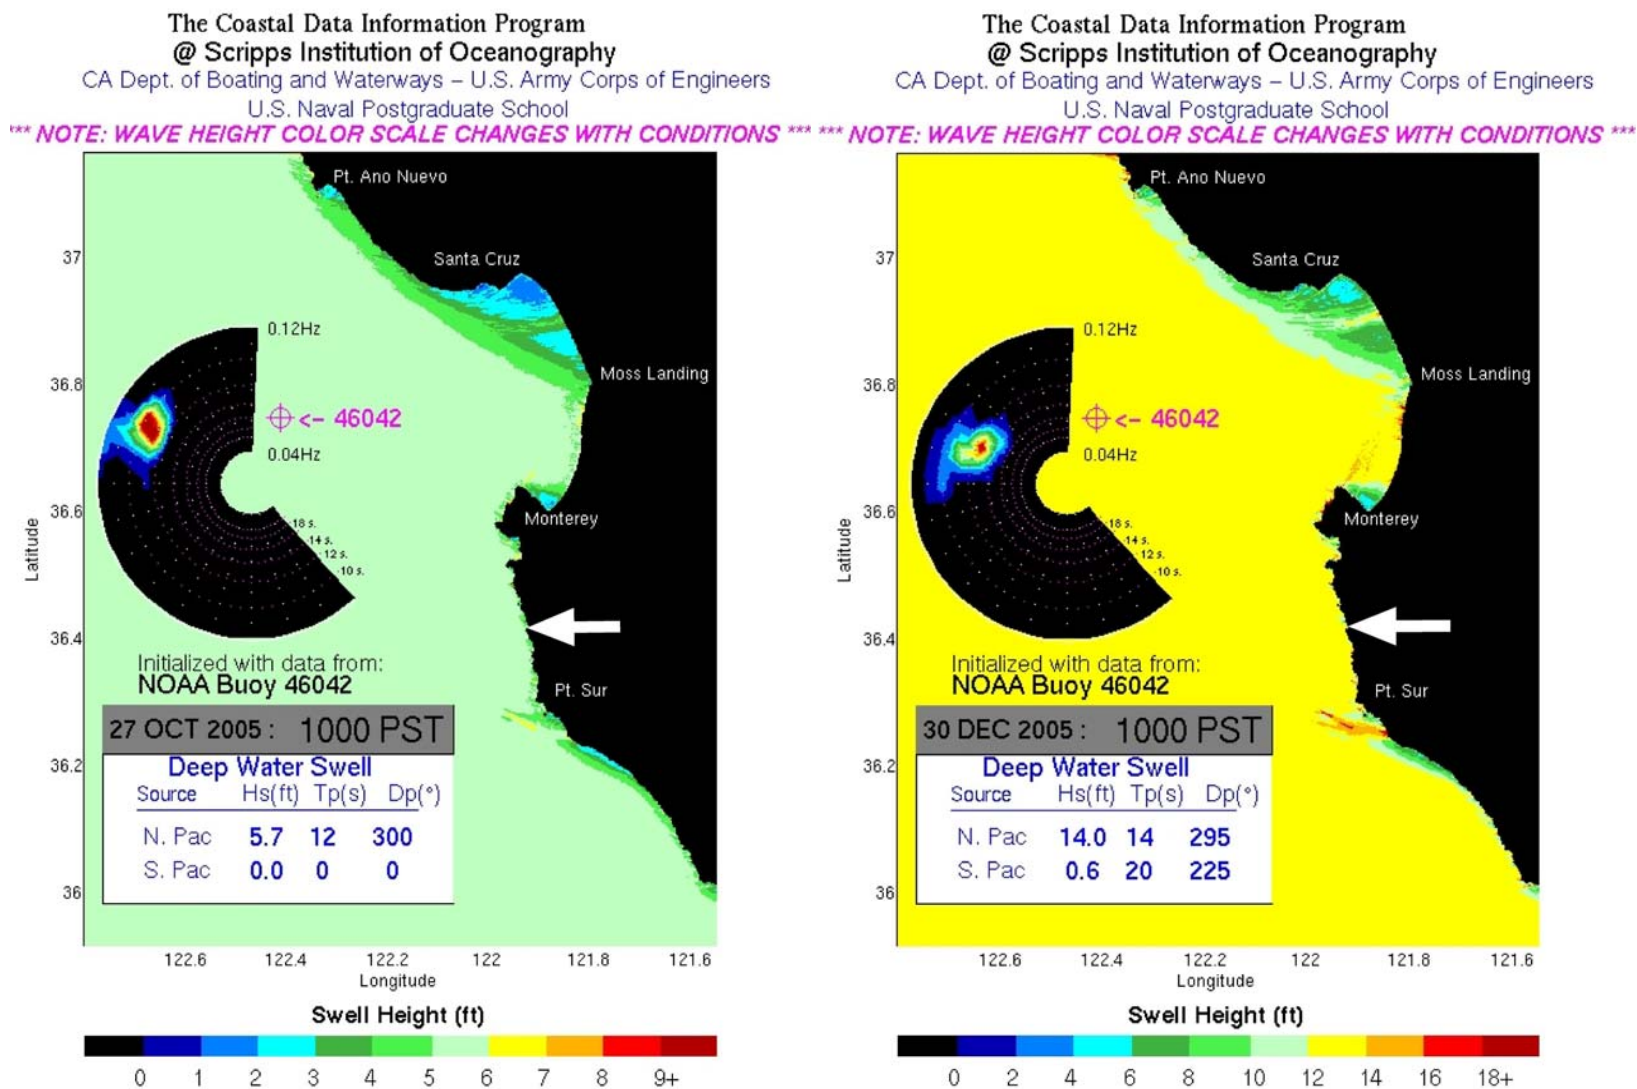
Figure 4.6 Deep water swell height for October 27th (smaller waves) and December 30th (larger waves) generated from NOAA Buoy 46042. White arrows show the approximate location of Garrapata Lagoon. Image Source: <http://cdip.ucsd.edu/models/monterey>.

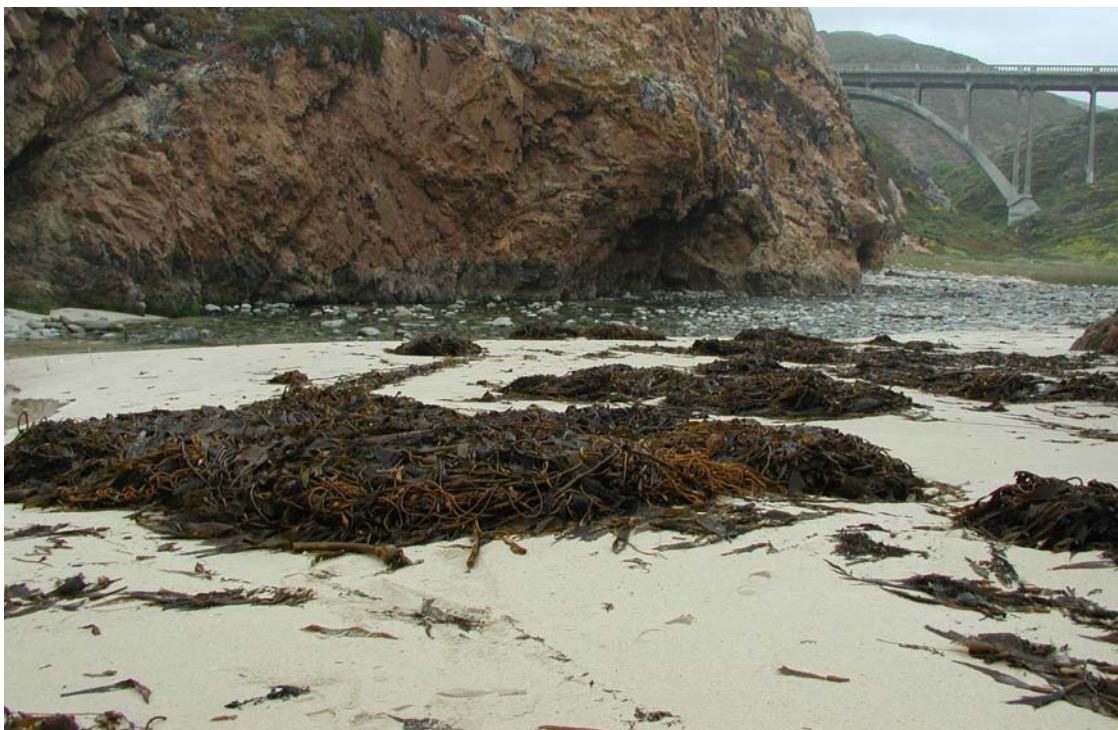
Figure 6.1. Fresh kelp at the lower end of the Garrapata Lagoon. Photo: Joel Casagrande 23 June 2005.

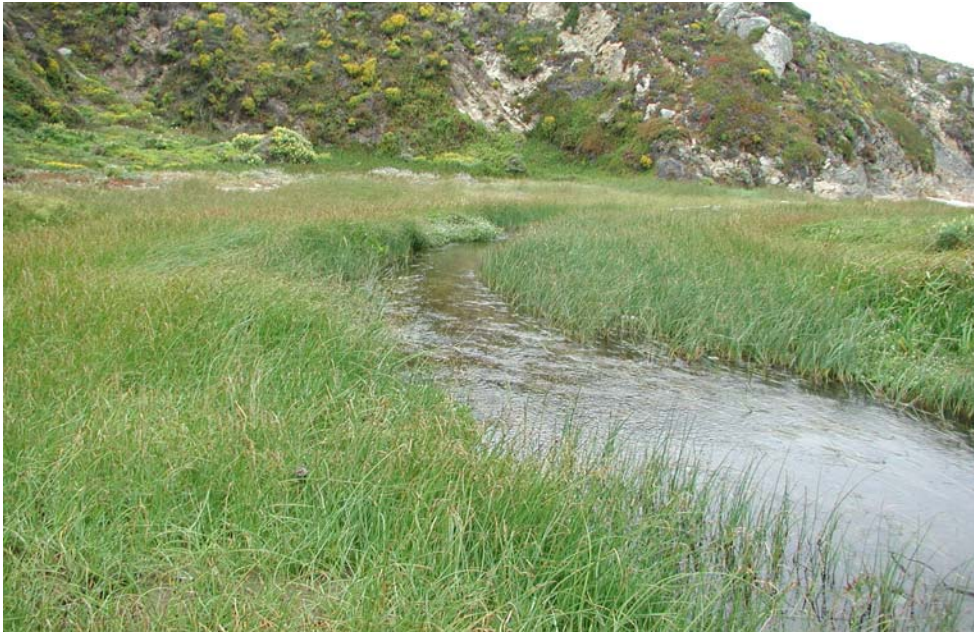
Figure 6.2 The lower reach of Garrapata Creek with emergent vegetation just upstream of the main embayments. Photo: Joel Casagrande 23 Jun 2005.

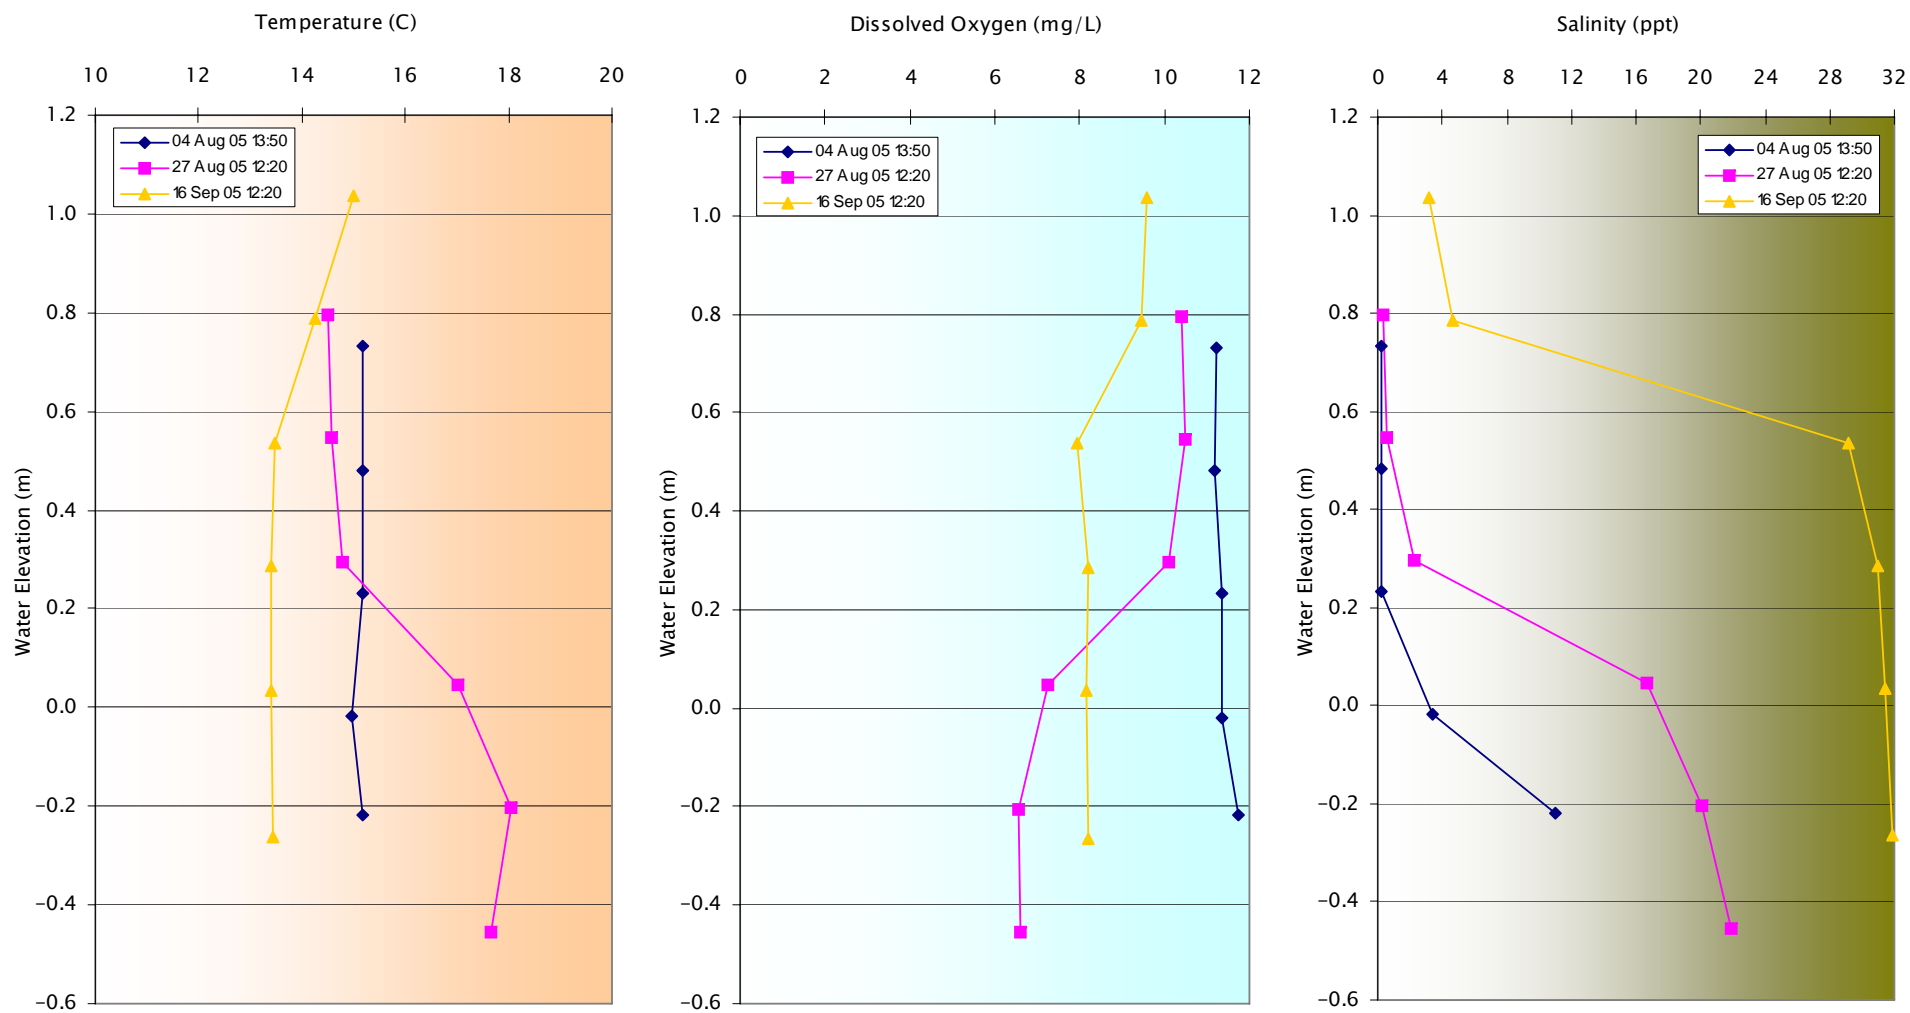
Figure 6.3 Summer water quality profiles (temperature, dissolved oxygen, and salinity) from Site 3 in the Garrapata Lagoon.

The water column in the lagoon was thermally stratified with an apparent halocline (Figs 6.3 & 6.4). This can have adverse consequences for water quality conditions. In general, saltwater on the lagoon bottom traps incoming solar energy, thus warming the bottom waters. Also, because of the density differences between salt- and freshwater, complete water column mixing is reduced substantially resulting in the inability for heavier saltwater to lose heat to the atmosphere. Warmer water temperatures then increase the depletion of oxygen along the bottom due to more rapid decomposition of organic matter (e.g. kelp). Although water quality conditions were suitable, no steelhead were observed in the lagoon,.

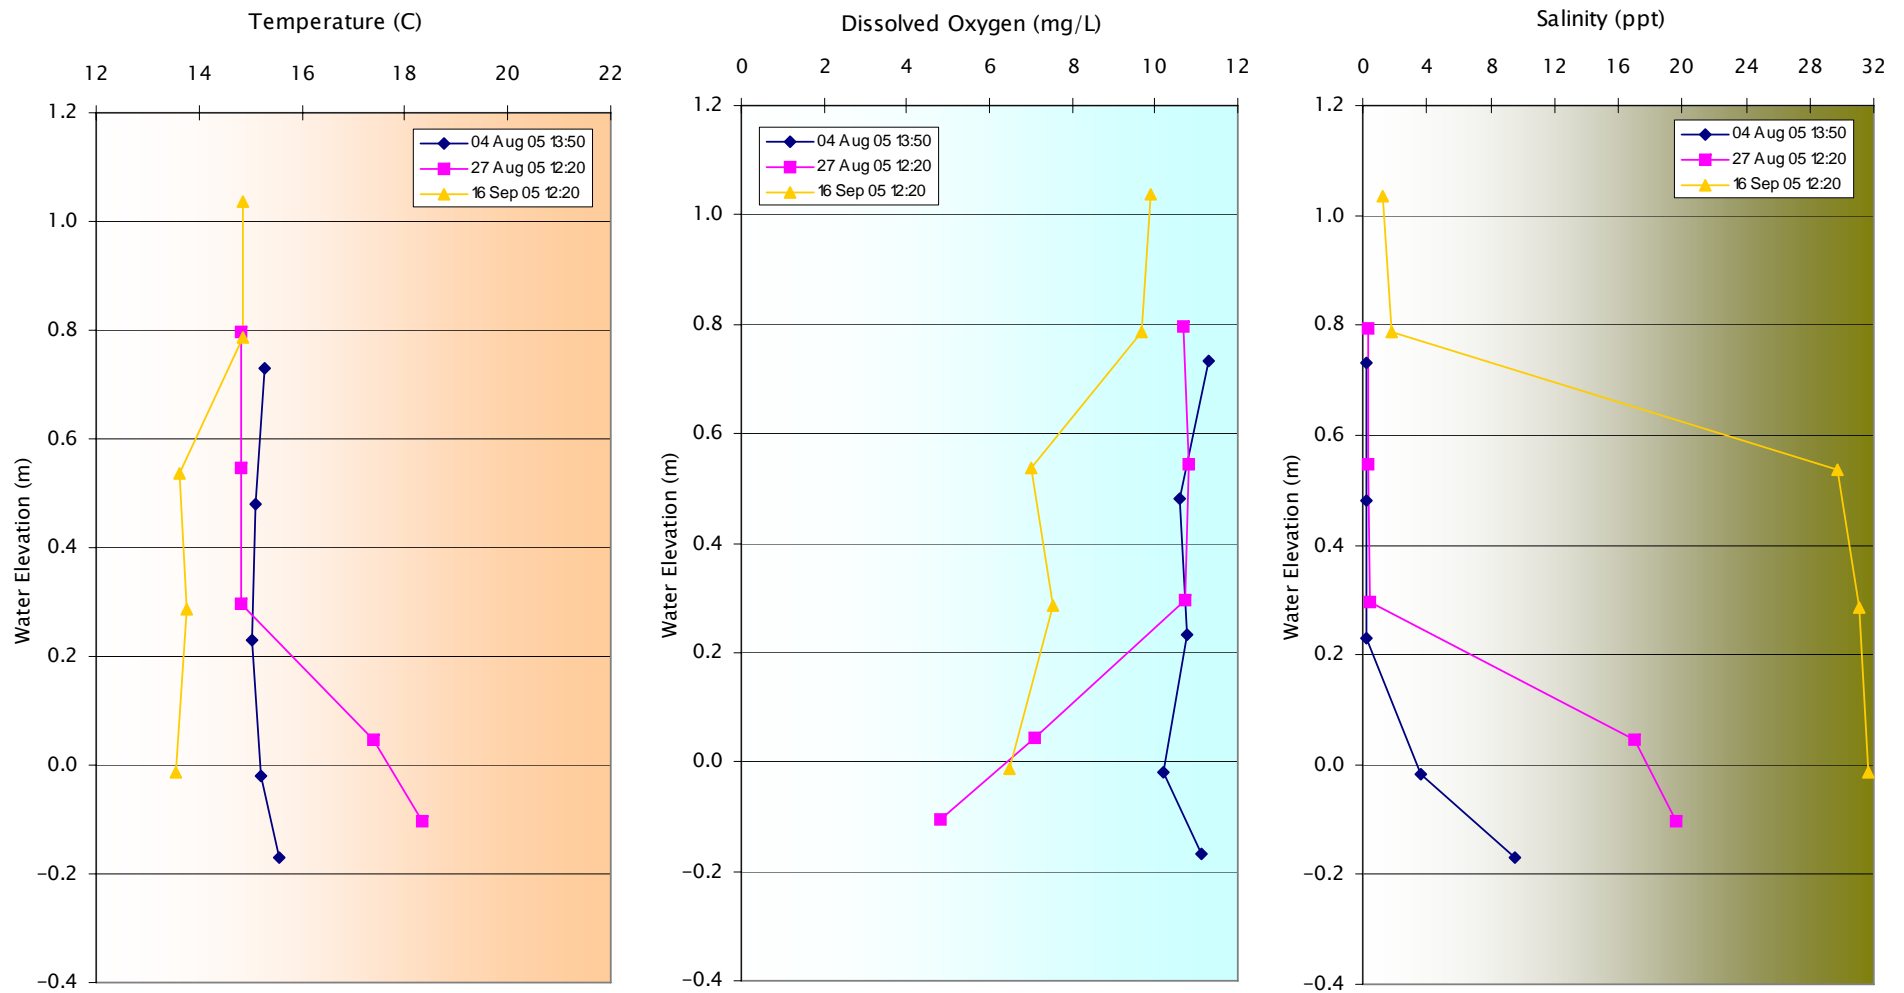
Figure 6.4 Summer water quality profiles (temperature, dissolved oxygen, and salinity) from Site 4 in the Garrapata Lagoon.

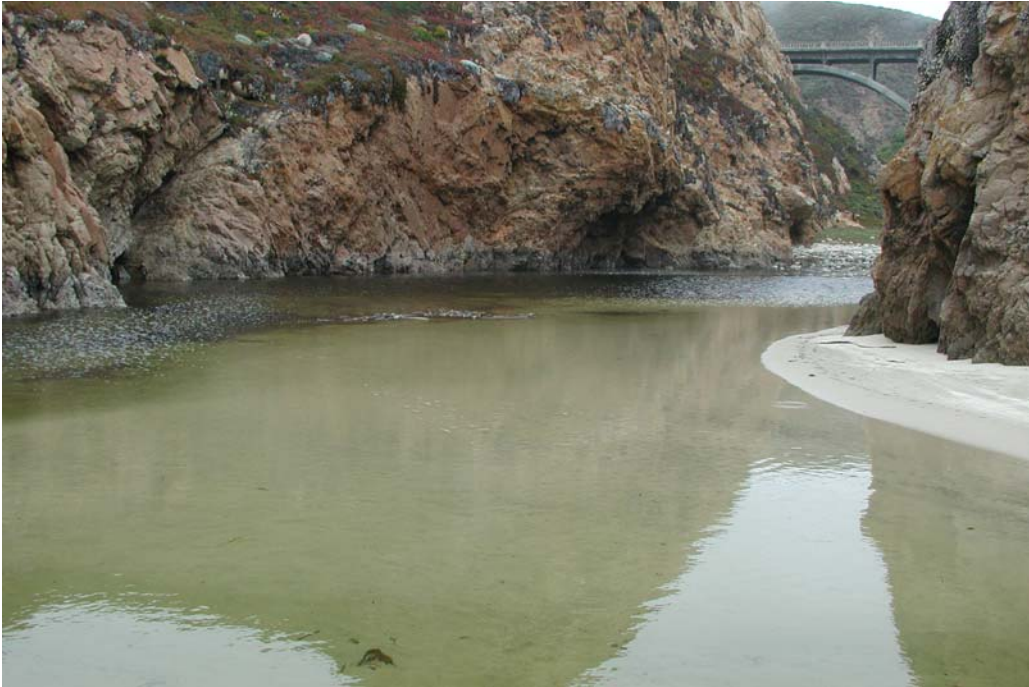
Figure 6.5 Garrapata Lagoon looking upstream. Note kelp floating on surface. Photo: Joel Casagrande, 04 August 2005

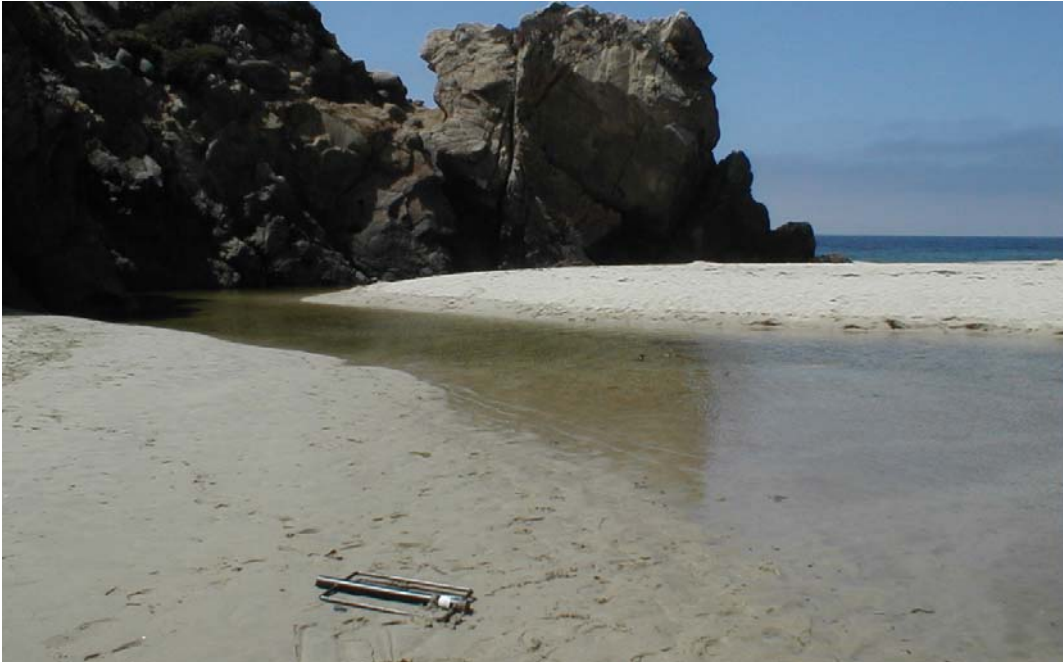
Figure 6.6 The mouth of the Garrapata Lagoon along the southern bluffs. Photo: Joel Casagrande 27 August 2005

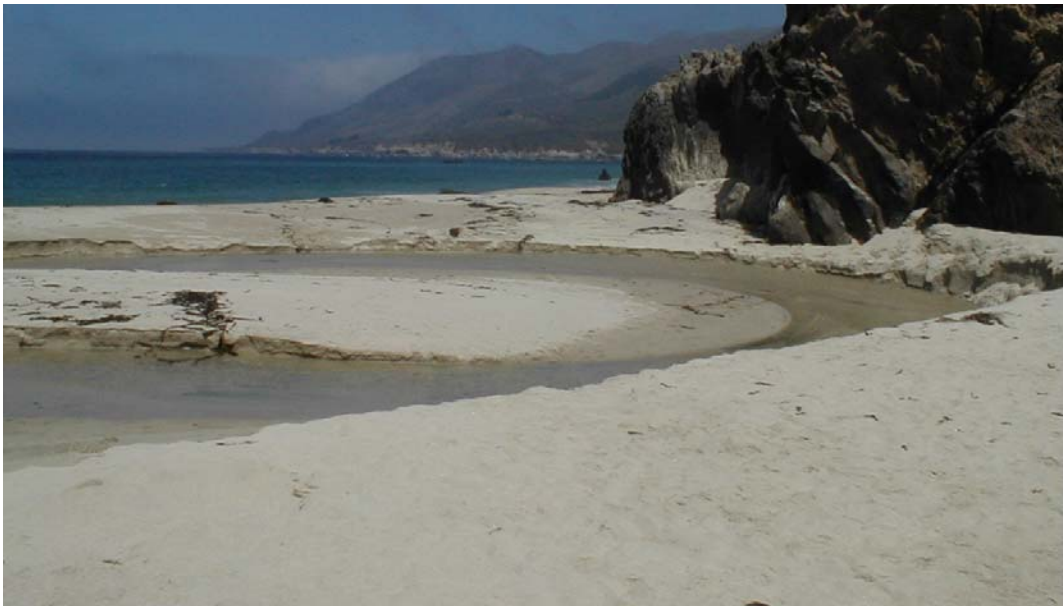
Figure 6.7 The outflow channel connecting the lagoon and the ocean (looking northwest). On August 4th, the channel was straight out along the southern bluff as opposed to the sinuous pattern shown here. Photo: Joel Casagrande, 27 August 2005
