Report No. WI-2006-01
31st January 2006
(minor revision 8th March 2006)

The Watershed Institute

Garrapata Creek Lagoon, Central Coast, California: A Preliminary Assessment

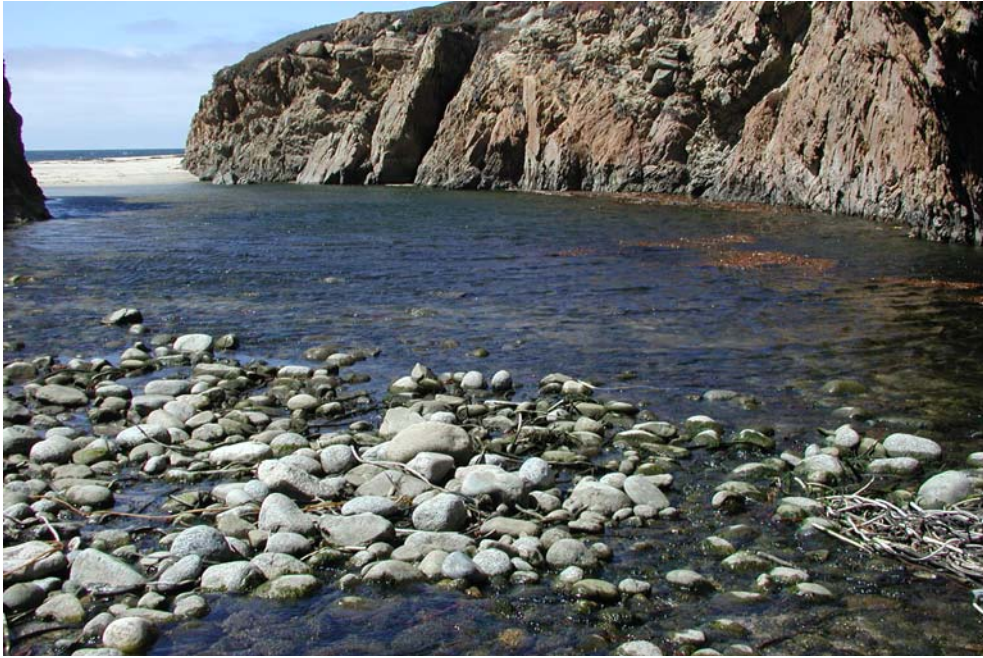
Figure 6.8 The main embayment of the Garrapata Lagoon on September 17, 2005. Note both the presence of kelp accumulated at the base of the bluff in the background and the inundation of the cobble riffle, showing the increasing in water elevation. Photo: Joel Casagrande 17 Sep 2005.

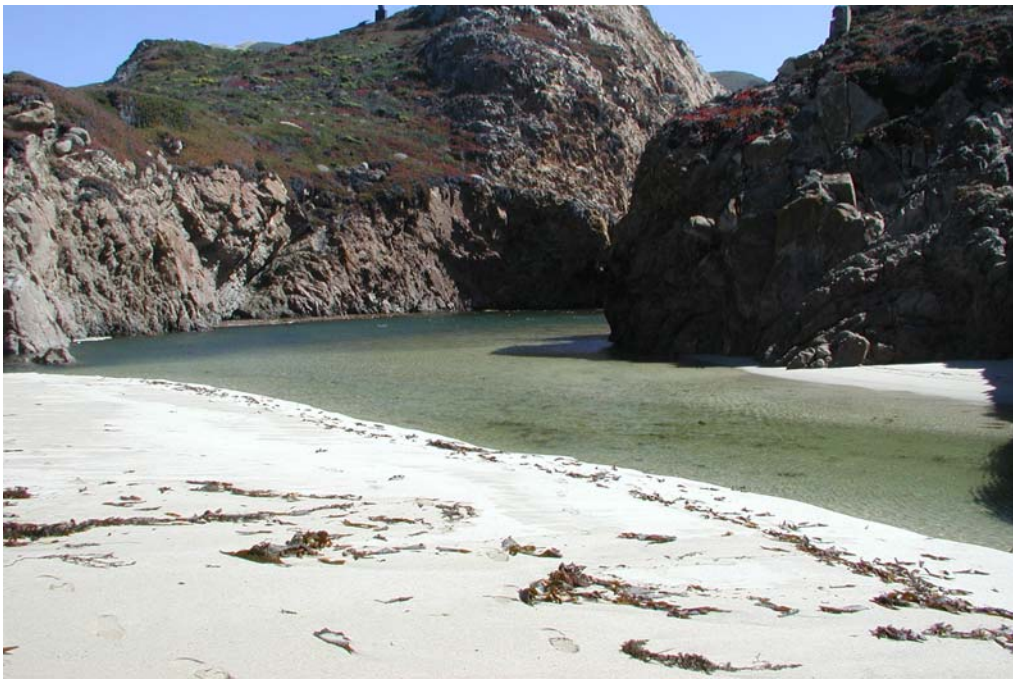
Figure 6.9 The inland side of the sandbar, or back beach, showing kelp deposits from recent waves overtopping the bar at high tide. Photo: Joel Casagrande, 17 Sep 2005.

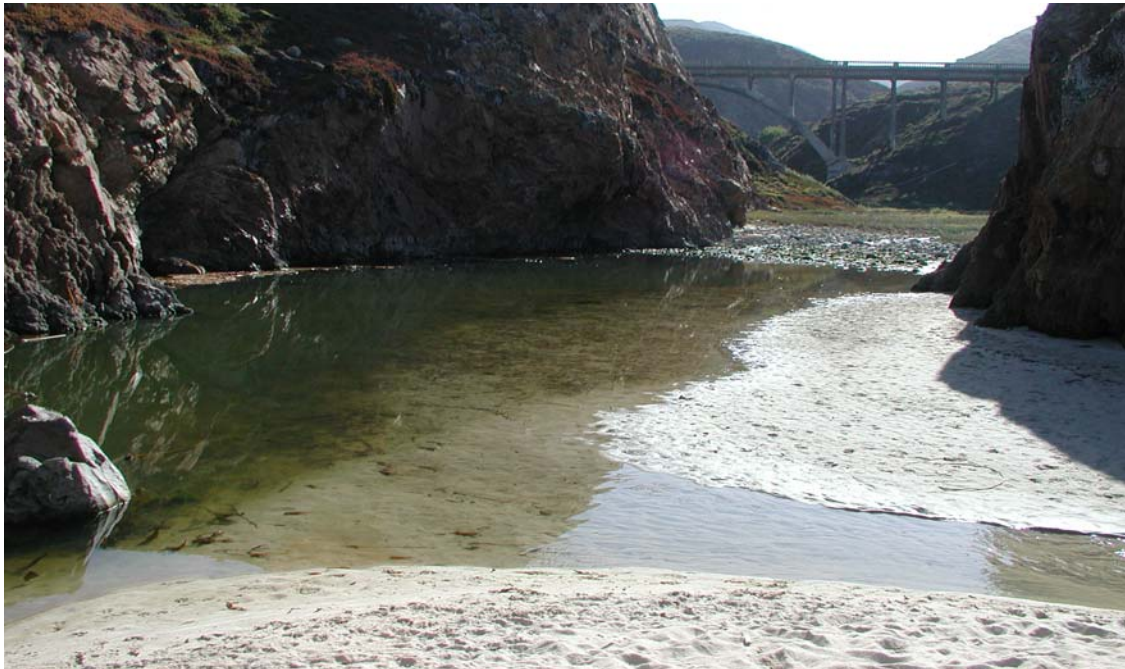
Figure 7.1 Main body of the lagoon. Photo: Joel Casagrande, 27 Sep 05.

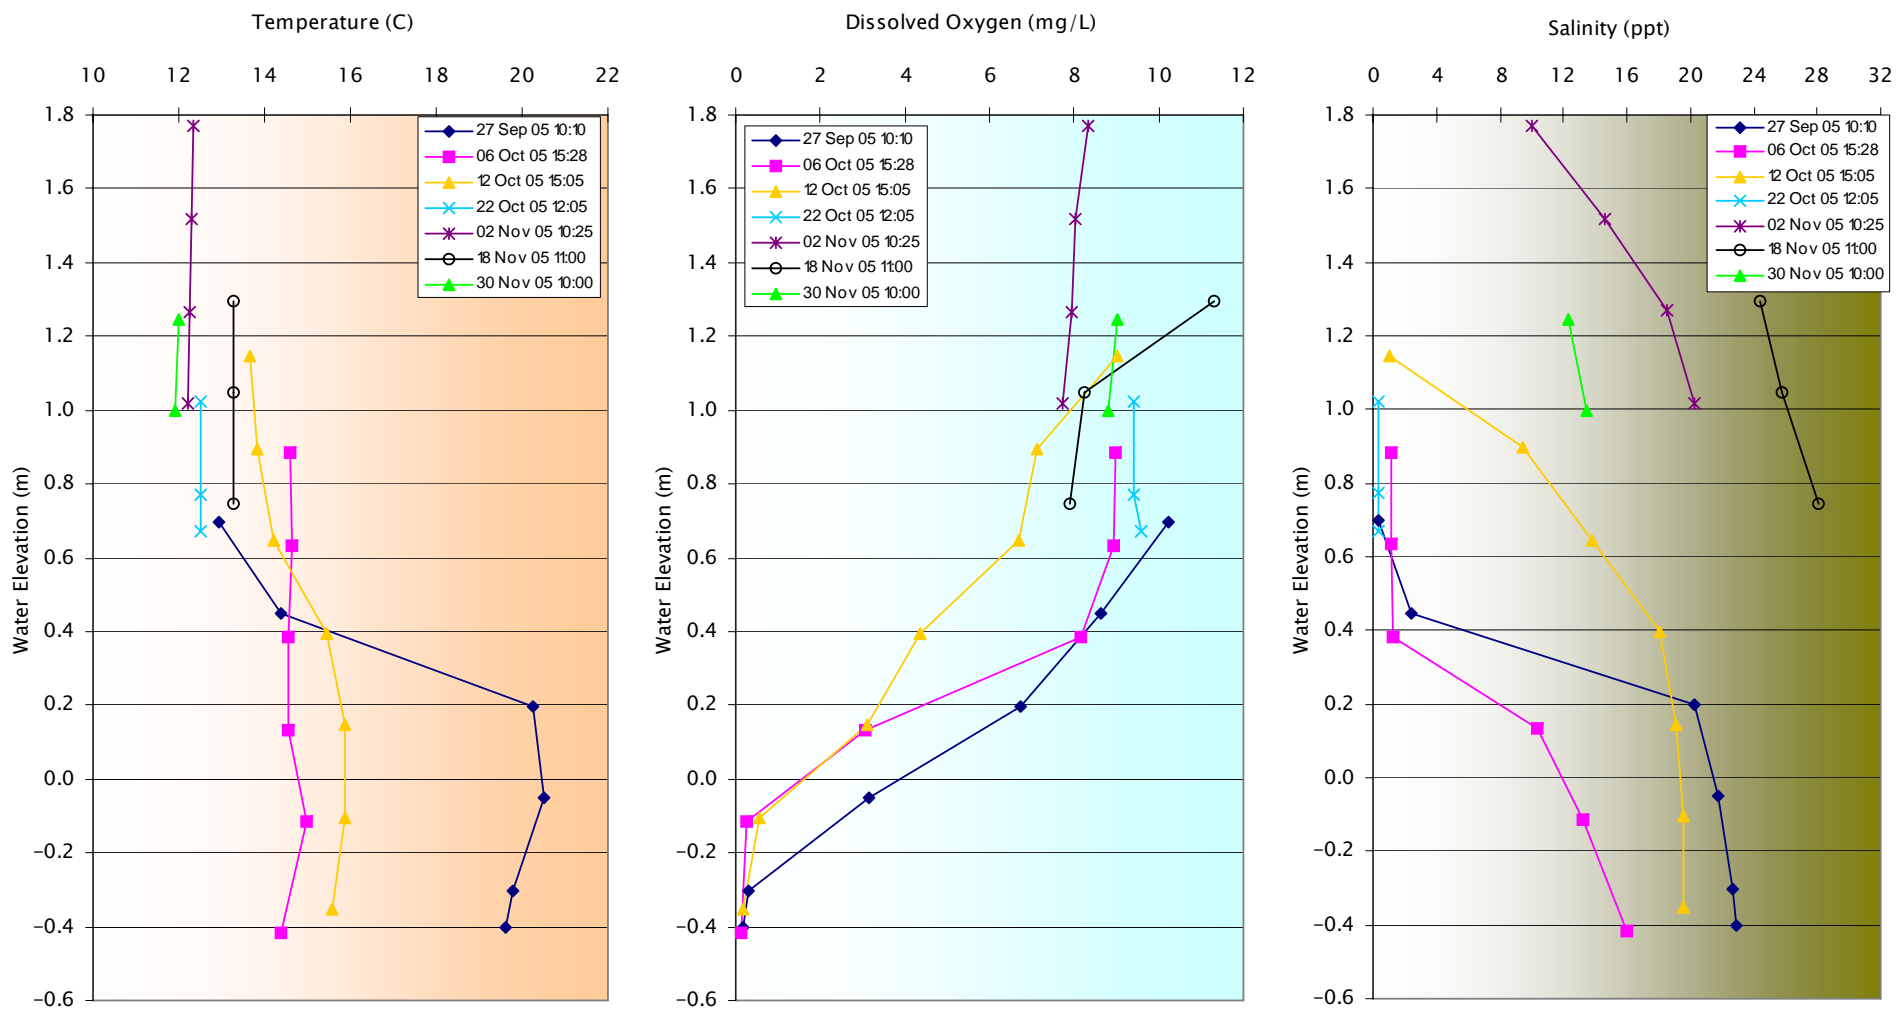
Figure 7.2 Fall water quality profiles (temperature, dissolved oxygen, and salinity) from Site 3 in the Garrapata Lagoon.

At this time the lagoon water elevation increased by approximately 0.2 m (0.6 ft) since September 27th. The salinity profiles (Figs 7.2 & 7.3) show an increase in the freshwater lens in the lagoon indicating increased retention of incoming freshwater and due to reduced seawater inputs. No waves were observed washing over the sandbar at this time, although an occasional wave did surge up the outflow channel and fresh kelp on the backside of the sandbar suggests that ocean waves recently had reached the lagoon over the bar.

Water quality in the lagoon was cool and mostly saline due to the wave event, although bottom waters were still diluted from incoming freshwater (Figs 7.2 & 7.3). Surface and subsurface salt concentrations were lower closer to the creek inflow. Mechanical mixing from ocean waves created well-mixed temperature and dissolved oxygen profiles.

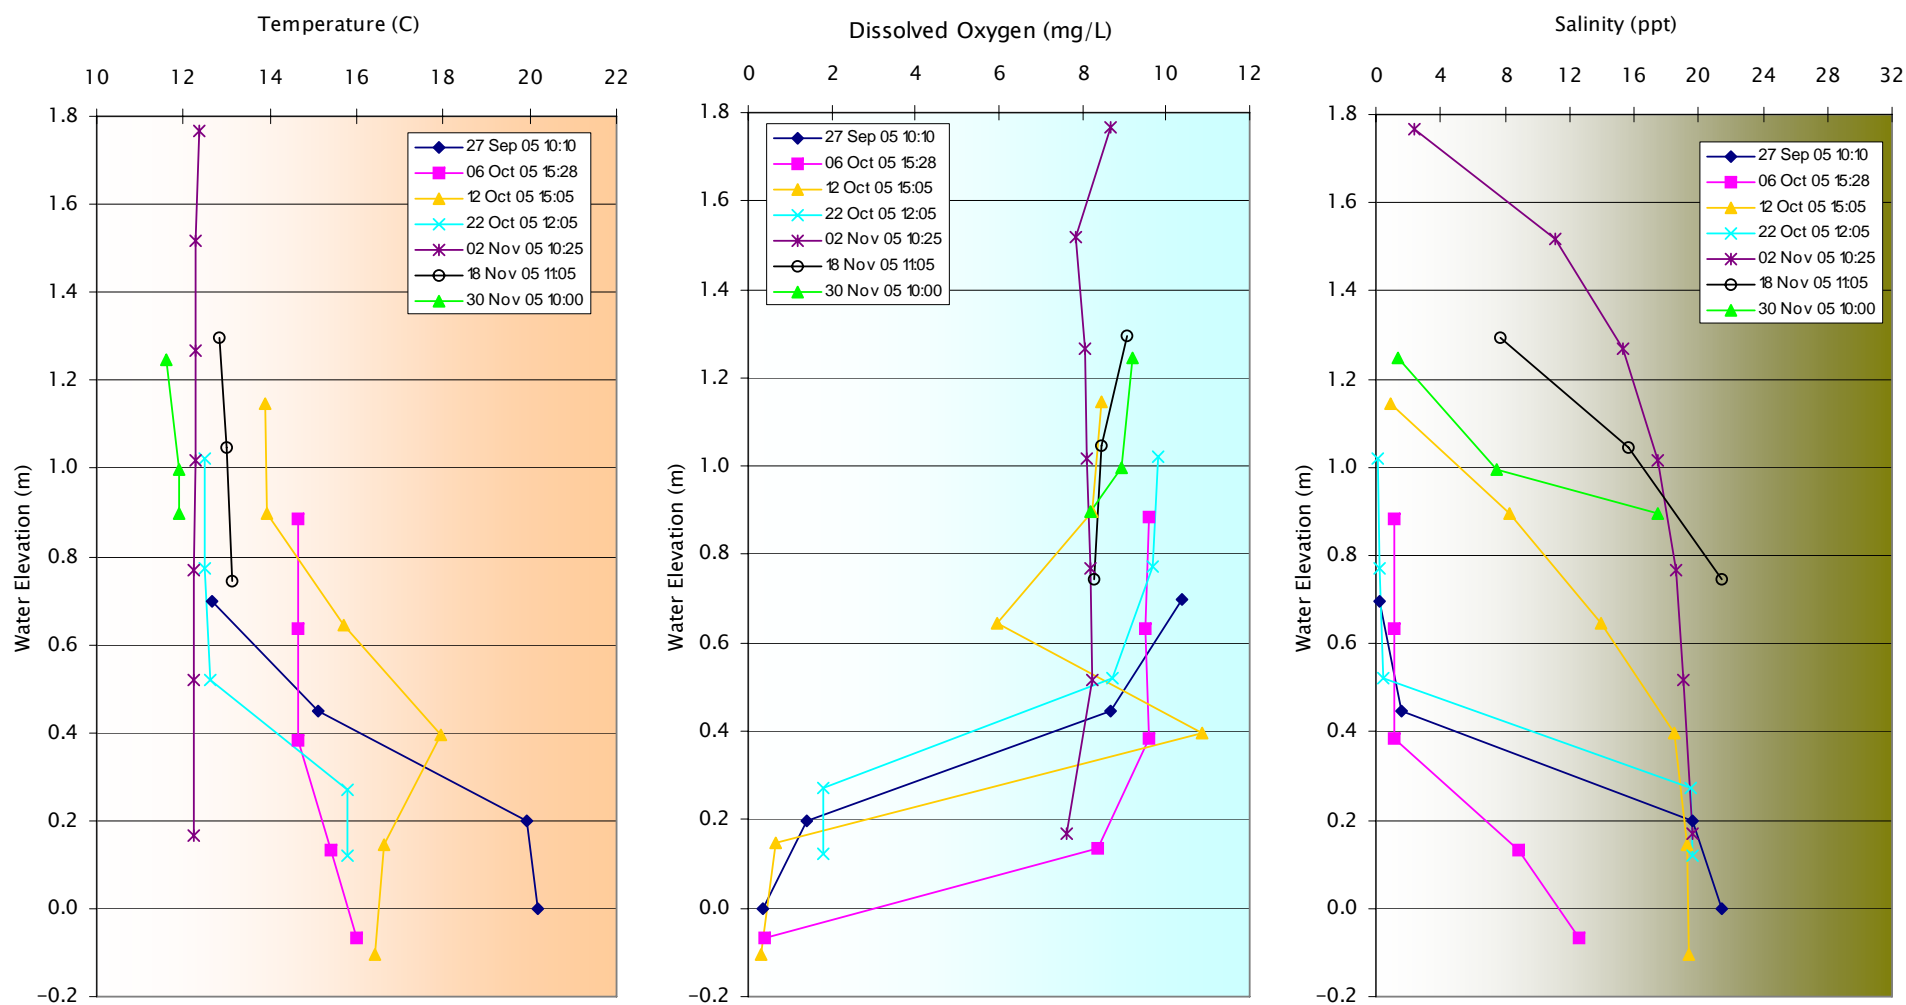
Figure 7.3 Fall water quality profiles (temperature, dissolved oxygen, and salinity) from Site 4 in Garrapata Lagoon.

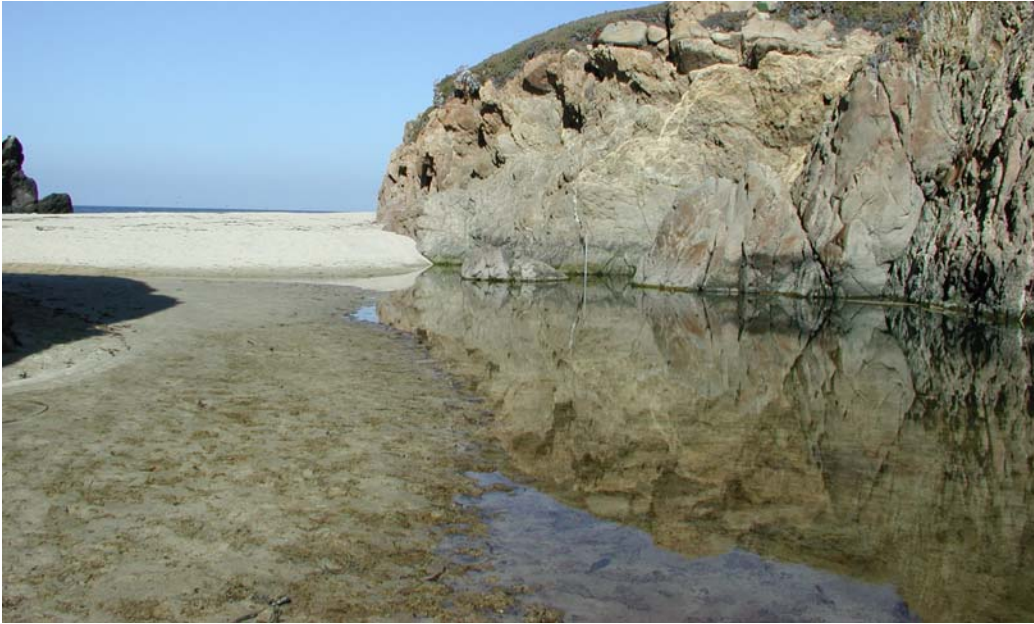
Figure 7.5 Looking downstream at the backside of the sandbar. Photo: Joel Casagrande, 27 Sep 2005.

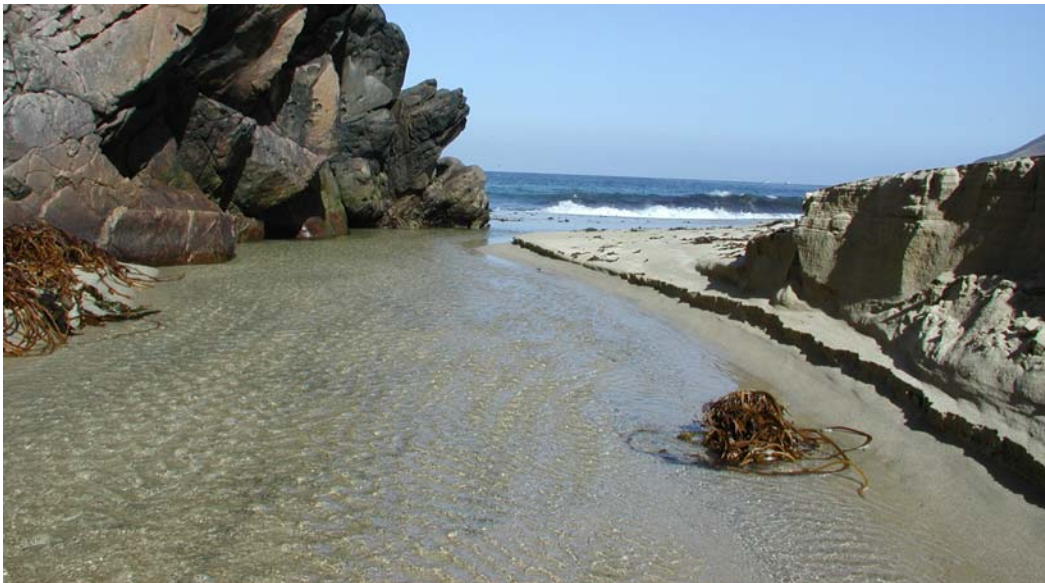
Figure 7.4 The outflow channel of the lagoon. Note the degree of down cutting through the sandbar. This did not exist 10 days prior and suggests a “filling/breaching” event in between the 17th and 27th of September. Photo: Joel Casagrande, 27 Sep 2005.

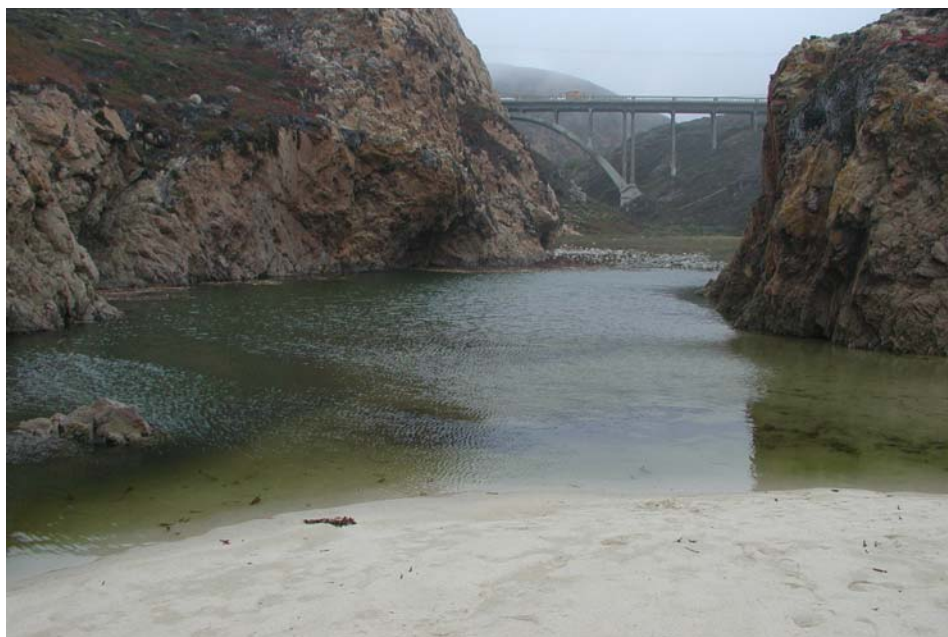
Figure 7.6 A fuller Garrapata Lagoon on October 12, 2005. Compare with Figure 7.1. Photo: Joel Casagrande 12 Oct 2005.

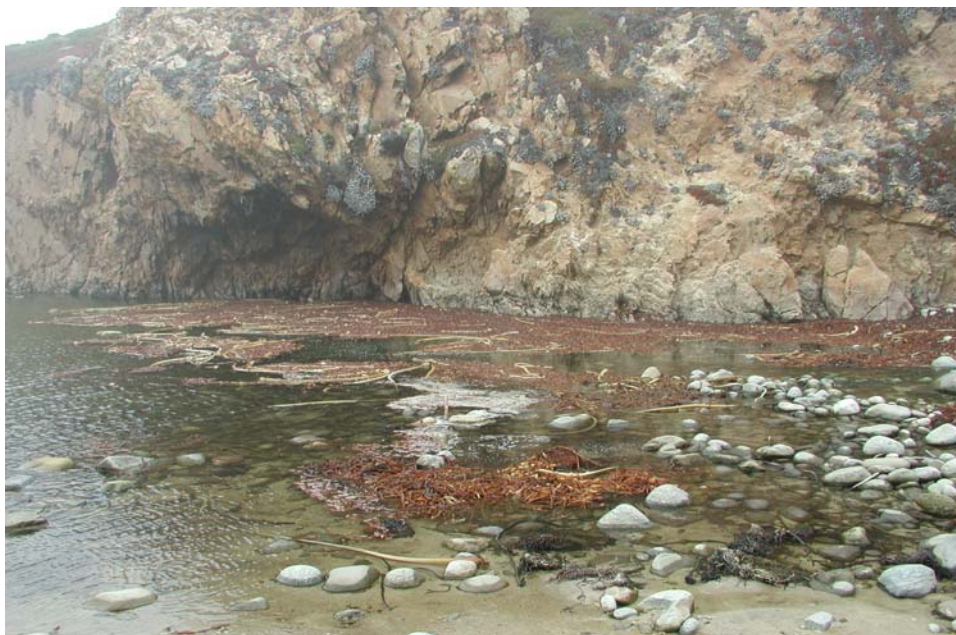
Figure 7.7 Kelp accumulations at the eastern edge of the lagoon near the cobble riffle. Photo: Joel Casagrande 12 Oct 2005.

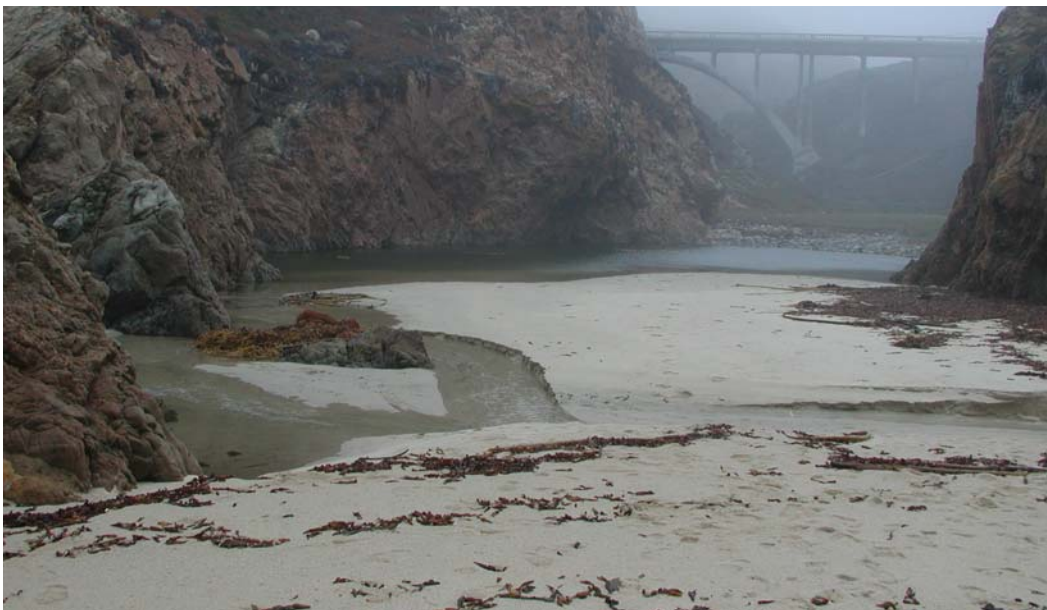
Figure 7.8 Sand deposition due to high surf in the lower half of the Garrapata Lagoon. Note: Compare with Figures 7.1 & 7.6. Photo: Joel Casagrande, 22 Oct. 2005

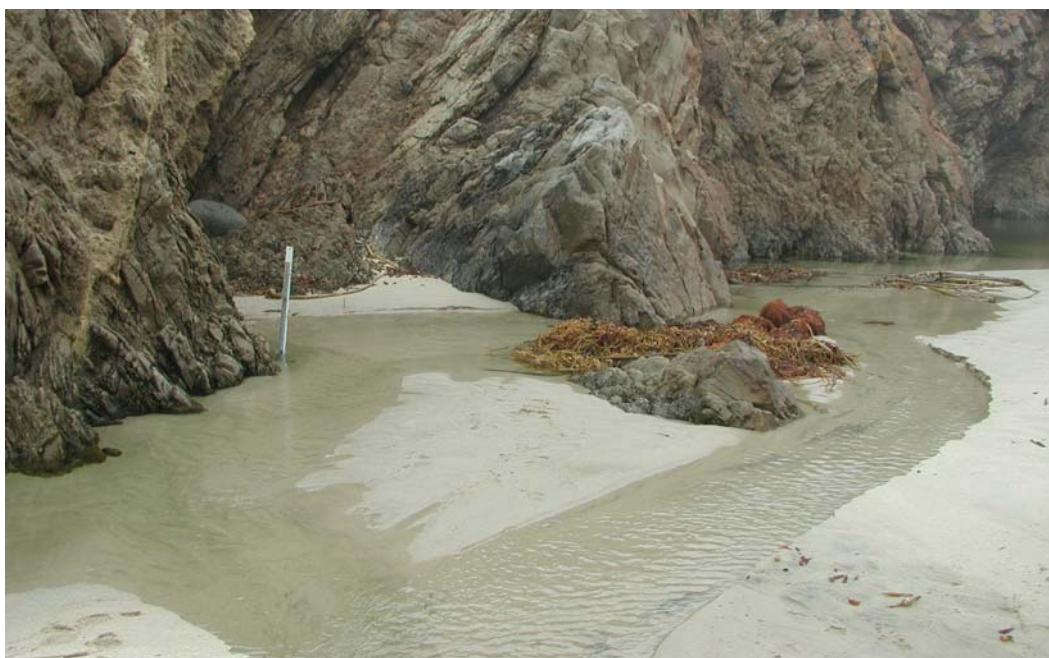
Figure 7.9 Loss of deeper water habitat at Site 3 due to sand deposition. Photo: Joel Casagrande, 22 Oct. 2005.

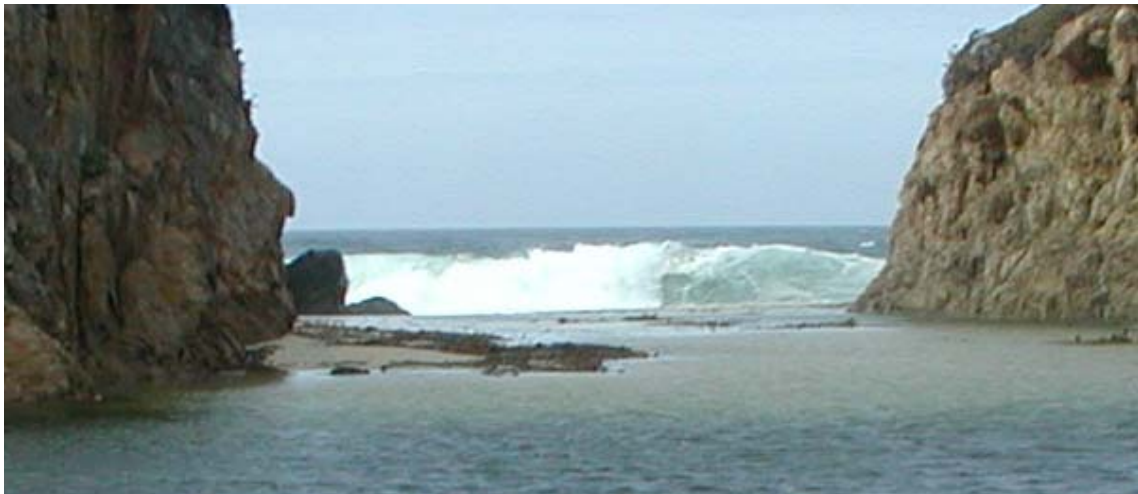
Figure 7.10 Ocean waves breaking on what used to be the sandbar separating the lagoon from the ocean. Photo: Joel Casagrande, 02 Nov. 2005

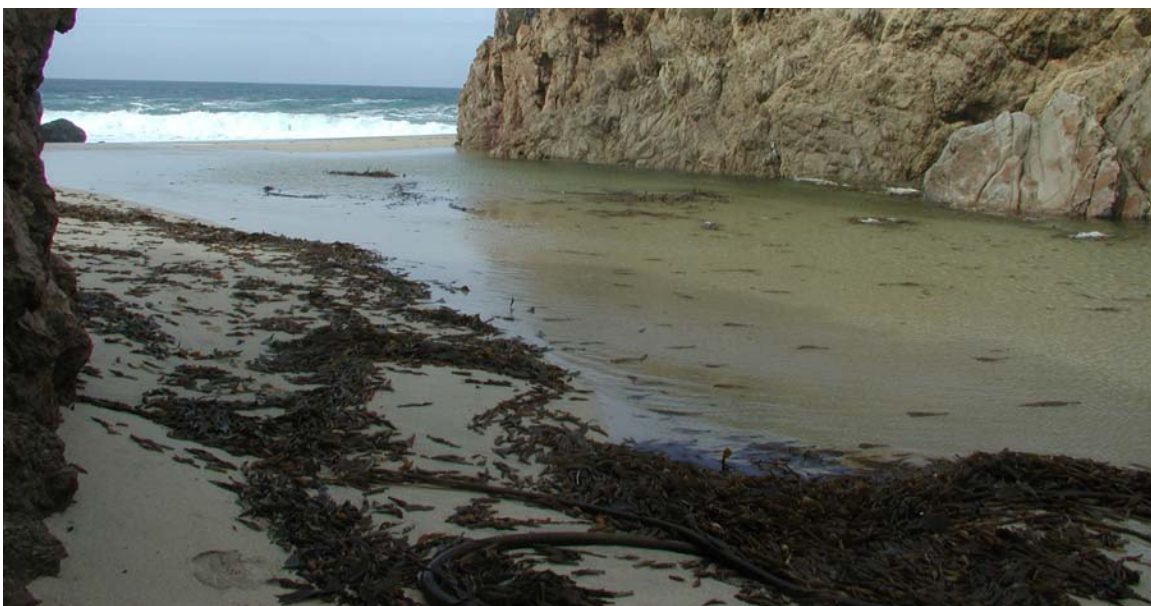
Figure 7.11 The front half of the Garrapata Lagoon. Water depths here were now reduced to inches although Site 3 (just out of view to the right) did re-scour some. Photo: Joel Casagrande, 02 Nov. 2005

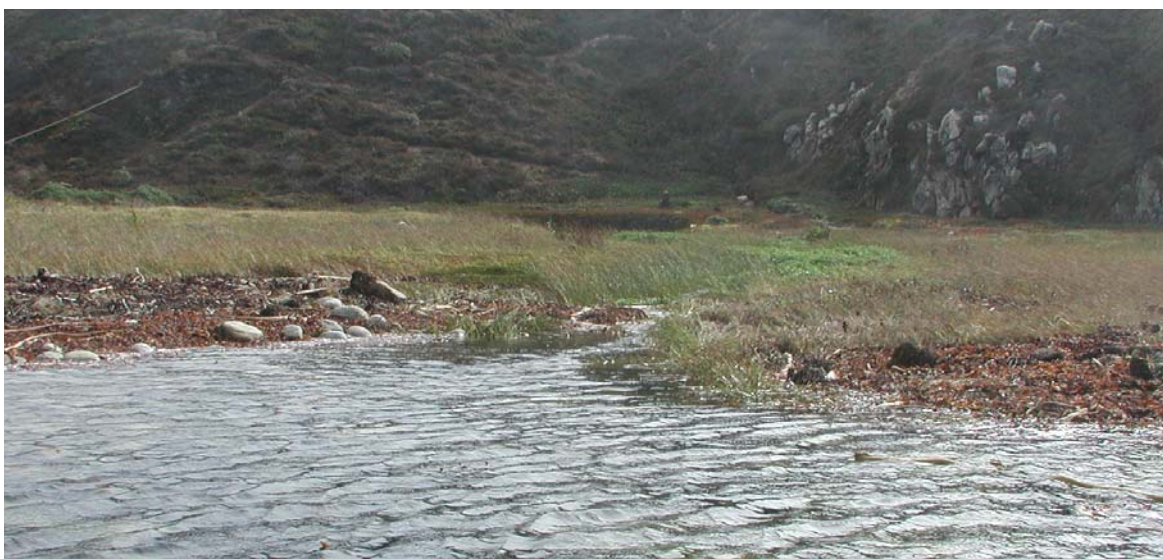
Figure 7.12 The cobble riffle (looking upstream) submerged – a result of significant sand delivery and accumulation in the lower lagoon. Compare with Figure 2.4. Photo: Joel Casagrande, 02 Nov. 2005.

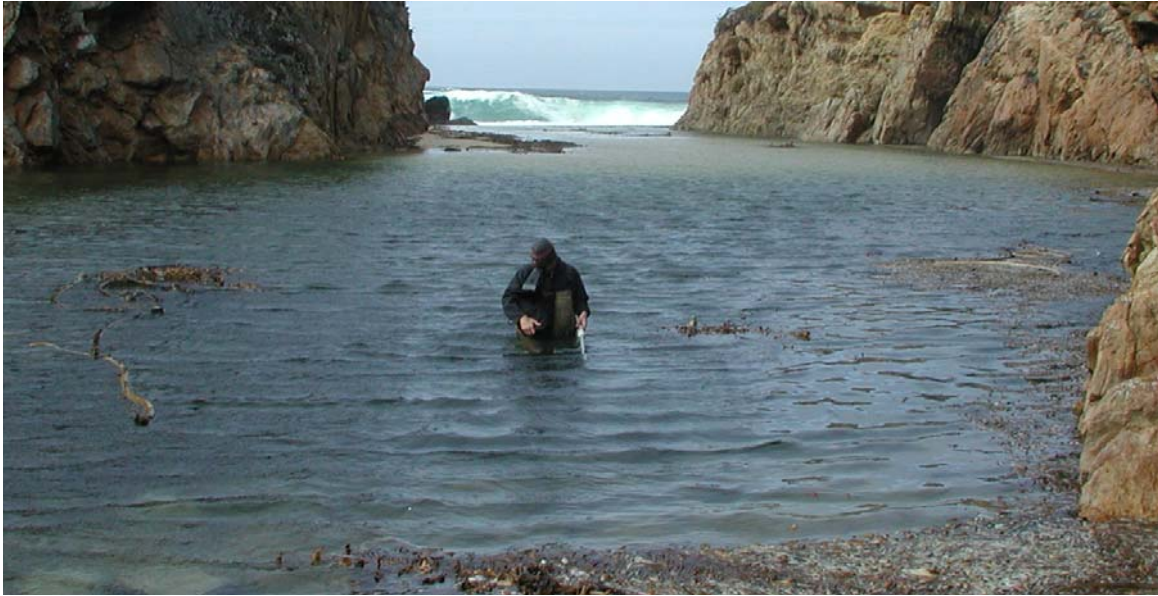
Figure 7.13 Using underwater cameras in an attempt to determining the presence of steelhead and other fish species. Photo: Julie Casagrande, 02 Nov. 2005.

A handheld underwater camera mounted on a rod was used to look for and potentially detect steelhead in the lagoon (Fig. 7.13). The lagoon was checked in a systematic manner walking from side to side (north to south) in an upstream progression. Visibility was approximately 1.5 m. No steelhead, or any other species of fish, were observed after approximately 45 minutes of viewing and no steelhead were observed during bank observations.

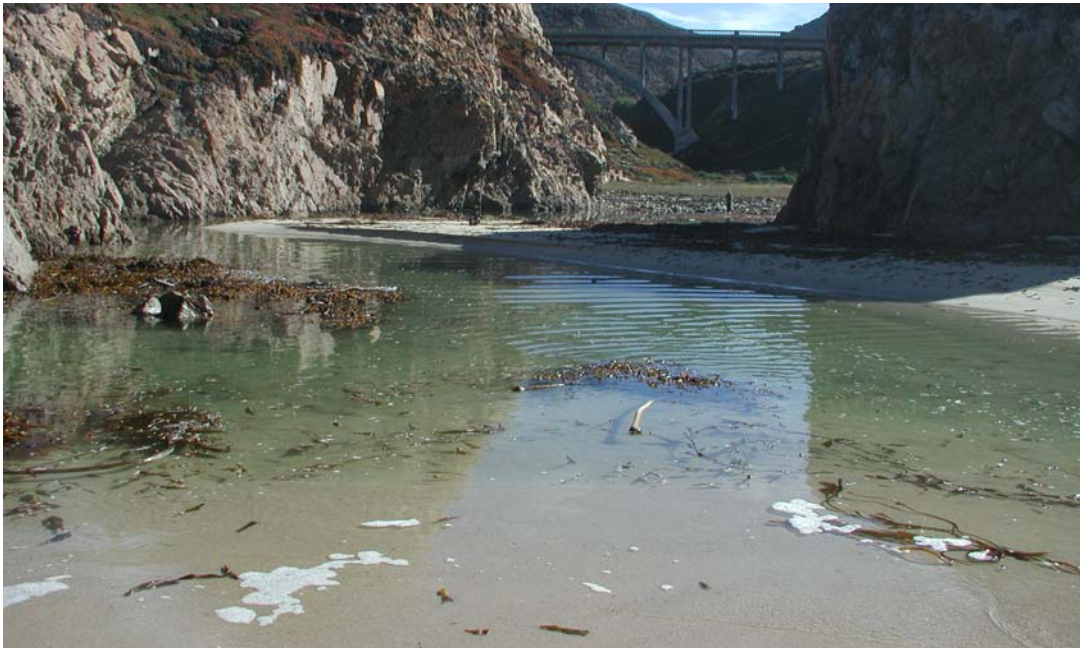
Figure 7.14 The lower half of the Garrapata Lagoon. Compare with earlier Figures especially Figures 7.1 & 7.8. Photo: Joel Casagrande, 18 Nov 2005.

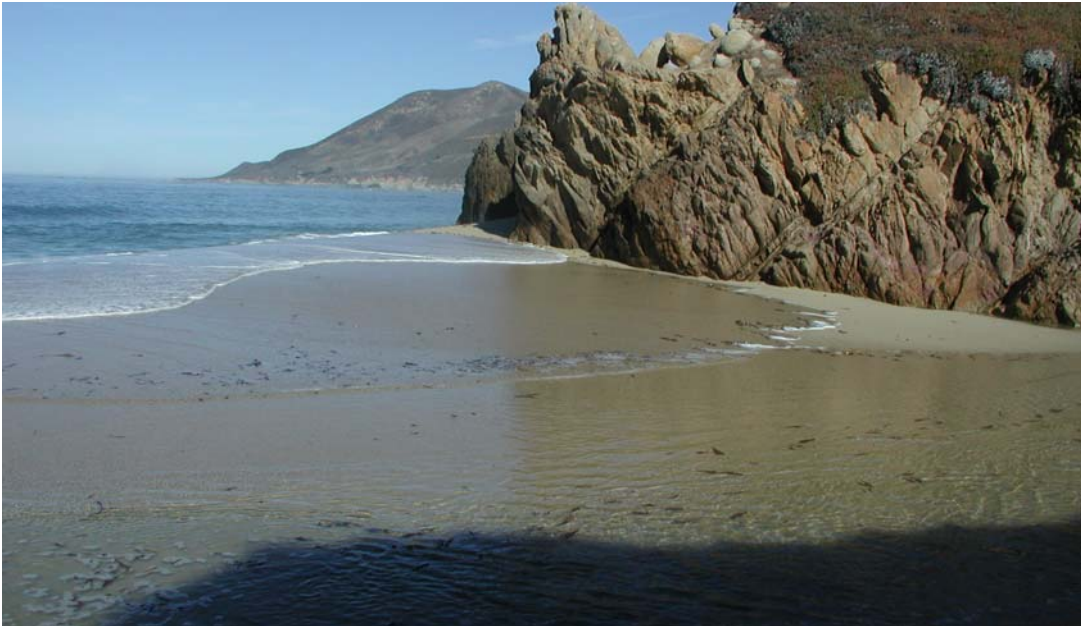
Figure 7.15 Consistent wave overwash into Garrapata Lagoon was observed during high tide. By mid-November, the sandbar height was minimal, a result of recent large surf. Photo: Joel Casagrande 18 Nov 05.

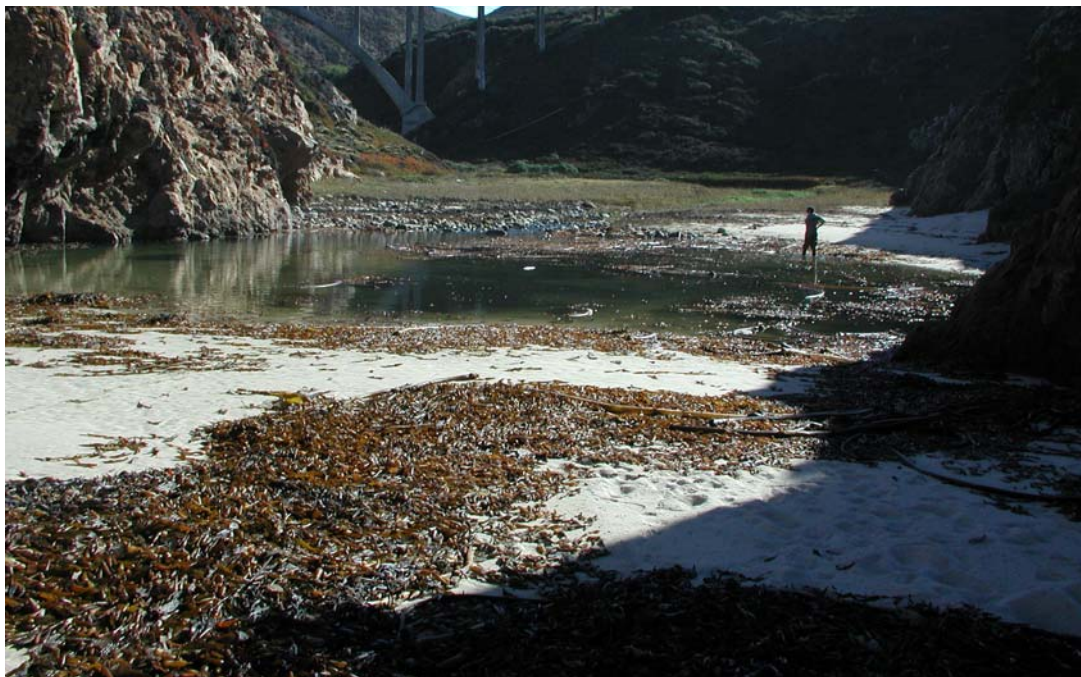
Figure 7.16 Extensive kelp accumulations within the lagoon area on November 18th, also a result of high surf conditions along the Big Sur Coast. Photo: Joel Casagrande, 18 Nov 05.

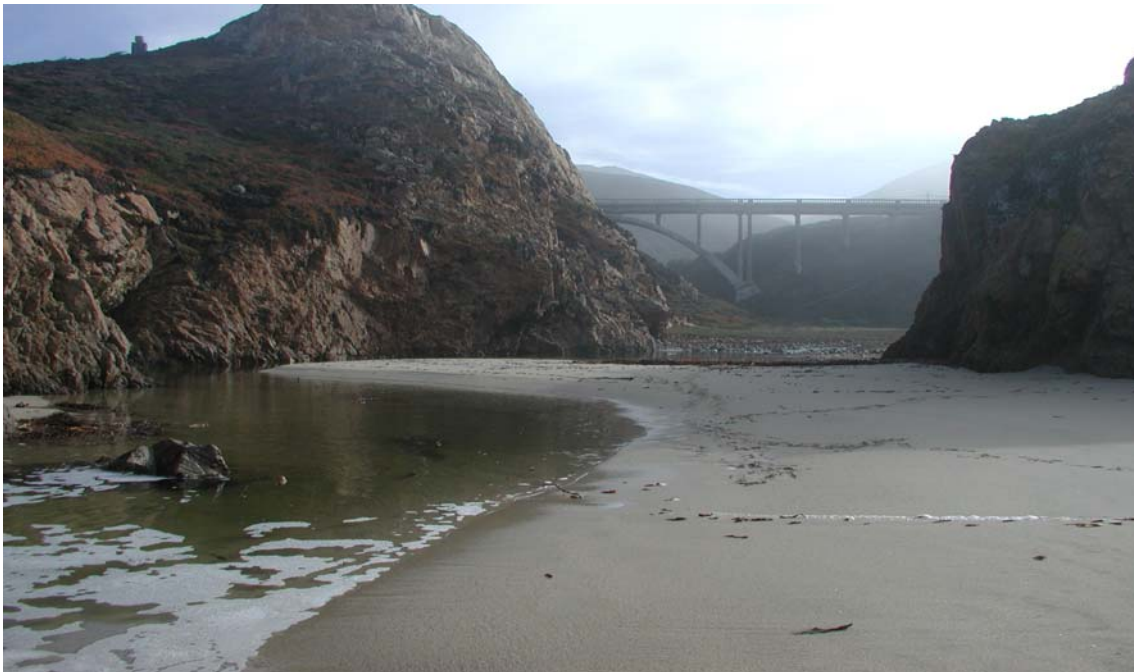
Figure 7.17 Garrapata Lagoon on November 30th 2005. Photo: Joel Casagrande, 30 Nov. 2005.

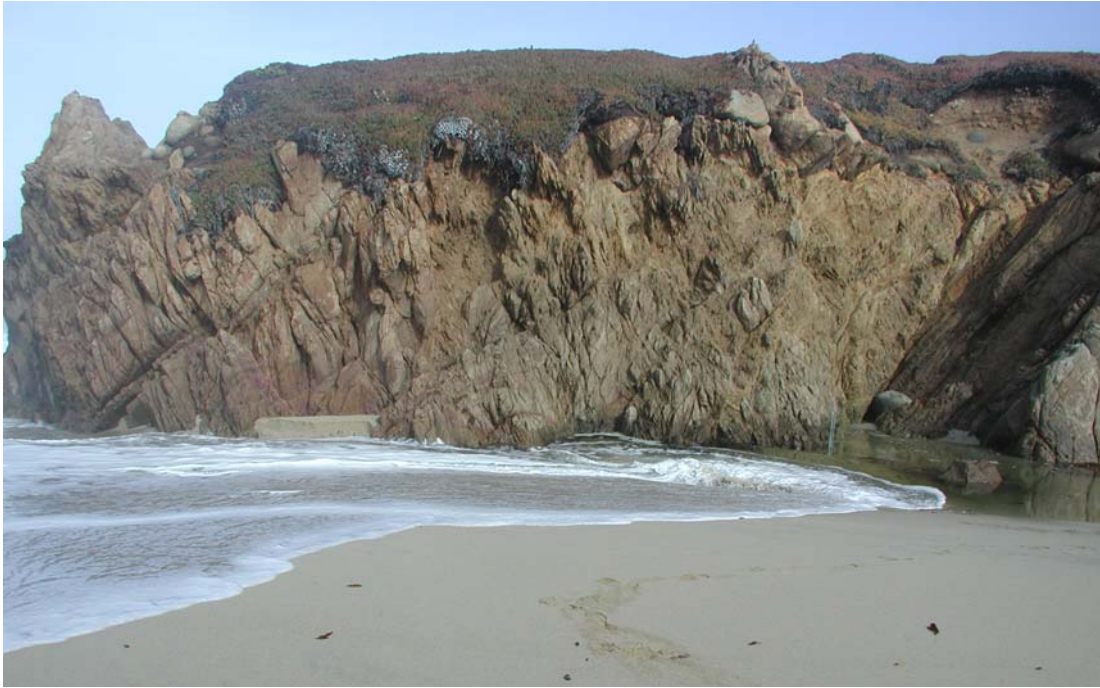
Figure 7.18 Ocean waves continuously entered the lagoon along the north side of the sandbar, often sending surge waves up the lagoon to the cobble riffle area. Photo: Joel Casagrande, 30 Nov. 2005.

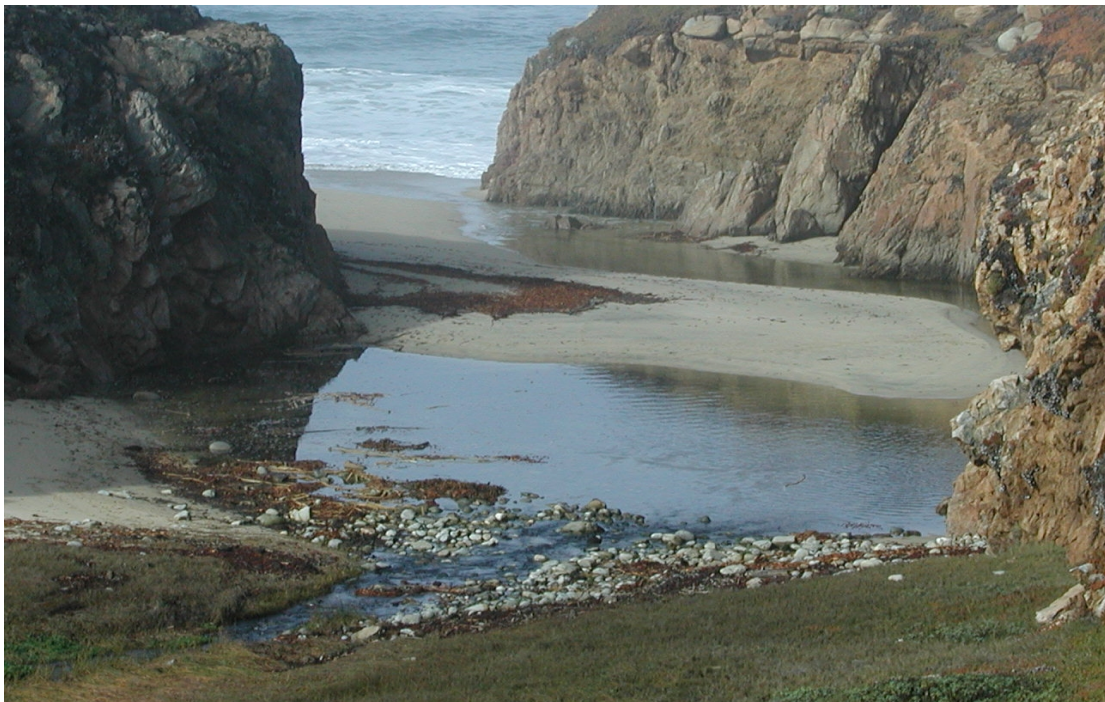
Figure 7.19 A shallow remnant of the Garrapata lagoon looking downstream. Photo: Joel Casagrande, 30 Nov 2005.

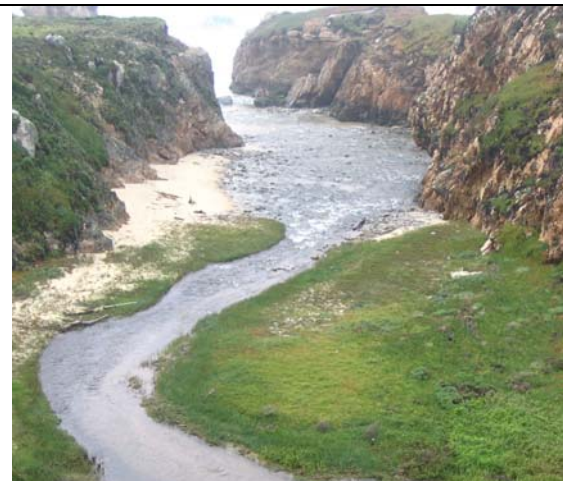
April 8th 2005 (Photo: Joel Casagrande)

The following series of pictures were taken from the southern end of the Highway 1 Bridge throughout 2005. The pictures illustrate the dynamic seasonal changes and in some cases, the weekly changes, in the lagoon and near lagoon areas. For example, compare April 8th and April 27th. Note the sandbar present along the north side of the lagoon on April 27th that was not present on April 8th. Then compare both with May 27th.

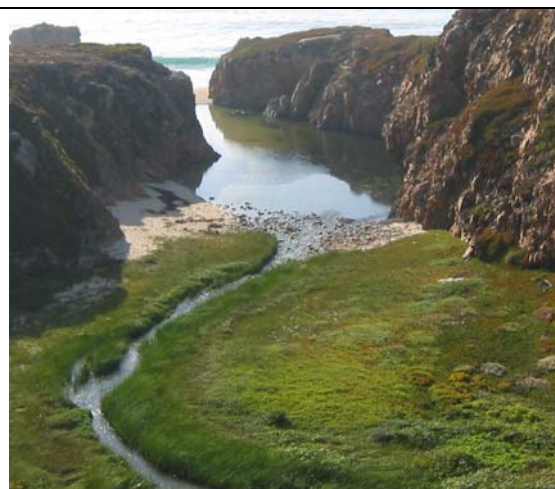
July 29th 2005 (Photo: Ken Ekelund)

The photos also show that the first significant amount of impounded water occurred near July 29th 2005, although earlier photos in July do show some impounded water. Finally, the photos clearly document that by early November sand delivery by ocean waves had reduced the lagoon's volume substantially. The November 30th photo shows large waves in the background. The December 18 photo was taken just before dark at the end of the first big storm event of the 2005/06 winter. On December 20th, an early morning photo shows that the remnants of the lagoon embayment were nearly gone and after the next storm, December 30th, the lagoon area was entirely lotic and against the northern bluffs. Photos from early January 2006 were taken during a significant storm. The January 3rd photo illustrates the considerable impact large waves have on the lagoon.
