Report No. WI-2005-03
23 February 2005

The Watershed Institute

Garrapata Watershed Assessment: Hydrology and Sedimentology (2001 to 2004)

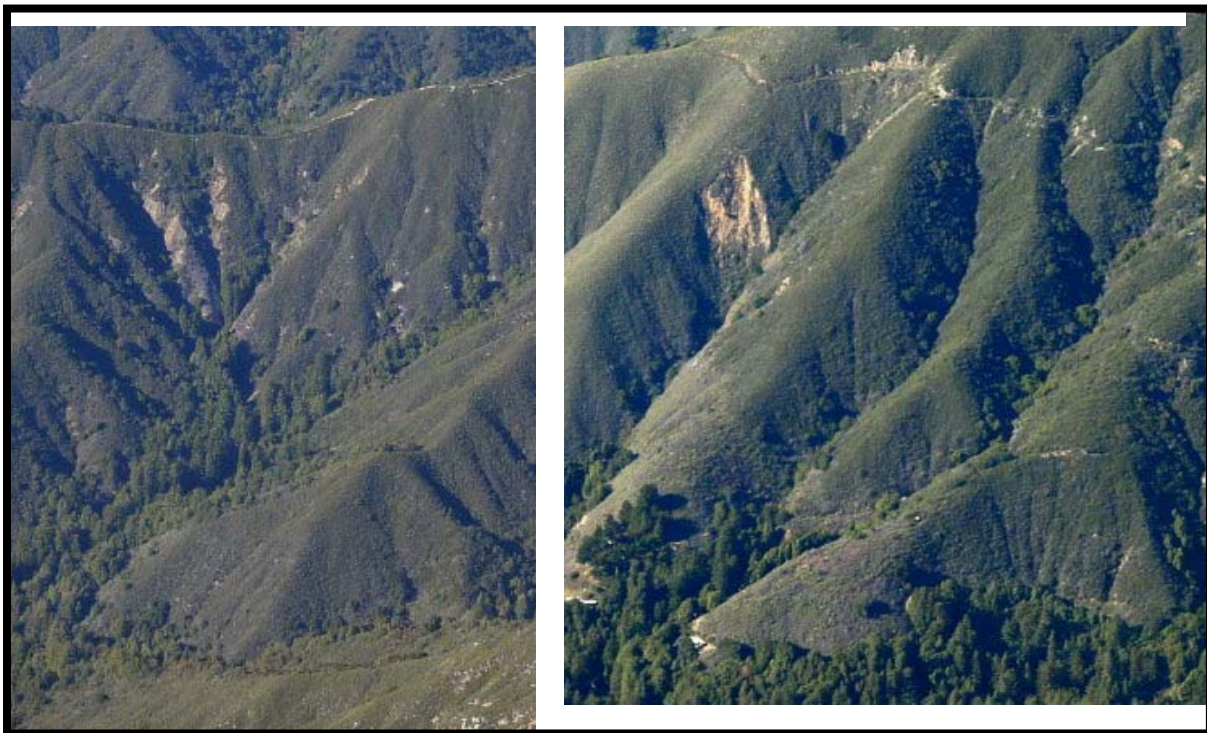
Figure 8: Two natural landslides along northern flank of Garrapata Creek (Oct. 31, 2004). Right photo also shows abandoned roads leading from Garrapata Creek to Wildcat Creek. Cut slopes along those roads appear to be continuing sediment sources.

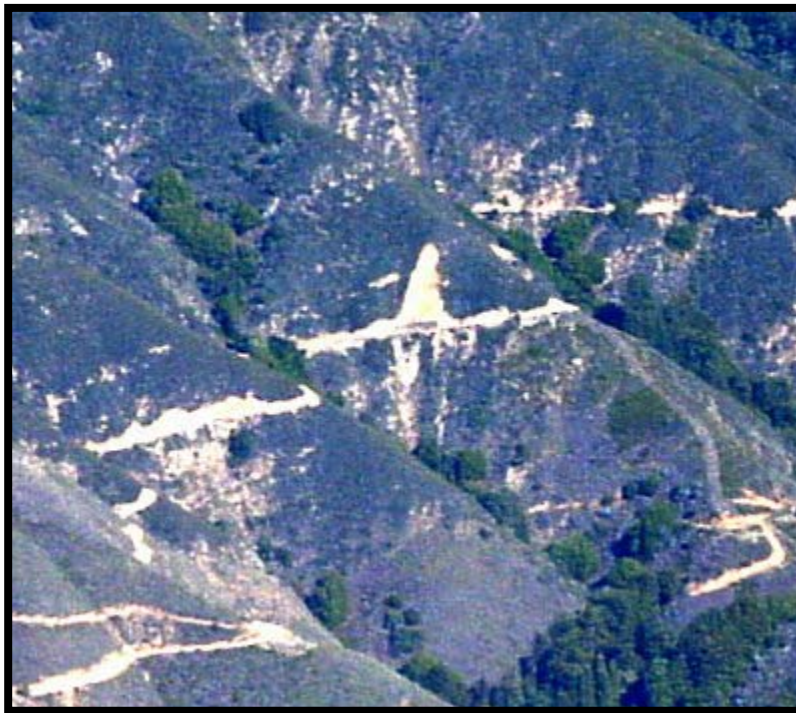
Fig. 10: Shallow soil slip in slope above Joshua Watershed road cut (Oct. 31, 2004).

There are also active shallow landslides associated with road cuts that have over-steepened the valley walls between Highway 1 and the Trout Farm and above Joshua Creek (Fig. 10).

The third erosion site is approximately 4.4 km (2.8 mi) of roadway cut into the steep slopes above Joshua Creek (Figs. 15 and 10).

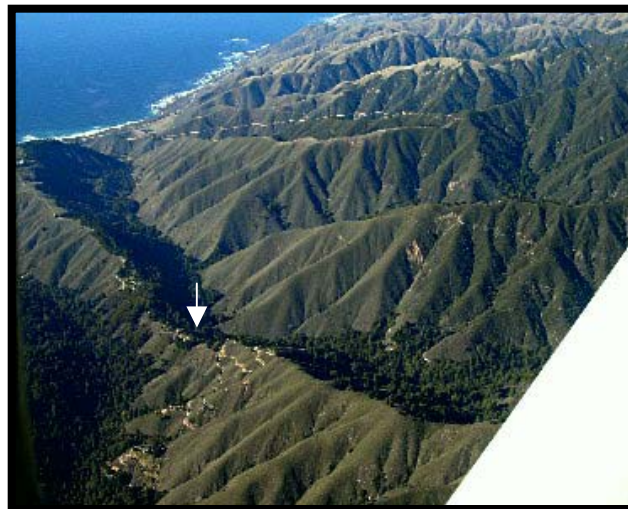
Figure 11: View down Garrapata Creek from above Rocky Creek Watershed. Garrapata Fault extends up canyon from offshore. The fault lies in the valley bottom and crosses into Palo Colorado Watershed at the low saddle (arrow).

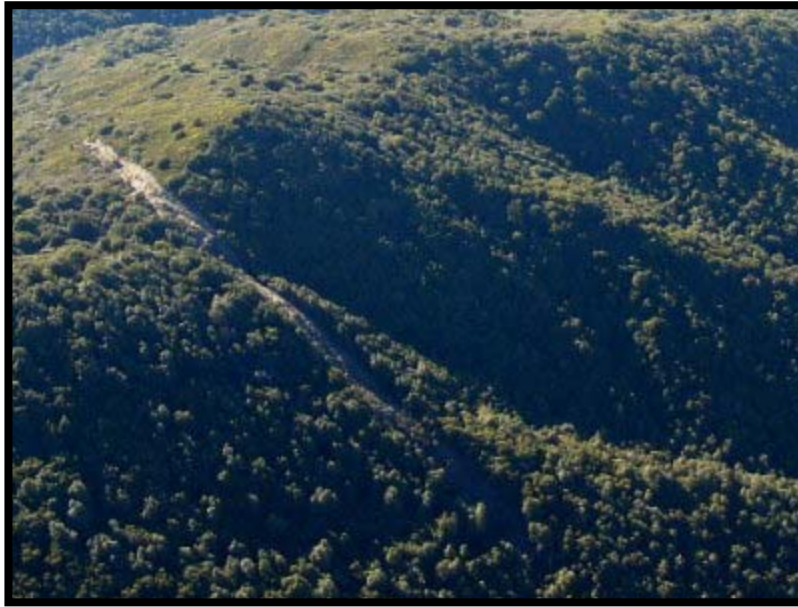
Figure 14: PG&E power line access road aimed steeply down slope in the headwaters of Garrapata Creek is potentially a chronic source of erosion and sediment delivery to Garrapata Creek (Oct. 31, 2004).

There are three locations in the Garrapata Watershed where chronic road-related sediment sources can be seen from the air; many more sites lie beneath forest canopy (Pacific Watershed Associates, 2003). One of these erosion sites is the abandoned road in the right-hand photo of Figure 8. The second site is an access road for the PG&E power lines (Fig. 14).

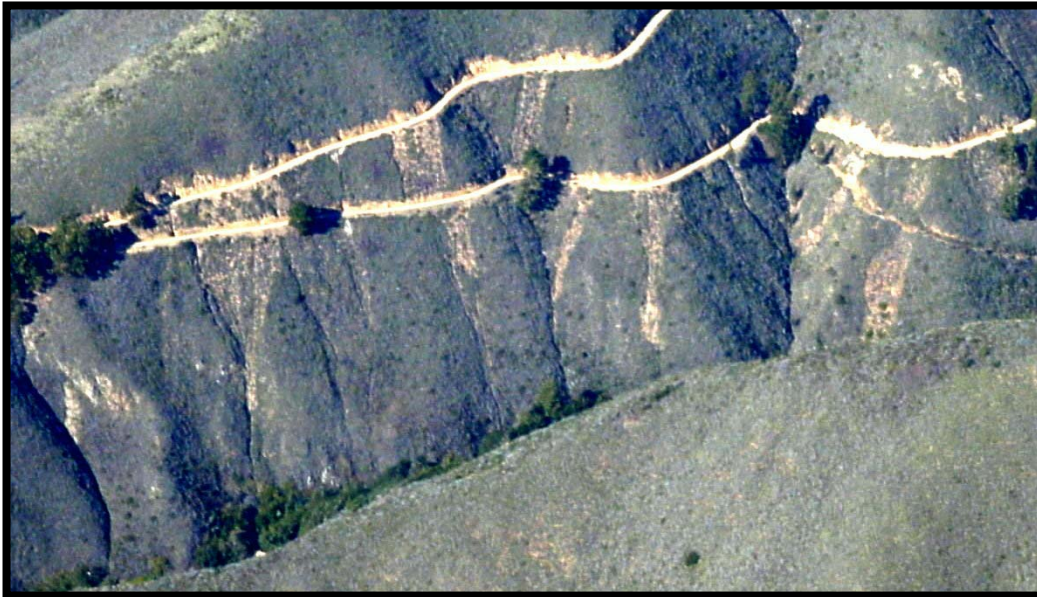
Figure 15: Detail of road in Joshua Creek subwatershed with erosion problems (Oct. 31, 2004).

The roads in Joshua Creek subwatershed exhibit the classic erosion associated with road construction across steep slopes (c.f. Fig. 12). Bare, un-vegetated substrate exposed in scalloped road-cut scarp suggest that erosion is still a chronic problem, years after road construction. The light colored aprons beneath the roads are talus slopes shed from side-cast material and eroded from cut side of road. The talus aprons below the road show the path of sediment from the road system to the creek below. During heavy rainfall, the narrow, steep gullies or debris chutes visible below the roads in Figure 15 route the loose sediment directly to the Joshua Creek channel.

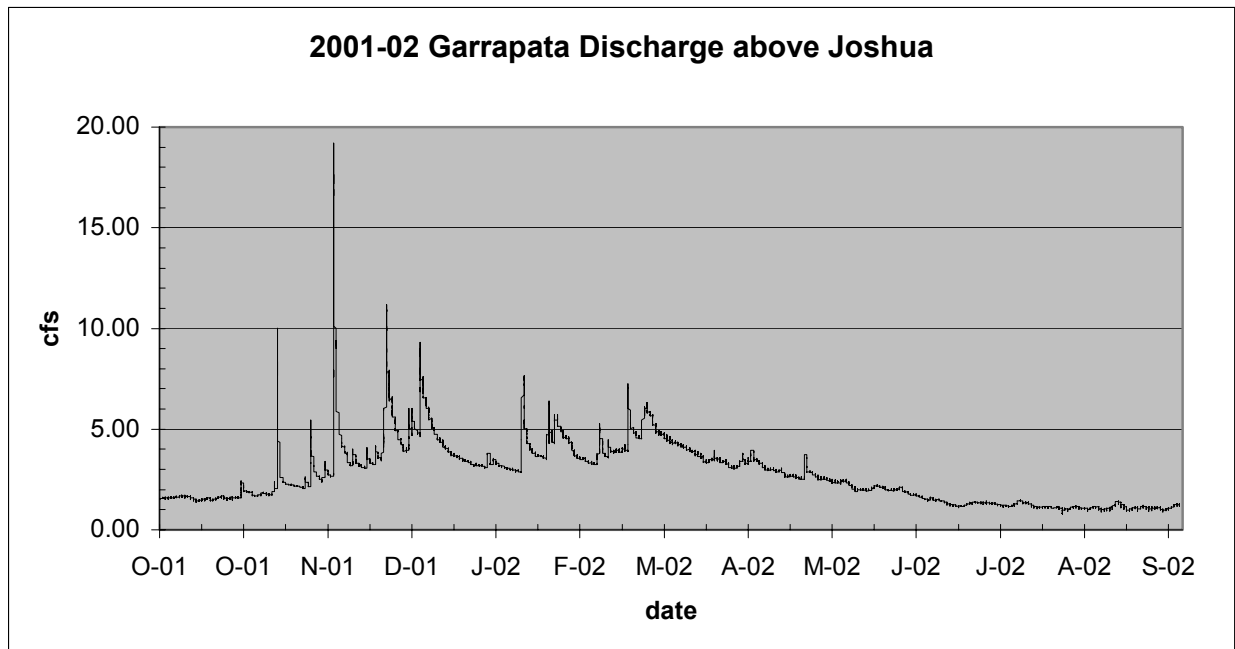
Figure 25: Garrapata discharge between October 1, 2001 and September 30, 2002.

The gauge on Garrapata Creek is rated by taking flow measurements with a calibrated Gurley brand pygmy flow meter at a straight section of channel near a wooden foot bridge located 25 m upstream from the weir. Discharge measurements are made using standard procedures for a small stream (Harrelson et al., 1994). At least 20 velocity readings are made during times of high flow, but the channel is wide enough to accommodate only 10 velocity measurements at lower flow conditions. The history of measurements is presented in Table 4. The relationship between staff plate and pressure gauge readings indicates that the stream geometry has remained stable over the life of the project (Fig. 23). An R^2 value of 0.96 indicates a very robust equation relating gauge depth to discharge (Fig. 24). We use that equation to convert from continuous gauge depth to continuous discharge (Figs 25, 26, 27).

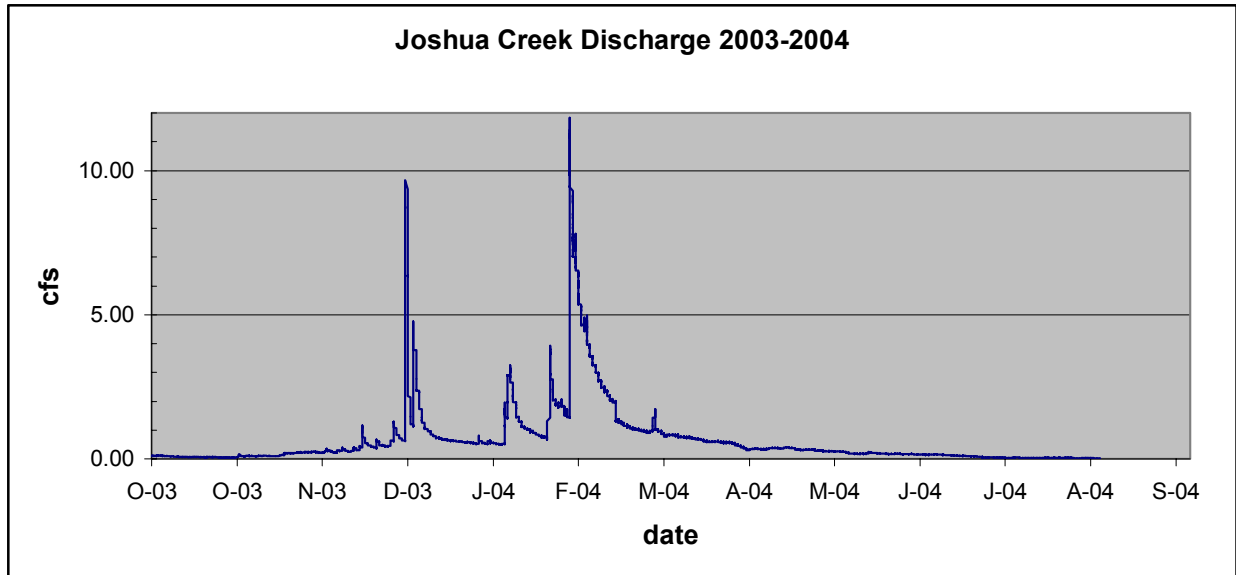
Figure 29: Joshua Creek discharge between October 1, 2003 and September 30, 2004.

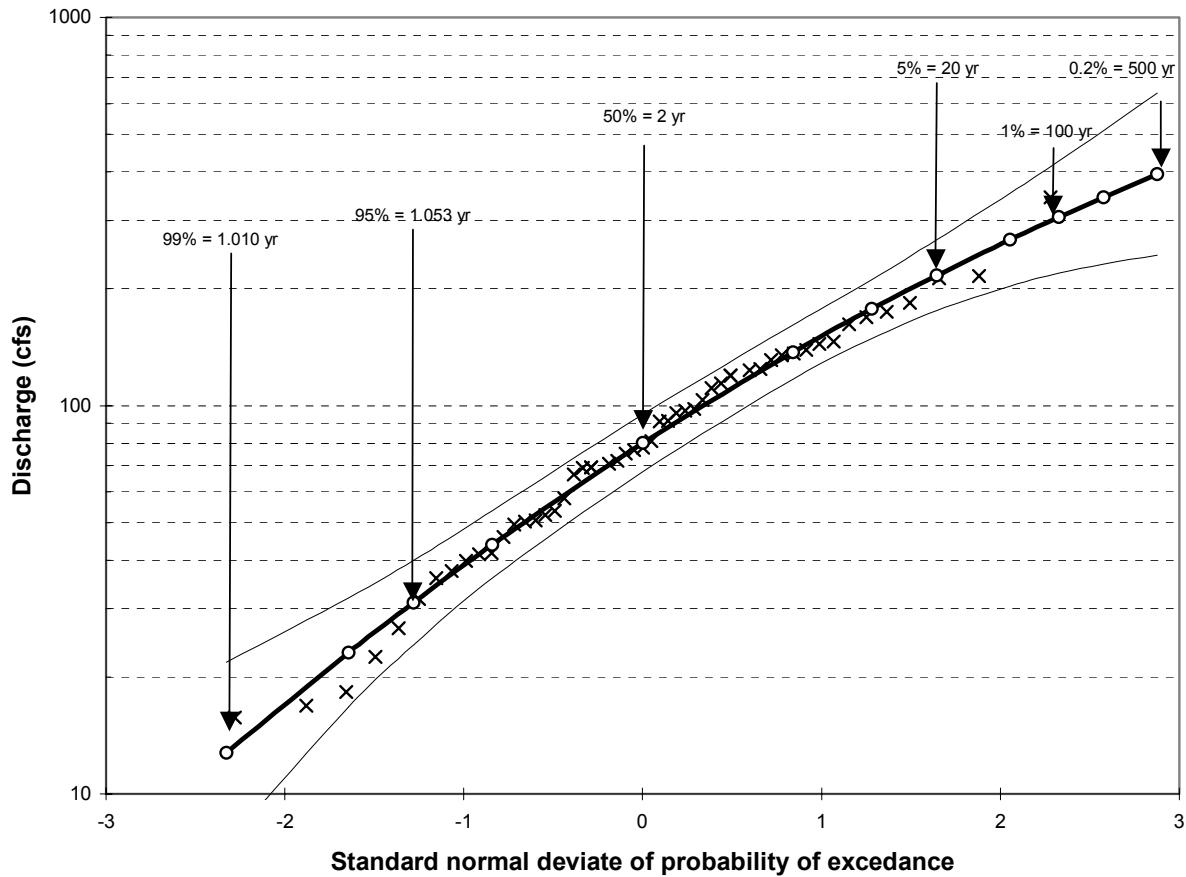
Figure 32: Exceedance probability and 95% confidence limits on synthesized 53 years of synthetic discharge at the Garrapata stream gauge. “x” shows data. “o” shows model points for various return periods. Thick line is log-Pearson type III model. Thinner lines are the 95% confidence limits on the model.

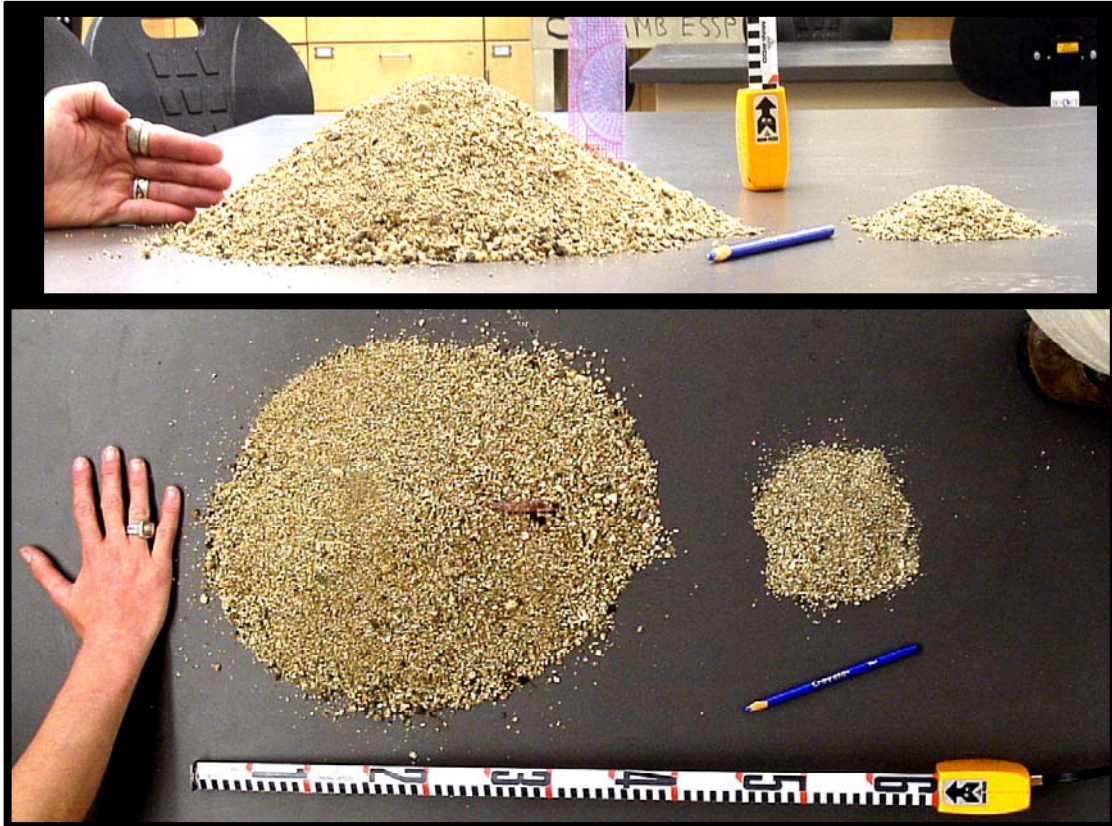
Fig 39: Bedload material collected on February 19, 2004. Left pile is 5260 g collected from Joshua Creek. Right pile is 710 grams collected from Garrapata Creek. Sampling time for both creeks was 20 minutes. Ruler numbers are decimeters.

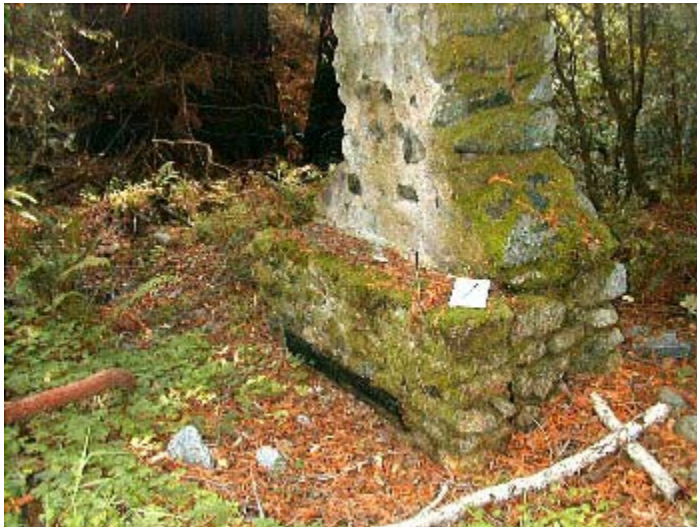
Figure 40: Fireplace of homestead ruins in Wildcat Creek. Sediment has buried the hearth and nearly all of the firebox. Photo by Nikki Nedeff (October 2004).

There is an historic homestead ruin located low in the Wildcat basin that is now partially buried in sediment (Fig. 40) It is clear that Wildcat Creek watershed has periodically been a source of sediment in the past, and continues to transport considerable sand from the upper watershed.
