Publication No. WI-2014-12

The Watershed Institute

## Hollister Hills SVRA Sediment Basin Volumes: Water Year 2012– 2013

FALL 2013

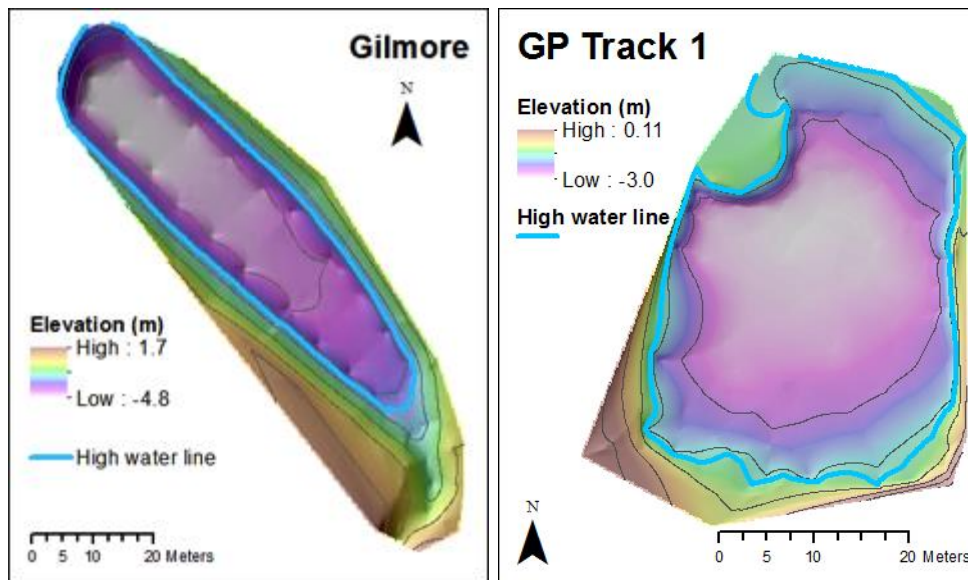
Figure 3. DEMs for basins surveyed with the total station. The elevations are in reference to the benchmark. The blue contour line indicates the elevation of the outflow pipe or spillway.

The following figures show the DEM of the baseline surveys for each basin. For the basins surveyed using the total station, the elevations are in reference to the BM. For the basins surveyed using RTK-GPS, the elevations are vertically referenced (NAVD88).

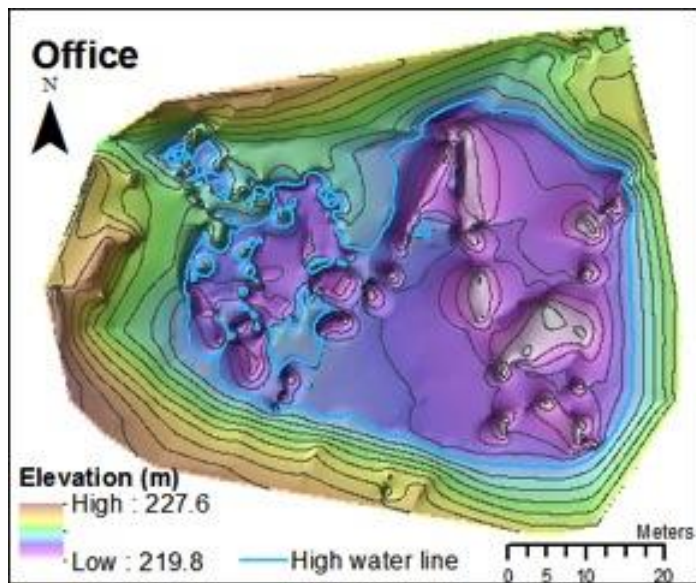
Figure 4. DEMs for the basins that were surveyed using RTK-GPS. The blue contour line indicates the elevation of the outflow pipe or spillway.

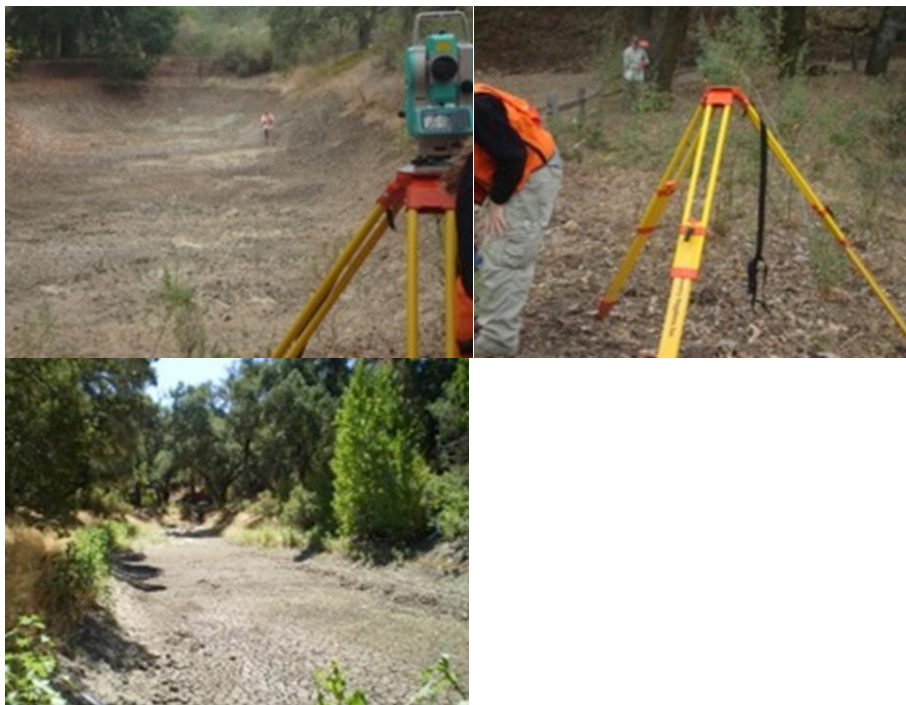
**Figure 5. Photograph of the total station and the basin facing west (left), total station and backshot facing south (right), and the basin taken from outlet pipe facing northeast (bottom).**

The total station was set up on the BM and was oriented to a false north using the BS. Using a prism pole and prism, transects of the basin were surveyed by traversing from the top of the berm from south to north taking points at the top left of the berm, left break in slope, left bottom of slope, the floor of the basin, right bottom of slope, right break in slope, and right top of the berm. Transects were performed approximately every 2 meters from the east to the west edges of the basin using the same feature class designations for each transect. A more random survey of topographic features was used to record the gully created by the input in the southeast corner, in an attempt to capture the highly variable topography in that location.

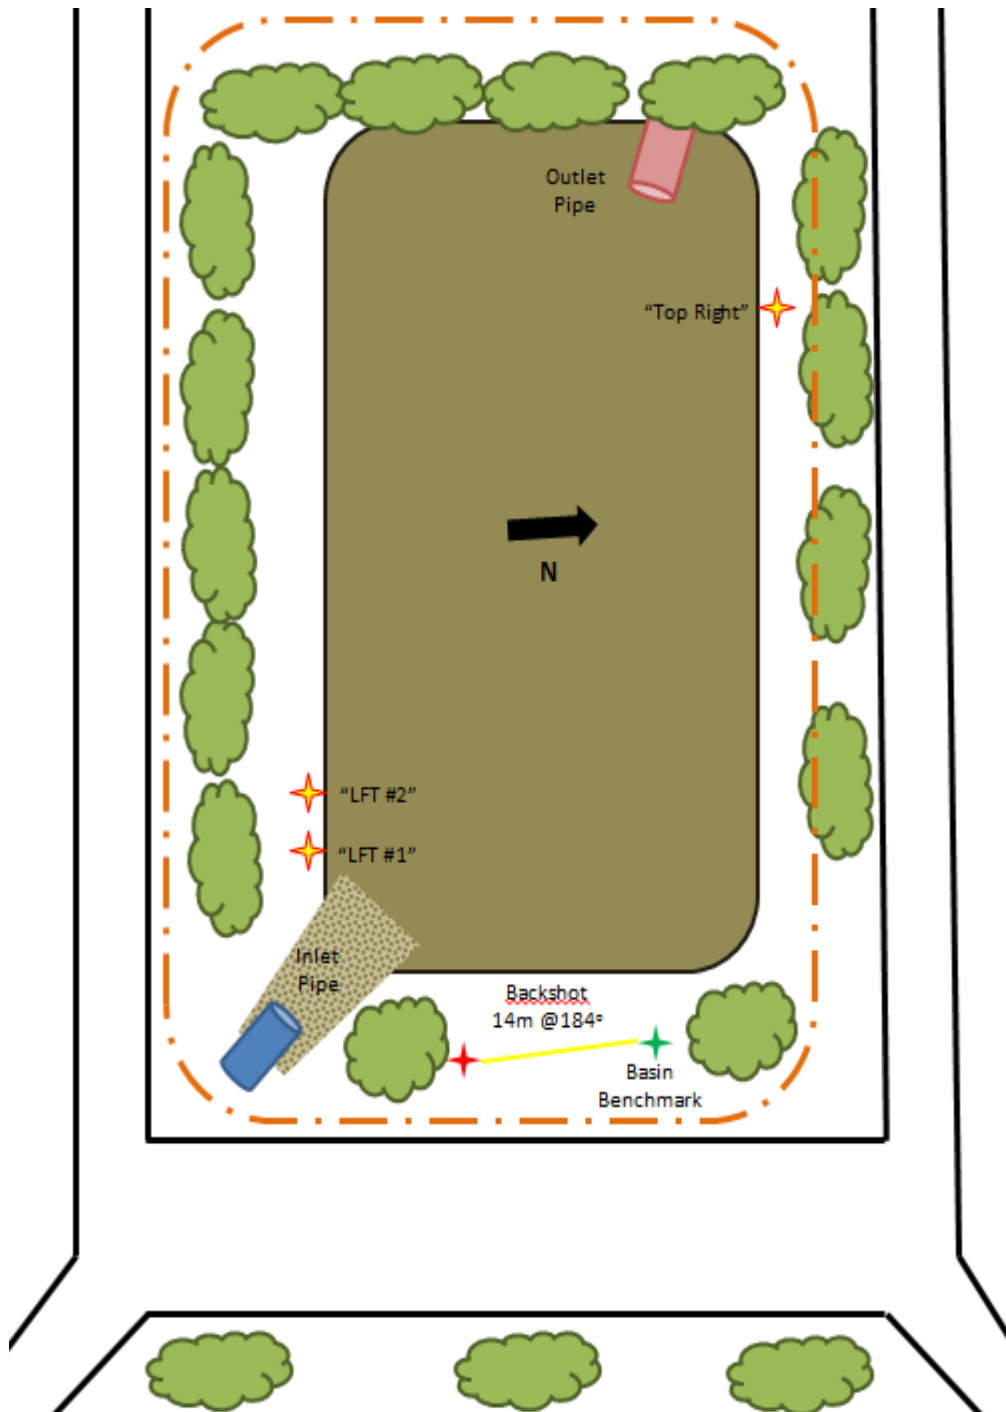
Figure 6. Diagram of Gilmore Basin showing the surrounding roads (black), the fences (orange), trees (green), inflow pipe (blue), and outflow pipe (red). The basin benchmark is shown as a green star, the backshot as a red star, and additional survey monuments are shown as yellow stars with red borders.

The Gilmore Basin is located in the Upper Ranch. To get to the basin, turn right from Cienga Road, approximately 0.65 miles southeast from the main SVRA entrance. Pass through a gated entrance to the Area 5 Group Campgrounds. Follow the dirt road past the campgrounds towards the hills in a southwest direction and the dirt road will lead to the Gilmore Basin. The basin is surrounded by a wood slat fence, has dirt trails running along both sides, and a large open space on the east side. Gilmore Basin extends approximately 20 meters from north to south, and 60 meters from east to west. The input for the basin is located in the southeast corner of the basin, and the outflow is located in the northwest corner.

As one stands in the middle of the east edge of the basin facing west, there are two distinct oak trees on the other side of the fence, one to the right, and one to the left. The basin's benchmark (BM) is located approximately 2 meters from the base of the tree to the right, and the basin's back-shot (BS) is located 1 meter from the base of the tree to the left. From the basin BM, the BS is located approximately 14 meters to the south, at a bearing of  $184^{\circ}$ . The BM was assigned a local position of 0,0,0 (E,N,Z) and the direction from the BM to the BS was used as the false northing.

In addition to the BM and the BS, four other monuments from previous surveys were located during the survey. The first monument is located approximately 8 meters from the BM and should NOT be used or mistaken for the BS in future surveys. Two monuments on the southeast slope of the basin were located and included in the survey as “LFT1” (point 8) and “LFT2” (point 11). Additionally, a monument was located on the northwest slope of the basin and included in the survey as “Top Right” (point 94).

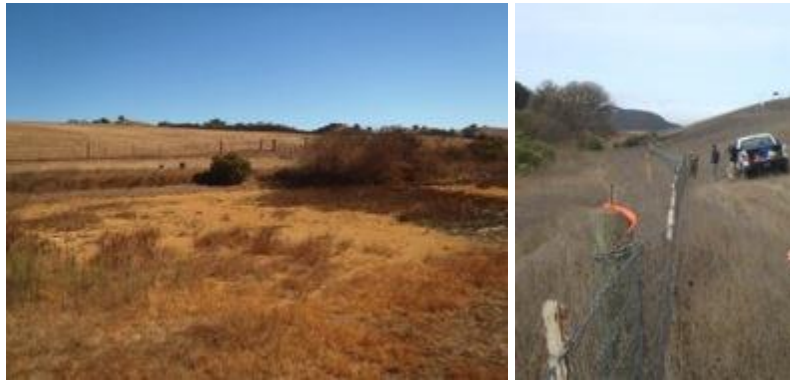
**Figure 8. Photograph of the GP 1 Track Basin facing east (left) and the view from the backshot facing the location of the total station (right).**

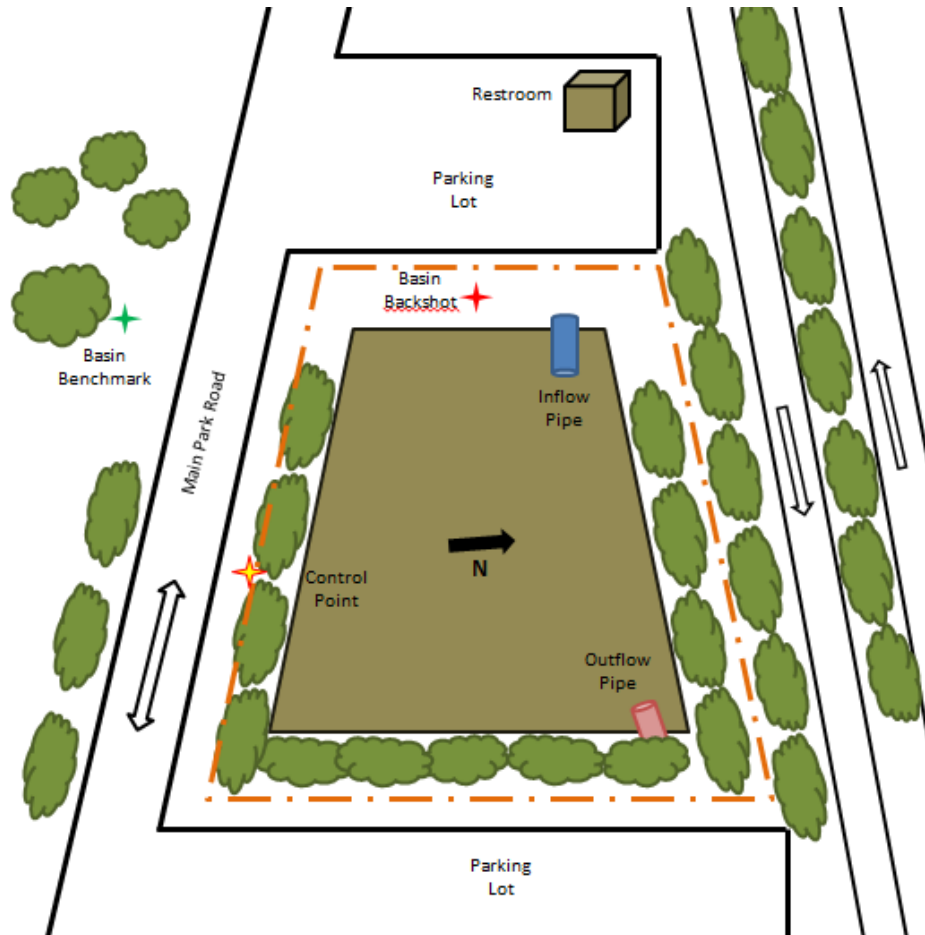
Figure 11. Diagram of the Office Basin showing surrounding roads (black), the direction of travel on roads (black arrows), fences (orange), trees (green), inflow pipe (blue), and outflow pipe (red). The basin benchmark is shown as a green star, the backshot as a red star, and additional survey monuments are shown as yellow stars with red borders.

The Office Basin is located in the Lower Ranch Property on the Main Park Road. To get to the basin, travel west on the Main Park Road approximately 300 meters; the basin is on the right side of the road nestled between the Day Use Parking Lot on the eastern side, and a large pullout with a handicap accessible restroom on the western side. The basin is bordered by the Main Park Road on the southern side and dirt trails on the north side, and is surrounded on all sides by a wood slat fence. The basin is trapezoidal with the western edge measuring approximately 20 meters across and the eastern edge approximately 30 meters across. The basin is approximately 50 meters from east to west.

Because of the amount of tall vegetation that can occur near the center of the basin, the basin BM for the survey was placed on the hillside to the south of the basin to ensure good line of sight throughout the survey. The BM is located across the Main Park Road approximately 35 meters up the slope from the southern edge of the road at the base of a large, solitary oak tree. Two monuments were used for reference during the survey; both pieces of rebar hammered flush to the ground. The first backshot (BS #1) is located on the plateau on the west side of the basin, inside and approximately 5 meters from the wood slat fence. The second backshot (BS #2) is located outside of the wood slat fence on the southern edge, approximately at the middle of the basin at a bearing of 70° from the benchmark on the southern slope.

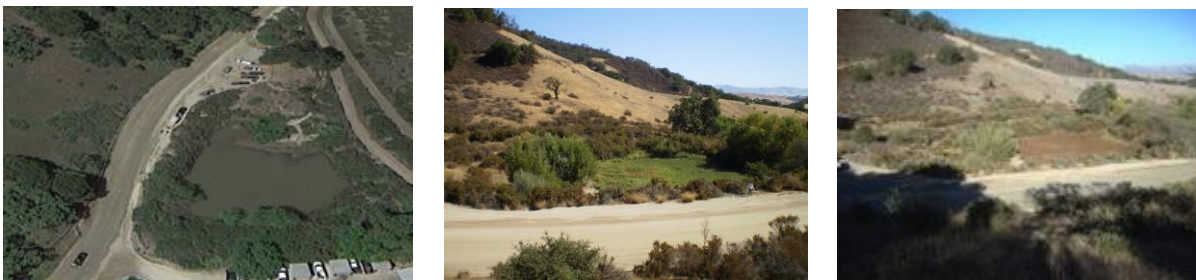
Figure 12. Ariel photograph of the Office Basin showing the location of the basin benchmark (BM#1) (left); a view of the basin from the basin benchmark (middle); and a view of the basin from the basin benchmark showing the RTK/GPS base station set up on the back-shot used for the total station surveys (BS #1) (right).

Additionally, the Office Basin was surveyed on at least two other occasions using RTK/GPS equipment. For these surveys, the monument denoted as BS #1 for this survey was used as the BM and points were taken throughout the basin complex, including the monuments used for the total station survey. From these surveys we have the UTM coordinates for BS #1 (641346.45E, 4070719.4N), and for the benchmark (BM #1) on the slope of the southern side (641342.45E, 4070646.9N) used in the total station survey of the basin.

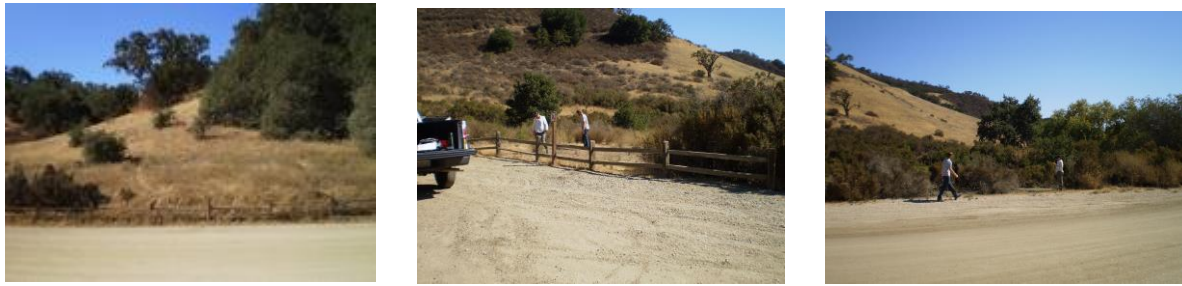
Figure 13. Photograph of the location of the basin benchmark (BM #1) from the southern edge of the basin (left); the location of the backshot (BS #1) used for the total station surveys (middle); and the location of the second backshot (BS #2) used for the survey (right).

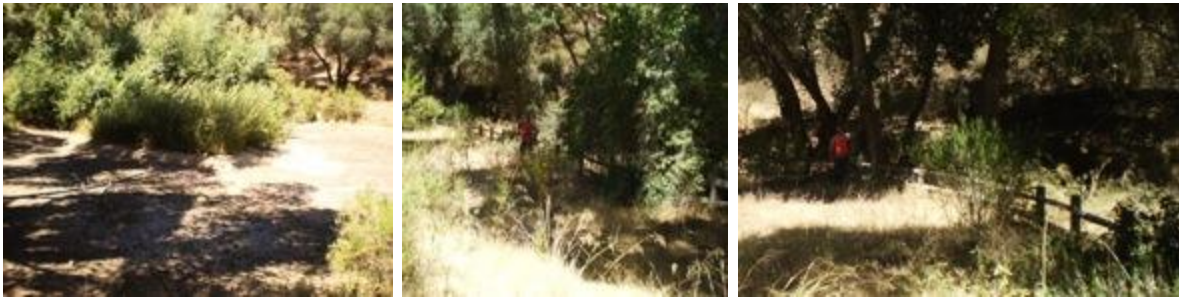
**Figure 16. The Sycamore Basin viewed from the southeast corner of the basin showing the channel cut island (left); the location of the basin benchmark near the fence at the center of the eastern edge of the basin (middle); and the location of the nail in the oak tree used for the backshot in the northeast corner of the basin (right).**

The BM is located inside the fence perimeter, about half way between the north and south edges, and about 1 meter west of the fence. The BS is a piece of rebar in the ground, 27 meters from the BM at a bearing of  $330^\circ$ . Nail #1 is located in an oak tree about 1.9 meters from the ground, is approximately 23 meters to the north, at a bearing of  $337^\circ$  (points 2 and 190). Nail #2 is located in an oak tree is located on the southwest face of a hillside bordering the basin is at a bearing of  $222^\circ$  from the BM, at a distance of approximately 30 meters (points 4 and 133).

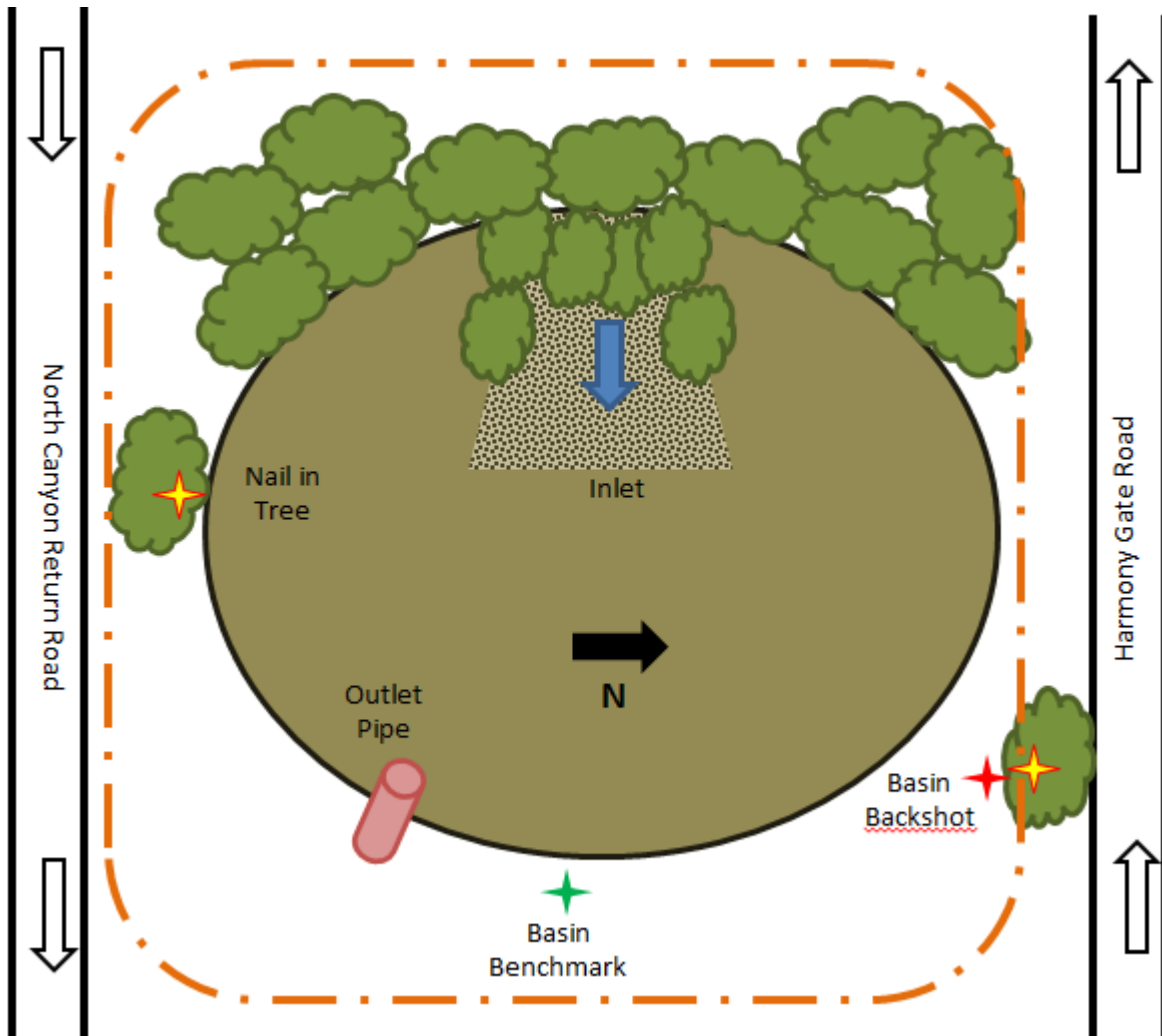
Figure 17. Diagram of the Sycamore Basin showing surrounding roads (black), fences (orange), trees (green), inflow (blue), outflow pipe (red), and channel cut island (dark brown). The basin benchmark is shown as a green star, the backshot as a red star, and additional survey monuments are shown as yellow stars with red borders.

The Sycamore Basin is located in the Lower Ranch property on Harmony Gate Road. To get to the basin, take the Main Park Road west from Park Headquarters until you reach Lodge Lake. Turn right onto Harmony Gate Road at Lodge Lake and Sycamore Basin is located approximately 0.3 miles up Harmony Gate Road on the left. The basin is roughly oval with a channel cut island on the western edge. The basin is surrounded by a wood slat fence, has dirt trails running along both sides, and a trail crossover on the east edge. The basin is approximately 40 meters from north to south and 20 meters from east to west. Water enters the basin through the channel on the western edge and exits through the outlet pipe located in the southeast corner of the basin.

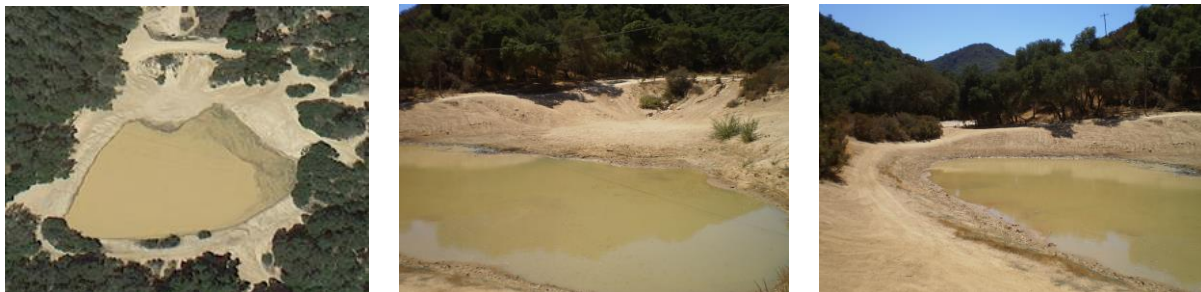
**Figure 21. Aerial photograph of the Whoopdeedoo Basin showing its trapezoidal shape (left); view of the western side of the basin and the basin inlet from the basin benchmark (middle); and view of the eastern side of the basin from the basin benchmark (right).**

The Whoopdeedoo Basin is located in the Lower Ranch property on Long Canyon Road. To get to the basin, take the Main Park Road west from Park Headquarters until you reach Lodge Lake. Turn right onto Harmony Gate Road at Lodge Lake, travel approximately 0.3 miles on Harmony Gate Road and then turn right onto Long Canyon Road. Whoopdeedoo Basin is located at the entrance to Long Canyon Road on the right. Whoopdeedoo is a large and deep basin bordered on the south side by Long Canyon Road with dirt trails bordering all other sides of the basin. The basin is trapezoidal with the narrow end at the western edge where the inlet pipe is located, with a triangular alluvial fan cut with multiple dykes channeling water into the basin. The outlet of the basin is located in the northeast corner of the basin next to a dirt trail and covered in thick coyote bushes. Unlike other basins in this survey, the outlet is a vertical drainpipe cut with outlet ports. The outlet pipe leads to a concrete channel with a cross section of approximately one square meter and a length of approximately 10 meters.

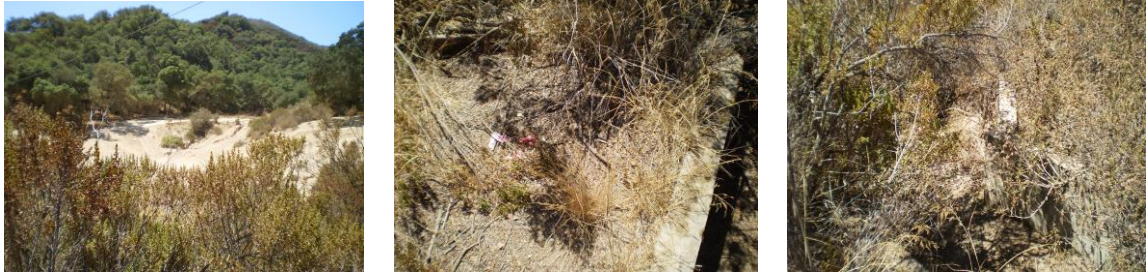
Figure 22. View of the western side of the Whoopdeedoo basin and the basin inlet from the basin benchmark (left); the basin benchmark located in the northeastern corner of the basin and next to the concrete culvert (middle); and view of the concrete culvert that diverts water from the basin outlet (right).

The RTK/GPS base station was set up on the single basin benchmark located in the northeast corner of the basin next to the concrete channel. The UTM coordinates for the benchmark established by the RTK/GPS unit during the survey are 639401.56E, 4070719.4N.

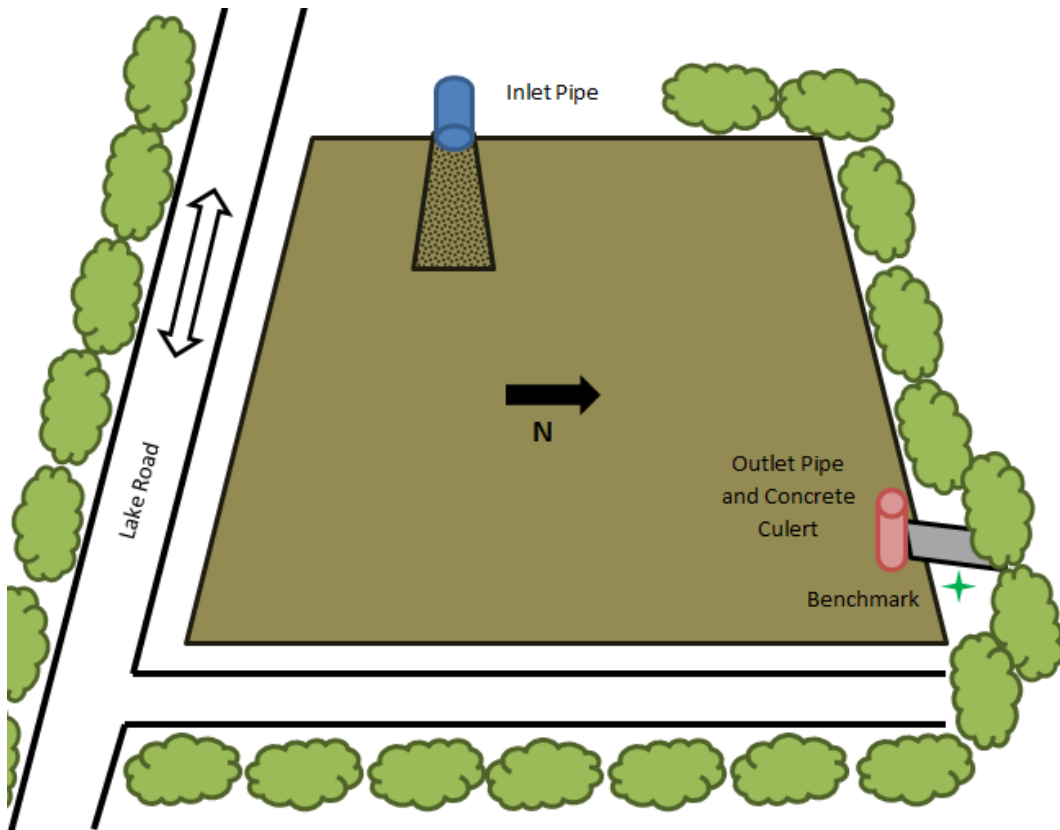
Figure 20. Diagram of the Whoopdeedoo Basin showing surrounding roads (black), direction of travel on roads (black arrows), trees (green), inflow pipe (blue), and outflow pipe (red). The basin benchmark used for RTK/GPS is shown as a green star in the northeastern corner of the basin.

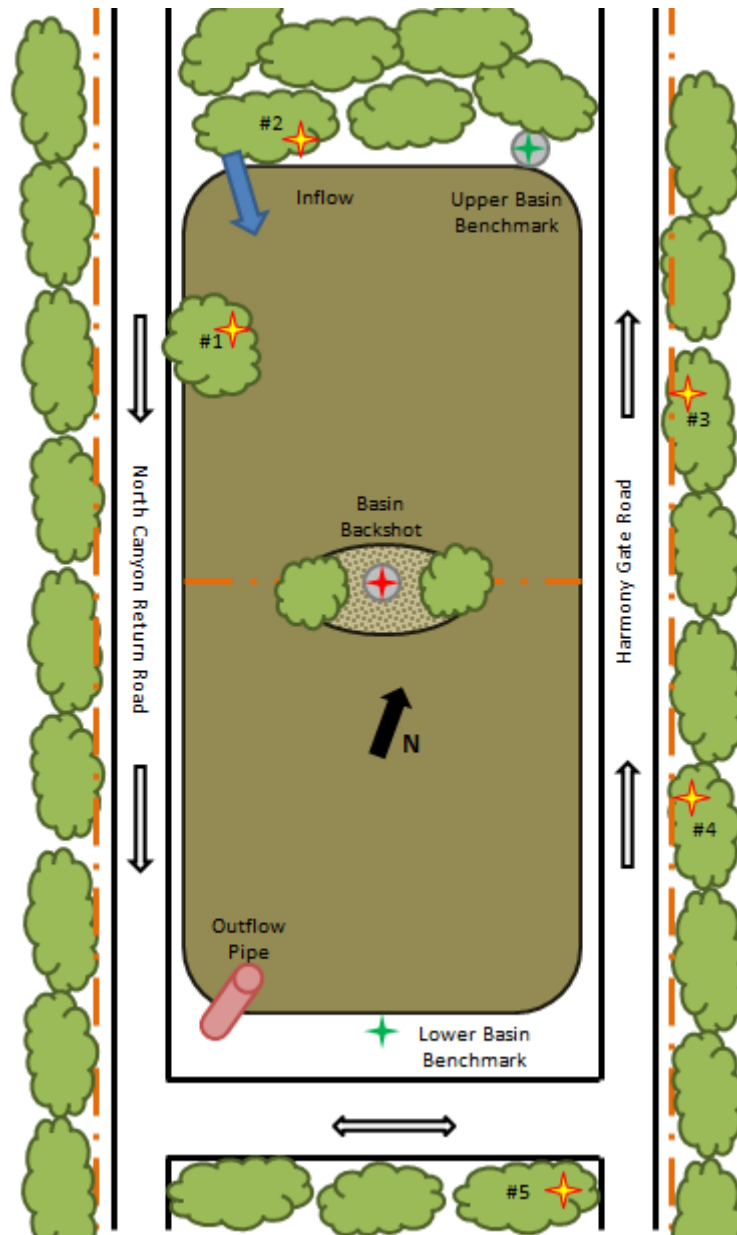
Figure 23. Diagram of the Woodwardia Basin showing surrounding roads (black), fences (orange), trees (green), rocks (grey), inflow (blue), and outflow pipe (red). The basin benchmarks are shown as a green stars, the back-shot as a red star, and additional survey monuments are shown as yellow stars with red borders. Numbers indicating monument identifications have also been included.

The Woodwardia Basin is located in the Lower Ranch property on Harmony Gate Road. To get to the basin, take the Main Park Road west from Park Headquarters until you reach Lodge Lake. Turn right onto Harmony Gate Road at Lodge Lake and Woodwardia Basin is located approximately 0.5 miles up Harmony Gate Road on the left. The basin is bordered on both sides by dirt trails and wood slat fences, with a large island and a wood slat fence bisecting the basin. A trail crossover from east to west borders the southern edge. The northern section is predominantly filled with dirt and is used heavily by off-road vehicles, while the southern section is covered with wetland vegetation. Extreme caution should be used when working in the northern section of the basin. The basin is approximately 60 meters long from north to south, and 30 meters from east to west. Water enters the basin through a channel in the northwest corner, and exits through the outlet pipe in the southwest corner of the basin.

Due to the length of the basin and the island with large trees in the middle of the basin, two benchmarks and total stations were used to survey the basin, one at the northern end and one at the southern end of the basin. The north basin benchmark (BM #1) is chiseled into a rock at the base of a large oak tree in the northeast corner of the basin. The south basin benchmark (BM #2) is a piece of rebar located at the top of the berm approximately half way across the southern edge of the basin. The BS is chiseled into a large rock located in the center of the island that bisects the basin and was used as the BS for both BMs. The BS is approximately 30 meters from the northern benchmark (BM #1) at a bearing of  $125^\circ$ , and approximately 30 meters from the southern benchmark (BM #2) at a bearing of  $306^\circ$ . The northern TS was setup on BM #1 and assigned a local position of 0,0,0 (E,N,Z) and the direction from the BM to the BS ( $125^\circ$ ) was used as the false northing. The southern TS was setup on BM #2 with a position of 86.808, -62.816, -1.172 (E,N,Z) and the direction from the BM to the BS ( $306^\circ$ ) was used as the false northing.

There are 5 monuments used for reference in the Woodwardia Basin complex. Monuments 1 through 3 are nails in trees used for reference with the northern BM, and nails 4 and 5 were used for reference for the southern BM. All nail monuments are hammered flush to the tree surface, and located approximately 2 meters from ground level facing the appropriate BM. From the northern BM, Nail #1 is approximately 20 meters southwest at a bearing of  $145^\circ$ . Nail #2 is approximately 15 meters west at a bearing of  $215^\circ$ , and Nail #3 is approximately 20 meters east at a bearing of  $80^\circ$ . From the southern BM, Nail #4 is approximately 20 meters northeast, and nail #5 is approximately 20 meters east; no bearings for these monuments are currently available and should be obtained during the next survey. The BM was assigned a local position of 0,0,0 (E,N,Z) and the direction from the BM to the BS was used as the false northing

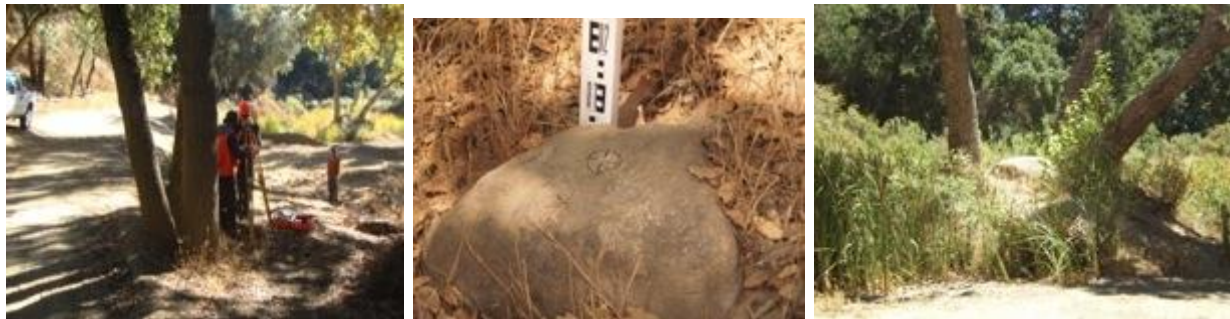
**Figure 24. The Woodwardia Basin viewed from the northeastern corner of the basin showing the northern benchmark and the island that bisects the basin (left), the northern benchmark (middle), and the island in the middle of the basin with the large rock on which the backshot is located (right).**

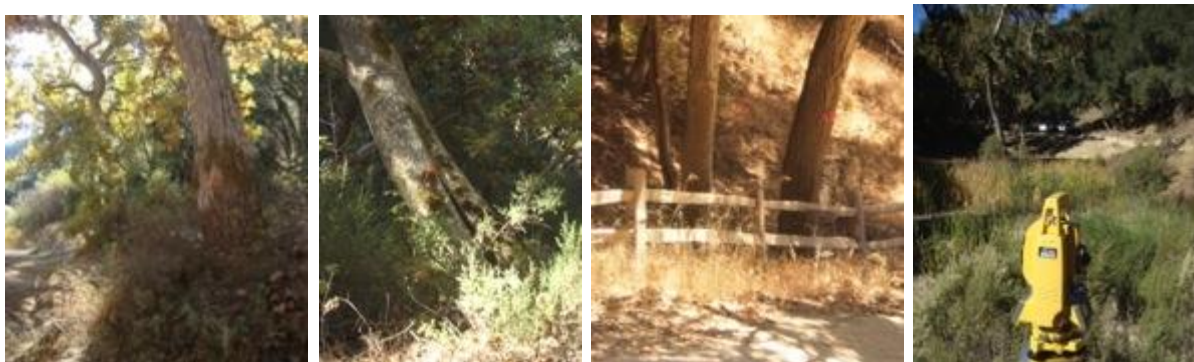
**Figure 25. The tree with monument #1 (far left), the tree with monument #2 (middle left), the tree with monument #3 (middle right), and the view from the southern benchmark (BM #2) showing the basin, the island, and the location of the northern benchmark (BM #1) in relation to the southern benchmark (far right).**
