WI Publication No. WI-2017-02

Hollister Hills SVRA

Sediment Basin Volumes:

Water Year 2016

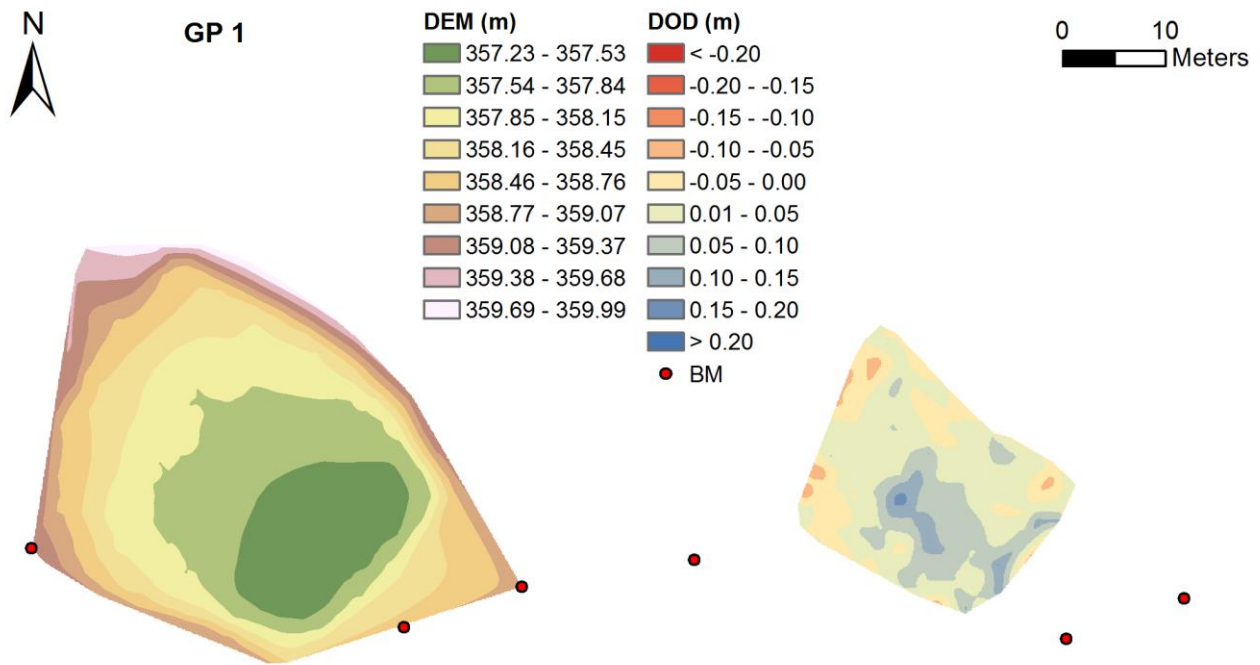
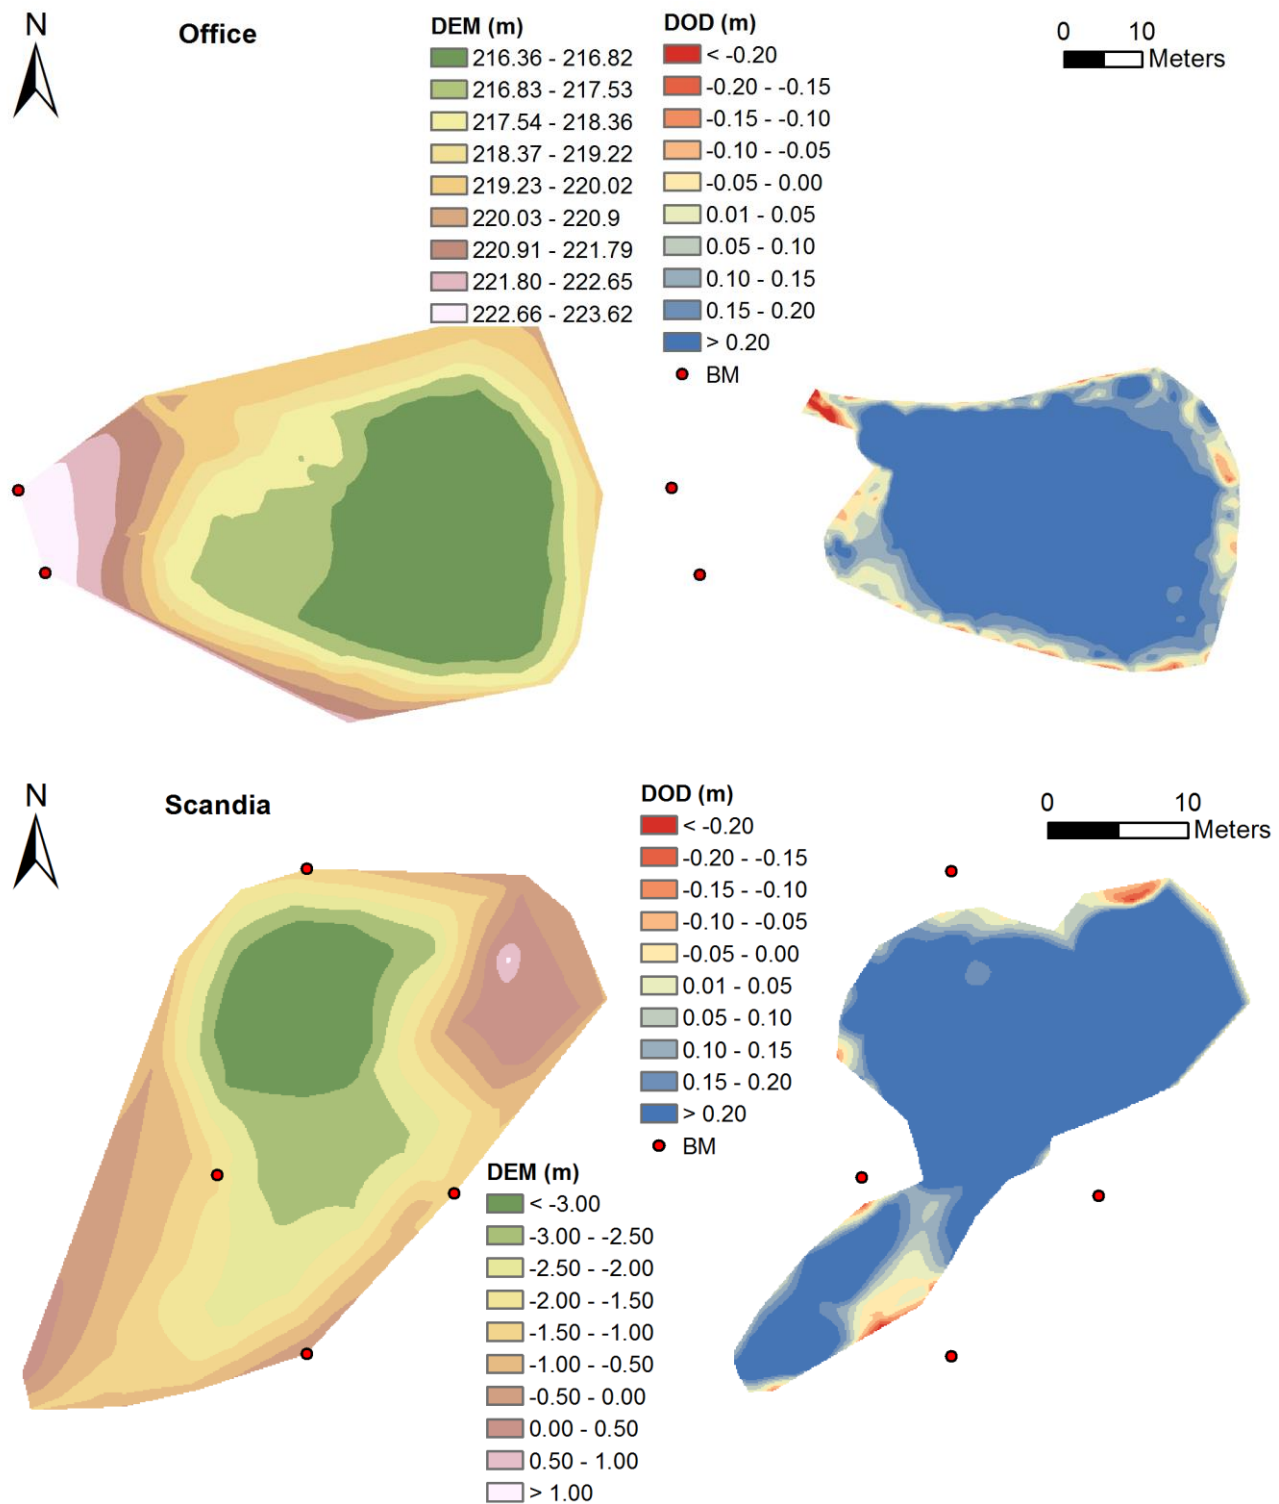
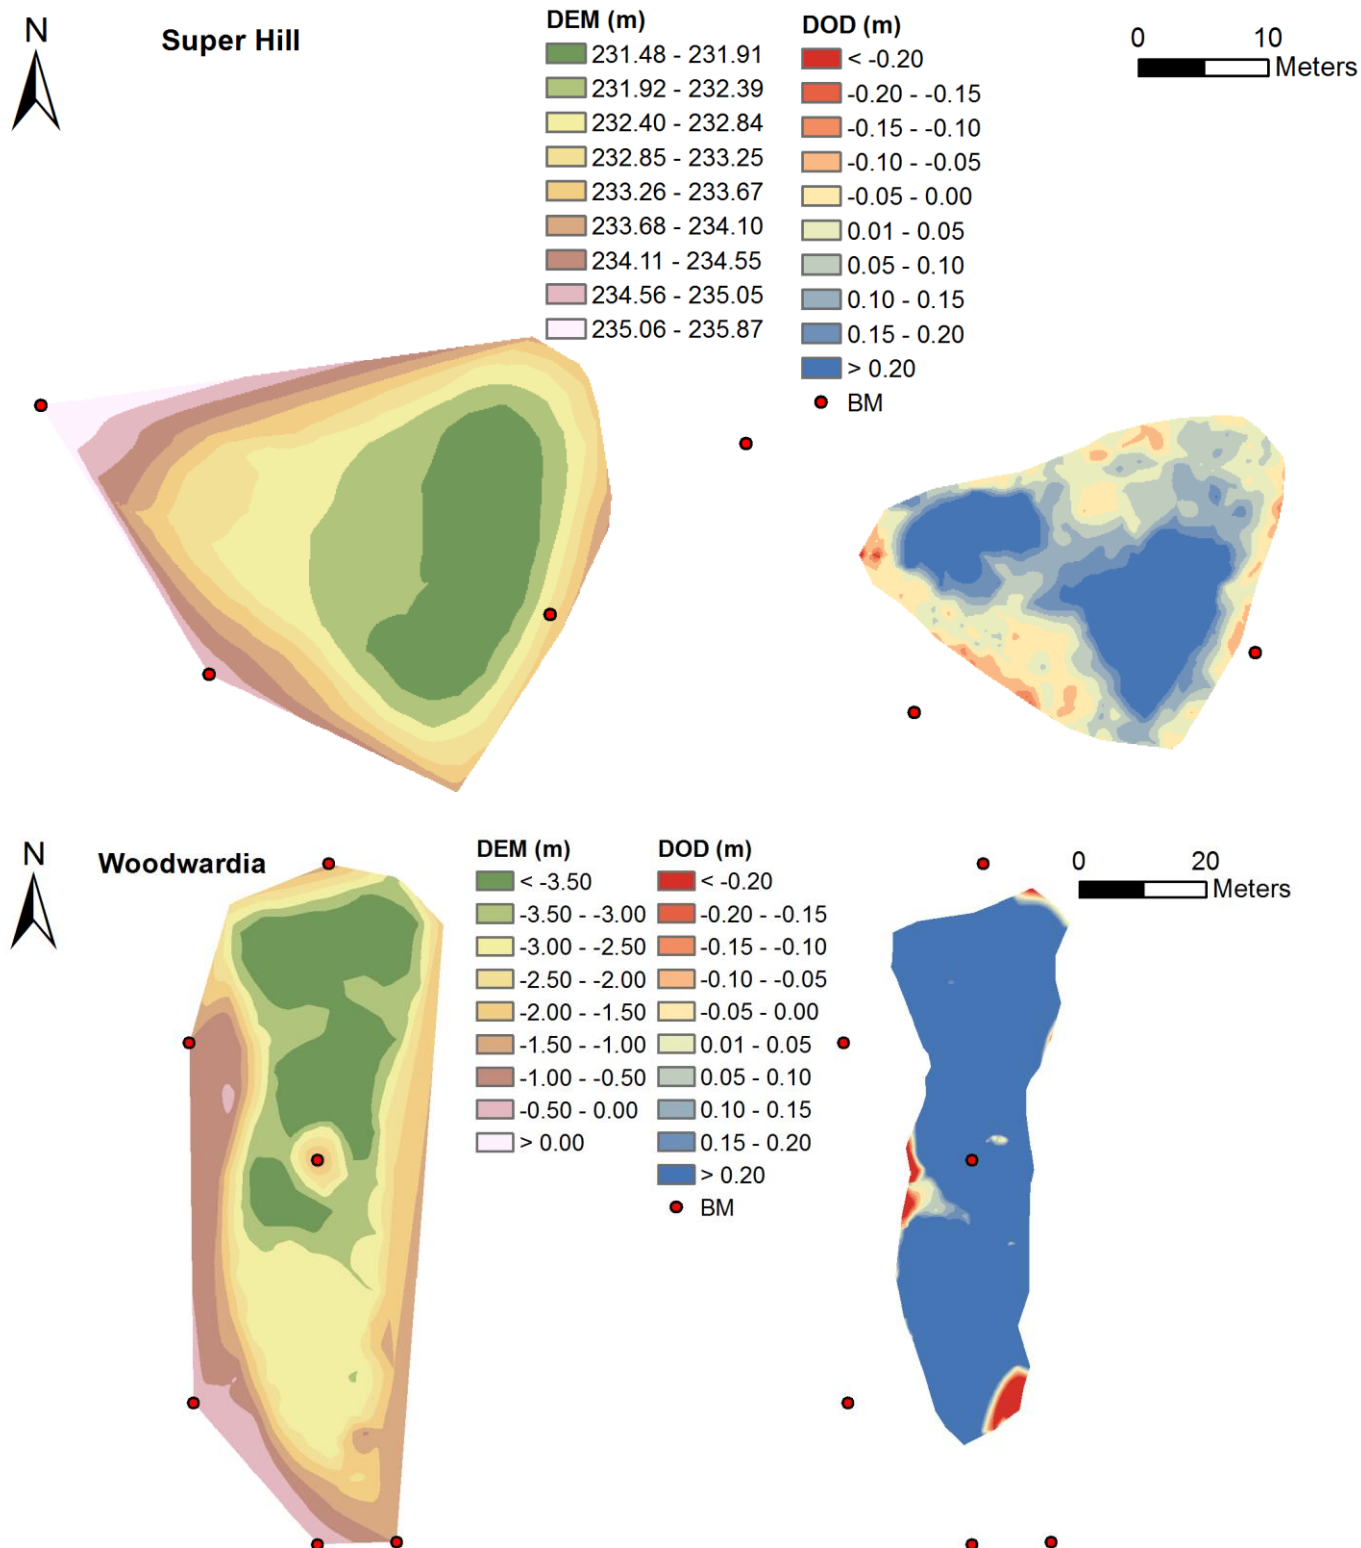
The following figures show the 2016 DEM and net aggradation and degradation for each basin. For the basins surveyed using the total station, the elevations are in reference to the BM. For the basins surveyed using RTK–GPS, the elevations are vertically referenced (NAVD88).

Figure 3. 2016 DEM and net aggradation and degradation (DOD) for each basin surveyed (GP1, Office, Scandia, Super Hill, Woodwardia). Red indicates net aggradation and blue indicates net degradation. The elevations are in reference to a local benchmark (BM).

Net aggradation and degradation of each sediment basin was calculated using the ArcMap Cut Fill tool, by inputting the initial year's DEM as the "before" raster and the most recent DEM as the "after" raster. Some basins point survey coverage was sparse along the edges causing unconstrained topographic interpolation in ArcGIS. To prevent this, basin areas were manually clipped to optimize the analysis for limited slope inclusion, high measured point density between "before" and "after" surveys, and basin floor inclusion, where we hypothesized the majority of the sediment was retained.

Post-winter sediment retention volume was calculated for the five basins that contained new deposits in WY 2016 (Table 1). The total sediment retained between the five basins was approximately 947 m³ (1237 yd³). GP 1 retained approximately 13 m³ (17 yd³) of sediment, which was over 10 times the amount that was retained in the previous survey in 2013. Office retained approximately 486 m³ (635 yd³) or 792 tonnes. Scandia retained 342 m³ (447 yd³). Super Hill captured approximately 67 m³ (88 yd³) or 109 tonnes of sediment. Woodwardia retained 39 m³ (50 yd³) of sediment at 63 tonnes.

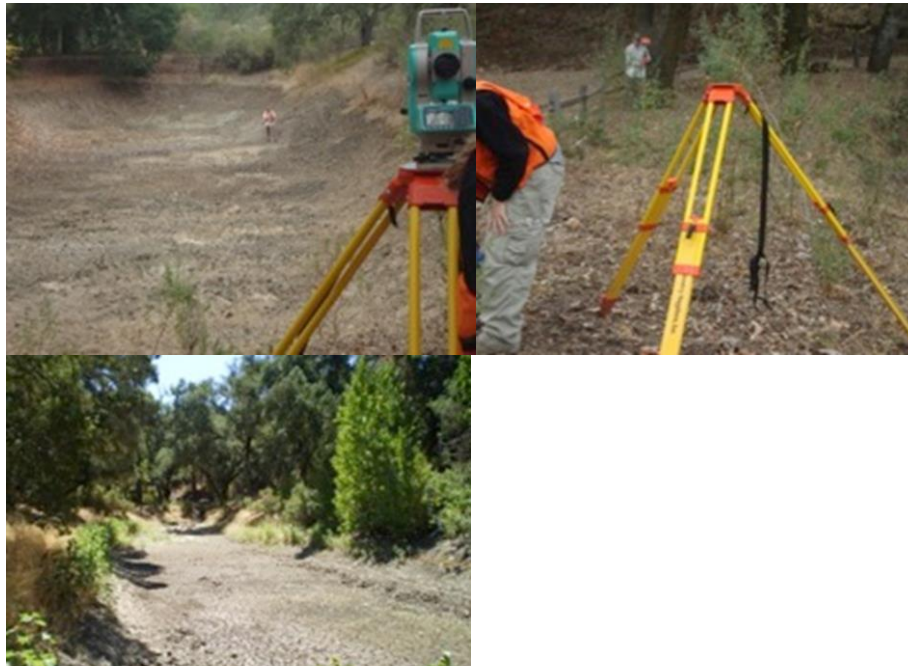
Figure 4.
Photograph of the total station and the basin facing west (left), total station and backshot facing south (right), and the basin taken from outlet pipe facing northeast (bottom).

The total station (TS) was set up on the BM and was oriented to a false north using the BS. Using a prism pole and prism, transects of the basin were surveyed by traversing from the top of the berm from south to north taking points at the top left of the berm, left break in slope, left bottom of slope, the floor of the basin, right bottom of slope, right break in slope, and right top of the berm. Transects were performed approximately every 2 meters from the east to the west edges of the basin using the same feature class designations for each transect. A more

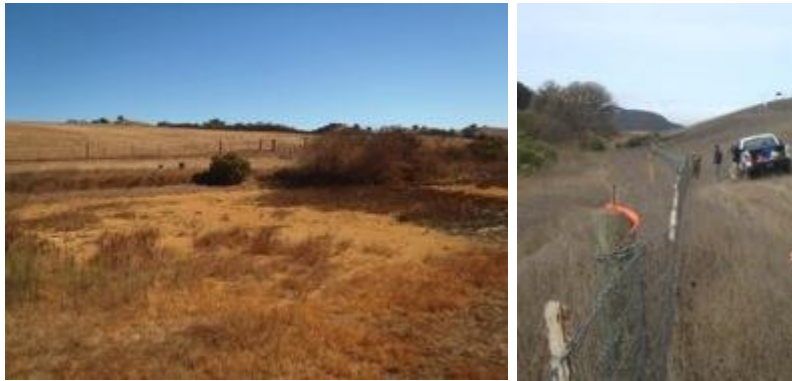
Figure 7. Photograph of the GP 1 Track Basin facing east (left) and the view from the backshot facing the location of the total station (right).

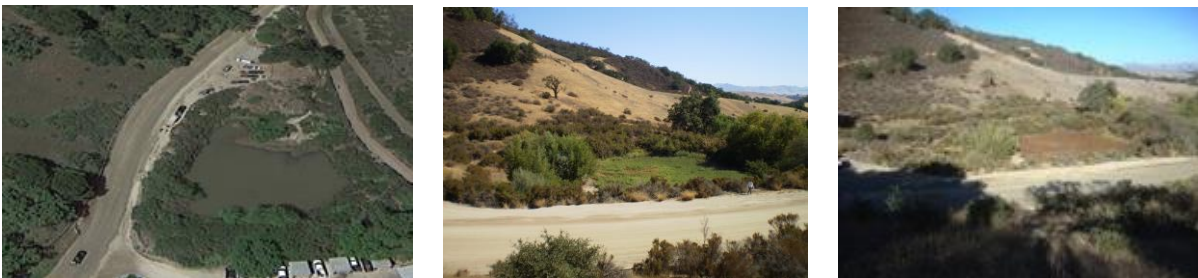
Figure 11. Ariel photograph of the Office Basin showing the location of the basin benchmark (BM#1) (left); a view of the basin from the basin benchmark (middle); and a view of the basin from the basin benchmark showing the RTK/GPS base station set up on the back-shot used for the total station

The TS was set up on the BM and oriented to a false north using the BS on the western side of the basin (BS #1). Using a prism pole and prism, transects of the basin were surveyed by traversing from the top of the berm from north to south taking points at the top left of the berm, left break in slope, left bottom of slope, the floor of the basin, right bottom of slope, right break in slope, and right top of the berm. Transects were performed approximately every 2 meters from the north to the south edges of the basin using the same feature class designations for each transect. A more random survey of topographic features was used to record unique features and the around the vegetated plateau in the center of the basin to capture the highly variable topography at that location.

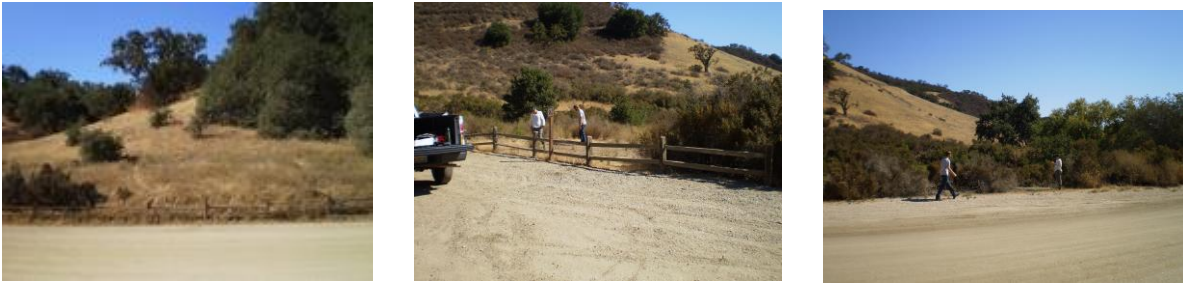
Figure 12. Photograph of the location of the basin benchmark (BM #1) from the southern edge of the basin (left); the location of the backshot (BS #1) used for the total station surveys (middle); and the location of the second backshot (BS #2) used for the survey (right).

across the Main Park Road approximately 35 meters up the slope from the southern edge of the road at the base of a large, solitary oak tree. Two monuments were used for reference during the survey; both pieces of rebar hammered flush to the ground. The first backshot (BS #1) is located on the plateau on the west side of the basin, inside and approximately 5 meters from the wood slat fence. The second backshot (BS #2) is located outside of the wood slat fence on the southern edge, approximately at the middle of the basin at a bearing of 70° from the benchmark on the southern slope.

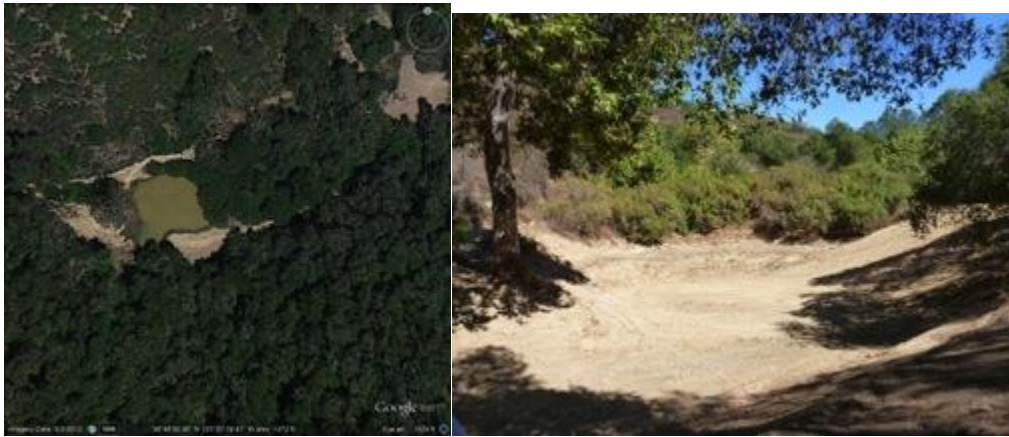
Figure 13. Aerial photograph of the Scandia Basin (left) and a view of the basin from location of the total station facing east (right).

The TS was set up on the BM and setup using the quick setup protocol. The BM was assigned a local position of 0,0,0 (E,N,Z) and the direction from the BM to the BS was used as the false northing.

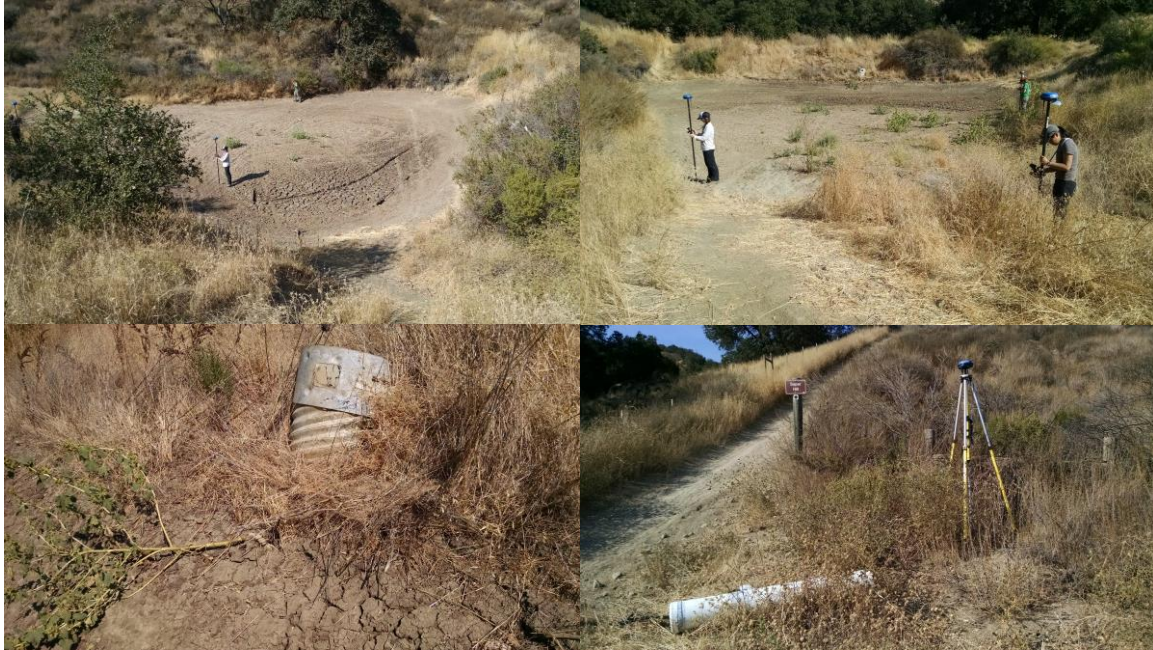
Figure 15. Overview of Super Hill Basin from the southeast (top left). Standing on the inflow trail and facing the spillway of Super Hill (top right). Super Hill's spillway culver (bottom left). RTK on top of BM next to Super Hill trail (bottom right).

Super Hill basin is triangle in shape with the apex facing approximately west. This small basin drains Super Hill Trail and is sometime subject to minor erosion from motorcycle riding within the basin. A small gully is forming in the west side of the basin between the trail and the basin, where runoff inflows. We captured this gully as well as the perimeter trail.

There are two benchmarks on the west side (closest to the trail) as capped rebar on either side of the basin's "triangle point." The RTK was set on the north BM located immediately next to coyote bush, halfway between the trail and the sediment basin. The south BM, used as a BS, is located due south of the BM on what used to be a vegetated peninsula. The spillway is located on the east side slope of the sediment basin as a vertical culvert with holes on the side.

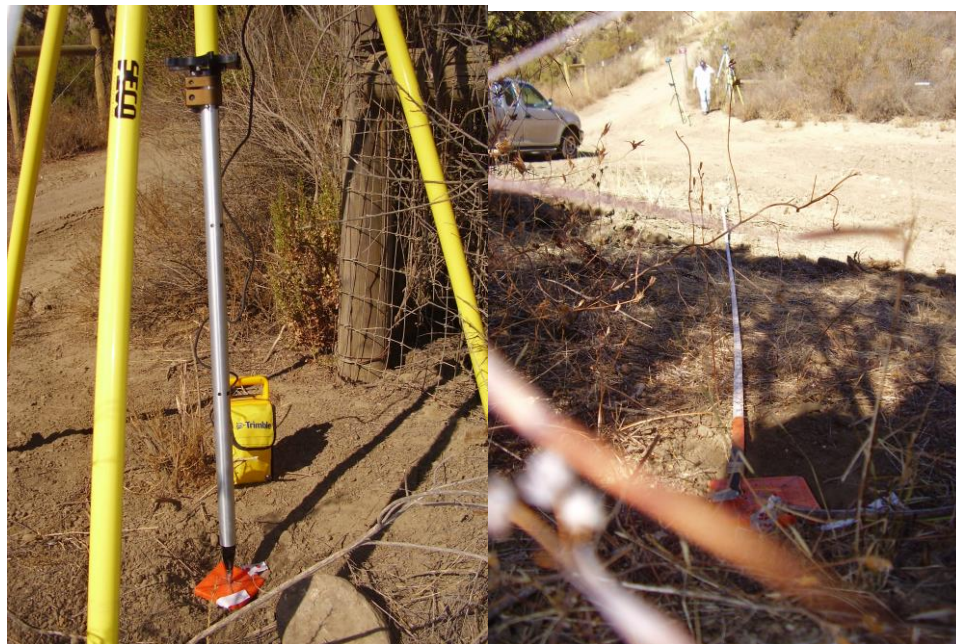
Figure 16. BM with RTK (left) and BS (right).

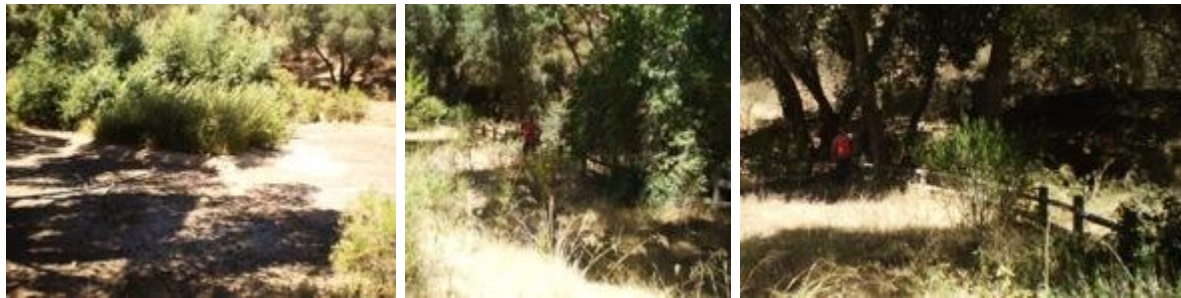
Figure 18. The Sycamore Basin viewed from the southeast corner of the basin showing the channel cut island (left); the location of the basin benchmark near the fence at the center of the eastern edge of the basin (middle); and the location of the nail in the oak tree used for the backshot in the northeast corner of the basin (right).

The BM is located inside the fence perimeter, about half way between the north and south edges, and about 1 meter west of the fence. The BS is a piece of rebar in the ground, 27 meters from the BM at a bearing of 330°. Nail #1 is located in an oak tree about 1.9 meters from the ground, is approximately 23 meters to the north, at a bearing of 337° (points 2 and 190). Nail #2 is located in an oak tree located on the southwest face of a hillside bordering the basin is at a bearing of 222° from the BM, at a distance of approximately 30 meters (points 4 and 133).

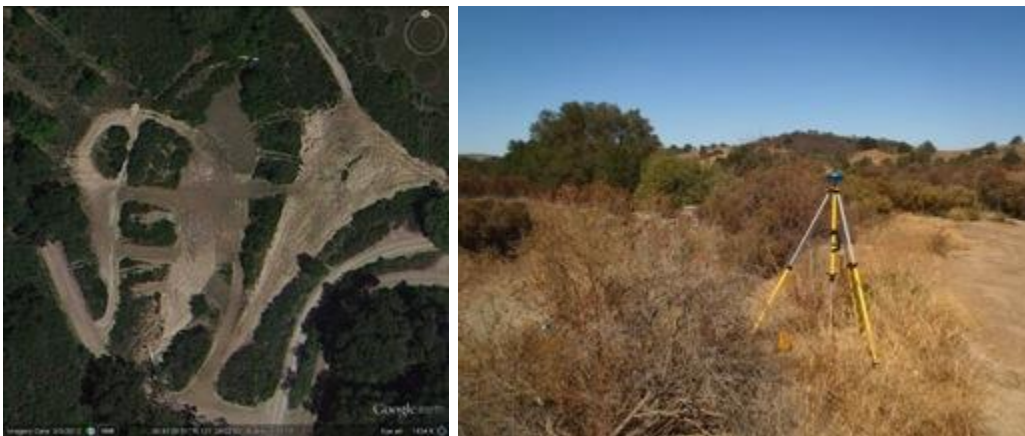
Figure 20. Aerial photograph of the Vineyard Basin (left) and the location of the RTK benchmark and backshot (right) on the top east edge of the basin.

Vineyard Basin is a relatively large basin shaped like a rounded rectangle with a length of approximately 80 meters and a width of approximately 40 meters. The basin is steeply sloped on both the east and west sides with an inflow to the south and a standpipe drain at the northern end of the basin. The inflow is a relatively steep slope protected by large rocks (riprap), while the northern end of the basin is closed with a wire tied rock dam. The BM is located on the east side of the basin approximately half way down the eastern side. The BM is approximately 20 meters away from a medium sized oak tree growing next to a wood slat fence on the eastern edge of the parking area at a bearing of 330° from the oak tree. A basin control point is located on the east side of the basin approximately 20 meters to the north of the basin benchmark. The RTK/GPS base station was set up on the BM and the basin was surveyed using RTK/GPS.

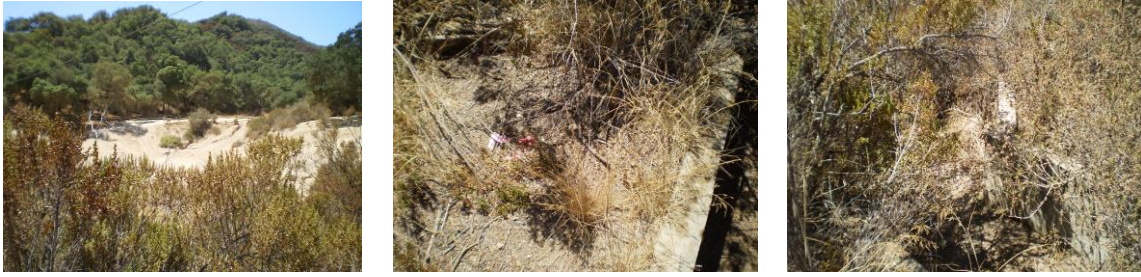
Figure 22. View of the western side of the Whoopdeedoo basin and the basin inlet from the basin benchmark (left); the basin benchmark located in the northeastern corner of the basin and next to the concrete culvert (middle); and view of the concrete culvert that diverts water from the basin outlet (right).

The RTK/GPS base station was set up on the single basin benchmark located in the northeast corner of the basin next to the concrete channel. The UTM coordinates for the benchmark established by the RTK/GPS unit during the survey are 639401.56E, 4070719.4N.

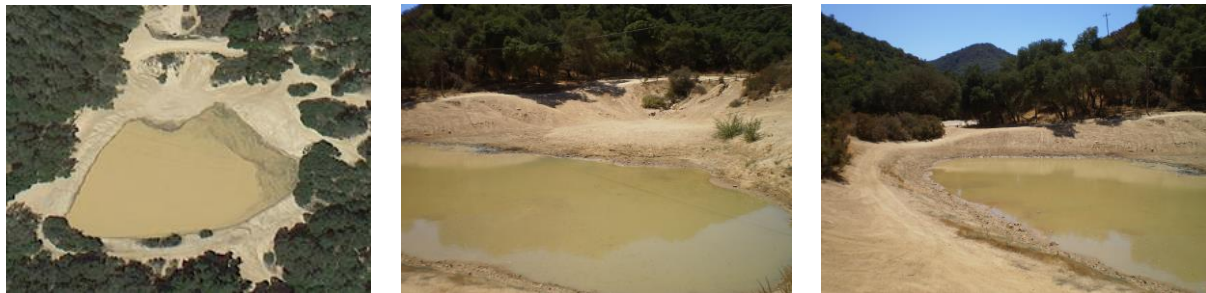
Figure 23. Aerial photograph of the Whoopdeedoo Basin showing its trapezoidal shape (left); view of the western side of the basin and the basin inlet from the basin benchmark (middle); and view of the eastern side of the basin from the basin benchmark (right).

The Whoopdeedoo Basin is located in the Lower Ranch property on Long Canyon Road. To get to the basin, take the Main Park Road west from Park Headquarters until you reach Lodge Lake. Turn right onto Harmony Gate Road at Lodge Lake, travel approximately 0.3 miles on Harmony Gate Road and then turn right onto Long Canyon Road. Whoopdeedoo Basin is located at the entrance to Long Canyon Road on the right. Whoopdeedoo is a large and deep basin bordered on the south side by Long Canyon Road with dirt trails bordering all other sides of the basin. The basin is trapezoidal with the narrow end at the western edge where the inlet pipe is located, with a triangular alluvial fan cut with multiple dykes channeling water into the basin. The outlet of the basin is located in the northeast corner of the basin next to a dirt trail and covered in thick coyote bushes. Unlike other basins in this survey, the outlet is a vertical drainpipe cut with outlet ports. The outlet pipe leads to a concrete channel with a cross section of approximately one square meter and a length of approximately 10 meters.

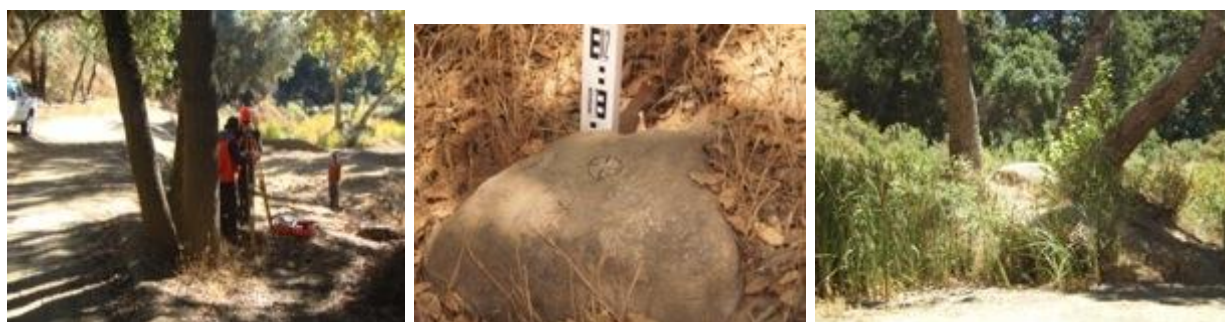
Figure 26. The Woodwardia Basin viewed from the northeastern corner of the basin showing the northern benchmark and the island that bisects the basin (left), the northern benchmark (middle), and the island in the middle of the basin with the large rock on which the backshot is located (right).

Due to the length of the basin and the island with large trees in the middle of the basin, two benchmarks and total stations were used to survey the basin, one at the northern end and one at the southern end of the basin. The north basin benchmark (BM #1) is chiseled into a rock at the base of a large oak tree in the northeast corner of the basin. The south basin benchmark (BM #2) is a piece of rebar located at the top of the berm approximately half way across the southern edge of the basin. The BS is chiseled into a large rock located in the center of the island that bisects the basin and was used as the BS for both BMs. The BS is approximately 30 meters from the northern benchmark (BM #1) at a bearing of 125° , and approximately 30 meters from the southern benchmark (BM #2) at a bearing of 306° . The northern TS was setup on BM #1 and assigned a local position of 0,0,0 (E,N,Z) and the direction from the BM to the BS (125°) was used as the false northing. The southern TS was setup on BM #2 with a position of 86.808, -62.816, -1.172 (E,N,Z) and the direction from the BM to the BS (306°) was used as the false northing.
