WI Publication No. WI-2019-04

Hollister Hills SVRA

Sediment Basin Volumes:

Water Years 2017–2018

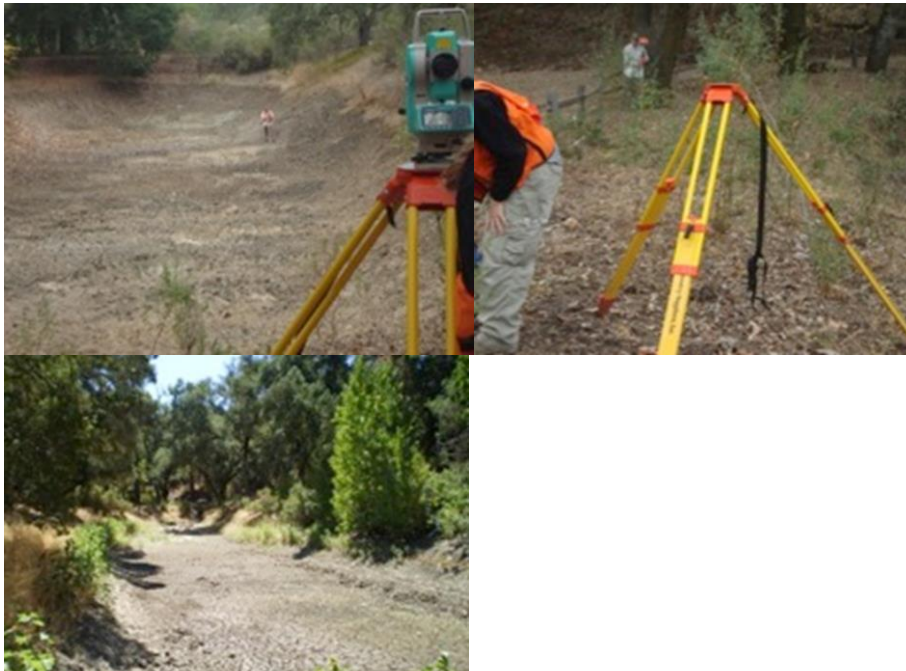
Figure 4.
Photograph of the total station and the basin facing west (left), total station and backshot facing south (right), and the basin taken from outlet pipe facing northeast (bottom).

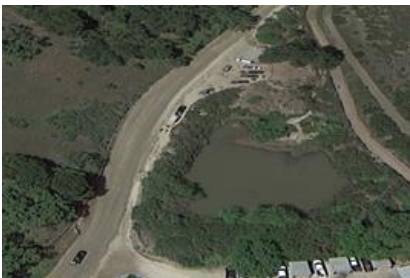
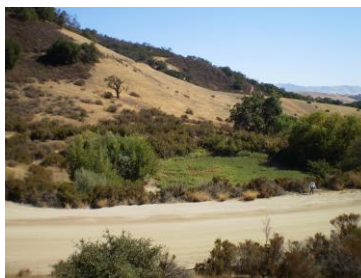
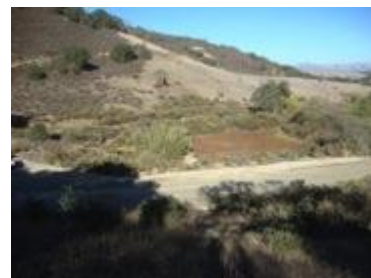
Figure 11. Ariel photograph of the Office Basin showing the location of the basin benchmark (BM#1) (left); a view of the basin from the basin benchmark (middle); and a view of the basin from the basin benchmark showing the RTK/GPS base station set up on the back-shot used for the total station

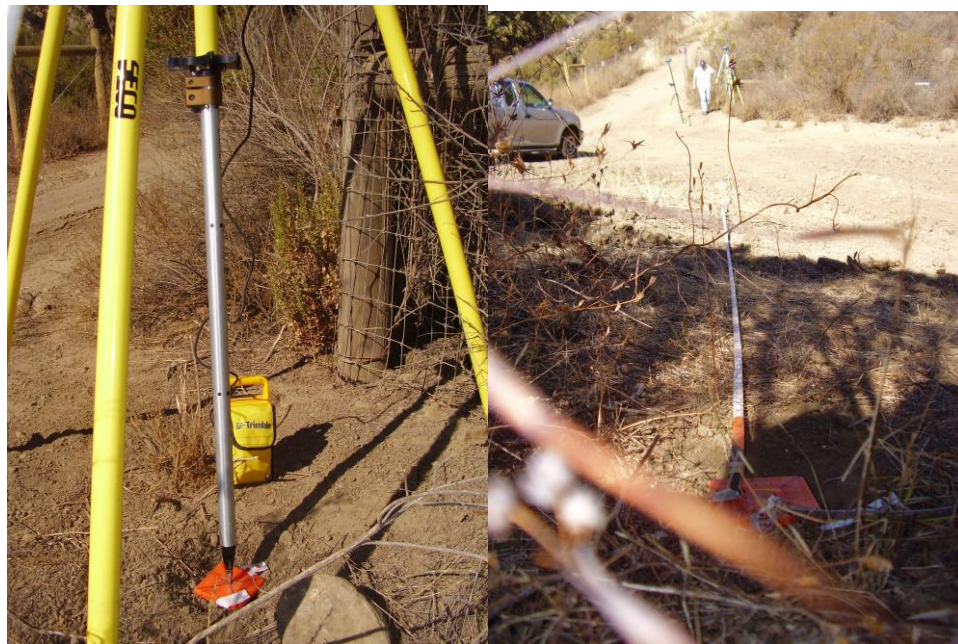
Figure 16. BM with RTK (left) and BS (right).

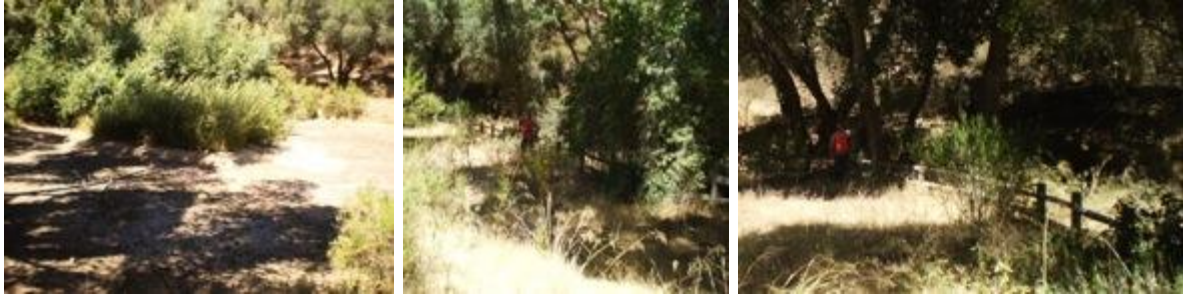
Figure 18. The Sycamore Basin viewed from the southeast corner of the basin showing the channel cut island (left); the location of the basin benchmark near the fence at the center of the eastern edge of the basin (middle); and the location of the nail in the oak tree used for the backshot in the northeast corner of the basin (right).

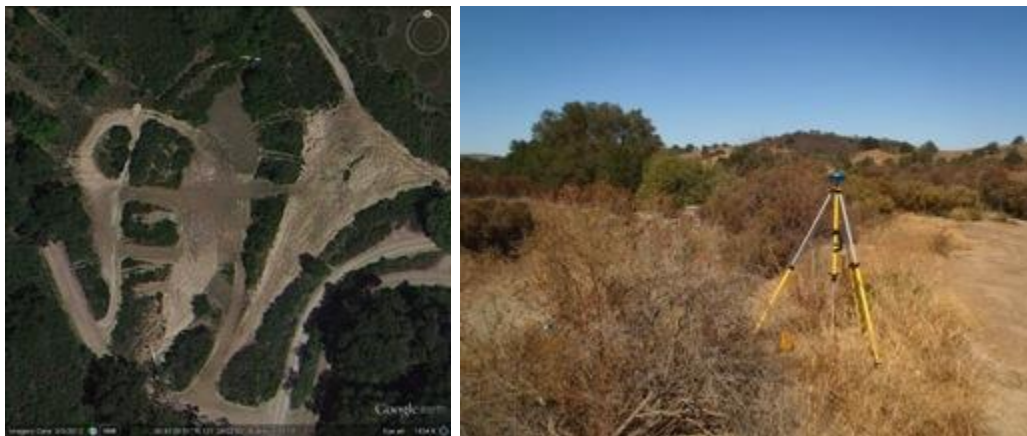
Figure 20. Aerial photograph of the Vineyard Basin (left) and the location of the RTK benchmark and backshot (right) on the top east edge of the basin.

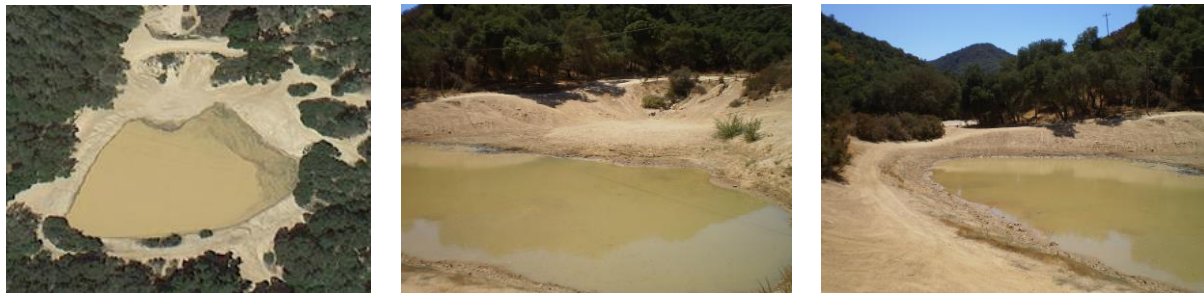
Figure 23. Aerial photograph of the Whoopdeedoo Basin showing its trapezoidal shape (left); view of the western side of the basin and the basin inlet from the basin benchmark (middle); and view of the eastern side of the basin from the basin benchmark (right).

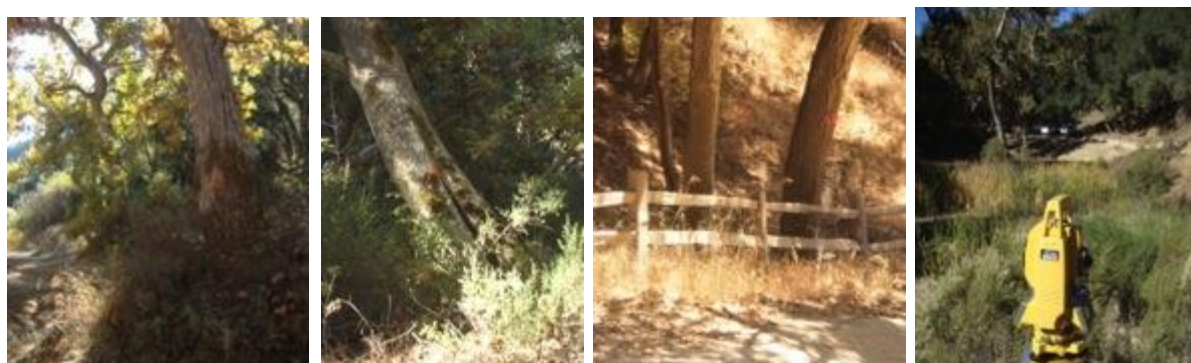
Figure 27. The tree with monument #1 (far left), the tree with monument #2 (middle left), the tree with monument #3 (middle right), and the view from the southern benchmark (BM #2) showing the basin, the island, and the location of the northern benchmark (BM #1) in relation to the southern benchmark (far right).
