Publication No. WI-2021-02

The Watershed Institute

**Eleven Year Summary of Watershed Studies
at Hollister Hills
State Recreational Vehicle Area:
Fall 2010 to Fall 2021**

Executive Summary

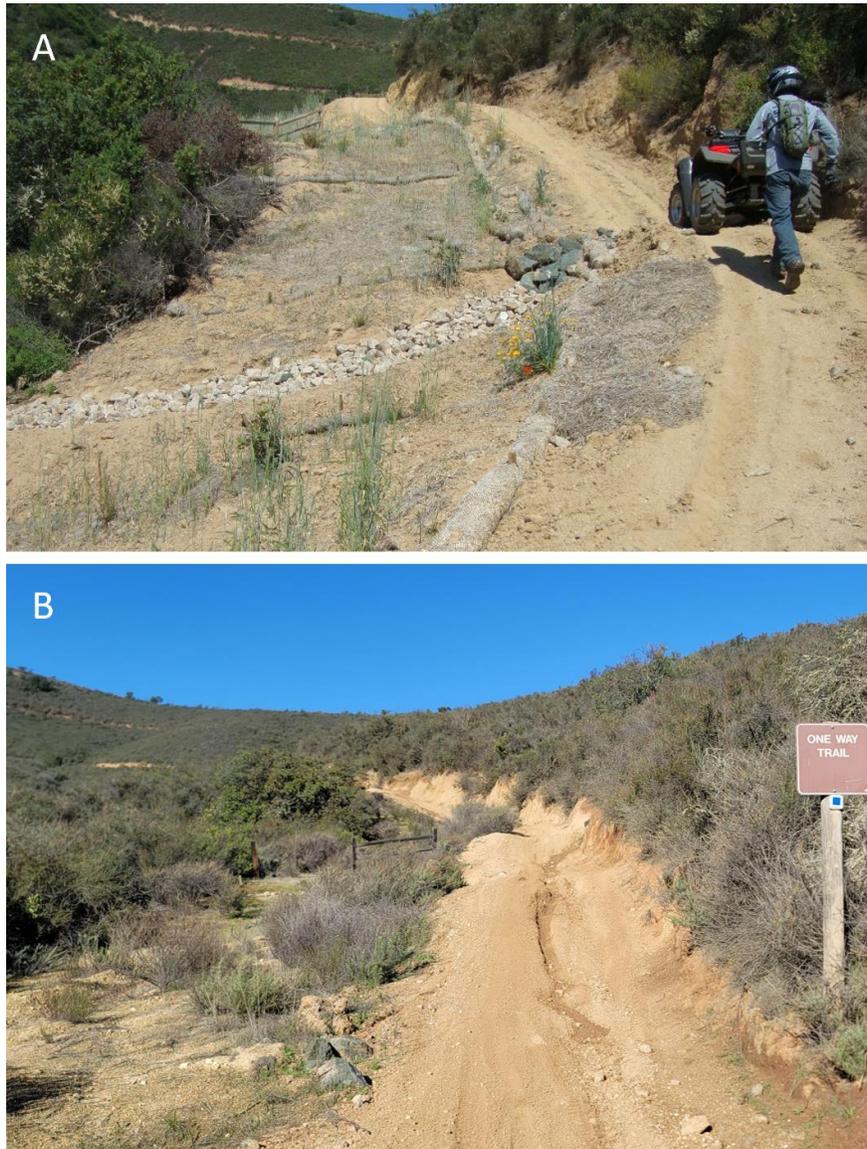
Figure 9. Example of BMP that includes trail narrowing, outsloping, and planting (A). Decommissioned part of trail has rock drainage and native plantings. Vegetation is sparse because it was recently planted on the newly graded slope. Planted and volunteer native vegetation is still filling in the graded slope after 10 years of maturation.

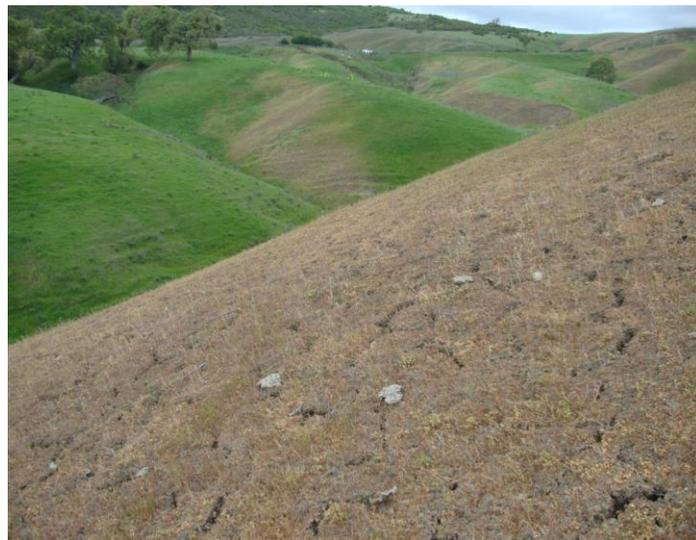
Figure 15. Deep, polygonal cracks form during the dry months. In 2013, the cracks formed prematurely in March. View west toward Cienega Road.

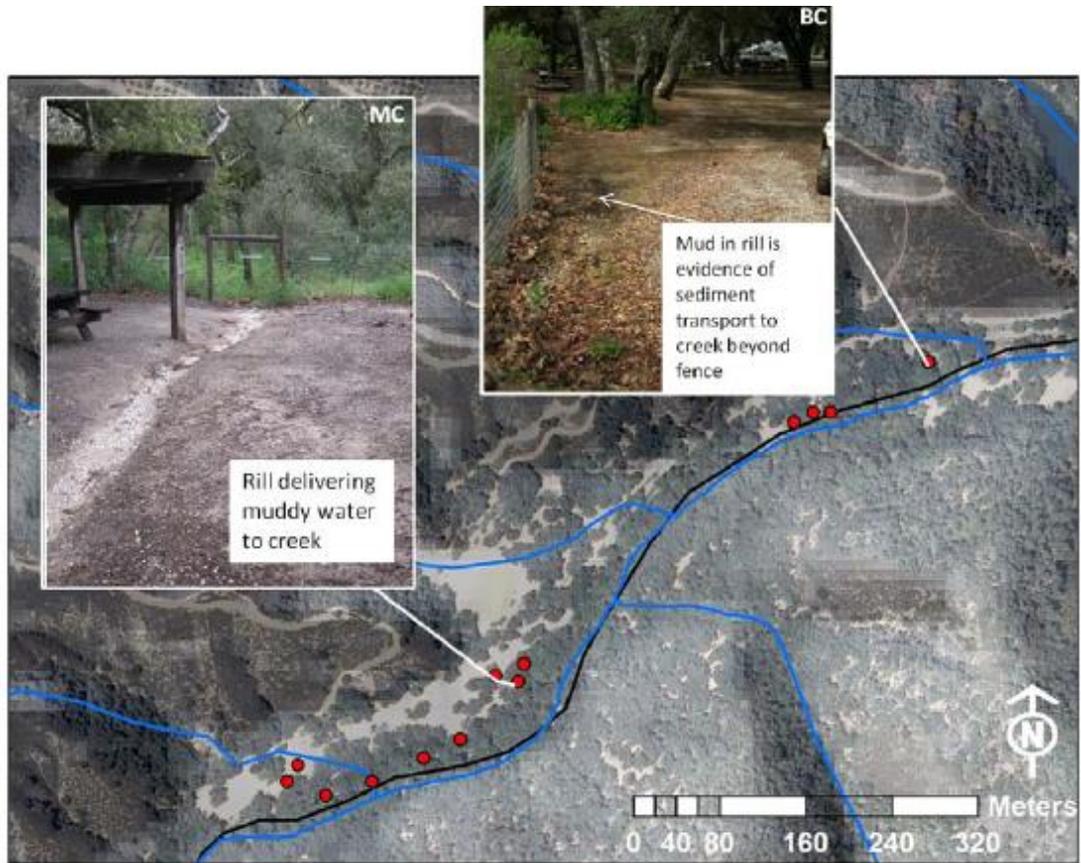
Figure 24. Rill channel pathways at Madrone (MC) and Bee Camp (BC) (GEOL 460 2012).

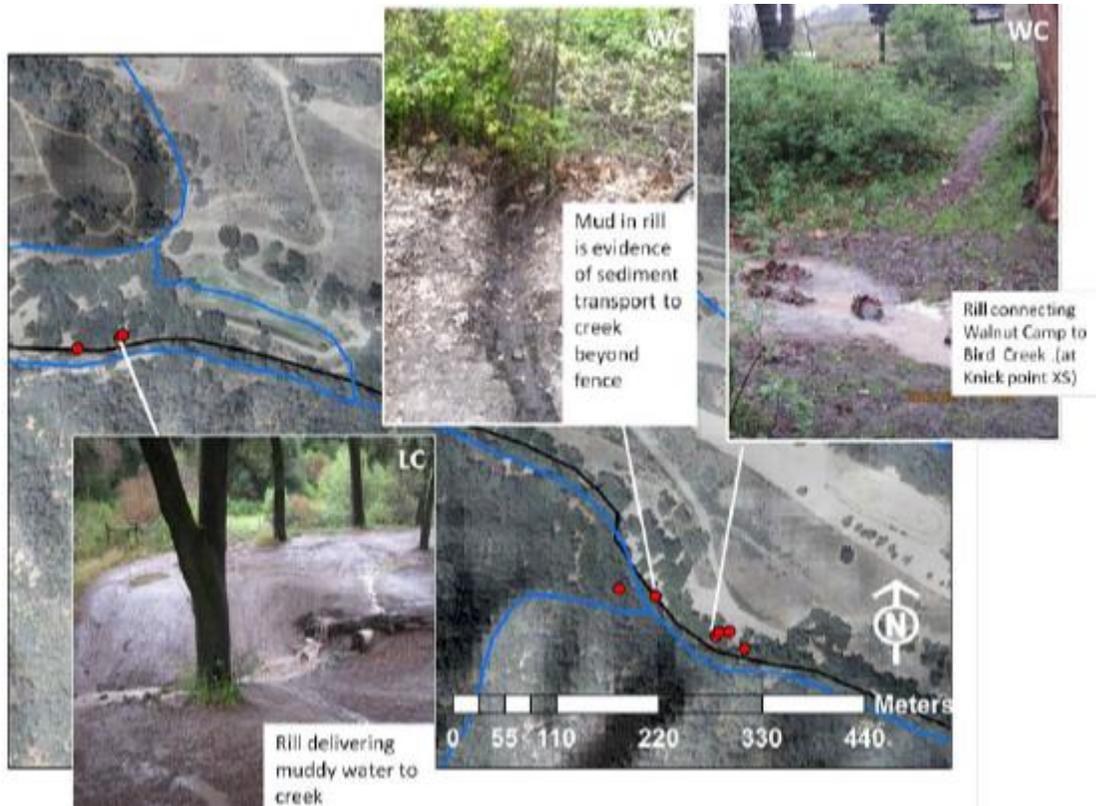
Figure 25. Rill channel pathways at Lodge (LC) and Walnut Camp (WC) (GEOL 460 2012).

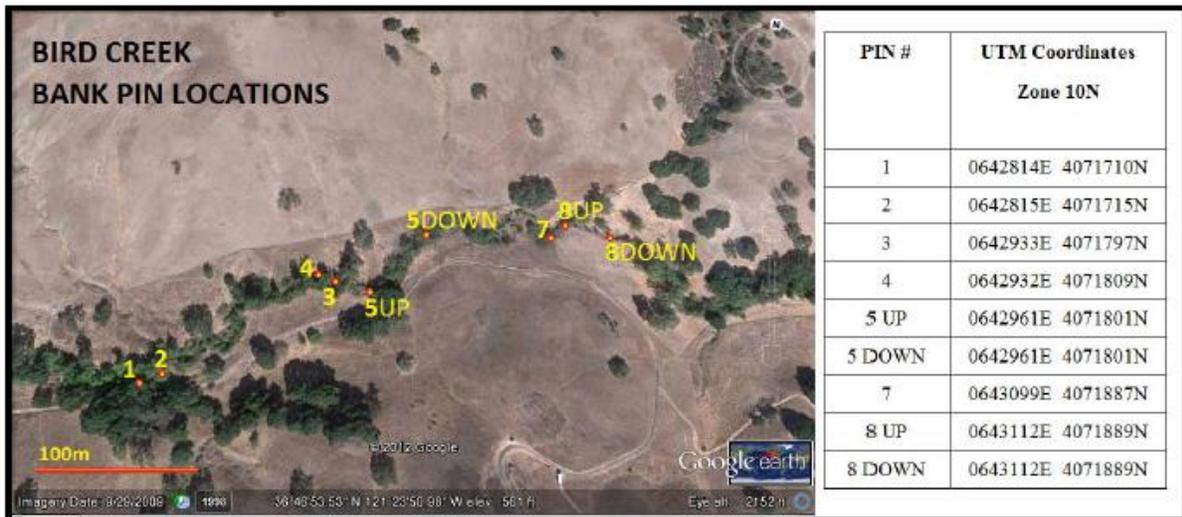
Figure 27. Bank pins located along Bird Creek (GEOL 460 2012). See Figure 26 for setting.

Bank pins were installed at 8 locations along the Hudner Ranch reach of Bird Creek in March 2011 to estimate the contribution of bank erosion to Bird Creek (Figs. 26 and 27). This study only extrapolated the results to the reach of Bird Creek that has similar morphology and geology to the reaches with bank pins. The extrapolation included 2800 m of stream located between the downstream boundary of the HHSVRA and the San Andreas Fault, where the watershed geology and topography significantly change. Pin sets 5 and 8 had upstream and downstream sets. Each bank pin set consisted of 2 to 3 rebar stakes inserted into the channel bank. Bank pin exposure was measured to the closest millimeter. Total volume of stream bank erosion was calculated by multiplying the average pin exposure by 2800 m stream length and the estimated average bank height (1.2 m). That erosion volume was multiplied by two to account for left and right stream banks. The mass of eroded

Bank pin exposure was used to calculate volume and mass of sediment eroded from Bird Creek stream banks in 2011, 2012, 2014, 2015, and 2016 (Table 8). The resulting masses

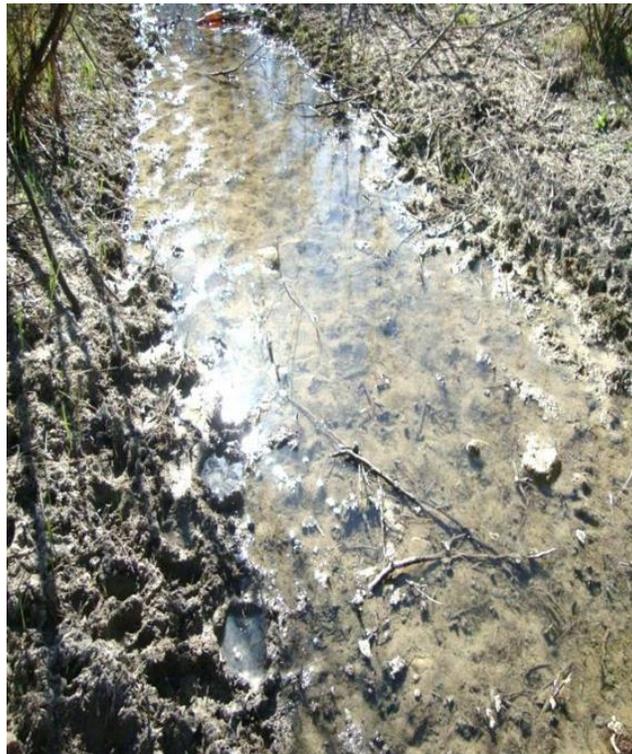
Figure 30. Hoof prints are visible in the mud in Bird Creek following an accidental breach of riparian fencing in 2012.

Direct cattle impact on the banks and bed of Bird Creek include sporadic, rare access when riparian cattle fencing within the HHSVRA is accidentally breached by cattle. A comparative study of one such incident indicated that the cattle hooves sheared fine-grained sediment in the stream banks, leaving a several-centimeter thick veneer of mud blanketing the previously gravelly channel bottom (Fig. 30; GEOL 460 2012). Drought years followed that accidental breach, and the mud veneer covered 350 m of channel until minor runoff of WY 2015 washed it downstream.

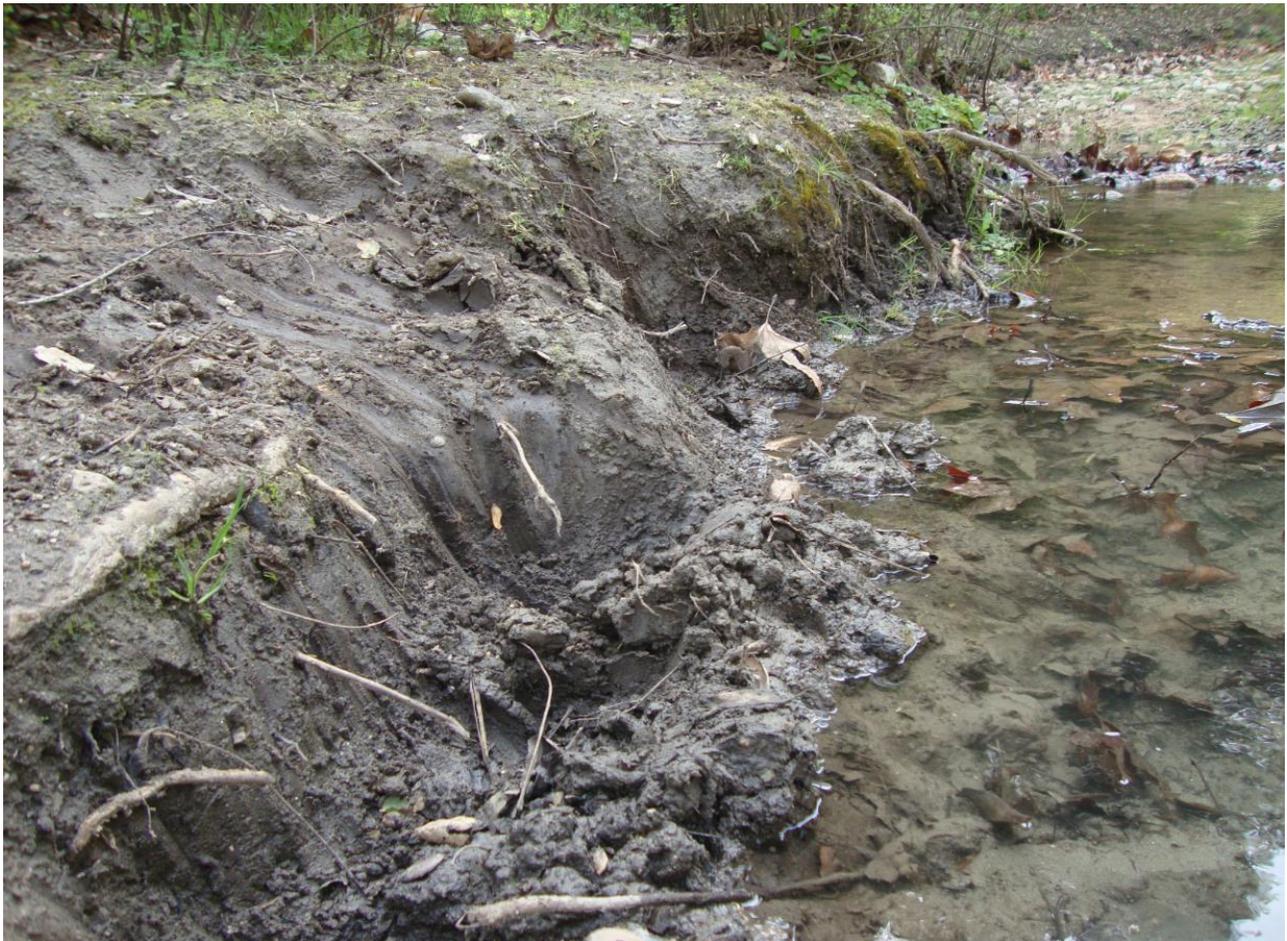
Figure 31. Upstream view of Bird Creek in March 2012, downstream of Walnut Camp. Cattle impact from neighboring property is indicated by sheared muddy stream banks.

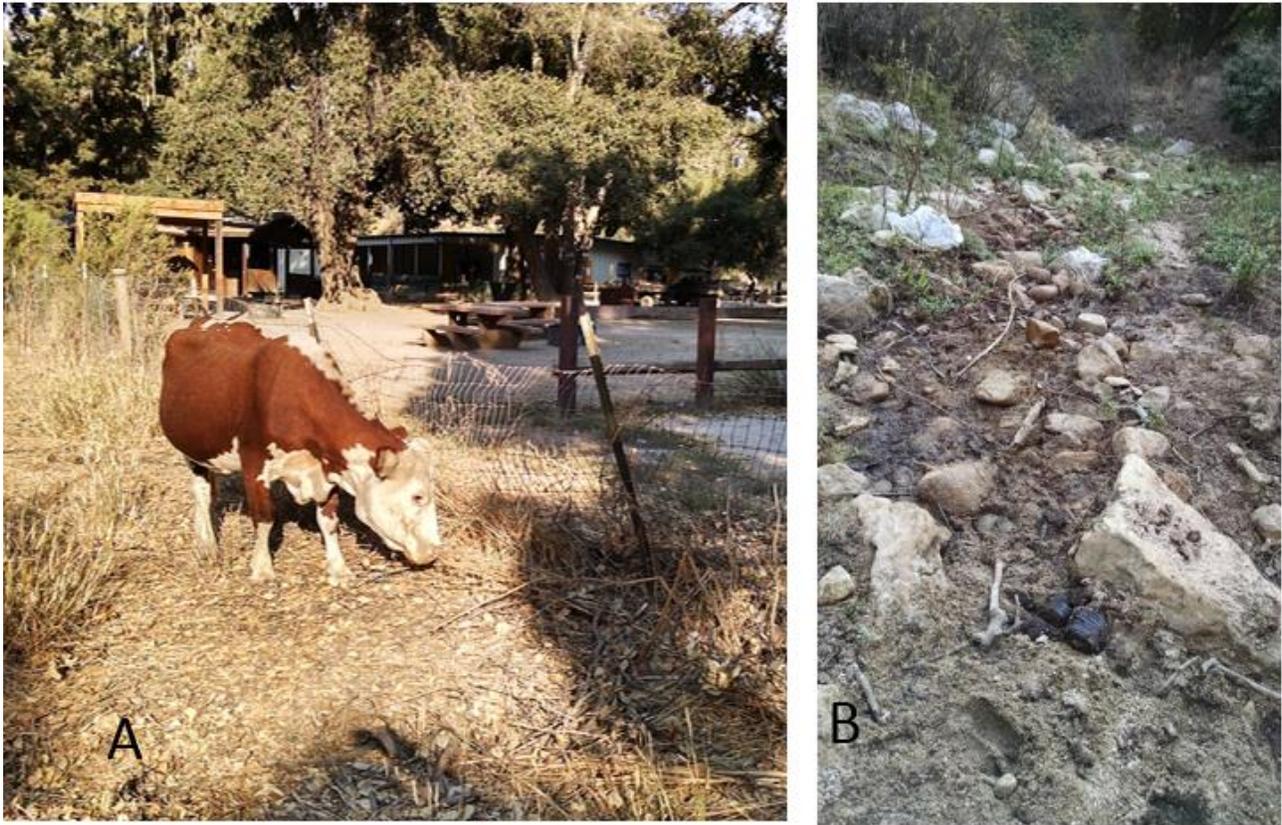
Figure 32. A) Cow in riparian terrace adjacent to park fence at Faultline Store. B) Manure in Bird Creek channel at same location as figure A.

The HHSVRA property line splits Bird Creek along much of its length southwest of the San Andreas Fault (Fig 11). However, the park fence is located high on the stream bank within the park property, leaving the stream channel and riparian areas open to neighboring properties. Along this reach, neighboring cattle enjoy unimpeded access to the riparian zone and channel invert (Fig. 31). Sheared stream banks and manure are a chronic problem along this reach (Fig. 32), but are not caused by park activities or management.

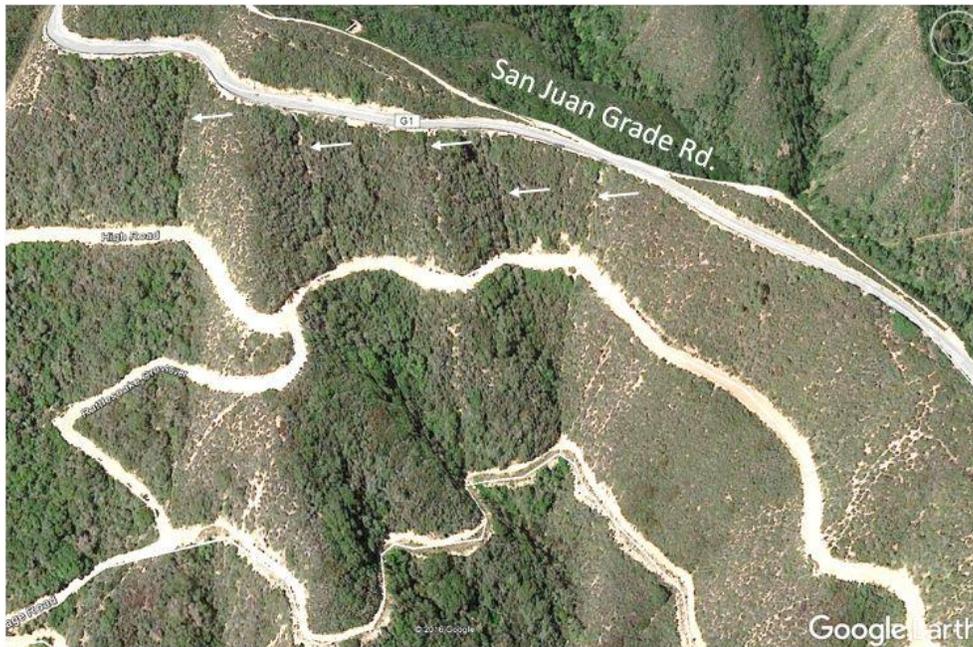
Figure 33. Oblique aerial photograph of hillslope erosion concentrated below a subset of culverts along San Benito County's San Juan Grade Road. White arrows point to vertical runoff paths delivering hydraulically concentrated culvert flow onto the HHSVRA slopes. Google Earth image from 2015.

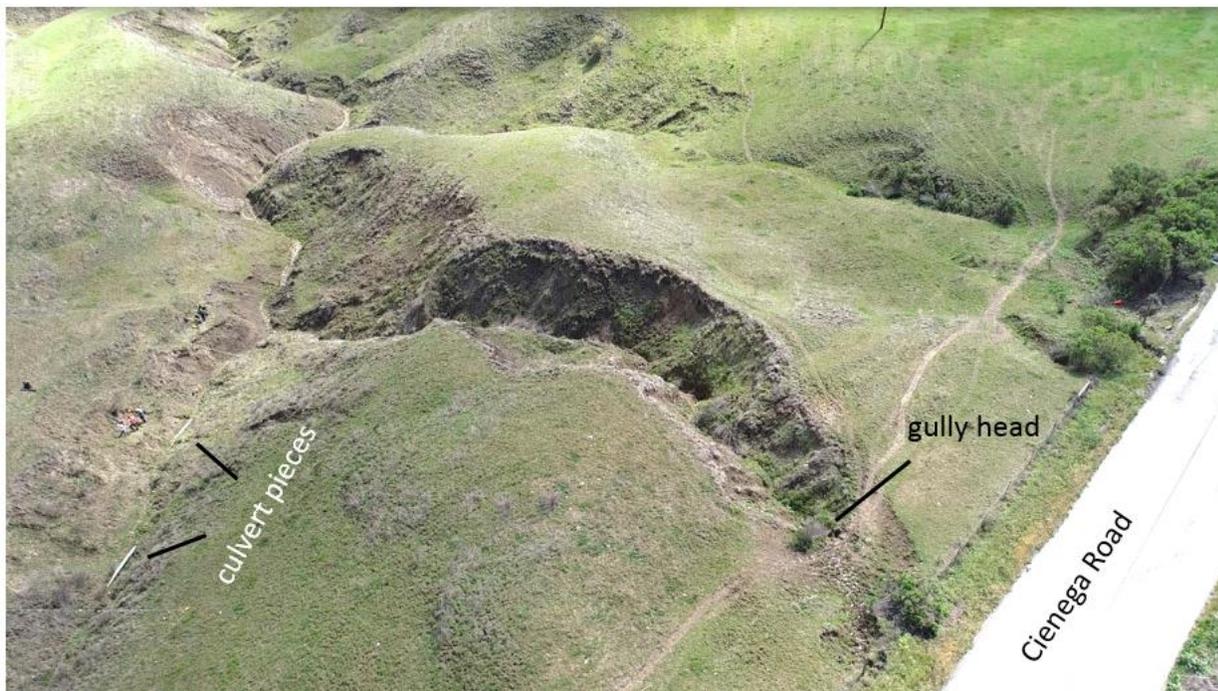
Figure 38. Oblique aerial photograph from sUAS showing active gully near Cienega Road. Feature is labeled “4” in Figure 36. Hillshade of feature is Figure 39. Ground-based photo is Figure 40.

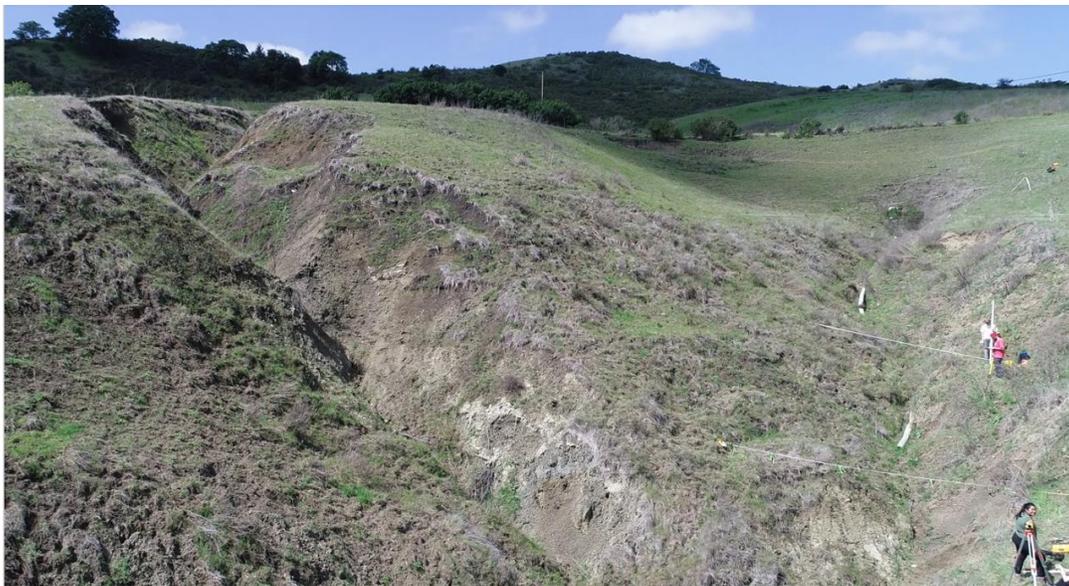
Figure 40. Gullies related to culvert drainage erosion. Right gully with surveyors terminates at the culvert labeled “2” in Figure 36. Broken white culvert pipe visible in thalweg is also visible in Figure 38. Left gully is feature number four in Figure 36, also shown in Figure 39.

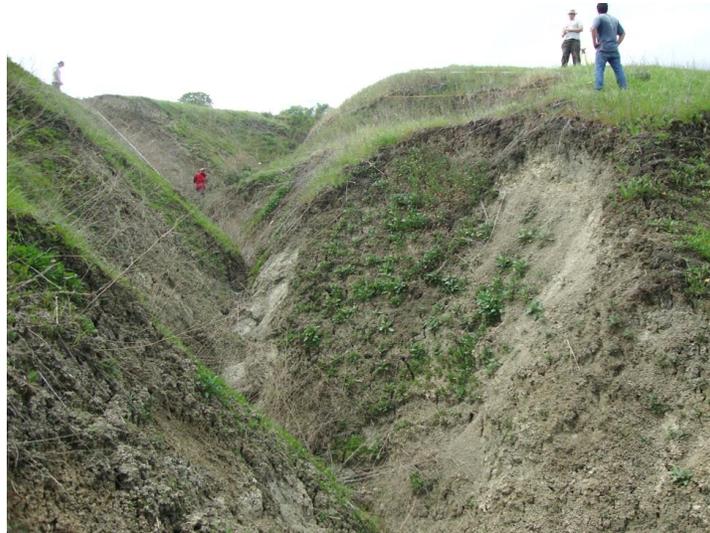
Figure 41. Close-up of gully walls seen in Figure 40.

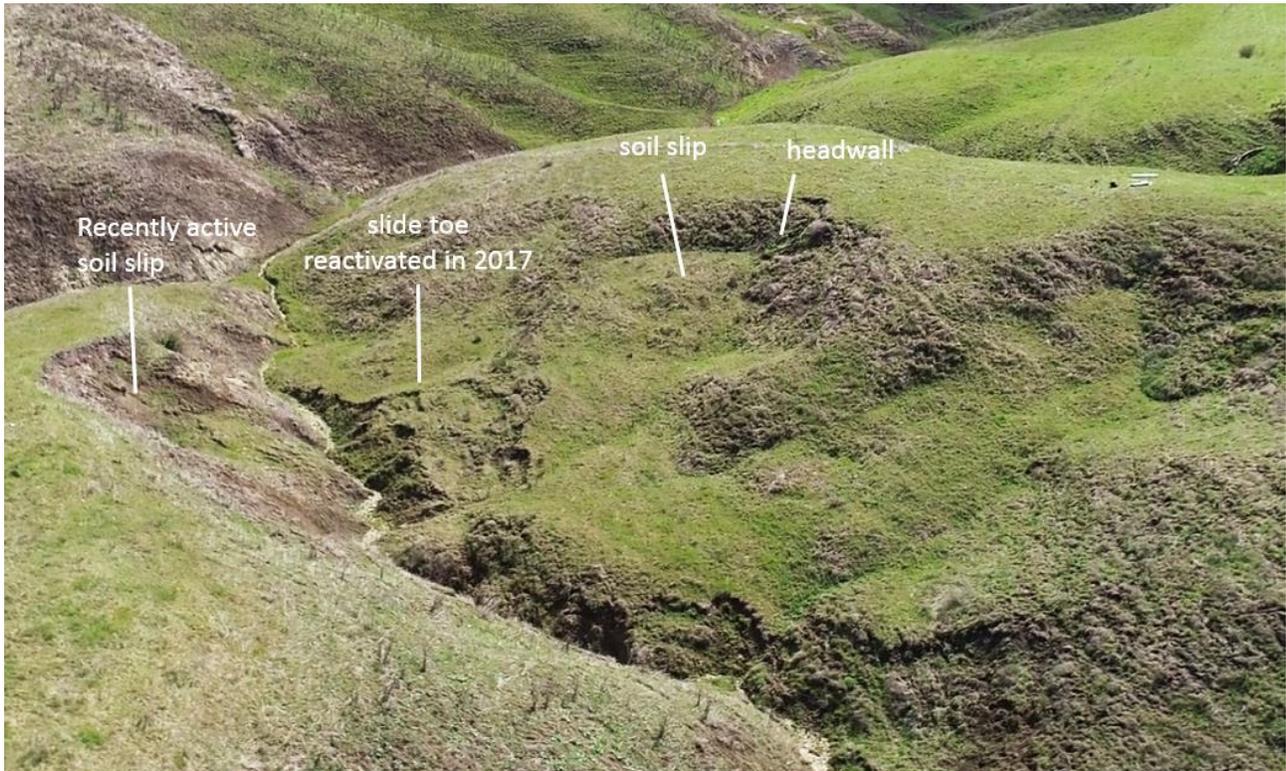
Figure 43. Down gradient view showing unstable slopes in gully system below culvert labeled “2” in Figure 36. Image is oblique aerial view from sUAS. Scene depicts feature five in Figure 36.

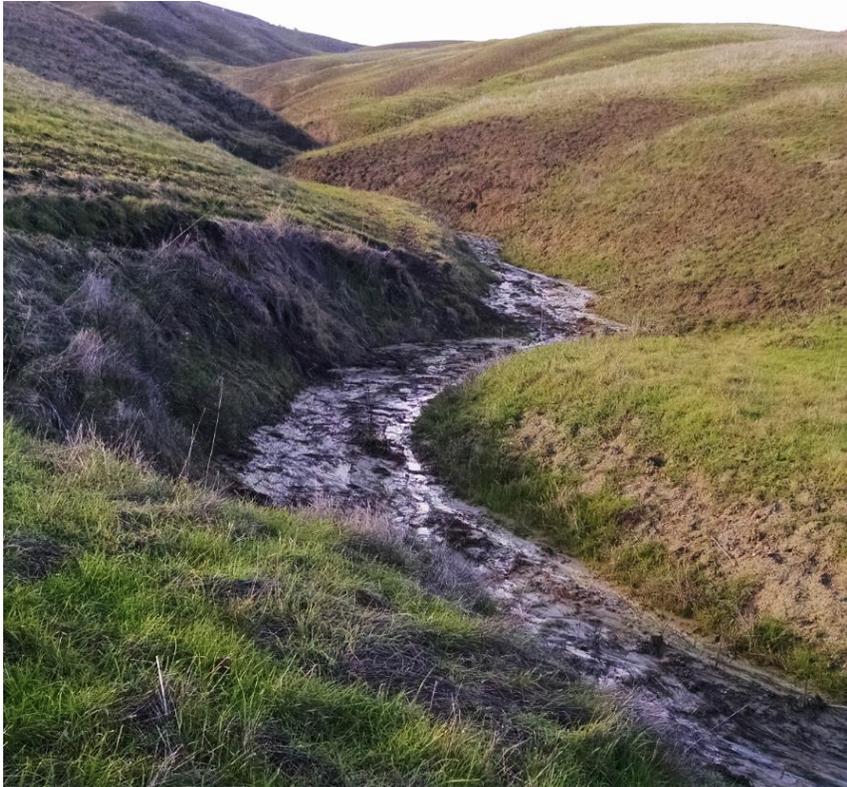
Figure 44. Upgradient view of sediment in ravine bottom downstream of Cienega Road gullies. Photograph from 1/25/2017.

Innumerable small soil slip features are located along the walls of the main gully below culvert two (Fig. 36). Visual observations indicate the toes of many slips were reactivated in winter 2017. One of those is labeled in Figure 43. Reactivation of gullies in the tributaries and reactivation of slide toes is evidence that the main gully incised in Winter 2017, lowering local base level for adjacent hill slopes. The system generated significant sediment that was transported to Bird Creek in winter 2017 (Fig. 44).

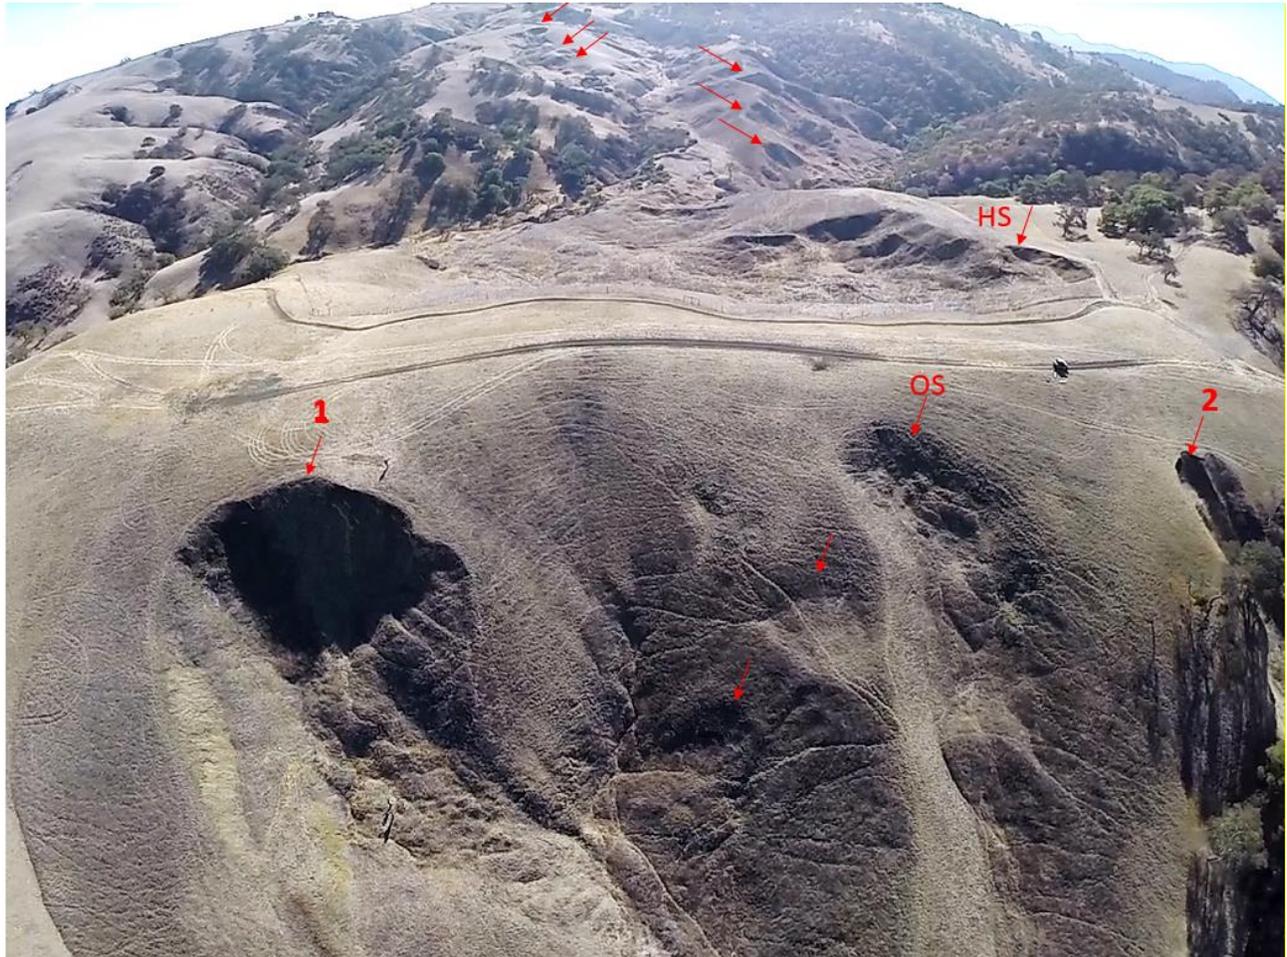
Figure 48. Low altitude oblique aerial view of unstable slopes in study area (foreground) and in the region, beyond. Red arrows point to a subset of slope failure features (typically “slumps”) present in the region. Foreground shows a subset of slump features in the Colluvial Creek complex. HS is headwall of Hudner Slide. OS is an example of a geomorphically “older” slide.

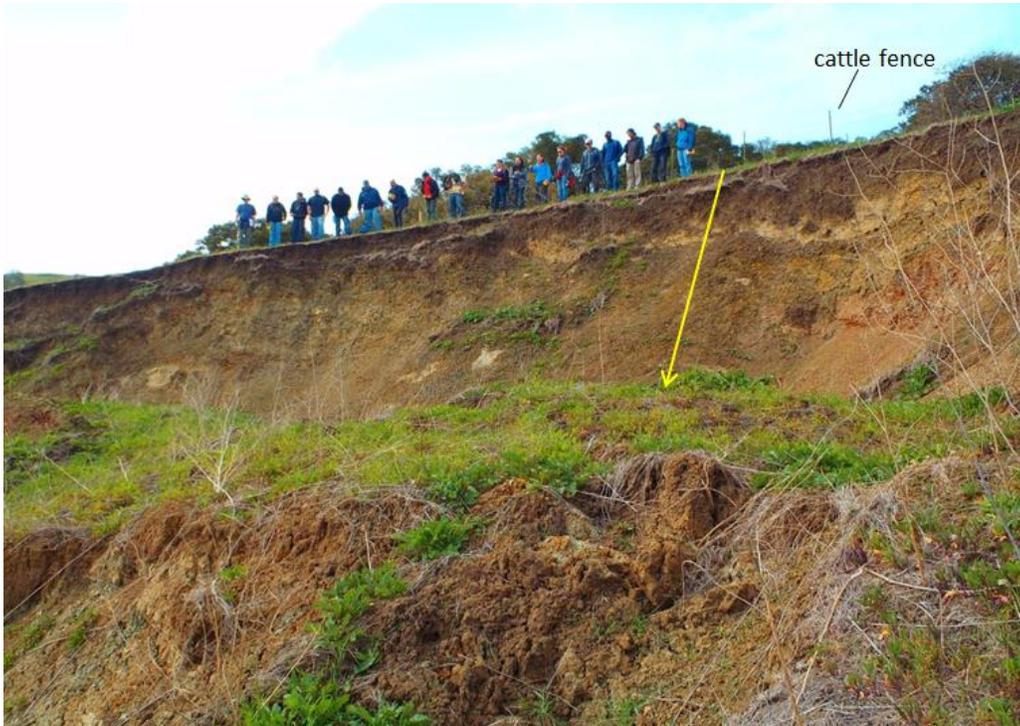
Figure 62. Hudner Slide headwall scarp in spring 2012. Lack of vegetation and sharp (locally overhanging) top corner on the headwall scarp indicates that the slide motion is young. Yellow arrow indicates approximately 6 m of displacement.

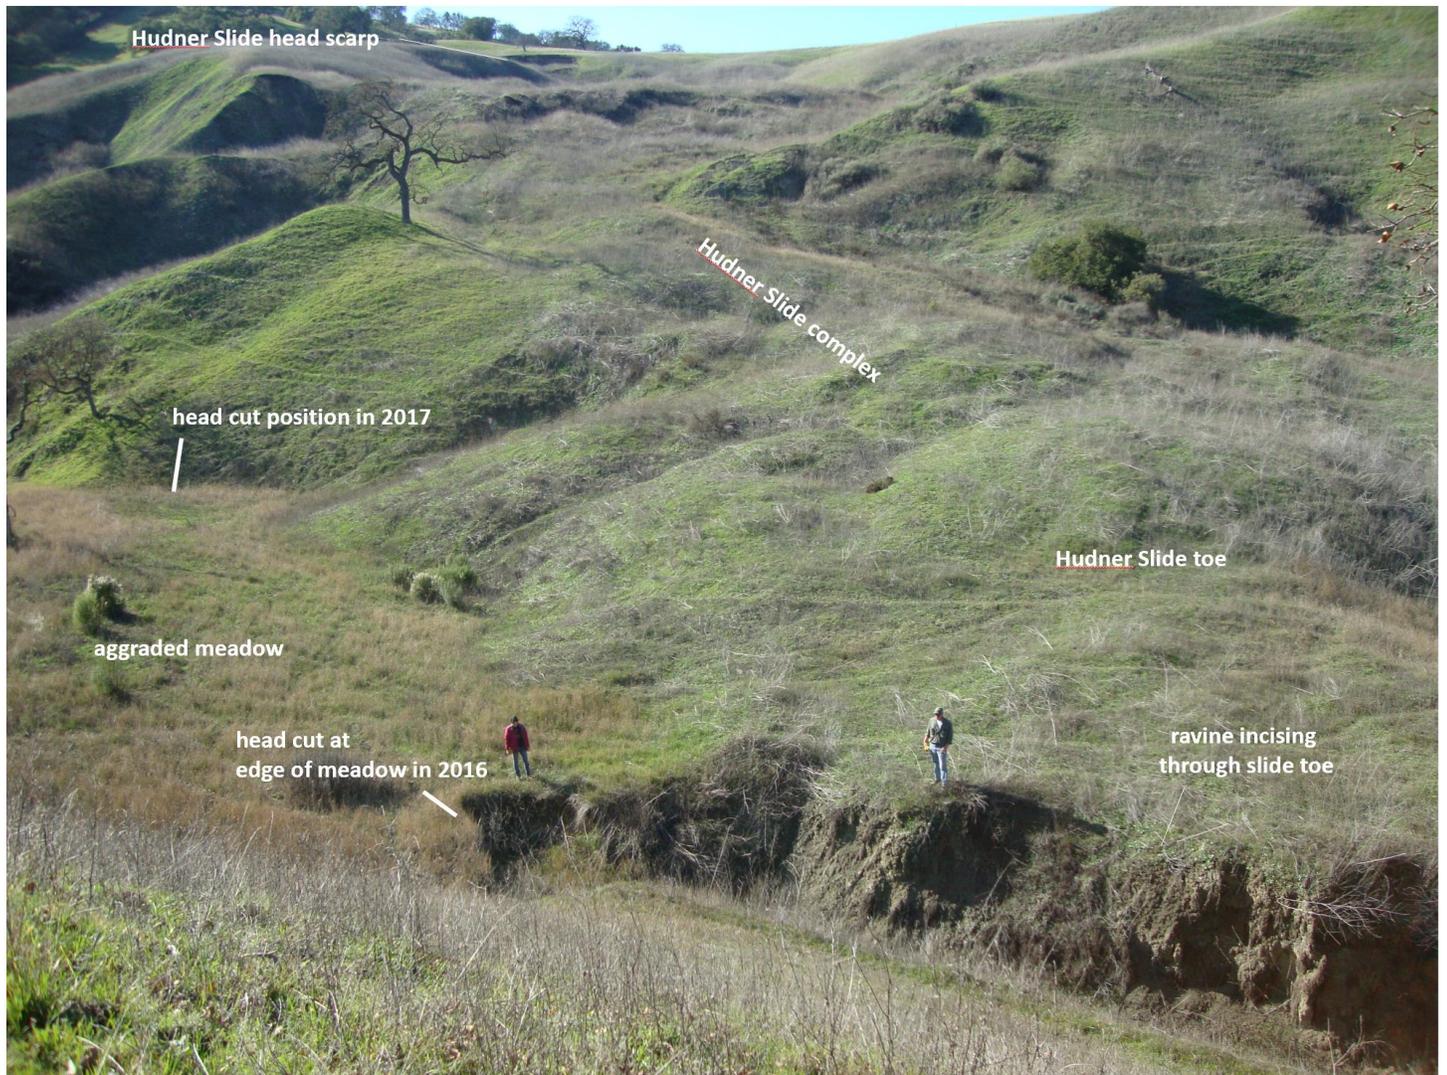
Figure 66. Oblique photo showing field relations between slide elements and valley sediment transport system. Meadow sediment filled in behind dam caused by slide toe. The creek eroded through the toe (see ravine) and advanced through the meadow in 2017.

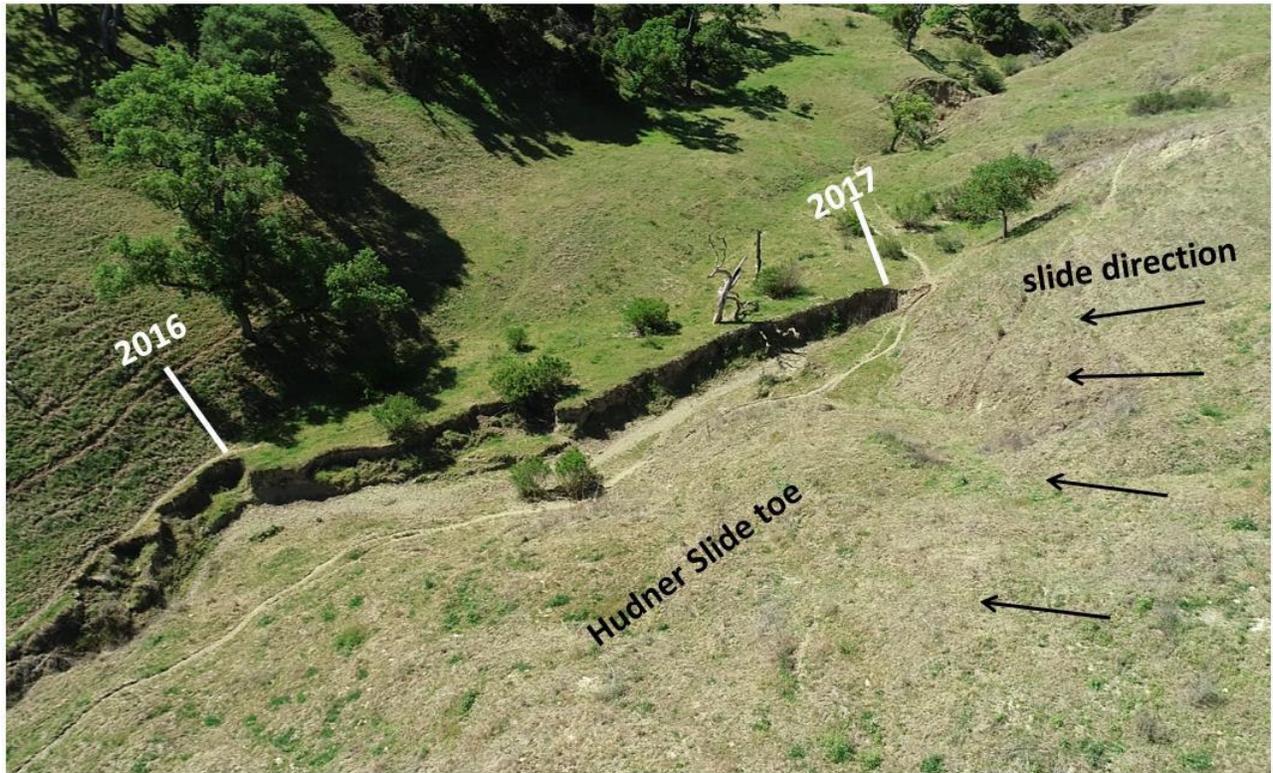
Figure 67. Low-altitude oblique aerial photograph (5/2/18) of Hudner Creek gully incising toe and trapped alluvium at base of Hudner Slide. Dates are locations of gully head in 2016 and 2017.

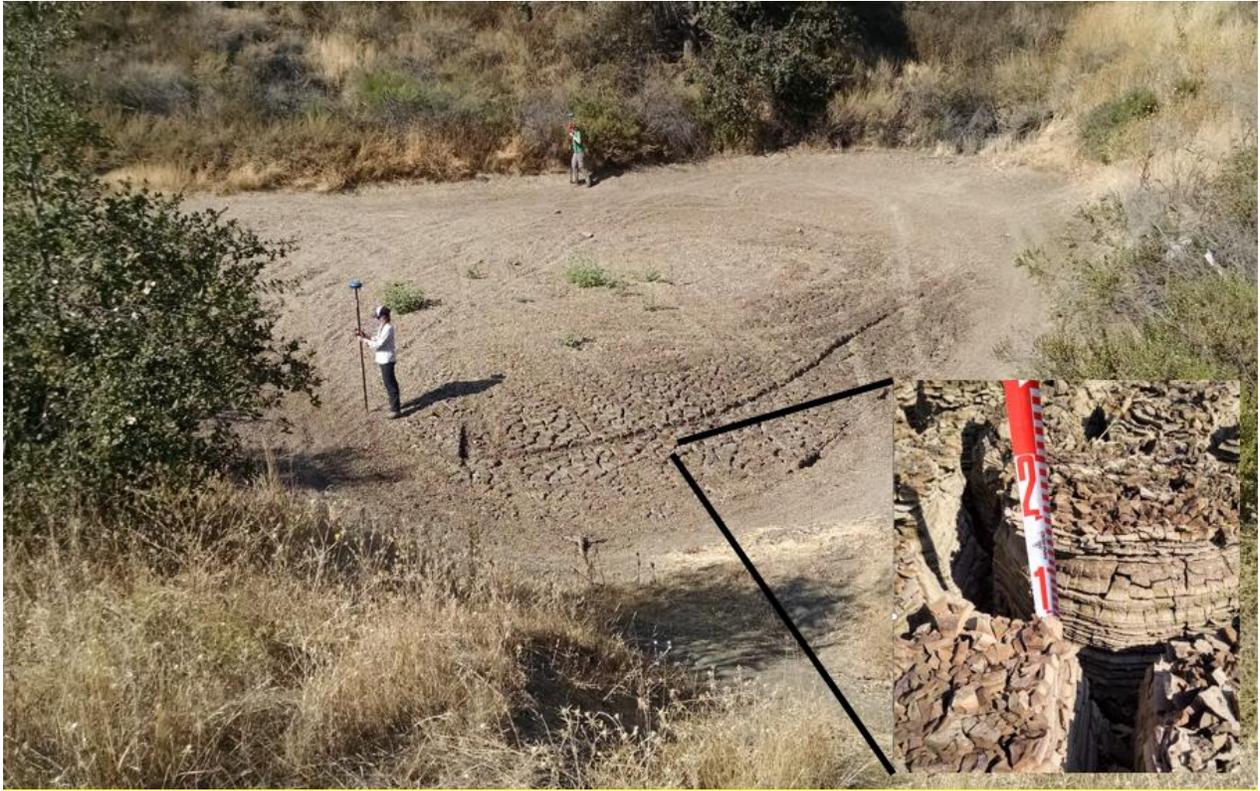
Figure 71. Superhill sediment basin receives runoff from clay soils east of the San Andreas Fault. Little bedload is present. Inset is a close-up view of laminated fine-grained deposits. Small color blocks on scale are 0.005m.

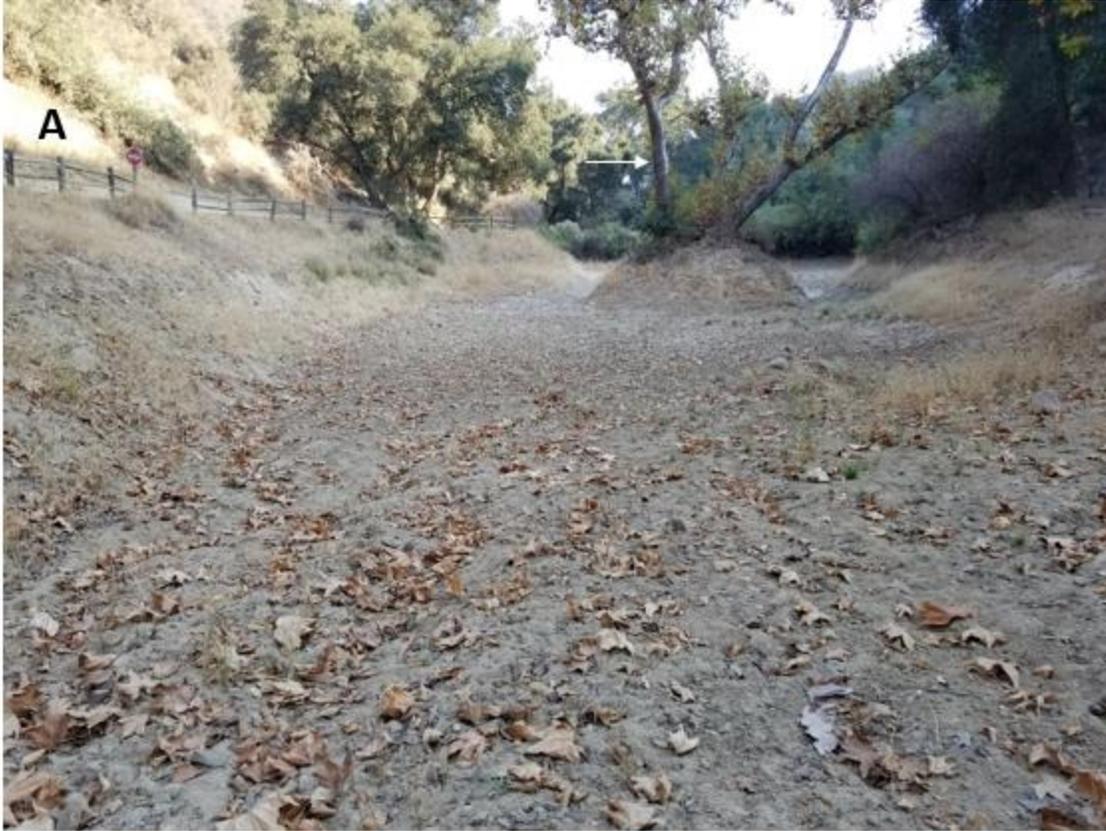
Figure 73: Woodwardia Basin showing capacity for sediment (A), and sediment captured in 2017 (B). Note “do not enter” sign near letters and arrow showing the same tree.

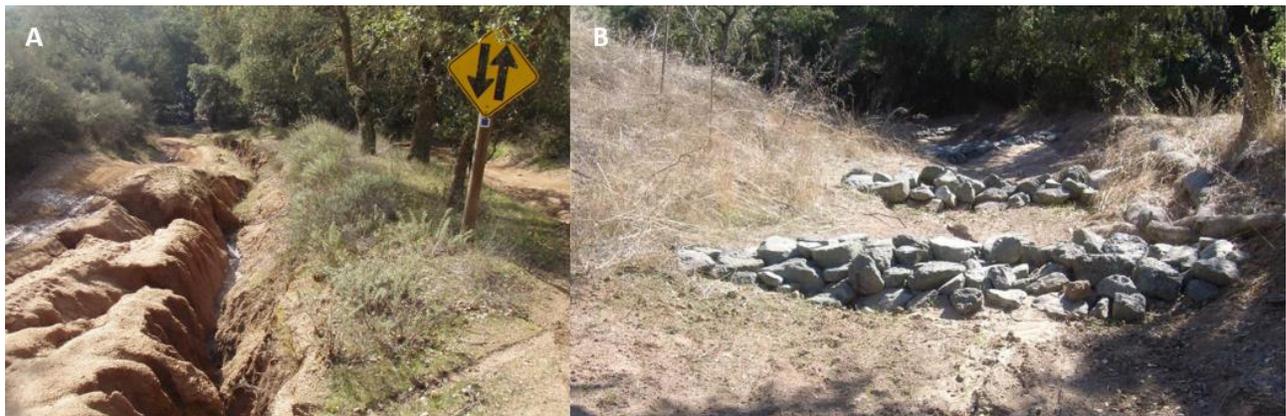
Figure 78. View down Coyote Trail restoration project. A) Before decommissioning, circa 2009. B) After grading and placement of rock berms, but before revegetation in July 2011.

Of the many restoration BMPs active at the HHSVRA, we selected the newly constructed Coyote Trail restoration site to monitor because it posed a significant engineering challenge. The project was designed to mitigate gully erosion on a 20% grade, bare slope with coarse granular granitic soils that are naturally prone to gully erosion. The engineering measures included filling and regrading a deeply incised trail system (Fig. 78). Once the steep site was regraded, 27 rip-rap grade control structures were installed to manage future erosion. The site was revegetated with native plants selected for the site conditions.

Despite the early indications that the site might not stabilize, the restoration effort eventually returned a deeply scarred landscape (Fig. 78) to near natural conditions. Future restoration designs on steep granitic soils might have earlier success by employing closer-spaced berms that are keyed deeper into the bed and banks. Figure 9, and the Coyote Trail study illustrate that native revegetation is challenging in the drought-prone regional climate; restoration sites might take a decade to fully mature.

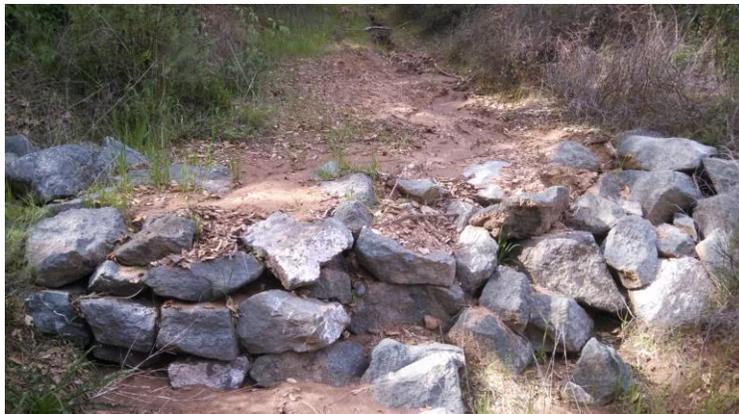
Figure 79. Berm-1: View up-gradient of a berm in the Coyote Trail gully restoration site in March 2014. The berms trapped sediment until the space behind the berms had filled with sediment. This berm is an example of successful sediment trapping and grade control.

Visual inspection, ground-based photography, and serial surveys of a subset of the berms indicate that some berms performed well (Fig. 79), while others underwent a period of adjustment. During the first surveys in 2012, many of the berms showed early signs of lateral and vertical failure. The 2014 inspection showed that several berms were compromised by erosion (Figs. 80 and 81). Revegetation efforts have been successful despite the drought. Reconnaissance and surveys performed in 2016 indicated that the site vegetation was very healthy, but cross section surveys indicated that the berm system was still evolving (Appendix A).

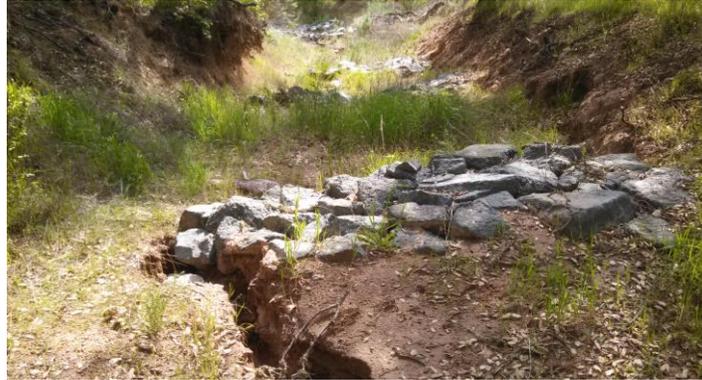
Figure 80. View down-gradient of a berm in the Coyote Trail gully restoration site in March 2014. Some berms provided incomplete grade control because lateral erosion outflanked the rock structure.

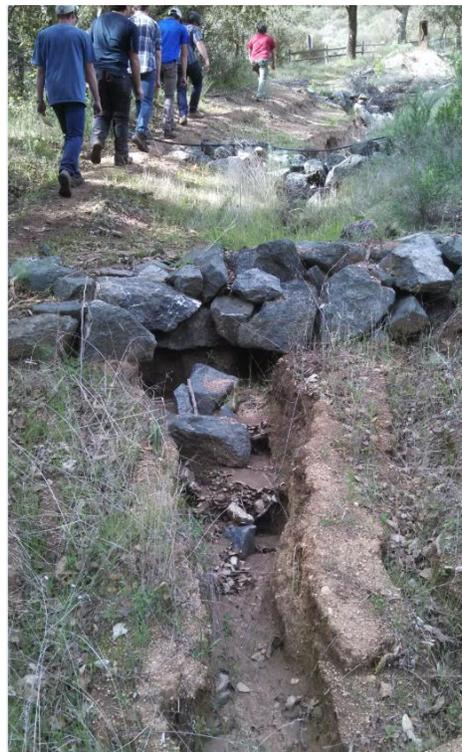
Figure 81. View up-gradient of a berm in the Coyote Trail gully restoration site in March 2014. While major gullying has been stopped, some berms provided incomplete grade control because of undercutting that bypassed the berm footers.

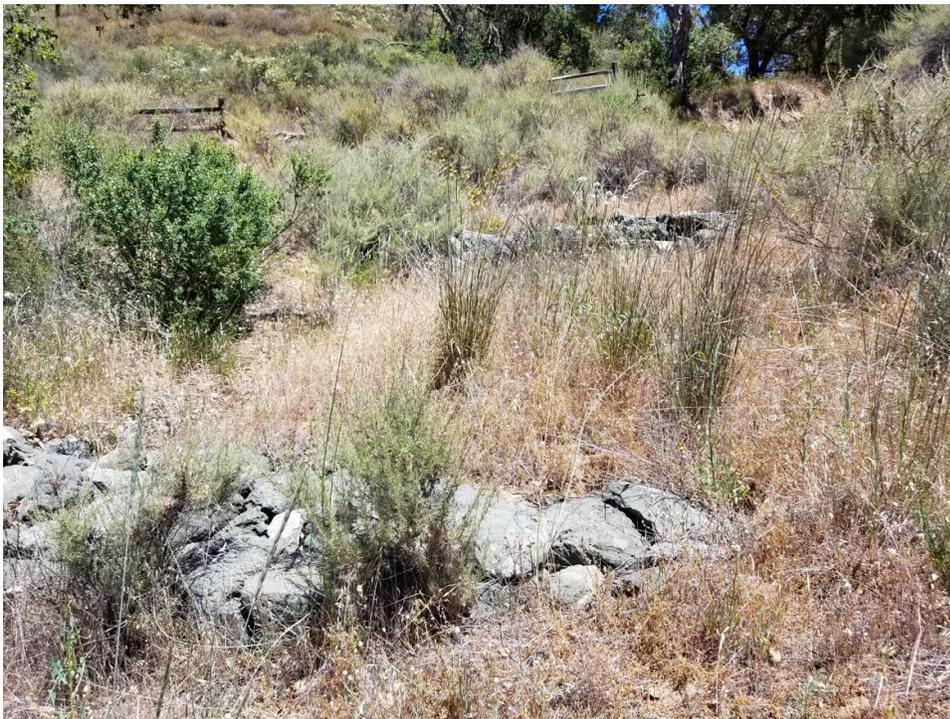
Figure 82: Coyote Trail restoration site in 2021. Native plants have stabilized the soil between the berms.

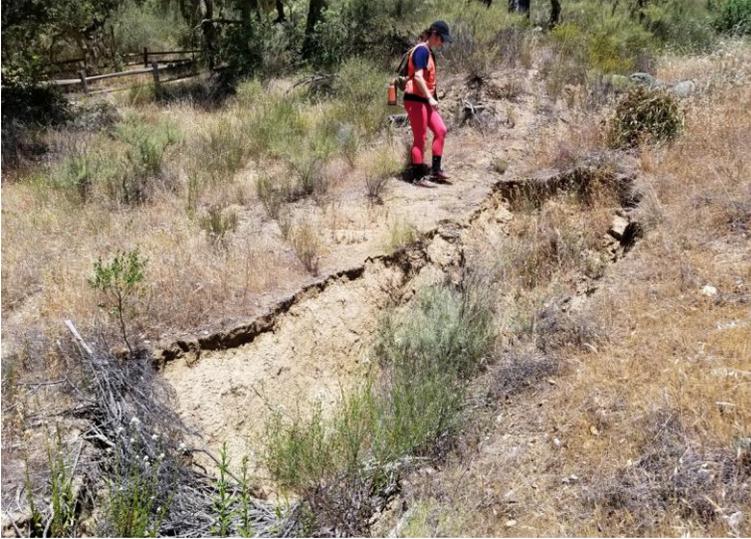
Figure 83: A gully in the Coyote Trail restoration site in 2021. Vegetation in the invert indicates that the feature may be stabilizing.

By 2021, 10 years after construction, the restoration site had a dense cover of deep-rooted native plants representing the plant community on the adjacent hill slopes (Fig. 82). The site had also geomorphically stabilized. Although one small gully is still present (Fig. 83), the site no longer has pervasive erosion noted in previous visits. Any sediment that leaves the site is caught in the sediment basins locate down valley.
