Publication No. WI-2021-02

The Watershed Institute

**Eleven Year Summary of Watershed Studies
at Hollister Hills
State Recreational Vehicle Area:
Fall 2010 to Fall 2021**

Executive Summary

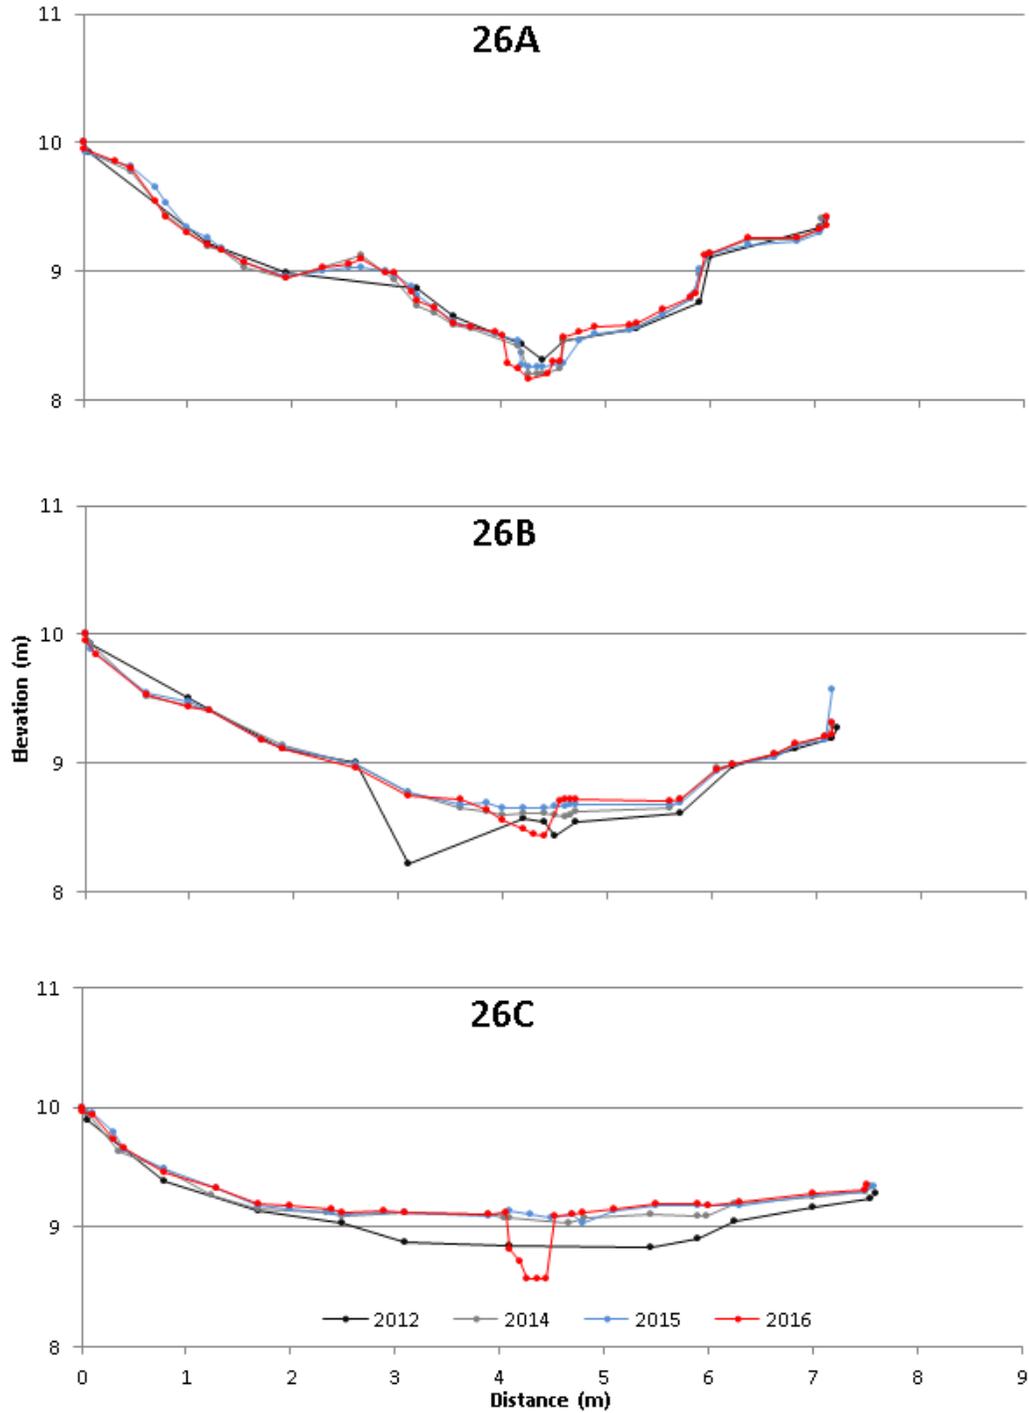
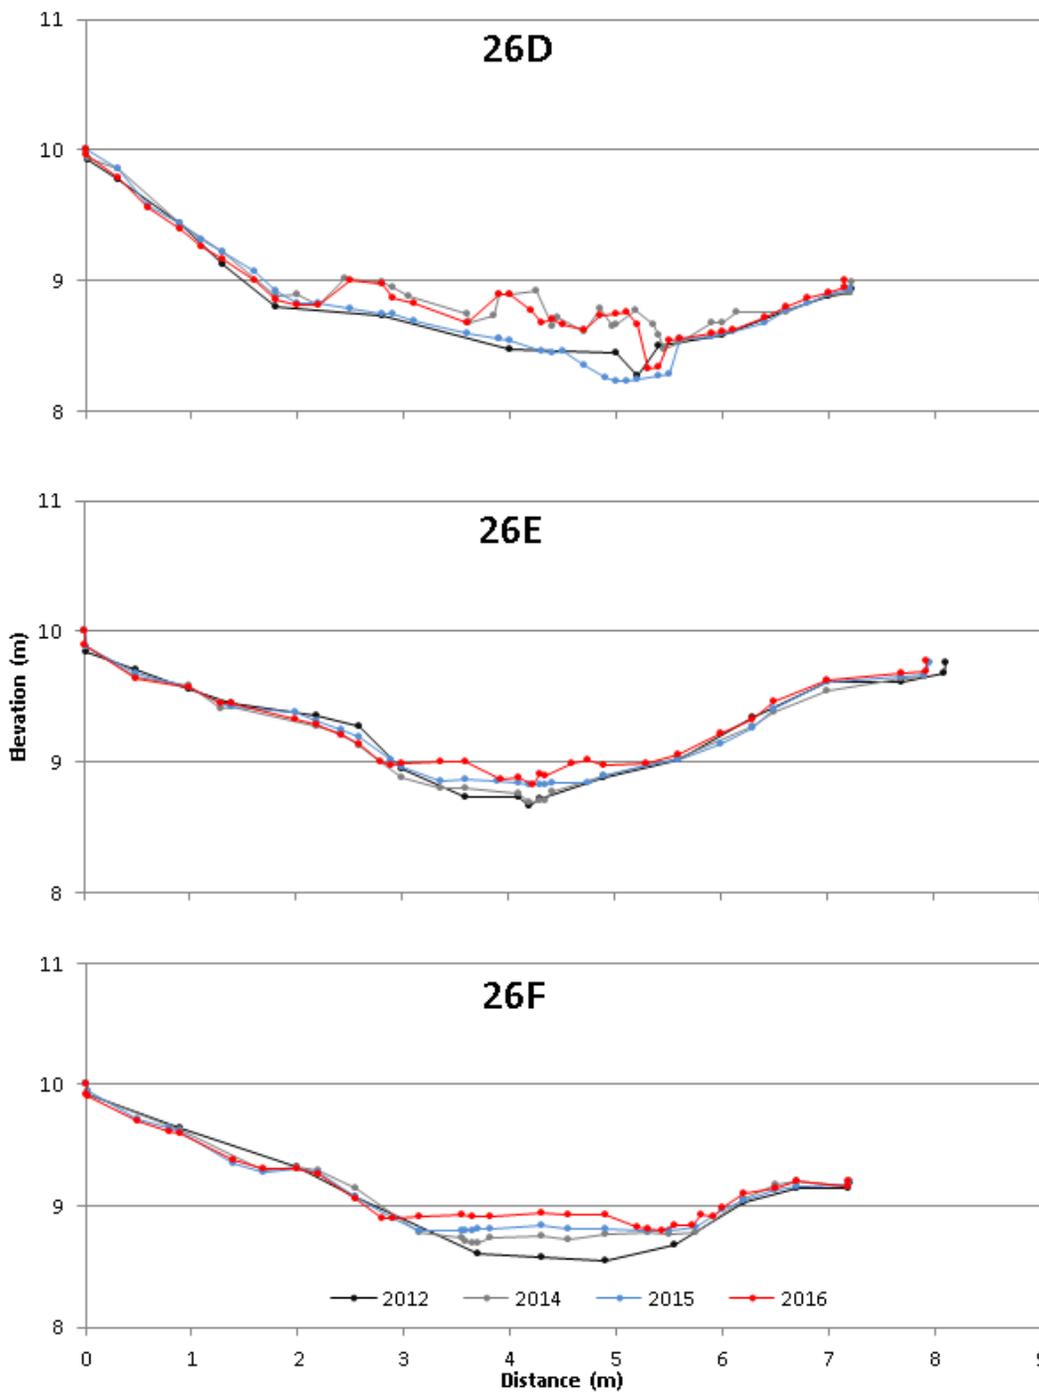
6 Appendix A

Cross sections from berm 26 of the Coyote Trail restoration site. The site showed typical behavior of the surveyed berms.

Visual inspection, ground-based photography, and serial surveys of a subset of the berms indicate that some berms performed well (Fig. 79), while others underwent a period of adjustment. During the first surveys in 2012, many of the berms showed early signs of lateral and vertical failure. The 2014 inspection showed that several berms were compromised by erosion (Figs. 80 and 81). Revegetation efforts have been successful despite the drought. Reconnaissance and surveys performed in 2016 indicated that the site vegetation was very healthy, but cross section surveys indicated that the berm system was still evolving (Appendix A).
