Publication No. WI-2016-12

The Watershed Institute

**Six Year Summary of Watershed Studies at  
Hollister Hills  
State Recreational Vehicle Area:  
Fall 2010 to Fall 2016**

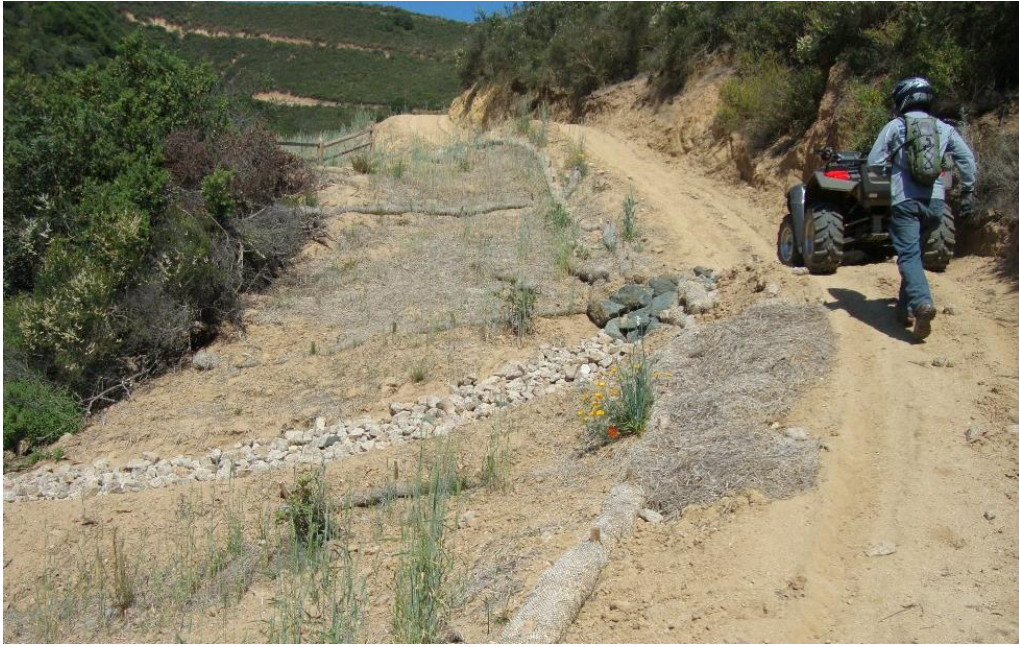
**Figure 8. Example of BMP that includes trail narrowing, outsloping, and planting. Decommissioned part of trail has rocked drainage and native plantings. Vegetation is sparse because it was recently planted on the newly graded slope.**

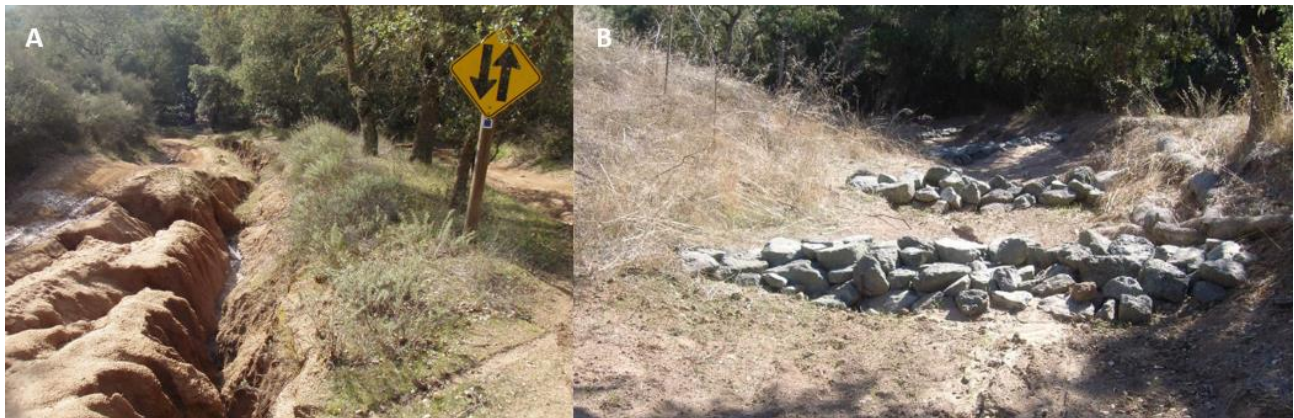
**Figure 9. View down Coyote Trail restoration project. A) Before decommissioning, circa 2009. B) After grading and placement of rock berms, but before revegetation in July 2011.**

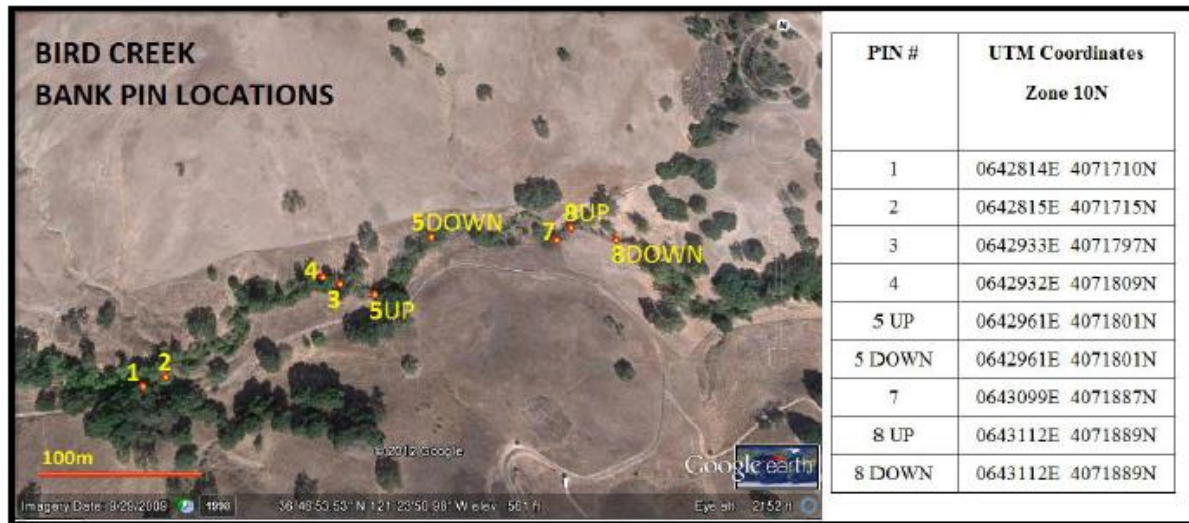
Figure 13. Bank pins located along Bird Creek plotted in Google Earth (GEOL 460 2012).

Bank pins were installed at 8 locations along the Hudner Ranch reach of Bird Creek in March 2011 to estimate the contribution of bank erosion to Bird Creek (Fig. 13). This study only extrapolates the results to the reach of Bird Creek that has similar morphology and geology to the reaches with bank pins. The extrapolation includes 2800 m of stream located between the downstream boundary of the HHSVRA and the San Andreas Fault, where the watershed geology and topography significantly change. Pin sets 5 and 8 have upstream and downstream sets. Each bank pin set consists of 2 to 3 rebar stakes inserted into the channel bank. Bank pin exposure was measured to the closest millimeter using a metric scale. Total volume of stream bank erosion was calculated by multiplying the average pin exposure, the 2800 m stream length, and the estimated average bank height (1.2 m). That product was multiplied by two to account for the two stream banks. The mass of eroded material was estimated by multiplying the volume of eroded material by the stream bank soil density ( $0.980 \text{ tonnes/m}^3$ ) measured in the CSUMB lab from many field samples (GEOL 460 2012).

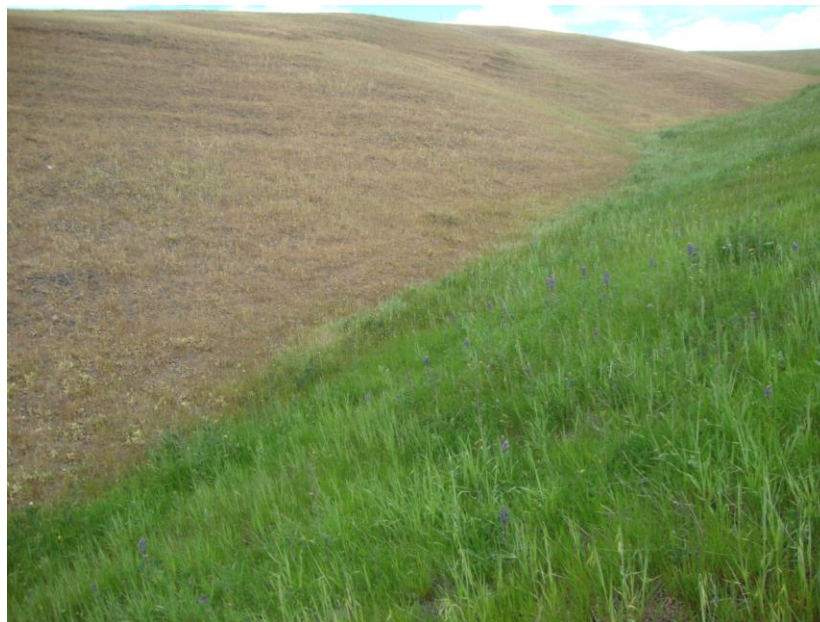
**Figure 16. In March, the HHSVRA grazing hills are typically green and full of wildflowers. In March 2013, prematurely dry south-facing hills were juxtaposed against more typical spring vegetation, including grasses and lupines, preserved for a few weeks longer on the north-facing slopes.**

During the study, Radio Ridge had the highest average annual precipitation at 11.82 inches while GP 1 had 10.47 inches (Table 2 and 3). The rain gages have similar rain records because they are closely spaced: 2.8 km away from each other and approximately 100 m elevation difference. The spatial variability in rainfall is driven by the highly variable topography and the HHSVRA location in the rain shadow of Fremont peak, the tallest peak of the Gabilan Range. The presence of steep-walled deep canyons might also drive variability by funneling wind. The majority of the rain occurs from October to April or May, while the remaining months are typically dry. In the State-wide drought water years of 2013 to 2015, the watershed vegetation dried, exposing the clay soils to the sun earlier than usual (Fig. 16).

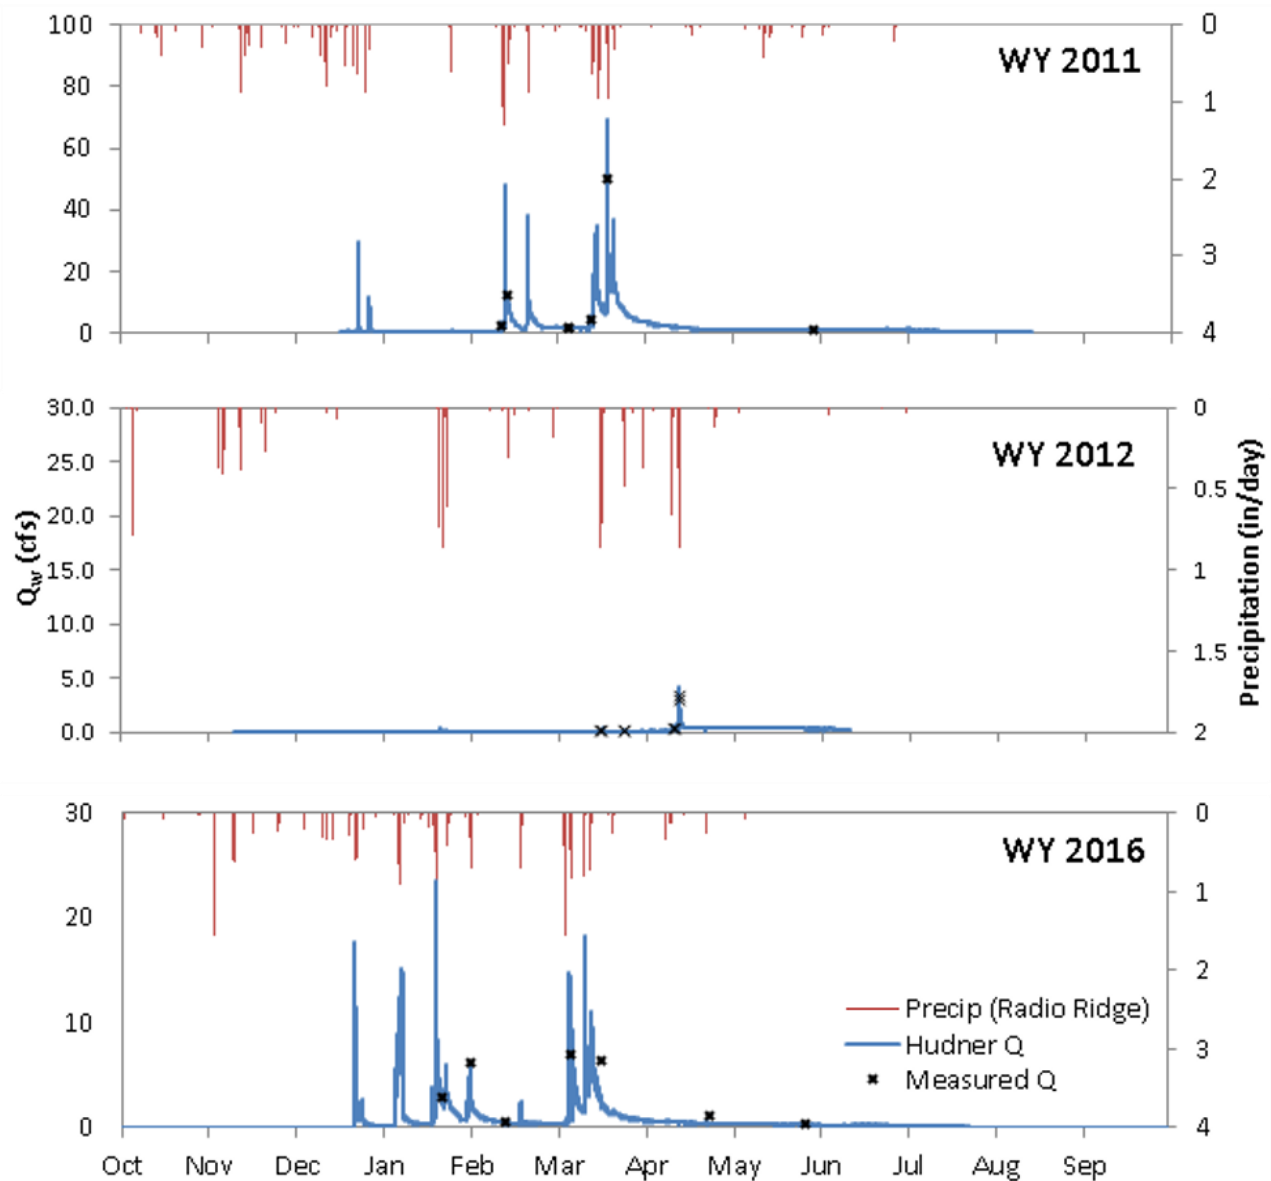
Figure 18. Rainfall at the Radio Ridge gage is plotted with stream discharge measured at the Hudner gage (Fig. 11). The Hudner gage showed insignificant flow in water years 2013 to 2015.

Water discharge was gaged at Nature and Hudner areas of the HHSVRA (Fig. 17 and 18). Variability in flow correlates directly with rainfall. The soils are very dry at the end of each water year, so the first several rainfall events infiltrate without producing surface runoff. Stream flow and winter base flow only occurs after several storms have saturated the soils. In the drought years, the clay soils developed exceptionally deep polygonal cracks, locally up to 0.4 m deep. The resulting macroporosity infiltrated nearly all the precipitation, leaving little for runoff in bird Creek (Fig. 19). Base flow typically ended at Nature in April, but continued throughout the year at Hudner when there was enough groundwater to serve the spring located upstream from the gage. In water years 2013 and 2014, Bird Creek did not have continuous flow between the Nature and Hudner gages, and it connected only briefly in water year 2015. On average, peak discharge at the Hudner gage was approximately three times the magnitude of peak discharge at Nature.

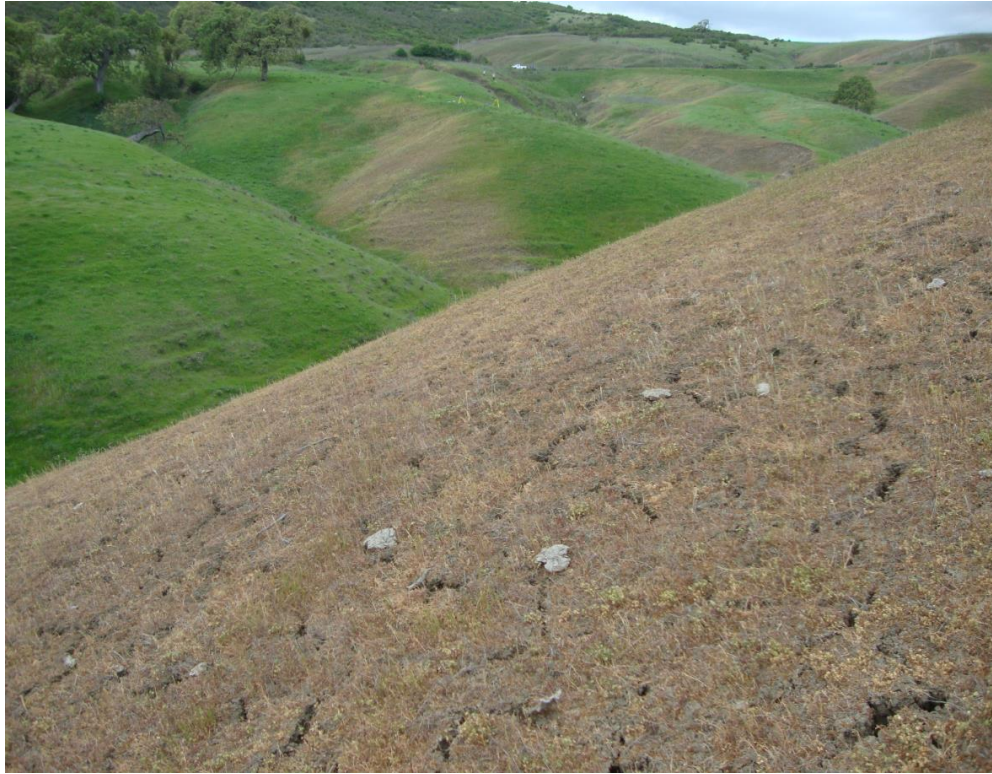
Figure 19. Deep, polygonal cracks form during the dry months. In 2013, the cracks formed prematurely in March. View west toward Cienega Road.

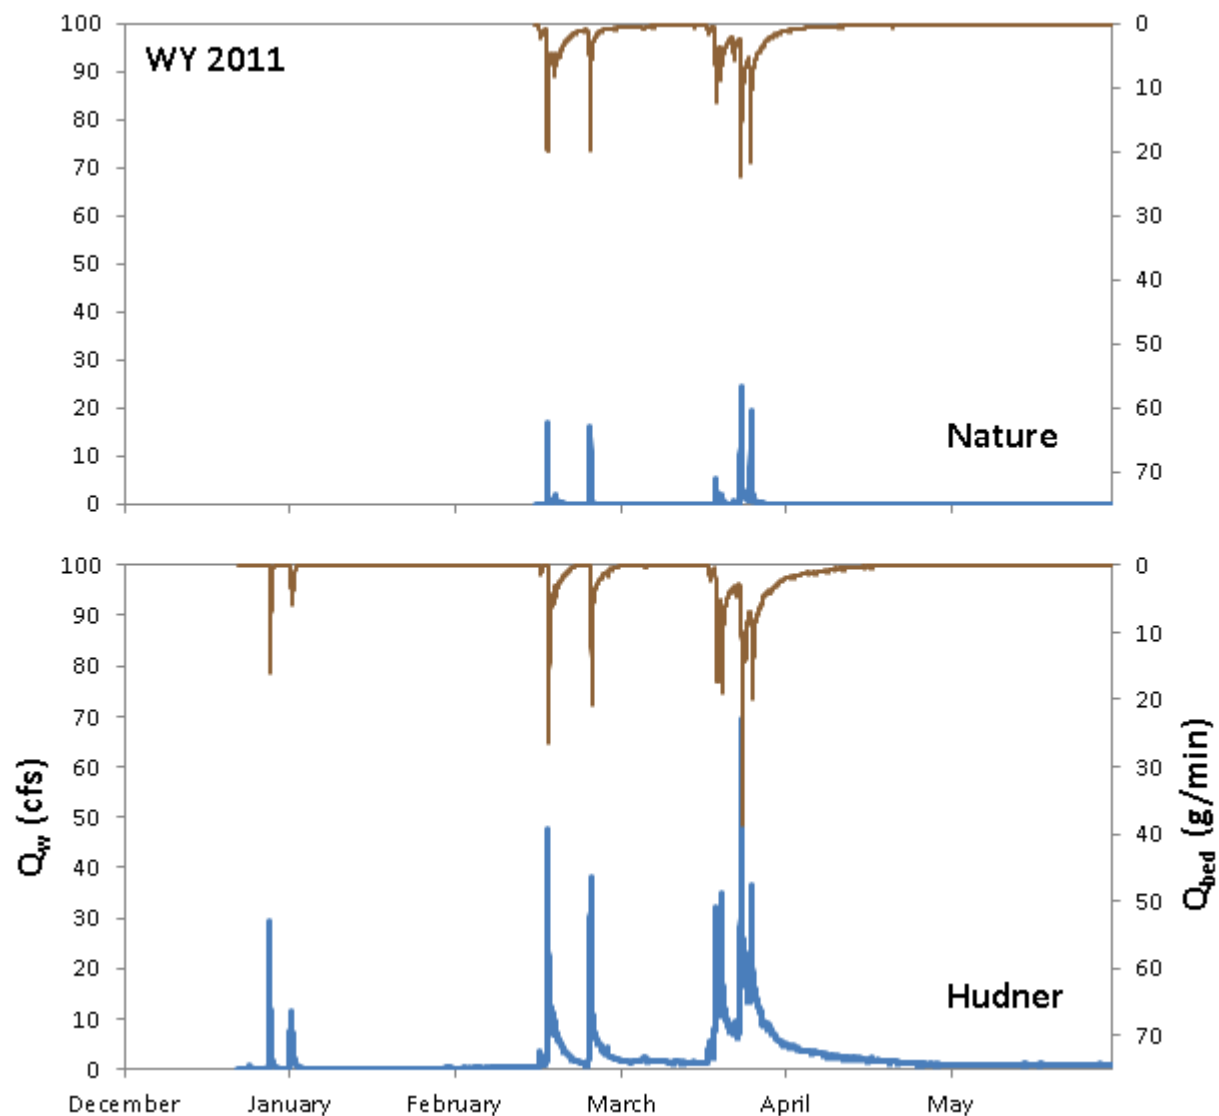
Figure 20. Bedload and water discharge for WY 2011.

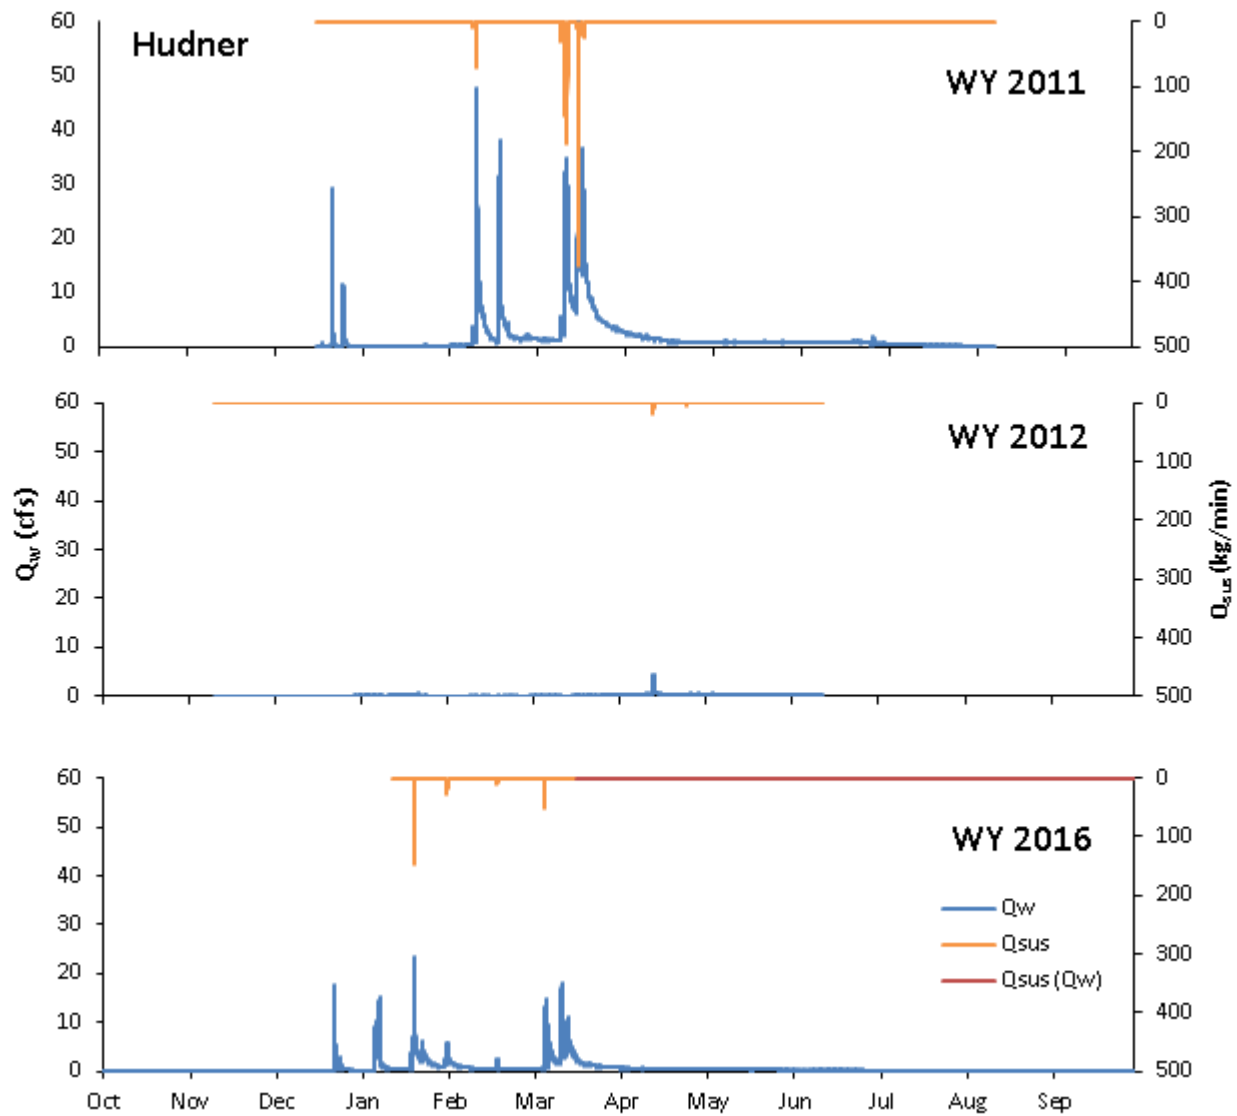
Figure 22. Gaging records for water discharge (blue) and suspended sediment discharge (orange) at Hudner gage. The record starts late in WY 2016 because the gage was not operating. The red line indicates when the suspended sediment was no longer rated using turbidity.

The Hudner gage was rated for suspended sediment in WY 2011, 2012, and 2016 (Fig. 22). There was no measurable sediment transport in WY 2013 and 2014. Low rainfall and runoff conditions of WY 2012 resulted in virtually no suspended sediment transport as indicated by visual inspection of the creeks and turbidity readings from the Hudner gage sonde (Fig. 22).

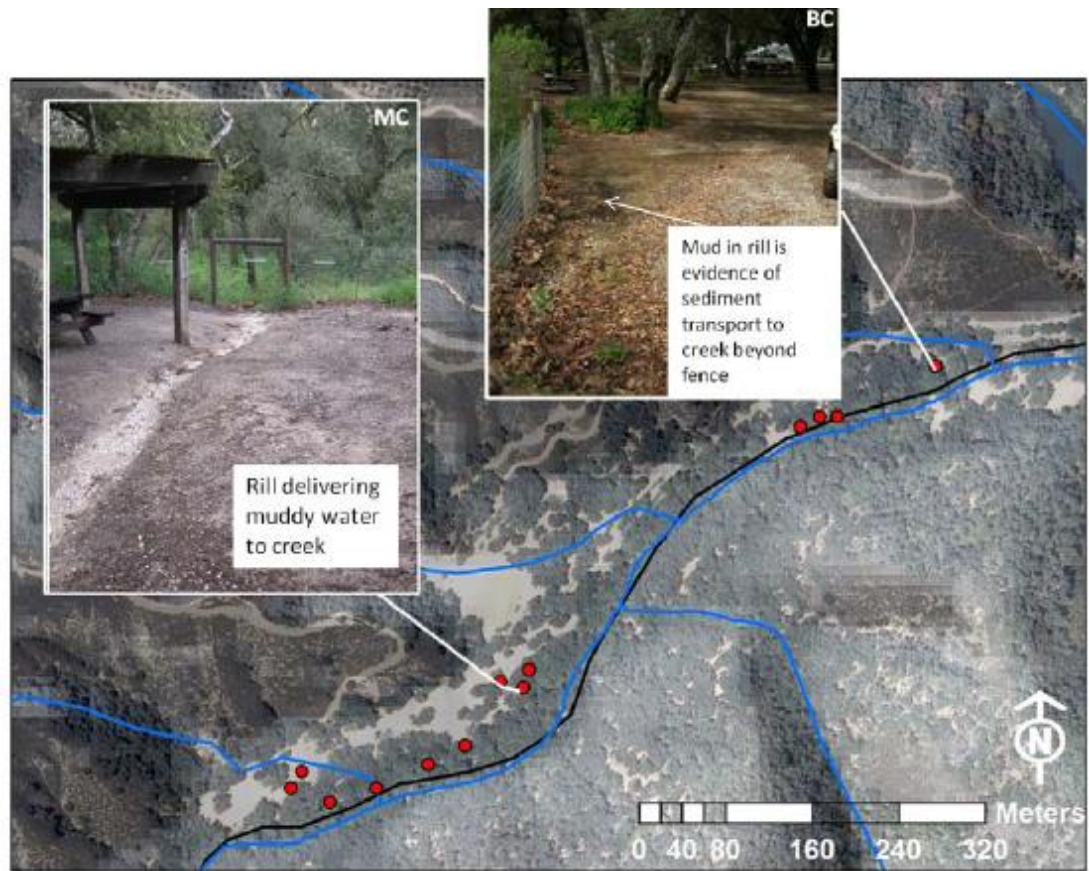
Figure 27. Rill channel pathways at Madrone (MC) and Bee Camp (BC) (GEOL 460 2012).

A CSUMB student study in 2012 evaluated runoff pathways from campgrounds and parking lots located along the banks of Bird Creek. Madrone and Bee campgrounds featured frequently disturbed landscaped with rolling terrain, heavy vehicular traffic, and deeply incised channels. Lodge and Walnut campgrounds featured gentle slopes and long winding channels leading to Bird Creek (Fig. 26 – 28, GEOL 460 2012).

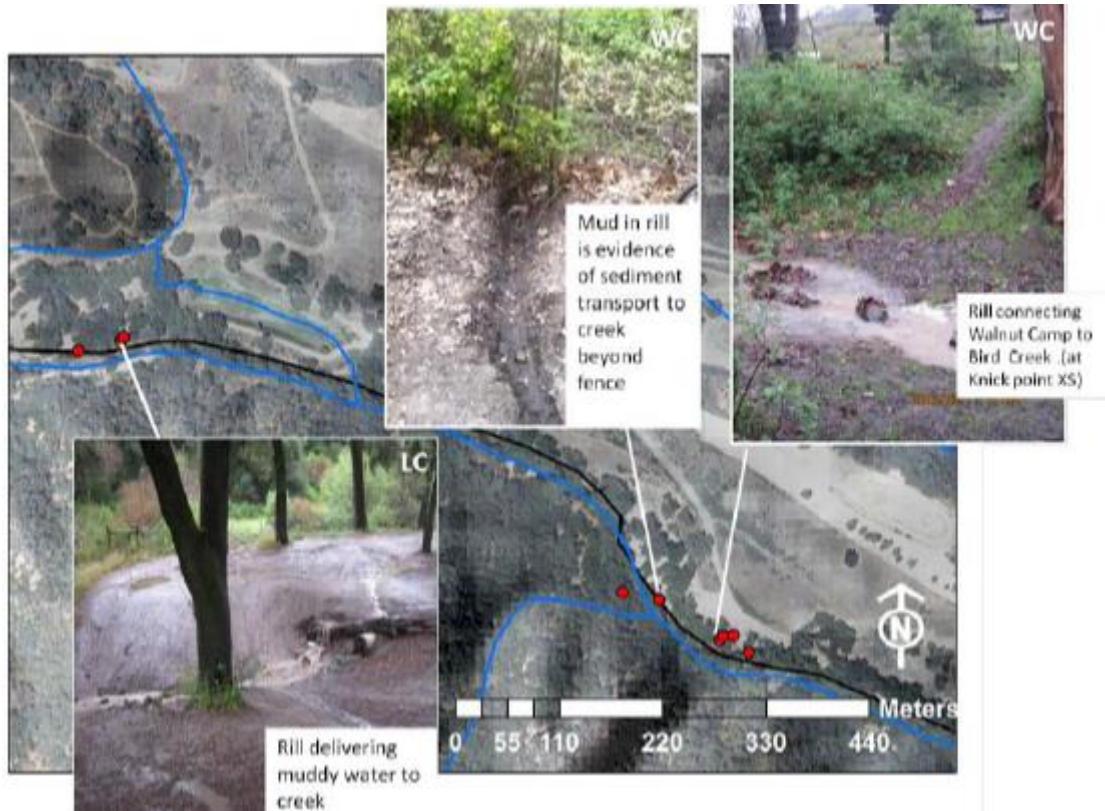
Figure 28. Rill channel pathways at Lodge (LC) and Walnut Camp (WC) (GEOL 460 2012).

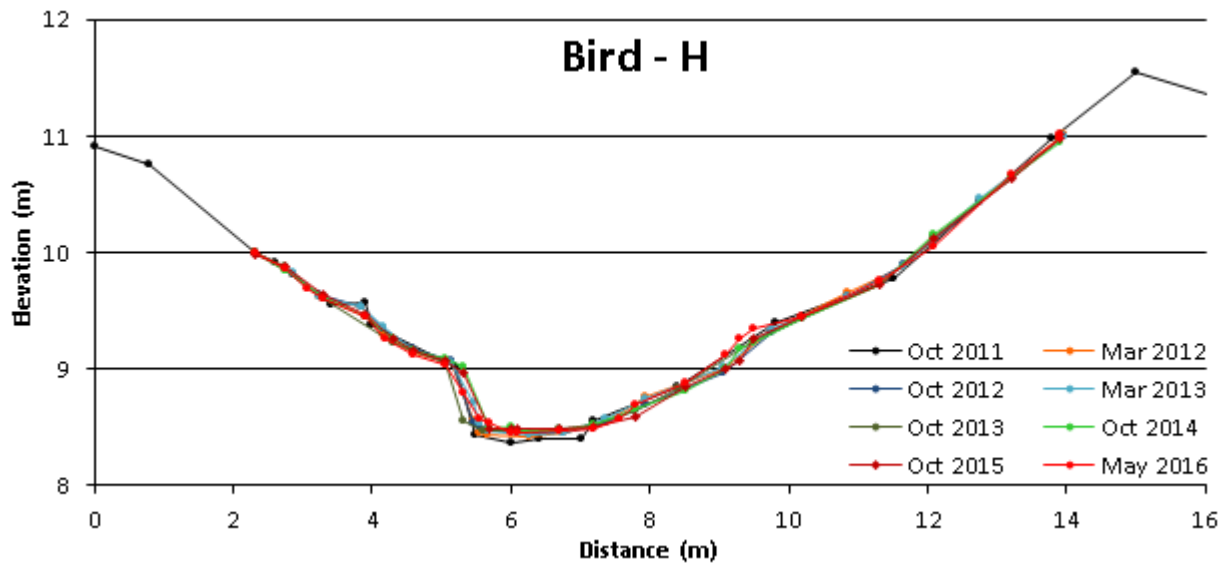
**Figure 29: Cross section H shows the typical history of all the cross section locations in the Hudner reach of Bird Creek. Other cross sections are in Appendix A.**

Benchmarked cross sections of Bird Creek at the Hudner area were surveyed approximately annually to capture major geomorphic changes that would indicate whether the creek is storing, sourcing, or just transporting sediment (Fig. 29; Appendix A). Serial cross sections surveyed for six years indicate that Bird Creek transported the sediment supplied to it without net aggradation or degradation of the channel. This behavior indicates that Bird Creek is in a state of steady-state equilibrium with the sediment supply from the watershed as measured over a 6-year period (e.g., Ritter et al. 2011). While local cattle-derived fine sediment locally covered the channel bottom with a few centimeters of fine sediment, the material washed through the system once stream discharge renewed, leaving no lasting geomorphic changes.

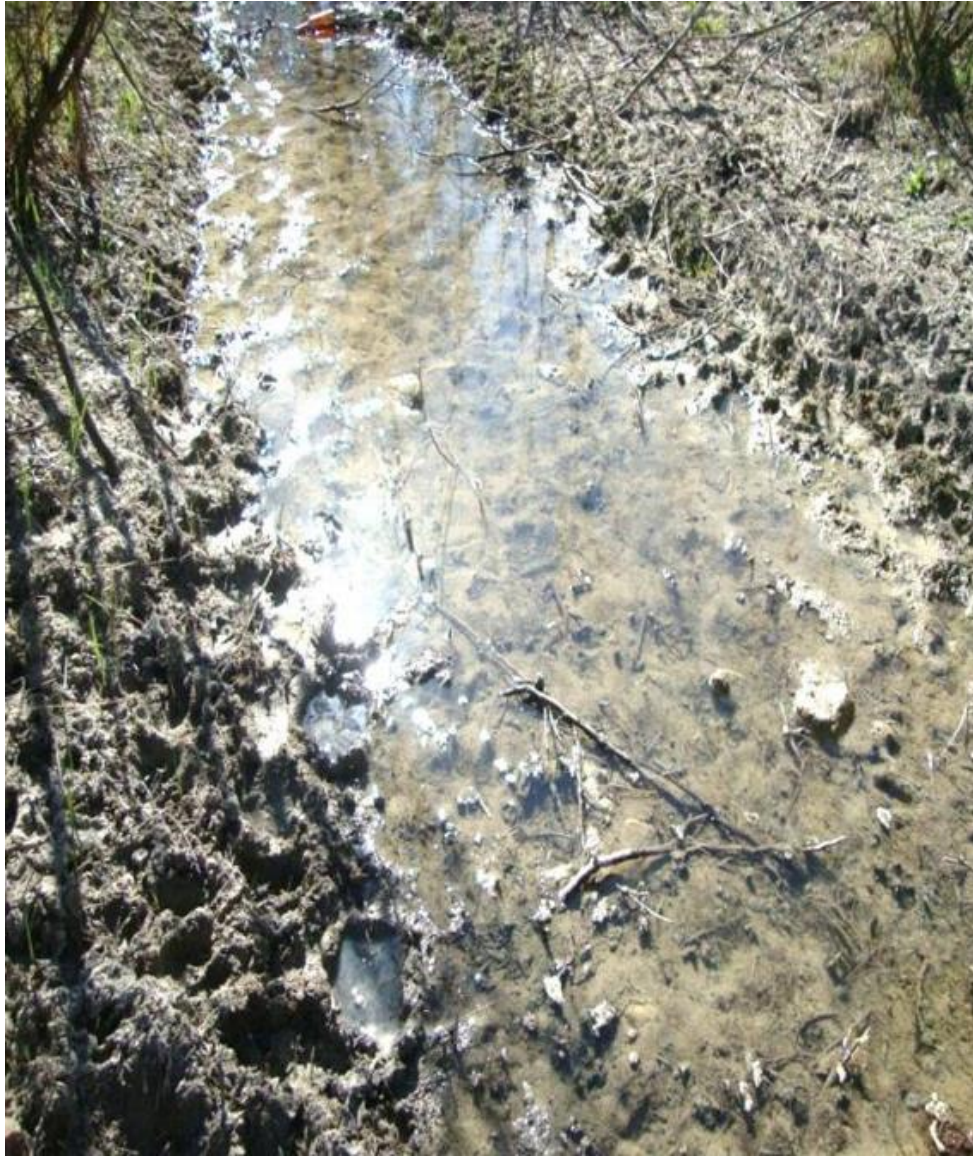
**Figure 30. Hoof prints are visible in the mud in Bird Creek following an accidental breach of riparian fencing in 2012.**

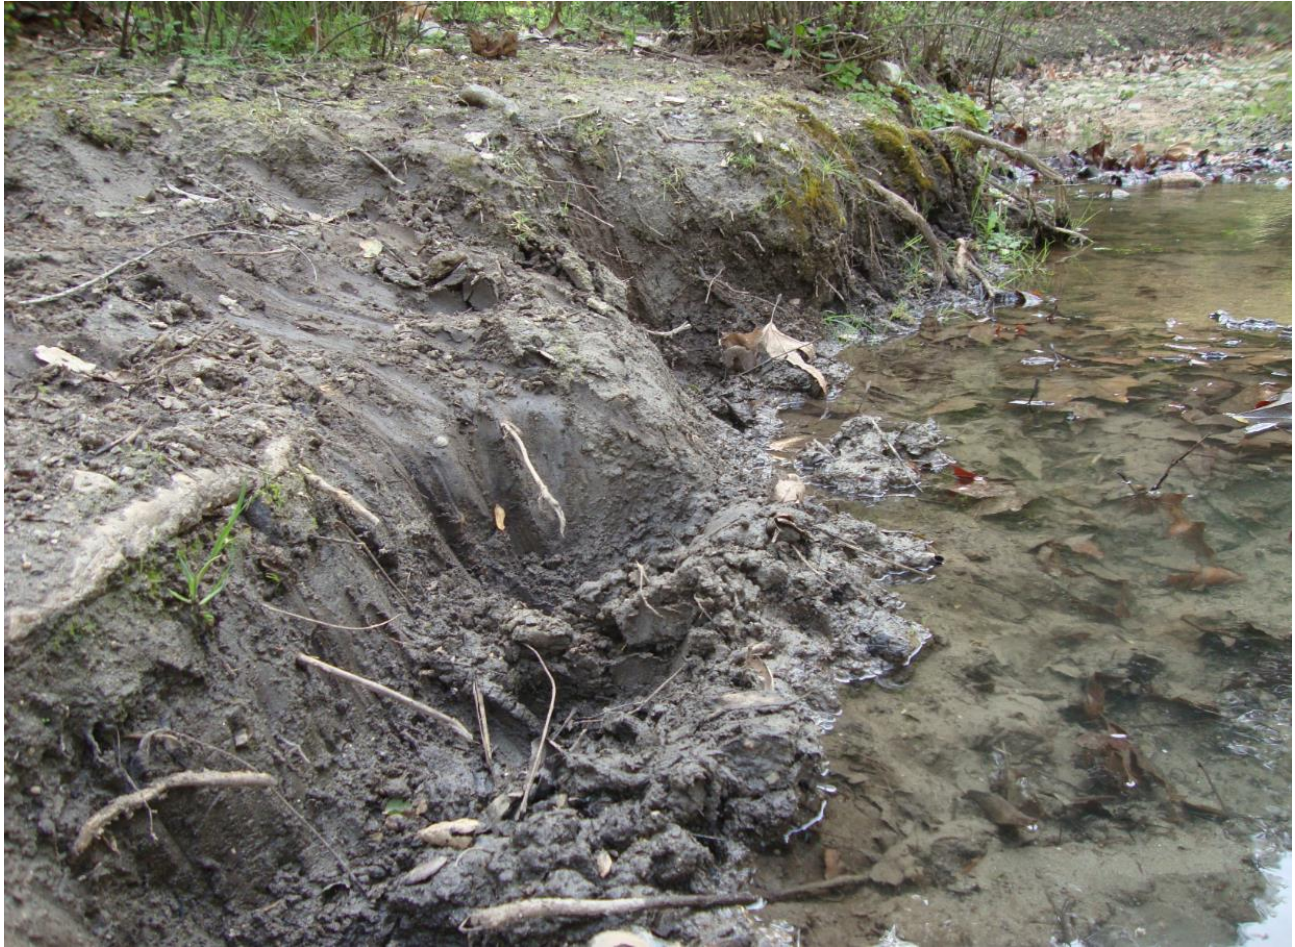
**Figure 31. Upstream view of Bird Creek in March 2012, downstream of Walnut Camp. Cattle impact from neighboring property is indicated by sheared muddy stream banks.**

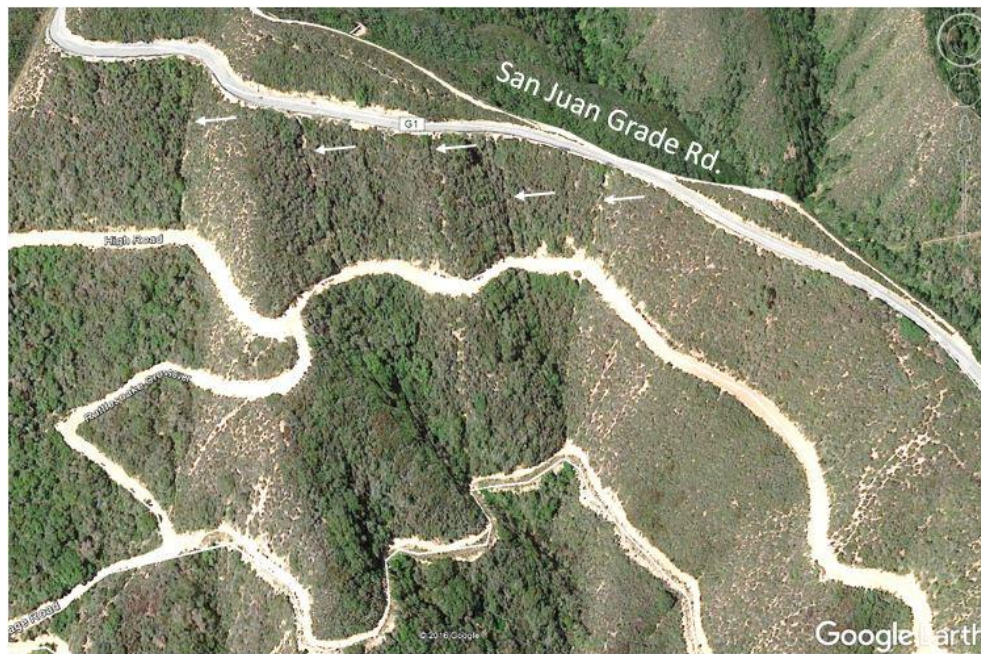
**Figure 33. Oblique aerial photograph of hillslope erosion concentrated below a subset of culverts along San Benito County's San Juan Grade Road. White arrows point to vertical runoff paths delivering hydraulically concentrated culvert flow onto the HHSVRA slopes. Google Earth image from 2015.**

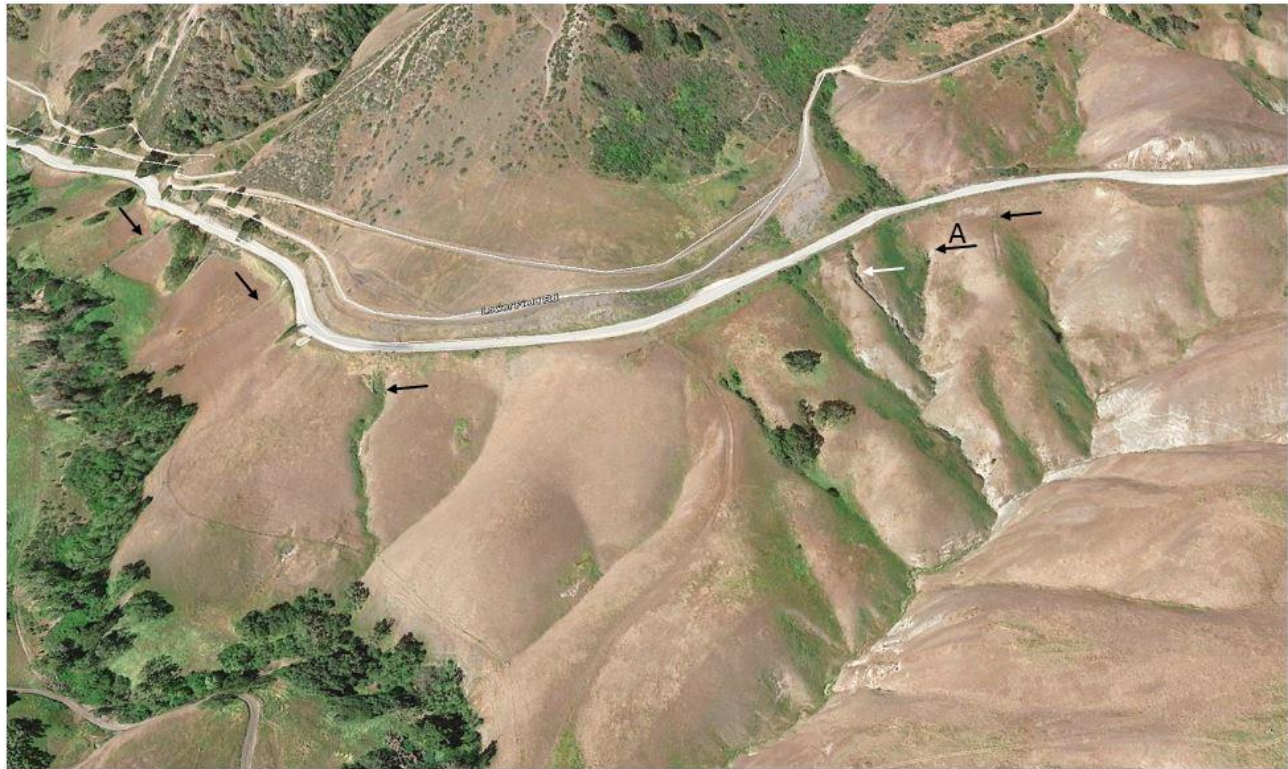
**Figure 36. Oblique aerial photograph of hillslope erosion concentrated below culverts along San Benito County's Cienega Road. Black arrows point to gullies below culverts. Gully A has benchmarked cross sections for long-term monitoring. White arrow points to a gully that developed as result of incision of culvert-related gully. Google Earth image from 2015.**

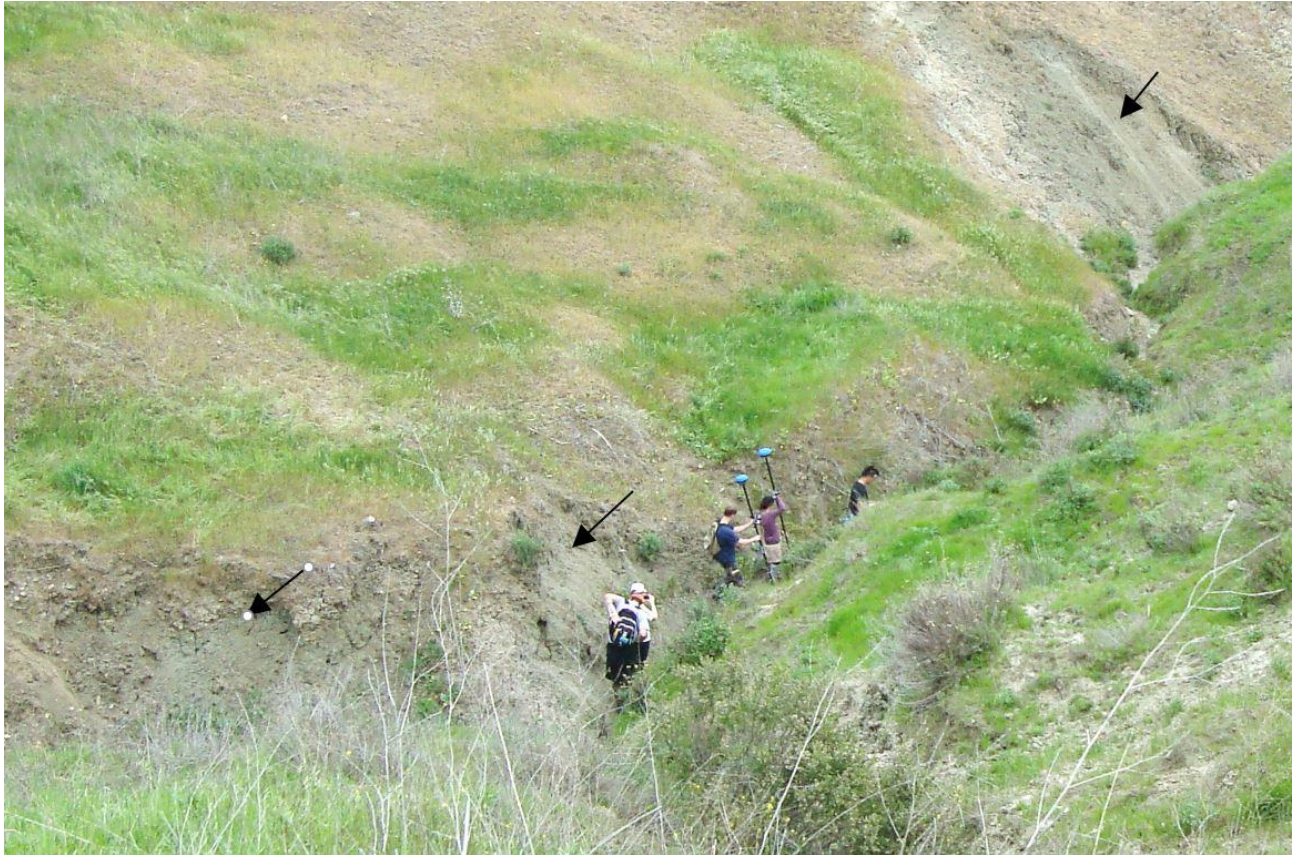
**Figure 37. Cienega Gully A: Downstream view of a portion of the gully labeled A in Figure 36. Arrows point to recently eroded gully sides with a range of heights.**

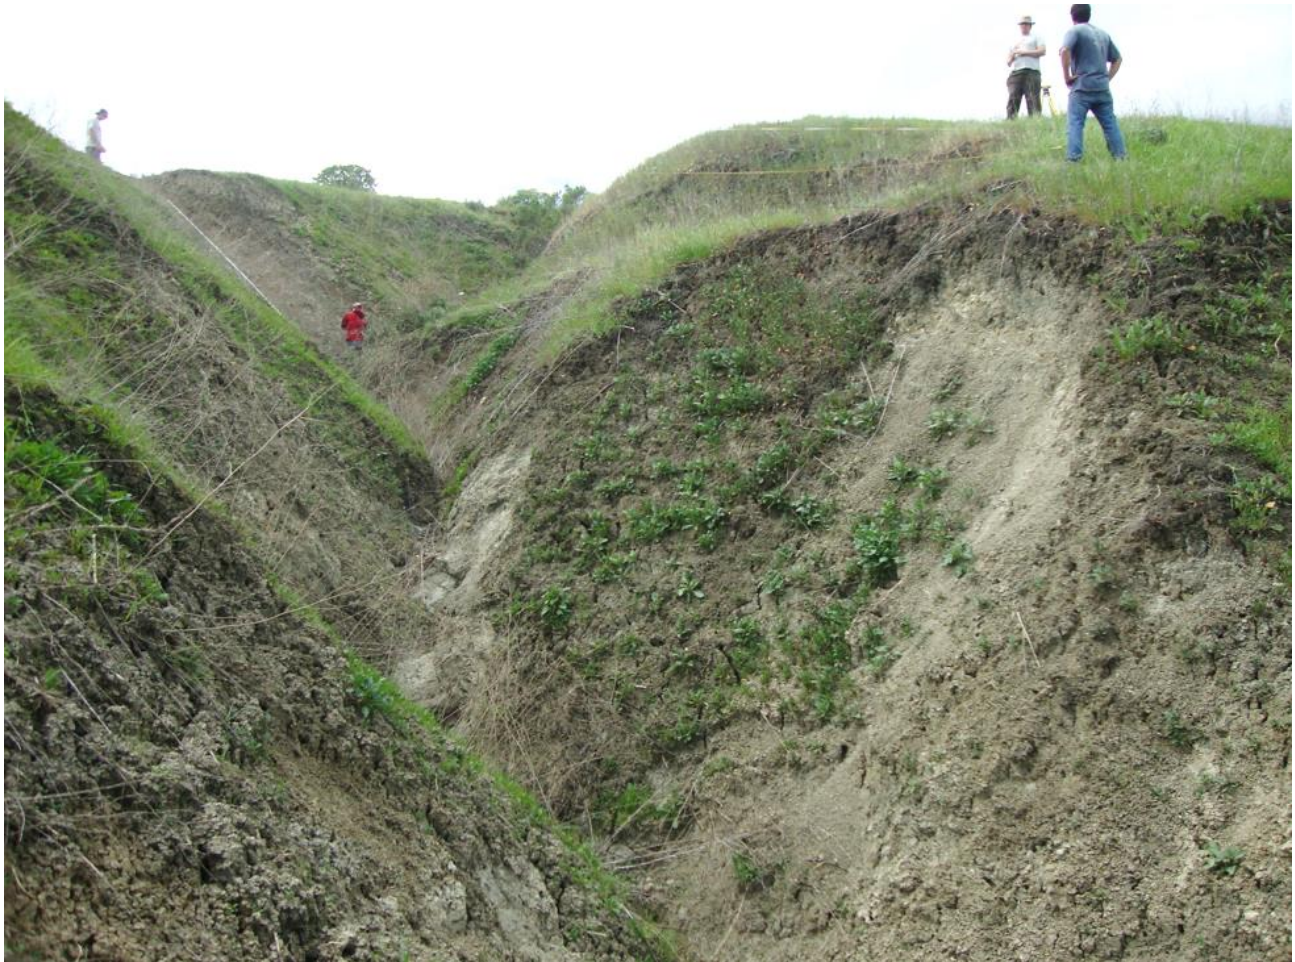
**Figure 38. A tributary to Gully A is a volumetrically important source of fine sediment in Bird Creek.**

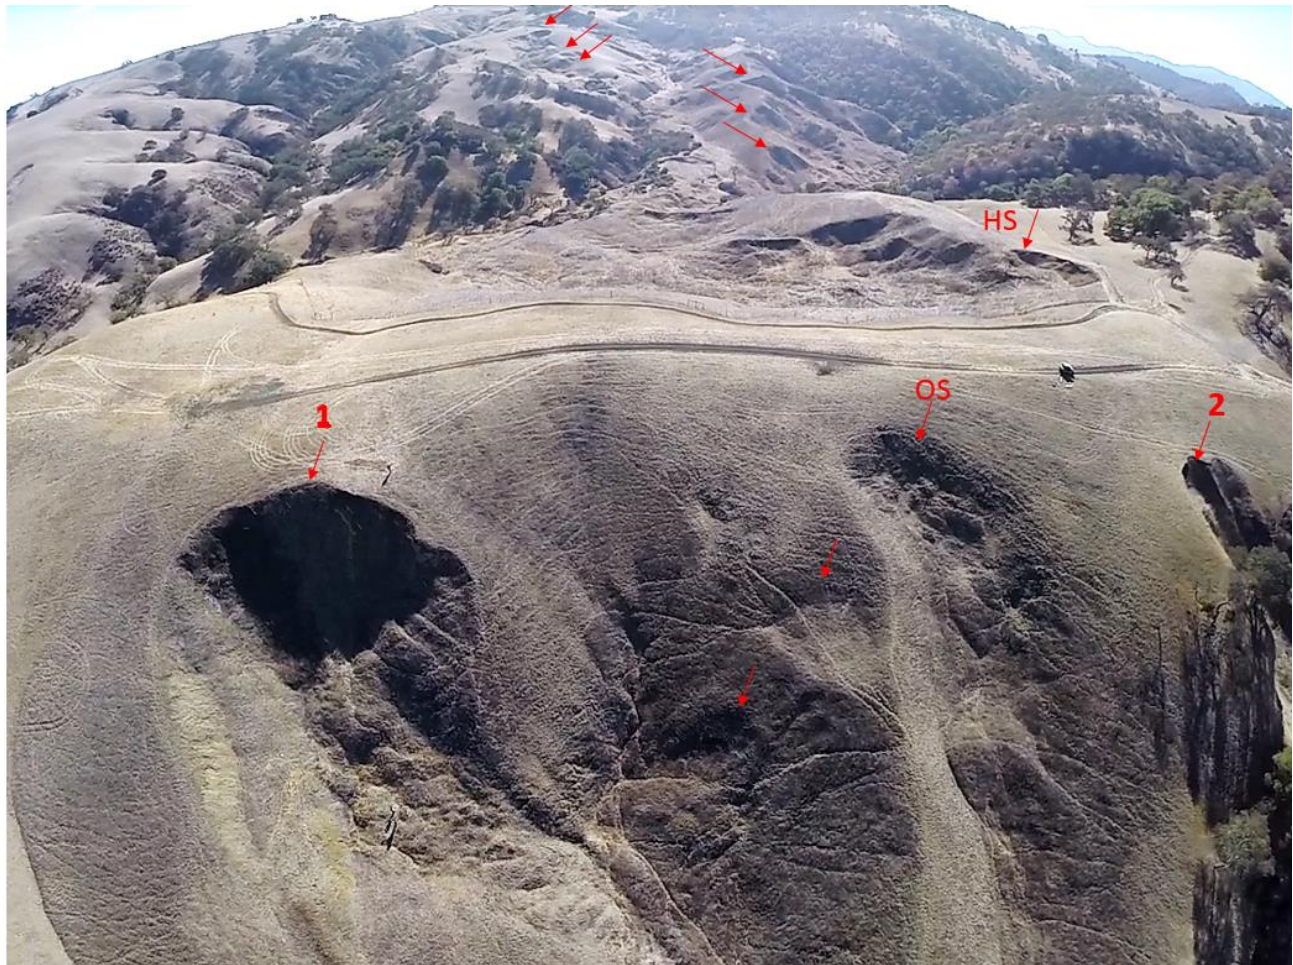
Figure 40. Low altitude oblique aerial view of unstable slopes in study area (foreground) and in the region, beyond. Red arrows point to a subset of slope failure features (typically “slumps”) present in the region. Numbered arrows correspond to the numbered features in Figure 46. HS is headwall of Hudner Slide. OS is an example of a geomorphically “older” slide.

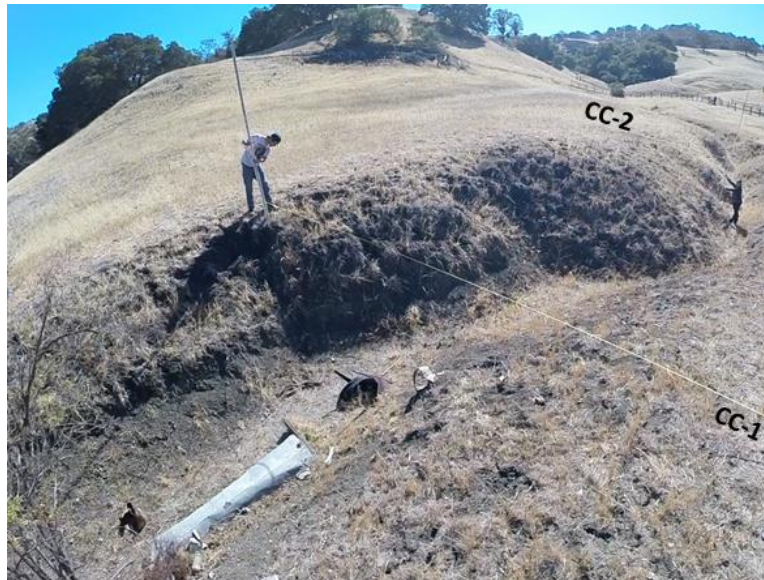
**Fig 48. Ranch implements, including glass bottles, fluid storage tank, and tires only several decades old are exposed by erosion of the fan fill. Up gradient wide-angle photo view of cross sections CC-1 and CC-2 (Appendix) from near Bird Creek.**

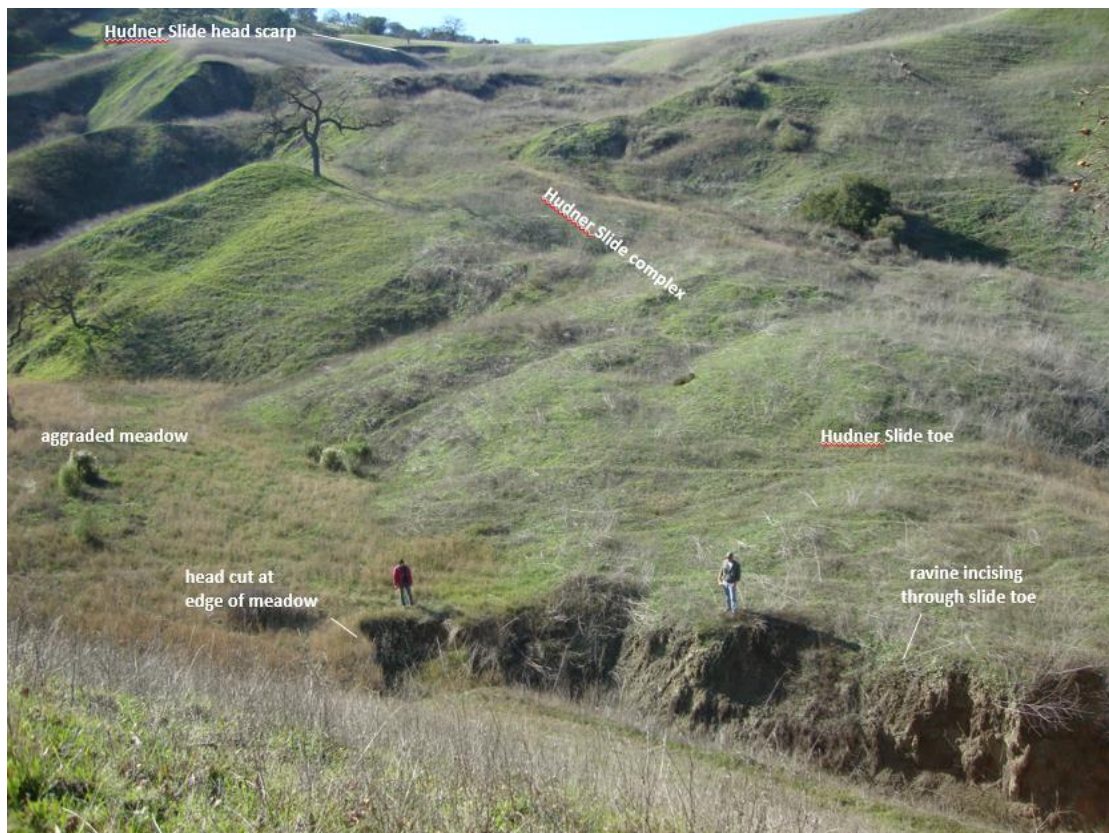
**Figure 51. Oblique photo showing field relations between slide elements and valley sediment transport system. Meadow sediment filled in behind dam caused by slide toe. The creek eroded through the toe (see ravine) and now has access to transport the sediment trapped behind the toe.**

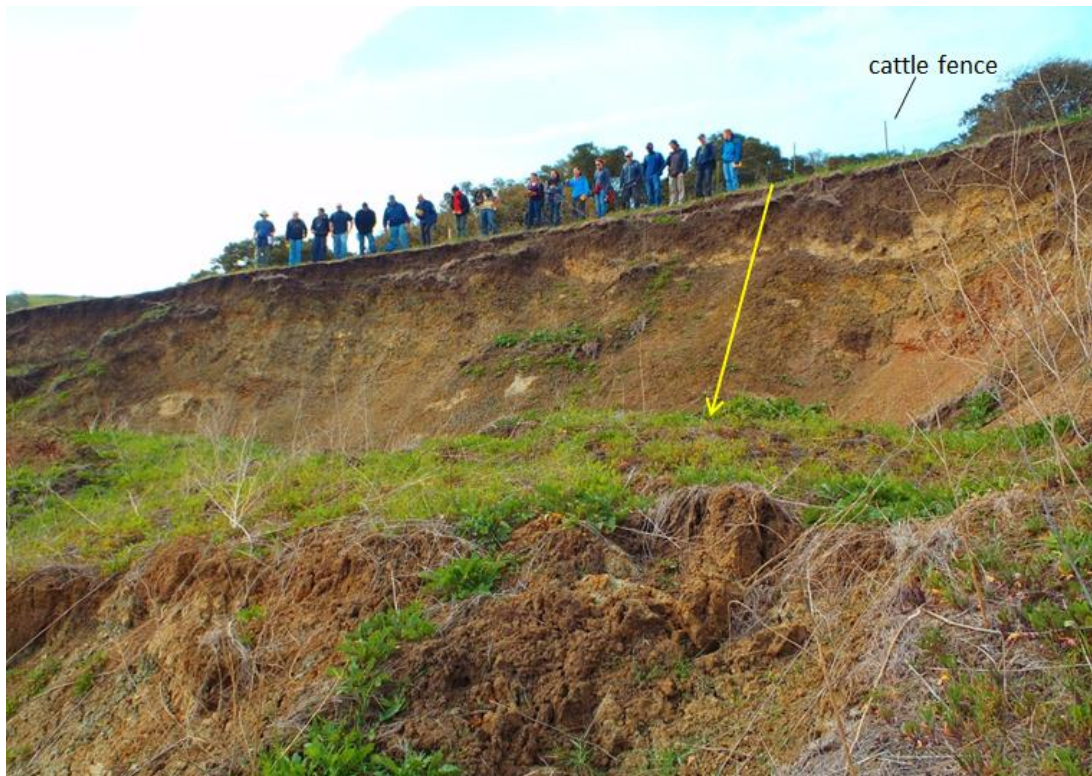
**Figure 52. Hudner Slide headwall scarp in spring 2012. Lack of vegetation and sharp (locally overhanging) top corner on the headwall scarp indicates that the slide motion is young. Yellow arrow indicates approximately 6 m of displacement. Cattle fence in background is indicated in Figure 53.**
