Publication No. WI-2016-12

The Watershed Institute

**Six Year Summary of Watershed Studies at  
Hollister Hills  
State Recreational Vehicle Area:  
Fall 2010 to Fall 2016**

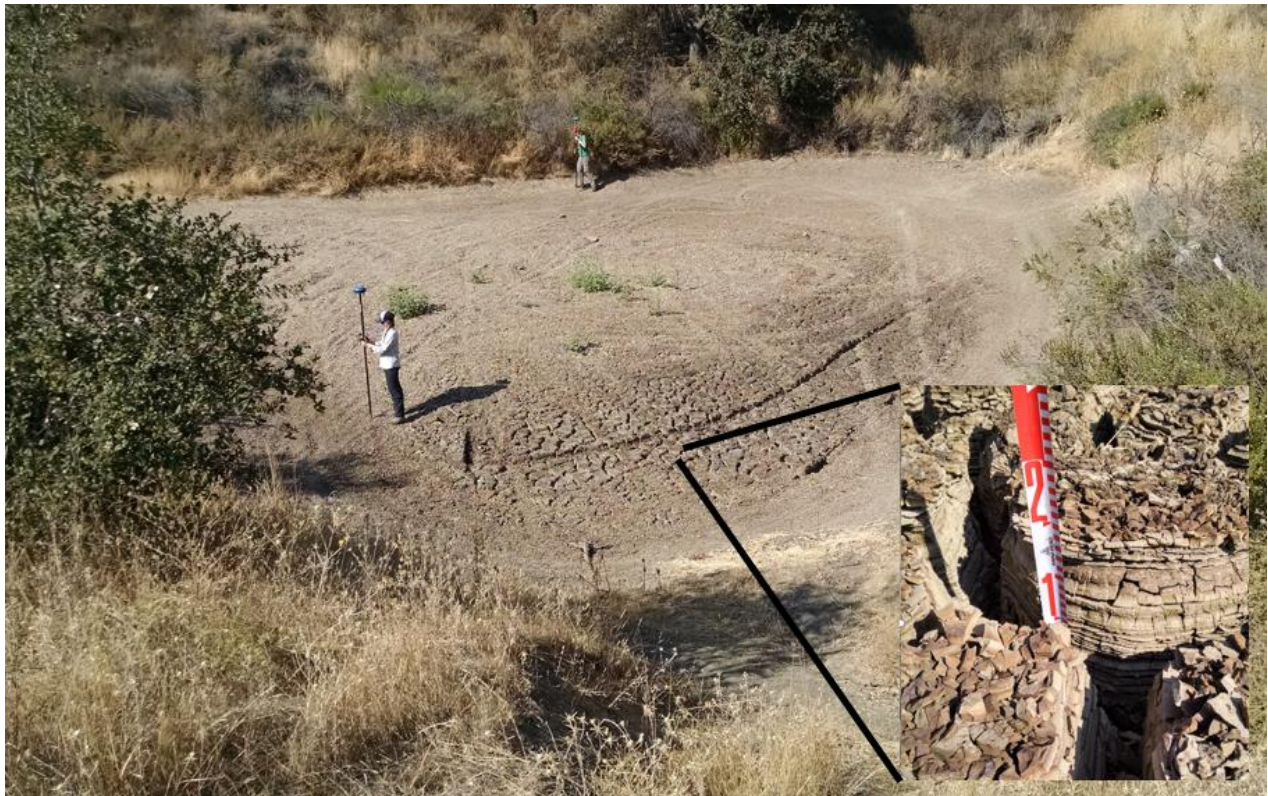
Figure 55. Superhill sediment basin receives runoff from clay soils east of the san Andreas Fault. Little bedload is present. Inset is a close-up view of laminated fine-grained deposits. Small color blocks on scale are 0.005 m.

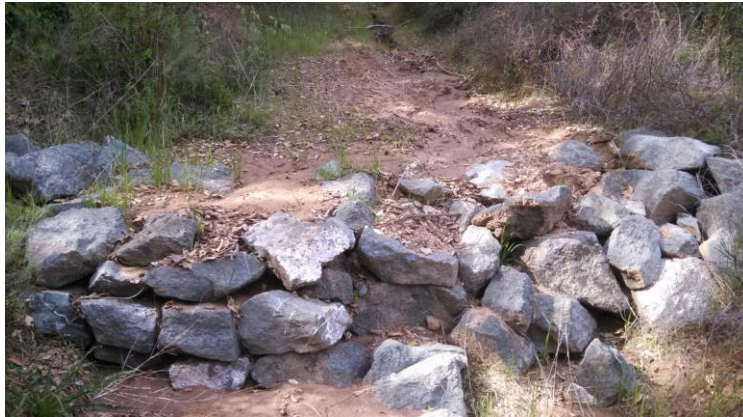
**Figure 57. Berm-1: View up-gradient of a berm in the Coyote Trail gully restoration site in March 2014. The berms trapped sediment until the space behind the berms had filled with sediment.**

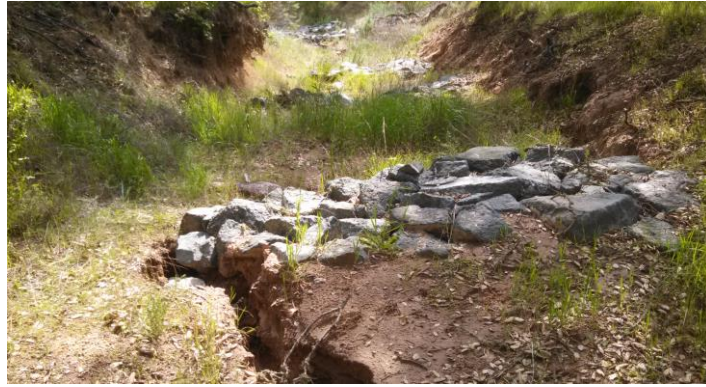
**Figure 58. lateral: View down-gradient of a berm in the Coyote Trail gully restoration site in March 2014. Some berms provided incomplete grade control because of lateral erosion.**

Visual inspection, ground-based photography, and serial surveys of a subset of the berms indicate that the berms underwent a period of adjustment. The berms trapped sediment until the shallow reservoirs upstream of the berms were filled (Fig. 57). During the first surveys in 2012, many of the berms showed early signs of lateral and vertical failure. Photographs in 2014 show that in some cases the berms are compromised by erosion (Figs. 58 and 60). Revegetation efforts have been successful despite the drought. Reconnaissance and surveys performed in 2016 indicate that the site vegetation is very healthy, but the berm system is still evolving (Appendix A). While the site is generating modest sediment runoff, the sediment is eventually caught in the sediment basins located down gradient. Future grade-control projects on steep granitic slopes should include closer spaced berms, and deeper keying into the bed and banks.

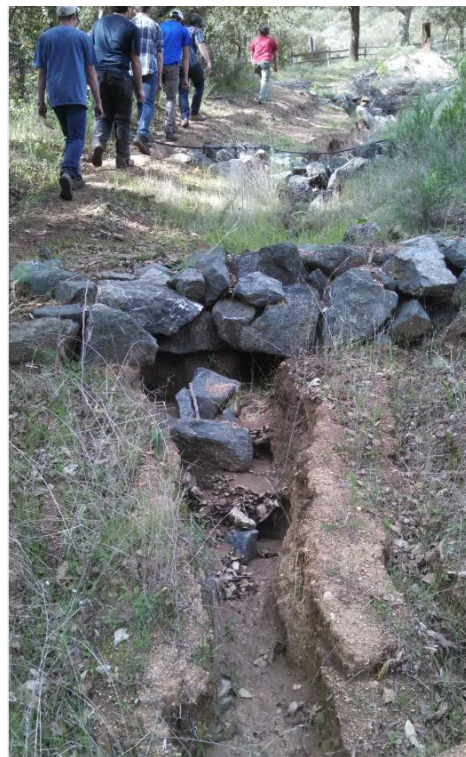
**Figure 59. undercutting: View up-gradient of a berm in the Coyote Trail gully restoration site in March 2014. While major gullying has been stopped, some berms provided incomplete grade control because of undercutting.**

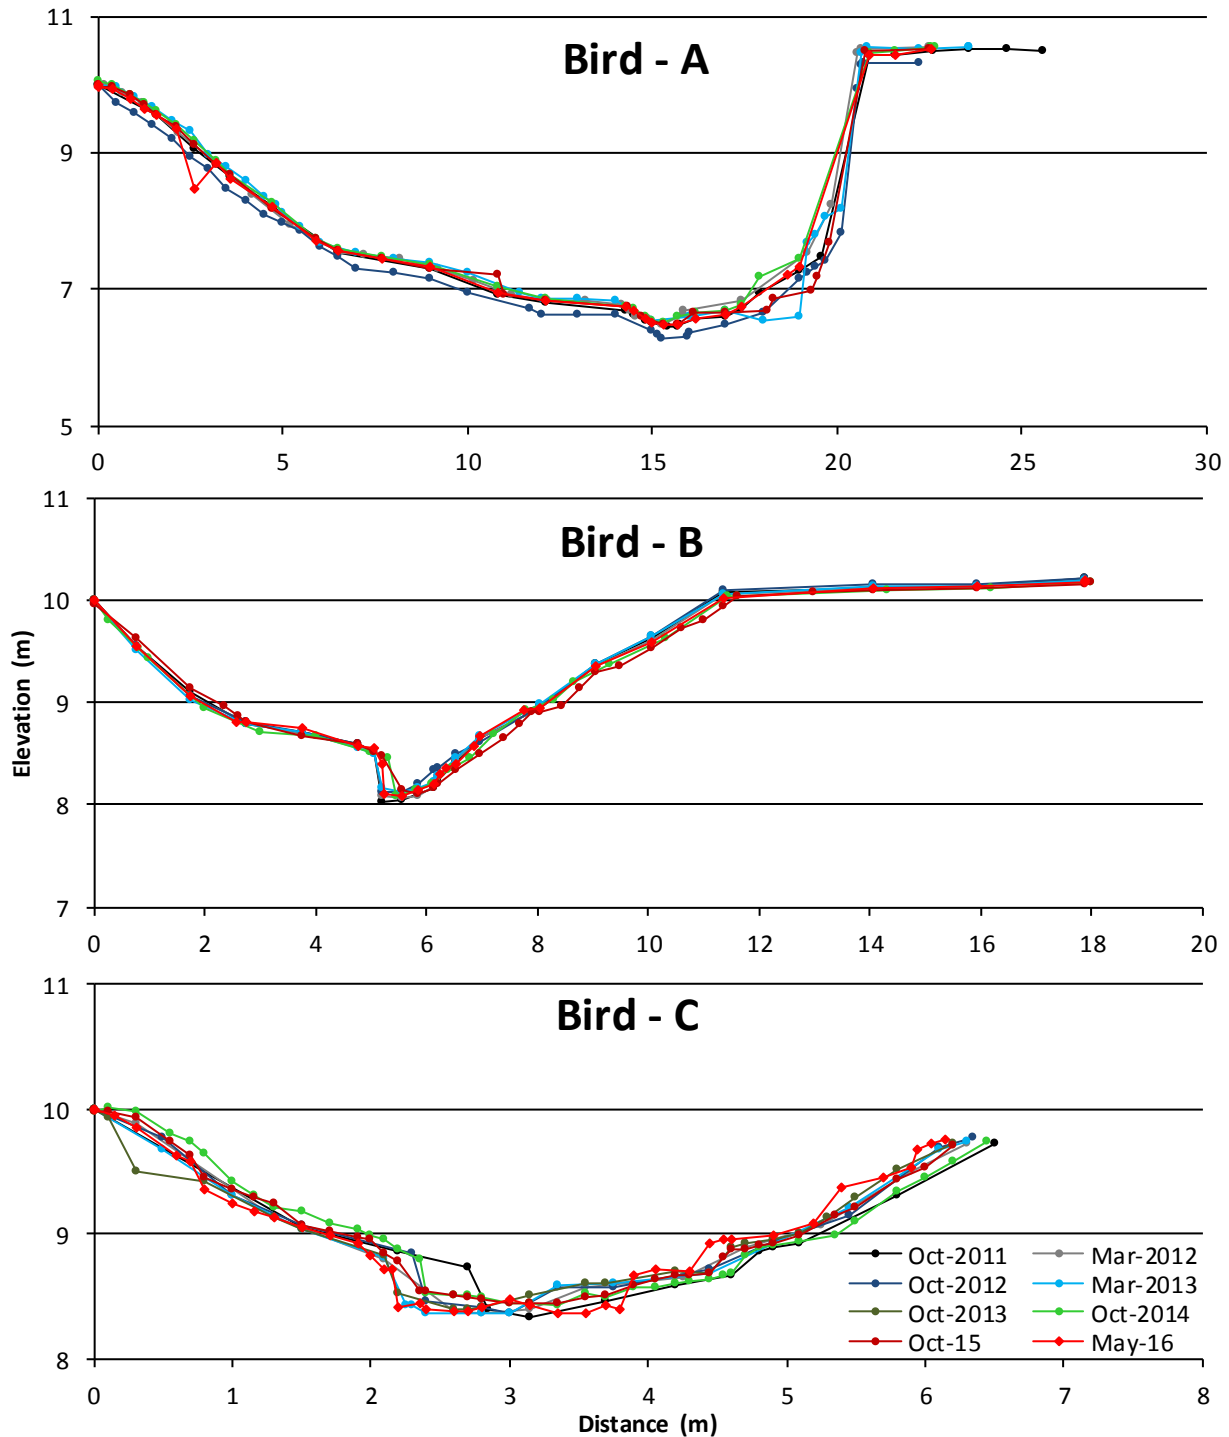
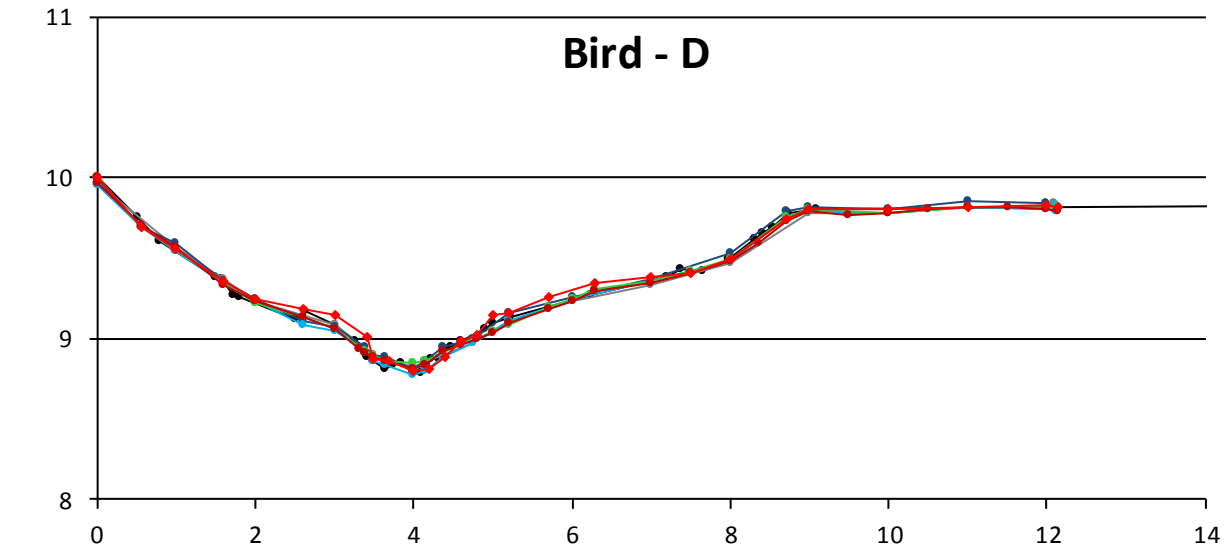
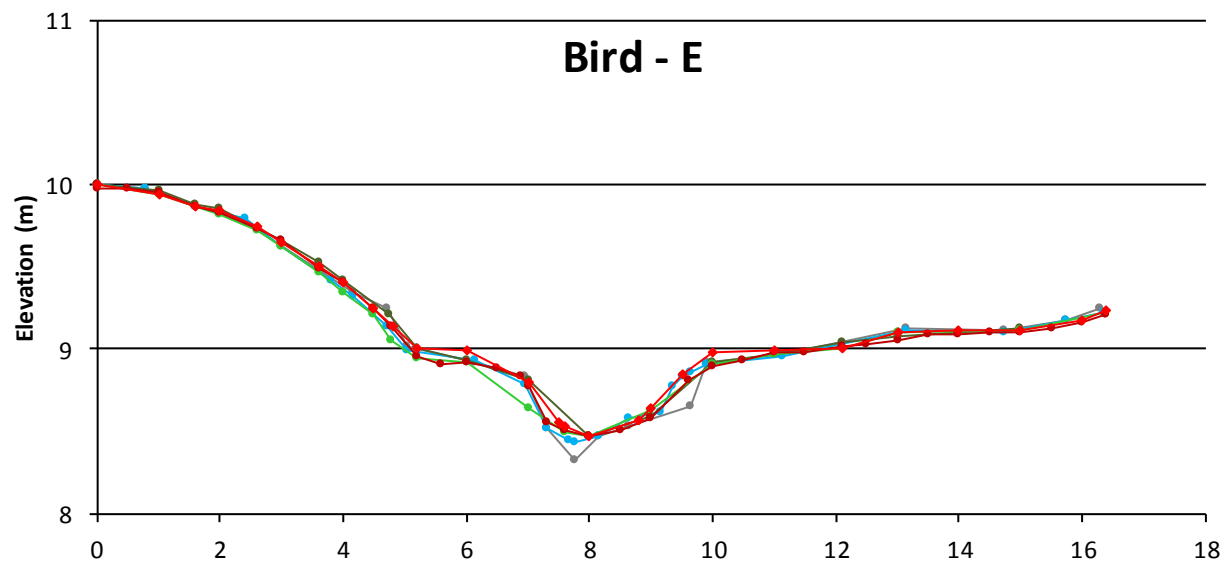
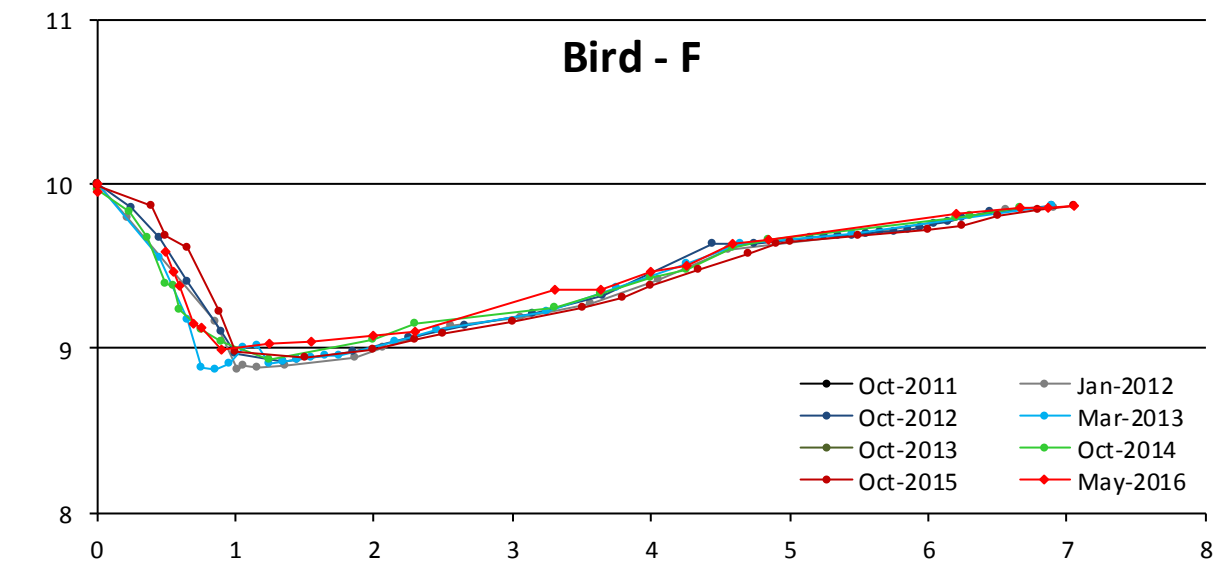
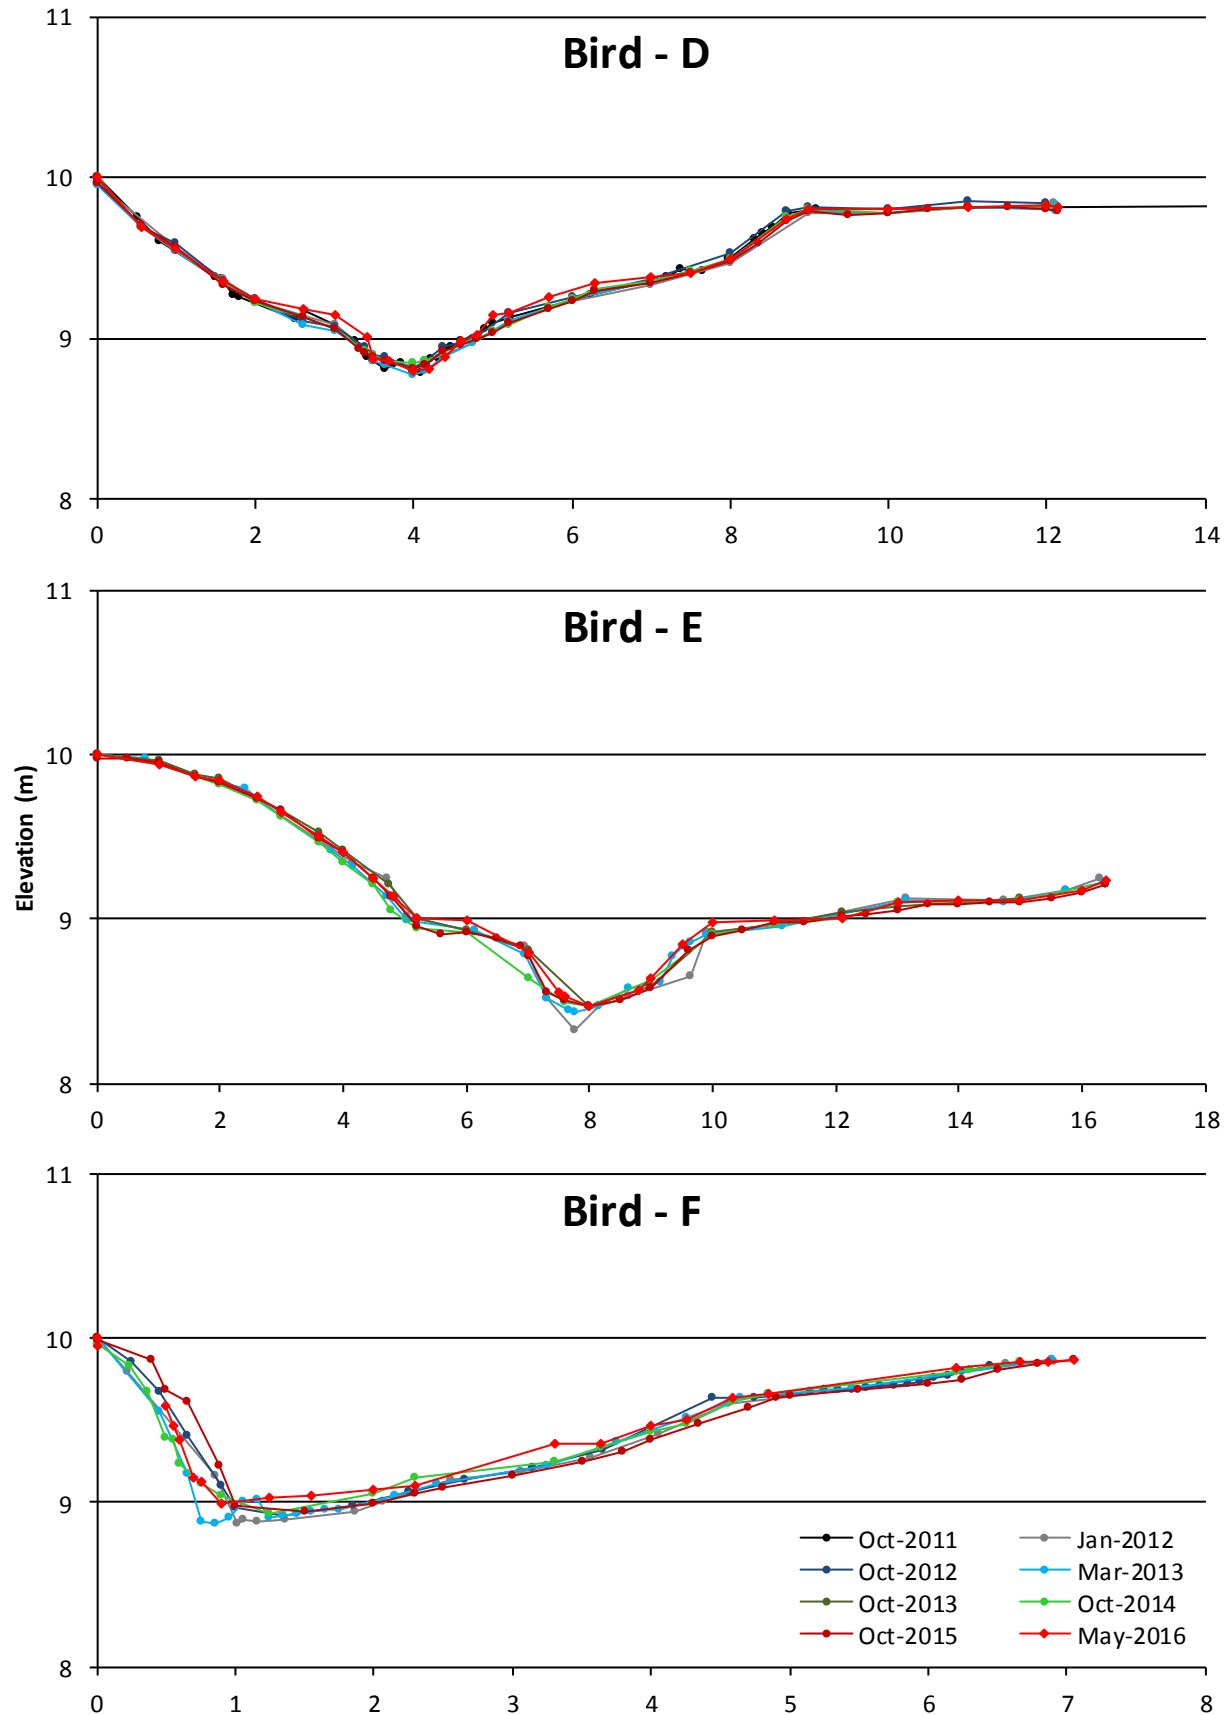
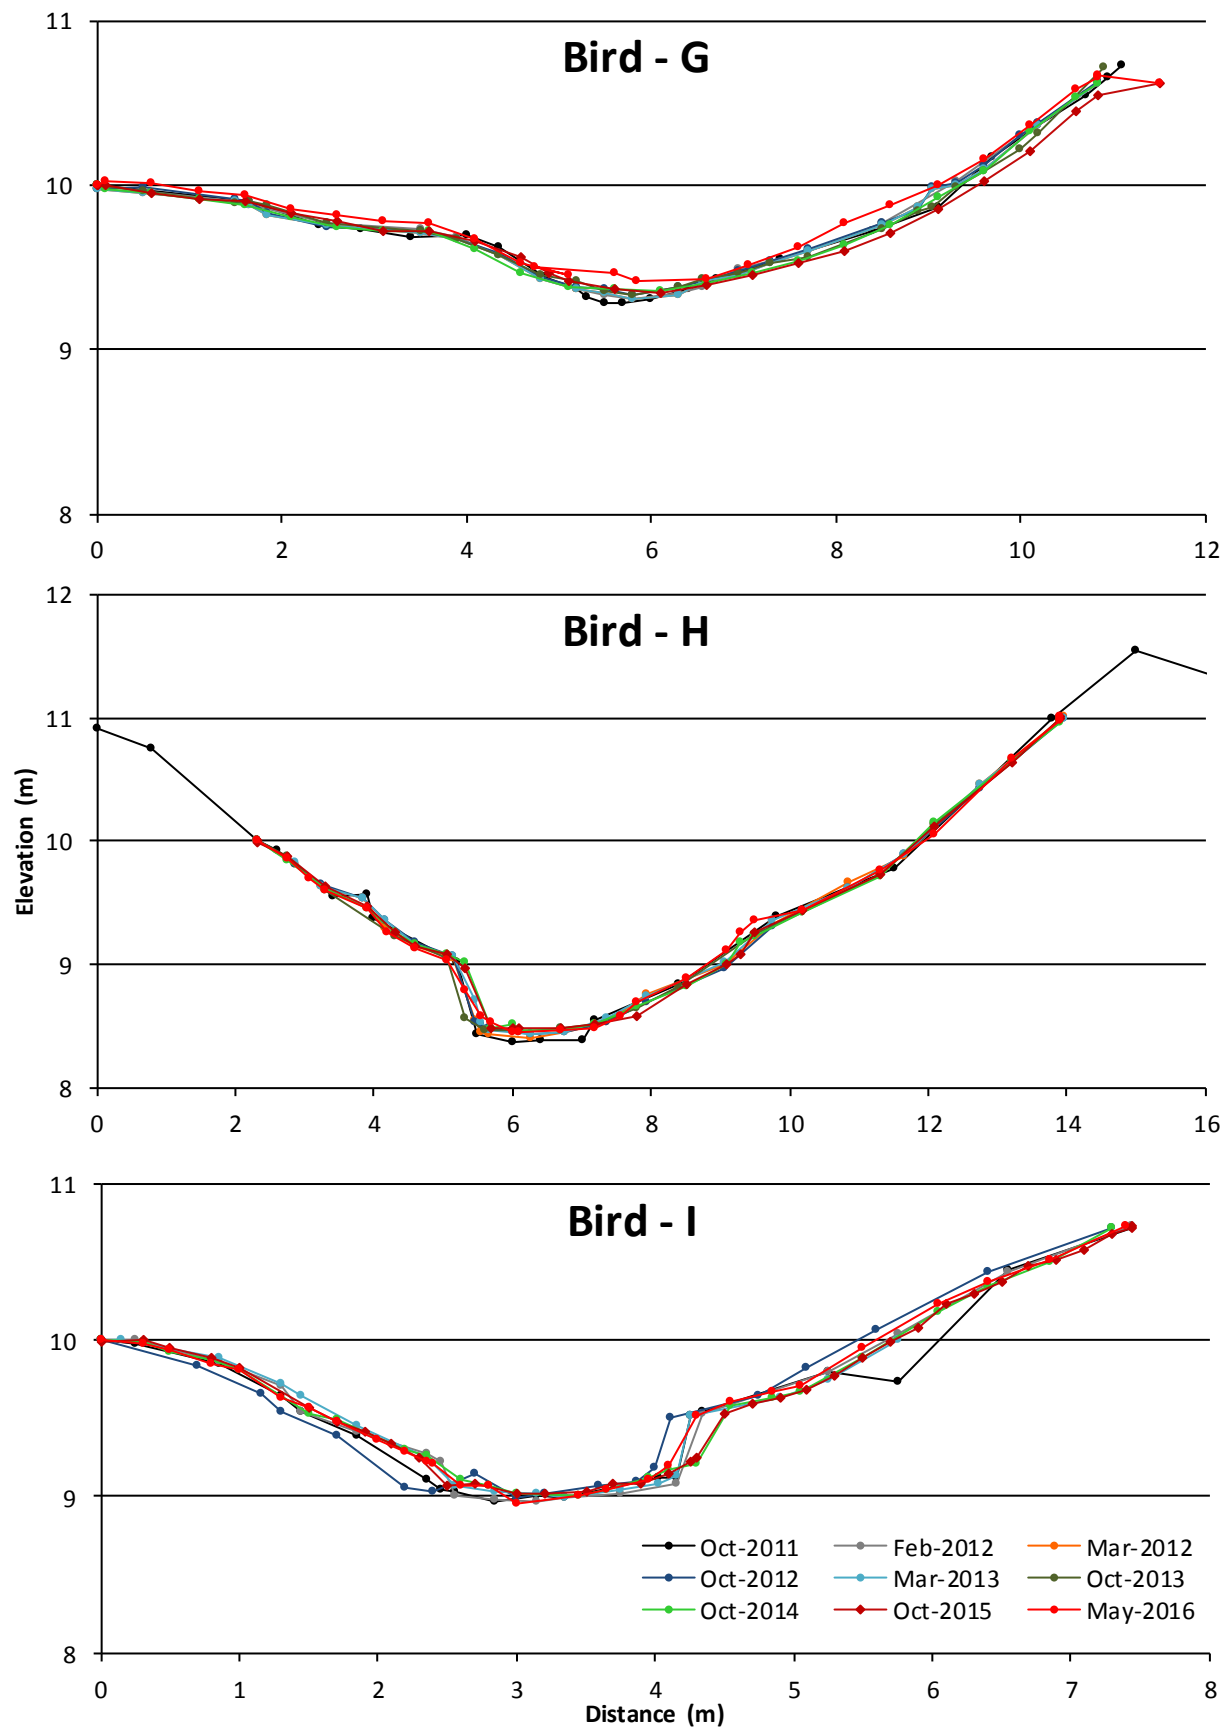
Subset of cross sections from the study. “Bird - X” is from Hudner Ranch reach of Bird Creek. “CC-X” is from Colluvial Creek. “CRC-X” is from Cienga Road culvert. “4X” is from Coyote Trail restoration site.
