Publication No. WI-2013-07

The Watershed Institute

Hollister Hills SVRA Trail Erosion Surveys Spring 2013

Aimee Teaby
John Silveus
Douglas Smith, PhD

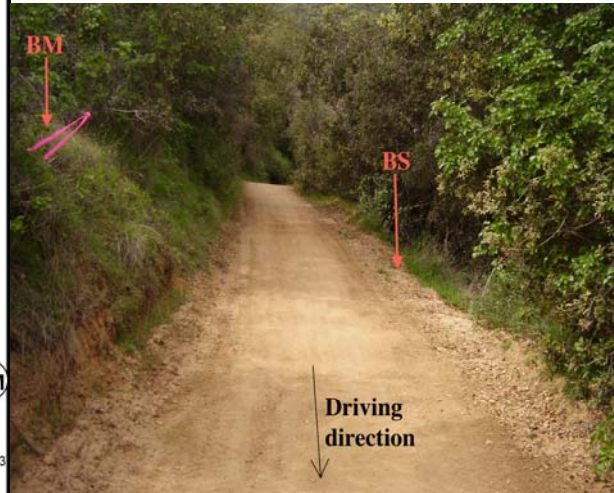
Figure 3. Top left: DEM of the RYC - Faultline Trail site. Small photo shows up-close shot of Benchmark (BM) and surveyed area (taken March 2013). Large photo shows location of the BM and Backshot (BS) in relation to the trail (taken July 2013).

RCY - Faultline

UTM Coordinates: 4071943.74 N, 639230.43 E

Site is located 0.5 miles from the Faultline trailhead. The BM is located on the right side of the trail approximately 2 meters from the edge of the trail. The BS is located at 10.57 meters and 25°N from the BM near a fence and tree.

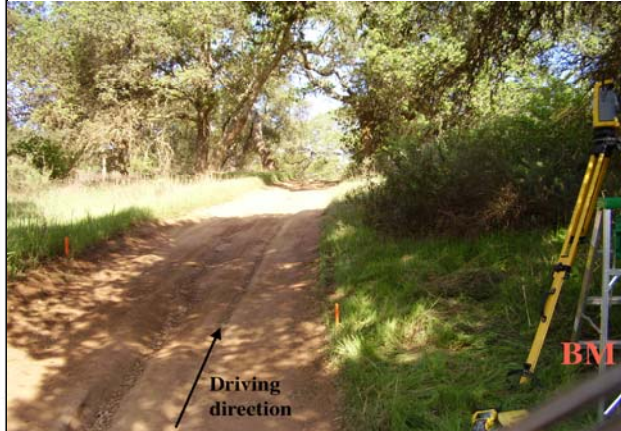
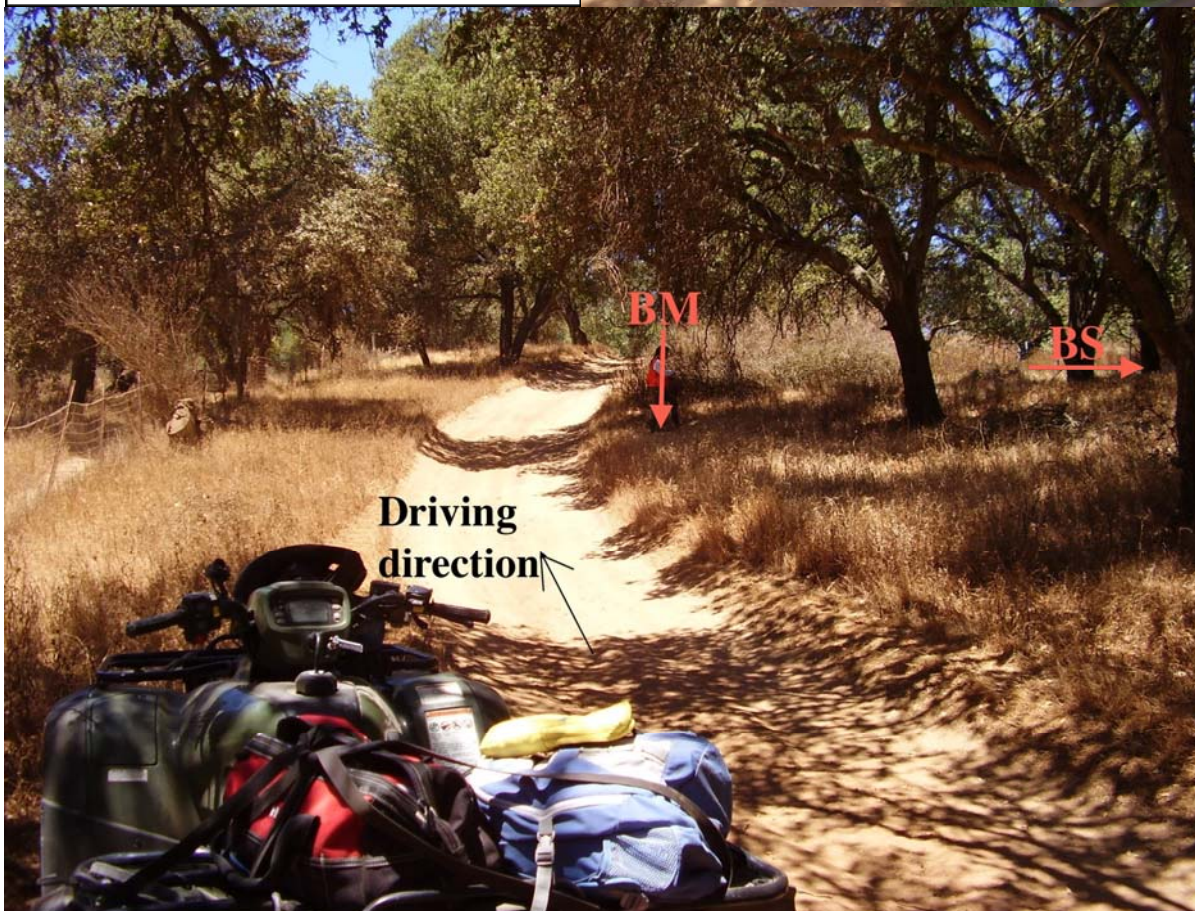
Figure 4. Top left: DEM of the RYG - North Canyon Trail site. Small photo shows locations of the Benchmark (BM) and Backshot (BS) while facing east (taken March 2013). Large photo shows their locations while facing west (taken August 2013).

RGY - North Canyon

UTM Coordinates: 4071860.53 N, 637444.31 E

Site is located approximately 57 meters before a DO NOT ENTER sign and approximately 90 meters before the ONE-WAY TRAIL & North Canyon Road signs. This site is somewhat difficult to locate since it doesn't have any major defining features. There is one other section located after this site

that looks identical to this site. For this reason, it is slightly easier to find this sight by approaching from the west, traveling in the direction of traffic. The BM is located on the right side of the trail within one meter of the trail's edge. The BS is located at 8.5 meters and 20°N from the BM on the right side of the trail.

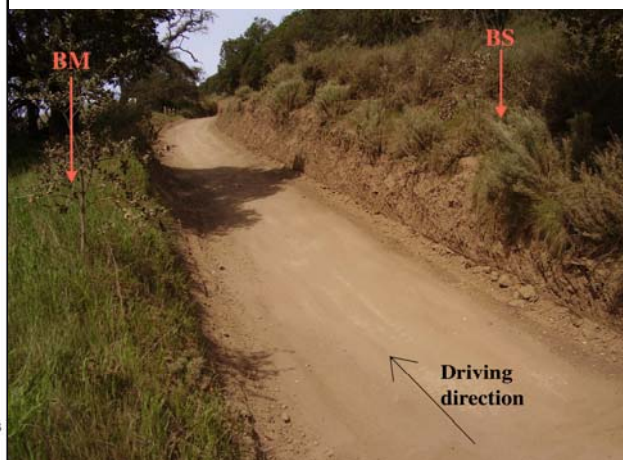
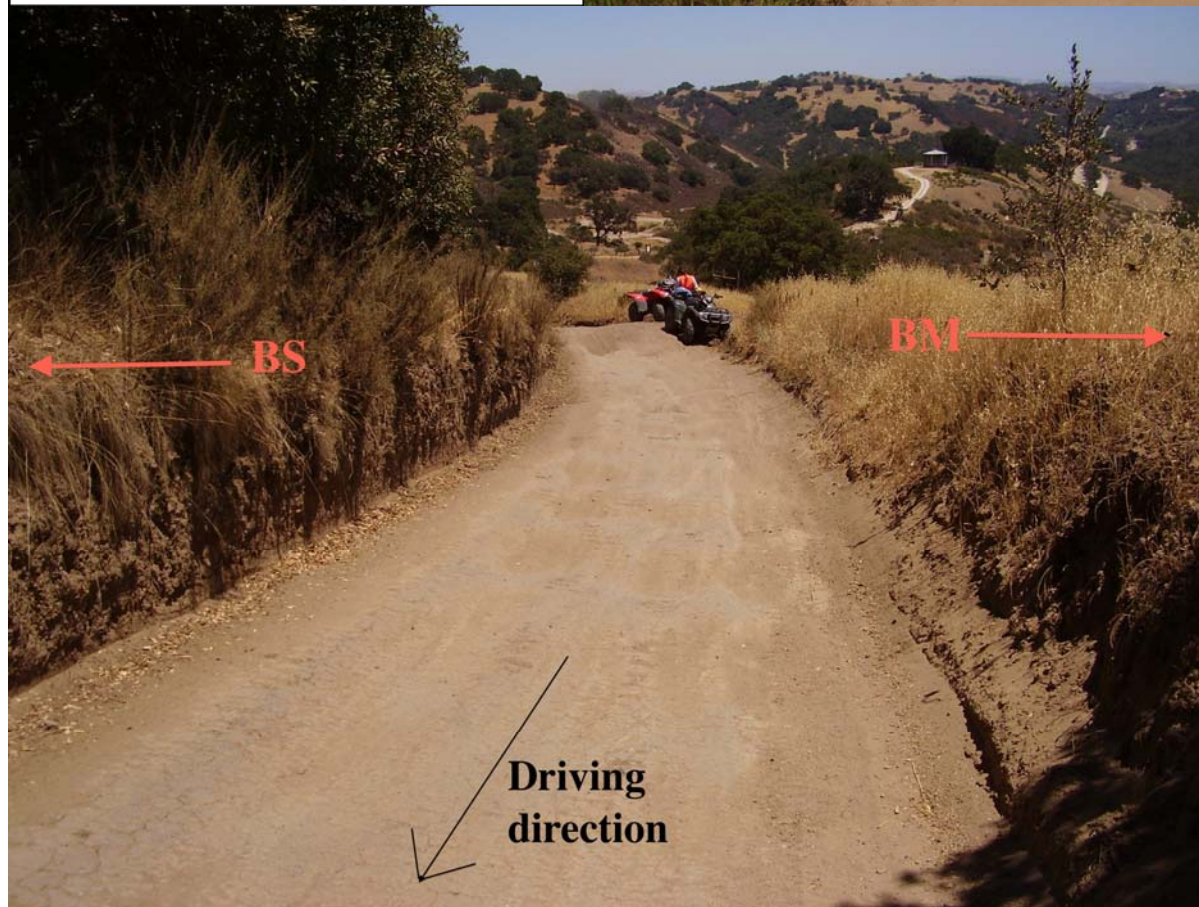
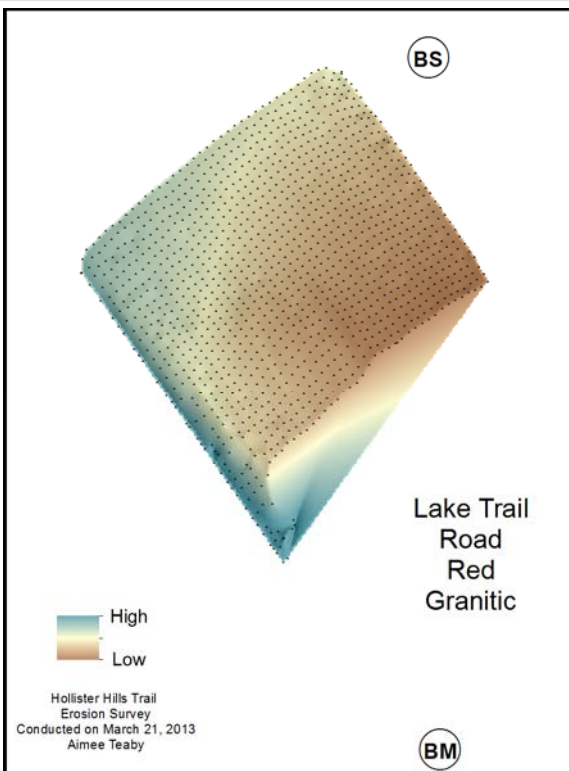
Figure 6. Top left: DEM of the RRG - Lake Trail site. Small photo shows locations of the Benchmark (BM) and Backshot (BS) while facing southeast (taken March 2013). Large photo shows their location while facing northwest (taken August 2013).

RGR - Lake

UTM Coordinates: 4071099.28 N, 639185.56 E

Site is located 0.9 miles from the Lake trailhead. The BM is located on the left side of the trail near a large tree. To access the BM, walk up approximately 60 meters from the survey site to the wood fence on left side of trail. Go over the fence and walk east (opposite of driving direction). BM located approximately 1 meter from top edge of trail wall. The BS is located at the top of the berm thru a hole in the fence on the right side of the trail. The BS is located at 9 meters and 340°N from the BM. An old olive orchard surrounds this site.

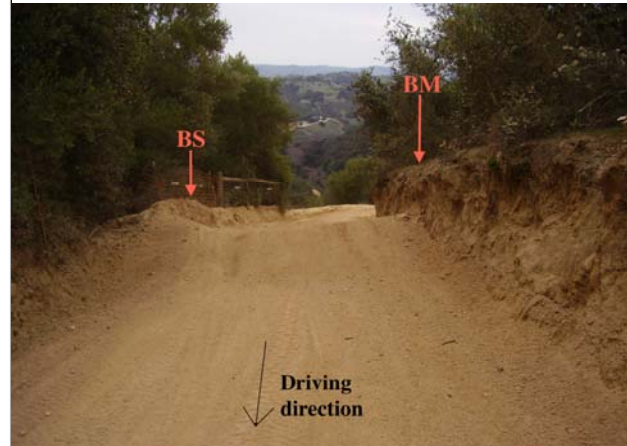
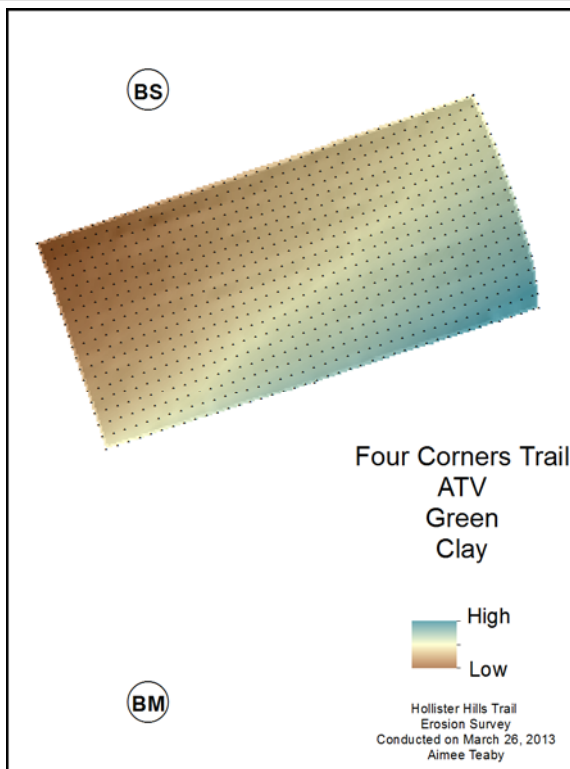
Figure 7. Top left: DEM of the AGC - Four Corners Trail site. Small photo shows locations of the Benchmark (BM) and Backshot (BS) while facing southeast (taken March 2013). Large photo shows their location while facing northwest (taken August 2013).

ACG - Four Corners

UTM Coordinates: 4072278.4 N, 640254.51 E

Site is located 0.9 miles from the Renz property entrance, 0.6 miles from the Four Corners trailhead, and 0.2 miles from the San Andreas trail split. There is a fiberglass marker (WR, P#1, D230) approximately 45 meters before the survey site on the left side of trail. The BM is located up on the hillside on the right side of the trail near a tree. The BS is located at 5.5 meters and 10°N from the BM near the base of a tree.

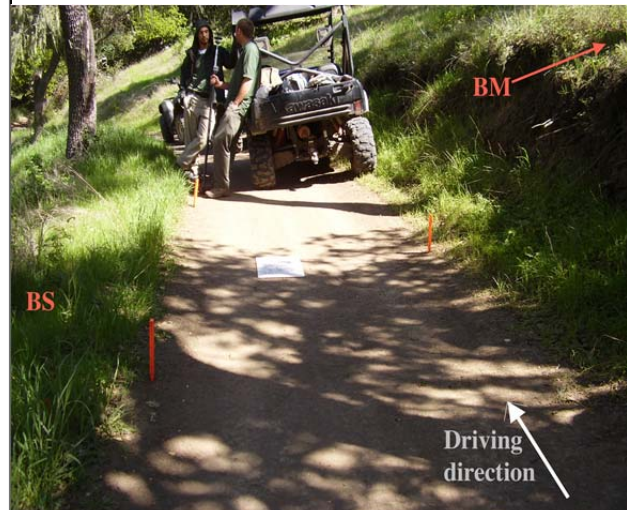
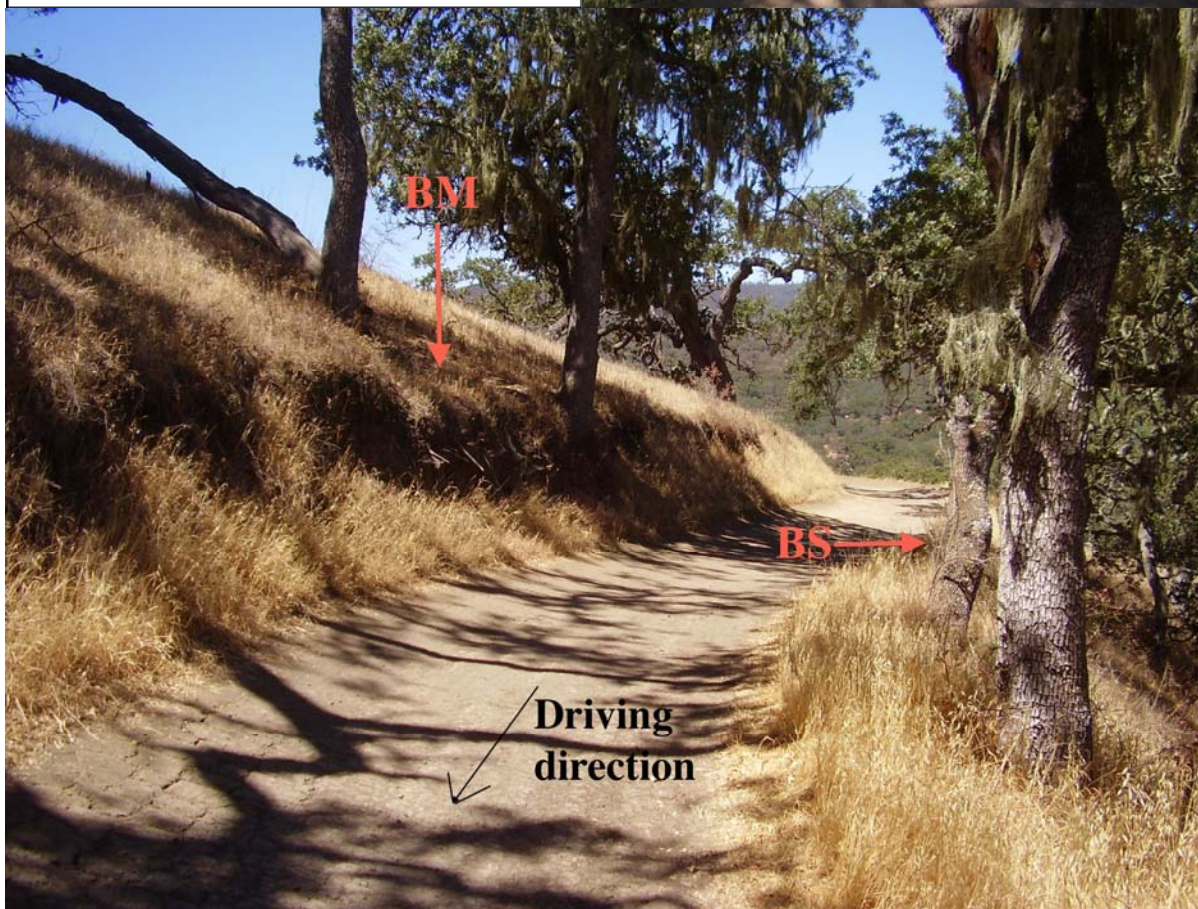
Figure 8. Top left: DEM of the AGC - Coyote Trail site. The small photo (taken August 2013) and the large photo (taken March 2013) both show the location of the Benchmark (BM) and Backshot (BS) while facing north.

AGG - Coyote

UTM Coordinates: 4072044.51 N, 637851.99 E

Site is located 0.5 miles from the Coyote trailhead, approximately 50 meters before the AGY site. The BM is located on the right side of the trail approximately 1 meter from edge of the trail. The BS is located at 9 meters and 23°N from the BM. The site is totally shaded with an abundance of tree litter on both sides of the trail, which will most likely completely cover both markers.

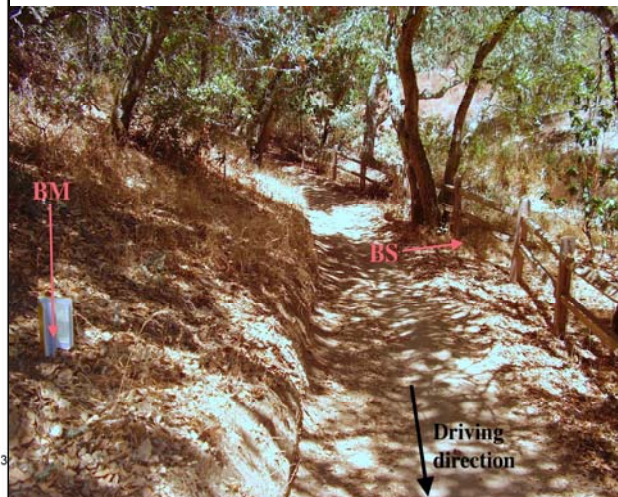
Figure 9. Top left: DEM of the AYC - Backsprings Trail site. Small photo shows location of the Benchmark (BM) and Backshot (BS) while facing north. Large photo shows their location while facing south (both taken July 2013).

ACY - Backsprings

UTM Coordinates: 4072088.63 N, 641547.15 E

Site is located in mid-Backsprings. The first trail split-off is for Adobe Road. The second trail split is unmarked. The site is located 0.1 miles after this split. The BM and BS are on right side of trail. The BM is less than 2 meters from edge of trail near a small shrub. The left side of trail is very thick with bushes and a lot of poison oak. The whole area is heavy with poison oak. The BS is located 4.3 meters and 18°N from the BM in an open space but near several bushes of poison oak.

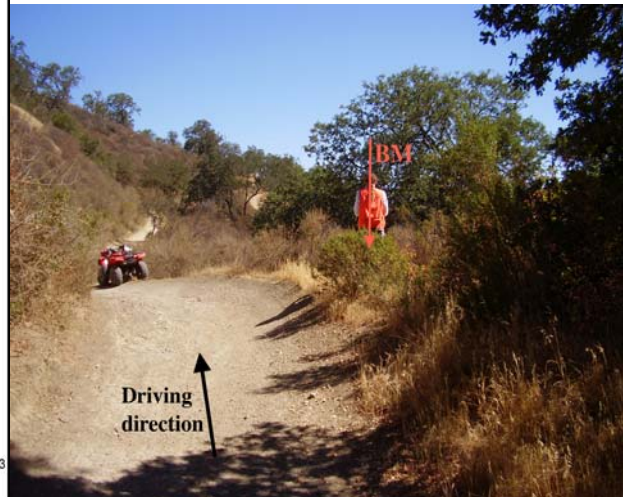
Figure 10. Top left: DEM of the AYG - Coyote Trail site. Small photo shows location of the Benchmark (BM) and the bottom edge of the surveyed area (B3) while facing south. Large photo shows the location of the BM and the Backshot (BS) while facing north (both taken August 2013).

AGY - Coyote

UTM Coordinates: 4072005.49 N, 637873.8 E

Site is located approximately 50 meters downhill from AGG. The BM is located in the left side of the trail near a fence post. The BS is located 3.5 meters and 0°N from the BM near a fence post and a tree. Both markers are accessed by going thru a gap in the fence near a tree in the opposition direction of the BS location.

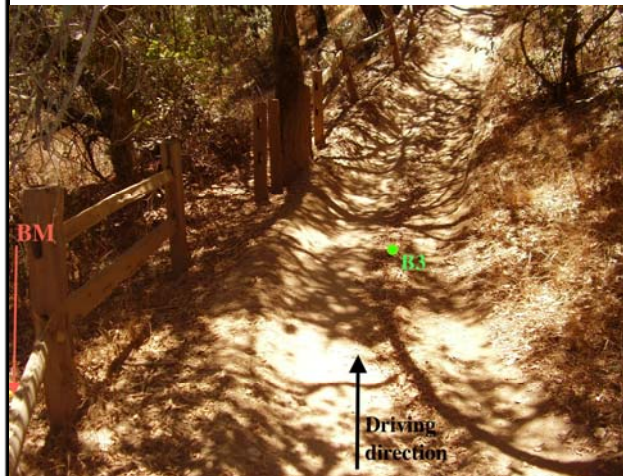
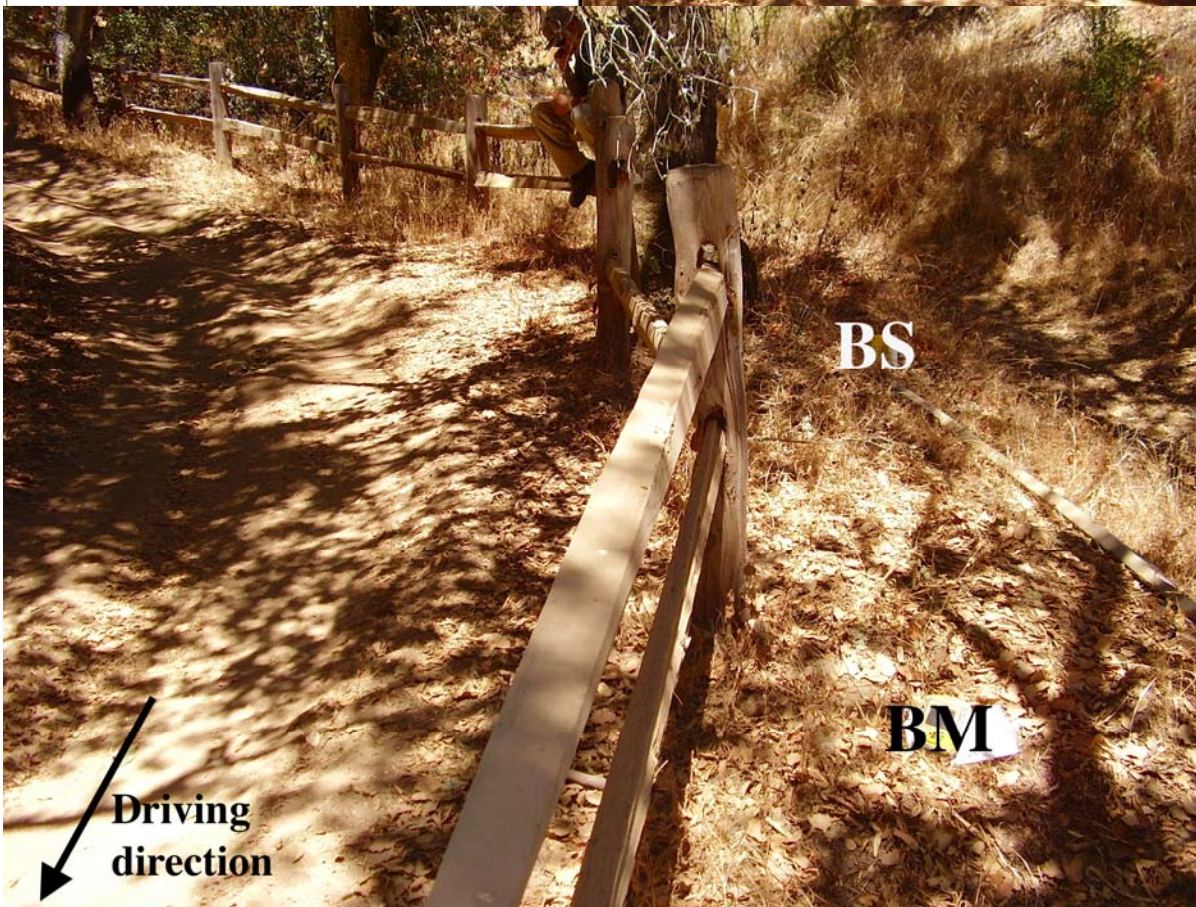
Figure 11. Top left: DEM of the ARC - Backsprings Trail site. Small photo shows the location of the Benchmark (BM) while facing east (taken July 2013). Large photo shows the location of the BM and the Backshot (BS) while facing northeast (taken March 2013).

ACR - Backsprings

UTM Coordinates: 4072118.68 N, 642124.07 E

Site is located near the beginning of the trail, just before the Middlefield trail turnoff, right next to the sign for the Lowerfield trail, on the left side of the trail. The BS marker is located at almost 7 meters and 2°N from the BM, on right side of trail at the top of the berm.

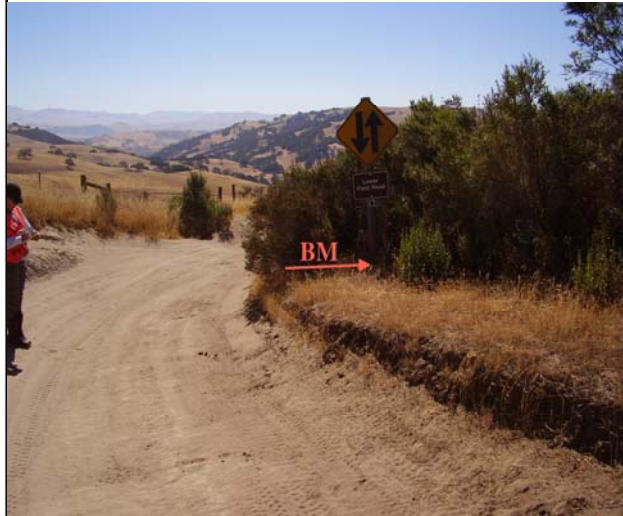
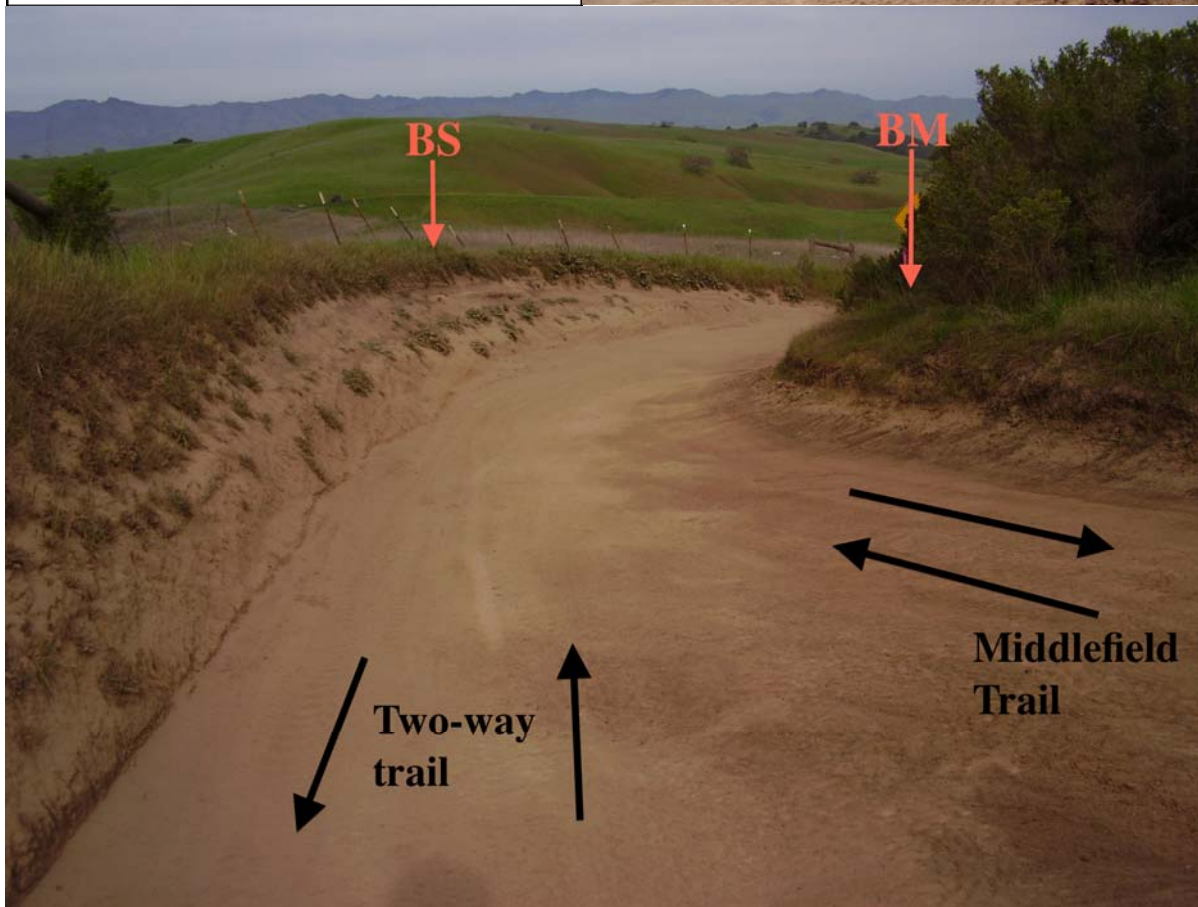
Figure 12. Top left: DEM of the ARG - Badger Trail site. Small photo shows the location of the Benchmark (BM) while facing west. Large photo shows the location of the BM and the Backshot (BS) while facing northeast (both taken March 2013).

AGR - Badger

UTM Coordinates: 4070599.57 N, 637339.46 E

Site is located approximately 50 meters from the Badger trailhead. The BM is located approximately 15 meters downhill from a ONE-WAY TRAIL & Badger Trail sign that are on the right side of trail. The BM is located less than 2 meters from the edge of the trail. The BS is located 2.2 meters downhill and 20° N from the BM near a large rock. There are many trees and bushes around the BM and BS.

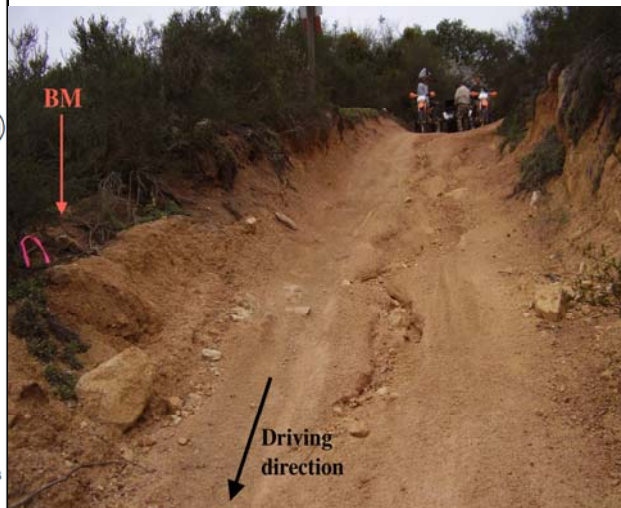
Figure 13. Top: DEM of the SGC - OK Corral Trail site. Middle: photo shows the location of the Benchmark (BM) and the Backshot (BS) while facing southeast (taken March 2013). Bottom: photo shows the location of the BM and the BS while facing north-northeast (taken July 2013).

SCG - OK Corral

UTM Coordinates: 4072238.31, 639593.81 E

Site should be accessed from the end/bottom of the OK Corral Trail, either on foot or motorcycle. The BM is located on right side of the trail, approximately 250 meters from the end of the trail and approximately 1 meter up from 'Trail Marker 4' sign. The BS is located at 8.66 meters and 205°N of the BM on the left side of trail. The BS could possibly be submerged during the wet season since it is in a depression.

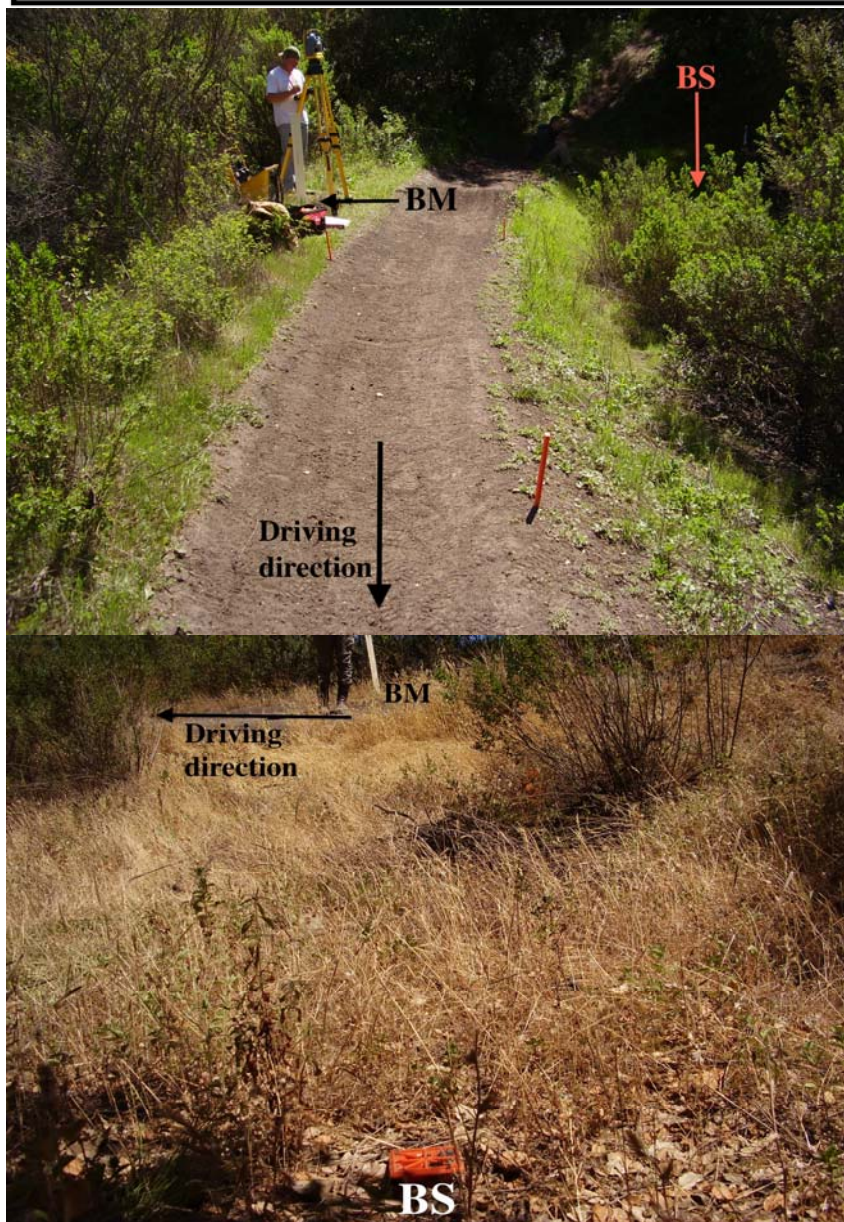
Figure 14. Top: DEM of the SGG - Donnybrook Trail site. Middle: photo shows the location of the Benchmark (BM) and the Backshot (BS) while facing east (taken August 2013). Bottom: photo shows the location of the BM while facing west (taken March 2013).

SGG - Donnybrook

UTM Coordinates: 4071705.41 N, 638210.21 E

Site should be accessed from the bottom/end of the Donnybrook Trail. Site is located approximately 53 meters from a 'DO NOT ENTER' sign at the bottom of the trail that is near the intersection of Harmony Gate Road and Donnybrook Trail. The BM is on the right side of the trail on the inside of the last right-hand turn of the trail. The BS is located across the trail and creek, up the hill approximately 20 meters and 23° N from the BM. It is marked by a nail in a tree located to the right of an unnamed volunteer trail.

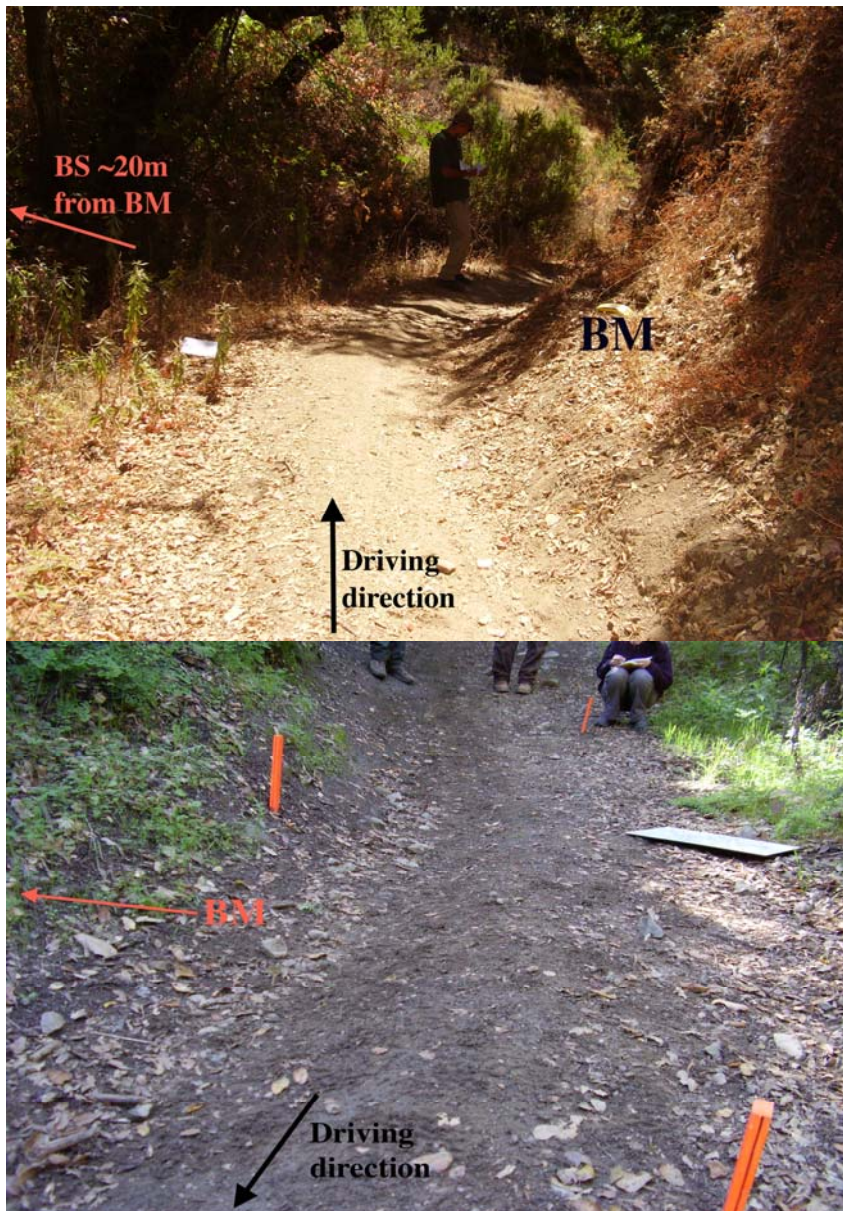
Figure 15. Top left: DEM of the SYC - OK Corral Trail site. Small photo shows the location of the Benchmark (BM) while facing east (taken March 2013). Large photo shows the location of the BM and the Backshot (BS) while facing west (taken July 2013).

SCY - OK Corral

UTM Coordinates: 4072247.49 N, 639159.7 E

Site is located approximately 1.75 miles from the OK Corral trailhead. Site is only accessible by foot or motorcycle so the trail mile markers should be used. The BM is located on right side of trail up on the hill near a Buckeye tree and poison oak bushes. The hill is fairly steep to climb up so having a step stool would be helpful. The BS is located at approximately 12 meters and 340°N from the BM, marked by a nail in a large tree.

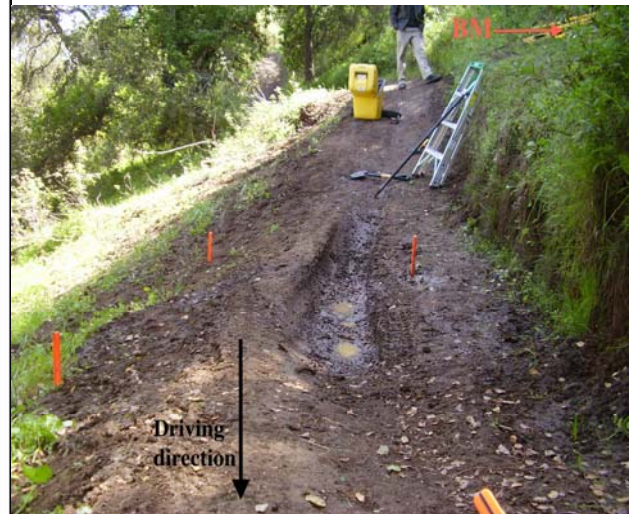
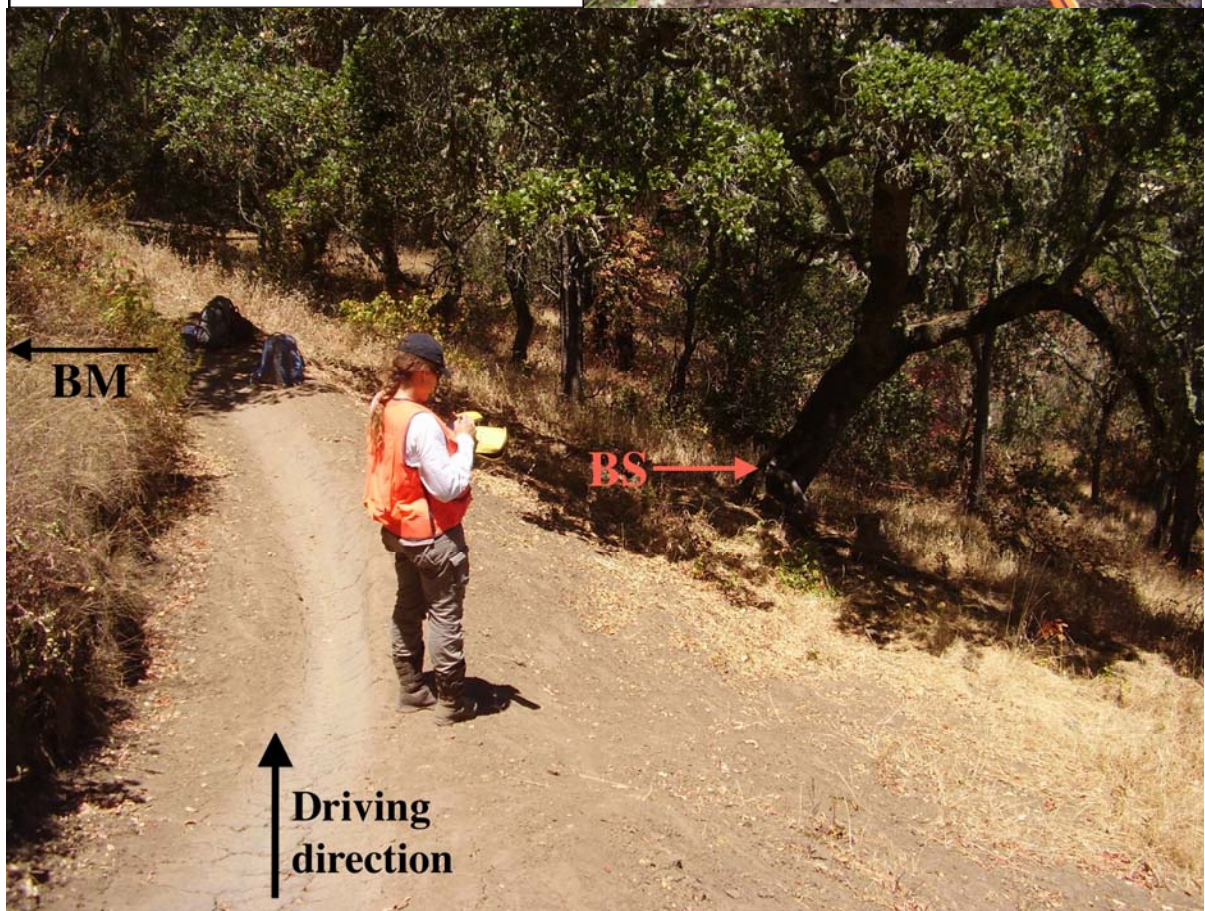
Figure 16. Top: DEM of the SYG - Mystic Trail site. Middle: photo shows the location of the Benchmark (BM) and the Backshot (BS) while facing east. Bottom: photo shows the location of the BM while facing west (both taken August 2013).

SGY - Mystic

UTM Coordinates: 4071969.82 N, 637339.32 E

Site is located at the first set of whoops (bumps in trail) going uphill that lead to a crest in the trail. The BM is on left side of trail approximately 0.5 meters from the edge of the trail. This area has a lot of loose dirt and the BM could become quite buried over time. The BM is also missing its rebar cap. The BS is located at 2.7 meters and 7° N from the BM on the right side of trail.

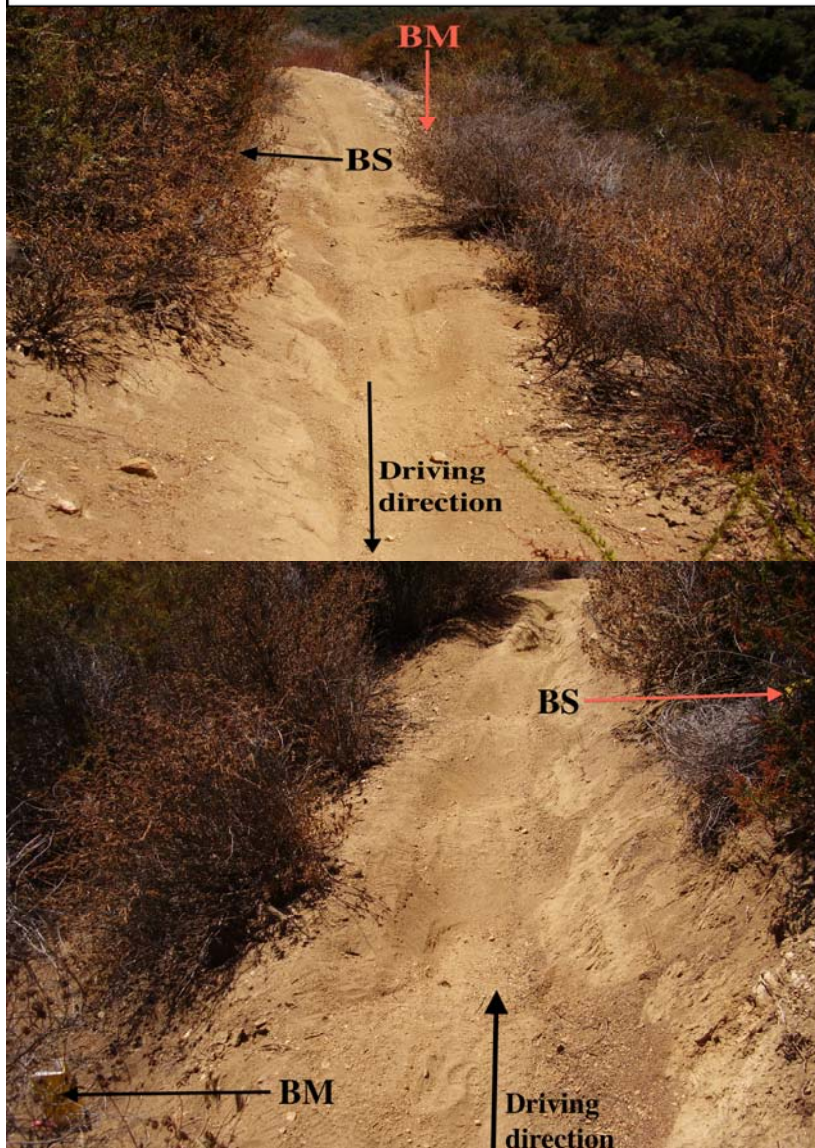
Figure 17. Top: DEM of the SRC - Psych Hill Trail site. Middle: photo shows the location of the Benchmark (BM) while facing east. Bottom: photo shows the location of the BM and the Backshot (BS) while facing east (both taken July 2013).

SCR - Psych Hill

UTM Coordinates: 4072158.05 N, 640914.62 E

Site is located 0.4 miles from the Buckeye Thicket Trail sign and 0.5 miles from the Backsprings Trail sign near the trail split. The BM is located to the right of the trail just behind the base of the Psych Hill Trail sign. The BS is located on berm near unmarked trail split at 6.3 meters and 12°N from the BM. A step stool is definitely needed to run the TS for this site.

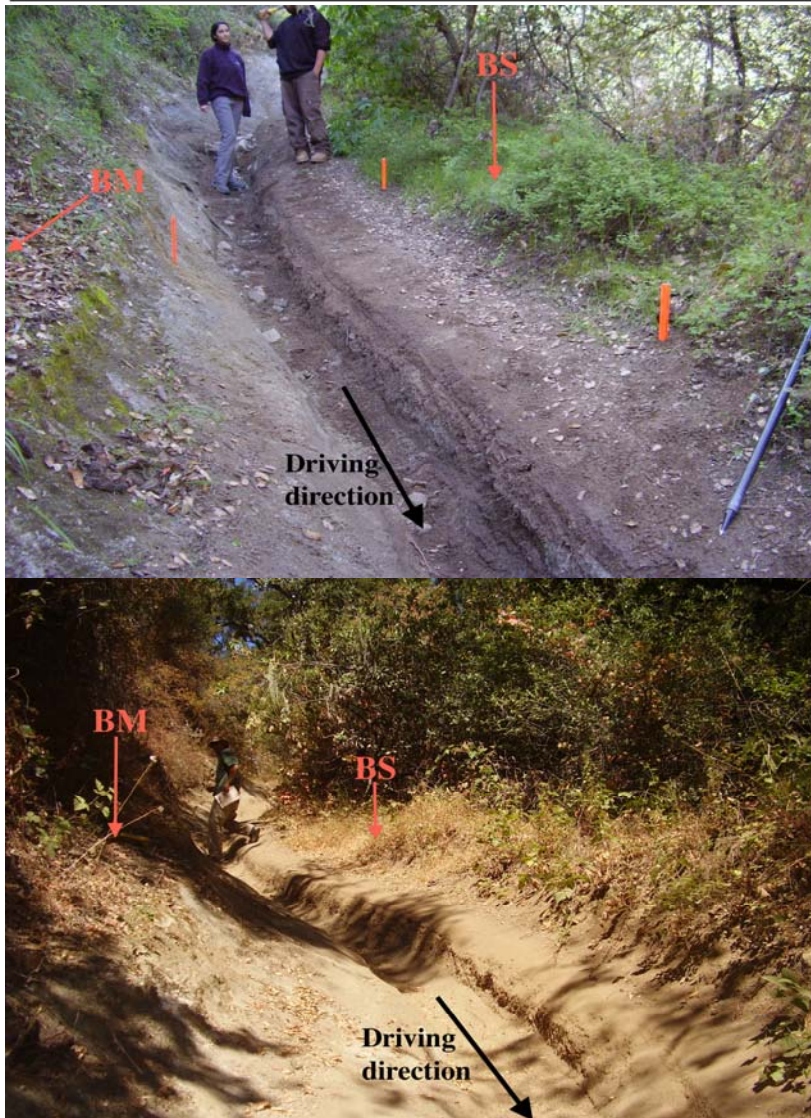
Figure 18. Top: DEM of the SRG - Donnybrook Hill Trail site. Middle: photo shows the location of the Benchmark (BM) and the Backshot (BS) while facing northwest (taken July 2013) Bottom: photo shows the location of the BM and the BS while facing east (taken July 2013).

SGR - Donnybrook

UTM Coordinates: 4071749.16 N, 638210.21 E

Site is located approximately 100 meters from the bottom of the trail and 50 meters from the other Donnybrook site. This site should also be accessed from the bottom/end of the Donnybrook Trail and is only accessible by foot or motorcycle. There is a small volunteer trail off to the left just after this survey site. The BM is on right side of trail. The BS is located 3.5 meters and 0°N from the BM.
