WI Publication No. WI-2016-06

**Hollister Hills SVRA**

**Trail Erosion Surveys**

**Summer 2016**

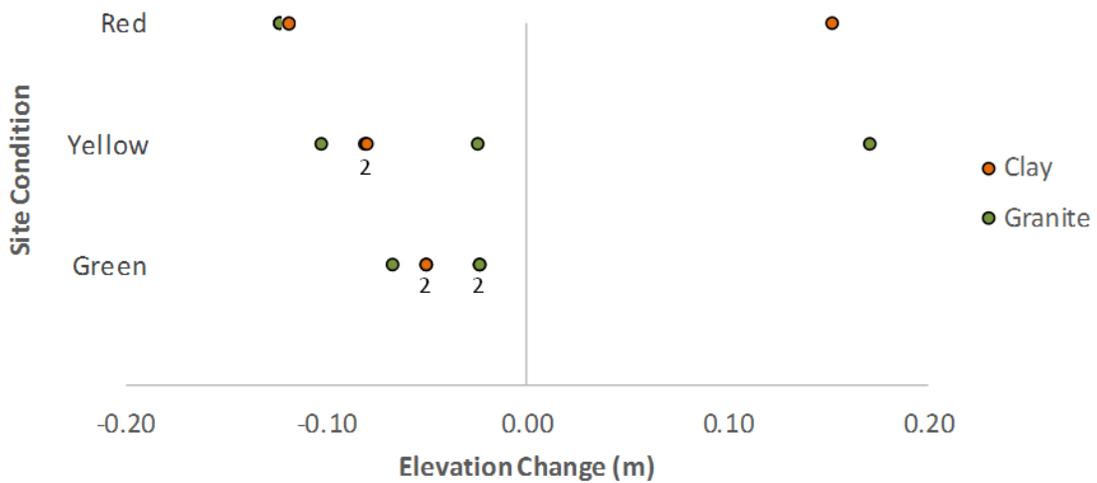
Figure 3: Total change in site elevations based on soil type and site condition for 2013 – 2016. Positive numbers indicate deposition and negative numbers indicate erosion. A “2” indicates the data point represents two sites with the same condition, substrate, and elevation change.

Most sites eroded less than 8 cm on average over the 2015–16 timeframe and less than 12 cm on average over the three–year span, regardless of trail type, substrate, or color rating (Figs 3 & 4). The 2015 – 2016 study year shows the highest variability in elevation change with 9 sites showing net erosion and 4 sites showing net aggradation. The highest average three–year erosion value was 12 cm on a red, granitic soil site. A yellow, granitic soil site showed the highest soil deposition at 17 cm within the three–year study period (Table 2). In both the annual change from 2015 to 2016 and the three–year change from 2013 to 2016, clay soils were less erosive than granitic soils in the red sites. From 2015 to 2016 and 2013 to 2016, clay soils were less stable than granitic soils in the yellow sites. There was no difference between the two soil types in the green sites between 2013 – 2016, but between 2015 – 2016 clay sites eroded more than granitic sites (Figs. 3 & 4).

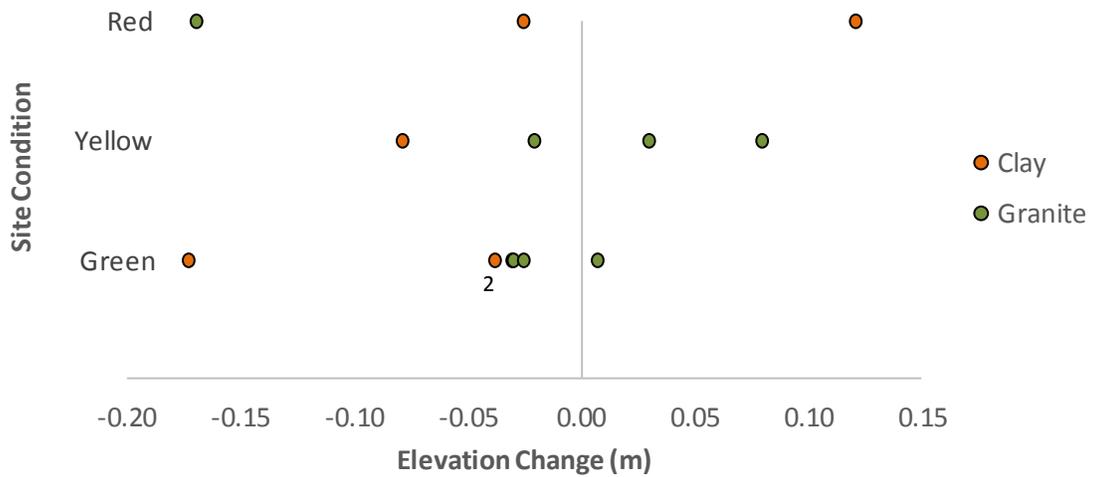
Figure 4: Annual change in site elevations based on soil type and site condition for 2015 – 2016. Positive numbers indicate deposition and negative numbers indicate erosion. A “2” indicates the data point represents two sites with the same condition, substrate, and elevation change.

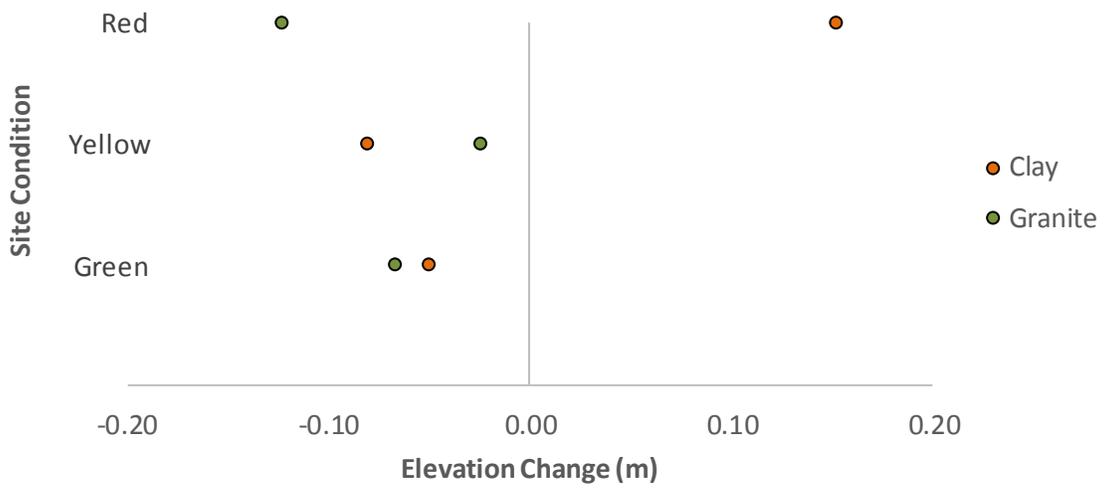
Figure 5: Total change in Single Track site elevations based on soil type and site condition for 2013 – 2016. Positive numbers indicate deposition and negative numbers indicate erosion.

Single Track trails appear to have larger elevation changes between green to red classification (Fig. 5). Regardless of substrate, elevation change was smallest at green sites, moderate at yellow, and largest at red classified sites throughout the three–year period. Based on the three ATV sites, yellow had the highest and only elevation change in the positive direction while the green site had the least and red had the most erosion over three years (Fig. 6). There were no red road sites included in the analysis because of trail maintenance this year, but from the remaining road sites green had less erosion than yellow classified trails (Fig. 7).

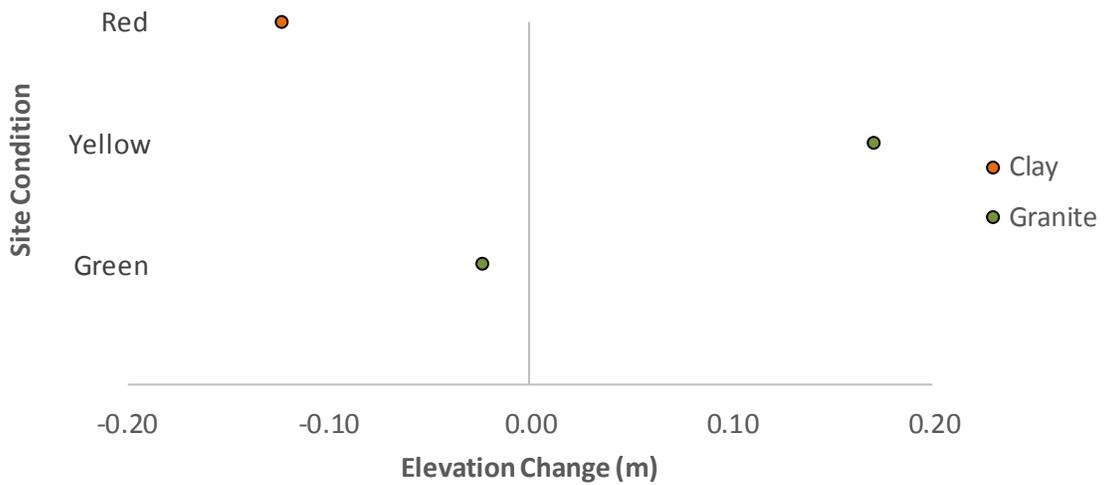
Figure 6: Total change in ATV site elevations based on soil type and site condition for 2013 – 2016. Positive numbers indicate deposition and negative numbers indicate erosion.

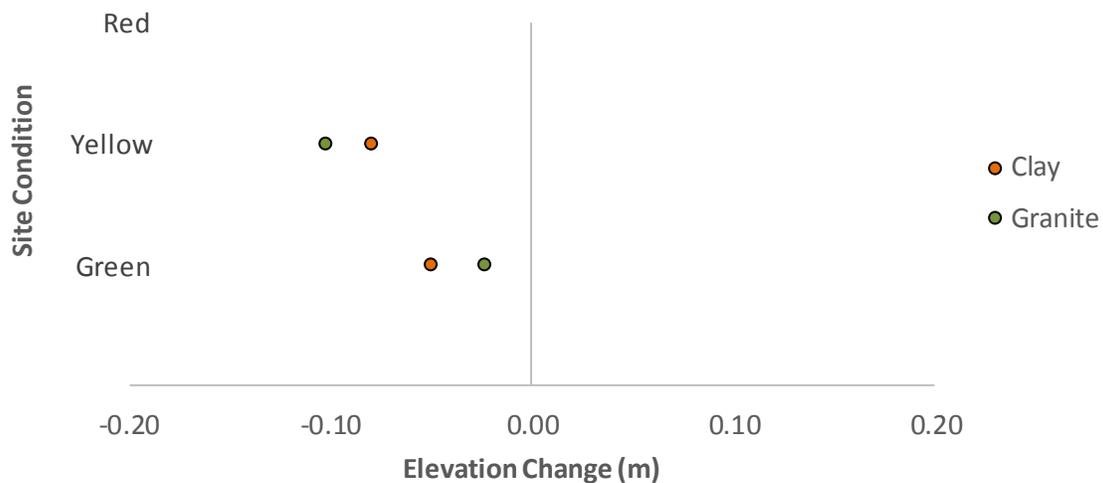
**Figure 7: Total change in Road site elevations based on soil type and site condition for 2013 – 2016. Positive numbers indicate deposition and negative numbers indicate erosion.**

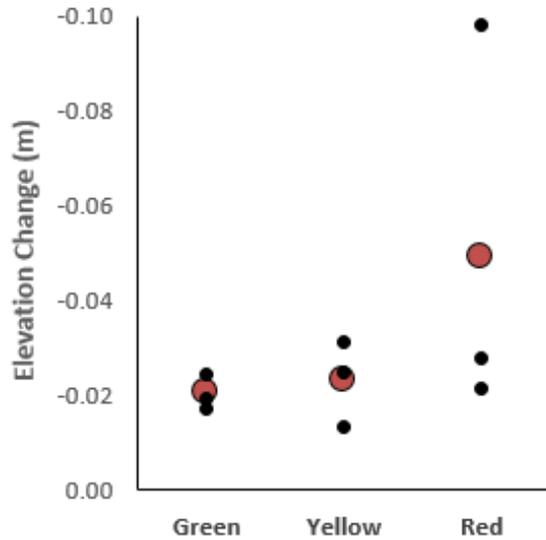
Average annual elevation differences between site condition show red trails as having the highest average erosion with 2015–2016 having the highest erosion (Fig. 8). Yellow trails are variable, but generally have an average erosion rate of 0.02 m of elevation change in a single year. Green trails consistently have an average, annual erosion of 0.02 m as well.

Figure 8. Average elevation change (“Avg Elev  $\Delta$ ,” m) for each year separated by site condition. Black dots indicate annual average erosion. The larger, red dots indicate total average erosion between 2013–2016. Positive numbers indicate deposition and negative numbers indicate erosion.

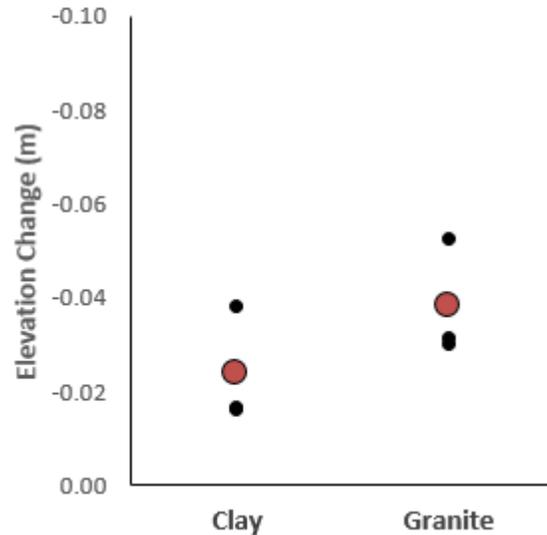
In 2015–2016, clay and granitic trails had the largest amount of elevation change at -0.04 m and -0.05 m respectively (Fig. 9). Granitic trails seem to consistently erode more than clay trails. Based off these observations, red granitic trails might erode more than other trail types.

Figure 9. Average elevation change (“Avg Elev  $\Delta$ ,” m) for each year separated by soil type. Black dots indicate annual average erosion. The larger, red dots indicate total average erosion between 2013–2016. Positive numbers indicate deposition and negative numbers indicate erosion.

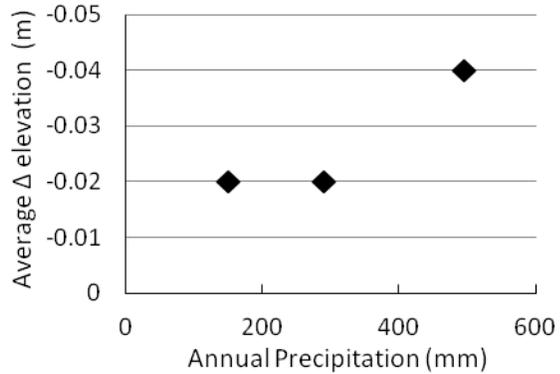
Within the study period, the lowest amount of precipitation was observed between 2013 and 2014. A moderate amount of precipitation fell between 2014 – 2015. Precipitation between the 2015 – 2016 surveys was the highest at 19.51 inches (Table 4). Despite slight variation, at average annual erosion seems to occur where annual precipitation is also large.

**Figure 10: Graphical interpretation of annual precipitation vs. average annual change in elevation. Elevation change remained somewhat constant during lower precipitation years and increased with increased precipitation.**

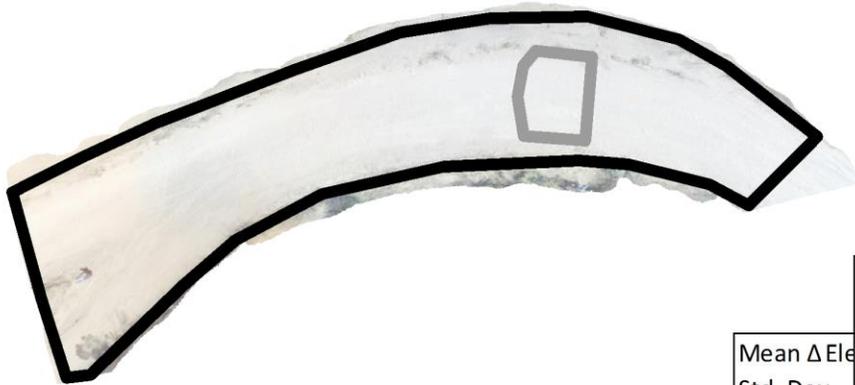
# Backsprings Clay ATV Red

Coverage Area (m <sup>2</sup> )	
2013	8.89
2014	8.89
2015	851.28
2016	180.20

2013 - 2016 (m)	2015 - 2016 (m)
Mean $\Delta$ Elev	-0.12	-0.17
Std. Dev	0.03	0.23
Max $\Delta$ Elev	-0.04	0.09
Min $\Delta$ Elev	-0.24	-1.32

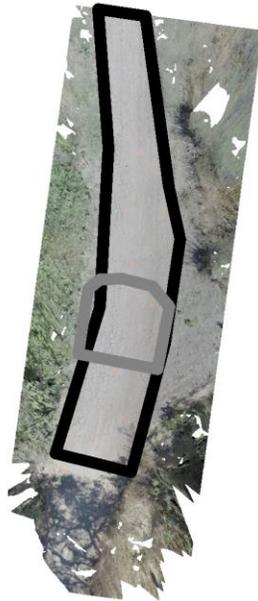
# Backsprings Clay ATV Yellow

$\Delta$ Elev	2013 - 2016 (m)	2015 - 2016 (m)
Mean	0.16	0.07
Std. Dev	0.18	0.17
Max	0.71	1.05
Min	-0.44	-0.51

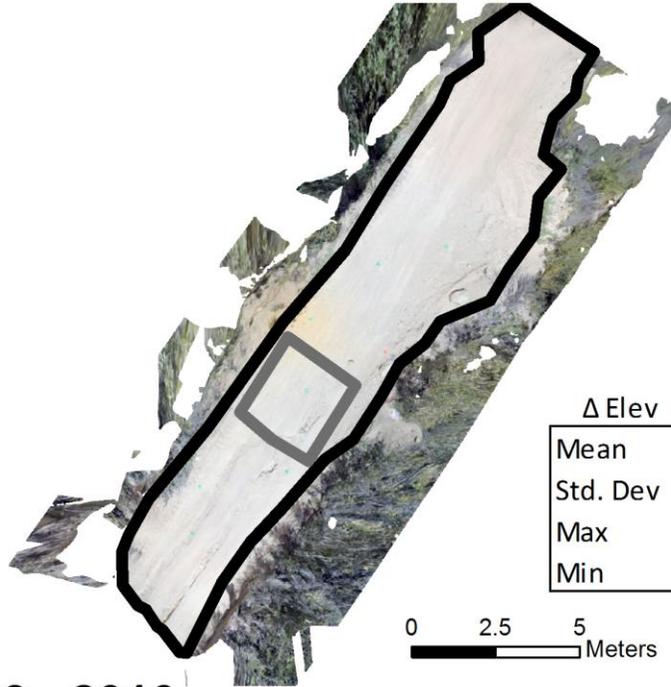
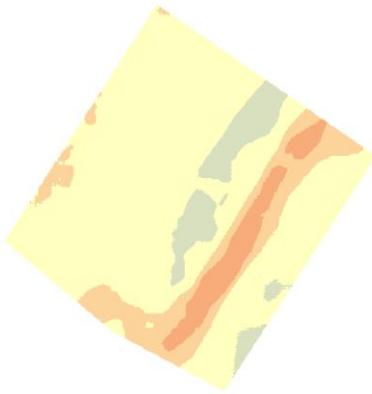
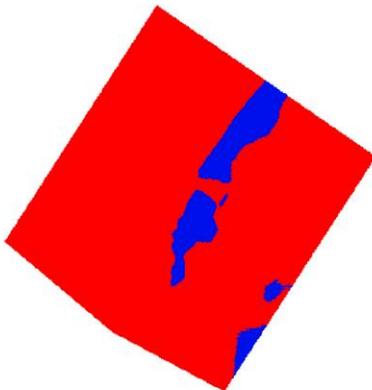
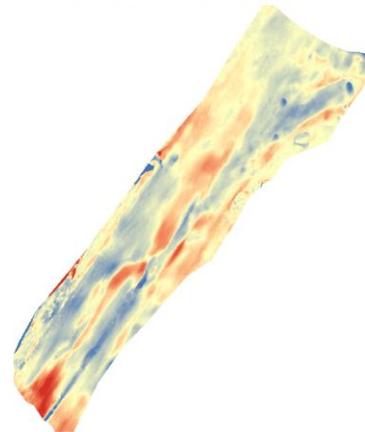
# Badger Granite ATV Red

Coverage Area (m <sup>2</sup> )	
2013	6.72
2014	6.73
2015	115.77
2016	58.82

Δ Elev	2013 - 2016 (m)	2015 - 2016 (m)
Mean	-0.07	-0.17
Std. Dev	0.06	0.23
Max	0.09	0.90
Min	-0.25	-1.32

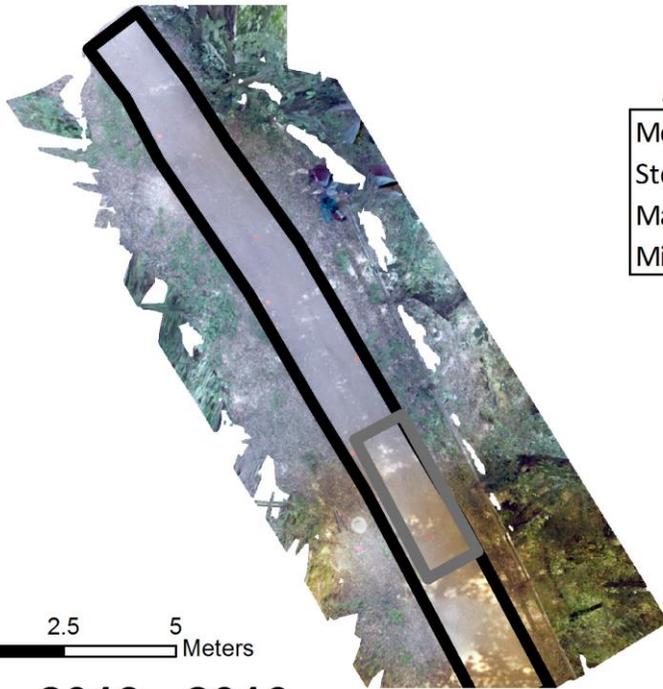
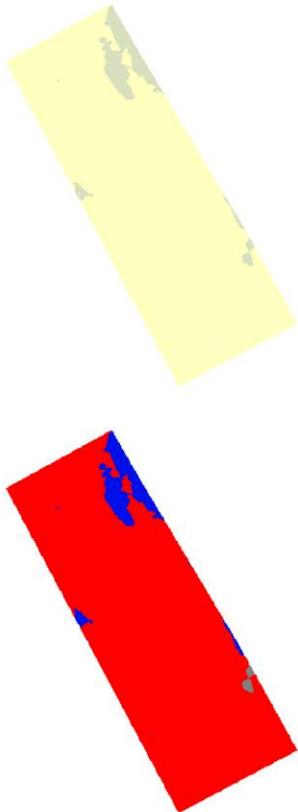
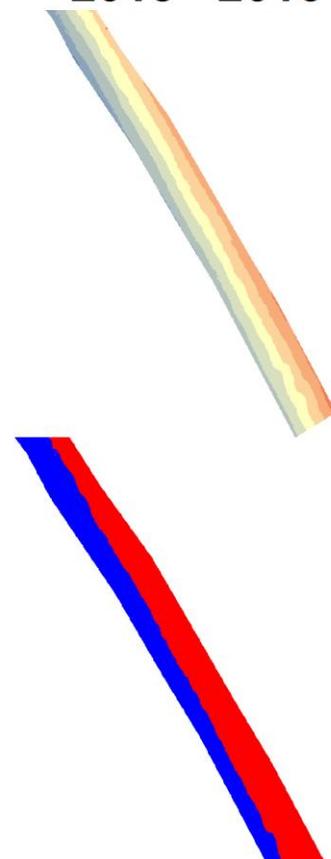
# Coyote Granite ATV Green

Δ Elev	2013 - 2016 (m)	2015 - 2016 (m)
Mean	-0.02	-0.03
Std. Dev	0.02	0.14
Max	0.01	0.59
Min	-0.07	-0.54

Coverage Area (m <sup>2</sup> )	
2013	4.24
2014	4.26
2015	109.63
2016	26.89

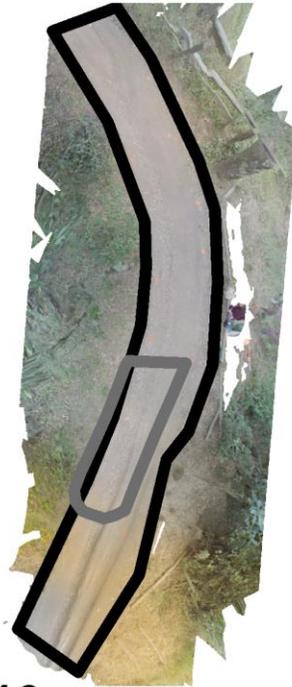
# Coyote Granite ATV Yellow

Δ Elev	2013 - 2016 (m)	2015 - 2016 (m)
Mean	0.17	0.03
Std. Dev	0.18	0.05
Max	1.08	0.47
Min	-0.12	-3.54

Coverage Area (m <sup>2</sup> )	
2013	4.16
2014	7.67
2015	144.09
2016	44.16

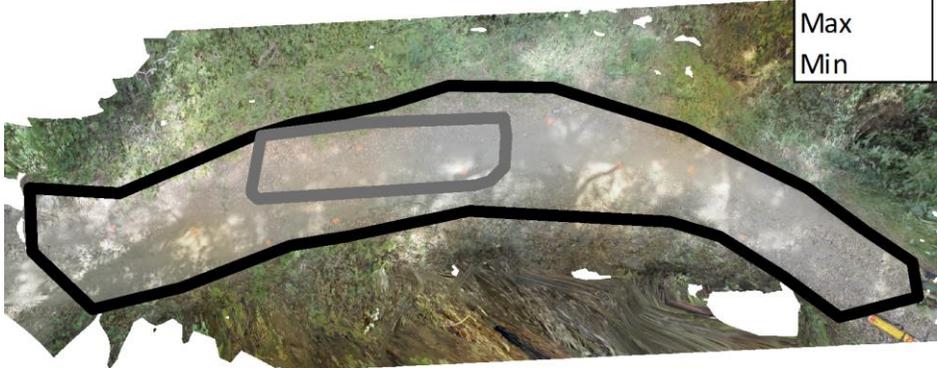
# Donnybrook Granite Single Track Green

2013 - 2016	2015 - 2016
$\Delta$ Elev	(m)	(m)
Mean	-0.07	0.01
Std. Dev	0.06	0.03
Max	0.15	1.32
Min	-1.54	-0.12

Coverage Area (m <sup>2</sup> )	
2013	4.40
2014	10.48
2015	99.84
2016	33.58

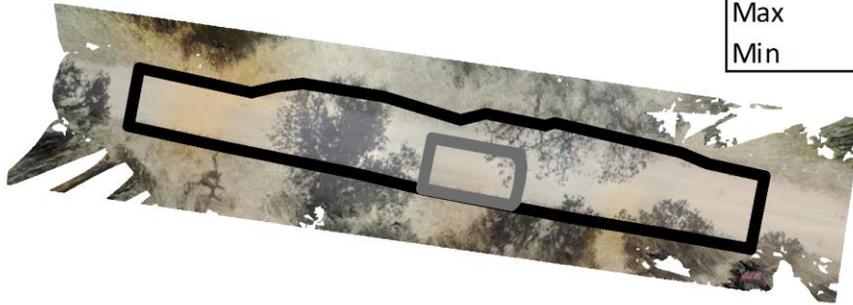
# Faultline Clay Road Green

2013 - 2016	2015 - 2016
$\Delta$ Elev	(m)	(m)
Mean	-0.05	-0.03
Std. Dev	0.02	0.08
Max	0.14	0.26
Min	-0.12	-0.49

Coverage Area (m <sup>2</sup> )	
2013	10.44
2014	10.45
2015	170.01
2016	80.85

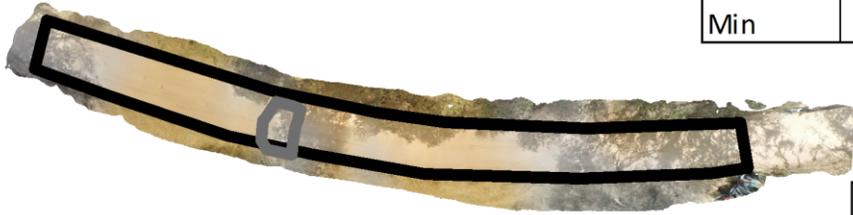
# Faultline Clay Road Yellow

Δ Elev	2013 - 2016 (m)	2015 - 2016 (m)
Mean	-0.08	-0.03
Std. Dev	0.18	0.06
Max	0.17	0.65
Min	-1.62	-0.23

Coverage Area (m <sup>2</sup> )	
2013	5.11
2014	5.10
2015	492.99
2016	97.32

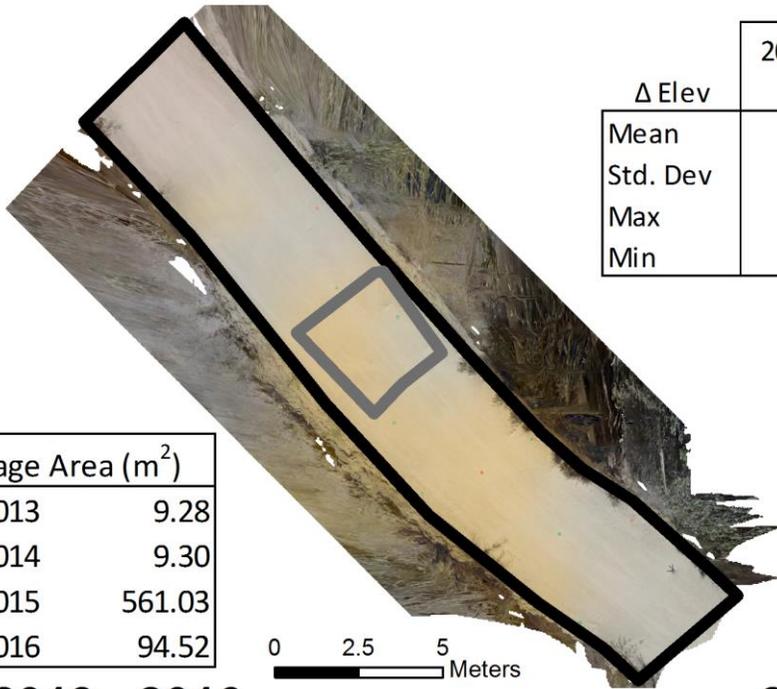
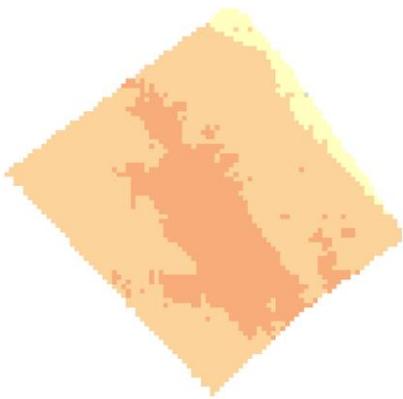
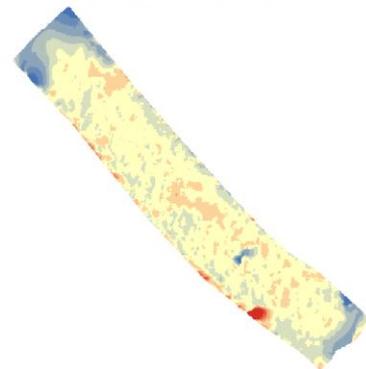
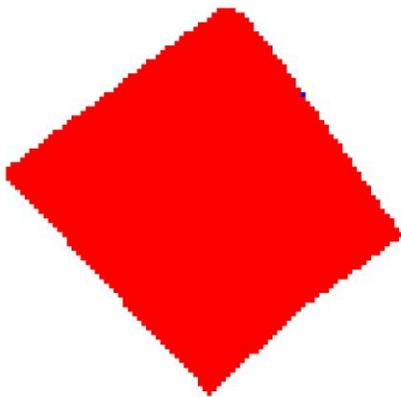
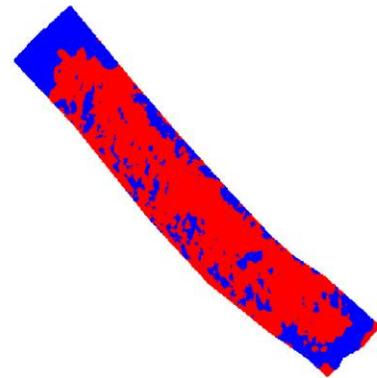
# Lake Granite Road Red

$\Delta$ Elev	2013 - 2016 (m)	2015 - 2016 (m)
Mean	-0.18	0.02
Std. Dev	0.04	0.13
Max	0.00	1.61
Min	-0.26	-1.75

Coverage Area (m <sup>2</sup> )	
2013	9.28
2014	9.30
2015	561.03
2016	94.52

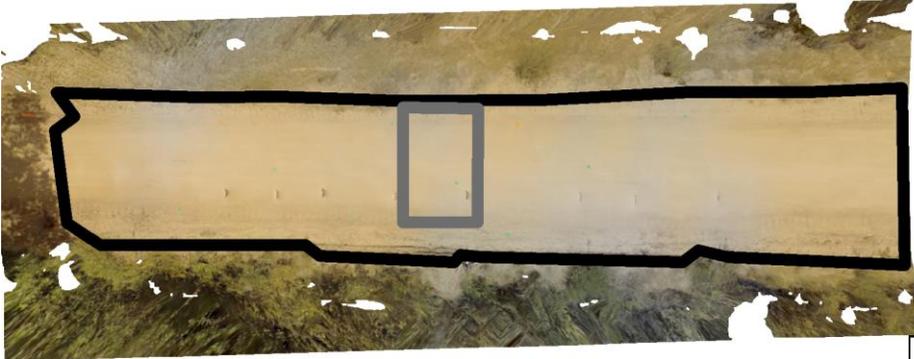
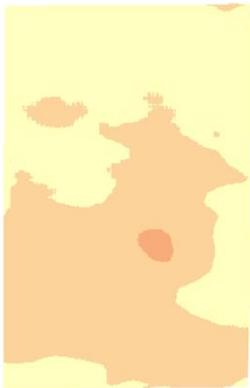
# North Canyon Granite Road Yellow

Coverage Area (m <sup>2</sup> )	
2013	7.55
2014	7.61
2015	241.45
2016	118.23

Δ Elev	2013 - 2016 (m)	2015 - 2016 (m)
Mean	-0.10	0.08
Std. Dev	0.03	0.20
Max	-0.03	1.37
Min	-0.21	-0.63

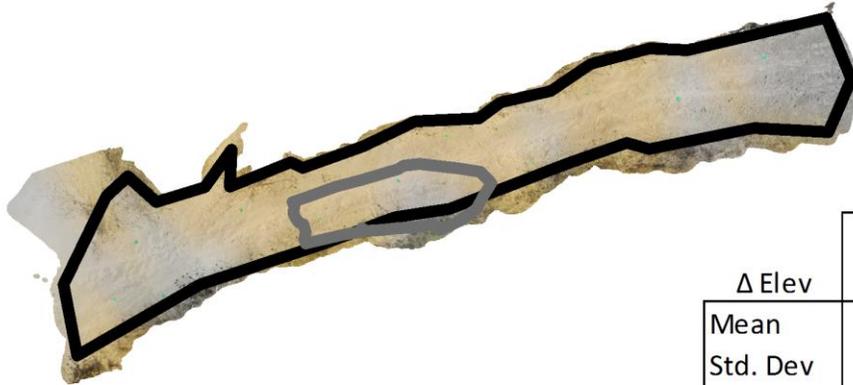
# Psych Hill Clay Single Track Red

Coverage Area (m <sup>2</sup> )	
2013	7.76
2014	N/A
2015	294.62
2016	58.27

Δ Elev	2013 - 2016 (m)	2015 - 2016 (m)
Mean	0.15	0.12
Std. Dev	0.15	0.13
Max	0.92	0.99
Min	-0.11	-1.10

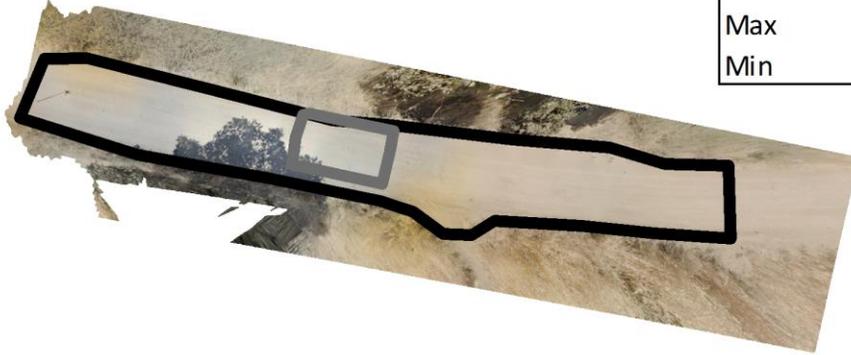
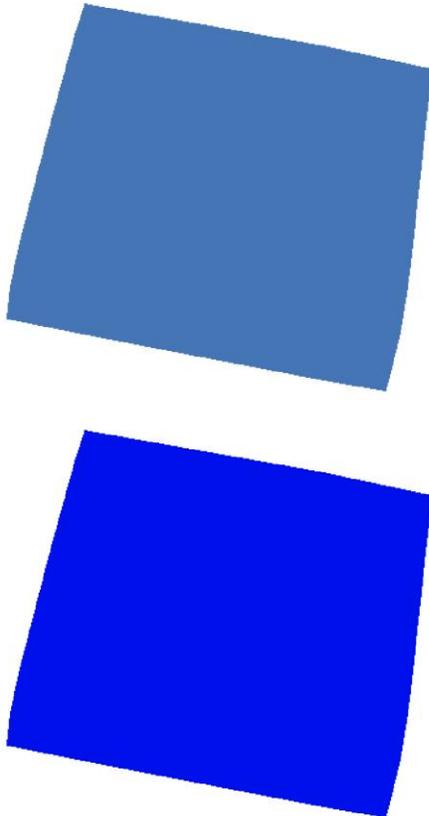
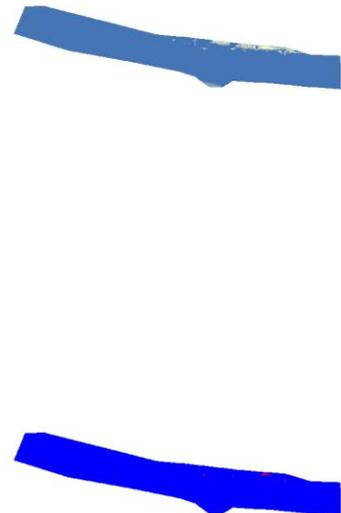
# Rancho Clay Road Red

2013 - 2016	2015 - 2016
$\Delta$ Elev	(m)	(m)
Mean	1.38	1.29
Std. Dev	0.05	0.37
Max	1.50	2.33
Min	1.26	-0.19

Coverage Area (m <sup>2</sup> )	
2013	9.10
2014	12.37
2015	633.47
2016	137.89
