WI Publication No. WI-2018-04

Hollister Hills SVRA

Trail Erosion Surveys

Summer 2017

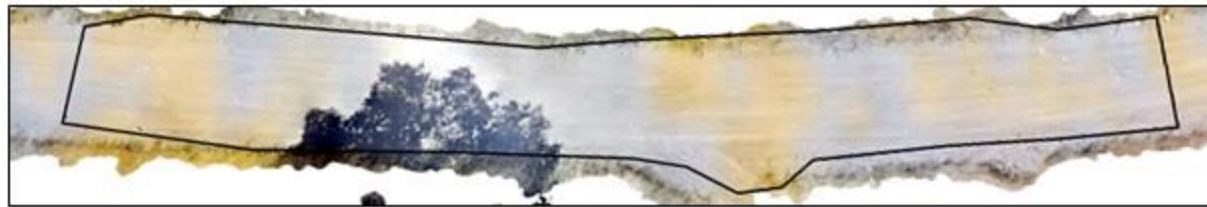
Δ Elevation 2016-2017 (meters)

2013-2017 Elevation Change (m)						Rancho (CRR)
Cumulative			Annual Average			2017 GCP Z Error (m)
all years	non-graded	graded	all years	non-graded	graded	0.008
1.215	-0.050	1.265	0.304	-0.025	0.633	
			n=4	n _u =2	n _g =2

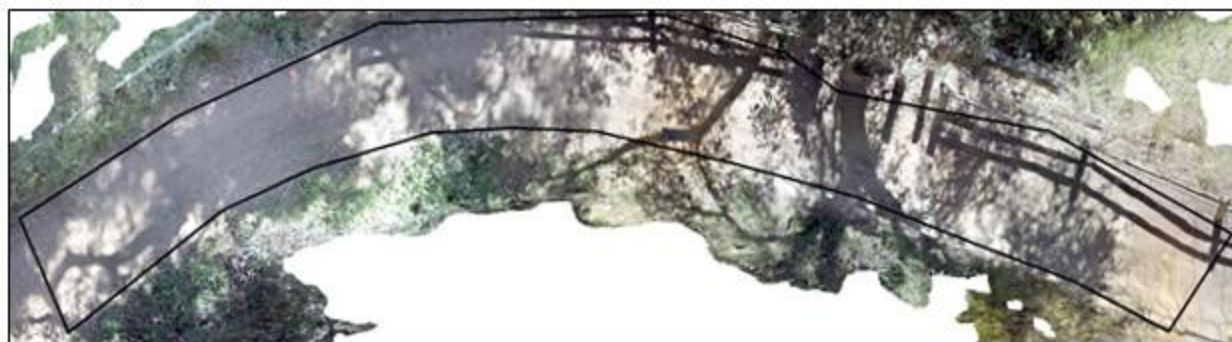
**Δ Elevation
2016-2017
(meters)**

2013-2017 Elevation Change (m)						Coyote 2 (GAY)
Cumulative			Annual Average			2017 GCP Z Error (m)
all years	non-graded	graded	all years	non-graded	graded	0.003
-0.018	0.000	-0.018	-0.006	0.000	-0.018	
			n=3	n _u =2	n _g =1

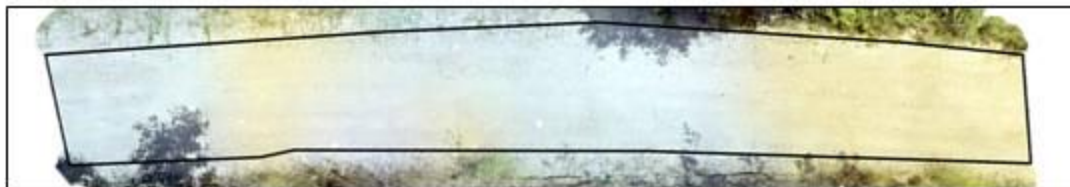
Δ Elevation 2016-2017 (meters)

2013-2017 Elevation Change (m)						Sage (GRG)
Cumulative			Annual Average			2017 GCP Z Error (m)
all years	non-graded	graded	all years	non-graded	graded	0.007
0.000	-0.040	0.040	0.000	-0.013	0.040	
			n=4	n _u =3	n _g =1
