WI Publication No. WI-2019-06

Hollister Hills SVRA

Trail Erosion Surveys

Summer 2019

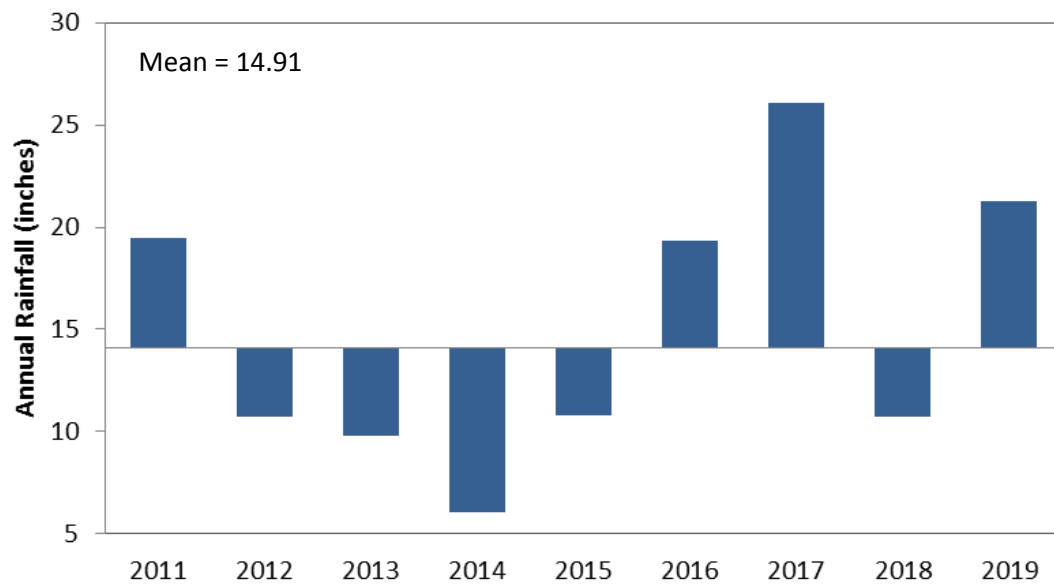
Approximately 21.25 inches of rain fell between the 2018 and 2019 trail surveys. That value is approximately double the median for 8 years of record, and is much wetter than the

Figure 3. Annual precipitation at Hollister Hills SVRA. Values shown with respect to the mean value of 14.91 inches.

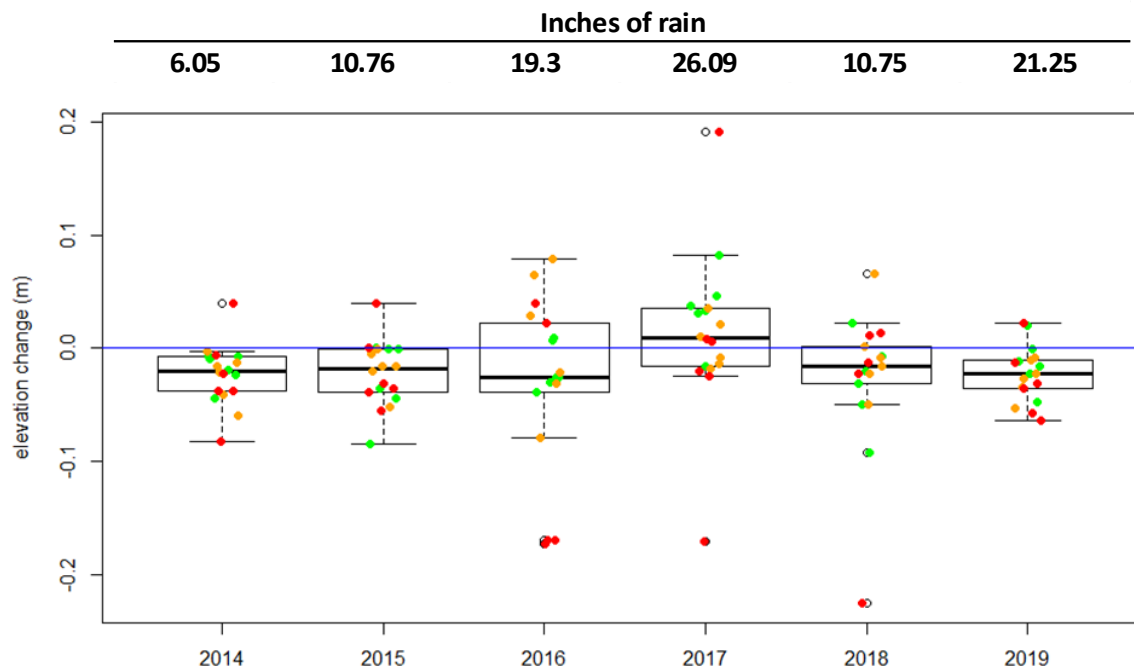
Topographic change is more variable starting in 2016 (Fig. 4). At that time, the analysis areas at each site were expanded through the use of photogrammetry, and site management increased. According to a one-way ANOVA with unequal variance, mean elevation changes do not significantly differ through time, ($df = 5/45.3$, $F=0.9$, $P=0.5$), despite the great differences in annual precipitation (Fig. 4).

Figure 4. Annual average elevation change for six years of assessment with corresponding annual precipitation . Dots show individual sites colored by sustainability index (Green, yellow, red). ANOVA $P= 0.5$.

lowest following the highest rain year (2017) when net topographic response was 0.01 m of deposition. There appears to be no correlation between rainfall and erosion rates (Fig. 4; Table 4). Further analysis shows that the poor correlation between rainfall and erosion rates applies to subsets of graded and non-graded sites.

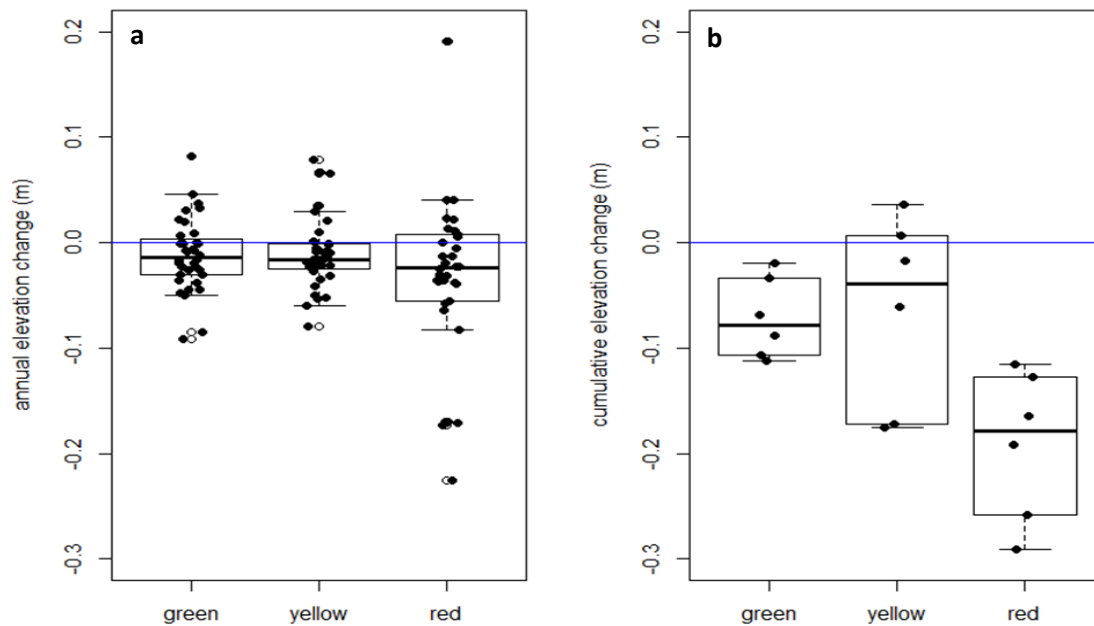
Table 5 summarizes the results over the six years as annual averages parsed by classification, soil type, vehicle usage, and whether the site was managed. When managed and unmanaged sites are examined together, a one-way ANOVA with unequal variance does not distinguish among the annual erosion rates of red, yellow and green rated trails ($df = 2/63.1$, $F=1.3$, $P=0.3$). Figure 5a illustrates the similarity in median values among the three trail classification levels, while Table 5 reports the similarity in mean values. The standard deviation of red sites (0.08 m/yr) is almost twice that of yellow (0.03 m/yr) and green sites (0.03m/yr). A Levene's test for homogeneity of variance shows that red site annual variability is significantly higher than annual variability of other color categories ($df=2$, $F=5.6$, $P=0.005$). Extreme annual values in red sites are more often erosional than depositional (Fig. 5a).

When six-year cumulative elevation change is computed, red sites show more erosion than the other two color categories (Fig. 5b). A one-way ANOVA with unequal variance and subsequent Tukey test indicate that red sites are significantly different from the other sites ($df = 2/8.8$, $F=6.6$, $P=0.02$), with red sites showing 0.12 m more erosion than green sites and 0.13 m more erosion than yellow sites over the six-year span.

Figure 5. Boxplots of all study sites parsed by sustainability index. (a) annual elevation change of all sites (ANOVA $p = 0.3$). (b) six-year cumulative elevation change of all sites (ANOVA $p=0.02$).

- 1) We expected the Green, Yellow, Red trail sustainability index to correlate with low, intermediate, and high rates of trail erosion (CDPR 2008; HHSVRA 2012). While no statistical differences between the categories are present at the annual scale, red sites erode significantly more than green or red sites when the cumulative effects of six years are considered ($p < 0.05$). Green and yellow sites have similar annual and cumulative erosion rates (Fig. 5).
- 2) The Universal Soil Loss Equation and other soil conservation models normally predict higher soil erosion rates with higher rainfall. Rainfall has varied from 6 inches to 26 inches during the study but the average annual erosion rate was

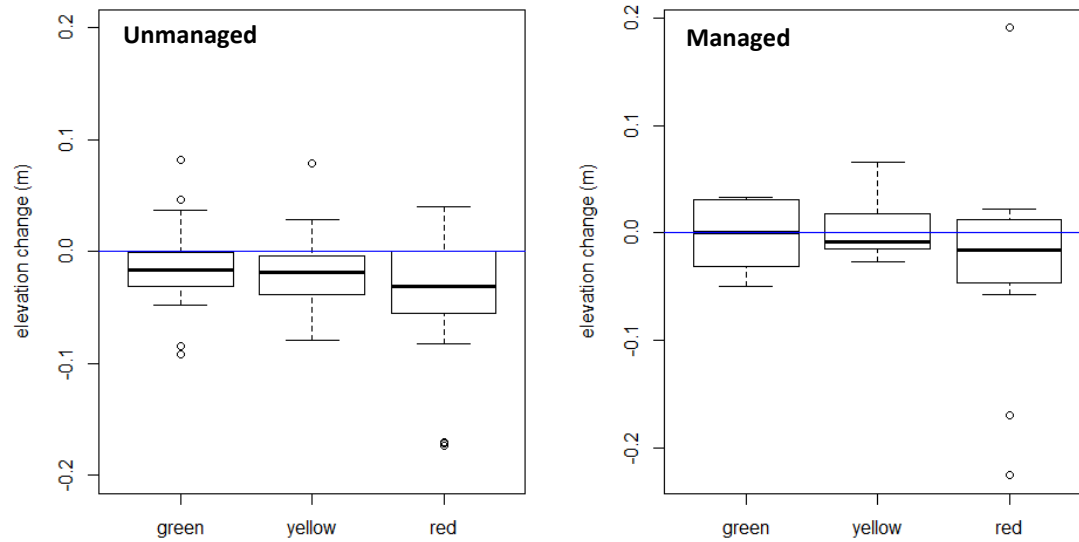
Trail management decreases median annual erosion rates to nearly 0 m/yr in all sustainability groups. The positive impact of management is also supported by the average values for each year (Tables 4 and 5) and the median values in most years (Fig. 7). The wide range of elevation changes noted in red sites is present in both managed and unmanaged sites (Figs. 6 and 7).

Figure 6: Boxplots of annual elevation change for all sites separated by management activity and sustainability index.

- 3) Clay and granite sites erode at approximately equal rates when averaged over several years (Fig. 8).
- 4) Trail use category did not highly influence the time-averaged erosion rates (Fig. 9; Table 4).
- 5) Trail management that mainly consists of replacing the sidecast berm back into the trail tread is an effective strategy for improving trail sustainability (Table 4; Table 5; Figs. 6 and 7).

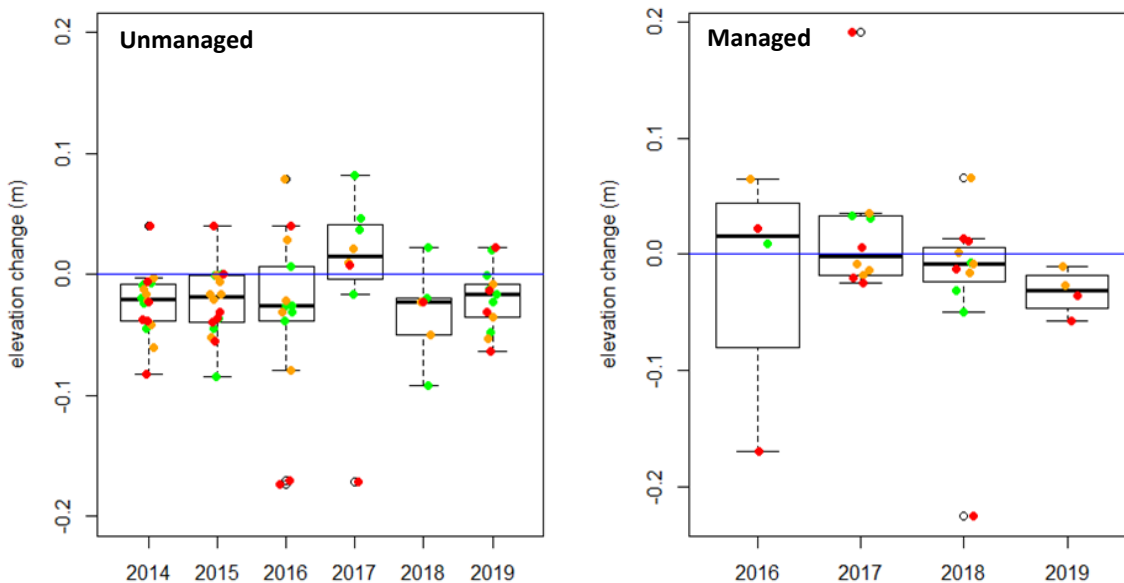
Figure 7: Boxplots of annual elevation change for all sites separated by year and management activity. Dots show individual sites colored by sustainability index (green, yellow, red).

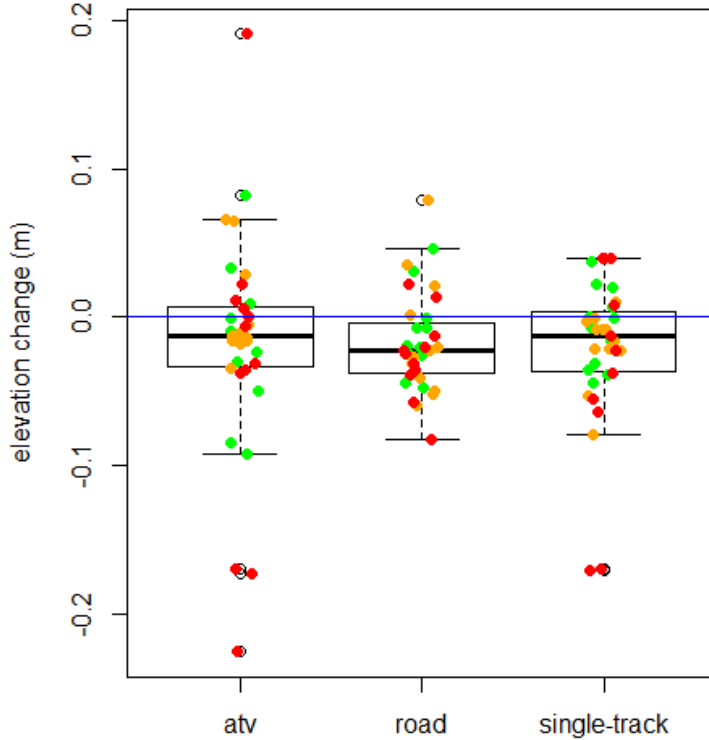
Annual erosion rates are plotted with respect to trail use category (ATV, road, single-track) in Figure 9. There is little difference between median erosion rates (Fig. 9) or mean rates (Table 5) among the three use classes. Managed sites in the ATV and road categories yield mean elevation changes of zero, while management of single-track sites had a slightly smaller impact on elevation change (Table 5). As previously noted, the three sustainability levels (green, yellow, red) do not show the expected correspondence with low, medium and high erosion rates, but red sites are notably more extreme than yellow or green.

Figure 9. Boxplot of study sites divided by trail use category. Dots show individual sites colored by sustainability index (green, yellow, red).

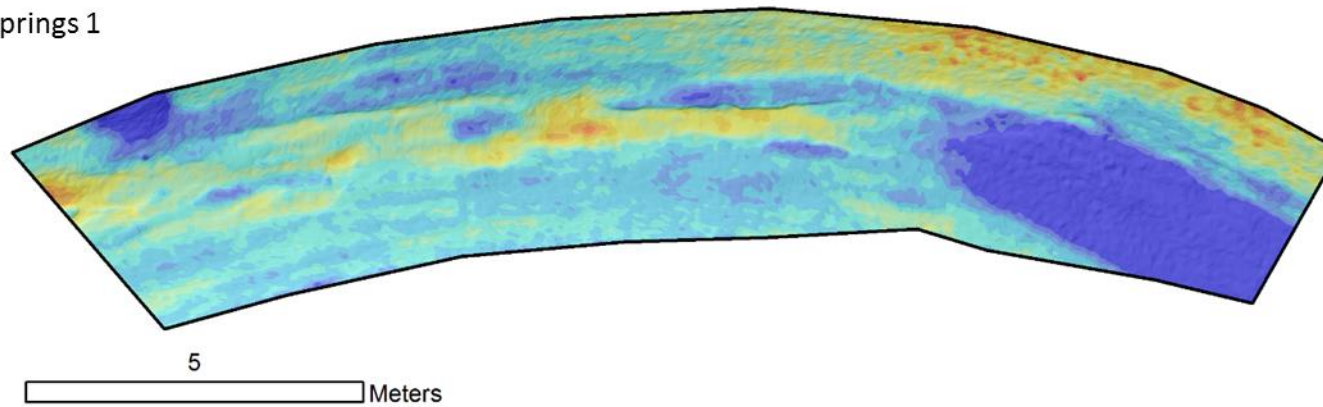
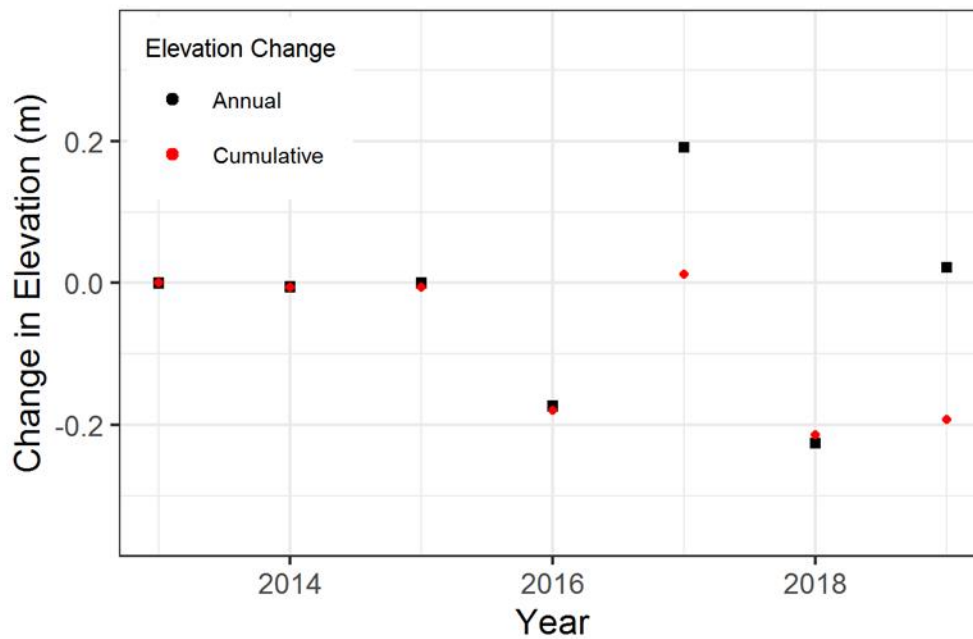
Elevation Change at Backsprings 1 (CAR)

Cumulative change	Annual Average
-0.192	0.022

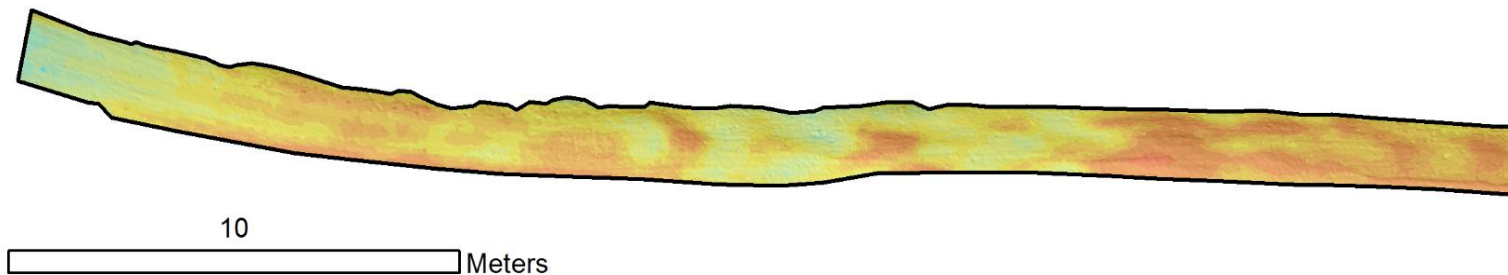
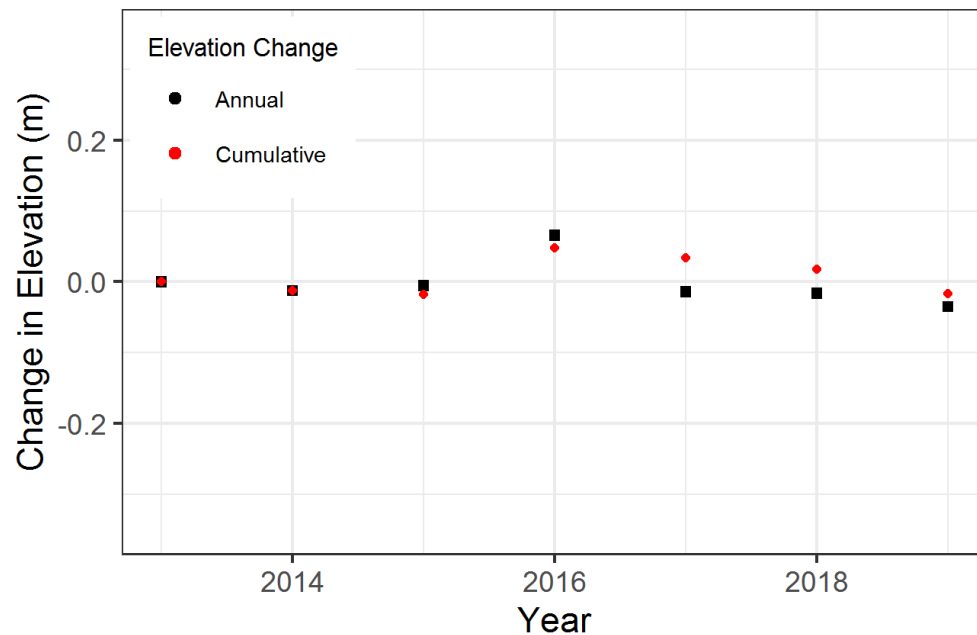
Elevation Change at Backsprings 2 (CAY)

2013-2019 Elevation Change (m)		Backsprings 2 (CAY)
Cumulative change	Annual Average	2019 GCP Z RMSE (m)
-0.017	-0.035	0.008

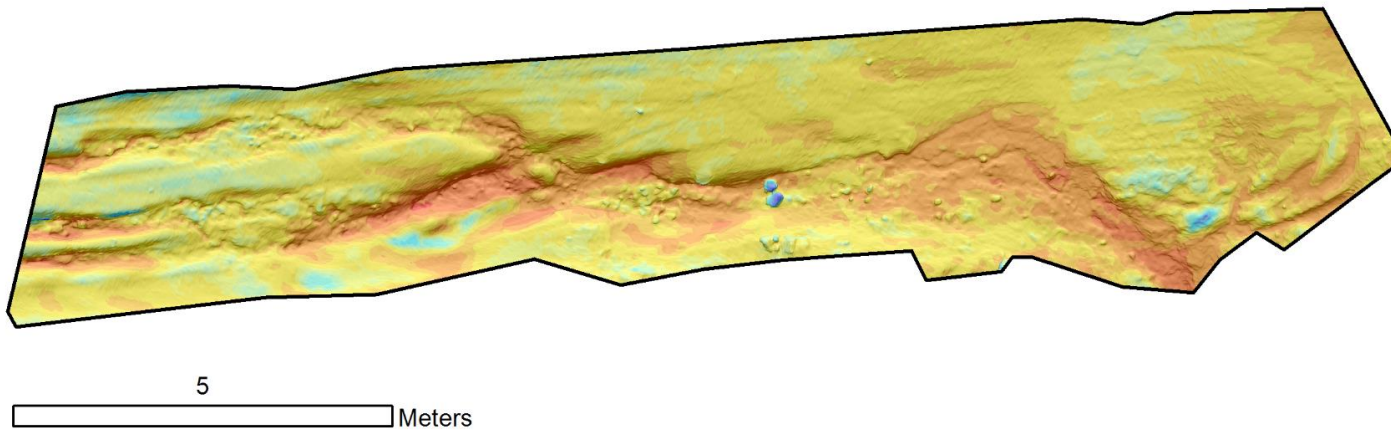
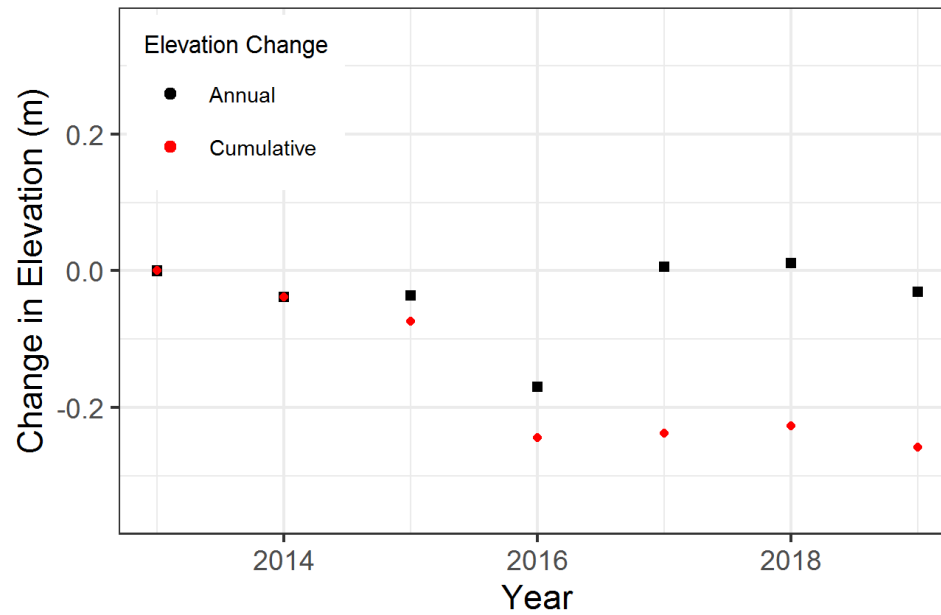
Elevation Change at Badger (GAR)

2013-2019 Elevation Change (m)		Badger (GAR)
Cumulative change	Annual Average	2019 GCP Z RMSE (m)
-0.258	-0.031	0.010

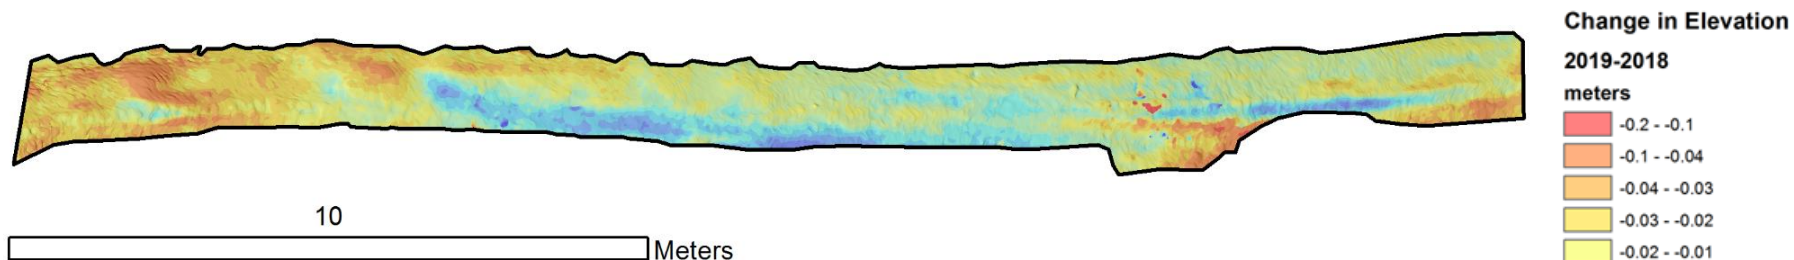
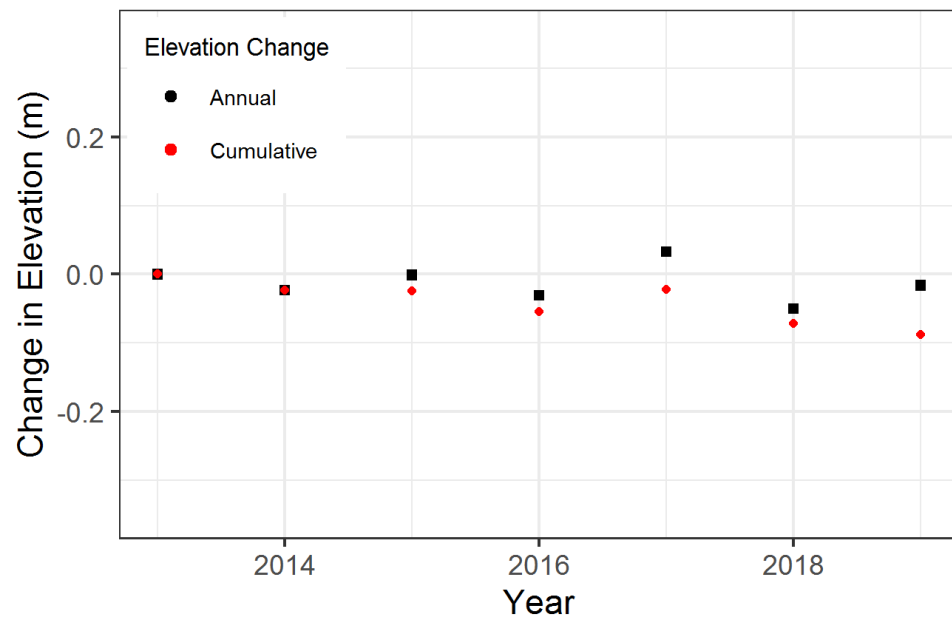
Elevation Change at Coyote 1 (GAG)

2013-2019 Elevation Change (m)		Coyote 1 (GAG)
Cumulative change	Annual Average	2019 GCP Z RMSE (m)
-0.088	-0.016	0.008

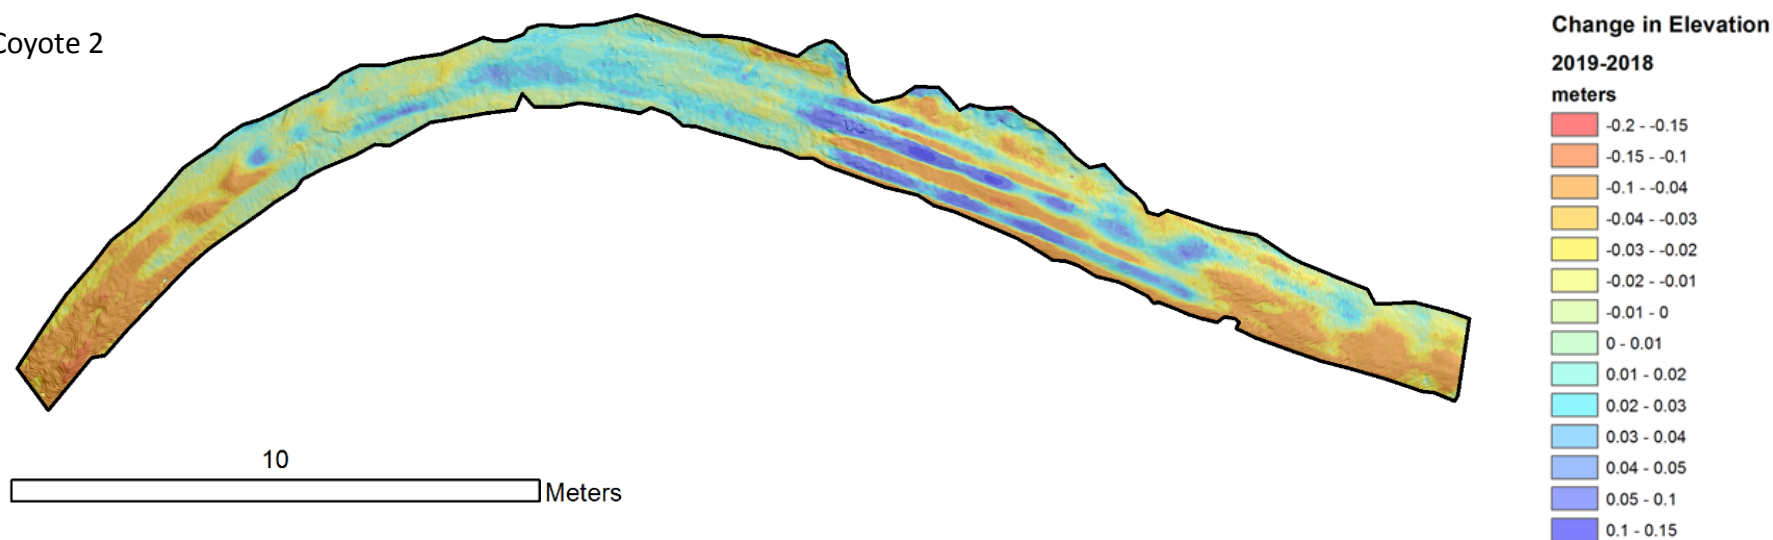
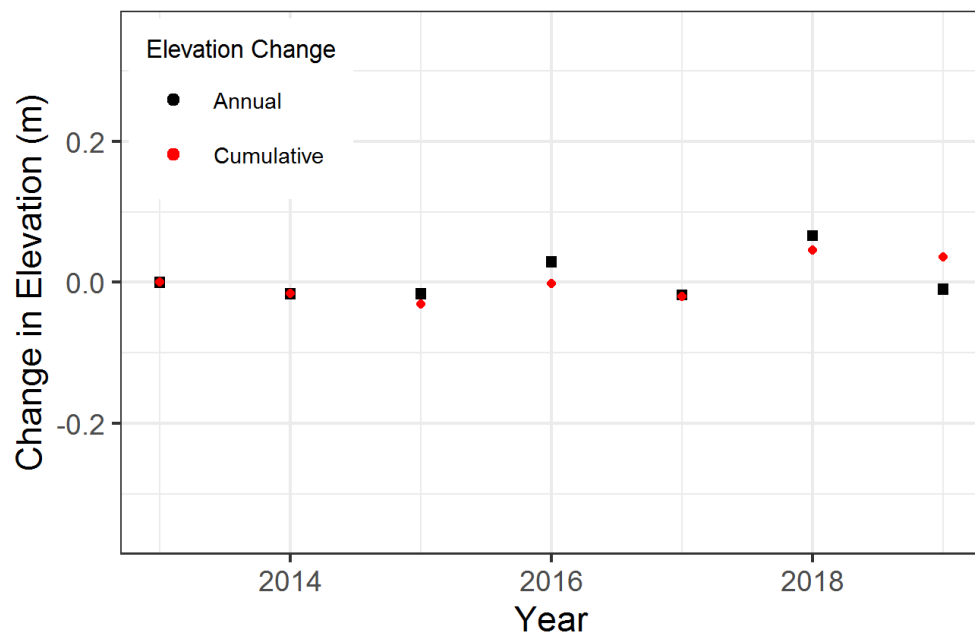
Elevation Change at Coyote 2 (GAY)

2013-2019 Elevation Change (m)		Coyote 2 (GAY)
Cumulative change	Annual Average	2019 GCP Z RMSE (m)
0.036	-0.010	0.004

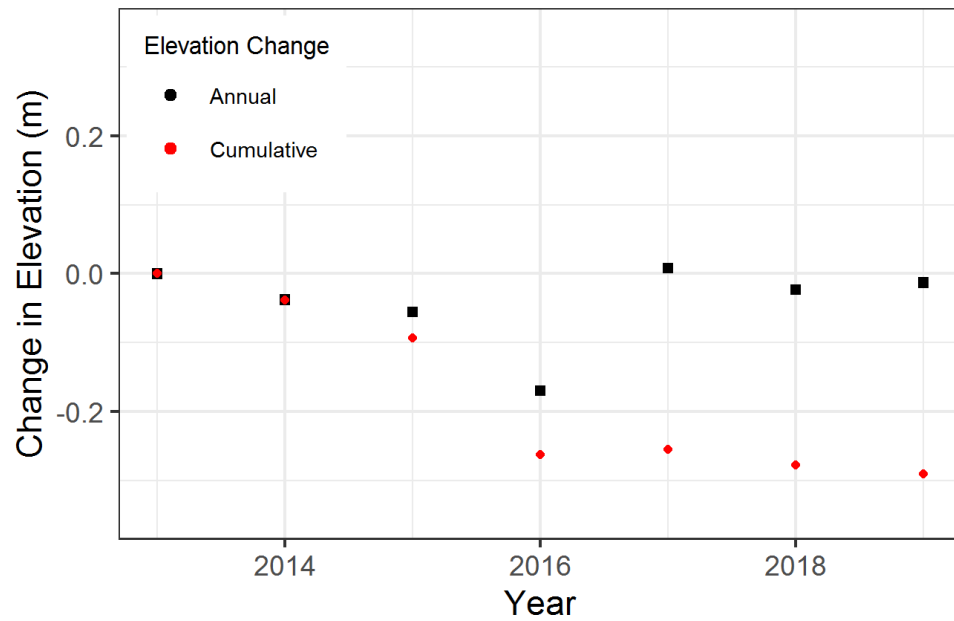
Elevation Change at Donnybrook 1 (GSR)

2013-2019 Elevation Change (m)		Donnybrook 1 (GSR)
Cumulative change	Annual Average	2019 GCP Z RMSE (m)
-0.291	-0.013	0.012

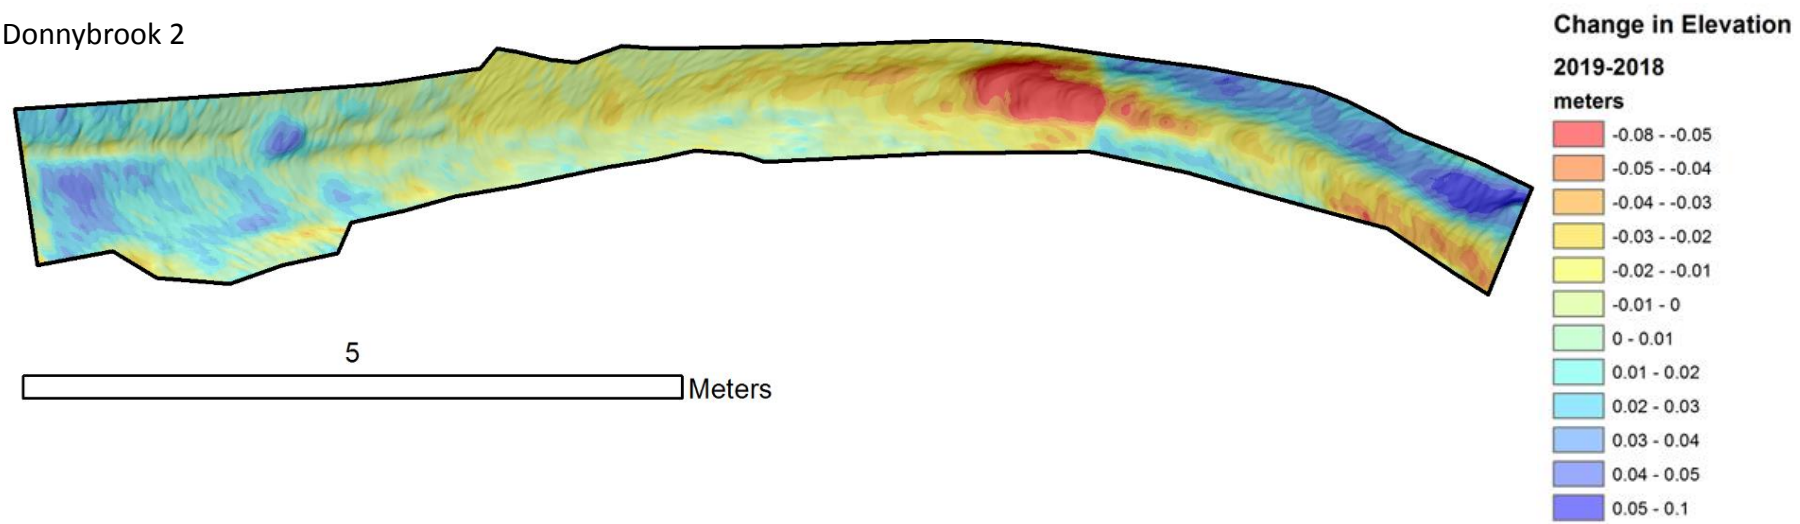
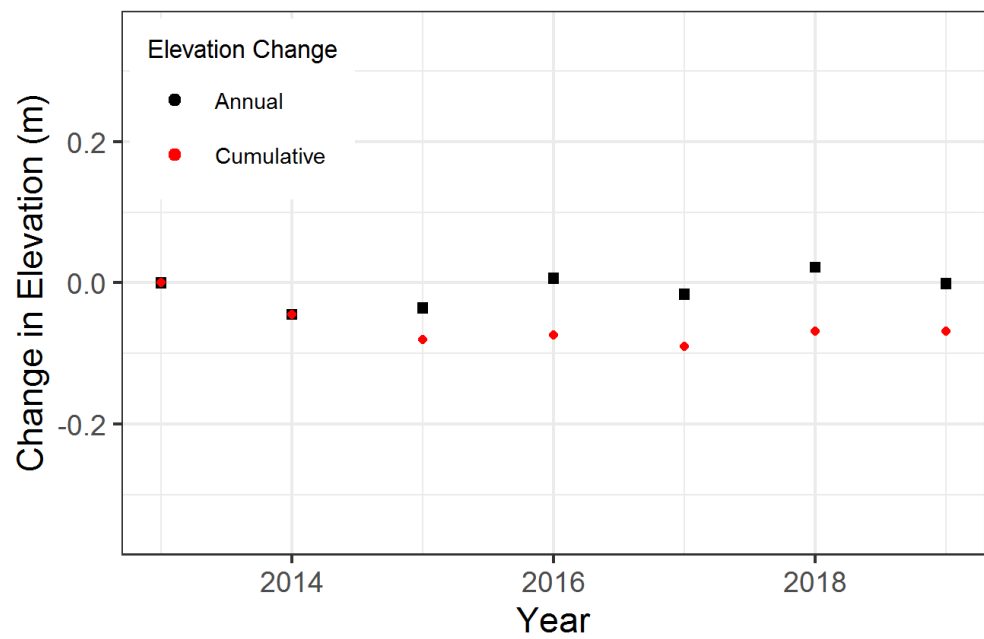
Elevation Change at Donnybrook 2 (GSG)

2013-2019 Ellevation Change (m)		Donnybrook 2 (GSG)
Cumulative change	Annual Average	2019 GCP Z RMSE (m)
-0.069	-0.001	0.002

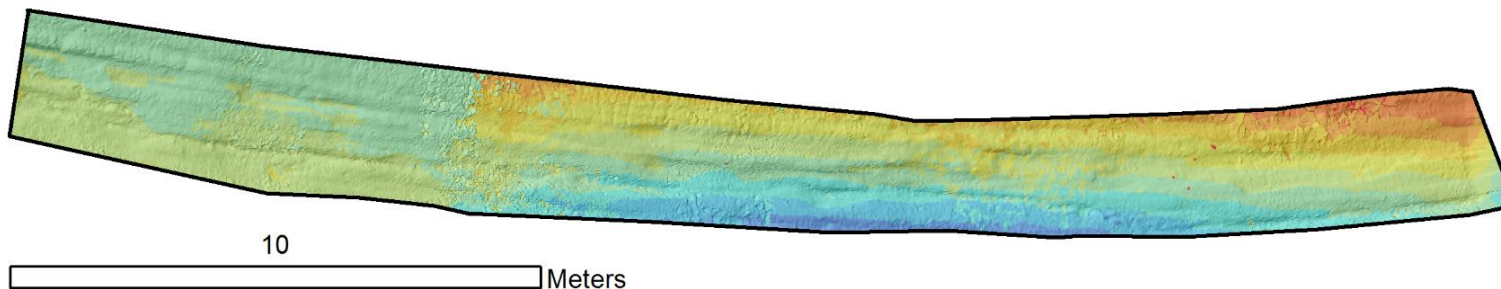
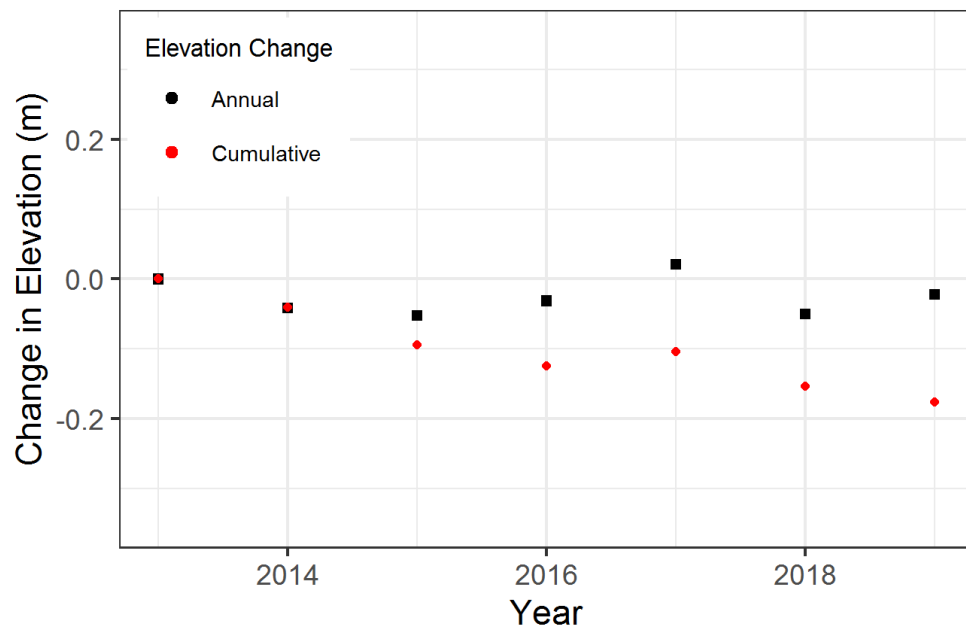
Elevation Change at Faultline 1 (CRY)

2013-2019 Elevation Change (m)		Faultline 1 (CRY)
Cumulative change	Annual Average	2019 GCP Z RMSE (m)
-0.176	-0.022	0.011

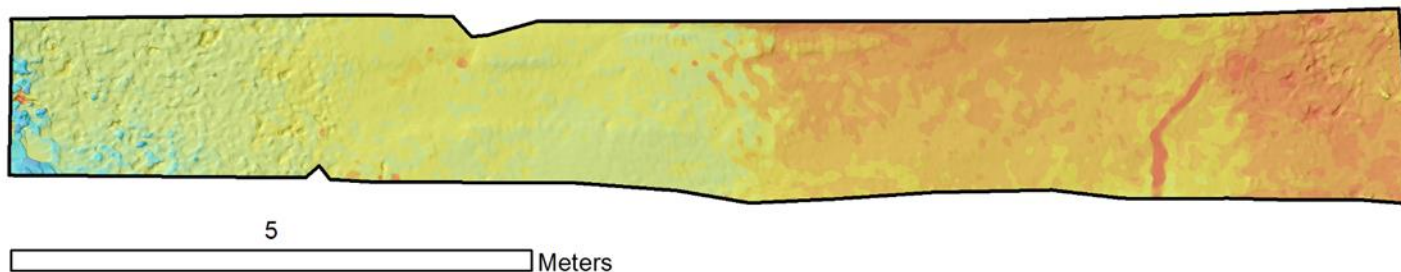
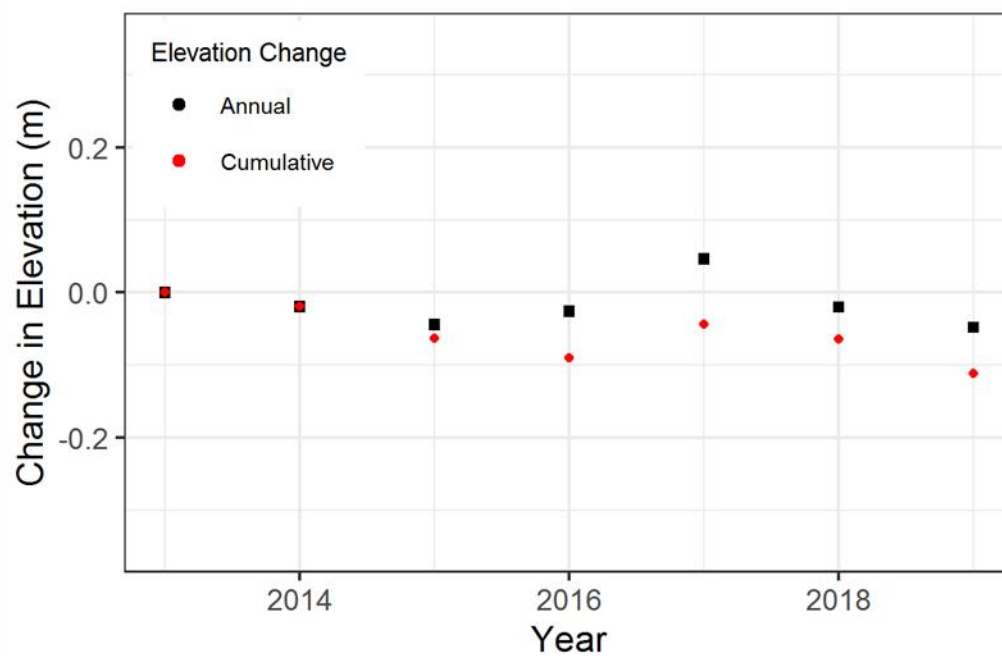
Elevation Change at Faultline 2 (CRG)

2013-2019 Elevation Change (m)		Faultline 2 (CRG)
Cumulative change	Annual Average	2019 GCP Z RMSE (m)
-0.112	-0.048	0.000

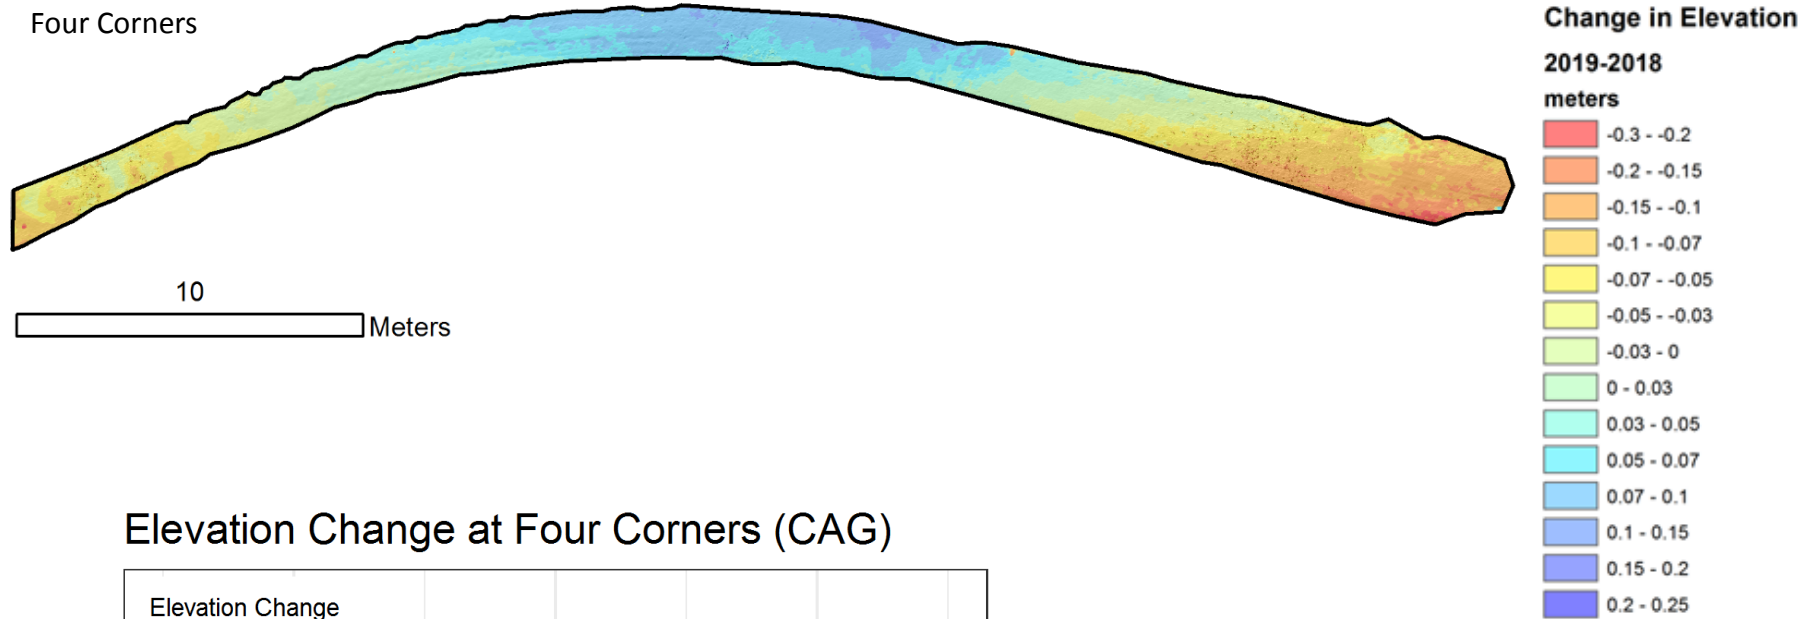
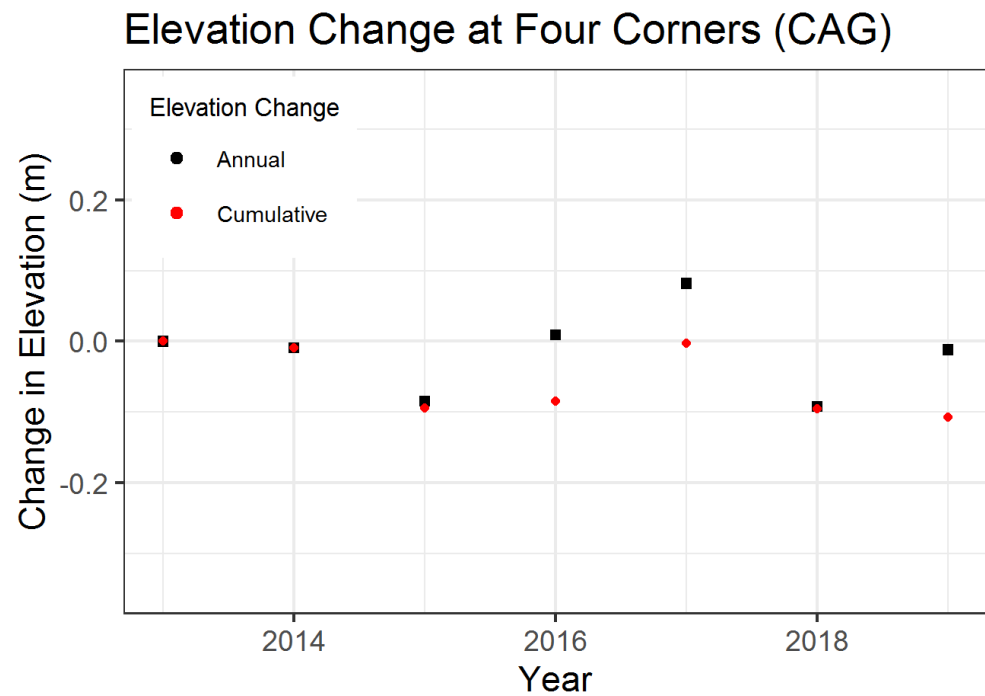
2013-2019 Elevation Change (m)		Four Corners (CAG)
Cumulative change	Annual Average	2019 GCP Z RMSE (m)
-0.107	-0.012	0.010

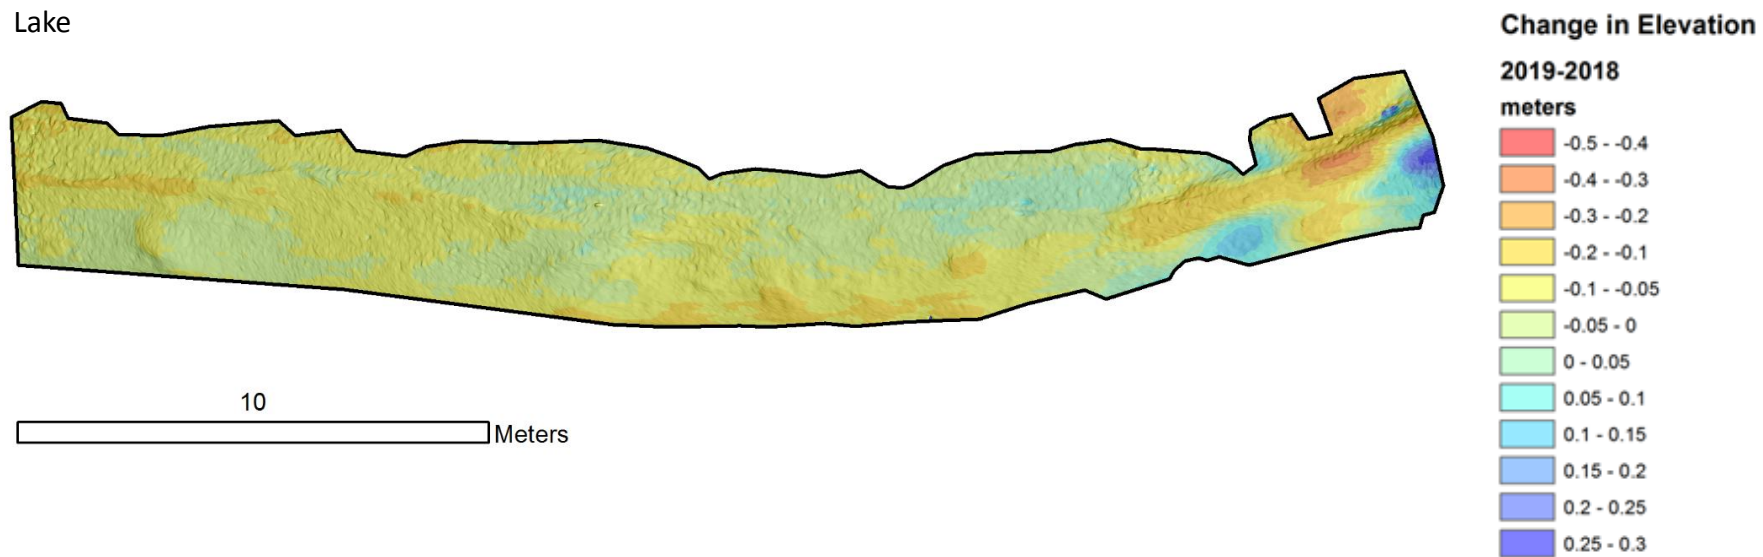
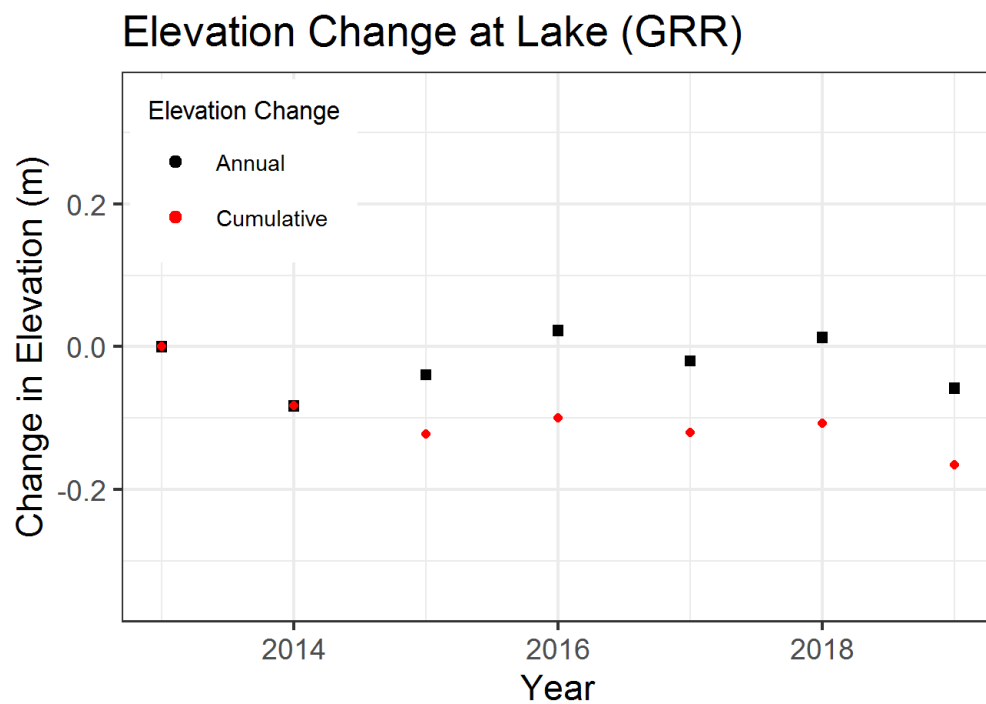
2013-2019 Elevation Change (m)		Lake (GRR)
Cumulative change	Annual Average	2019 GCP Z RMSE (m)
-0.165	-0.058	0.008

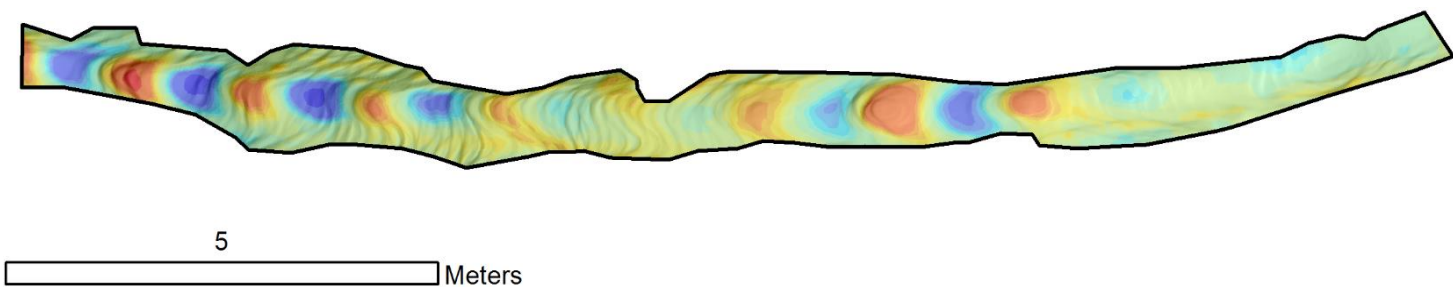
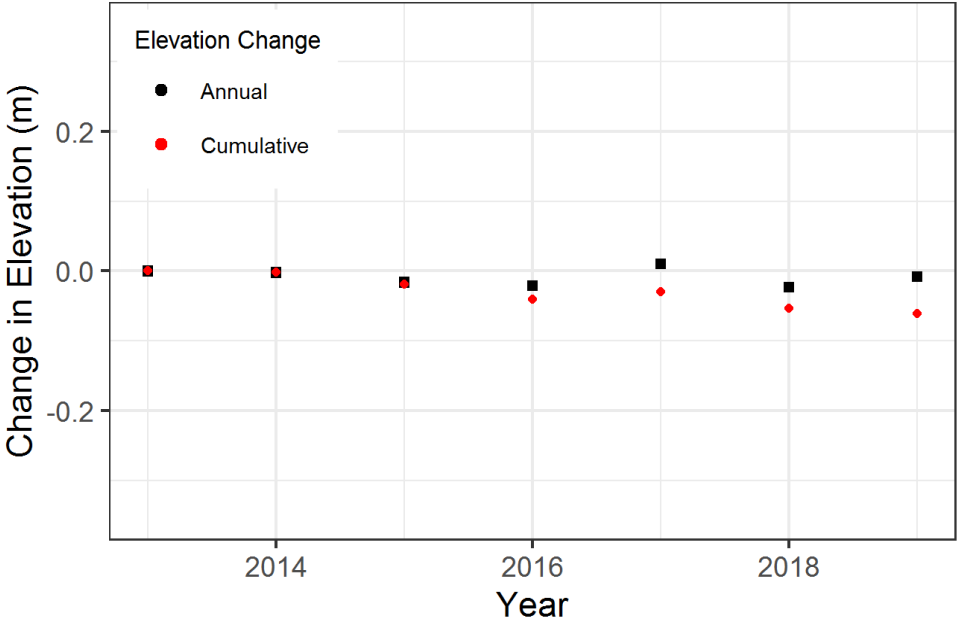
Elevation Change at Mystic (GSY)

2013-2019 Elelvation Change (m)		Mystic (GSY)
Cumulative change	Annual Average	2019 GCP Z RMSE (m)
-0.061	-0.008	0.003

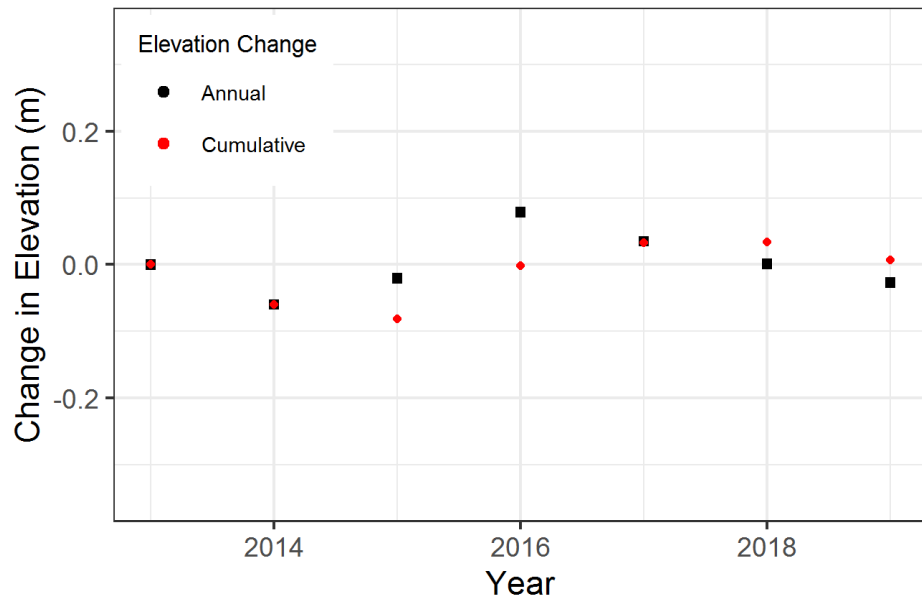
Elevation Change at North Canyon (GRY)

2013-2019 Ellevation Change (m)		North Canyon (GRY)
Cumulative change	Annual Average	2019 GCP Z RMSE (m)
0.007	-0.027	0.008

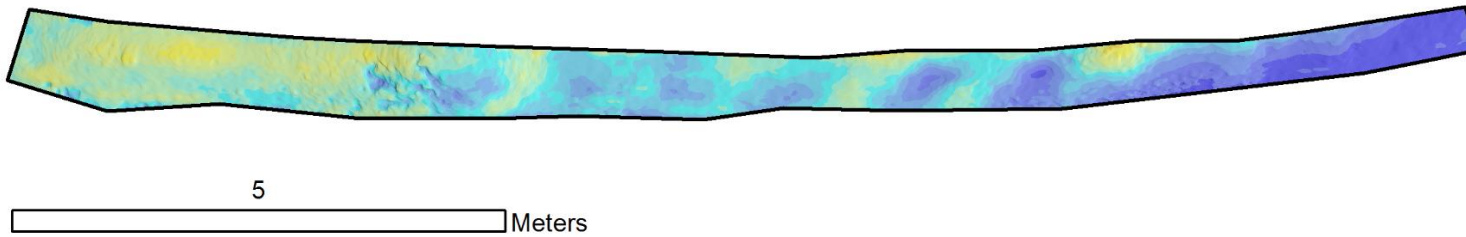
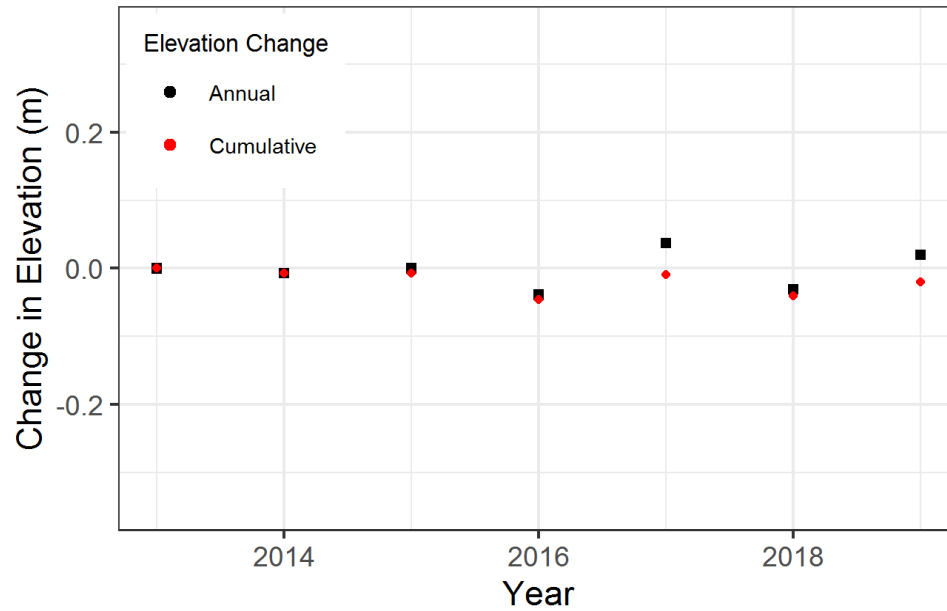
OK 1

Elevation Change at OK Corral 1 (CSG)

2013-2019 Ellevation Change (m)		OK Corral 1 (CSG)
Cumulative change	Annual Average	2019 GCP Z RMSE (m)
-0.020	0.020	0.016
