WI Publication No. WI-2019-06

Hollister Hills SVRA

Trail Erosion Surveys

Summer 2019

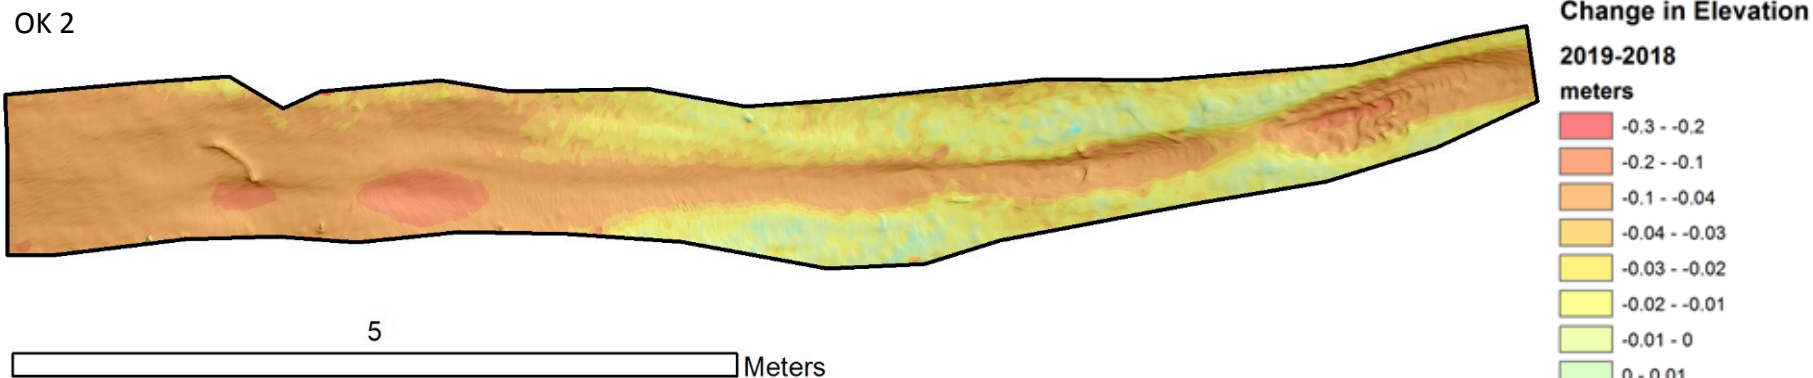
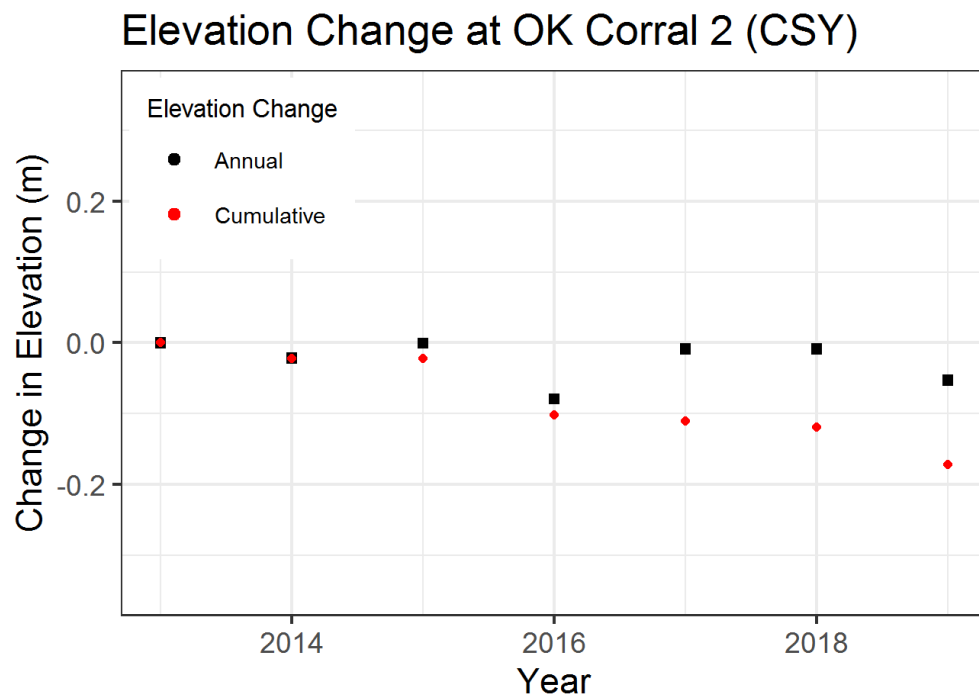
2013-2019 Elevation Change (m)		OK Corral 2 (CSY)
Cumulative change	Annual Average	2019 GCP Z RMSE (m)
-0.172	-0.053	0.008

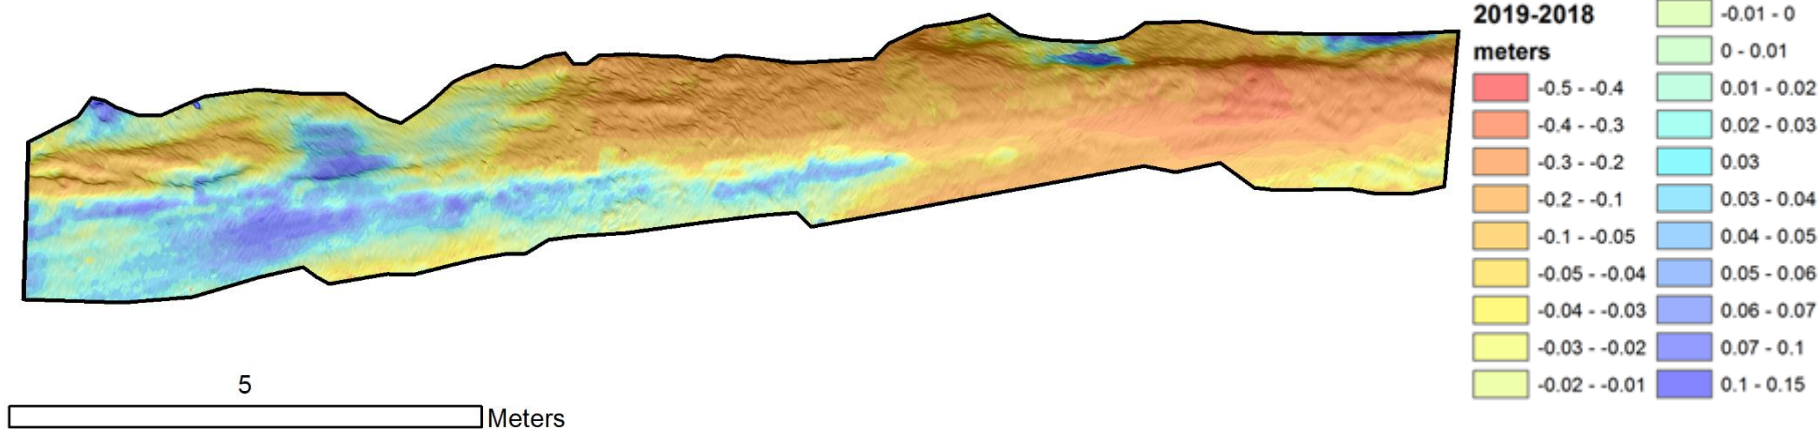
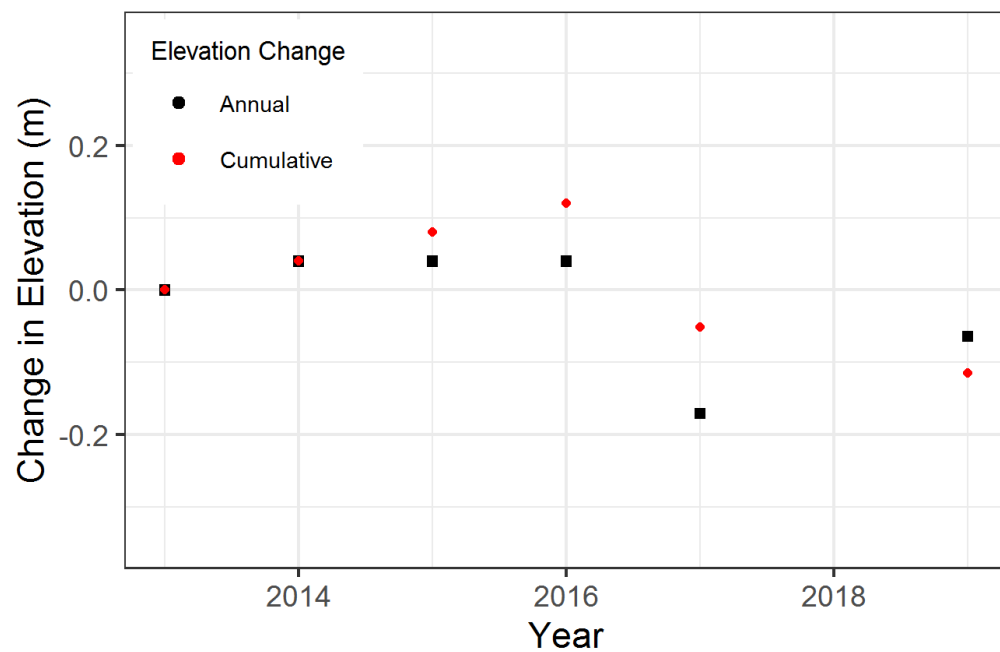
Elevation Change at Psych Hill (CSR)

2013-2019 Elevation Change (m)		Psych Hill (CSR)
Cumulative change	Annual Average	2019 GCP Z RMSE (m)
-0.115	-0.064	0.015

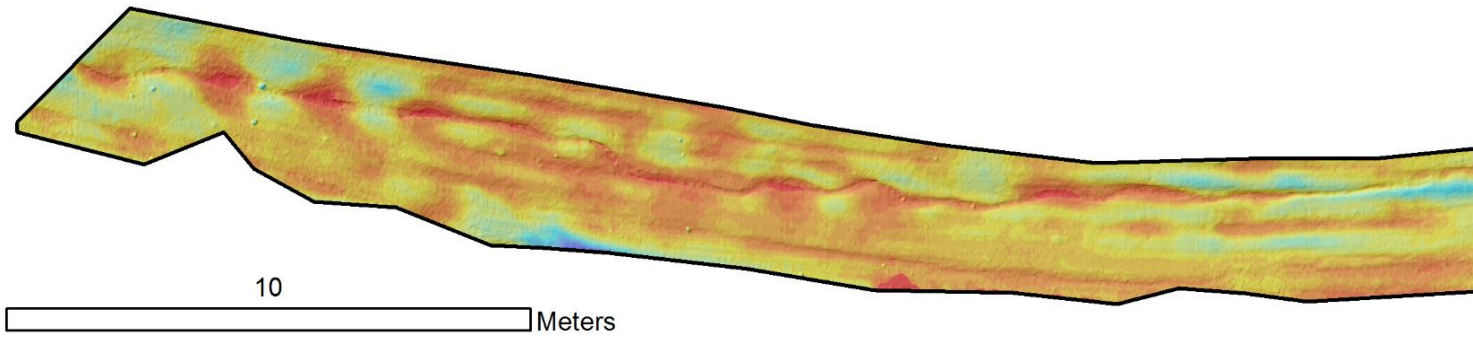
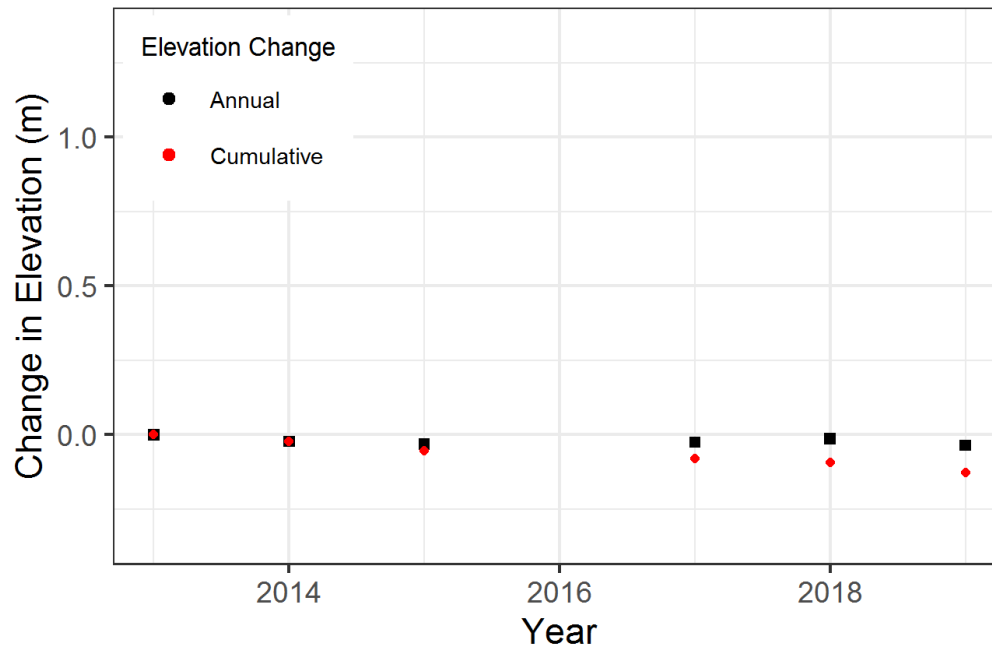
Elevation Change at Rancho (CRR)

2013-2019 Elevation Change (m)		Rancho (CRR)
Cumulative change	Annual Average	2019 GCP Z RMSE (m)
1.158	-0.036	0.009

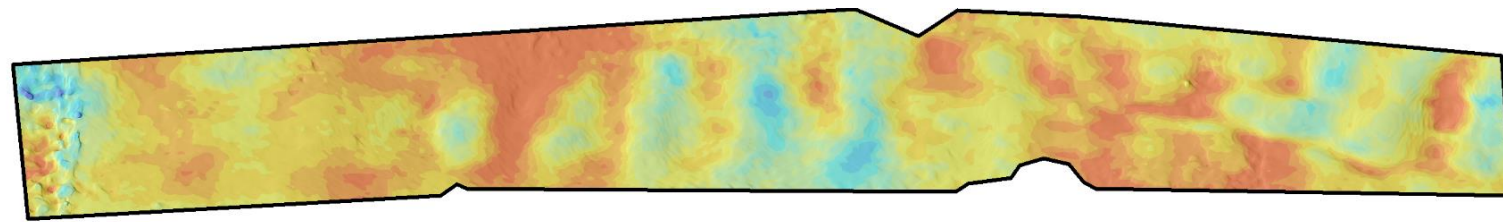
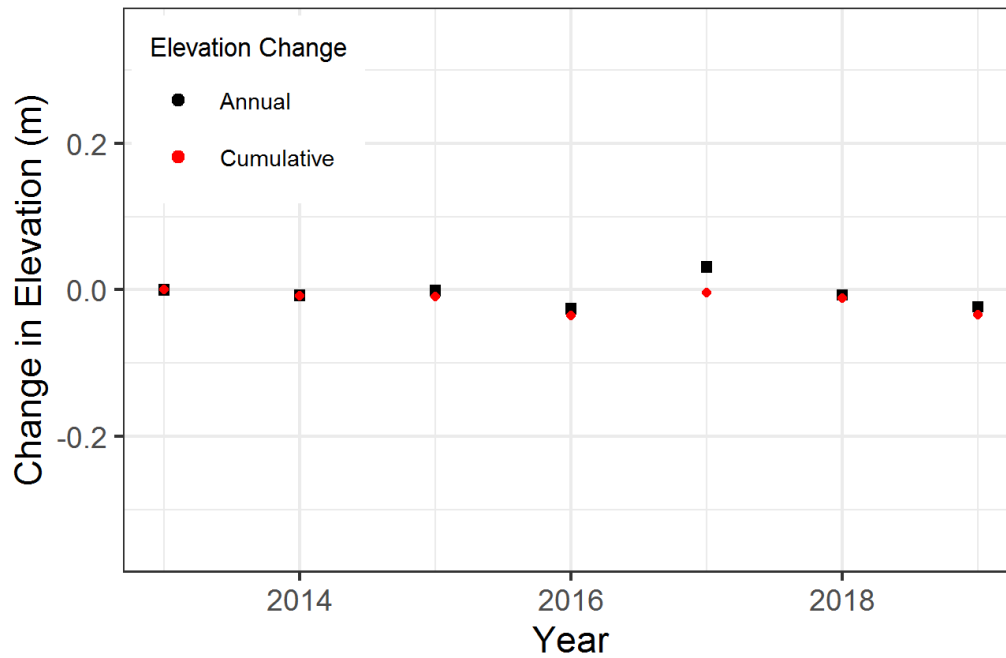
Elevation Change at Sage (GRG)

Cumulative change

-0.034
