WI Publication No. WI-2021-01

Hollister Hills SVRA

Trail Erosion Surveys

Summer 2020

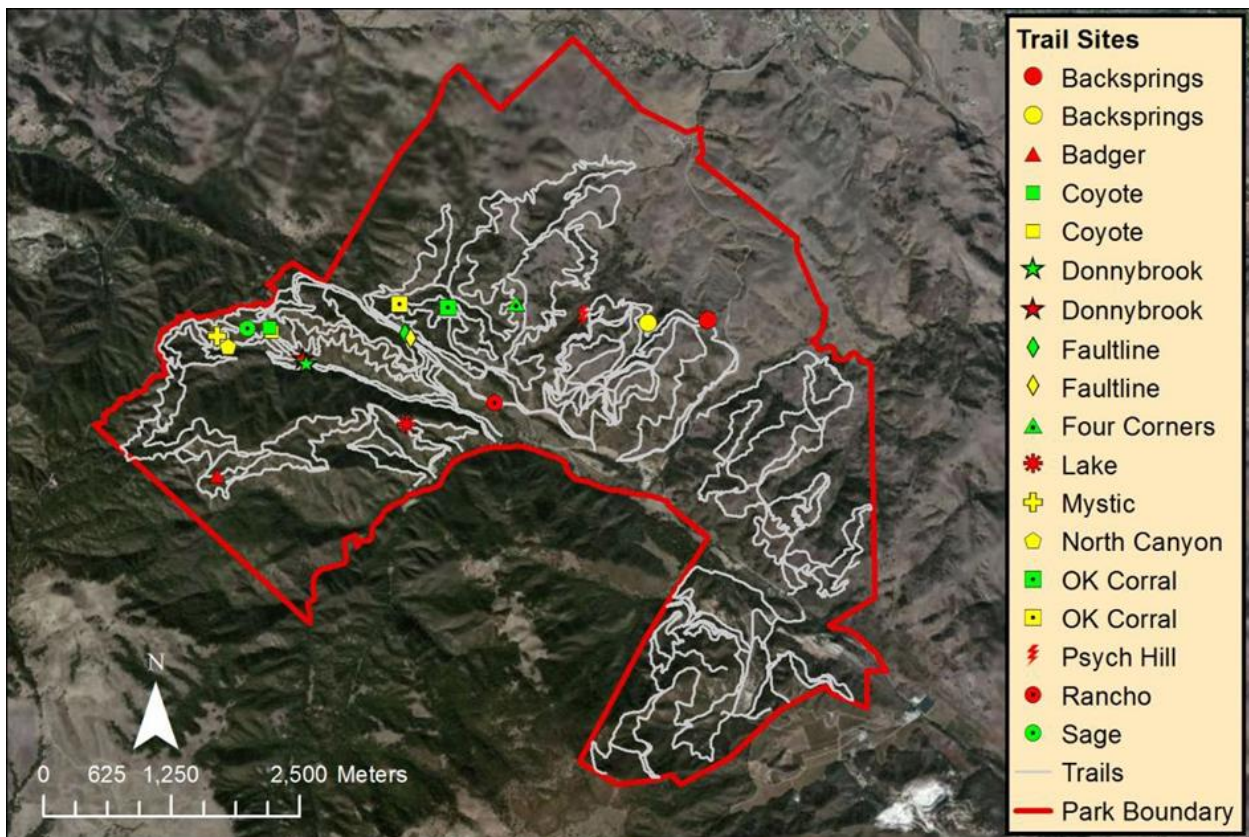
Figure 2. Trail site locations within Hollister Hills State Vehicular Recreation Area, Hollister, CA. Legend colors correspond to sustainability index.

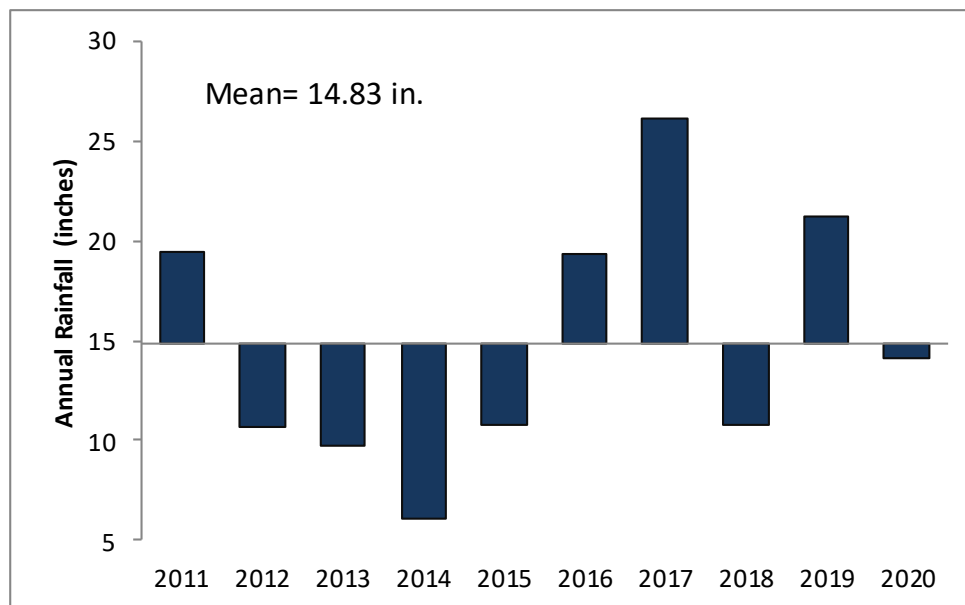
Figure 3. Annual precipitation at Hollister Hills SVRA. Values shown with respect to the mean value of 14.83 inches.

1). The total rainfall from the previous year is slightly below the mean, 14.83 in (Fig 3). Monthly precipitation was obtained from the Radio Ridge Hollister Hills Weather Monitoring Station within the park SVRA (Western Weather Group 2017).

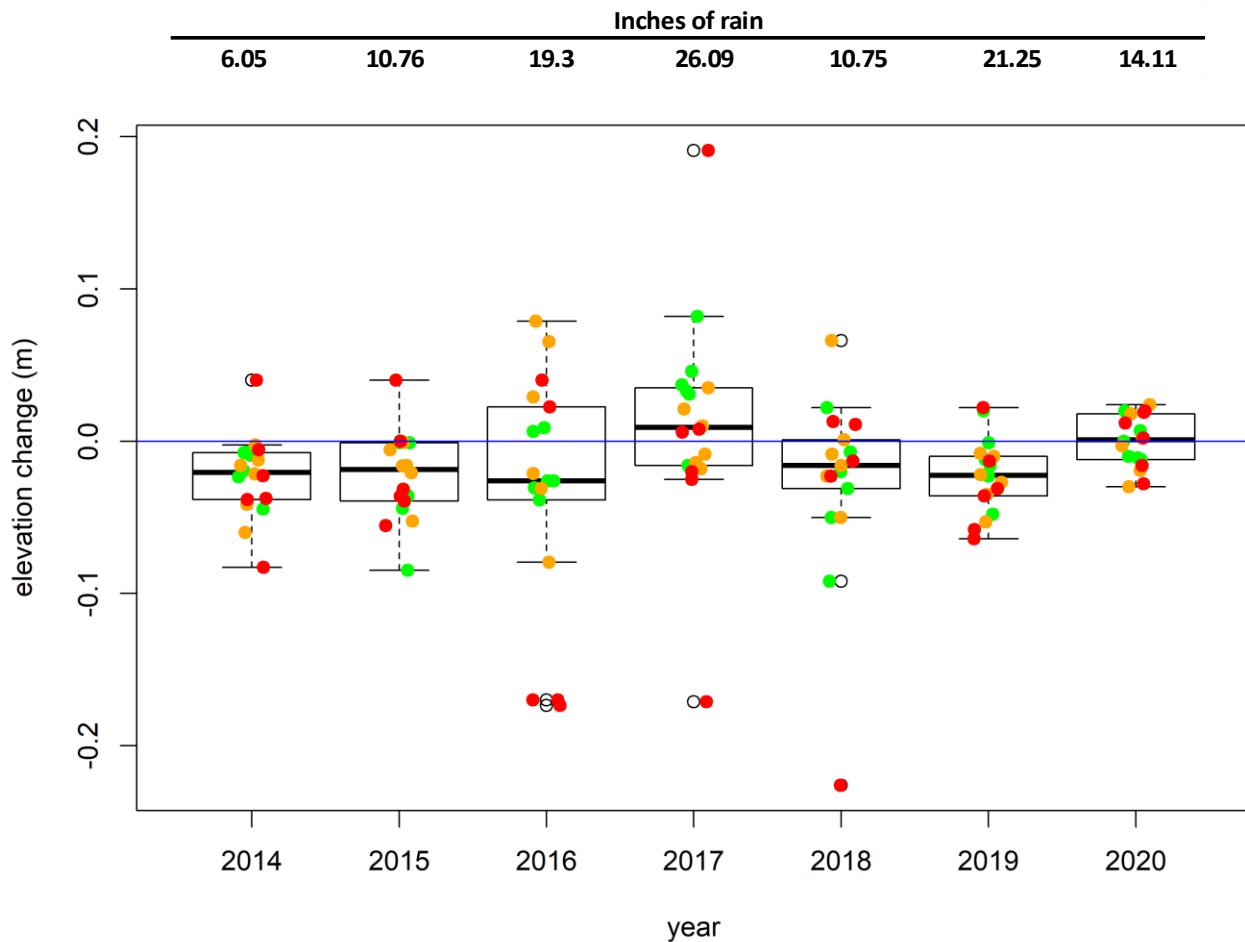
Figure 4. Annual average elevation change for seven years of assessment with corresponding annual precipitation. Dots show individual sites colored by sustainability index (green, yellow, red). ANOVA $P= 0.007$.

Before 2016, the results did not show much variability. In 2016, park staff began management on selected trails and photogrammetry implementation enlarged the sample sites and created a more detailed result. Annual average elevation change became more variable in 2016, 2017 and 2018, but variability has not been great in 2019 or 2020. A low p-value in a one-way ANOVA with unequal variance ($F=3.4$, $df=6/50.6$, $P=0.007$) indicates that mean elevation change varies through time. The variability does not seem to track rainfall.

- 1) We expected the Green, Yellow, Red trail sustainability index to correlate with low, intermediate, and high rates of trail erosion (CDPR 2008; HHSVRA 2012). While no statistical differences between the categories are present at the annual scale, red sites erode significantly more than green or yellow sites when the cumulative effects of seven years are considered ($p < 0.05$; Table 5). Green and yellow sites have similar annual and cumulative erosion rates (Fig. 5).
- 2) The Universal Soil Loss Equation and other soil conservation models normally predict higher soil erosion rates with higher rainfall. Rainfall has varied from 6 inches to 26 inches during the study but the average annual erosion rate was lowest following the highest rain year (2017). There appears to be little correlation between rainfall and erosion rates (Fig. 4; Table 4).

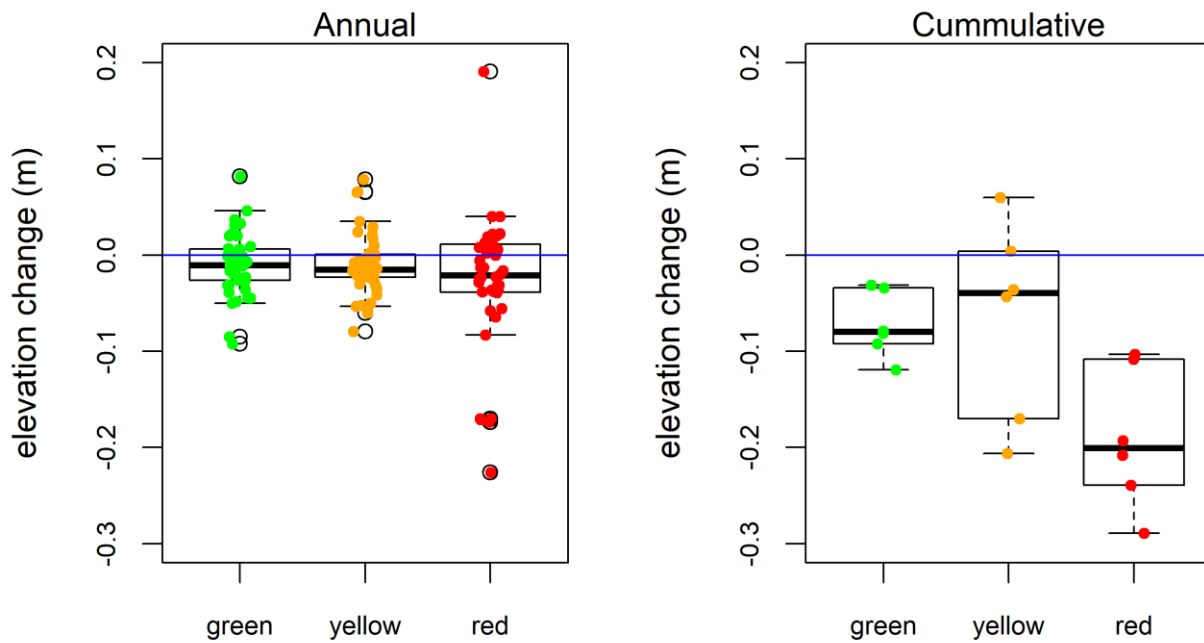
Figure 5. Boxplots of all study sites parsed by sustainability index. (Left) Annual elevation change of all sites (ANOVA $p = 0.3$). (Right) seven-year cumulative elevation change of all sites (ANOVA $p=0.02$).

When considering cumulative elevation change over the seven-year period, red sites show more erosion than either green or yellow sites (Fig. 5). A one-way ANOVA with unequal variance and subsequent Tukey test indicate that red sites are significantly different from the other sites ($df = 2/8.3$, $F=6.05$, $P=0.02$), with red sites showing more erosion than green and yellow sites by 0.14 m each (Table 5).

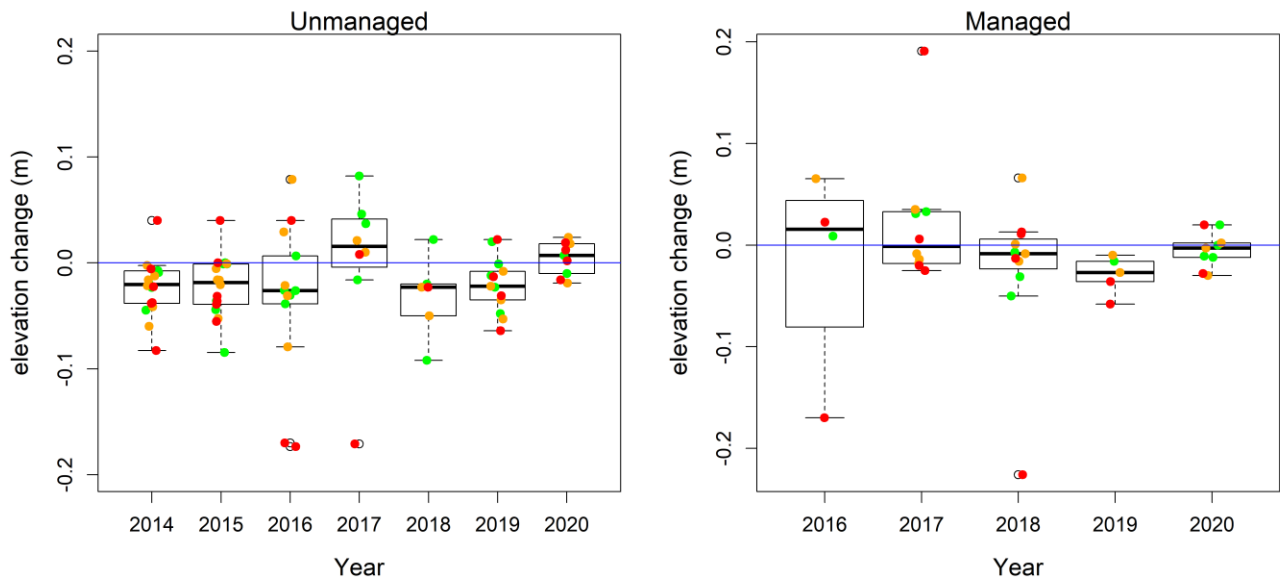
Figure 6: Boxplots of annual elevation change for all sites separated by year and management activity. Dots show individual sites colored by sustainability index (green, yellow, red).

While managed and unmanaged sites showed no overall change in 2020, the net effect of management has been to reduce erosion in nearly all categories and in both annual and cumulative analyses (Table 5, Fig. 6). Managed sites show 0.12 m less cumulative erosion than unmanaged sites (Table 5). In both managed and unmanaged sites, red sites have much more extreme values (Fig. 6).

- 3) Clay and granite sites erode at approximately equal rates cumulatively and when averaged over several years (Fig. 7).
- 4) Differences in trail classification did not influence erosion rates cumulatively or annually (Fig. 8; Table 4).
- 5) Trail management that mainly consists of replacing the sidecast berm back into the trail tread is an effective strategy for improving trail sustainability in nearly all trail categories (Table 4; Table 5; Fig. 6).

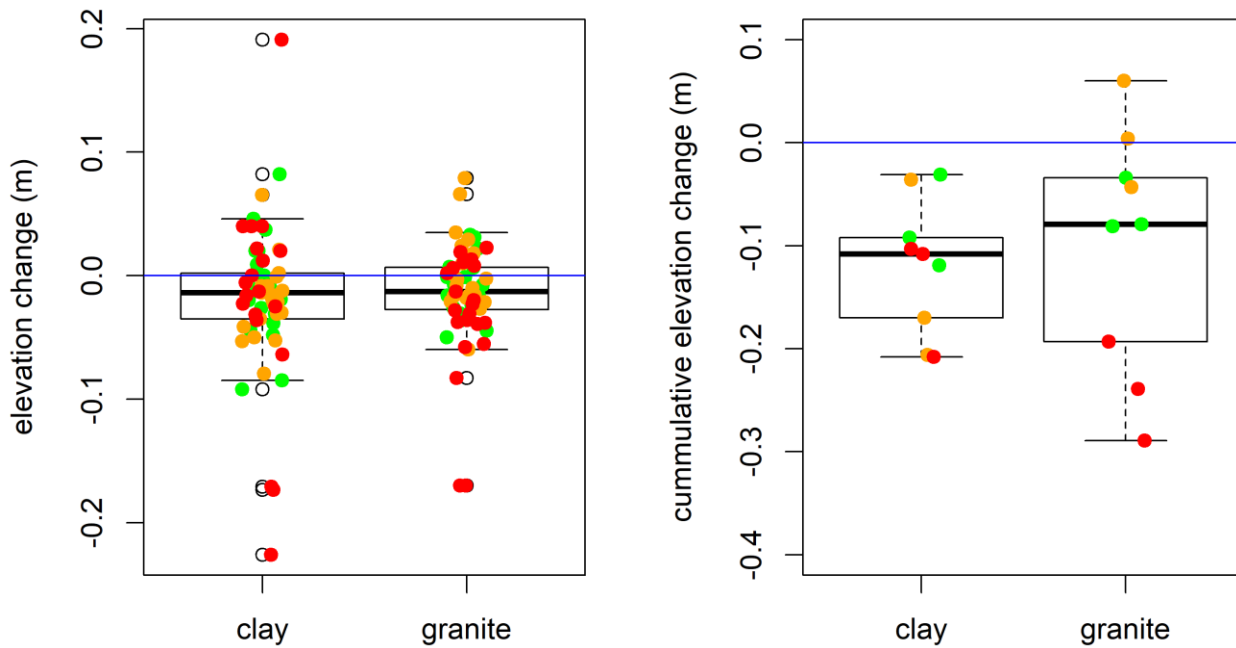
Figure 7. (Left) Annual elevation change of all sites separated by soil type. (Right) Cumulative elevation change of all sites separated by soil type. Dots show individual sites colored by sustainability index (green, yellow, red).

Soil type (clay and granite) did not impact mean erosion rates when analyzed on an annual averaged scale (Fig.7; Table 5). The cumulative erosion of clay is greater than granite (Table 5), but a two-sample t-test, suggests that the differences are not significant when considered annually ($p=0.7$) or cumulatively ($p=0.7$; Fig. 7). Managed clay soil sites had an average annual erosion rate of 0.00 m/yr, whereas unmanaged clay soil sites had 0.03 m/yr of erosion (Table 5). The positive impact of managing clay trails is underscored by the cumulative values, with unmanaged clay sites eroding 0.21 m as compared to 0.02 m of deposition on managed clay sites. The impact of management on granitic trails is less clear (Table 5). Trails with a red sustainability index had more cumulative erosion than trails with green or yellow indices (Fig. 7; Table 5).

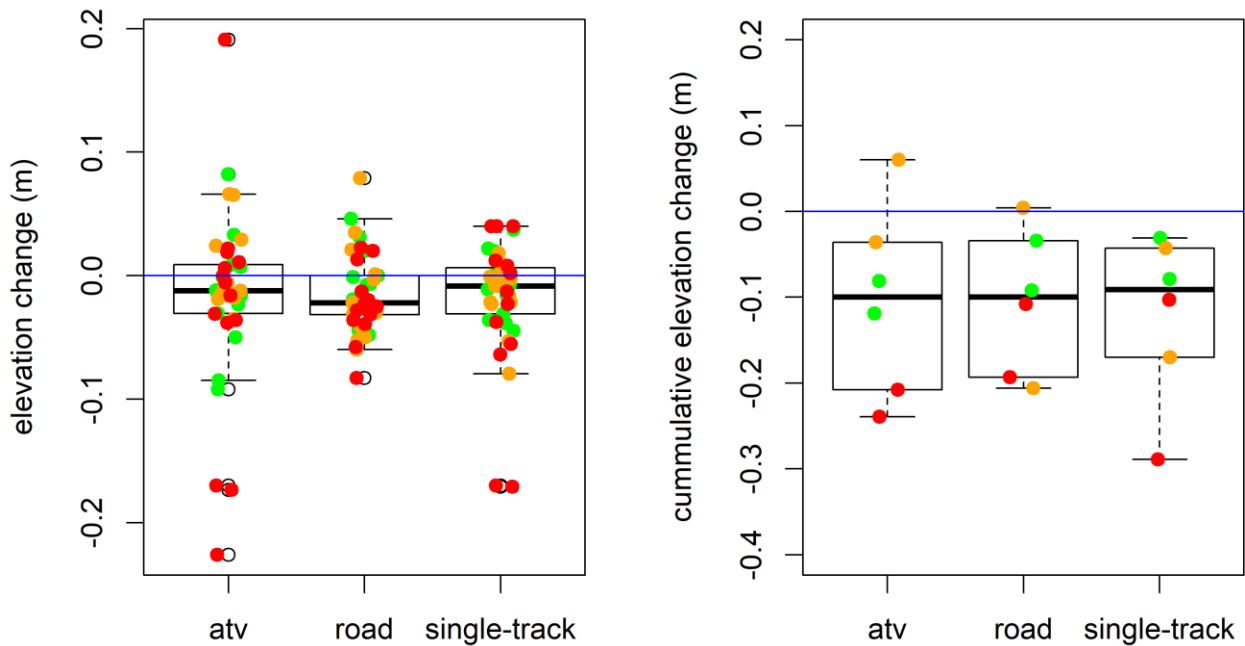
Figure 8. (Left) Annual elevation change of all sites separated by trail use. (Right) Cumulative elevation change of all sites separated by trail use. Dots show individual sites colored by sustainability index (green, yellow, red).

There are no significant differences between the erosion rates when parsed by trail use (Fig. 8; Table 5). There is no significant difference among the trail uses annually or cumulatively ($p=0.97/p=0.96$), but red sites appear to have higher cumulative erosion rates for all trail use types (Fig. 8).

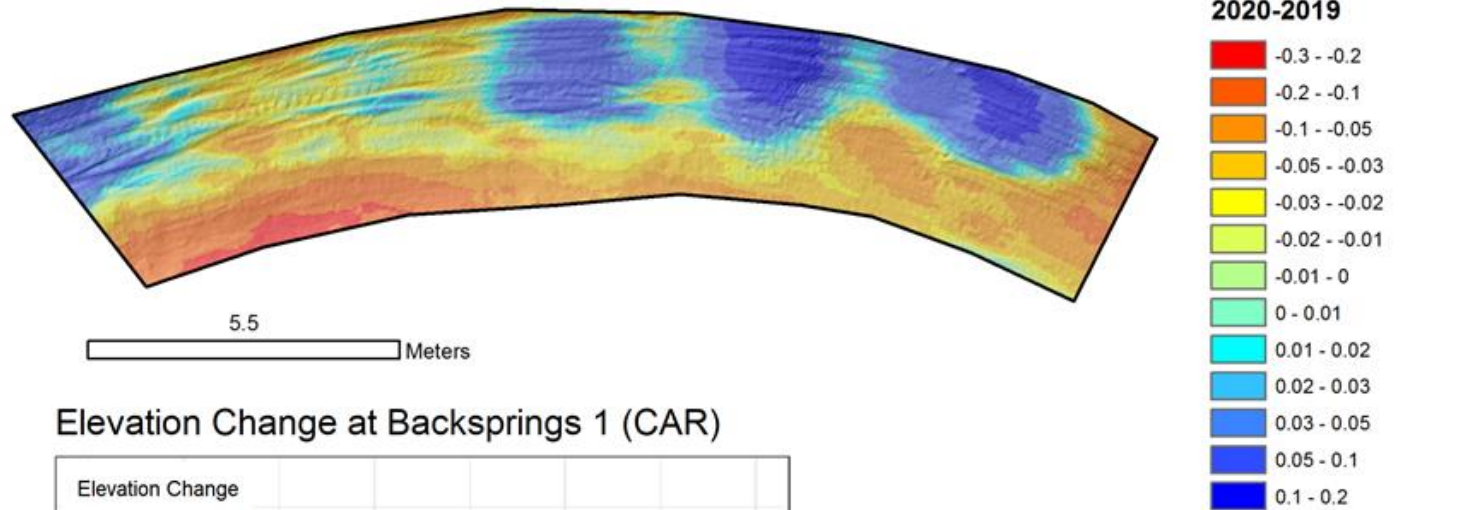
Backsprings 1

The top image for each site shows 2020 (black polygon) extent overlaid on the orthomosaic photo of the site. The bottom image shows 2020 extent over a “difference of DEM” (DOD) raster generated by subtracting the 2020 raster from the 2019 raster. Positive values indicate sediment deposition and negative values indicate erosion.

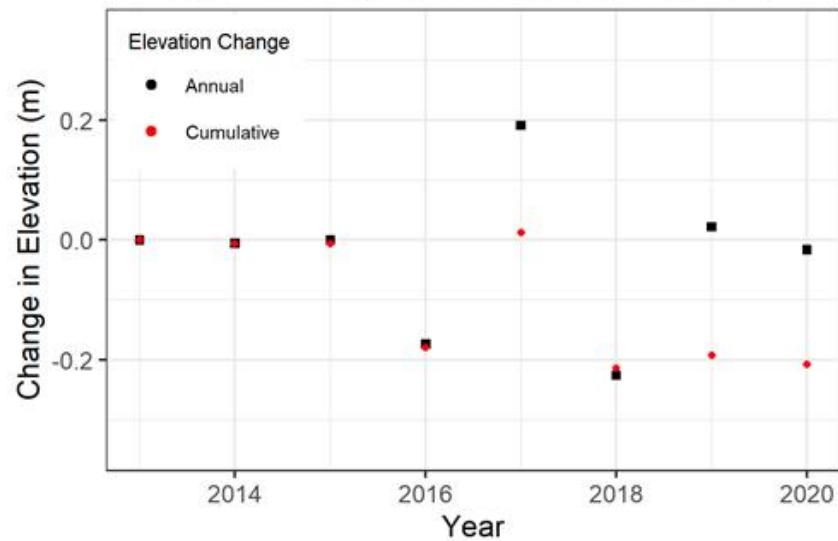
Elevation Change at Backsprings 1 (CAR)

2013-2020 Elevation Change (m)		Backsprings 1 (CAR)
Cumulative change	Annual Average	2020 GCP Z RMSE (m)
-0.208	-0.016	0.006

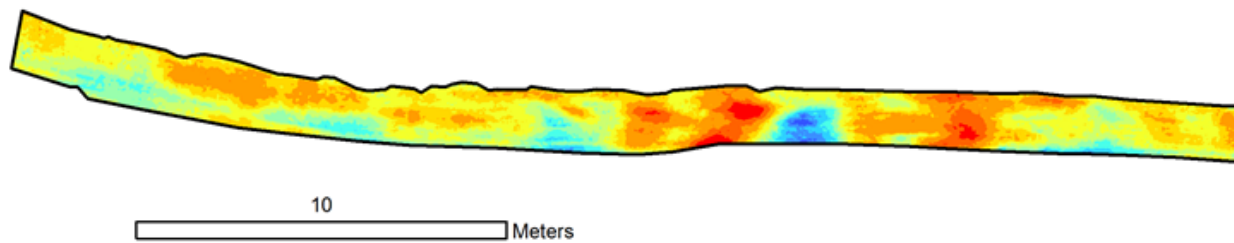
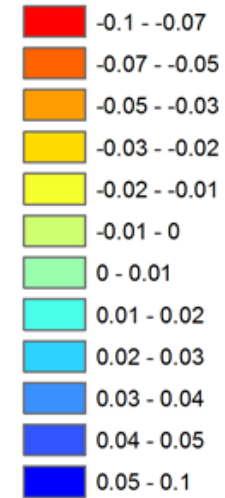
Backsprings 2

Change in Elevation 2020-2019

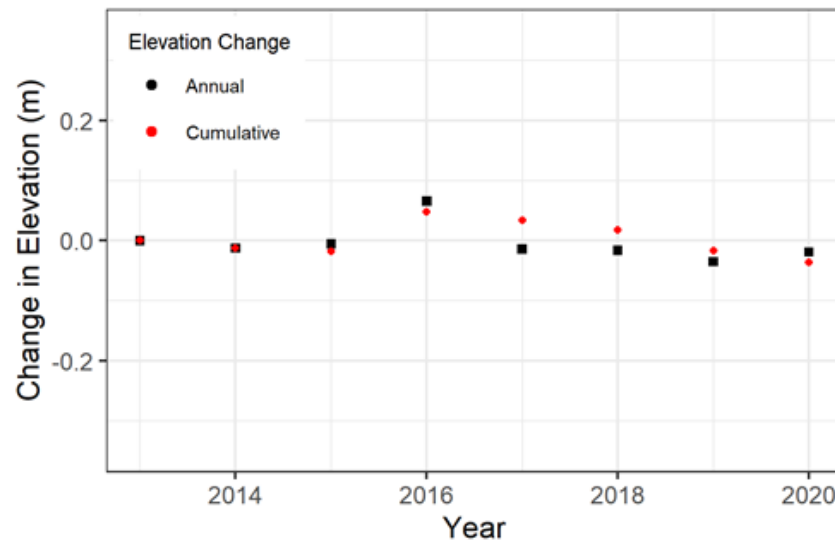
Elevation Change at Backsprings 2 (CAY)

2013-2020 Elevation Change (m)		Backsprings 2 (CAY)
Cumulative change	Annual Average	2020 GCP Z RMSE (m)
-0.036	-0.019	0.003

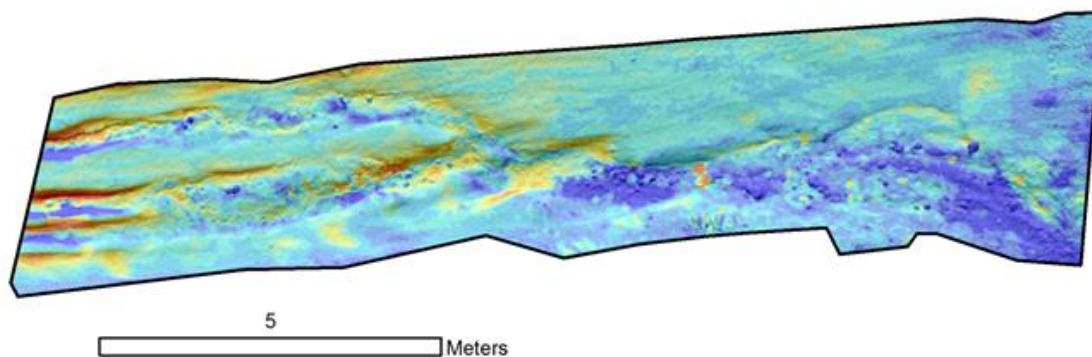
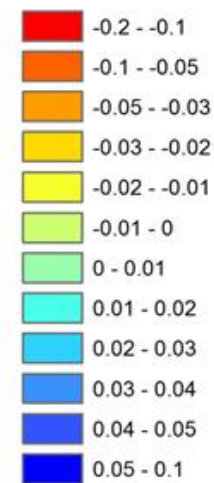
Badger

Change in Elevation 2020-2019

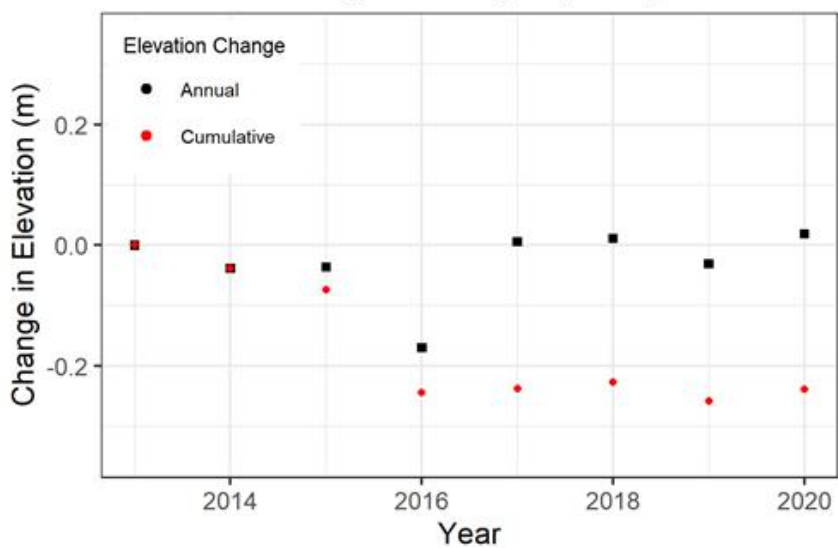
Elevation Change at Badger (GAR)

2013-2020 Elevation Change (m)		Badger (GAR)
Cumulative change	Annual Average	2020 GCP Z RMSE (m)
-0.239	0.019	0.008

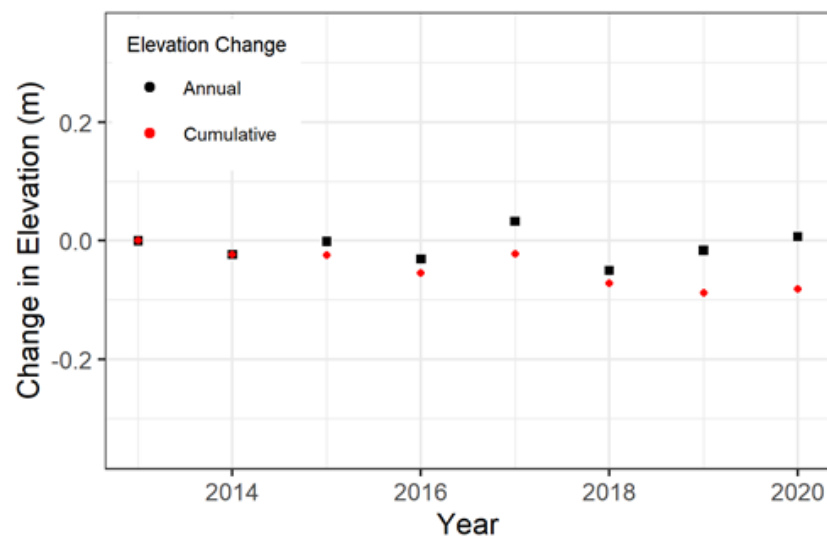
Elevation Change at Coyote 1 (GAG)

2013-2020 Elevation Change (m)		Coyote 1 (GAG)
Cumulative change	Annual Average	2020 GCP Z RMSE (m)
-0.081	0.007	0.003

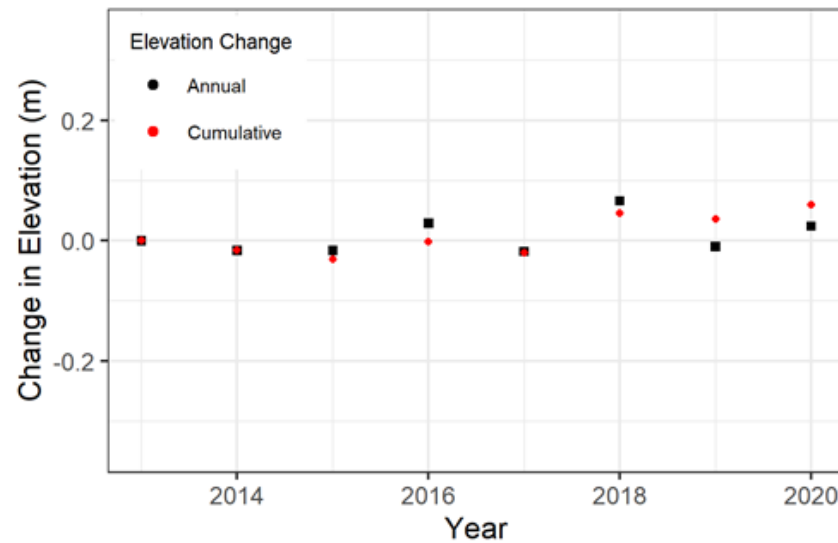
Elevation Change at Coyote 2 (GAY)

2013-2020 Elevation Change (m)		Coyote 2 (GAY)
Cumulative change	Annual Average	2020 GCP Z RMSE (m)
0.06	0.024	0.005

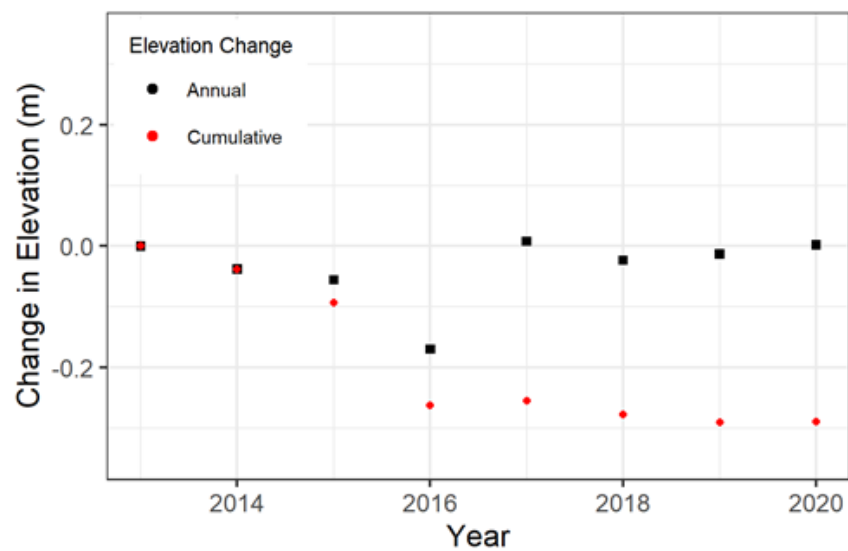
Elevation Change at Donnybrook 1 (GSR)

2013-2020 Elevation Change (m)		Donnybrook 1 (GSR)
Cumulative change	Annual Average	2020 GCP Z RMSE (m)
-0.289	0.002	0.005

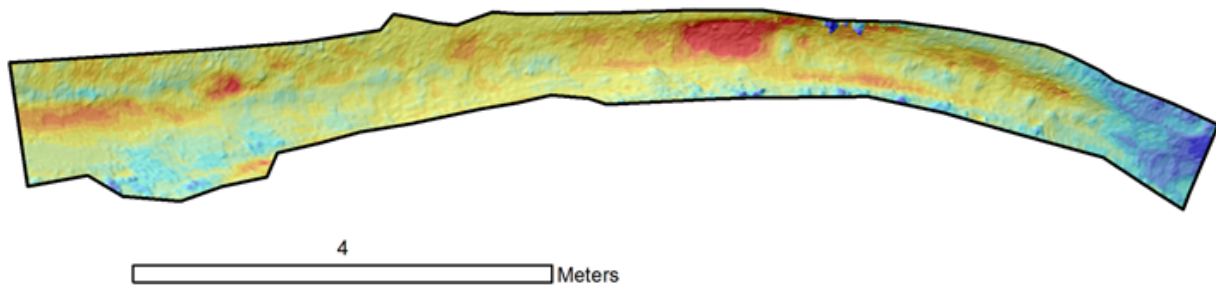
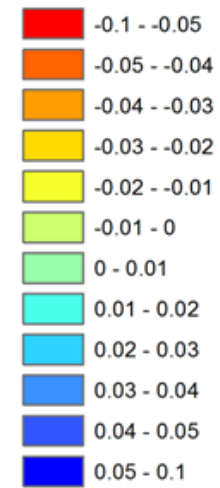
Donnybrook 2

Change in Elevation
2020-2019

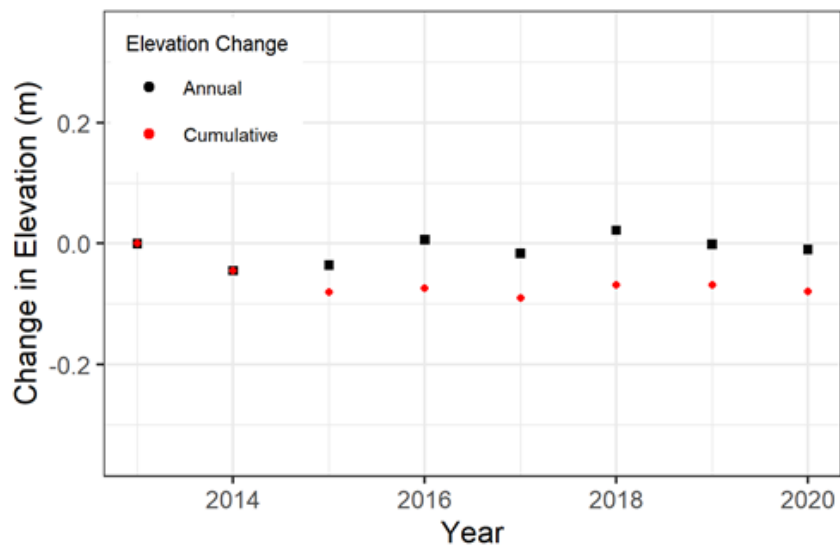
Elevation Change at Donnybrook 2 (GSG)

2013-2020 Elevation Change (m)		Donnybrook 2 (GSG)
Cumulative change	Annual Average	2020 GCP Z RMSE (m)
-0.079	-0.010	0.005

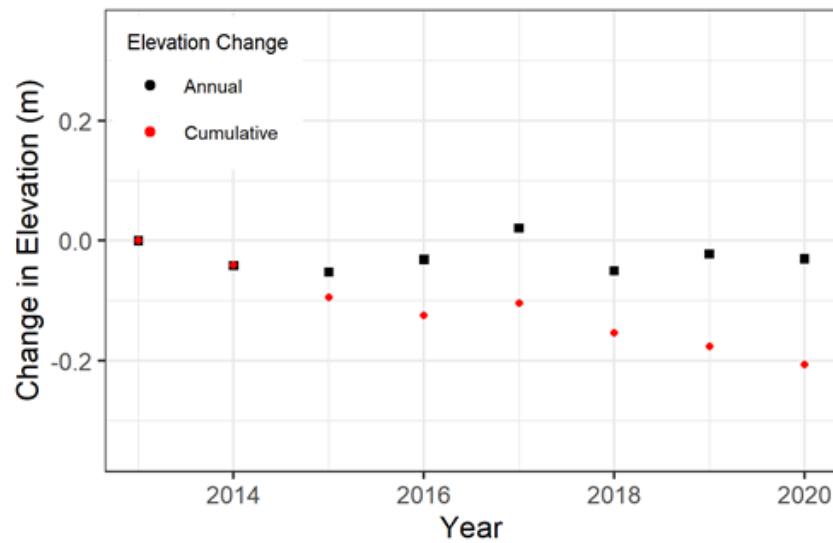
Elevation Change at Faultline 1 (CRY)

2013-2020 Elevation Change (m)		Faultline 1 (CRY)
Cumulative change	Annual Average	2020 GCP Z RMSE (m)
-0.206	-0.030	0.009

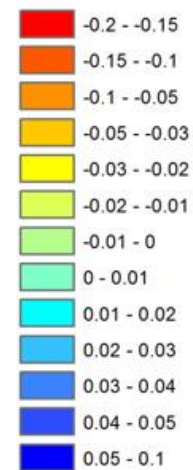
Faultline 2

Change in Elevation 2020-2019

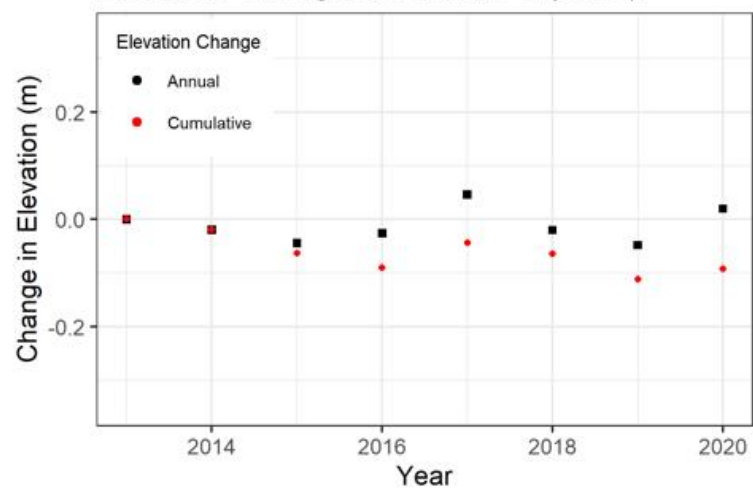
Elevation Change at Faultline 2 (CRG)

2013-2020 Elevation Change (m)		Faultline 2 (CRG)
Cumulative change	Annual Average	2020 GCP Z RMSE (m)
-0.092	0.020	0.008

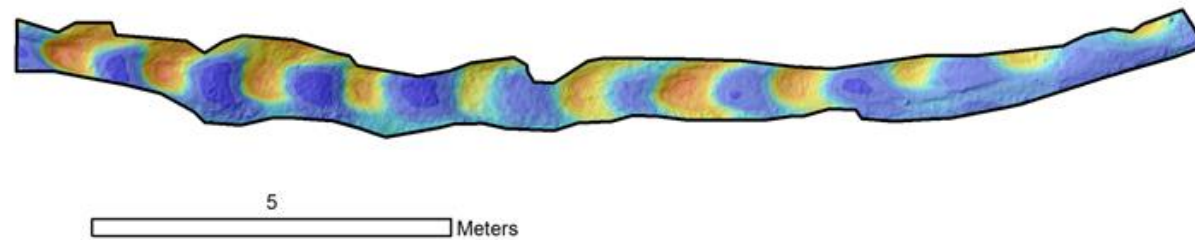
Mystic

**Change in Elevation
2020-2019**

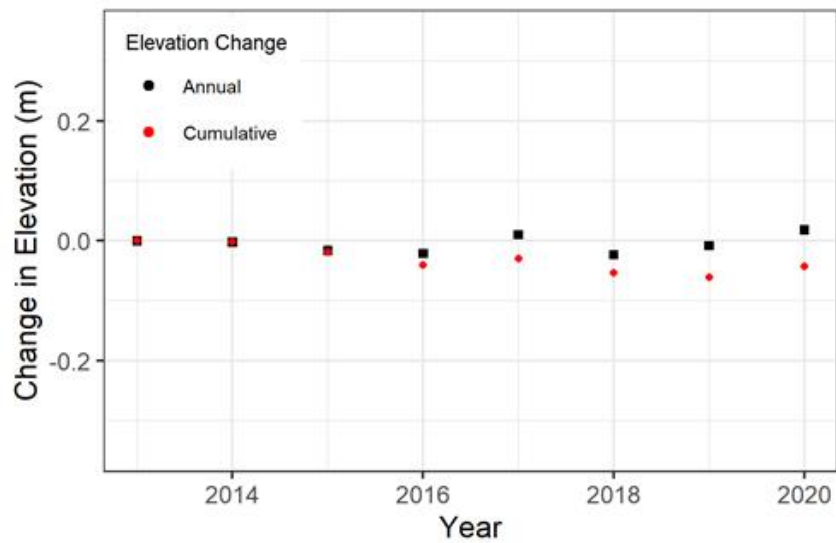
Elevation Change at Mystic (GSY)

2013-2020 Elevation Change (m)		Mystic (GSY)
Cumulative change	Annual Average	2020 GCP Z RMSE (m)
-0.043	0.018	0.010

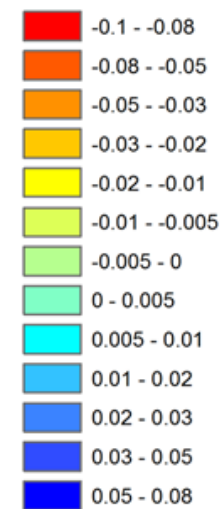
North Canyon

Change in Elevation 2020-2019

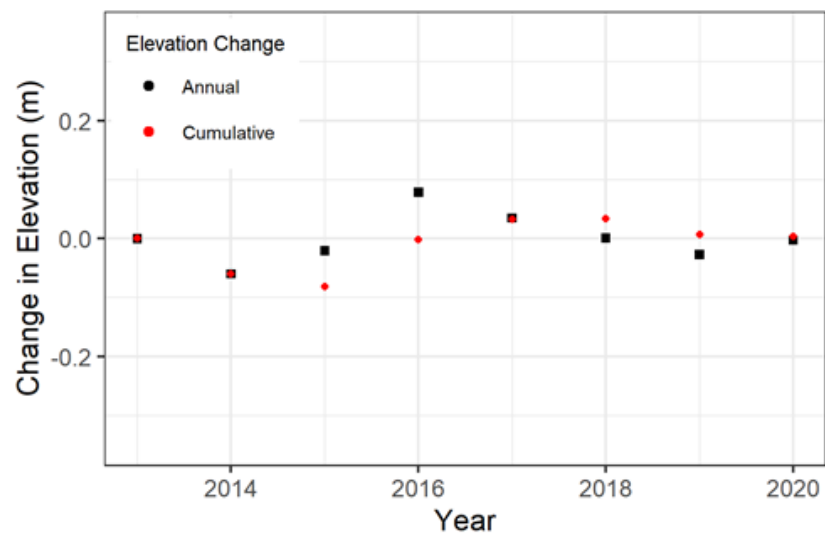
Elevation Change at North Canyon (GRY)

2013-2020 Elevation Change (m)		North Canyon (GRY)
Cumulative change	Annual Average	2020 GCP Z RMSE (m)
0.004	-0.003	0.009

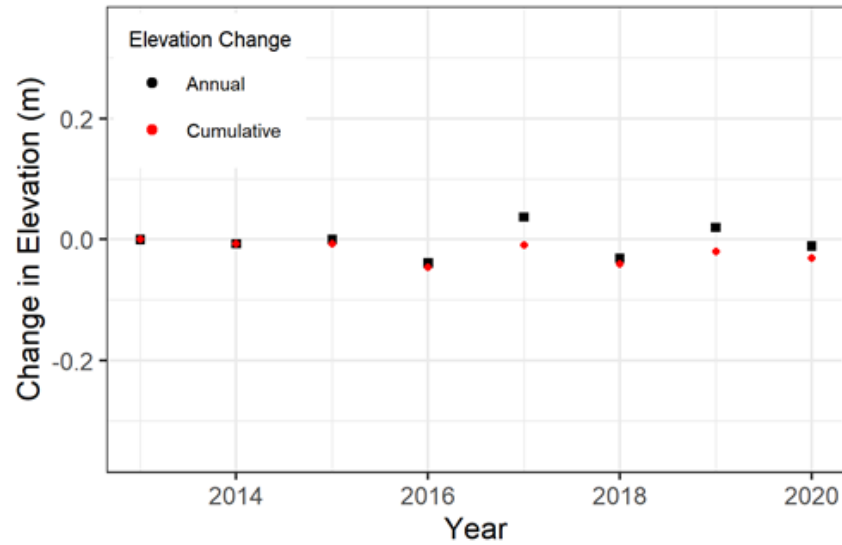
Elevation Change at OK Corral 1 (CSG)

2013-2020 Elevation Change (m)		OK Corral 1 (CSG)
Cumulative change	Annual Average	2020 GCP Z RMSE (m)
-0.031	-0.011	0.010

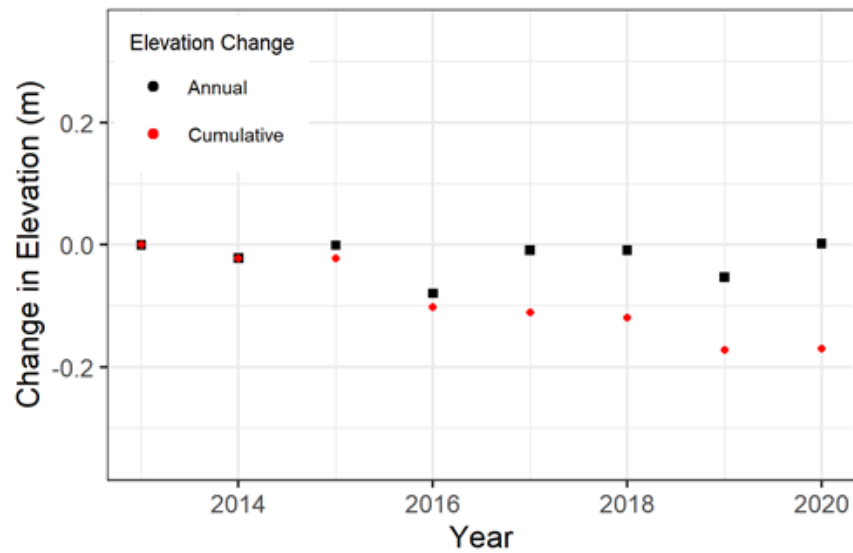
Elevation Change at OK Corral 2 (CSY)

2013-2020 Elevation Change (m)		OK Corral 2 (CSY)
Cumulative change	Annual Average	2020 GCP Z RMSE (m)
-0.170	0.002	0.003

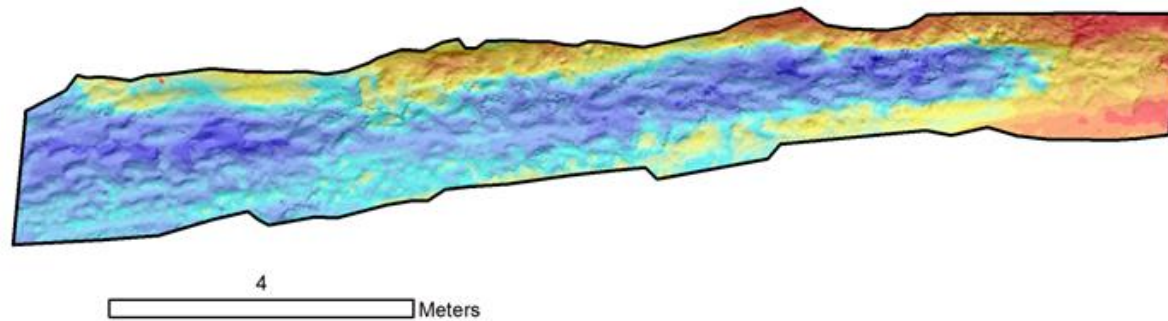
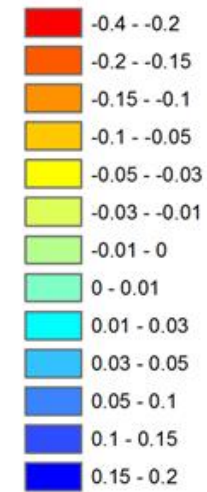
Psych Hill

Change in Elevation 2020-2019

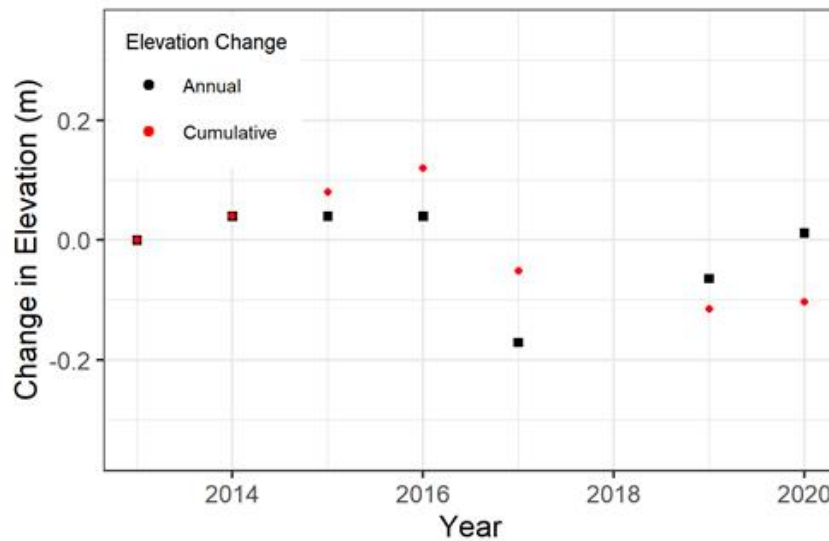
Elevation Change at Psych Hill (CSR)

2013-2020 Elevation Change (m)		Psych Hill (CSR)
Cumulative change	Annual Average	2020 GCP Z RMSE (m)
-0.103	0.012	0.003

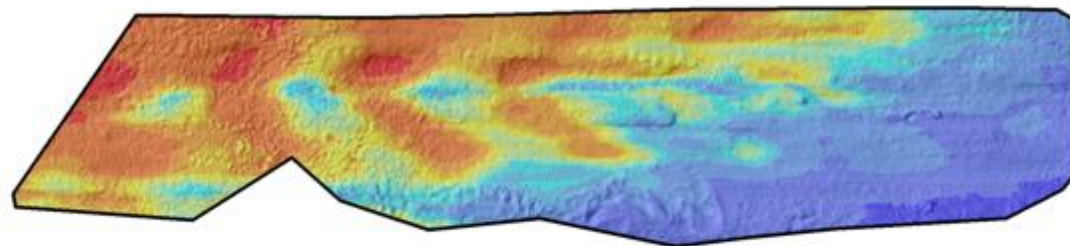
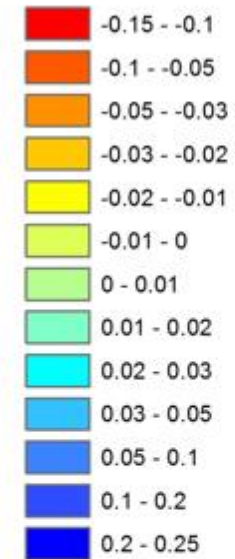
Rancho

**Change in Elevation
2020-2019**

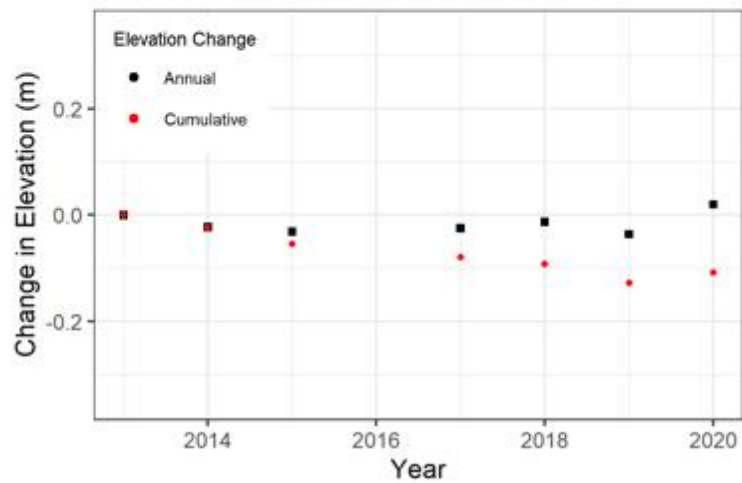
Elevation Change at Rancho (CRR)

2013-2020 Elevation Change (m)		Rancho (CRR)
Cumulative change	Annual Average	2020 GCP Z RMSE (m)
-0.108	0.020	0.001

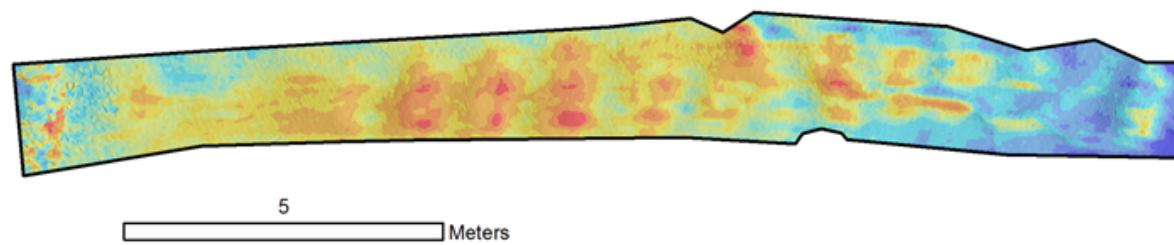
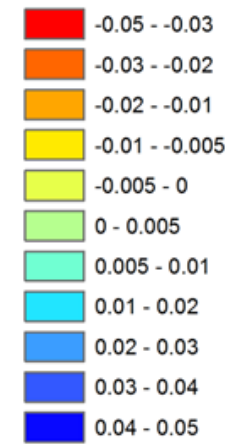
Sage

**Change in Elevation
2020-2019**

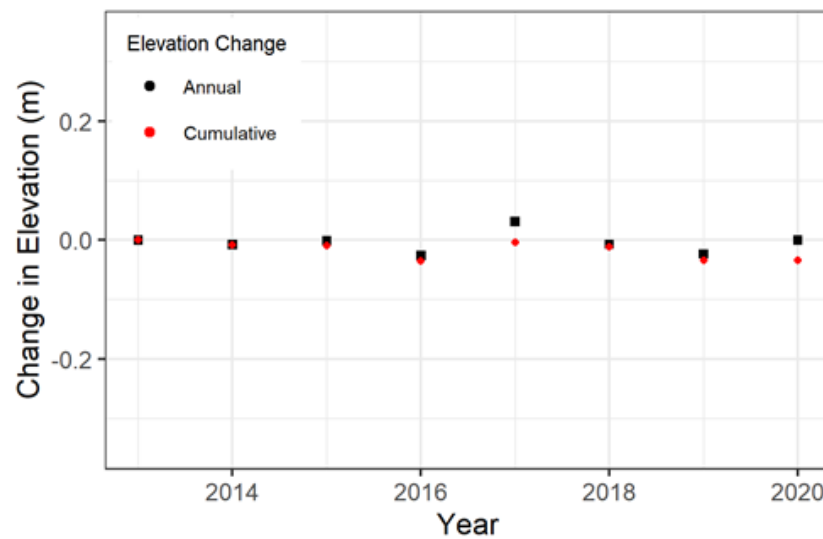
Elevation Change at Sage (GRG)

2013-2020 Elevation Change (m)		Sage (GRG)
Cumulative change	Annual Average	2020 GCP Z RMSE (m)
-0.034	0.000	0.008
