Report No. WI-2002-04
September 17, 2002

The Watershed Institute

*Central
Coast
Watershed
Studies*

Hydrology and Water Quality of the Carmel and Salinas Lagoons Monterey Bay, California 2001/2002

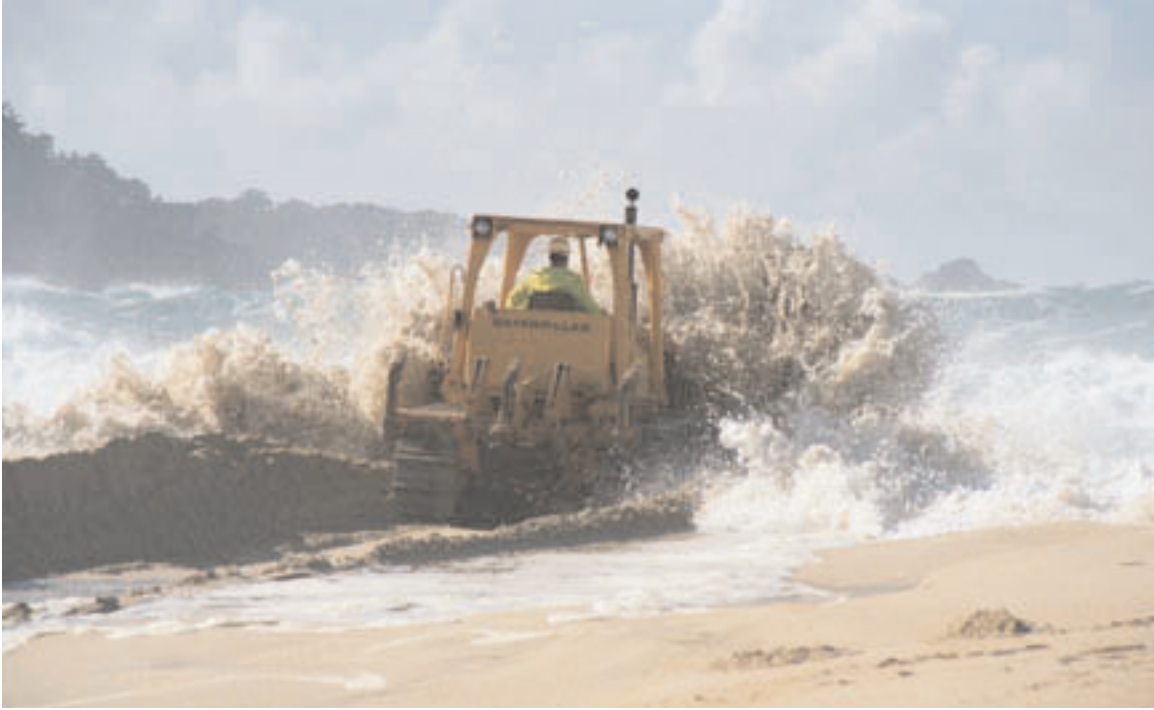
Figure 1.1. Monterey County Public Works fighting against large waves while breaching the Carmel Lagoon – December 3, 2001.

Monterey County Public Works (in the Carmel Lagoon) and the Monterey County Water Resources Agency (in the Salinas Lagoon) intervene each year by either causing or assisting the breach using heavy earth-moving equipment. This activity is subject to permitting requirements, which in turn require water quality monitoring. The impact of the breaching process on Steelhead populations is unknown. The juveniles require a substantial amount of time for smoltification. A precise means of determining when they are ready, or the conditions under which they would be most likely to survive the migration, is not known for these runs. It is possible that early breaching might degrade lagoon conditions and lead to premature out-migration. Because of this possibility, decision-makers currently delay breaching as long as possible. However, this entails risk, because if a river flood peak and a spring tide arrive at the same time, it can be difficult to access the sandbar using heavy equipment (Fig. 1.1).

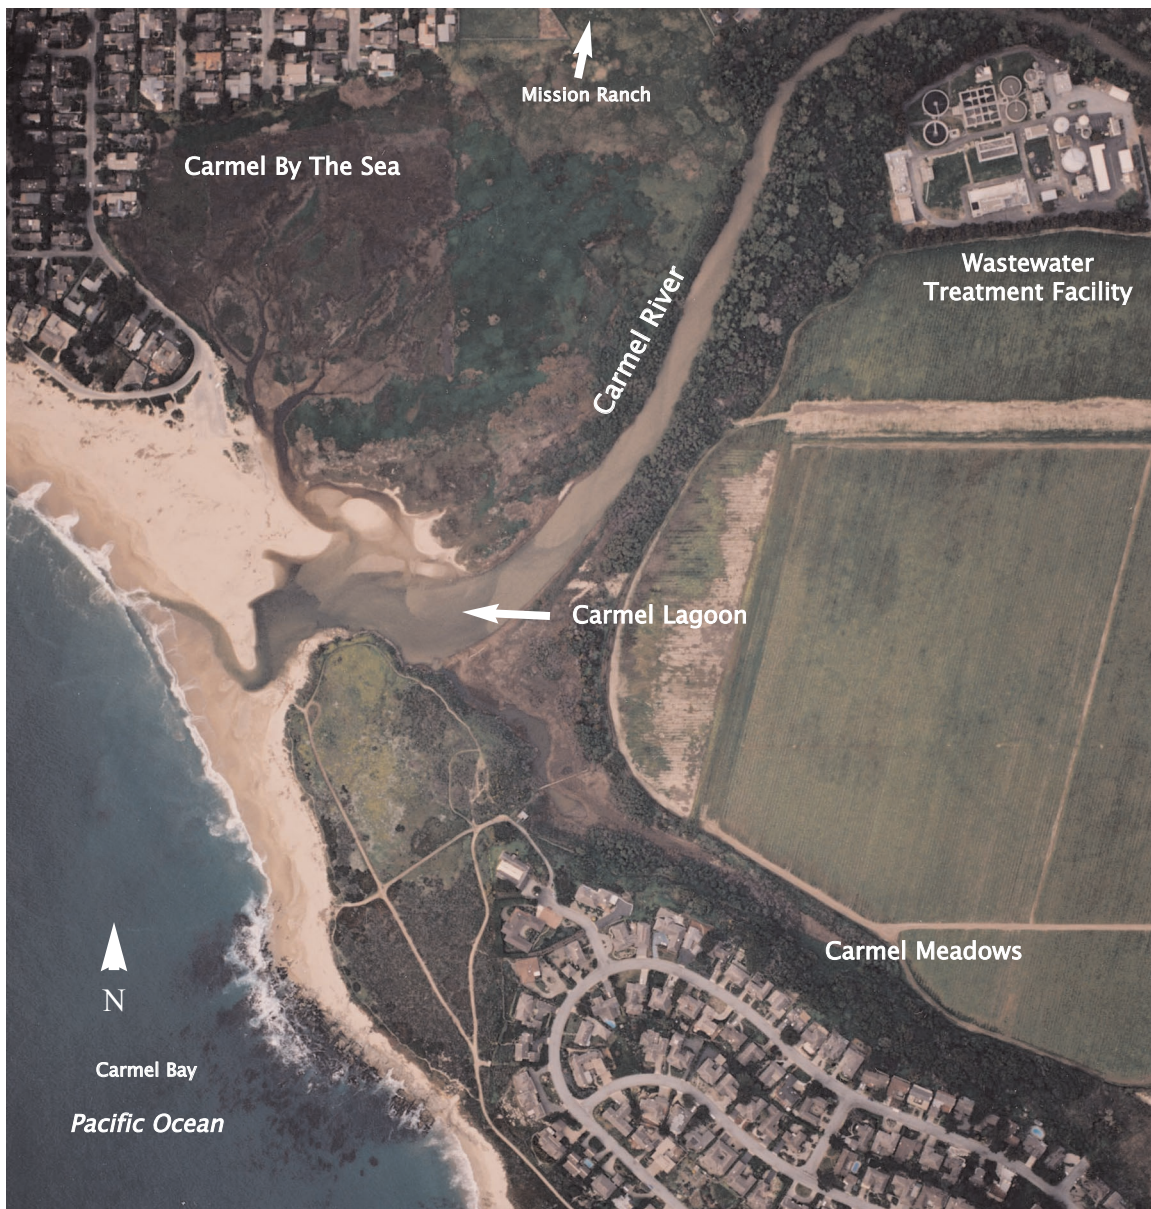
Figure 2.1. Carmel Lagoon and surrounding area. This image was taken on March 27, 1996.

The Carmel Lagoon (Fig. 2.1) lies at the end of the Carmel River between two residential areas Carmel By The Sea to the north (Fig. 2.2) and Carmel Meadows to the south. The lagoon is much smaller than the Salinas Lagoon (Fig. 2.6). However, the surface area of the lagoon expands and contracts with seasonal changes. In winter, the lagoon expands with the addition of increased stream flow, inundating terrestrial vegetation until the lagoon is breached. In summer, the lagoon shrinks, becoming more shallow and exposing small channels and islands in the lagoon bed (Figs 2.3 & 2.4).

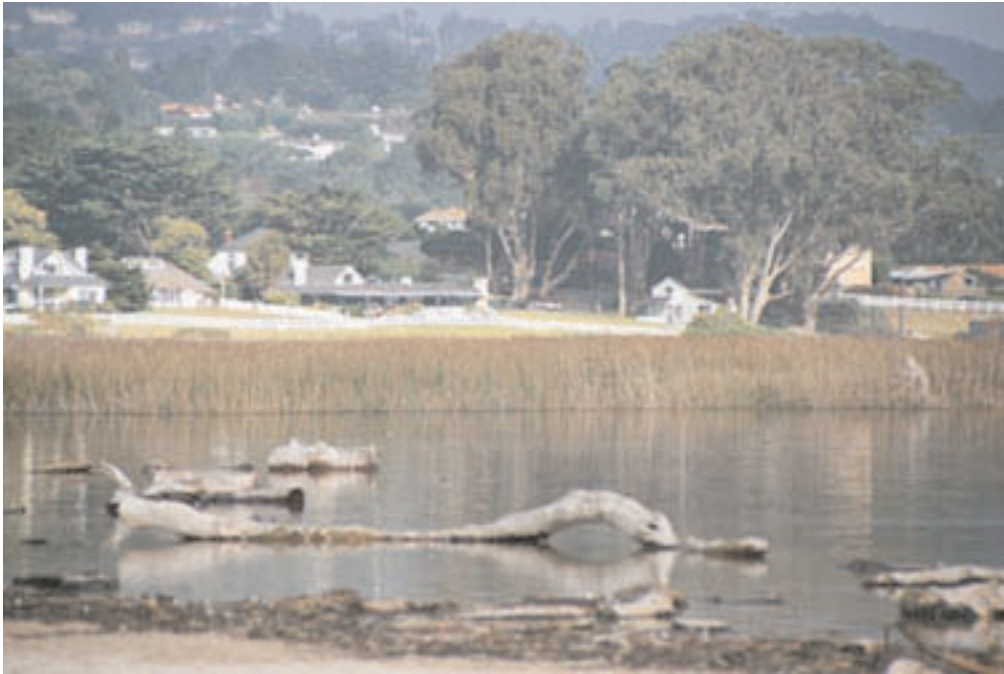
Figure 2.2 The northern portion (North Arm) of the Carmel Lagoon. Mission Ranch and Carmel By The Sea in the far background.

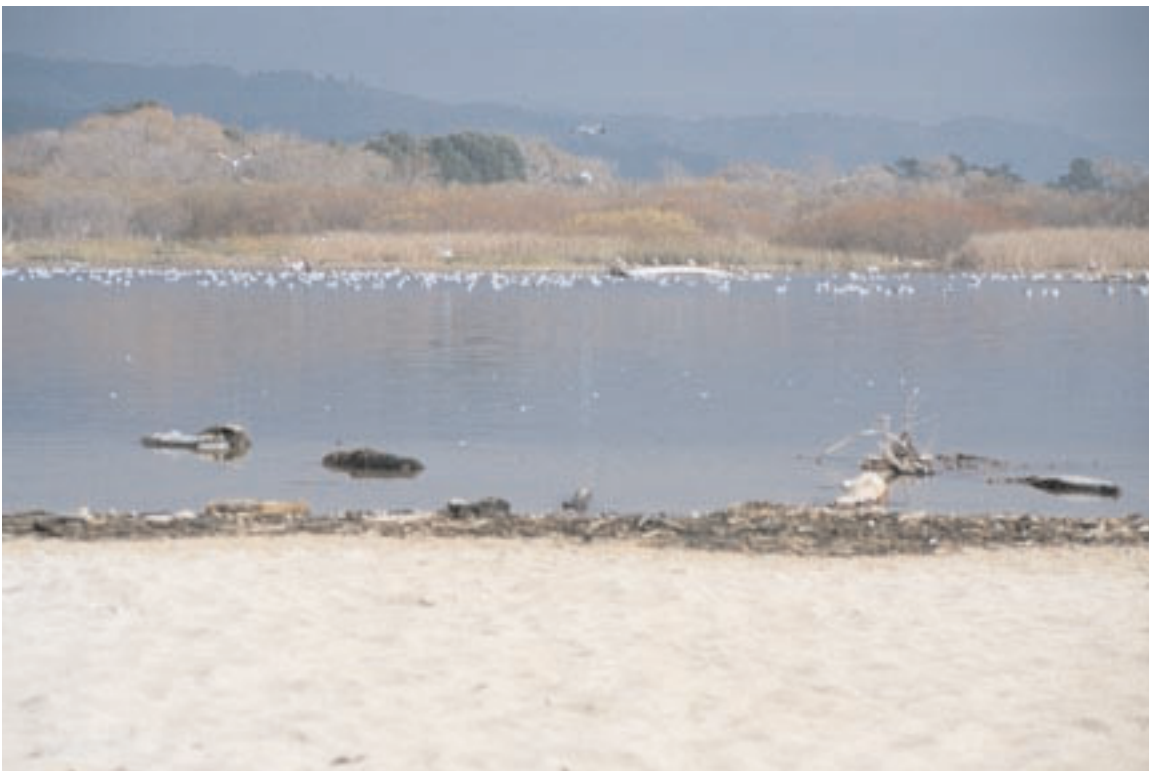
Figure 2.3 Carmel River Lagoon, January 2001, at close to maximum water level – looking inland toward the river from the sand bar.

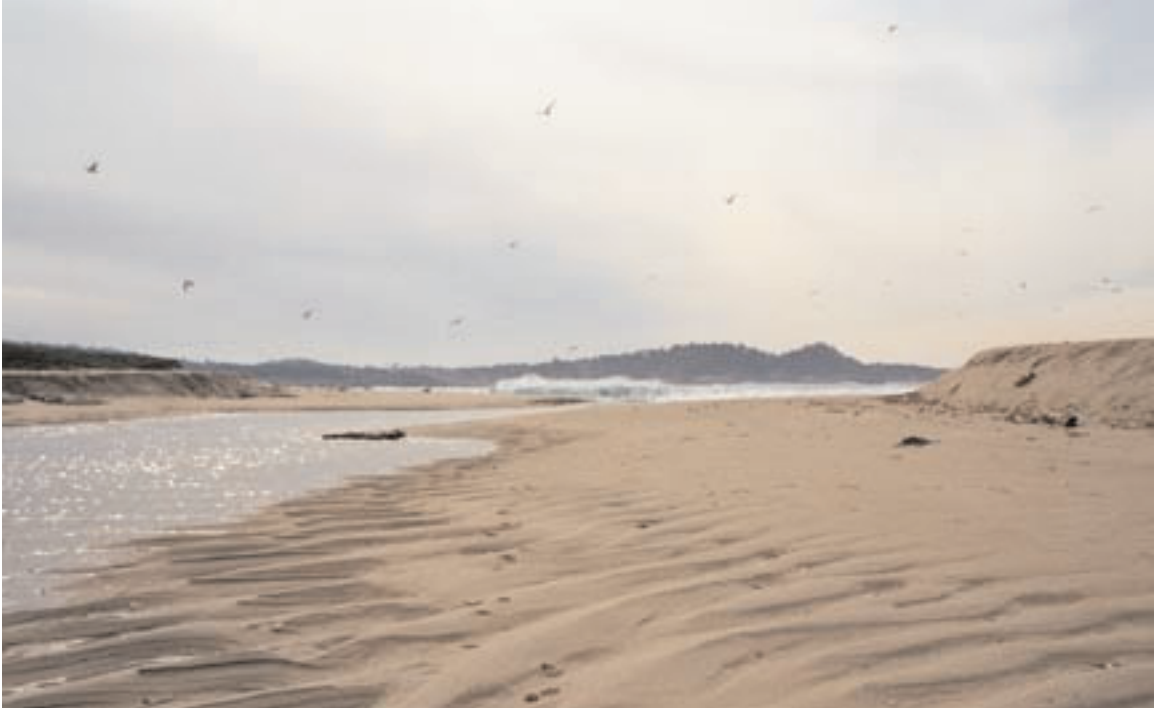
Figure 2.4 Seaward view of the Carmel River Lagoon (open) with very low water levels. Here the lagoon is more or less a flowing river, with small pockets of pooled water in the confined South Arm.

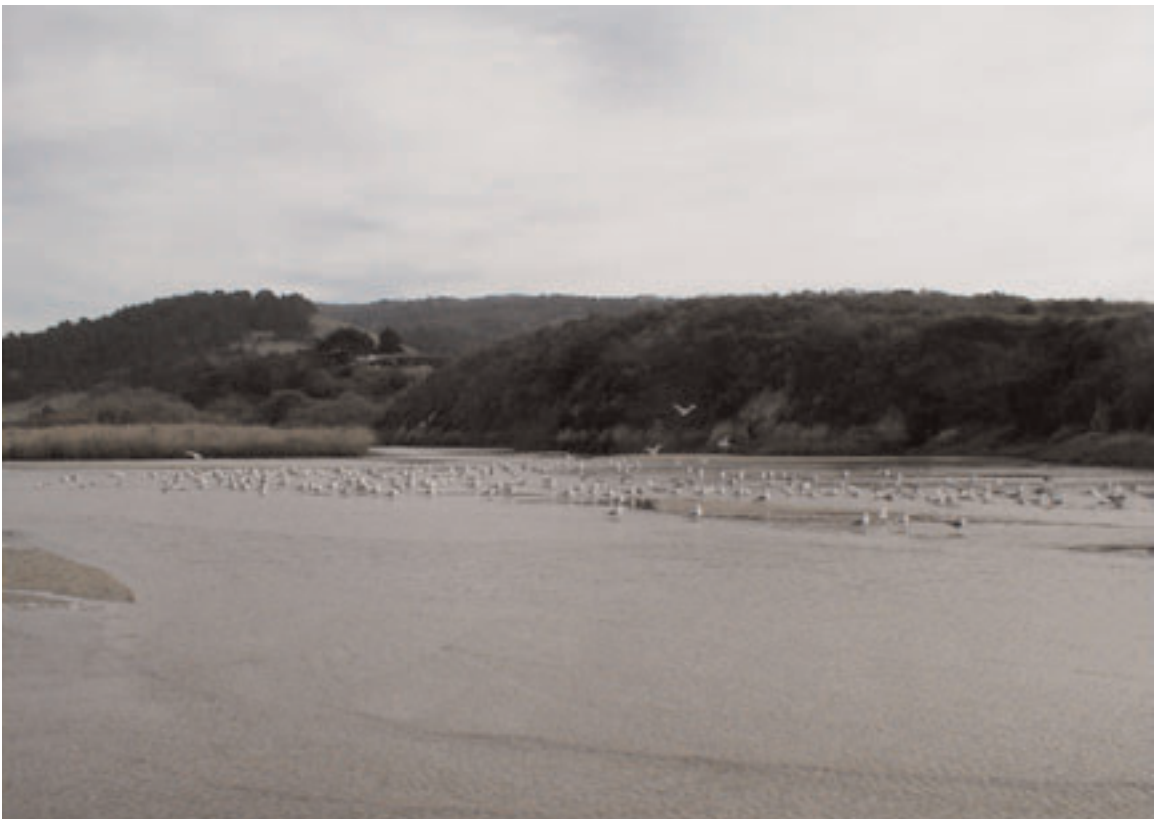
Figure 2.5 Looking into the South Arm (center) of the Carmel Lagoon. Note granitic bluffs on the right.

The smaller Southern Arm of the lagoon is much more linear and confined (c. 200m long) (Fig. 2.5). The formation of the South Arm is still unknown. However, it is hypothesized that it was once occupied by the river's main channel which has since migrated to the north (PWA, 1999). Currently, a small hill with underlying granitic bedrock confines the South Arm into a narrow channel that swells at high water into a wetland once used for agriculture. The granite is the outcrop of a larger upthrown block beneath the lagoon. This block protects the Carmel Valley aquifer from seawater intrusion (Johnson, 2000) and would most likely have been the control feature for a cascade or waterfall in the Carmel River at times of lower sea level. Deep-water habitat, currently found in the South Arm, is a result of dredging that occurred in 1996 and 1998 (Entrix, 2001). This dredging was conducted to increase the amount of deep-water habitat for steelhead.

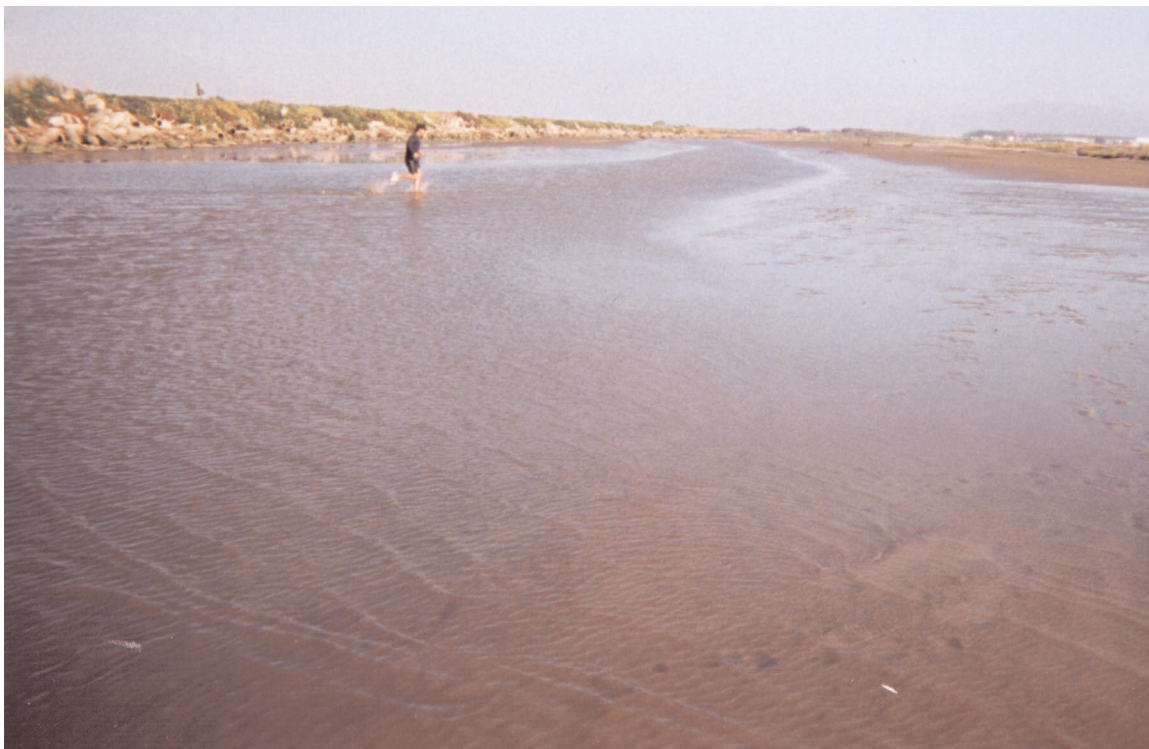
Figure 2.7 The shallow waters of the Salinas Lagoon at its north western corner--post breach 2000/01 winter.

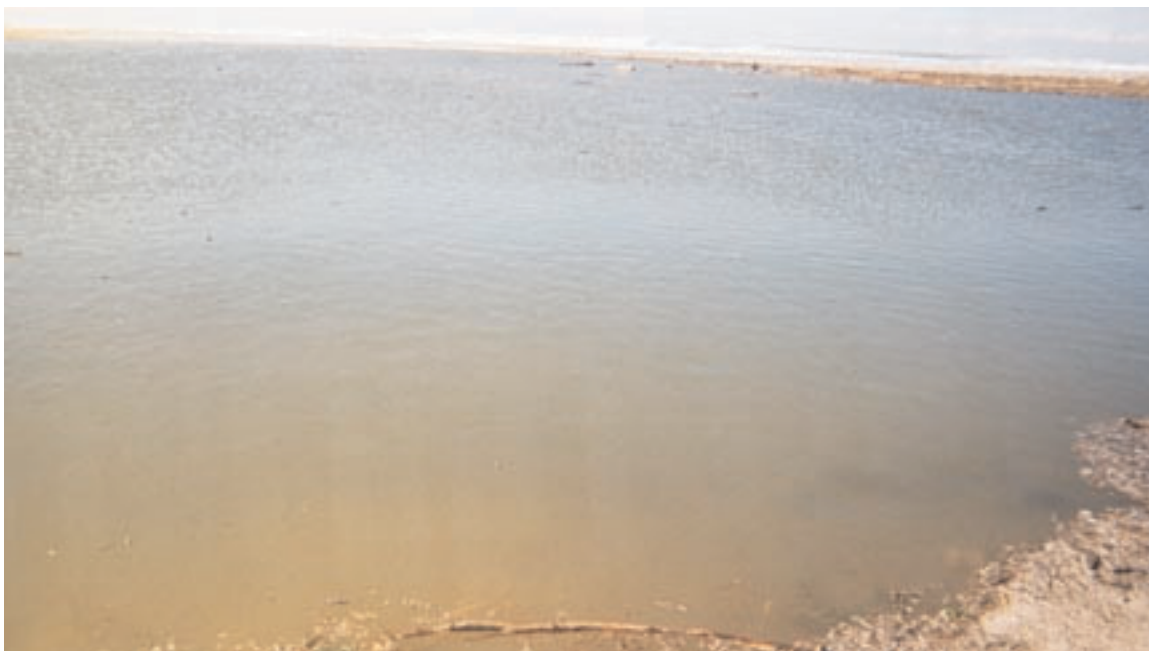
Figure 2.8 The Salinas River Lagoon, December 2001, with higher water levels just prior to breaching--looking west at the ocean.

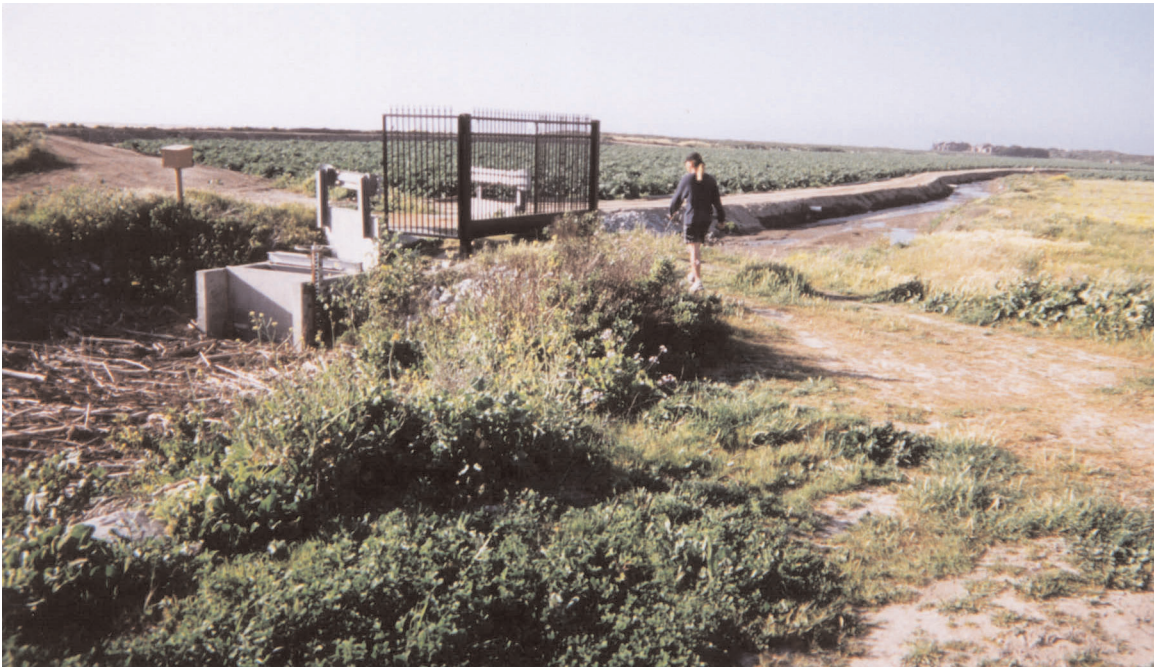
Figure 2.9 The Old Salinas River Channel and flow gates. This channel still occupies the historical route of the Salinas River from the lagoon northward to Moss Landing Harbor via the Potrero Road Tide gates.

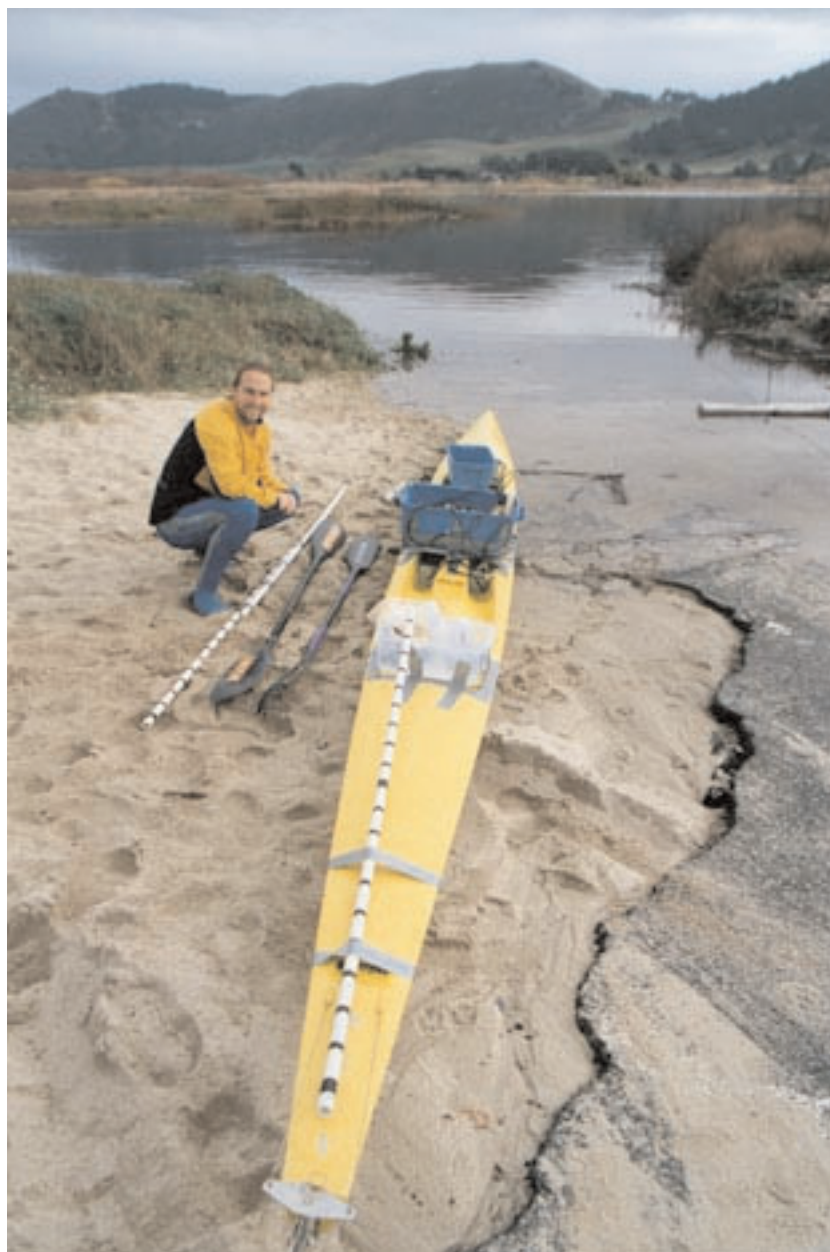
Figure 3.1 One of two tandem kayaks used for water quality monitoring showing the variety of equipment used for collecting water quality information, depth, and bathymetrical data.

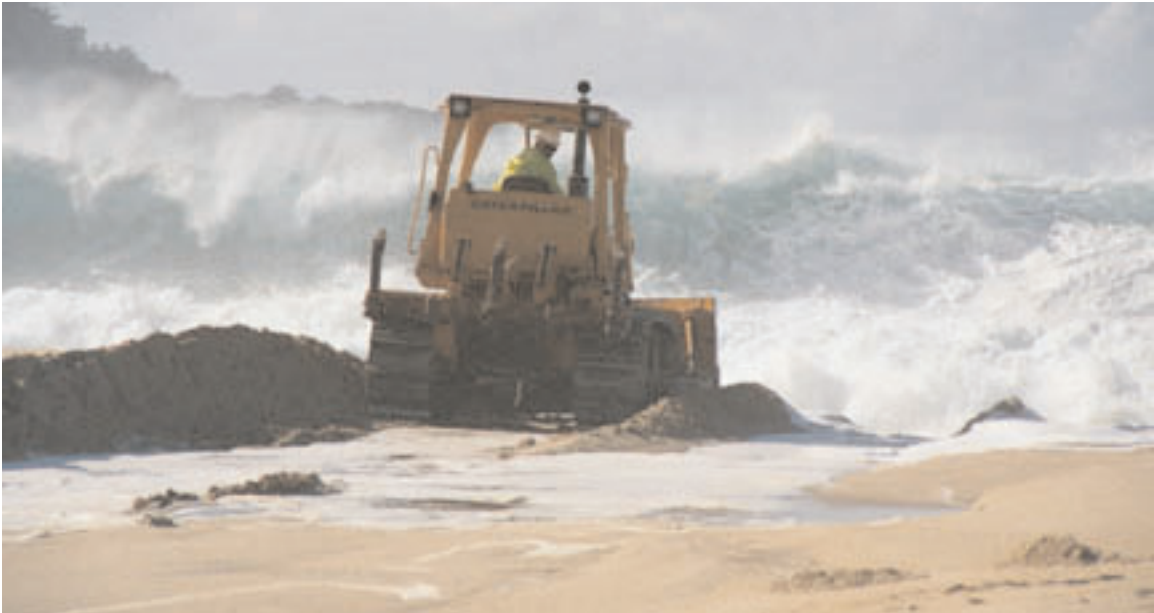
Figure 4.1 Monterey County Public Works bulldozer in the process of breaching the Carmel Lagoon during the afternoon of December 3, 2001.

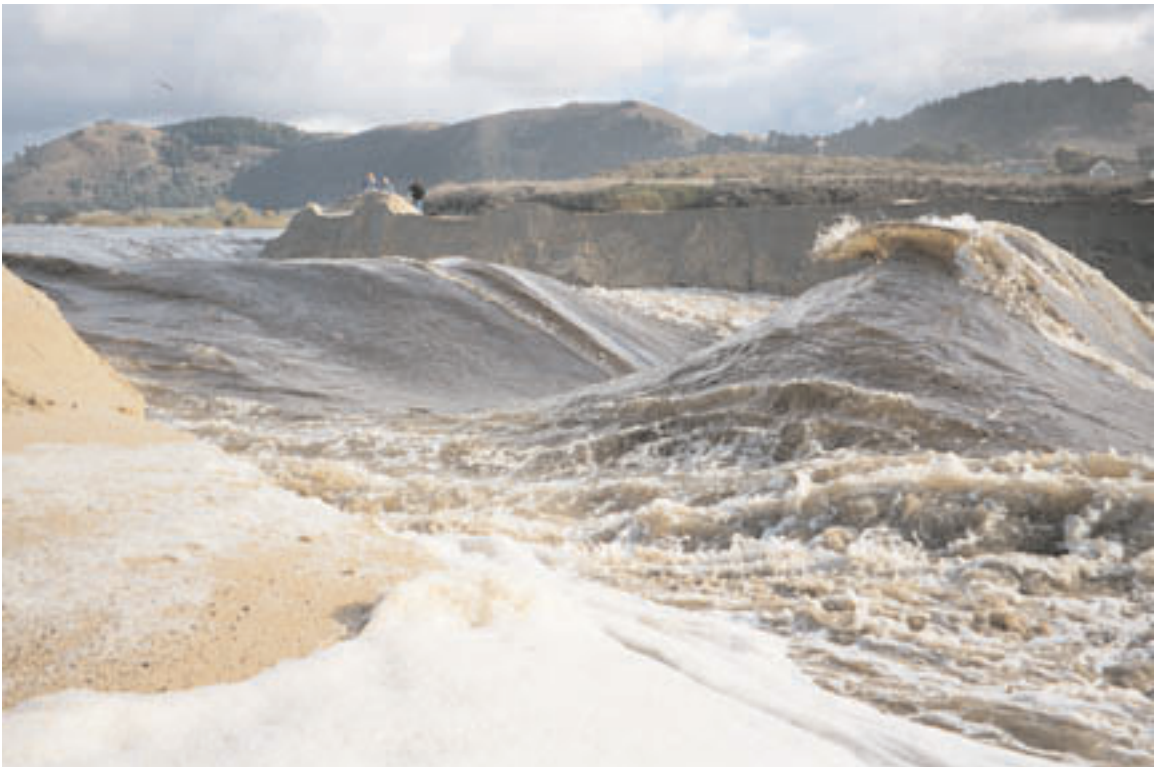
Figure 4.2 Standing waves formed during maximum breach flow. Within two hours the lagoon surface level dropped approximately 2.3 meters.

day. Water quality monitoring began at 09:30 hours and continued throughout the afternoon. Manual breaching was successful at approximately 14:00 hours with a peak stage of 3.25 m NGVD (10.66 ft) (Figs. 4.1 & 4.2). After breaching, the lagoon levels dropped 2.5 m (8.20 ft) in less than three hours.

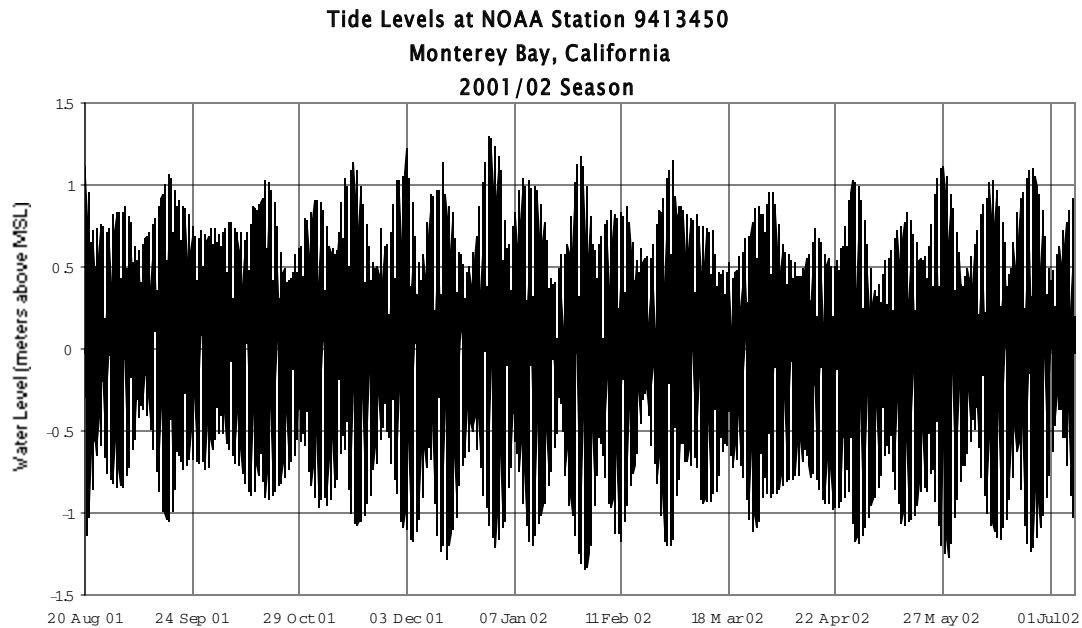
Figure 4.5 Hourly tide levels for Monterey Bay. Data range is from August 20, 2001 to January 20, 2002.

Tidal and ocean wave height data for Monterey Bay (Figs 4.5 & 4.6) are being analyzed to confirm a relationship with increases in lagoon water level. Qualitatively, it is clear from Figure 4.6 that high ocean waves occurred during periods of non-streamflow resulting in a more rapid increase in lagoon water level. Waves were observed to wash into the lagoon on August 28 and October 9th, when the Monterey Bay wave height was recorded as 3.1m (10.17ft) and 3.3m (10.82ft) respectively. In-wash is presumed to have also occurred on many other dates during this period.

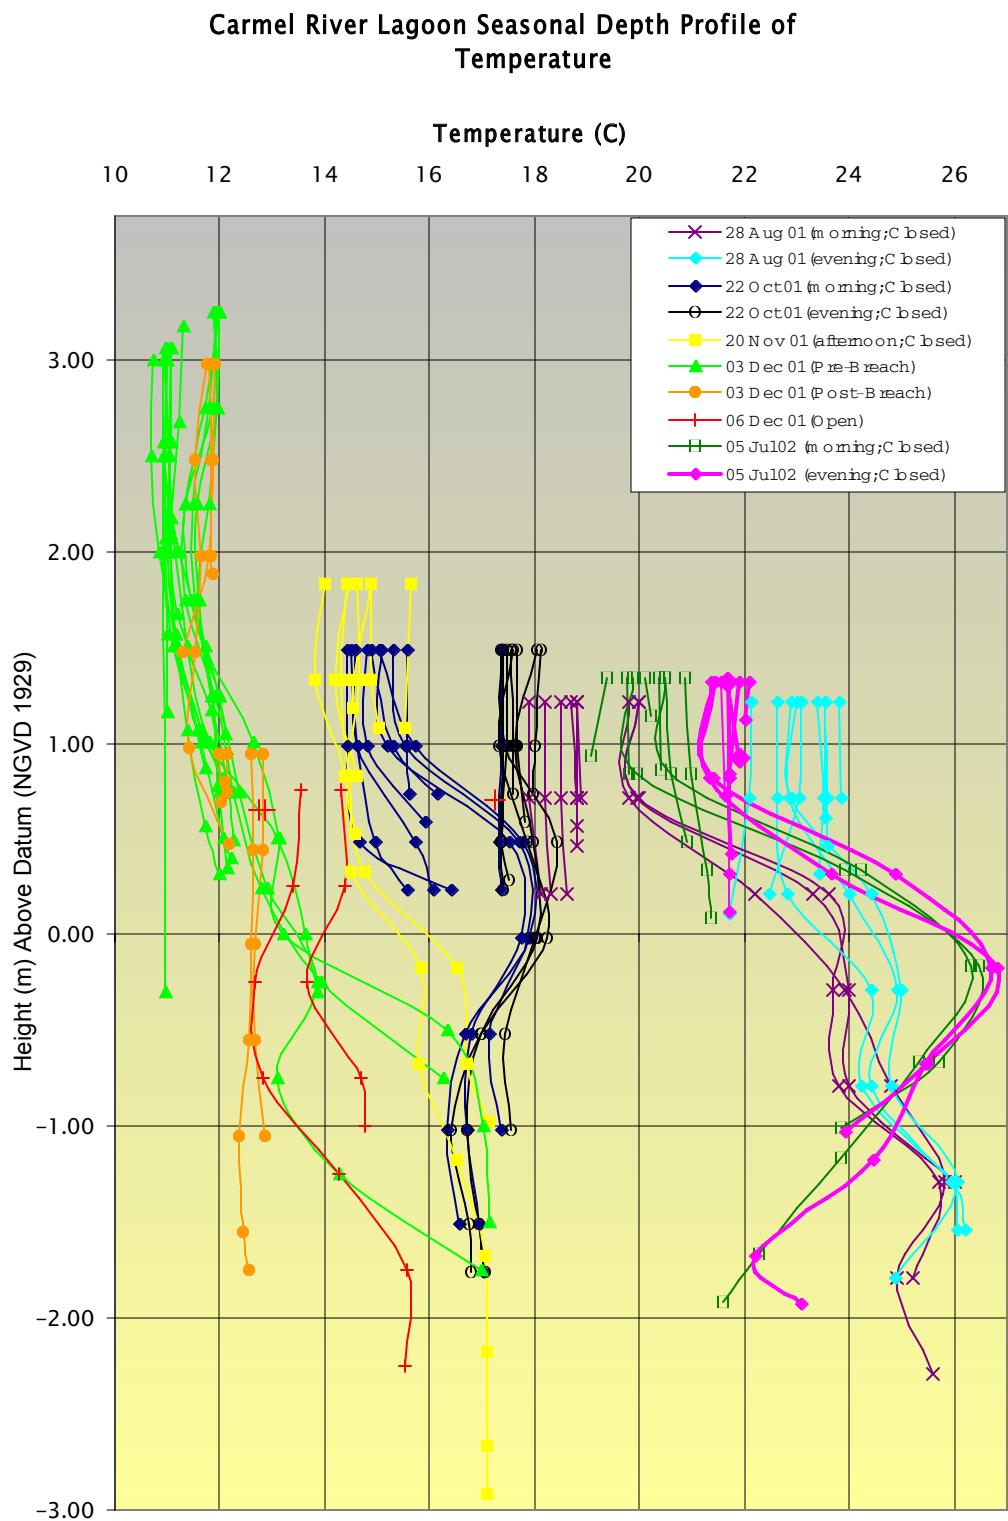
Figure 4.11 Carmel River Lagoon depth profile of temperature for all seasonal and lagoon conditions.

In late August, lagoon waters are expected to begin a cooling phase due to a reduction in average daily air temperatures from those experienced during July and early August. At this time stream flow was not entering the Carmel Lagoon. Water at all levels was relatively warm, and in agreement with the expectation of an early cooling phase at this time of year, afternoon surface waters slightly cooler than at depth, and significantly cooler at night. Diurnal fluctuation was large at the surface, and minimal at depth. Isothermal conditions persisted to about one meter depth, a result of moderate wind-forced mixing.

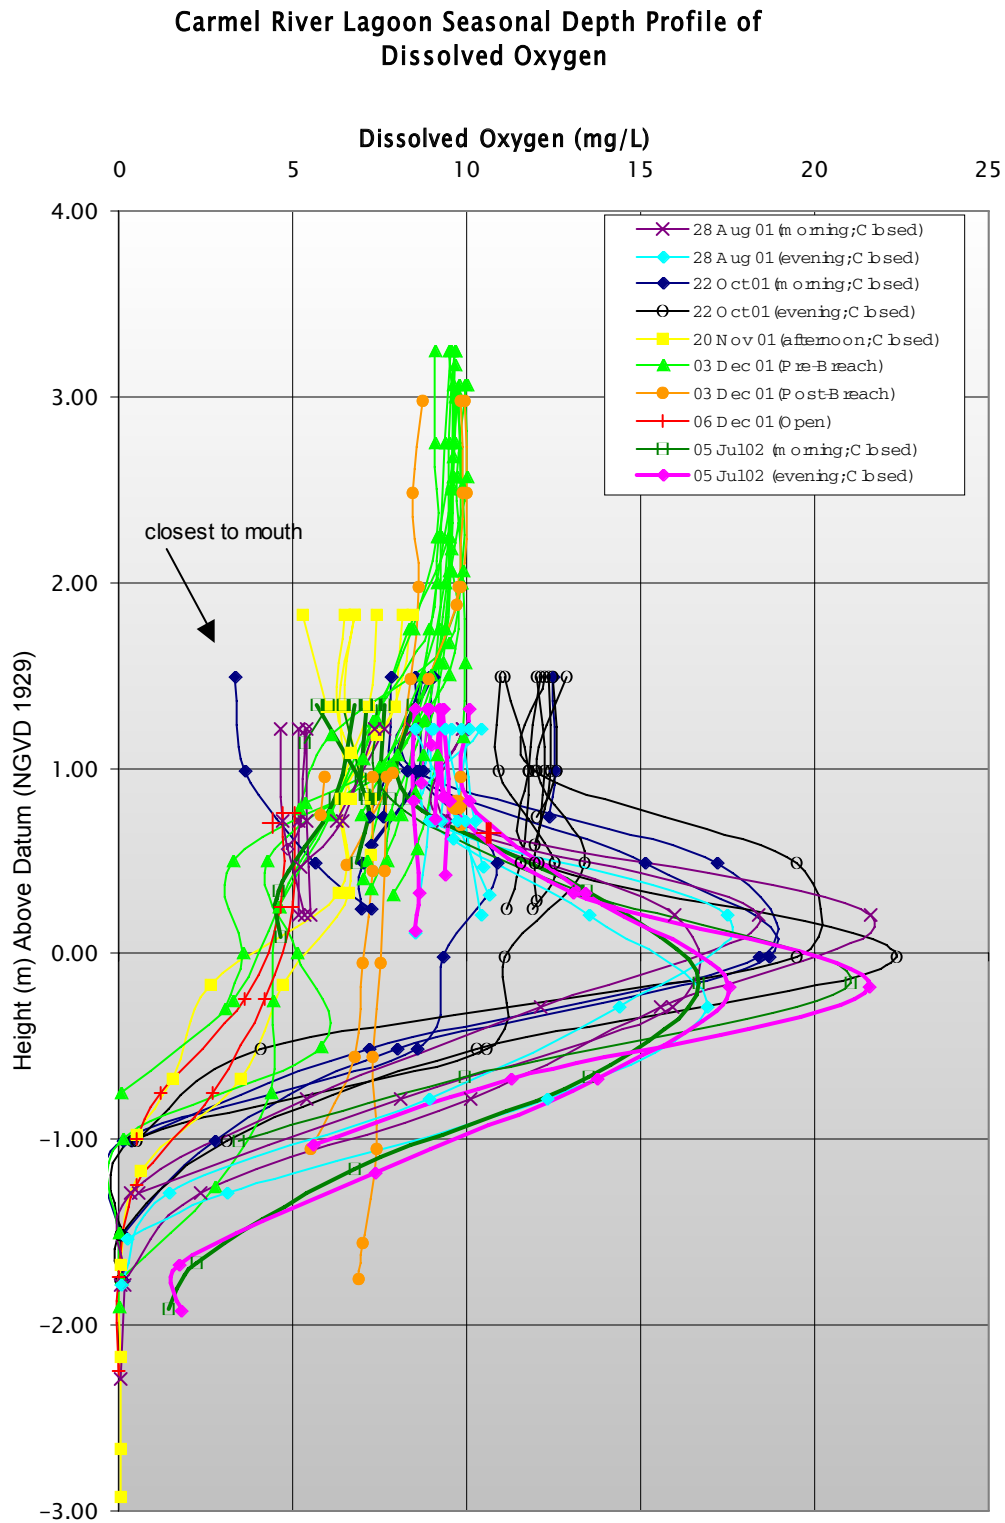
Figure 4.12 Carmel River Lagoon depth profile of dissolved oxygen for all seasonal and lagoon conditions.

Dissolved oxygen concentrations were moderate at the surface, very high (super-saturated) in mid-level waters, and anoxic at depth. This is termed a positive heterograde oxygen distribution (Cole, 1994). Diurnal fluctuation was pronounced at the surface, and slightly lower at mid-level. A number of hypotheses can be invoked to explain the positive heterograde oxygen distribution observed in late summer and early fall for this lagoon. The first is that higher air temperatures may have occurred just prior to sampling, so that surface layers were cooled relative to layers deeper than the typical mixing depth (~1m). This hypothesis is confounded by the fact that the warm mid-level waters are observed in almost every summer and fall sampling event. The second hypothesis is that a positive feedback is occurring between algal production and light absorption at all depths—higher production leads to greater opacity, greater absorption of solar radiation, warmer temperatures, which completes the cycle by fueling higher production. The surface layers may experience this phenomenon equally as much as the deeper layers, but their exposure to the colder atmosphere at night means that they would equilibrate at a lower temperature than the deeper layers. A third hypothesis involves photo-inhibition – lower production due to super-saturated light (particularly ultra-violet) levels in the uppermost layers. This is unlikely to explain all observations, as photo-inhibition is generally limited to depths less than one meter (Cole, 1994). A fourth hypothesis is that both surface and mid-level waters display algal production capable of super-saturating the water with oxygen, but that only the surface waters may degas this excess oxygen to the atmosphere. Surface DO is slightly higher above the deeper, more-productive mid-level waters, which suggests diffusion of oxygen upward from the mid-level hyper-oxic layers. Yet another hypothesis is that the algal or bacterial species responsible for the production of oxygen are sensitive to turbulence near the surface, or display optimal photosynthesis in lower light conditions.

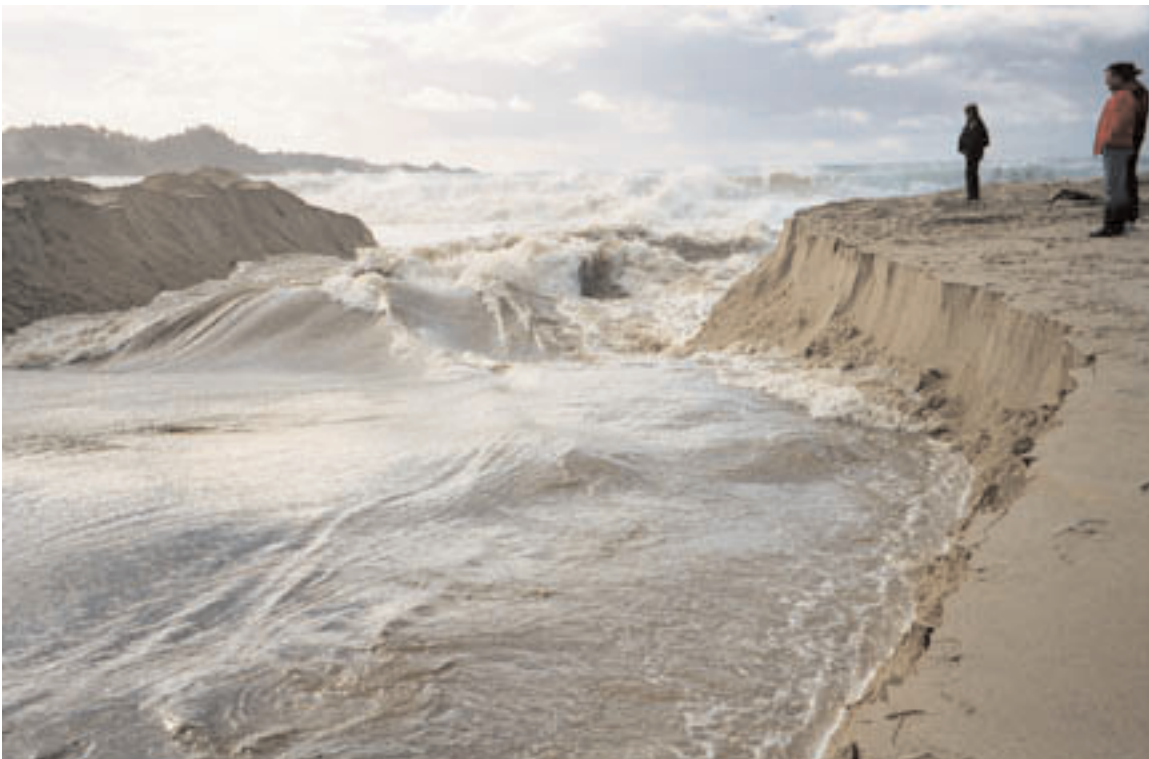
Figure 4.14 The mixing of fresh and salt water shortly after the Carmel Lagoon breached at approximately 14:00 of December 3, 2001.

The breaching flow was violent, draining the entire lagoon in about two hours with high velocity, high volume flows forming standing waves over two meters high at the mouth (Fig. 4.14). The pre and post-breach depth profiles indicate that most of the drained water was taken from the upper 2.5 meters of the lagoon, but that the deeper water in the South Arm sump was by no means hydraulically isolated. The deep-water thermocline became isothermal over the bottom 2.5 meters; the near-benthic anoxic zone was enriched to moderate oxygen levels, and the slightly hypersaline sump became almost fresh in places. The South Arm sump is not in the direct path of the River as it flows to the ocean,

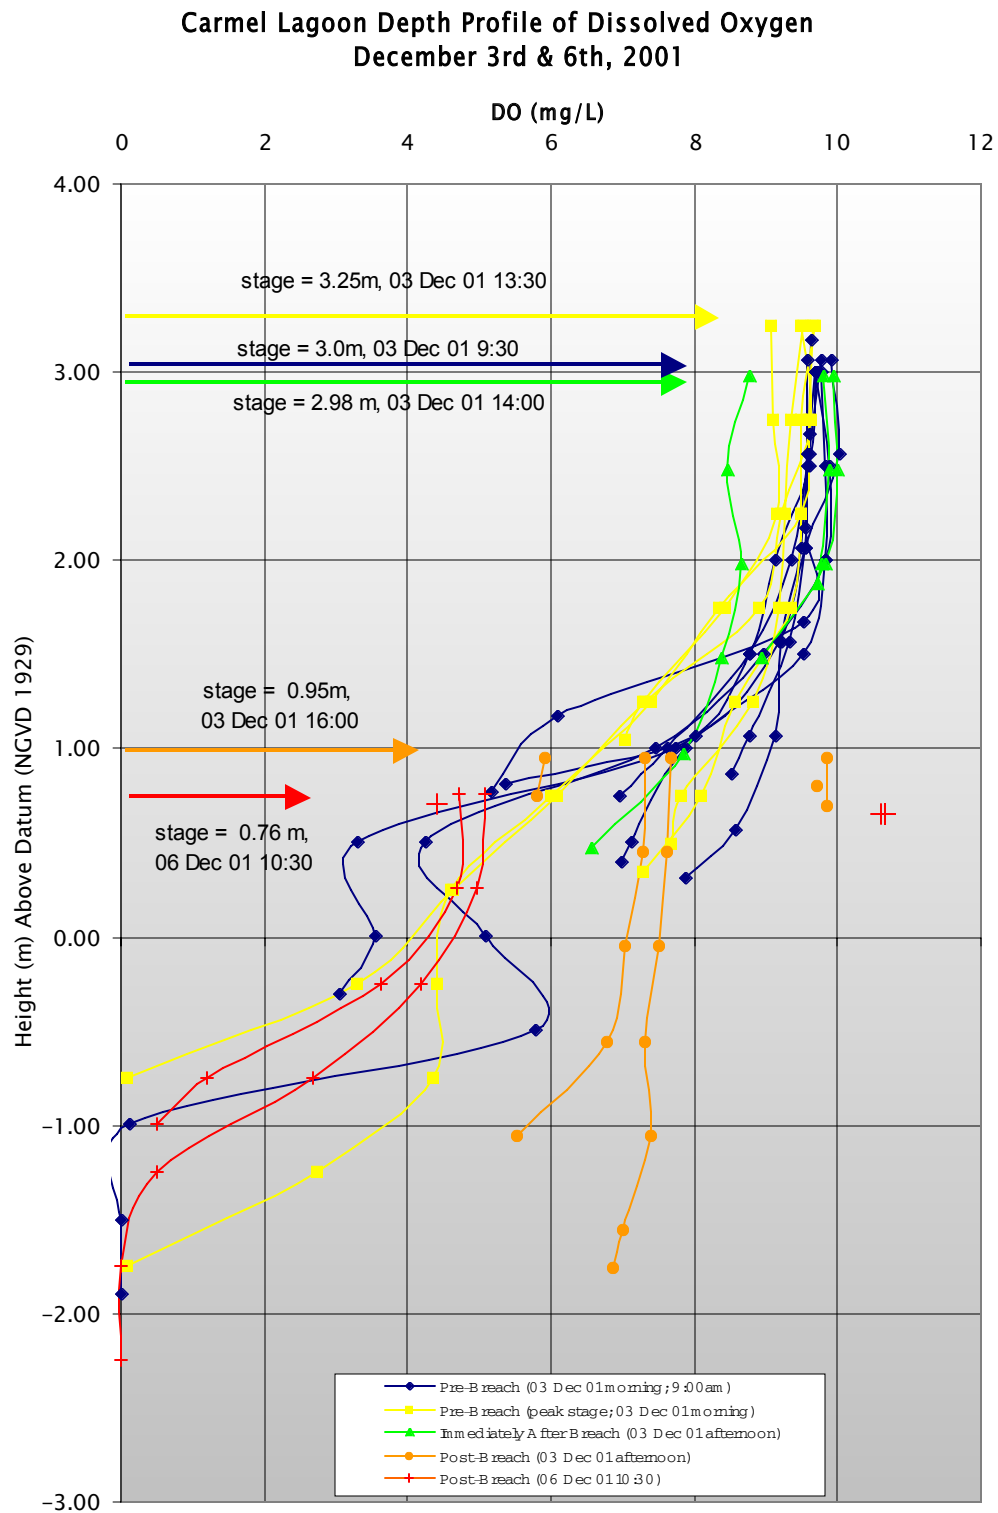
Figure 4.16 Stage/timeline of depth profile measurements for dissolved oxygen during December 3&6th monitoring events. Note the change in surface level in the lagoon between 13:30 and 16:00 of December 3, 2001.

Deep-water dissolved oxygen remained low during this period, removing the possibility that the deep-water warming might have been due to inflow from warmer, oxygenated surface sources, or some phenomenon related to algal-production. The lagoon sediments would be expected to be low in oxygen due to respiratory processes. Surface oxygen was moderate in the lagoon proper, and saturated upstream in the River itself. The moderation of oxygen rich river water in the lagoon may have been due to mixing with tidal ocean water.

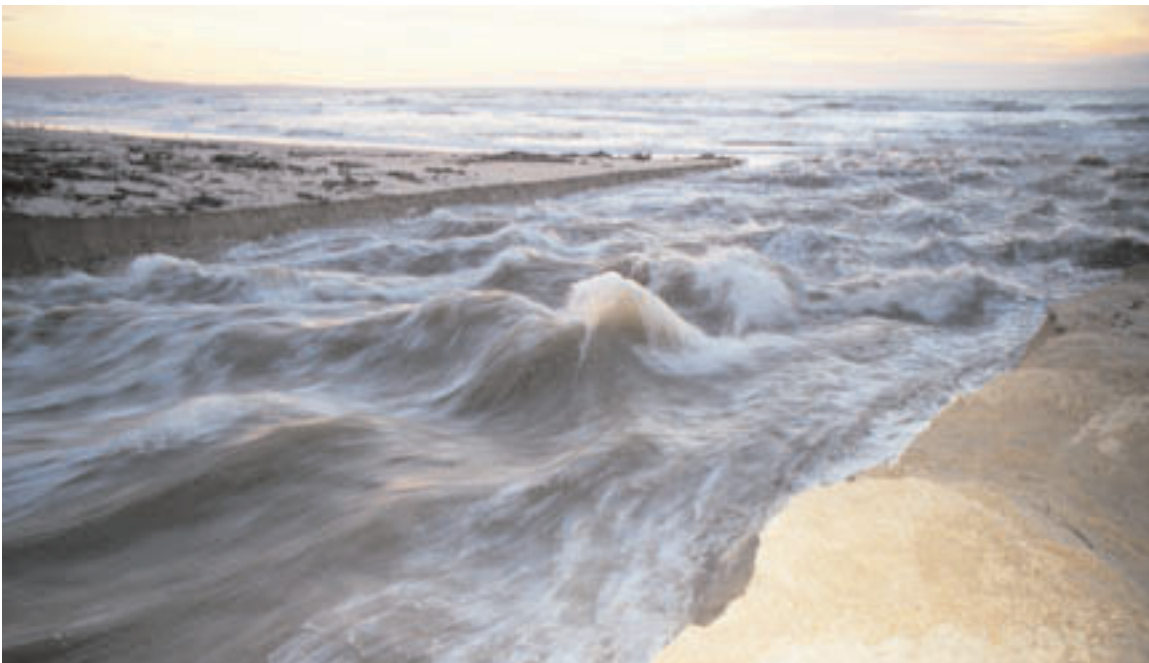
Figure 5.8 The Salinas Lagoon flowing out to sea (foreground); ocean background.
