Report No. WI-2003-14
30th June 2003

The Watershed Institute

Hydrology and Water Quality Of the Carmel and Salinas Lagoons Monterey Bay, California 2002/2003

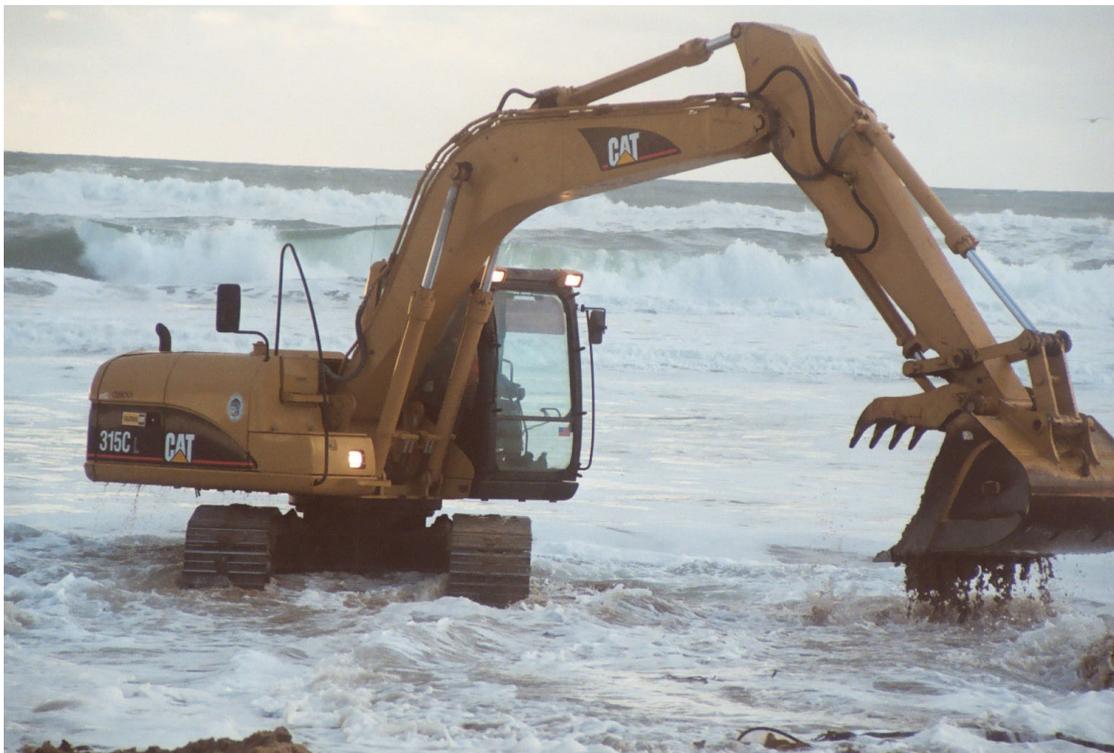
Figure 1.1 MCWRA crew using heavy equipment to breach the Salinas Lagoon. Photo: Fred Watson, 17 Dec 02

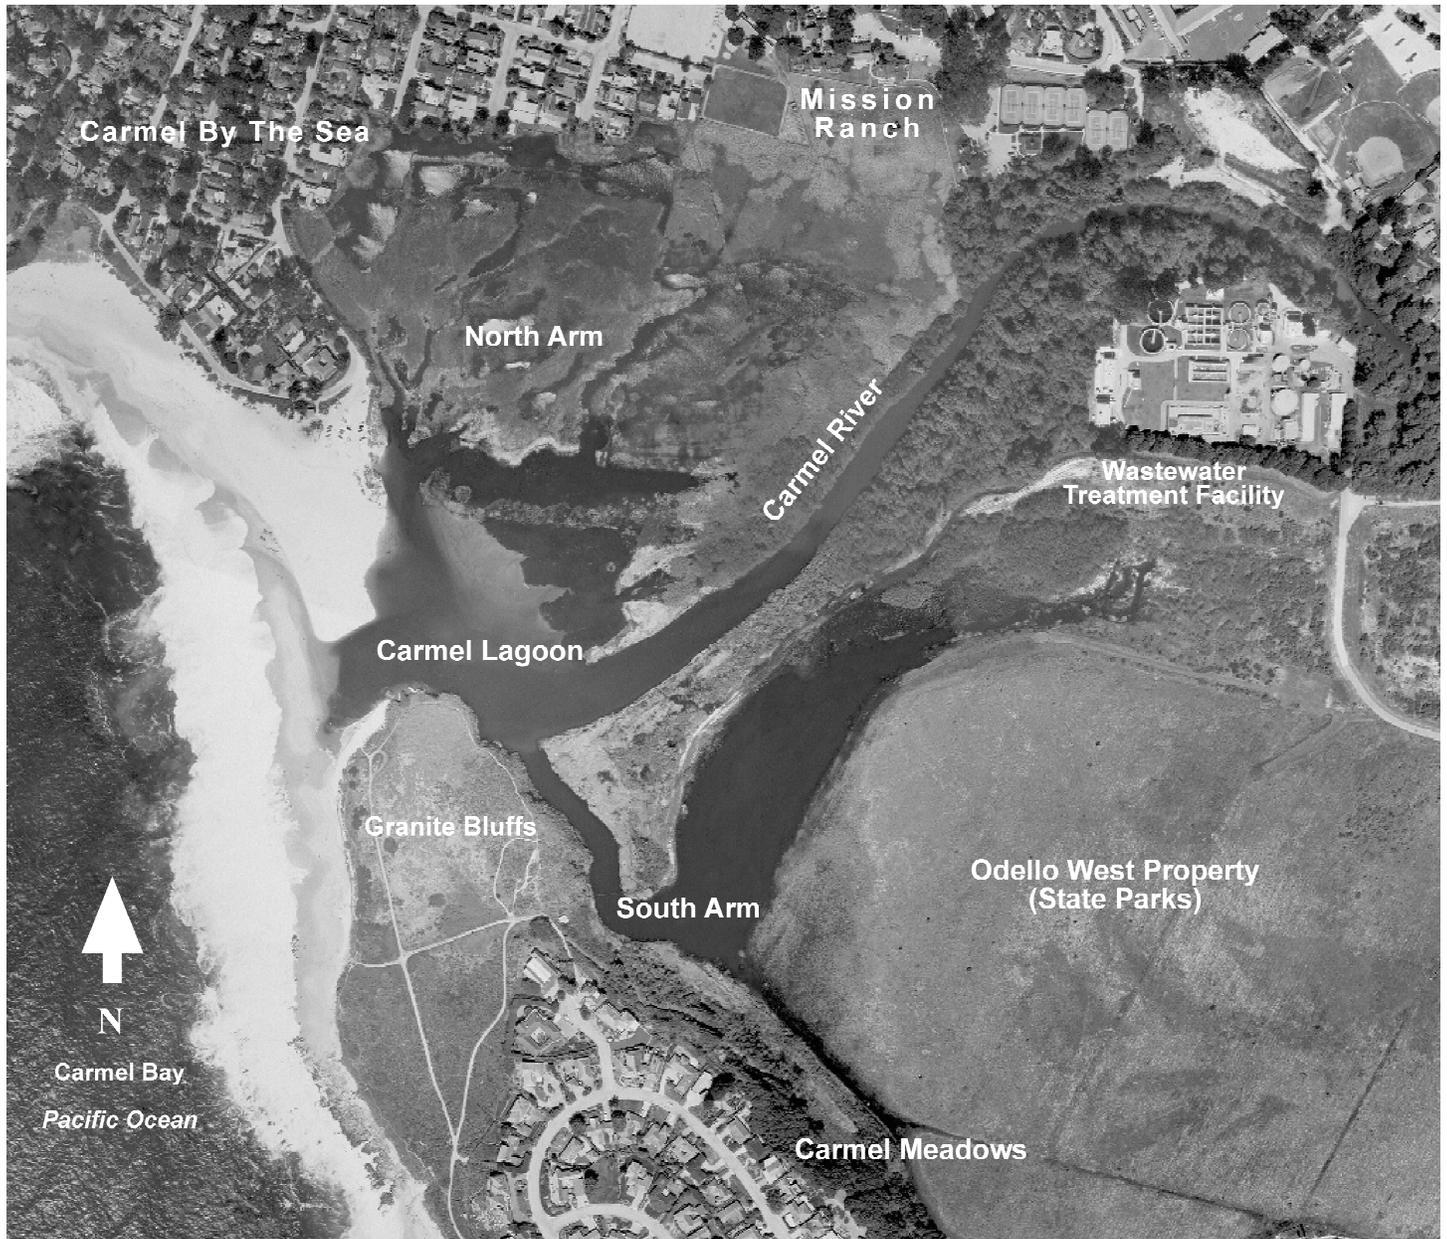
Figure 2.1 The Carmel Lagoon, surrounding residential areas and the Wastewater Treatment Facility.

The Carmel Lagoon (Figs 2.1 to 2.5) lies at the end of the Carmel River between two residential areas: Carmel By The Sea and Mission Ranch to the north and Carmel Meadows to the south. The Carmel Lagoon is much smaller than the Salinas Lagoon. However, the surface area of the lagoon expands and contracts with seasonal inputs into the lagoon. In the fall, the lagoon receives wave overwash, which can raise the lagoon water elevation by several feet. In the winter, the lagoon will expand with the addition of increased streamflow, inundating both aquatic and terrestrial vegetation until the lagoon is breached. In summer, the lagoon shrinks, becoming more shallow and exposing small channels and islands in the lagoon bed.

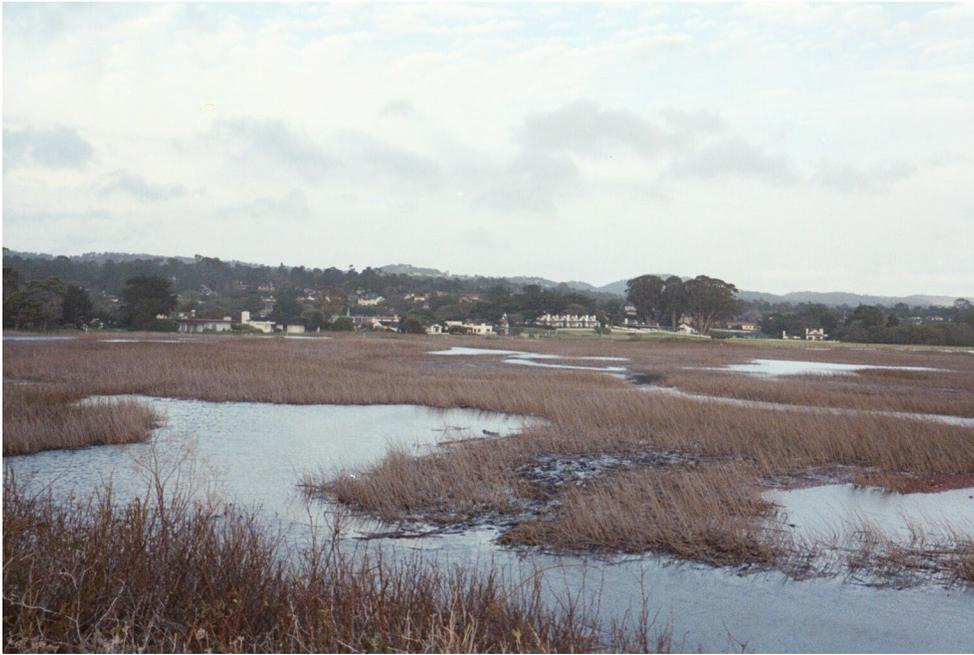
Figure 2.2 The northern backwaters (North Arm) of the Carmel Lagoon at high water elevation – Mission Ranch and Carmel By the Sea in the background. Photo: Joel Casagrande, 15 Dec 02.

The northern backwater (North Arm) section of the lagoon is approximately circular in shape (c. 300 m diameter) and comprises a system of channels and islands filled with aquatic vascular vegetation (Fig 2.2).

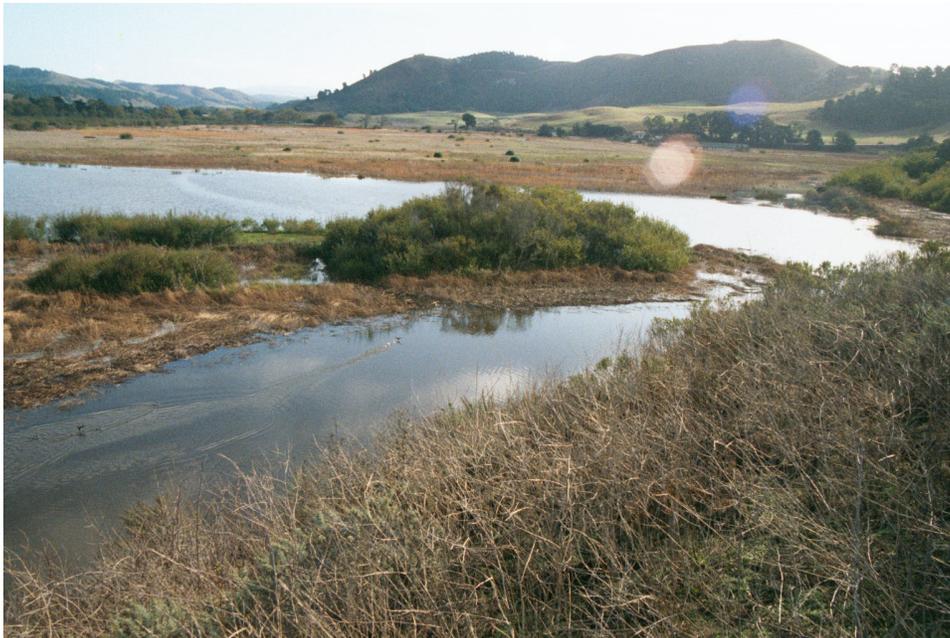
Figure 2.3 The southern backwaters (South Arm) of the Carmel Lagoon. The Odello Property (Odello West) is in the background. Photo: Fred Watson Dec 2001.

The smaller Southern Arm of the lagoon is much more linear and confined (c. 200m long) (Fig. 2.3). The original geomorphology of the South Arm is poorly understood. However, it is hypothesized that it was once occupied by the river's main channel, which has since migrated to the north (PWA, 1999). Currently, a small hill with underlying granitic bedrock confines the South Arm into a narrow channel that swells at high water into a wetland once used for agriculture – the Odello West area. The granite is the outcrop of a larger up thrown block beneath the lagoon. This upthrown block, on the Cypress Point Fault, protects the Carmel Valley aquifer from seawater intrusion (Johnson, 2000; Logan, 1983 as cited in SGD, 1989) and would most likely have been the control feature for a cascade or waterfall in the Carmel River at times of lower sea level. Deep-water habitat, currently found in the South Arm, is a result of dredging that occurred in 1996 and 1998 (Entrix, 2001). The dredging was conducted to increase the amount of deep-water habitat for steelhead.

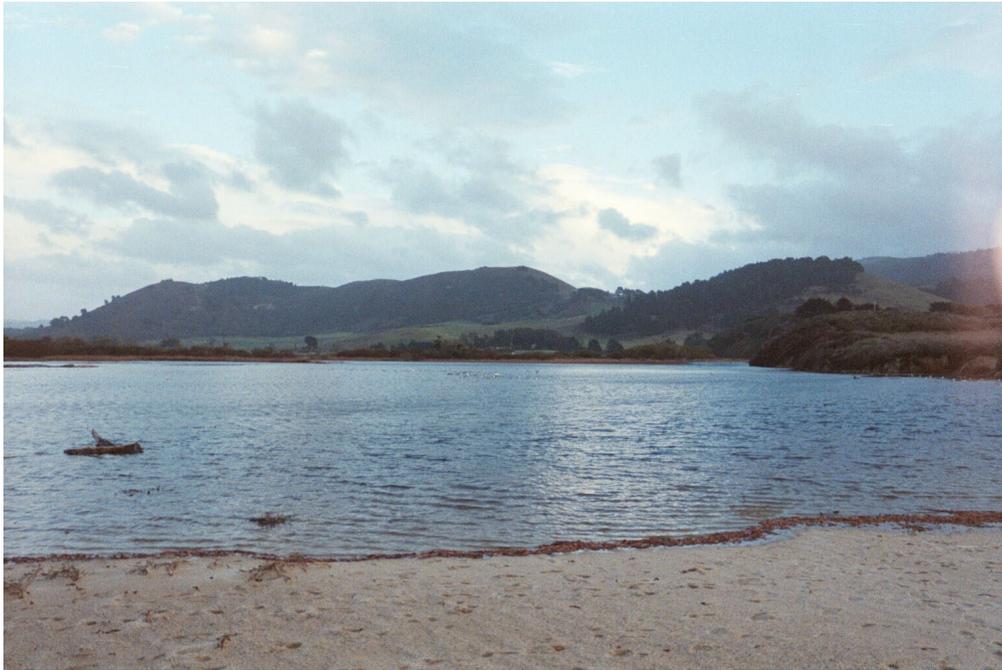
Figure 2.4 The main body of the Carmel Lagoon during high water looking east. Photo: Joel Casagrande, 15 Dec 02.

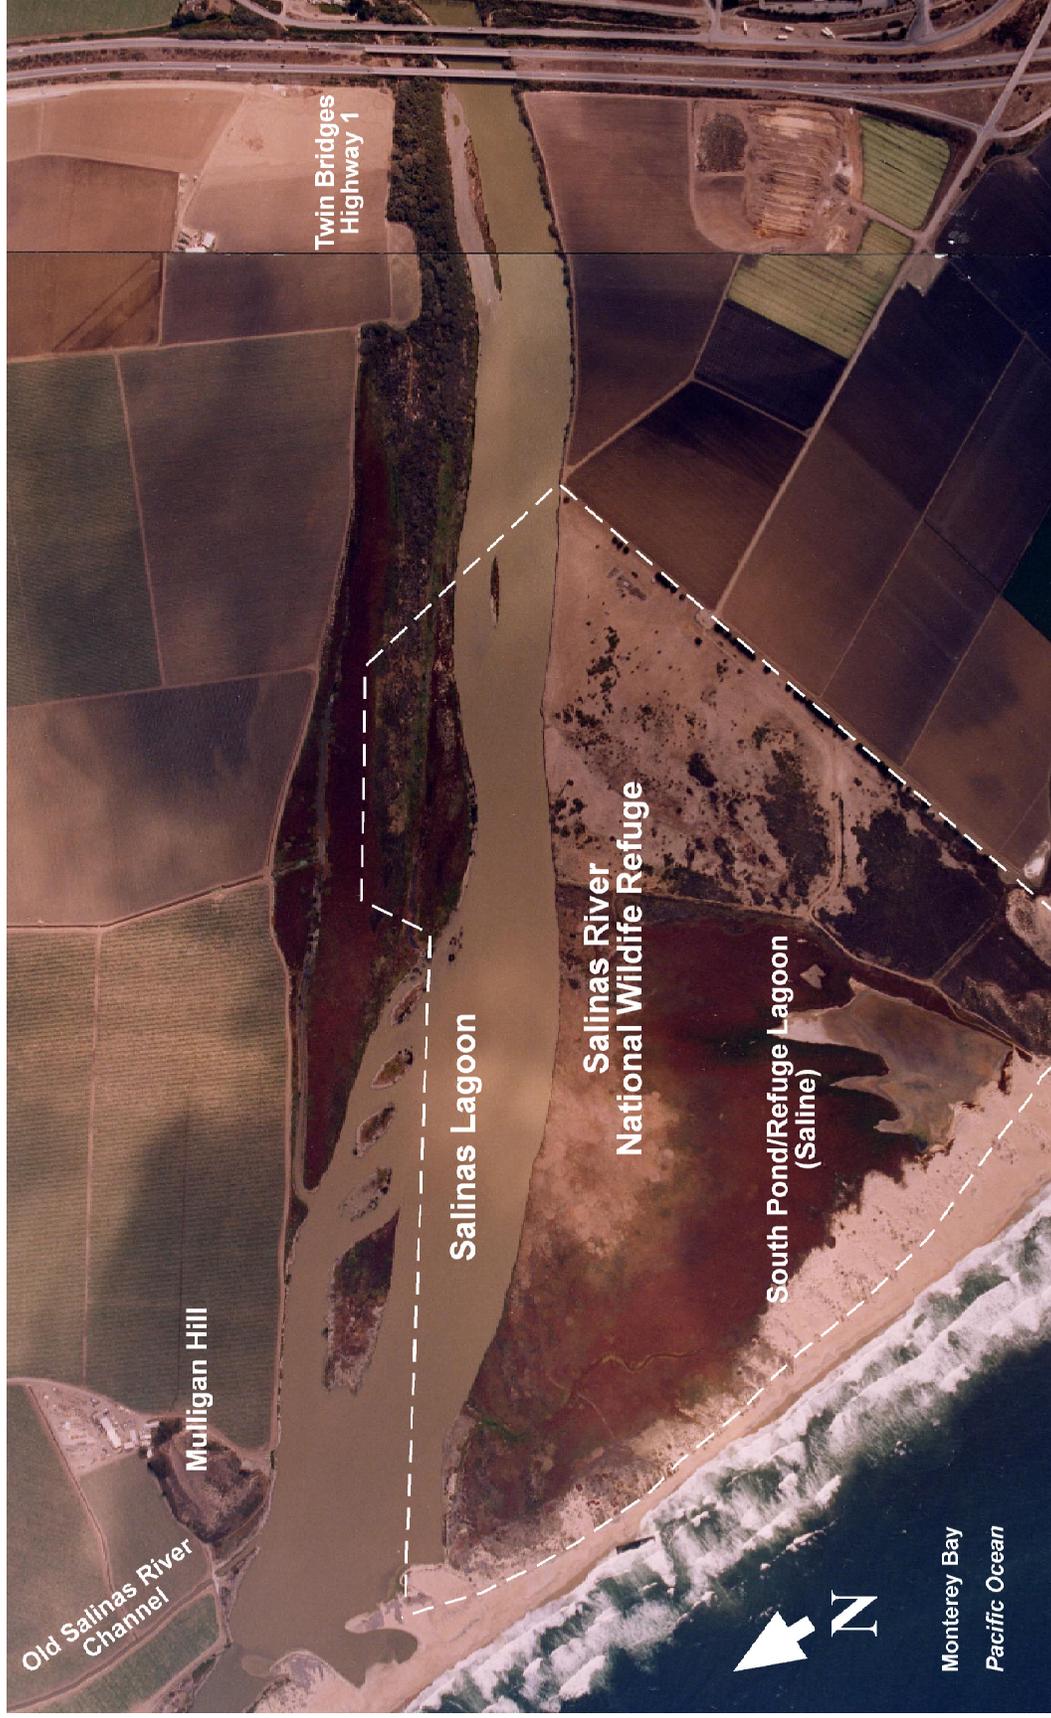
Figure 2.6 The lower Salinas Lagoon and National Wildlife Refuge (outlined area) and their surrounding features.

The Salinas Lagoon (Figs 2.6 to 2.11) differs from the Carmel Lagoon in size, shape, adjacent land uses, and vegetation. It is approximately 3 km long and is located in a broad, low-lying, open agricultural setting. Its banks are better defined, so the surface area does not shrink as much during the summer. It has a tapered linear outline, sinuously narrowing inland from its widest point of roughly 300 m near the mouth until it becomes the Salinas River itself approximately 12.5 km upstream (7.5 miles). The northern bank is well vegetated with riparian and phreatophytic vegetation. Large woody debris is found scattered throughout the lagoon, but mainly along the northern and western shores. *Arundo donax*, giant perennial grass, also found throughout the lagoon, is invading large sections of the northern banks. The southern banks are actively eroding and have a nearly vertical slope in many places. Currently, riparian restoration efforts are in place along a large portion of the southern bank located in the Salinas River National Wildlife Refuge as well as the agricultural lands neighboring to the east.

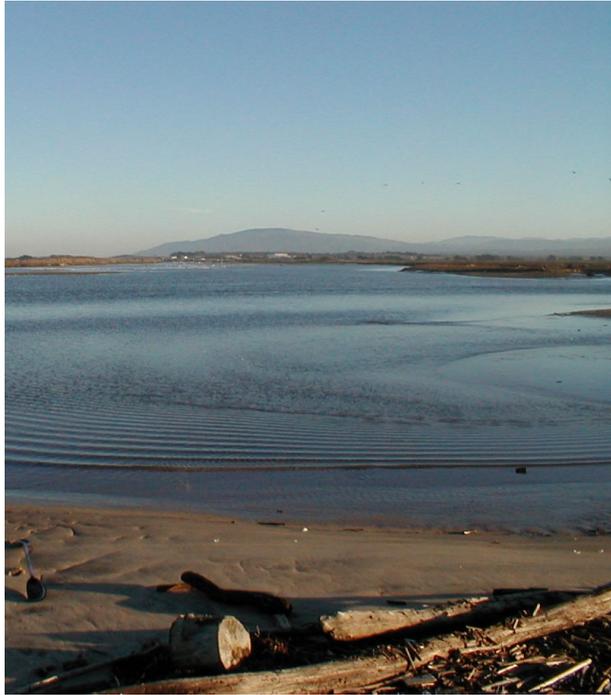
Figure 2.7 The main body of the Salinas Lagoon looking east from the sand bar with Toro Peak in the background. Photo: Don Kozlowski 26 Dec. 2001.

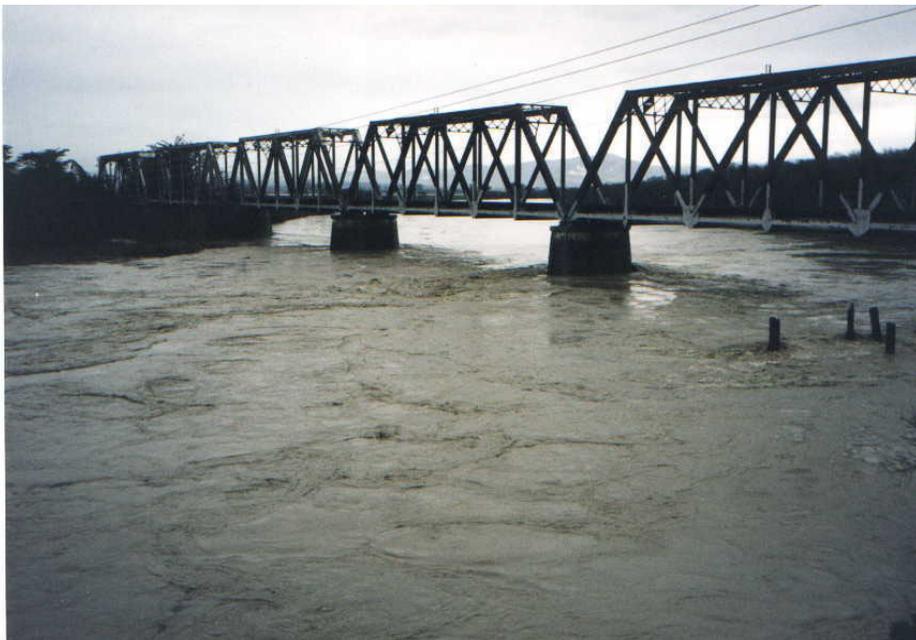
Figure 2.8 The middle reach of the Salinas Lagoon at Twin Bridges looking east. Photo: Watershed Institute, 1998 flood.

Four closely spaced bridges cross the lagoon at a confining point near the river/lagoon interface (the site known as the Twin Bridges) (Fig 2.8). The nearest active USGS streamflow gauge is located approximately 22.2 km (13.3 miles) upstream from the lagoon at Highway 68 at Spreckels. However, low streamflow volumes recorded at this gage may not actually reach the lagoon due to the distance and the porosity of channel substrates between the lagoon and the gage site.

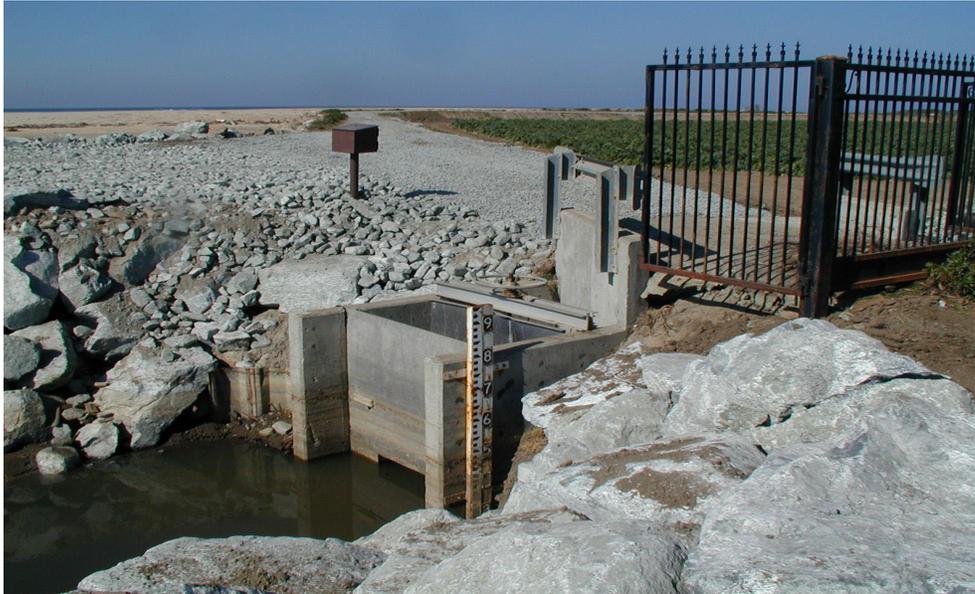
Figure 2.9 The slide gate to the Old Salinas River Channel and water elevation gage. Photo: Bob Curry, February 2003.

When the lagoon is closed, water levels in the lagoon are monitored by a county gage and staff plate located at the Old Salinas River outlet gate (Fig 2.10) in the northwestern corner of the lagoon. The county maintains the water elevation in the lagoon (Gilchrist et al., 1997) at an elevation of 3 ft by closing off or releasing flows to the Old Salinas River Channel using a manually operated slide gate, which is also located in the northwest corner of the lagoon (Fig. 2.9). In the event a manual breach is deemed necessary, a channel is excavated through the sandbar leaving only a “plug” of sand to be removed at the last minute. After enough hydrostatic head is built up in the lagoon, the plug is removed and the lagoon quickly drains. Once the sandbar has opened, the outlet gate to the Old Salinas River remains closed allowing water to exit the lagoon only through the

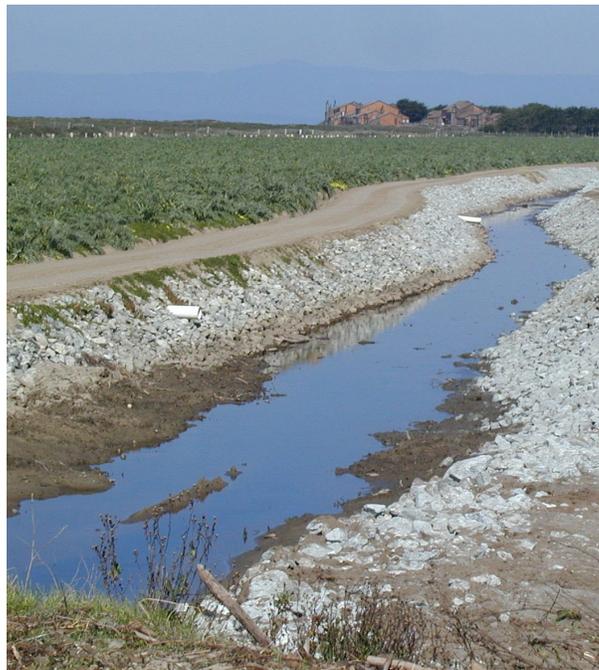
Figure 2.10 The Old Salinas Channel downstream of the outflow gate. The residential Monterey Dunes Colony is shown in the background. Photo: Bob Curry, February 2003.

breaching corridor (Gilchrist et al., 1997). This is to ensure that excess water doesn't flow down the Old Salinas Channel, which receives substantial runoff from the Gabilan Creek Watershed/Reclamation Ditch and Tembladero Slough drainages.

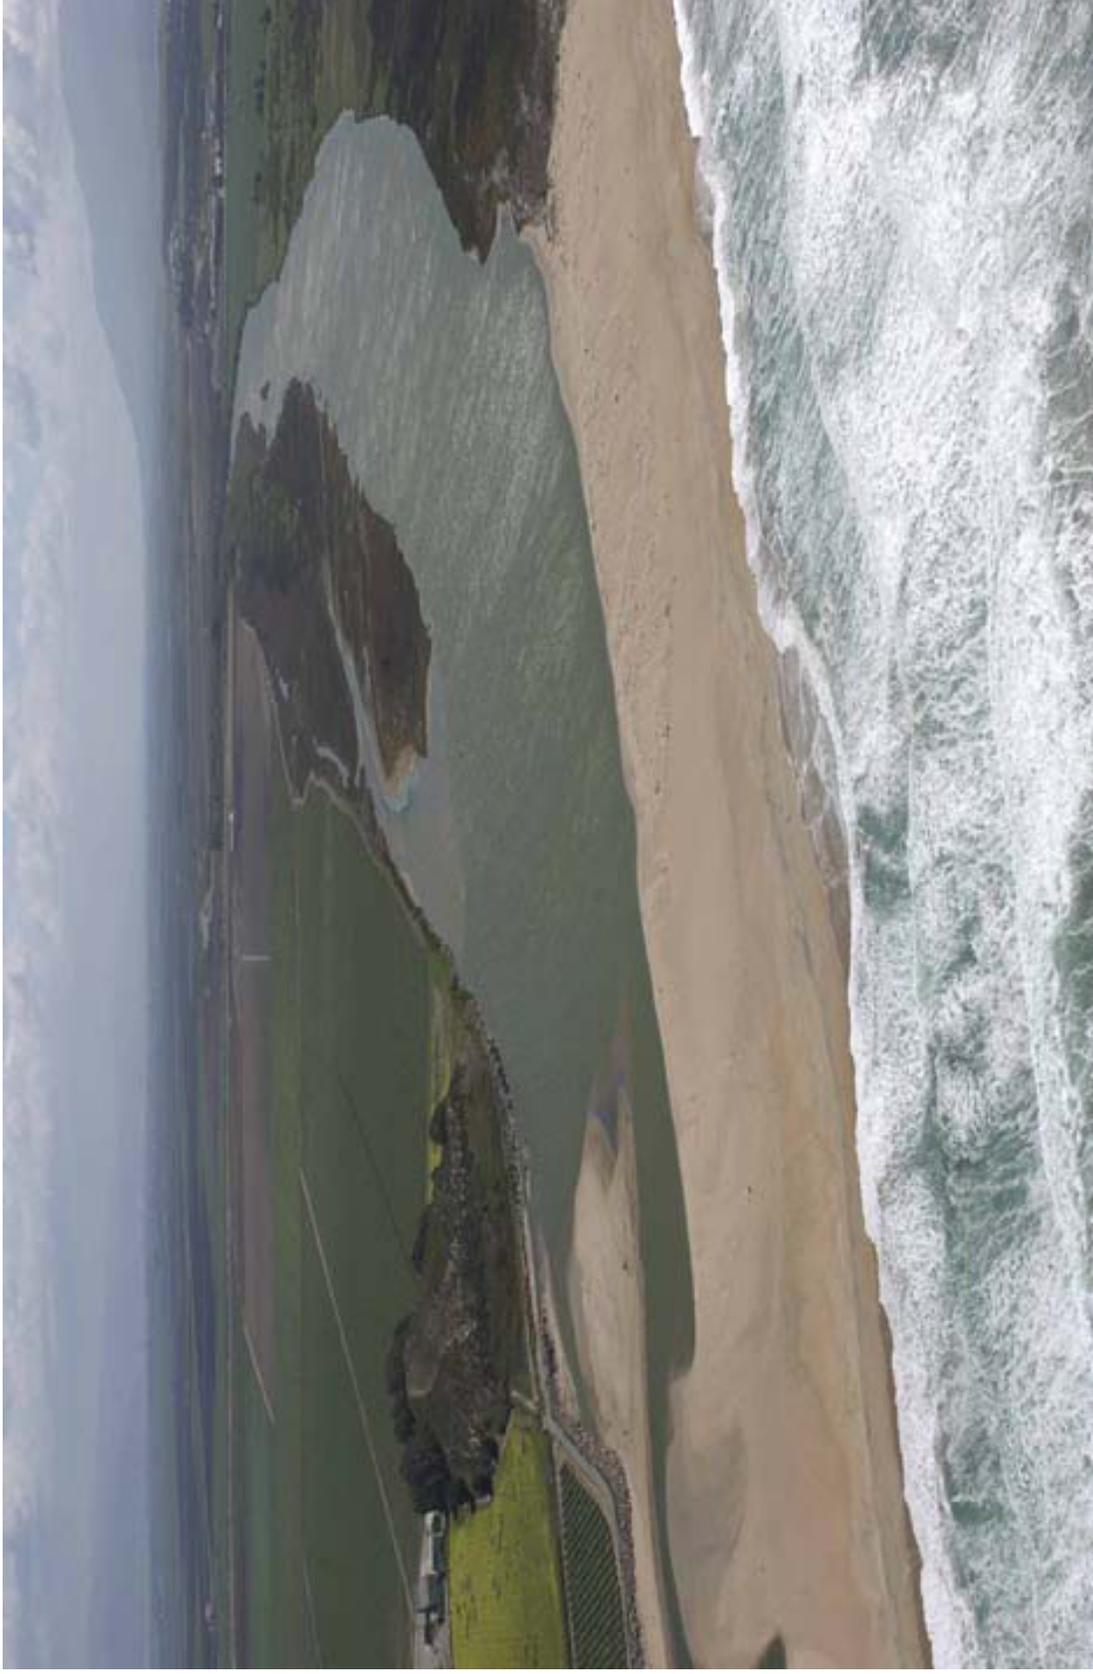
Figure 2.11 A view of the western portion of the Salinas Lagoon and surrounding area taken from over Monterey Bay, 16 March 2002.
Photo: Copyright (C) 2002 Kenneth Adelman, California Coastal Records Project, www.californiacoastline.org.

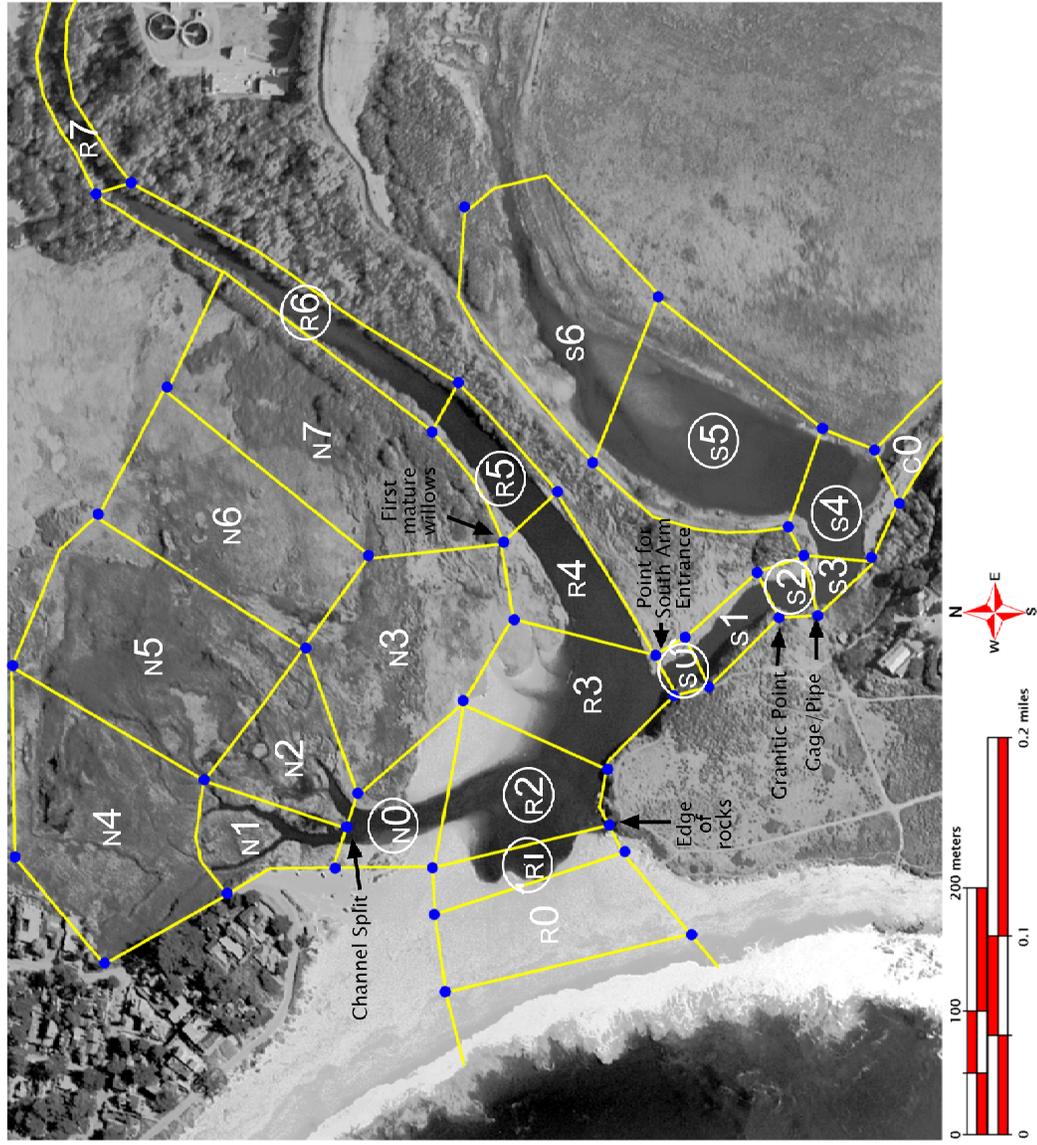
Carmel Lagoon Water Quality Sampling Zones

Figure 3.1 Sampling zones for the Carmel Lagoon. Note zones that are circled are the primary sample locations for water quality assessment.

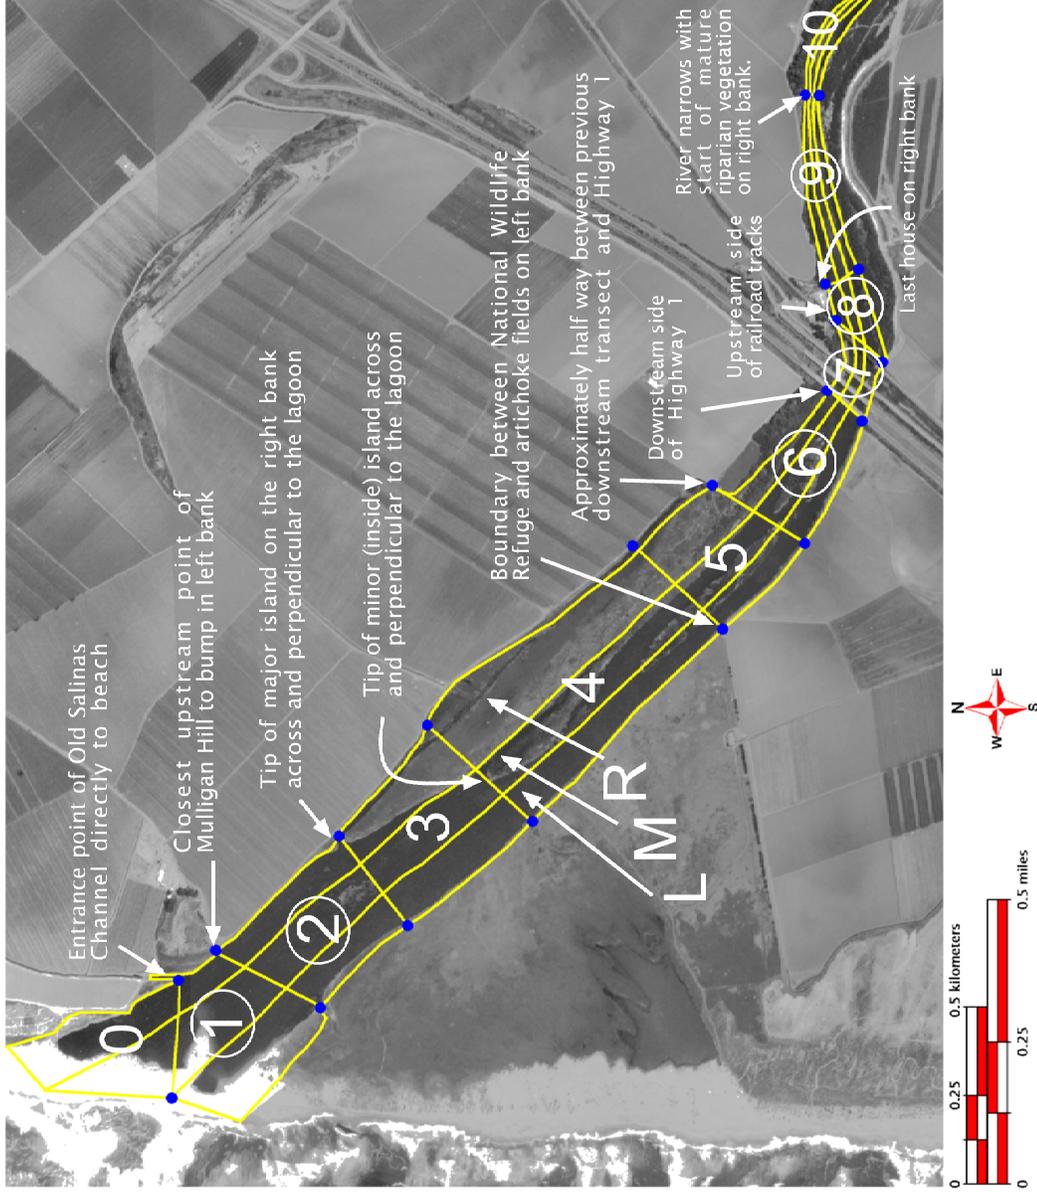
Salinas Lagoon Water Quality Sampling Zones

Figure 3.2 Sampling zones for the Salinas Lagoon. Note zones that are circled are the primary sample locations for water quality assessment.

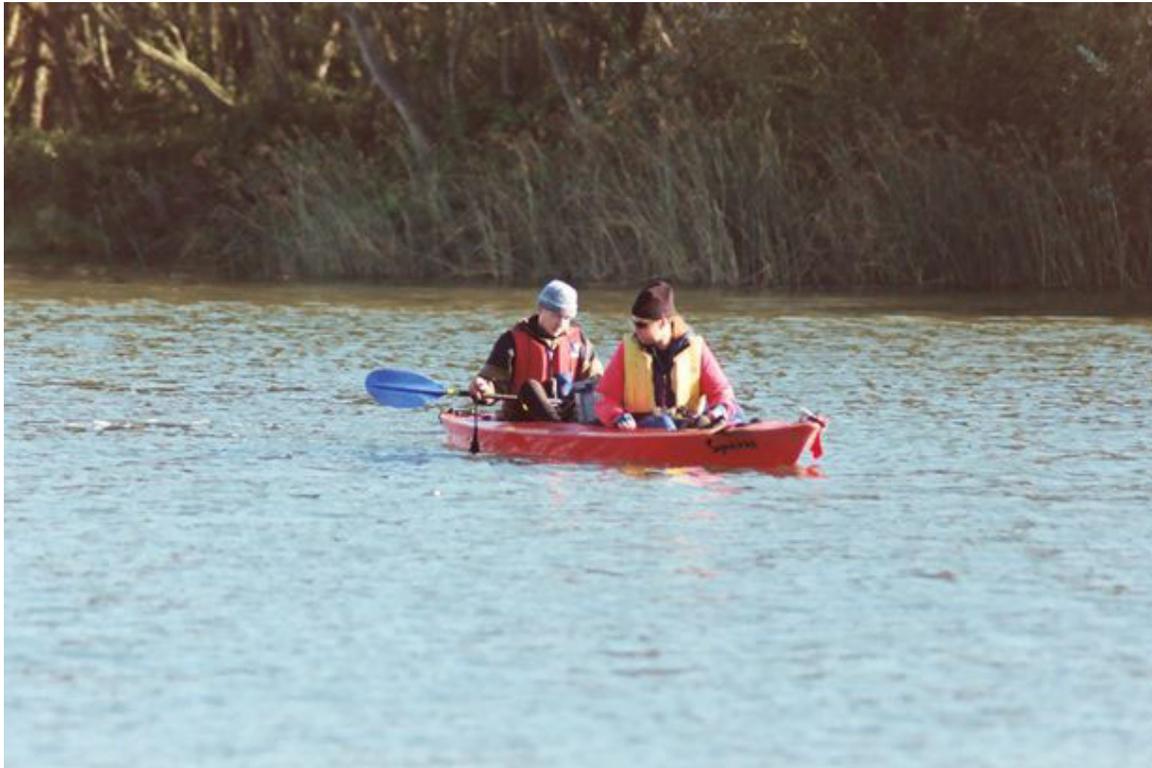
Figure 3.3 One of two tandem kayaks used for water quality monitoring showing the method for collecting water quality information, depth, and bathymetrical data. Photo: Fred Watson 17 Dec. 02

The lagoons are easily accessible by kayak. The use of a tandem kayak allows for easy launching, ability to maneuver between sites with ease and efficiency and the transportation and of monitoring instruments (Fig. 3.3).

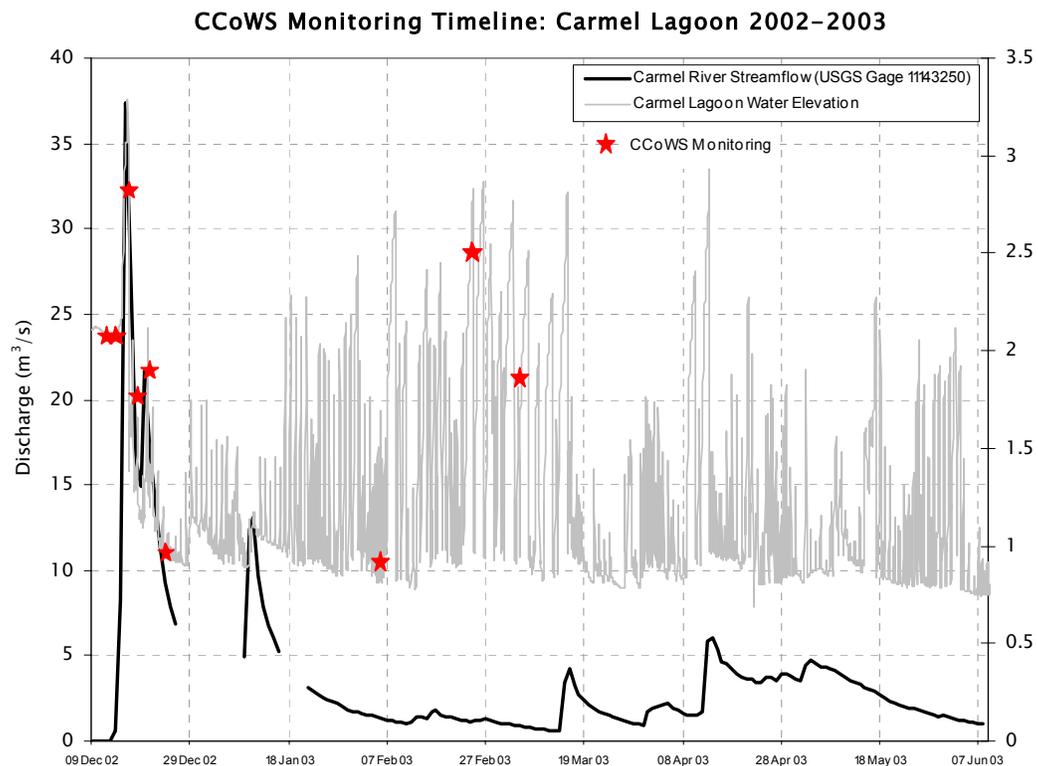
Figure 4.1 Monitoring timeline with respect to lagoon water elevation and streamflow in the Carmel River.

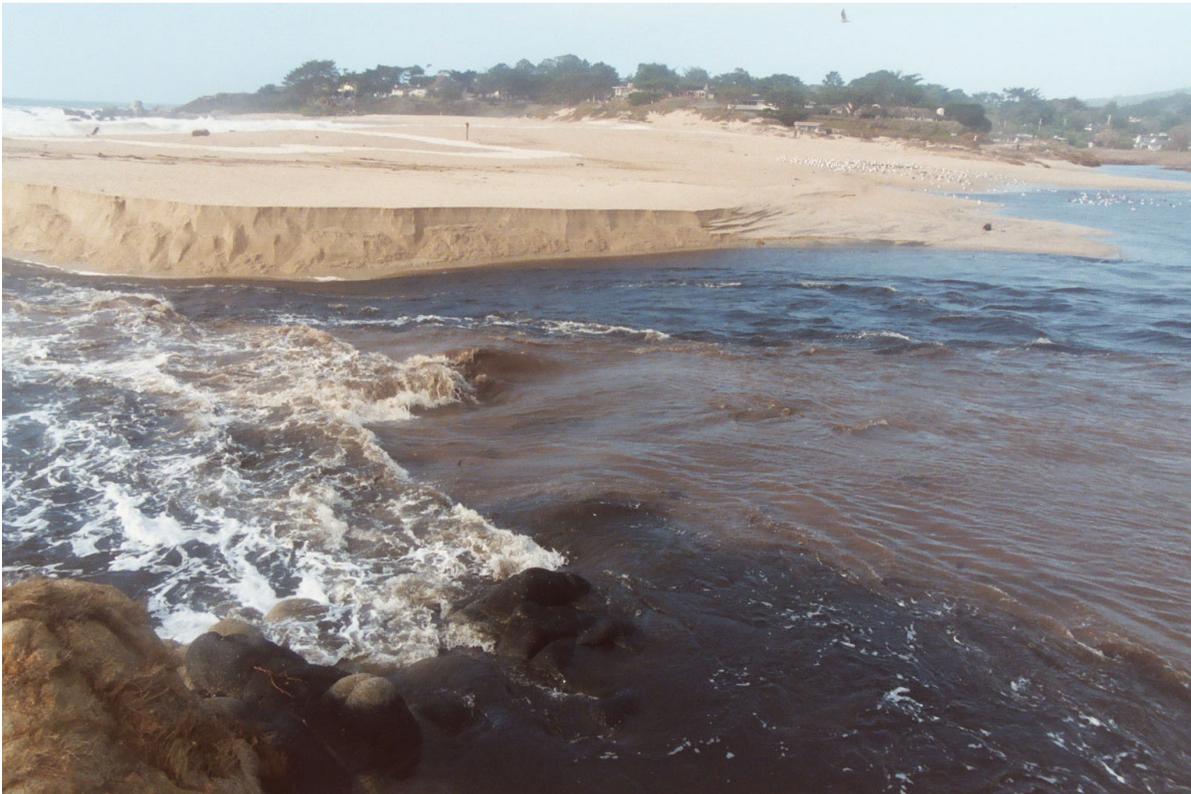
Figure 4.2 Water exiting the Carmel Lagoon on December 16, 2002. Brown water (center) is runoff from the Carmel River flows and darker water (top and bottom) is residual lagoon water. Photo: Fred Watson, 16 Dec. 02.

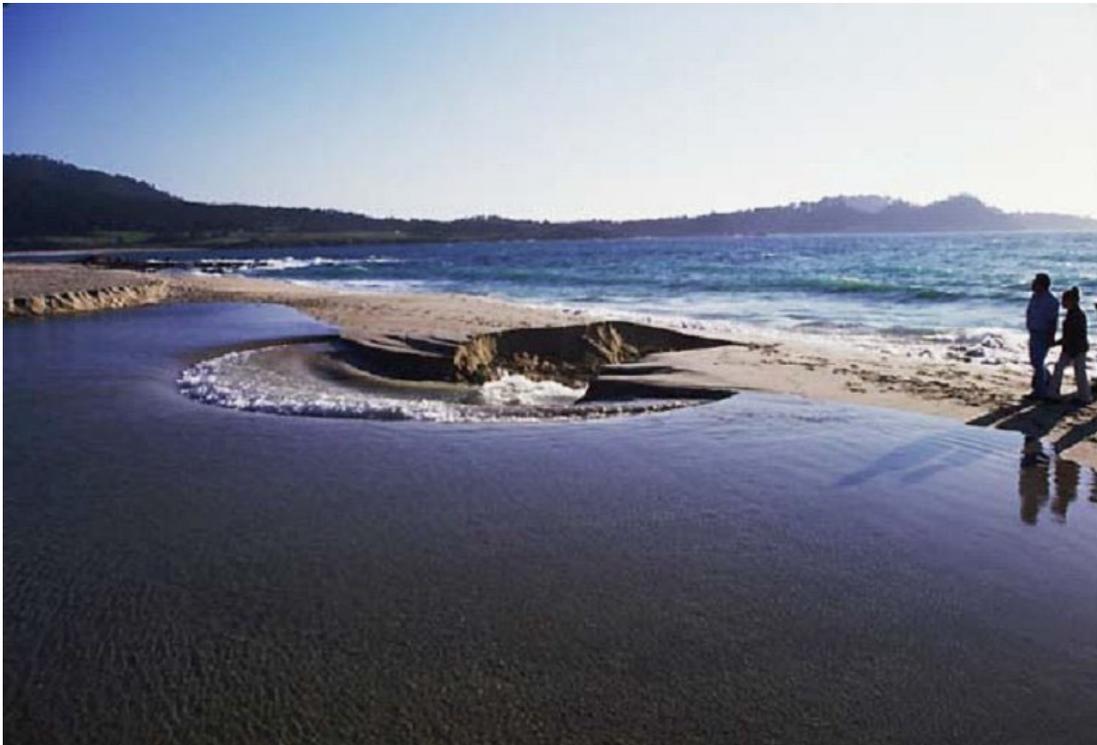
Figure 4.3 A psuedo-natural breach of the Carmel Lagoon on March 15, 2003. Psuedo is used because an earlier artificial breaching had already altered the sandbar. (Photo: Paul Huntington, March 15, 2003).

A series of small storms in mid to late April, as well as early May, kept streamflow in the lower Carmel River and the sandbar open into early June. During this time, the lagoon repeatedly filled and breached itself (Figs 4.3 & 4.5).

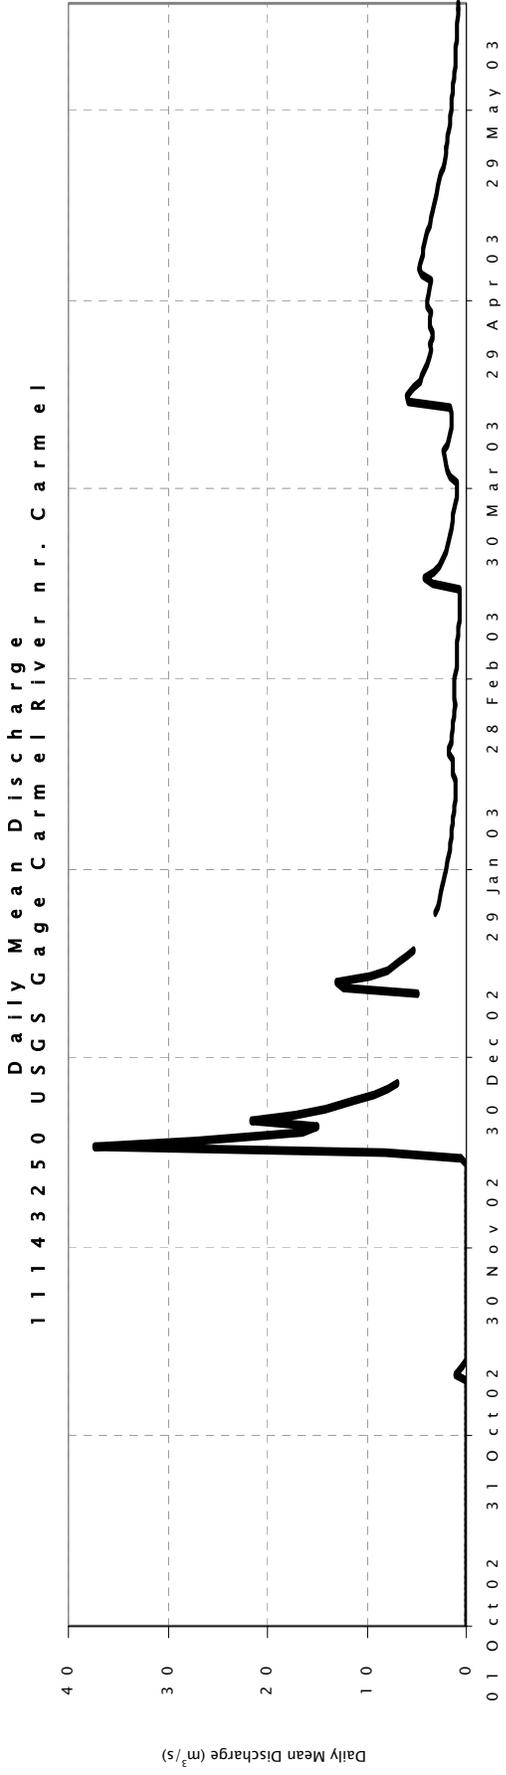
Figure 4.4 Daily mean discharge for the Carmel River USGS station 11143250 nr Carmel at Via Mallorca Road. Note some data are missing.

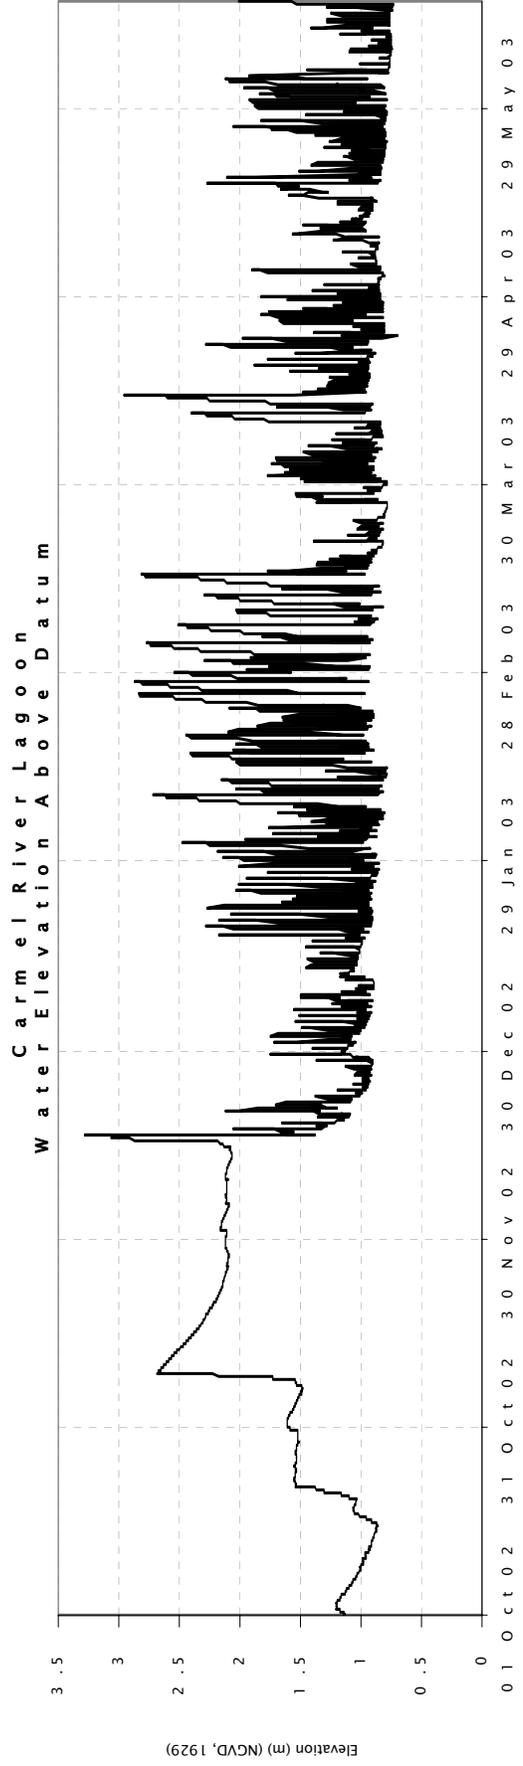
Figure 4.5 Hourly water elevation data for the Carmel Lagoon. Data was collected by the Monterey Peninsula Water Management District.

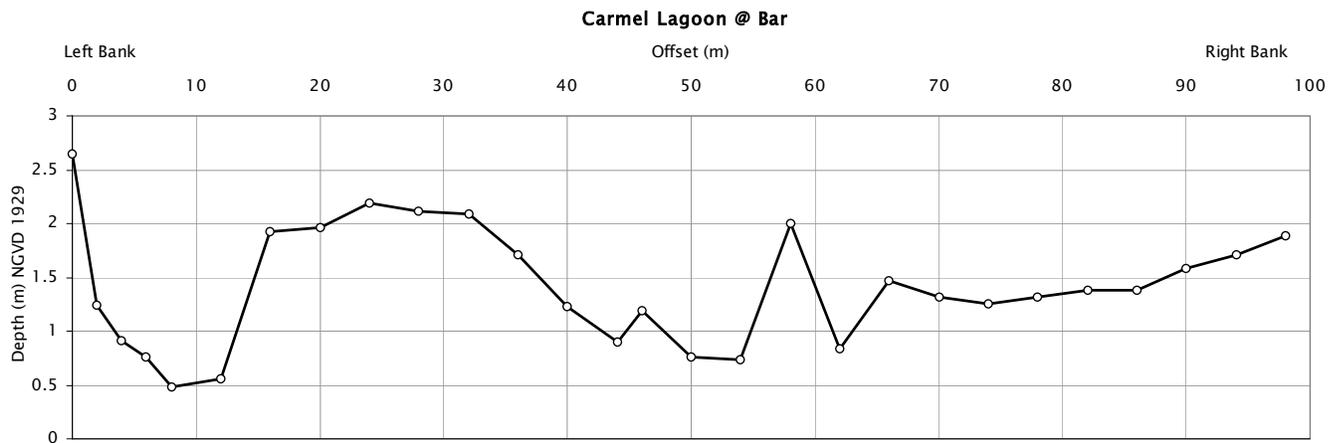
Figure 4.9 This bathymetric transect was taken just inside the bar hours prior to breaching the Carmel Lagoon.

On December 15th, a bathymetric transect was measured inside the sandbar prior to the breach of the Carmel Lagoon (Fig. 4.9). The intention was to measure several more transects in different areas of the lagoons, however strong winds on two different attempts (December 13th and 14th) resulted in unfavorable conditions for measuring water depths in deeper water.

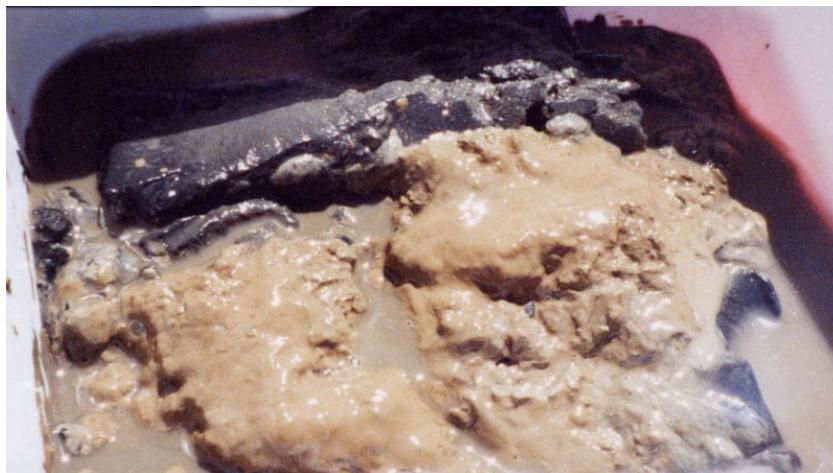
Figure 4.10 Sapropel (black sediments at top) taken from the bottom of the Salinas Lagoon. Samples similar to this one were collected at the bottom of the South Arm of the Carmel Lagoon. Once exposed to oxygen in either air or water, sapropel will turn brown but retain its watery texture (Cole, 1994). The light-brown sediments (bottom) were on the top of the sample and were the first to be exposed to oxygen. (Photo: Joel Casagrande, 06 Jun 02)

prep). It is likely that oxygen concentrations did not improve between June 2002 and December of 2002, therefore creating conditions (long periods of anoxia) likely to form sapropel.

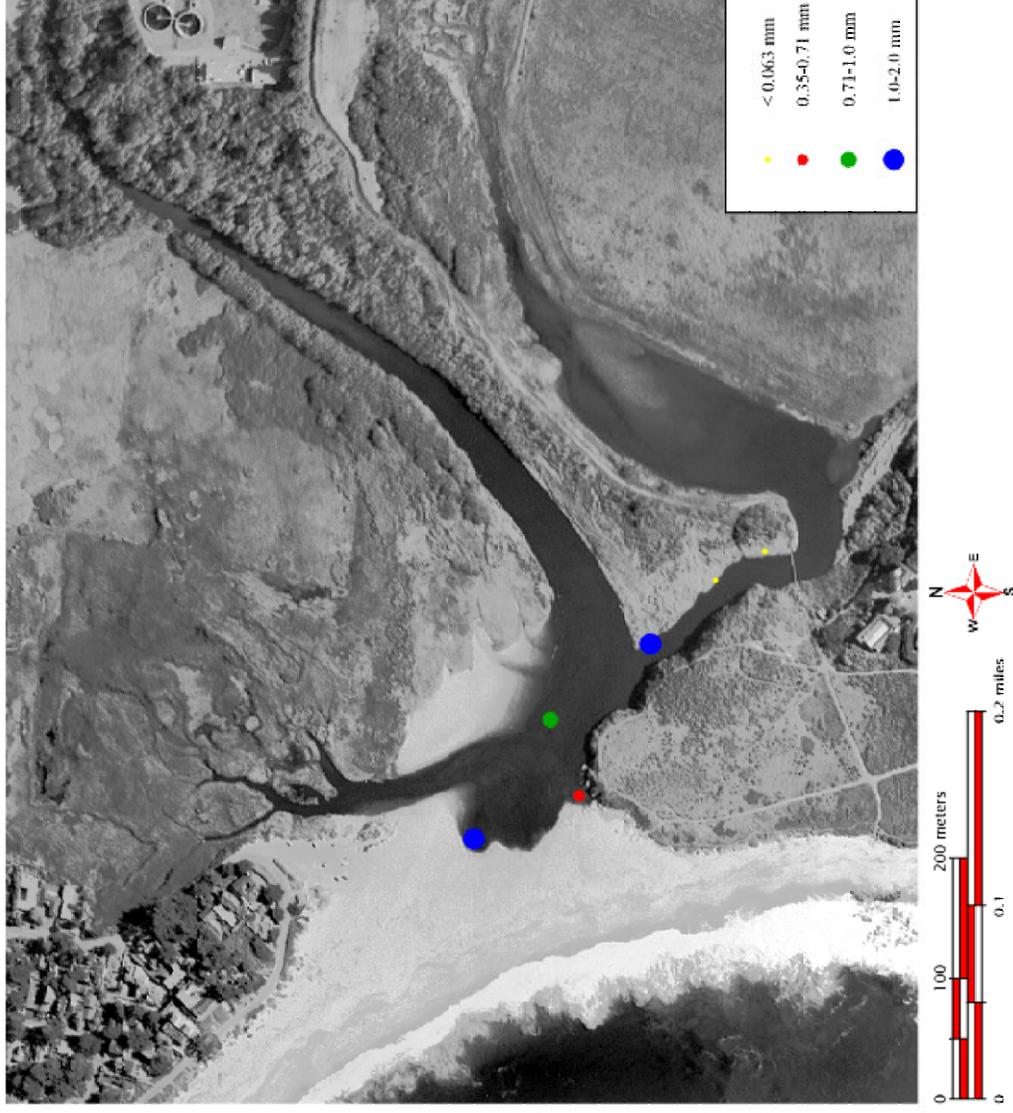
Carmel Lagoon Bottom Sediment d_{50} Pre-breach

Figure 4.11 This map illustrates the benthic sediment d_{50} in the deep portions of the South Arm as well as the main lagoon during pre-breach conditions.
