Report No. WI-2003-14
30th June 2003

The Watershed Institute

Hydrology and Water Quality Of the Carmel and Salinas Lagoons Monterey Bay, California 2002/2003

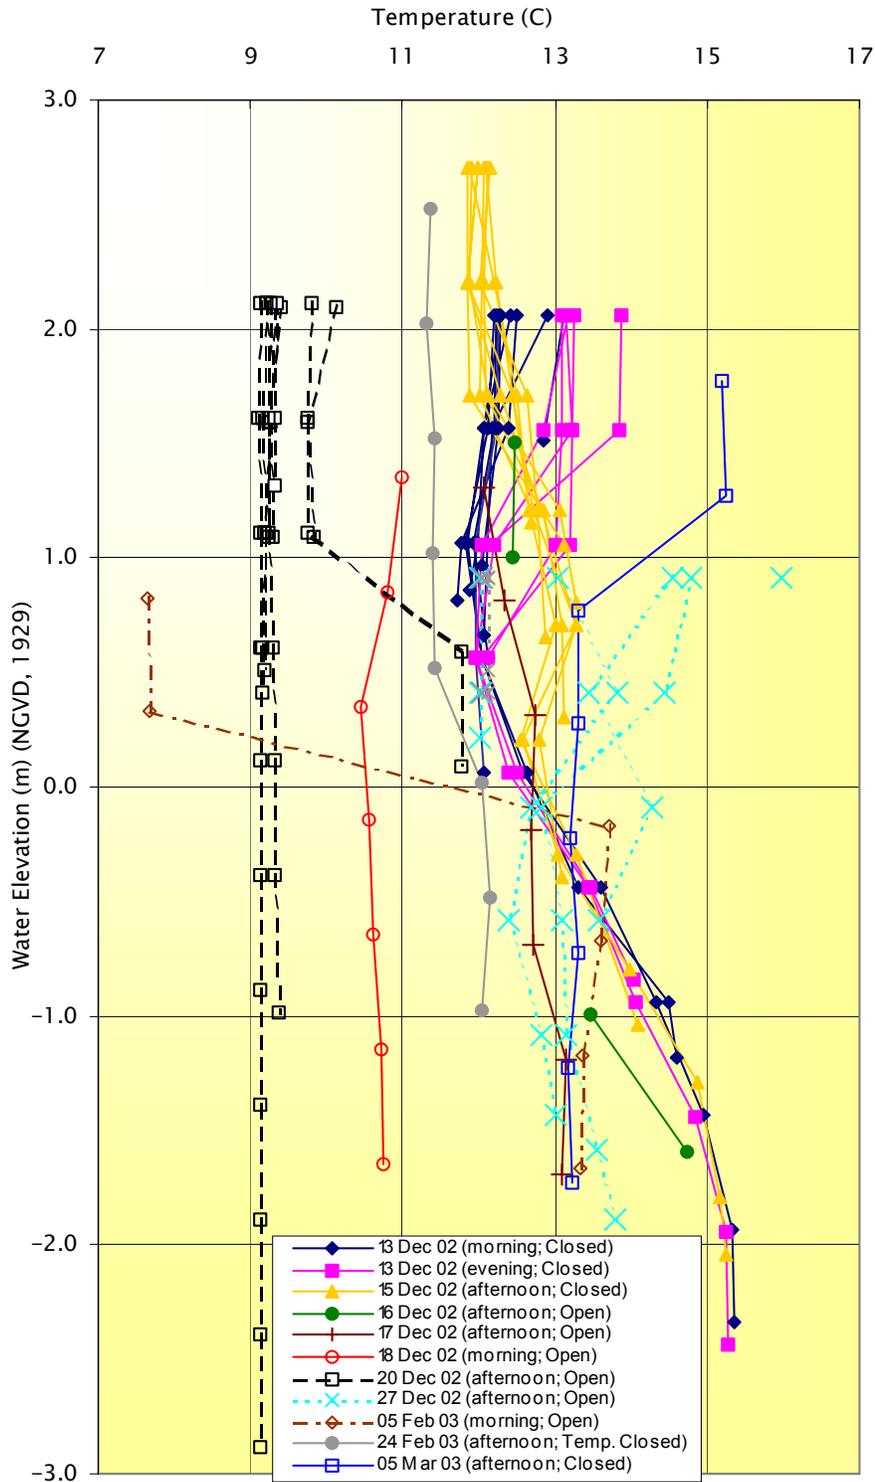
Carmel River Lagoon Temperature Depth Profiles

Figure 4.12 Temperature depth profiles for the Carmel Lagoon.

Afternoon weather conditions were clear and warm with a slight breeze. The previous week had similar weather conditions, which led to an increase in overall temperature readings throughout the water column. The surface layers (0–0.5m) were the warmest followed by a mild thermocline, which then led to isothermal temperatures to depth (Fig. 4.12). A secchi disk reading from the South Arm measured 1.4 m.

This generally uniform temperature profile is typical of the equinoxes, and is a transitional state between the negative clinograde conditions of winter and the positive clinograde conditions of summer.

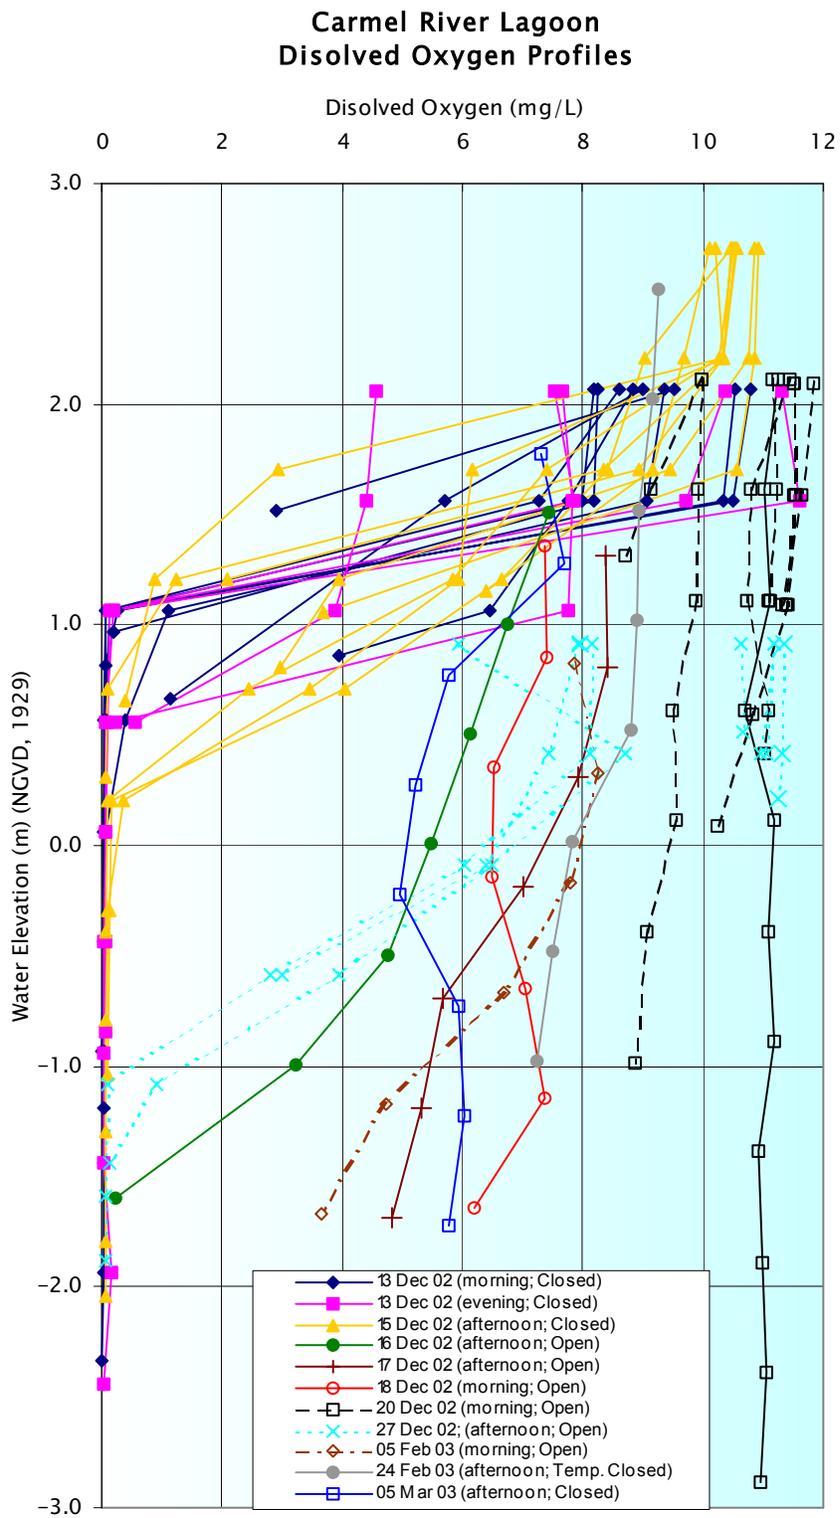
Figure 4.13 Dissolved oxygen depth profiles taken at the Carmel Lagoon

Afternoon readings of dissolved oxygen in the South Arm had slightly increased at all depths (Fig. 4.13) from measurement taken on the 5th of February, but especially at the surface and bottom layers. In the days prior to this monitoring, the weather was clear, warm and slightly breezy in the afternoon. These conditions could have increased algal and plant production, thus increasing the amount of oxygen in the water column. This is supported by the very high secchi depth readings of 2.45 m.

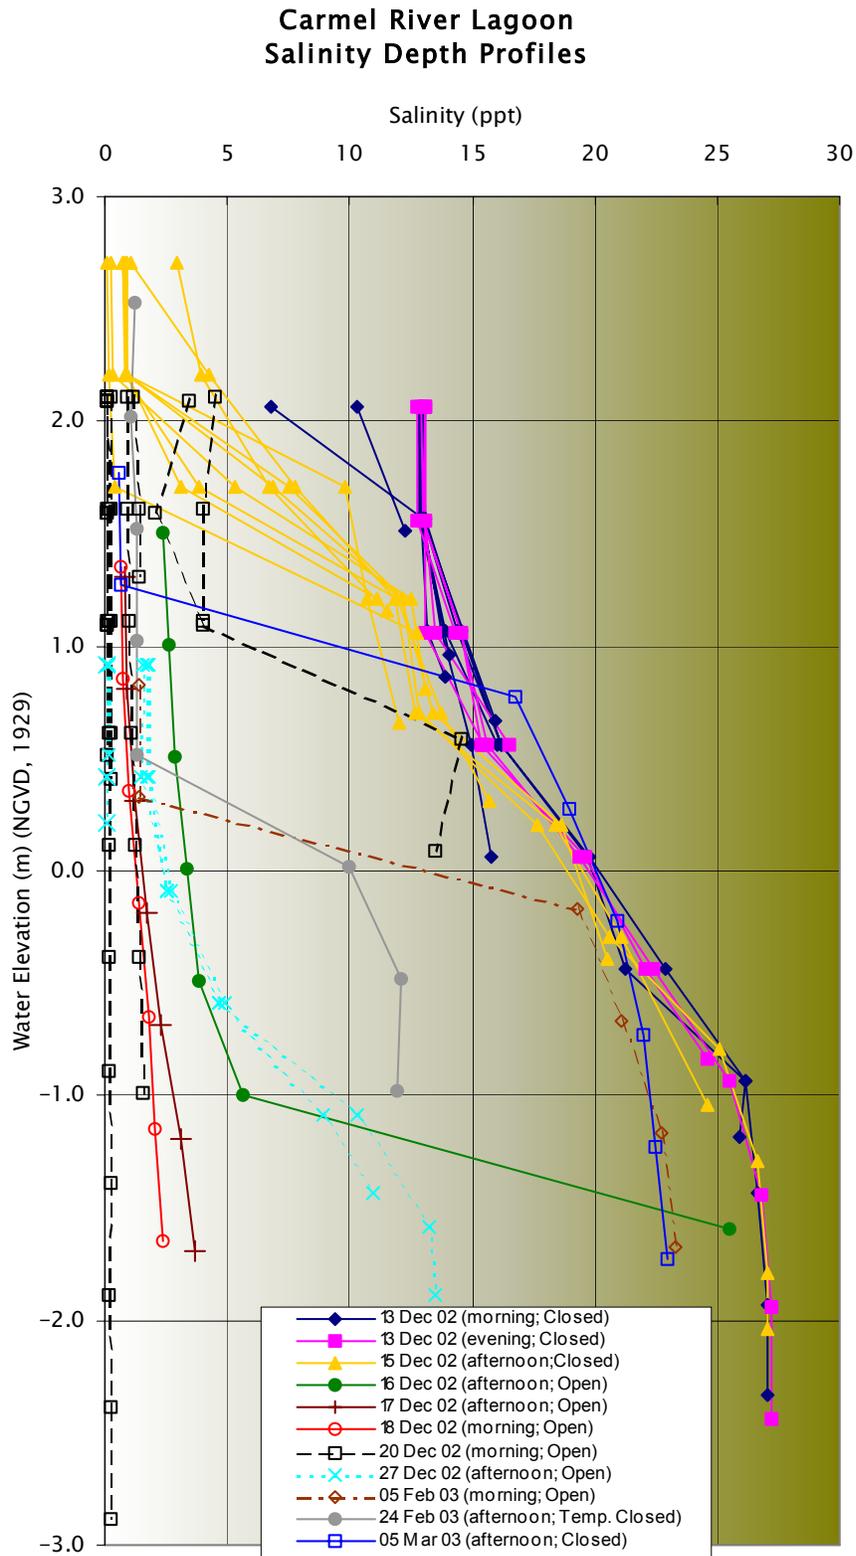
Figure 4.14 Salinity depth profiles taken in the Carmel Lagoon.

Surface waters were brackish with gradually increasing salt concentrations down to 3-meters (Fig. 4.14). Below the 3-meter depth, concentrations remained between 26 and 27 ppt down to the bottom. No wave overwash was observed during either the morning or evening monitoring events, but the presence of fresh bull kelp in the lagoon indicated that recent ocean overwash had occurred.

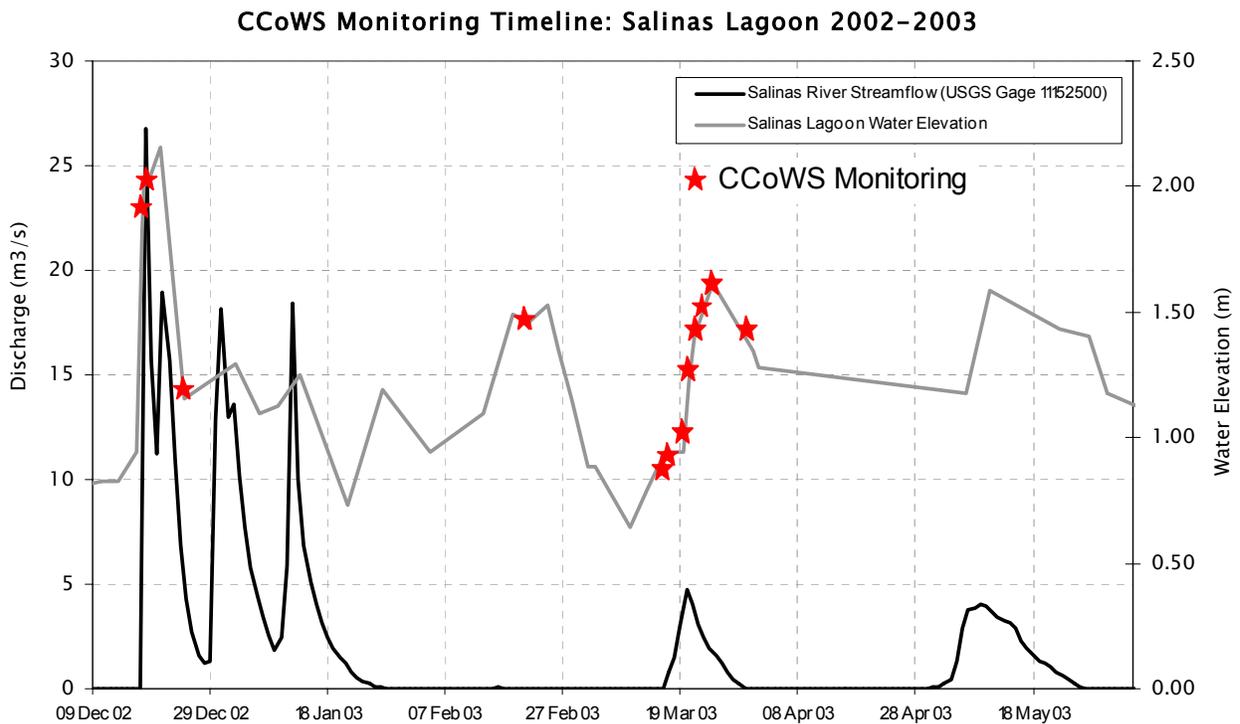
**Figure 5.1** Monitoring timeline for the Salinas Lagoon with respect to lagoon water elevation and streamflow in the Salinas River.

Pre-breach water quality monitoring in the Salinas Lagoon began on the morning of the December 17, 2002 (Table 5.1 & Fig. 5.1). In the days prior to this monitoring, significant wave overwash was observed entering the lagoon and raised the lagoon water elevation to 2.02 m (6.63 ft.).

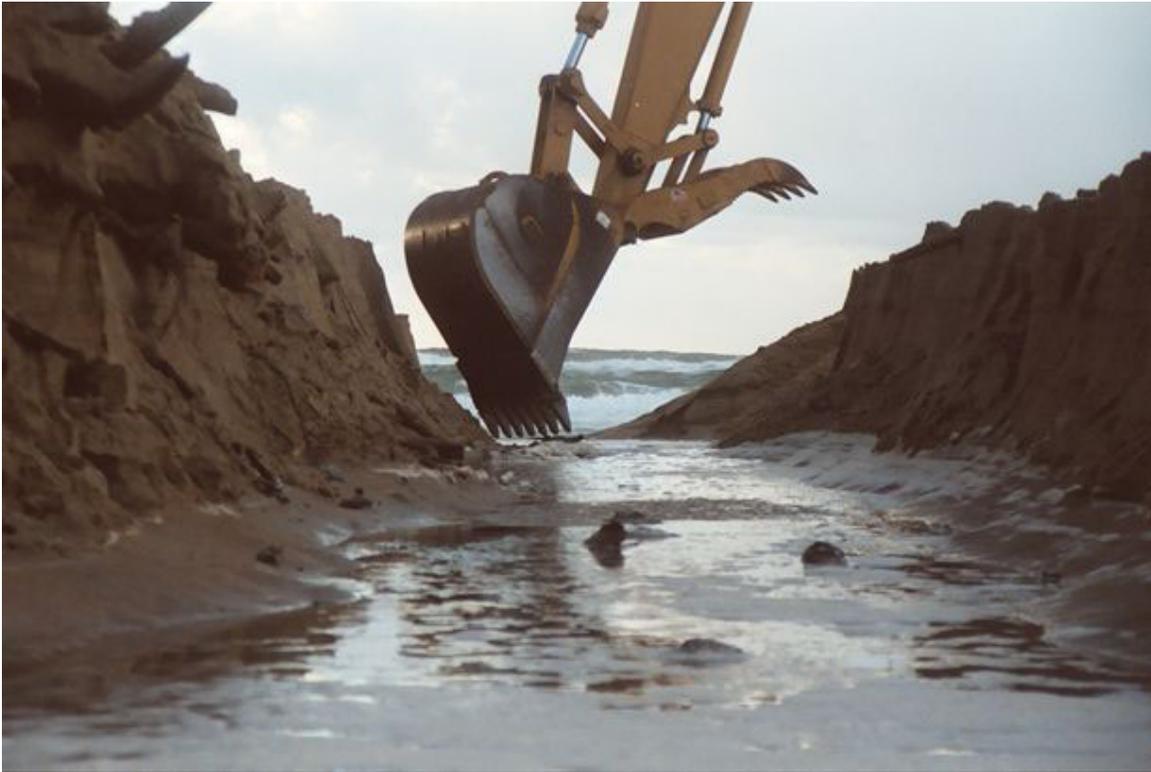
Figure 5.2 Excavation of the breach corridor at the Salinas Lagoon 17th December 2002.
Photo: Fred Watson 17 Dec. 02

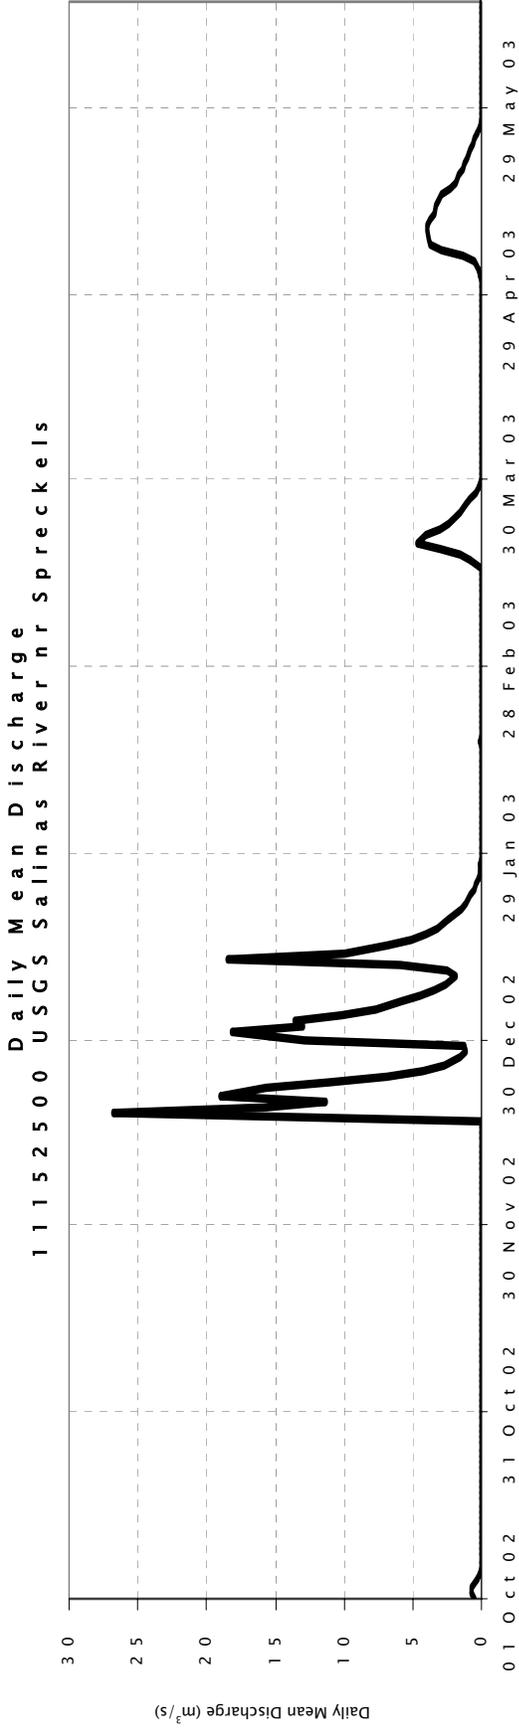
Figure 5.3 Daily mean discharge for the Salinas River USGS station 11152500 near Spreckels.

Weather prior to this sampling event had been cold, windy, overcast and rainy at times. Daily mean streamflow had decreased to 7.3 m³/s (258 cfs) (Fig. 5.3). In general, the lagoon showed signs of increasing river influence, with freshening, cooling conditions.

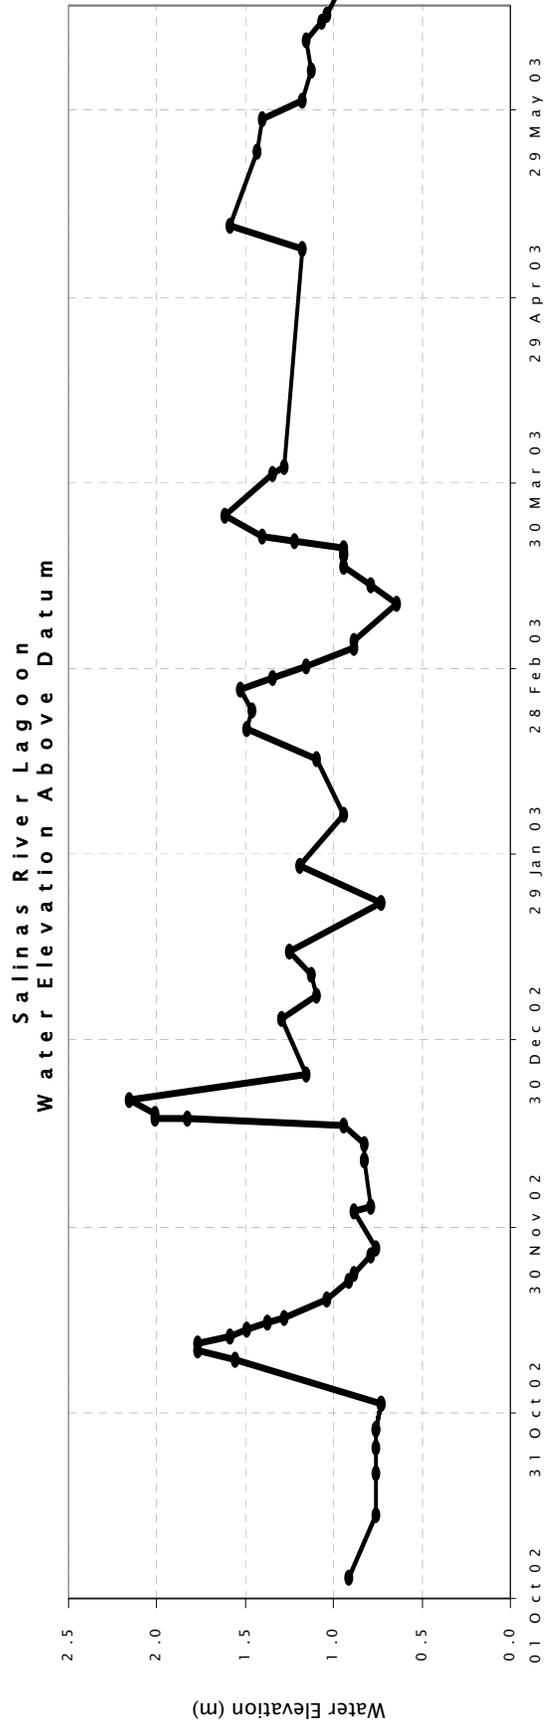
Figure 5.4 Salinas Lagoon water elevation. Data was collected by the Monterey County Water Resources Agency and COWS.

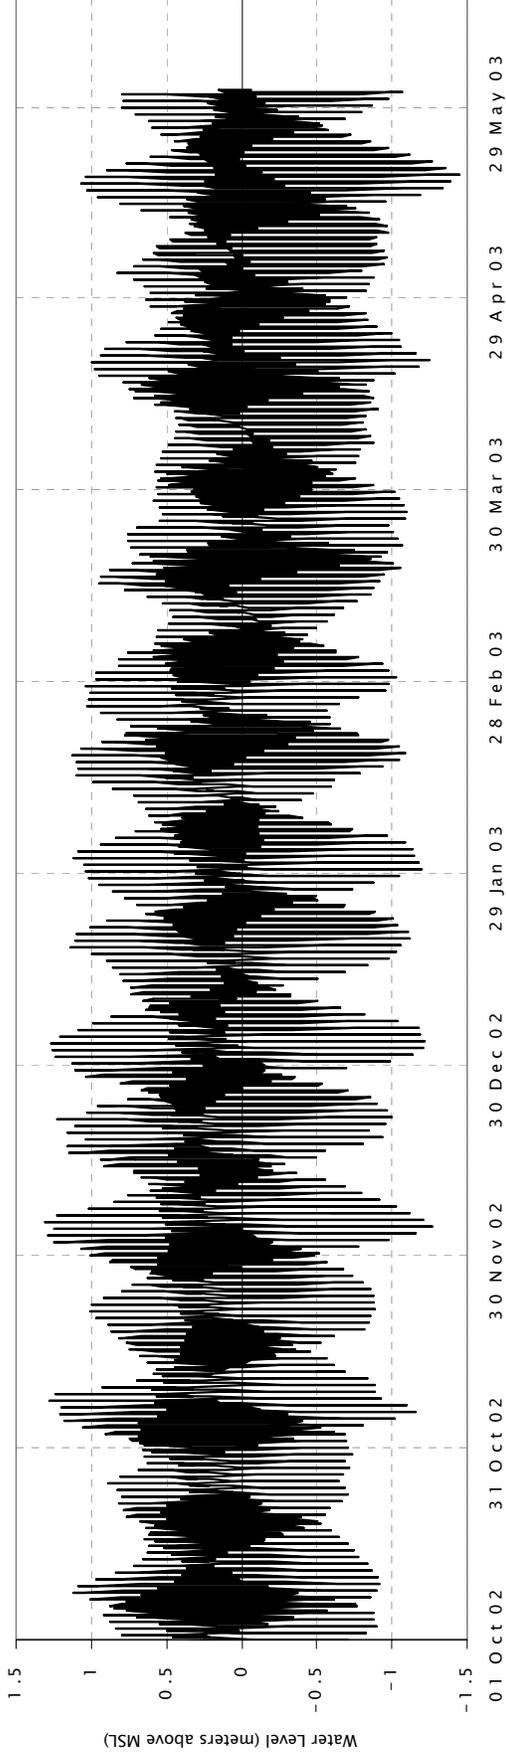
Figure 5.5 Hourly tide levels for Monterey Bay. Data source: NOAA. Verified data not available after May 31st.

In mid-November, large ocean swells caused significant wave overwash, which increased the lagoon water elevation to 1.77 m (5.8 ft). Peak tides were recorded between November 9th–12th and in early December (Fig. 5.5) and peak wave heights were recorded between the 9th–12th of November (Fig. 5.6).

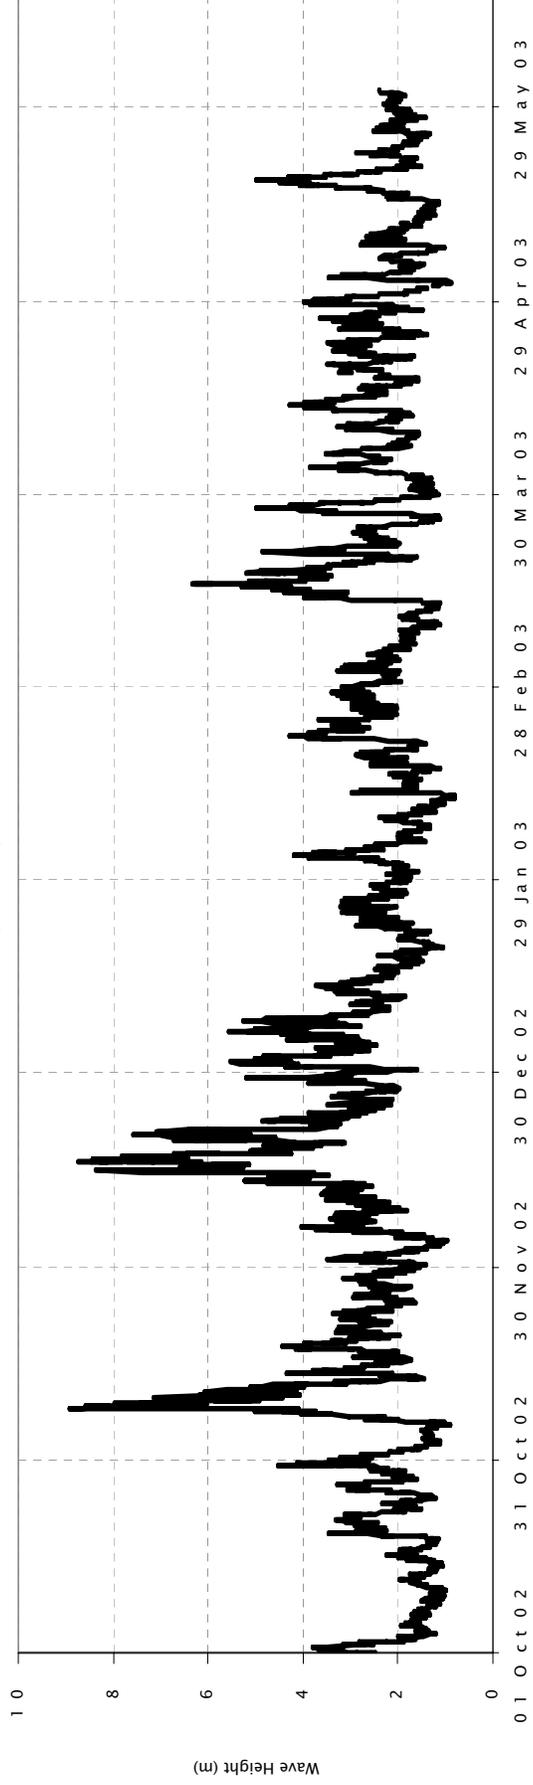
Figure 5.6 Hourly significant wave height for Monterey Bay. Data source: NOAA. Verified data not available after May 31st.

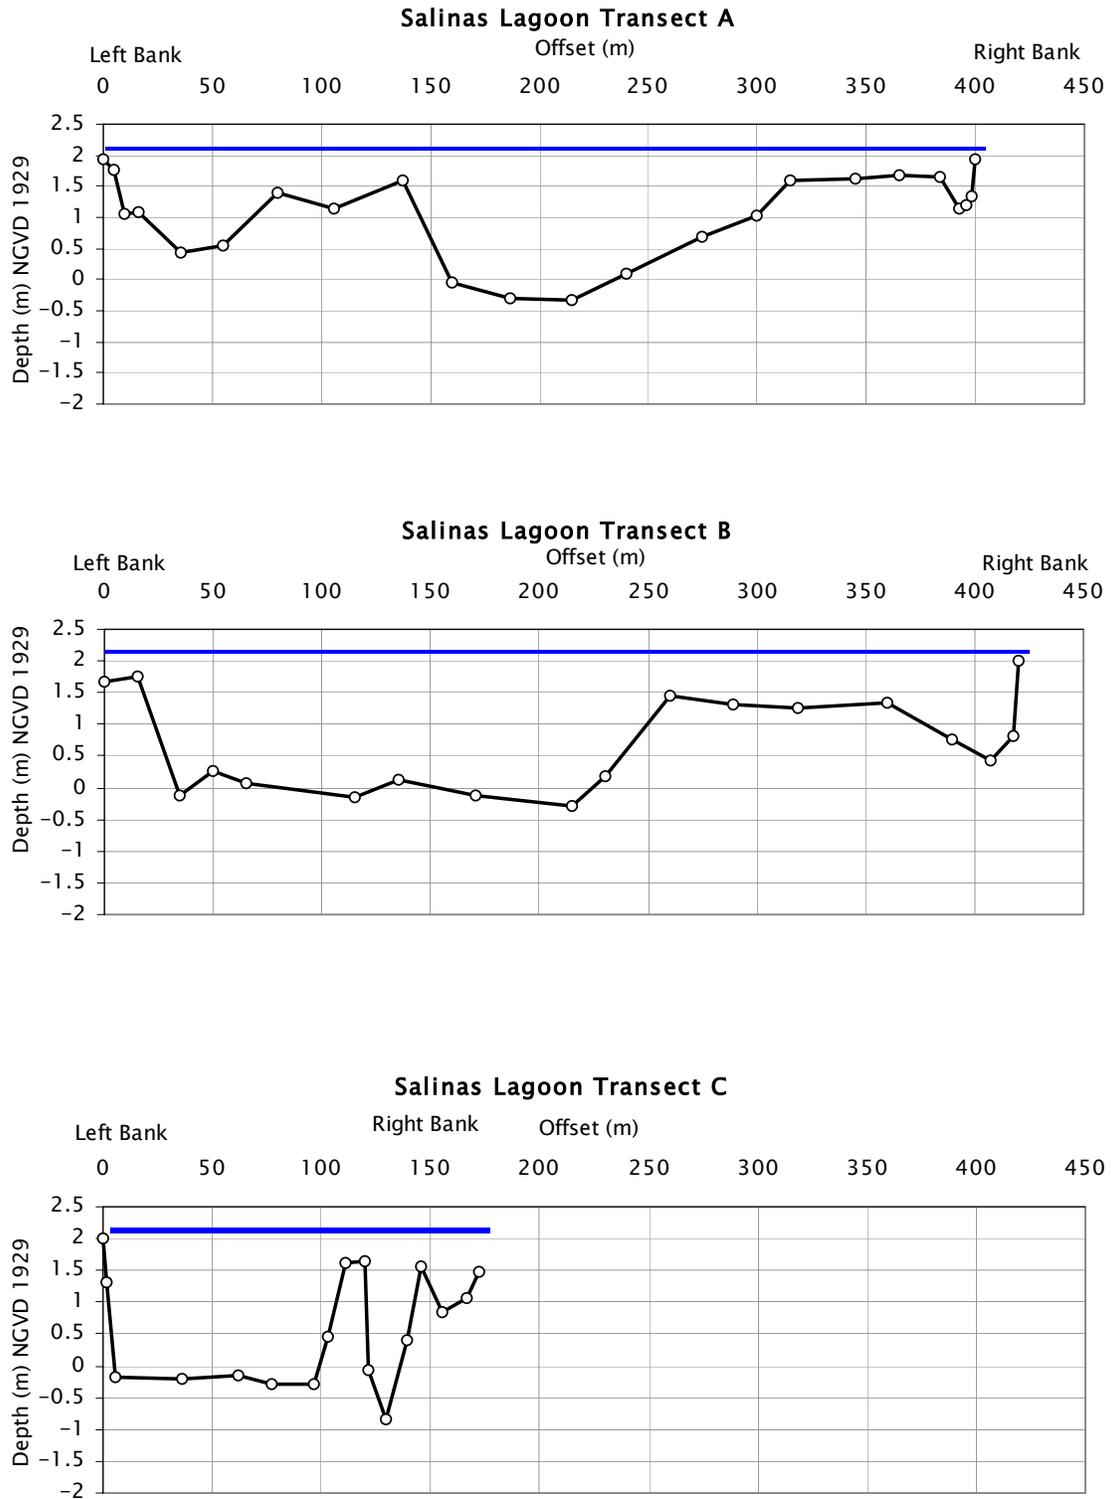
Figure 5.8 Channel cross sections for the Salinas Lagoon measured on December 17th 2002. This year's high water mark is represented with a blue horizontal line on each cross section.

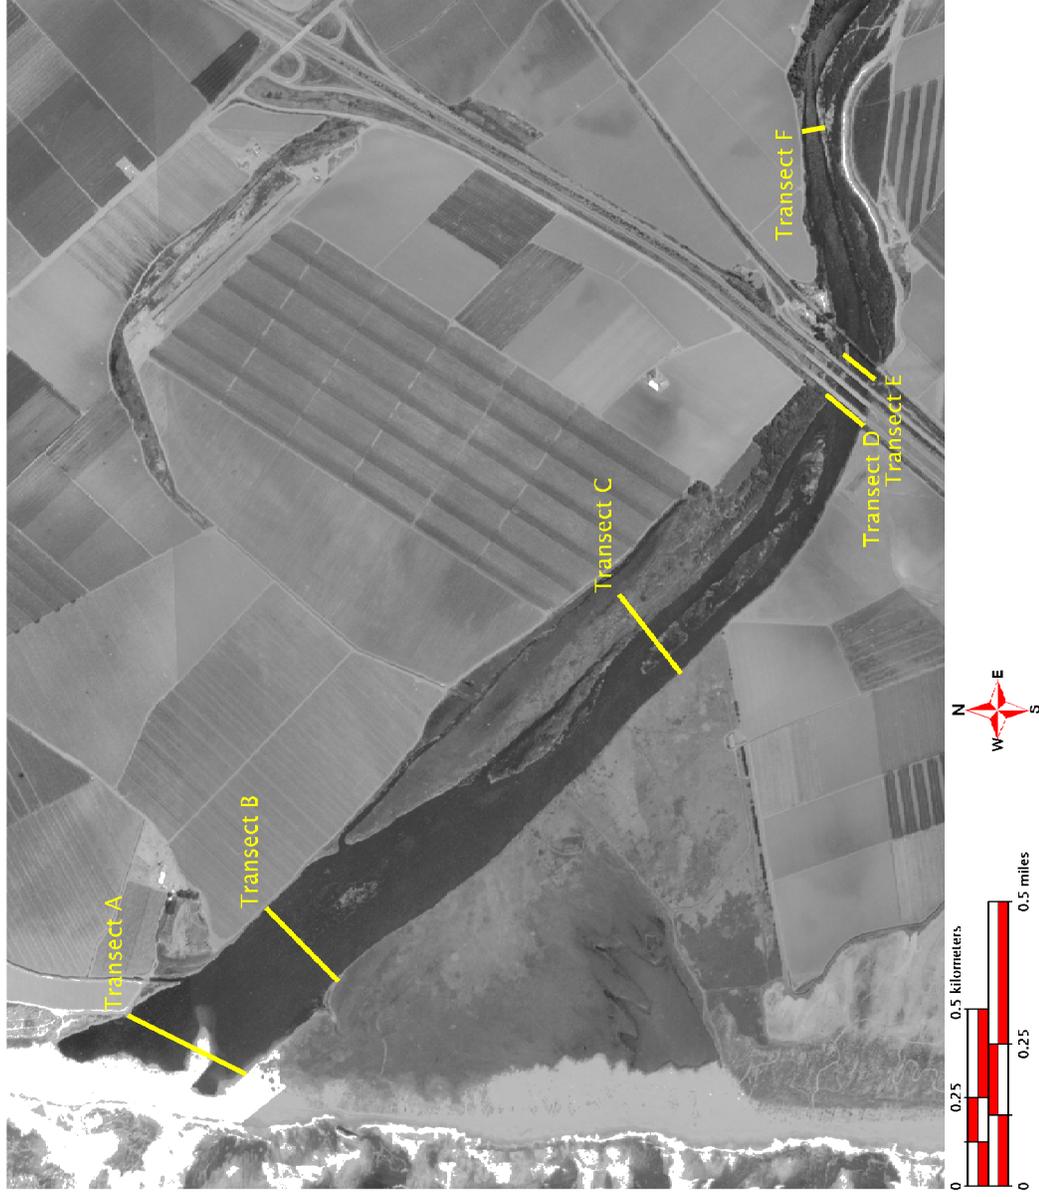
Figure 5.9 Bathymetric transect locations for the Salinas Lagoon.

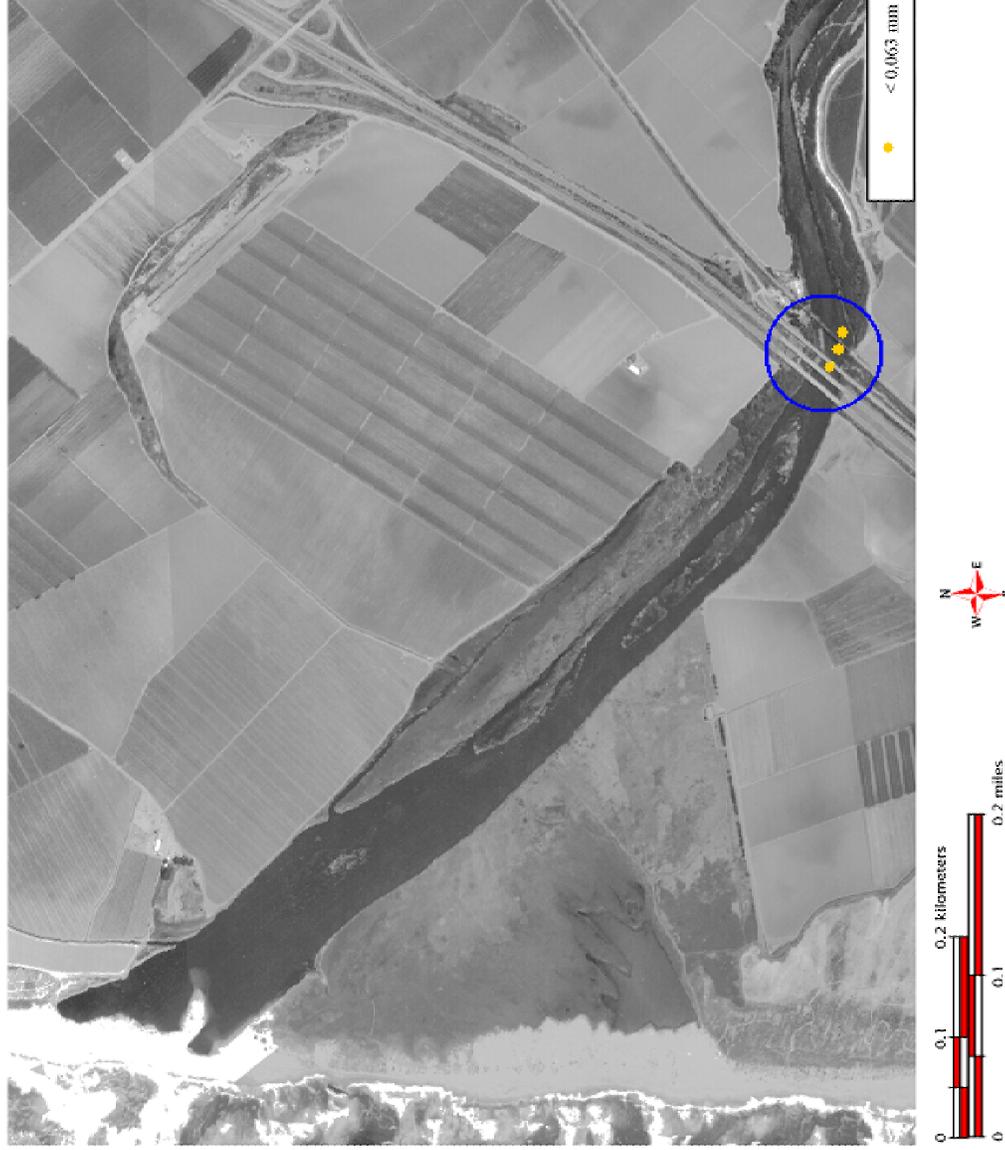
Figure 5.1.1 This map illustrates the bottom sediment d_{50} for deep sump in the Salinas Lagoon during pre-breach conditions. The blue circle shown at the lower end of the figure highlights the locations of three bottom sediment samples collected.

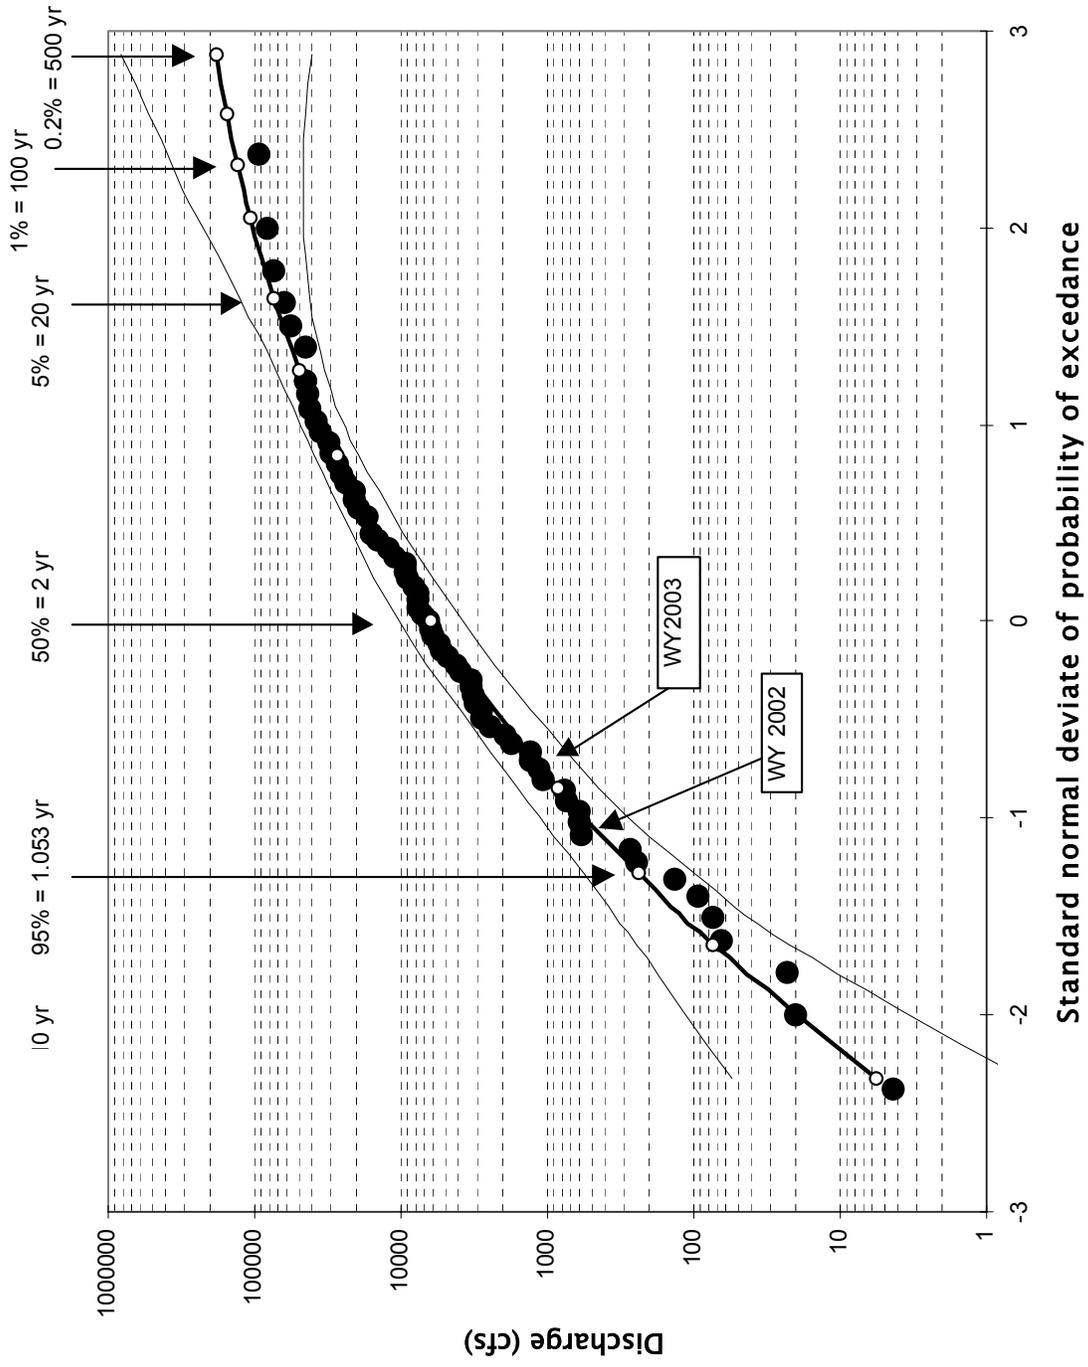
Figure 5.12 Annual peak flood frequency for the Salinas River at Spreckels.

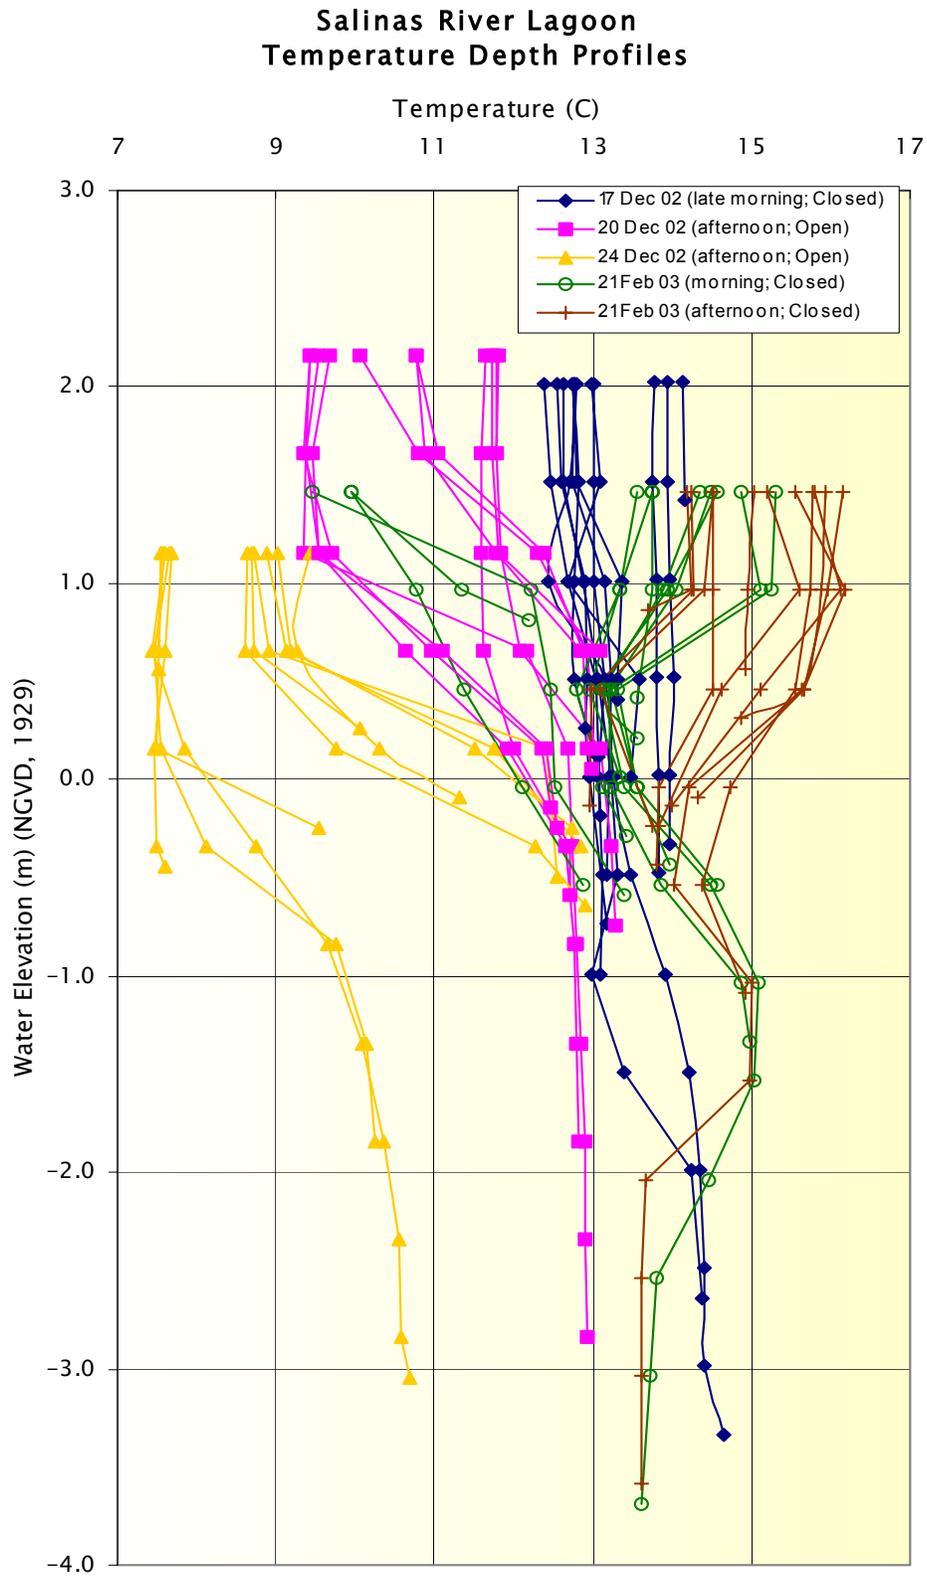
Figure 5.13 Temperature depth profiles from the Salinas Lagoon for all monitoring sessions.

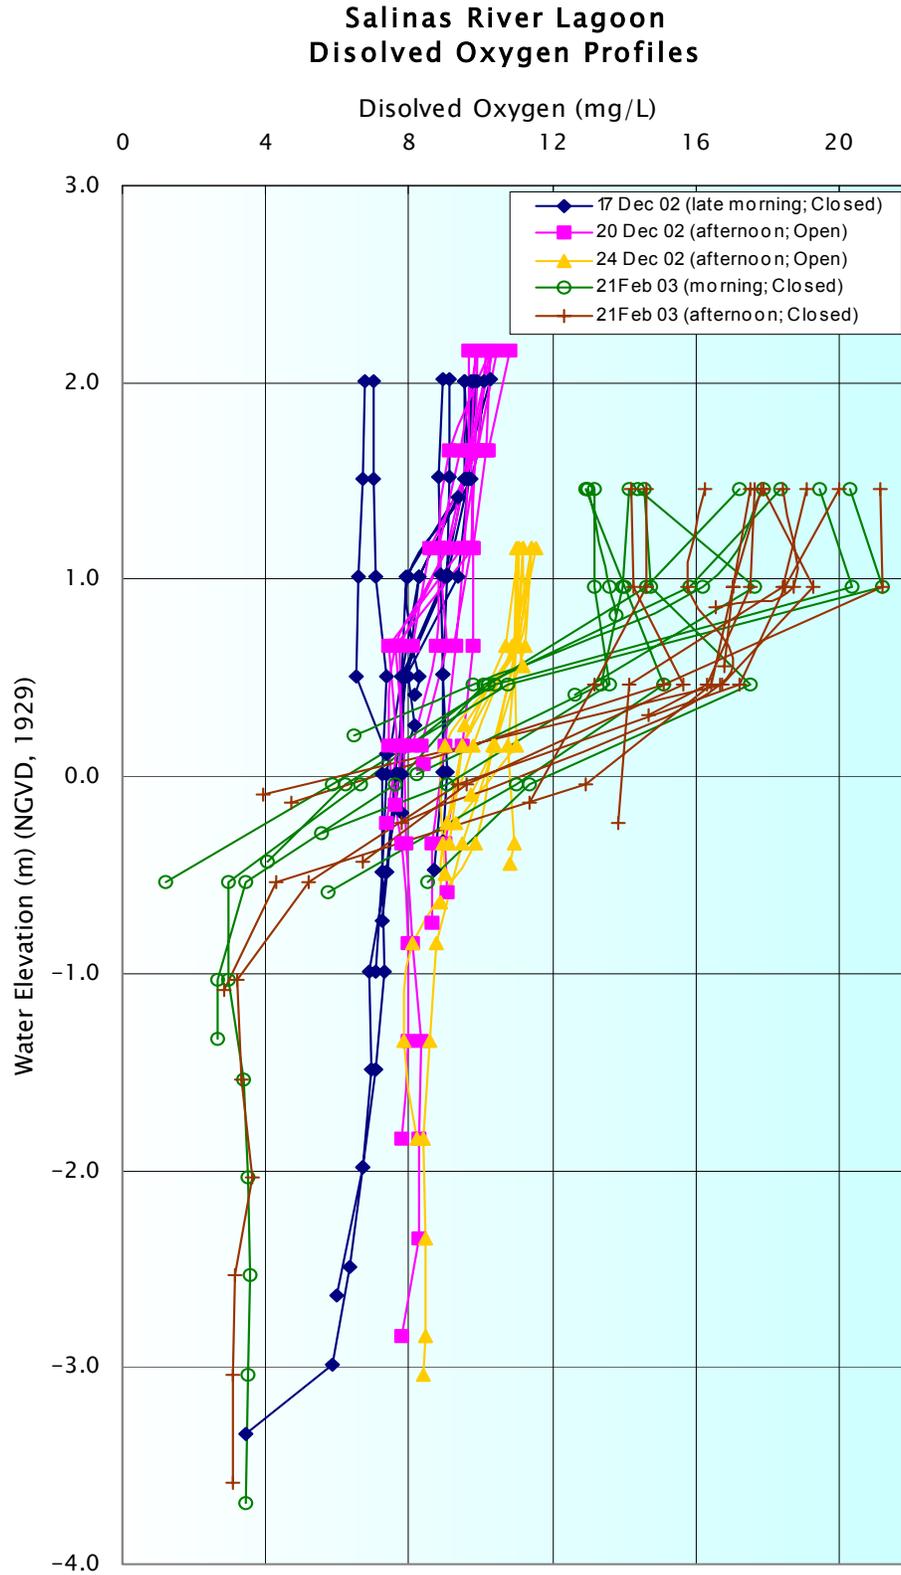
Figure 5.14 Dissolved oxygen depth profiles from the Salinas Lagoon for all monitoring sessions.

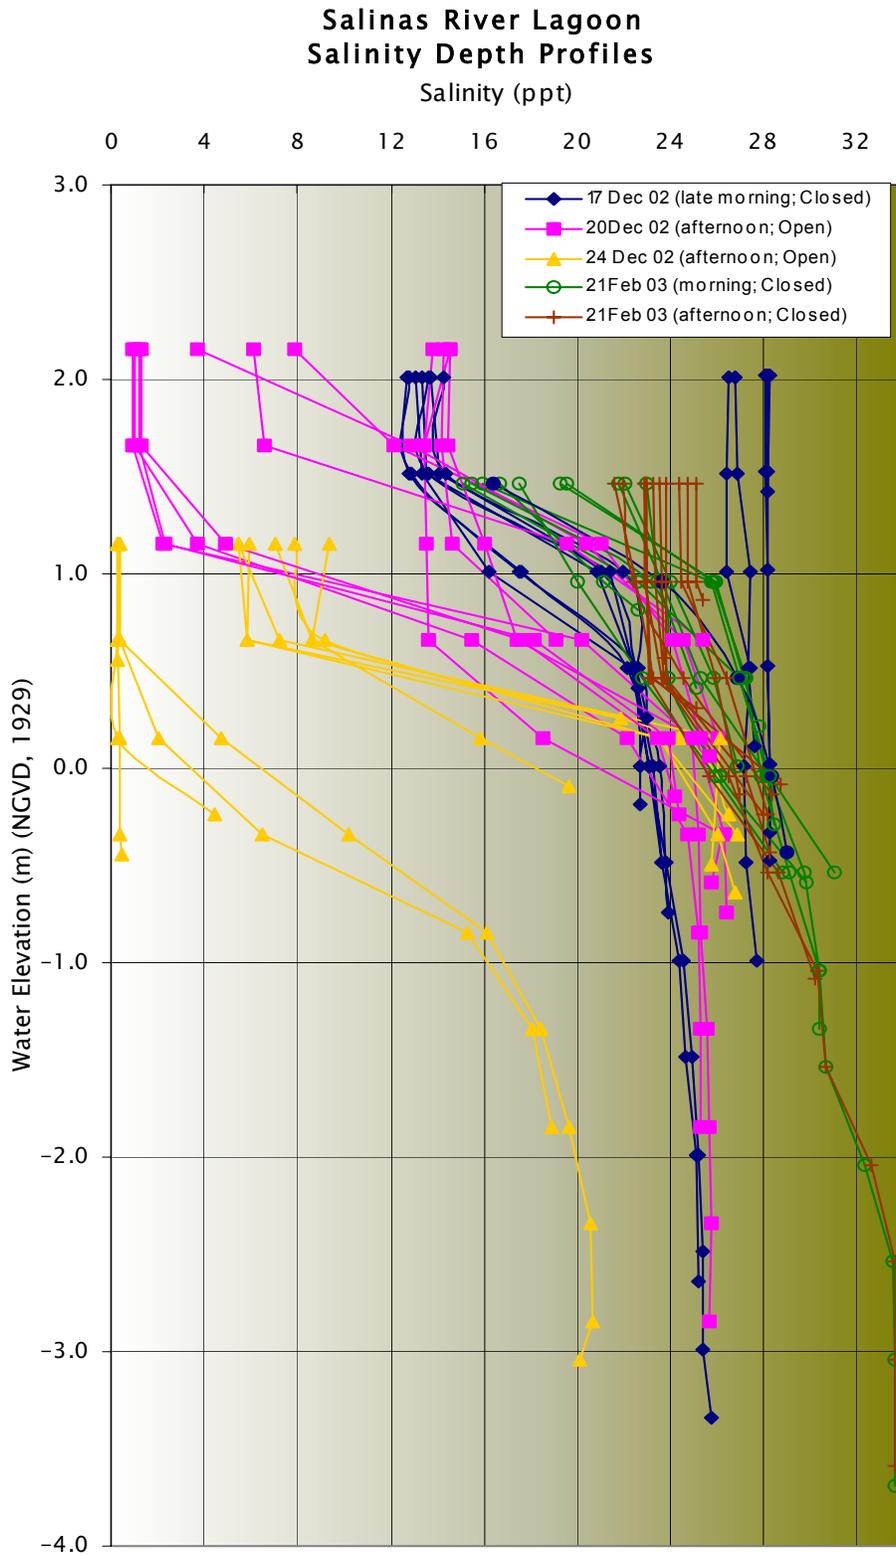
Figure 5.15 Salinity depth profiles from the Salinas Lagoon for all monitoring sessions.

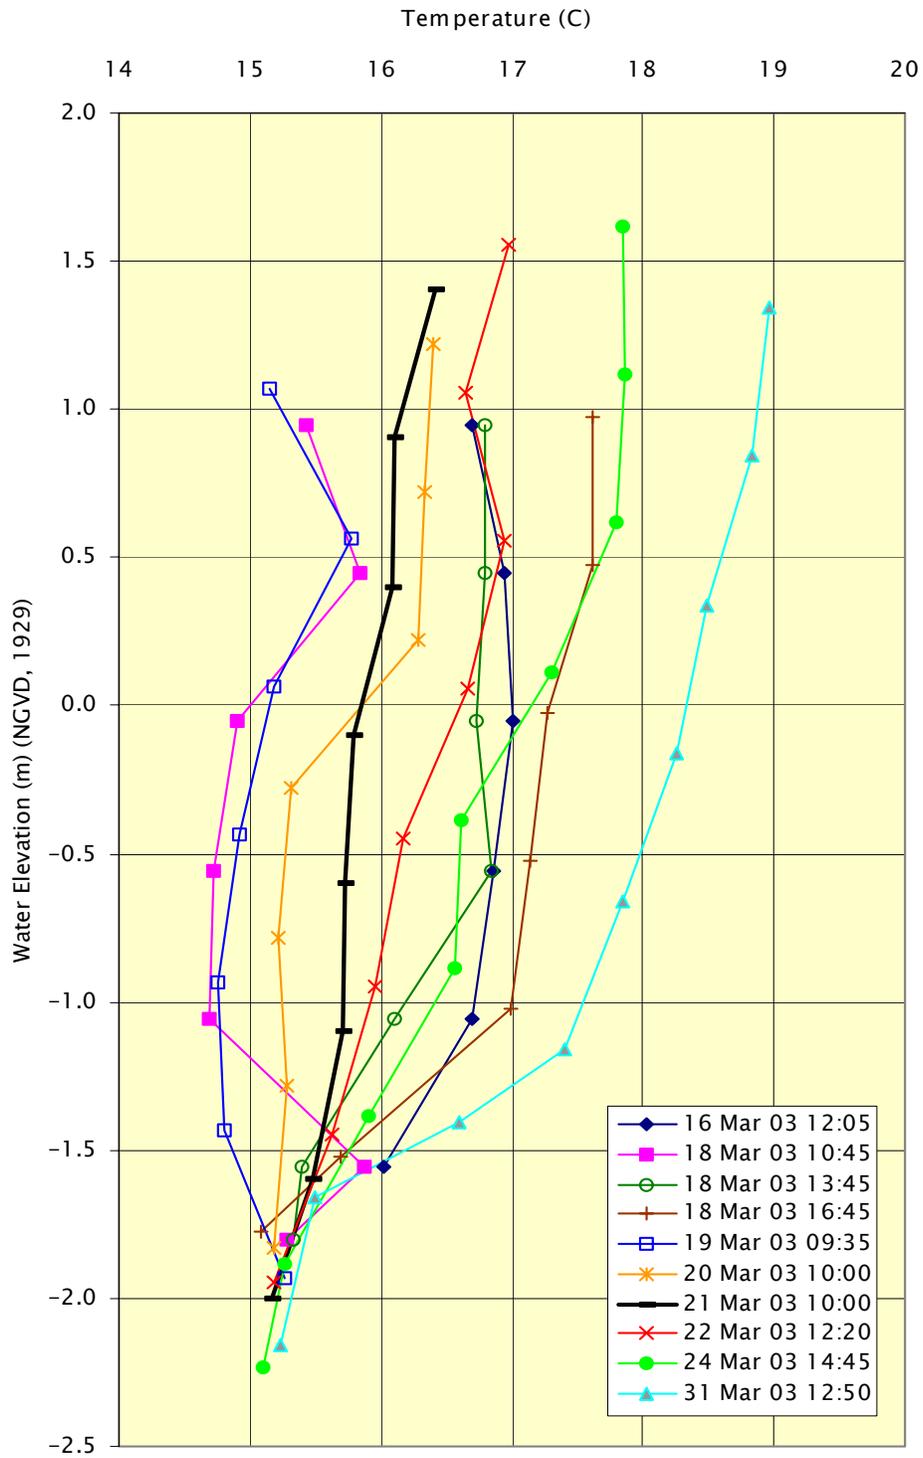
Figure 5.16 Temperature profiles collected during the rising hydrograph following the mid March rain event.

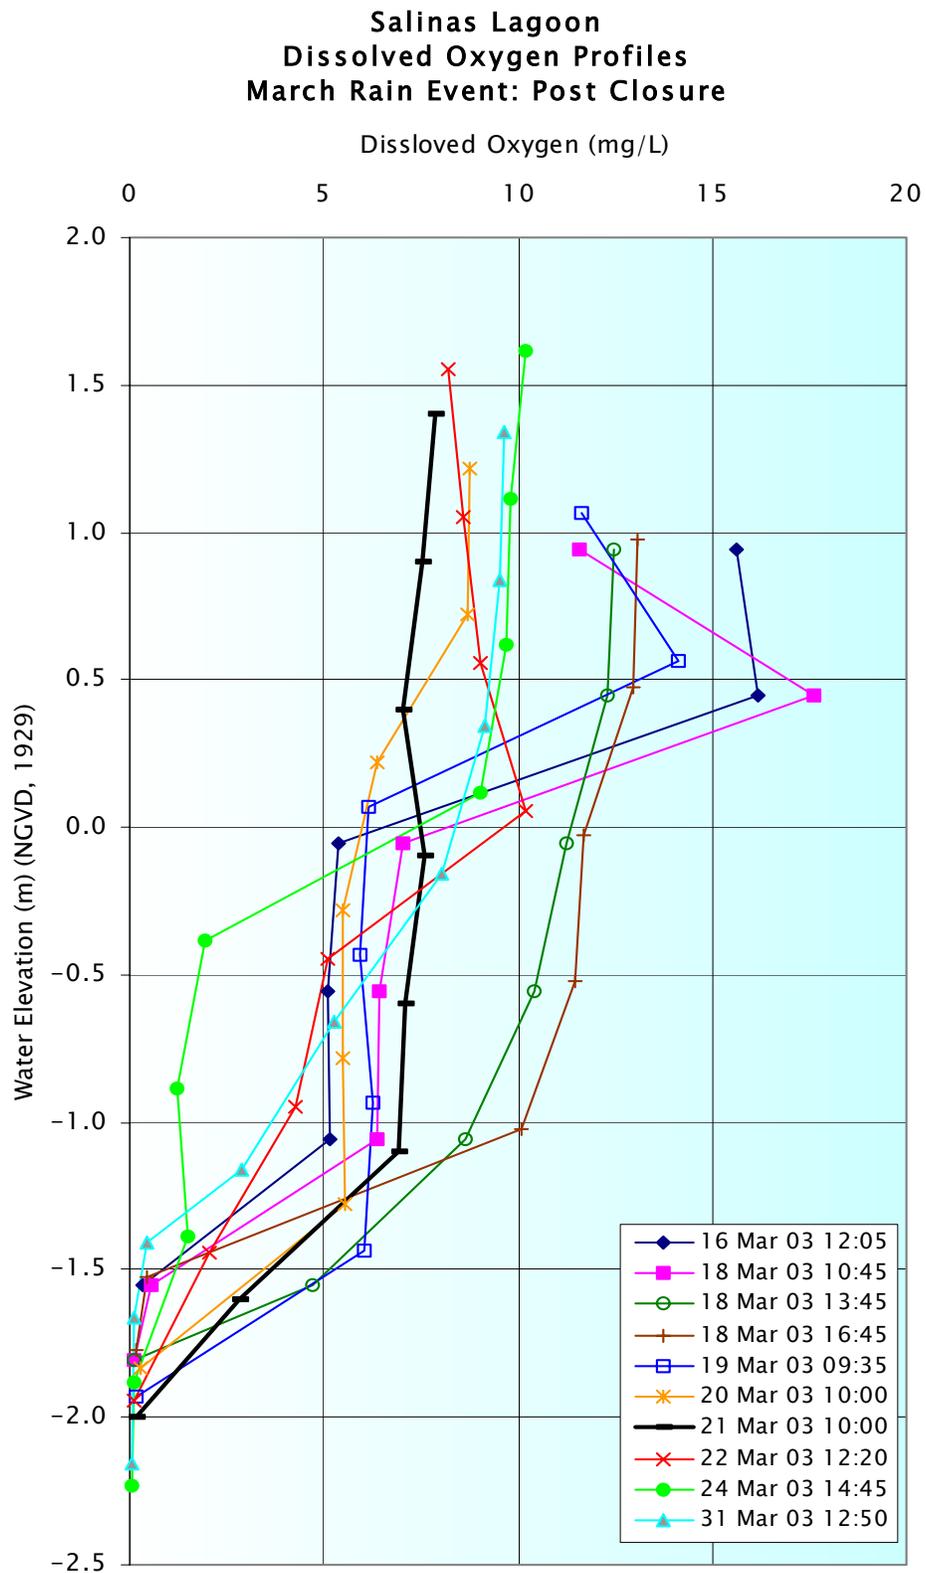
Figure 5.17 Dissolved oxygen profiles collected during the rising hydrograph following the mid March rain event.
